The Motor Claims Department  
MS FIRST CAPITAL INSURANCE LTD

**INITIAL INSPECTION REPORT OF VEHICLE NO. SKX 6738J**

| Affiliated to Federation Internationale Des Experts En Automobile | | | |
|--|---|---|---|
| MS FIRST CAPITAL INSURANCE LTD | | Ref : CS/FCI18012502/Dvbn2 | |

### ADJUSTMENT ON REPAIR COST FOR VEHICLE NO. SKX 6738J

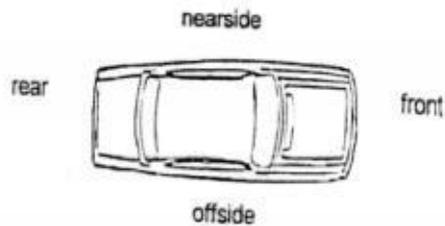
Description of Damage:

The vehicle sustained damages at the rear portion

Comments/Present Status:  
Damages Consistent
