Your Ref: Honda Engine
Our Ref : CI/TP18012598/D

M/s Mega Car Pte Ltd
160 Sin Ming Drive #05-21
Sin Ming Autocity
Singapore 575722

INSPECTION REPORT OF A HONDA ENGINE

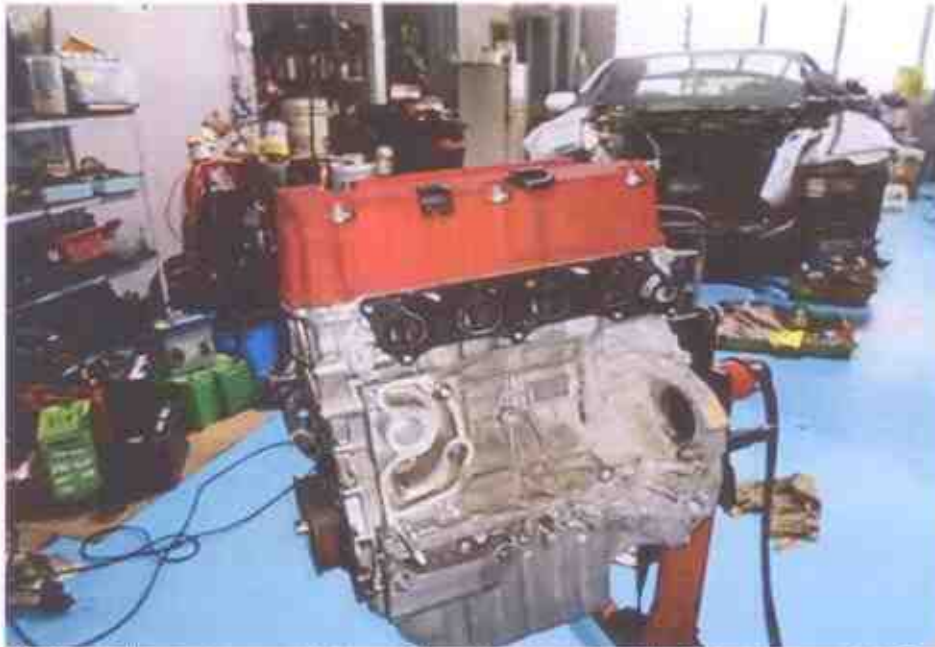
Photo 1 shows a general view of the Honda engine that I had inspected. The Honda engine was observed to be a used engine and was not fitted on any motor car. It was also observed to be a complete assembly with all mechanical parts still intact, within the engine housing.

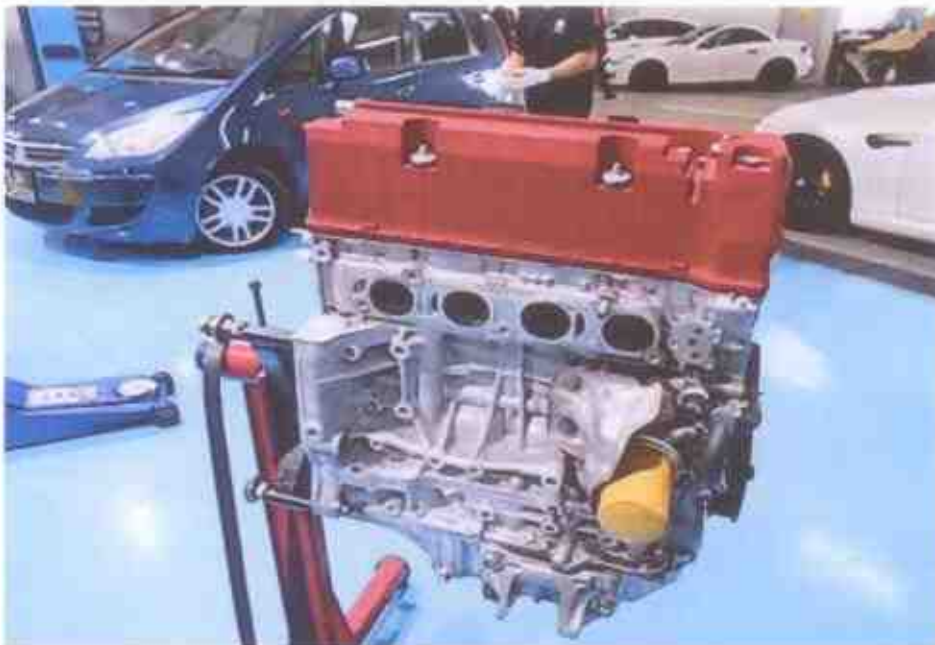
Photo 2 shows a general view of the Honda engine that I had inspected. The Honda engine was not fitted on any motor car. It was observed to be a complete assembly with all mechanical parts still intact, within the engine housing.

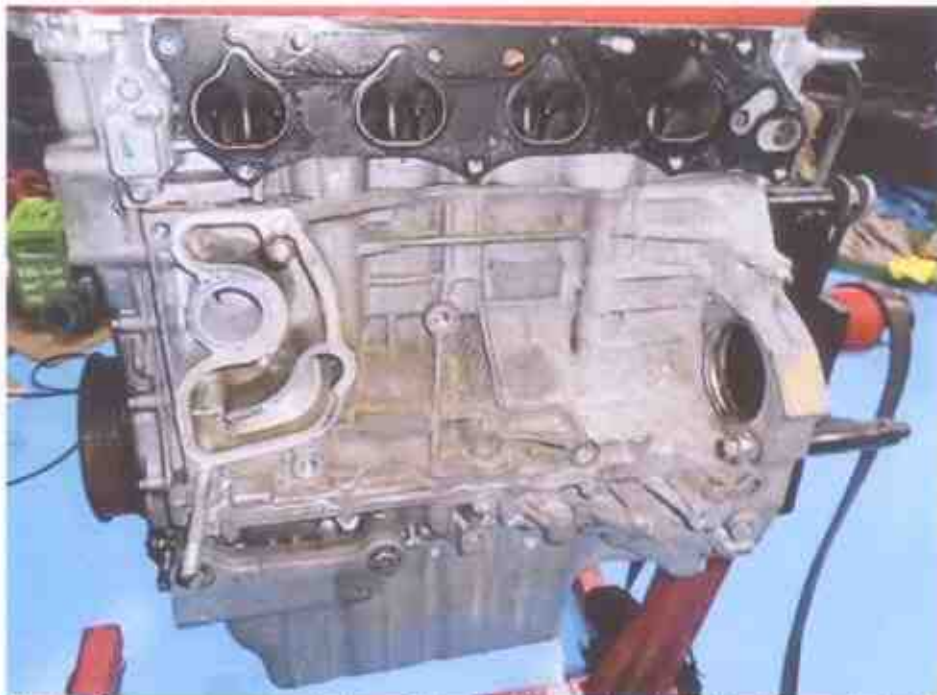
Photo 3 shows a general view of the Honda engine that I had inspected. My visual examination of the engine housing revealed the housing to be of serviceable/satisfactory condition. There was no crack and/or hole observed on the engine housing.

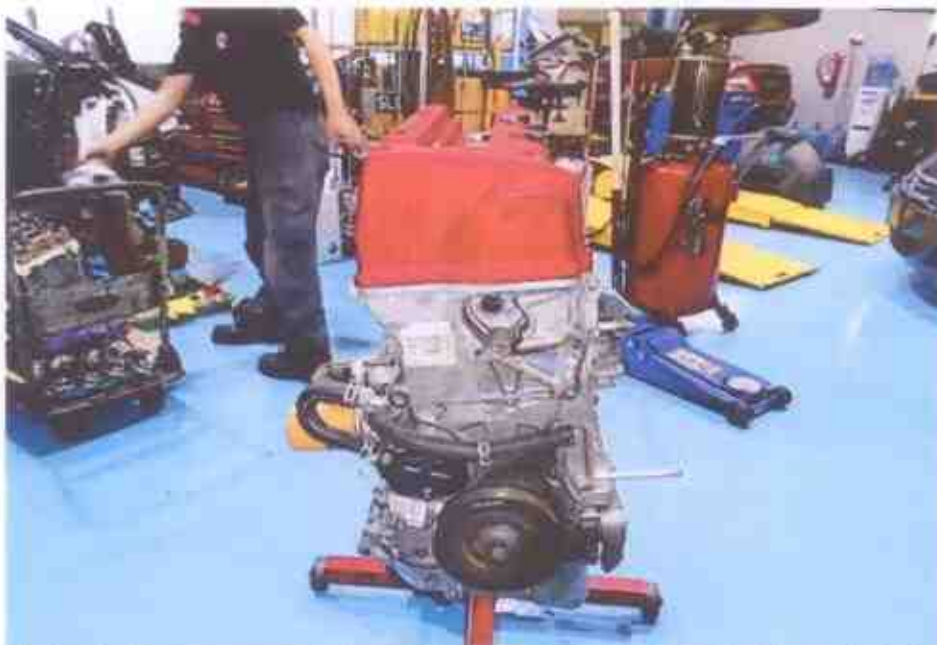
Photo 4 shows a general view of the Honda engine that I had inspected. My visual examination of the engine housing revealed the housing to be of serviceable/satisfactory condition. There was no crack and/or hole observed on the engine housing.

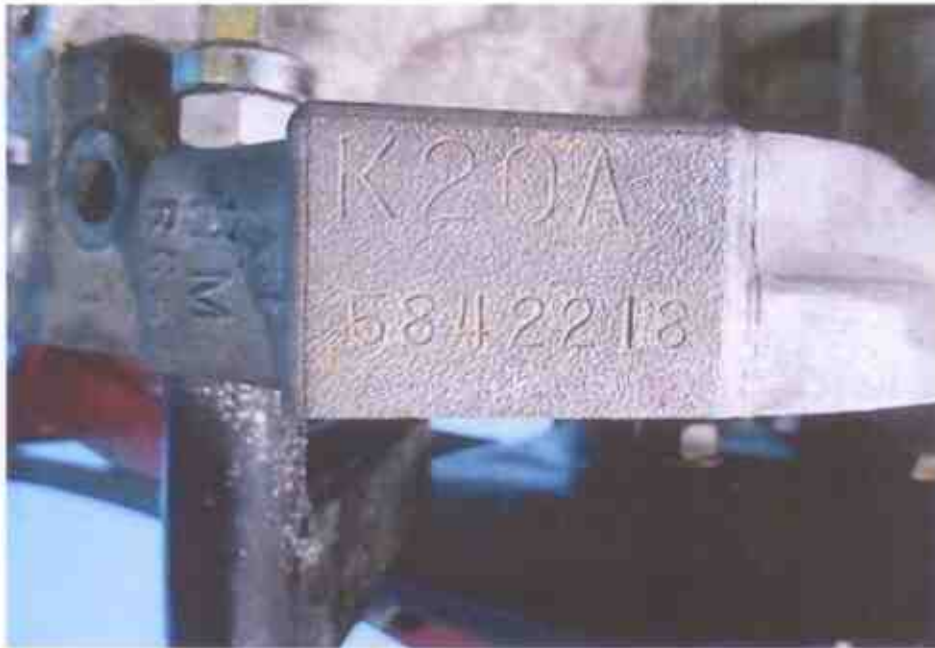
Photo 5 shows the engine number engraved on the housing of the Honda engine that I had inspected. The engine number was K20A5842218.

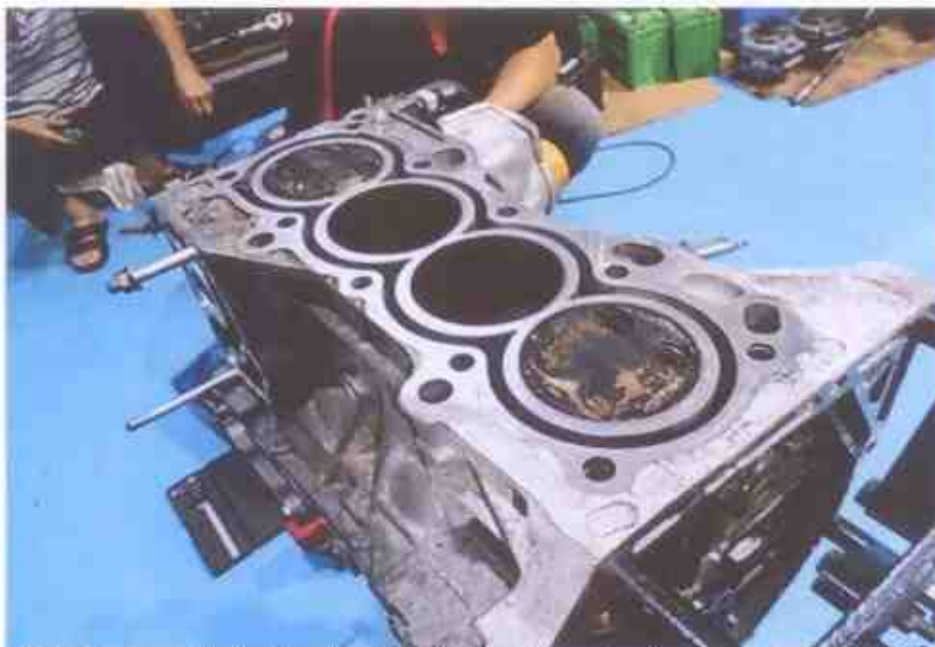
Photo 6 shows the bottom block of the Honda engine that I had inspected. The top block was separated from the bottom block for measurements of the cylinders, in particular the bore and stroke measurements of each cylinder, which typically can be used to determine the engine displacement or more commonly referred to as engine cc.

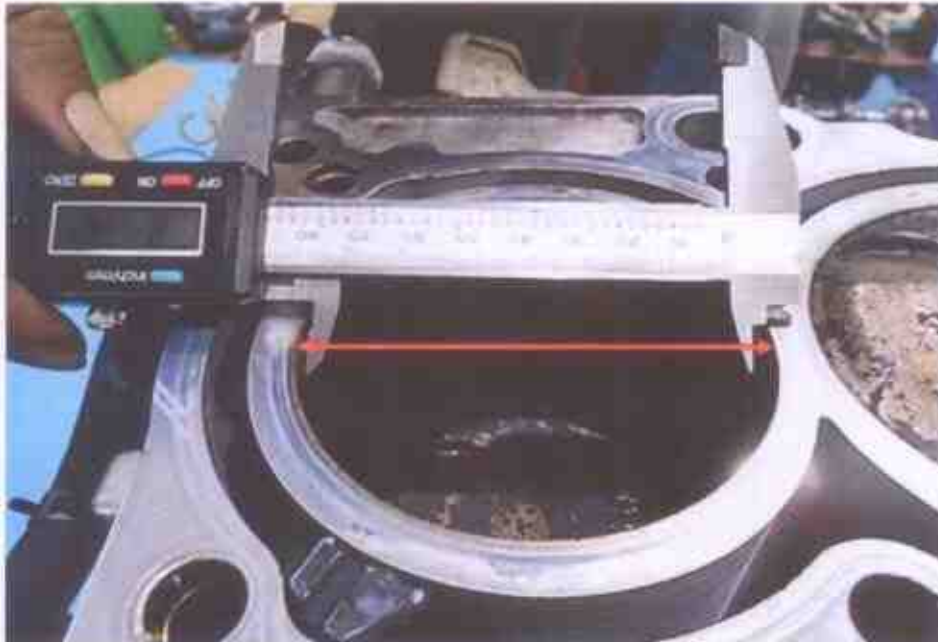
Photo 7 shows measurement being carried out to the bore of cylinder 1 of the Honda engine. The bore and stroke measurements of the Honda engine were carried out using a Vernier Caliper.

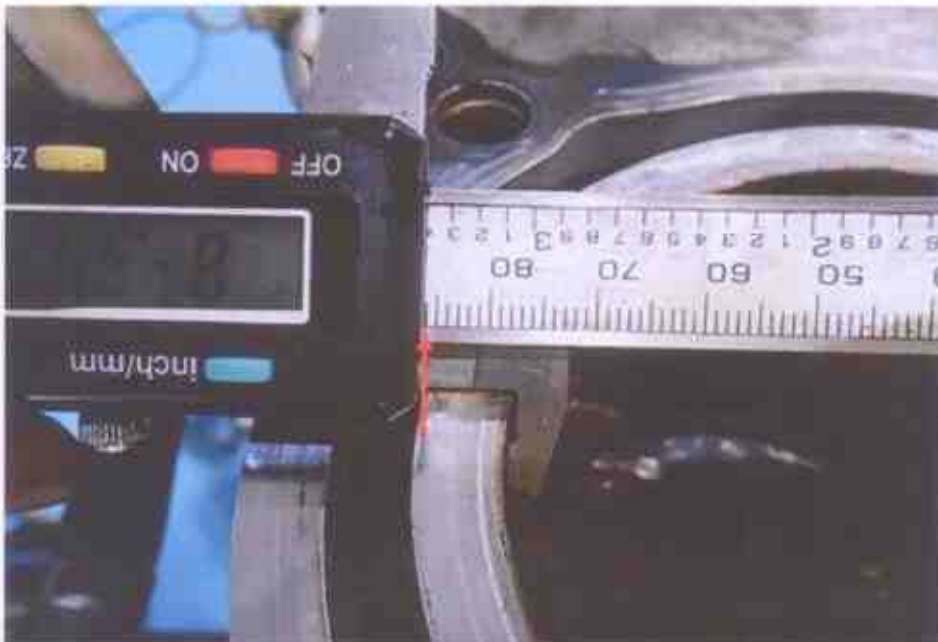
Photo 8 shows the bore measurement of cylinder 1, which was recorded to be 86.00mm.

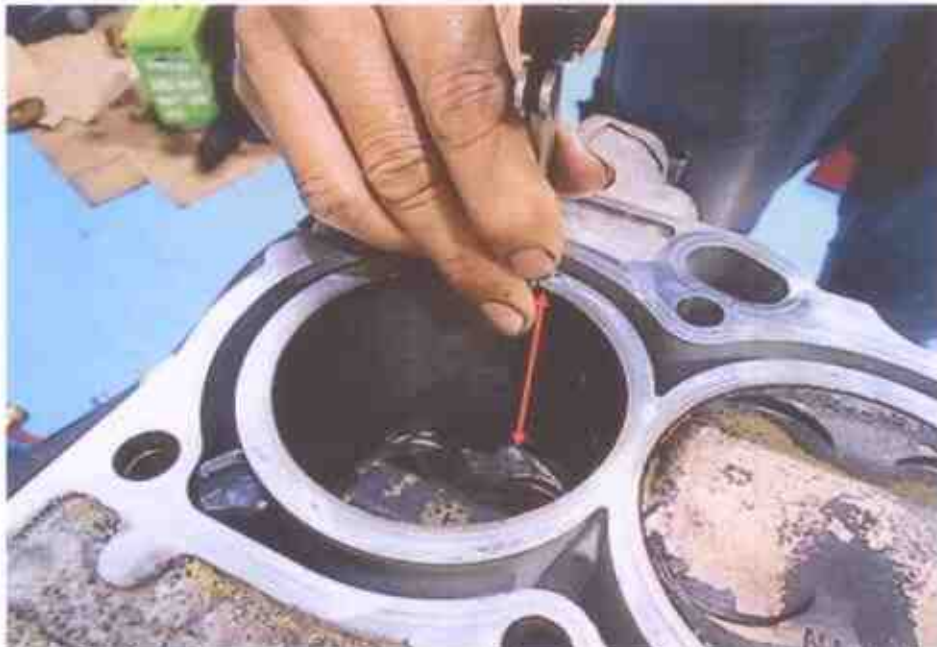
Photo 9 shows measurement being carried out to the stroke of cylinder 1 of the Honda engine. The bore and stroke measurements of the Honda engine were carried out using a Vernier Caliper.

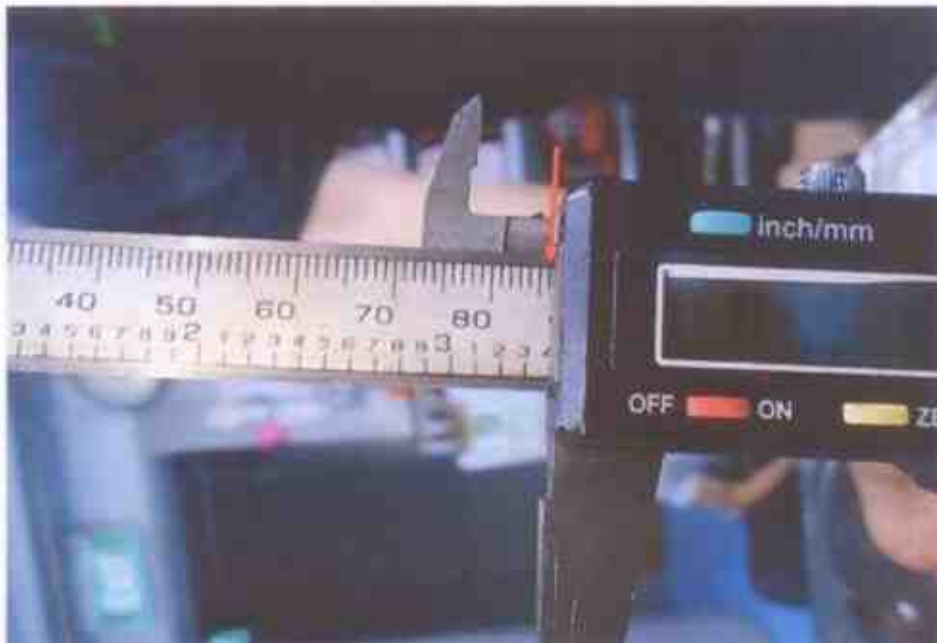
Photo 10 shows the stroke measurement of cylinder 1, which was recorded to be 86.00mm.

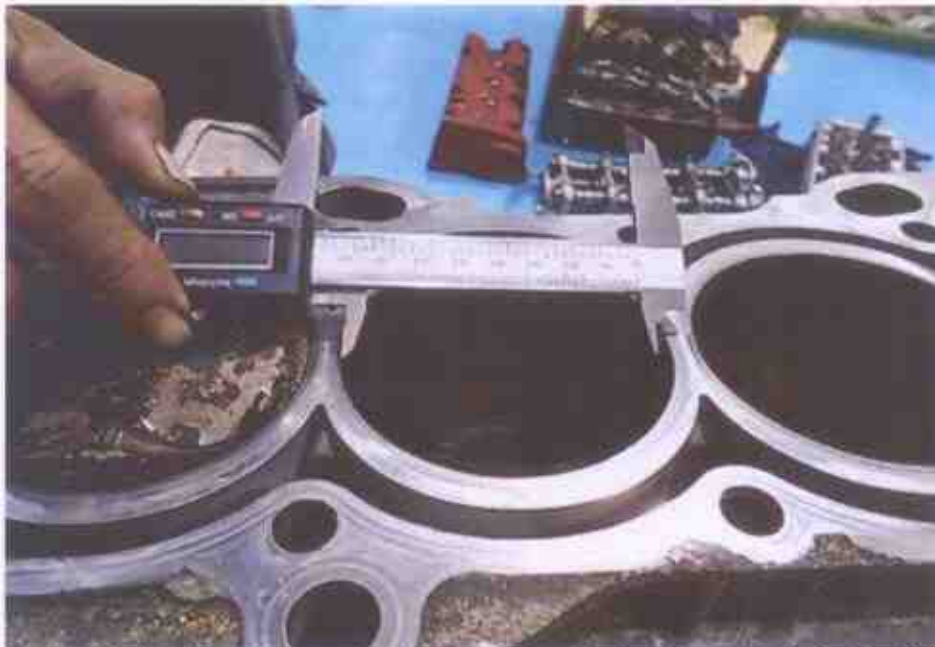
Photo 11 shows measurement being carried out to the bore of cylinder 2 of the Honda engine. The bore and stroke measurements of the Honda engine were carried out using a Vernier Caliper.

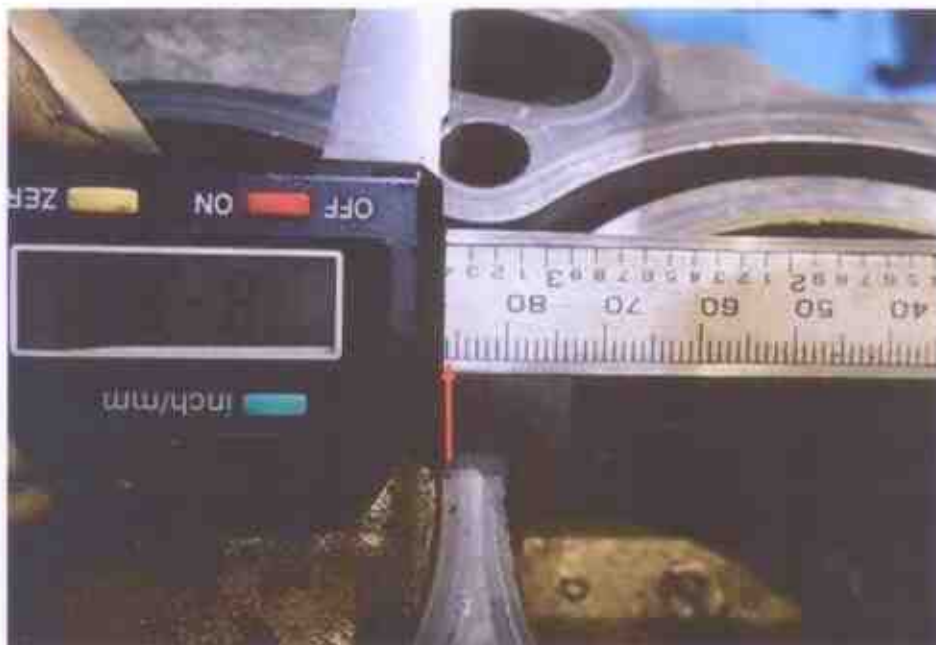
Photo 12 shows the bore measurement of cylinder 2, which was recorded to be 86.00mm.

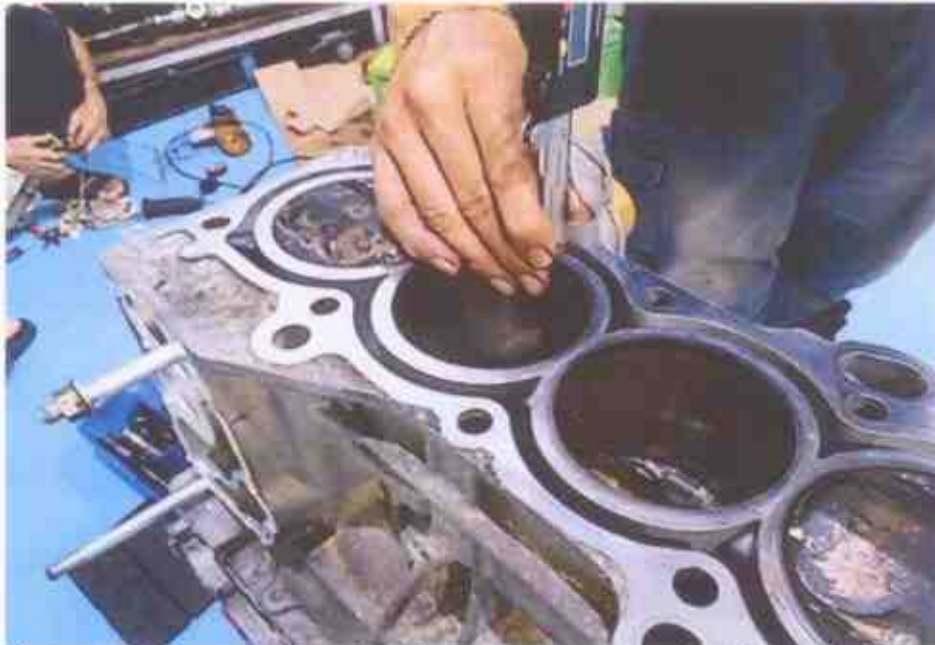
Photo 13 shows measurement of the stroke for cylinder 2 of the Honda engine that I had inspected.

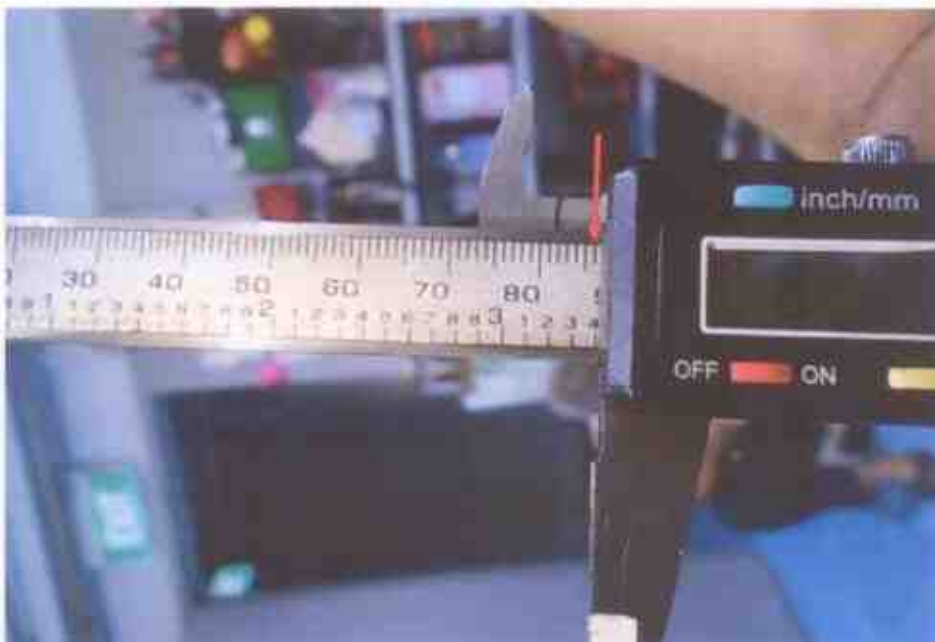
Photo 14 shows the stroke measurement of cylinder 2, which was recorded to be 86.00mm.

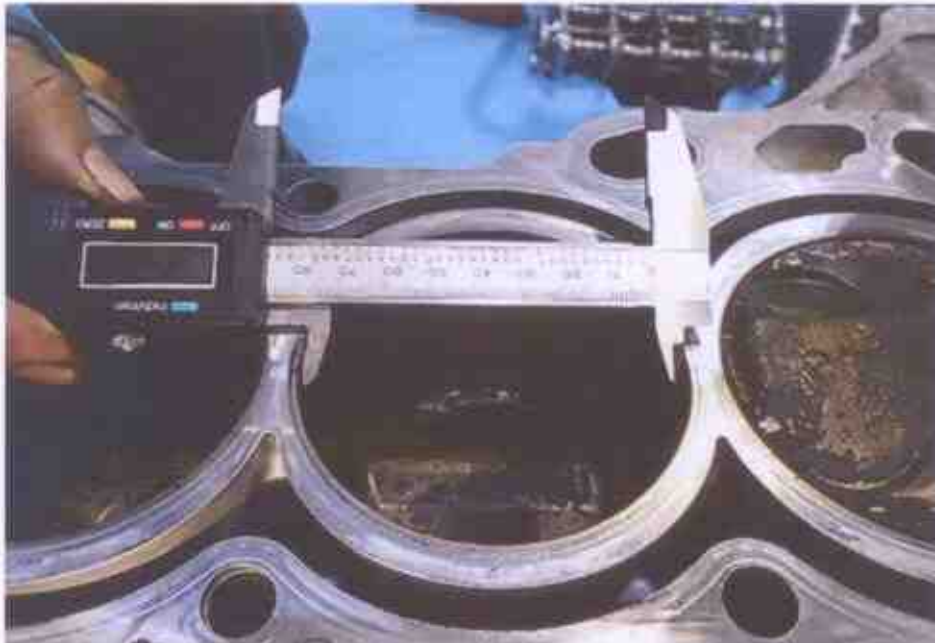
Photo 15 shows measurement being carried out to the bore of cylinder 3 of the Honda engine. The bore and stroke measurements of the Honda engine were carried out using a Vernier Caliper.

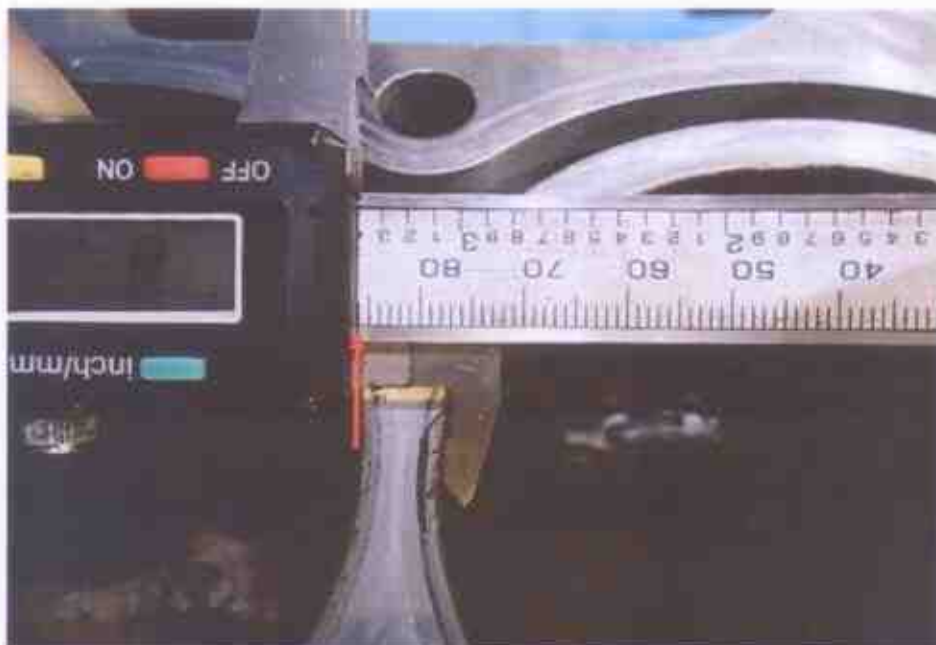
Photo 16 shows the bore measurement of cylinder 3, which was recorded to be 86.00mm.

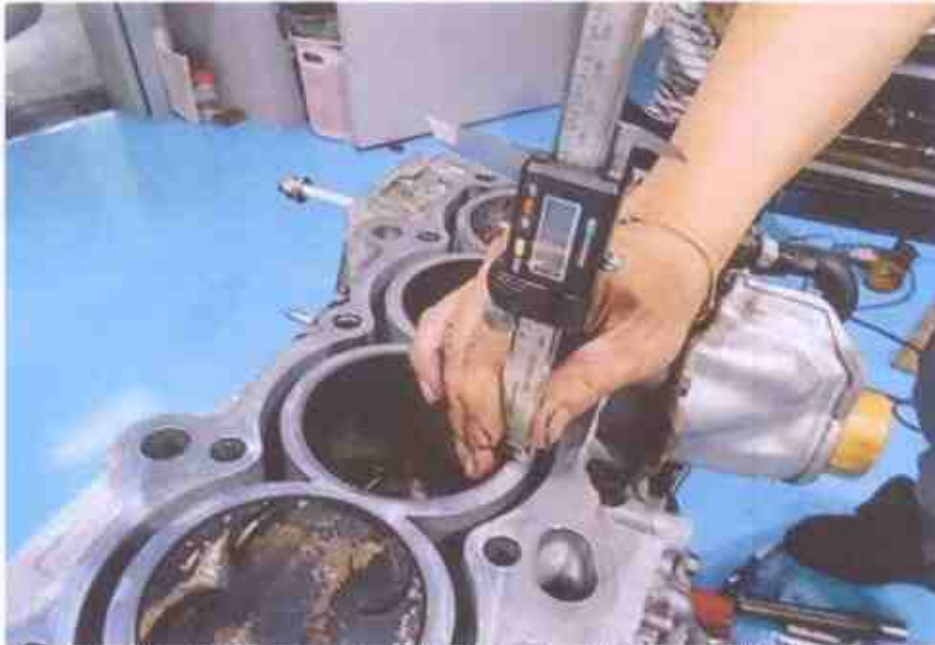
Photo 17 shows measurement of the stroke for cylinder 3 of the Honda engine that I had inspected.

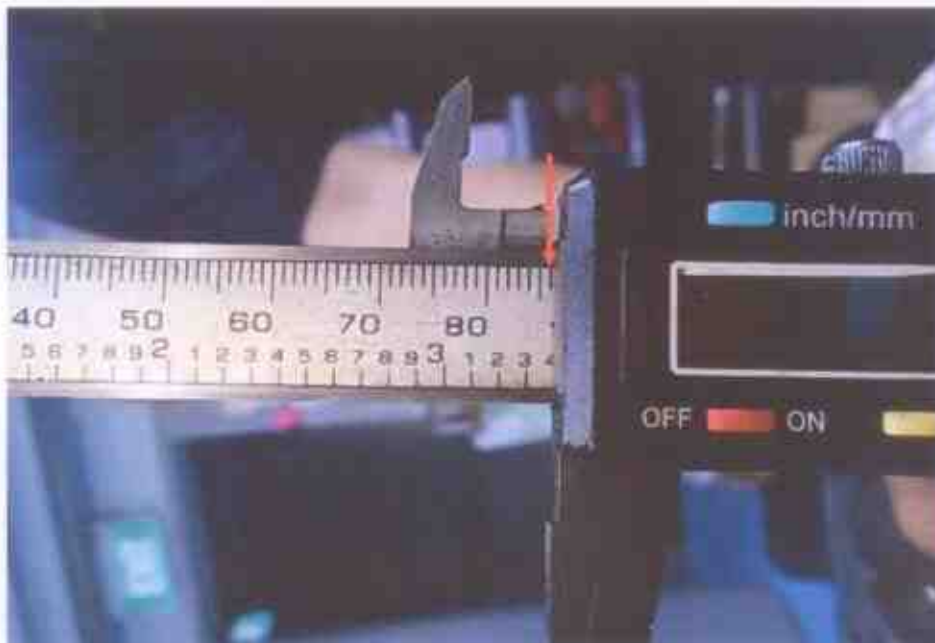
Photo 18 shows the stroke measurement of cylinder 3, which was recorded to be 86.00mm.

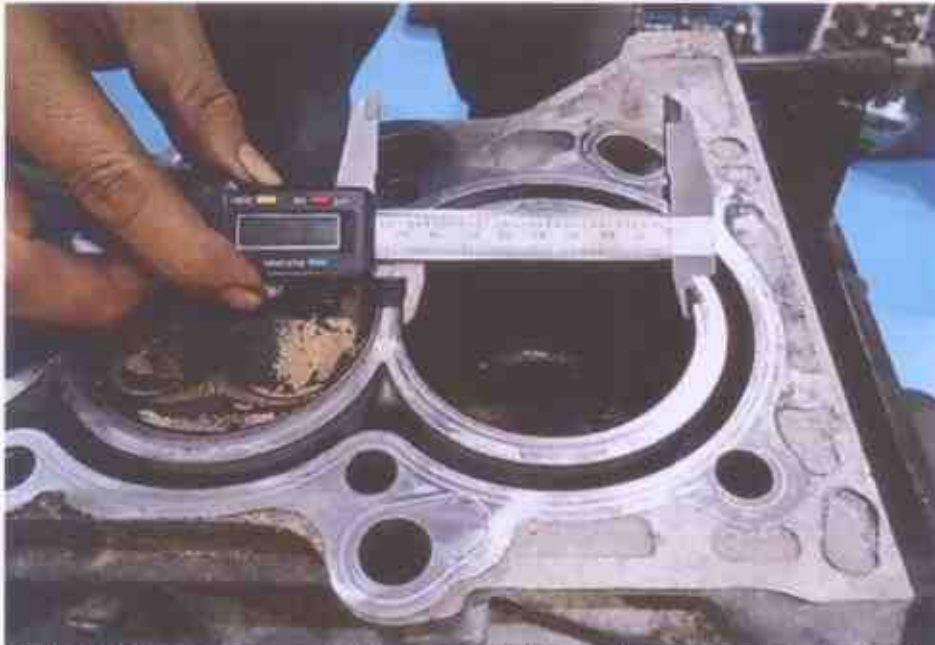
Photo 19 shows measurement being carried out to the bore of cylinder 4 of the Honda engine. The bore and stroke measurements of the Honda engine were carried out using a Vernier Caliper.

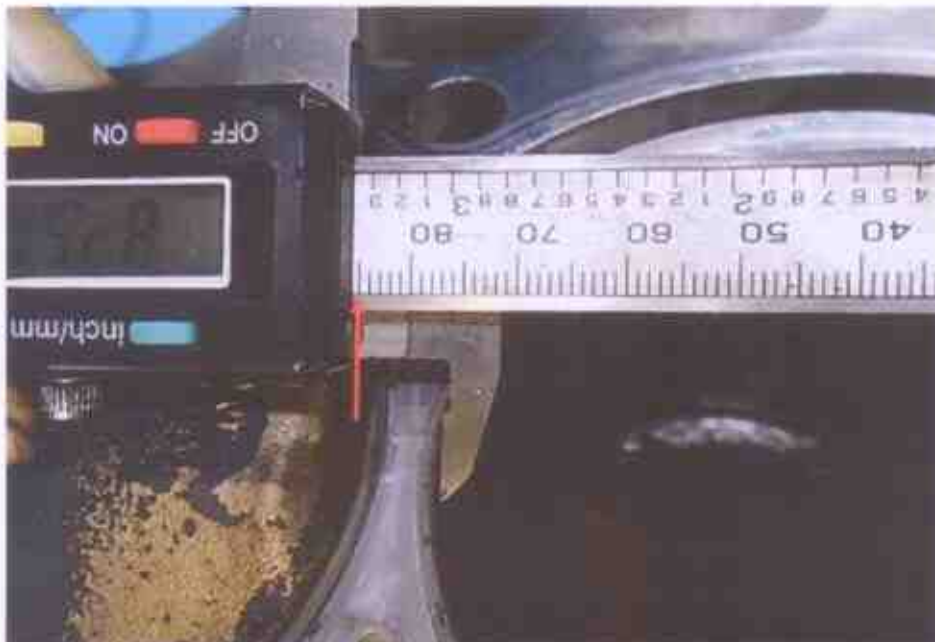
Photo 20 shows the bore measurement of cylinder 4, which was recorded to be 85.00mm.

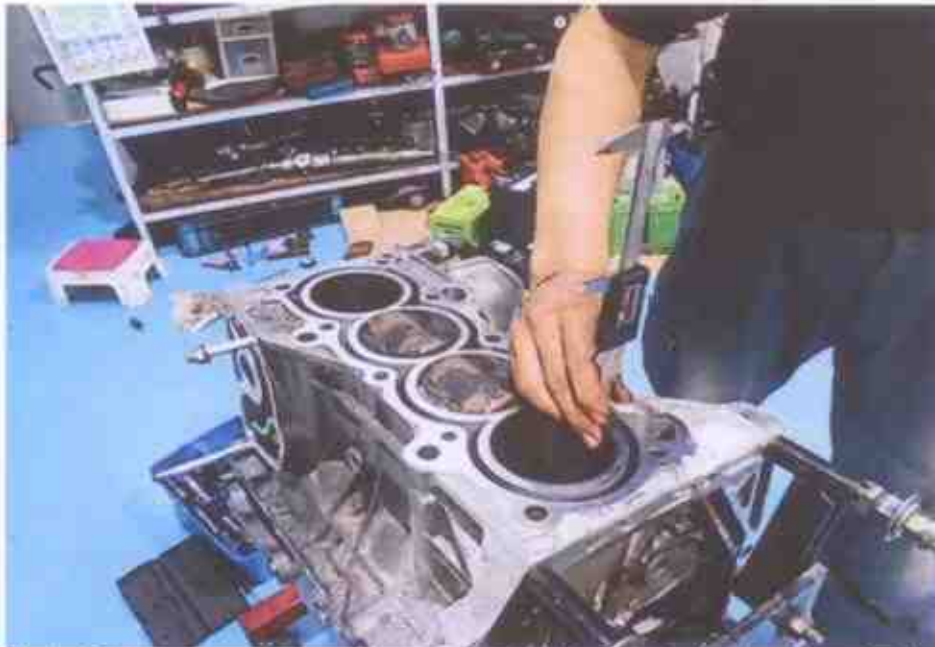
Photo 21 shows measurement being carried out to the stroke of cylinder 4 of the Honda engine. The bore and stroke measurements of the Honda engine were carried out using a Vernier Caliper.

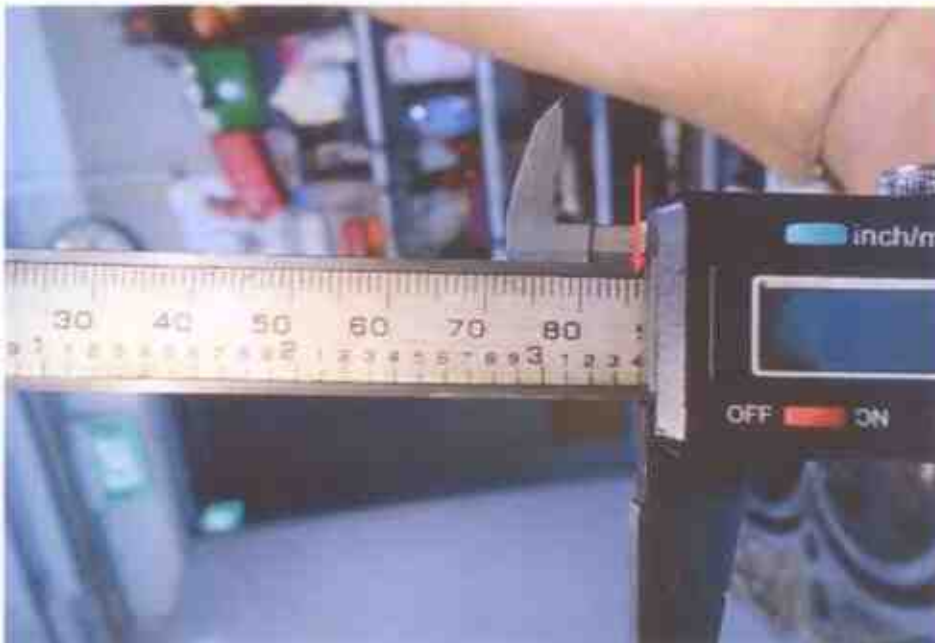
Photo 22 shows the stroke measurement of cylinder 4, which was recorded to be 86.00mm.
