Your Ref: Honda Engine Our Ref: CI/TP18012599/D

11 July 2018

#### INSPECTION REPORT OF A HONDA ENGINE

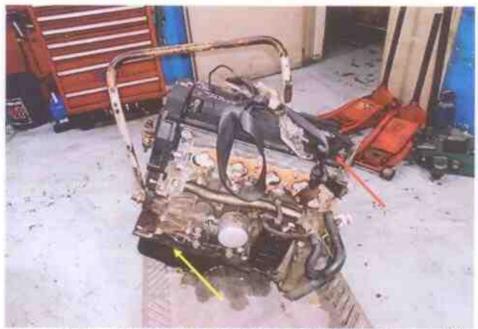
Photo 1 shows a general view of the Honda engine that I had inspected. The Honda engine was observed to be a used engine and was not fitted on any motor car. There was no crack and/or hole observed on the engine housing.

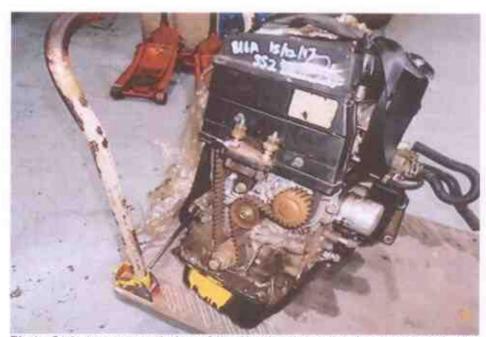
Photo 3 shows a general view of the Honda engine that I had inspected. The Honda engine was observed to be a used engine and was not fitted on any motor car. It was also observed to be a complete assembly with all mechanical parts still intact, within the engine housing.

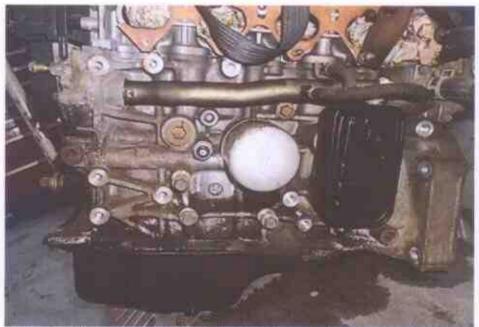
Photo 3 shows a general view of the Honda engine that I had inspected. My visual examination of the engine housing revealed the housing to be of serviceable/satisfactory condition. There was no crack and/or hole observed on the engine housing.

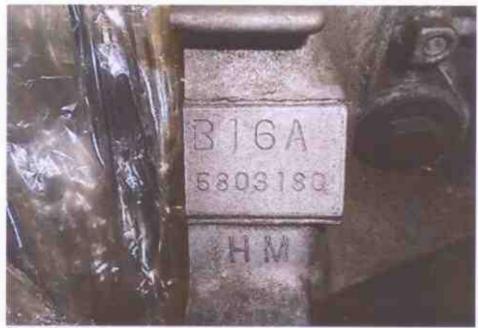
Photo 4 shows the engine number engraved on the housing of the Honda engine that I had inspected. The engine number was B16A5803180.

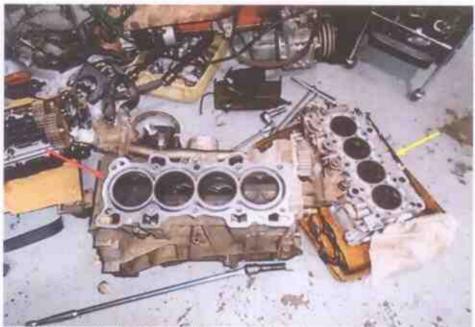
Photo 5 shows the top block (yellow arrow) of the Honda engine separated from its bottom block (red arrow). This was to enable me to carry out measurements of its cylinders, in particular the bore and stroke measurements of each cylinder, which typically can be used to determine the engine displacement or more commonly referred to as engine cc.

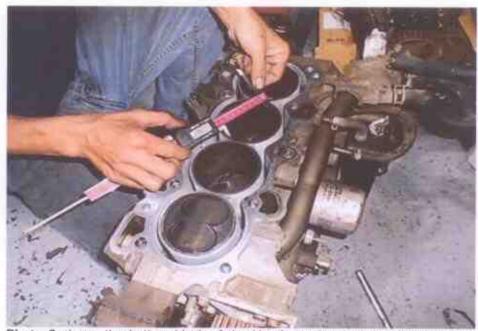
Photo 6 shows the bottom block of the Honda engine and the digital Vernier Caliper that was used to measure the bore and stroke of the Honda engine. The digital Vernier Caliper was calibrated before the start of the measurements.

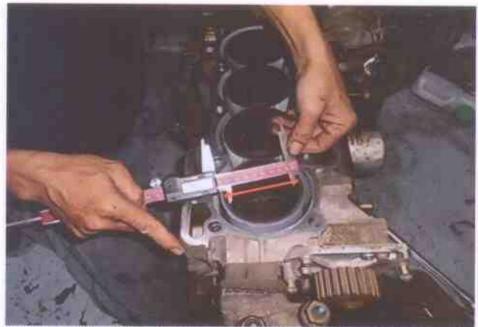
Photo 7 shows measurement being carried out to the bore of cylinder 1 of the Honda engine. The measurement was carried out using a digital Vernier Caliper.

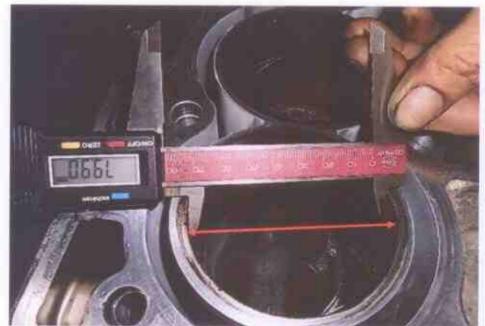
Photo 8 shows measurement being carried out to the bore of cylinder 1 of the Honda engine. The bore measurement of cylinder 1 was recorded to be 79.90mm.

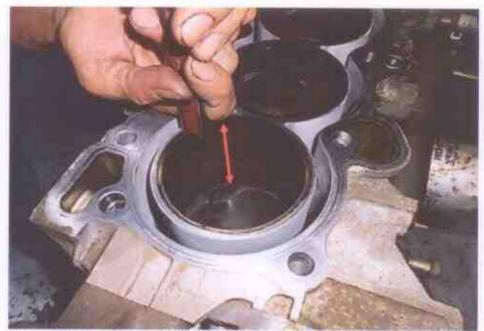
Photo 9 shows measurement being carried out to the stroke of cylinder 1 of the Honda engine. The bore and stroke measurements of the Honda engine were carried out using a digital Vernier Caliper that was calibrated before the start of the measurement.

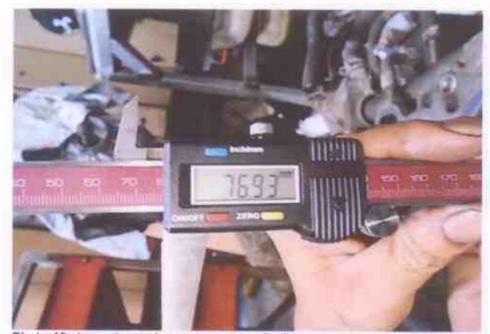
Photo 10 shows the stroke measurement of cylinder 1, which was recorded to be 76.93mm.

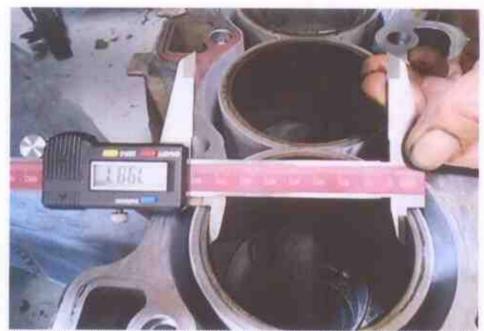
Photo 11 shows measurement being carried out to the bore of cylinder 2 of the Honda engine. The bore measurement of cylinder 2 was recorded to be 79.87mm.

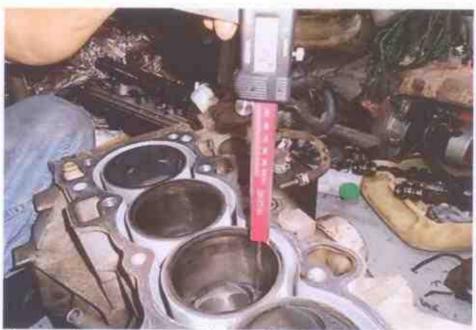
Photo 12 shows measurement of the stroke of cylinder 2 of the Honda engine that I had inspected. The bore and stroke measurements of the Honda engine were carried out using a digital Vernier Caliper that was calibrated before the start of the measurement.

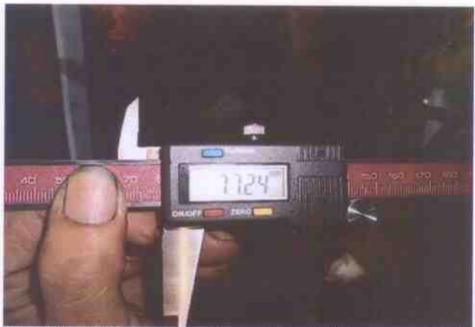
Photo 13 shows the stroke measurement of cylinder 2, which was recorded to be 77.24mm.

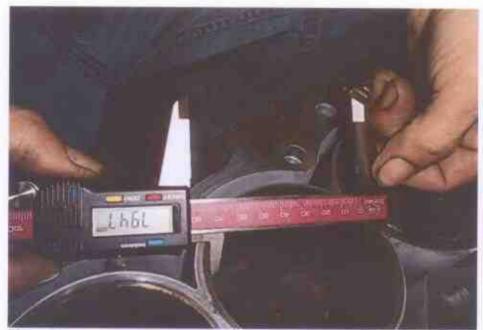
Photo 14 shows measurement being carried out to the bore of cylinder 3 of the Honda engine. The bore and stroke measurements of the Honda engine were carried out using a digital Vernier Caliper. The bore measurement of cylinder 3 was recorded to be 79.47mm.

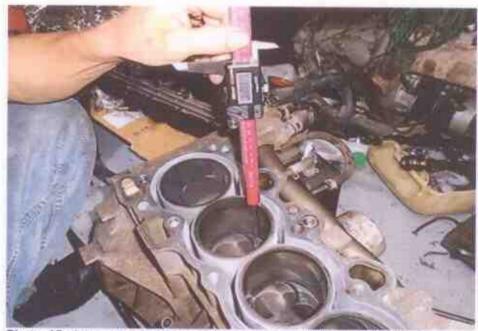
Photo 15 shows measurement of the stroke of cylinder 3 of the Honda engine that I had inspected. The bore and stroke measurements of the Honda engine were carried out using a digital Vernier Caliper that was calibrated before the start of measurements.

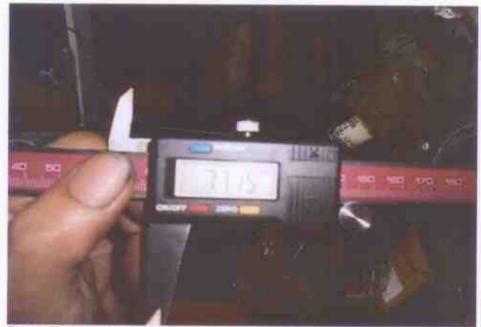
Photo 16 shows the stroke measurement of cylinder 3, which was recorded to be 77.15mm.

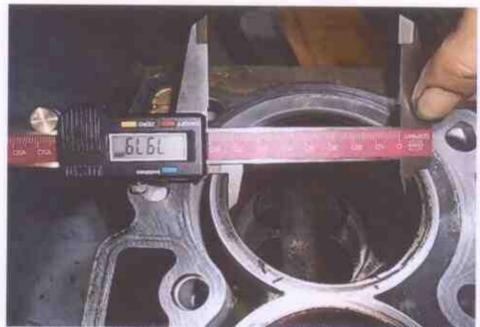
Photo 17 shows measurement being carried out to the bore of cylinder 4 of the Honda engine. The bore measurement of cylinder 4 was recorded to be 79.79mm.

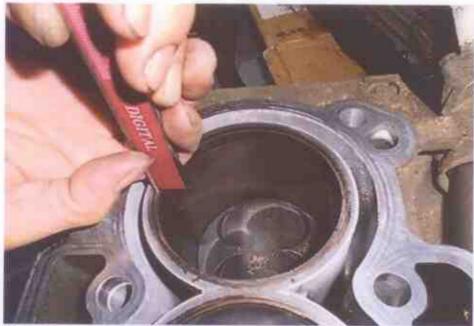
Photo 18 shows measurement being carried out to the stroke of cylinder 4 of the Honda engine. The bore and stroke measurements of the Honda engine were carried out using a digital Vernier Caliper that was calibrated before the start of measurements.

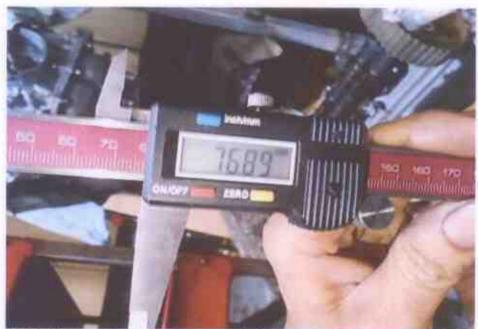
Photo 19 shows the stroke measurement of cylinder 4, which was recorded to be 76.89mm.
