Your Ref: 2666262496SG
Our Ref : CI/AIG18012700/D

13 July 2018

**TECHNICAL INVESTIGATION REPORT OF FIRE INCIDENT INVOLVING THE
INSURED VEHICLE SCK 234Z ON 18 JUNE 2018**

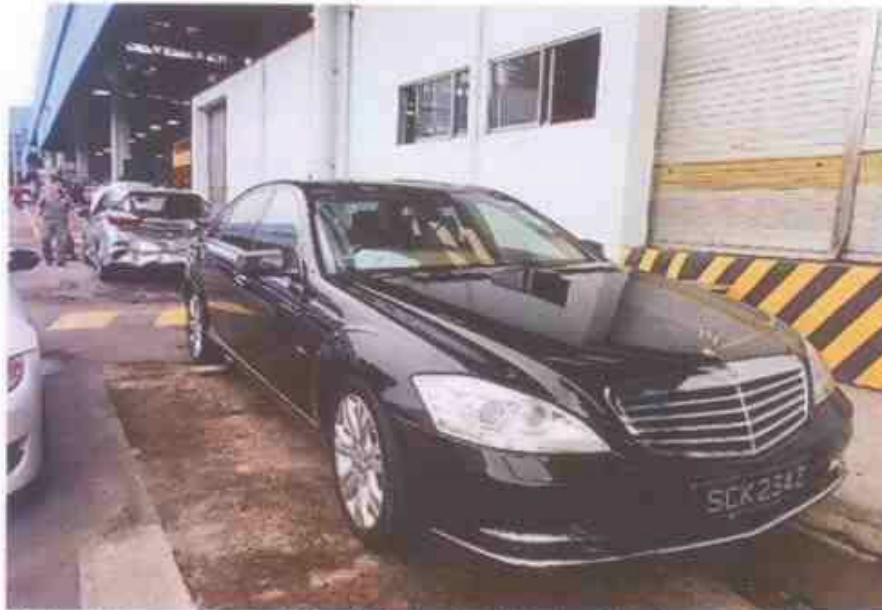
Photo 1 shows a general view of the front right body of the Insured Vehicle at the time of my inspection. The exterior body of the Insured Vehicle was observed to be in good general condition with no damage of burn nature found.

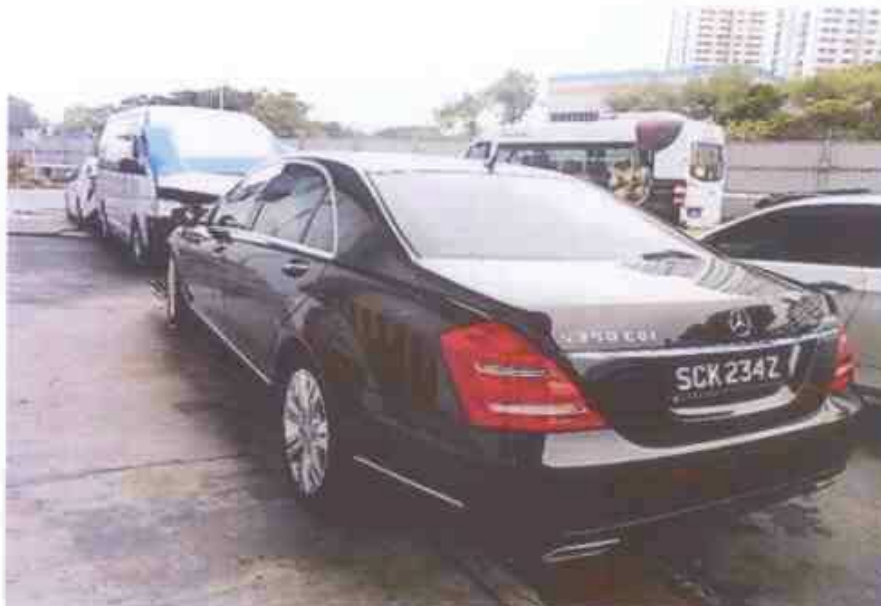
Photo 2 shows a general view of the rear left body of the Insured Vehicle at the time of inspection. The exterior body of the Insured Vehicle was observed to be in good general condition with no damage of burn nature found.

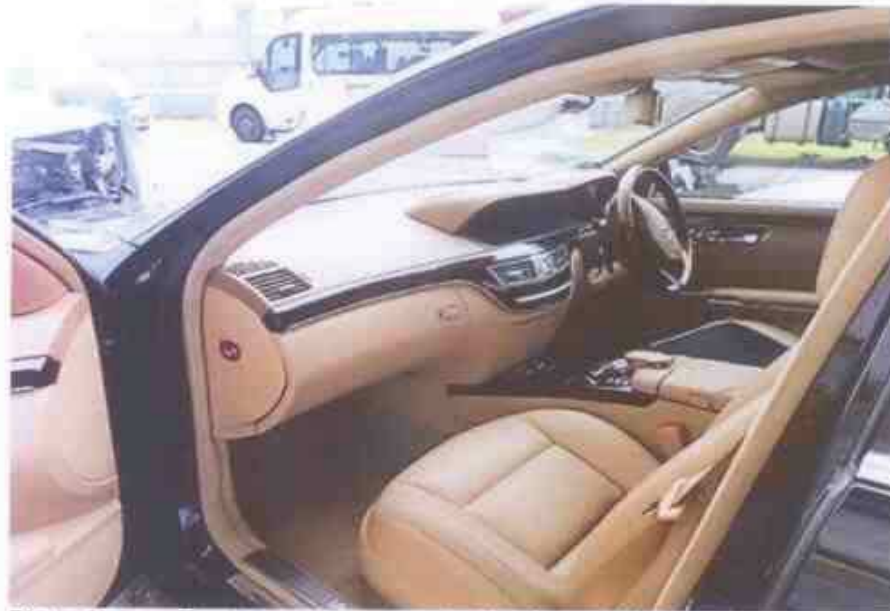
Photo 3 shows the interior compartment of the Insured Vehicle at the time of my inspection. There was no damage of burn nature observed within the interior compartment.

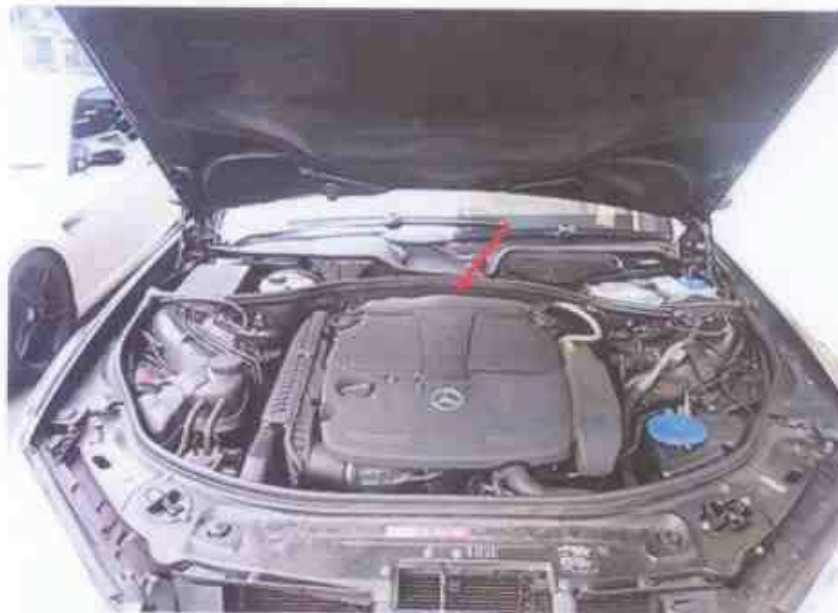
Photo 4 shows a general view of the engine compartment of the Insured Vehicle. Upon checking the engine compartment, I had found a stretch of wiring harness partially burnt/melted. This was towards the centre rear area (arrowed) of the engine compartment. The firewall insulator behind the stretch of partially burnt/melted wiring harness was also observed to be with minor burn marks.

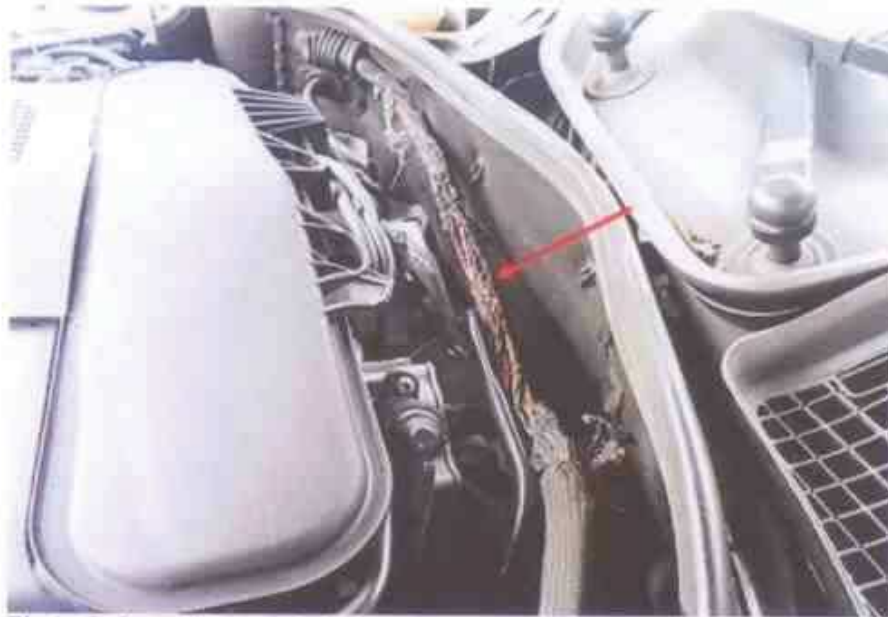
Photo 5 shows the stretch of wiring harness (arrowed) that was observed to be partially burnt/melted. This was towards the centre rear area of the engine compartment. There was no other damage of burn nature observed on the Insured Vehicle other than this partially burnt/melted wiring harness and firewall insulator that was directly behind the wiring harness.

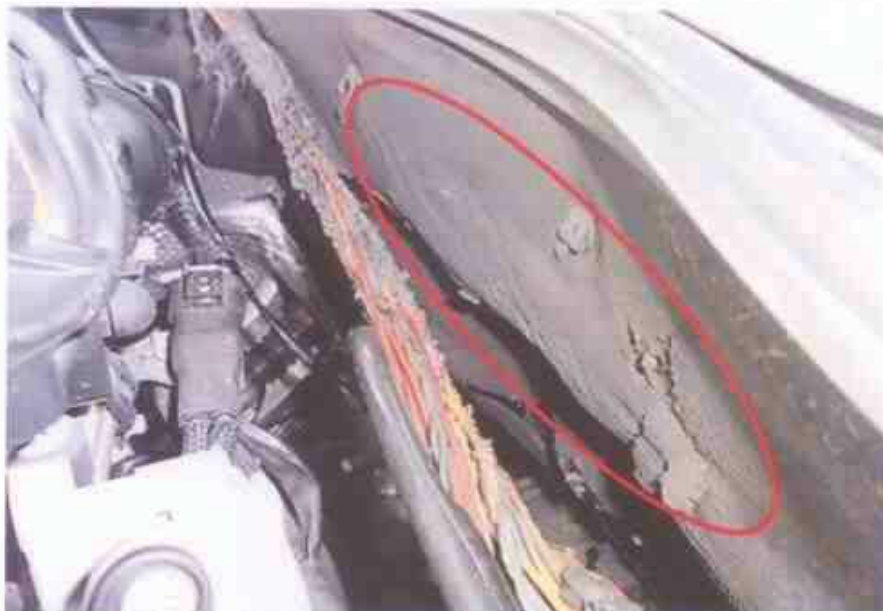
Photo 6 shows the damage of burn nature that was observed on the Insured Vehicle. This was towards the centre rear area of the engine compartment, where I had observed a stretch of partially burnt/melted wiring harness. The firewall insulator behind the stretch of partially burnt/melted wiring harness was also observed to be with minor burn marks (circled).

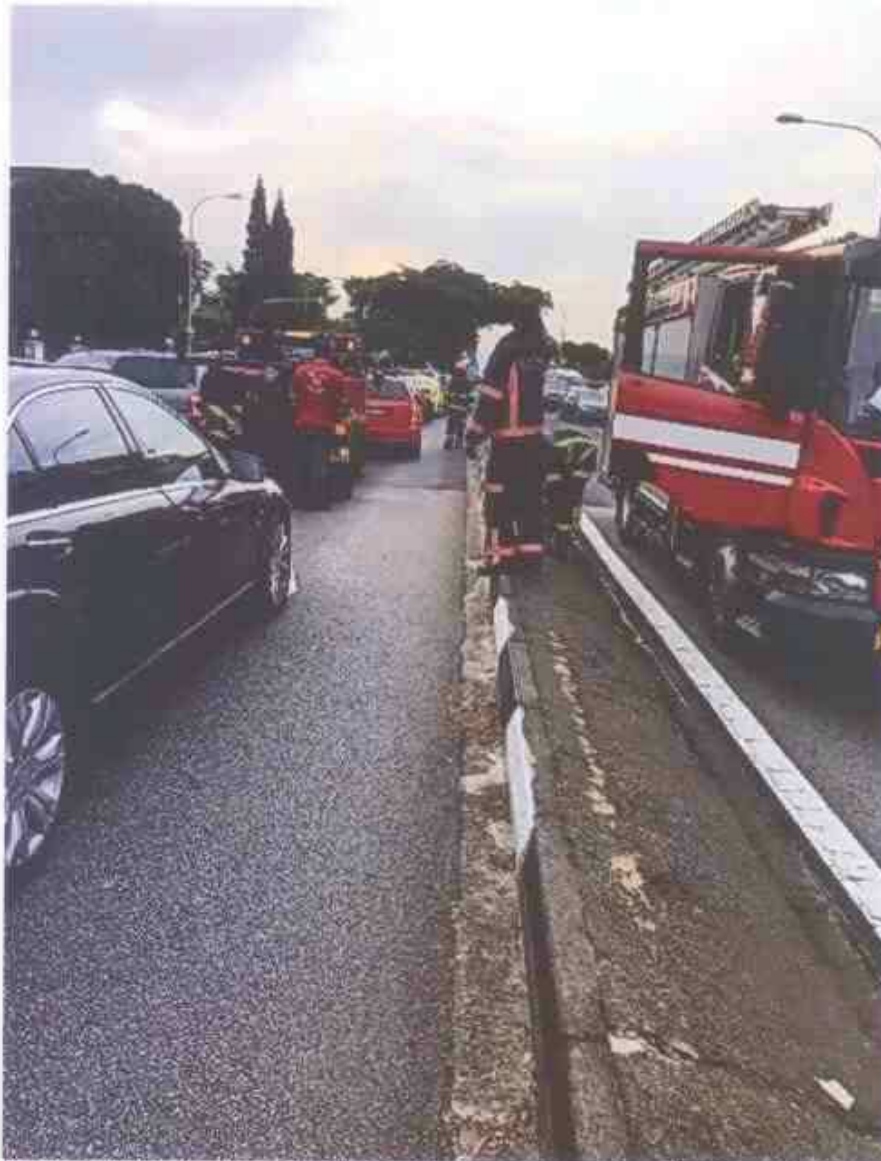
15. The photographs provided to me had showed the Insured Vehicle stopped on the extreme right lane of a roadway. SCDF officers and a tow truck was at scene. There was no smoke or fire seen coming out from the Insured Vehicle as according to Mr Salleh, he had extinguished the fire before SCDF arrived. Upon closer examination of the photographs provided, I had noted that there was no unusual foreign material(s), object(s) and/or fluid accumulation on the ground where the Insured Vehicle had stopped.

Photo 7 shows the Insured Vehicle at the incident location. There was no smoke or fire seen coming out from the Insured Vehicle as according to Mr Salleh, he had extinguished the fire before SCDF arrived. Upon closer examination of the photographs provided, I had noted that there was no unusual foreign material(s), object(s) and/or fluid accumulation on the ground where the Insured Vehicle had stopped. In general, the observations gathered from my review of the photographs that were taken by Mr Salleh at the incident scene had corresponded to the description of events that he had related to me during our conversation on 03 July 2018.

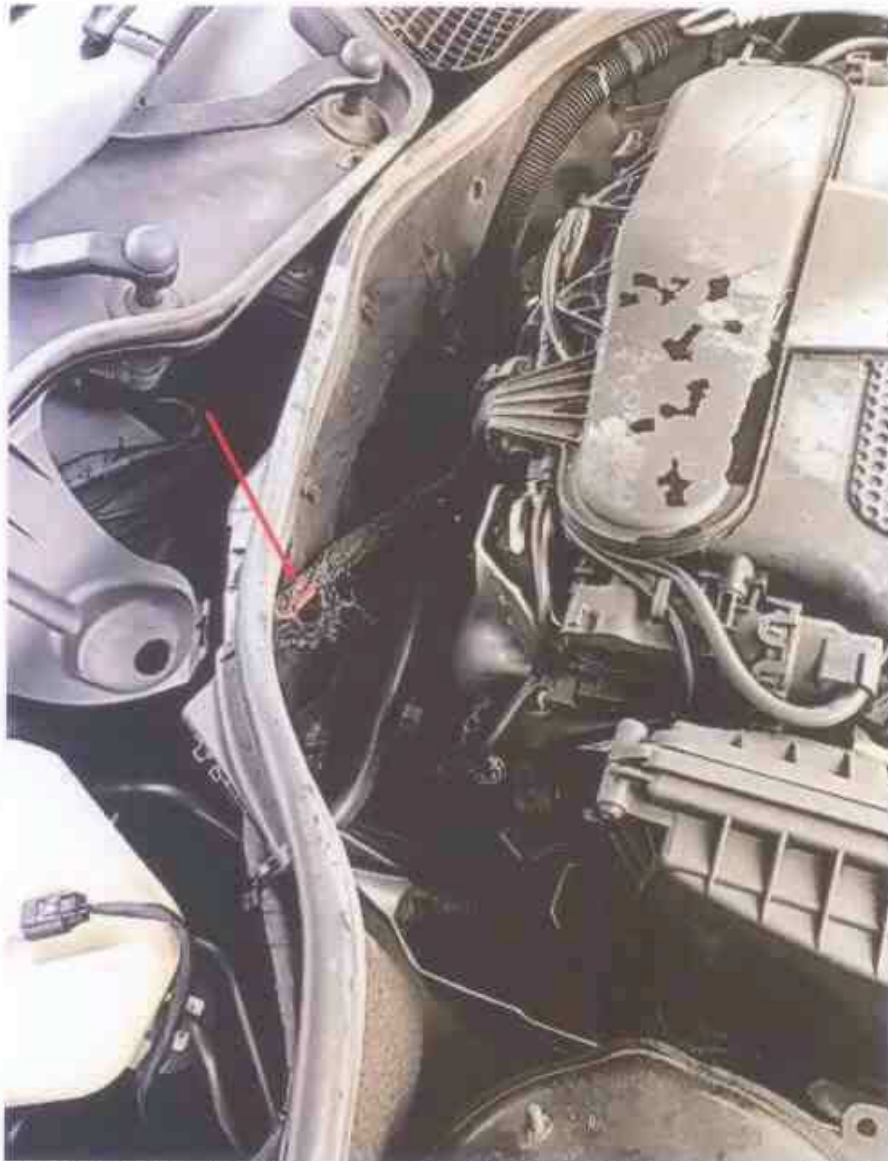
16. In general, the observations gathered from my review of the photographs that were taken by Mr Salleh at the incident scene had corresponded to the description of events that he had related to me during our conversation on 03 July 2018. The damage of fire nature to the Insured Vehicle, as seen from the photographs provided, was also observed to be similar to what I had observed during my inspection of the Insured Vehicle See photo 7 & 8 below.

Photo 8 shows the wirings (arrowed) within the engine compartment of the Insured Vehicle that were partially burnt/melted. The damage of fire nature to the Insured Vehicle, as seen from the photographs provided, was observed to be similar to what I had observed during my inspection of the Insured Vehicle. In general, the observations gathered from my review of the photographs that were taken by Mr Salleh at the incident scene had corresponded to the description of events that he had related to me during our conversation on 03 July 2018.

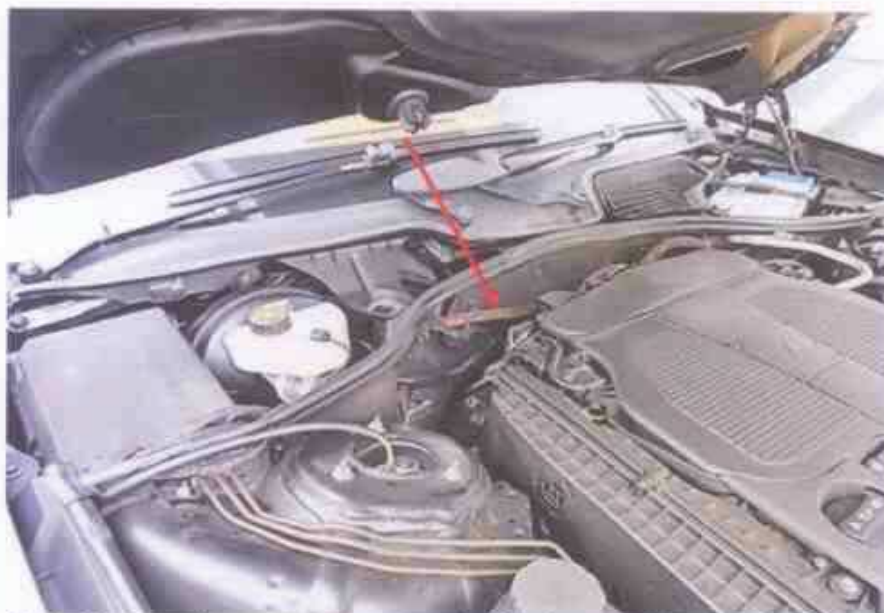
18. For this case, the fire to the Insured Vehicle had originated within the engine compartment, at the centre rear area of the engine compartment. This was established given that the centre rear area of the engine compartment was the only area on the Insured Vehicle where damage of burn nature was found.

Photo 11 shows the engine compartment of the Insured Vehicle. The fire to the Insured Vehicle had originated within the engine compartment, at the centre rear area (arrowed) of the engine compartment. This was established given that there was only a single area on the Insured Vehicle where damage of burn nature was found.

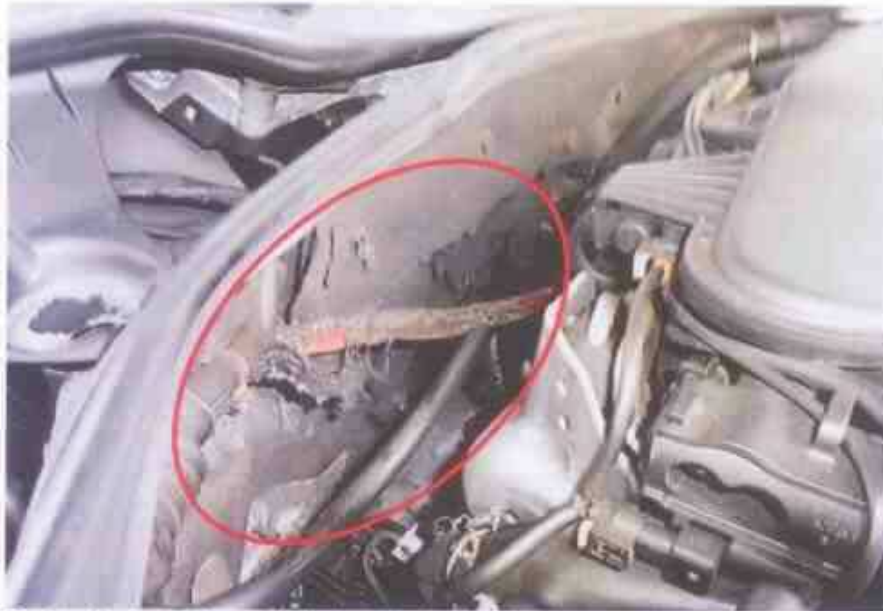
19. My examination of the centre rear area of the engine compartment, which was where the fire to the Insured Vehicle had originated, revealed wirings that were partially burnt/melted. There was no other part(s)/component(s) that was exposed to high heat intensity around this area of the engine compartment. The firewall insulator, which was observed to be partially burnt/melted, was not the igniting source of the fire as the firewall insulator is not a conductor of heat given that it is made of cloth type material. The physical damage and burn pattern found on the Insured Vehicle appears to then indicate that the cause of fire was due to electrical nature.

20. This partially burnt/melted stretch of wiring harness was an original factory fitted wiring harness which connects the Engine Control Unit (ECU) to the fuse box of the Insured Vehicle. The rubber insulation of the wiring harness could have been exposed to the heat generated during engine operation. After a prolong period, the rubber insulation of the wirings started to deteriorate and melt, exposing live wires that came into contact with each other, creating sparks that had ignited the fire. Unlike countries with different seasons, the hot local climate enhances the deterioration of any rubber material parts or components of a motor vehicle, in particular for those contained within its engine compartment. See photo 11 & 12 below.

Photo 12 shows the partially burnt/melted wiring harness at the centre rear area of the engine compartment. The wiring harness was an original factory fitted wiring harness which connects the Engine Control Unit (ECU) to the fuse box of the Insured Vehicle. Heat generated during engine operation could have caused the rubber insulation of the wirings started to melt, exposing live wires that came into contact with each other, creating sparks that had ignited the fire.

22. Having investigated and technically analysed the damages of burnt nature to the Insured Vehicle, I am of the view that the cause of fire to the Insured Vehicle was of electrical in nature. For this particular case, the fire had originated along the wirings inside the engine compartment, at the centre rear area of the engine compartment. The wirings were original factory fitted wirings connecting the Engine Control Unit (ECU) to the fuse box of the Insured Vehicle.
