Your Ref: TP/IP/18933/2018  
Our Ref : CI/TPD18012780/Z

**Fatal Accident Investigation Team**  
Traffic Police Department  
Singapore Police Force  
10 Ubi Avenue 3  
Singapore 408865

### **MECHANICAL INSPECTION REPORT OF MOTORCYCLE FBD 7456C**

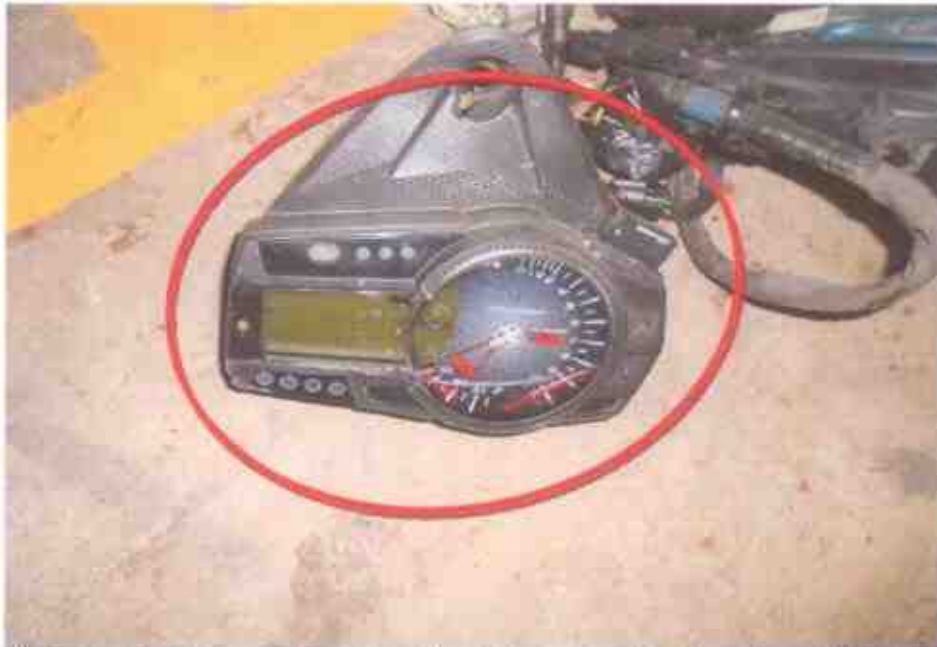
**Photo 1** shows the speedo-meter of the Motorcycle where it was found dislodged from the original installation.

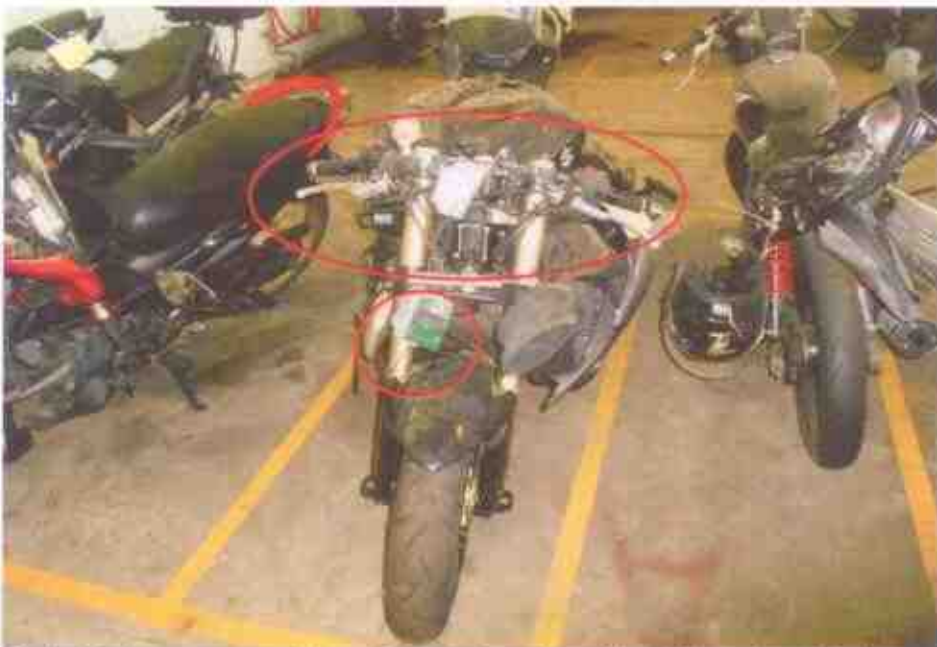
**Photo 2** shows a general view of the front portion of the Motorcycle at the time of our inspection. The Motorcycle was observed to be sustained with damages due to the accident collision. (Circled)

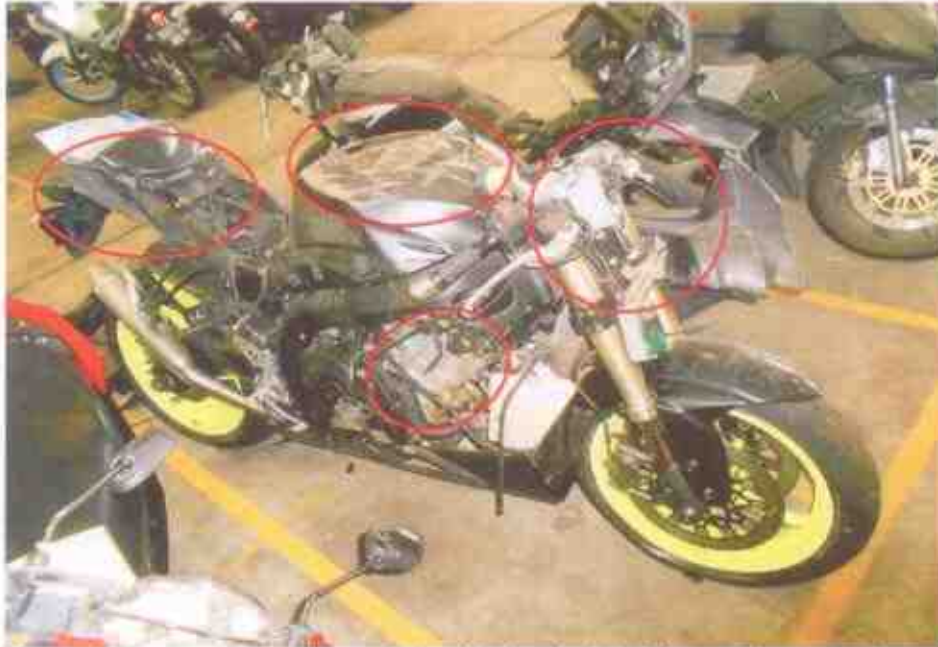
**Photo 3** shows a general view of the right body of the Motorcycle at the time of our inspection. The Motorcycle was observed to have sustained extensive damages at the frontal, rear portion & along its right side. (Circled)

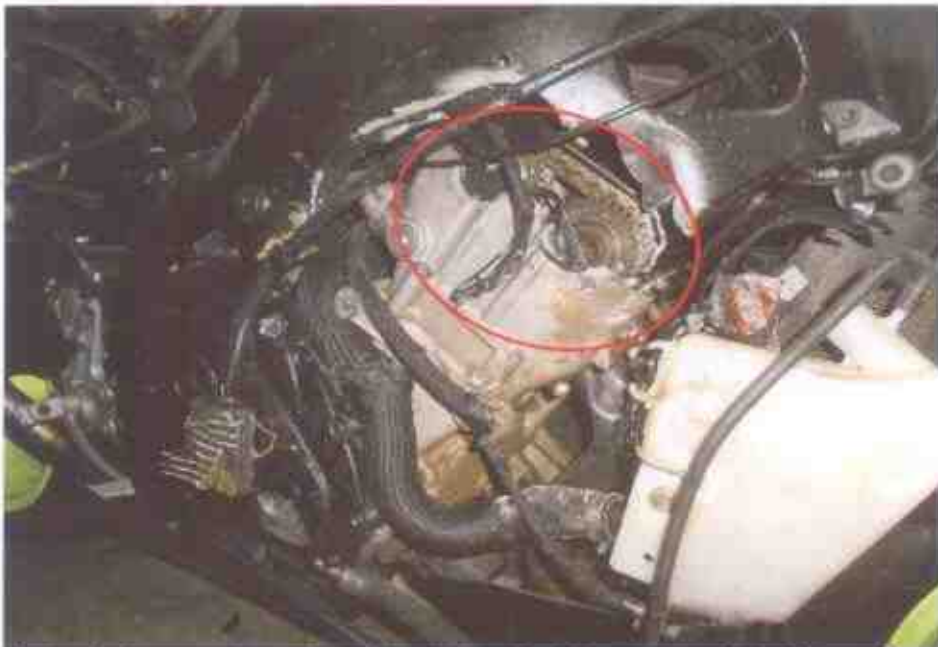
**Photo 4** shows a closer view of the right side of the engine of the Motorcycle at the time of our inspection that was observed to have sustained with extensive damages due to the accident collision. (Circled)

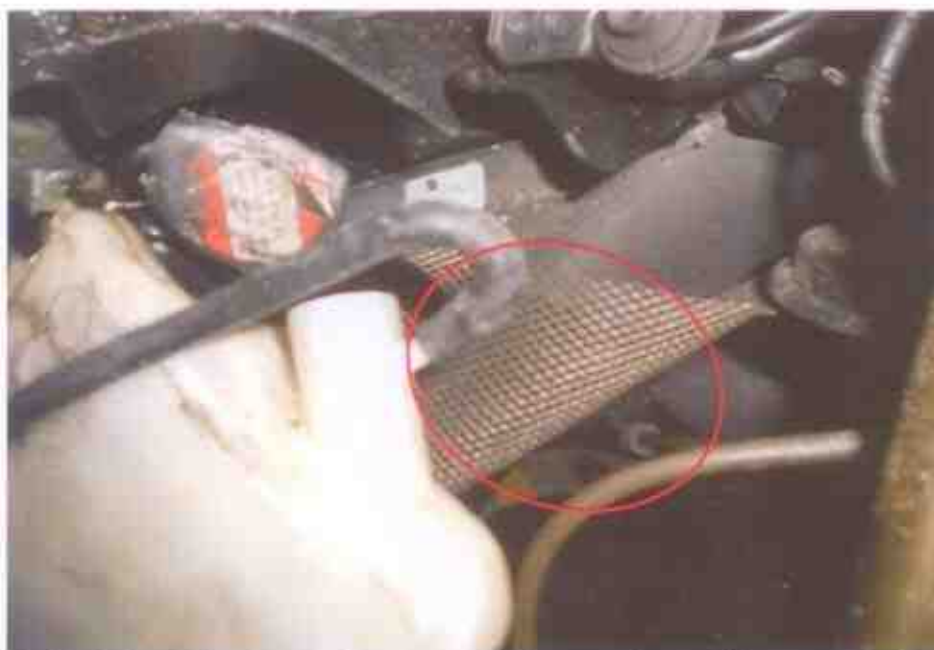
**Photo 5** shows the damaged engine coolant reservoir & radiator as a result of the accident.(Circled)

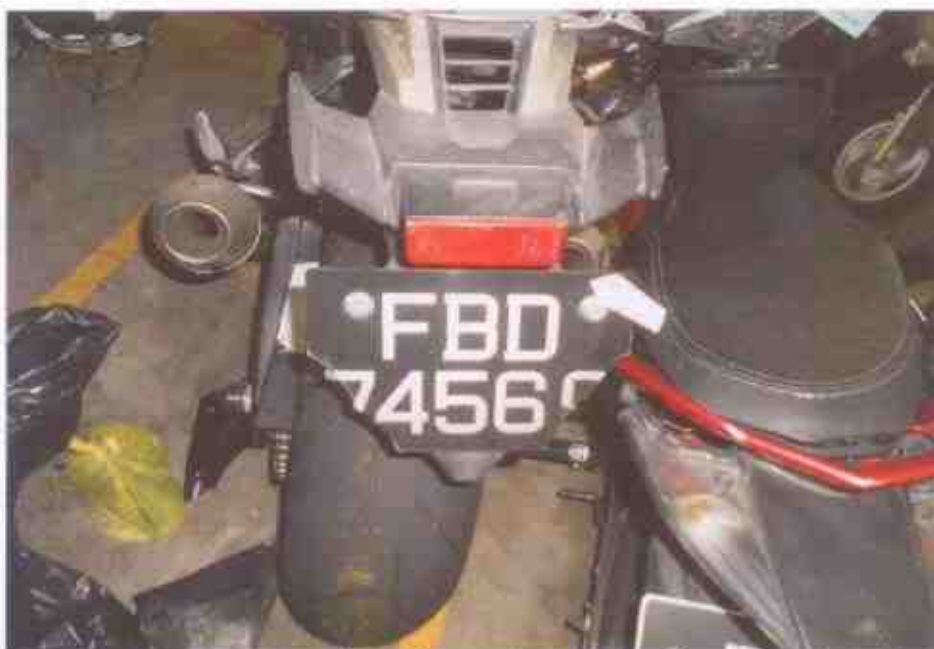
**Photo 6** shows a rear view of the Motorcycle at the time of our inspection. It was observed to be in good condition not affected by the accident.

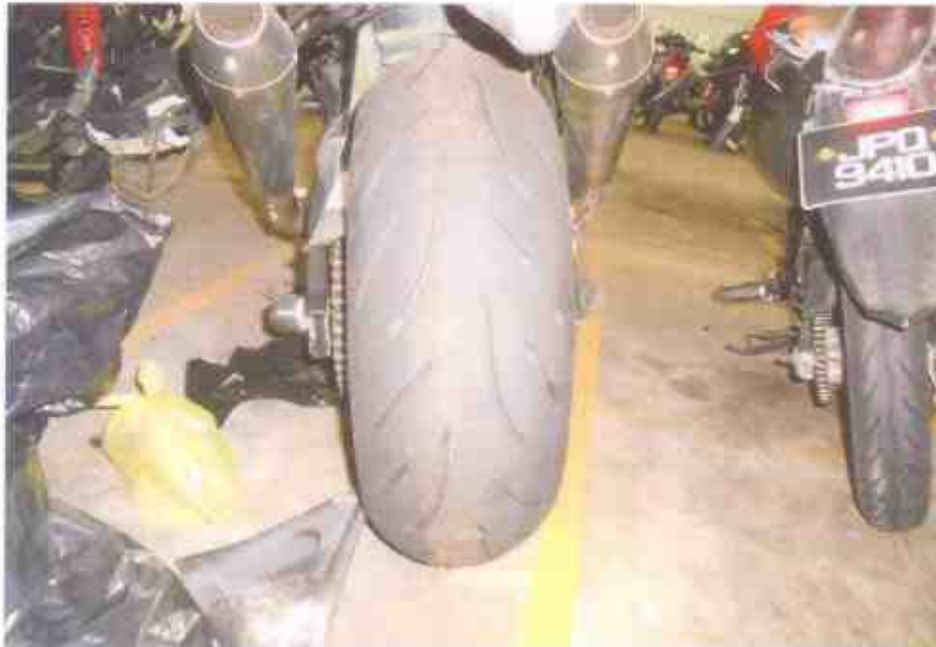
8. The rear tyre was wrapped around alloy wheel rim that was found to be without any significant damage. As for the front wheel rim, it was observed to have sustained with damages due to the accident's impact. See photo 7 & 8 below.

**Photo 7** shows the rear tyre of the Motorcycle. The rear tyre was observed to be in serviceable condition with remaining tread depth of approximately 3mm. The tyre was also observed to be sufficiently inflated for vehicular operation.

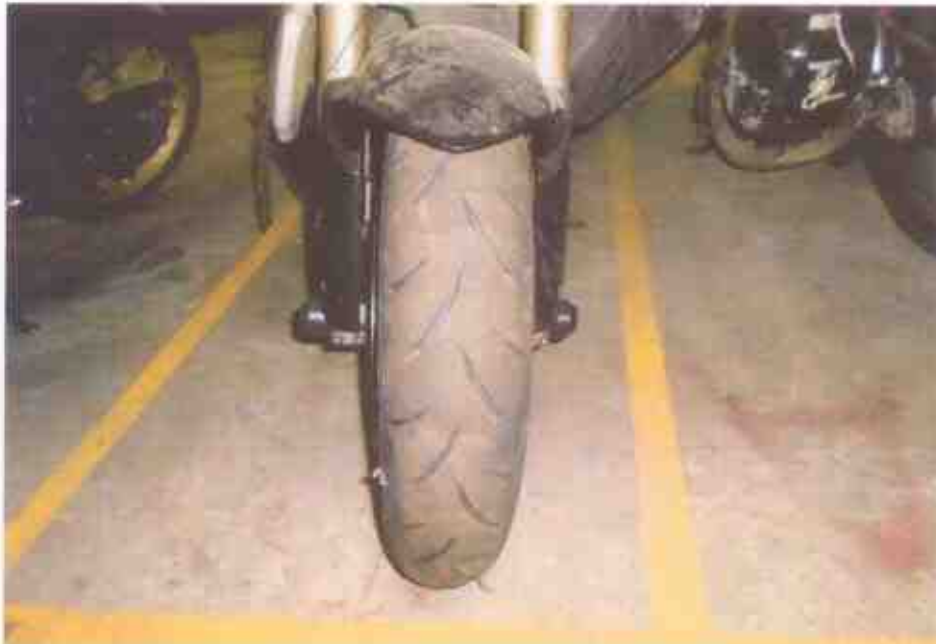
7. The condition of the Motorcycle's rear tyre was observed to be in serviceable condition whereas the front tyre was found to be deflated likely due to the accident impact. However, the tread pattern of the 2 tyres was clearly visible. We did not observe any tear, burst mark(s) and/or punctured hole(s) on the sidewalls as well as across the tread of the 2 tyres. The rear tyre was observed to be sufficiently inflated for vehicular operation. The tyre brand, tyre size and remaining tread depth of the 2 tyres were recorded as follows:-

**Photo 8** shows the front tyre of the Motorcycle. The pattern of the tread was clearly visible. There was no tear, burst mark(s) and/or punctured hole(s) on the sidewalls as well as across the tread of the front tyre. Except for it was observed to be deflated likely due to the accident's impact.

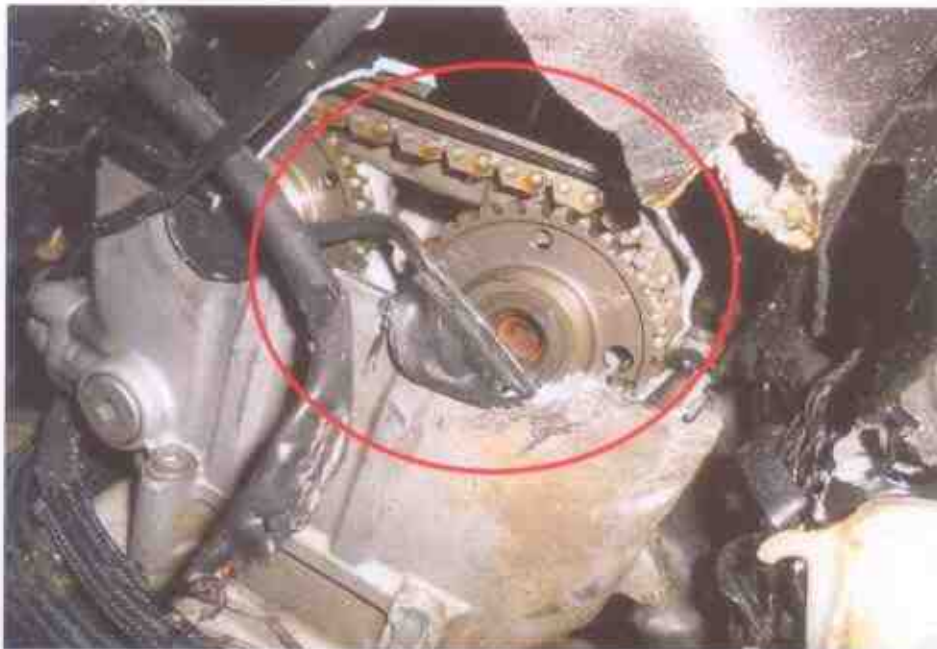
9. Upon examination of the Motorcycle's engine area, we had observed that the engine block had sustained with extensive damages due to the accident's collision impact. Hence, causing the operating fluids such as engine fluid to leak from the cracked/ damage areas.
10. The gear chain of the motorcycle was found to be intact without any misalignment. It was also adequately lubricated for operating purposes. Free play tension test was also conducted & found adequately acceptable. See photo 9 – 13 below.

Photo 9 shows extensive damages on the engine block. It was observed to be damaged as a result of the accident.

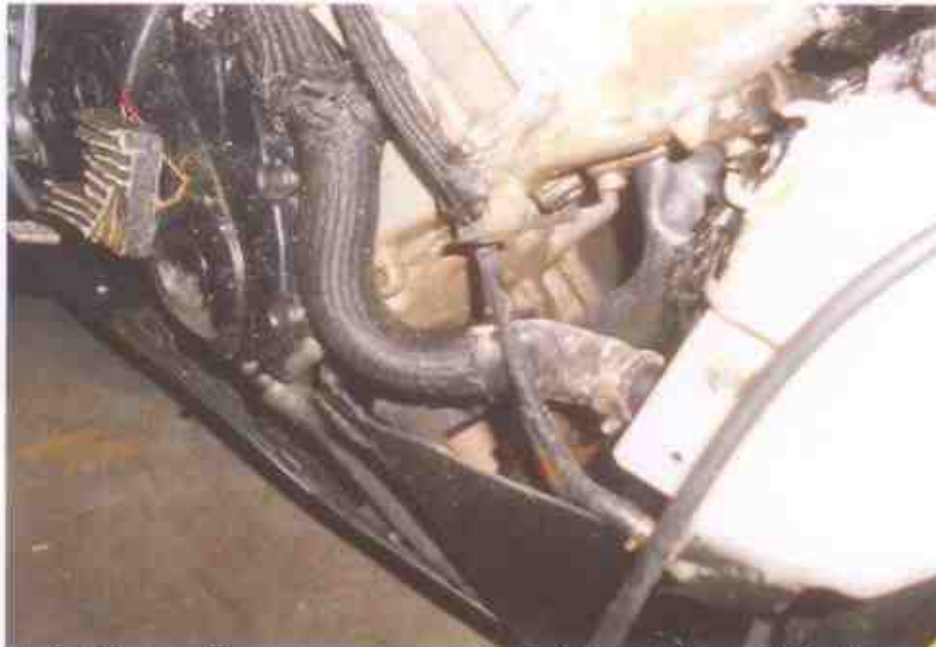
Photo 10 shows the engine was covered with fluid, indication(s) of fluid leakage stain observed around the engine area of the Motorcycle.

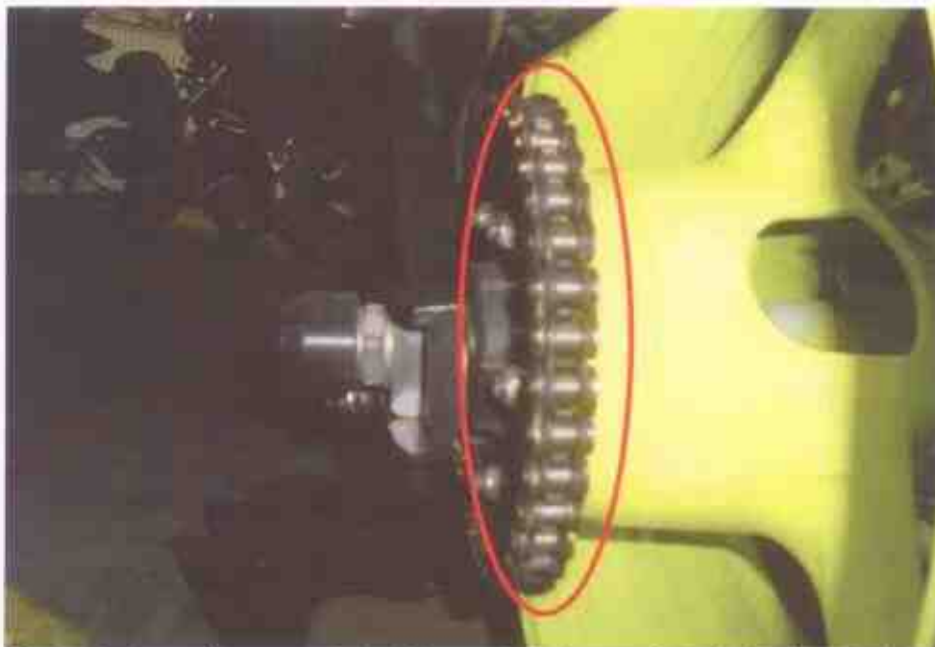
Photo 11 shows the gear chain of the motorcycle was found to be intact without any misalignment. It was also adequately lubricated for operating purposes.

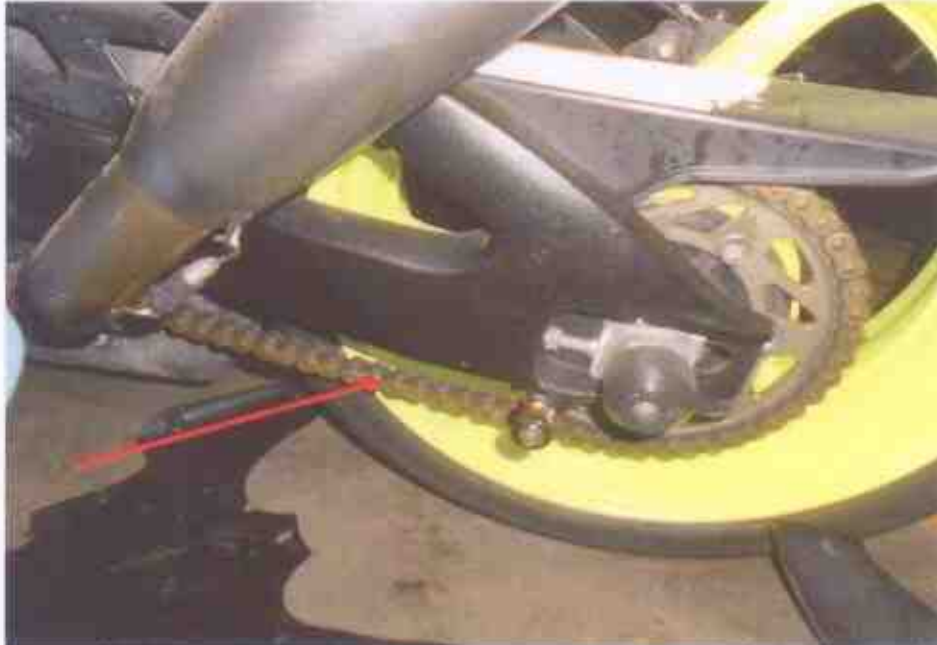
**Photo 12** shows the general view of the gear train (arrowed) of the Motorcycle, which was observed to be intact with no misalignment. It was also adequately lubricated for operating purposes.

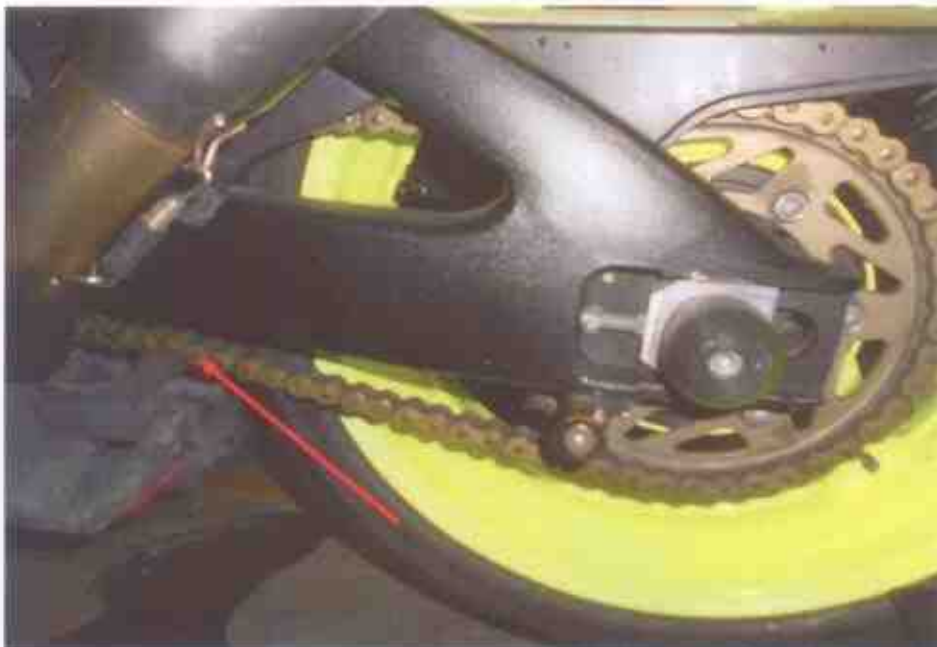
**Photo 13** shows the general view of the gear train (arrowed) of the Motorcycle, which was observed to be intact with no misalignment. It was also adequately lubricated for operating purposes. Free play tension was also observed & found adequately acceptable.

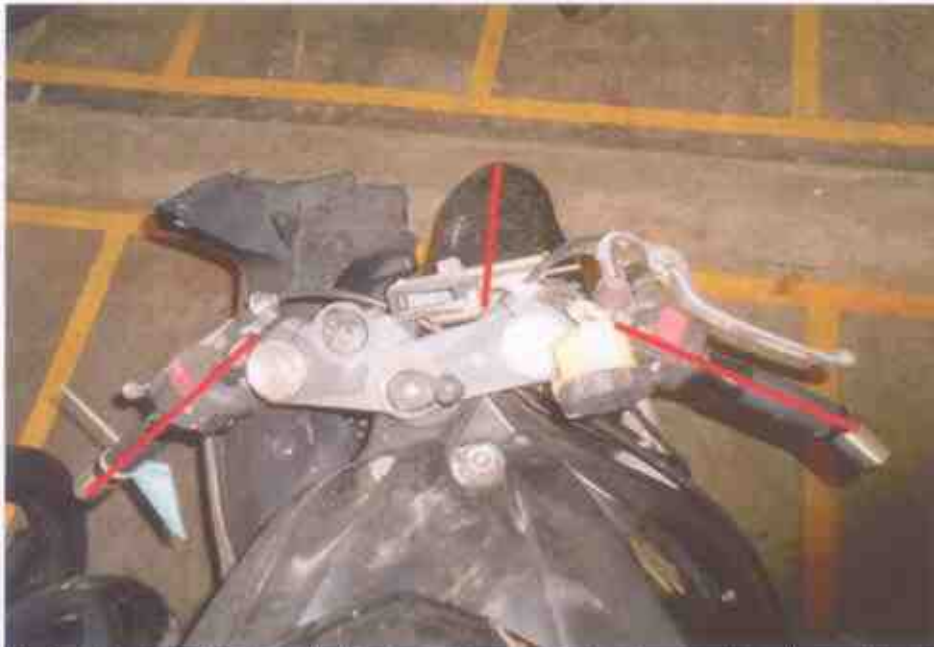
11. Our checks on the various steering components of the Motorcycle had revealed that its steering system was in not serviceable condition. Its handle bar was found to be bent/ damage likely due to the accident's impact collision.

Photo 14 shows the handle bar was observed to be damaged by the accident's impact. It was observed to be misaligned likely due to the accident's impact.

16. Basing on our physical inspection of the Motorcycle, it appears that the steering system was not in serviceable condition. Its handle bar was found to be bent/ damaged due to the accident's impact collision.

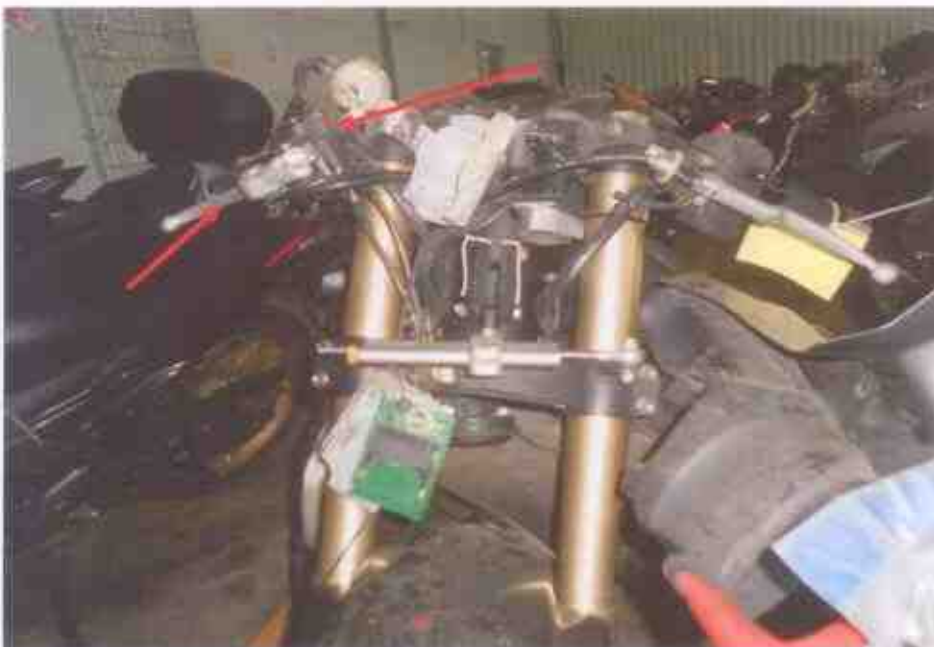
Photo 15 shows the steering system was observed to be damaged likely due to the accident's impact.

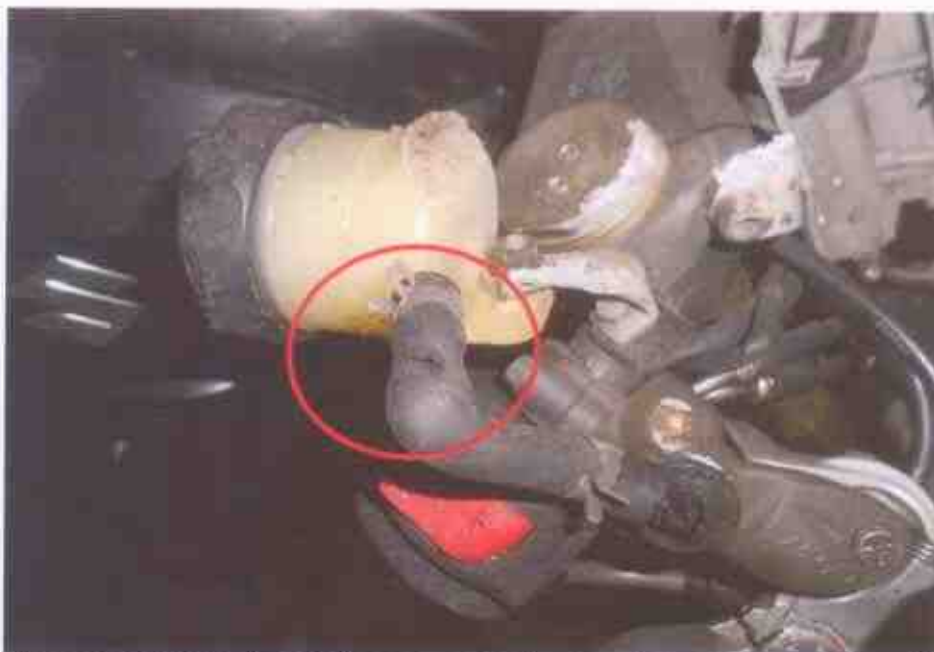
14. As for the front brake, its brake fluid reservoir was found to have been broken/cracked & the connecting hose was observed to be cut due to the accident's impact collision. However, the Motorcycle's braking system like the brake discs, brake callipers, brake pad and brake foot pedal revealed all to be intact and without damage. Our checks on the brake fluid had also indicated that the brake fluid was insufficient level for operational purposes due to the broken brake fluid reservoir.

Photo 16 shows the fluid brake reservoir for the front brake that was observed to be broken due to the accident. Its brake hose was also found to be cut/damaged.

17. The front braking systems of the Motorcycle could not be tested due to the damages sustained to the front brake fluid reservoir & cut front brake fluid hose as a result of the accident. However, further observation reveal that the front brake components such as brake cables, brake calliper brake pad amongst others were in serviceable condition. As for the rear brake, it was observed to be in serviceable condition as per our static brake test.

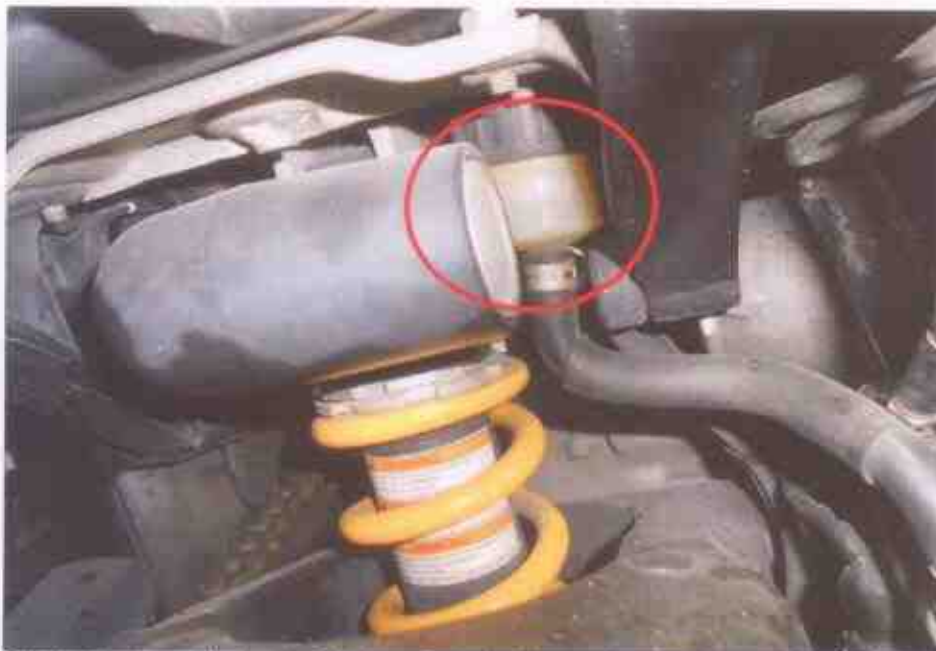
13. Static brake tests conducted only on the Motorcycle rear brake had appeared to indicate that it was in serviceable condition. There was some resistance felt (spongy like feel) upon stepping on the rear brake pedal. This would indicate that there was no leakage of pressure/vacuum in the rear brake system. Our checks on the brake fluid had also indicated that the brake fluid was of sufficient level for operational purposes, and without contamination.

Photo 17 shows the brake fluid reservoir for the rear brake. It was observed to be at sufficient level not affected by the accident.

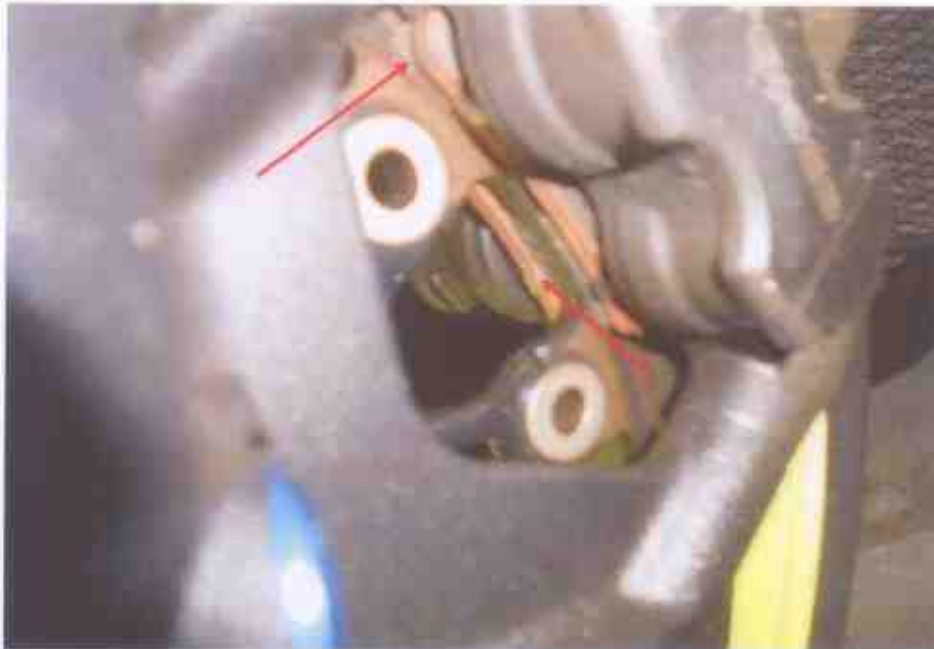
**Photo 18** shows the brake pad for the front brake, observed to be in serviceable condition at time of our inspection. The frictional material found to be sufficient for operational purposes.

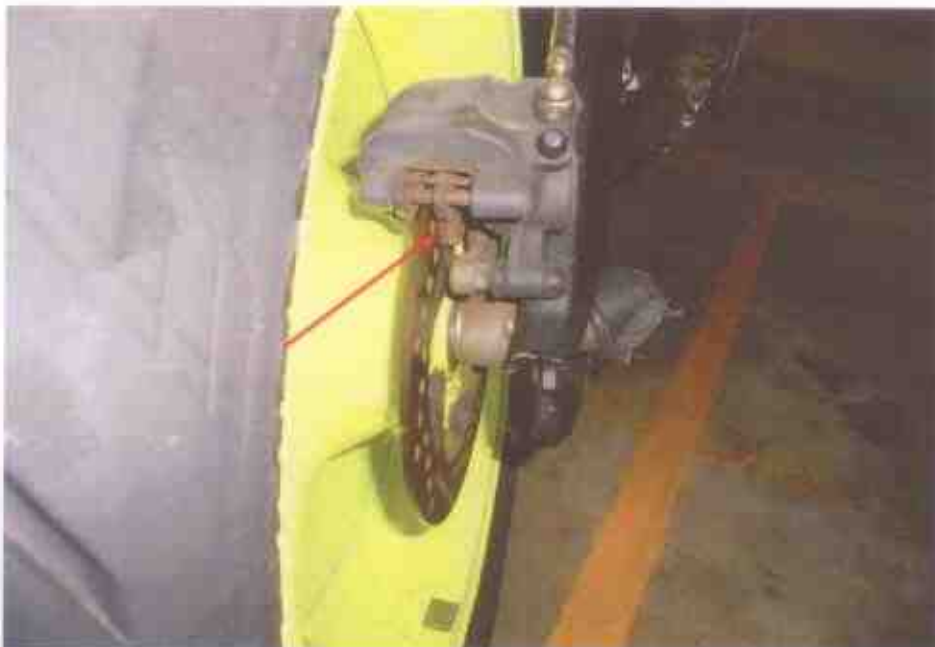
**Photo 19** shows the brake pad for the rear brake observed to be in serviceable condition at time of our inspection. The frictional material found to be sufficient for operational purposes.
