Your Ref: 6310331408SG
Our Ref :CI/AIG18012846/D

20 July 2018

TECHNICAL INVESTIGATION REPORT OF FIRE INCIDENT INVOLVING THE INSURED VEHICLE SJS 5270K ON 18 JUNE 2018

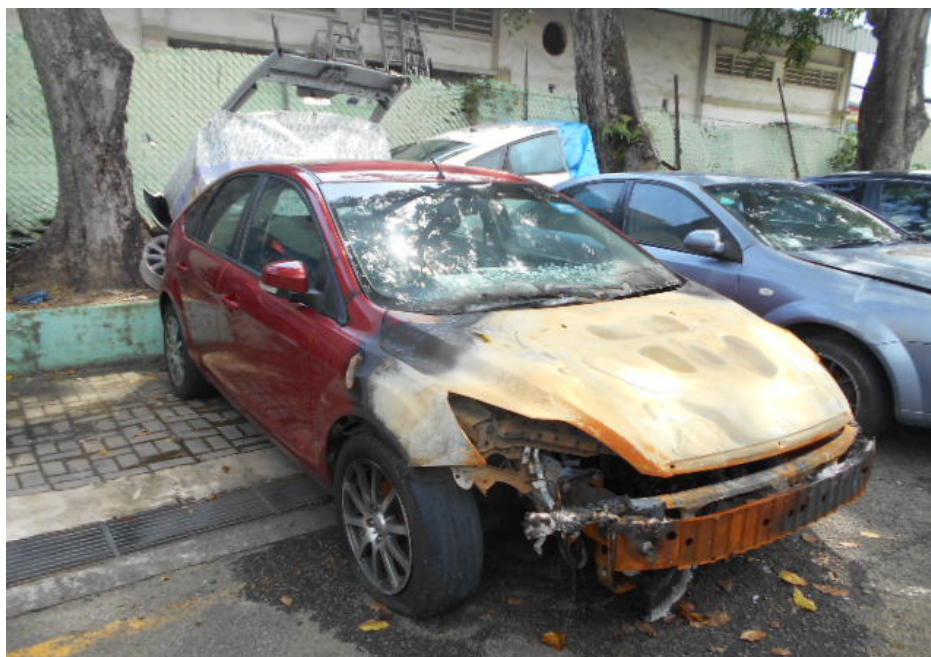
Photo 1 shows a general view of the front right body of the Insured Vehicle at the time of inspection. The Insured Vehicle was observed to have sustained severe fire damage at its frontal body. Its front bumper, front bonnet, front grille, front right headlamp and front right fender were amongst the body parts that were found to have been burnt as a result of the fire.

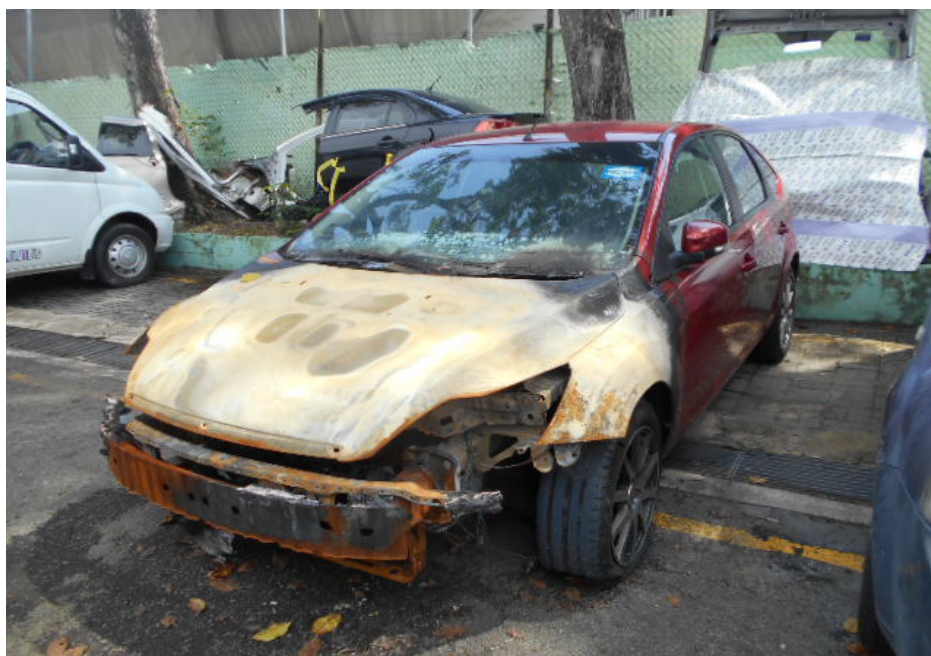
Photo 2 shows a general view of the front left body of the Insured Vehicle at the time of inspection. The Insured Vehicle was observed to have extensive sustained fire damage at its frontal body. Its front bumper, front left fender, front left headlamp, front bonnet and front windscreen were amongst the body parts that were found to have been burnt as a result of the fire.

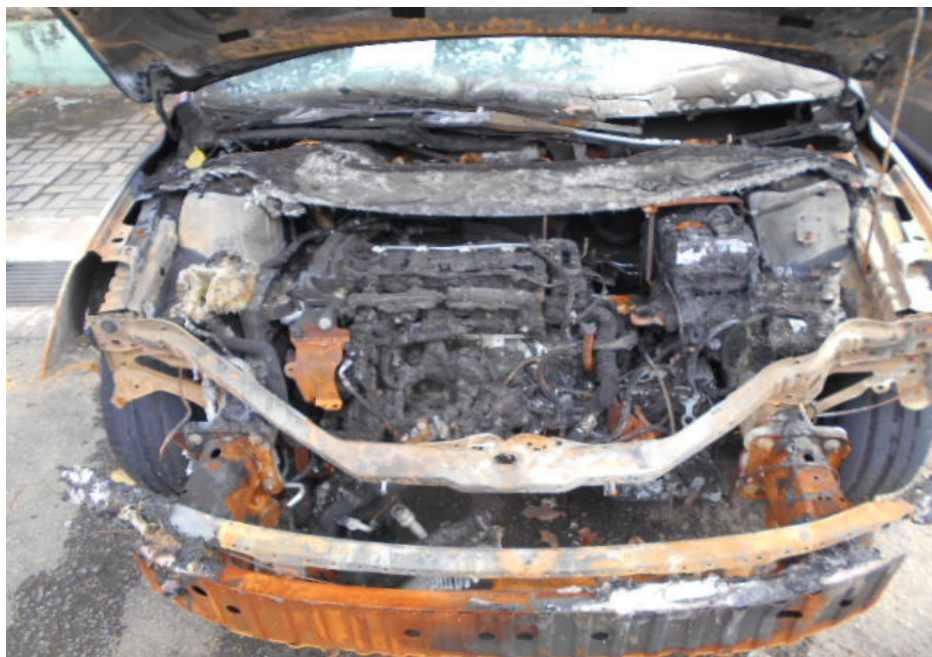
Photo 3 shows the engine compartment of the Insured Vehicle at the time of inspection. Almost all the parts inside the engine compartment were observed to be burnt and/or melted as a result of the fire. These parts had included its radiator, air condenser, cooling fan, intake manifold, fuse box, battery, air duct, hoses and pipes amongst others.

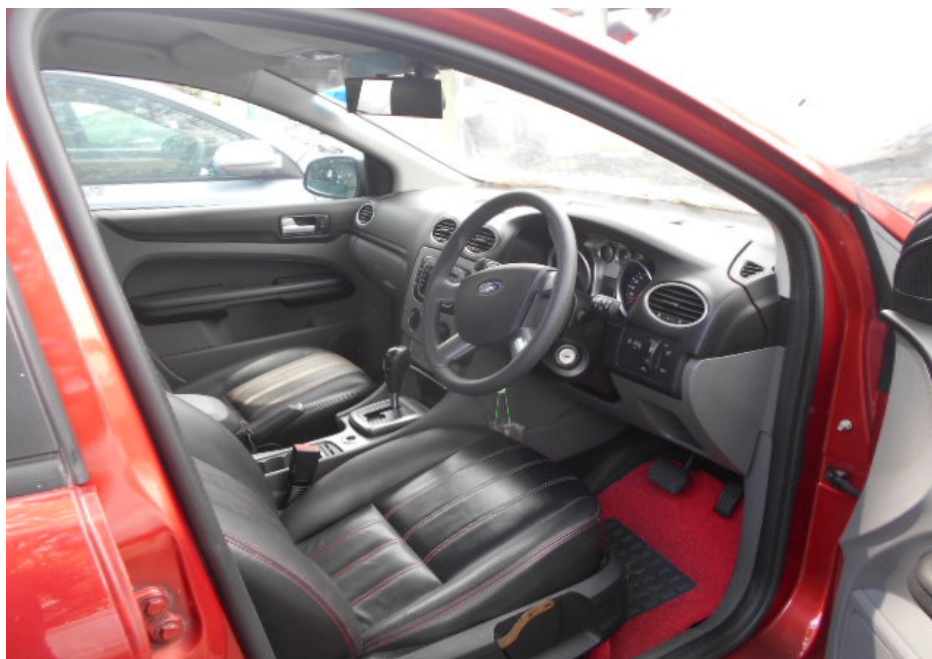
Photo 4 shows the interior compartment of the Insured Vehicle, which was unaffected by the incident.

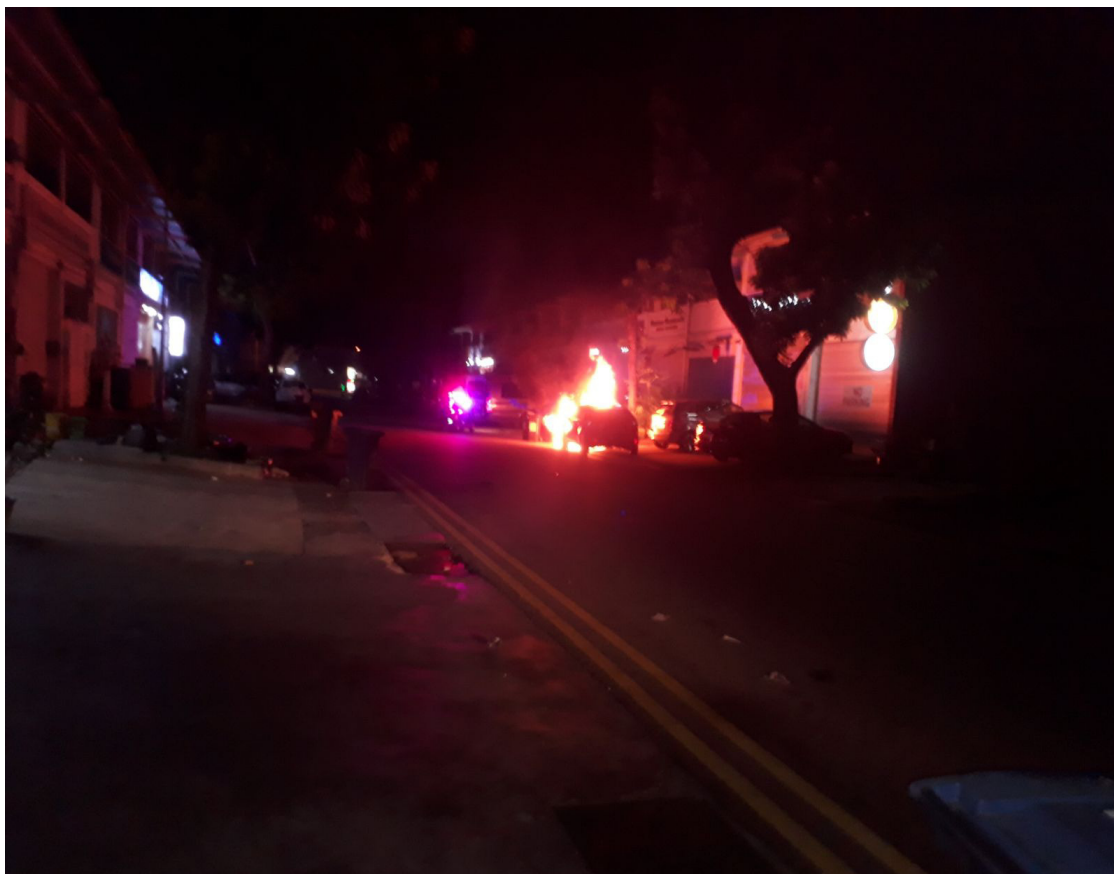
Photo 5 shows the Insured Vehicle at the incident location. The photographs provided to me were mostly taken a distance away from where the Insured Vehicle could be seen. The quality of the photographs was relatively poor but had showed the frontal body of the Insured Vehicle engulfed in flames. In general, the observations gathered from my review of the photographs that were taken by Mr Shahrem at the incident scene had corresponded to his description of the events that he had related to me during our conversation on 12 July 2018.

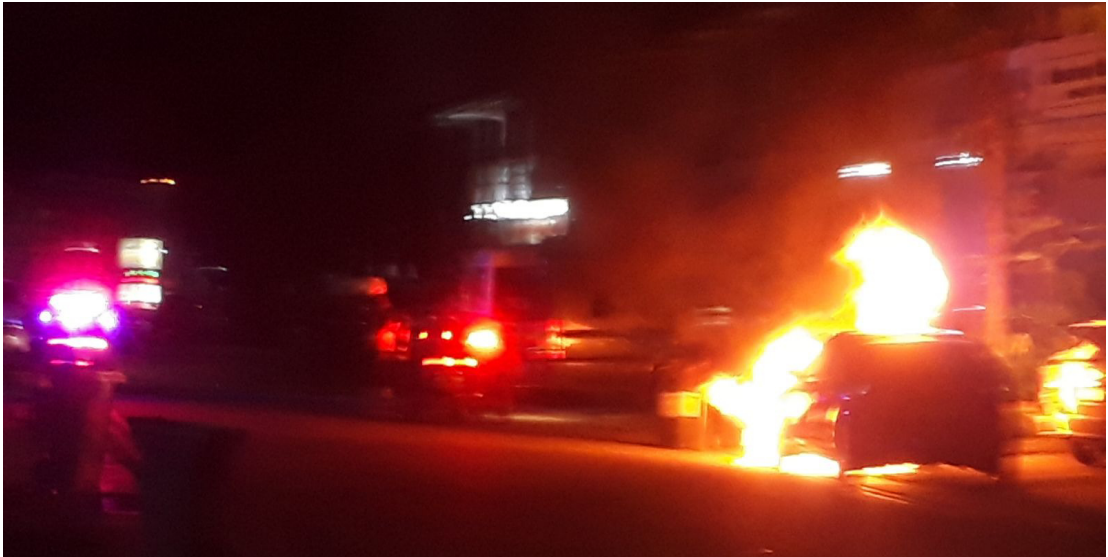
Photo 6 shows the Insured Vehicle at the incident location. The photographs provided to me were mostly taken a distance away from where the Insured Vehicle could be seen. The quality of the photographs was relatively poor but had showed the frontal body of the Insured Vehicle engulfed in flames.

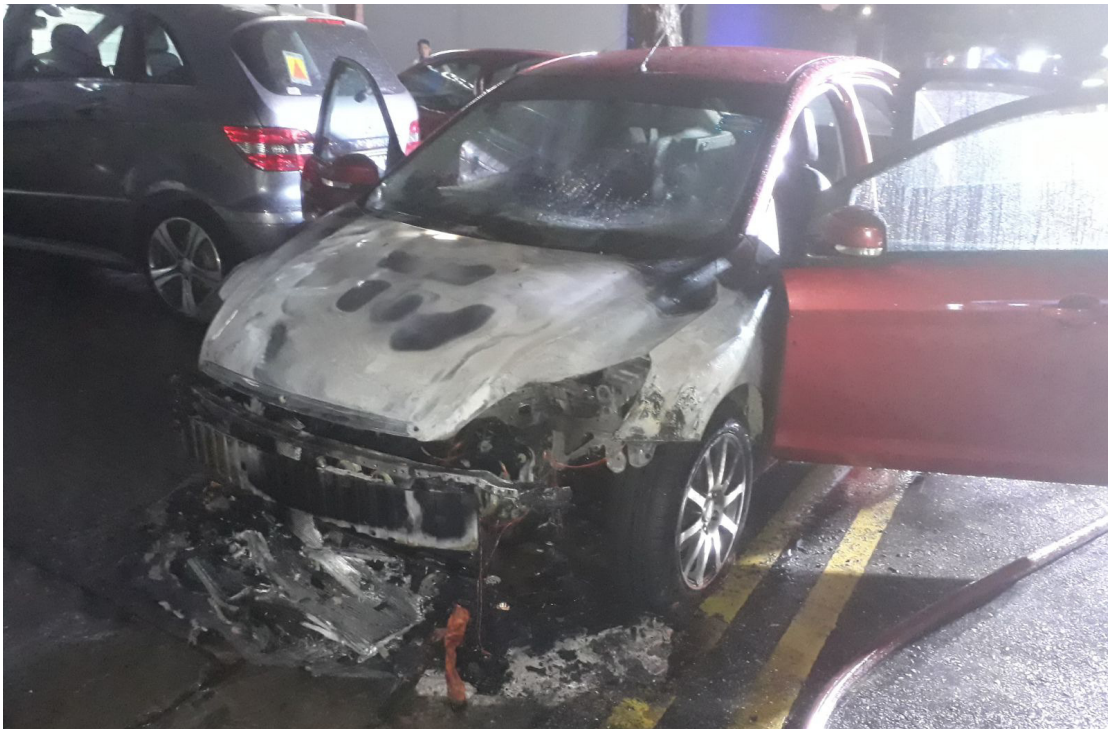
Photo 7 shows the Insured Vehicle at the incident location after the fire was extinguished. The damage of burnt nature to the Insured Vehicle had corresponded to the damages as seen by me during my inspection of the Insured Vehicle. There was also no unusual foreign material(s) and/or object(s) on the ground in the immediate area of where the Insured Vehicle was located. In general, the observations gathered from my review of the photographs that were taken by Mr Shahrem at the incident scene had corresponded to his description of the events that he had related to me during our conversation on 12 July 2018.

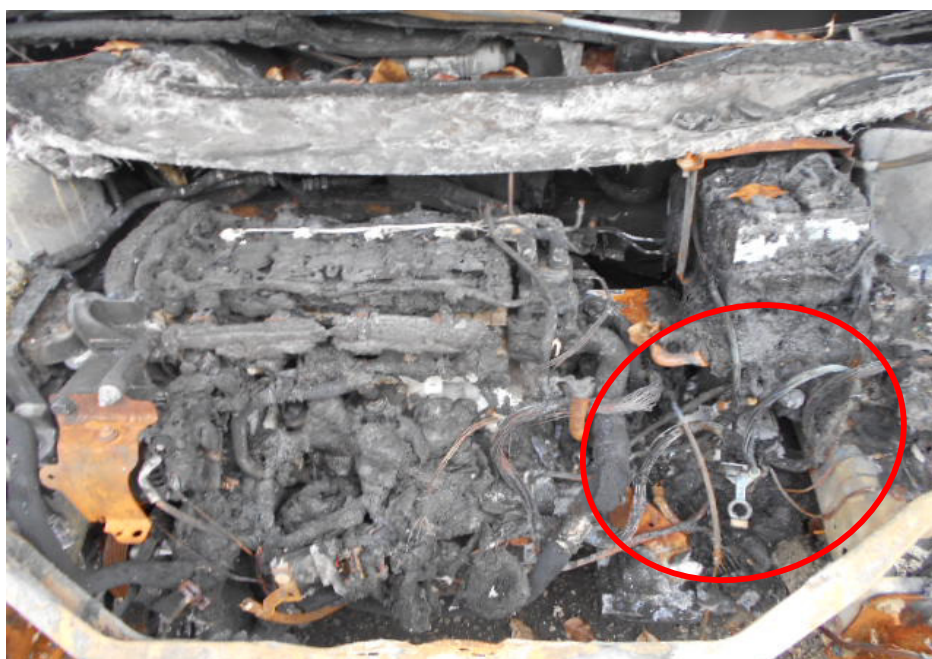
21. The fire being due to electrical in nature is also supported by the physical condition of the wirings within the engine compartment. During my inspection of the Insured Vehicle, I had observed faint greenish residue along the wirings at the centre left area of the engine compartment. These wirings were original factory fitted wirings. The presence of such greenish residue indicates internal heating of copper wires, which is a sign of an electrical short circuit occurring. The greenish residue is normally left behind from oxidation as a result of chemical reaction involving the copper wires. See photo 8 - 10 below.

Photo 8 shows a general view of the Insured Vehicle's engine compartment. Faint greenish residue was observed along the wirings at the centre left area (circled) of the engine compartment. The presence of such greenish residue indicates internal heating of copper wires, which is a sign of an electrical short circuit occurring.

29. Having investigated and technically analysed the damages of burnt nature to the Insured Vehicle, I am of the view that the cause of fire to the Insured Vehicle was of electrical in nature. For this particular case, the fire had originated along the wiring inside the engine compartment, somewhere around the centre left area of the engine compartment. The wiring was an original factory wiring harness.
30. I did not find any evidence which had suggested that the cause of fire to the Insured Vehicle was due to poor maintenance and/or recurring electrical problem.
31. I did not find any modification(s) and/or additional electronic and/or electrical component(s) fitted on the Insured Vehicle at the time of my inspection.
32. My investigations also revealed that at the time of writing this report, there is no manufacturer recall of similar make and model vehicle as the Insured Vehicle.

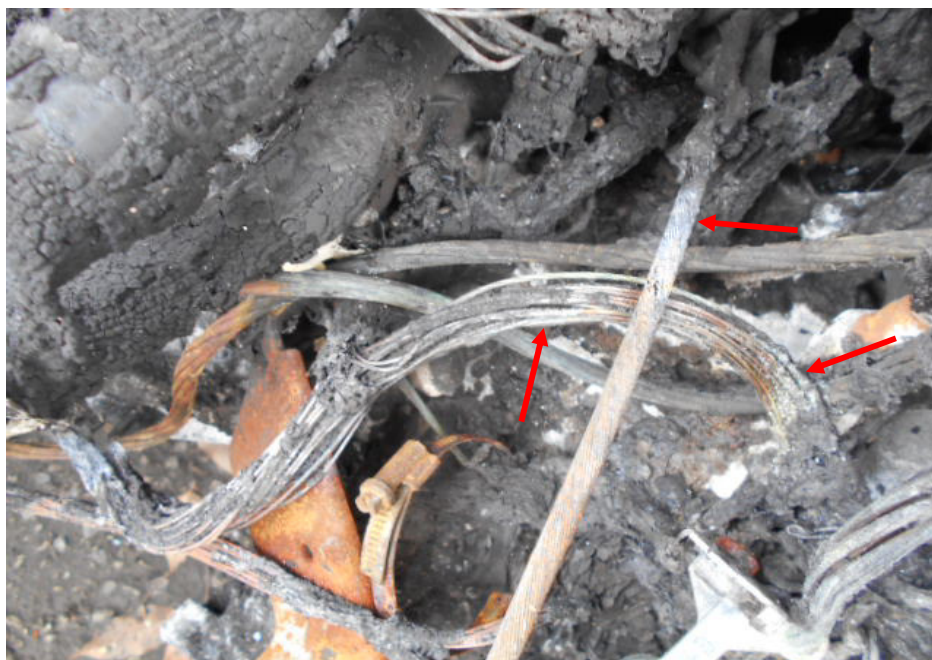
Photo 9 shows a closer view of the wirings (arrowed) at the centre left area of the Insured Vehicle's engine compartment, where faint greenish residue was found. These wirings were original factory fitted wirings.

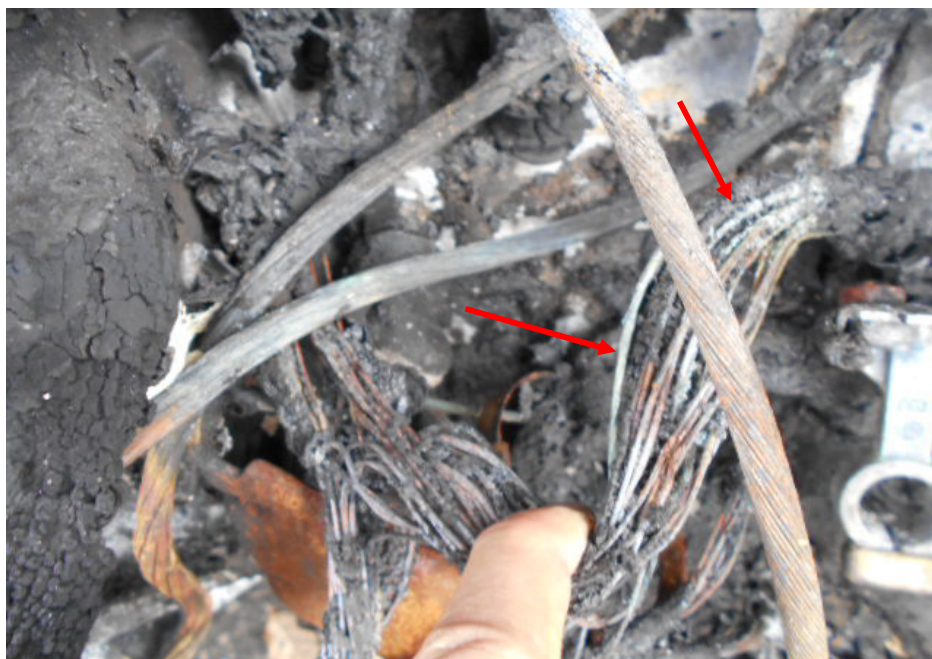
Photo 10 shows a closer view of the wirings (arrowed) at the centre left area of the Insured Vehicle's engine compartment, where faint greenish residue was found. These wirings were original factory fitted wirings. The presence of such greenish residue indicates internal heating of copper wires, which would suggest that the cause of fire to the Insured Vehicle was due to electrical in nature.
