Your Ref: 6310331408SG
Our Ref : CI/AIG18012846/D

20 July 2018

**TECHNICAL INVESTIGATION REPORT OF FIRE INCIDENT INVOLVING THE
INSURED VEHICLE SJS 5270K ON 18 JUNE 2018**

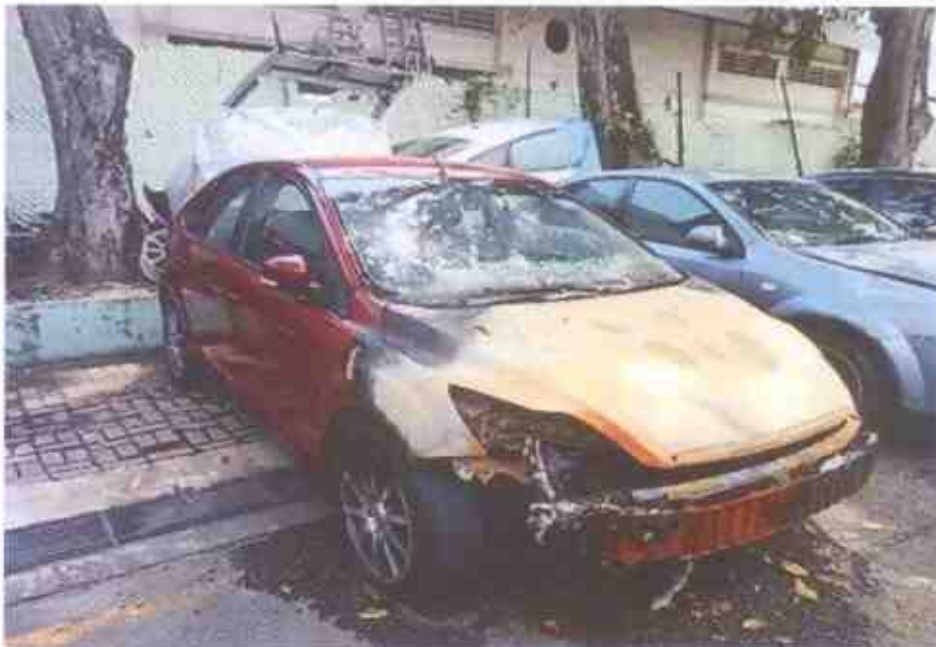
Photo 1 shows a general view of the front right body of the Insured Vehicle at the time of inspection. The Insured Vehicle was observed to have sustained severe fire damage at its frontal body. Its front bumper, front bonnet, front grille, front right headlamp and front right fender were amongst the body parts that were found to have been burnt as a result of the fire.

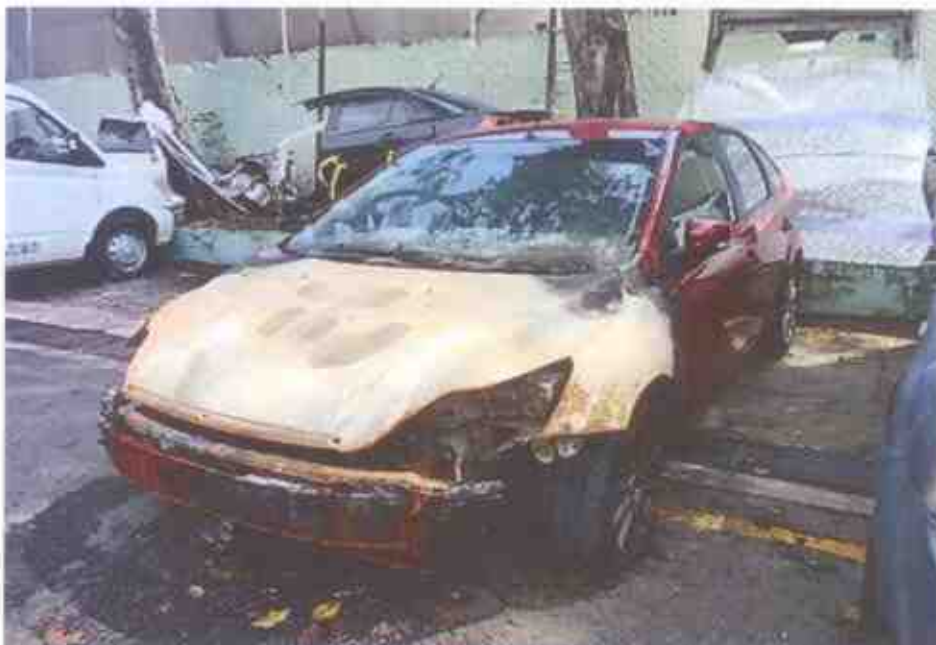
Photo 2 shows a general view of the front left body of the Insured Vehicle at the time of inspection. The Insured Vehicle was observed to have extensive sustained fire damage at its frontal body. Its front bumper, front left fender, front left headlamp, front bonnet and front windscreen were amongst the body parts that were found to have been burnt as a result of the fire.

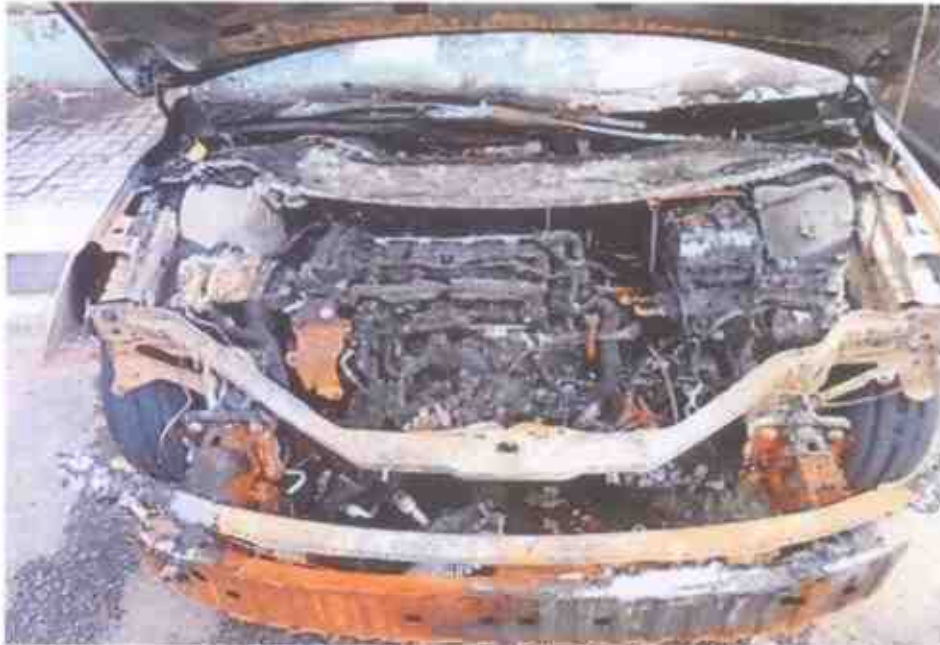
Photo 3 shows the engine compartment of the Insured Vehicle at the time of inspection. Almost all the parts inside the engine compartment were observed to be burnt and/or melted as a result of the fire. These parts had included its radiator, air condenser, cooling fan, intake manifold, fuse box, battery, air duct, hoses and pipes amongst others.

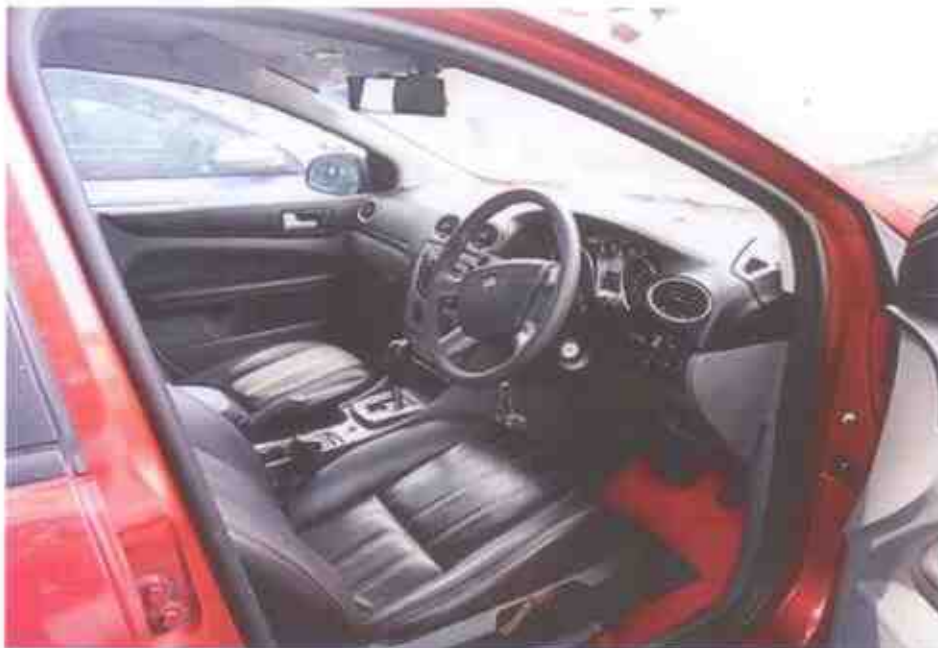
Photo 4 shows the interior compartment of the Insured Vehicle, which was unaffected by the incident.

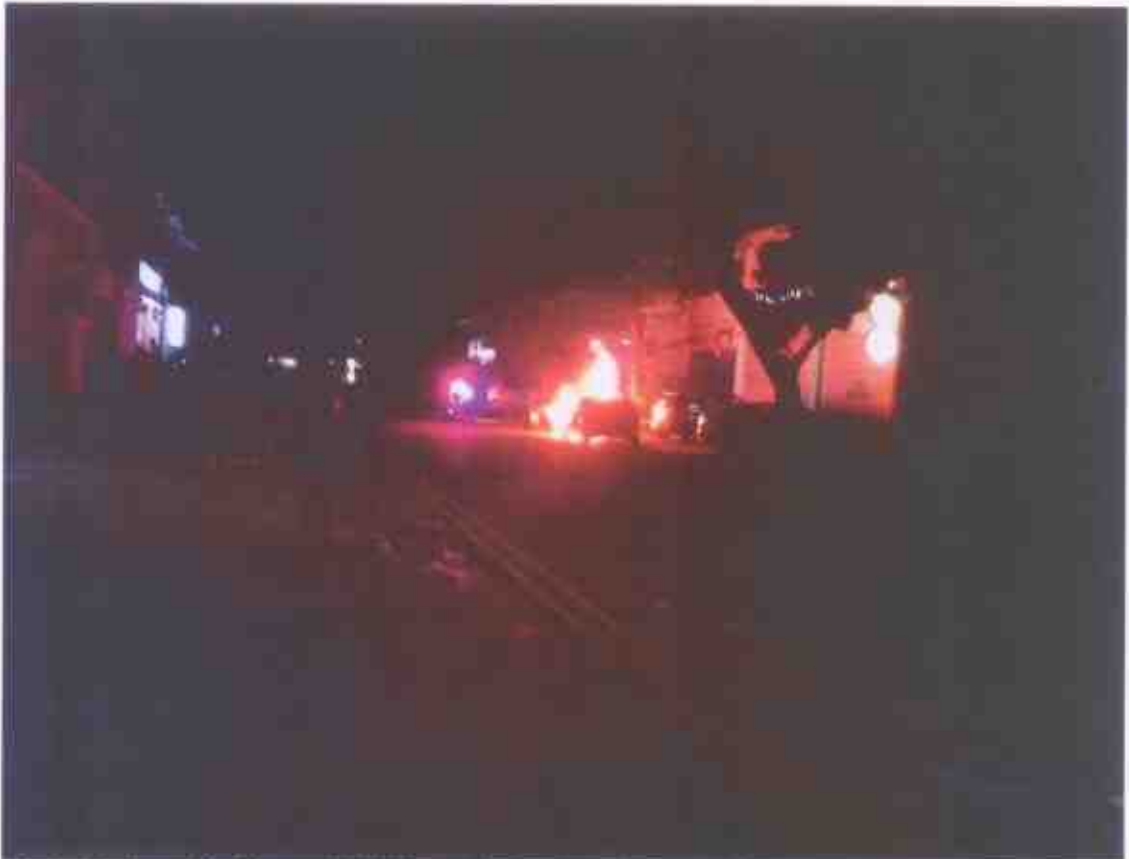
Photo 5 shows the Insured Vehicle at the incident location. The photographs provided to me were mostly taken a distance away from where the Insured Vehicle could be seen. The quality of the photographs was relatively poor but had showed the frontal body of the Insured Vehicle engulfed in flames. In general, the observations gathered from my review of the photographs that were taken by Mr Shahrem at the incident scene had corresponded to his description of the events that he had related to me during our conversation on 12 July 2018.

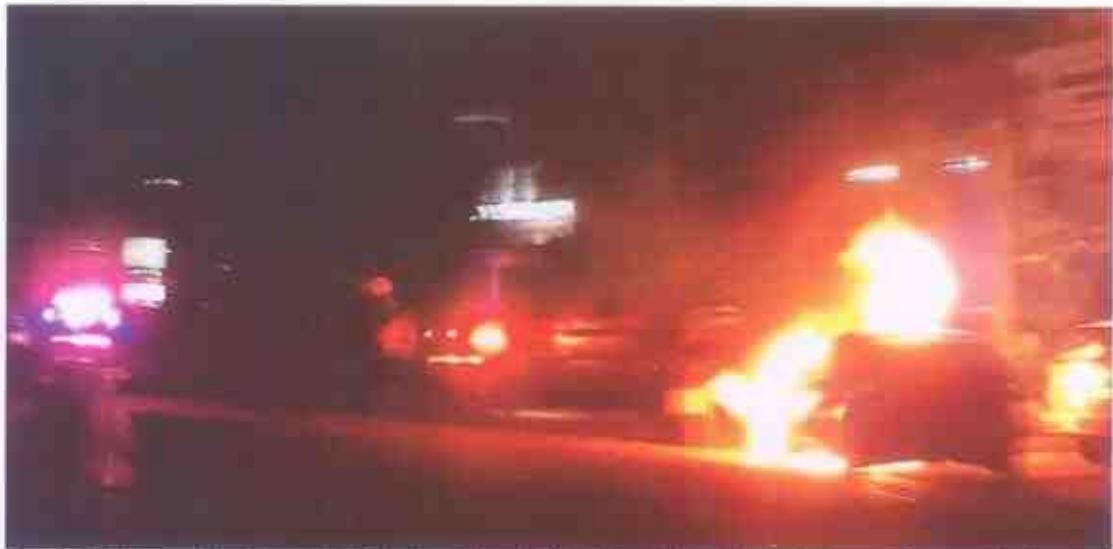
Photo 6 shows the Insured Vehicle at the incident location. The photographs provided to me were mostly taken a distance away from where the Insured Vehicle could be seen. The quality of the photographs was relatively poor but had showed the frontal body of the Insured Vehicle engulfed in flames.

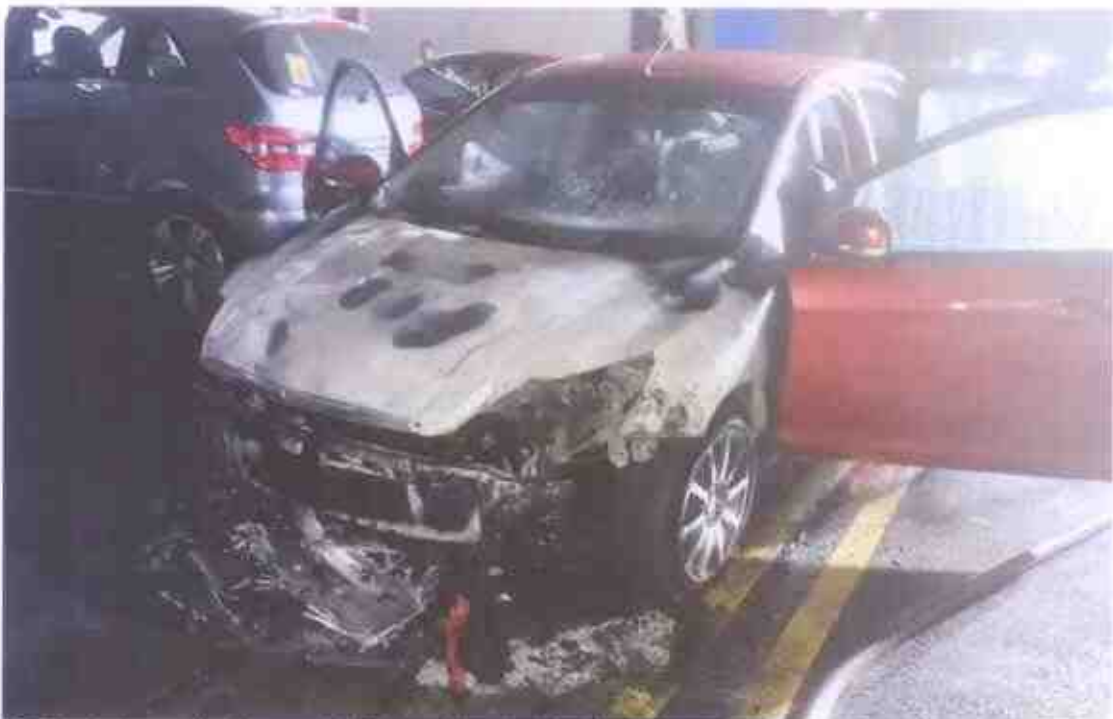
Photo 7 shows the Insured Vehicle at the incident location after the fire was extinguished. The damage of burnt nature to the Insured Vehicle had corresponded to the damages as seen by me during my inspection of the Insured Vehicle. There was also no unusual foreign material(s) and/or object(s) on the ground in the immediate area of where the Insured Vehicle was located. In general, the observations gathered from my review of the photographs that were taken by Mr Shahrem at the incident scene had corresponded to his description of the events that he had related to me during our conversation on 12 July 2018.

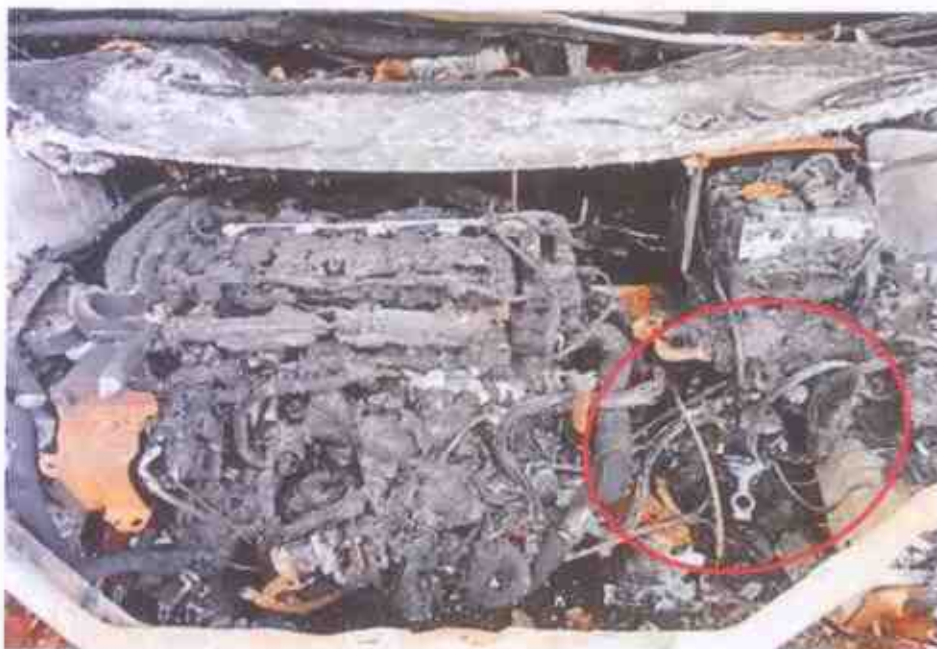
21. The fire being due to electrical in nature is also supported by the physical condition of the wirings within the engine compartment. During my inspection of the Insured Vehicle, I had observed faint greenish residue along the wirings at the centre left area of the engine compartment. These wirings were original factory fitted wirings. The presence of such greenish residue indicates internal heating of copper wires, which is a sign of an electrical short circuit occurring. The greenish residue is normally left behind from oxidation as a result of chemical reaction involving the copper wires. See photo 8 - 10 below.

Photo 8 shows a general view of the Insured Vehicle's engine compartment. Faint greenish residue was observed along the wirings at the centre left area (circled) of the engine compartment. The presence of such greenish residue indicates internal heating of copper wires, which is a sign of an electrical short circuit occurring.

29. Having investigated and technically analysed the damages of burnt nature to the Insured Vehicle, I am of the view that the cause of fire to the Insured Vehicle was of electrical in nature. For this particular case, the fire had originated along the wiring inside the engine compartment, somewhere around the centre left area of the engine compartment. The wiring was an original factory wiring harness.
30. I did not find any evidence which had suggested that the cause of fire to the Insured Vehicle was due to poor maintenance and/or recurring electrical problem.
31. I did not find any modification(s) and/or additional electronic and/or electrical component(s) fitted on the Insured Vehicle at the time of my inspection.
32. My investigations also revealed that at the time of writing this report, there is no manufacturer recall of similar make and model vehicle as the Insured Vehicle.

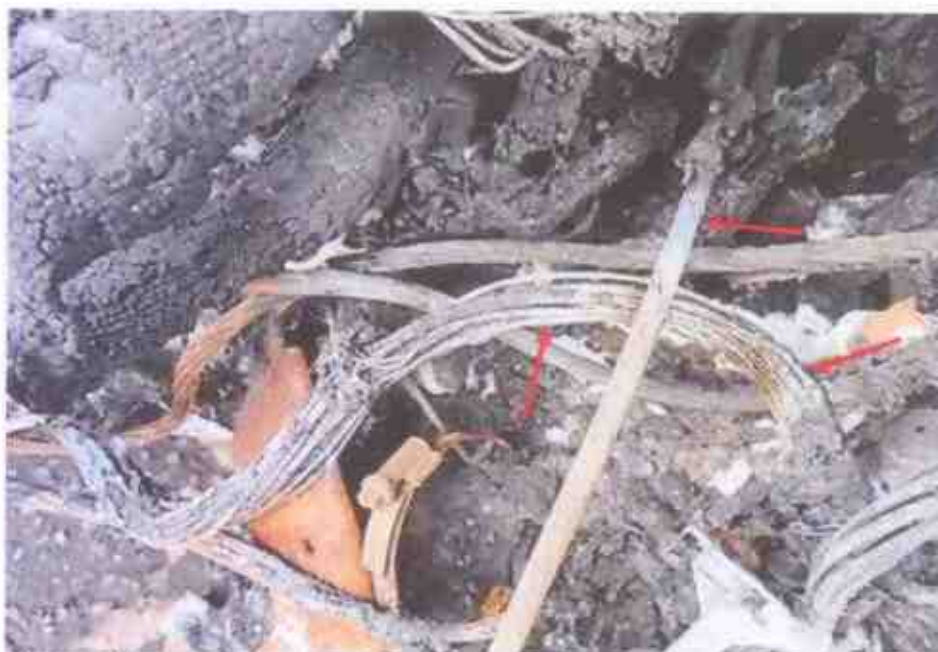
Photo 9 shows a closer view of the wirings (arrowed) at the centre left area of the Insured Vehicle's engine compartment, where faint greenish residue was found. These wirings were original factory fitted wirings.

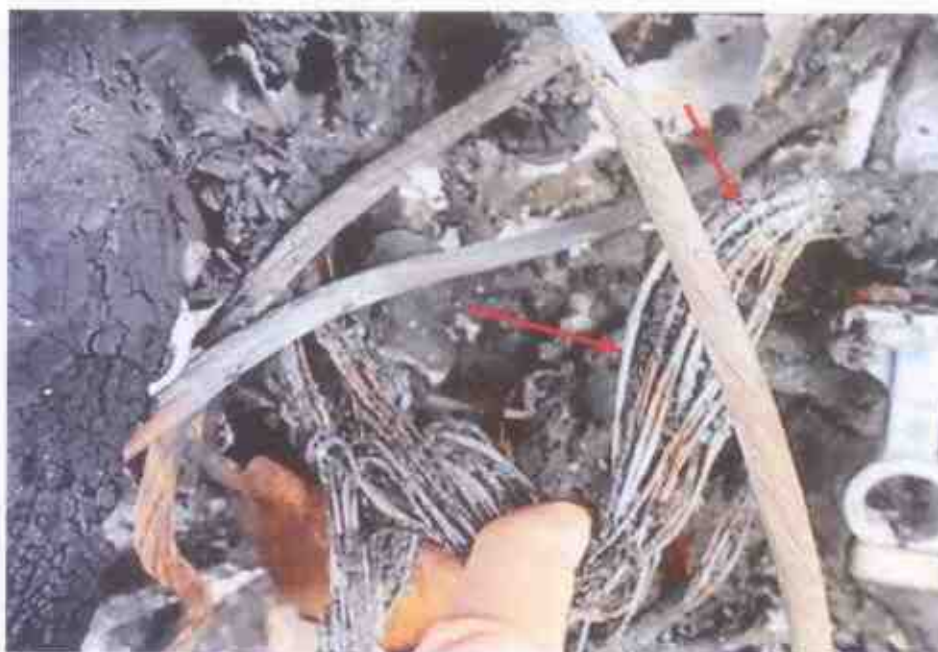
Photo 10 shows a closer view of the wirings (arrowed) at the centre left area of the Insured Vehicle's engine compartment, where faint greenish residue was found. These wirings were original factory fitted wirings. The presence of such greenish residue indicates internal heating of copper wires, which would suggest that the cause of fire to the Insured Vehicle was due to electrical in nature.
