Your Ref : M548459
Our Ref : CI/MSG18012883/N

**AUTOMOBILE TECHNICAL INVESTIGATION REPORT OF ACCIDENT
INVOLVING YN 6639Z AND XD 4304S ON 1 FEBRUARY 2018**

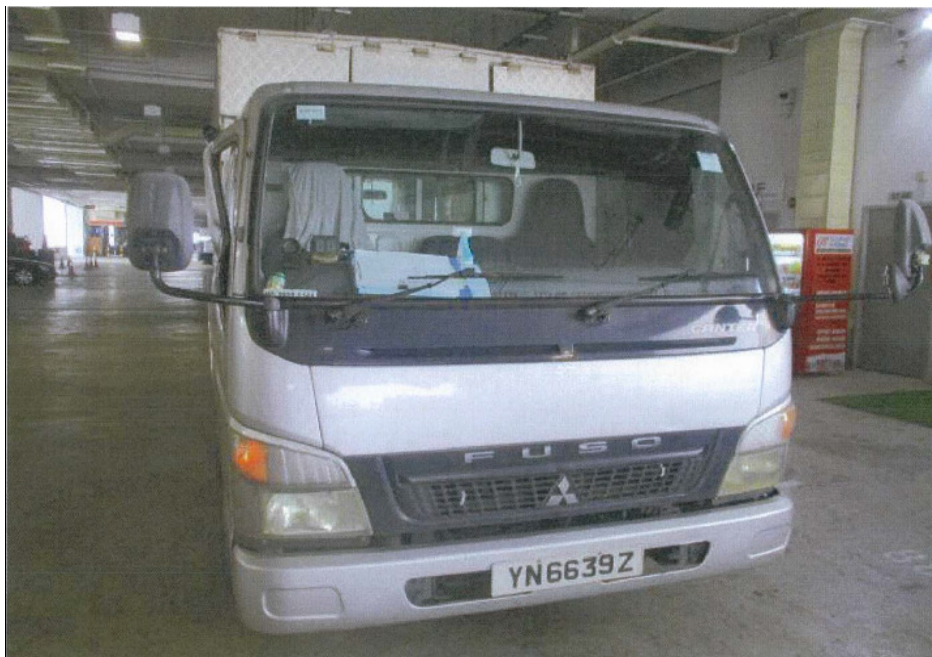
7. Based on the circumstances of the case contained in the Singapore Accident Statement and photographs which were taken during the accident reporting on the next day after the accident, we note that the Mitsubishi had sustained an impact onto its right front portion, particularly to the driver door.
8. Examination of these photographs had showed dislodgement and buckling of the driver door. There was a slight dent on the right front portion. The right side mirror cover was missing and graze marks were found on the front portion of the right side mirror. The extent of the damages observed clearly indicates that the impact onto the Mitsubishi was more to the right front portion and relatively significant. See photos 1 – 4 below.

Photo 1 shows a general view of the front portion of the Mitsubishi at the time of reporting, which was taken the next day after the accident. Based on the circumstances of the case contained in the Singapore Accident Statement, we note that the Mitsubishi had sustained damages to its right front portion.

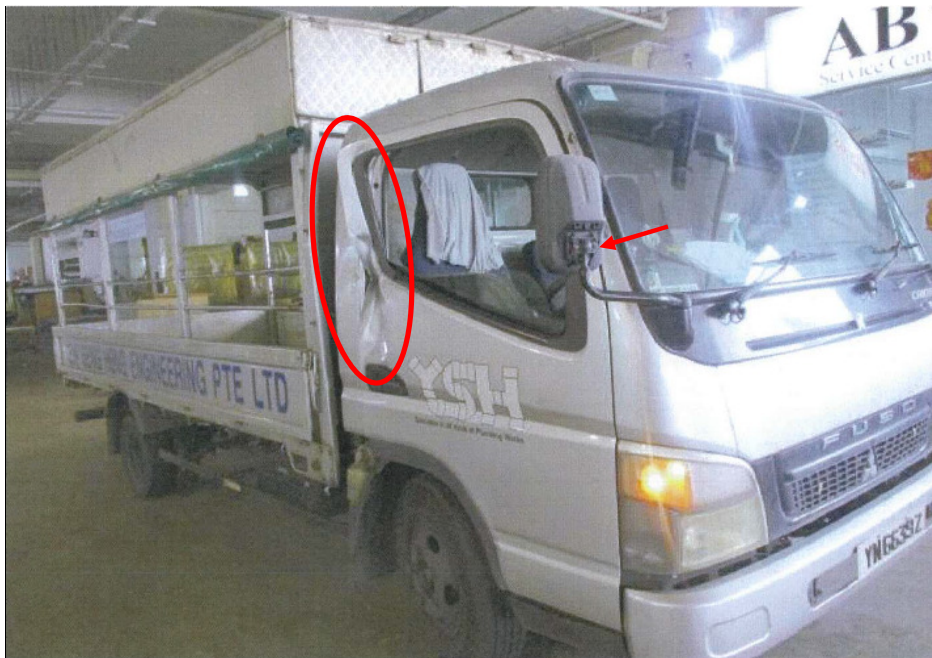
Photo 2 shows a right side view of the Mitsubishi. We observed dislodgement and buckling of the driver door (circled). The right side mirror cover was missing (arrowed).

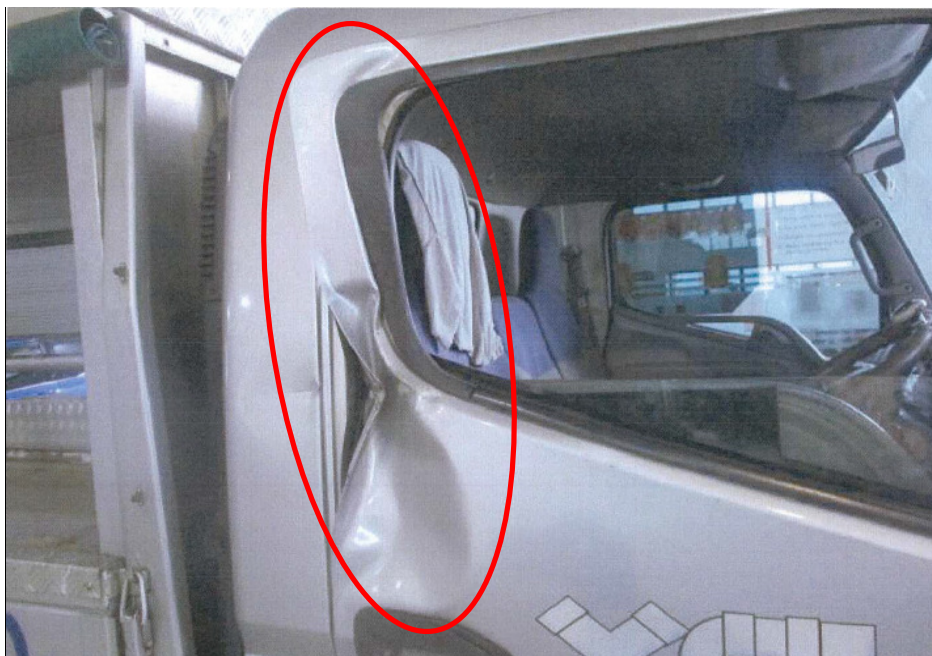
Photo 3 shows a closer view of the dislodgement and buckling of the driver door and a slight dent on the right front portion (circled).

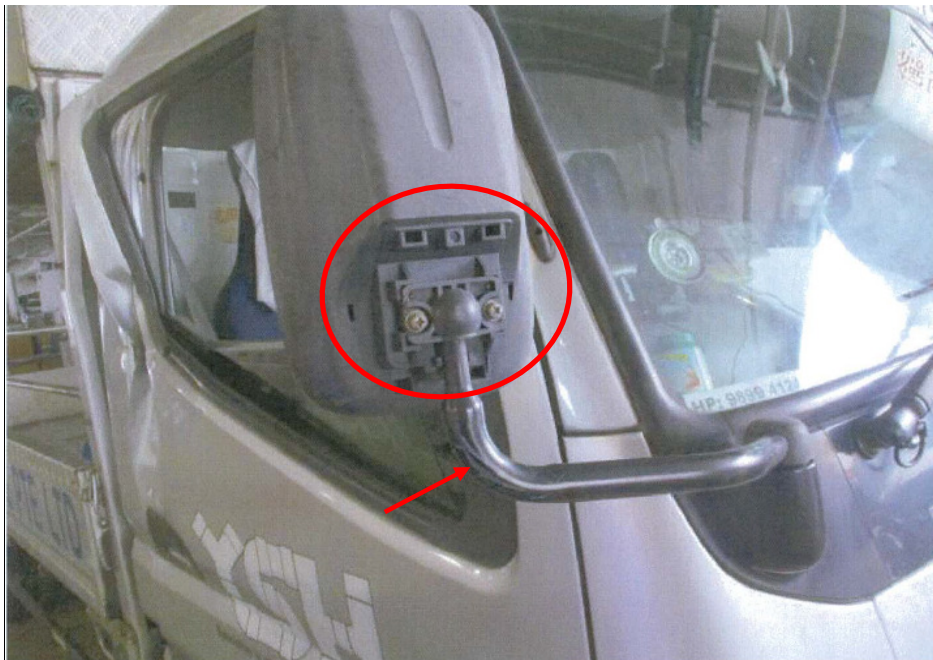
Photo 4 shows a close up view of the Mitsubishi's right side mirror. The right side mirror cover was missing (circled) and graze marks were found on the front portion of the right side mirror (arrowed).

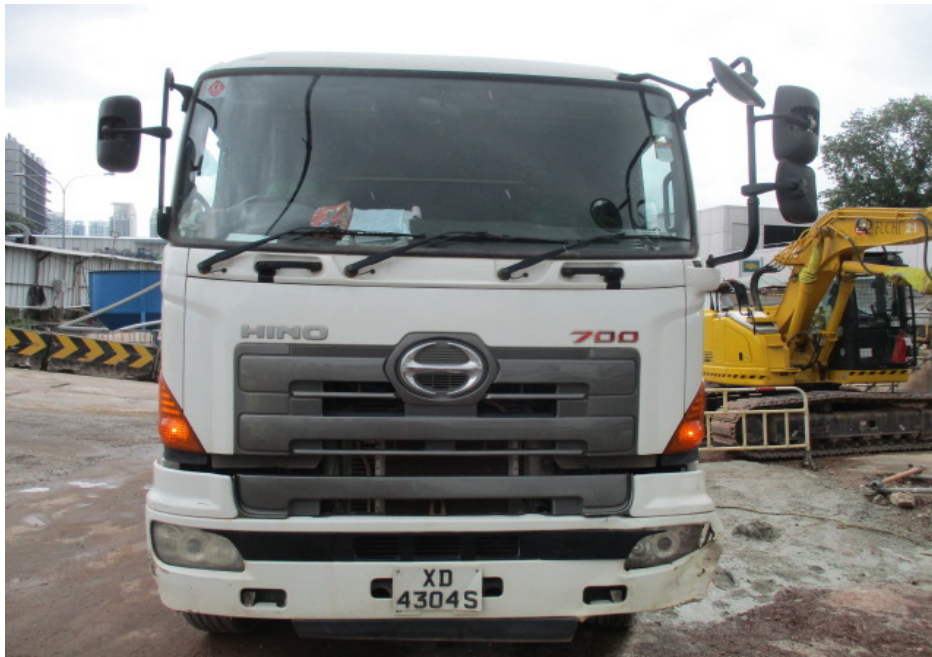
Photo 5 shows the general view of the front portion of the Hino at the time of inspection.

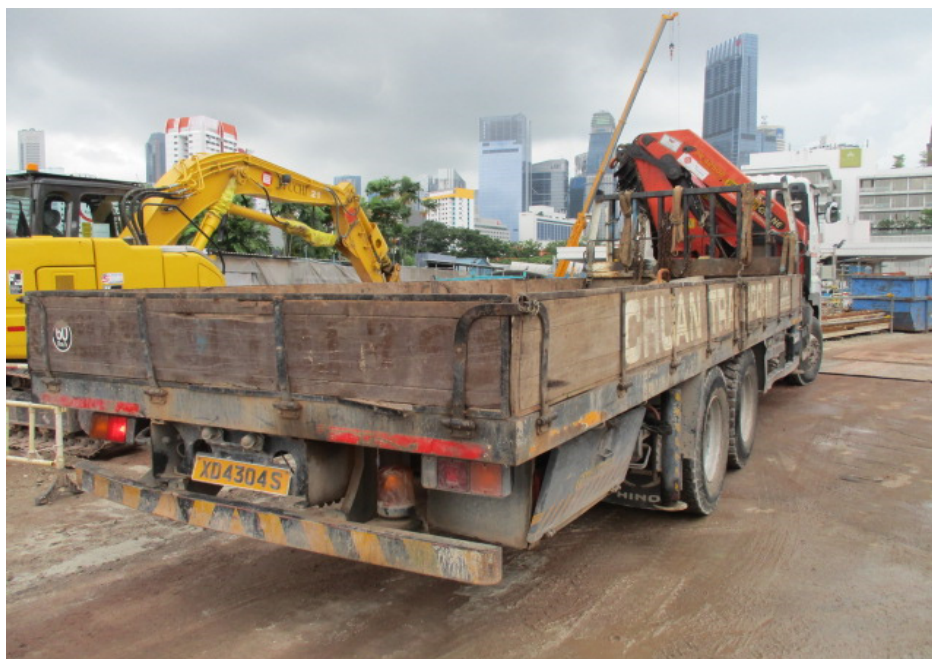
Photo 6 shows a rear right view of the Hino at the time of inspection.

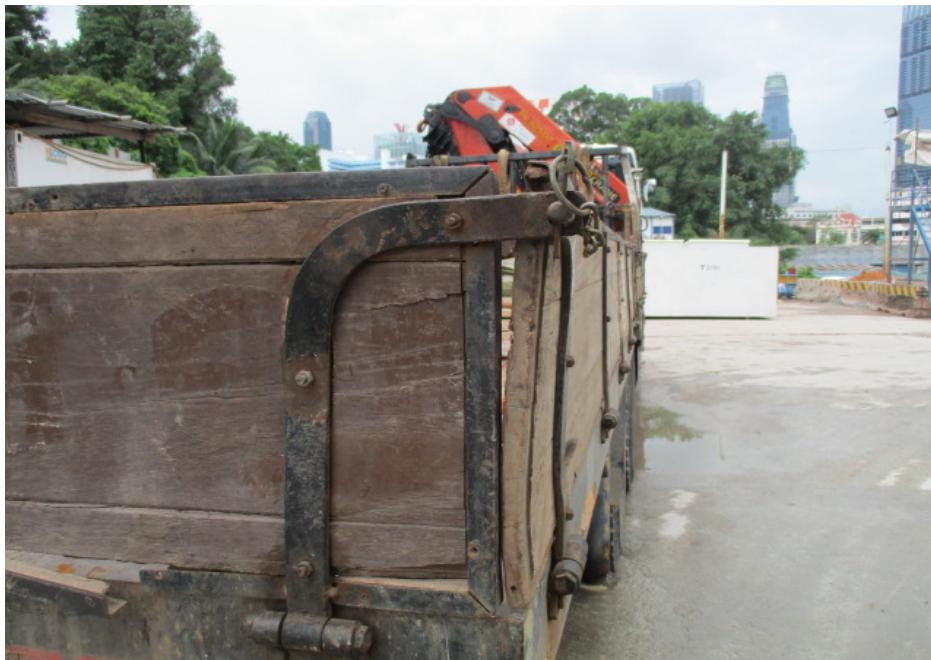
Photo 7 shows a closer up view of the right side hinge of the Hino's tailgate.

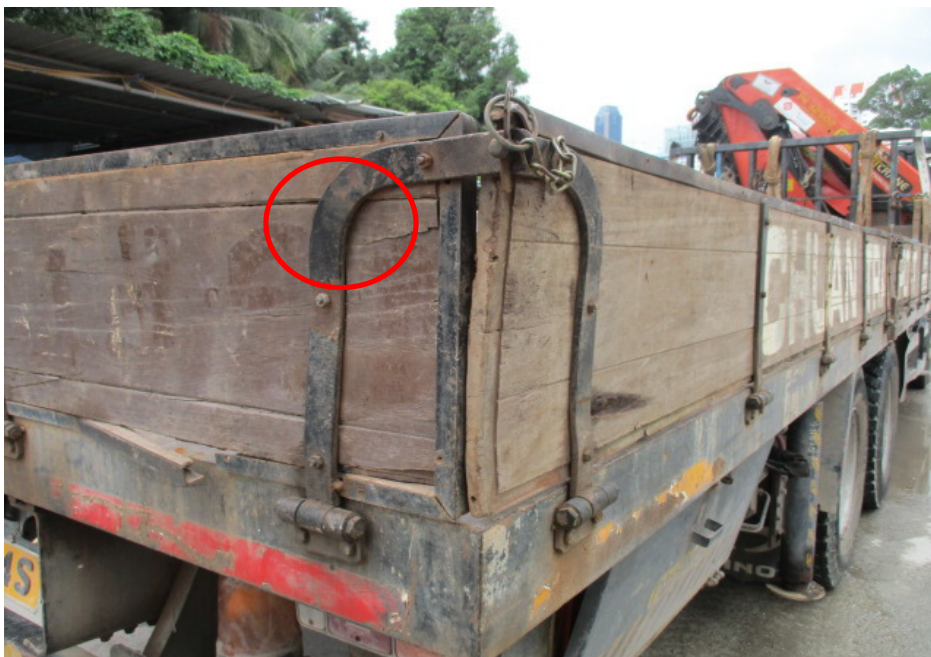
Photo 8 shows at the time of our inspection, we found the right side hinge of the Hino's tailgate to be buckled (circled).

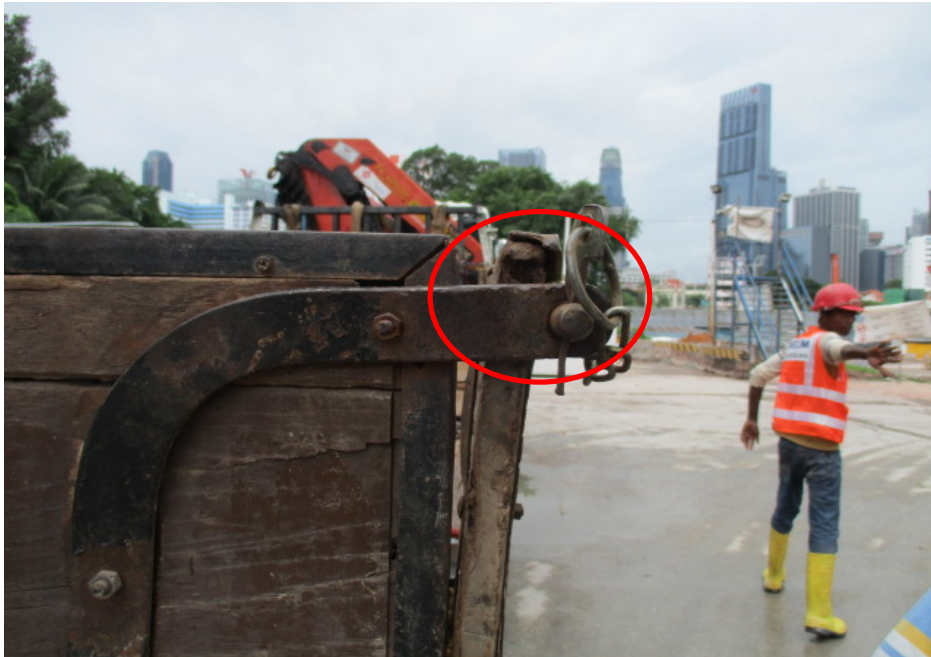
Photo 9 shows upon closer examination, we observed faint graze marks on the right tailgate lock (circled).

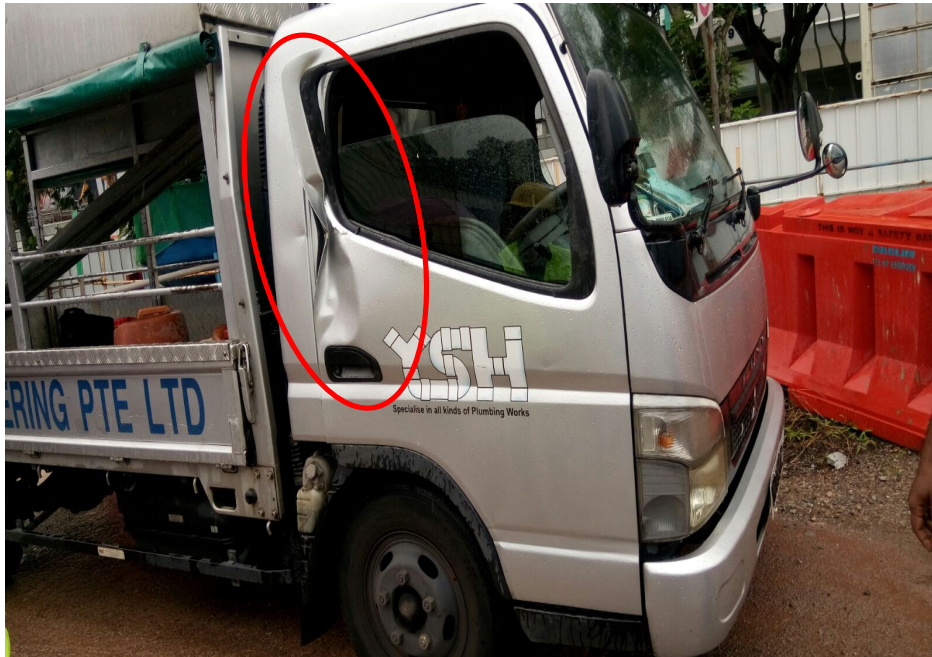
Photo 10 shows the damages sustained to the right front portion of the Mitsubishi post- accident (circled).

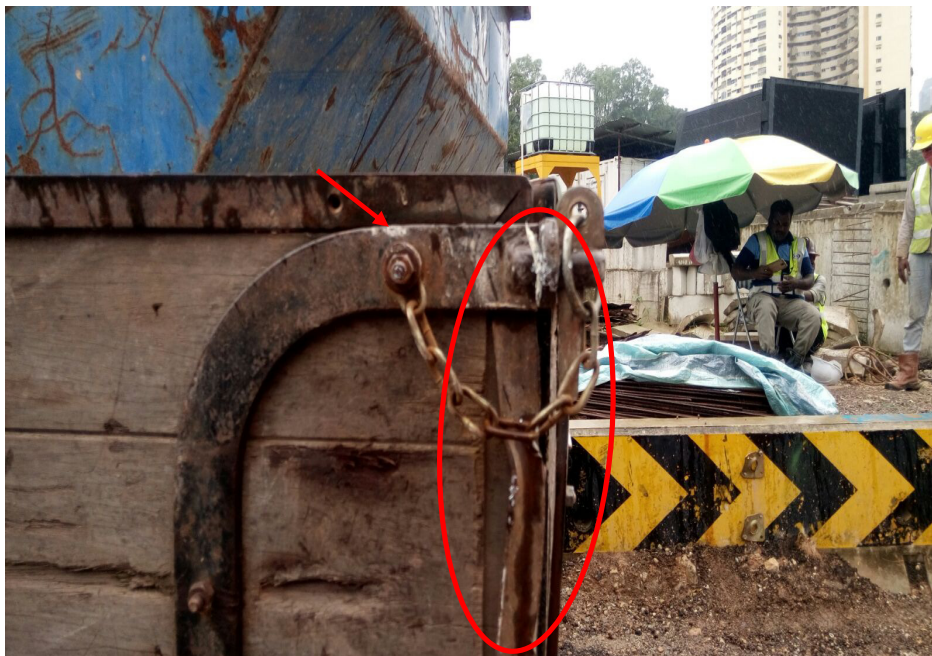
12. We were able to obtain post- accident photographs of the Involved Motor Vehicles from both drivers. The photographs show the damages sustained to both vehicles. We noticed the same graze marks on the right tailgate lock of the Hino. Closer examination of these photographs revealed what appeared to be silver- coloured paint transfer marks on the Hino's right tailgate lock, which is similar to the colour of the Mitsubishi. See photos 10 & 11 below.

Photo 11 shows the damages sustained to the rear right portion of the Hino post-accident. We noticed the same graze marks on the right tailgate of the Hino (arrowed). Closer examination of this photograph revealed what appeared to be silver- coloured paint transfer marks on the Hino's right tailgate lock, which is similar to the colour of the Mitsubishi (circled).

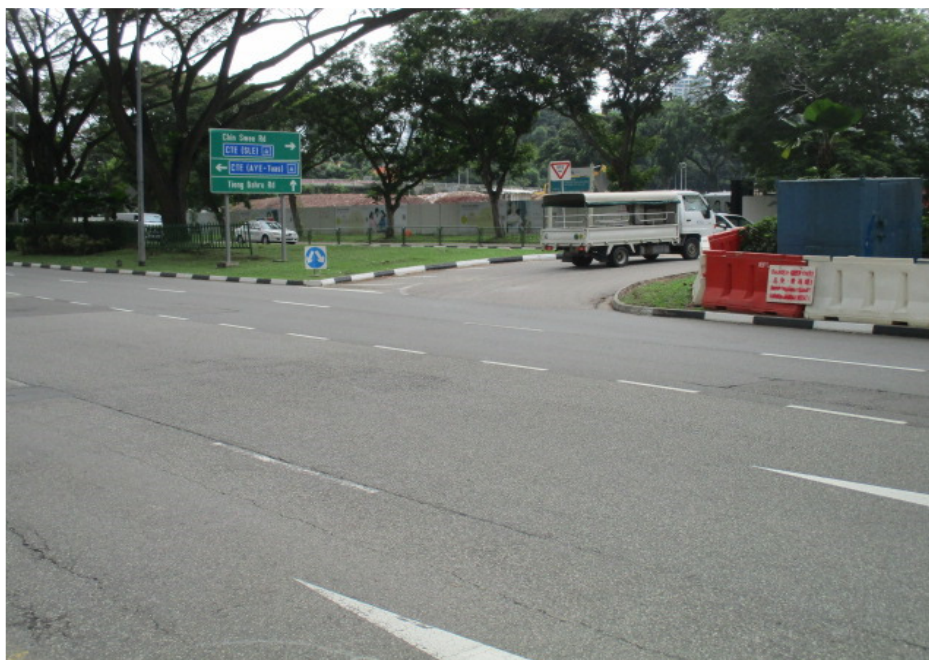
14. The accident had occurred at the U-turn opening in the road divider along Outram Road. There are 4 lanes along Outram Road. The 1st lane is for motorists to either make a U- turn or proceed straight. Following the circumstances according to Mr Nathan, the Mitsubishi would have either been positioned along the 2nd lane beside the Hino right before Mr Ong made the right turn or behind the Hino on the 1st lane and came into contact with the Hino as it proceeded to go straight right before Mr Ong completed making the right turn. See photo 12 below.

Photo 12 shows the U-turn opening in the road divider along Outram Road where the accident occurred. There are 4 lanes along Outram Road. The 1st lane is for motorists to either make a U- turn or proceed straight.

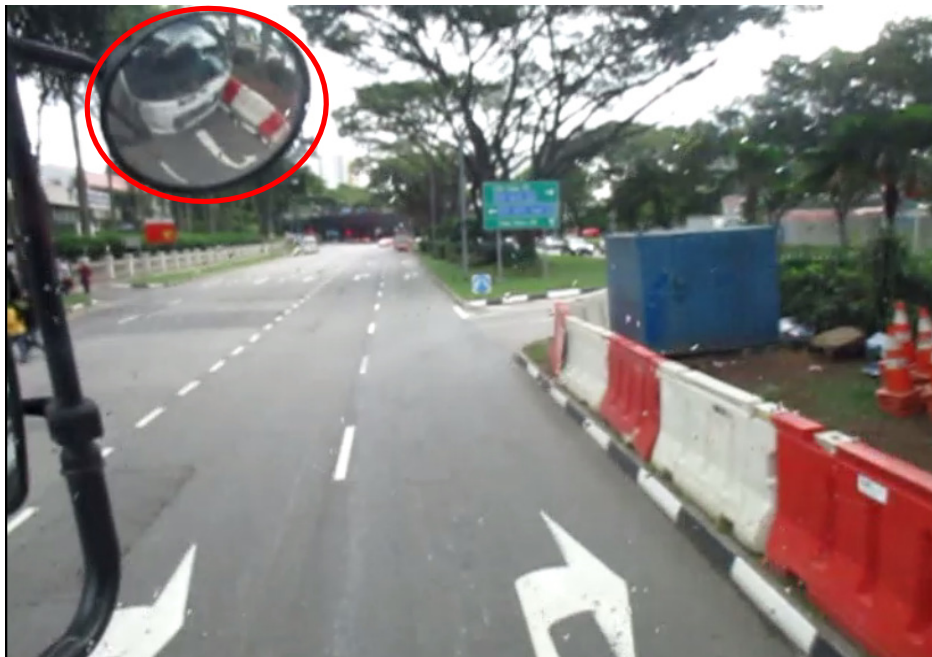
Photo 13 shows the Hino travelling along Outram Road on the 1st lane and slowly approaching the U-turn opening in the road divider, preparing to turn right. We noticed from the front mirror that the Hino was completely within the 1st lane (circled).

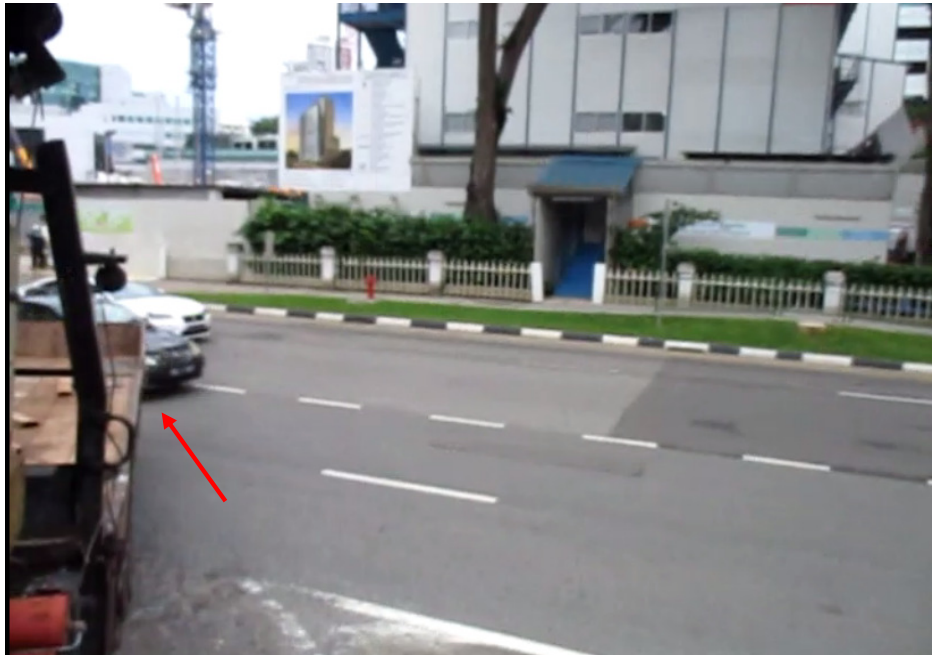
Photo 14 shows the Hino turning right. We observed another vehicle passing the rear portion of the Hino as Mr Ong made the right turn (arrowed).

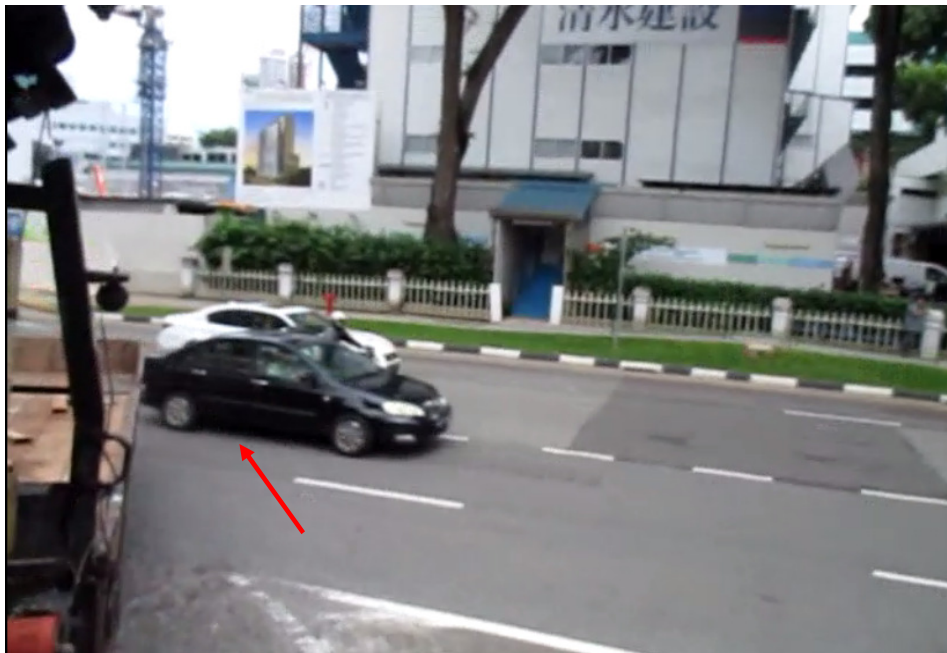
Photo 15 shows the vehicle proceeding to go straight along the 2nd lane without coming into contact with the rear portion of the Hino as Mr Ong completed the right turn (arrowed).

16. Based on our examination of these photographs, it is unlikely that there would be any contact between the right front portion of the Mitsubishi and the rear right portion of the Hino if the Mitsubishi was travelling along the 2nd lane while the Hino was turning right at the accident location.
17. Since it is unlikely that the Mitsubishi was travelling along the 2nd lane, it is more plausible that the Mitsubishi was travelling along the 1st lane, behind the Hino when the accident occurred. Both vehicles may have come into contact when the Mitsubishi proceeded to go straight along the 1st lane before the Hino had completed the right turn.

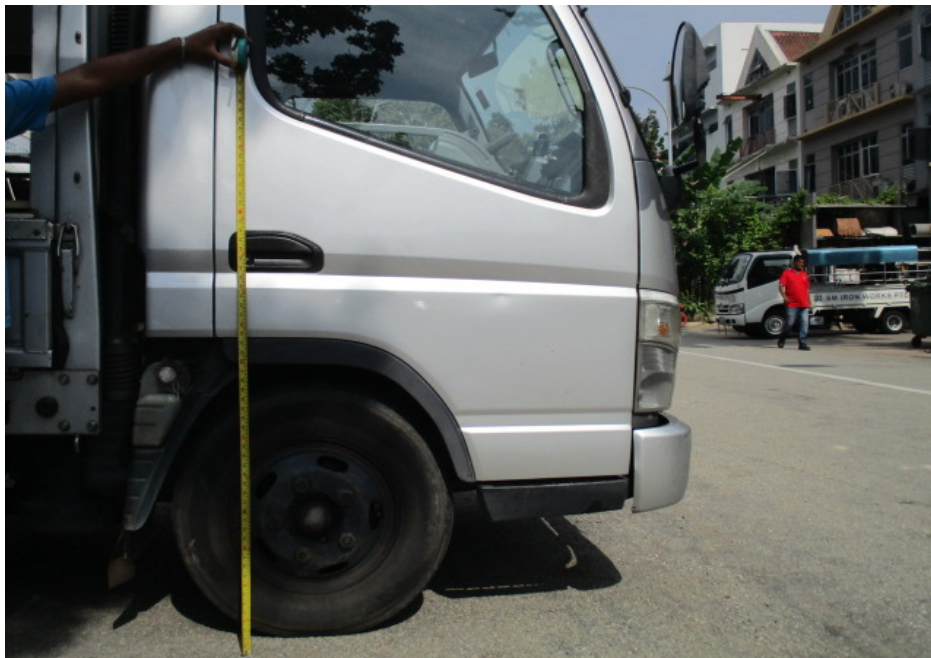
Photo 16 shows the height measurement being conducted on the right front portion of the Mitsubishi.

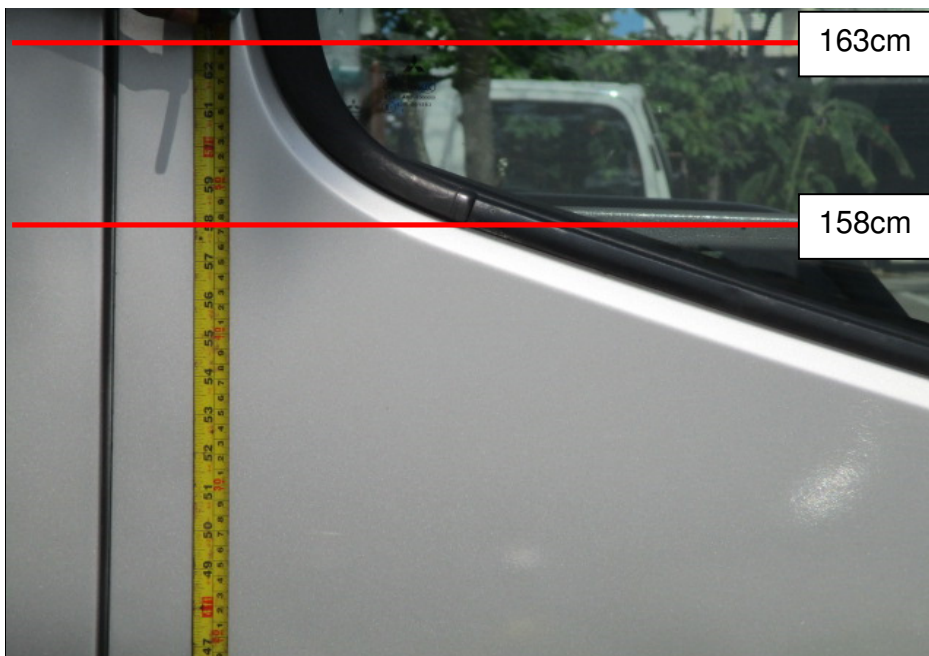
Photo 17 shows a closer view of the height measurement being conducted on the right front portion of the Mitsubishi. The height range above ground level of the driver door at the area where the driver door was buckled was measured to be approximately between 158cm to 163cm.

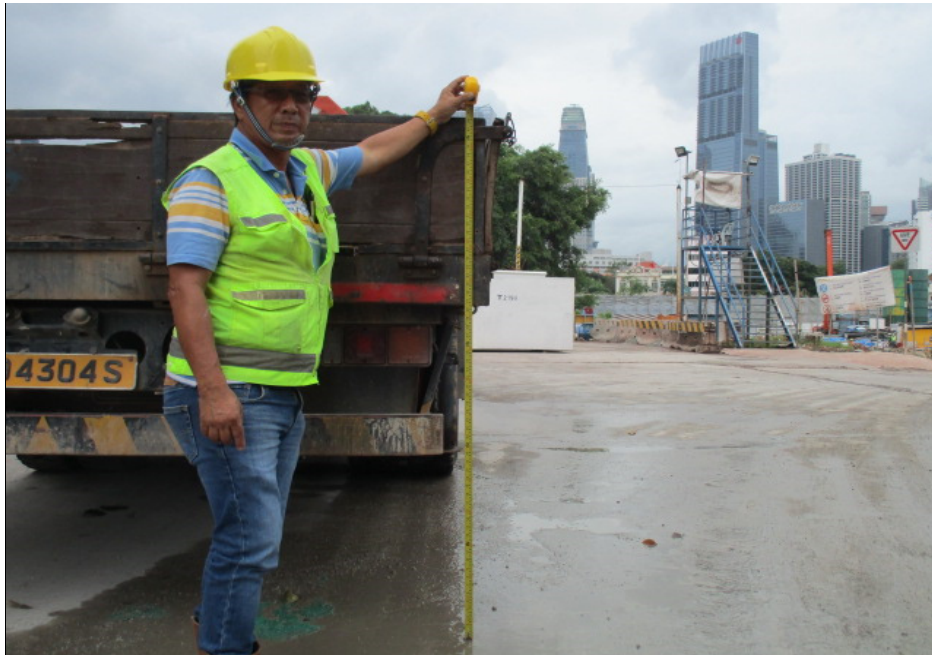
Photo 18 shows the height measurement being conducted on the rear right portion of the Hino.

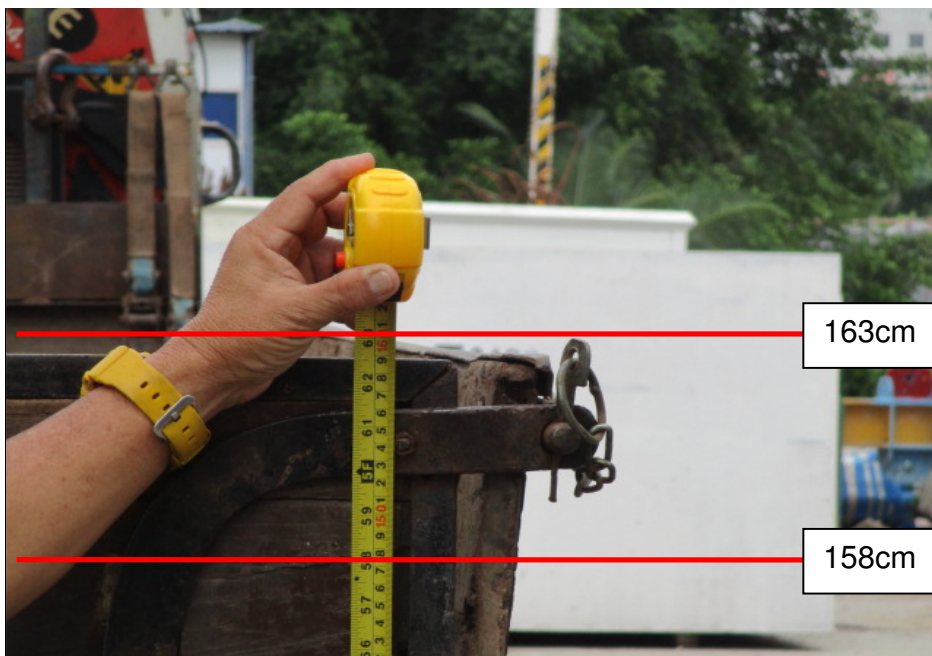
Photo 19 shows a closer view of the height measurement being conducted on the rear right portion of the Hino. The body part within the height range of 158cm to 163cm above ground was the right tailgate lock where the graze marks were found.

- a) the height range above ground level of the driver door of the Mitsubishi at the area where the driver door was buckled was measured to be approximately between 158cm to 163cm;
- b) the body part of the Hino within the height range of 158cm to 163cm above ground was the right tailgate lock where the graze marks were found;
- c) the height measurements appear to support the findings of possible contact between the right front portion of the Mitsubishi and the rear right portion of the Hino;
- d) our findings are further supported by, upon our examination of the post-accident photographs of the Hino, revealing what appeared to be silver-coloured paint transfer marks on the Hino's right tailgate lock, which is similar to the colour of the Mitsubishi.
