Your Ref : M548459
Our Ref : CI/MSG18012883/N

**AUTOMOBILE TECHNICAL INVESTIGATION REPORT OF ACCIDENT
INVOLVING YN 6639Z AND XD 4304S ON 1 FEBRUARY 2018**

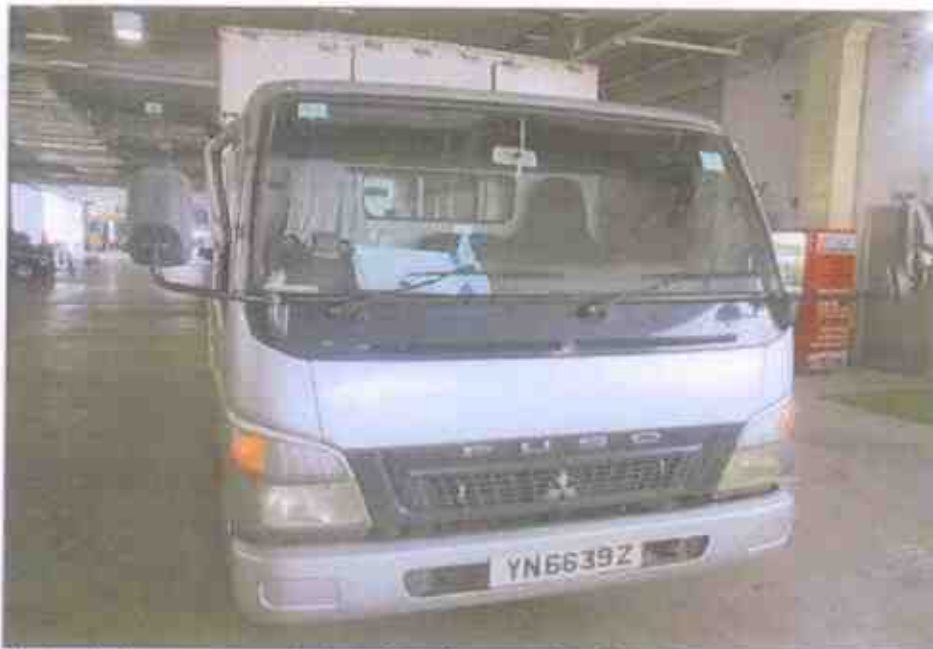
7. Based on the circumstances of the case contained in the Singapore Accident Statement and photographs which were taken during the accident reporting on the next day after the accident, we note that the Mitsubishi had sustained an impact onto its right front portion, particularly to the driver door.
8. Examination of these photographs had showed dislodgement and buckling of the driver door. There was a slight dent on the right front portion. The right side mirror cover was missing and graze marks were found on the front portion of the right side mirror. The extent of the damages observed clearly indicates that the impact onto the Mitsubishi was more to the right front portion and relatively significant. See photos 1 – 4 below.

Photo 1 shows a general view of the front portion of the Mitsubishi at the time of reporting, which was taken the next day after the accident. Based on the circumstances of the case contained in the Singapore Accident Statement, we note that the Mitsubishi had sustained damages to its right front portion.

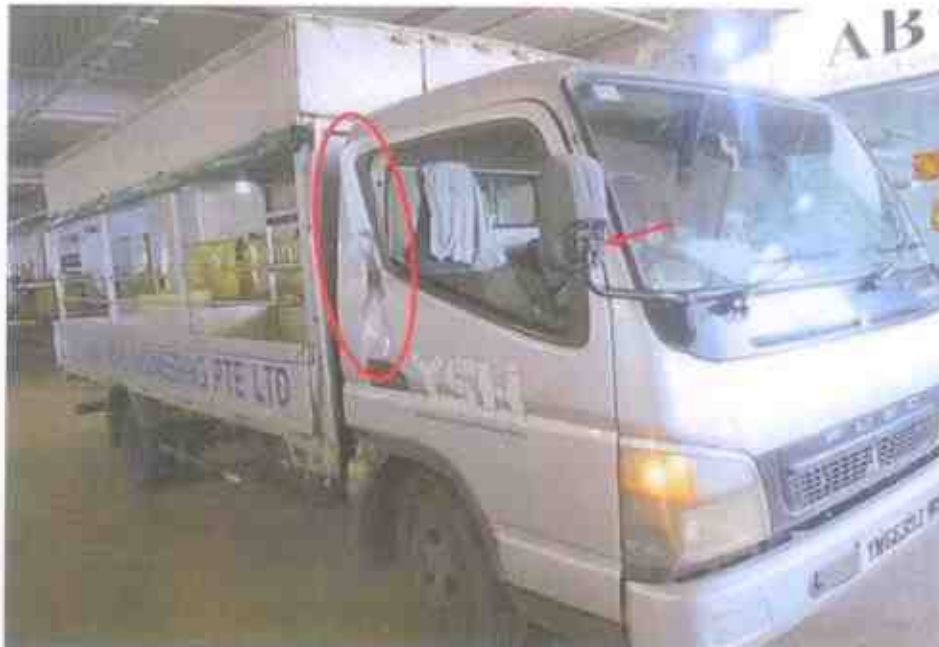
Photo 2 shows a right side view of the Mitsubishi. We observed dislodgement and buckling of the driver door (circled). The right side mirror cover was missing (arrowed).

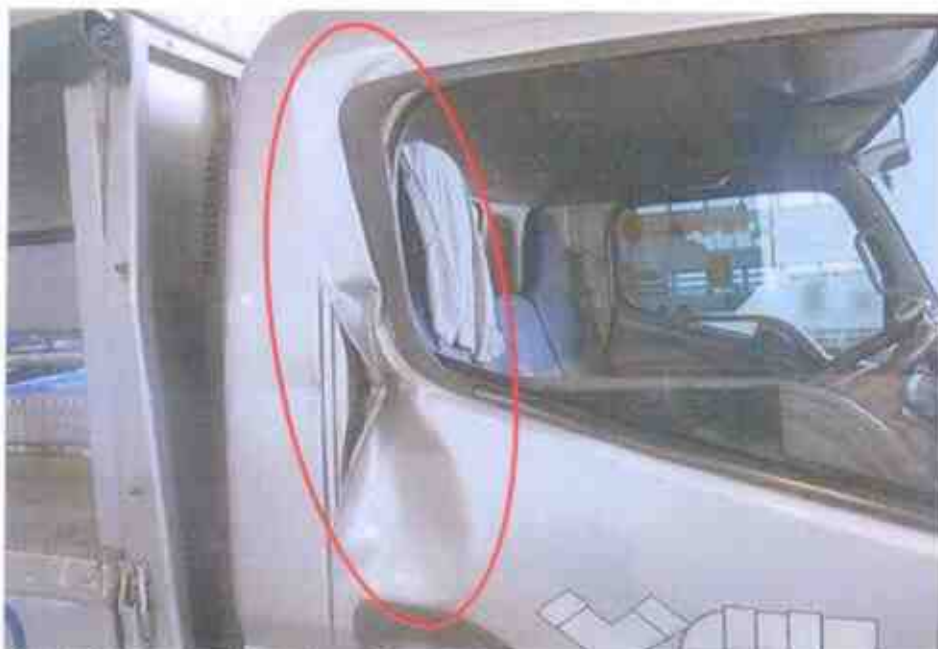
Photo 3 shows a closer view of the dislodgement and buckling of the driver door and a slight dent on the right front portion (circled).

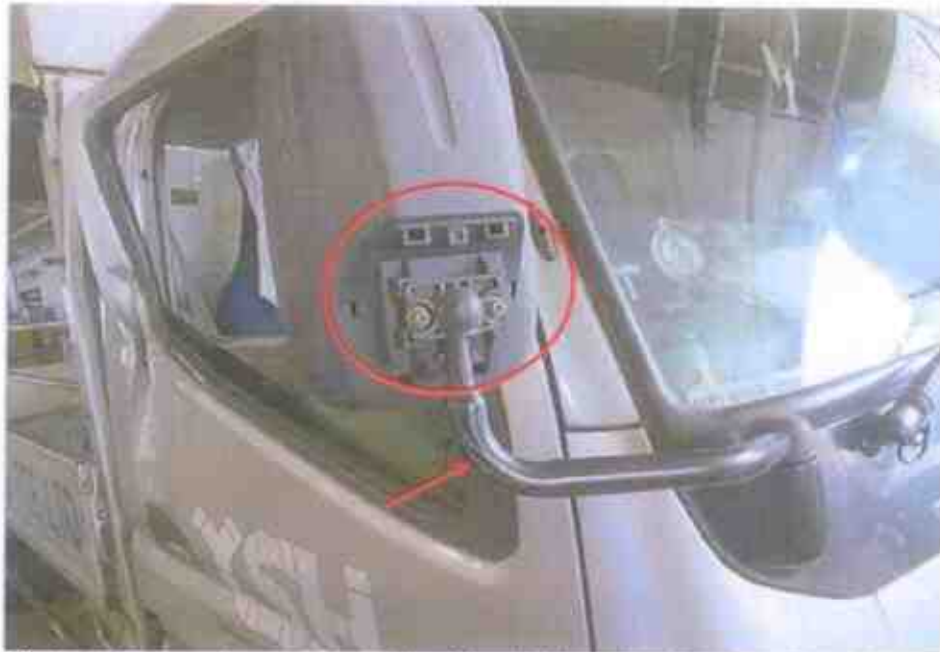
Photo 4 shows a close up view of the Mitsubishi's right side mirror. The right side mirror cover was missing (circled) and graze marks were found on the front portion of the right side mirror (arrowed).

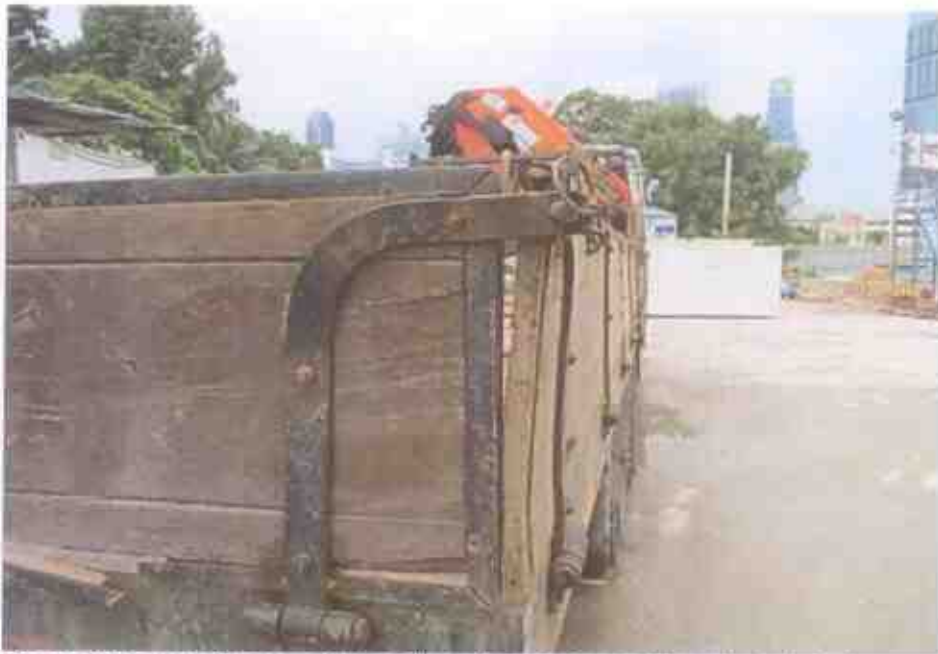
Photo 8 shows at the time of our inspection, we found the right side hinge of the Hino's tailgate to be buckled (circled).

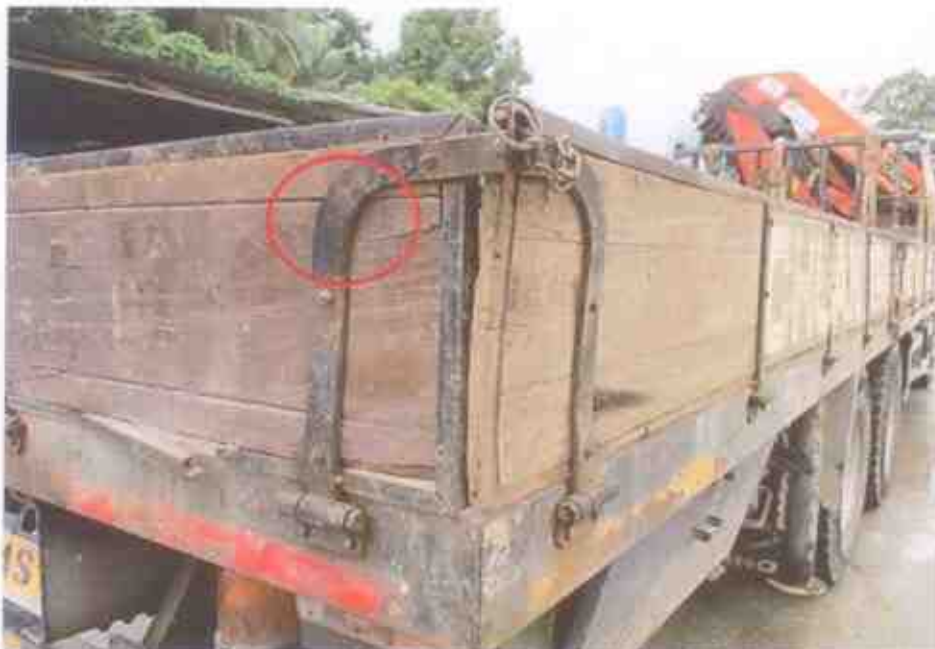
Photo 9 shows upon closer examination, we observed faint graze marks on the right tailgate lock (circled).

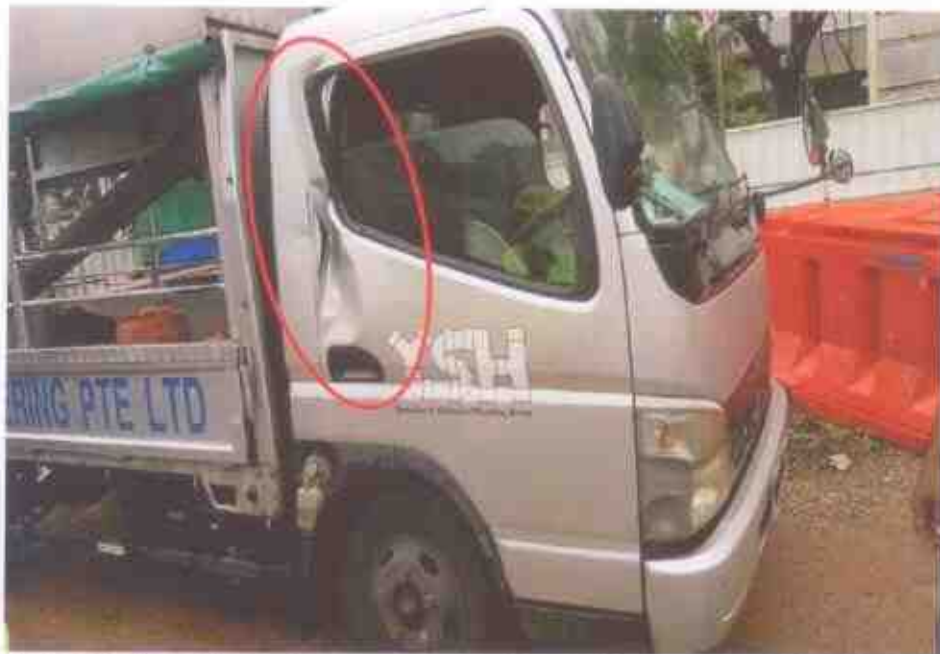
Photo 10 shows the damages sustained to the right front portion of the Mitsubishi post- accident (circled).

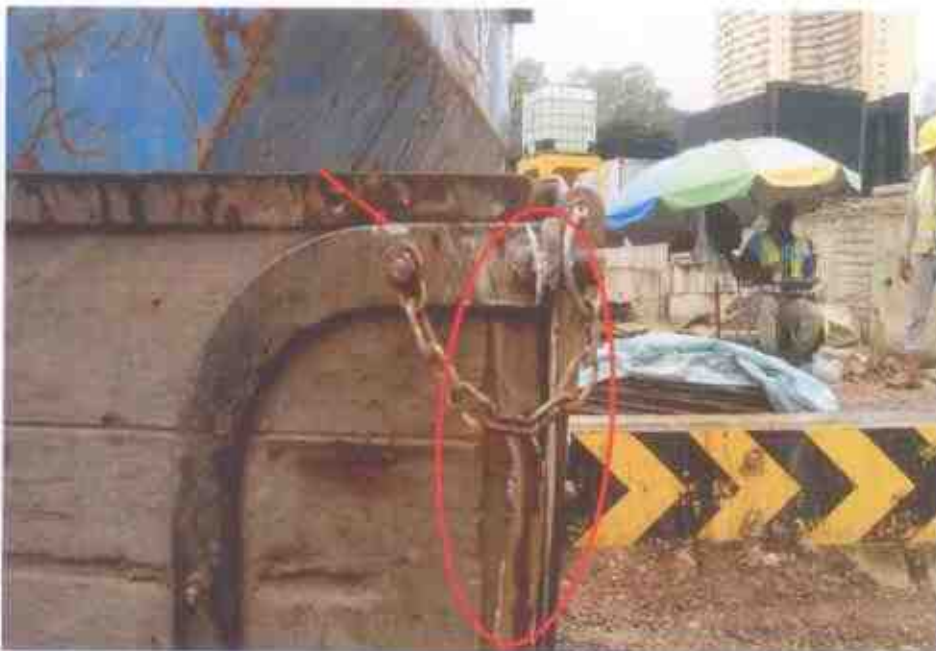
12. We were able to obtain post- accident photographs of the Involved Motor Vehicles from both drivers. The photographs show the damages sustained to both vehicles. We noticed the same graze marks on the right tailgate lock of the Hino. Closer examination of these photographs revealed what appeared to be silver- coloured paint transfer marks on the Hino's right tailgate lock, which is similar to the colour of the Mitsubishi. See photos 10 & 11 below.

Photo 11 shows the damages sustained to the rear right portion of the Hino post-accident. We noticed the same graze marks on the right tailgate of the Hino (arrowed). Closer examination of this photograph revealed what appeared to be silver- coloured paint transfer marks on the Hino's right tailgate lock, which is similar to the colour of the Mitsubishi (circled).

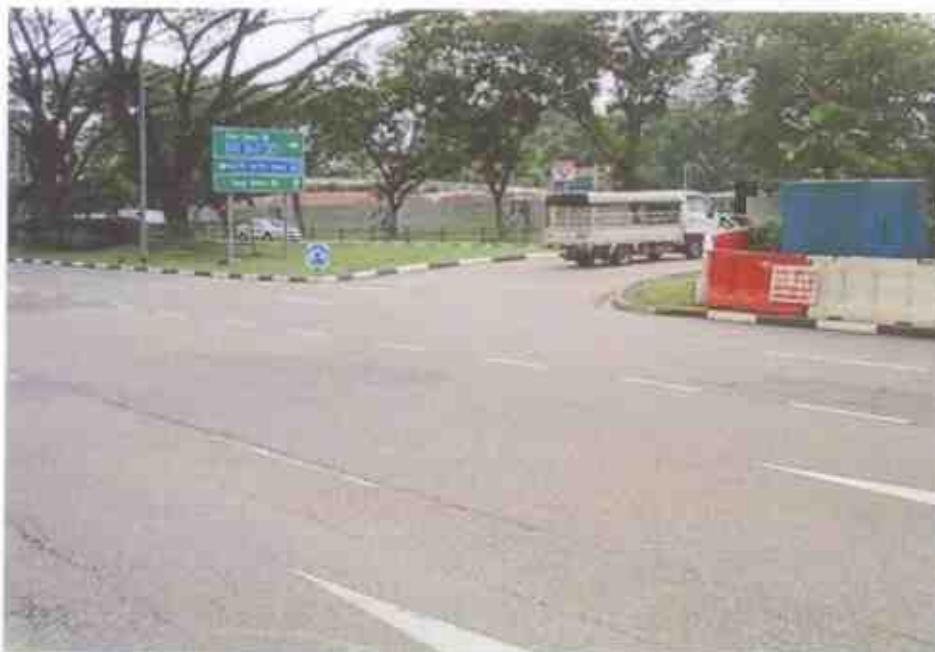
14. The accident had occurred at the U-turn opening in the road divider along Outram Road. There are 4 lanes along Outram Road. The 1st lane is for motorists to either make a U- turn or proceed straight. Following the circumstances according to Mr Nathan, the Mitsubishi would have either been positioned along the 2nd lane beside the Hino right before Mr Ong made the right turn or behind the Hino on the 1st lane and came into contact with the Hino as it proceeded to go straight right before Mr Ong completed making the right turn. See photo 12 below.

Photo 12 shows the U-turn opening in the road divider along Outram Road where the accident occurred. There are 4 lanes along Outram Road. The 1st lane is for motorists to either make a U- turn or proceed straight.

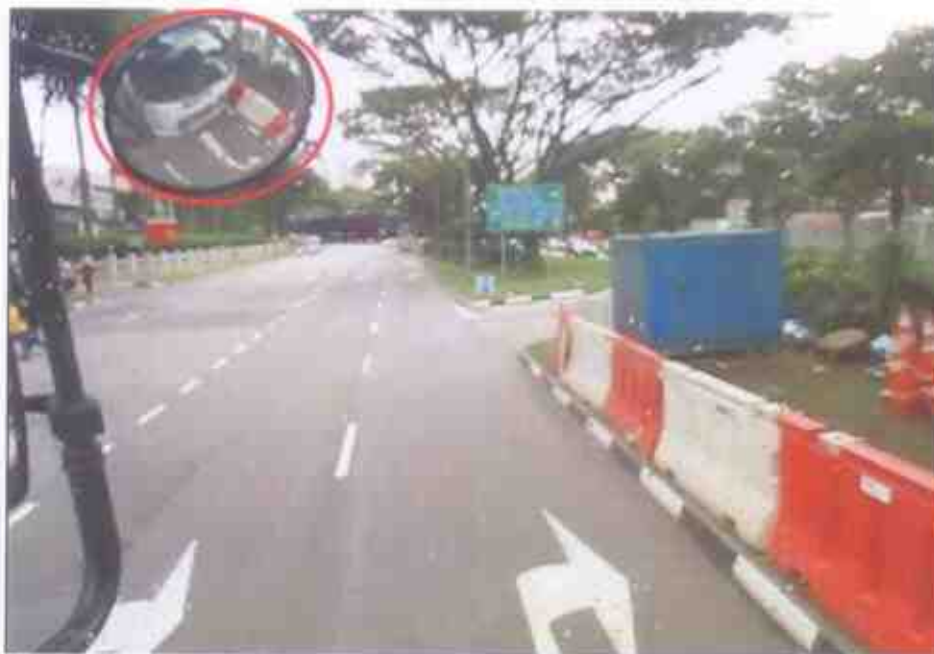
Photo 13 shows the Hino travelling along Outram Road on the 1st lane and slowly approaching the U-turn opening in the road divider, preparing to turn right. We noticed from the front mirror that the Hino was completely within the 1st lane (circled).

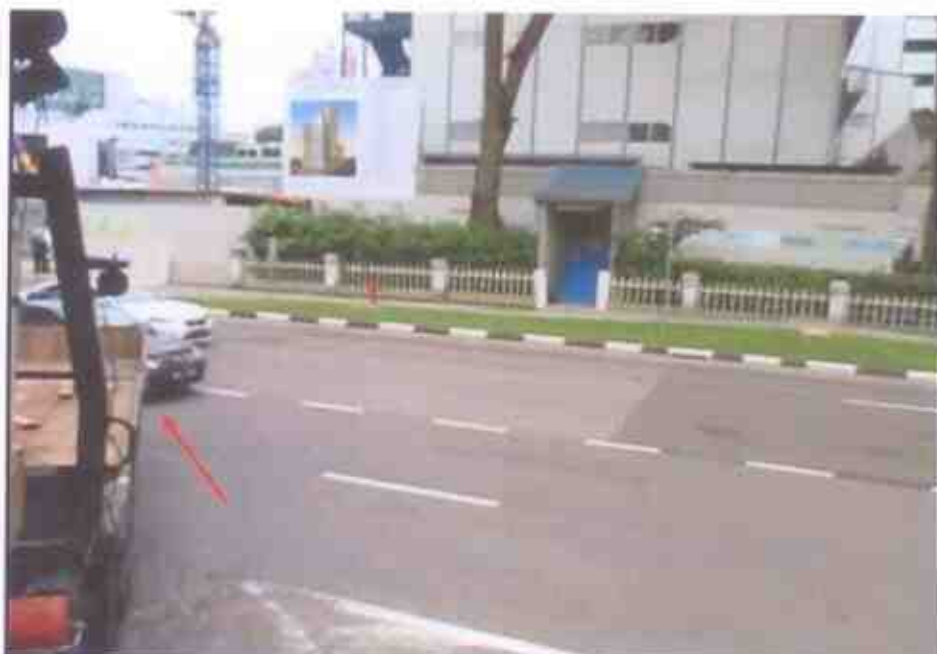
Photo 14 shows the Hino turning right. We observed another vehicle passing the rear portion of the Hino as Mr Ong made the right turn (arrowed).

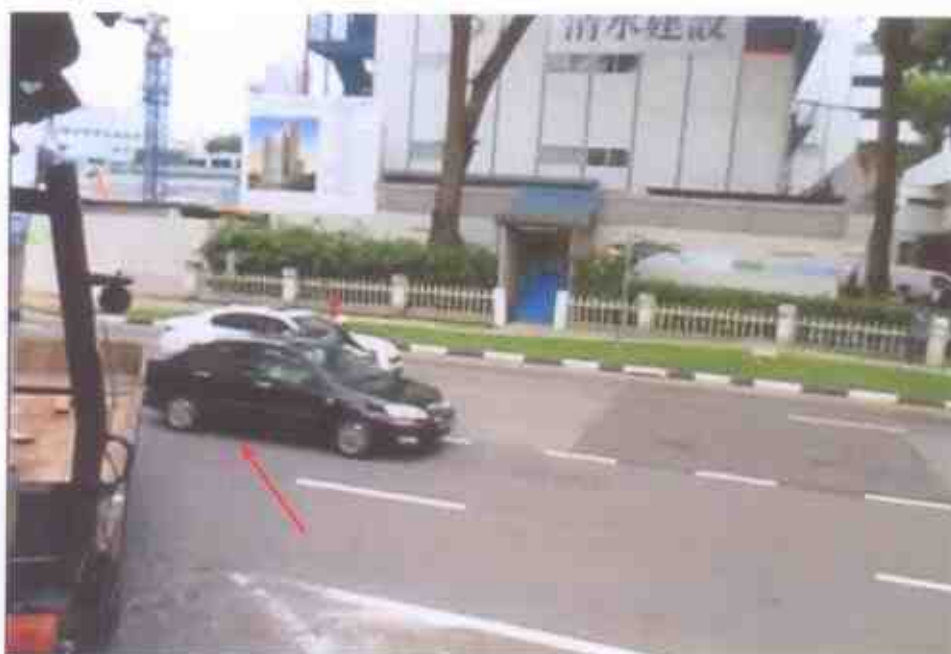
Photo 15 shows the vehicle proceeding to go straight along the 2nd lane without coming into contact with the rear portion of the Hino as Mr Ong completed the right turn (arrowed).

16. Based on our examination of these photographs, it is unlikely that there would be any contact between the right front portion of the Mitsubishi and the rear right portion of the Hino if the Mitsubishi was travelling along the 2nd lane while the Hino was turning right at the accident location.
17. Since it is unlikely that the Mitsubishi was travelling along the 2nd lane, it is more plausible that the Mitsubishi was travelling along the 1st lane, behind the Hino when the accident occurred. Both vehicles may have come into contact when the Mitsubishi proceeded to go straight along the 1st lane before the Hino had completed the right turn.

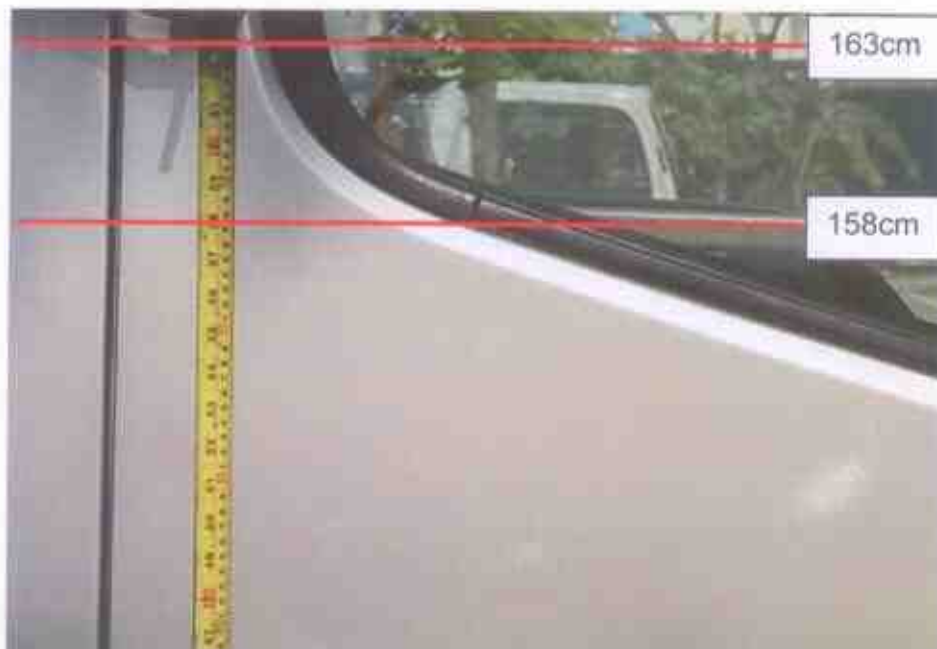
Photo 17 shows a closer view of the height measurement being conducted on the right front portion of the Mitsubishi. The height range above ground level of the driver door at the area where the driver door was buckled was measured to be approximately between 158cm to 163cm.

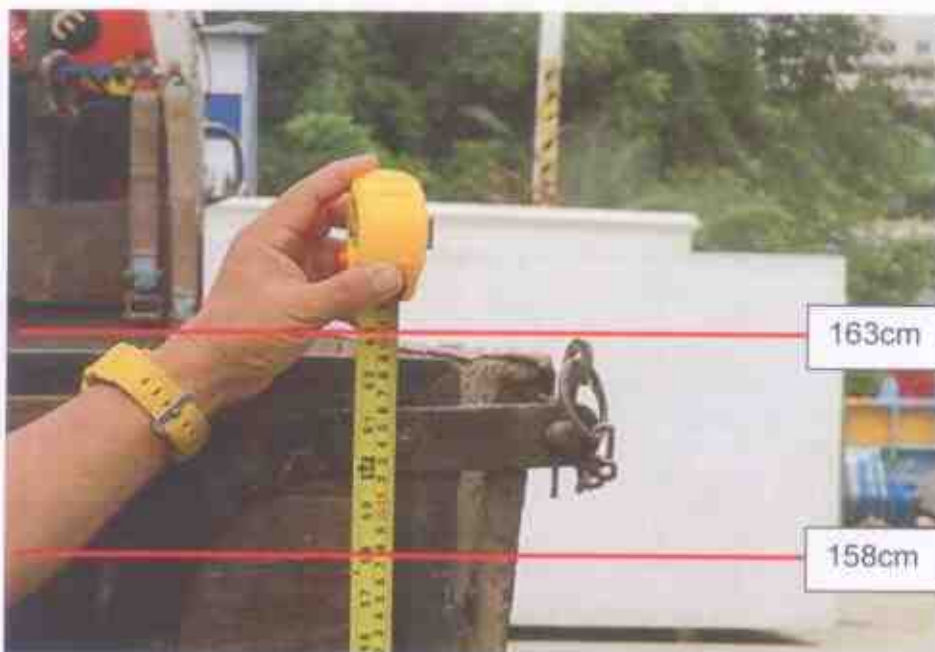
Photo 19 shows a closer view of the height measurement being conducted on the rear right portion of the Hino. The body part within the height range of 158cm to 163cm above ground was the right tailgate lock where the graze marks were found.

- a) the height range above ground level of the driver door of the Mitsubishi at the area where the driver door was buckled was measured to be approximately between 158cm to 163cm;
- b) the body part of the Hino within the height range of 158cm to 163cm above ground was the right tailgate lock where the graze marks were found;
- c) the height measurements appear to support the findings of possible contact between the right front portion of the Mitsubishi and the rear right portion of the Hino;
- d) our findings are further supported by, upon our examination of the post-accident photographs of the Hino, revealing what appeared to be silver-coloured paint transfer marks on the Hino's right tailgate lock, which is similar to the colour of the Mitsubishi.
