Your Ref : P0526408
Our Ref : CS/ASM18012926/Z

25th July 2018

**TECHNICAL INVESTIGATION REPORT OF FIRE INCIDENT INVOLVING
THE MOTOR VEHICLE GW 4398Y ON 12th July 2018**

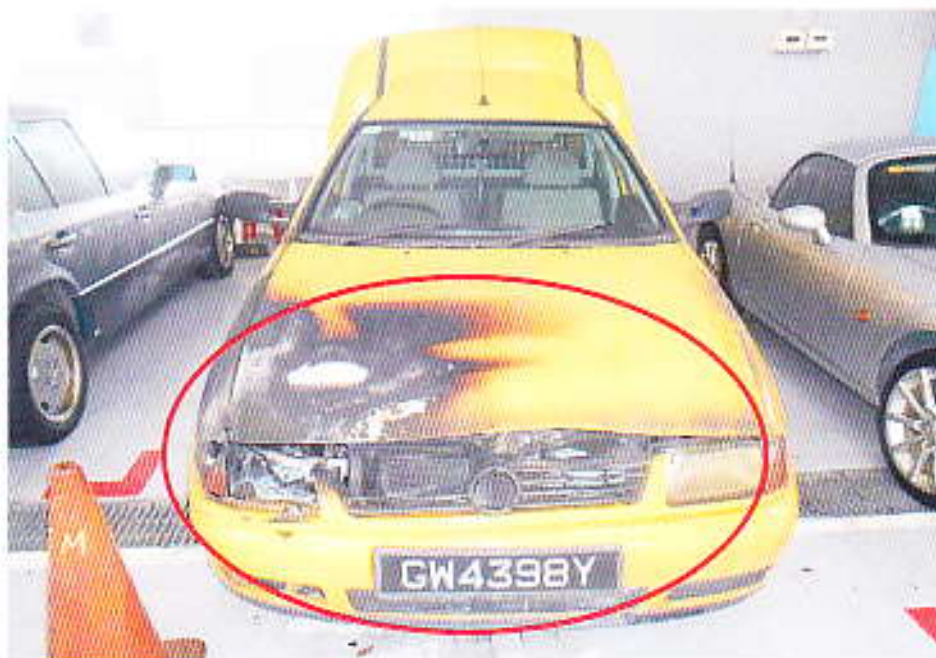
5. The Insured Vehicle was noted to have sustained fire damage that was confined to its front portion. The entire engine compartment of the Insured Vehicle was observed to be burnt while the interior compartment was observed to be relatively unaffected by the fire.
6. The fire had resulted in the body parts at the front right portion of the Insured Vehicle to be burnt. This had included its front bonnet, headlamp, front bumper & grill & left & right side fenders amongst others. See photos 1 – 4 below.

Photo 1 shows the general view of the front portion of the Insured Vehicle at the time of our inspection. The fire damage to the Insured Vehicle was confined to its front bonnet, headlamp, front bumper & grill & left & right side fenders were amongst the body parts that were found to have been affected as a result of the fire.

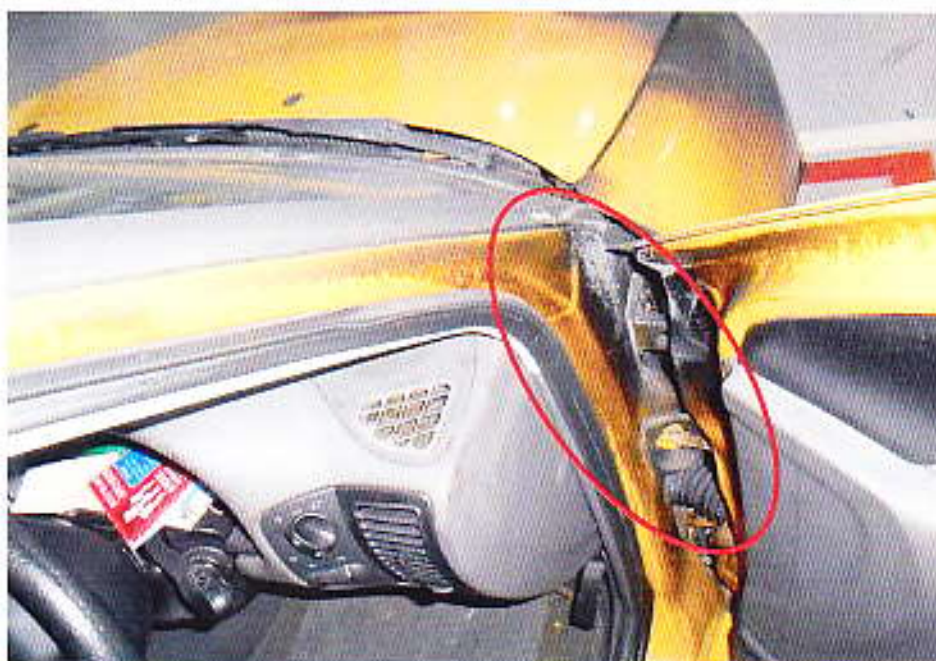
Photo 2 shows the semi close-up view of the front right door of the Insured Vehicle at the time of our inspection. The fire damage to the Insured Vehicle was observed to be affecting the driver side door internally.

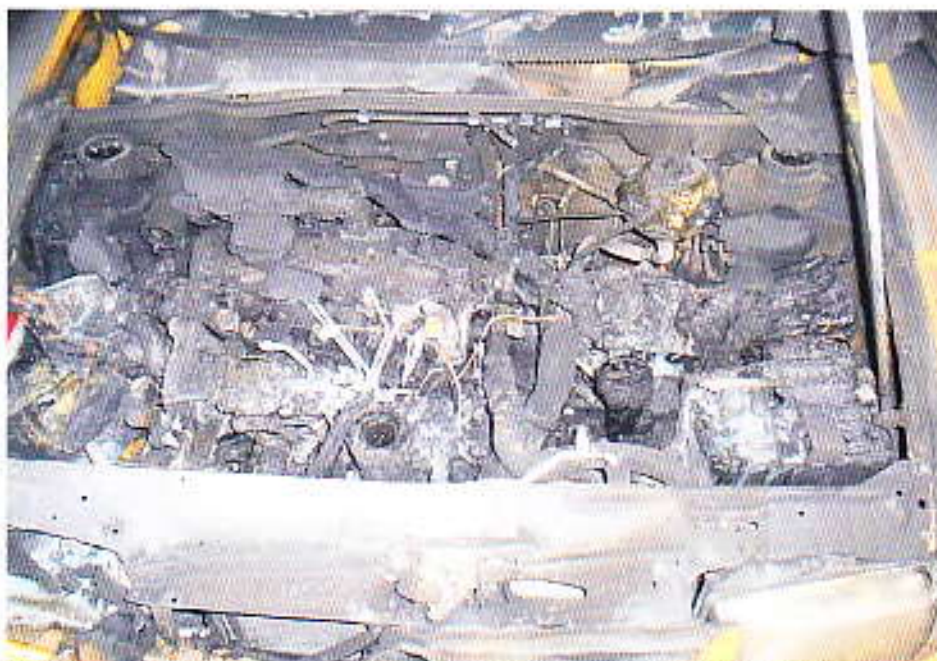
Photo 3 shows the engine compartment of the Insured Vehicle at the time of our inspection. The entire engine compartment of the Insured Vehicle was observed to be burnt and/or melted as a result of the fire.

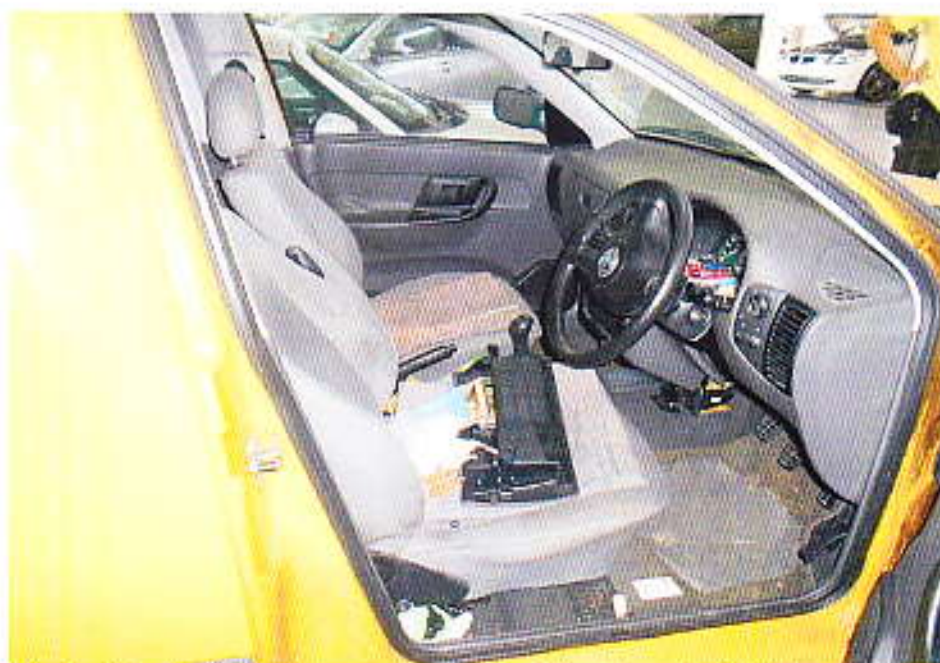
Photo 4 shows the interior compartment of the Insured Vehicle, which was observed to be relatively unaffected by the fire.

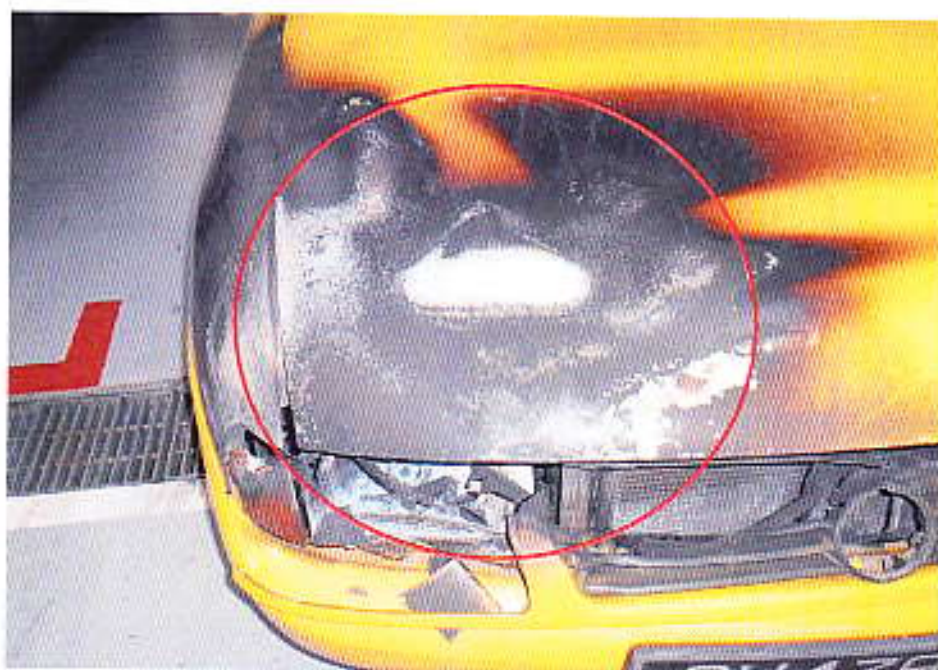
8. For this particular case, the fire appears to have originated within the engine compartment of the Insured Vehicle, somewhere around the front right side of the engine compartment. This can be determined from the burn pattern and the high heat intensity burn marks (whitish burn marks) found on the front right side of the bonnet of the Insured Vehicle and also the discolouration of the insulating material that had developed on the underside of the front bonnet, at the front right side portion.

9. The whitish burn marks are a result of exposure to prolonged heat intensity. Rust would normally start to develop around these areas soon after a fire as prolonged exposure to high heat intensity usually causes steel/metal material body parts to be exposed to natural environmental condition. The discolouration of the insulating material on the underside of the front bonnet, around the front right side area, is an indication that the front right side area of the engine compartment had sustained exposure to prolonged high heat intensity. See photos 5 to 7 below.

Photo 5 shows the burn pattern and whitish burn marks (circled) that were found on the rear left side of the front bonnet of the Insured Vehicle. Such whitish burn marks are a result of exposure to prolonged heat intensity, which may indicate where the fire had started. Rust would also begin to develop on these areas soon after the fire.

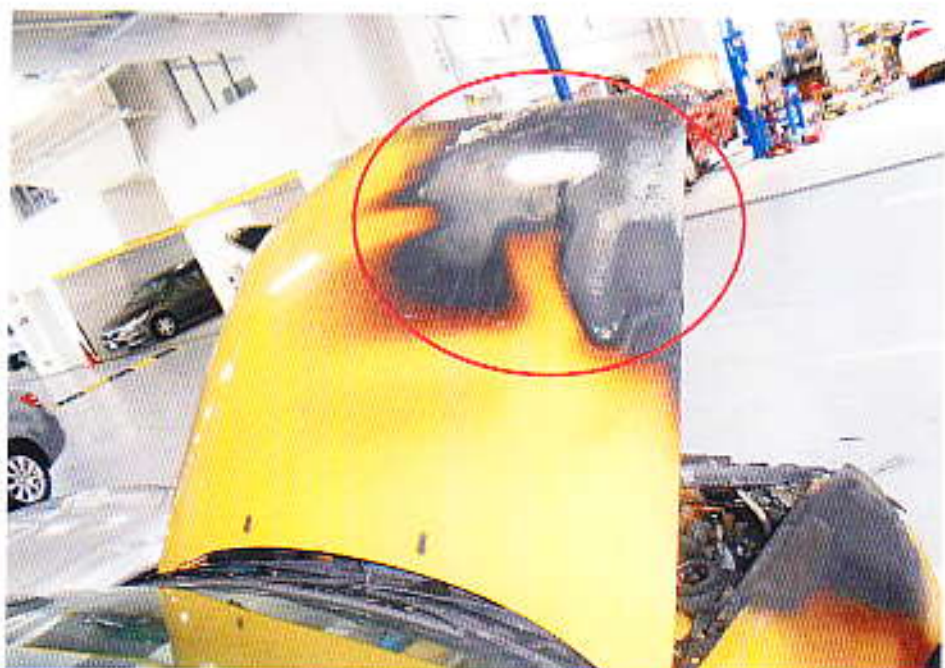
Photo 6 shows a close-up view of the burn pattern and whitish burn marks (circled) that were found on the front right side of the front bonnet of the Insured Vehicle. Such whitish burn marks are a result of exposure to prolonged heat intensity, which may indicate where the fire had started. Rust would also begin to develop on these areas soon after the fire.

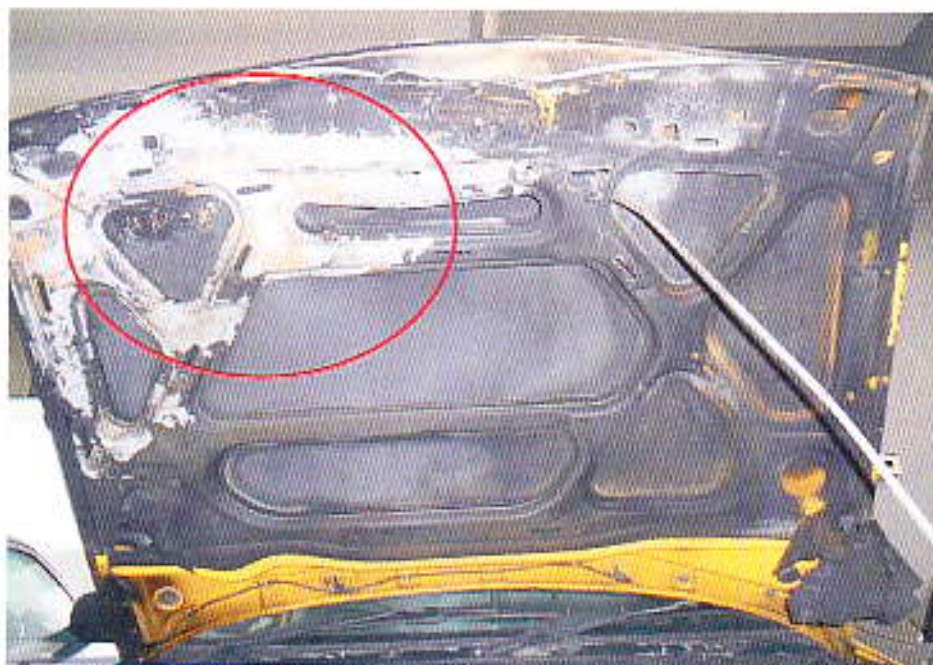
Photo 7 shows the discolouration of the insulating material on the underside of the front bonnet, around the front right side area (circled). The discolouration of the insulating material is an indication that the front right side area of the engine compartment had sustained exposure to prolonged high heat intensity. Hence the fire to the Insured Vehicle can be determined to have originated towards the front right side of the engine compartment.

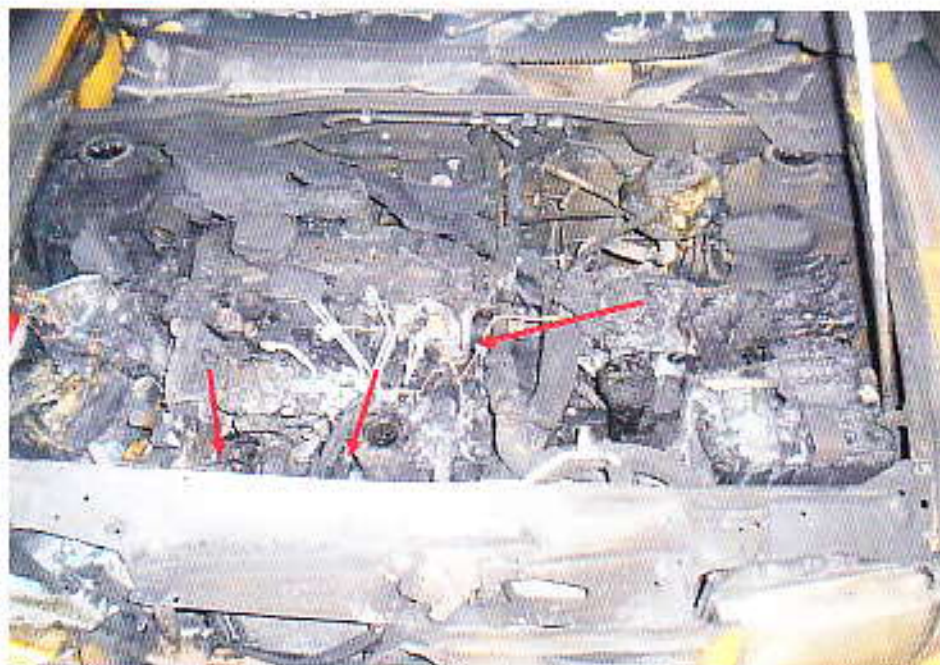
10. Upon closer examination of the rear left side of the engine compartment which was where the fire to the Insured Vehicle had likely started, we had found several stretches of burnt wiring around the Insured Vehicle's engine compartment. These wirings were original factory fitted wirings that were mainly around the centre to the right side of the engine compartment near the right headlamp area. Such condition normally indicates internal heating of copper wires which is a sign of an electrical short circuit occurring. This would then appear to suggest that the cause of fire to the Insured Vehicle could have possibly been due to electrical in nature. See photos 8 to 12 below.

Photo 8 shows the wirings around the front right side of the engine compartment which is near to the vicinity where the fire to the Insured Vehicle had likely started.

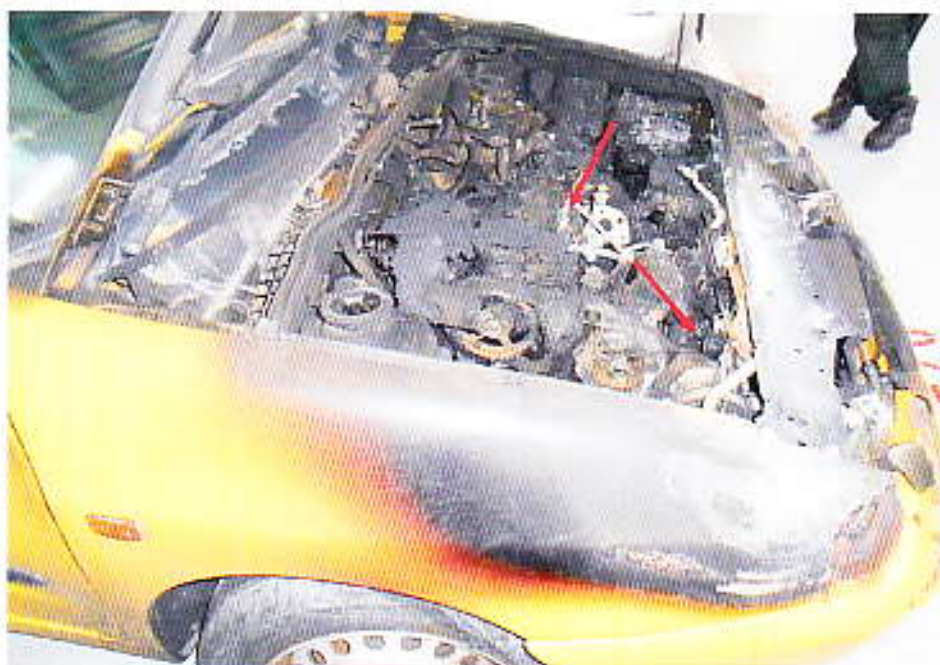
Photo 9 shows the wirings around the front right side of the engine compartment which is near to the vicinity where the fire to the Insured Vehicle had likely started.

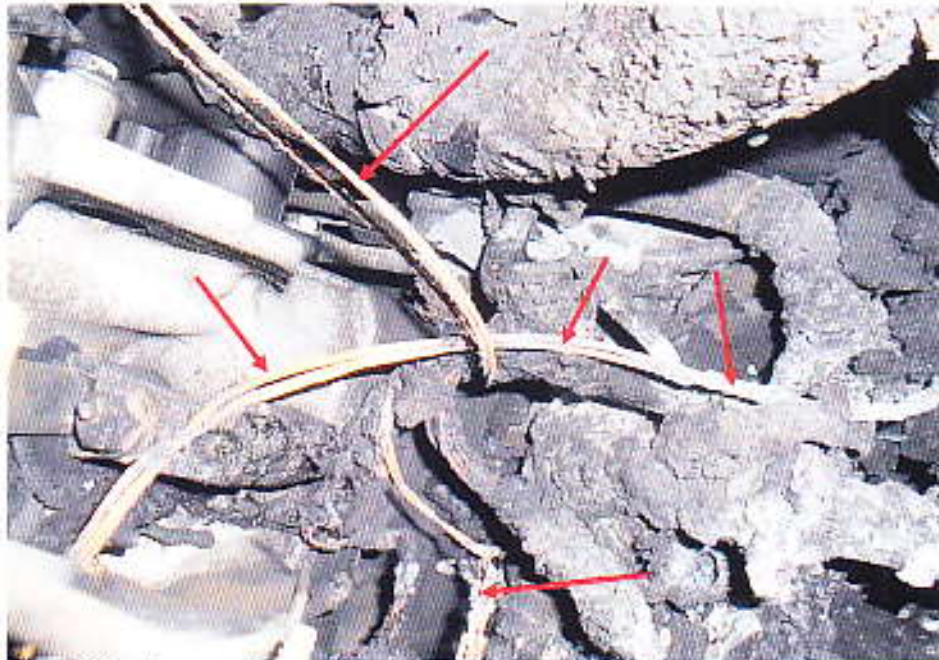
Photo 10 shows a close-up view of the wirings around the front right side of the engine compartment which is near to the vicinity where the fire to the Insured Vehicle had likely started.

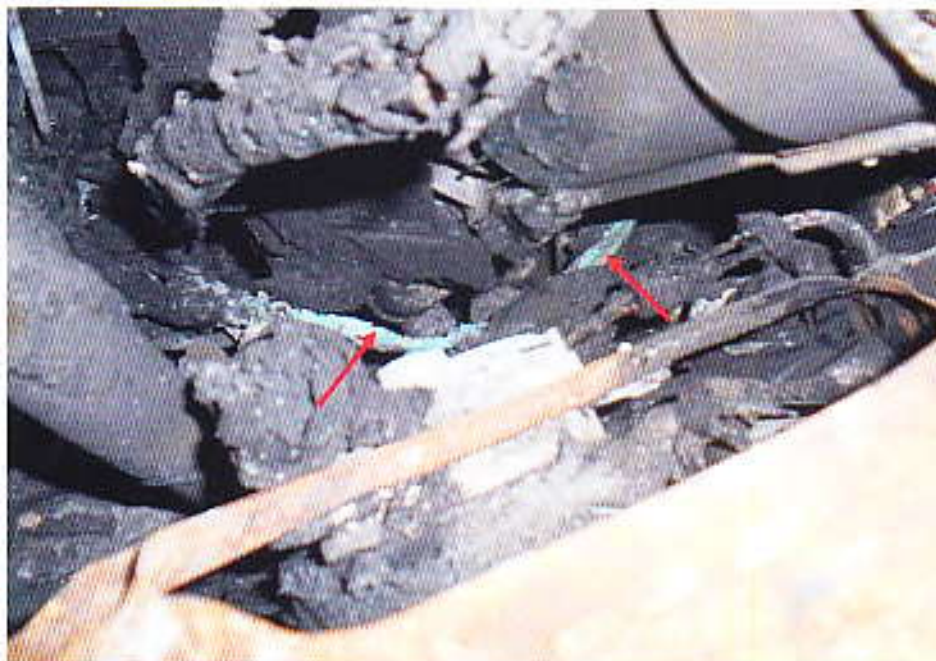
Photo 11 shows a closer view of the burnt wirings (red arrows) at the rear left side of the engine compartment. Such condition normally indicates internal heating of copper wires which is a sign of an electrical short circuit occurring.

29. The possibility of the fire being due to electrical in nature would then seem more likely given that engine overheating and external factors would both seem unlikely. The fire being due to electrical nature is also supported by the condition of the wirings that were found in the engine compartment of the Insured Vehicle, which was earlier discussed in paragraph 10 above.

31. Having investigated and technically analysed the damages of burnt nature to the Insured Vehicle, we are of the view that the cause of fire to the Insured Vehicle was of electrical in nature. For this particular case, the fire had originated along the wiring inside the engine compartment, somewhere around the front right area of the engine compartment.

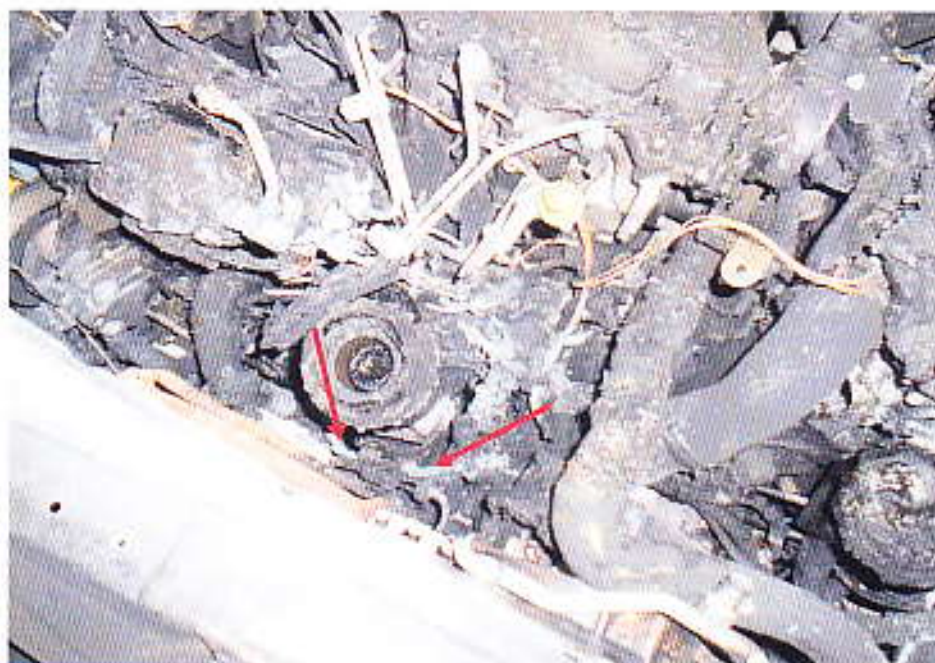
Photo 12 shows a close up view of the burnt wirings (red arrows) at the rear left side of the engine compartment. Such condition normally indicates internal heating of copper wires which is a sign of an electrical short circuit occurring

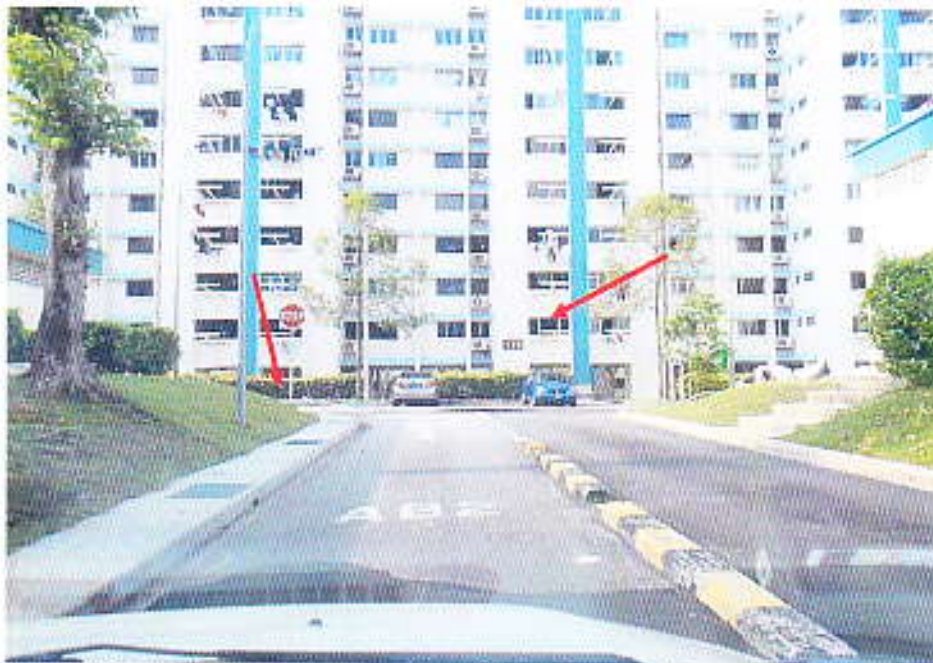
Photo 14 shows a general view of the fire incident location which is at blk 175 Ang Mo Kio Avenue 4, parking lot 172.

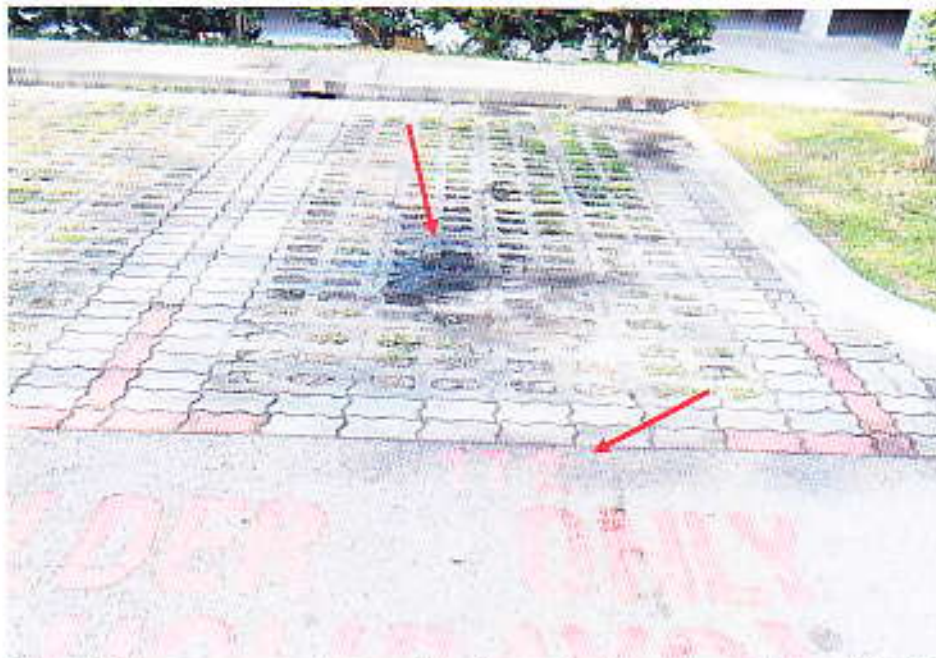
Photo 15 shows a general view of the fire incident location which is at blk 175 Ang Mo Kio Avenue 4, parking lot 172

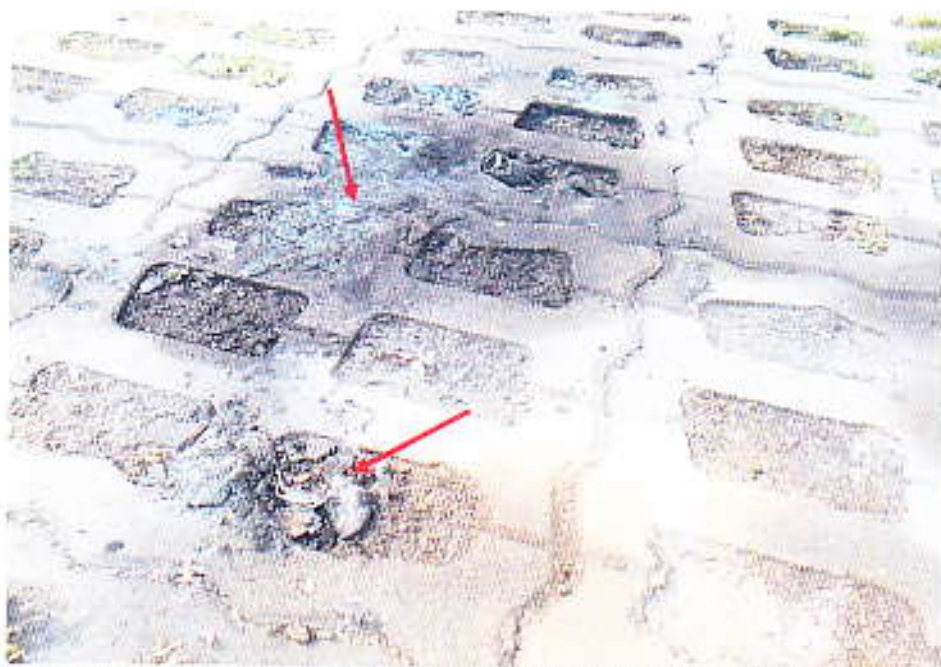
Photo 16 shows a semi close-up view of the fire incident location which is at blk 175 Ang Mo Kio Avenue 4, parking lot 172. Burnt debris was observed on the parking lot ground at time of our visit.

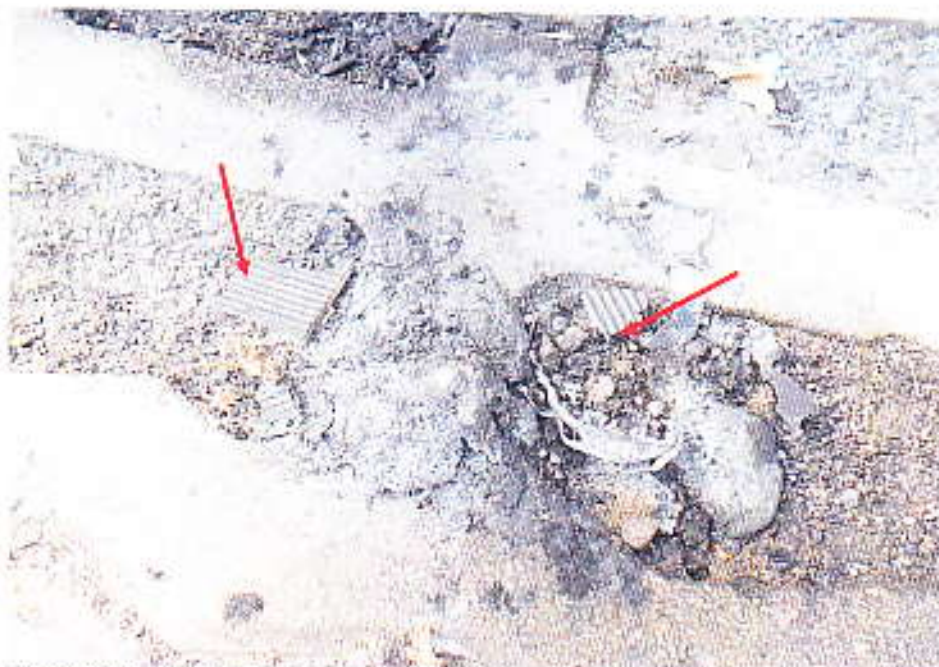
Photo 17 shows a close-up view of the fire incident location which is at blk 175 Ang Mo Kio Avenue 4, parking lot 172. Burnt debris was observed on the parking lot ground at time of our visit believed to be from the burnt Insured Vehicle.
