# LKK Auto Consultants Pte Ltd

RE: ESTIMATE COST OF REPAIR TO SHD2244J TOYOTA VELLFIRE (2015)

| Affiliated to Federation Internationale Des Experts En Automobile | | | | |
|---|---|---|---|--|
| FIRST CAPITAL INSURANCE LTD | | Ref : CS/FCI18012995/R1rd3n2 | | |

## ADJUSTMENT ON REPAIR COST FOR VEHICLE NO. SHD 2244J

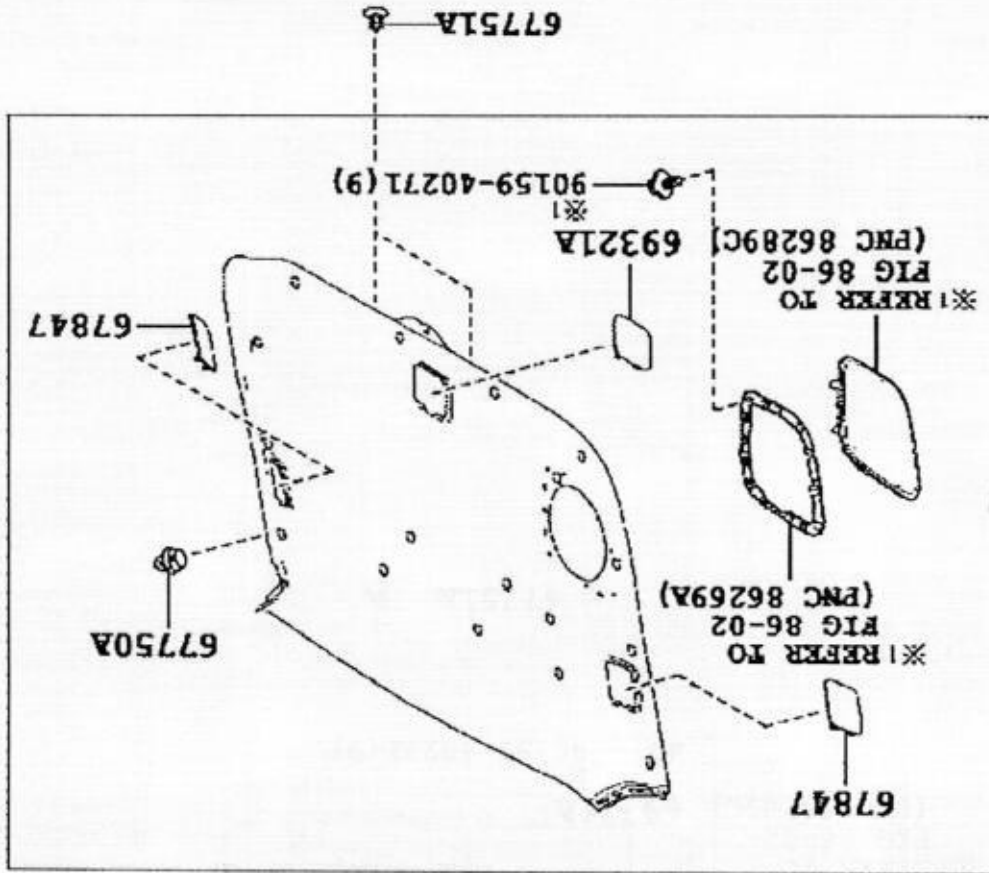
67750-58090-00  
Rear Body part  
from

※1 有リ(穴-カ-)
