VEHICLE DAMAGE INSPECTION REPORT

Our File No: CS3/AIG17011819/JBE2

Handling Insurer:	AIG Asia Pacific Insurance Pte. Ltd.	Policy No:	1700013775
Claimant Vehicle No :	SLN1087C	Insured Vehicle No :	FBK795H
Date of Loss:	16/06/2017	Nature of Claim:	TP
		Claim No:	1324550053SG

VEHICLE INSPECTION REPORT

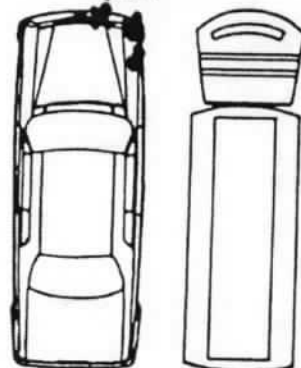
IMPACT: ARROW INDICATES
DIRECTION OF IMPACT.

The impact was confined to the front portion of the vehicle.

The above vehicle sustained damaged were front o/s fender inner panel - buckled,
front o/s chassis frame - buckled, front bonnet - bent.

780.00	325.00
	<u>LABOUR</u>			
	TO DISMANTLE FRONT PORTION DAMAGED PARTS, STRAIGHTEN FRONT O/S FENDER INNER PANEL, FRONT O/S CHASSIS FRAME, FRONT BONNET AND REWELD FRONT SUPPORT PANEL. INCLUSIVE OF THE REPAIR OF FRONT BUMPER ENFORCEMENT, FRONT SUPPORT PANEL, FRONT SUPPORT PANEL BRACKET AND FRONT O/S FENDER BRACKET (INNER).		1,600.00	800.00
	TO PUTTY AND SPRAY PAINTING.		1,500.00	600.00
	TO REMOVE AND REFIT AIR-CONDITION CONDENSER, VACUUM AND REFILL GAS INORDER TO FACILITATE REPAIRS.	NOT NECESSARY	200.00	-
	TO CHECK WIRING AND RE-ALIGN FRONT HEAD-LAMP.		120.00	50.00
	TO RE-SEAL ANTI RUST.		180.00	60.00
			3,600.00	1,510.00
GRAND TOTAL			17,493.30	8,015.00
RECOMMENDED COST OF LUMP SUM REPAIRS (TO ITS PRE-ACCIDENT CONDITION)				6,400.00
