Your Ref : D18004798-LJ
Our Ref : CI/FCI18013191/N

29 June 2018

**TECHNICAL INVESTIGATION REPORT OF FIRE INCIDENT INVOLVING THE
INSURED VEHICLE SHC 7200H ON 15 JUNE 2018**

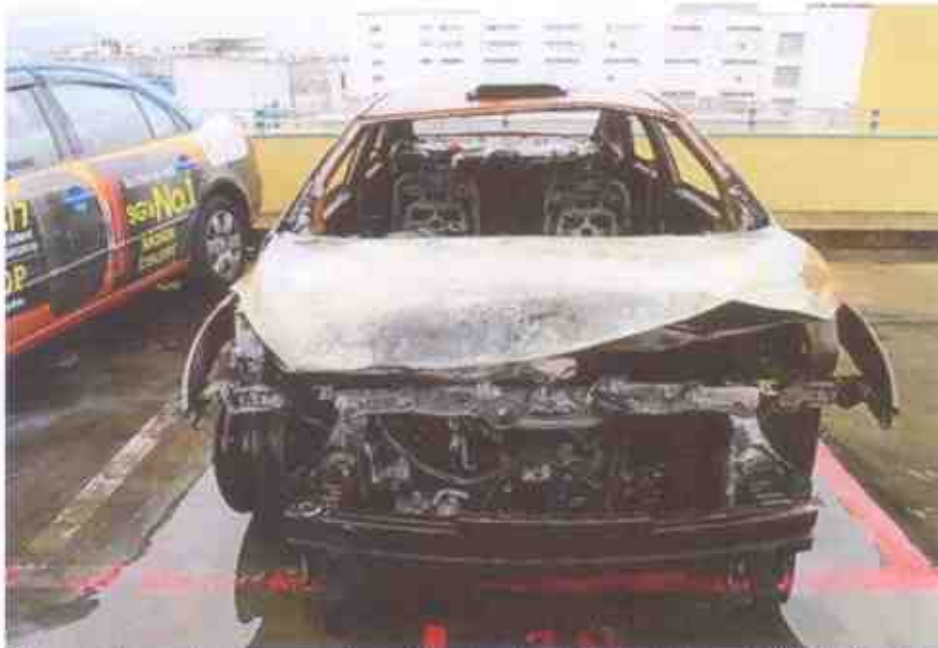
Photo 1 shows the general view of the front portion of the Insured Vehicle at the time of our inspection. The Insured Vehicle was observed to have sustained extensive fire damage all around. Its engine compartment and interior compartment were completely burnt. Rust had accumulated all over the Insured Vehicle as a result of exposure to environmental condition for a period of time.

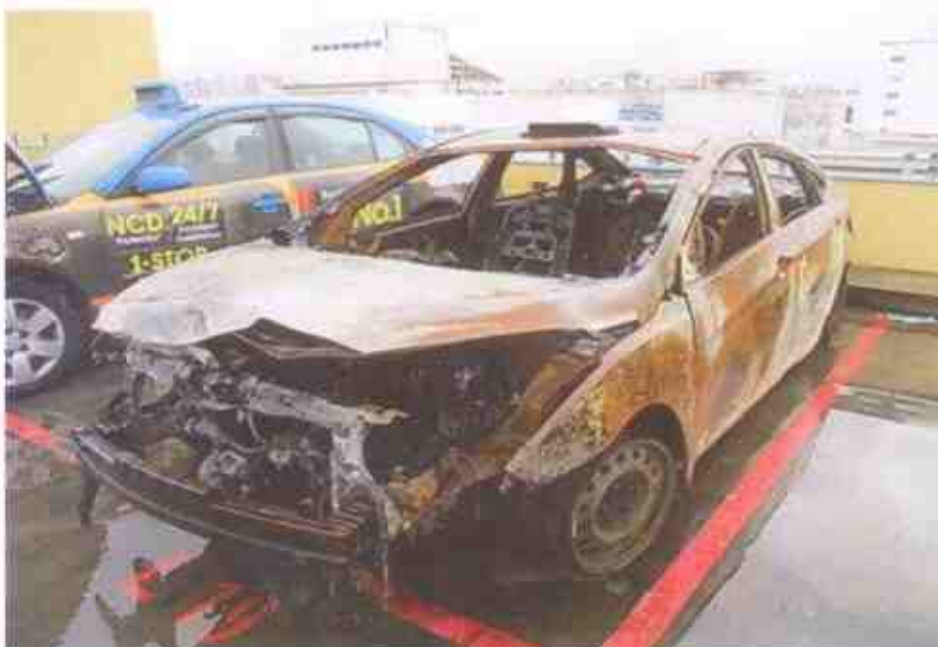
Photo 2 shows the general view of the left body of the Insured Vehicle at the time of our inspection. The Insured Vehicle was observed to have sustained extensive fire damage all around. Rust had accumulated all over the Insured Vehicle as a result of exposure to environmental condition for a period of time.

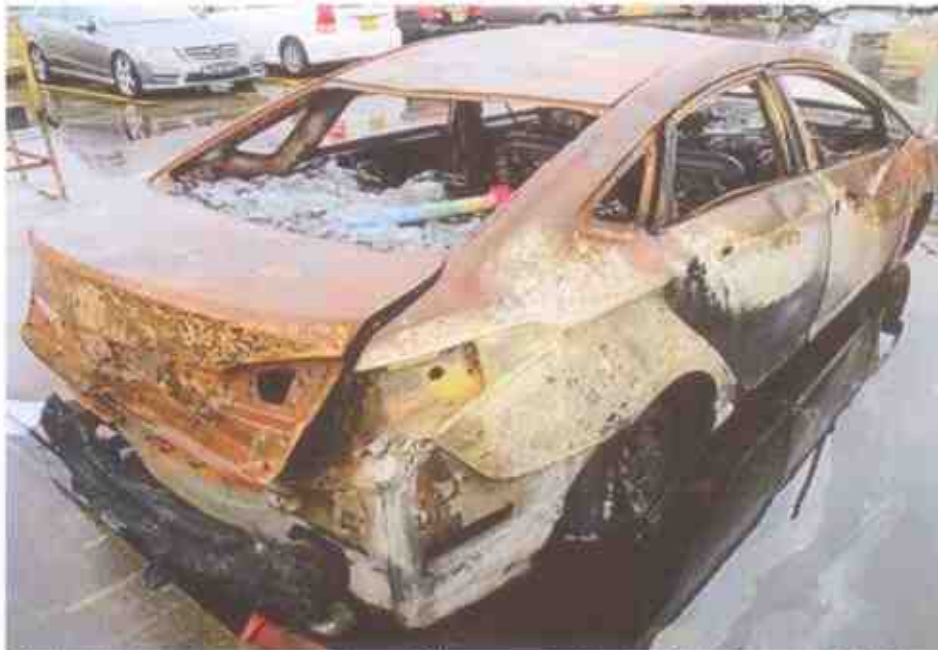
Photo 3 shows the general view of the rear right body of the Insured Vehicle at the time of our inspection. The Insured Vehicle was observed to have sustained extensive fire damage all around. Rust had accumulated all over the Insured Vehicle as a result of exposure to environmental condition for a period of time.

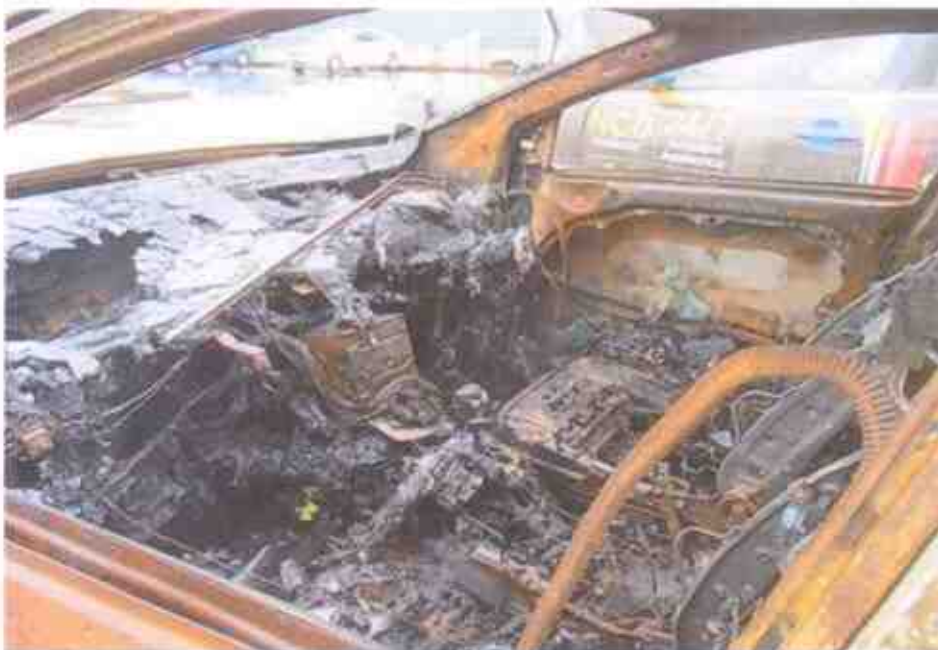
Photo 4 shows the general view of the interior compartment of the Insured Vehicle at the time of our inspection. Its interior compartment was completely burnt as a result of the fire.

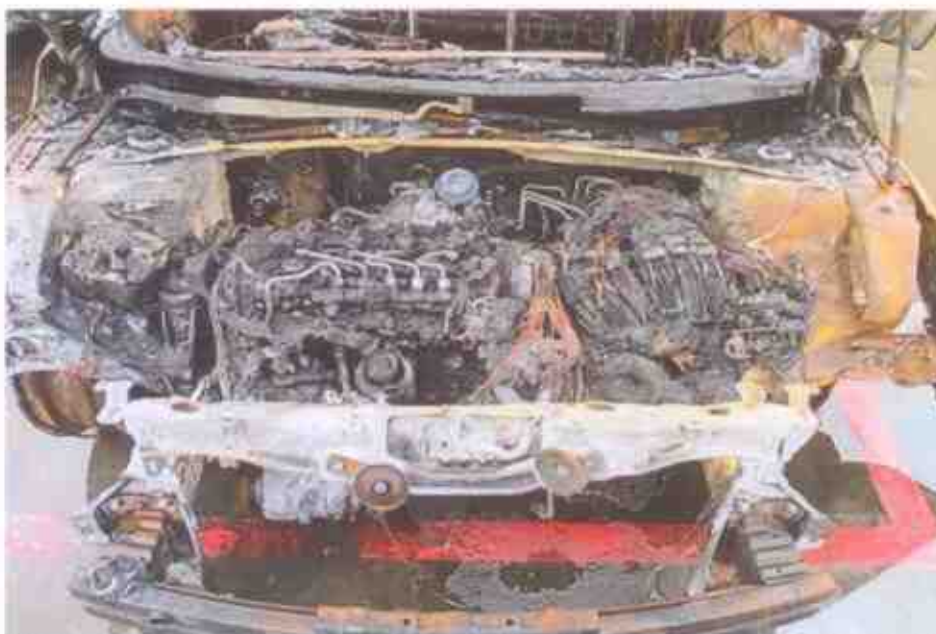
Photo 5 shows the engine compartment of the Insured Vehicle at the time of our inspection. The entire engine compartment of the Insured Vehicle was observed to be severely burnt. Most of the parts inside the engine compartment were found to be burnt and/or melted as a result of the fire.

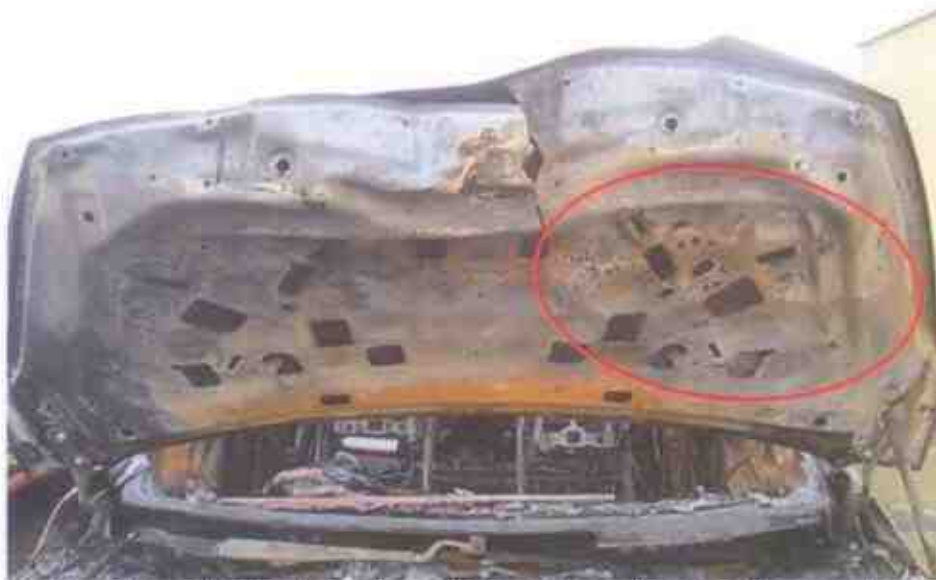
6. For this particular case, the fire appears to have originated within the engine compartment of the Insured Vehicle, somewhere around the rear left portion of the engine compartment. This can be determined from the burn pattern and the high heat intensity burn marks (whitish burn marks) as well as the rust that had developed on the underside of the front bonnet, at the bottom left portion of the Insured Vehicle.

7. The whitish burn marks are a result of exposure to prolonged heat intensity. Rust would normally start to develop around these areas soon after a fire as prolonged exposure to high heat intensity usually causes steel/metal material body parts to be exposed to natural environmental condition. The rust that had developed on the underside of the front bonnet, around the bottom left portion, is an indication that the rear left portion of the engine compartment had sustained exposure to prolonged high heat intensity. See photo 6 below.

Photo 6 shows the rust that had developed on the underside of the front bonnet, around the bottom left portion (circled). The development of rust is an indication that this area was subjected to prolonged exposure to high heat intensity, which had caused the steel/metal material of the front bonnet to be exposed to natural environmental condition. Hence the fire to the Insured Vehicle can be determined to have originated towards the rear left portion of the engine compartment.

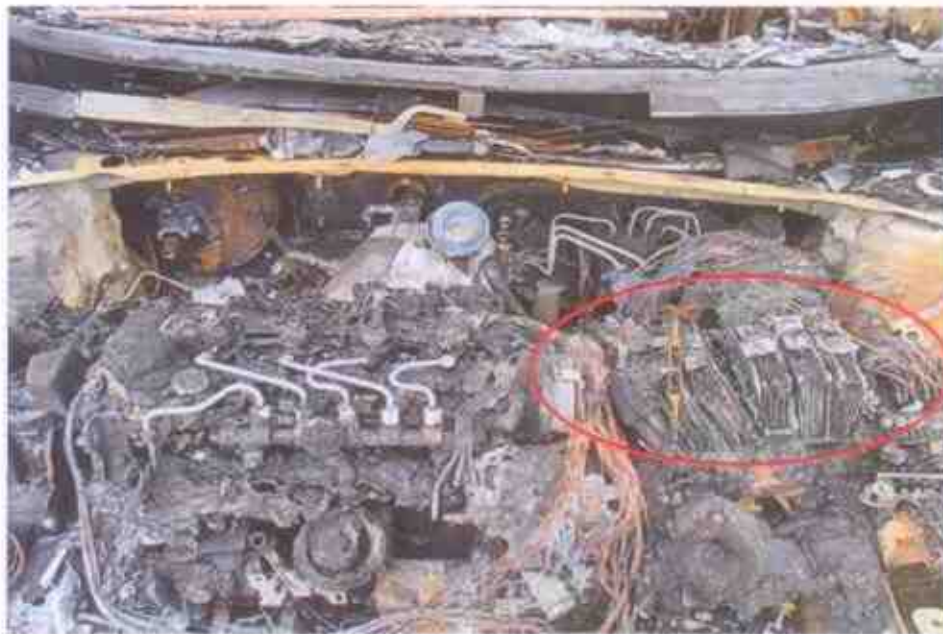
8. Upon closer examination of the rear left portion of the engine compartment, which was where the fire to the Insured Vehicle had likely started, we had found greenish residue on several burnt stretches of original factory fitted wirings around the rear left portion of the engine compartment. The presence of such greenish residue indicates internal heating of copper wires, a sign of an electrical short circuit occurring. The greenish residue is normally left behind from oxidation as a result of chemical reaction involving the copper wires. This physical evidence would then appear to suggest that the cause of fire to the Insured Vehicle could have possibly been due to electrical in nature. See photos 7 - 10 below.

Photo 7 shows the original factory fitted wirings around the rear left portion of the engine compartment, which is in the immediate vicinity where the fire to the Insured Vehicle had likely started. We had found greenish residue on several burnt stretches of these wirings (circled). The presence of such greenish residue indicates internal heating of copper wires, a sign of an electrical short circuit occurring. The greenish residue is normally left behind from oxidation as a result of chemical reaction involving the copper wires.

32. Having investigated and technically analysed the damages of burnt nature to the Insured Vehicle, we are of the view that the cause of fire to the Insured Vehicle was of electrical in nature. For this particular case, the fire had originated along the original factory fitted wirings inside the engine compartment, somewhere around the rear left portion of the engine compartment.

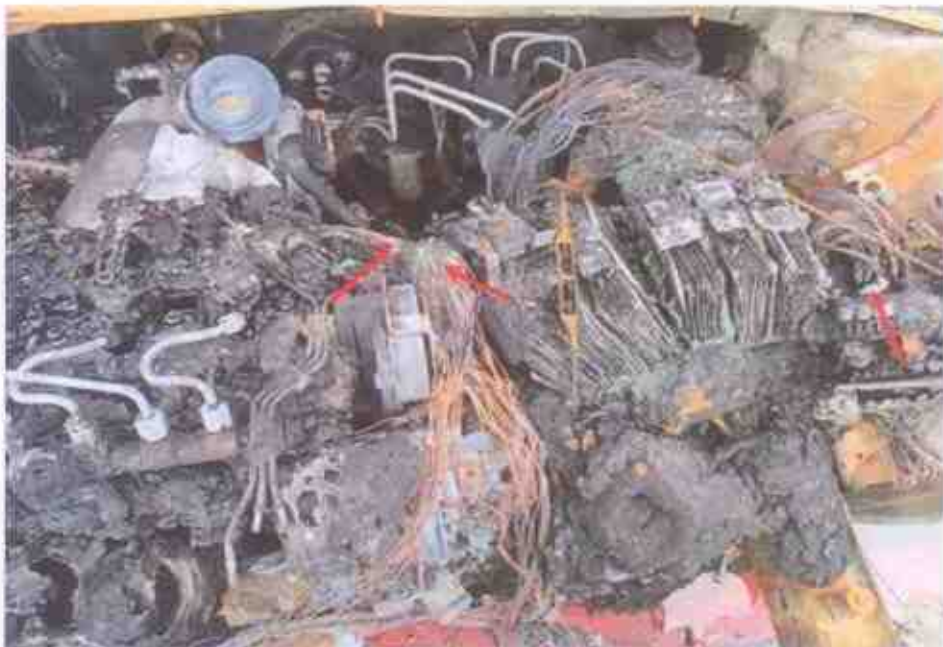
Photo 8 shows a closer view of the greenish residue found on some of the burnt stretches of original factory fitted wirings (arrowed). The presence of such greenish residue suggests occurrence of an electrical short circuit.

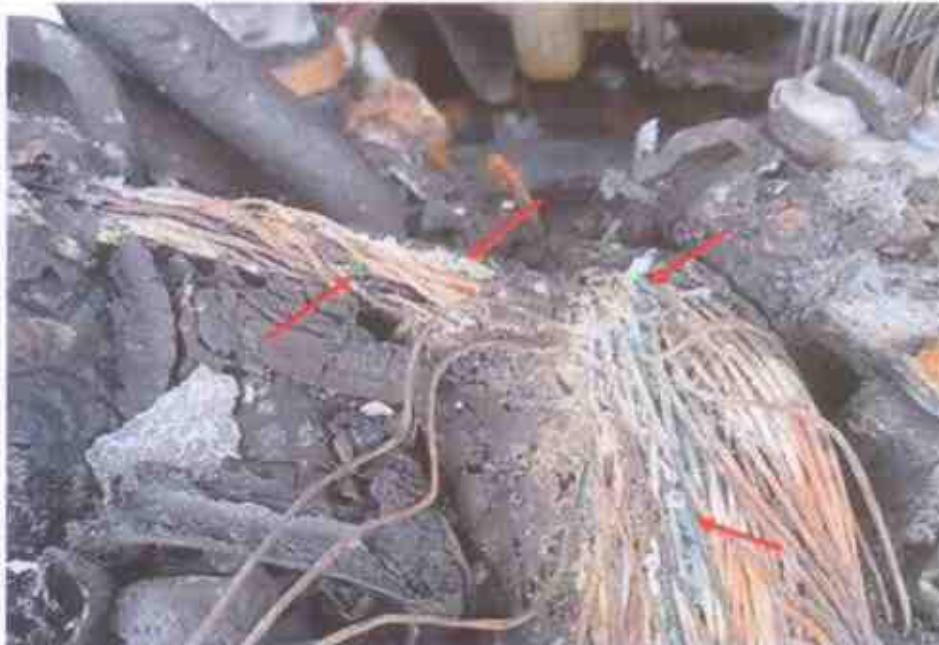
Photo 9 shows a close up view of the greenish residue found on some of the burnt stretches of original factory fitted wirings (arrowed). The presence of such greenish residue suggests occurrence of an electrical short circuit.

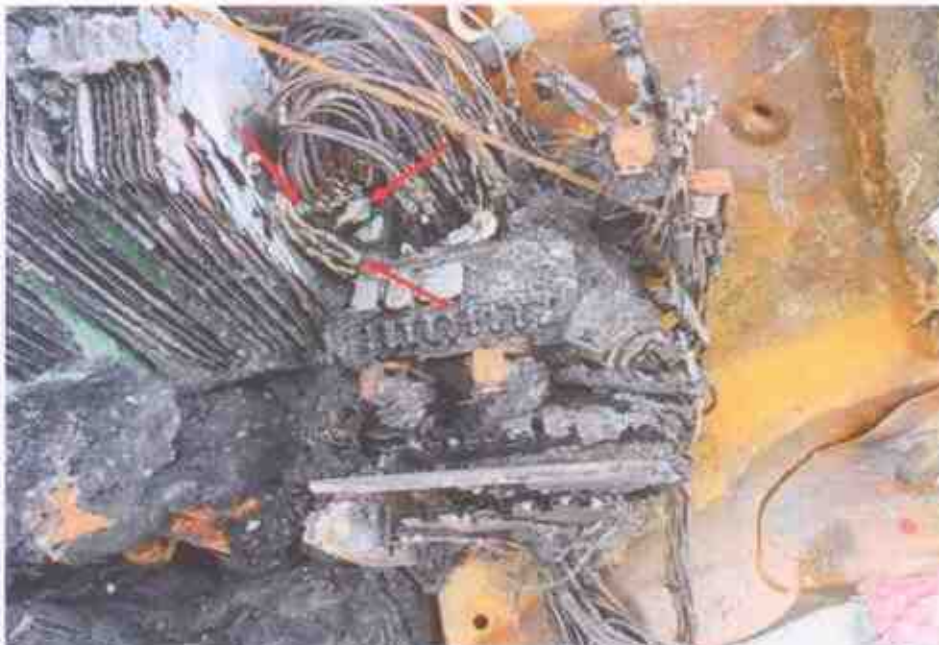
Photo 10 shows a close up view of the greenish residue found on some of the burnt stretches of original factory fitted wirings (arrowed). The presence of such greenish residue suggests occurrence of an electrical short circuit.

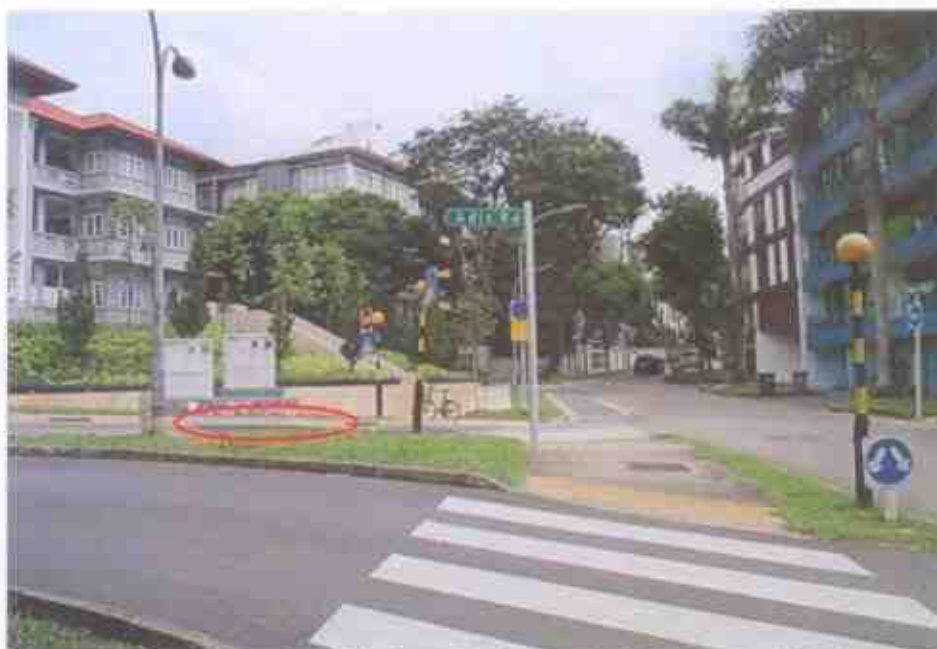
Photo 11 shows Adis Road in front of Sophia Hills before the filter lane into Sophia Road where the incident occurred (circled).

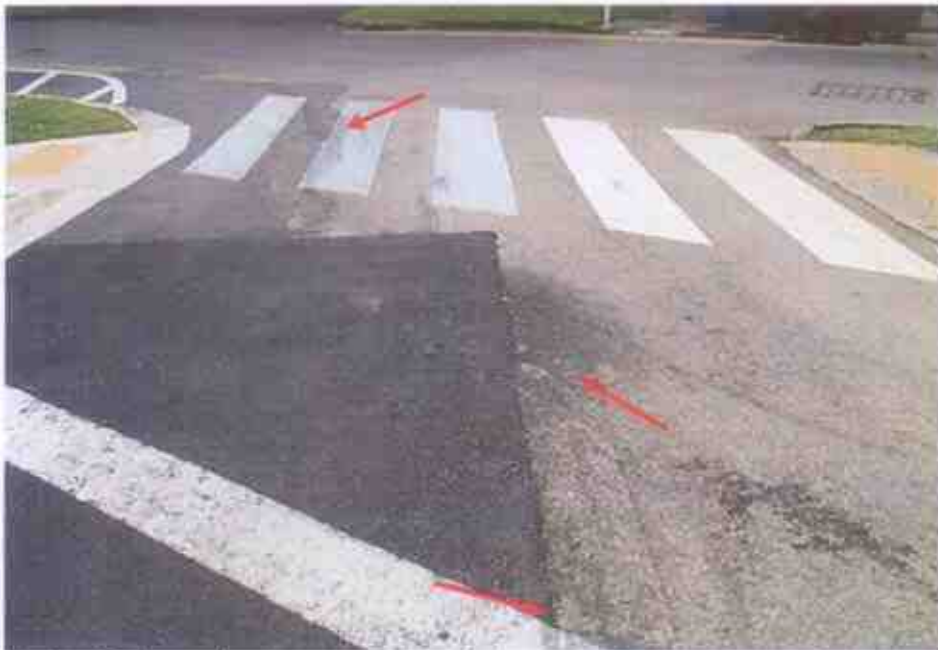
Photo 12 shows the burn marks and/or burnt residual remains on the ground before the filter lane into Sophia Road where the incident occurred (arrowed).

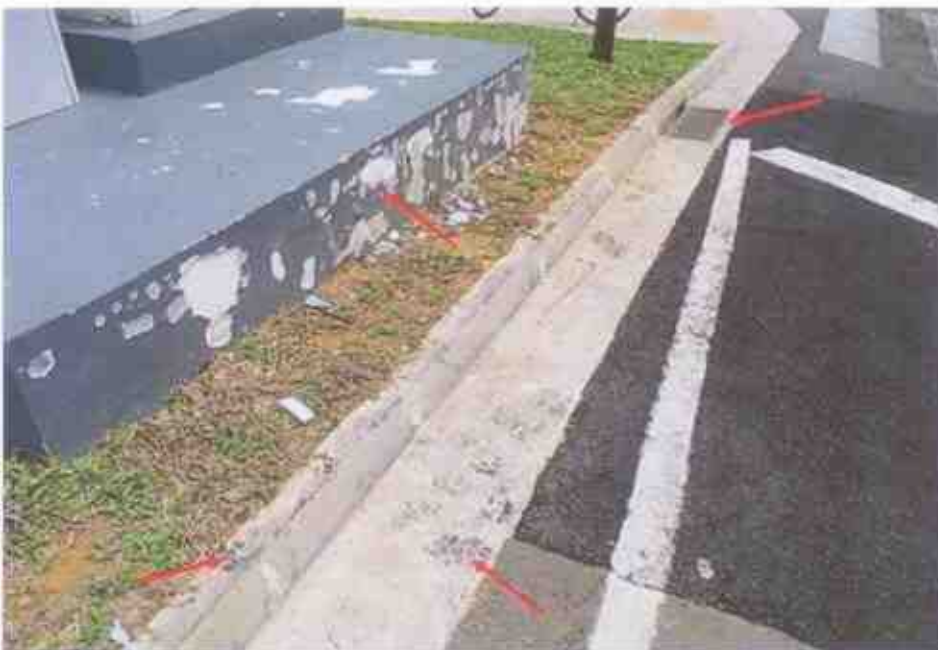
Photo 13 shows the burn marks and/or burnt residual remains on the ground, kerb, electrical fixtures and drain grating nearest to where the Insured Vehicle was positioned when the fire occurred (arrowed).

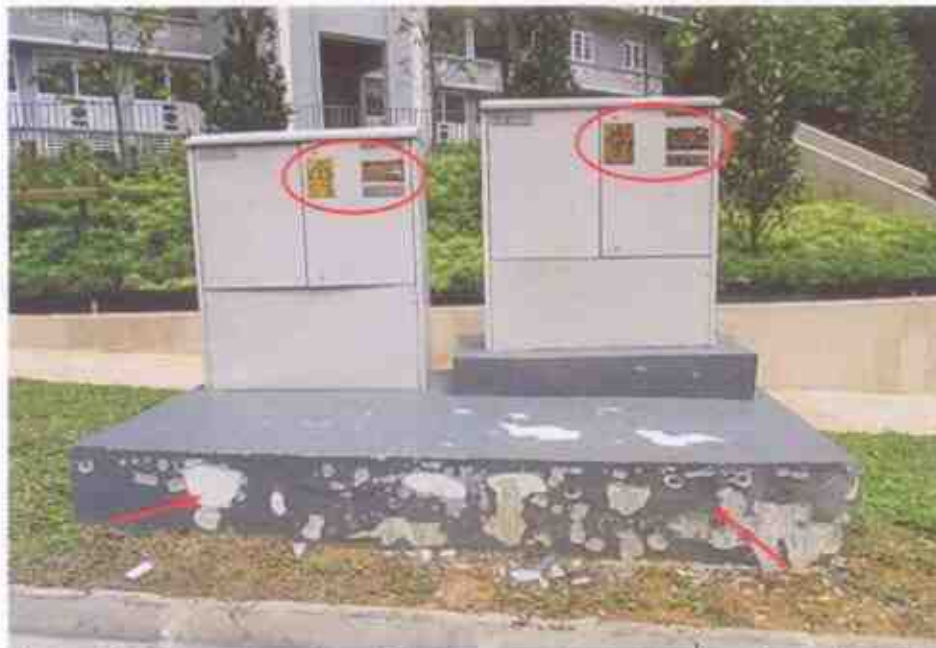
Photo 14 shows a closer view of the damage observed on the adjacent electrical fixtures. The paint is discoloured and flaky (red arrows). Bubbles have also formed on the warning and information signs due to exposure to prolonged high heat intensity from the fire (circled).

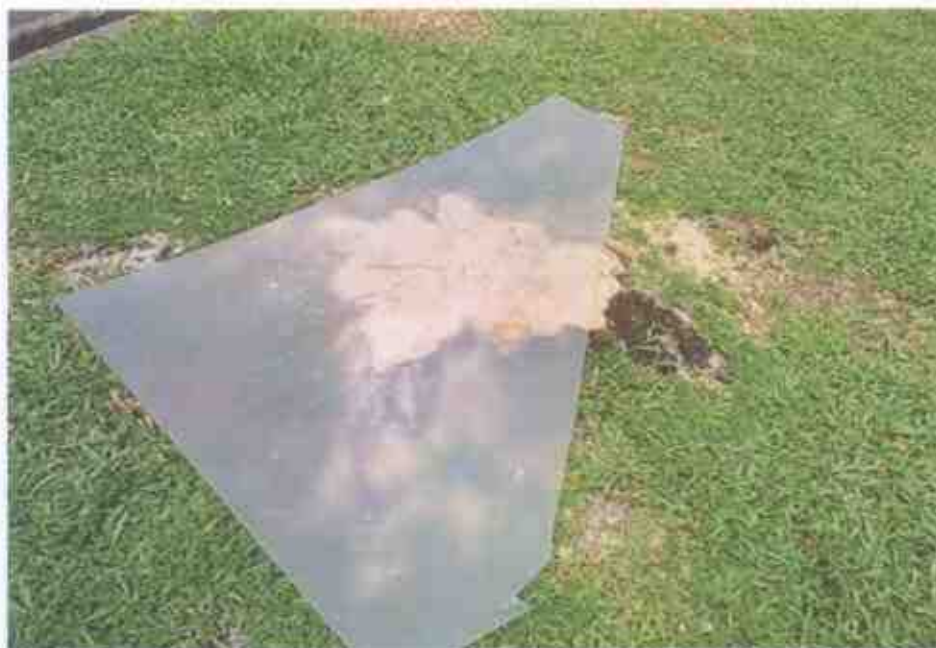
Photo 15 shows the remains of a tree which was affected by the fire.

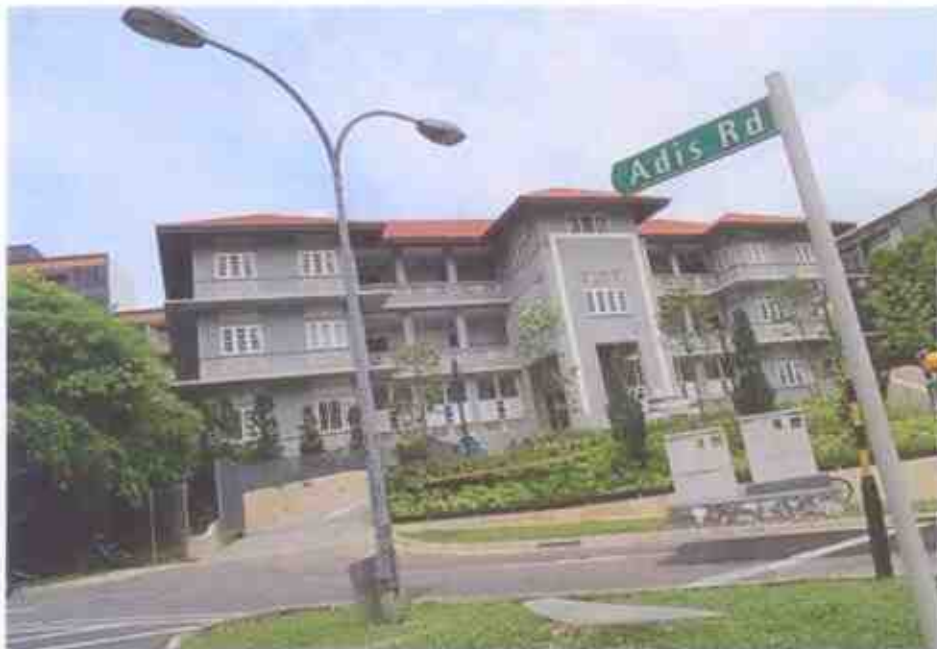
Photo 16 shows the lamp post which was affected by the fire.

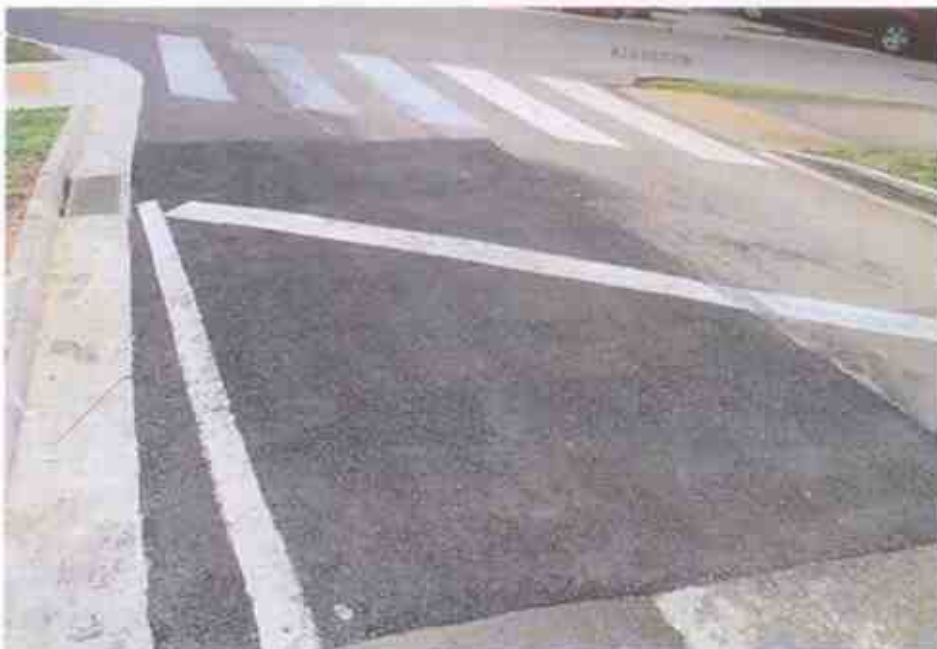
Photo 17 shows the repaved part of the road where the Insured Vehicle was positioned when the fire broke out.

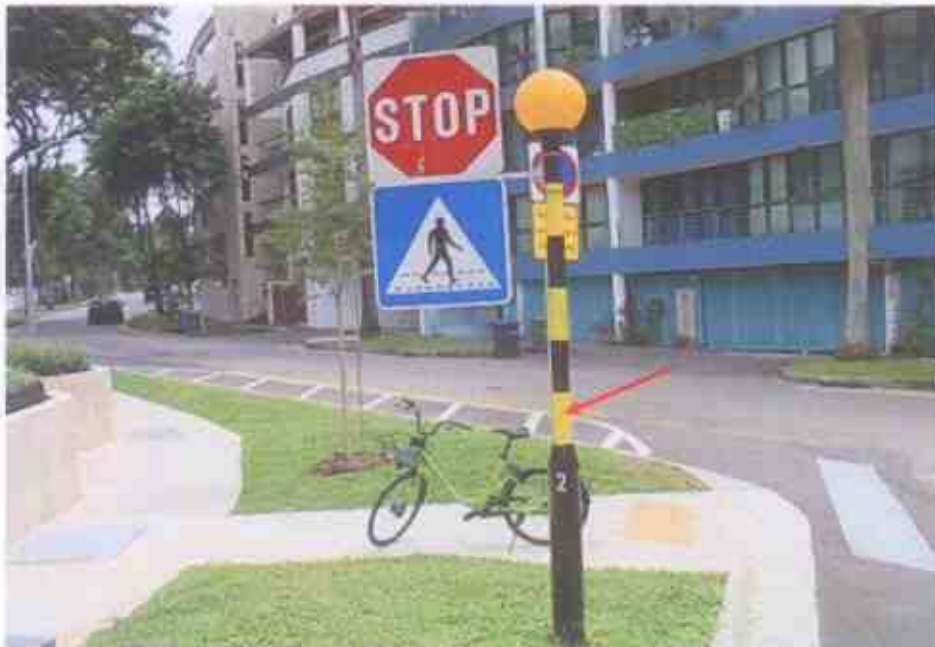
Photo 18 shows the replaced Belisha beacon closest to the Insured Vehicle which was affected by the fire (arrowed).

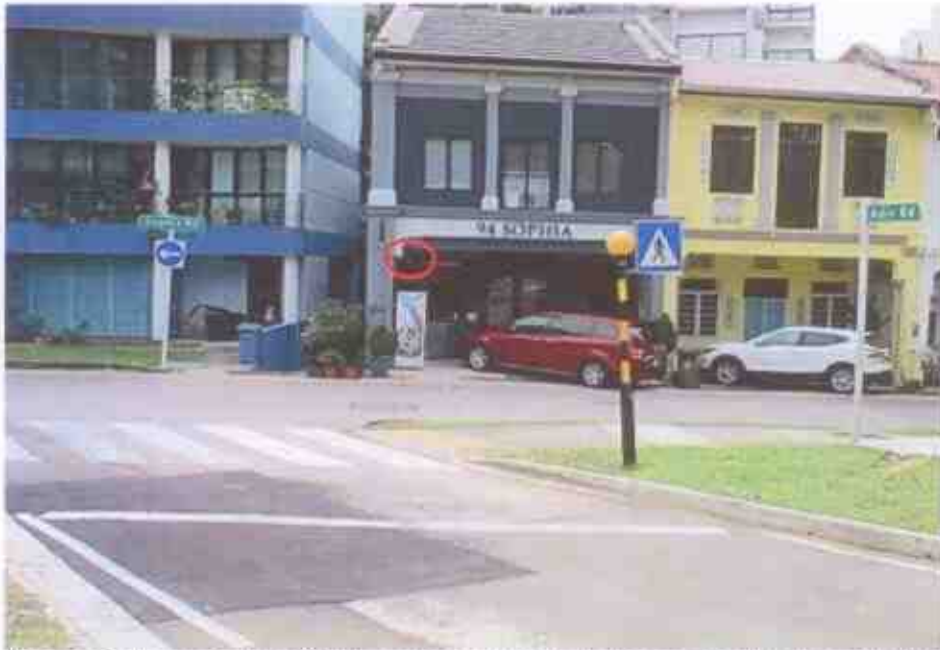
Photo 19 shows 1 of 2 CCTV cameras nearest to the incident location (circled) that belong to BWLS.

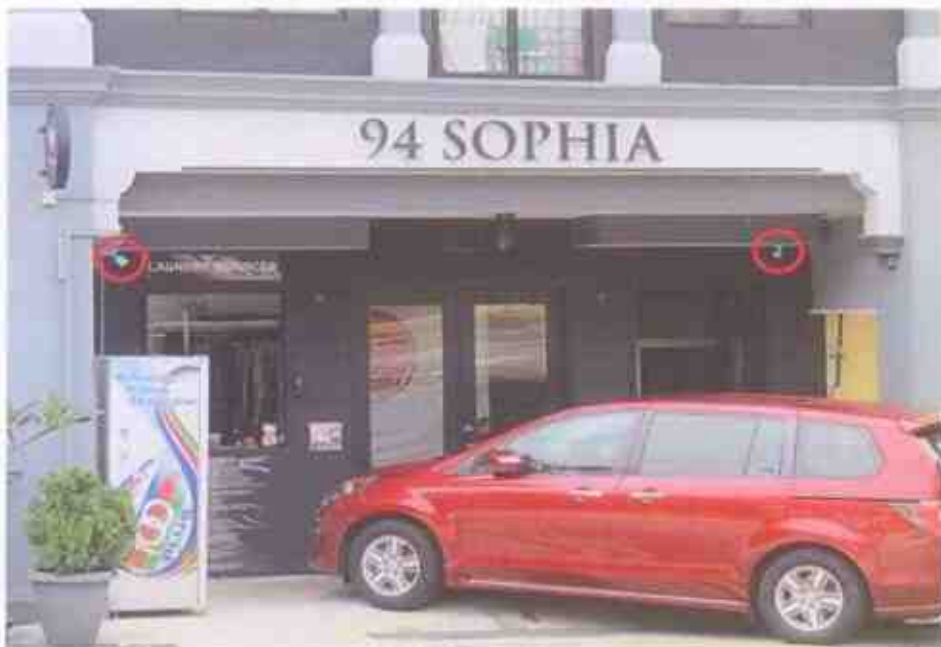
Photo 20 shows the position of BWLS's 2 CCTV cameras (circled). The CCTV cameras were positioned on the ceiling at the front of the shop. The placements of the cameras are such that they are facing the entrance of the shop and out of range of the incident location. Hence the cameras would have been unable to record any footage of the incident from those angles.

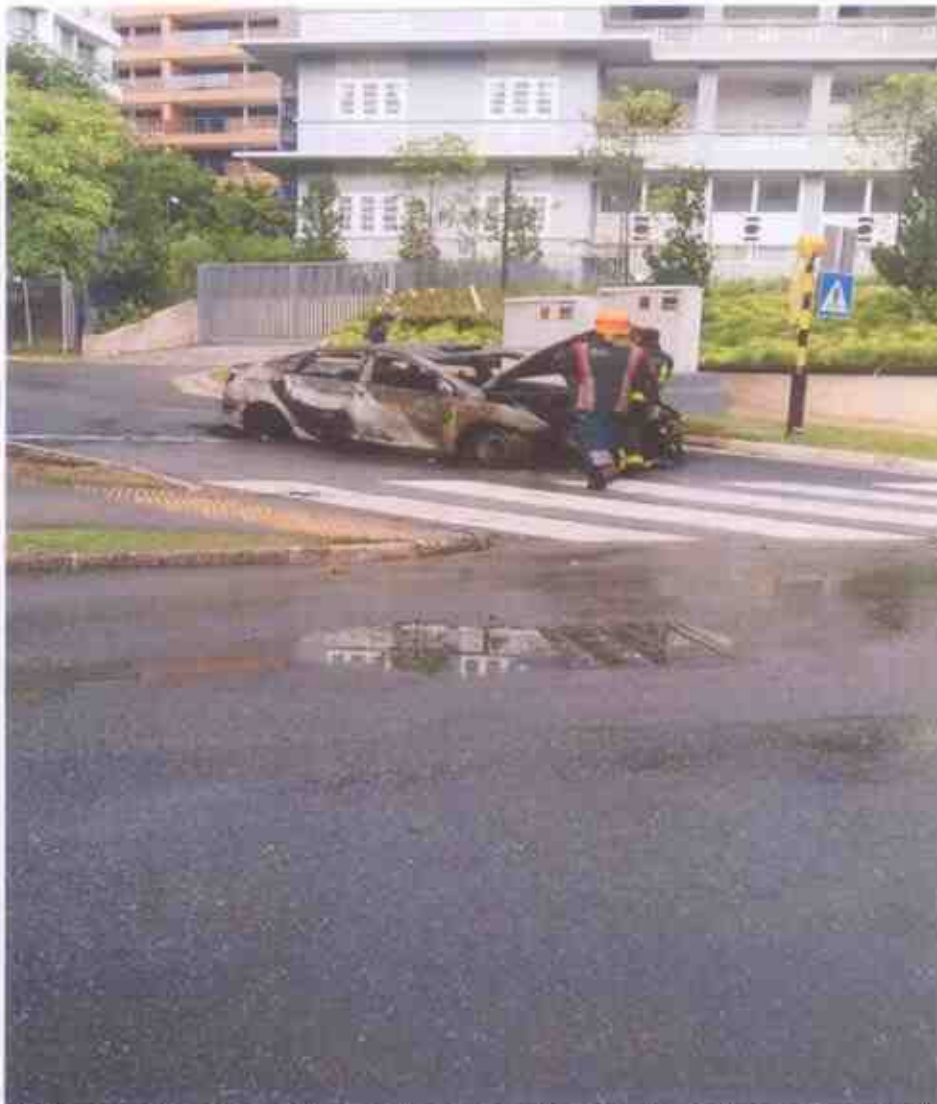
Photo 21 shows the SCDF making sure that the fire had been completely extinguished.

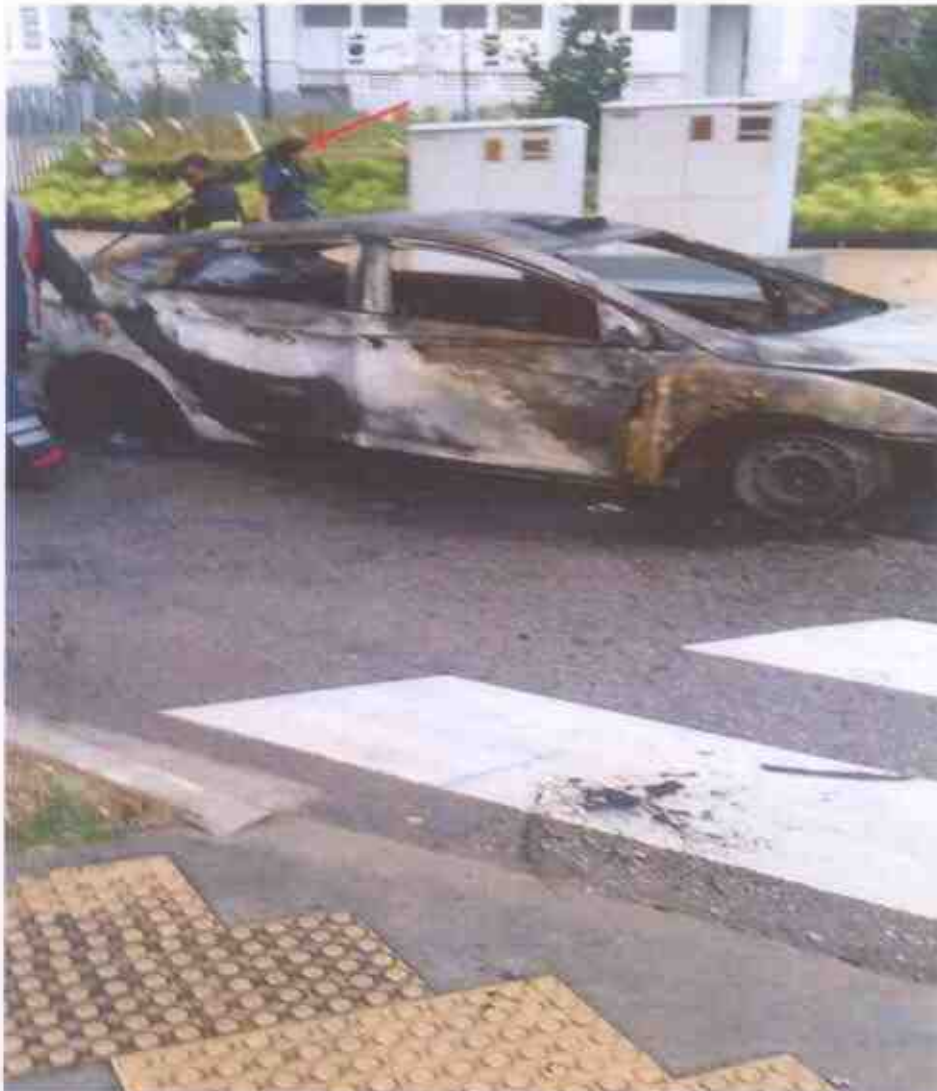
Photo 22 shows the Insured Vehicle after the fire was extinguished. In general, the information that could be gathered from this photograph had corresponded to the events that were related to us by Mr Soh, which is the police were also present at the incident scene (arrowed).
