Your Ref: 6227479448SG
Our Ref : CI/AIG18013192/N

16 July 2018

TECHNICAL INVESTIGATION REPORT OF FIRE INCIDENT INVOLVING THE INSURED VEHICLE GBD 4782E ON 14 JUNE 2018

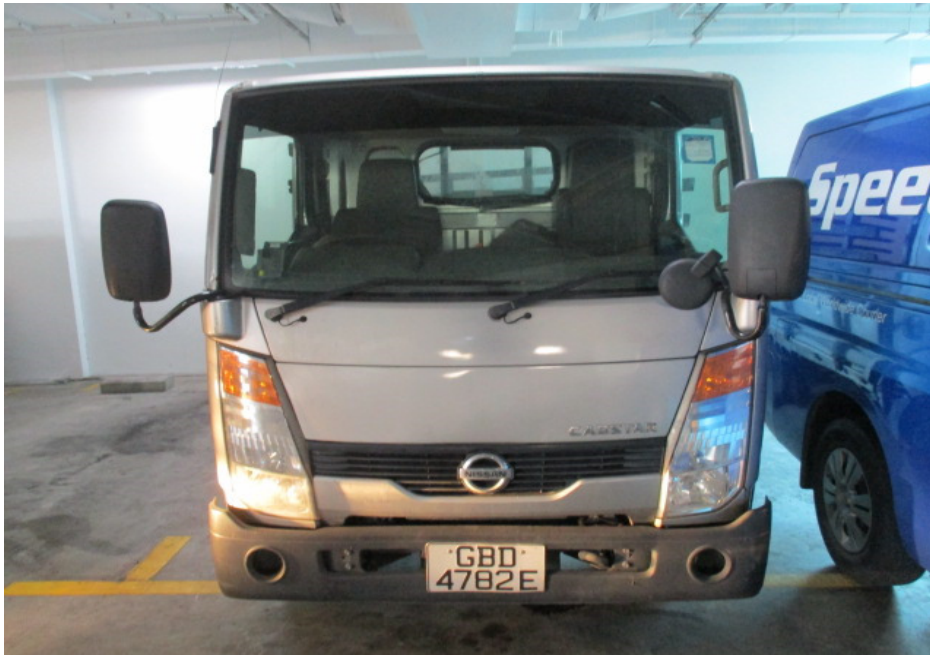
Photo 1 shows the front view of the Insured Vehicle at the time of our inspection. The fire damage to the Insured Vehicle was confined to its centre portion. The exterior body of the Insured Vehicle was relatively unaffected by the fire except for the centre portion.

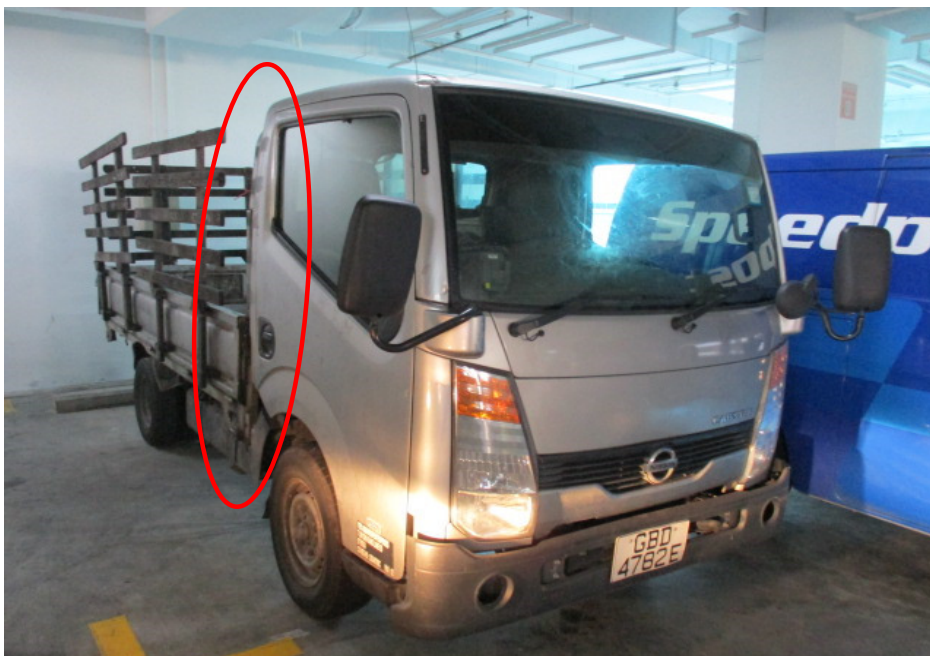
Photo 2 shows the right side view of the Insured Vehicle at the time of our inspection. The exterior body of the Insured Vehicle was relatively unaffected by the fire except for the centre portion. The fire damage to the Insured Vehicle was confined to its centre portion (circled).

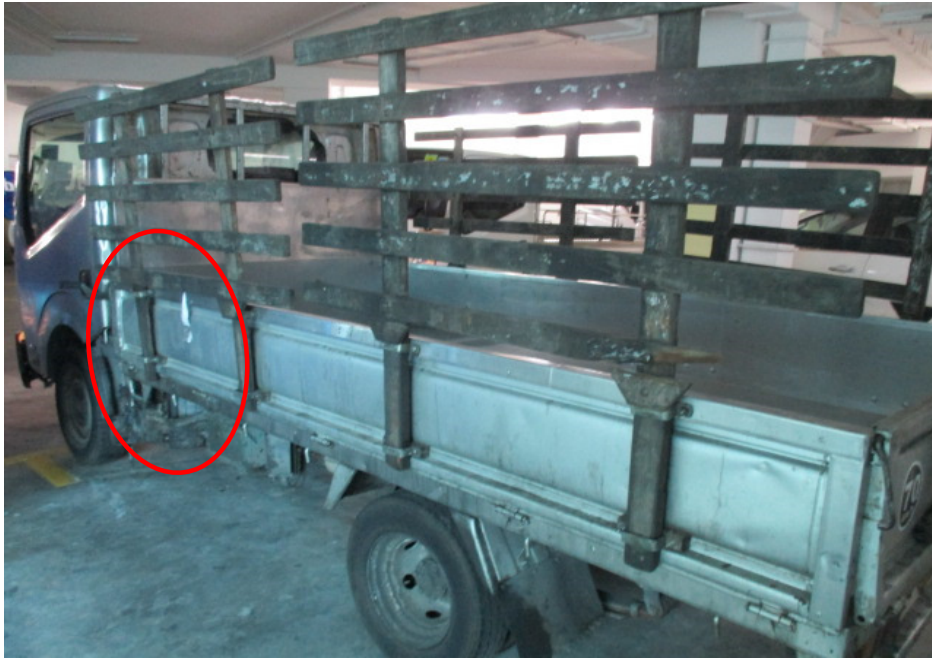
Photo 3 shows the left rear view of the Insured Vehicle at the time of our inspection. The exterior body of the Insured Vehicle was relatively unaffected by the fire except for the centre portion. The fire damage to the Insured Vehicle was confined to its centre portion. The fire damage was observed to be most severe at its left centre portion (circled).

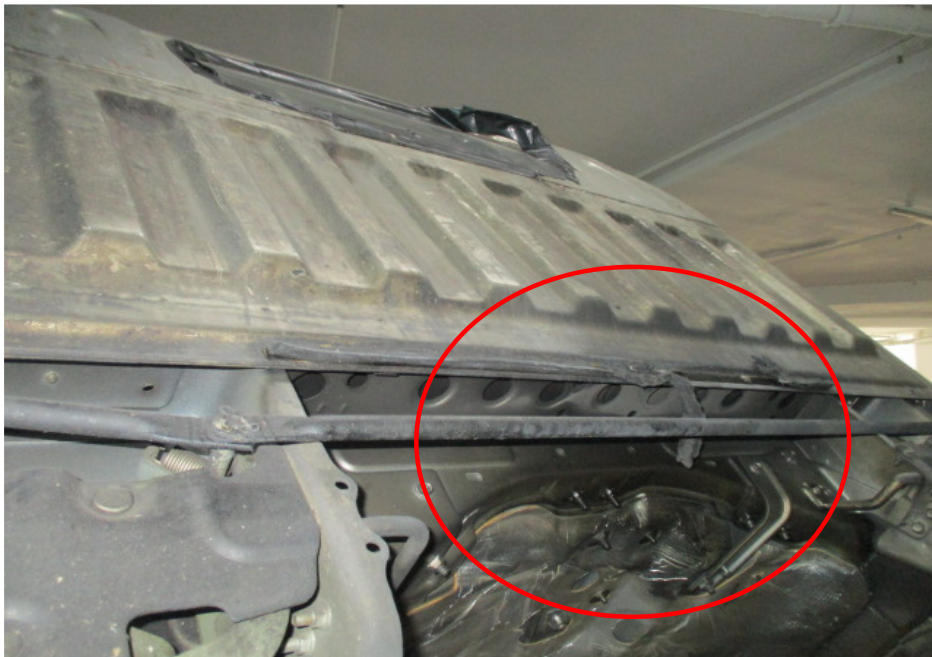
Photo 4 shows the exterior rear portion of the cab of the Insured Vehicle at the time of our inspection. The fire damage to the Insured Vehicle was confined to its centre portion (circled).

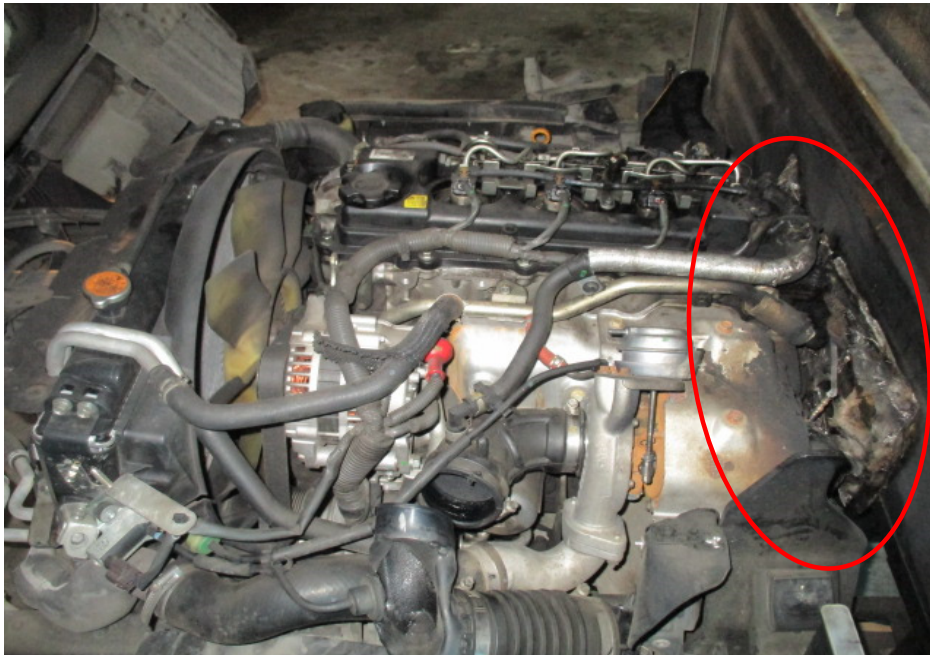
Photo 5 shows the engine compartment of the Insured Vehicle which is situated beneath the cab at the time of our inspection. The rear portion of the engine compartment of the Insured Vehicle was significantly unaffected by the fire (circled).

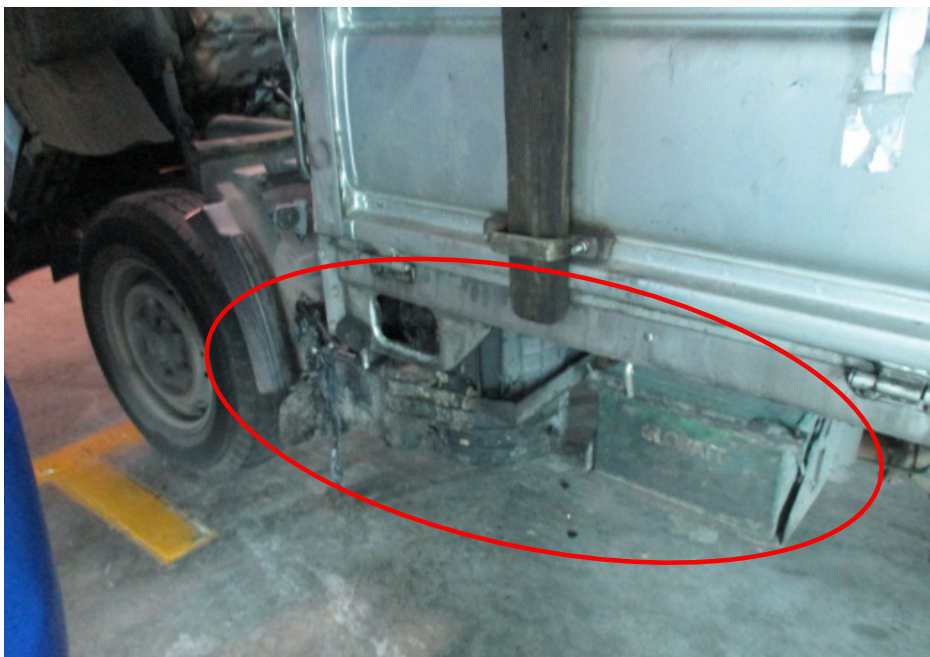
7. For this particular case, the fire appears to have originated from the left centre portion of the Insured Vehicle, where the air cleaner assembly and battery are located as the nature of fire damage was confined to these particular areas. This can be determined from the burn pattern of the air cleaner assembly components which were observed to have been partly melted from the high heat intensity and the high heat intensity burn marks (whitish burn marks) found on the metal brackets holding the battery of the Insured Vehicle. Rust had also developed on these metal brackets.

Photo 6 shows the left centre portion of the Insured Vehicle, where the air cleaner assembly and battery are located. The nature of fire damage was confined to these particular areas (circled).

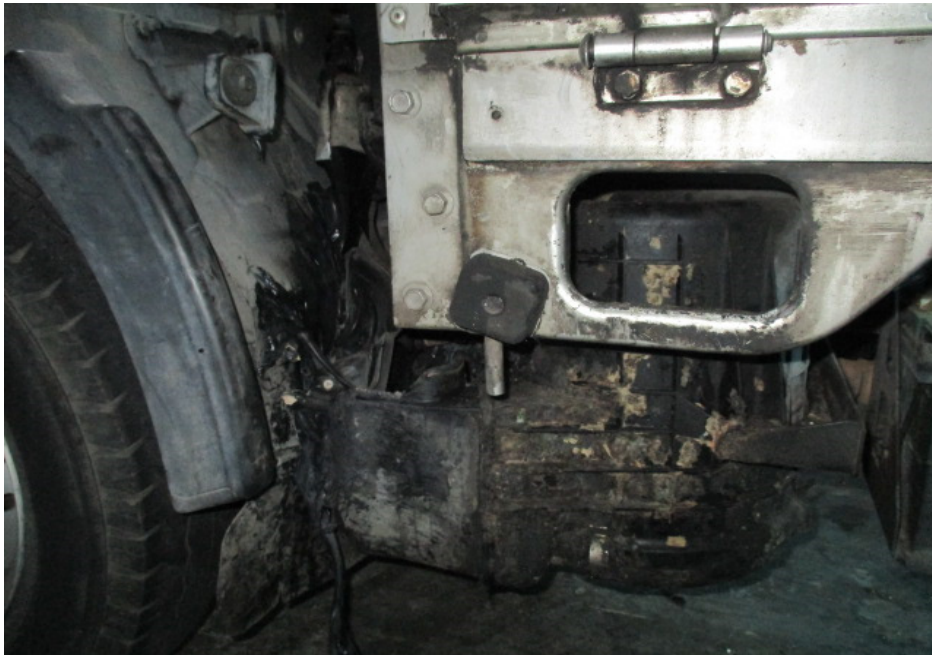
Photo 7 shows a closer view of the air cleaner assembly. The various components of the air cleaner assembly were observed to have been partly melted from the high heat intensity.

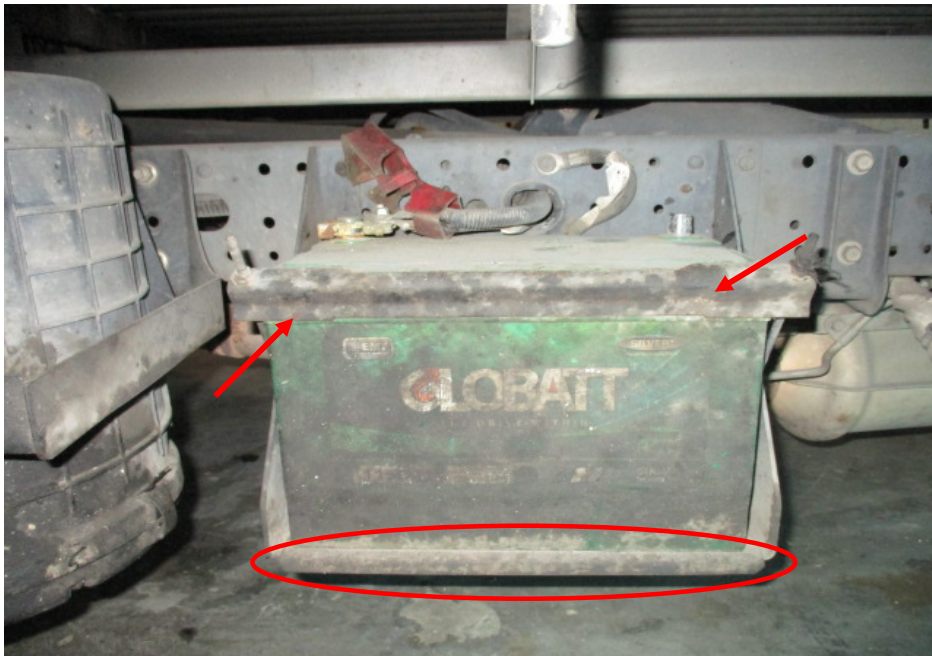
8. The whitish burn marks are a result of exposure to prolonged heat intensity. Rust would normally start to develop around these areas soon after a fire as prolonged exposure to high heat intensity usually causes steel/metal material body parts to be exposed to natural environmental condition. The rust that had developed on the metal brackets holding the battery is an indication that the left centre position of the Insured Vehicle had sustained exposure to prolonged high heat intensity. See photos 6 - 8 below.

Photo 8 shows the high heat intensity burn marks (whitish burn marks) found on the metal brackets holding the battery of the Insured Vehicle (circled). Rust had also developed on these metal brackets (arrowed). The nature of fire damage is an indication as to where the fire started.

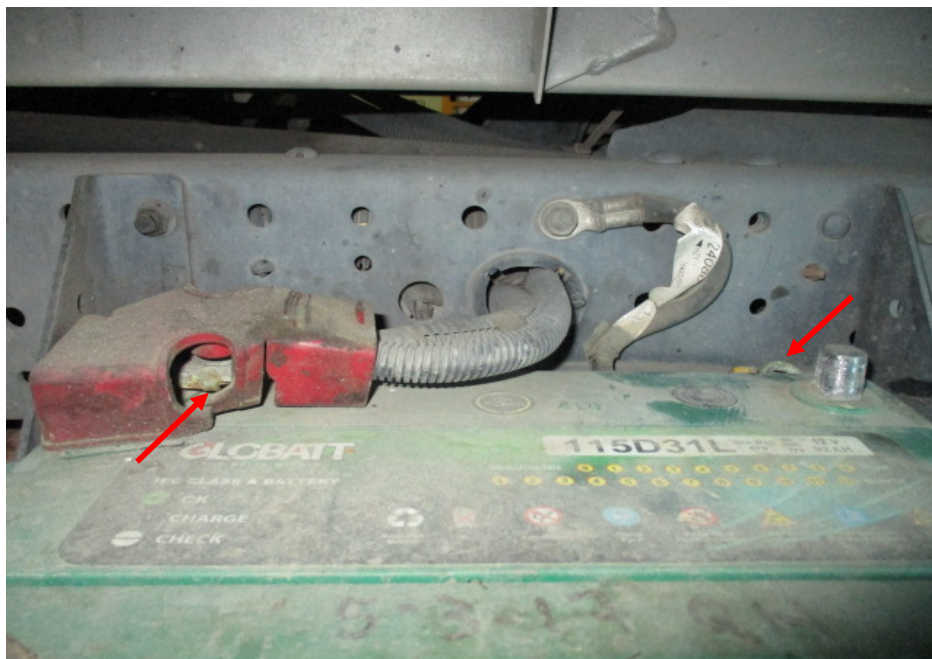
9. Upon closer examination of the left centre portion of the Insured Vehicle which was where the fire had likely started, we had found traces of greenish residue on the wirings leading from the battery as well as on the wirings of the air cleaner assembly. The wirings were original factory fitted wirings. The presence of greenish residue indicates internal heating of copper wires, a sign of an electrical short circuit occurring. The greenish residue is normally left behind from oxidation as a result of chemical reaction involving the copper wires. This physical evidence would then appear to suggest that the cause of fire to the Insured Vehicle could have possibly been due to electrical in nature. See photos 9 - 13 below.

Photo 9 shows the wirings leading from the battery of the Insured Vehicle. The wirings were original factory fitted wirings. We observed traces of greenish residue on these wirings (arrowed). The presence of such greenish residue indicates internal heating of copper wires, a sign of an electrical short circuit occurring. The greenish residue is normally left behind from oxidation as a result of chemical reaction involving the copper wires. This physical evidence would then appear to suggest that the cause of fire to the Insured Vehicle could have possibly been due to electrical in nature.

21. The possibility of the fire being due to electrical in nature would then seem more likely given that engine overheating and external factors would both seem unlikely. The fire being due to electrical nature is also supported by the condition of the wirings that were found leading from the battery of the Insured Vehicle, which was earlier discussed in paragraph 9 above.

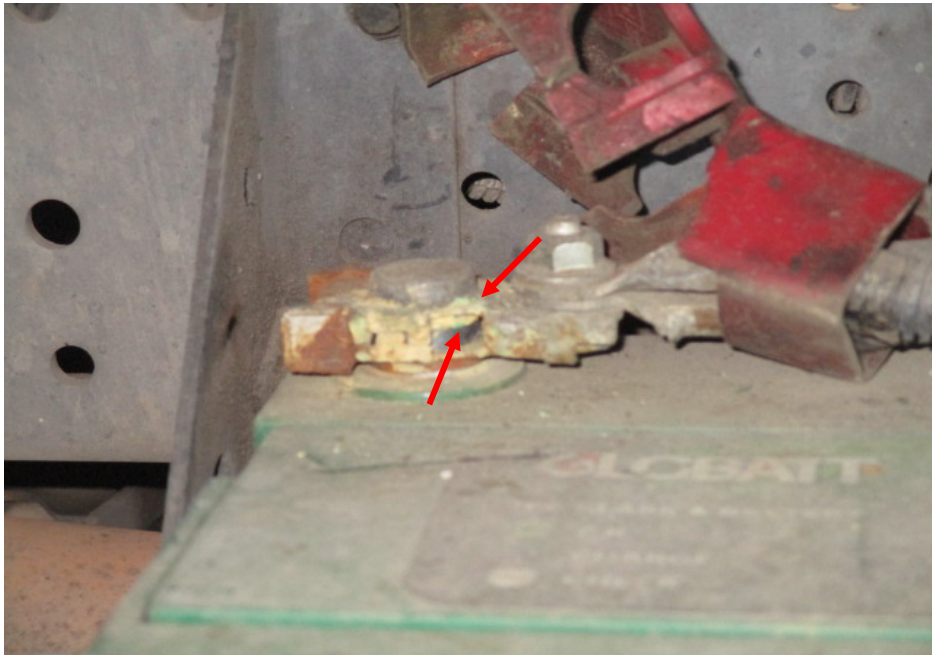
Photo 10 shows a closer view of the greenish residue found on the wirings leading from the battery of the Insured Vehicle (arrowed). This seems to suggest the occurrence of an electrical short circuit.

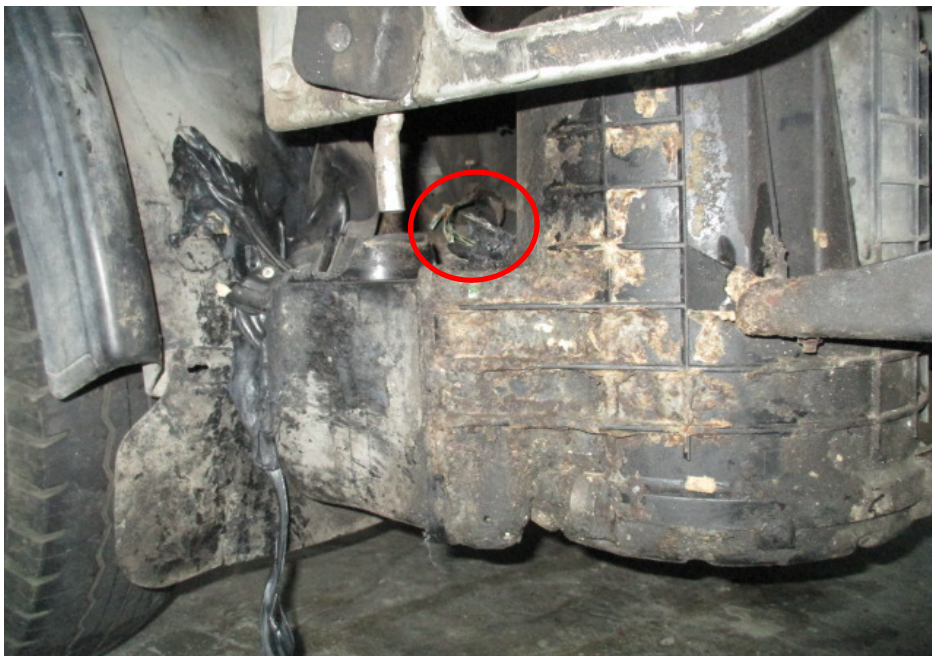
Photo 11 shows the burnt wirings of the Insured Vehicle's air cleaner assembly. We observed traces of greenish residue on some of these wirings (circled).

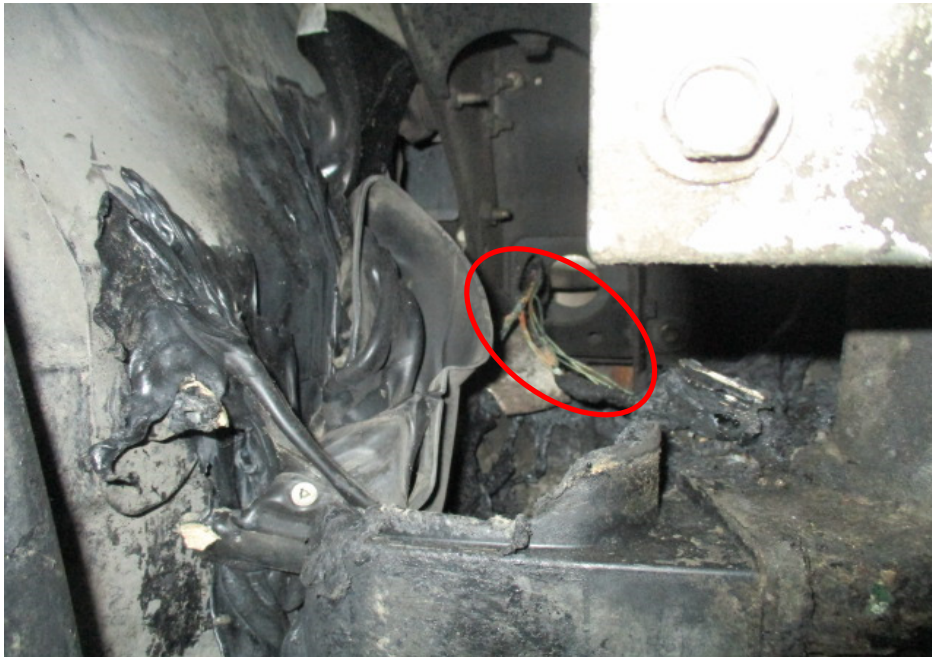
Photo 12 shows a closer view of the greenish residue found on the burnt wirings of the Insured Vehicle's air cleaner assembly (circled). This seems to suggest the occurrence of an electrical short circuit.

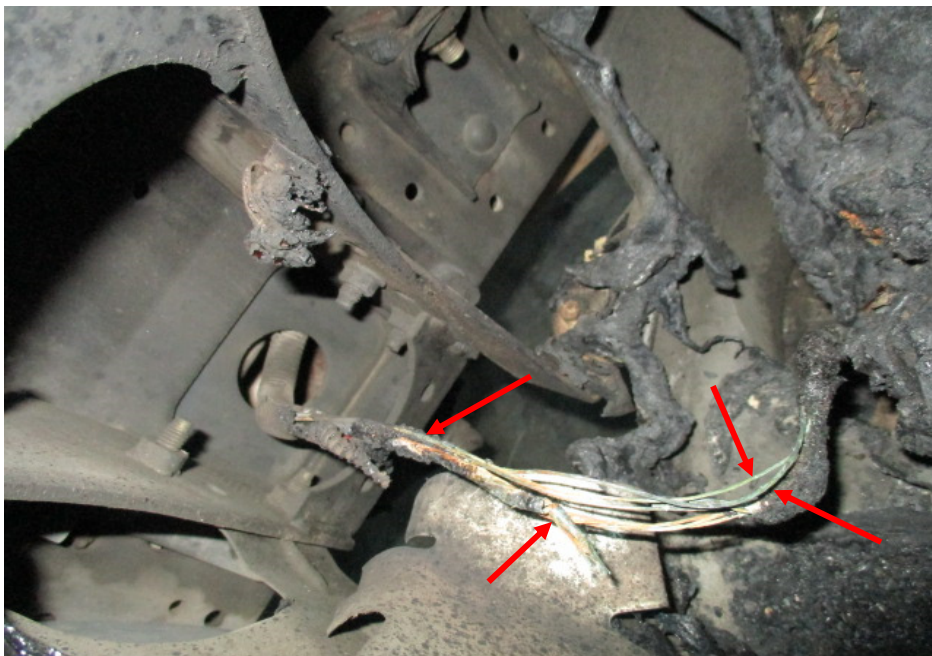
Photo 13 shows a close up view of the greenish residue found on some of the burnt wirings of the Insured Vehicle's air cleaner assembly (arrowed). This seems to suggest the occurrence of an electrical short circuit.
