Your Ref: 6227479448SG
Our Ref : CI/AIG18013192/N

16 July 2018

**TECHNICAL INVESTIGATION REPORT OF FIRE INCIDENT INVOLVING THE
INSURED VEHICLE GBD 4782E ON 14 JUNE 2018**

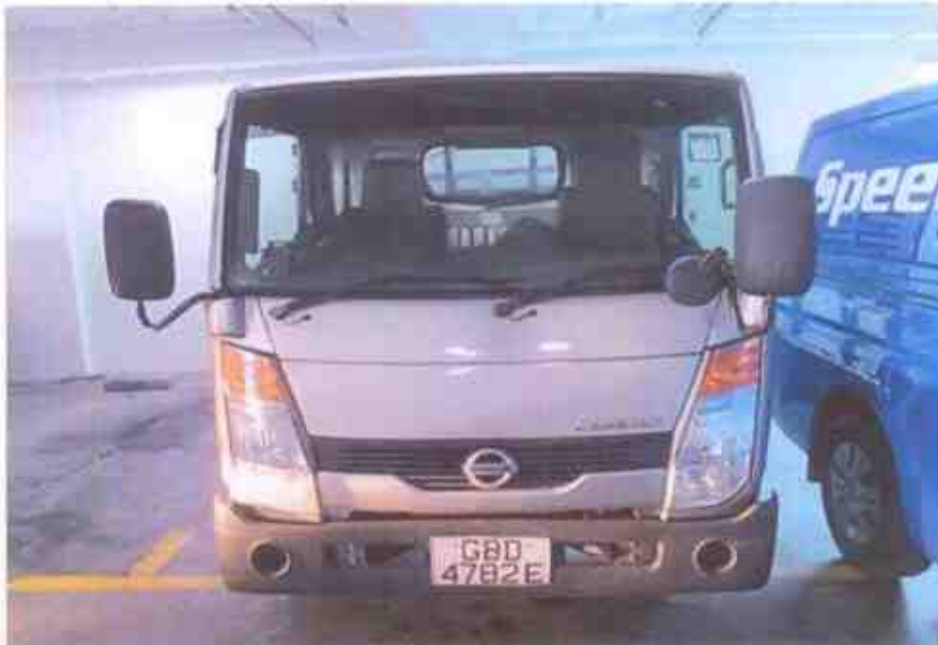
Photo 1 shows the front view of the Insured Vehicle at the time of our inspection. The fire damage to the Insured Vehicle was confined to its centre portion. The exterior body of the Insured Vehicle was relatively unaffected by the fire except for the centre portion.

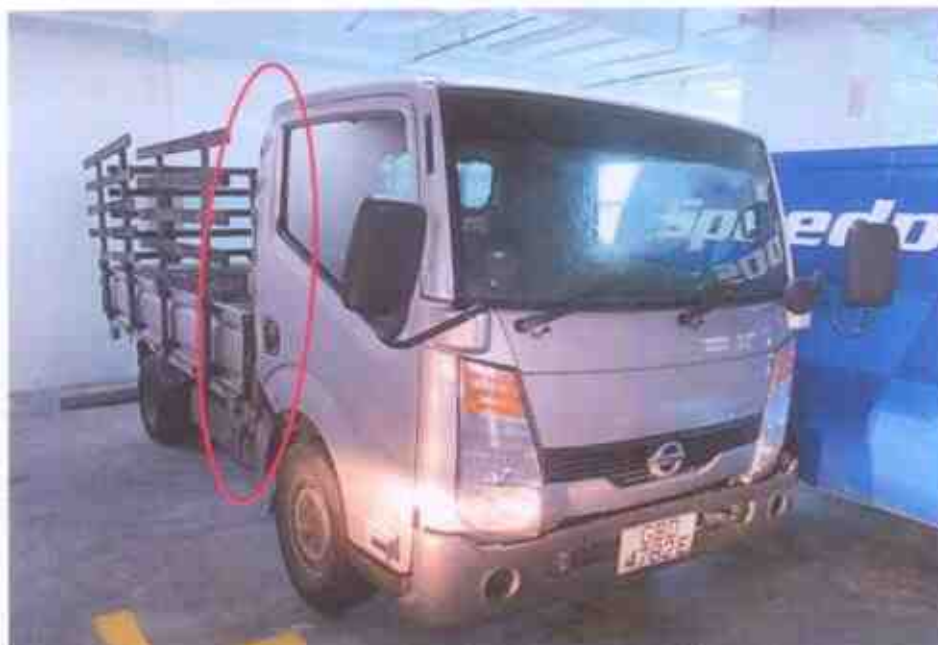
Photo 2 shows the right side view of the Insured Vehicle at the time of our inspection. The exterior body of the Insured Vehicle was relatively unaffected by the fire except for the centre portion. The fire damage to the Insured Vehicle was confined to its centre portion (circled).

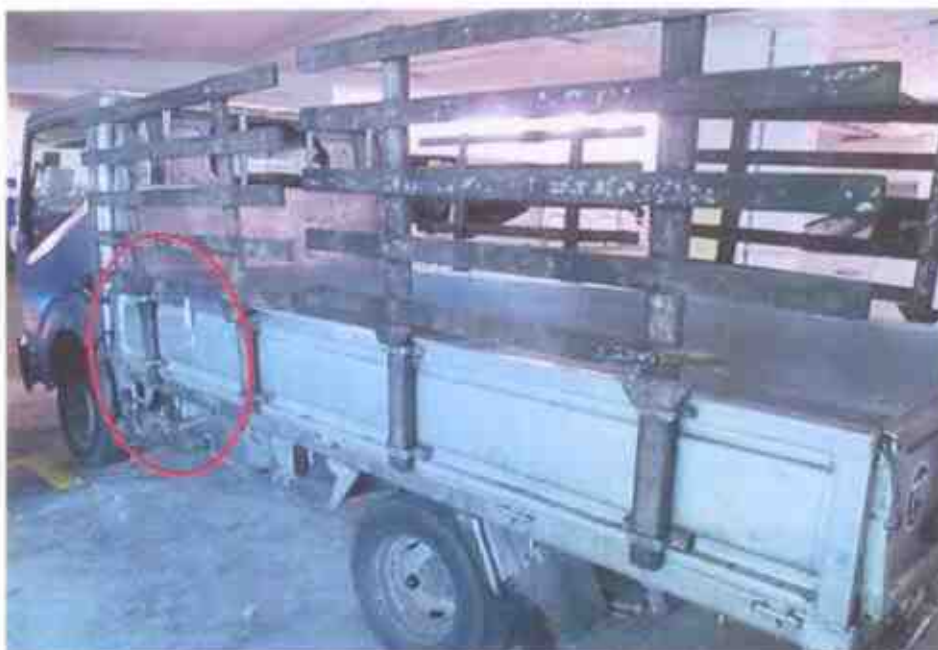
Photo 3 shows the left rear view of the Insured Vehicle at the time of our inspection. The exterior body of the Insured Vehicle was relatively unaffected by the fire except for the centre portion. The fire damage to the Insured Vehicle was confined to its centre portion. The fire damage was observed to be most severe at its left centre portion (circled).

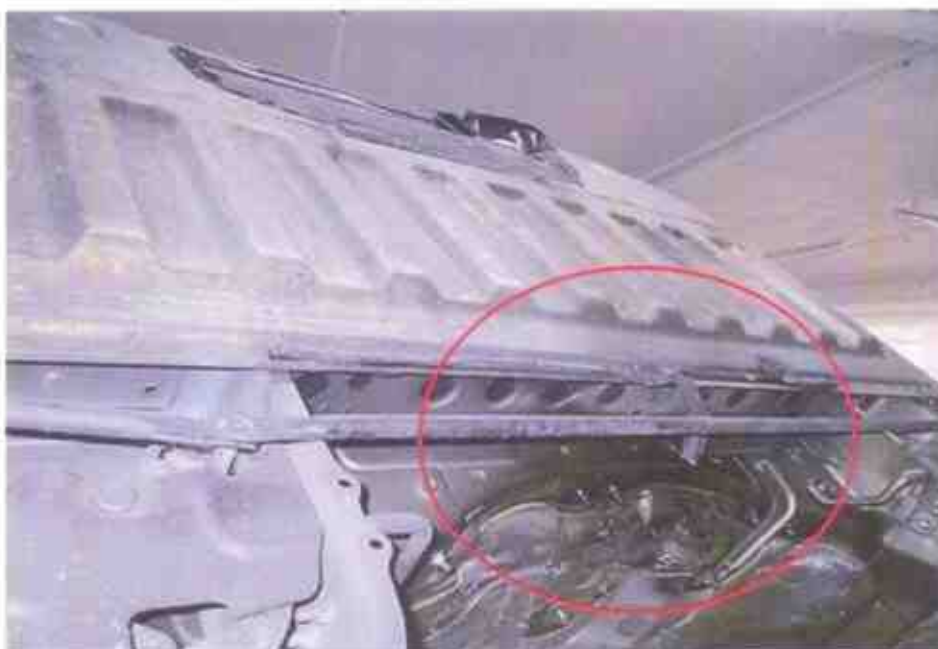
Photo 4 shows the exterior rear portion of the cab of the Insured Vehicle at the time of our inspection. The fire damage to the Insured Vehicle was confined to its centre portion (circled).

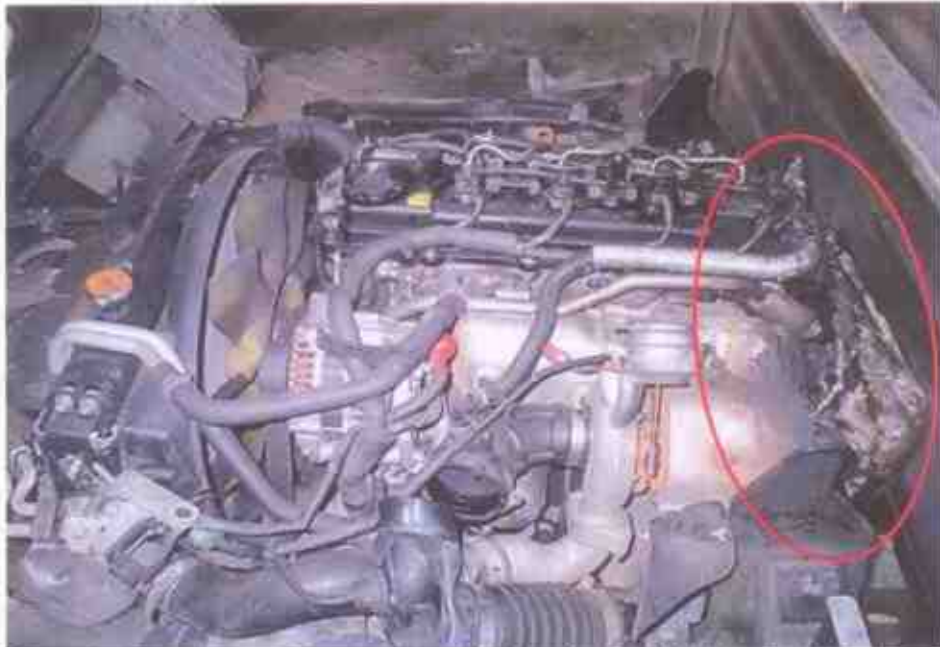
Photo 5 shows the engine compartment of the Insured Vehicle which is situated beneath the cab at the time of our inspection. The rear portion of the engine compartment of the Insured Vehicle was significantly unaffected by the fire (circled).

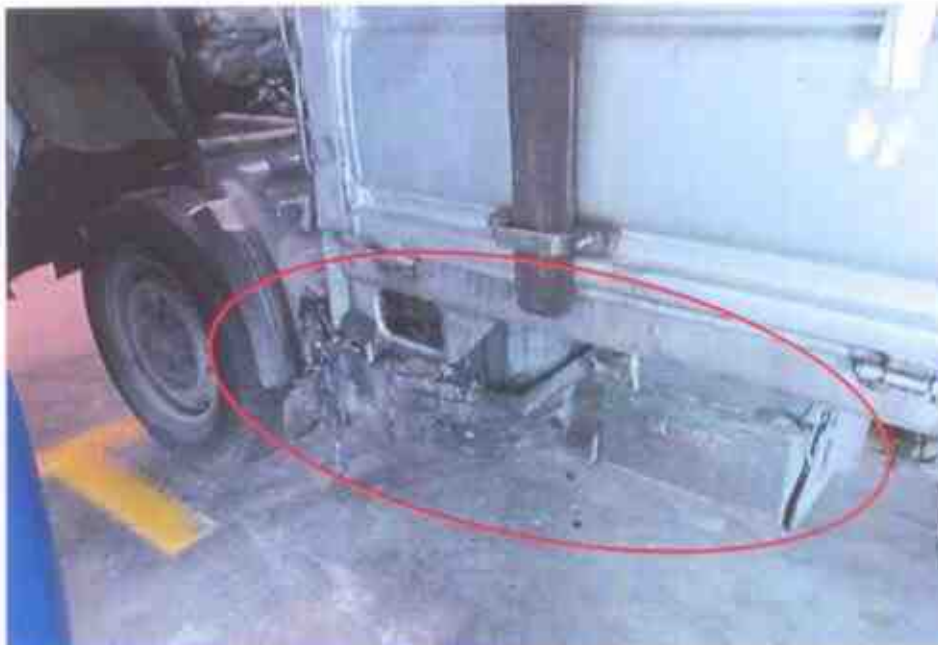
7. For this particular case, the fire appears to have originated from the left centre portion of the Insured Vehicle, where the air cleaner assembly and battery are located as the nature of fire damage was confined to these particular areas. This can be determined from the burn pattern of the air cleaner assembly components which were observed to have been partly melted from the high heat intensity and the high heat intensity burn marks (whitish burn marks) found on the metal brackets holding the battery of the Insured Vehicle. Rust had also developed on these metal brackets.

Photo 6 shows the left centre portion of the Insured Vehicle, where the air cleaner assembly and battery are located. The nature of fire damage was confined to these particular areas (circled).

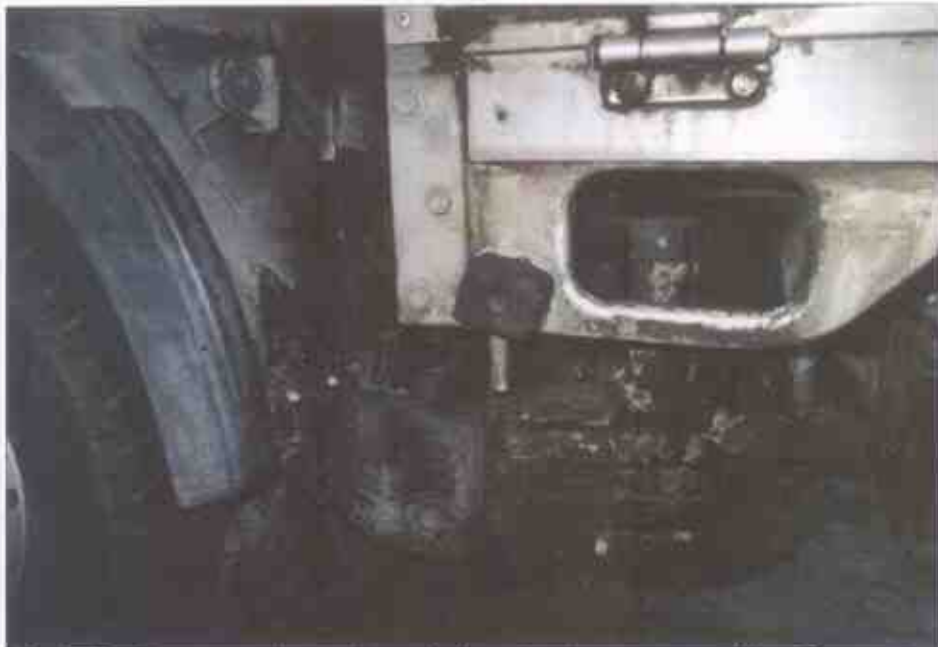
Photo 7 shows a closer view of the air cleaner assembly. The various components of the air cleaner assembly were observed to have been partly melted from the high heat intensity.

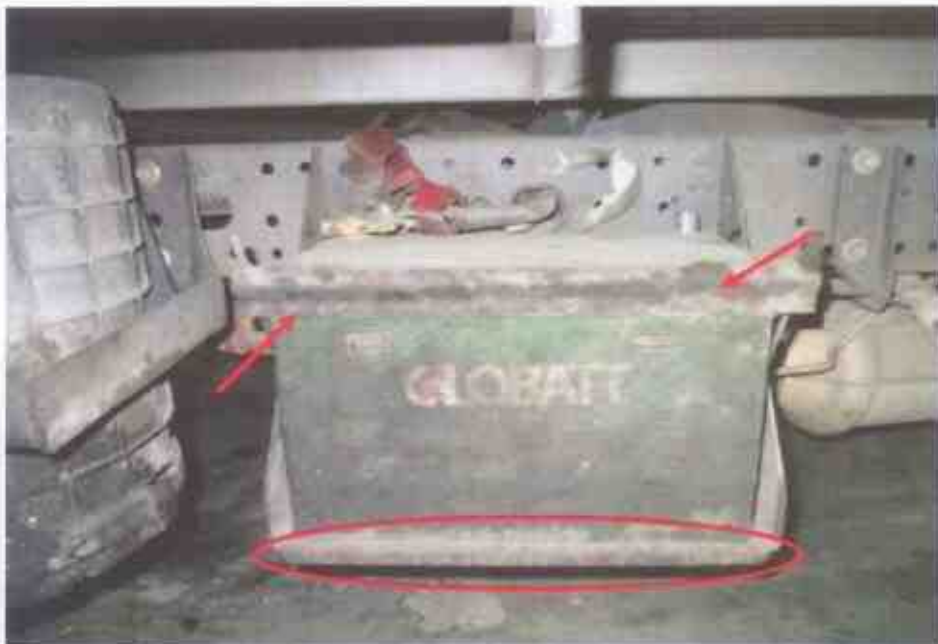
8. The whitish burn marks are a result of exposure to prolonged heat intensity. Rust would normally start to develop around these areas soon after a fire as prolonged exposure to high heat intensity usually causes steel/metal material body parts to be exposed to natural environmental condition. The rust that had developed on the metal brackets holding the battery is an indication that the left centre position of the Insured Vehicle had sustained exposure to prolonged high heat intensity. See photos 6 - 8 below.

Photo 8 shows the high heat intensity burn marks (whitish burn marks) found on the metal brackets holding the battery of the Insured Vehicle (circled). Rust had also developed on these metal brackets (arrowed). The nature of fire damage is an indication as to where the fire started.

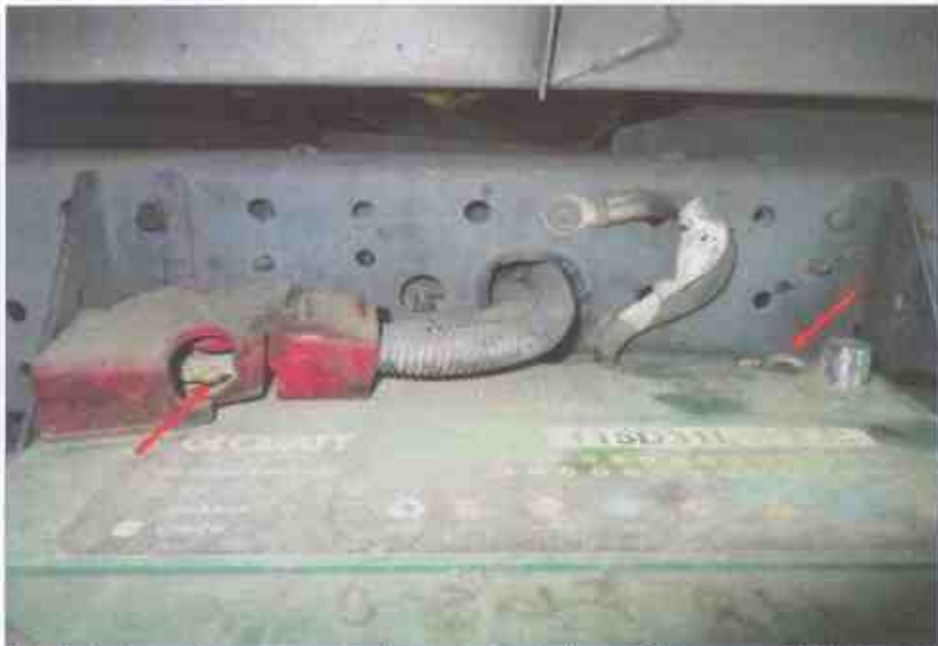
9. Upon closer examination of the left centre portion of the Insured Vehicle which was where the fire had likely started, we had found traces of greenish residue on the wirings leading from the battery as well as on the wirings of the air cleaner assembly. The wirings were original factory fitted wirings. The presence of greenish residue indicates internal heating of copper wires, a sign of an electrical short circuit occurring. The greenish residue is normally left behind from oxidation as a result of chemical reaction involving the copper wires. This physical evidence would then appear to suggest that the cause of fire to the Insured Vehicle could have possibly been due to electrical in nature. See photos 9 - 13 below.

Photo 9 shows the wirings leading from the battery of the Insured Vehicle. The wirings were original factory fitted wirings. We observed traces of greenish residue on these wirings (arrowed). The presence of such greenish residue indicates internal heating of copper wires, a sign of an electrical short circuit occurring. The greenish residue is normally left behind from oxidation as a result of chemical reaction involving the copper wires. This physical evidence would then appear to suggest that the cause of fire to the Insured Vehicle could have possibly been due to electrical in nature.

21. The possibility of the fire being due to electrical in nature would then seem more likely given that engine overheating and external factors would both seem unlikely. The fire being due to electrical nature is also supported by the condition of the wirings that were found leading from the battery of the Insured Vehicle, which was earlier discussed in paragraph 9 above.

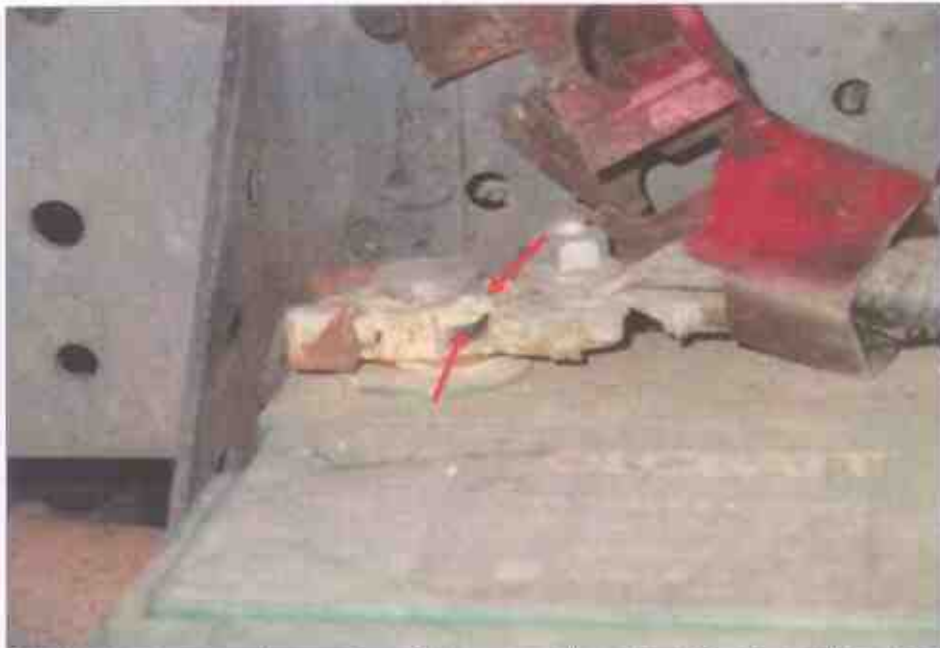
Photo 10 shows a closer view of the greenish residue found on the wirings leading from the battery of the Insured Vehicle (arrowed). This seems to suggest the occurrence of an electrical short circuit.

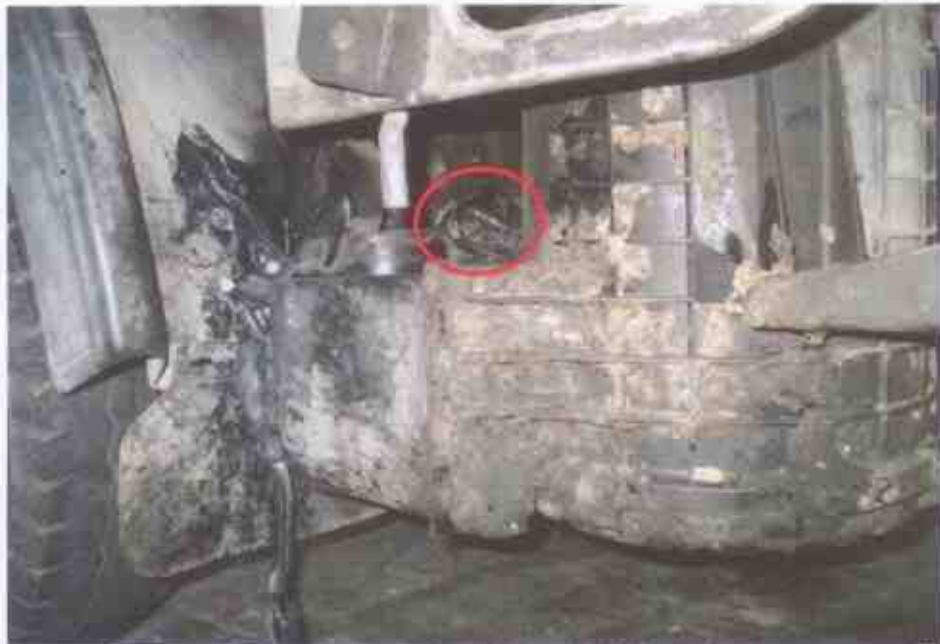
Photo 11 shows the burnt wirings of the Insured Vehicle's air cleaner assembly. We observed traces of greenish residue on some of these wirings (circled).

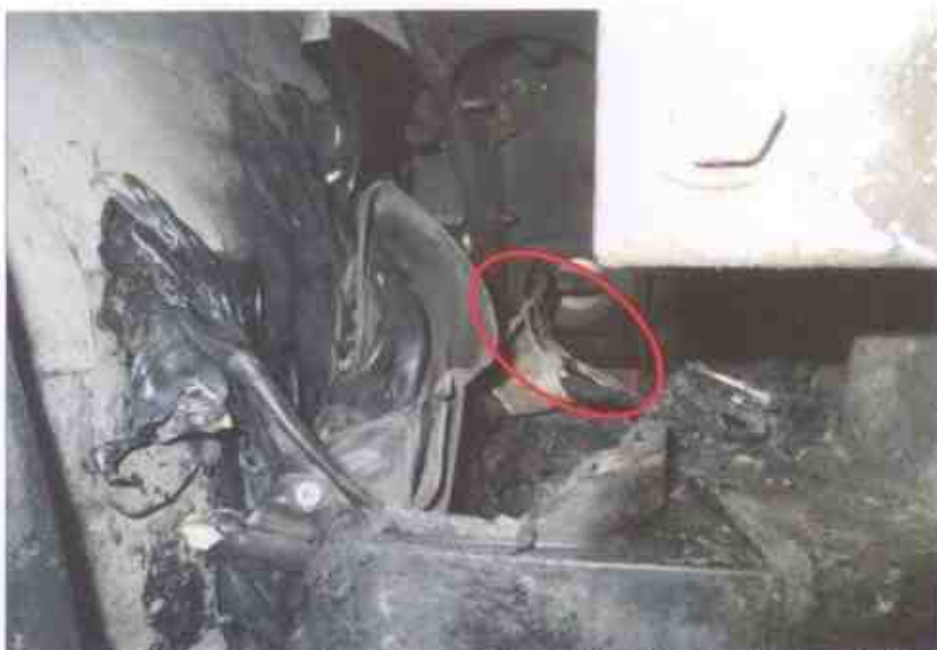
Photo 12 shows a closer view of the greenish residue found on the burnt wirings of the Insured Vehicle's air cleaner assembly (circled). This seems to suggest the occurrence of an electrical short circuit.

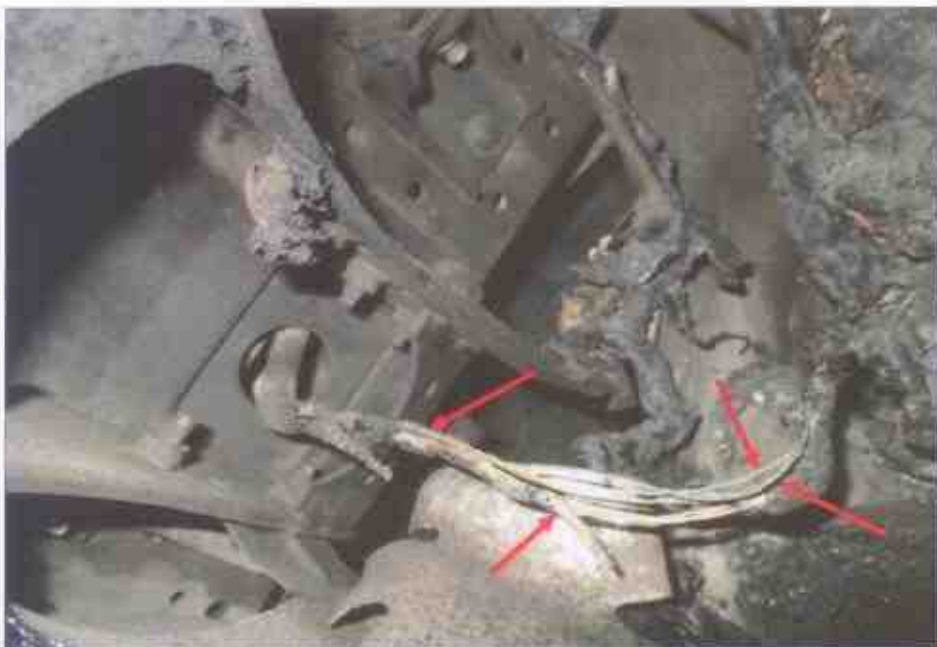
Photo 13 shows a close up view of the greenish residue found on some of the burnt wirings of the Insured Vehicle's air cleaner assembly (arrowed). This seems to suggest the occurrence of an electrical short circuit.
