Your Ref: S8M00PJ3
Our Ref : CS/ASM18013515/N

6 August 2018

**TECHNICAL INVESTIGATION REPORT OF FIRE INCIDENT INVOLVING THE
INSURED VEHICLE SGV 187X ON 22 JULY 2018**

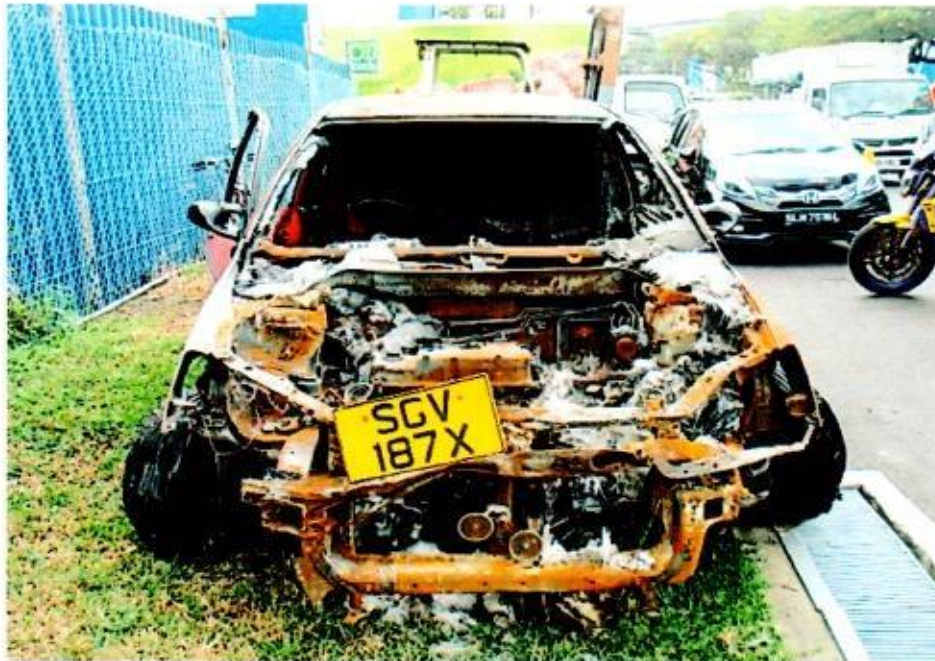
Photo 1 shows the general view of the front portion of the Insured Vehicle at the time of our inspection. The exterior body of the Insured Vehicle had sustained visible fire damage. This included its windscreen, front bonnet, headlights, front bumper, front bumper reinforcement panel, side panels, front rims and front tyres.

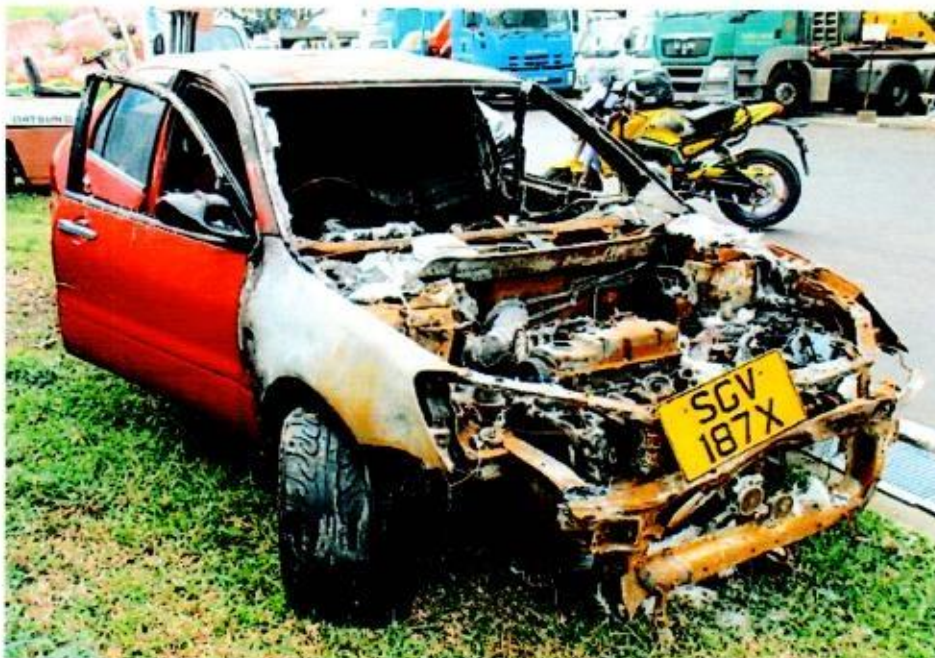
Photo 2 shows the general view of the right portion of the Insured Vehicle at the time of our inspection. The exterior body of the Insured Vehicle had sustained visible fire damage. This included its windscreen, front bonnet, headlights, front bumper, front bumper reinforcement panel, right side panel, right front rim and right front tyre.

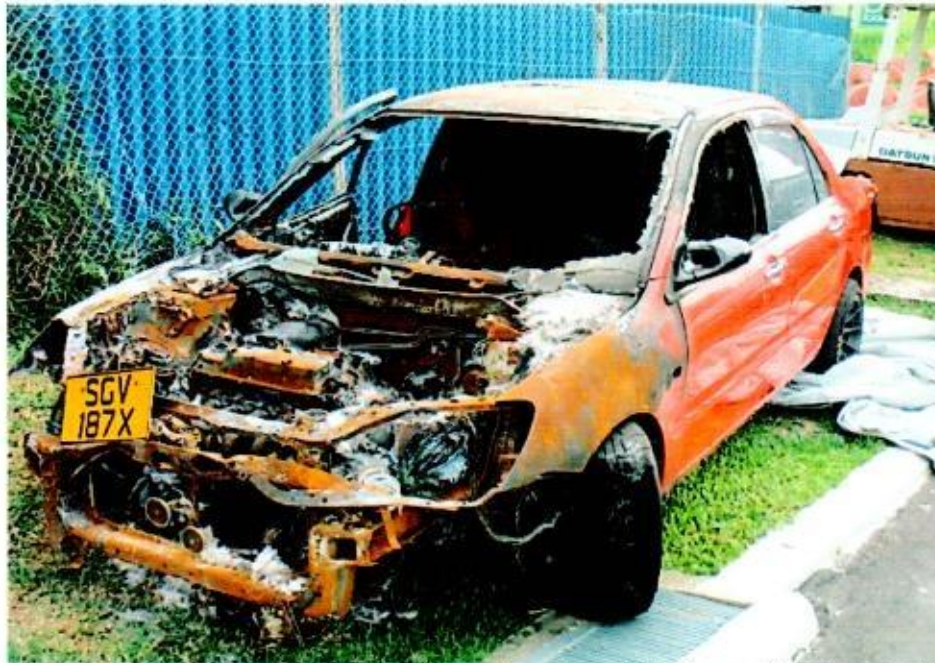
Photo 3 shows the general view of the left portion of the Insured Vehicle at the time of our inspection. The exterior body of the Insured Vehicle had sustained visible fire damage. This included its windscreen, front bonnet, headlights, front bumper, front bumper reinforcement panel, left side panel, left front rim and left front tyre.

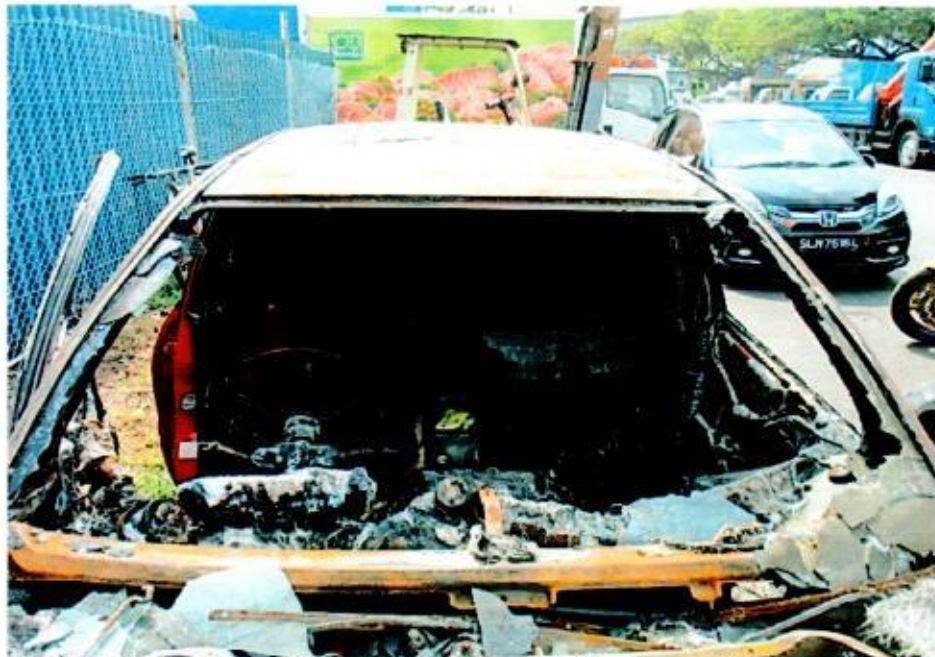
Photo 4 shows a closer view of the windscreen of the Insured Vehicle at the time of our inspection. The windscreen had sustained extensive fire damage.

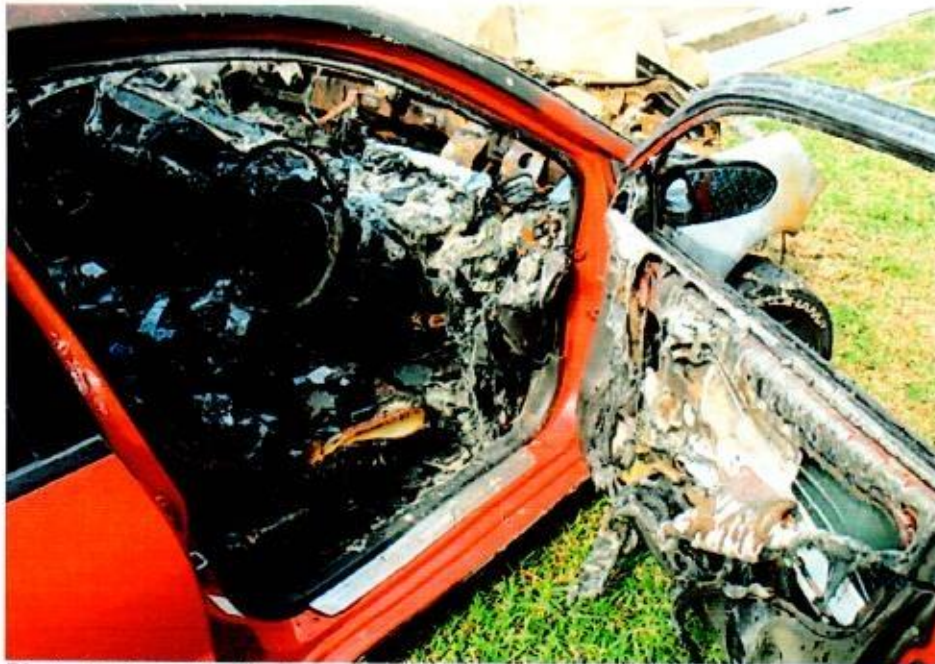
Photo 5 shows the interior compartment of the Insured Vehicle at the time of our inspection. The interior compartment of the Insured Vehicle was observed to be severely affected by the fire.

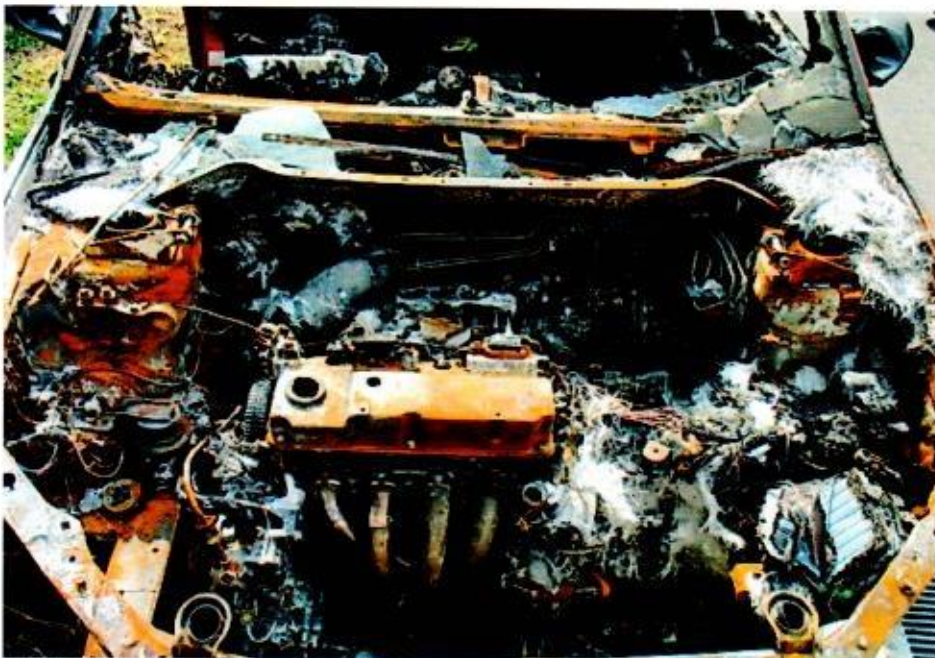
Photo 6 shows a general view of the engine compartment of the Insured Vehicle at the time of our inspection. Most of the components inside the engine compartment were found to be severely burnt and/or melted as a result of the fire.

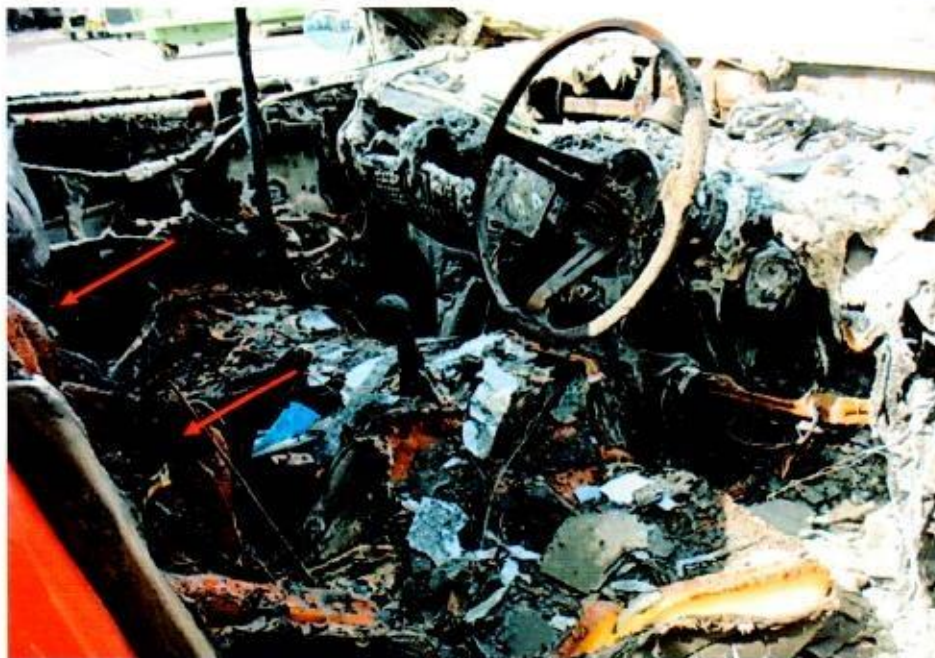
Photo 7 shows the aftermarket front seats that were fitted onto the Insured Vehicle upon our inspection (arrowed).

31. Although the aftermarket front seats, alloy rims and full exhaust system fitted on the Insured Vehicle were not the standard type for the Insured Vehicle, we are of the view that these parts did not cause and/or contribute to the fire incident.

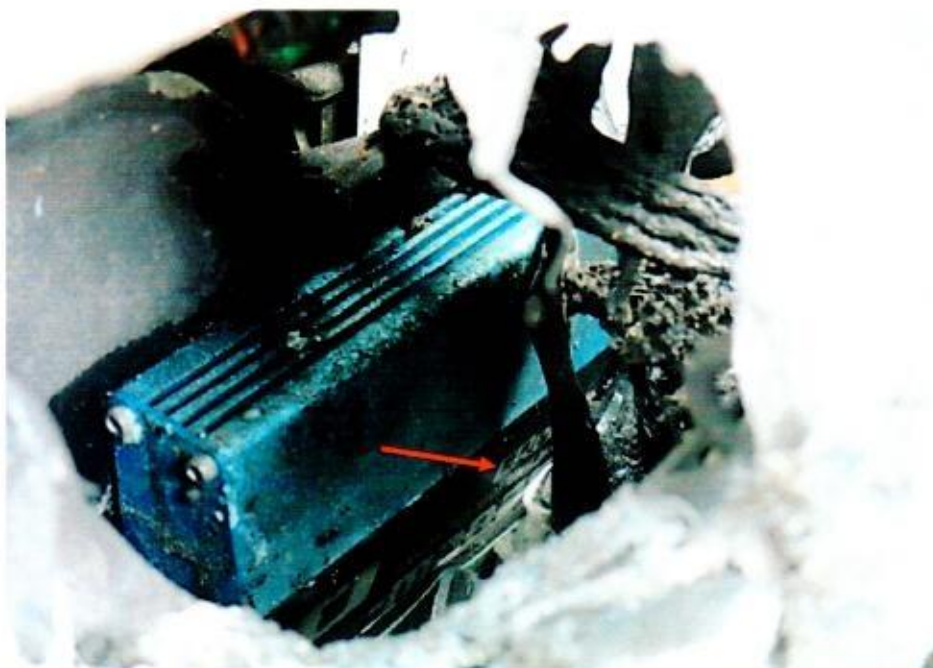
Photo 8 shows the fuel management system module that was fixed underneath the left portion of the front dashboard of the Insured Vehicle which had sustained serious fire damage. The brand of the module was 'GREDDY' (arrowed).

30. We are further of the opinion that the additionally fitted electrical/electronic components found on the Insured Vehicle could have possibly caused overloading to the electrical system of the Insured Vehicle. However considering that the installation was carried out shortly after the Insured Vehicle was purchased which was approximately more than 10 years prior to the fire incident, the overloading was likely to be minimal.

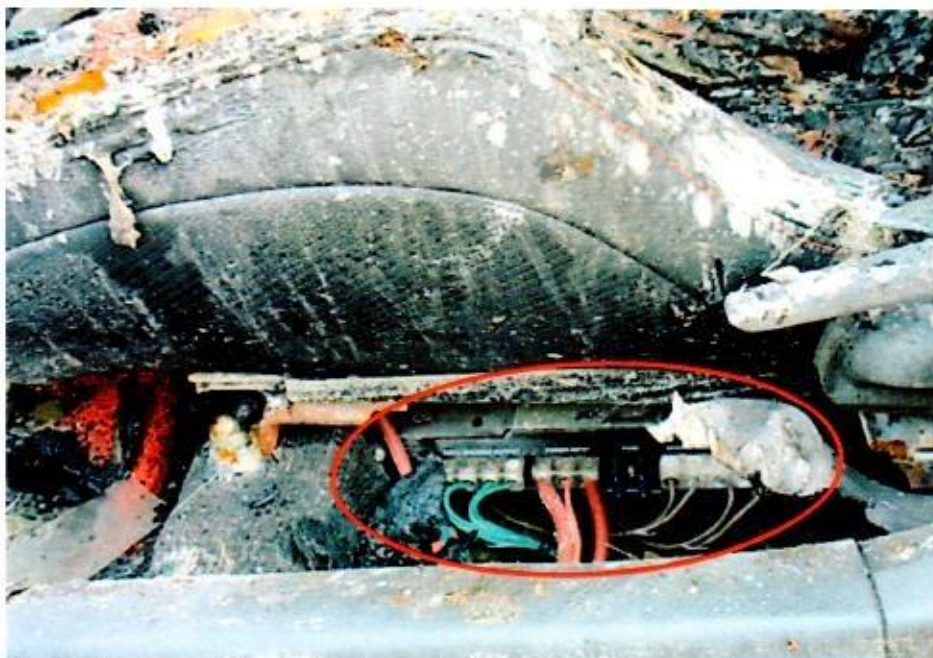
Photo 9 shows the 1st aftermarket amplifier fitted underneath the front passenger seat of the Insured Vehicle upon our inspection (circled).

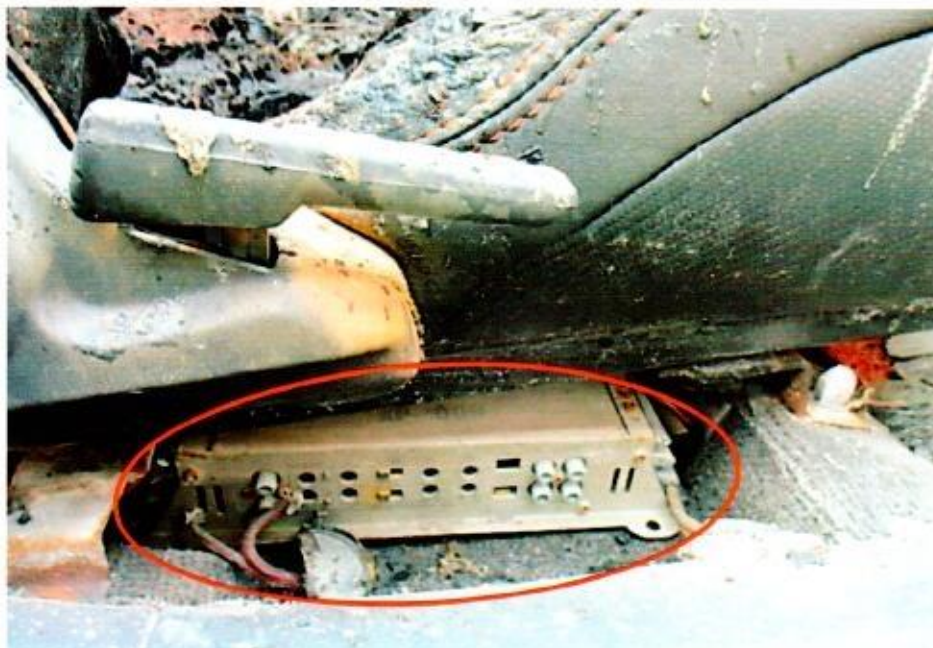
Photo 10 shows the 2nd aftermarket amplifier fitted underneath the driver seat of the Insured Vehicle upon our inspection (circled).

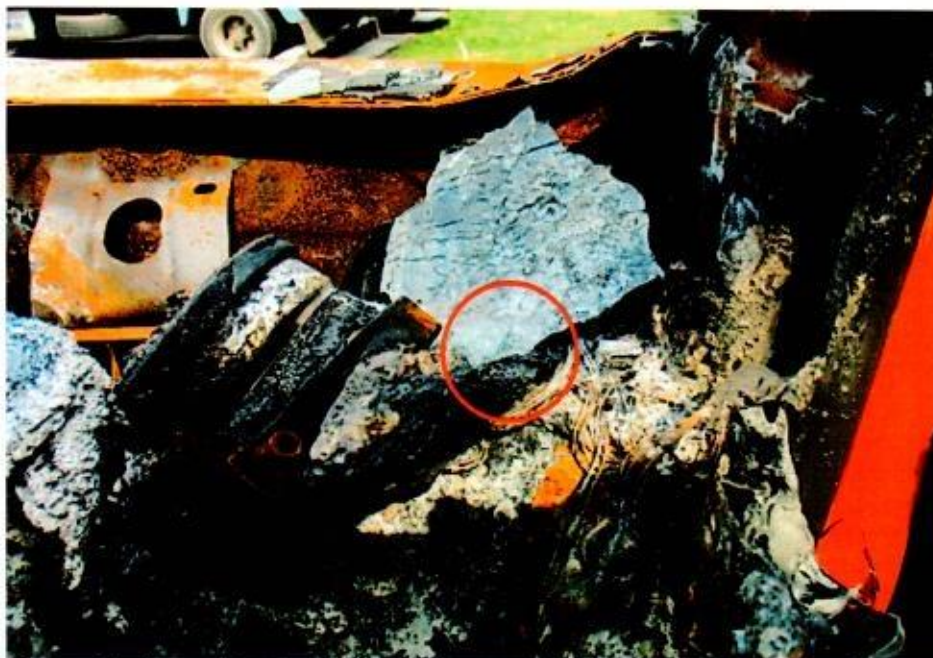
Photo 11 shows the 1st aftermarket twitter fitted onto the right corner of the dashboard of the Insured Vehicle upon our inspection which had sustained extensive fire damage (circled).

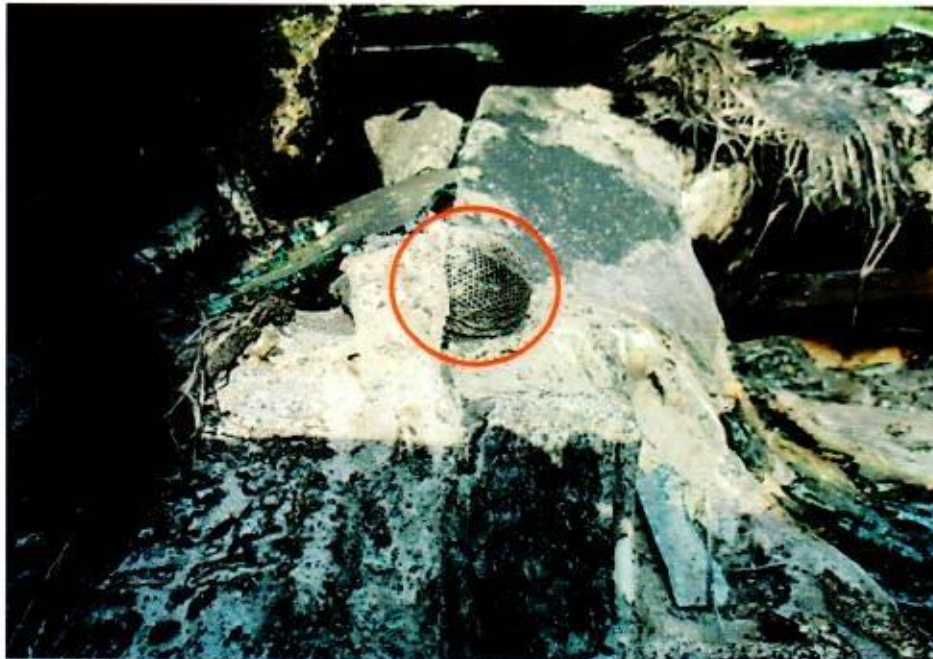
Photo 12 shows the 2nd aftermarket twitter fitted onto the left corner of the dashboard of the Insured Vehicle upon our inspection (circled) which had sustained serious fire damage.

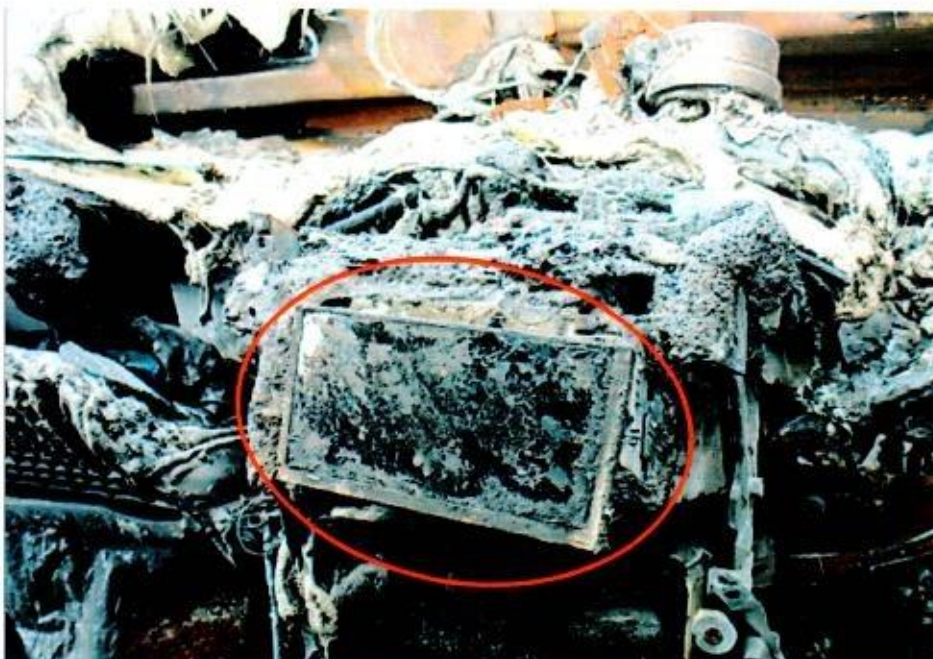
Photo 13 shows the in-car DVD player that was fitted at the centre portion of the front dashboard of the Insured Vehicle which had sustained extensive fire damage (circled).

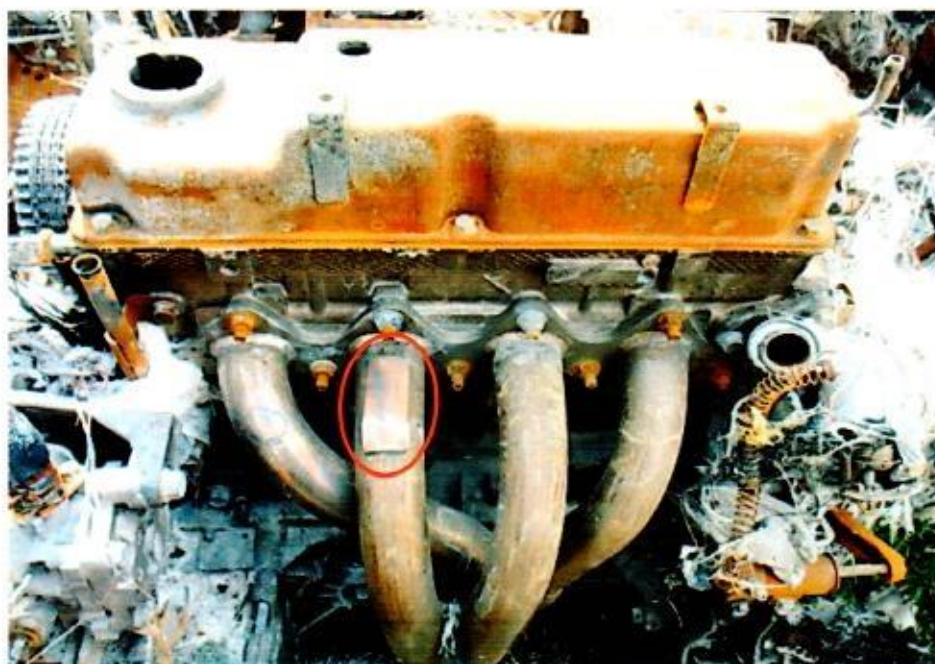
Photo 14 shows a front view of the headers of the non-standard full exhaust system that was found to be fitted on the Insured Vehicle at the time of our inspection. The brand of the exhaust system was 'DRIFT RACING' (circled).

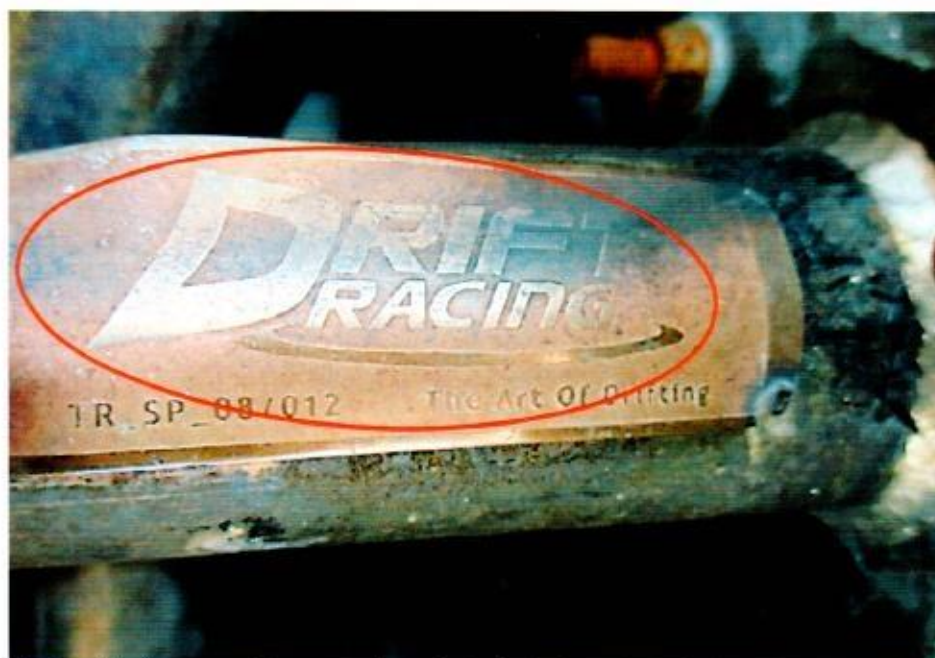
Photo 15 shows a close up view of 1 of the headers of the non-standard full exhaust system that was found to be fitted on the Insured Vehicle at the time of our inspection. The brand of the exhaust system was 'DRIFT RACING' (circled).

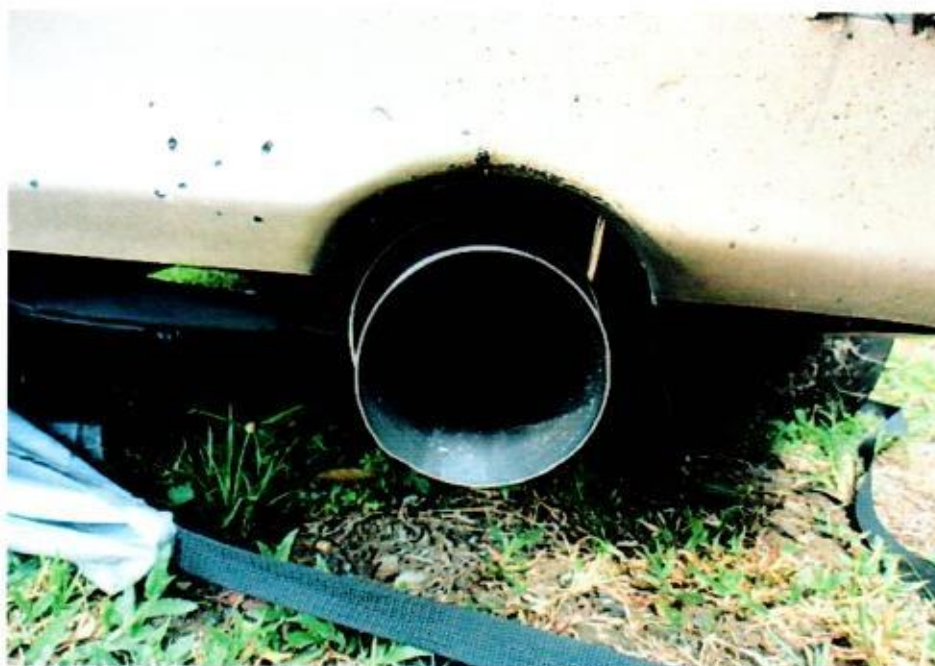
Photo 16 shows a front view of the non-standard rear exhaust muffler that was found to be fitted on the Insured Vehicle at the time of our inspection.

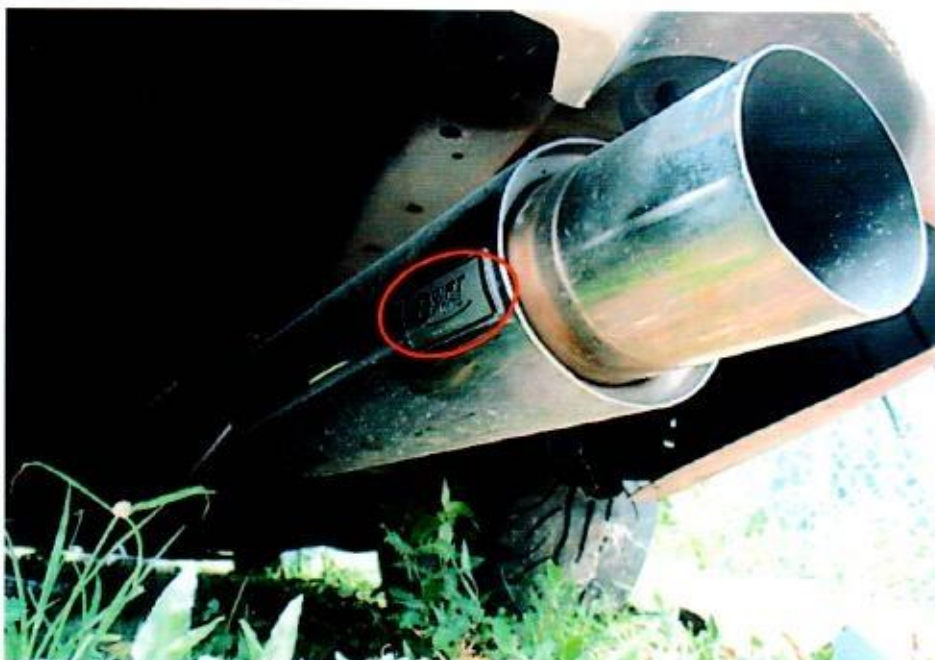
Photo 17 shows a close up left side view of the non-standard rear exhaust muffler that was found to be fitted on the Insured Vehicle at the time of our inspection. The brand of the rear exhaust muffler was 'DRIFT RACING' (circled).

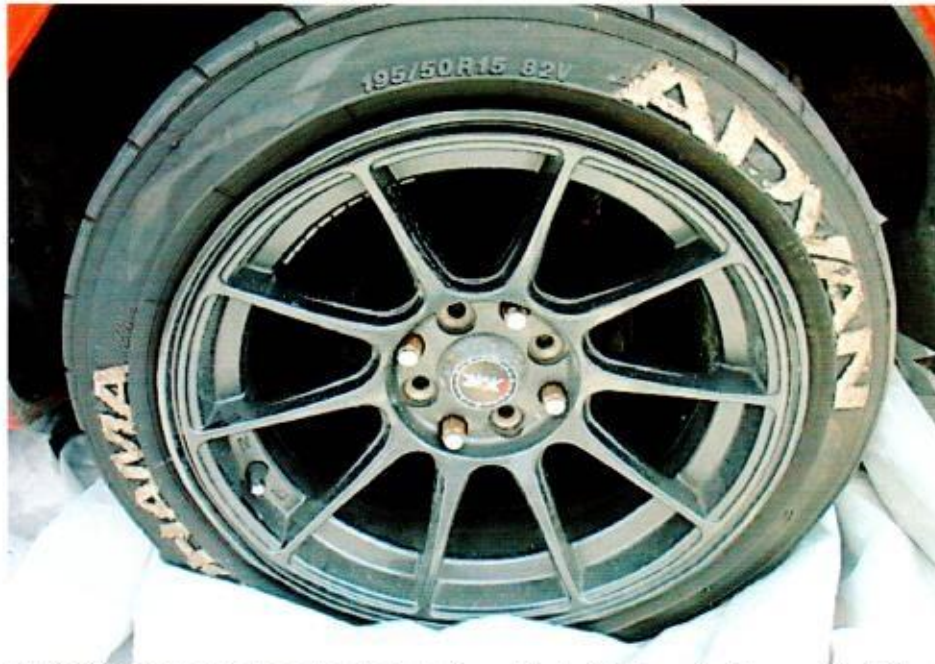
Photo 18 shows the non-standard rim found to be fitted on the Insured Vehicle at the time of our inspection. The 15- inch alloy rims fitted on the Insured Vehicle were not the standard type for the Insured Vehicle.

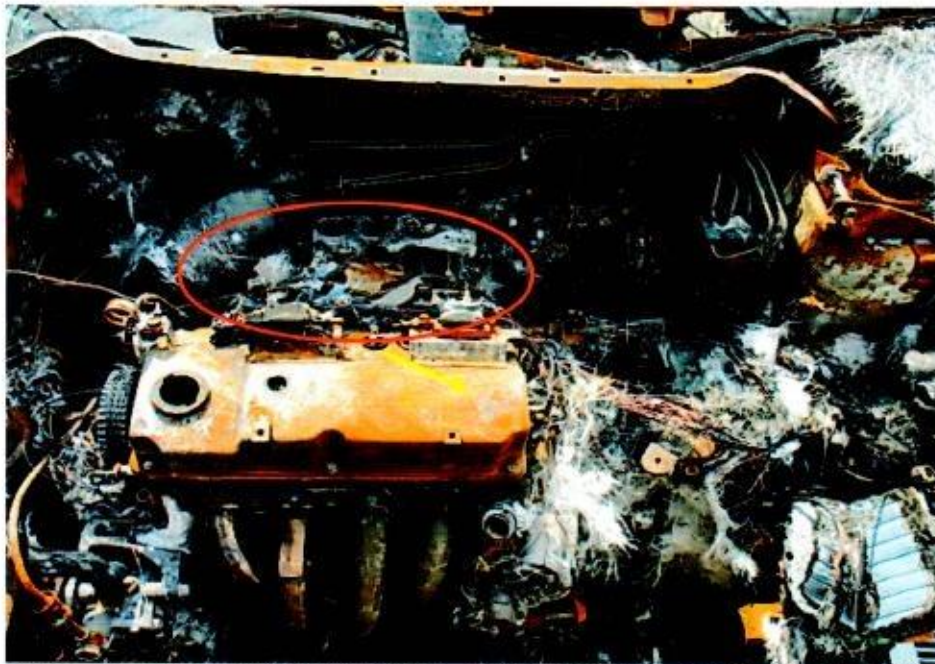
8. For this particular case, the fire appears to have originated within the engine compartment of the Insured Vehicle, somewhere around the rear portion of the engine compartment. This can be determined from the greenish residue that was found on several stretches of burnt original factory fitted wirings mainly around the rear portion of the engine compartment. The presence of greenish residue indicates internal heating of copper wires, a sign of an electrical short circuit occurring. The greenish residue is normally left behind from oxidation as a result of chemical reaction involving the copper wires. These physical evidences would appear to suggest that the cause of fire to the Insured Vehicle could have possibly been due to electrical in nature. See photos 19 – 22 below.

Photo 19 shows the burnt wirings around the rear portion of the engine compartment which is near to the vicinity where the fire to the Insured Vehicle had likely started (circled).

27. Having investigated and technically analysed the damages of burnt nature to the Insured Vehicle, we are of the view that the cause of fire to the Insured Vehicle was of electrical in nature. For this particular case, the fire had originated along the wirings inside the engine compartment, somewhere around the rear portion of the engine compartment. The wirings were original factory fitted wirings of the Insured Vehicle.

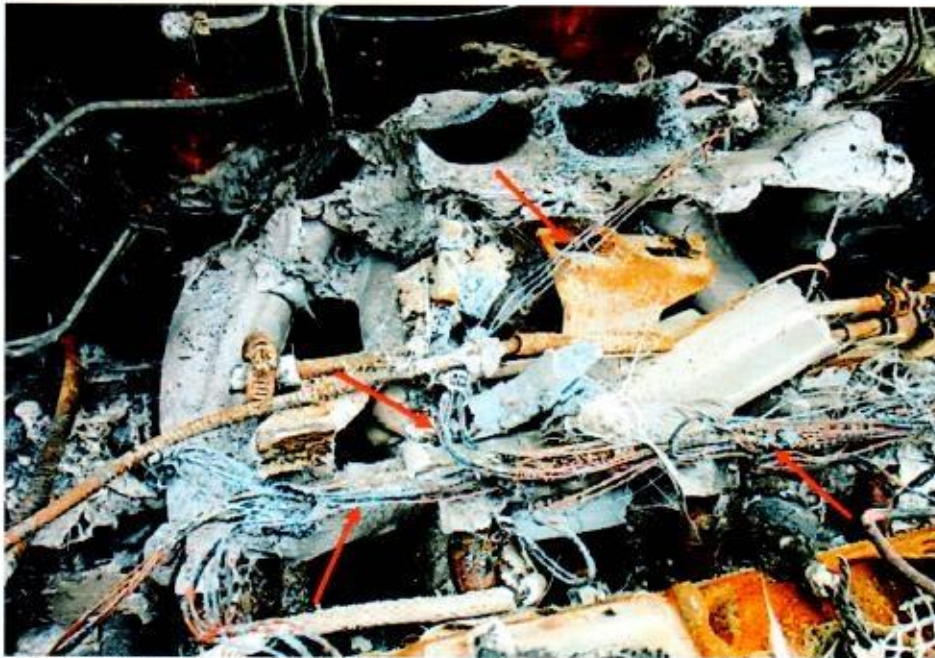
Photo 20 shows a closer view the greenish residue on several stretches of burnt wirings at the rear portion of the engine compartment (red arrows). The presence of greenish residue indicates internal heating of copper wires, a sign of an electrical short circuit occurring. The greenish residue is normally left behind from oxidation as a result of chemical reaction involving the copper wires.

25. The possibility of the fire being due to electrical in nature would then seem more likely given that engine overheating and external factors would both seem unlikely. The fire being due to electrical in nature is also supported by the burnt wirings found in the engine compartment of the Insured Vehicle, which was earlier discussed in paragraph 8 above.

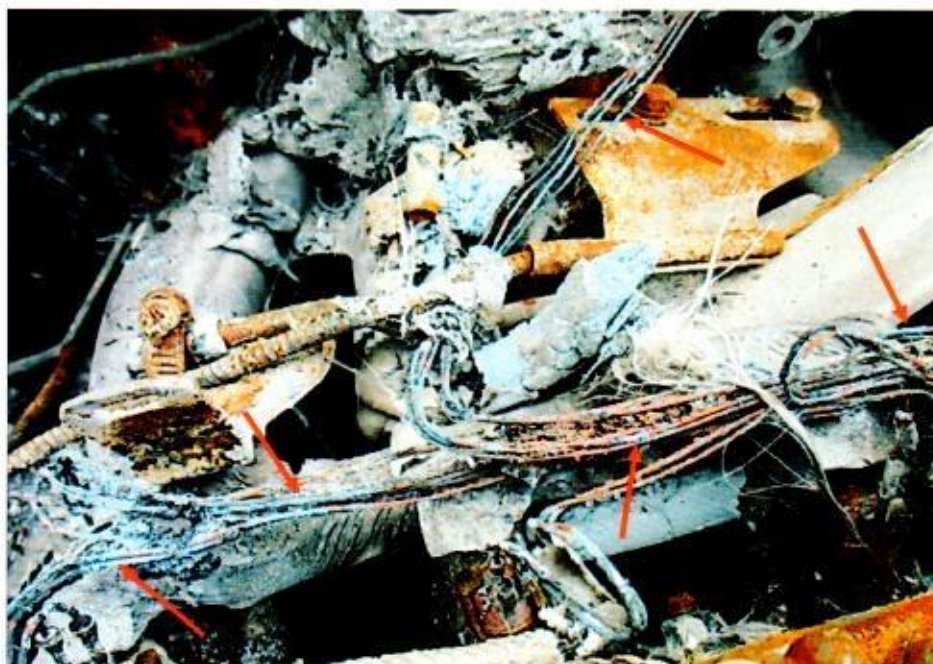
Photo 21 shows a close up view of the greenish residue on the wirings at the rear portion of the engine compartment. The presence of such greenish residue suggests occurrence of an electrical short circuit.

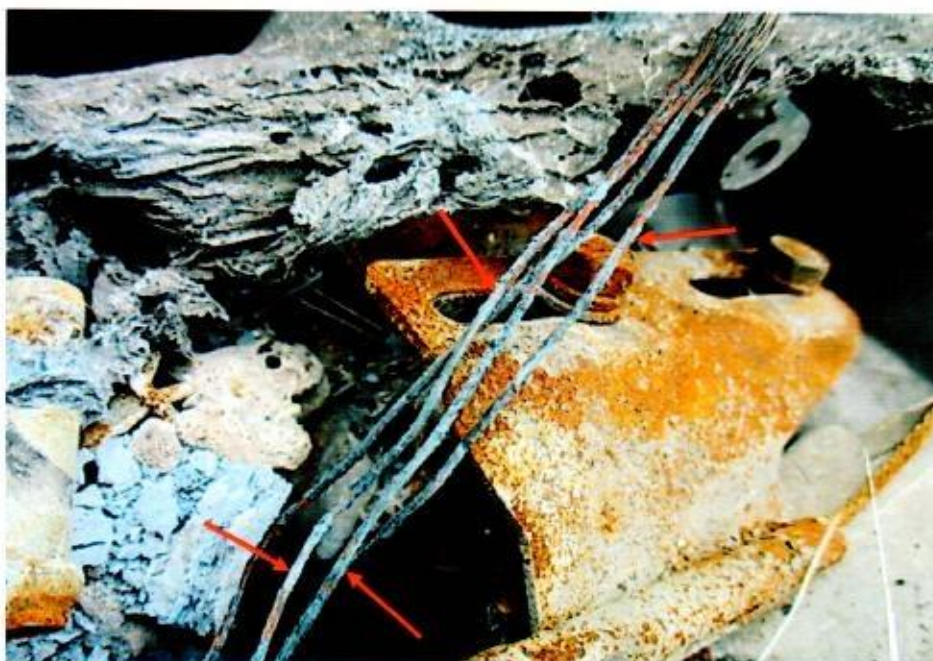
Photo 22 shows a close up view of the greenish residue on several burnt wirings at the rear portion of the engine compartment (arrowed). The presence of such greenish residue suggests occurrence of an electrical short circuit.

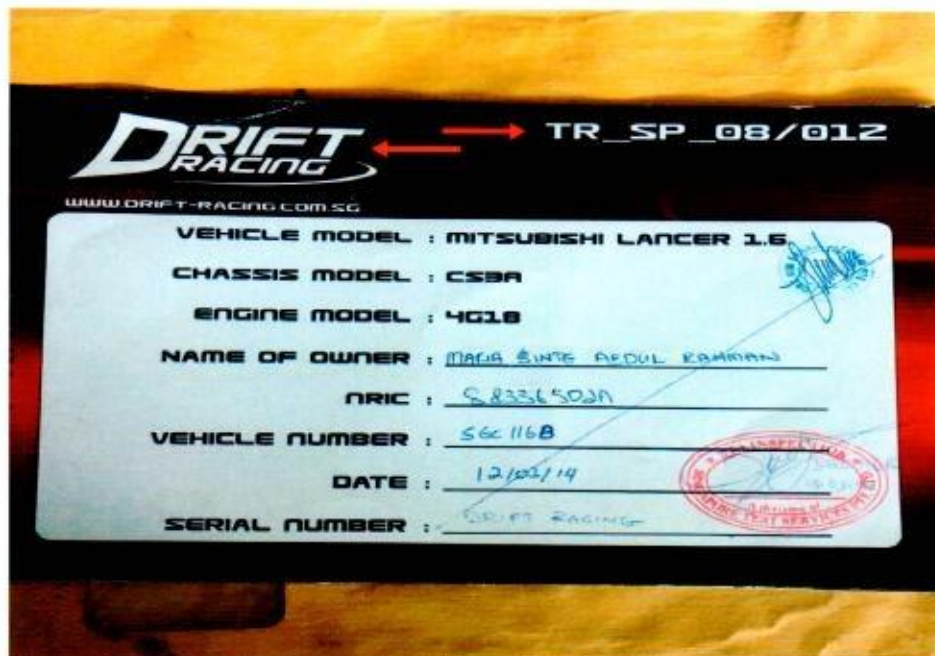
Photo 23 shows the front copy of the DRIFT RACING full exhaust system authentication certificate with its serial number (arrowed).

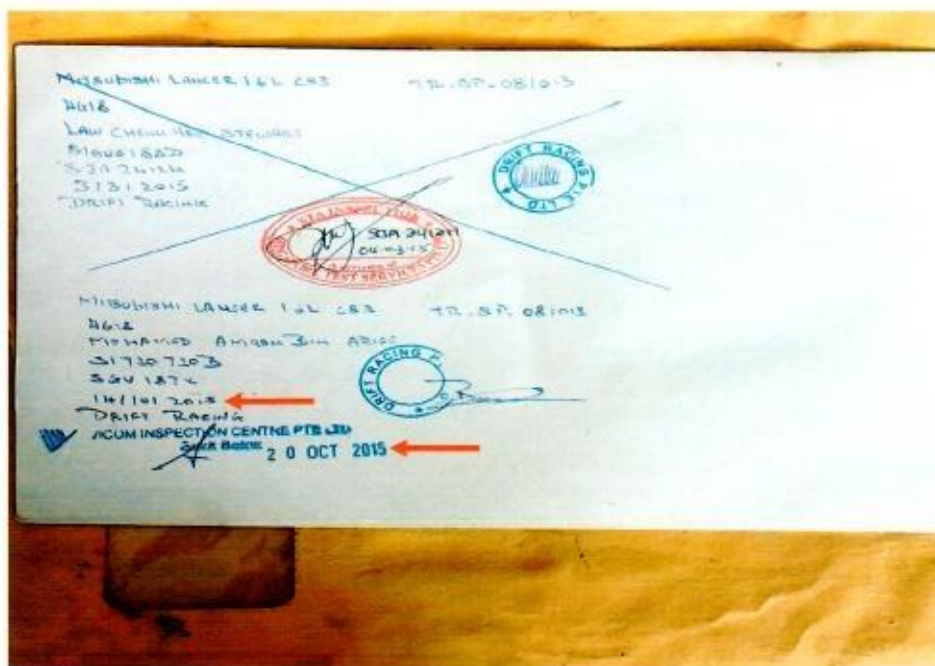
Photo 24 shows the rear copy of the DRIFT RACING full exhaust system authentication certificate. The full exhaust system was fitted onto the Insured Vehicle on 14 October 2015 and had passed the mandatory inspection at Vicom Inspection Centre on 20 October 2015 (arrowed).

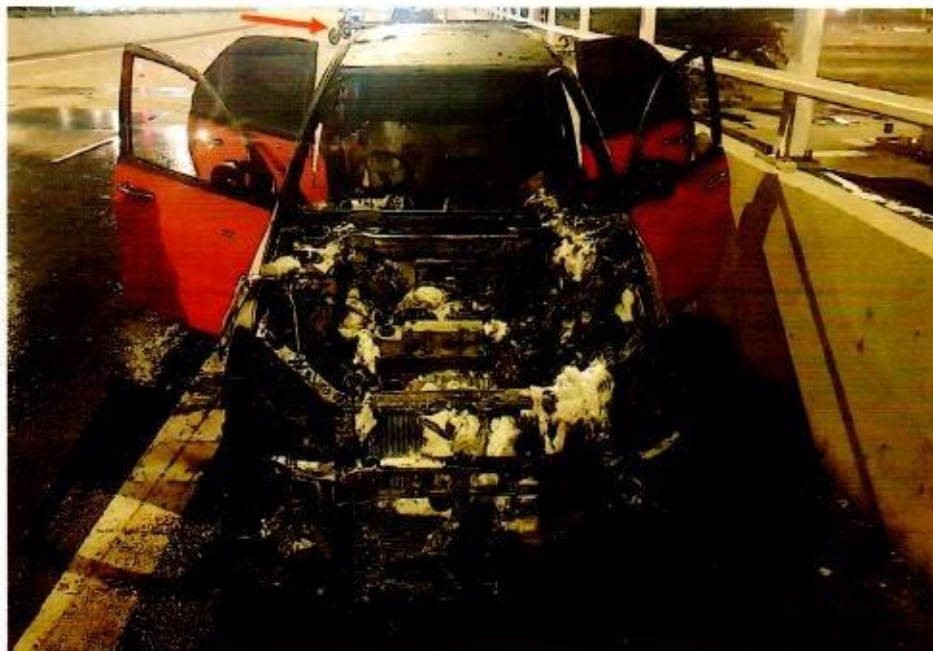
Photo 26 shows the front portion of the Insured vehicle after the fire had been extinguished. In general, the fire truck parked in the background had corresponded to the events that were related to us by Mr Nur, which is the SCDF had arrived at the incident location and assisted Mr Nur in putting out the fire (arrowed).

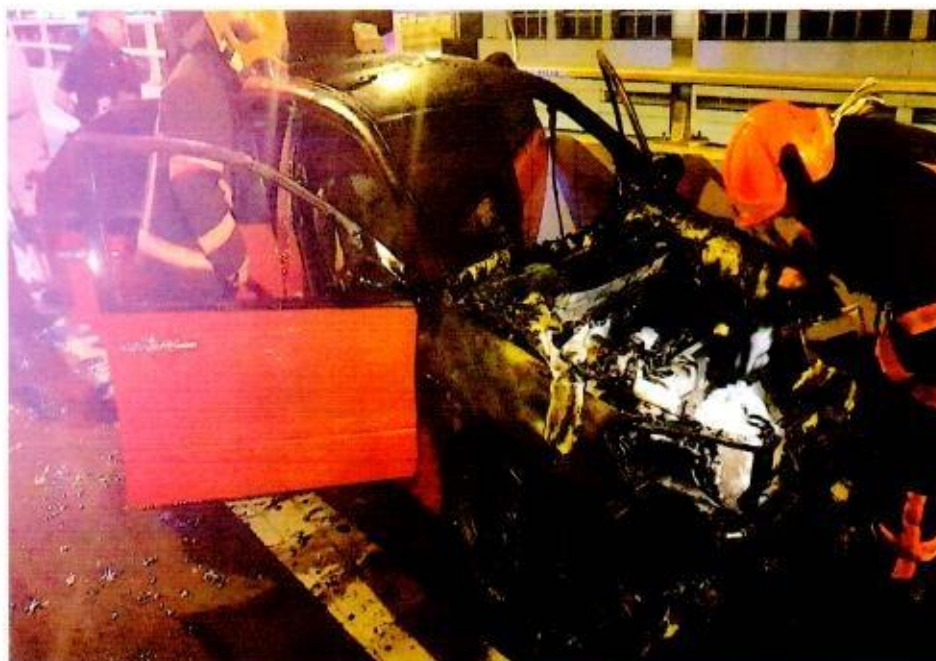
Photo 27 shows SCDF personnel conducting preliminary investigations as to how the fire to the Insured vehicle had started.

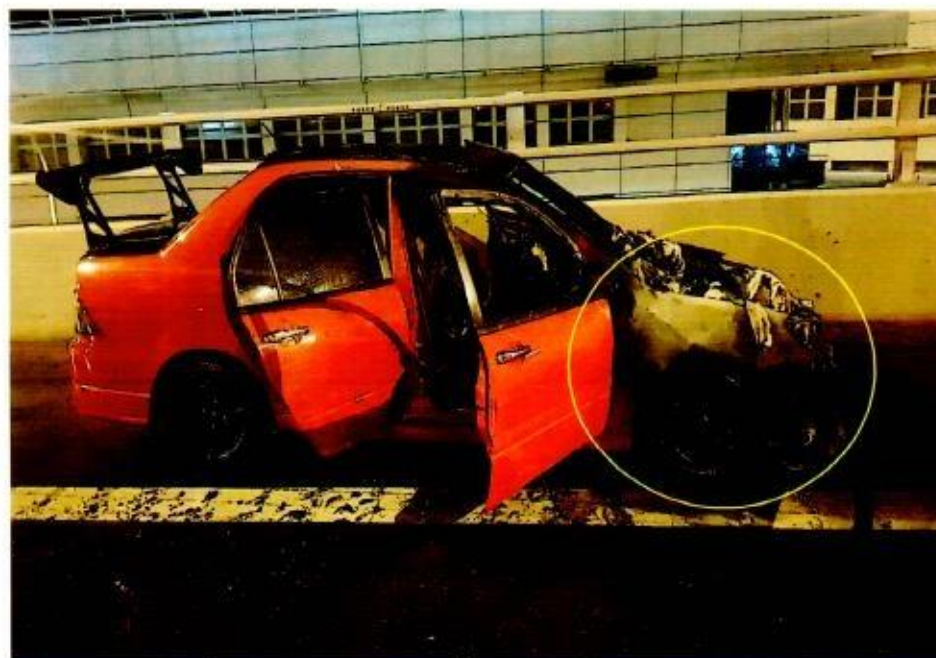
Photo 28 shows the right side view of the Insured Vehicle after the fire was extinguished. In general, the extensive damages sustained to the front portion had corresponded to the events that were related to us by Mr Nur, which is the fire started from the front bonnet (circled).
