Your Ref : D18/5600M/CT/EE/OD
Our Ref : CS/FCI18013589/N

31 July 2018

TECHNICAL INVESTIGATION REPORT OF FIRE INCIDENT INVOLVING THE INSURED VEHICLE SHD 4218Y ON 19 JULY 2018

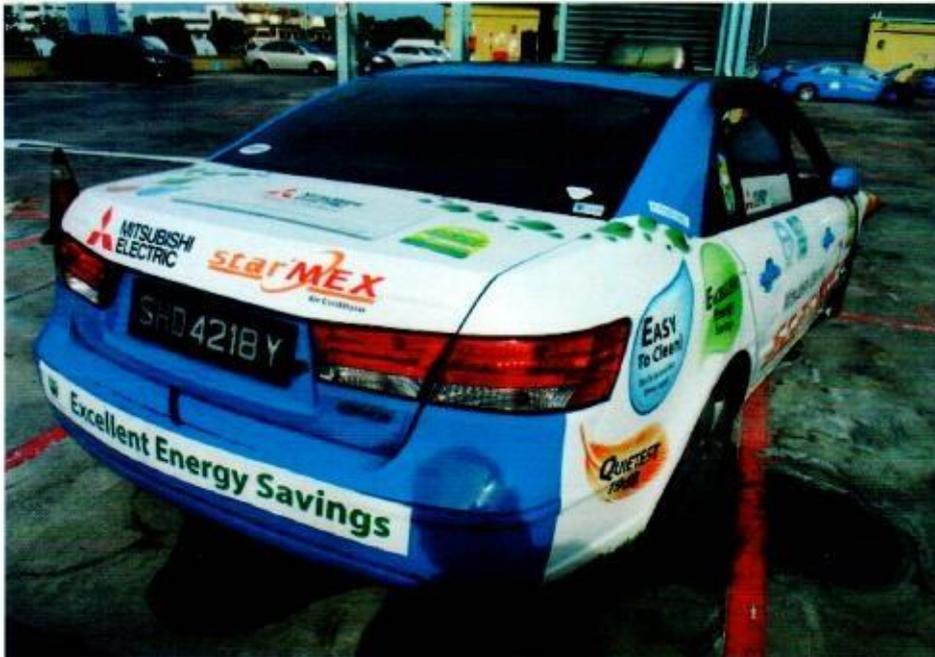
Photo 1 shows the general view of the rear right body of the Insured Vehicle at the time of our inspection. The rear portion of the Insured Vehicle was observed to be unaffected by the fire.

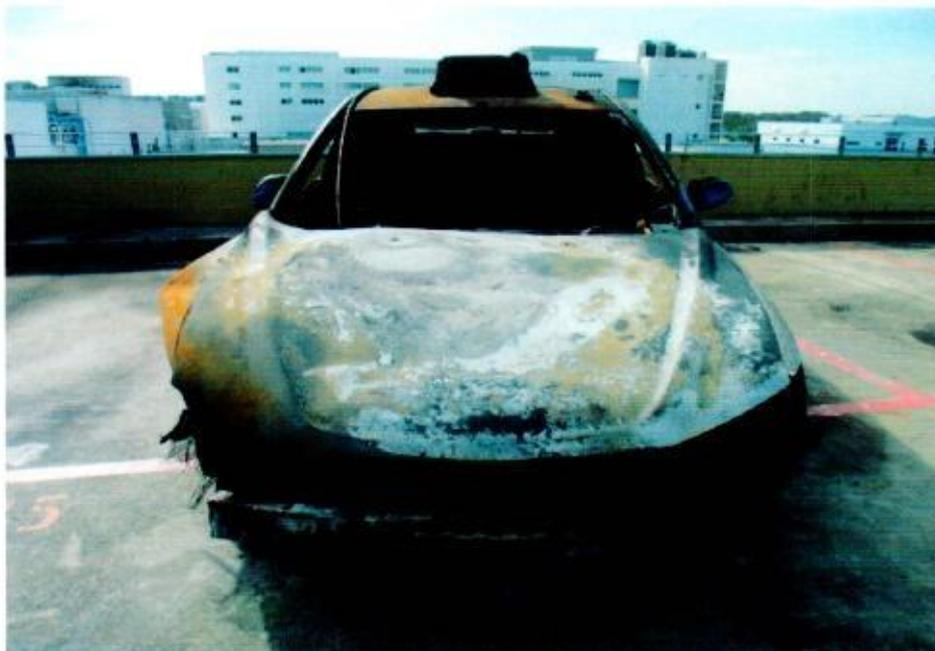
Photo 2 shows the general view of the front portion of the Insured Vehicle at the time of our inspection. The fire damage to the Insured Vehicle was confined to its front portion. Its front bumper, front bonnet, front support panel, front grille, front headlamps, front windscreen, front rims and front tyres were amongst the body parts that were found to have been affected as a result of the fire.

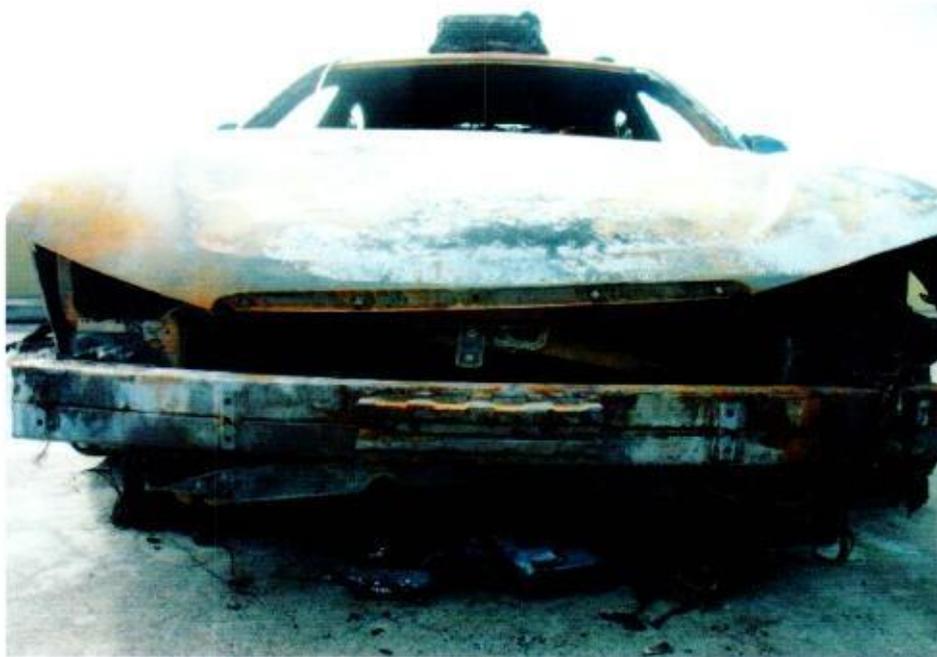
Photo 3 shows the closer view of the front portion of the Insured Vehicle at the time of our inspection. The fire damage to the Insured Vehicle was confined to its front portion. Its front bumper, front bonnet, front support panel, front rims, front tyres and front headlamps were amongst the body parts that were found to have been affected by the fire.

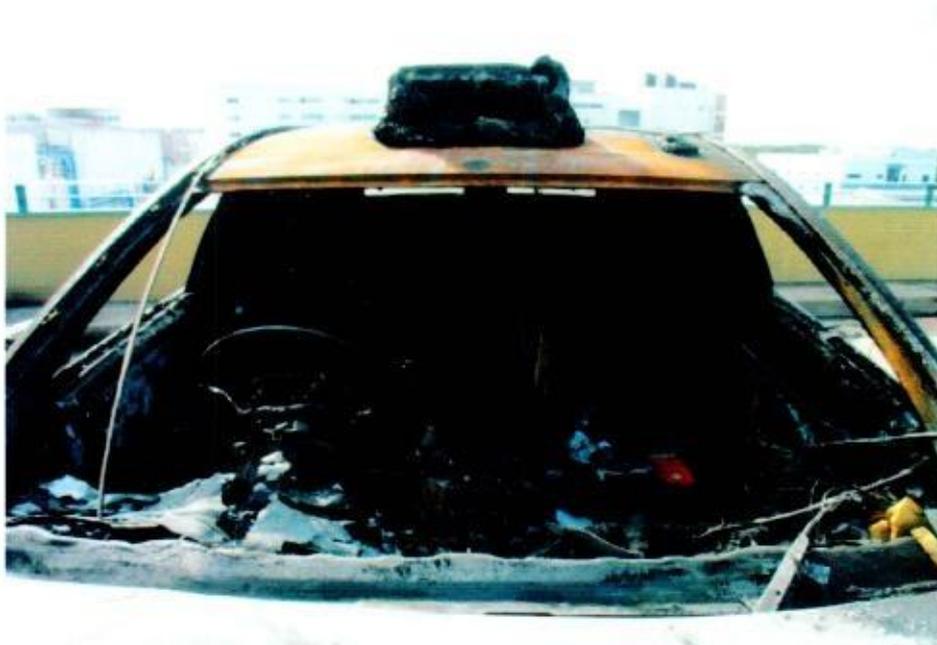
Photo 4 shows the general view of the front windscreen of the Insured Vehicle at the time of our inspection. The fire damage to the windscreen was extensive.

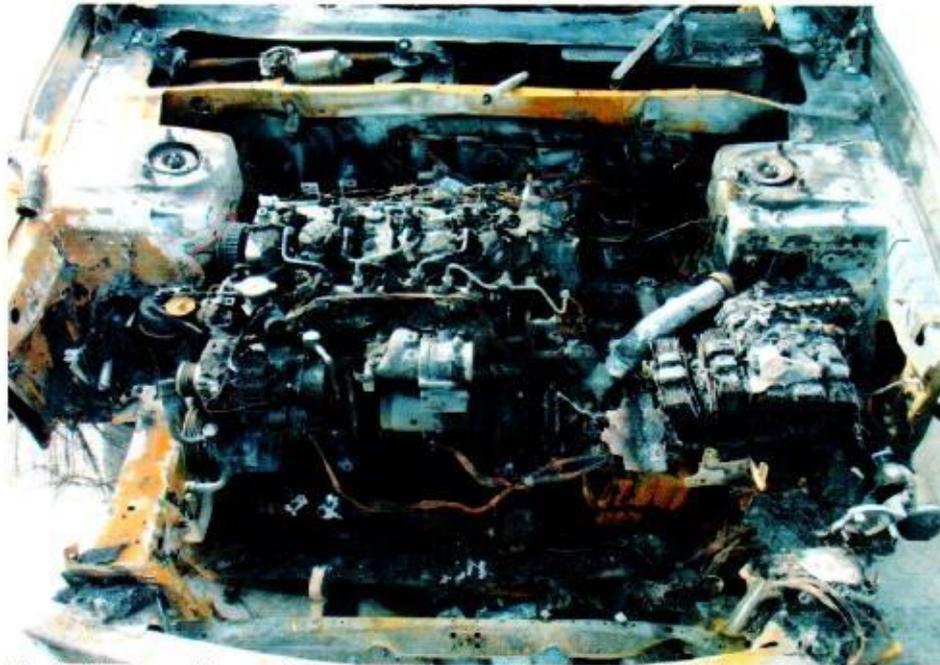
Photo 5 shows the engine compartment of the Insured Vehicle at the time of our inspection. The entire engine compartment of the Insured Vehicle was observed to be severely burnt. Most of the parts inside the engine compartment were found to be burnt and/or melted as a result of the fire.

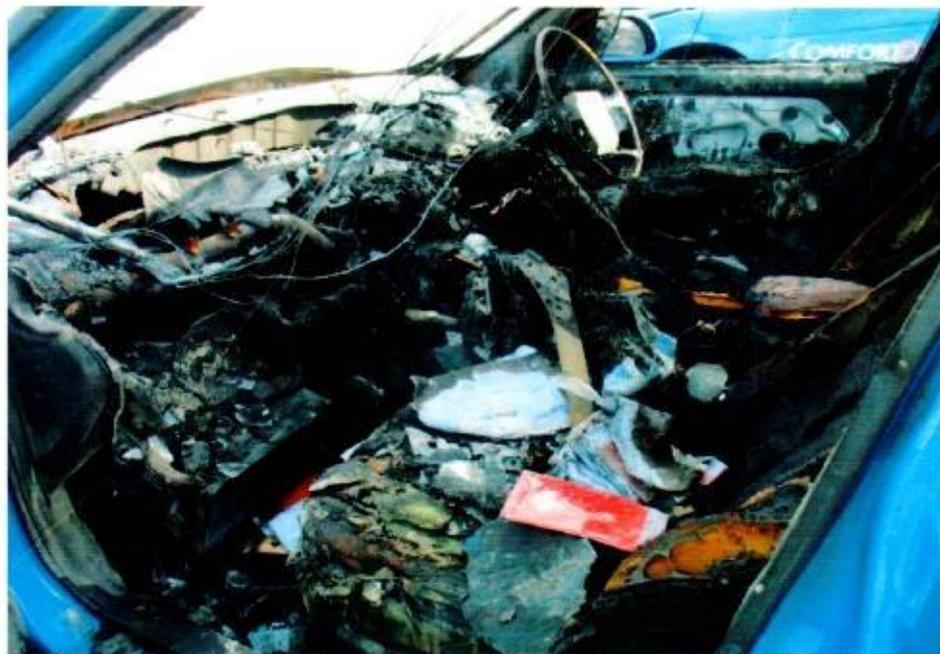
Photo 6 shows the interior compartment of the Insured Vehicle, which was significantly affected by the fire.

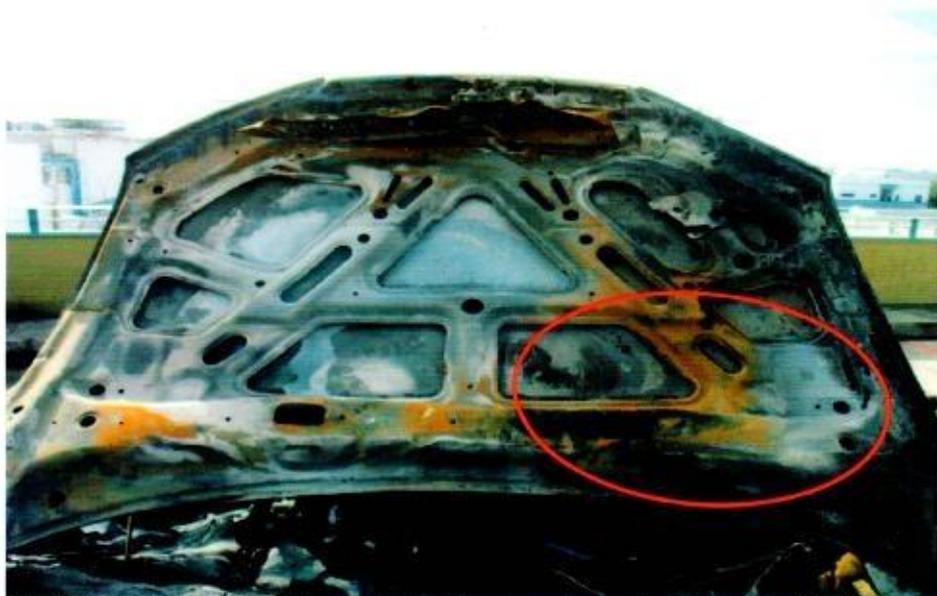
7. For this particular case, the fire appears to have originated within the engine compartment of the Insured Vehicle, somewhere around the left rear portion of the engine compartment. This can be determined from the burn pattern and the high heat intensity burn marks (whitish burn marks) as well as the rust that had developed on the underside of the front bonnet, at the bottom left portion.

8. The whitish burn marks are a result of exposure to prolonged heat intensity. Rust would normally start to develop around these areas soon after a fire as prolonged exposure to high heat intensity usually causes steel/metal material body parts to be exposed to natural environmental condition. The rust that had developed on the underside of the front bonnet, around the bottom left portion, is an indication that the left rear portion of the engine compartment had sustained exposure to prolonged high heat intensity. See photo 7 below.

Photo 7 shows the rust that had developed on the underside of the front bonnet, around the bottom left portion (circled). The development of rust is an indication that this area was subjected to prolonged exposure to high heat intensity, which had caused the steel/metal material of the front bonnet to be exposed to natural environmental condition. Hence the fire to the Insured Vehicle can be determined to have originated towards the left rear portion of the engine compartment.

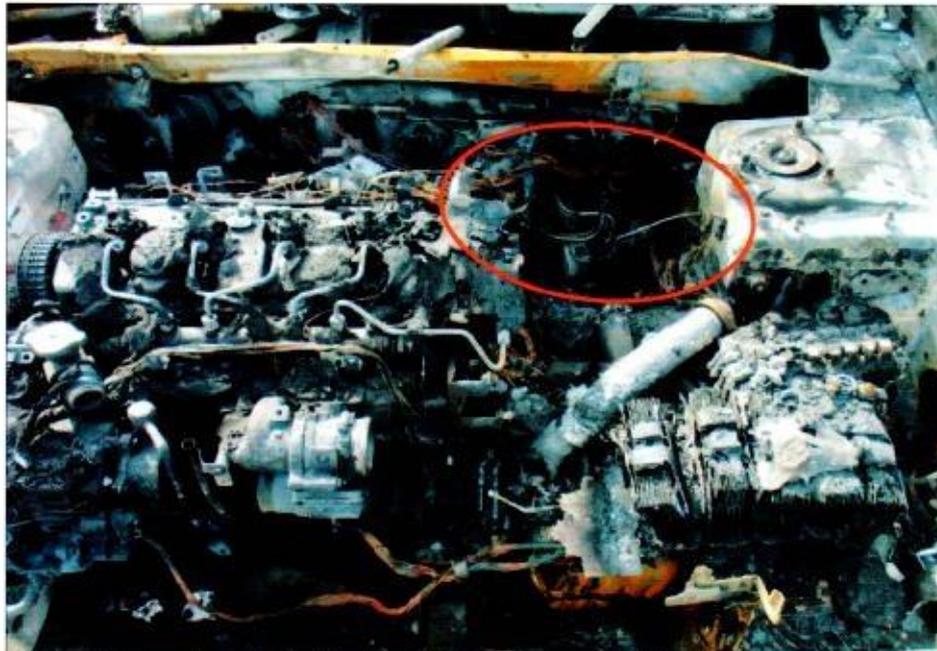
9. Upon closer examination of the left rear portion of the engine compartment, which was where the fire to the Insured Vehicle had likely started, we had found greenish residue on several burnt stretches of original factory fitted wirings around the left rear portion of the engine compartment. The presence of such greenish residue indicates internal heating of copper wires, a sign of an electrical short circuit occurring. The greenish residue is normally left behind from oxidation as a result of chemical reaction involving the copper wires. This physical evidence would then appear to suggest that the cause of fire to the Insured Vehicle could have possibly been due to electrical in nature. See photos 8 - 10 below.

Photo 8 shows the original factory fitted wirings around the left rear portion of the engine compartment, which is in the immediate vicinity where the fire to the Insured Vehicle had likely started (circled). We had found greenish residue on several burnt stretches of these wirings. The presence of such greenish residue indicates internal heating of copper wires, a sign of an electrical short circuit occurring. The greenish residue is normally left behind from oxidation as a result of chemical reaction involving the copper wires.

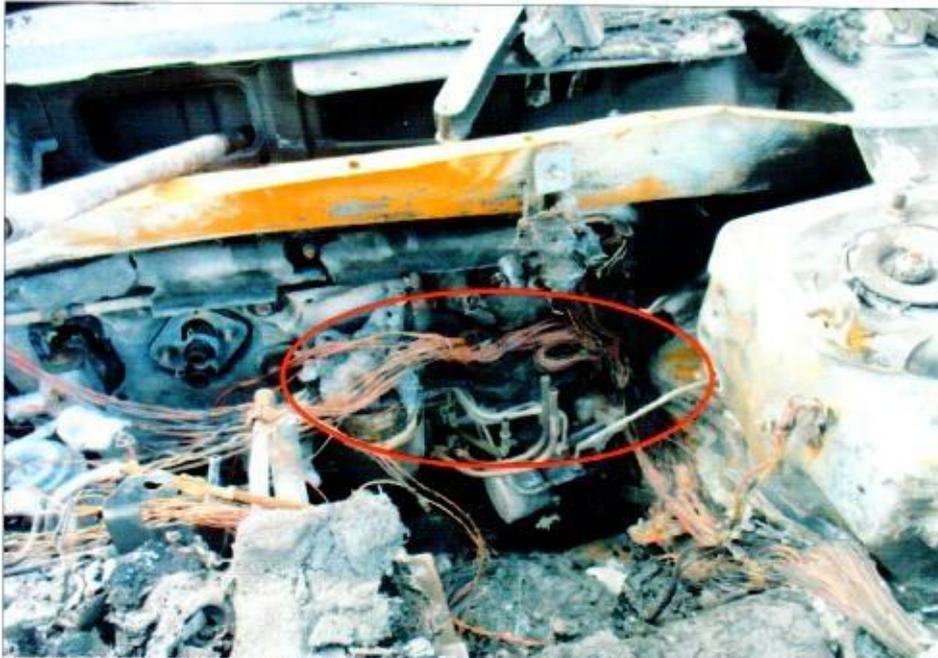
Photo 9 shows a closer view of the original factory fitted wirings around the left rear portion of the engine compartment. Greenish residue was found on some of these burnt stretches of original factory fitted wirings (circled). The presence of such greenish residue suggests occurrence of an electrical short circuit.

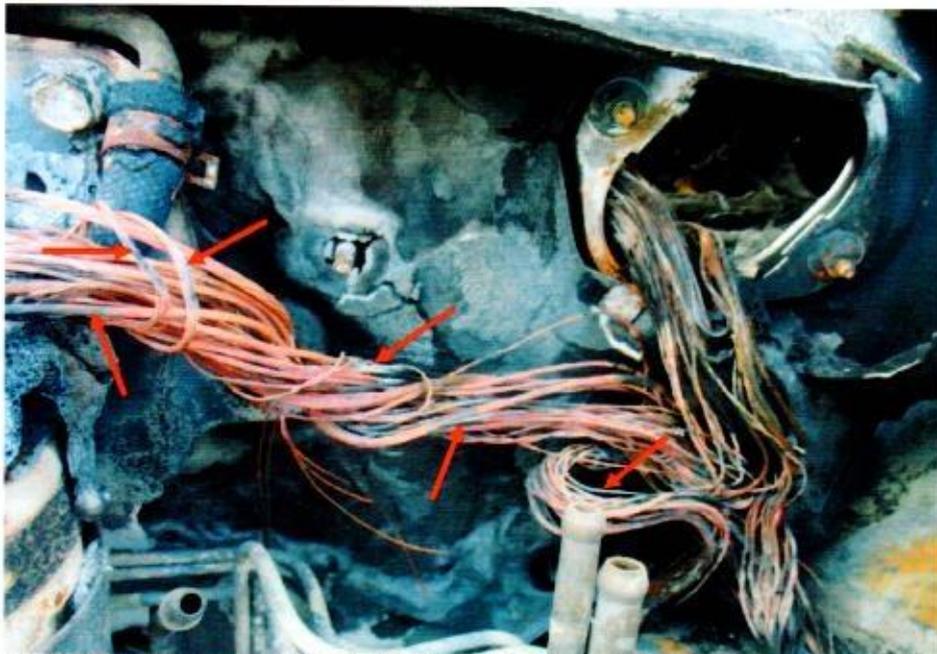
Photo 10 shows a close up view of the greenish residue found on some of the burnt stretches of original factory fitted wirings (arrowed). The presence of such greenish residue suggests occurrence of an electrical short circuit.

25. The possibility of the fire being due to electrical in nature would then seem more likely given that engine overheating and external factors would both seem unlikely. The fire being due to electrical nature is also supported by the condition of the wirings that were found in the engine compartment of the Insured Vehicle, which was earlier discussed in paragraph 9 above.

27. Having investigated and technically analysed the damages of burnt nature to the Insured Vehicle, we are of the view that the cause of fire to the Insured Vehicle was of electrical in nature. For this particular case, the fire had originated along the original factory fitted wirings inside the engine compartment, somewhere around the left rear portion of the engine compartment.
28. We did not find any evidence which had suggested that the cause of fire to the Insured Vehicle was due to poor maintenance and/or recurring electrical problem.

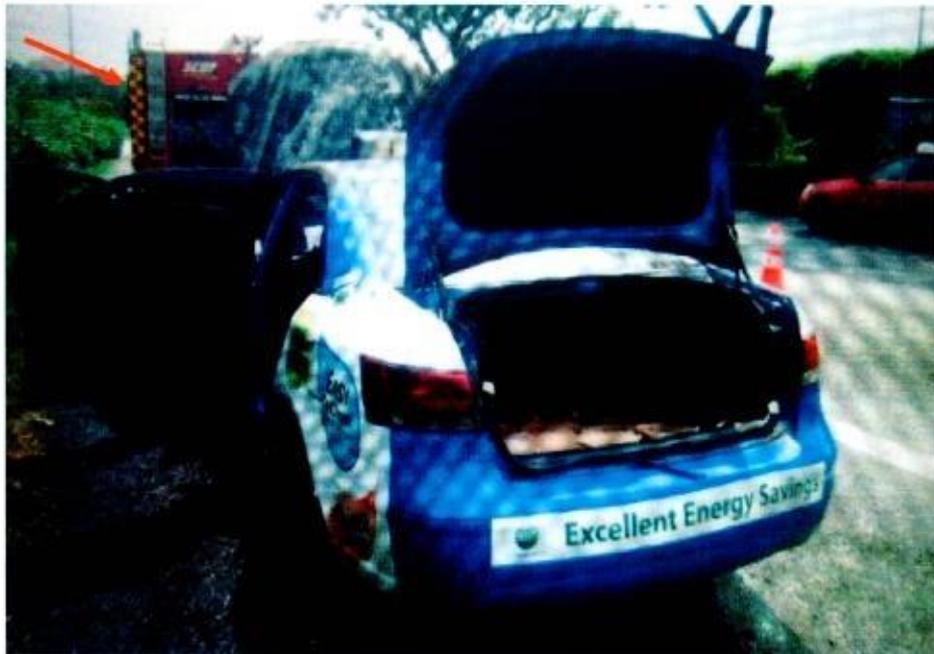
Photo 11 shows SCDF having arrived at the incident location and assisting Mr Ang in putting out the fire (arrowed).
