Your Ref : D18/5600M/CT/EE/OD
Our Ref : CS/FC18013589/N

31 July 2018

TECHNICAL INVESTIGATION REPORT OF FIRE INCIDENT INVOLVING THE INSURED VEHICLE SHD 4218Y ON 19 JULY 2018

Vehicle Registration No.	: SHD 4218Y
Make / Model	: HYUNDAI SONATA NF 2.0 CRDI AT ABS 2WD 4DR TURBO
Chassis No	: KMHET41VMCA825050
Year of Registration	: May 2012
Mileage	: N.A. (battery melted)

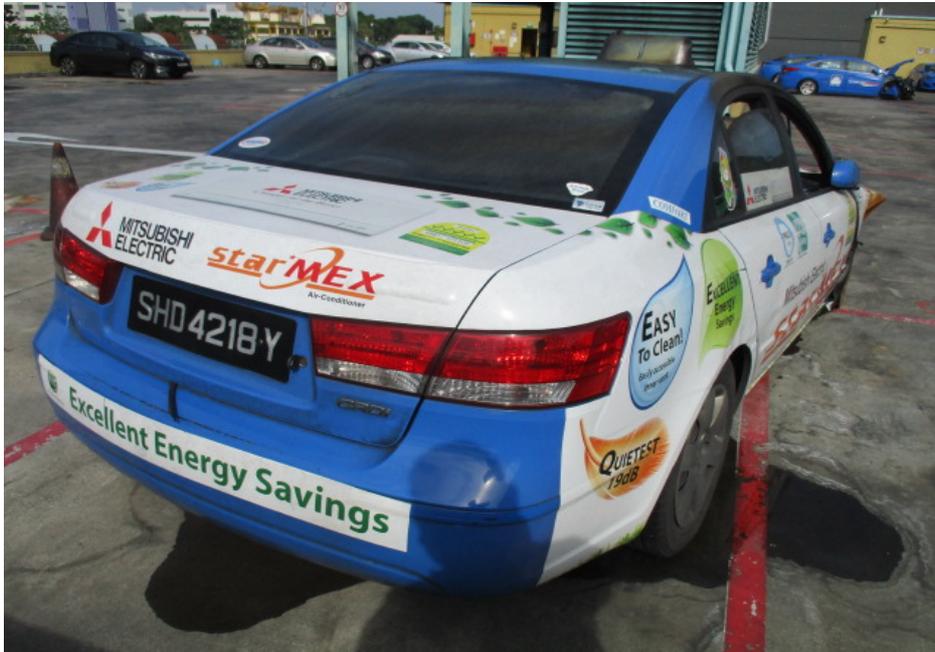
Photo 1 shows the general view of the rear right body of the Insured Vehicle at the time of our inspection. The rear portion of the Insured Vehicle was observed to be unaffected by the fire.

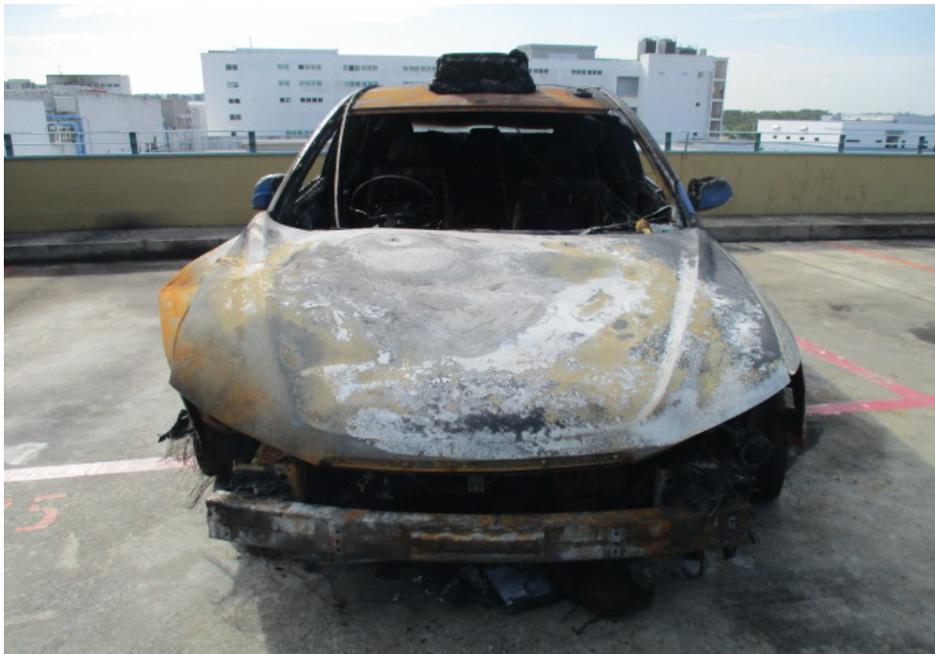
Photo 2 shows the general view of the front portion of the Insured Vehicle at the time of our inspection. The fire damage to the Insured Vehicle was confined to its front portion. Its front bumper, front bonnet, front support panel, front grille, front headlamps, front windscreen, front rims and front tyres were amongst the body parts that were found to have been affected as a result of the fire.

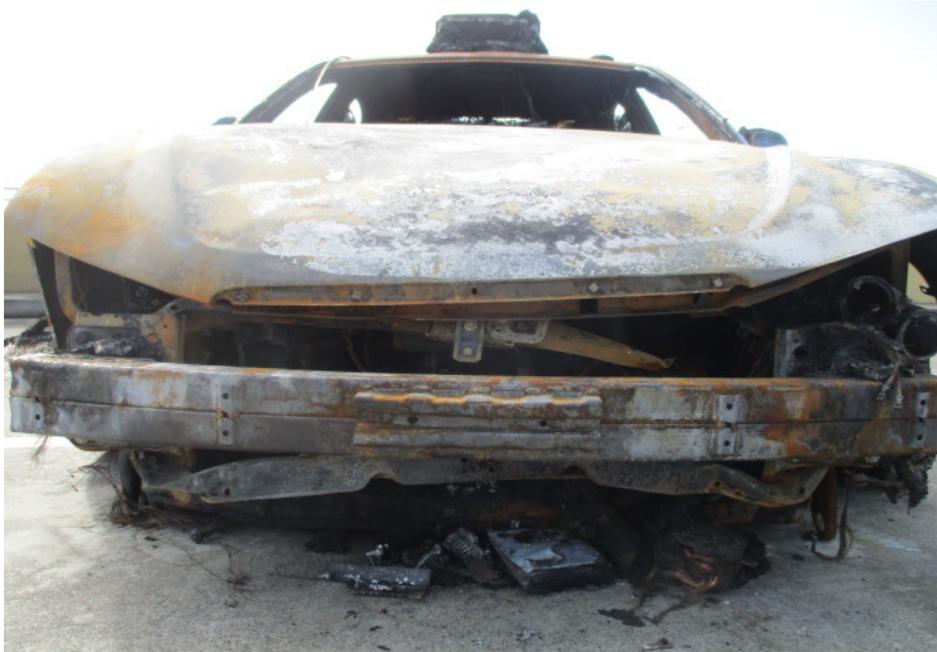
Photo 3 shows the closer view of the front portion of the Insured Vehicle at the time of our inspection. The fire damage to the Insured Vehicle was confined to its front portion. Its front bumper, front bonnet, front support panel, front rims, front tyres and front headlamps were amongst the body parts that were found to have been affected by the fire.

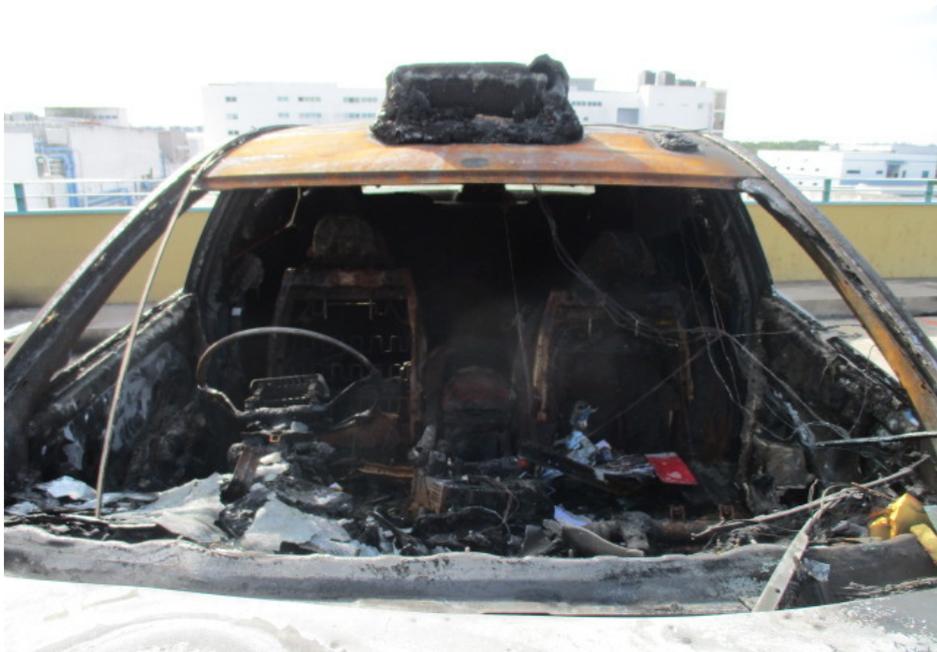
Photo 4 shows the general view of the front windscreen of the Insured Vehicle at the time of our inspection. The fire damage to the windscreen was extensive.

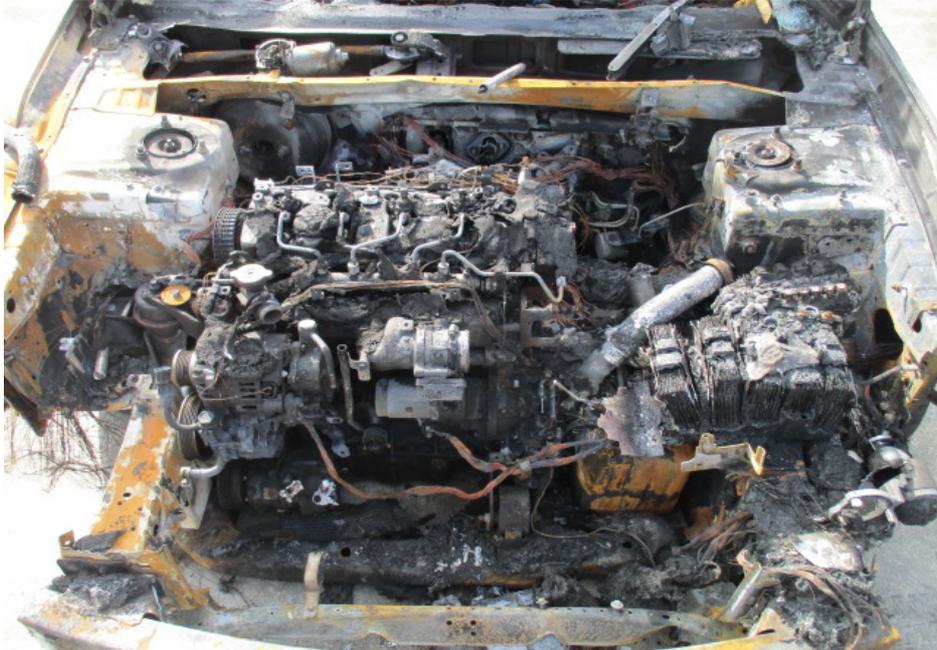
Photo 5 shows the engine compartment of the Insured Vehicle at the time of our inspection. The entire engine compartment of the Insured Vehicle was observed to be severely burnt. Most of the parts inside the engine compartment were found to be burnt and/or melted as a result of the fire.

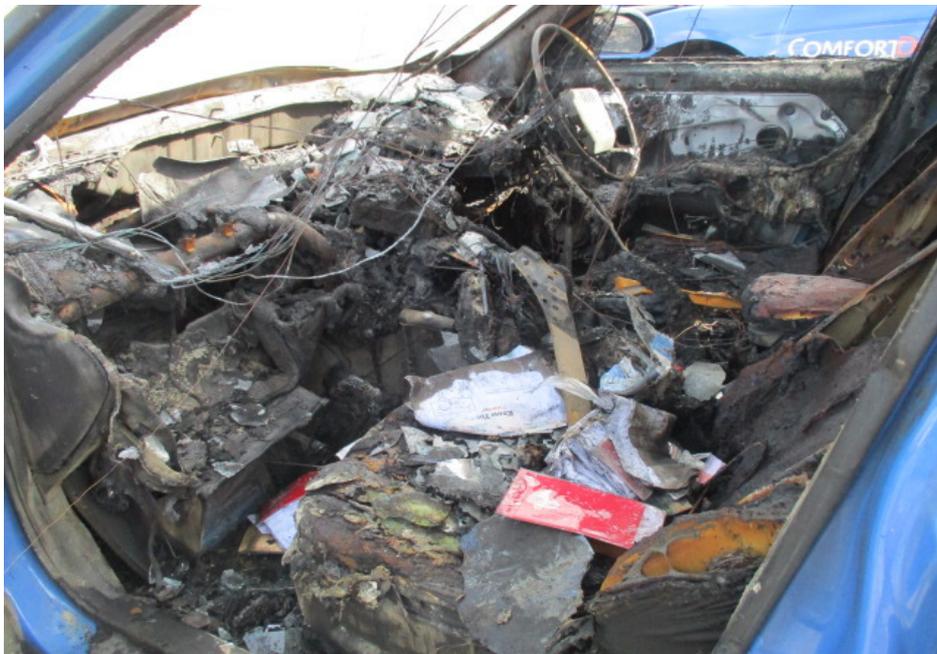
Photo 6 shows the interior compartment of the Insured Vehicle, which was significantly affected by the fire.

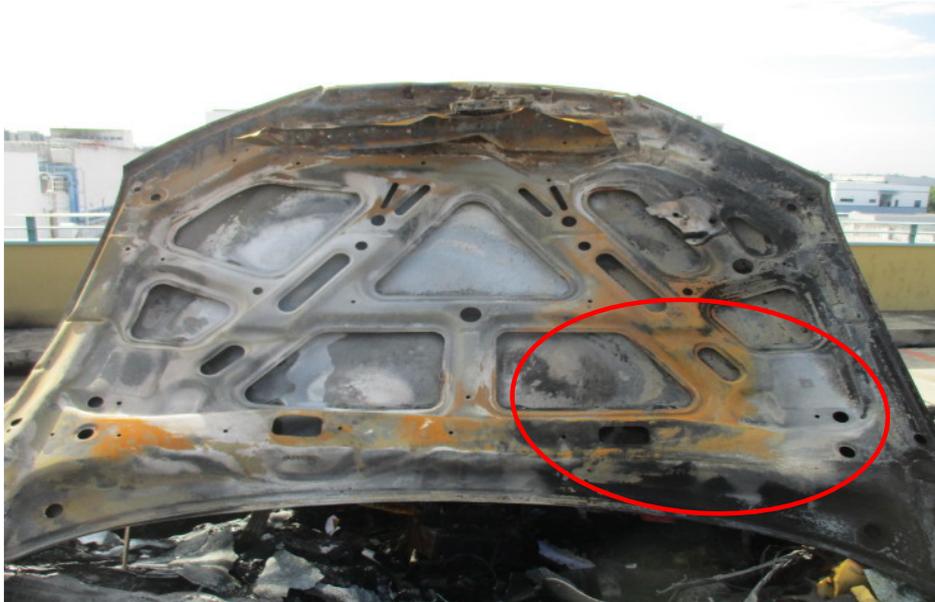
7. For this particular case, the fire appears to have originated within the engine compartment of the Insured Vehicle, somewhere around the left rear portion of the engine compartment. This can be determined from the burn pattern and the high heat intensity burn marks (whitish burn marks) as well as the rust that had developed on the underside of the front bonnet, at the bottom left portion.

8. The whitish burn marks are a result of exposure to prolonged heat intensity. Rust would normally start to develop around these areas soon after a fire as prolonged exposure to high heat intensity usually causes steel/metal material body parts to be exposed to natural environmental condition. The rust that had developed on the underside of the front bonnet, around the bottom left portion, is an indication that the left rear portion of the engine compartment had sustained exposure to prolonged high heat intensity. See photo 7 below.

Photo 7 shows the rust that had developed on the underside of the front bonnet, around the bottom left portion (circled). The development of rust is an indication that this area was subjected to prolonged exposure to high heat intensity, which had caused the steel/metal material of the front bonnet to be exposed to natural environmental condition. Hence the fire to the Insured Vehicle can be determined to have originated towards the left rear portion of the engine compartment.

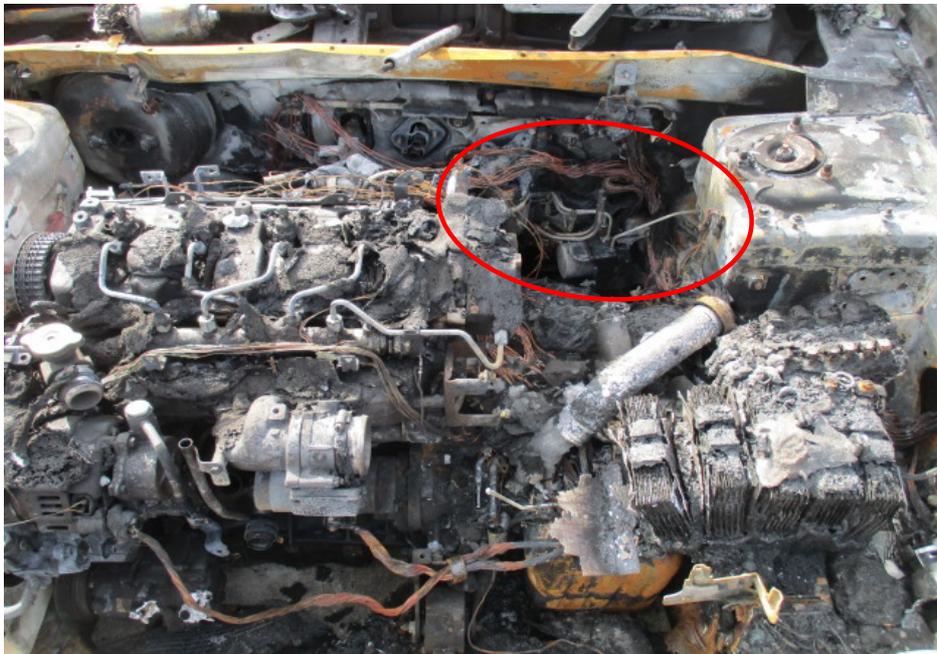
9. Upon closer examination of the left rear portion of the engine compartment, which was where the fire to the Insured Vehicle had likely started, we had found greenish residue on several burnt stretches of original factory fitted wirings around the left rear portion of the engine compartment. The presence of such greenish residue indicates internal heating of copper wires, a sign of an electrical short circuit occurring. The greenish residue is normally left behind from oxidation as a result of chemical reaction involving the copper wires. This physical evidence would then appear to suggest that the cause of fire to the Insured Vehicle could have possibly been due to electrical in nature. See photos 8 - 10 below.

Photo 8 shows the original factory fitted wirings around the left rear portion of the engine compartment, which is in the immediate vicinity where the fire to the Insured Vehicle had likely started (circled). We had found greenish residue on several burnt stretches of these wirings. The presence of such greenish residue indicates internal heating of copper wires, a sign of an electrical short circuit occurring. The greenish residue is normally left behind from oxidation as a result of chemical reaction involving the copper wires.

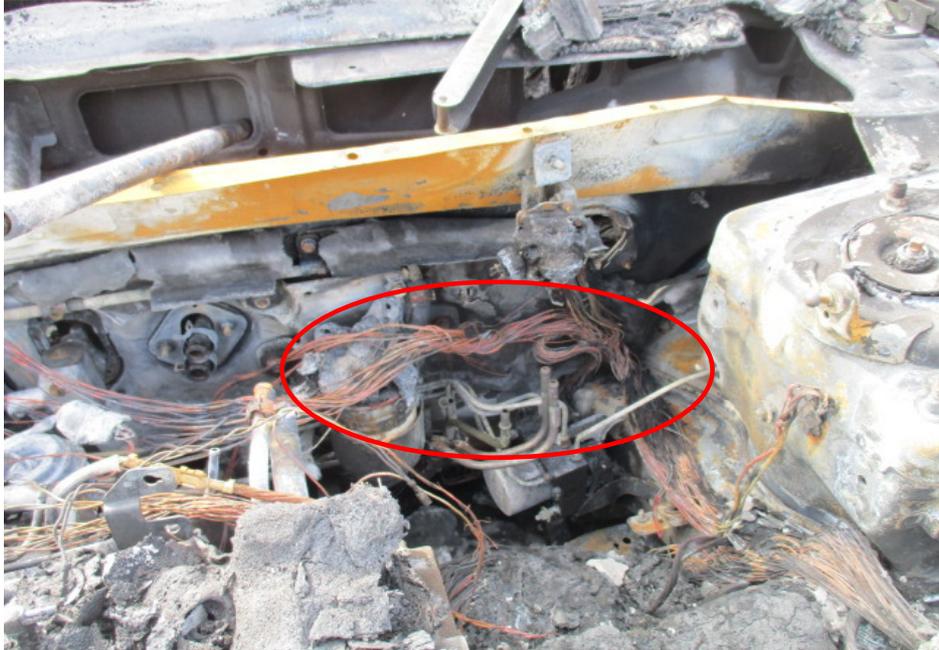
Photo 9 shows a closer view of the original factory fitted wirings around the left rear portion of the engine compartment. Greenish residue was found on some of these burnt stretches of original factory fitted wirings (circled). The presence of such greenish residue suggests occurrence of an electrical short circuit.

25. The possibility of the fire being due to electrical in nature would then seem more likely given that engine overheating and external factors would both seem unlikely. The fire being due to electrical nature is also supported by the condition of the wirings that were found in the engine compartment of the Insured Vehicle, which was earlier discussed in paragraph 9 above.

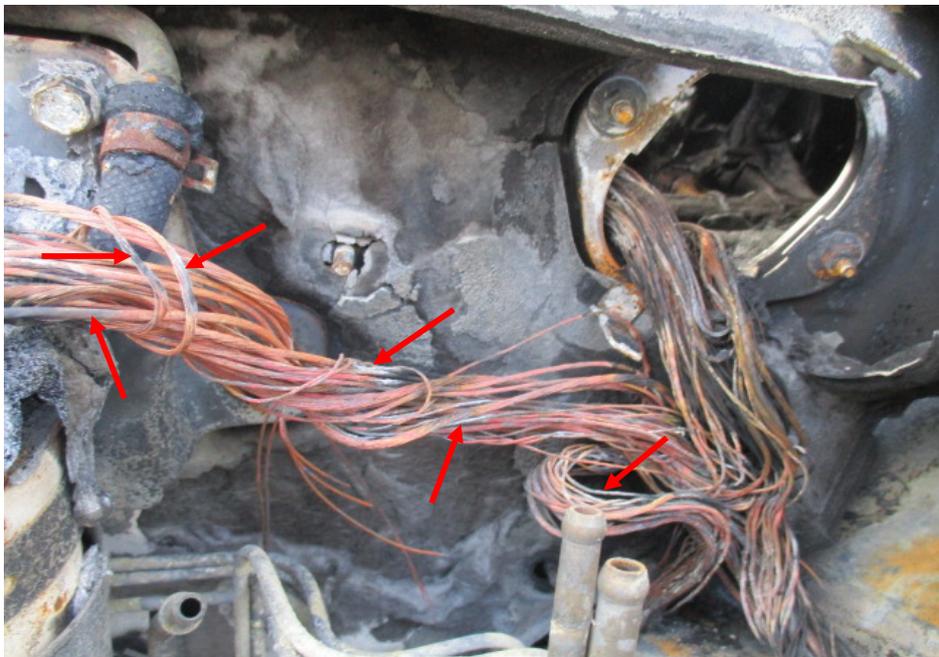
Photo 10 shows a close up view of the greenish residue found on some of the burnt stretches of original factory fitted wirings (arrowed). The presence of such greenish residue suggests occurrence of an electrical short circuit.

27. Having investigated and technically analysed the damages of burnt nature to the Insured Vehicle, we are of the view that the cause of fire to the Insured Vehicle was of electrical in nature. For this particular case, the fire had originated along the original factory fitted wirings inside the engine compartment, somewhere around the left rear portion of the engine compartment.
28. We did not find any evidence which had suggested that the cause of fire to the Insured Vehicle was due to poor maintenance and/or recurring electrical problem.

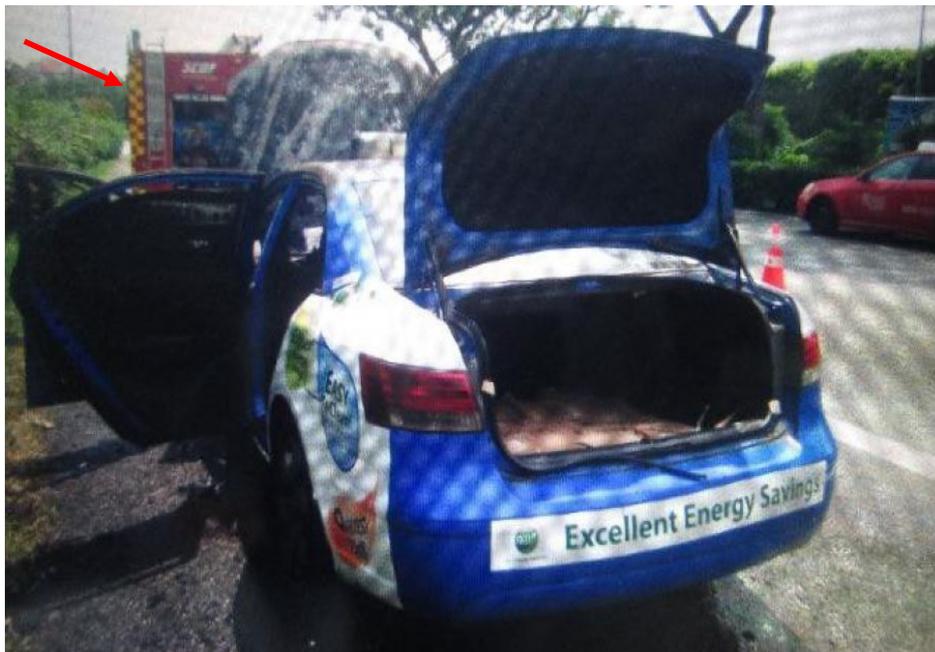
Photo 11 shows SCDF having arrived at the incident location and assisting Mr Ang in putting out the fire (arrowed).

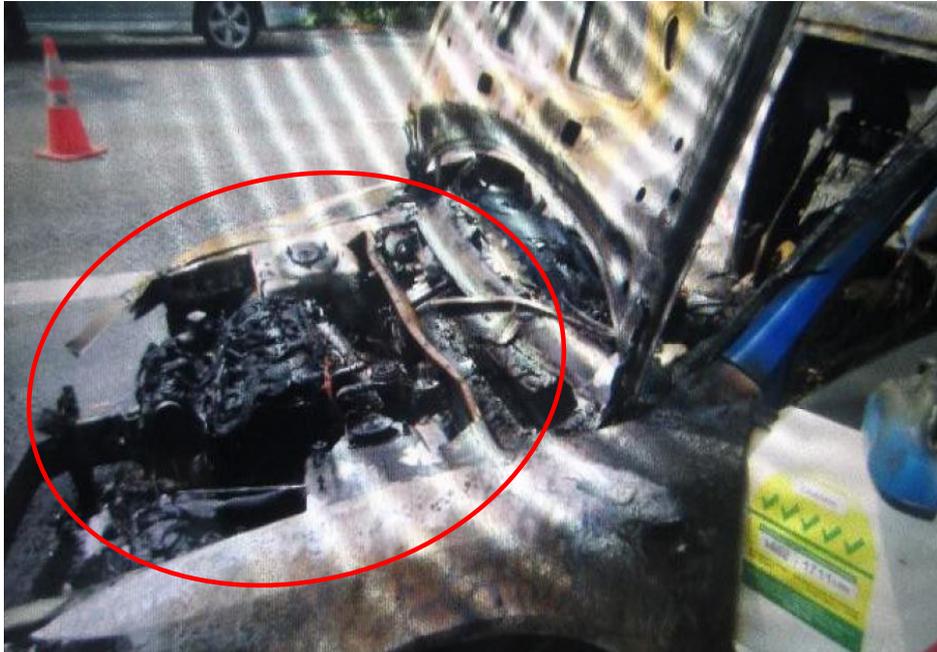
Photo 12 shows the front portion of the Insured Vehicle post- incident. In general, the extensive damages sustained to the front portion of the Insured Vehicle had corresponded to the events that were related to us by Mr Ang, which is the fire had started from the engine compartment (circled).
