Your Ref: S8MOOPU9
Our Ref :CS/ASM18013652/D

01 August 2018

**TECHNICAL INVESTIGATION REPORT OF FIRE INCIDENT INVOLVING THE
INSURED VEHICLE SGU 8854G ON 24 JULY 2018**

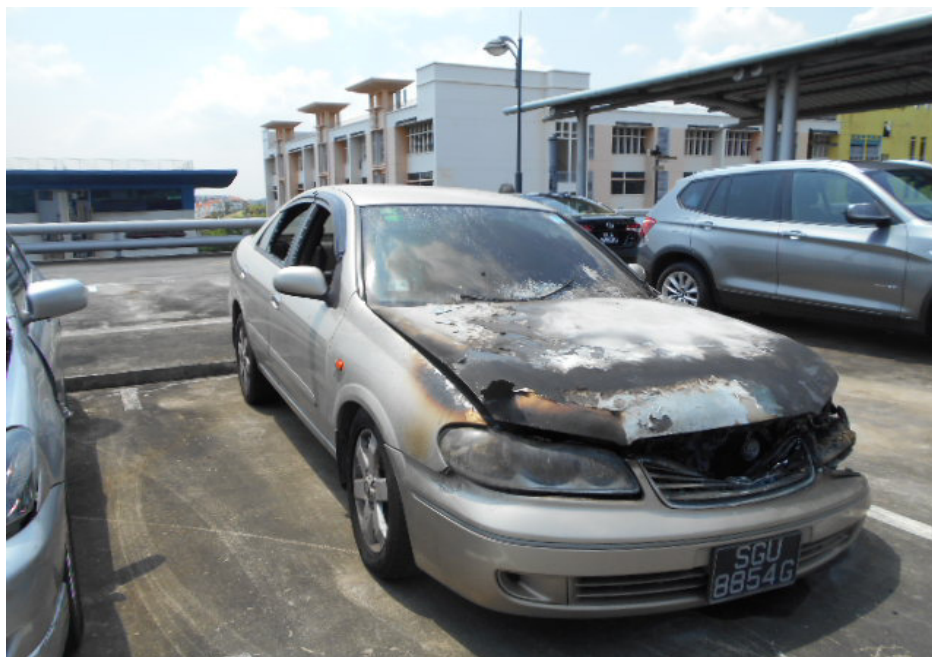
Photo 1 shows a general view of the front right portion of the Insured Vehicle at the time of my inspection. The fire damage to the Insured Vehicle was confined to its frontal portion. Its front bumper, front bonnet, front grille, front right headlamp and front right fender were amongst the body parts that were found to have been affected as a result of the fire.

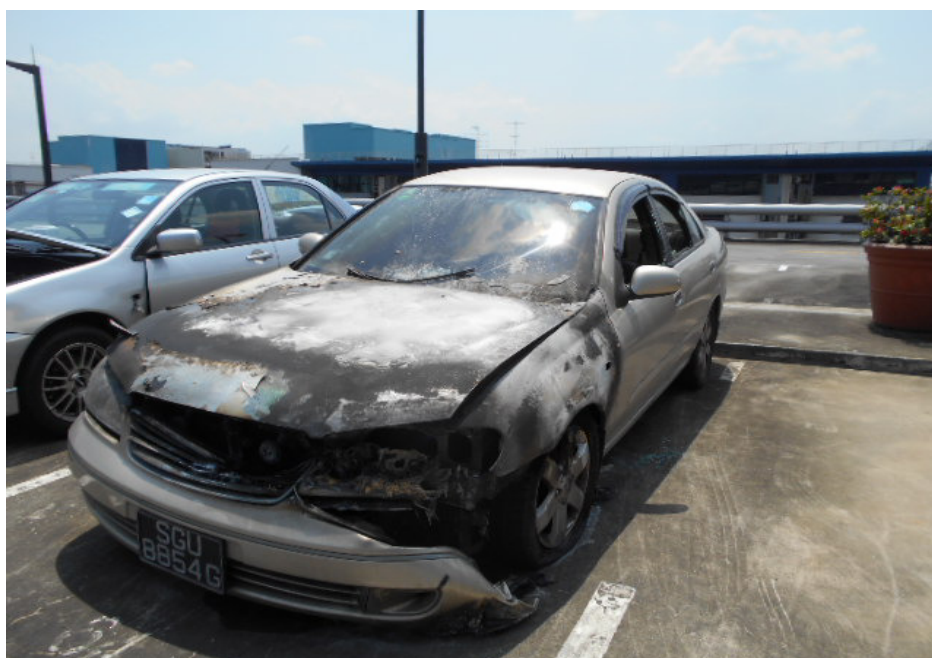
Photo 2 shows a general view of the front left portion of the Insured Vehicle at the time of my inspection. The fire damage to the Insured Vehicle was confined to its front portion. Its front bumper, front bonnet, front left headlamp, front windscreen and front left fender were amongst the body parts that were found to have been affected as a result of the fire.

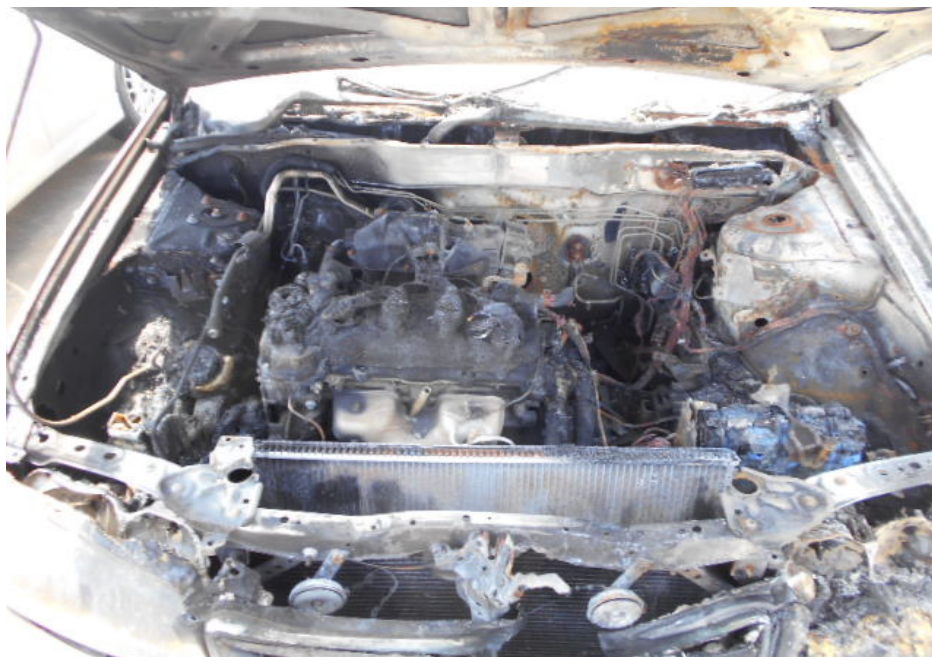
Photo 3 shows the engine compartment of the Insured Vehicle at the time of my inspection. The entire engine compartment of the Insured Vehicle was observed to be severely burnt. Most of the parts inside the engine compartment were found to be burnt and/or melted as a result of the fire.

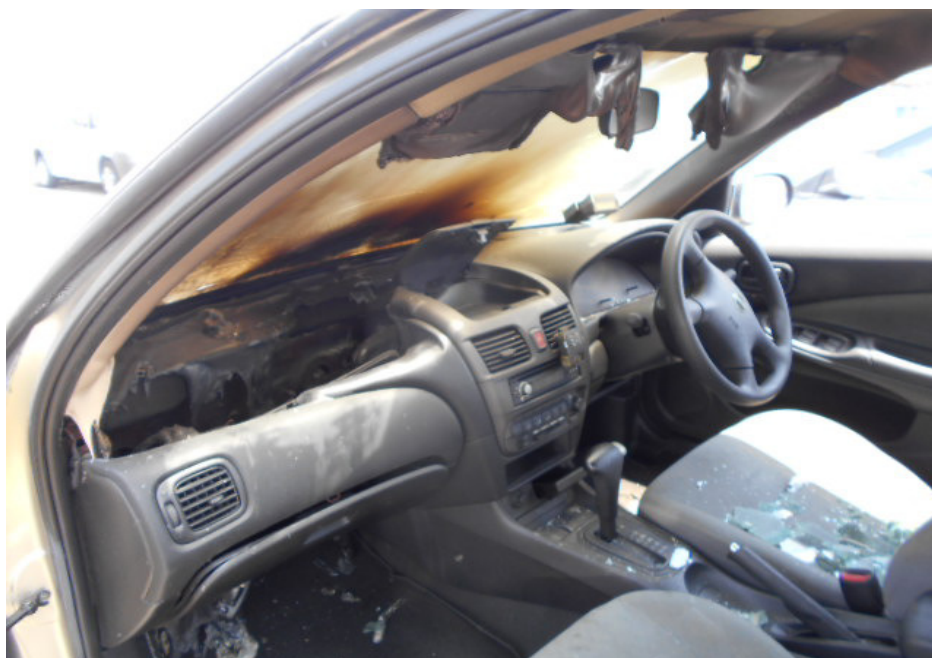
Photo 4 shows the interior compartment of the Insured Vehicle, which was observed to be partially burnt and/or melted at the front area. The front dashboard and roof upholstery were amongst the parts that were found to have been burnt and/or melted as a result of the fire.

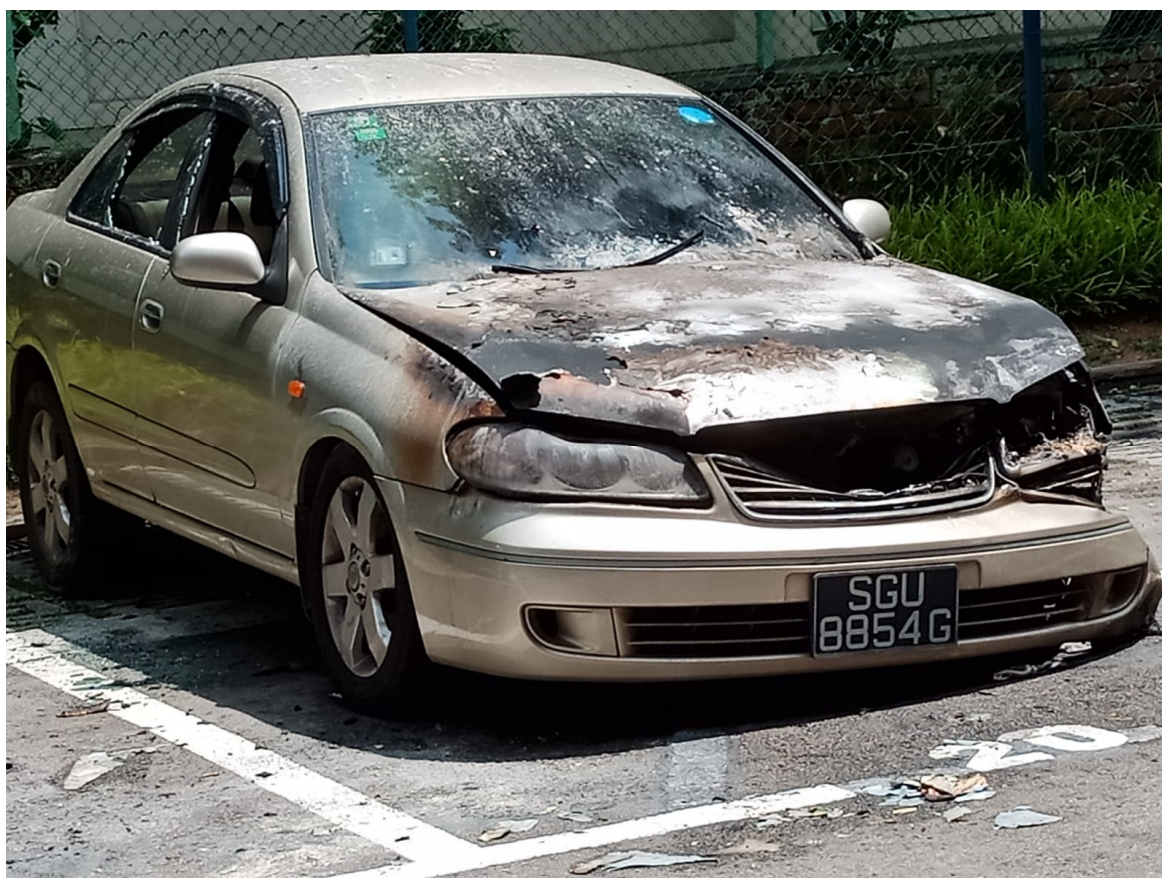
Photo 5 shows the Insured Vehicle at the incident location after the fire was extinguished. It was observed that the Insured Vehicle was parked inside a parking lot number 20 at the material time of incident. My close examination of the photographs provided had showed no unusual foreign material(s) and/or object(s) on the ground in the immediate area of where the Insured Vehicle was parked. The damage of burnt nature to the Insured Vehicle immediately after the fire was put out had also corresponded to the damages as seen by me during my inspection of the Insured Vehicle.

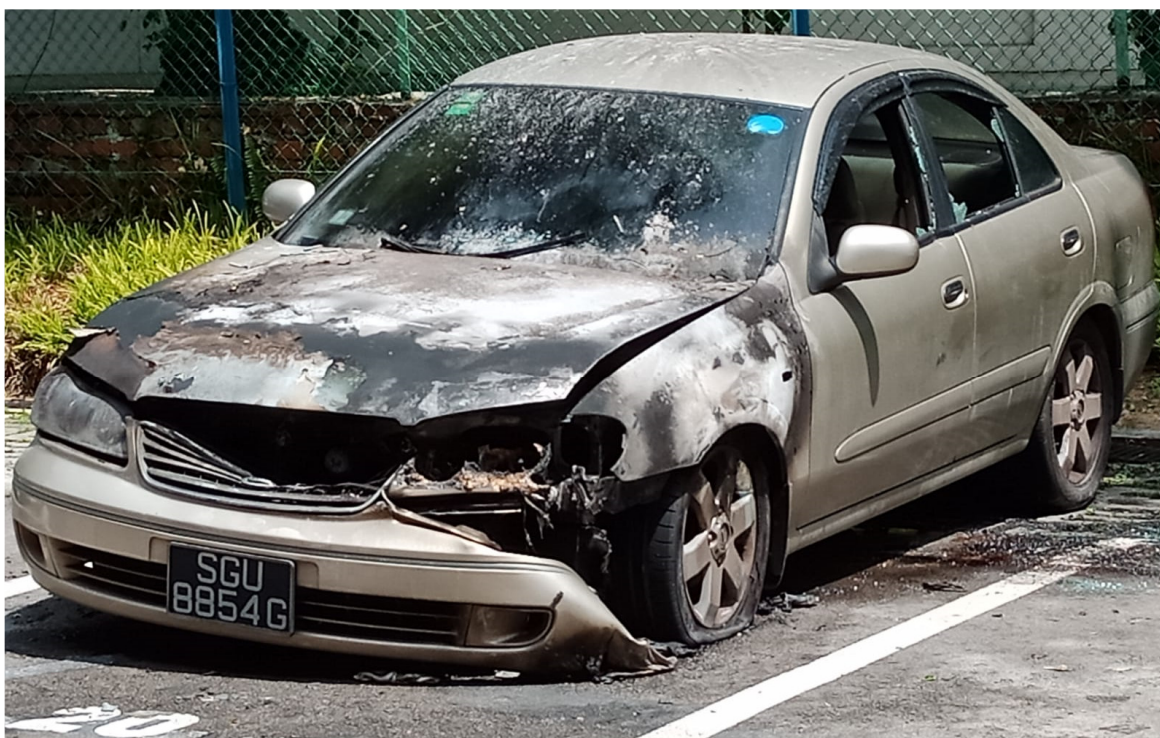
Photo 6 shows the Insured Vehicle at the incident location after the fire was extinguished. It was observed that the Insured Vehicle was parked inside a parking lot number 20 at the material time of incident. My close examination of the photographs provided had showed no unusual foreign material(s) and/or object(s) on the ground in the immediate area of where the Insured Vehicle was parked. In general, the observations gathered from my review of the photographs that were taken by Mr How at the incident scene had corresponded to his description of the events that he had related to me during our conversation on 27 July 2018.

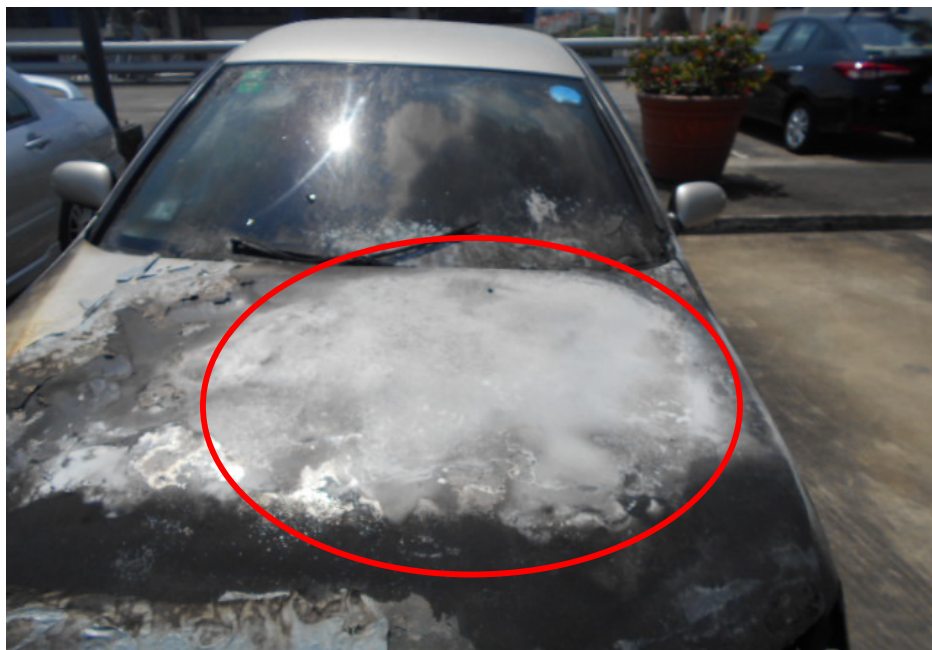
22. Firstly, high heat intensity burned marks (whitish burn marks) were found at the rear left area of the front bonnet. These whitish burn marks are a result of exposure to prolong heat intensity. Rust would normally start to develop around these areas soon after a fire as prolonged exposure to high heat intensity usually causes steel/metal material body parts to be exposed to natural environmental condition.

Photo 7 shows the whitish burn marks (circled) that were found on the rear left area of the Insured Vehicle's front bonnet. Such whitish burn marks are a result of exposure to prolong heat intensity. Following the characteristic of heat rising upwards, the fire to the Insured Vehicle can then be determined to have originated around the rear left area of the engine compartment.

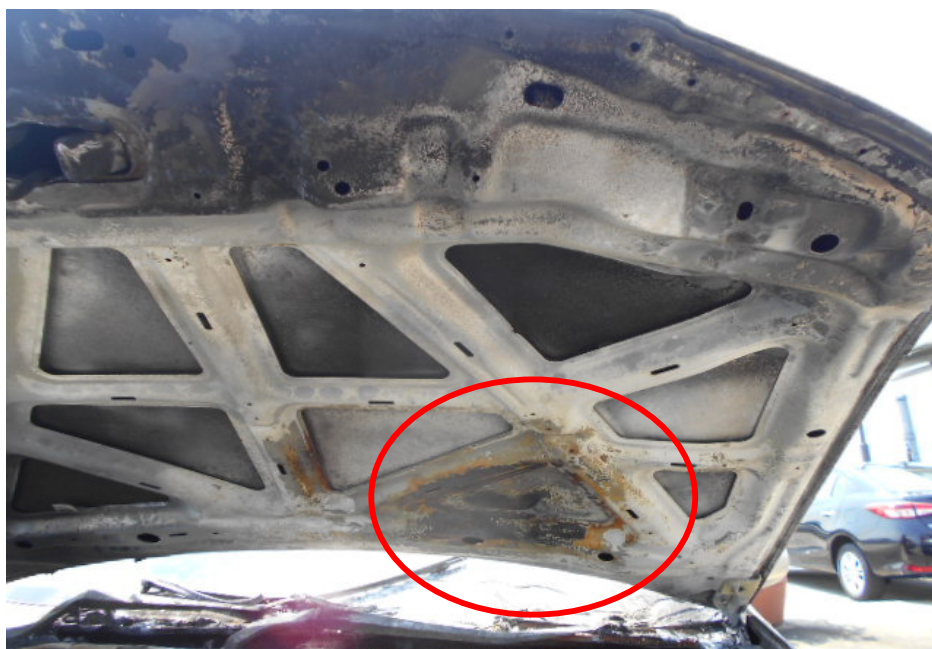
23. Correspondingly, the underside of the front bonnet at the rear left area was found with similar high heat intensity burn marks (whitish burn marks). Rust had also started to develop at this area. Following the characteristic of heat rising upwards, the burn pattern of the front bonnet would than indicate that the origin of fire was at the rear left area of the Insured Vehicle's engine compartment. See photo 7 - 9 below.

Photo 8 shows the whitish burn marks on the underside of the front bonnet, directly under the area where similar whitish burn marks were found. These whitish burn marks are a result of exposure to prolong heat intensity. Rust (circled) would normally start to develop around these areas soon after a fire as prolonged exposure to high heat intensity causes steel/metal material body parts to be exposed to natural environmental condition.

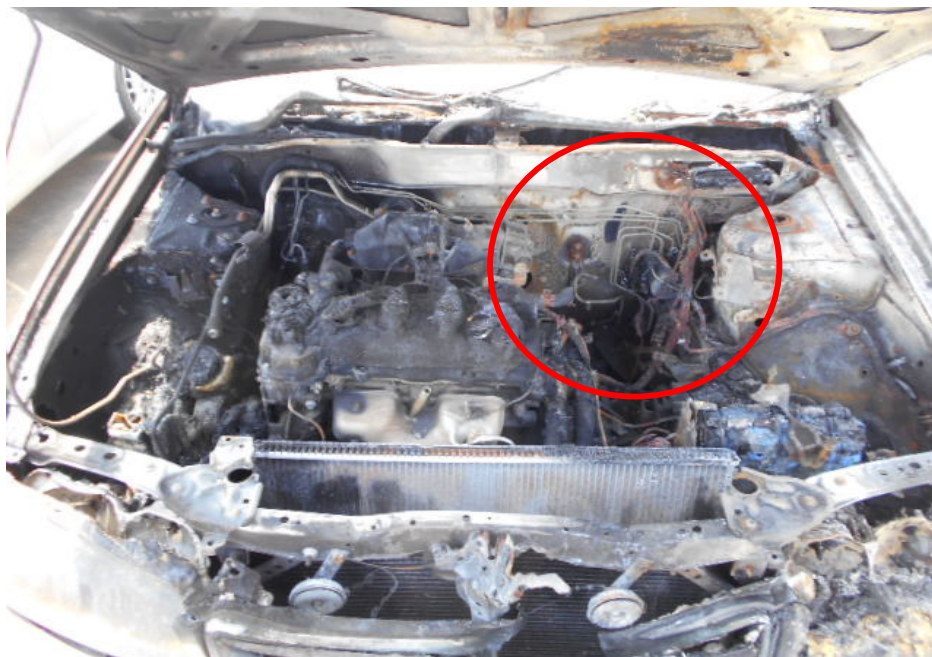
Photo 9 shows a general view of where the fire to the Insured Vehicle had originated, which was around the rear left area of the engine compartment (circled). This was established basing on the burn pattern (whitish burn marks and rust) that was found on the Insured Vehicle's front bonnet.

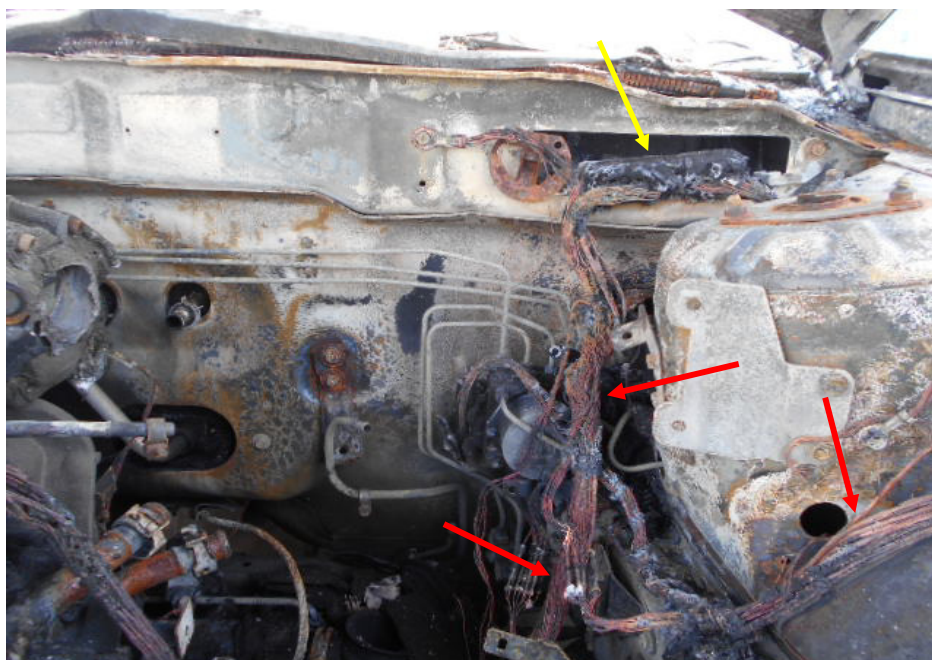
24. My examination of the rear left area of the engine compartment, during my inspection of the Insured Vehicle, revealed wirings that were completely burned to its bare copper state. These wirings were original factory fitted wirings leading to the Engine Control Module (ECM) of the Insured Vehicle. The reddish colour of the copper wires suggest that the wirings were exposed to high heat. Such condition normally indicates internal heating of copper wires which is a sign of an electrical short circuit occurring. Hence the physical condition of the wirings at the area where the fire had originated indicates that the cause of fire to the Insured Vehicle was due to electrical in nature. See photo 10 - 12 below.

Photo 10 shows the wirings around the rear left area of the engine compartment, which was where the fire to the Insured Vehicle had likely started. The wirings (red arrow) leading to the Engine Control Module (ECM) (yellow arrow) were found to be burnt to its bare copper state. Such condition normally indicates internal heating of copper wires, which is a sign of an electrical short circuit occurring. These burnt wirings were original factory fitted wirings.

27. Having investigated and technically analysed the damages of burnt nature to the Insured Vehicle, I am of the view that the cause of fire to the Insured Vehicle was of electrical in nature. For this particular case, the fire had originated along the wiring inside the engine compartment, somewhere around the rear left area of the engine compartment. The wiring was an original factory wiring leading to the Engine Control Module (ECM) of the Insured Vehicle.

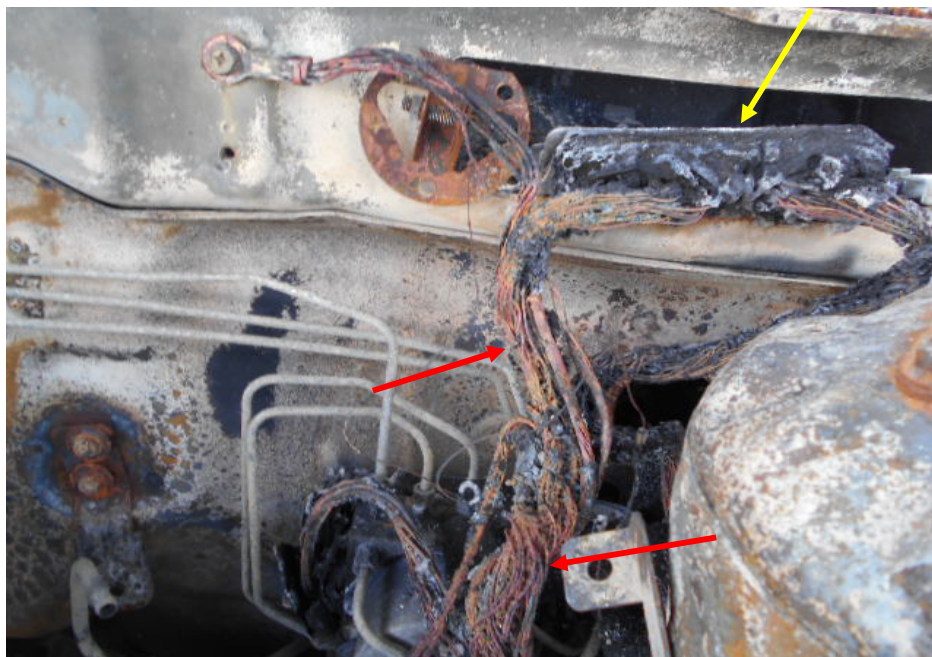
Photo 11 shows a closer view of the burnt wirings leading to the Engine Control Module (ECM) (yellow arrow). The reddish colour (red arrow) of the copper wires suggest that the wirings were exposed to high heat. Such condition normally indicates internal heating of copper wires, which is a sign of an electrical short circuit occurring.

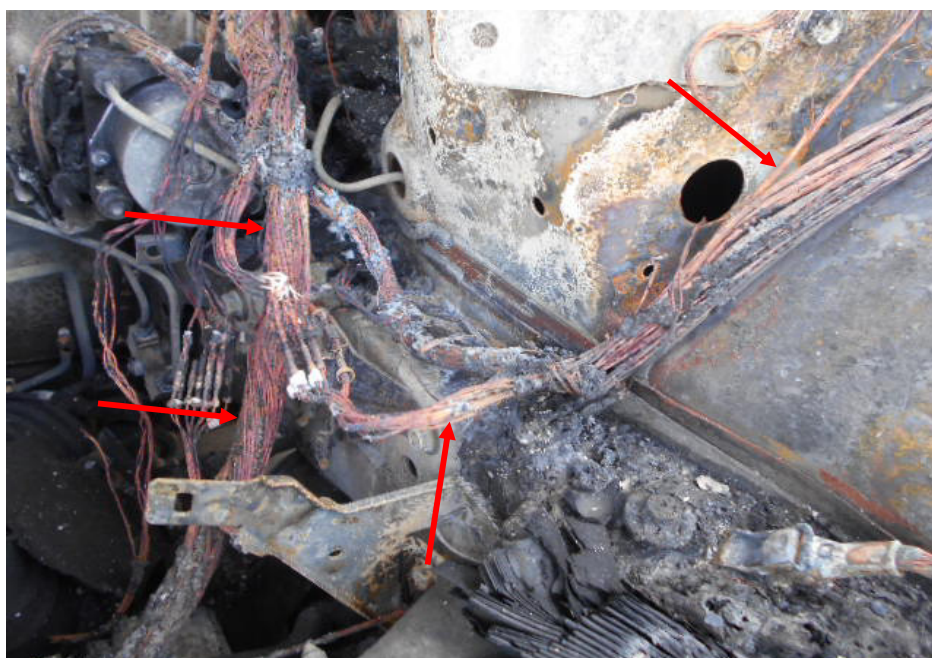
Photo 12 shows another stretch of wirings, at the rear left area of the Insured Vehicle's engine compartment, burnt to its bare copper state. The reddish colour (arrowed) of the copper wires suggest that the wirings were exposed to high heat. Such condition normally indicates internal heating of copper wires, which is a sign of an electrical short circuit occurring.
