To Inspect Vehicle No: SHD 9249A

INITIAL INSPECTION REPORT OF VEHICLE NO. SHD 9249A

ADJUSTMENT ON REPAIR COST FOR VEHICLE NO. SHD 9249A

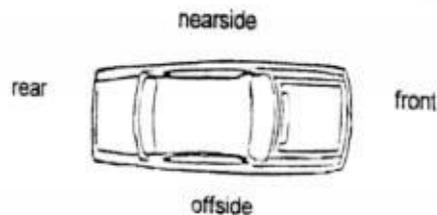
The vehicle sustained damages at the o/s rear portion

Damages Consistent
