Your Ref: TP/IP/36553/2018  
Our Ref : CI/TPD18013726/Z

18<sup>th</sup> October 2018

### **MECHANICAL INSPECTION REPORT OF MOTOR LORRY YN 5405M**

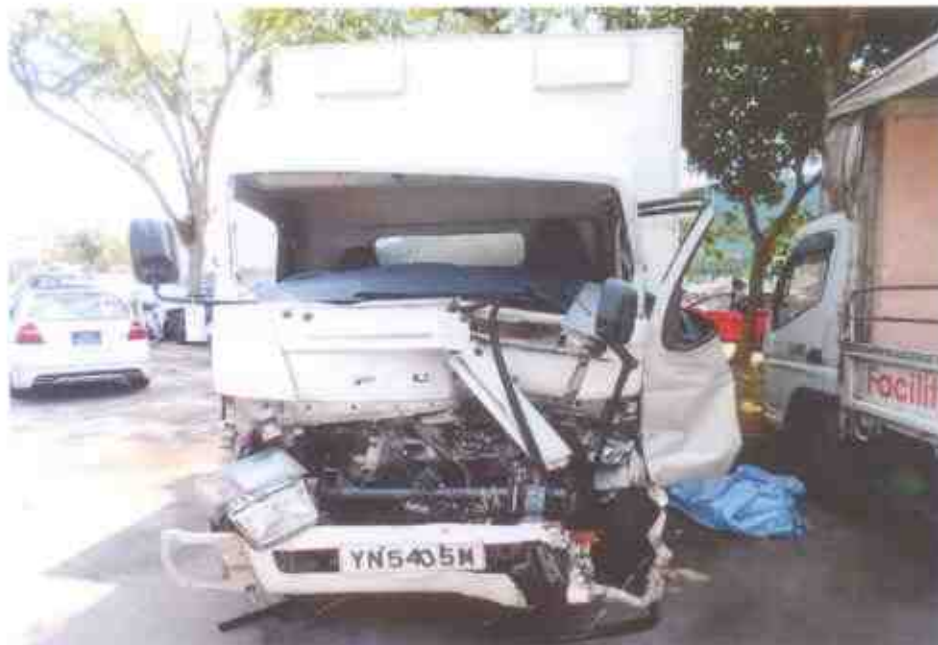
**Photo 1** shows a general view of the frontal portion of the Motor Lorry at the time of my inspection. The Motor Lorry was observed to have sustained extensive impact damage at its frontal portion. The impact force was relatively significant, causing its entire front cabin to be buckled and crumpled.

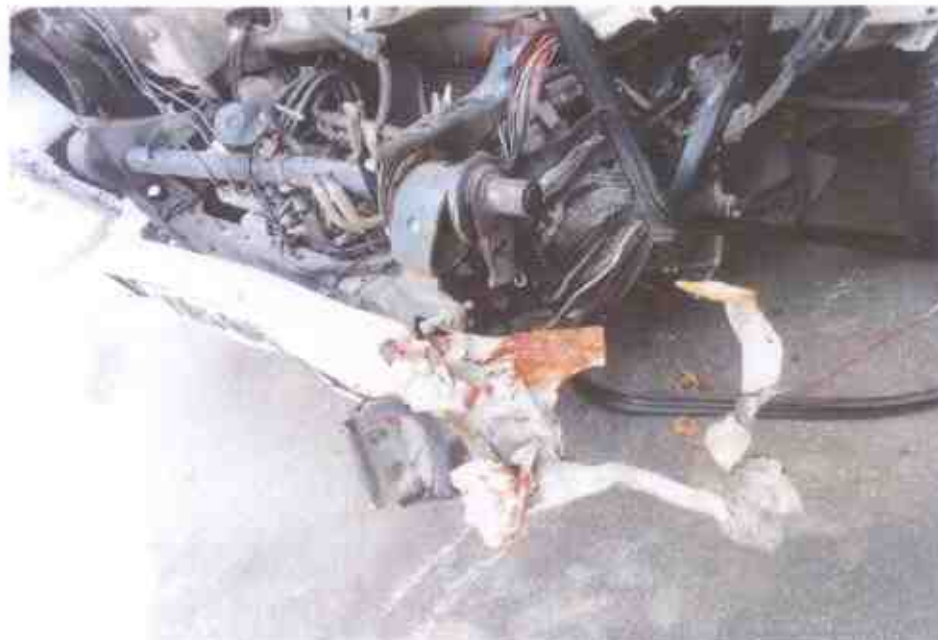
**Photo 2** shows a closer view of the frontal portion (engine) of the Motor Lorry at the time of my inspection. A number of mechanical parts and components at the frontal portion (engine) were also severely damaged as a result of the accident.

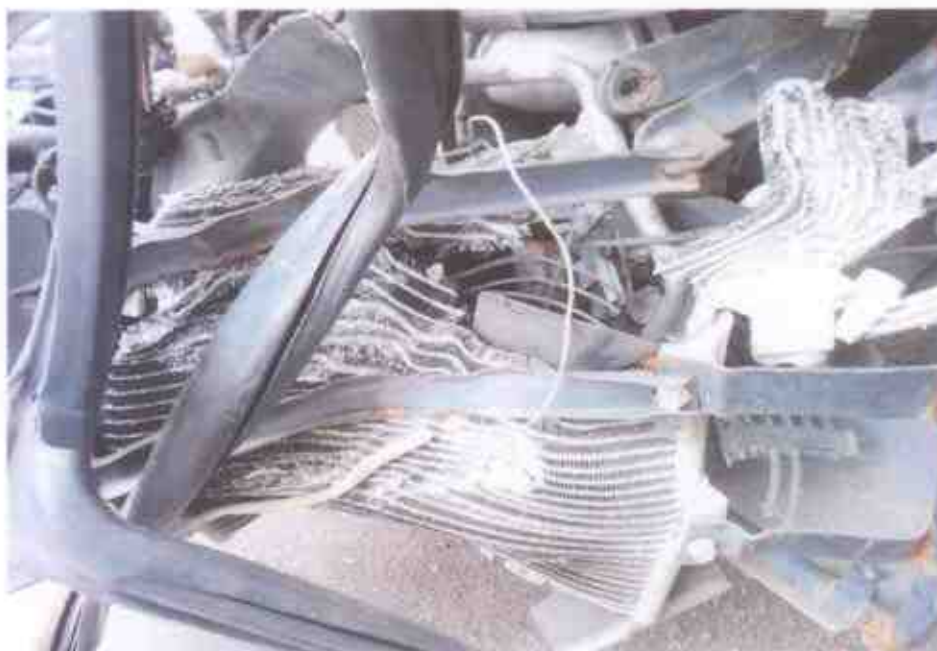
**Photo 3** shows a closer view of the frontal portion (engine) of the Motor Lorry at the time of my inspection. A number of mechanical parts and components at the frontal portion (engine) were also severely damaged as a result of the accident.

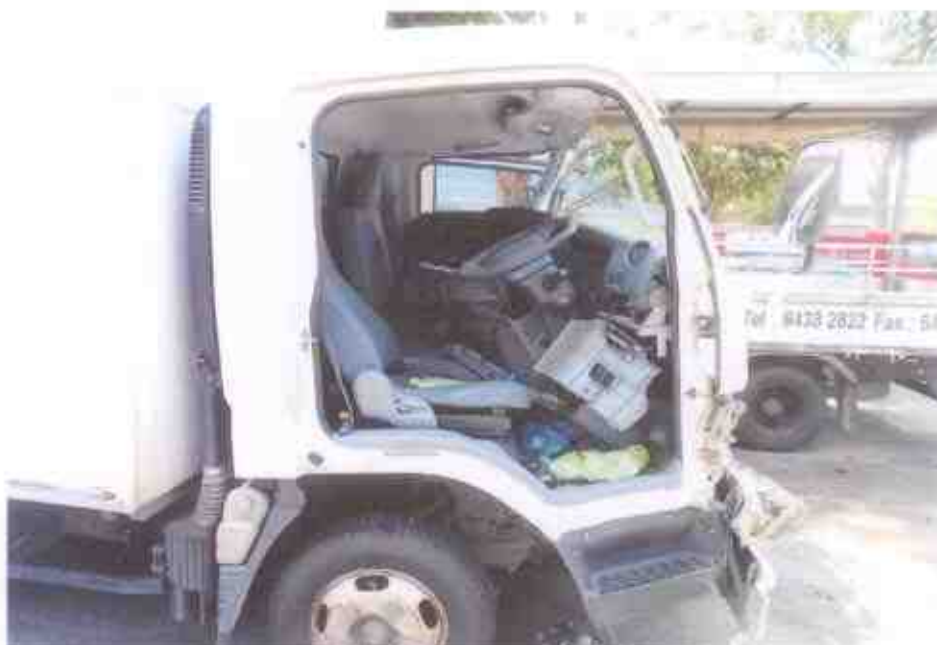
**Photo 4** shows a general view of the distorted structure of the Motor Lorry at the time of our inspection. It had sustained damaged as a result of the accident.

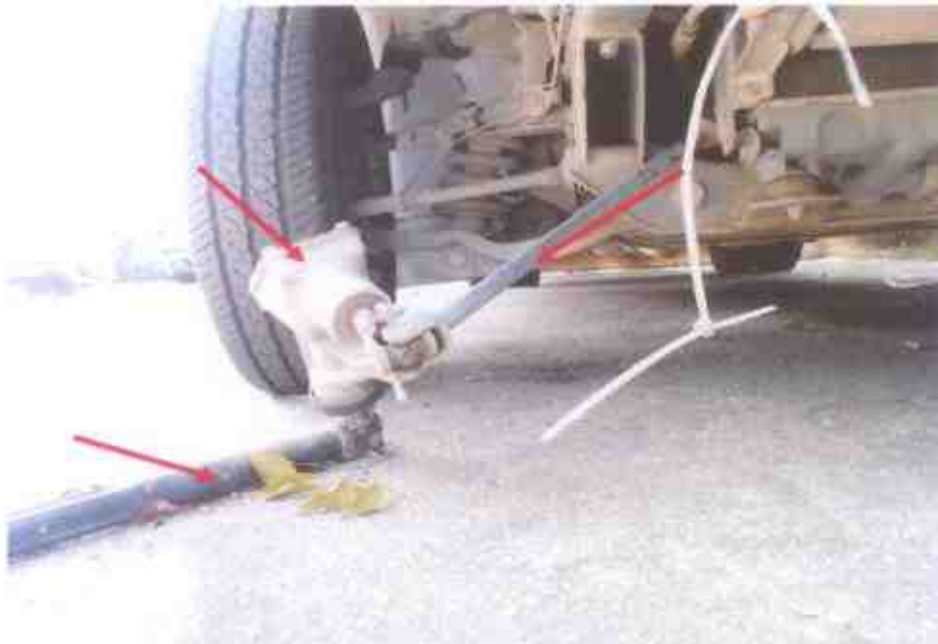
**Photo 5** shows a closer view of the dislodged steering wheel rod of the Motor Lorry at the time of my inspection. It was likely due the result of the accident.

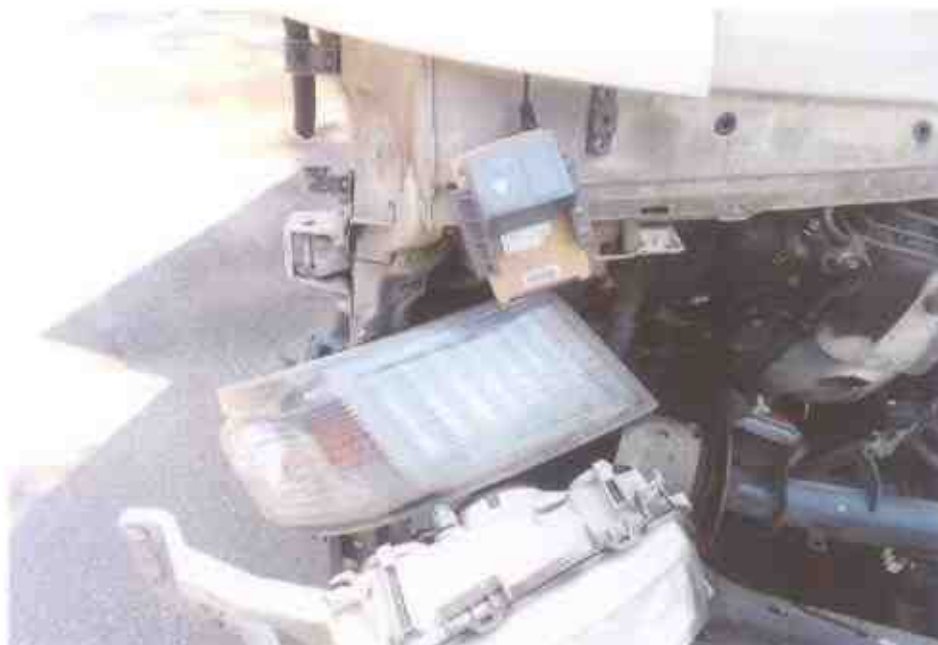
**Photo 6** shows a closer view of the frontal right portion of the Motor Lorry at the time of my inspection. A number of mechanical parts and components at the frontal portion were also severely damaged as a result of the accident.

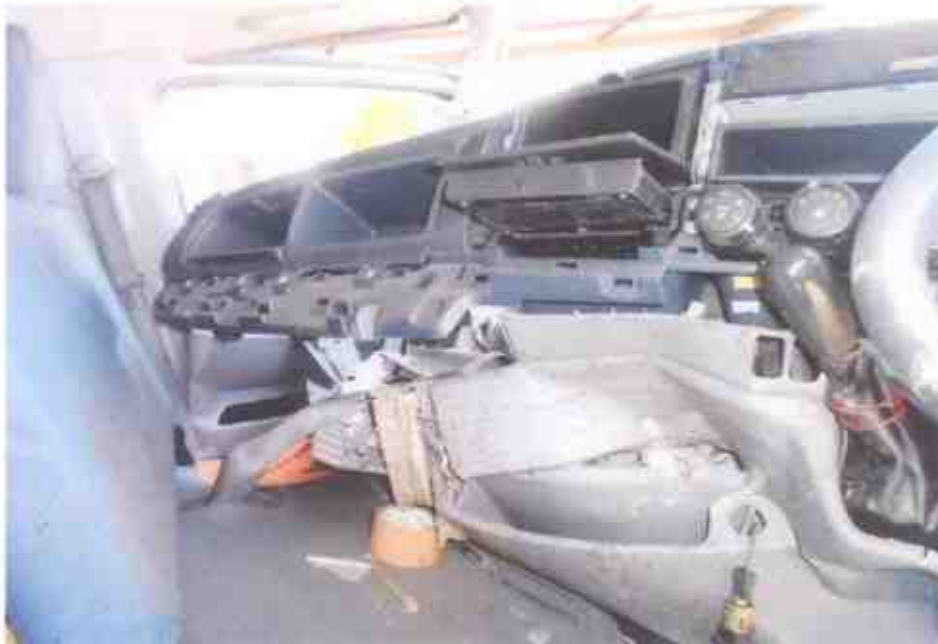
**Photo 7** shows the interior of the front cabin. The dashboard, steering wheel, seats, floor panel and roof panel inside the front cabin were all observed to be pushed/buckled inwards, towards the rear of the Motor Lorry. This is consistent to the nature of this accident where the direction of impact onto the Motor Lorry was from a front to rear direction.

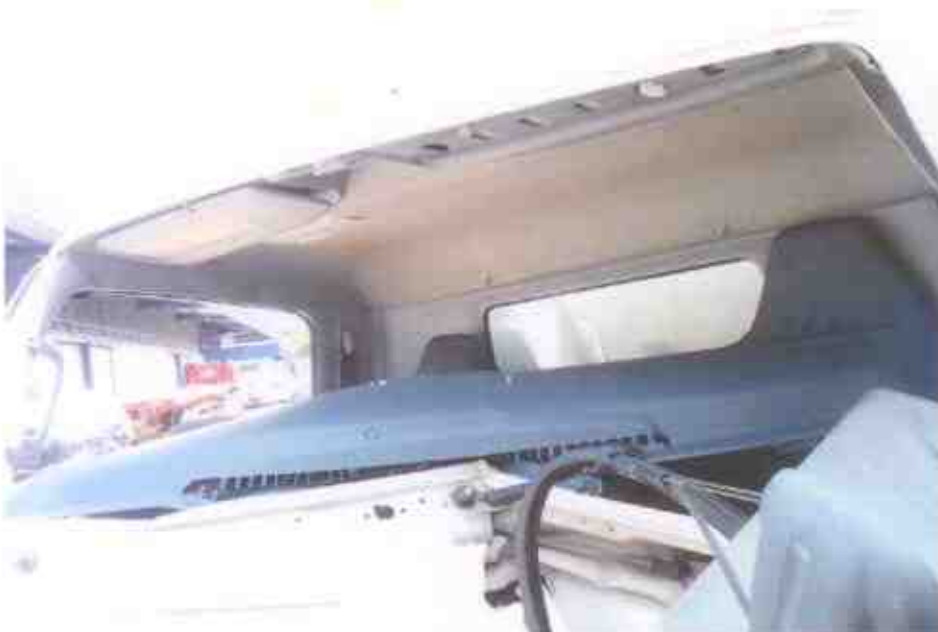
**Photo 8** shows the interior of the front cabin. The windshield was observed to be cracked due to the accident.

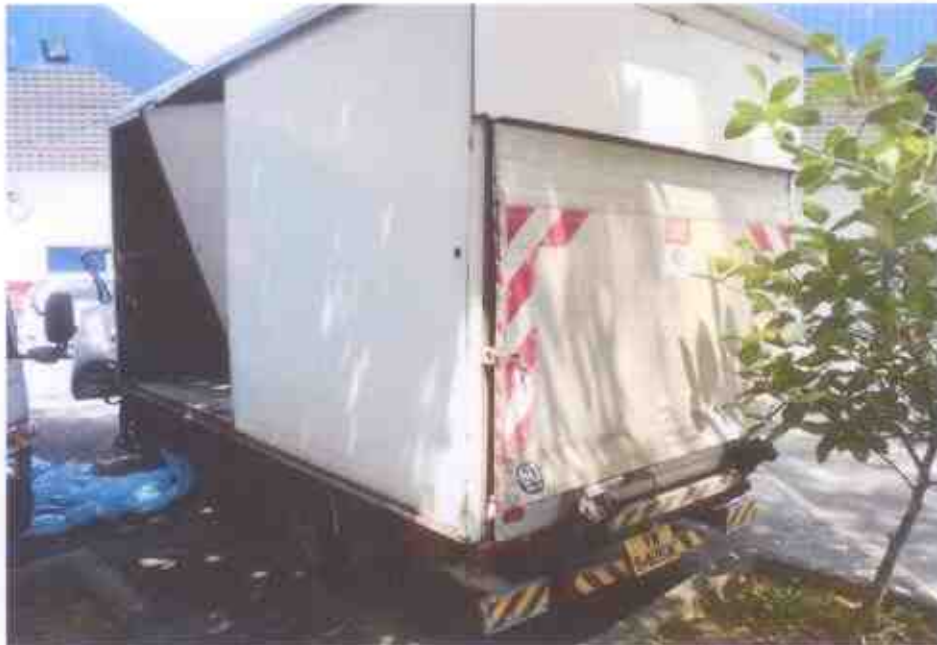
Photo 9 shows a general view of the rear left portion of the Motor Lorry at the time of my inspection. The rear portion was observed to be relatively unaffected by the accident.

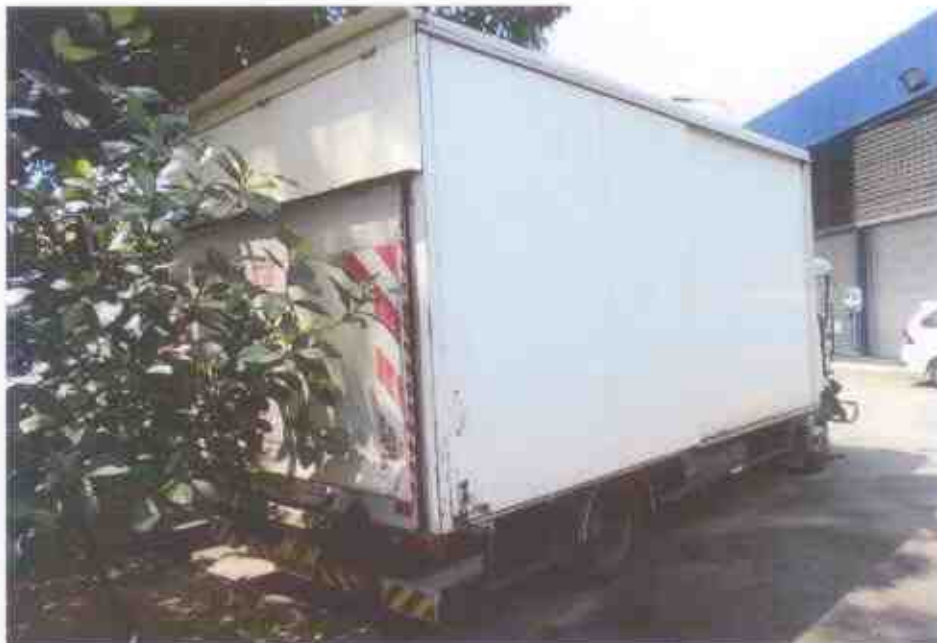
Photo 10 shows a general view of the rear right portion of the Motor Lorry at the time of my inspection. The rear portion was observed to be relatively unaffected by the accident.

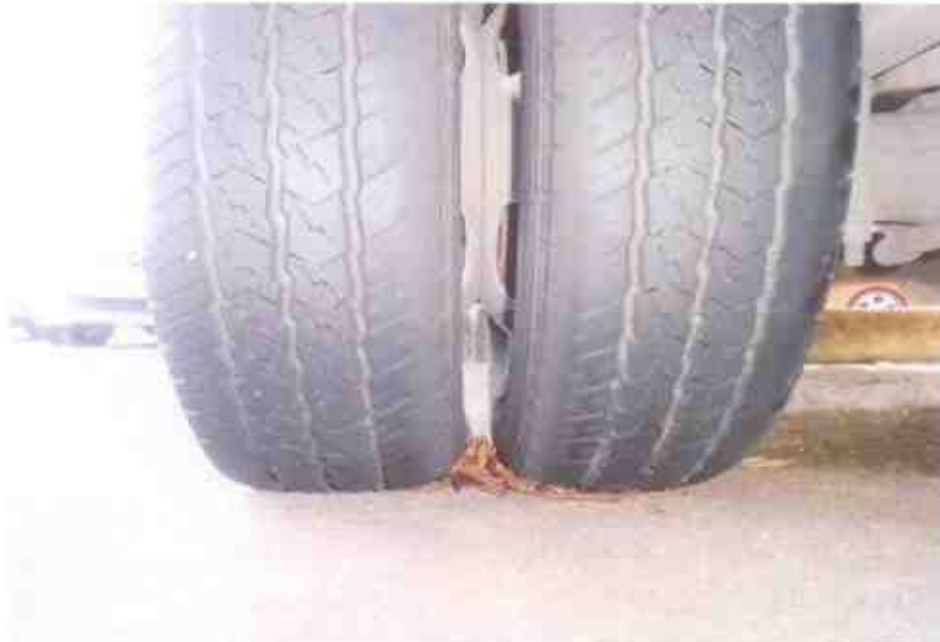
**Photo 11** shows the condition of the rear right tyres of the Motor Lorry, which was observed to be in serviceable condition with remaining tread depth of approximately 8mm.

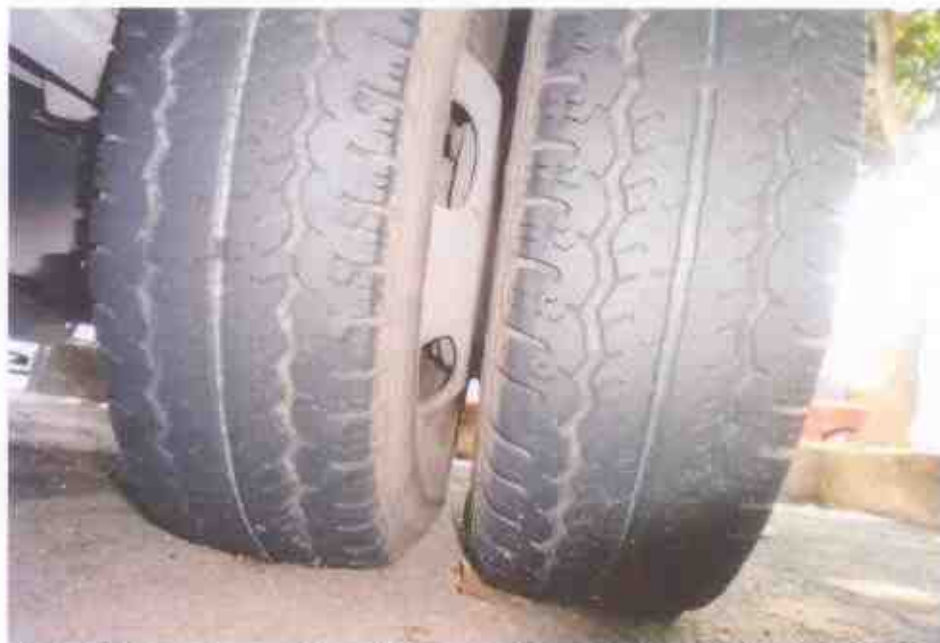
**Photo 12** shows the condition of the rear left tyres of the Motor Lorry, which was observed to be in serviceable condition with remaining tread depth of approximately 8mm. There was no tear, cut or burst mark(s) on the outer and the inner sidewalls as well as across the tread of these 2 tyres, which were also observed to be sufficiently inflated for vehicular operation.

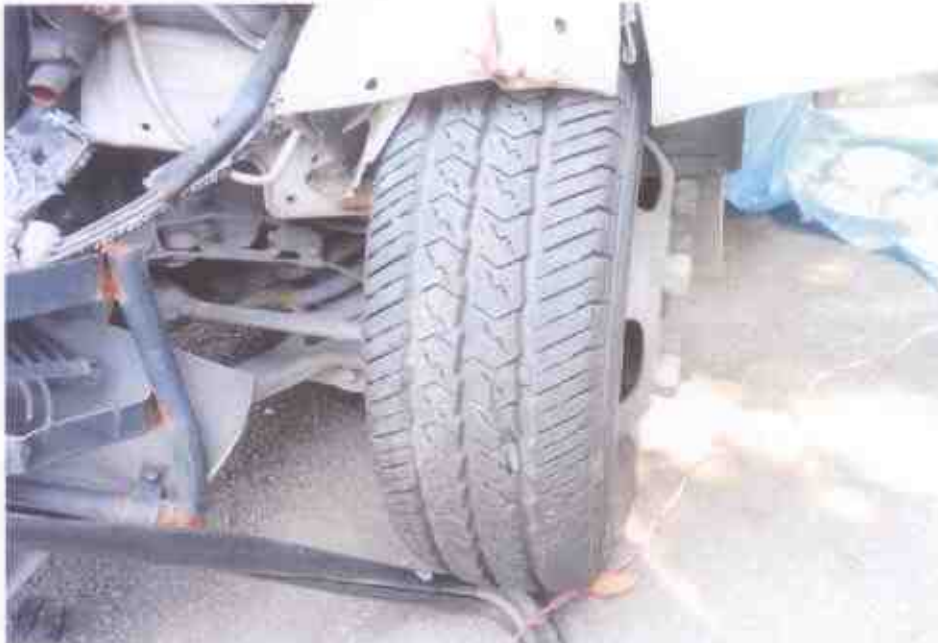
**Photo 13** shows the condition of the front left tyre of the Motor Lorry, which was observed to be in serviceable condition with remaining tread depth of approximately 7mm. There was also no tear, cut or burst mark(s) on the outer and the inner sidewalls as well as across the tread of this tyre.

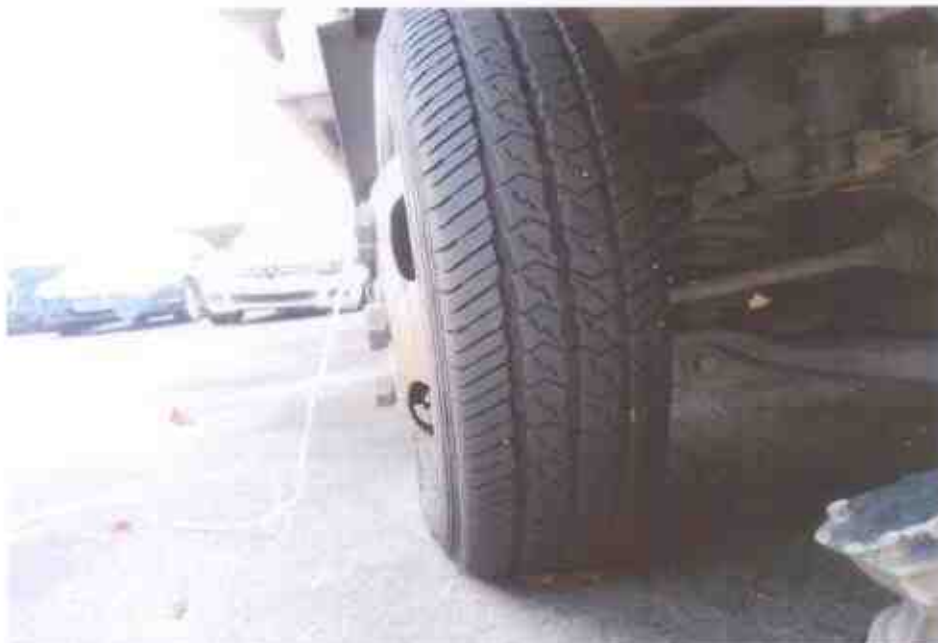
**Photo 14** shows the condition of the front right tyre of the Motor Lorry. The front right tyre was observed to be in serviceable condition with remaining tread depth of approximately 7mm. There was also no tear, cut or burst mark(s) on the outer and the inner sidewalls as well as across the tread of this tyre. The tyre, which was wrapped around alloy wheel rim, was also observed to be sufficiently inflated for vehicular operation.

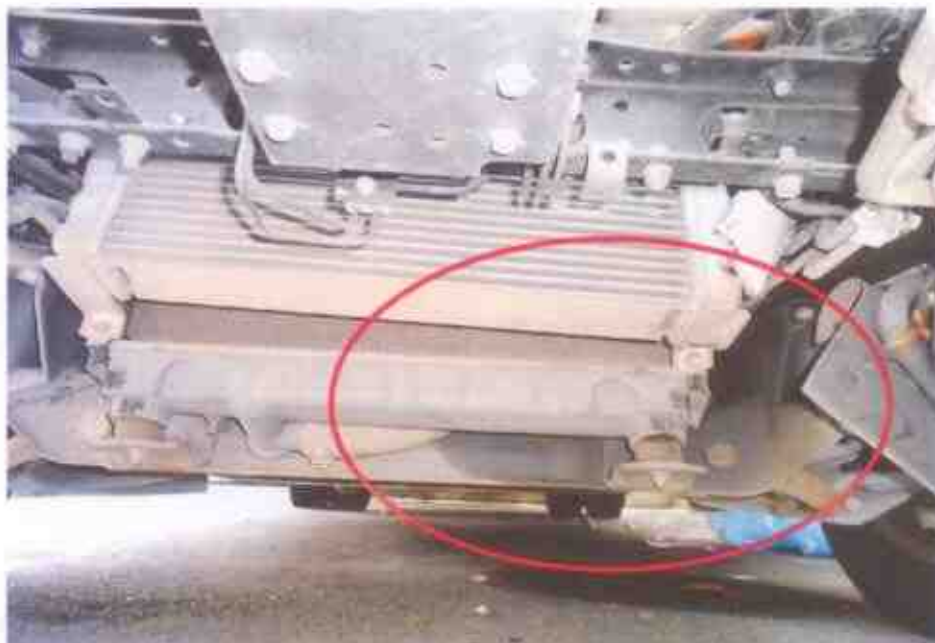
Photo 15 shows that there was also a fresh fluid stains covering the engine underside, indicating fluid leakage that had occurred due to the accident's impact.

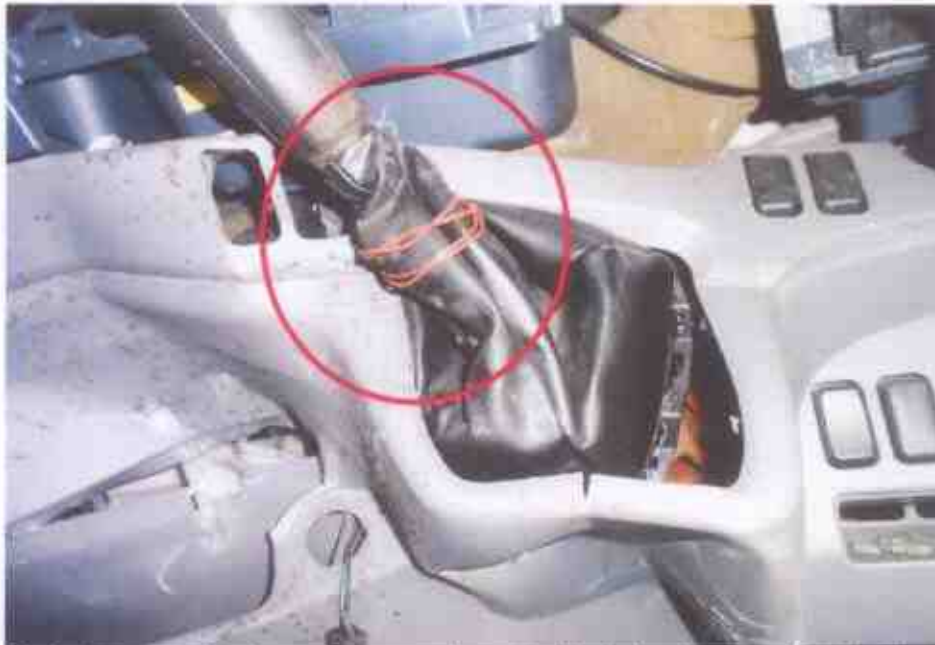
Photo 16 shows the transmission system which includes the gear knob (circled) of the Motor Lorry was observed to be bent due to the accident's collision.

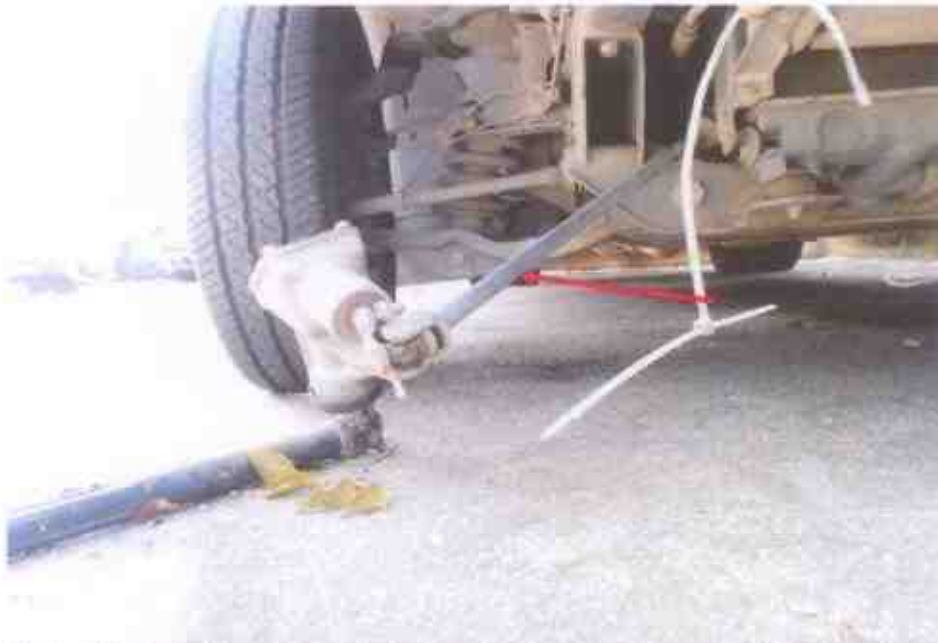
**Photo 17** shows the damaged steering wheel rod (red arrow) of the Motor Lorry. Hence, we were not able to conduct any tests on the steering system of the Motor Lorry.

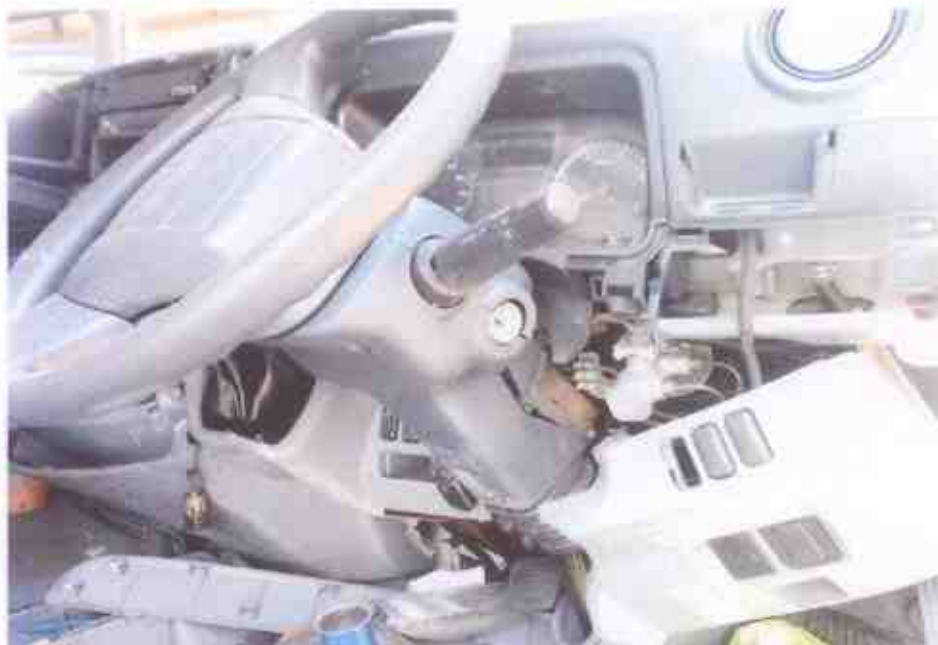
**Photo 18** shows the damaged steering wheel rod due to the accident's impact.

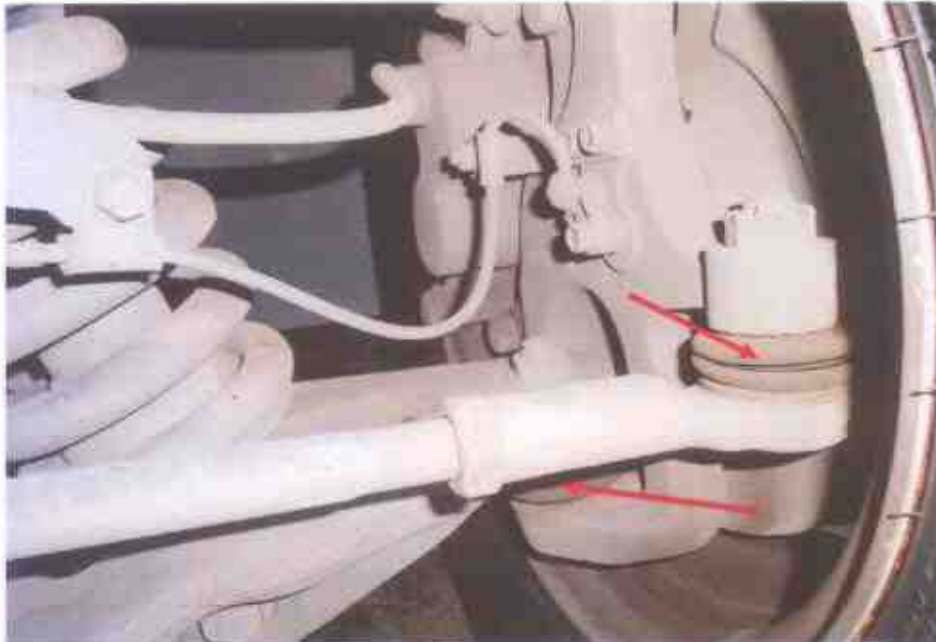
**Photo 19** shows the unaffected mechanical components on the front left wheel of the steering system. The steering shaft and steering rack of the Motor Lorry were observed to be intact and securely attached to the front left wheel. No fluid leakage on the brake fluid hoses.

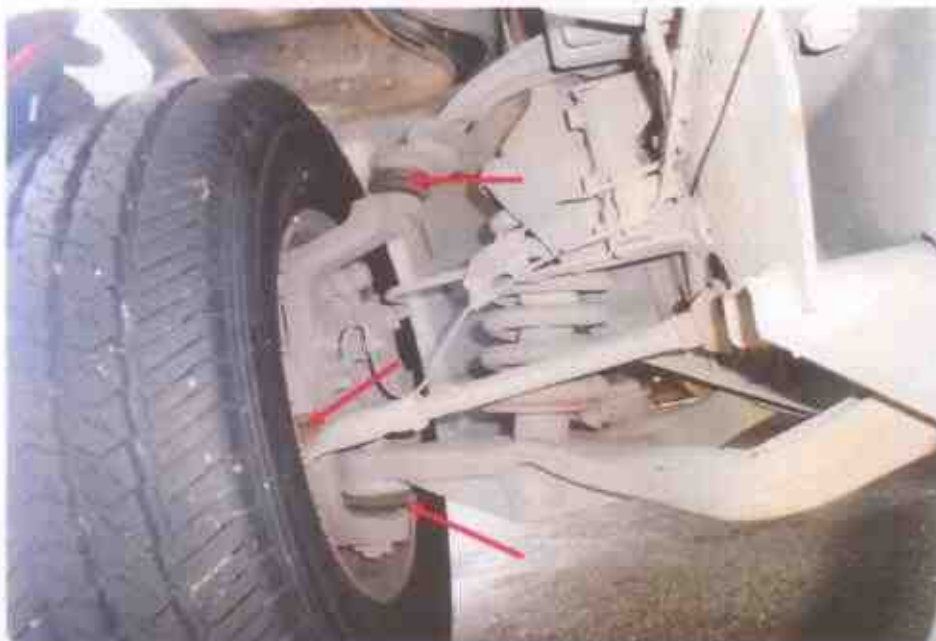
**Photo 20** shows the unaffected mechanical components on the front right wheel of the steering system. The steering shaft and steering rack of the Motor Lorry were observed to be intact and securely attached to the front left wheel. No fluid leakage on the brake fluid hoses.

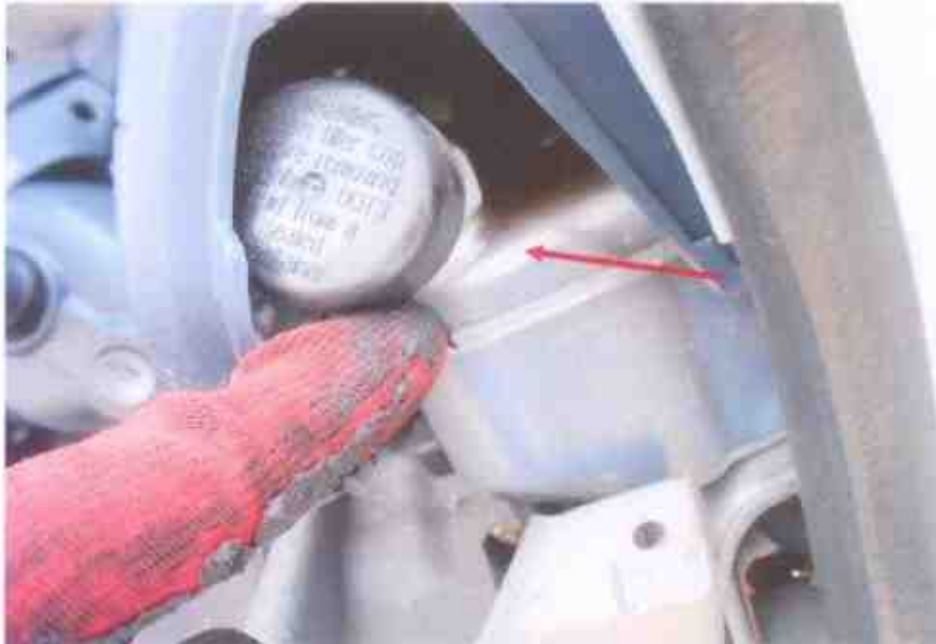
**Photo 21** shows the brake fluid reservoir of the Motor Lorry. We had found the brake fluid to be of sufficient level for operational purposes. Visually there was also no contamination found to the brake fluid.

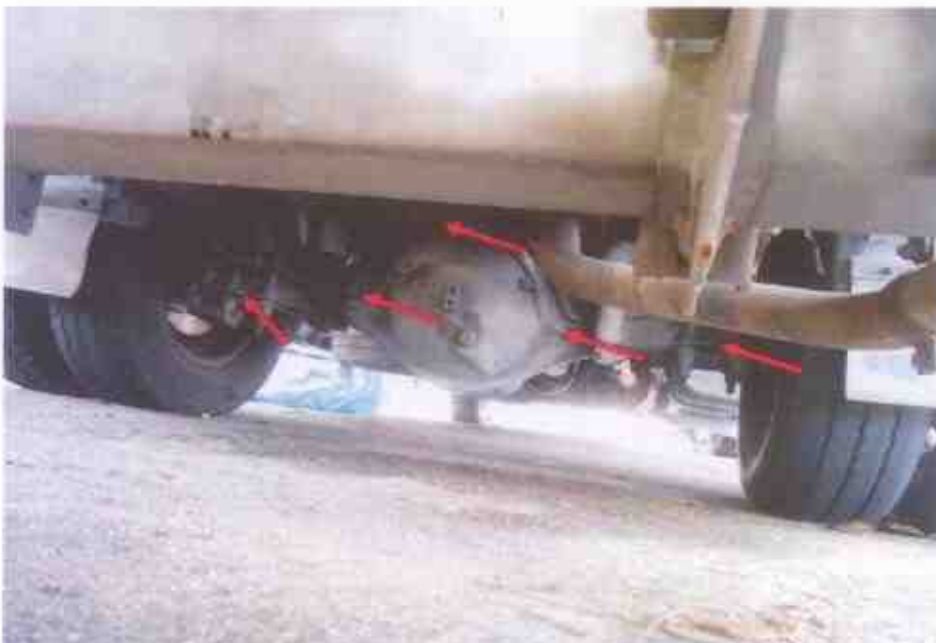
**Photo 22** shows the brake pipes and hoses, which were visibly unaffected by the accident. We were however not able to carry out any operational tests to the braking system of the Motor Lorry due to the extent of damage to its front cabin, which had affected several mechanical components of the Motor Lorry.
