Your Ref: TP/IP/37553/2018  
Our Ref : CI/TPD18013727/Z

**Fatal Accident Investigation Team**  
Traffic Police Department  
Singapore Police Force  
10 Ubi Avenue 3  
Singapore 408865

### **MECHANICAL INSPECTION REPORT OF MOTORCYCLE FBE 2009M**

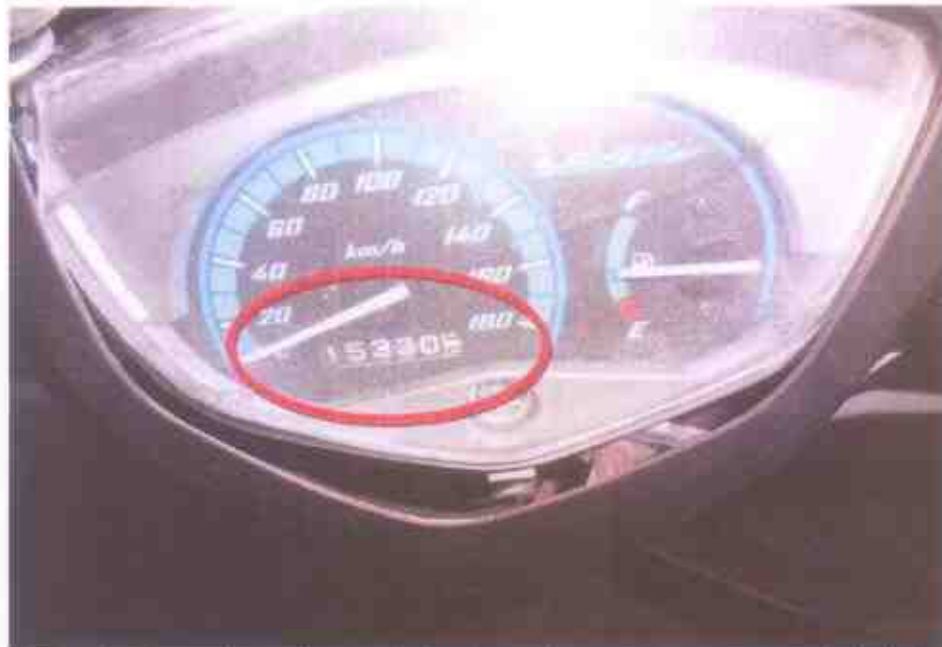
**Photo 1** shows the mileage at the time of inspection was recorded to be 153304km.

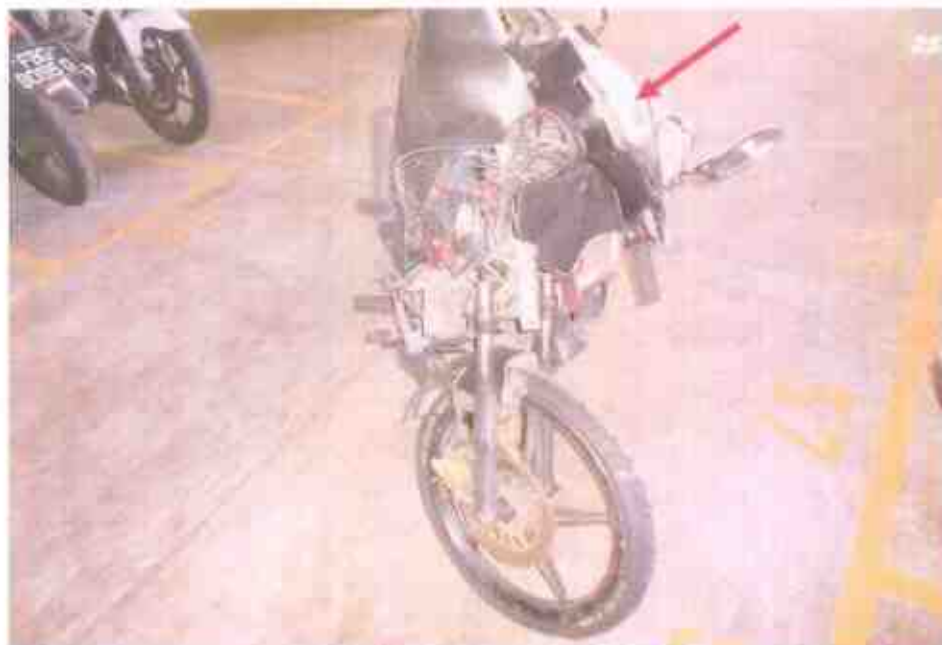
4. The mileage of the Motorcycle at the time of our inspection was 153304km.
5. The Motorcycle was observed to have sustained damages at the frontal portion, rear portion & along its left & right side. The body parts that were found to have been damaged include its front headlamp & small lamp assembly, left & right wing mirrors, right fairing, foot rest and left gear shift pedal amongst others. Its handle bar was also observed to be dislodged as a result of the accident.
6. This was consistent with the accident's case facts that the motorcyclist was riding along Bukit Batok Road towards Choa Chu Kang Road, when he collided onto a pedal cyclist that was cycling across the signalised pedestrian crossing, at the T-junction of Bukit Batok West Avenue 7, from the motorcyclist right to left. See photo 1 to 8 below.

**Photo 2** shows a general view of the front body of the Motorcycle at the time of our inspection. The Motorcycle was observed to be sustained with relatively extensive impact due to the accident collision. Amongst the body parts damaged was its handle bar (arrowed), which was observed to be dislodged.

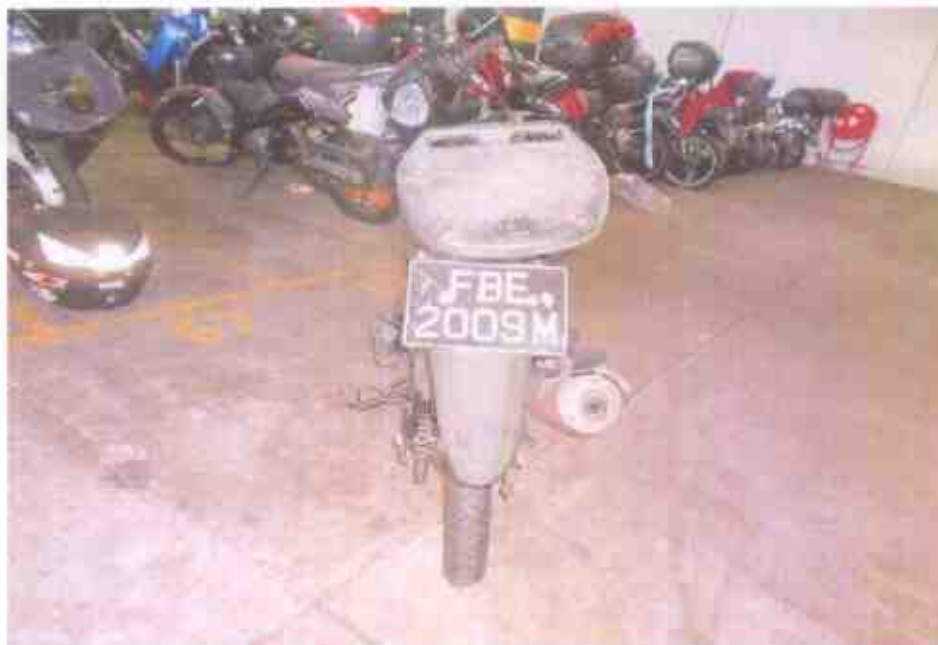
**Photo 3** shows a general view of the rear left body of the Motorcycle at the time of our inspection. The Motorcycle was observed to have sustained minor damages at the rear portion.

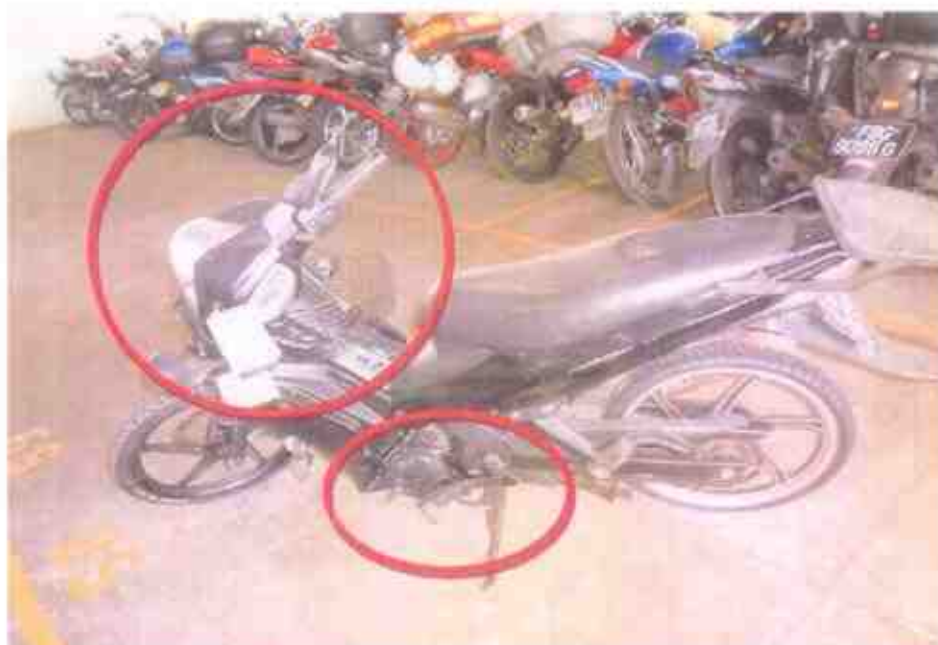
**Photo 4** shows a general view of the frontal left portion of the Motorcycle at the time of our inspection. The Motorcycle was observed to be sustained relatively extensive impact due to the accident collision.

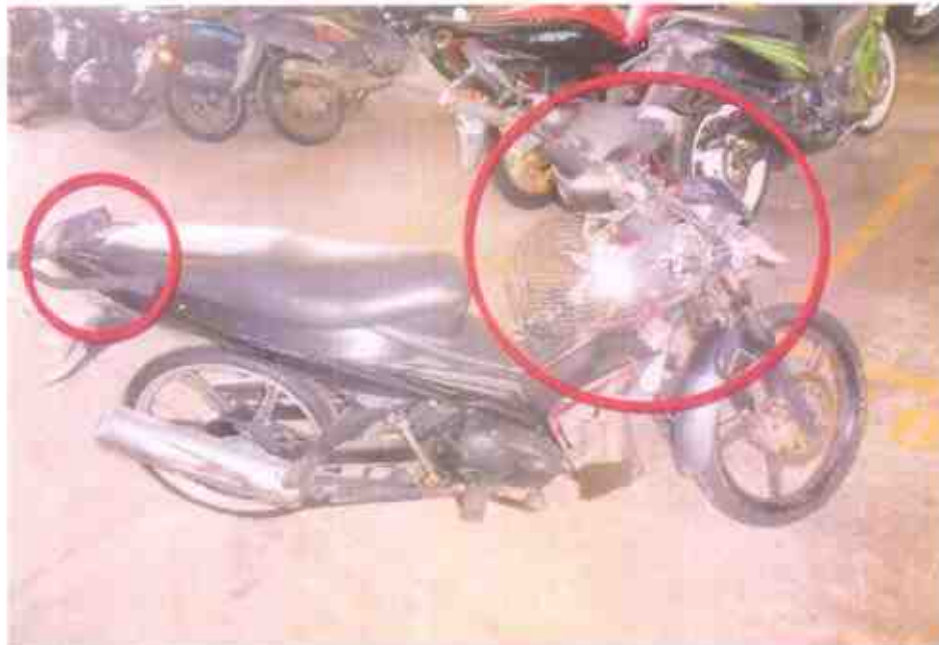
**Photo 5** shows a general view of the frontal right portion of the Motorcycle at the time of our inspection. The Motorcycle was observed to be sustained relatively extensive impact due to the accident collision.

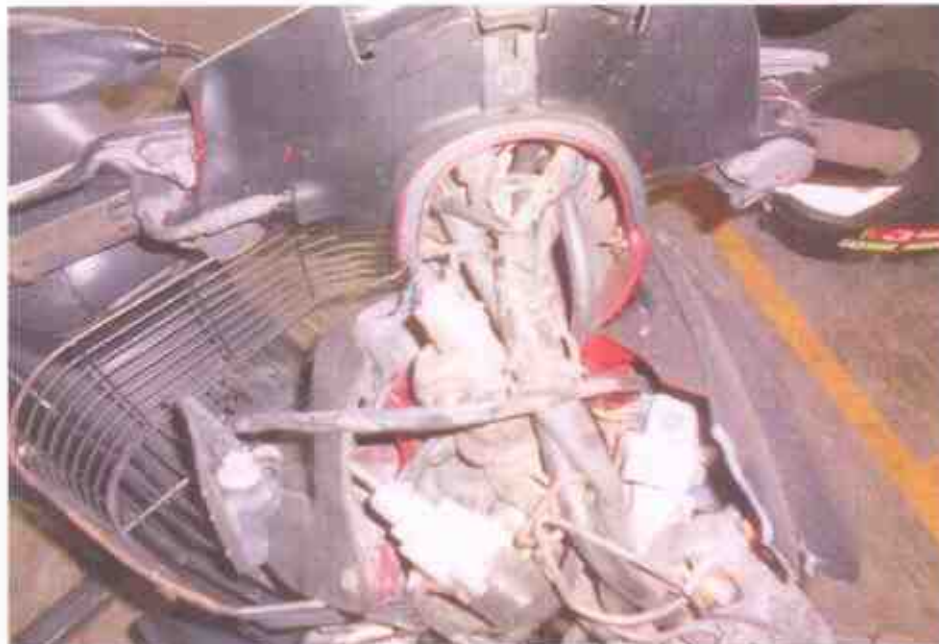
**Photo 6** shows a close-up view of the damaged steering system & ignition system of the Motorcycle at the time of our inspection. The Motorcycle was observed to be sustained relatively extensive impact due to the accident collision.

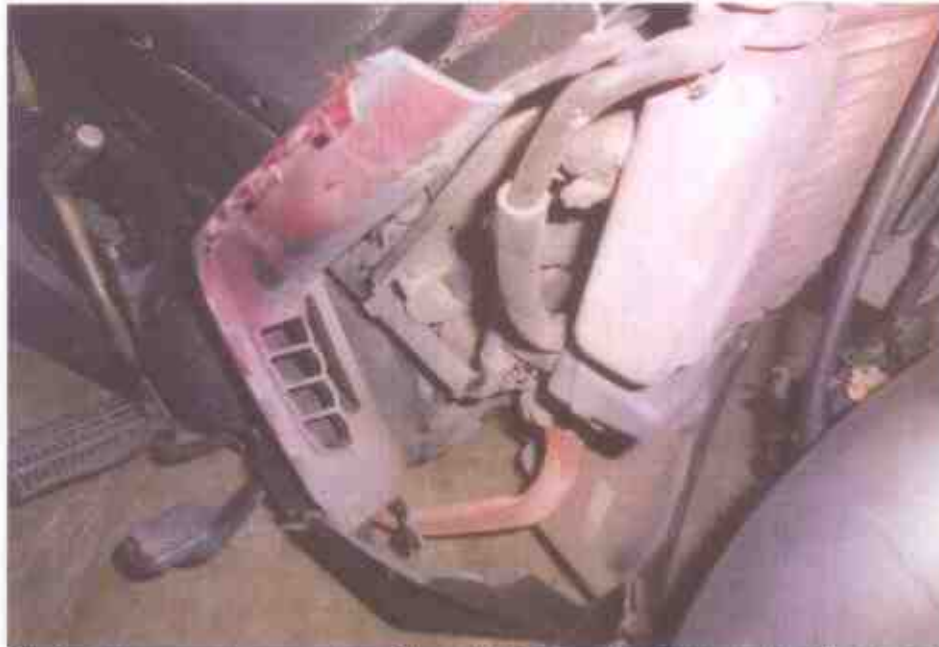
**Photo 7** shows a close-up view of the right fairing of the Motorcycle at the time of our inspection. The Motorcycle was observed to be sustained relatively extensive impact due to the accident collision.

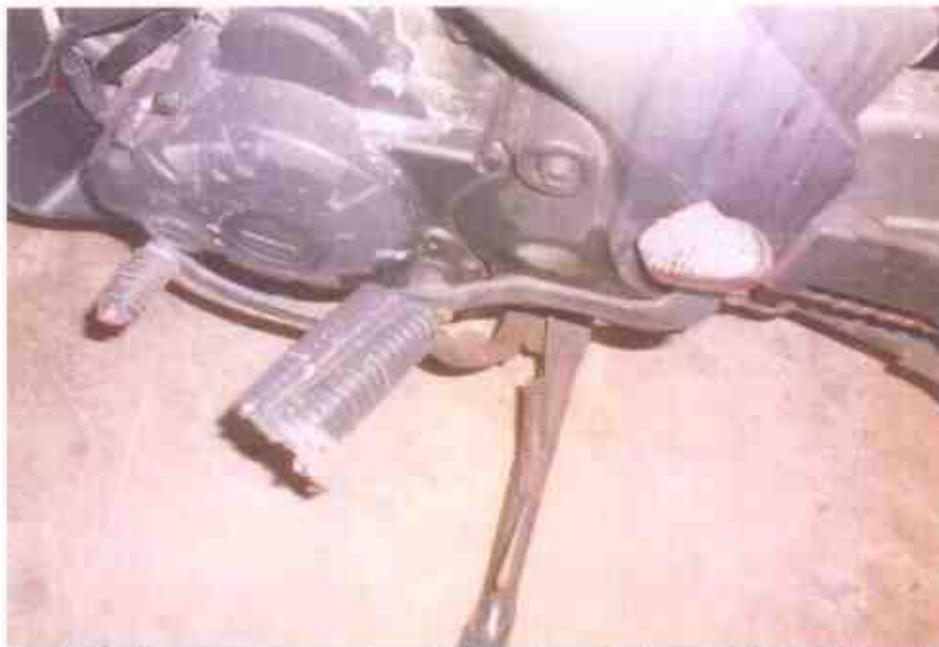
**Photo 8** shows a close-up view of the foot pedal & gear shift pedal of the Motorcycle at the time of our inspection. The Motorcycle was observed to be dented inwards due to the accident collision.

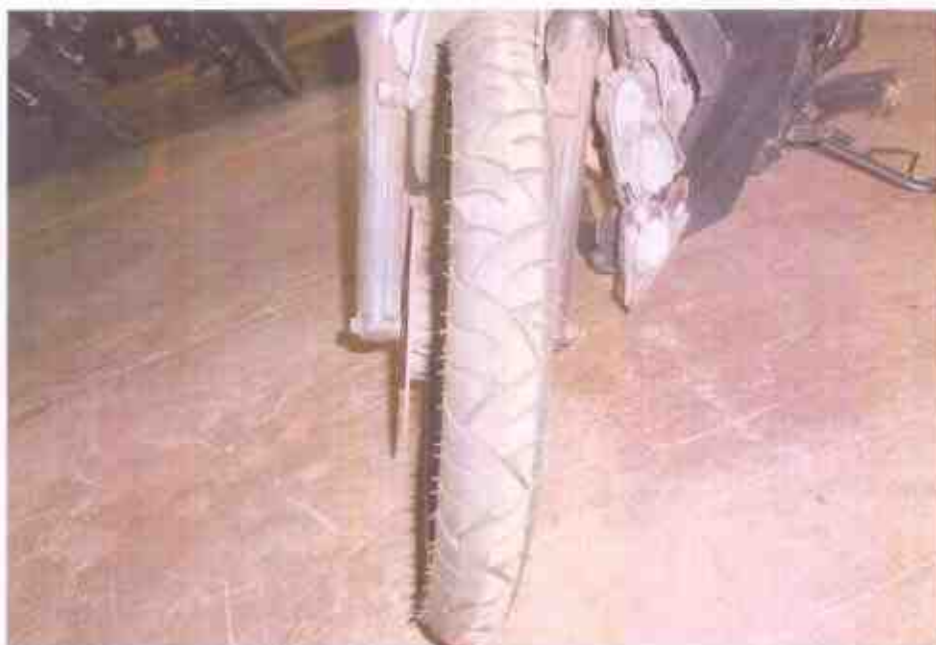
7. The condition of the Motorcycle's 2 tyres was observed to be in serviceable condition. The tread pattern of the 2 tyres was clearly visible. We did not observe any tear, burst mark(s) and/or punctured hole(s) on the sidewalls as well as across the tread of the 2 tyres. The 2 tyres were both observed to be sufficiently inflated for vehicular operation. The tyre brand, tyre size and remaining tread depth of the 2 tyres were recorded as follows:- See photo 9 & 10 below.

**Photo 9** shows the front tyre of the Motorcycle at the time of our inspection. The rear tyre was observed to be in serviceable condition with remaining tread depth of approximately 5mm. The tyre was also observed to be sufficiently inflated for vehicular operation. There was no significant damage observed on the rear wheel rim & tyre.

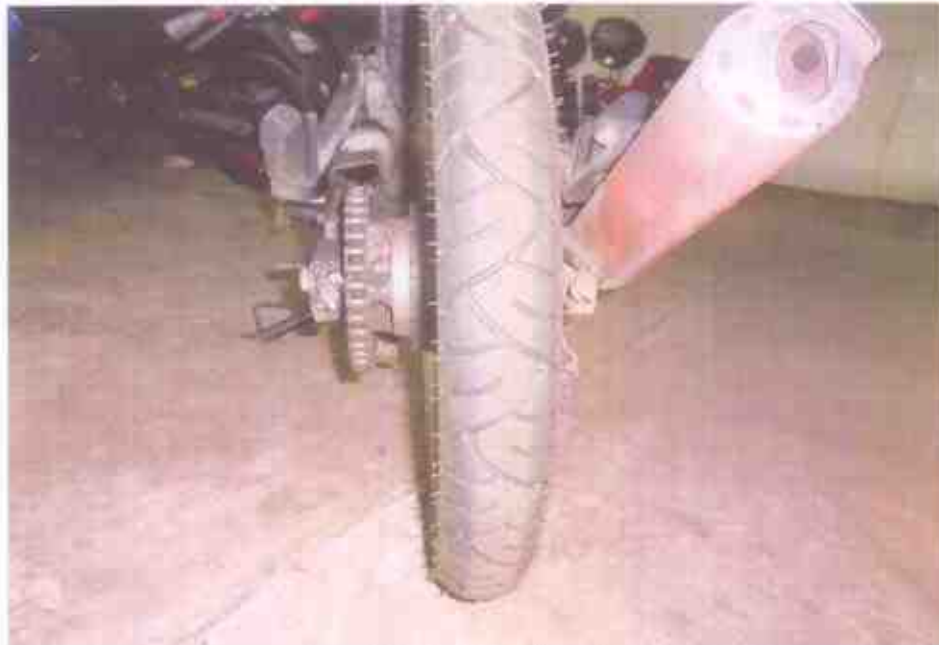
**Photo 10** shows the rear tyre of the Motorcycle at the time of our inspection. The rear tyre was observed to be in serviceable condition with remaining tread depth of approximately 4mm. Although the rim was observed to be slightly it was also sufficiently inflated for vehicular operation.

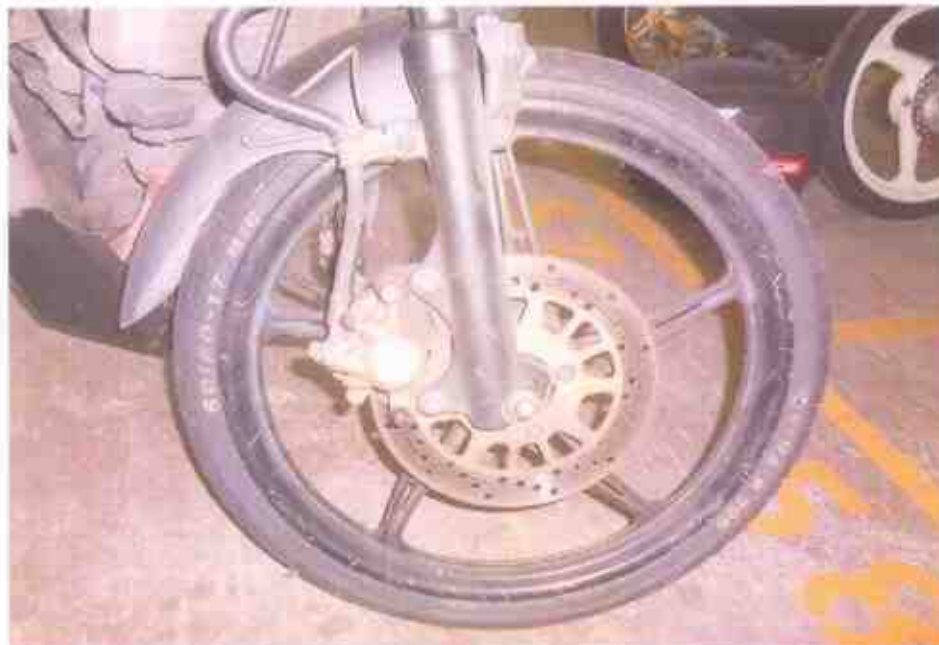
**Photo 11** shows the front tyre was wrapped around alloy wheel rim that was found to be without any significant damage.

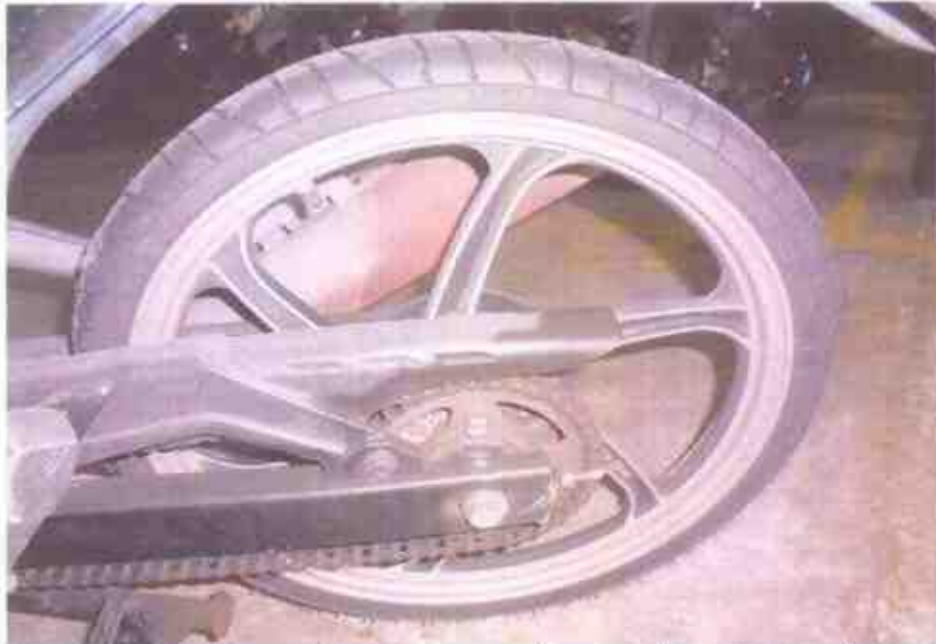
Photo 12 shows the rear tyre was wrapped around alloy wheel rim that was found to be without any significant damage.

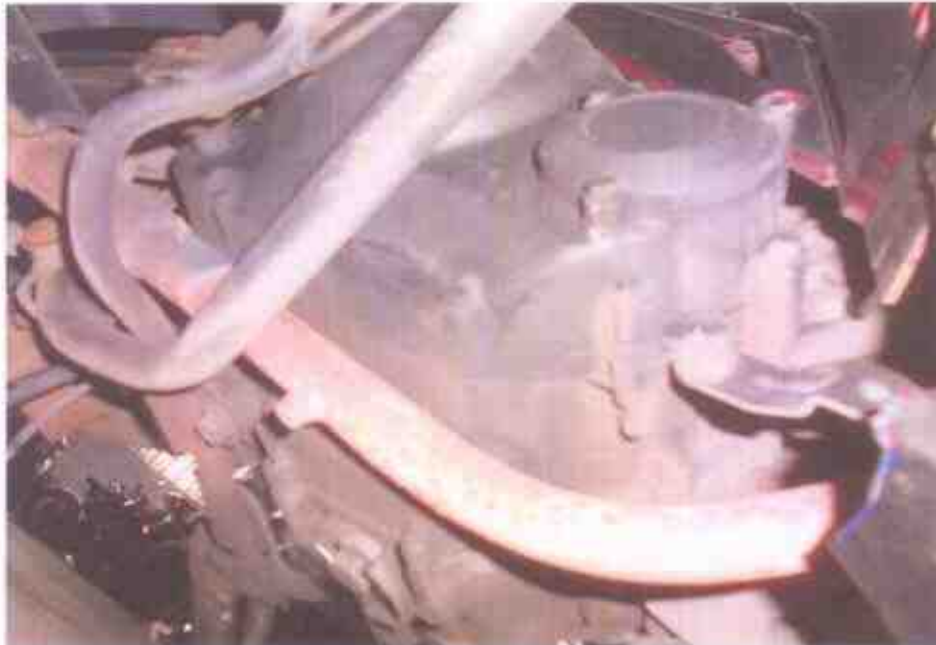
9. Upon examination of the Motorcycle's engine area, we had observed that the various engine related parts and components were intact with no visible damage. There was also no sign(s) or indication(s) of fluid leak observed around the engine area of the Motorcycle.
10. The gear chain of the motorcycle was found to be intact without any misalignment. It was also adequately lubricated for operating purposes. Free play tension test was also conducted & found adequately acceptable. See photo 13 - 15 below.

**Photo 13** shows no sign(s) or indication(s) of fluid leak observed around the engine area of the Motorcycle.

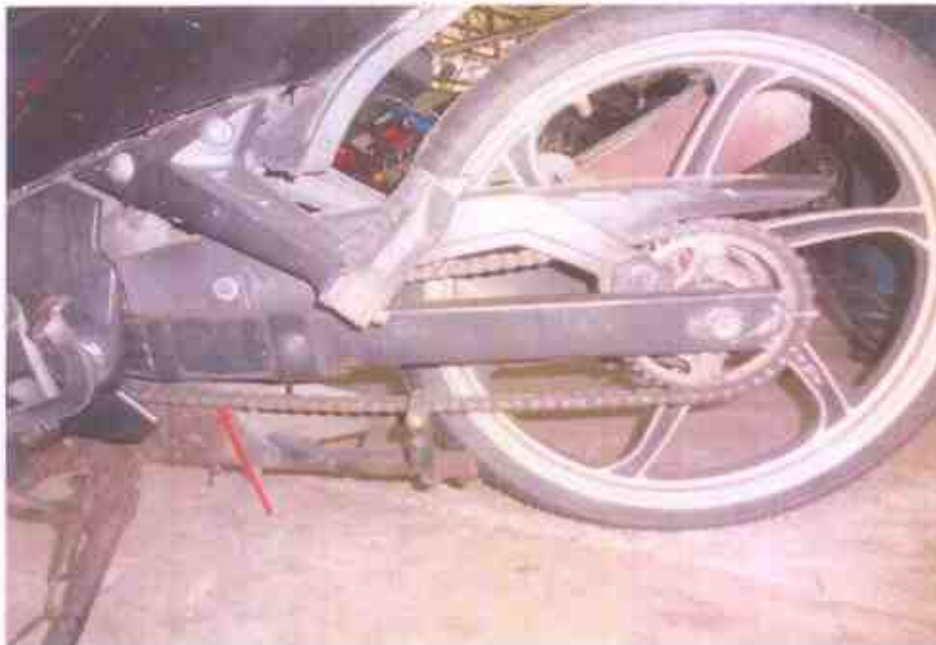
**Photo 14** shows the general view of the gear train (arrowed) of the Motorcycle, which was observed to be intact with no misalignment. It was also adequately lubricated for operating purposes.

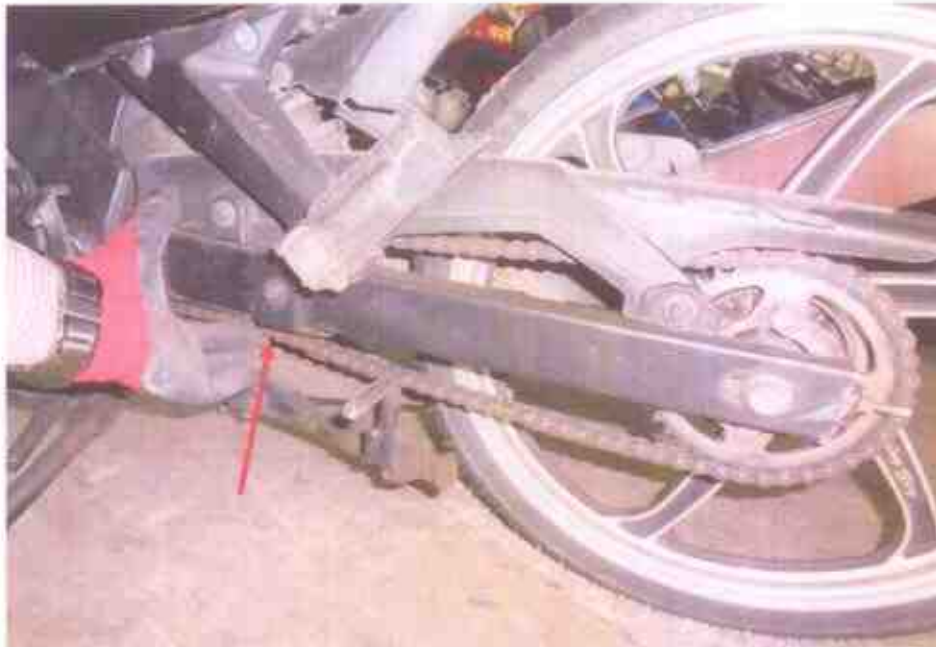
**Photo 15** shows the general view of the gear train (arrowed) of the Motorcycle, which was observed to be intact with no misalignment. It was also adequately lubricated for operating purposes. Free play tension was also observed & found adequately acceptable.

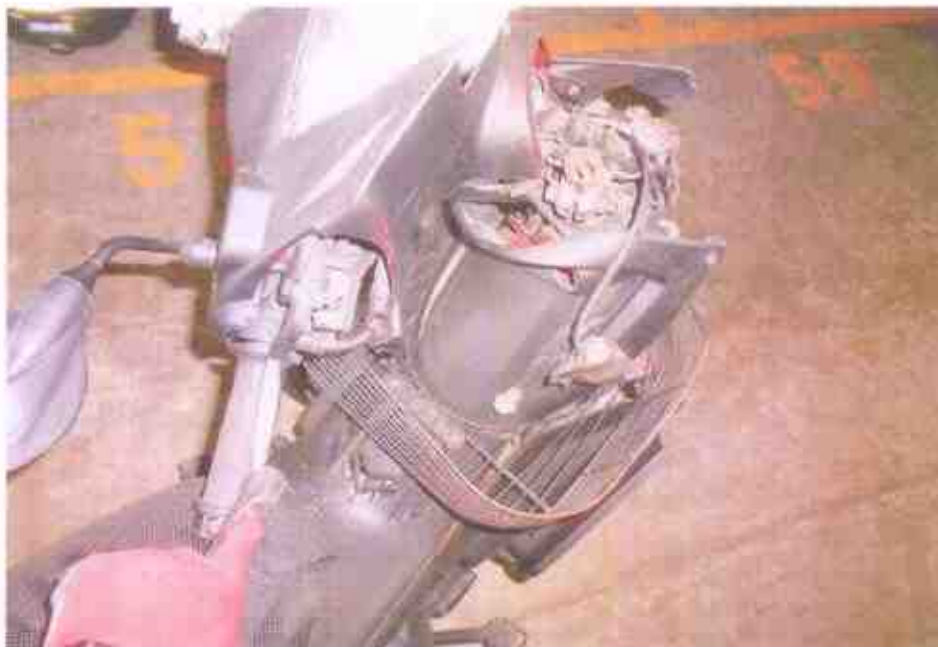
11. For this case, we were not able to conduct any test(s) on the steering system of the Motorcycle due to the damage on its steering system. It was found to be dislodged as a result of the accident, hence causing the whole steering system not to be in a serviceable condition.
12. The brake system of the Motorcycle was of a semi-hydraulic type, where hydraulic (brake fluid) pressure controls the brake for the front wheel while the brake for the rear wheel is controlled by mechanical means (cables and springs). Our visual examination of the various components in the brake system, like the brake disc, brake calliper, drum and brake foot pedal, revealed all to be intact and without damage. There was also no visible tear or cut observed on the connecting hoses and cables.

Photo 13 shows the front handle bar was observed to be dislodged as a result of the accident. Hence, we are not able to conduct any tests on the steering system of the Motorcycle.

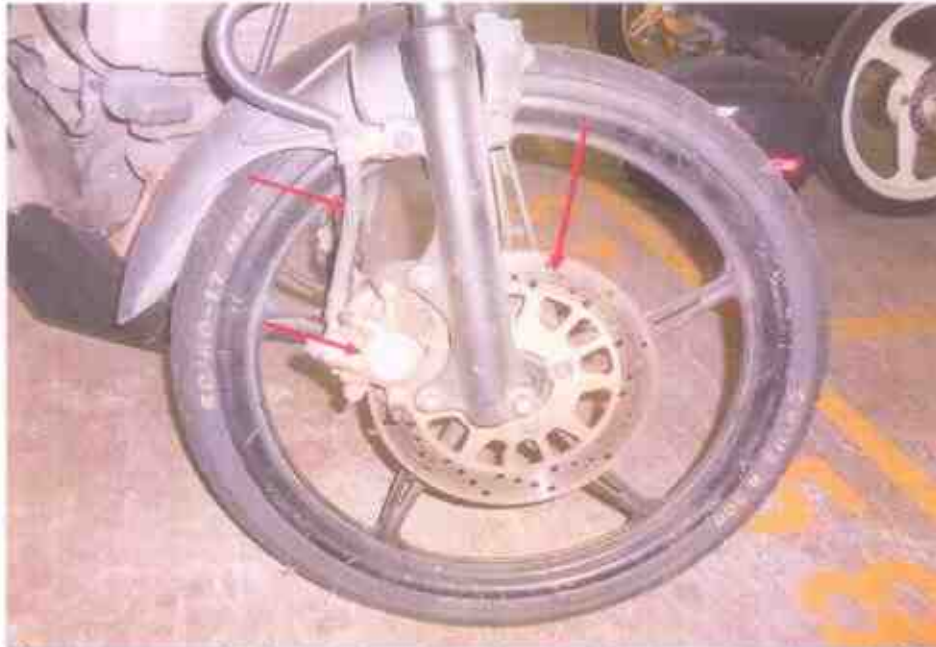
**Photo 14** shows the front brake calliper, front brake disc and brake pad of the Motorcycle (arrowed), which are all part of the components in the front brake system of the Motorcycle. Our visual checks of these various components had revealed all to be intact with no visible damage. No leakage of brake fluid was also observed.

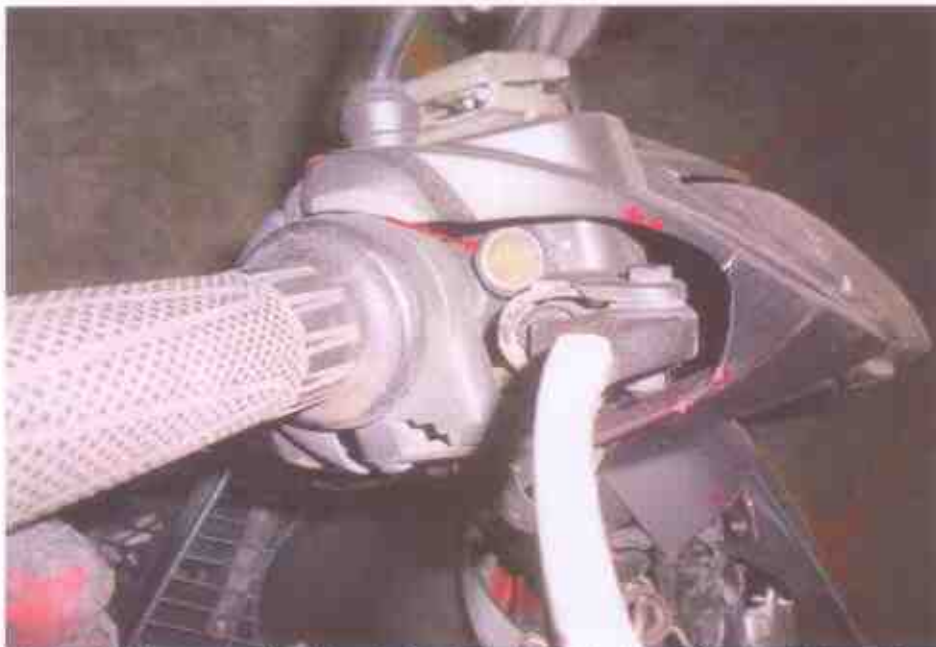
**Photo 15** shows the front brake fluid observed to be sufficient at time of our inspection.

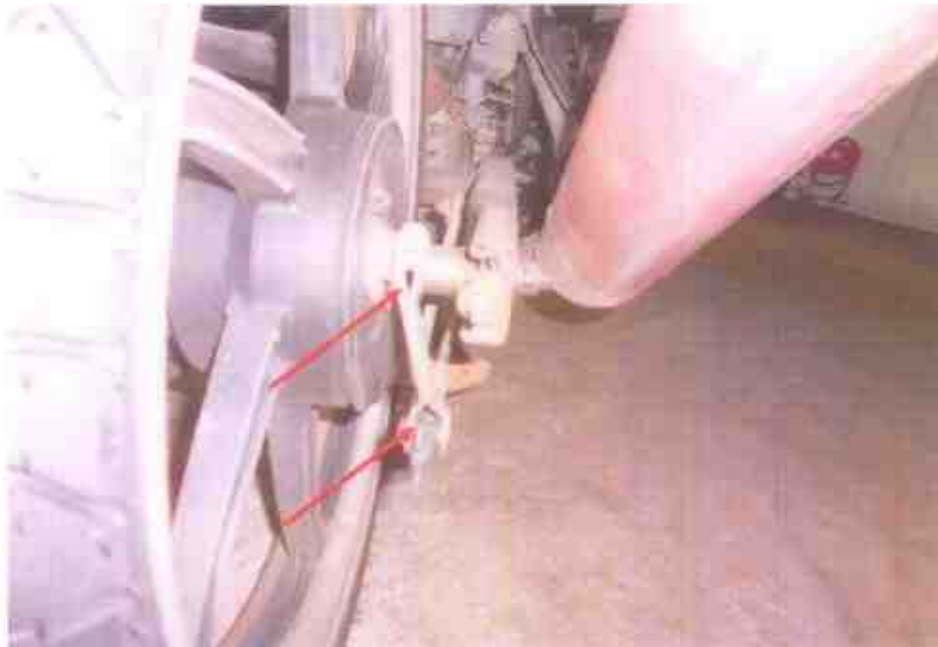
**Photo 16** shows the rear wheel of the Motorcycle. The type of brake system for the rear wheel was of mechanical type, controlled by the brake foot pedal of the Motorcycle. Our checks of the cable (arrowed), spring and drum, which are all part of the components in the rear brake system of the Motorcycle reveal all to be intact and without damage.
