Your Ref: TP/IP/25945/2018
Our Ref : CI/TPD18013729/Z

19th September 2018

MECHANICAL INSPECTION REPORT OF MOTOR CAR SLG 3578B

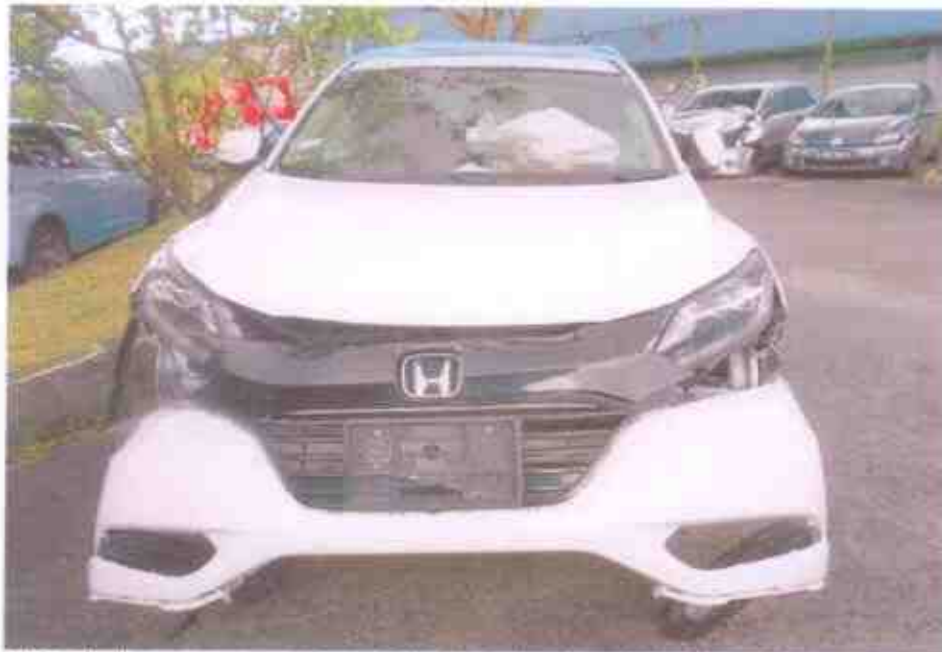
Photo 1 shows a general view of the frontal portion of the Motor Car at the time of our inspection. The Motor Car was observed to have sustained extensive impact damage at its frontal portion. The impact force was significant, causing the various parts and components inside the engine compartment to be damaged.

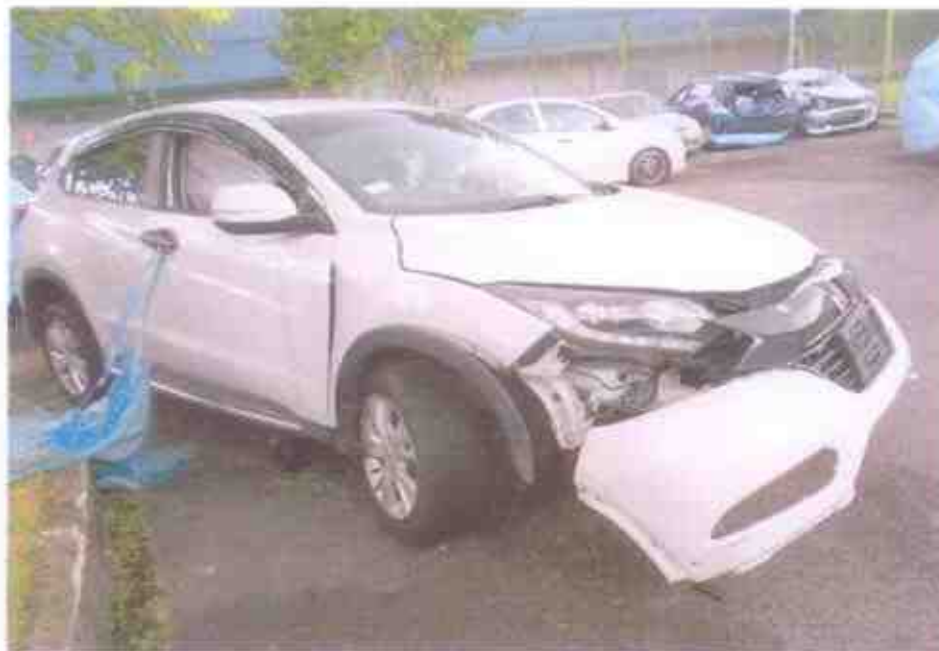
Photo 2 shows a general view of the front right portion of the Motor Car at the time of our inspection. The Motor Car was observed to have sustained extensive impact damage at its frontal portion.

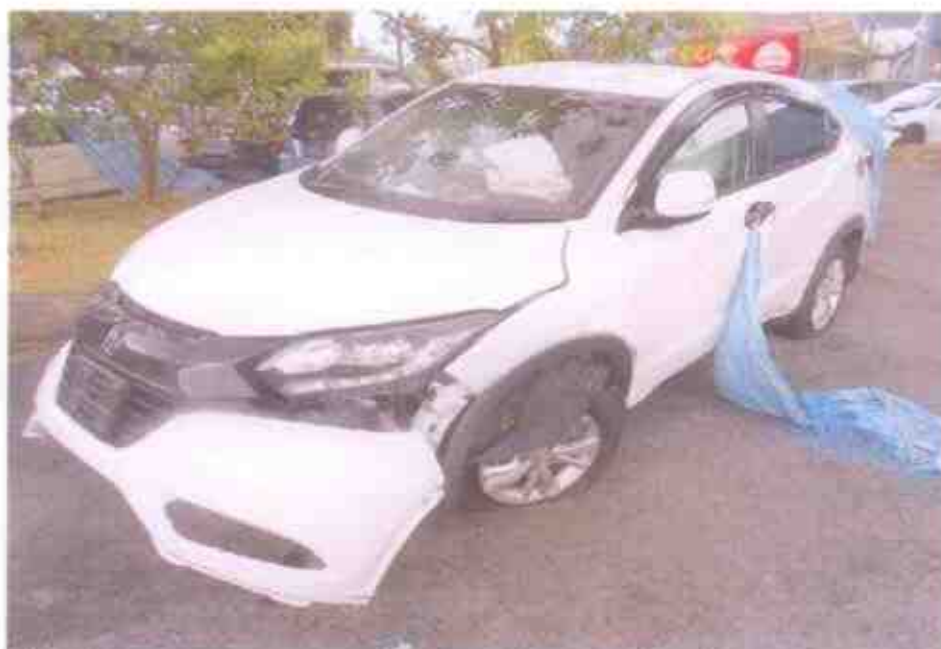
Photo 3 shows a general view of the front left portion of the Motor Car at the time of our inspection. The Motor Car was observed to have sustained with extensive impact damage at its frontal portion.

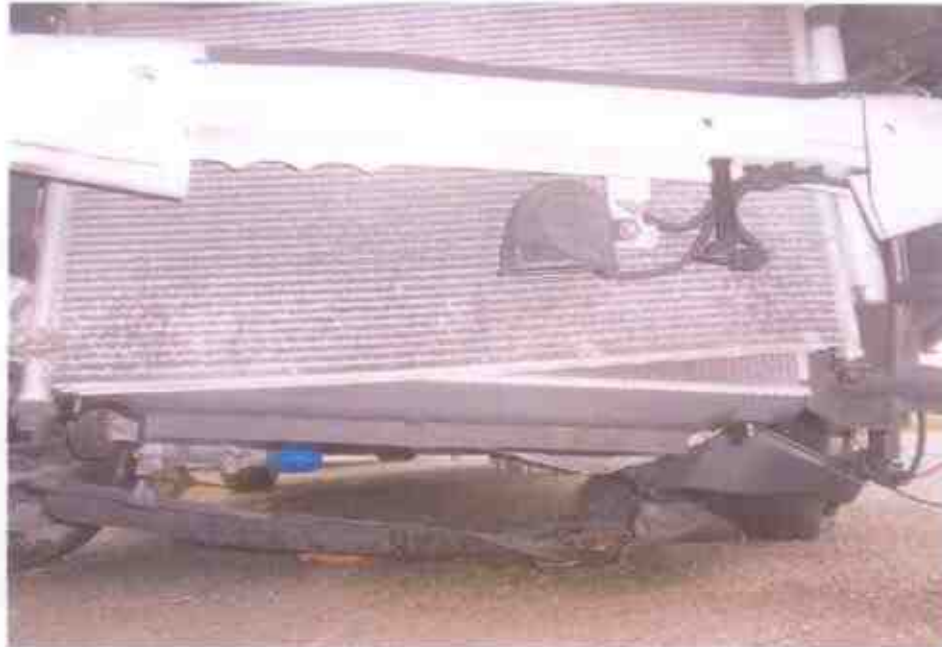
Photo 4 shows a closer view of the damage at the frontal portion of the Motor Car's engine. The impact force was significant, causing the various parts and components inside the engine compartment to be pushed inwards.

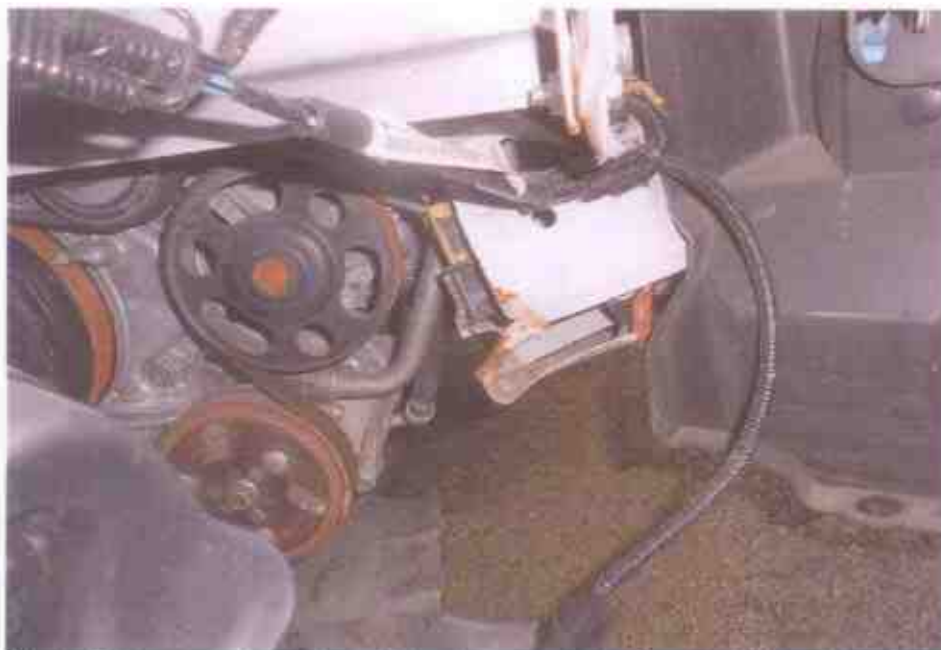
Photo 5 shows a closer view of the damage at the frontal right portion of the Motor Car. The impact force was significant, causing the re-inforcement bar to be pushed inwards.

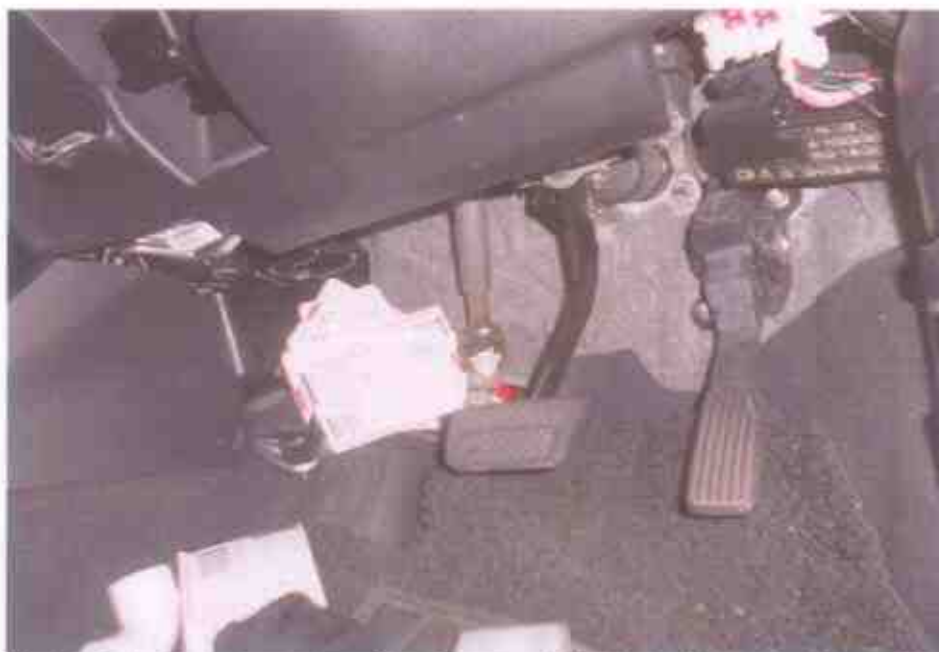
Photo 6 shows a closer view of the damage at the frontal internal portion of the Motor Car which includes the steering system & ignition system. The impact force was significant, causing the various parts and components inside the interior cabin to be pushed inwards, towards the rear of the Motor Car.

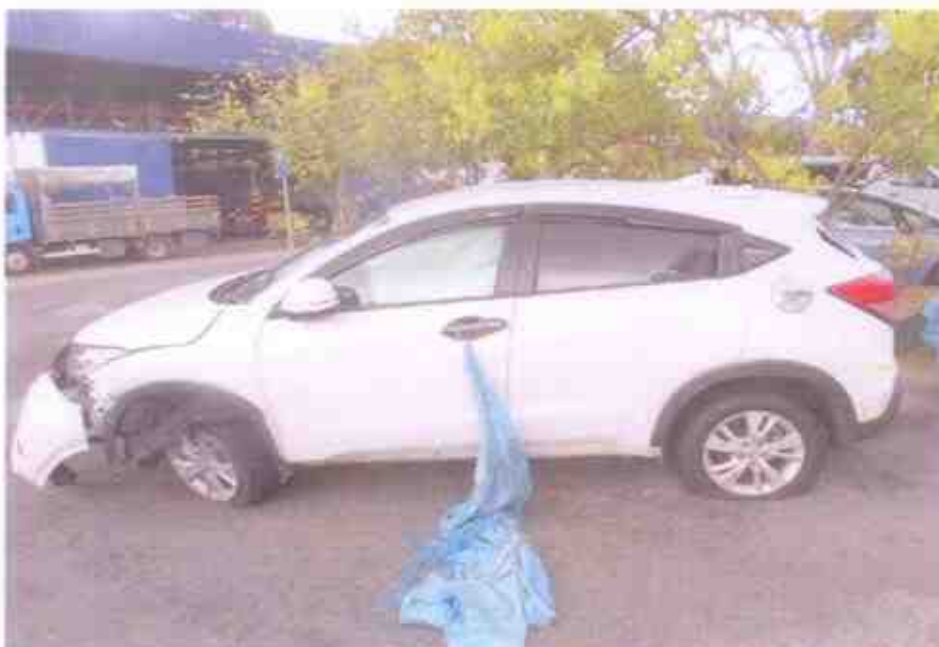
Photo 7 shows a general view of the damage at the left portion of the Motor Car. The impact force was significant, causing the body structure to be affected by the accident's impact collision.

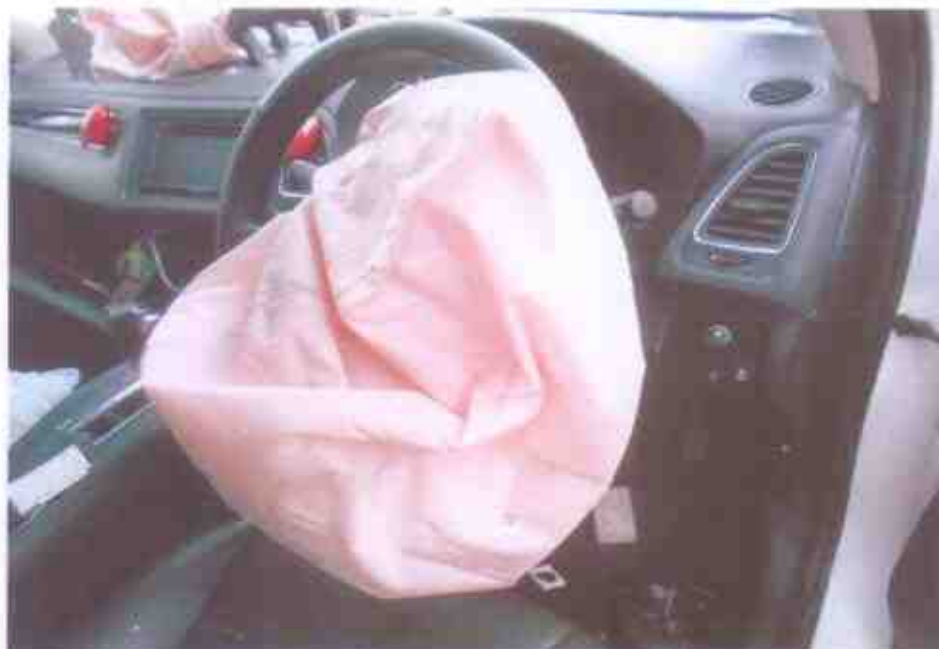
Photo 8 shows a closer view of the damage at the driver's seat of the Motor Car. The impact force was significant, causing the various parts and components inside the interior compartment to be pushed inwards, including its ignition system. The driver's airbag was also activated.

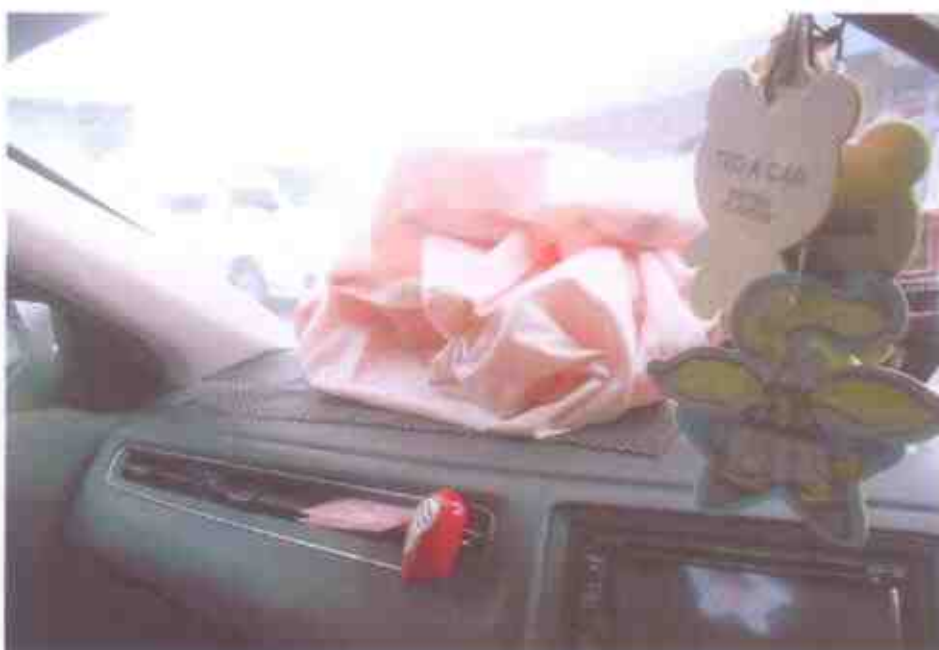
Photo 9 shows a closer view of the left front passenger seat of the Motor Car. The impact force was significant, causing the airbag to be activated.

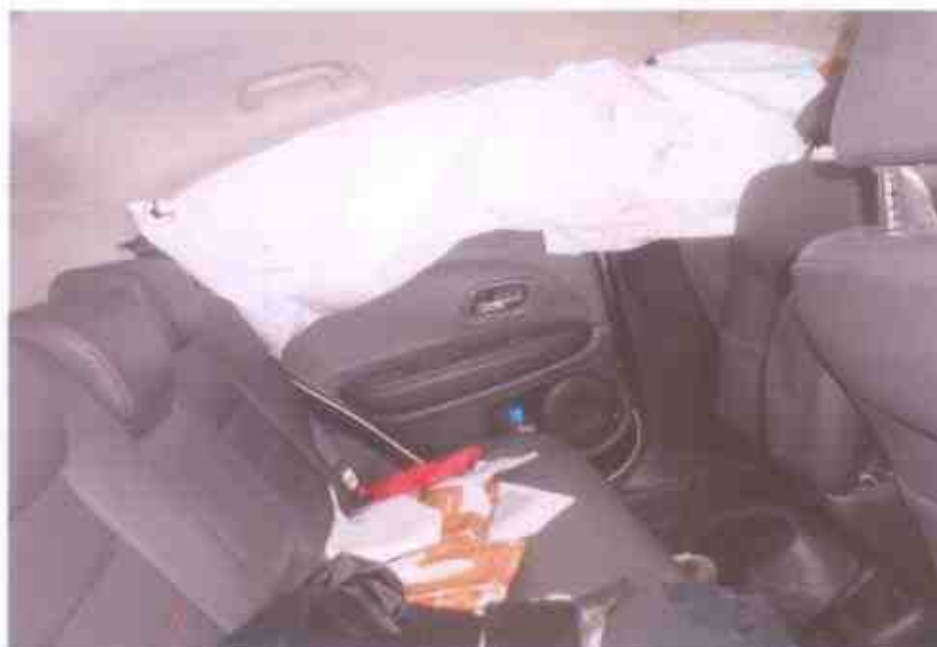
Photo 10 shows a closer view of the damages at the interior portion of the Motor Car due to the extensive impact collision at time of the accident. The window's airbag was also observed to be activated.

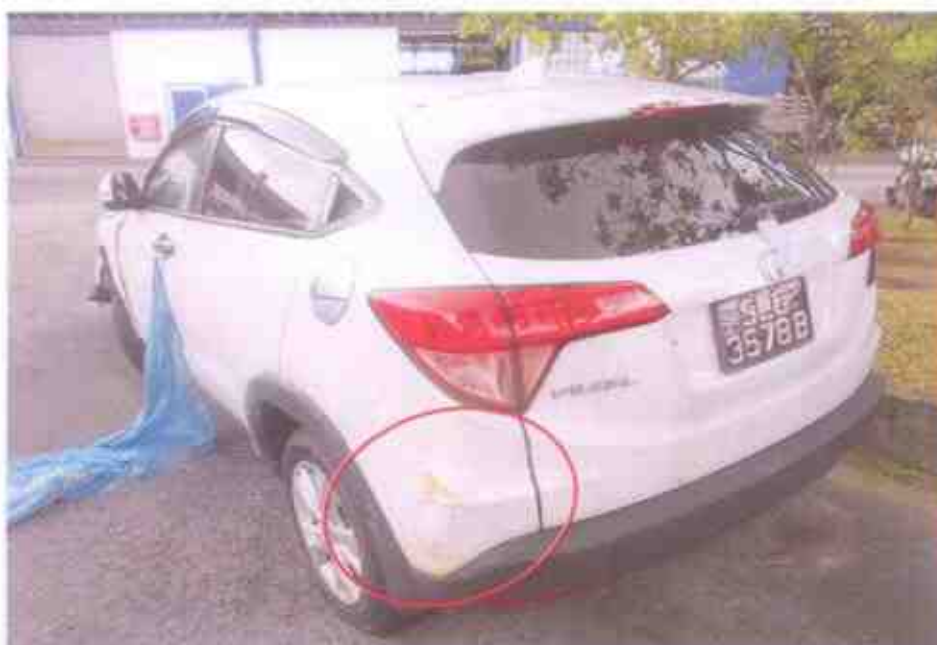
Photo 11 shows a general view of the rear left portion of the Motor Car at the time of our inspection. The rear portion was observed to be relatively sustained with minor impact by the accident.

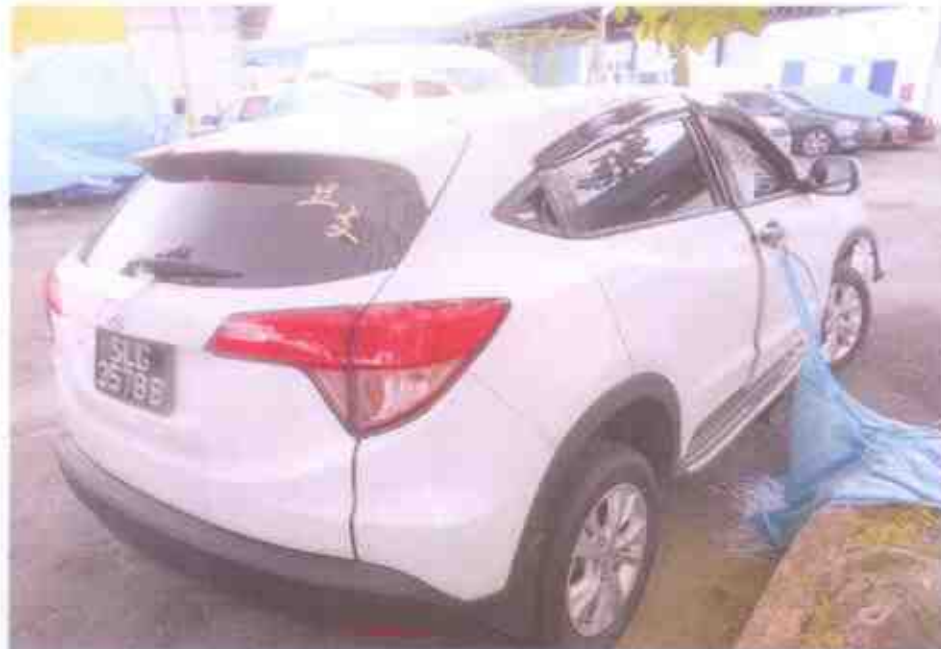
Photo 12 shows a general view of the rear right portion of the Motor Car at the time of our inspection. The rear portion was observed to be unaffected by the accident.

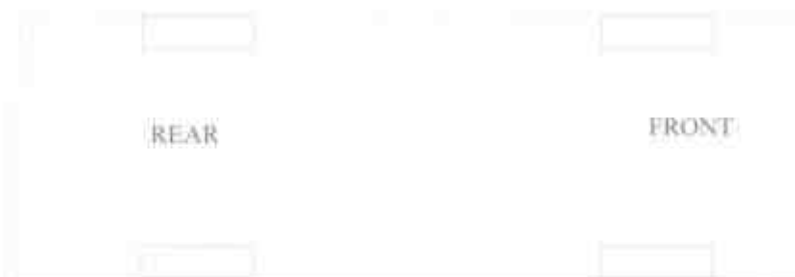
Ling Long - Crosswind
215/60R16 (6mm)(Deflated)(Torn
at outer sidewall)

Ling Long - Crosswind
215/60R16 (6mm)(Deflated)

Dunlop Enasave EC300
215/60R16 (6mm)(Deflated)

Dunlop Enasave EC300
215/60R16 (5mm)(Deflated)

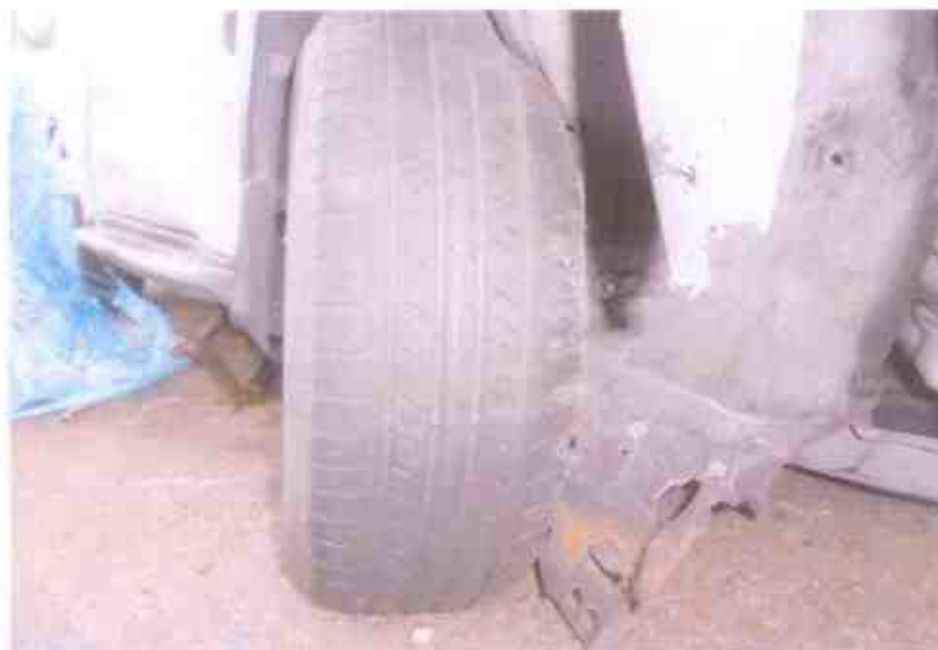
Photo 13 shows the condition of the front right portion of the Motor Car, which was observed to be in severe damage. The tyre was found to be deflated & the alloy wheel rim was damaged due to the accident's impact.

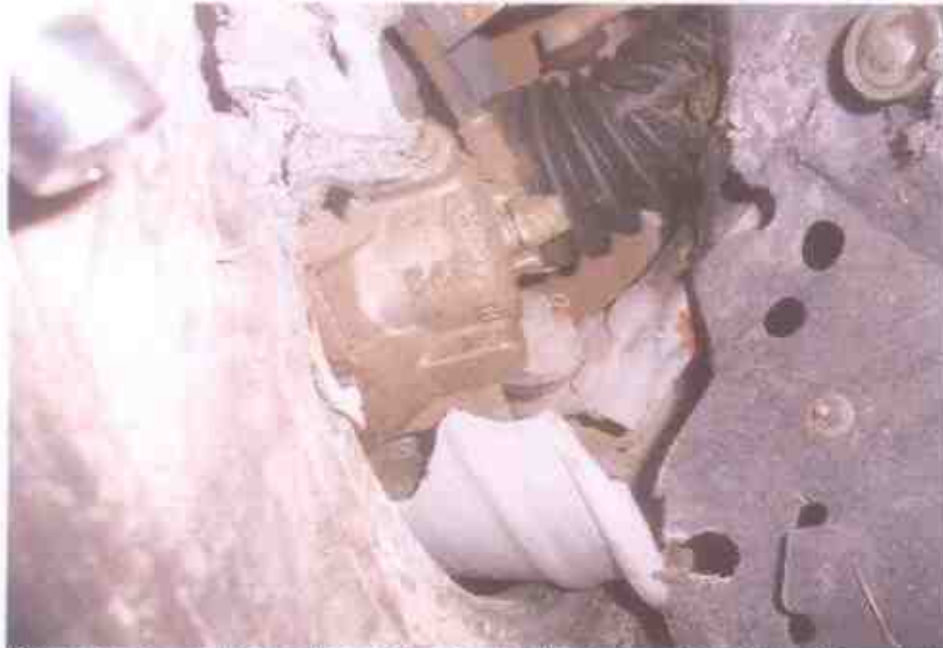
Photo 14 shows the condition of the front right portion of the Motor Car, which was observed to be in severe damage. The tyre was found to be deflated & the alloy wheel rim was damaged due to the accident's impact.

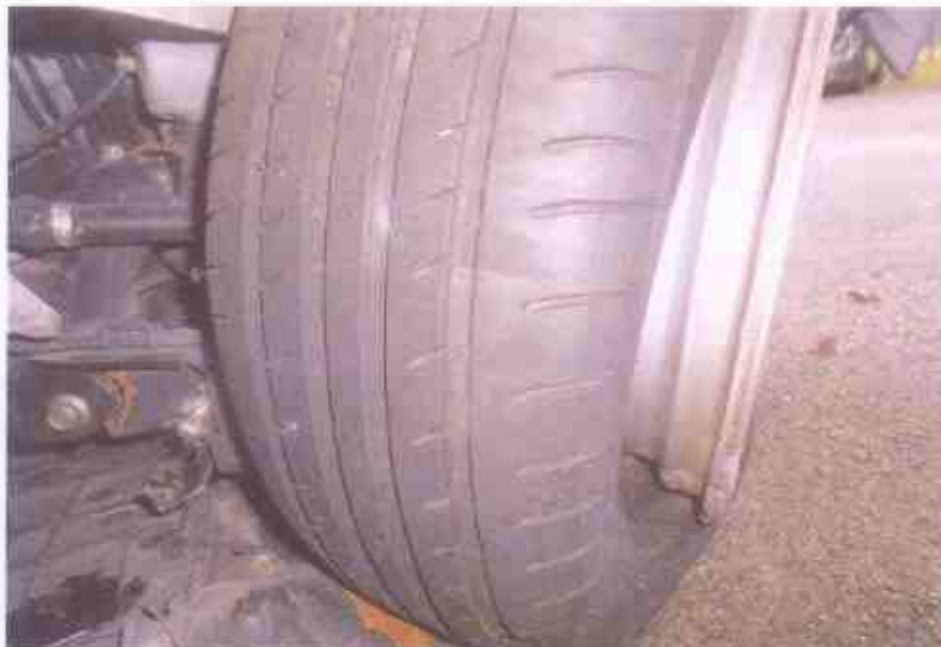
Photo 15 shows the condition of the front left tyre of the Motor Car, which was observed to be deflated not in serviceable condition. The alloy wheel rim was also observed to have come off slightly from the tyre fitting due to the accident's impact.

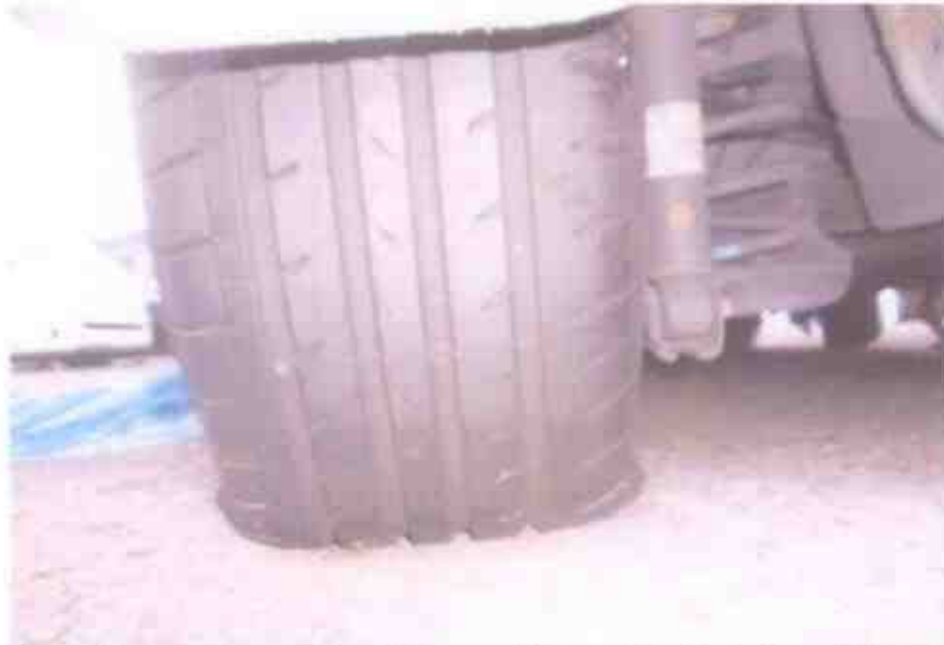
Photo 16 shows the condition of the rear left tyre of the Motor Car, which was observed to be deflated not in serviceable condition likely due to the accident's impact collision. However, its tread depth was clearly visible, measured approximately around 6mm.

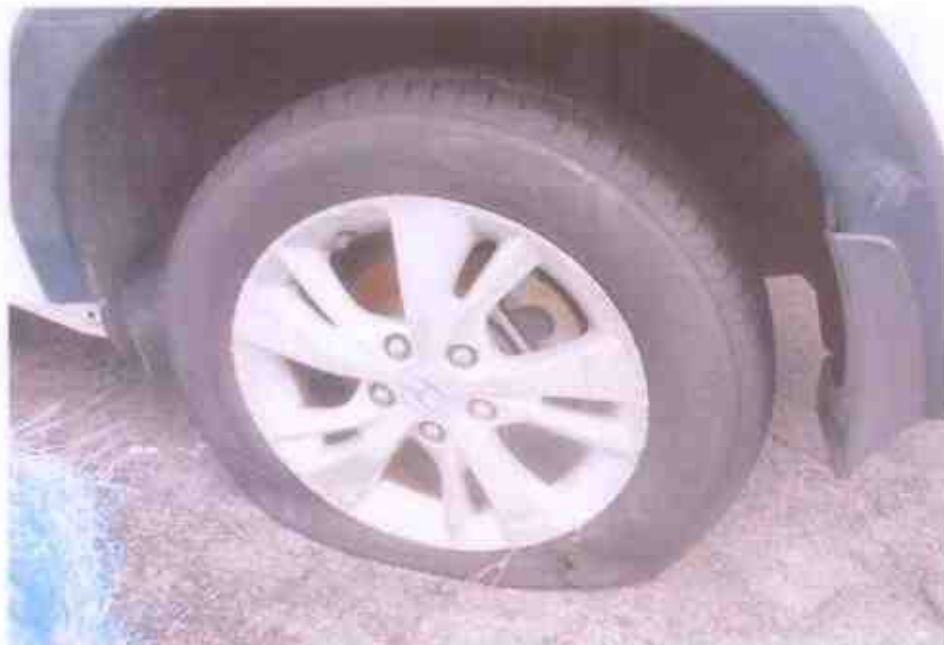
Photo 17 shows the condition of the rear left tyre of the Motor Car, which was observed to be deflated not in serviceable condition likely due to the accident's impact collision. However, its tread depth was clearly visible, measured approximately around 6mm.

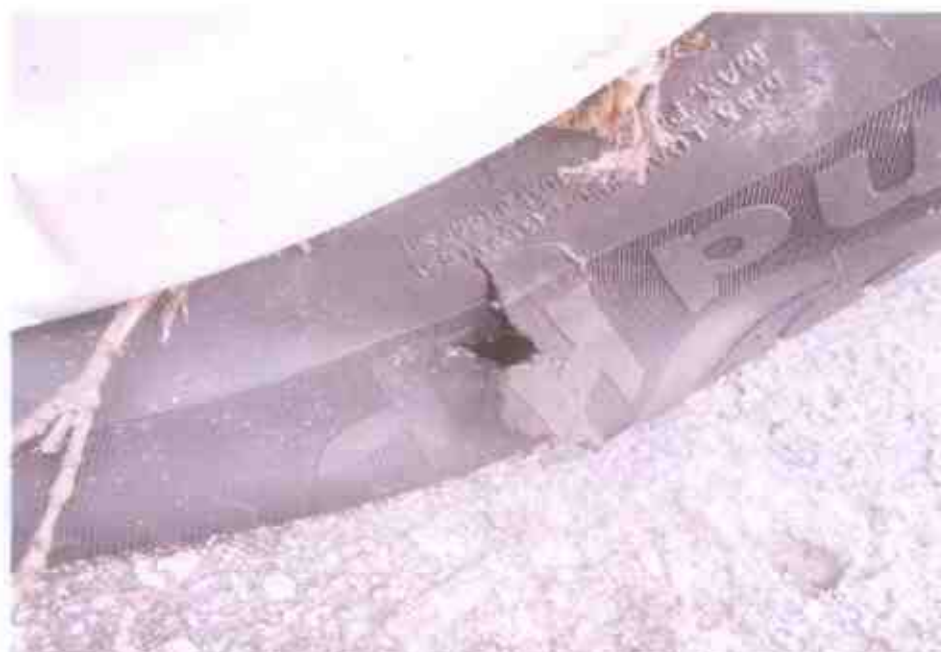
Photo 18 shows the condition of the rear left tyre of the Motor Car, which was observed to be deflated not in serviceable condition likely due to the accident's impact collision. However, its tread depth was clearly visible, measured approximately around 6mm.

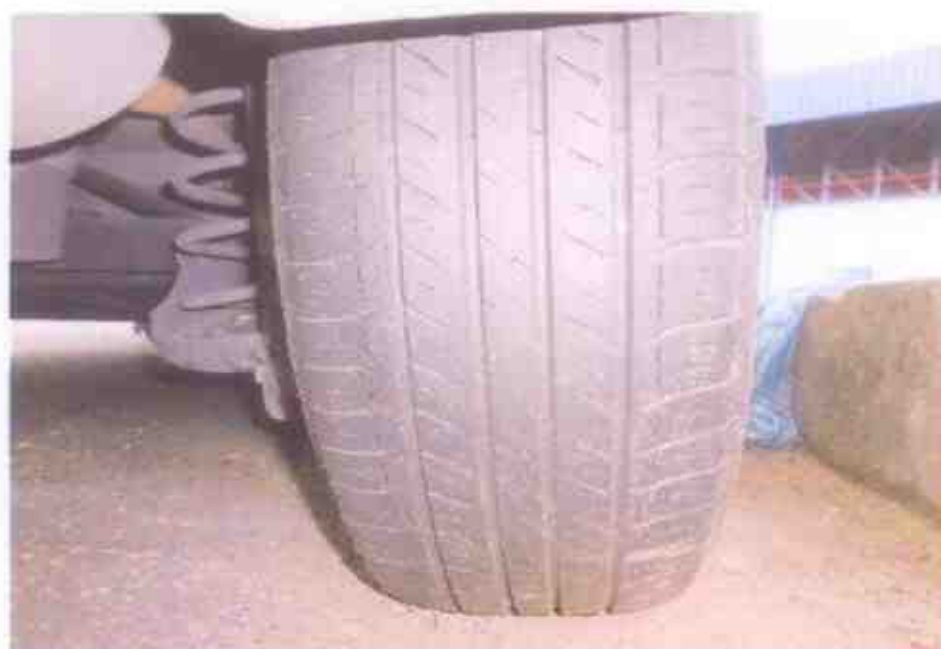
Photo 19 shows the condition of the rear right tyre of the Motor Car, which was observed to be deflated not in serviceable condition likely due to the accident's impact collision. However, its tread depth was clearly visible, measured approximately around 6mm.

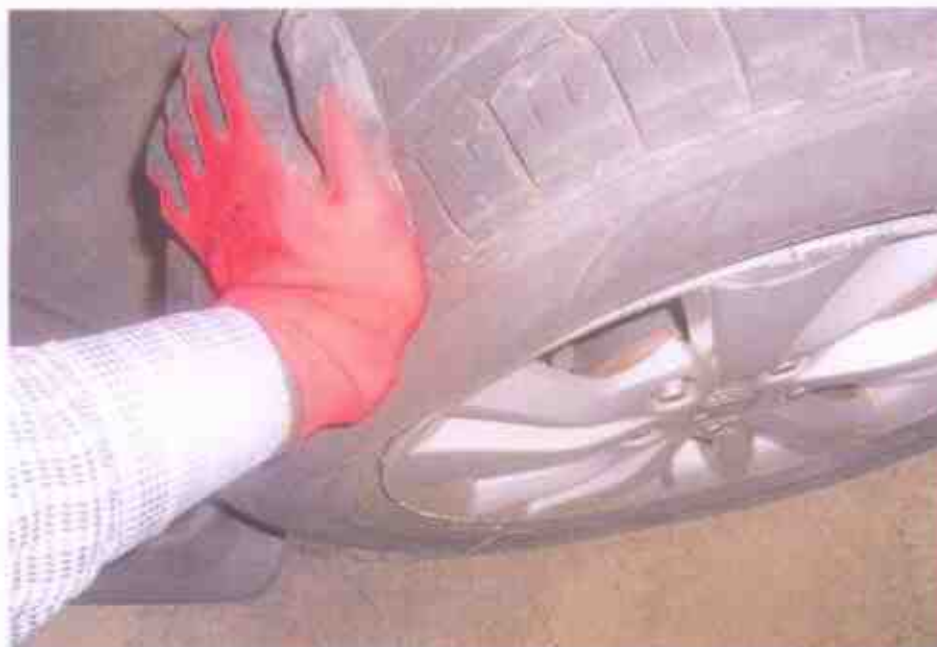
Photo 20 shows the condition of the rear right tyre of the Motor Car, which was observed to be deflated not in serviceable condition likely due to the accident's impact collision. However, its tread depth was clearly visible, measured approximately around 6mm.

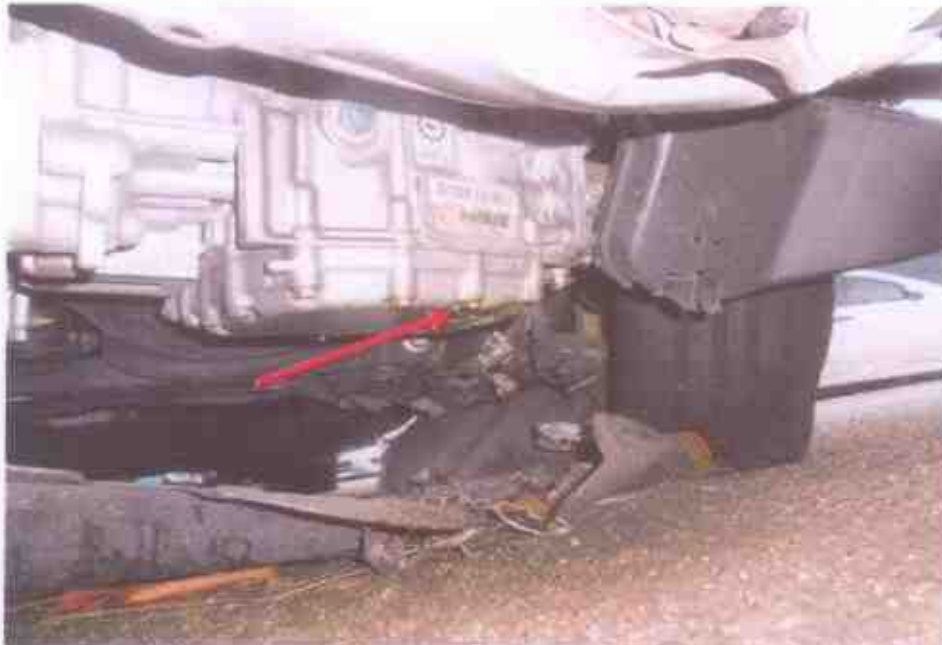
Photo 21 shows the close up view of the undercarriage of the Motor Car. Signs of fluid leakage were observed due to the accident's impact.

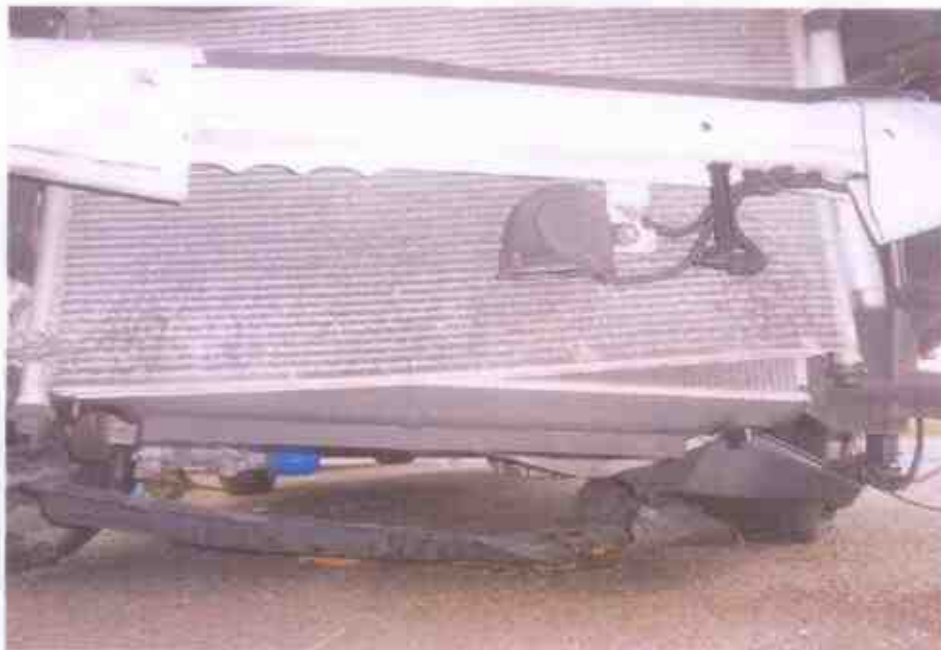
Photo 22 shows the close up view of the radiator's tank that was observed to be damaged likely due to the accident impact.

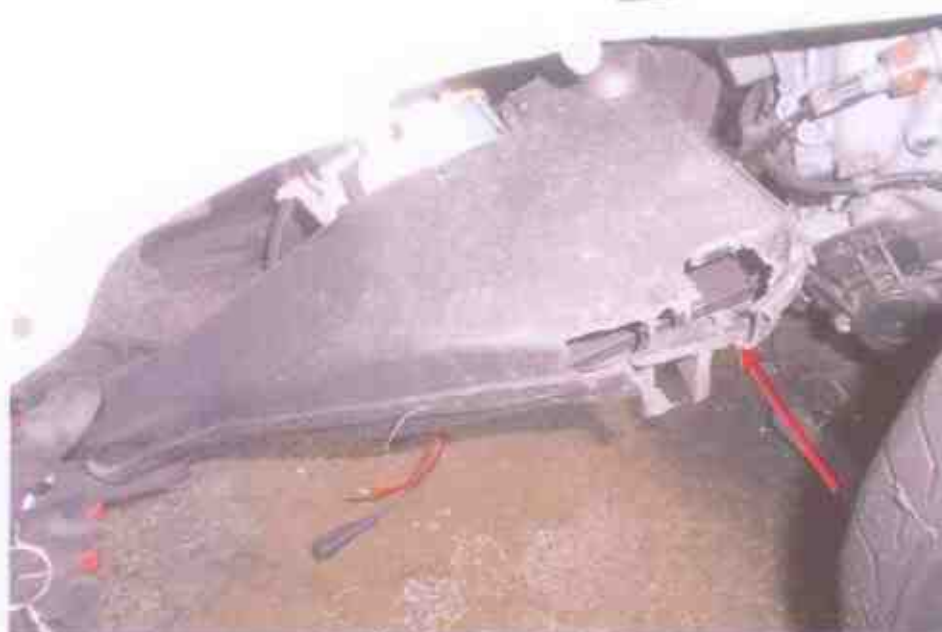
Photo 23 shows the close up view of the damage air intake due to the accident impact.

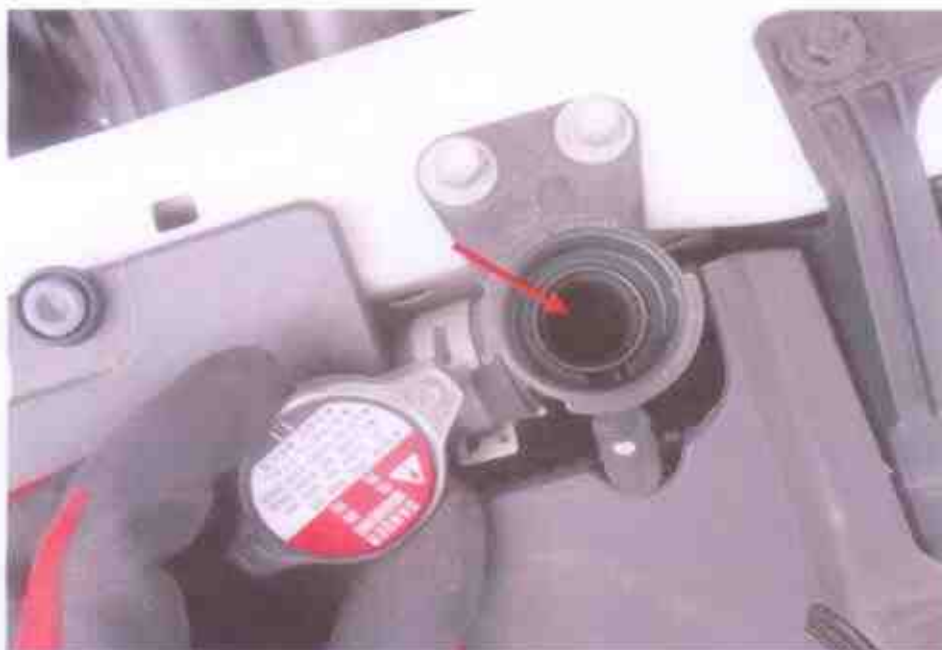
Photo 24 shows the close up view of the empty coolant fluid reservoir due to the damages sustained due to the accident's impact.

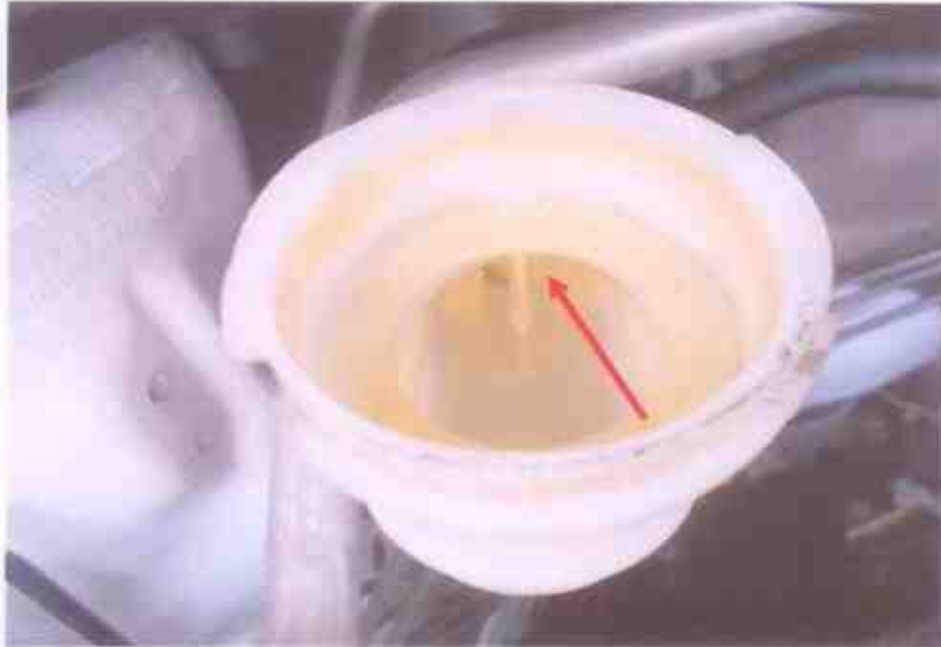
Photo 25 shows a close up view of an empty brake fluid reservoir due to the accident impact. It relatively affects the braking system.

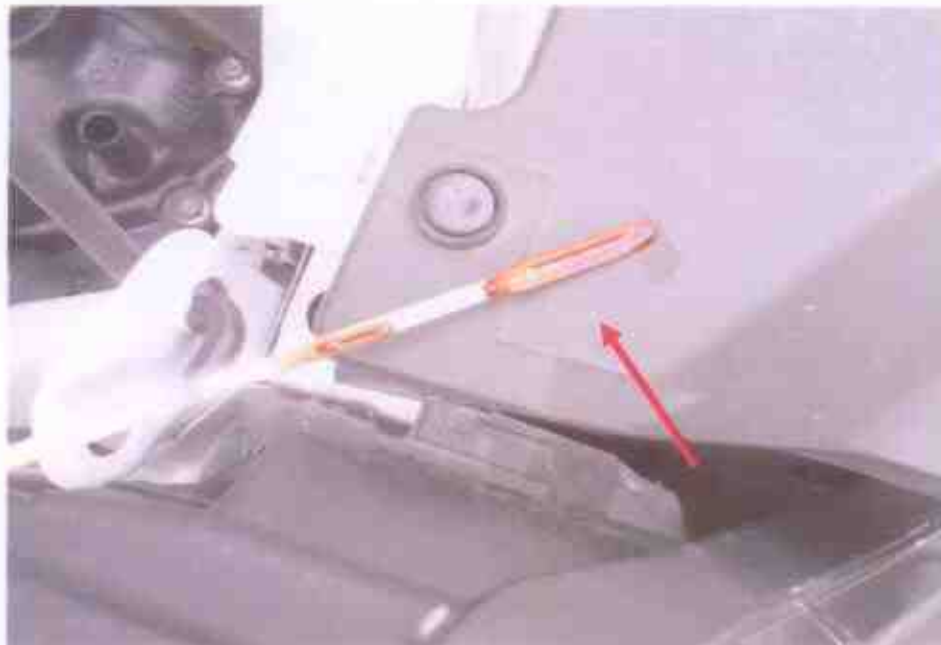
Photo 26 shows a close up view of the engine fluid. Despite there's leakage to the engine fluid, it still contain sufficient level.

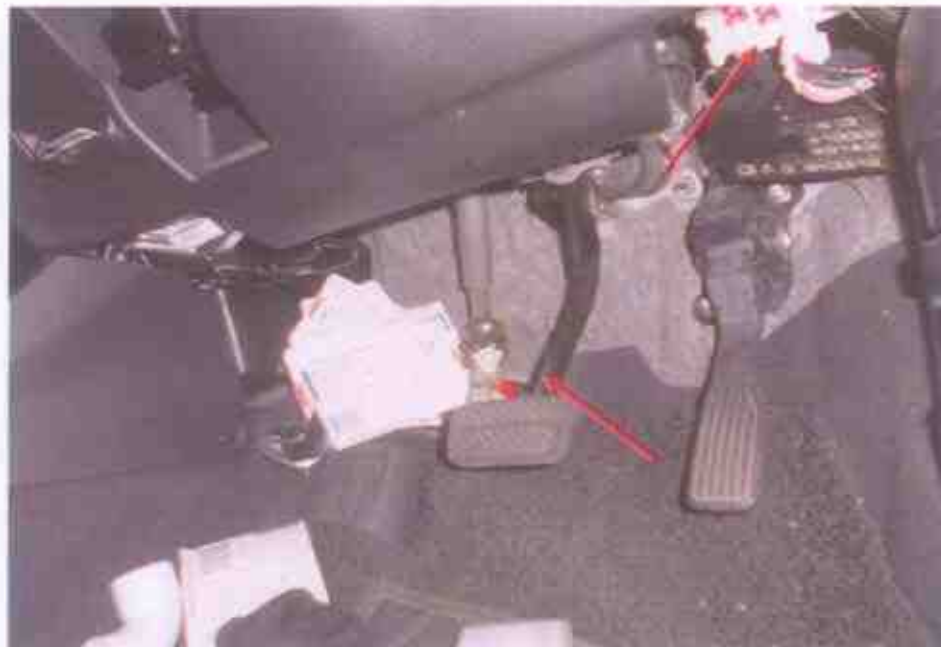
Photo 27 shows a close up view on the steering system that was affected by the accident's impact collision.

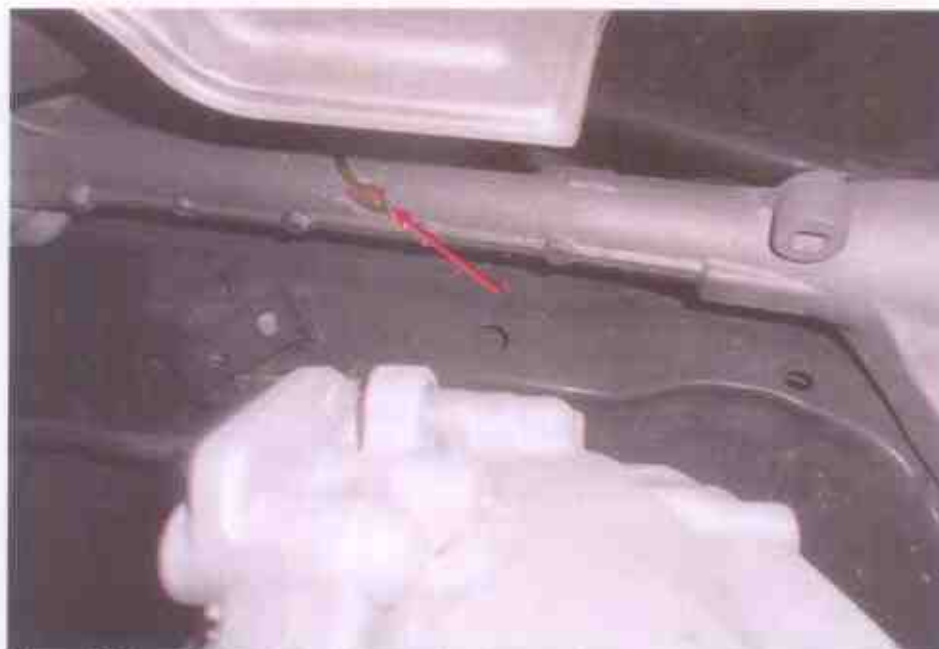
Photo 28 shows a close up view on the damaged steering rack as a result of the accident's impact collision.

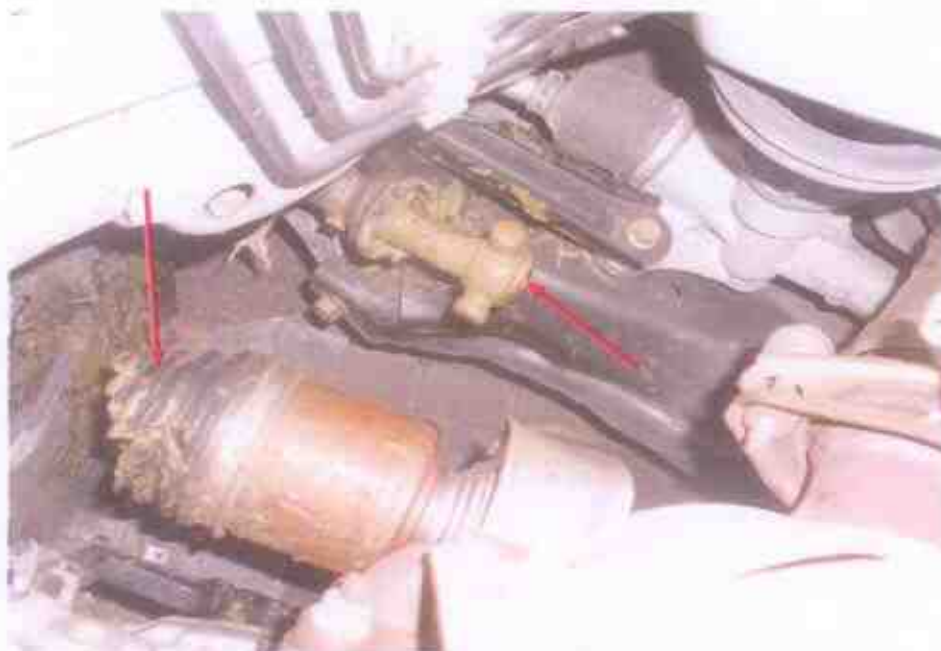
Photo 29 shows a close up view on the front right drive shaft of the Motor Car that were damaged due to the accident's impact collision.

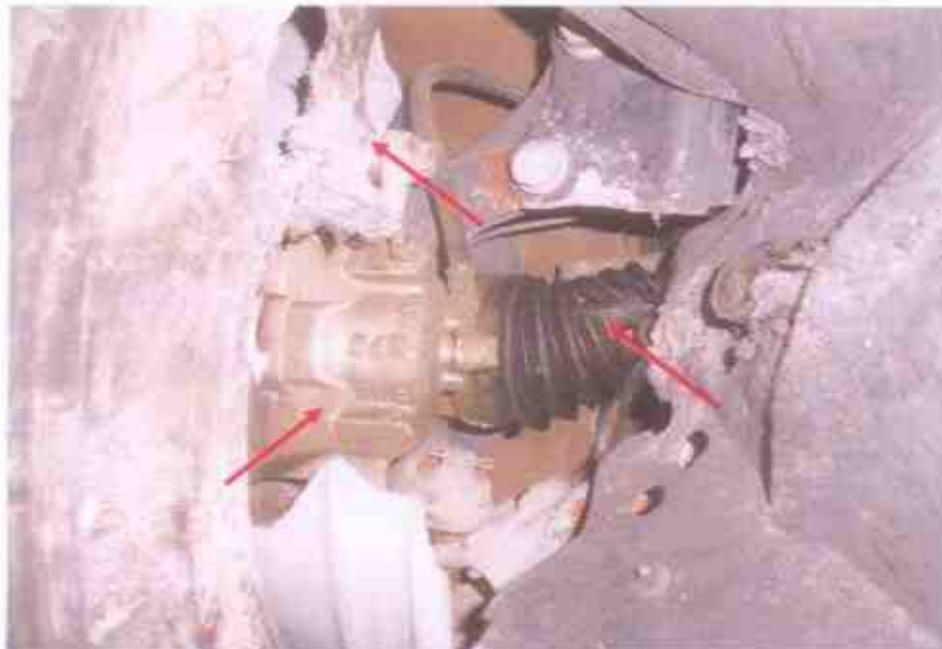
Photo 30 shows the damaged on the front left drive shaft of the Motor Car. We were not able to conduct any tests on the steering system of the Motor Car due to the damage to this components, as well as leakage of fluids.

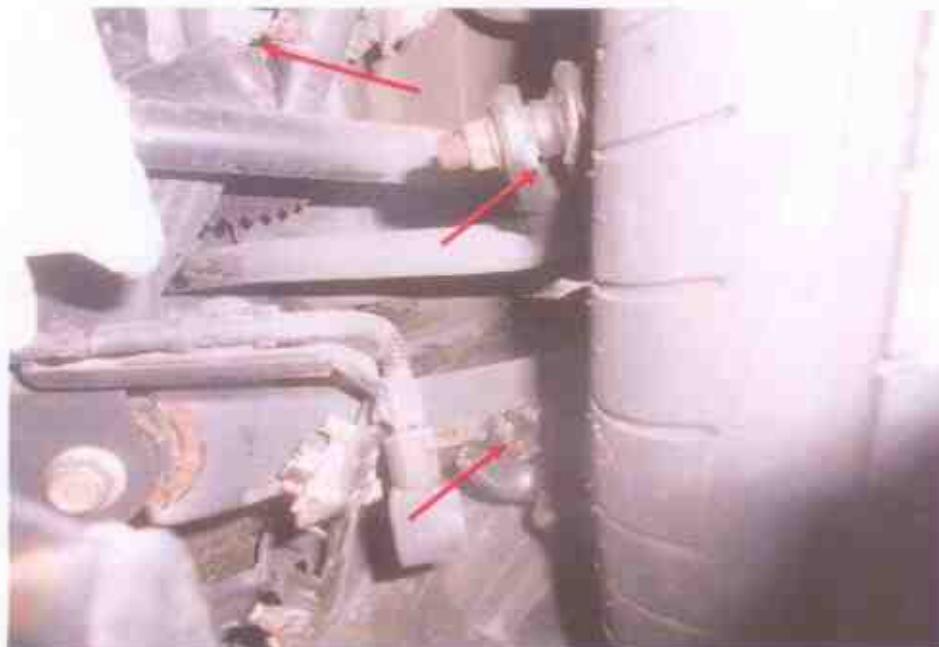
Photo 31 shows the damaged on the front right drive shaft of the Motor Car. We were not able to conduct any tests on the steering system of the Motor Car due to the damage to this components, as well as leakage of fluids.

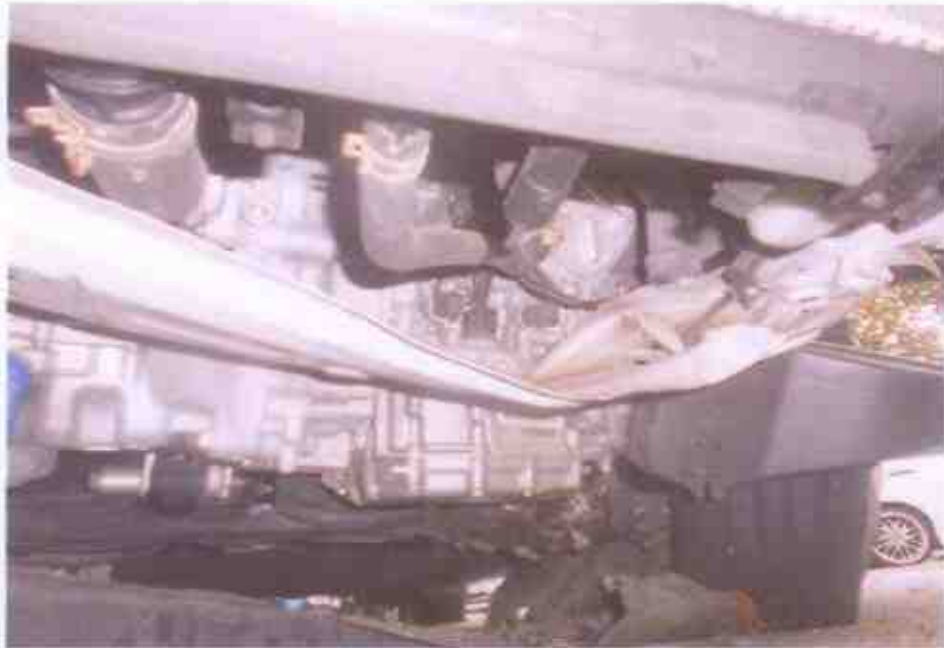
Photo 32 shows the undercarriage components of the Motor Car. It was observe to sustain an extensive damage at the time of our inspection.

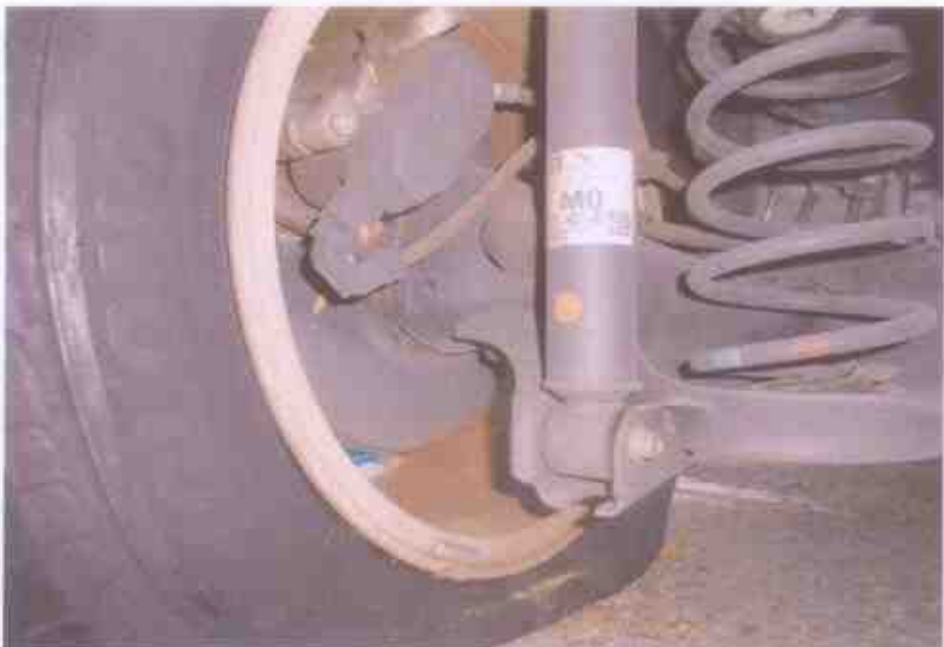
Photo 33 shows the rear left braking & undercarriage components that was unaffected by the accident's impact collision.

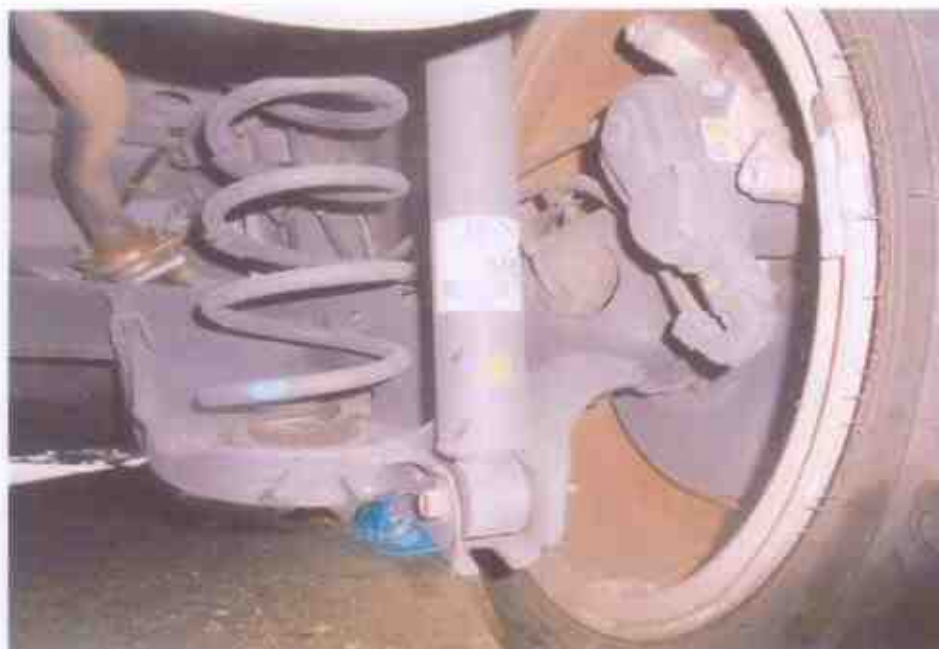
Photo 34 shows the rear right braking & undercarriage components that was unaffected by the accident's impact collision.
