Your Ref: TP/IP/25945/2018
Our Ref : CI/TPD18013729/Z

19th September 2018

MECHANICAL INSPECTION REPORT OF MOTOR CAR SLG 3578B

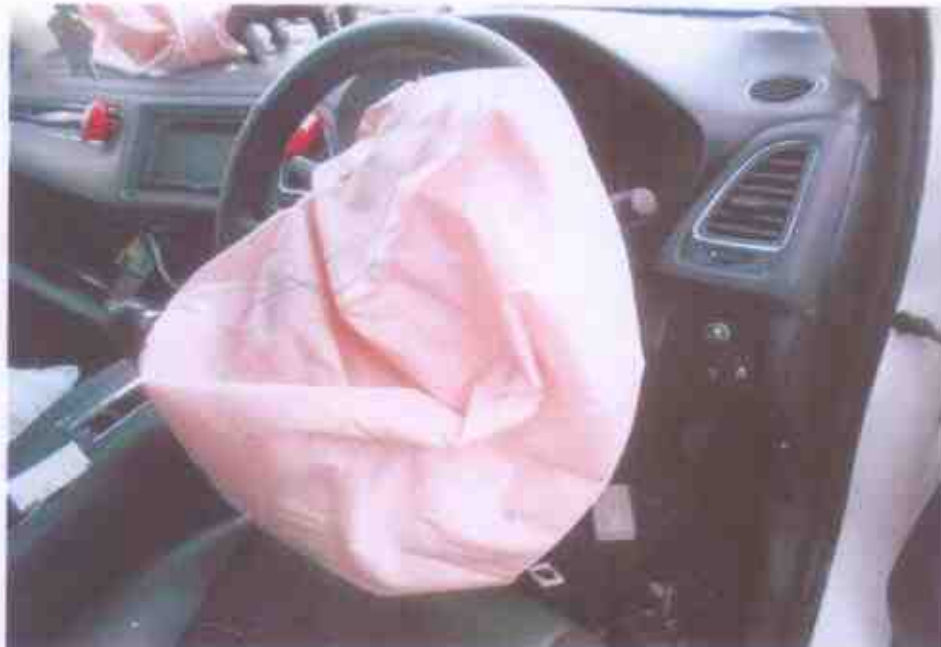
Photo 35 shows the Supplemental Restraint System (SRS) of the Motor Car was however likely to be in normal operating condition at the material time of the accident. The evidence of the deployed front driver's airbag indicates that the impact sensors and control module of the Motor Car's SRS were all in serviceable condition at the material time of accident.

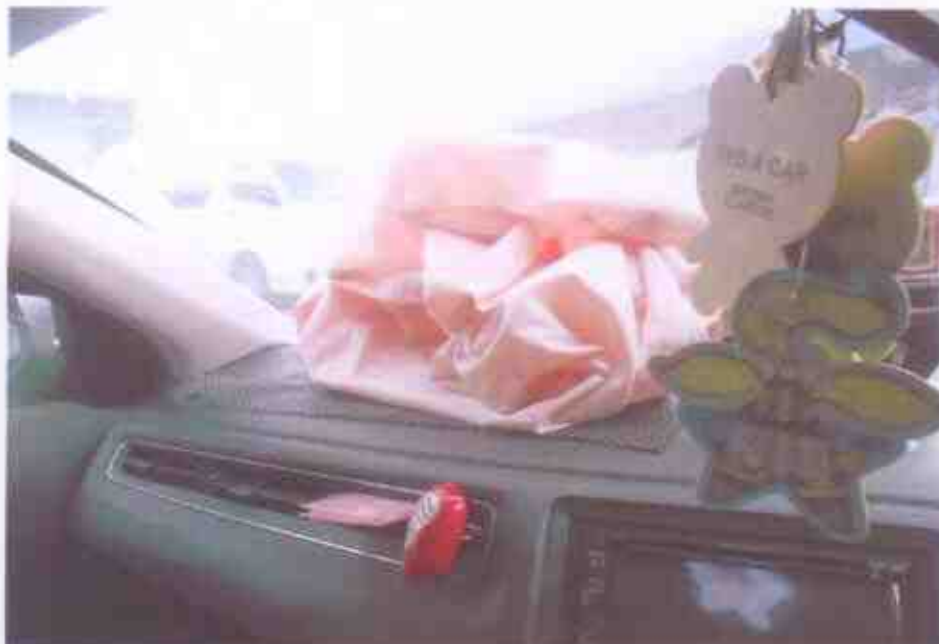
Photo 36 shows the Supplemental Restraint System (SRS) of the Motor Car was however likely to be in normal operating condition at the material time of the accident. The evidence of the deployed front passenger's airbag indicates that the impact sensors and control module of the Motor Car's SRS were all in serviceable condition at the material time of accident.

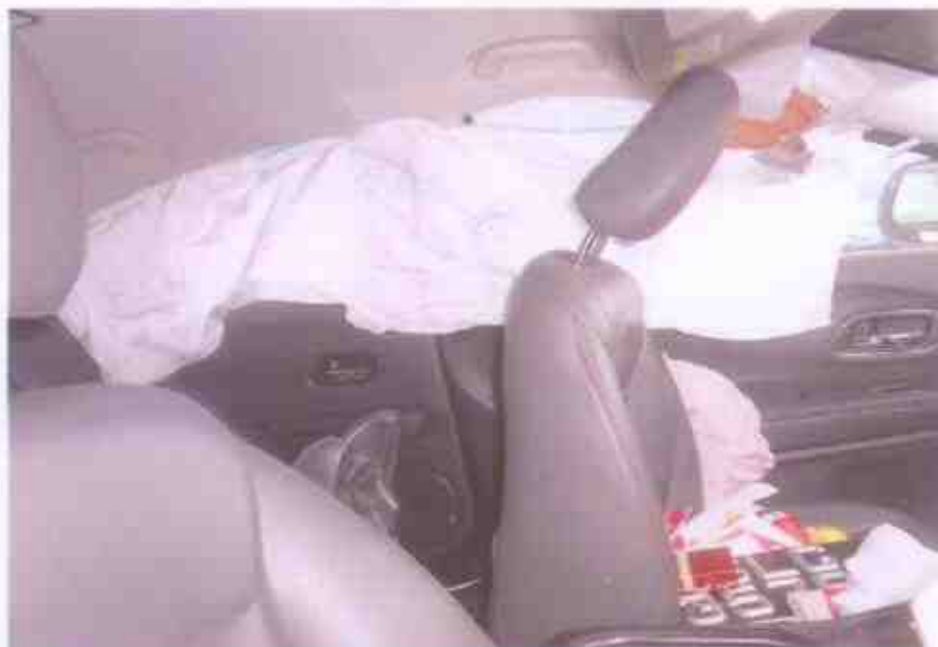
Photo 37 shows the Supplemental Restraint System (SRS) of the Motor Car was however likely to be in normal operating condition at the material time of the accident. The evidence of the deployed left window's airbag indicates that the impact sensors and control module of the Motor Car's SRS were all in serviceable condition at the material time of accident.

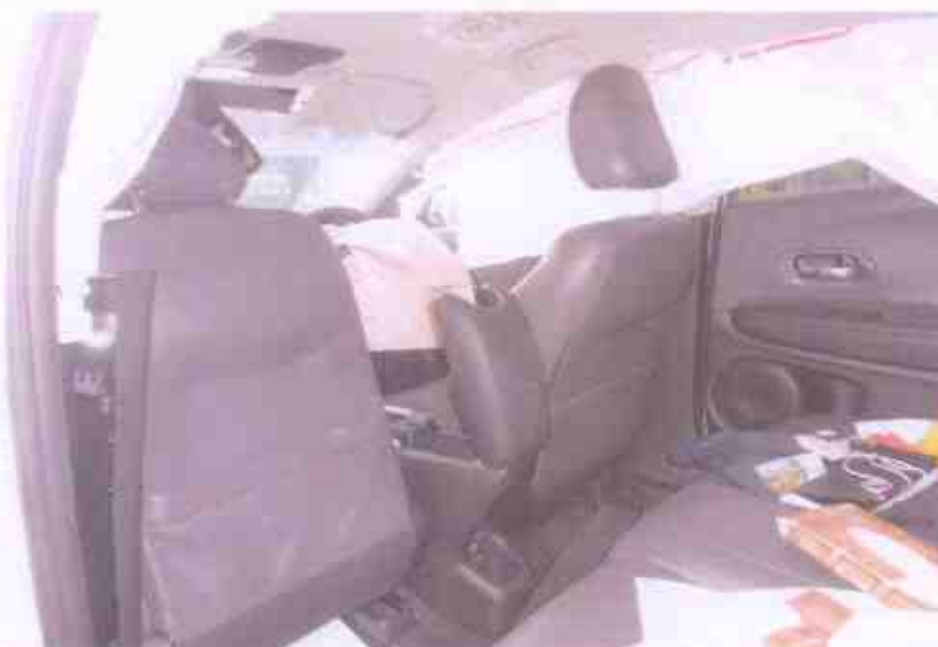
Photo 38 shows the Supplemental Restraint System (SRS) of the Motor Car was however likely to be in normal operating condition at the material time of the accident. The evidence of the deployed right window's airbag indicates that the impact sensors and control module of the Motor Car's SRS were all in serviceable condition at the material time of accident.
