Your Ref: TP/IP/38117/2018
Our Ref : CI/TPD18013730/Z

10th September 2018

MECHANICAL INSPECTION REPORT OF MOTOR LORRY JRV 1328

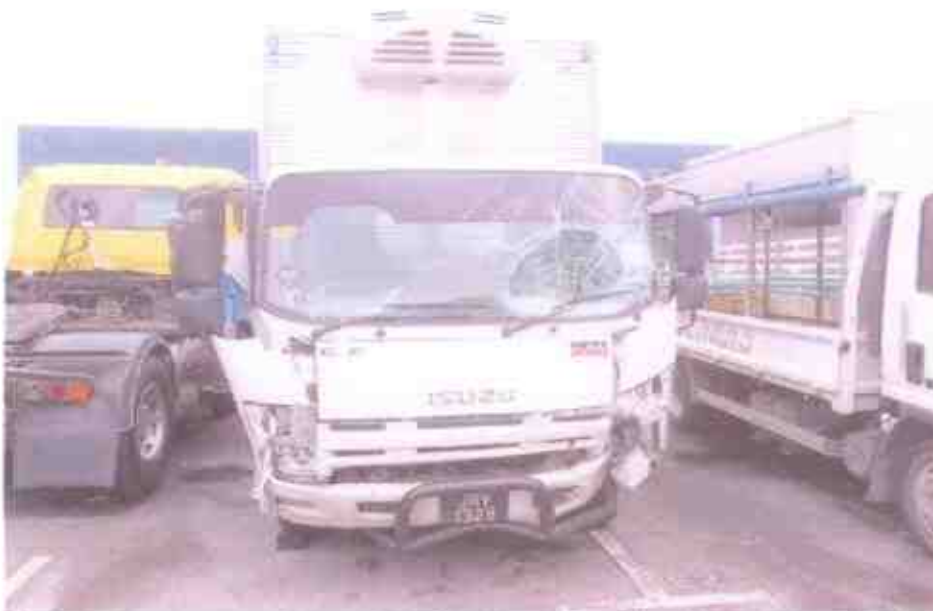
Photo 1 shows a general view of the frontal portion of the Motor Lorry at the time of our inspection. The Motor Lorry was observed to have sustained extensive impact damage at its frontal portion. The impact force was relatively significant, causing its front portion to be pushed towards the rear.

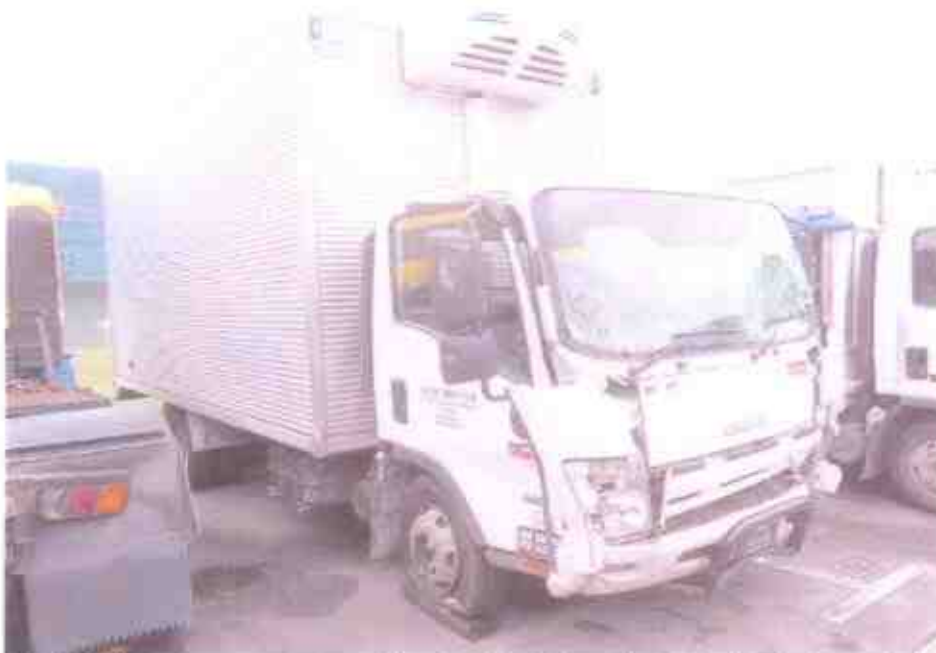
Photo 2 shows a general view of the frontal right portion of the Motor Lorry at the time of our inspection. The Motor Lorry was observed to have sustained extensive impact damage at its frontal portion. The impact force was relatively significant, causing its front portion to be pushed towards the rear.

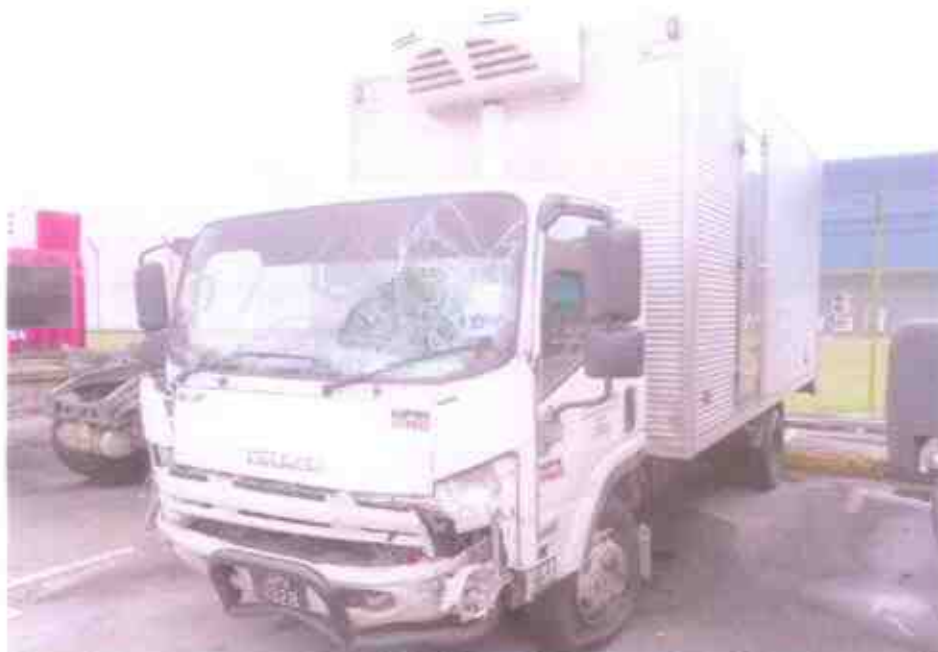
Photo 3 shows a general view of the frontal left portion of the Motor Lorry at the time of our inspection. The Motor Lorry was observed to have sustained extensive impact damage at its frontal portion. The impact force was relatively significant, causing its front portion to be pushed towards the rear.

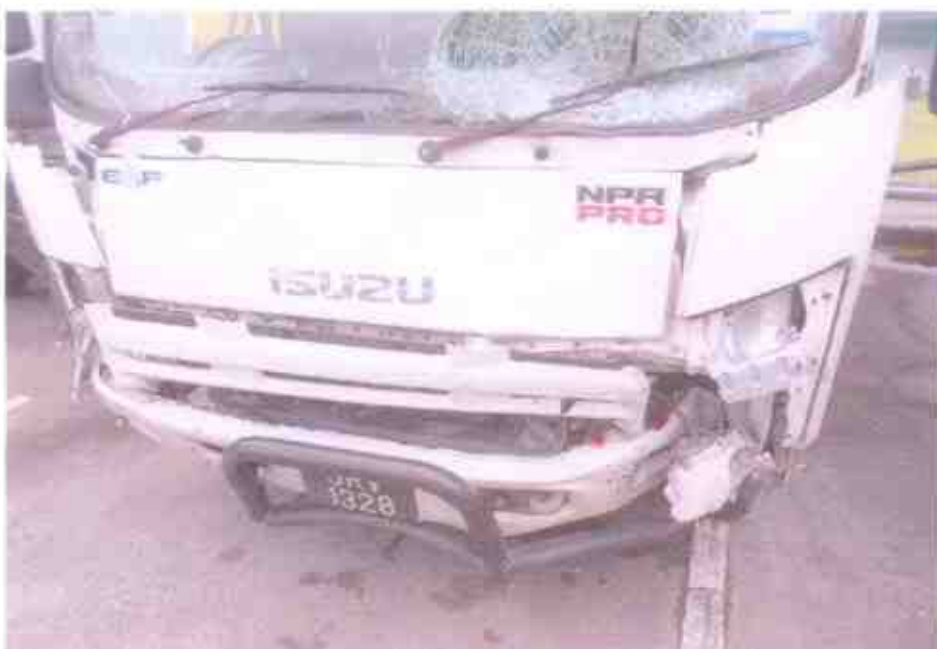
Photo 4 shows a closer view of the frontal portion of the Motor Lorry at the time of our inspection. A number of mechanical parts and components at the frontal portion were also severely damaged as a result of the accident.

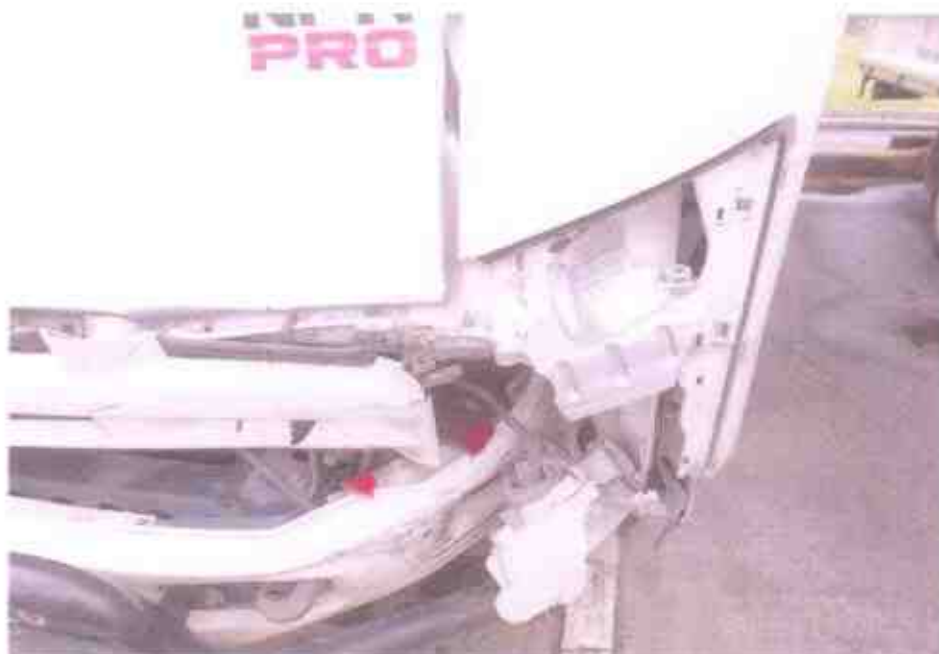
Photo 5 shows a closer view of the left headlamp of the Motor Lorry at the time of our inspection. It had also sustained damages on other components as a result of the accident.

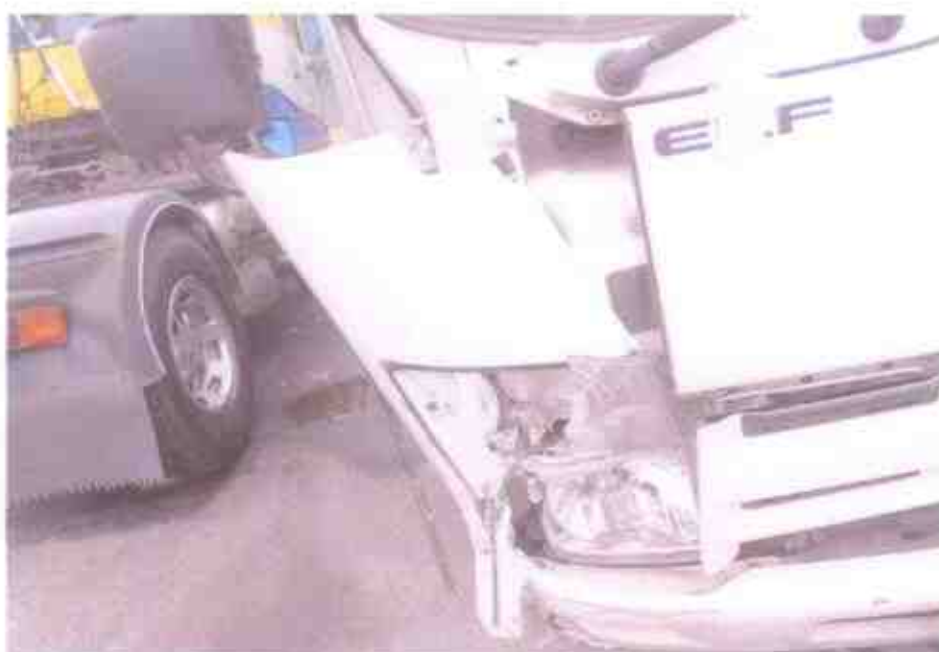
Photo 6 shows a closer view of the right headlamp of the Motor Lorry at the time of our inspection. It had also sustained damages on other components as a result of the accident.

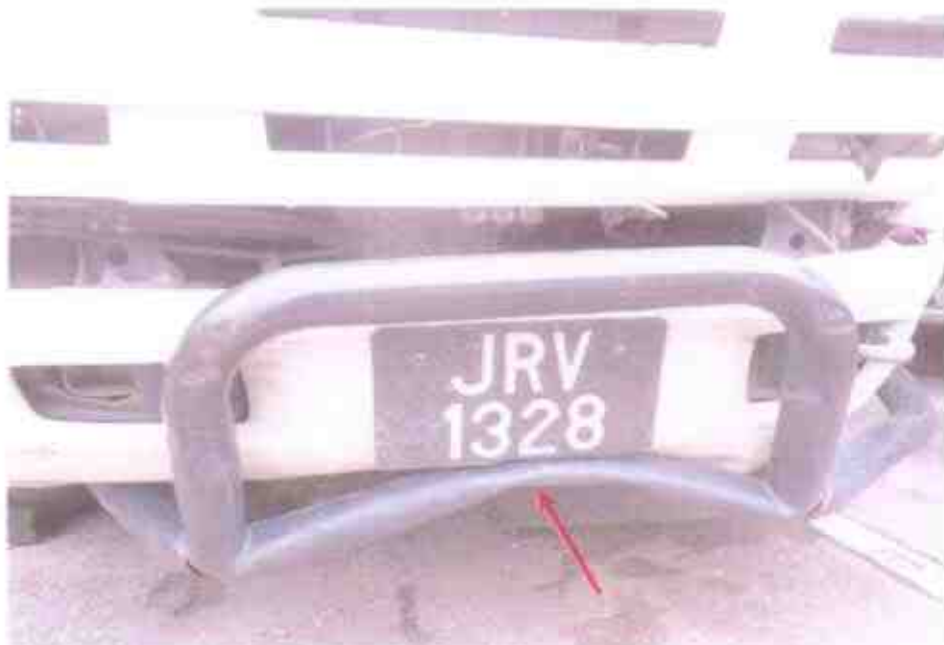
Photo 7 shows a closer view of the frontal lower portion (crash bar) of the Motor Lorry at the time of our inspection. A number of mechanical parts and components at the frontal portion were also severely damaged as a result of the accident.

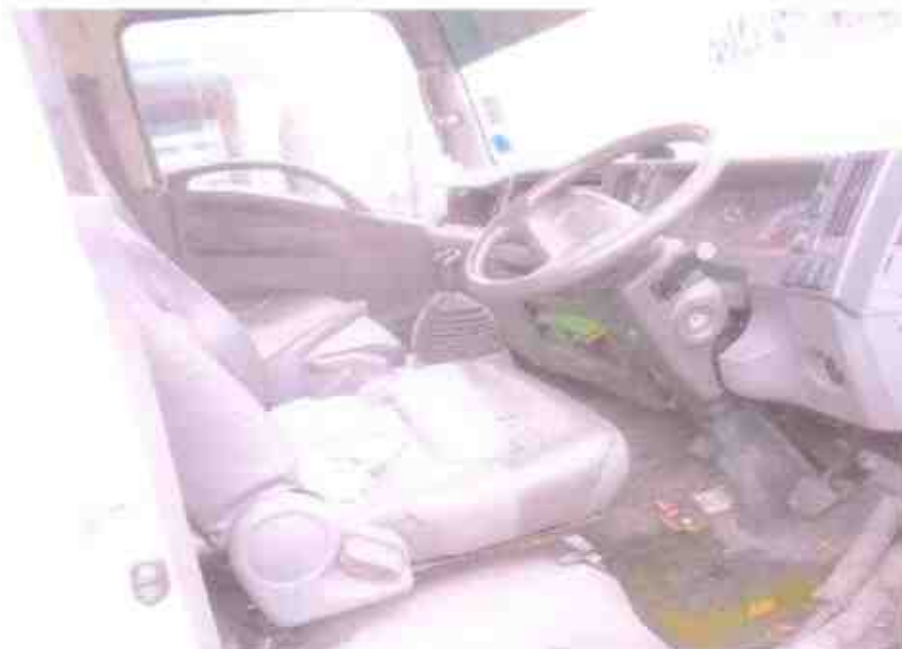
Photo 8 shows the interior of the front cabin. It was observed to be unaffected by the accident's impact collision.

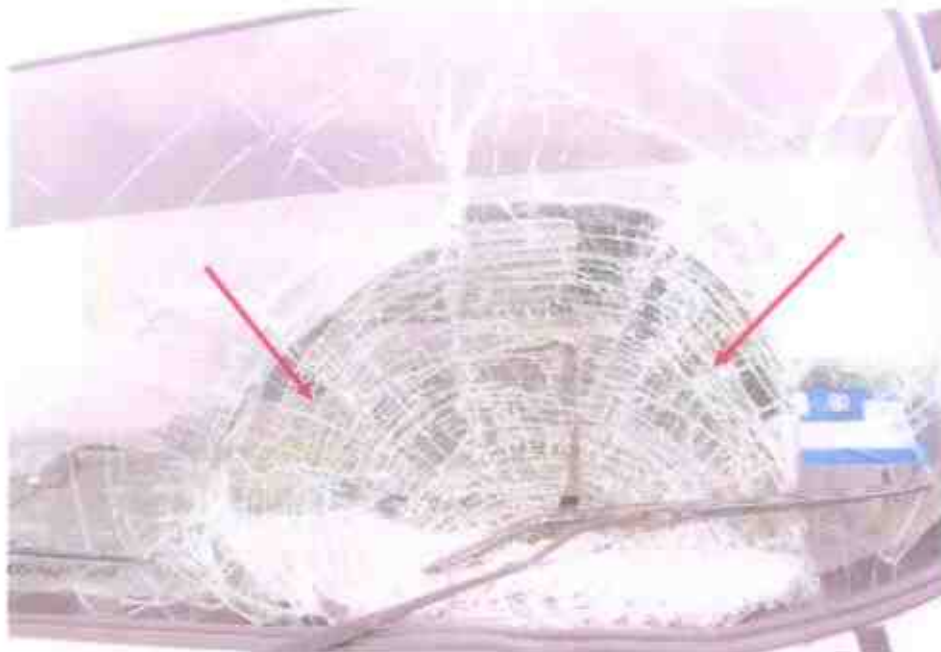
Photo 9 shows the front cabin. The windshield was observed to be cracked due to the accident.

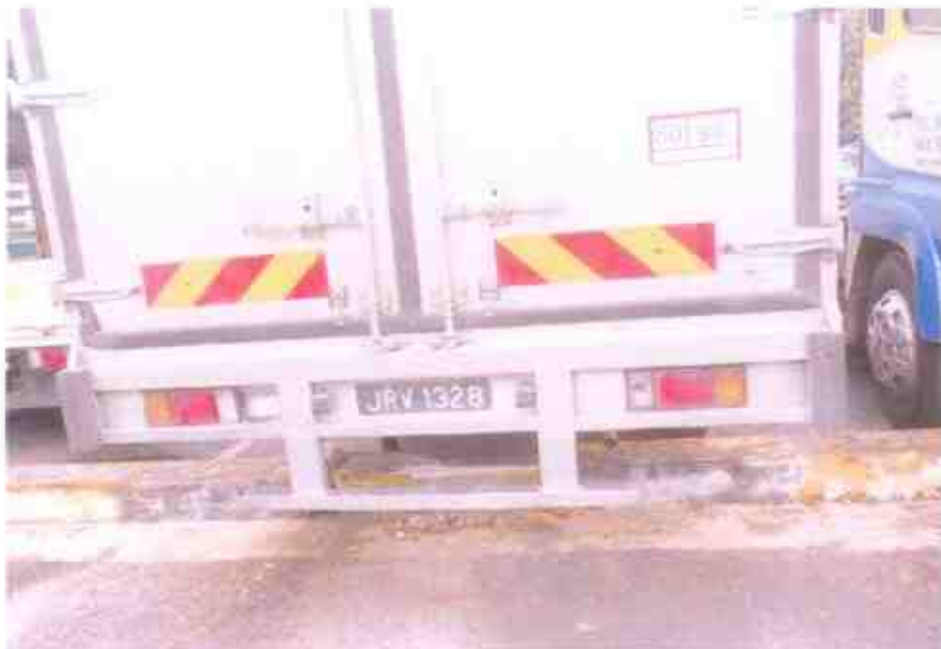
Photo 10 shows a general view of the rear left portion of the Motor Lorry at the time of my inspection. The rear portion was observed to be relatively unaffected by the accident.

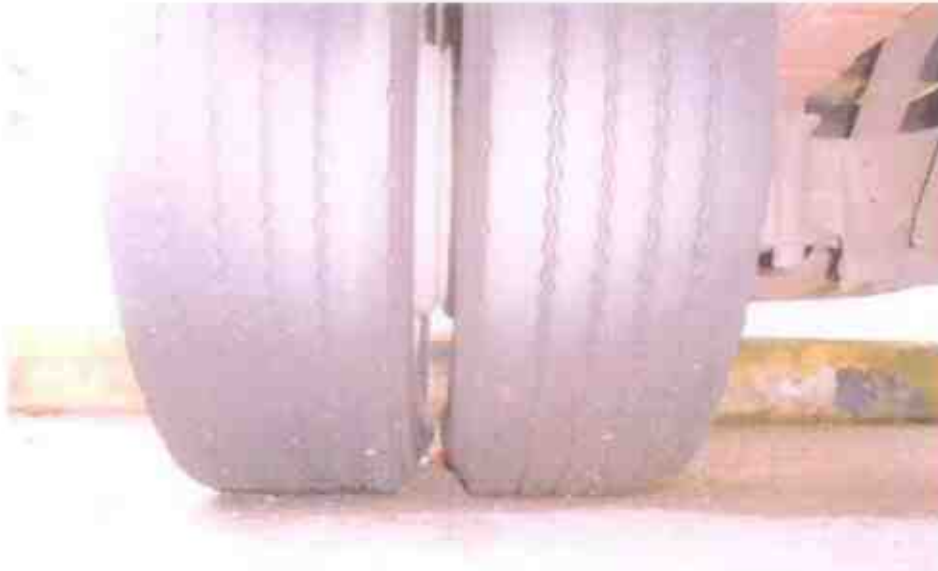
9. The 6 tyres were observed to be wrapped around steel wheel rims. However, 04 of the wheel rims were found to be dented due to the accident's impact collision. The front left wheel rim, front right wheel rim, rear left inner wheel rim & rear right outer wheel rim was observed to be dented likely due to the accident's impact collision. Hence causing deflation on the affected tyres. See photo 11 to 14 below.

Photo 11 shows the condition of the rear right tyres of the Motor Lorry with remaining tread depth of approximately 4mm. However, the outer tyre was found to be deflated with cut mark on the outer sidewall & dented wheel rim.

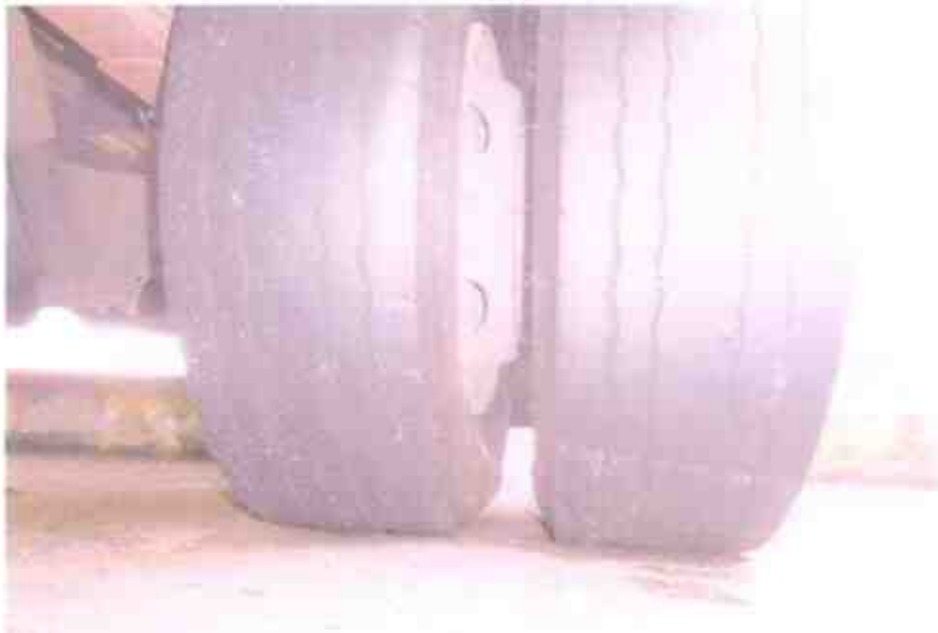
Photo 12 shows the condition of the rear left tyres of the Motor Lorry with remaining tread depth of approximately 1.6mm. However, the inner tyre was found to be deflated with dented wheel rim.

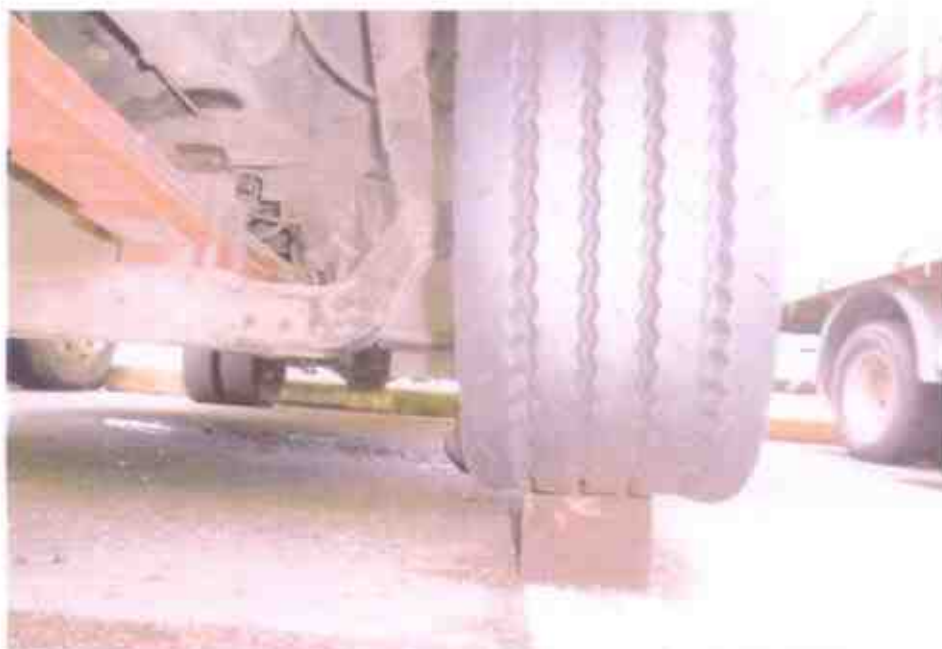
Photo 13 shows the condition of the front left tyre of the Motor Lorry with remaining tread depth of approximately 8mm. However, it was found to be deflated with cut mark on the sidewall & dented wheel rim.

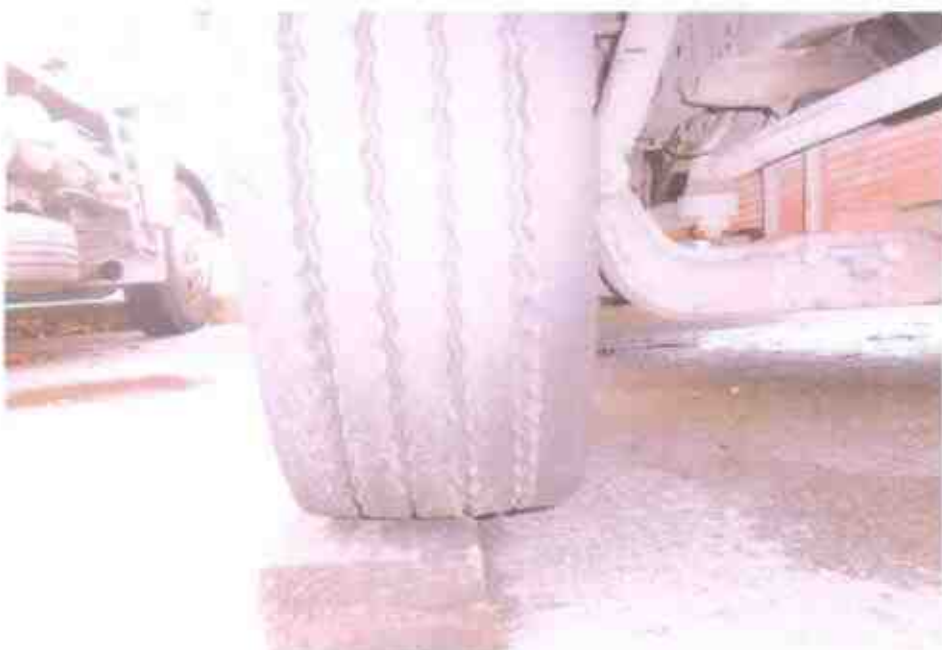
Photo 14 shows the condition of the front right tyre of the Motor Lorry with remaining tread depth of approximately 7mm. However, it was found to be deflated with dented wheel rim.

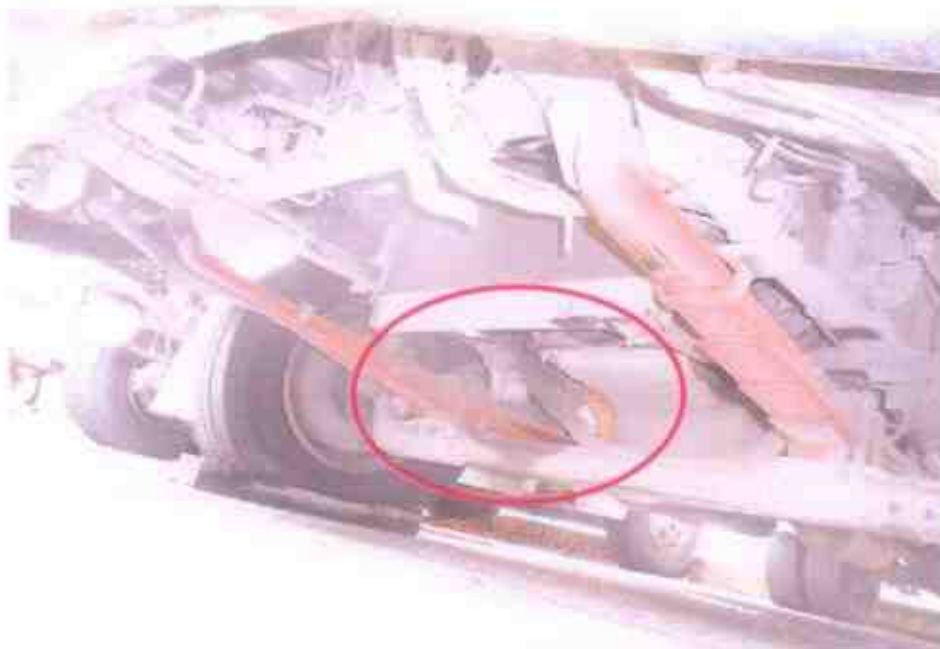
10. The engine compartment of the Motor Lorry, which was located beneath the front cabin, could not be closely inspected given the extensive damage to the front cabin. The cabin could not be lifted due to the accident's impact that caused the misalignment to the lifting components. Our visual checks from the underside of the Motor Lorry had however appear to indicate that the engine assembly and transmission assembly were both unaffected by the collision. Visually, there were fluid stains covering the engine underside. However, having further investigation revealed that it was a pre-existed fluid stain prior the material time of the accident. This was concluded with the dust stain associated with the fluid stain.

Photo 15 shows that there was also fluid stains covering the engine underside, indicating fluid leakage. However, it was associated with dust which concluded to pre-existed leakage prior the material time of the accident.

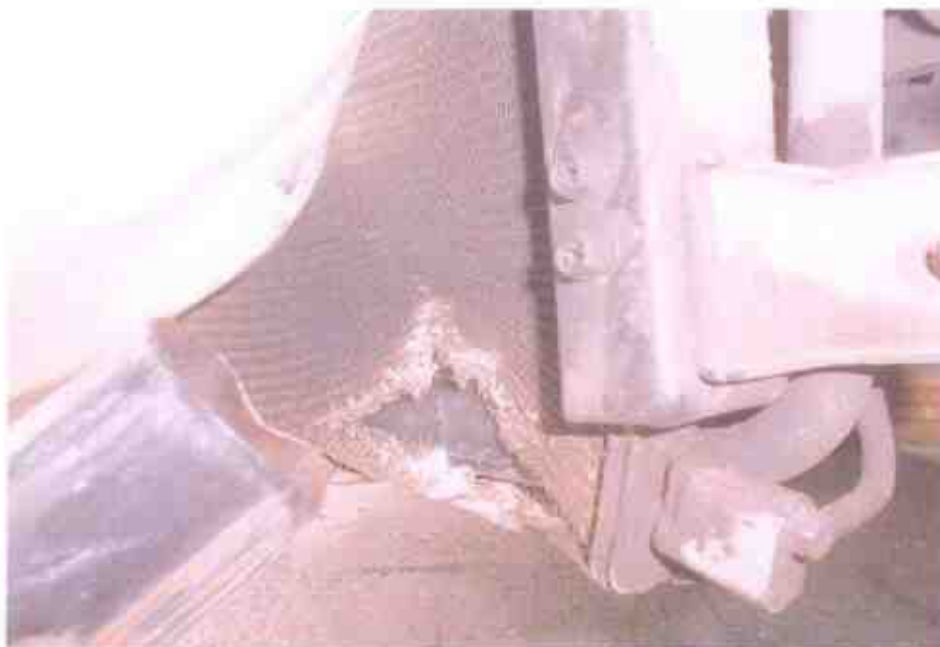
Photo 16 shows the radiator was observed to be damaged due to the accident's impact.

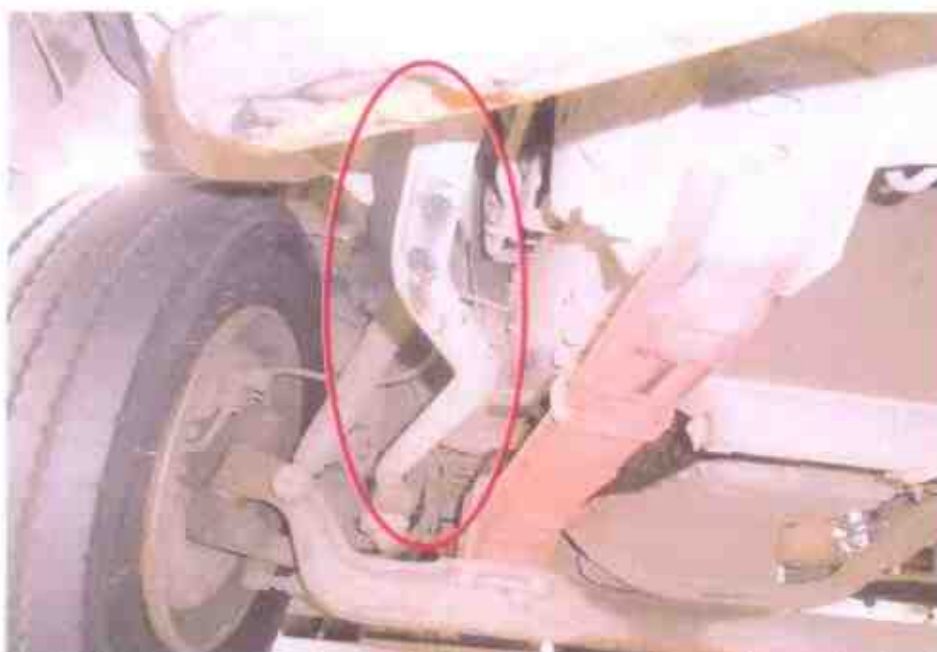
Photo 18 shows the steering rod of the Motor Lorry. It was observed to be in serviceable condition unaffected by the accident's impact collision.

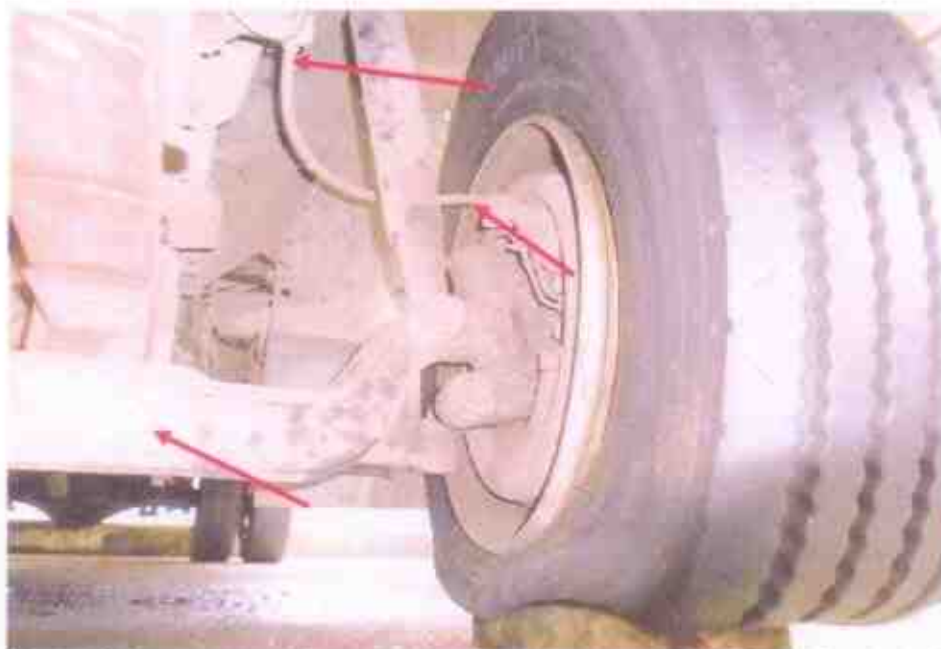
Photo 19 shows the unaffected mechanical components on the front left wheel of the steering system. The steering shaft and steering rack of the Motor Lorry were observed to be intact and securely attached to the front left wheel. No fluid leakage on the brake fluid hoses.

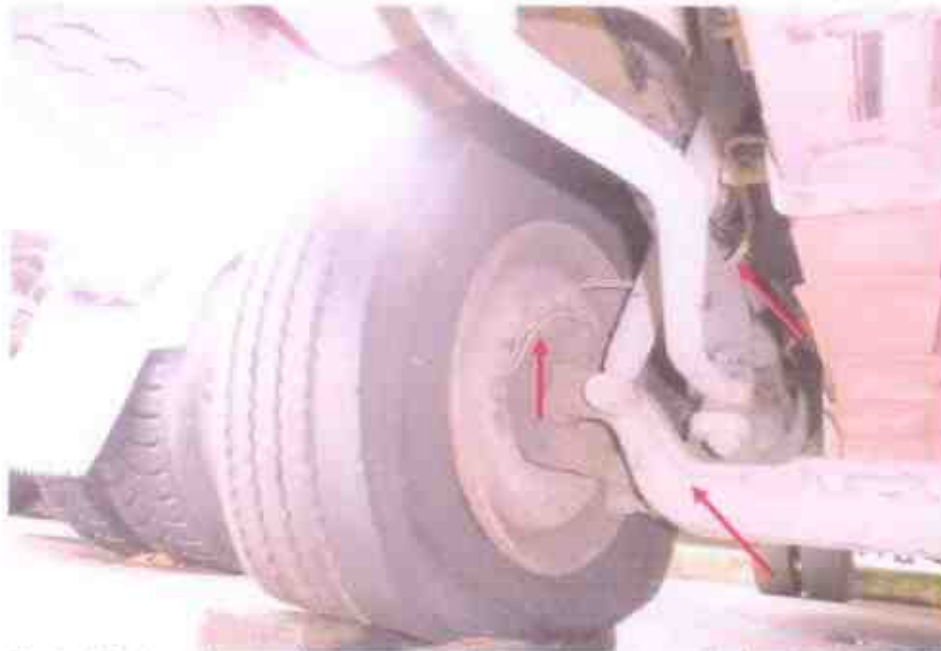
Photo 20 shows the unaffected mechanical components on the front right wheel of the steering system. The steering shaft and steering rack of the Motor Lorry were observed to be intact and securely attached to the front left wheel. No fluid leakage on the brake fluid hoses.

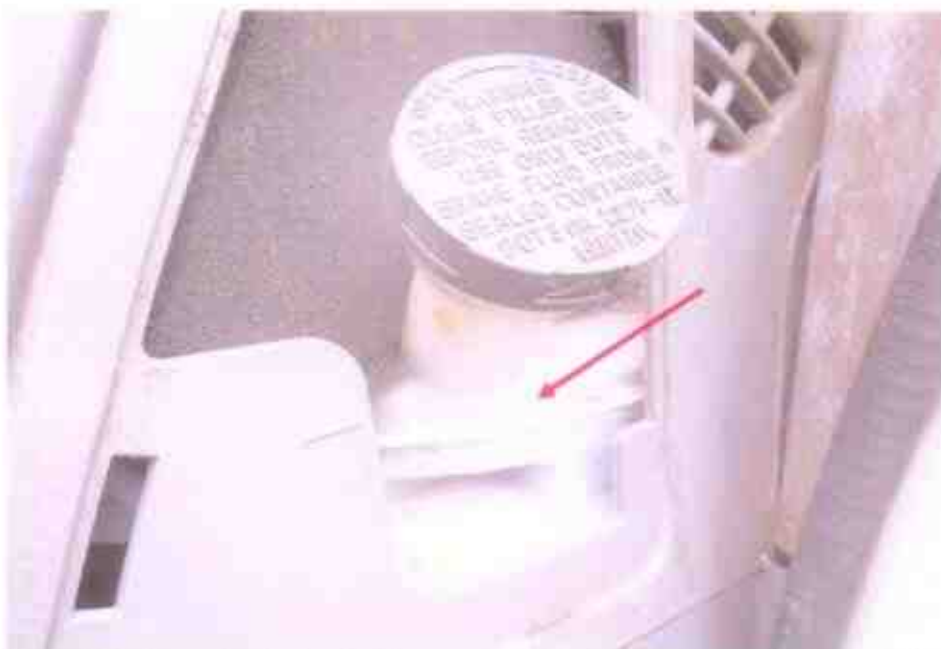
Photo 21 shows the brake fluid reservoir of the Motor Lorry. I had found the brake fluid to be of sufficient level for operational purposes. Visually there was also no contamination found to the brake fluid.

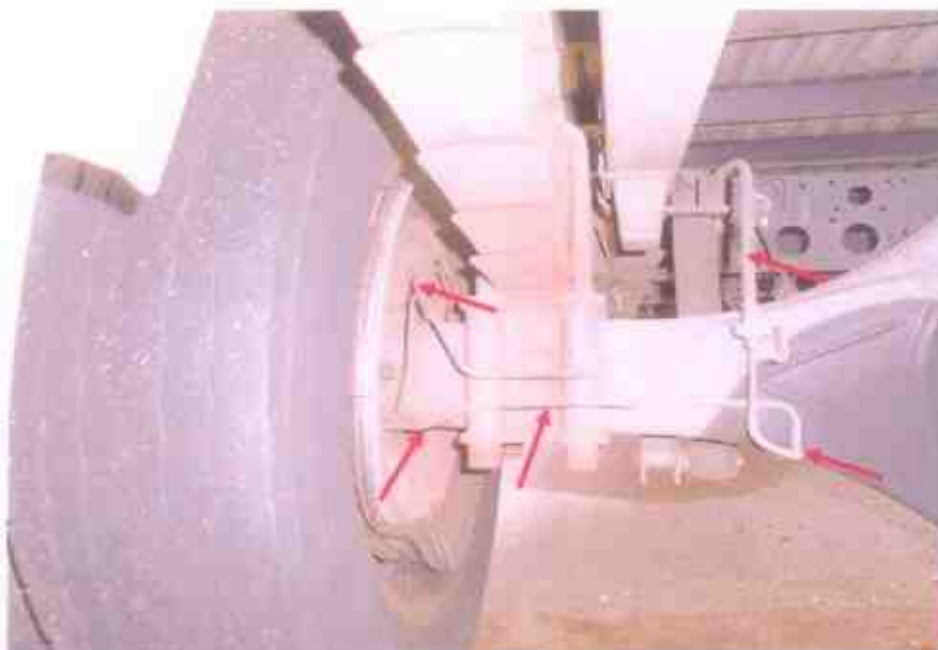
Photo 22 shows the brake pipes and hoses, which were visibly unaffected by the accident. We were however not able to carry out any operational tests to the braking system of the Motor Lorry due to the extent of damage to its front cabin, which had affected several mechanical components of the braking system like the brake booster and brake pedal amongst others.

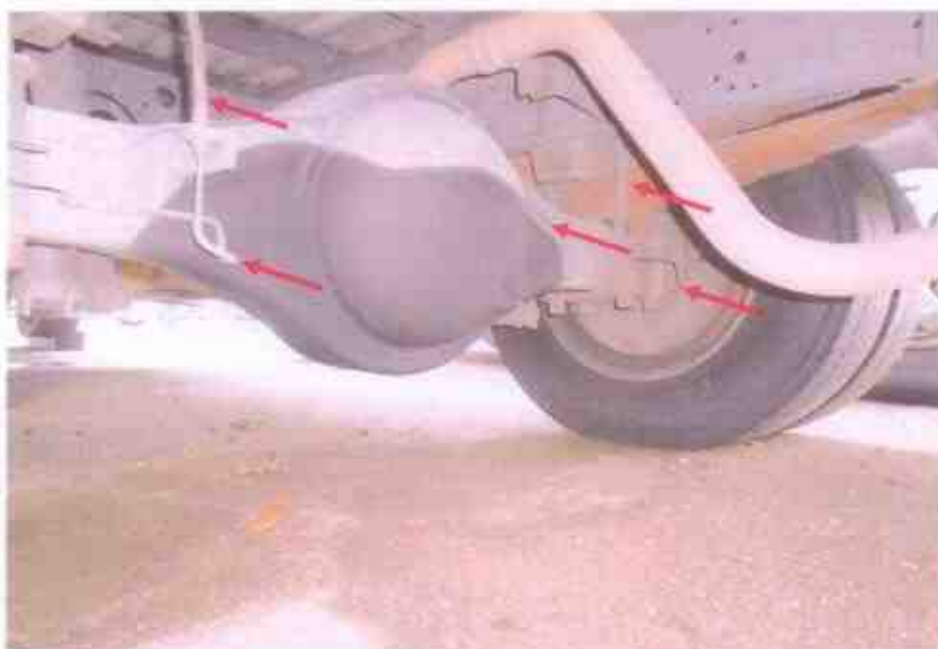
Photo 23 shows the brake pipes and hoses, which were visibly unaffected by the accident. We were however not able to carry out any operational tests to the braking system of the Motor Lorry due to the extent of damage to its front cabin, which had affected several mechanical components of the braking system like the brake booster and brake pedal amongst others.
