Your Ref: TP/IP/38117/2018
Our Ref :CI/TPD18013731/Z

13th September 2018.

MECHANICAL INSPECTION REPORT OF MOTORCYCLE JRY 7606

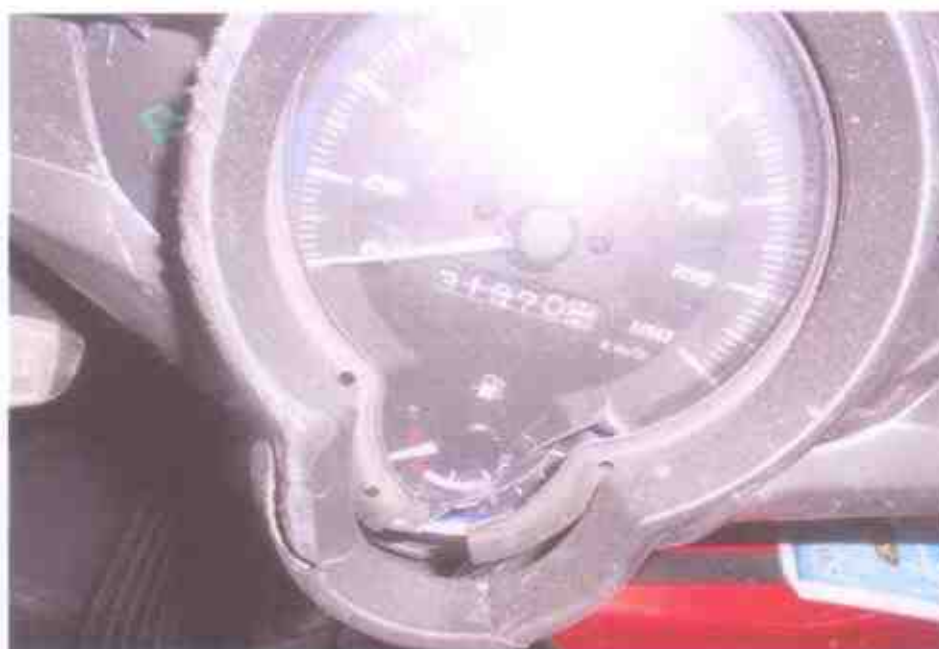
Photo 1 shows the mileage of the Motorcycle at the time of our inspection was recorded at 319707km.

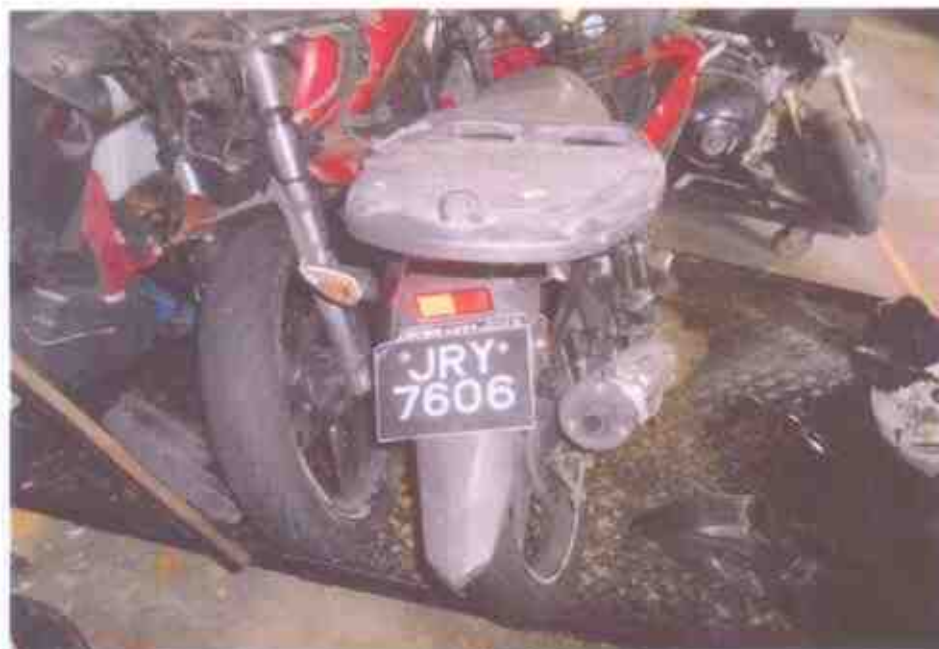
Photo 2 shows the Motorcycle number plate for identification.

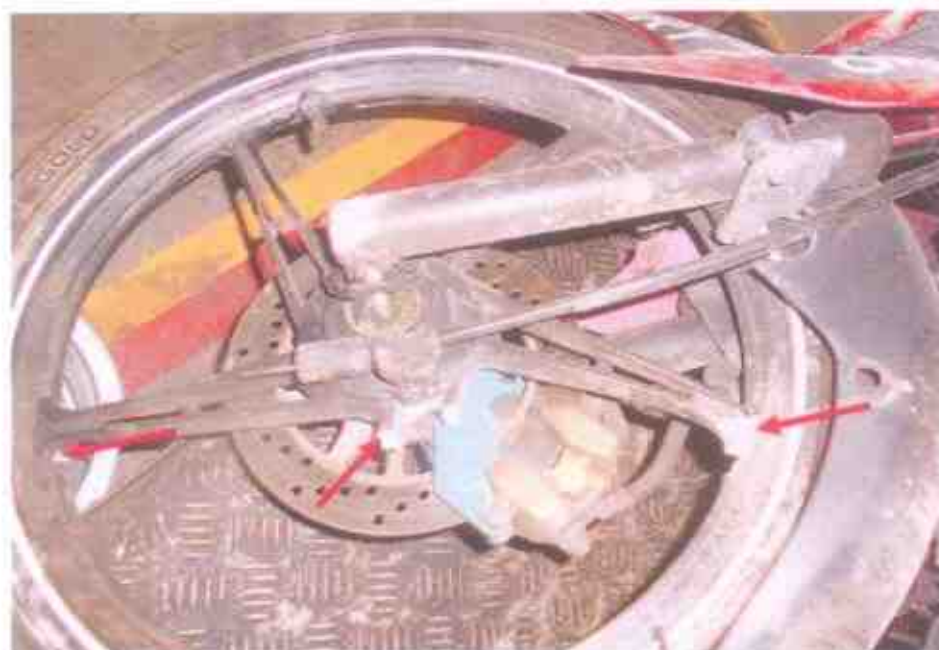
Photo 3 shows a general view of the front wheel of the Motorcycle at the time of our inspection. The Motorcycle was observed to have sustained with relatively extensive impact due to the accident collision. Amongst the body parts damaged was its front fork & broken rim (arrowed), which was observed to be broken.

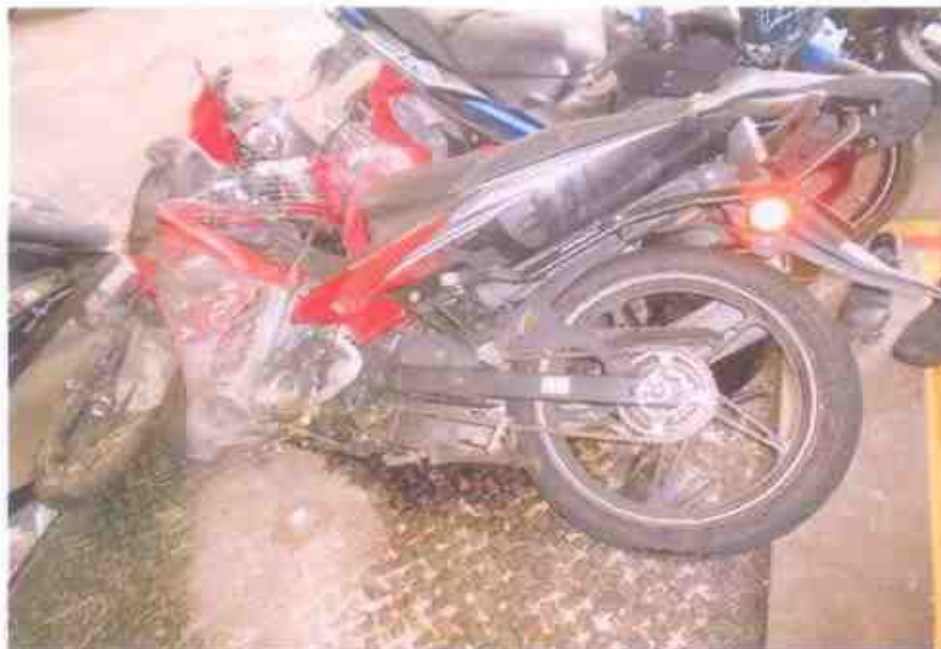
Photo 4 shows a general view of the left body of the Motorcycle at the time of our inspection. The Motorcycle was observed to have sustained damages at the frontal portion, rear portion, along both its left side and right side.

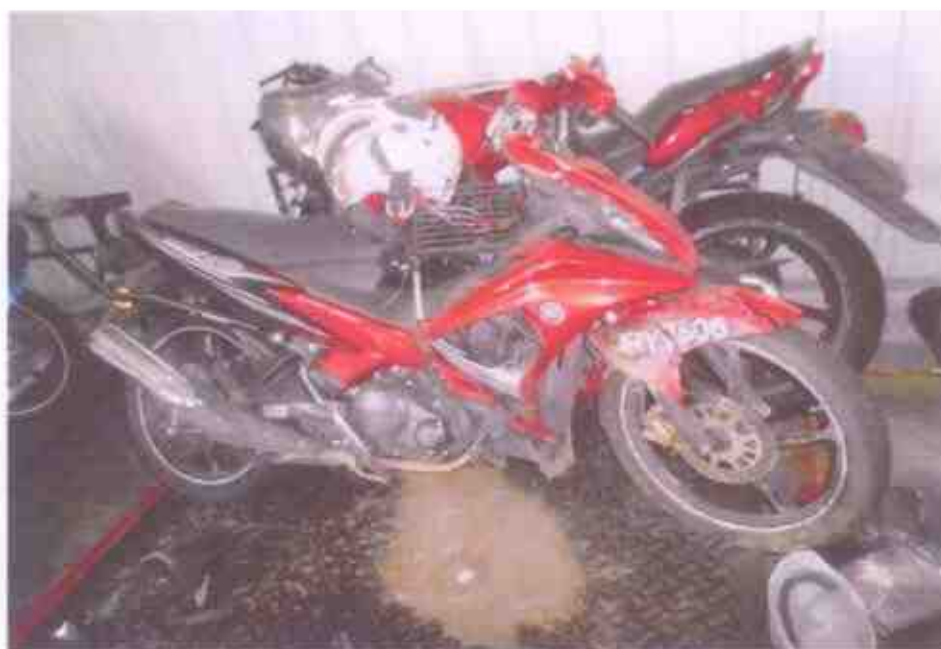
Photo 5 shows a general view of the right portion of the Motorcycle at the time of our inspection. The Motorcycle was observed to have sustained relatively extensive impact due to the accident collision.

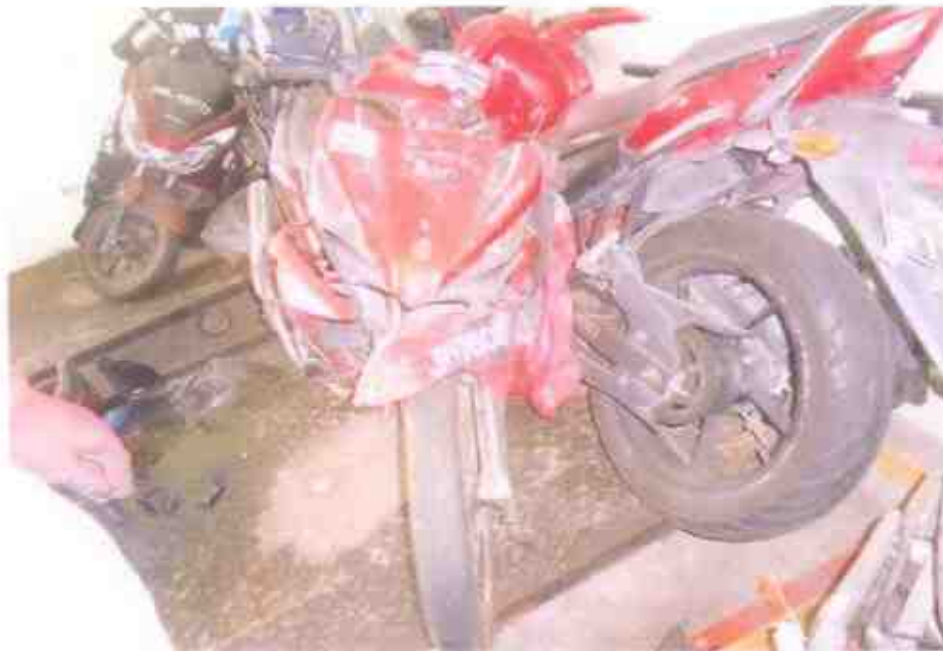
Photo 6 shows a close-up view of the frontal portion of the Motorcycle at the time of our inspection. The Motorcycle was observed to have sustained relatively extensive impact including damages to the steering system to the accident collision.

13. For this case, we were not able to conduct any test(s) on the steering system of the Motorcycle due to the damages on its handle bar, front fork and broken front wheel rim. It was found to be damaged as a result of the accident, hence causing the whole steering system to be in a state of immobility.

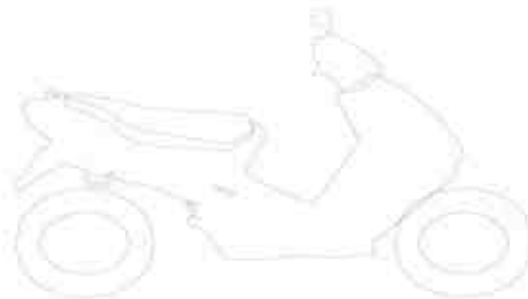
Michelin 80/90 – 17(4mm)

IRC Wing 70/90 – 17(5mm)

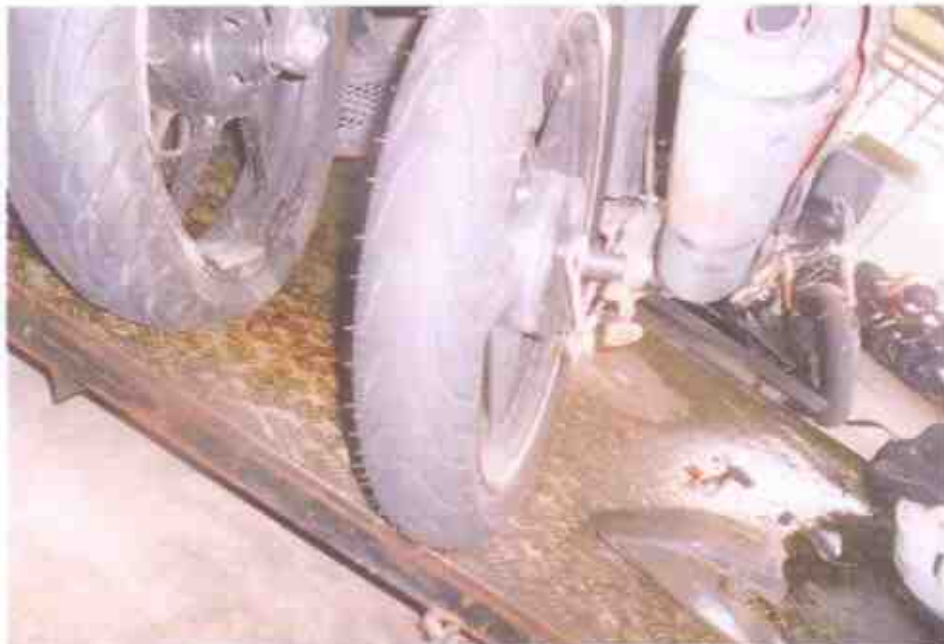
Photo 7 shows the rear tyre of the Motorcycle at the time of our inspection. The rear tyre was observed to be in serviceable condition with remaining tread depth of approximately 4mm. The tyre was also observed to be sufficiently inflated for vehicular operation. There was no significant damage observed on the rear wheel rim & tyre.

18. The condition of the Motorcycle's rear tyre was observed to be in serviceable condition. The tread pattern of the rear tyre was clearly visible. We did not observe any tear, burst mark(s) and/or punctured hole(s) on the sidewalls as well as across the tread of the rear tyre. Its tread depth was measured & found to be around approximately 4mm.

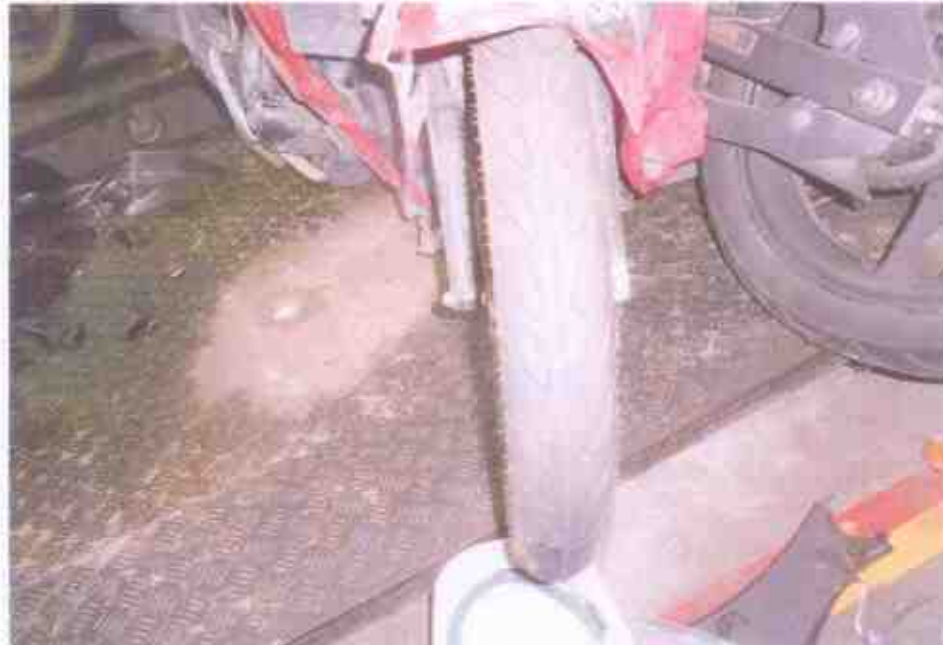
Photo 8 shows the front tyre of the Motorcycle at the time of our inspection. The pattern of the tread was clearly visible with remaining tread depth of approximately 5mm. There was no tear, burst mark(s) and/or punctured hole(s) on the sidewalls as well as across the tread of the front tyre. However, the wheel rim was observed to be broken as a result of the accident.

19. As for the front tyre, it was found to be deflated likely due to the broken wheel rim as a result of the accident's collision. However, the tread pattern of the front tyre was clearly visible with tread depth of 5mm. We did not observe any tear, burst mark(s) and/or punctured hole(s) on the sidewalls as well as across the tread of the front tyre.

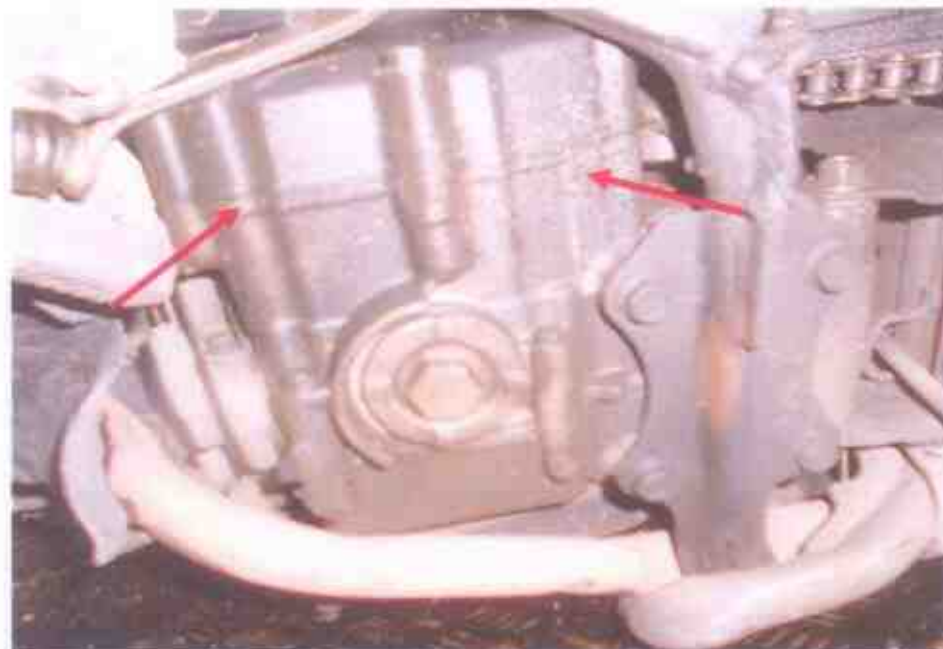
Photo 9 shows sign(s) or indication(s) of fluid leakage observed around the engine's underside area of the Motorcycle.

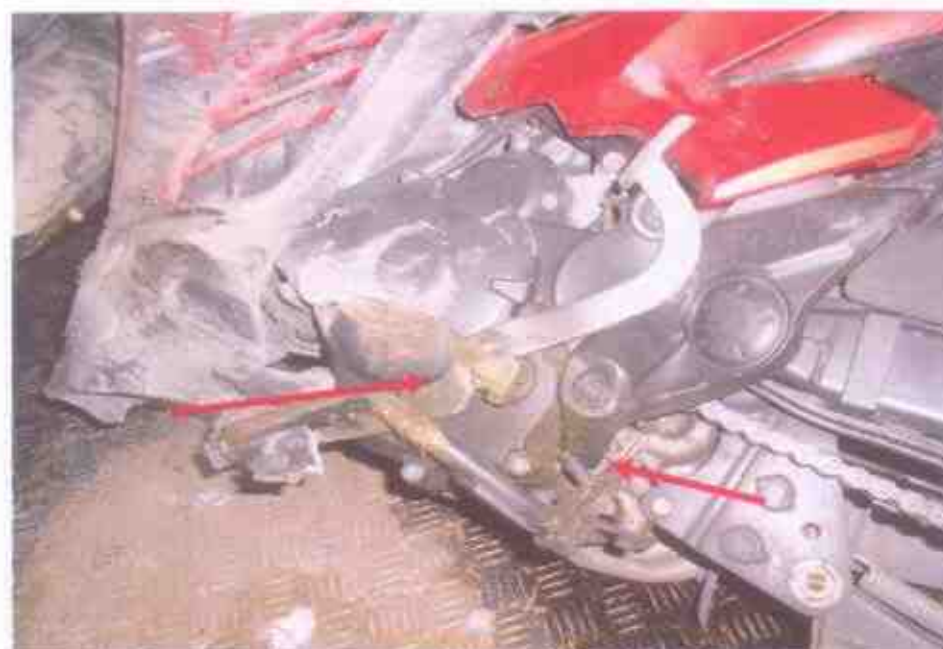
Photo 10 shows sign(s) or indication(s) of fluid leakage observed around the engine's area & fluid stain on the floor right under the engine pan of the Motorcycle.

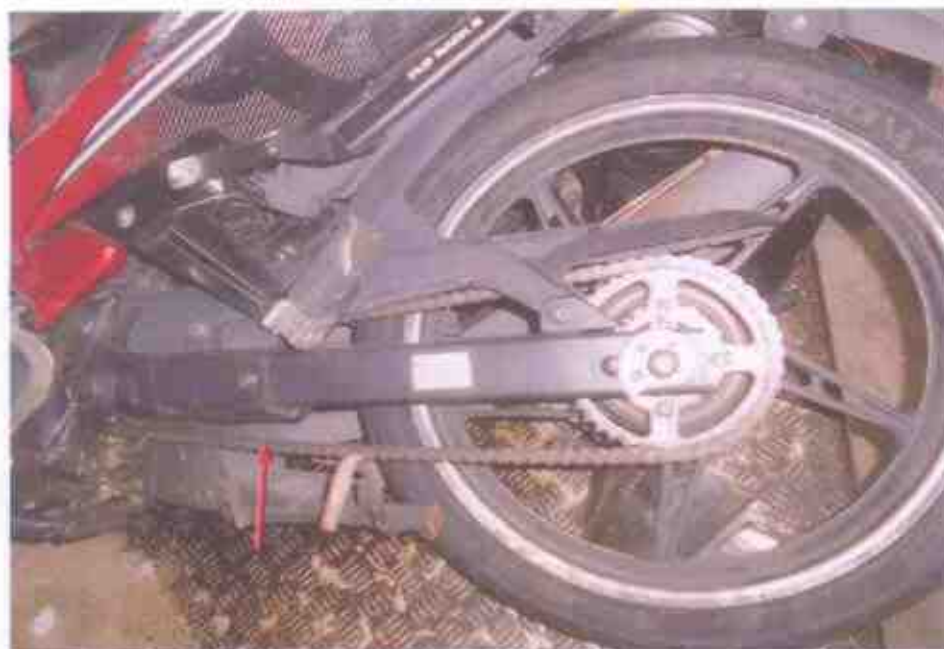
Photo 11 shows the general view of the gear train (arrowed) of the Motorcycle, which was observed to be intact with no misalignment. It was also adequately lubricated for operating purposes.

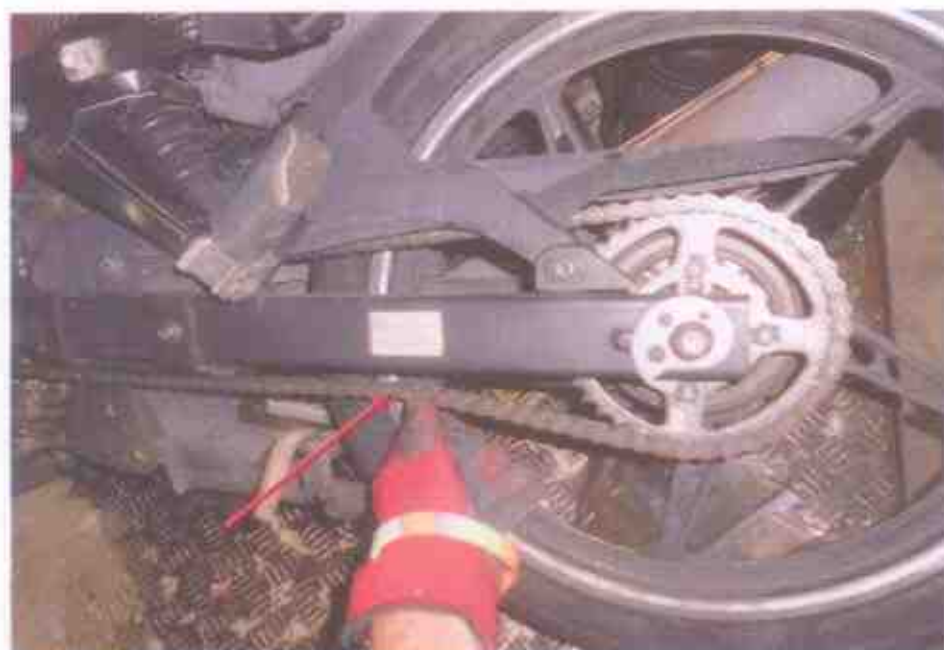
Photo 12 shows the general view of the gear train (arrowed) of the Motorcycle, which was observed to be intact with no misalignment. It was also adequately lubricated for operating purposes.

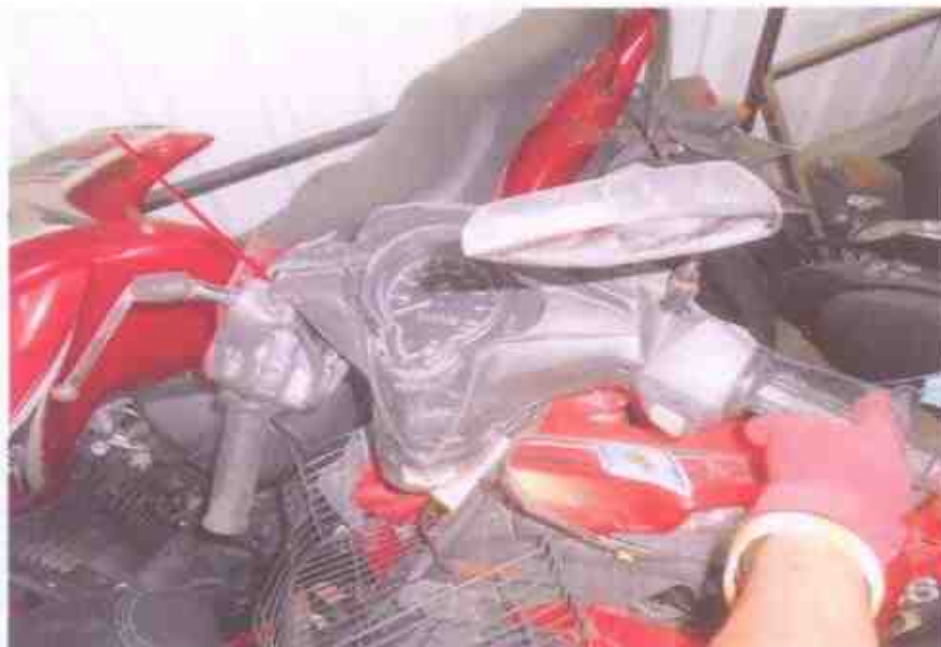
Photo 13 shows the handle bar (arrowed) was observed to be damaged as a result of the accident.

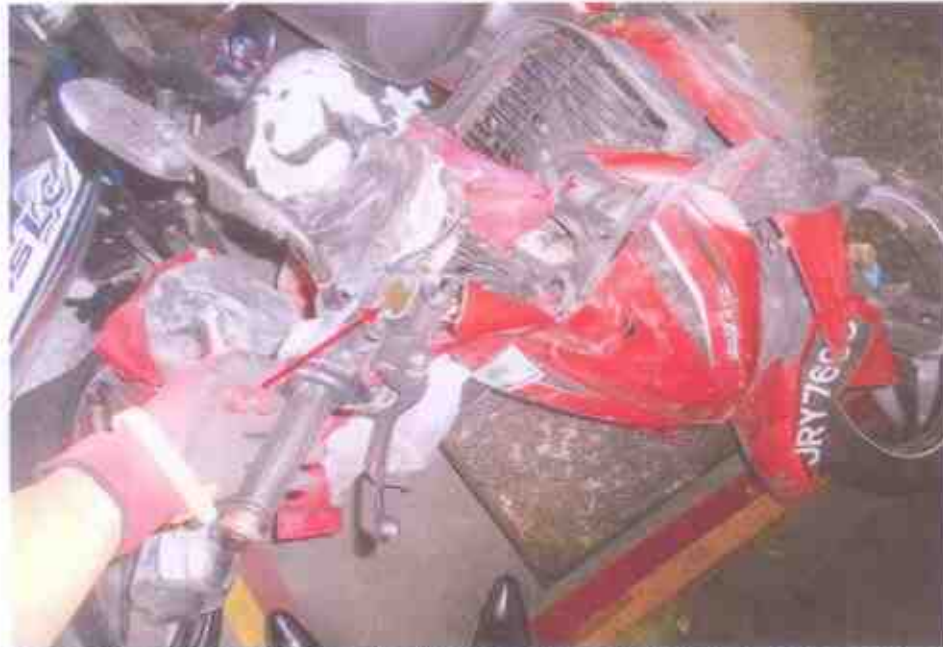
Photo 14 shows the front brake fluid reservoir (arrowed) was observed to be unaffected by the accident. It was observed to be of sufficient level & not contaminated at the time of our inspection.

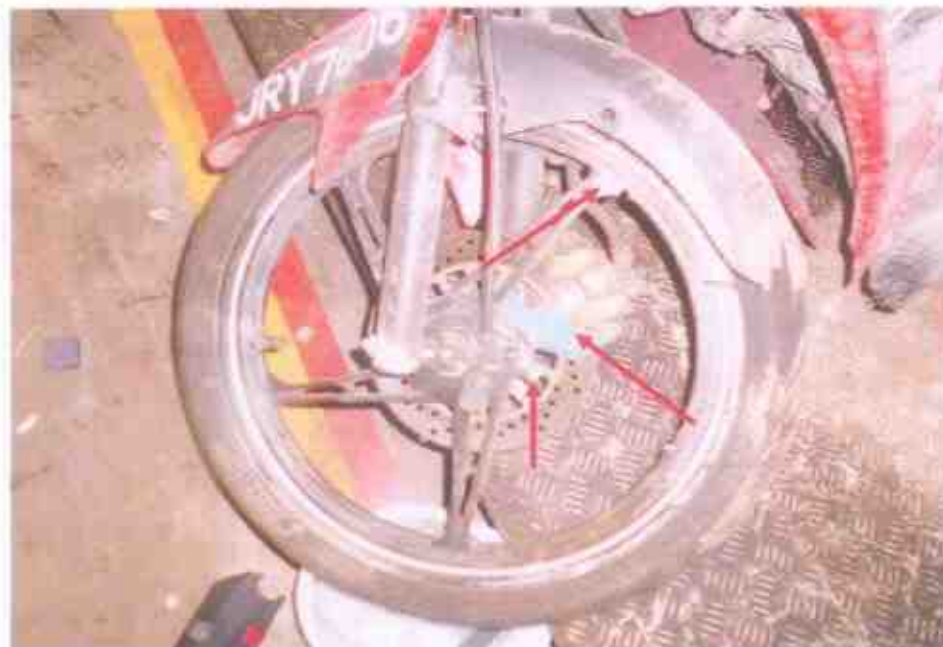
Photo 15 shows the front wheel rim & braking components was observed to be damaged by the accident.

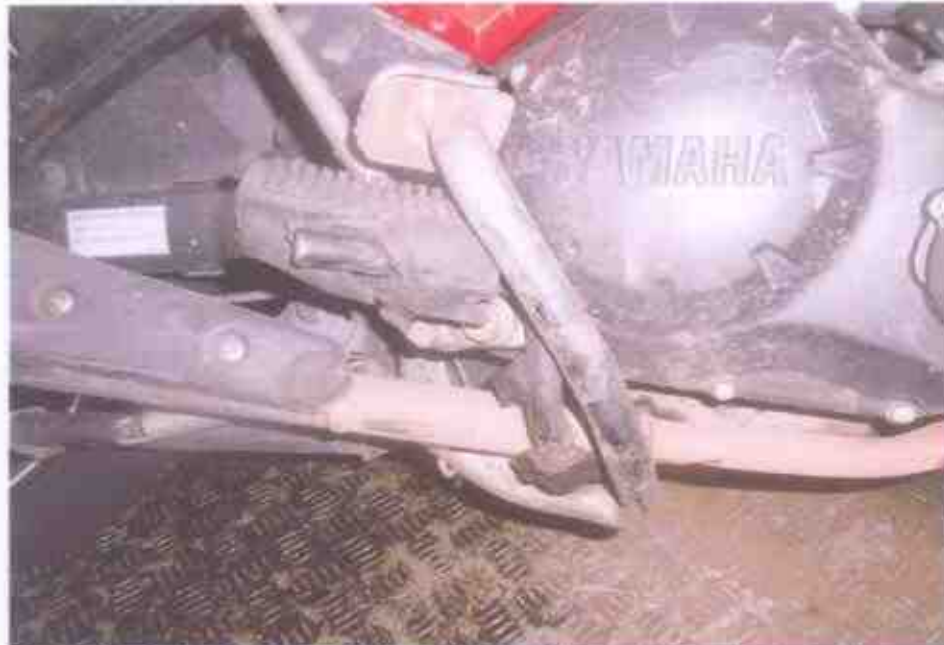
Photo 16 shows the rear brake pedal (arrowed) was observed to be in damaged due to the accident's impact collision.

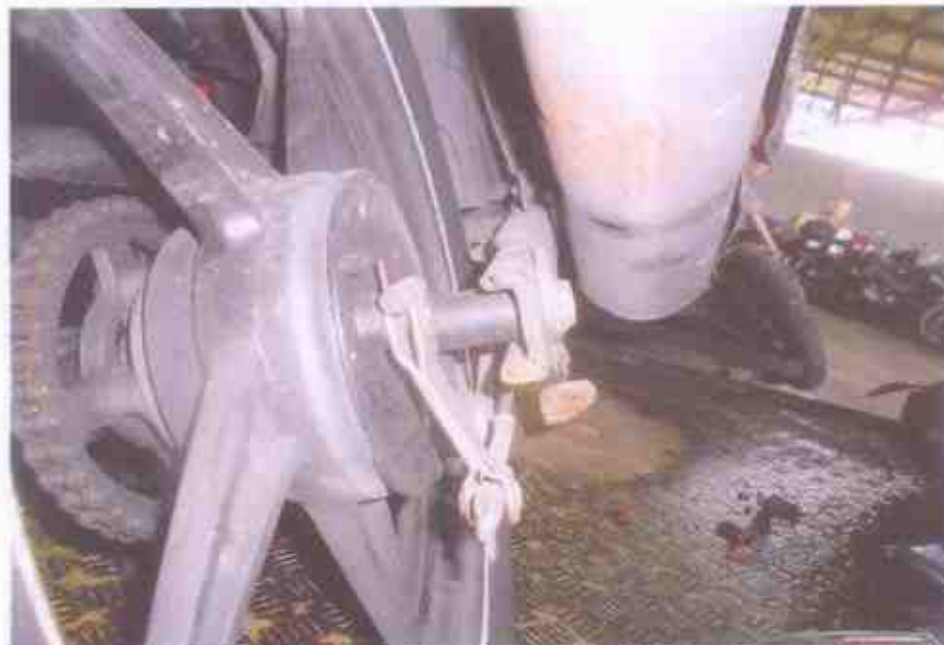
Photo 17 shows the rear brake drum spring & cable was observed to be in serviceable condition unaffected by the accident despite the damage sustained on the foot brake pedal.

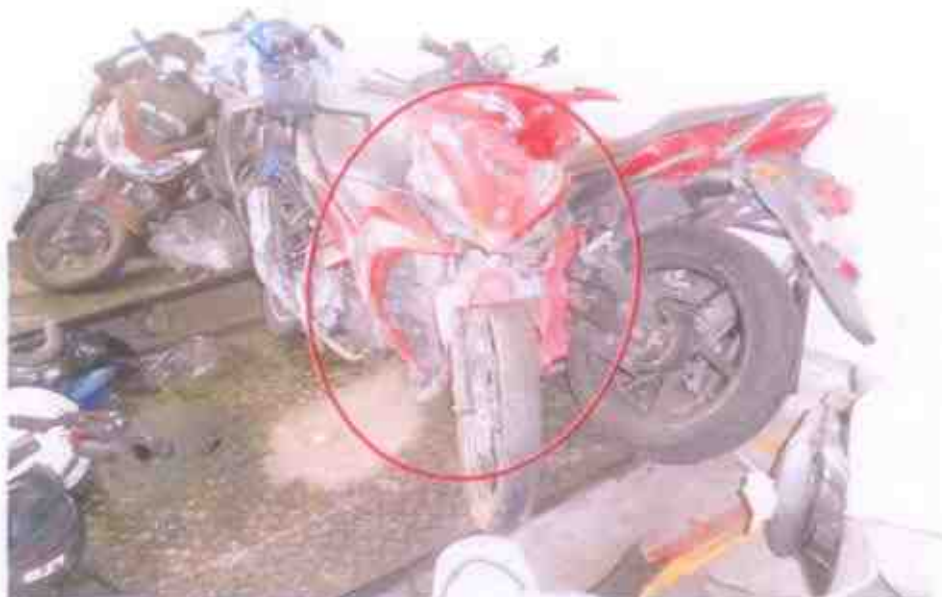
Photo 18 shows the front fork (circled) was observed to be misaligned & the brake disc was damaged as a result of the accident. Hence, we are unable to conduct any tests on the steering system of the Motorcycle. However, the brake pad was noted to be with sufficient frictional material at time of our inspection.

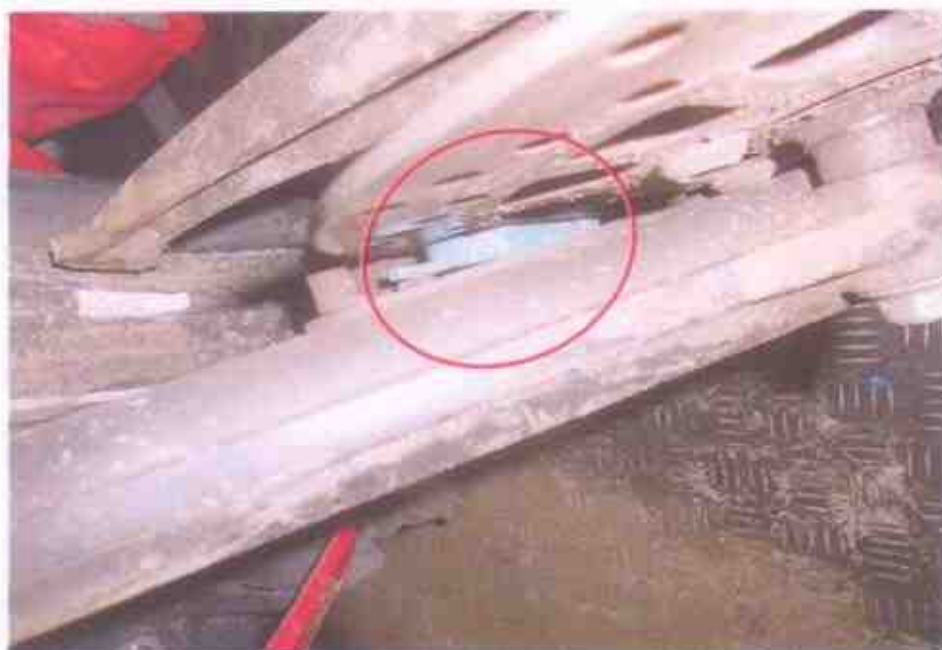
Photo 19 shows the brake pad was noted to be with sufficient frictional material at time of our inspection.
