Your Ref: TP/IP/38117/2018  
Our Ref : CI/TPD18013732/Z

**Fatal Accident Investigation Team**  
Traffic Police Department  
Singapore Police Force  
10 Ubi Avenue 3  
Singapore 408865

### **MECHANICAL INSPECTION REPORT OF MOTORCYCLE JSA 5371**

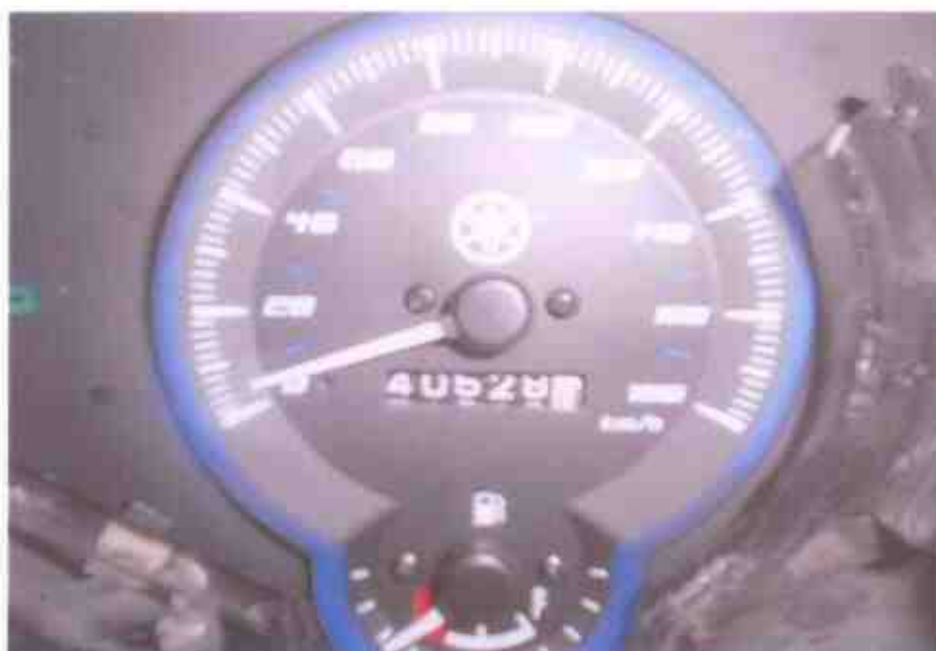
Photo 1 shows the mileage of the Motorcycle at the time of our inspection was recorded at 405288km.

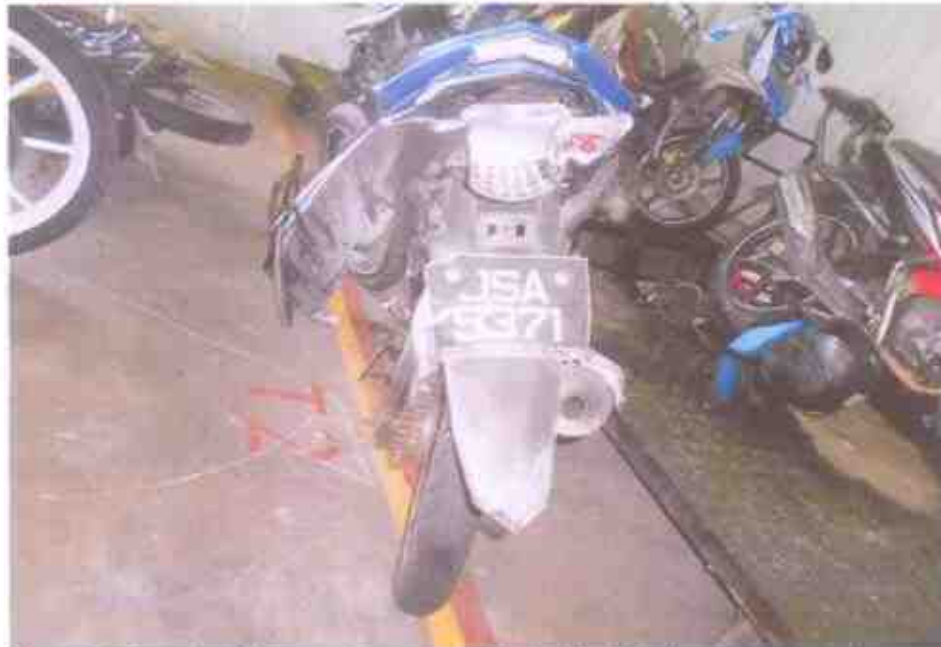
Photo 2 shows the Motorcycle number plate for identification.

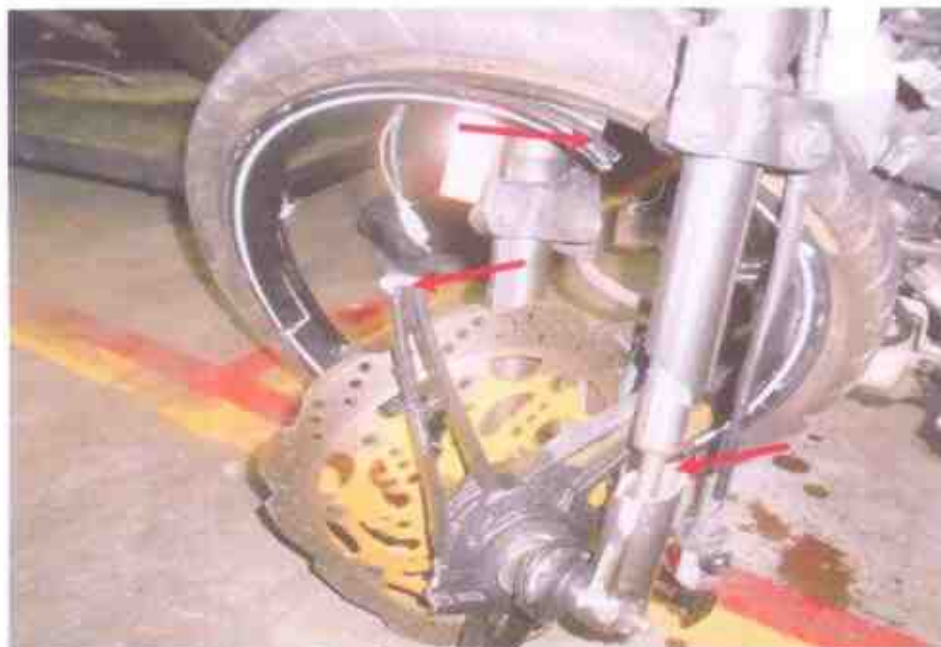
Photo 3 shows a general view of the front wheel of the Motorcycle at the time of our inspection. The Motorcycle was observed to have sustained with relatively extensive impact due to the accident collision. Amongst the body parts damaged was its front fork & broken rim (arrowed), which was observed to be broken.

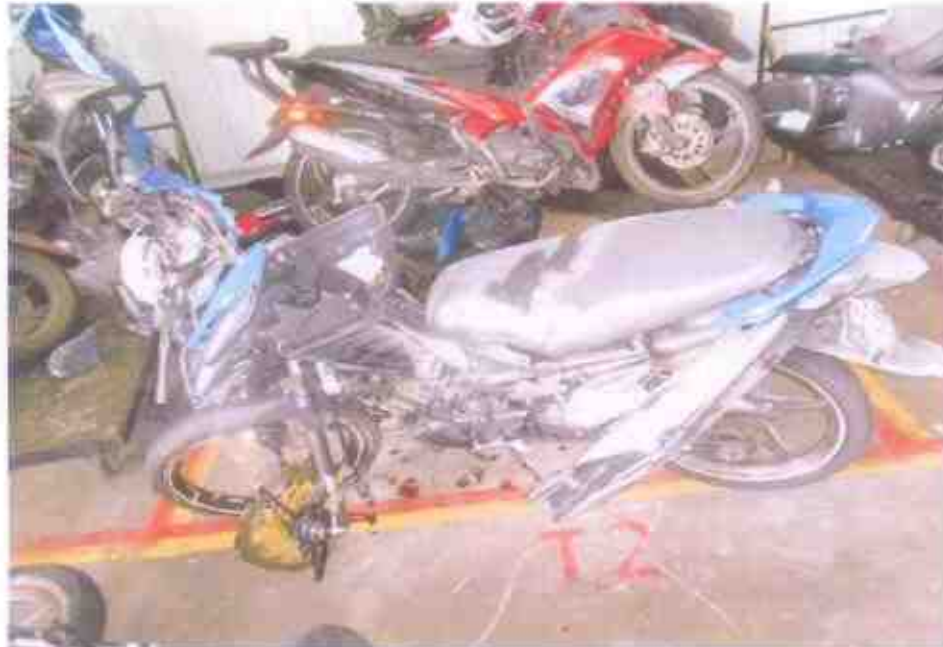
**Photo 4** shows a general view of the left body of the Motorcycle at the time of our inspection. The Motorcycle was observed to have sustained damages at the frontal portion, rear portion, along both its left side and right side.

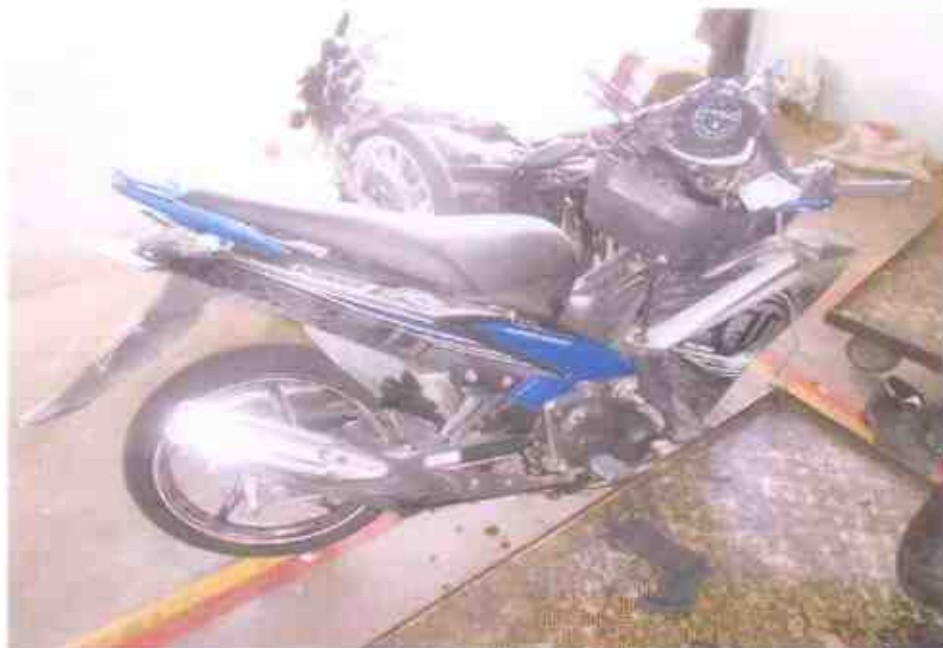
**Photo 5** shows a general view of the right portion of the Motorcycle at the time of our inspection. The Motorcycle was observed to have sustained relatively extensive impact due to the accident collision.

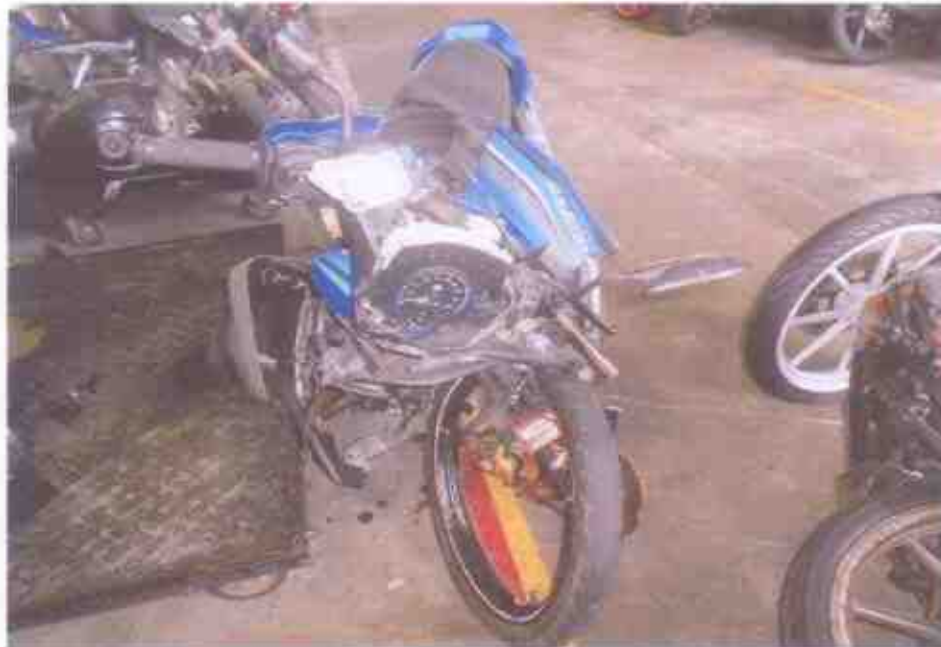
Photo 6 shows a close-up view of the frontal portion of the Motorcycle at the time of our inspection. The Motorcycle was observed to have sustained relatively extensive impact including damages to the steering system to the accident collision.

13. For this case, we were not able to conduct any test(s) on the steering system of the Motorcycle due to the damages on its handle bar, front fork and broken front wheel rim. It was found to be damaged as a result of the accident, hence causing the whole steering system to be in a state of immobility.

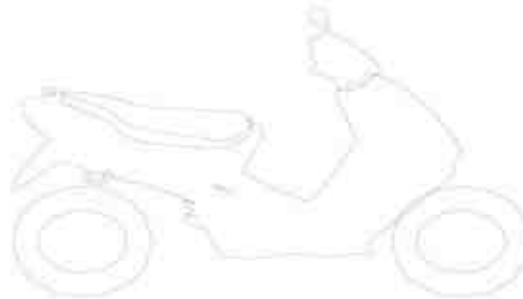
Maxxis 70/90 – 17(2mm)

Maxxis 70/90 – 17(1.6mm)

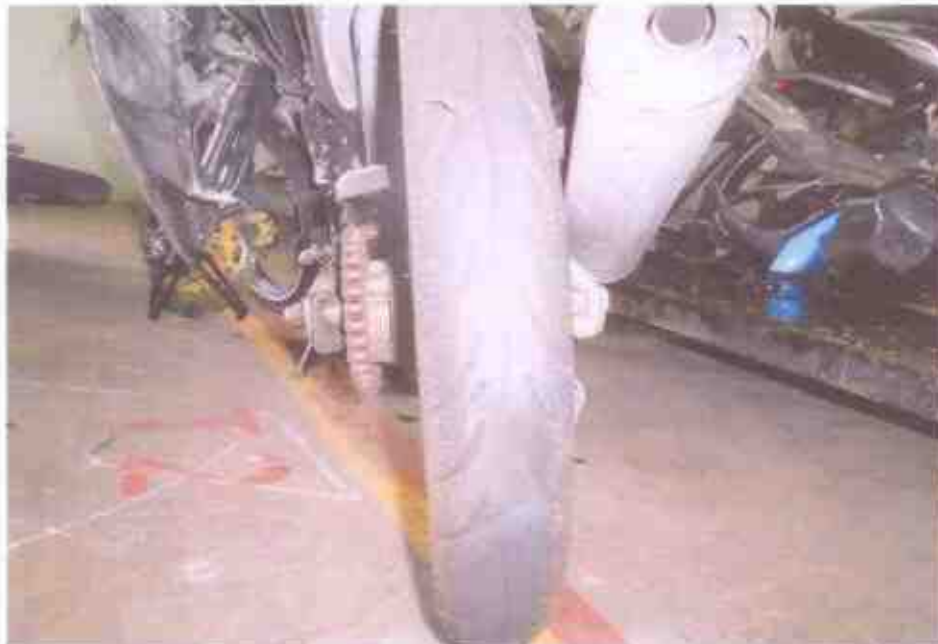
**Photo 7** shows the rear tyre of the Motorcycle at the time of our inspection. The rear tyre was observed to be in serviceable condition with remaining tread depth of approximately 2mm. The tyre was also observed to be sufficiently inflated for vehicular operation. There was no significant damage observed on the rear wheel rim & tyre.

18. The condition of the Motorcycle's rear tyre was observed to be in serviceable condition. The tread pattern of the rear tyre was clearly visible. We did not observe any tear, burst mark(s) and/or punctured hole(s) on the sidewalls as well as across the tread of the rear tyre. Its tread depth was measured & found to be around approximately 2mm.

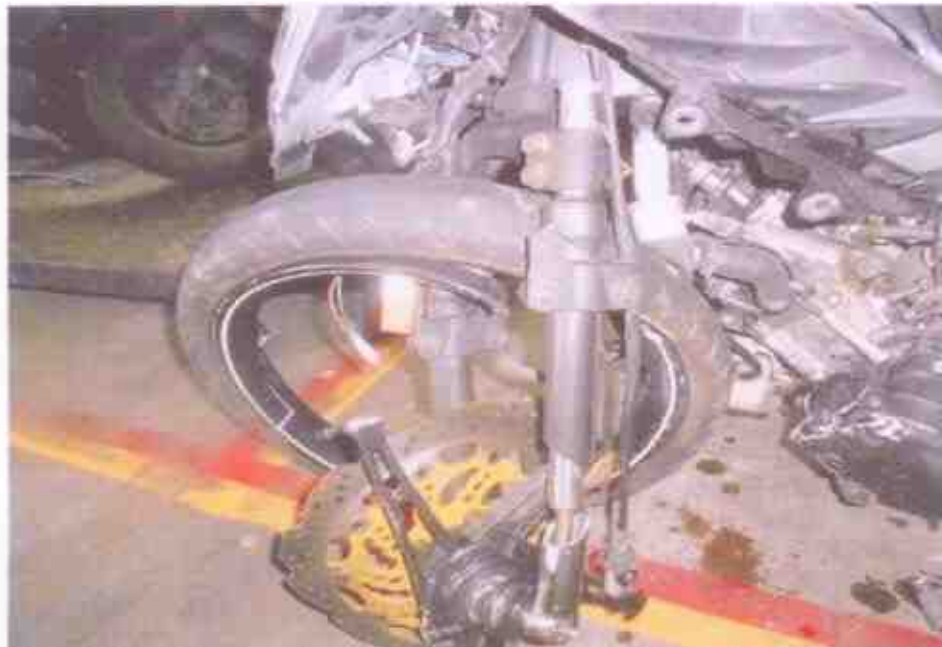
**Photo 8** shows the front tyre of the Motorcycle at the time of our inspection. The pattern of the tread was clearly visible. There was no tear, burst mark(s) and/or punctured hole(s) on the sidewalls as well as across the tread of the front tyre. However, the wheel rim was observed to be broken as a result of the accident.

19. As for the front tyre, it was found to be deflated likely due to the broken wheel rim as a result of the accident's collision. However, the tread pattern of the front tyre was clearly visible with tread depth of 1.6mm. We did not observe any tear, burst mark(s) and/or punctured hole(s) on the sidewalls as well as across the tread of the front tyre.

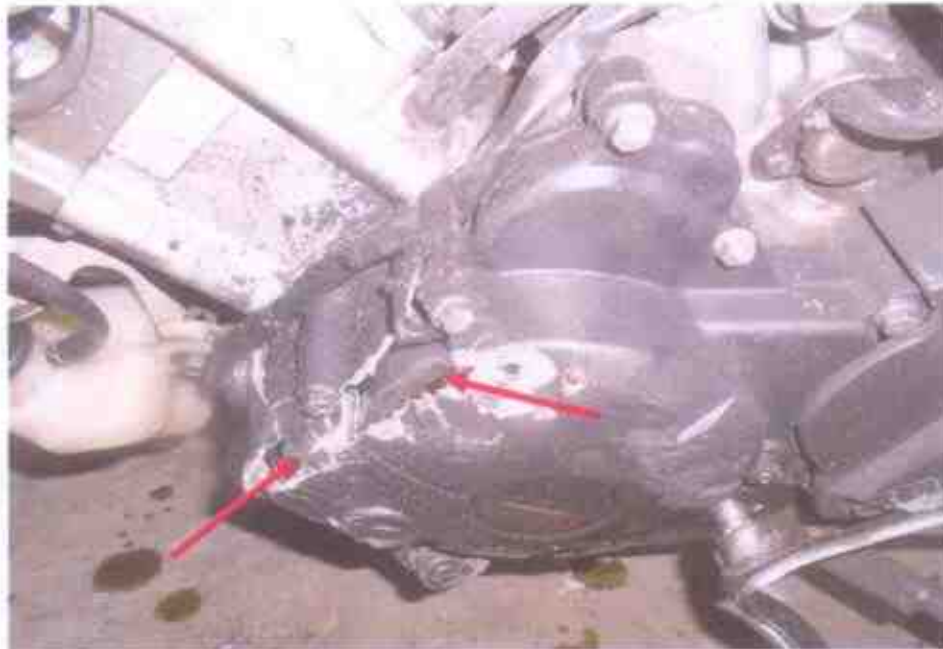
11. Upon examination of the Motorcycle's engine area, we had observed that the engine block had sustained with extensive damages due to the accident's collision impact. Hence, causing the operating fluids such as engine fluid to leak from the cracked/ damage areas.
12. The gear chain of the Motorcycle was found to be intact without any misalignment. It was also adequately lubricated for operating purposes. See photo 9 – 12 below.

Photo 9 shows sign(s) or indication(s) of fluid leakage observed around the engine's underside area of the Motorcycle.

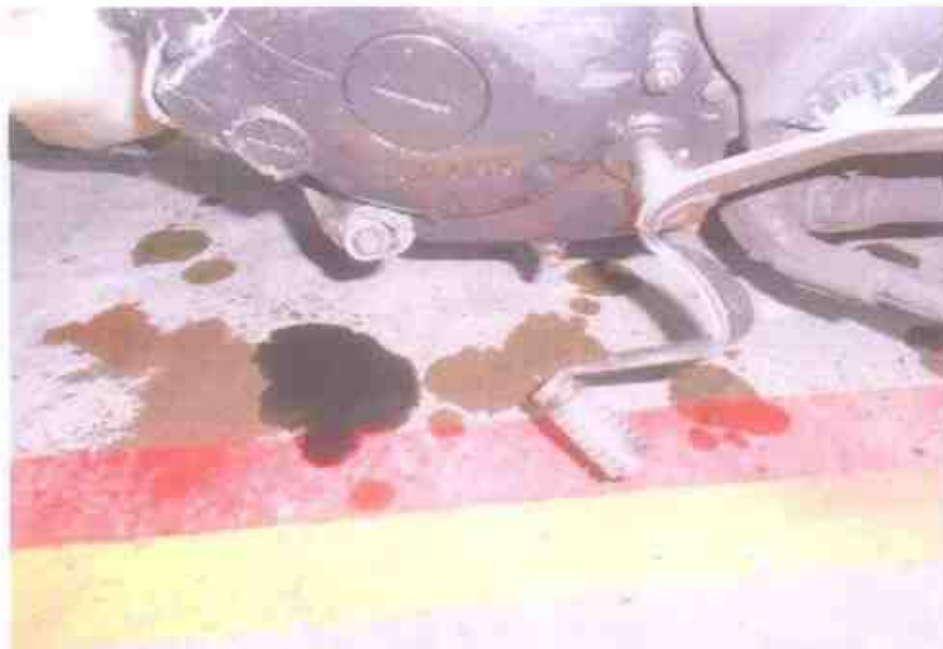
Photo 10 shows sign(s) or indication(s) of fluid leakage observed around the engine's area & fluid stain on the floor right under the engine pan of the Motorcycle.

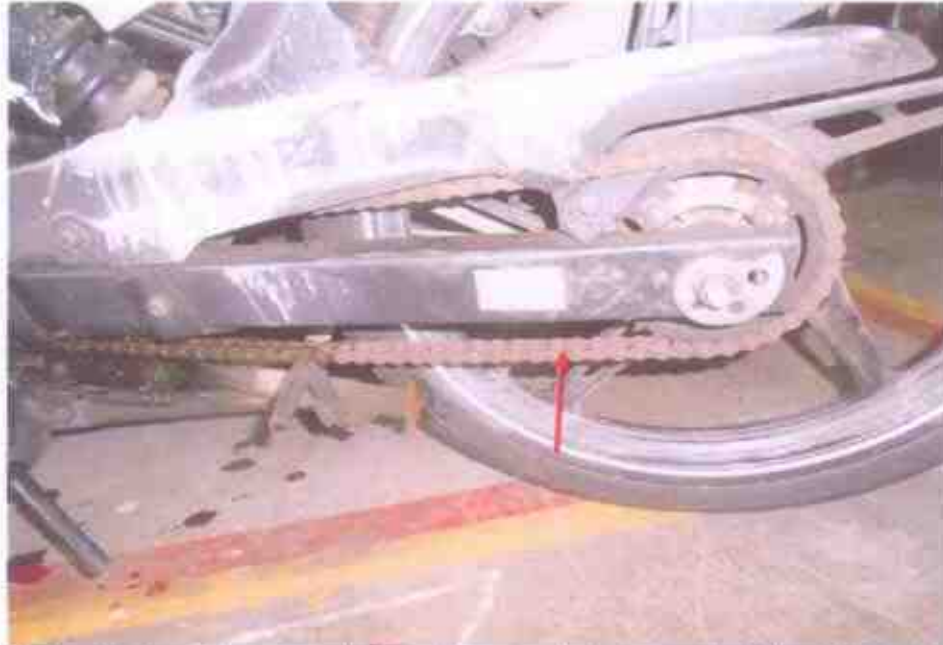
**Photo 11** shows the general view of the gear train (arrowed) of the Motorcycle, which was observed to be intact with no misalignment. It was also adequately lubricated for operating purposes.

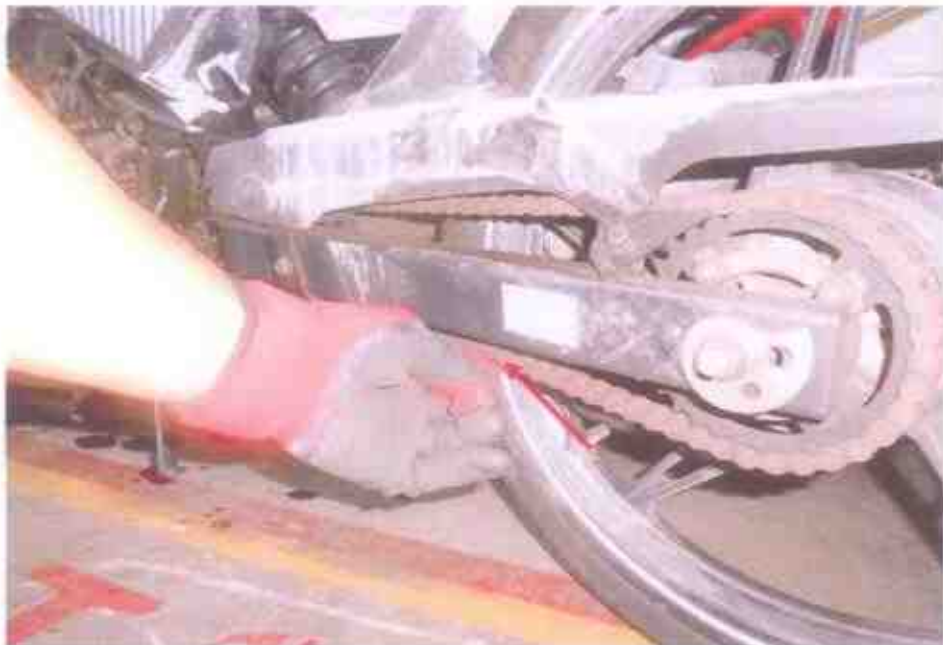
**Photo 12** shows the general view of the gear train (arrowed) of the Motorcycle, which was observed to be intact with no misalignment. It was also adequately lubricated for operating purposes.

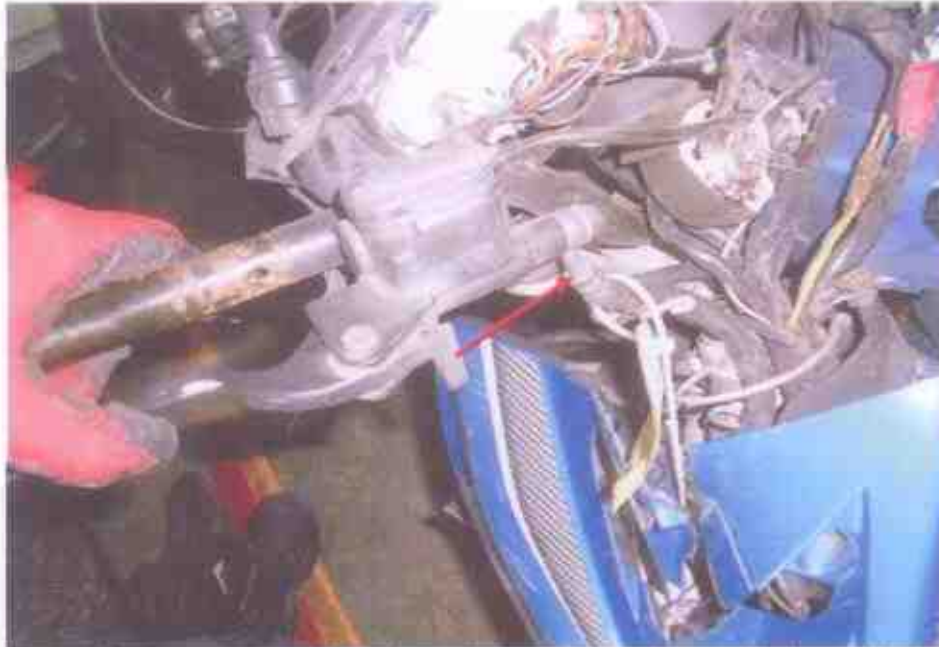
Photo 13 shows the hand brake lever (arrowed) was observed to be unaffected by the accident. However, we are unable to conduct any tests on the braking system of the Motorcycle due to some other braking system were damaged as a result of the accident.

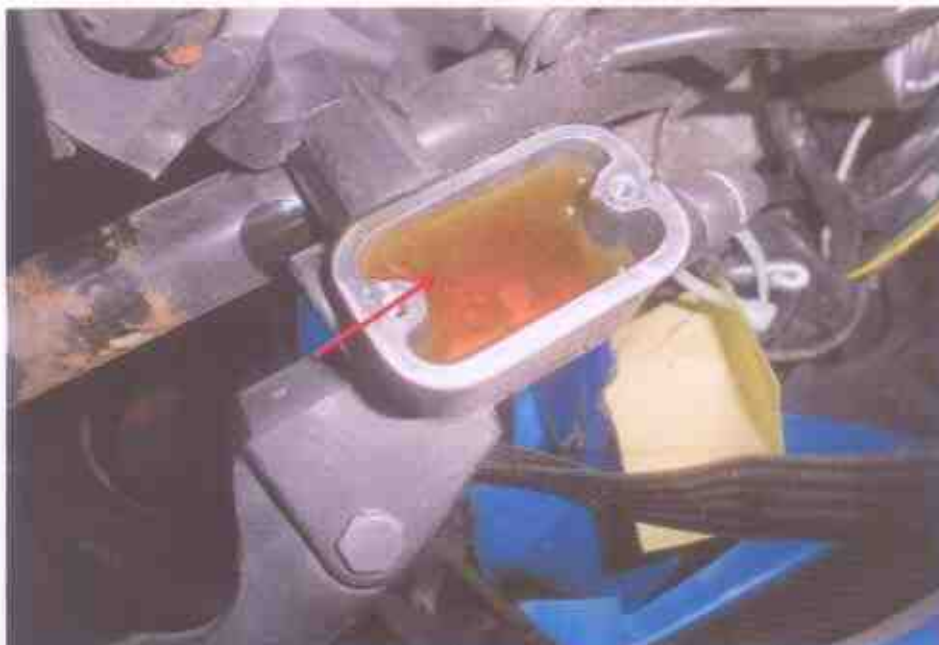
Photo 14 shows the front brake fluid reservoir (arrowed) was observed to be unaffected by the accident. It was observed to be of sufficient level & not contaminated at the time of our inspection.

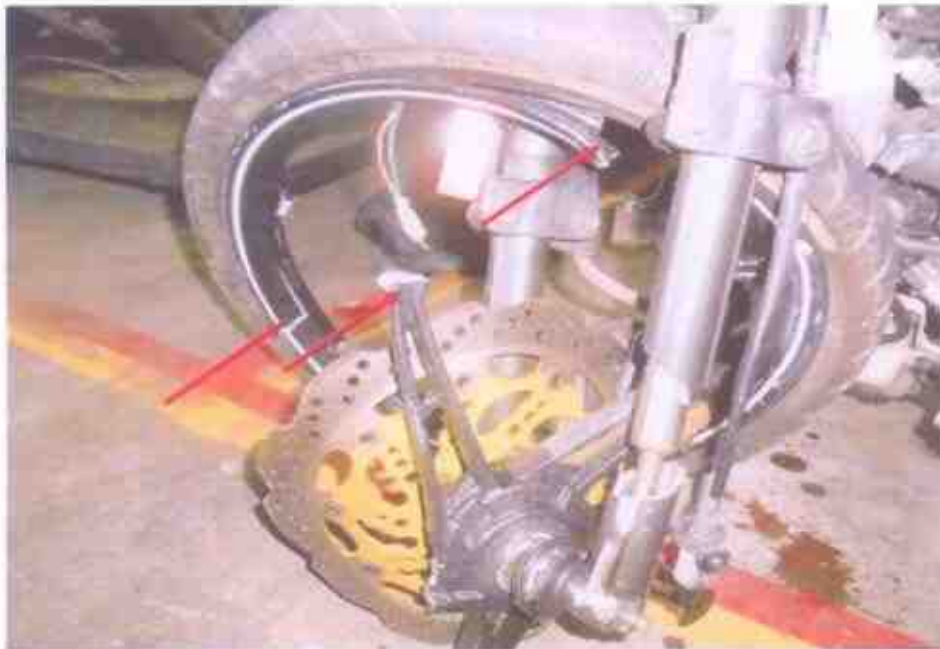
15. Static brake tests was unable to be conducted on the Motorcycle front braking system due to some braking components were noted to be extensively damaged such as front brake calliper & brake disc at the material time of our inspection. As for the rear brake, static brake test was conducted successfully. It was observed to be in serviceable condition unaffected by the accident's impact collision.

Photo 15 shows the front brake was observed to be dislodged from the original installation affected by the accident.

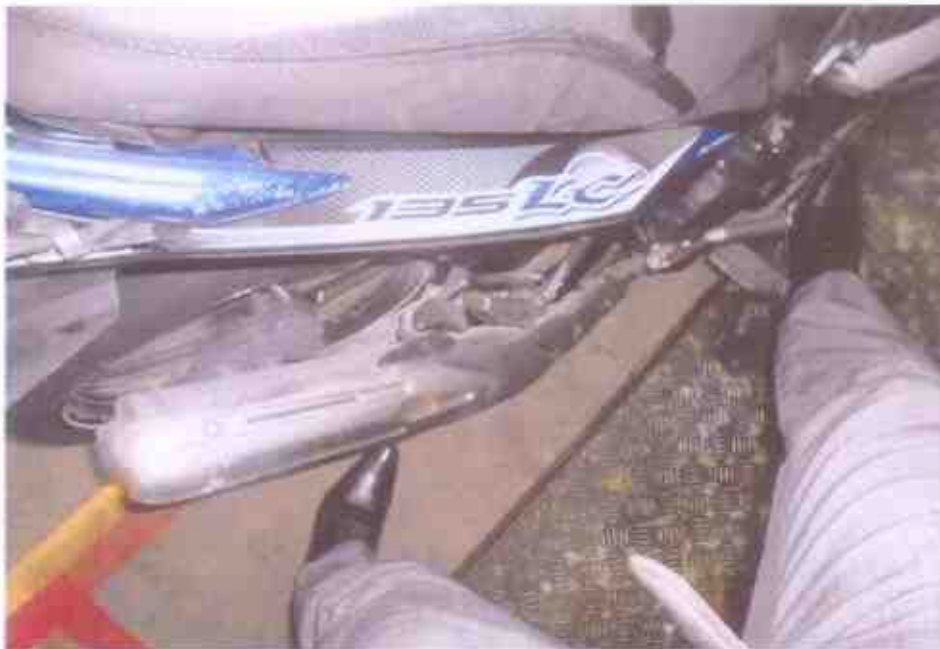
Photo 16 shows the rear brake pedal (arrowed) was observed to be in serviceable unaffected by the accident.

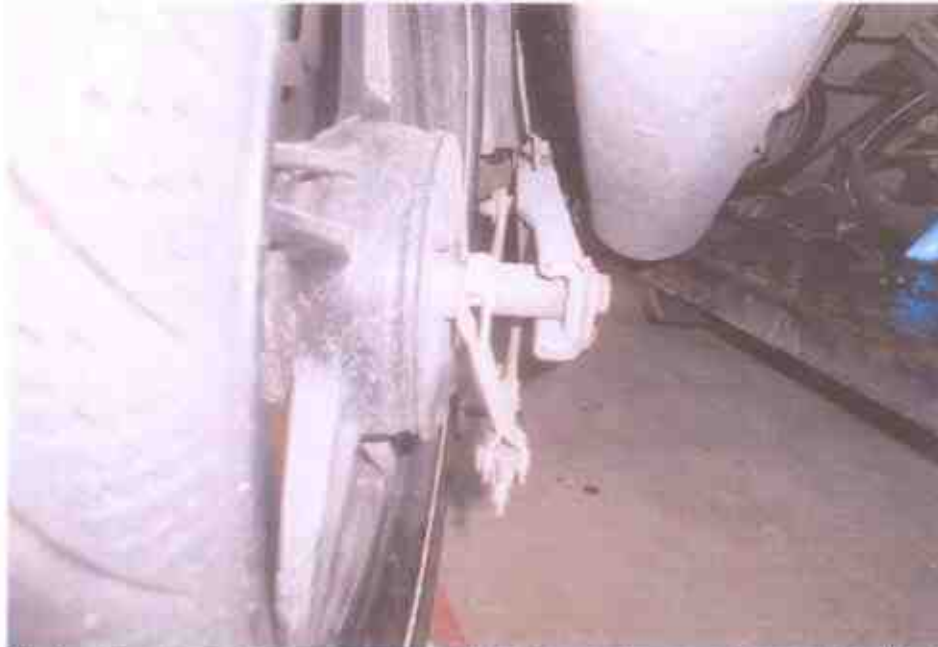
Photo 17 shows the rear brake pedal (arrowed) was observed to be in serviceable unaffected by the accident.

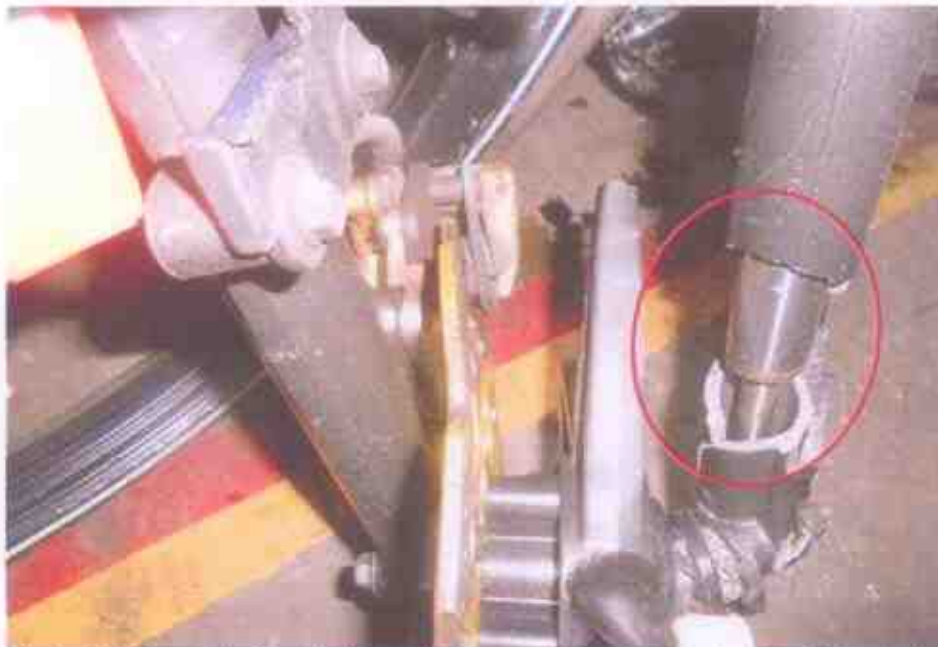
Photo 18 shows the front fork (circled) was observed to be broken & the brake disc was damaged as a result of the accident. Hence, we are unable to conduct any tests on the steering system of the Motorcycle. However, the brake pad was noted to be with sufficient frictional material at time of our inspection.
