Your Ref: TP/IP/38117/2018  
Our Ref : CI/TPD18013735/Z

**Fatal Accident Investigation Team**  
Traffic Police Department  
Singapore Police Force  
10 Ubi Avenue 3  
Singapore 408865

### **MECHANICAL INSPECTION REPORT OF MOTORCYCLE FBH 5117Z**

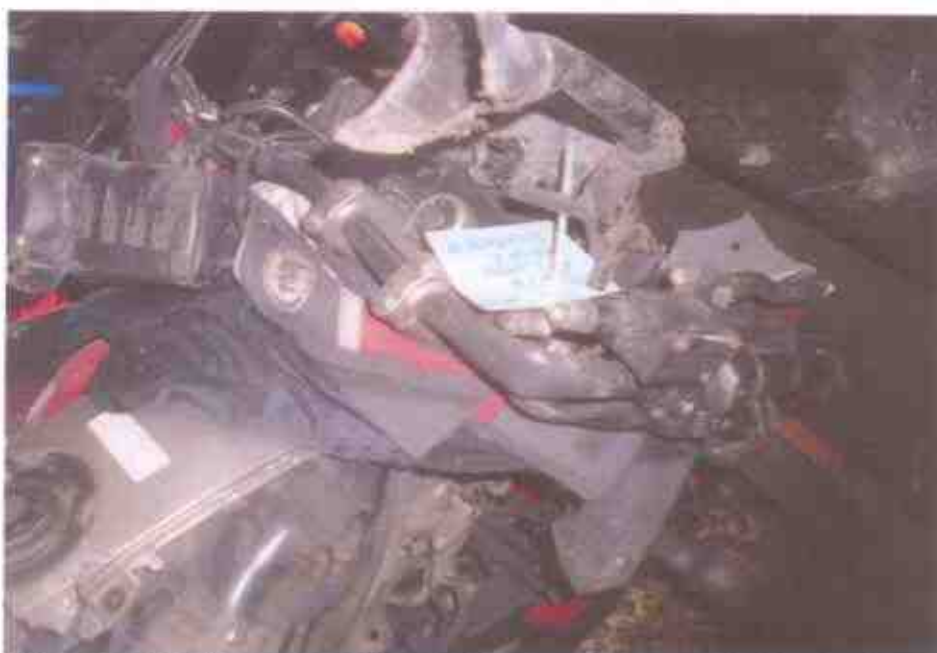
4. The mileage of the Motorcycle at the time of our inspection was not recorded due to missing speedo meter as a result of the accident.
5. The Motorcycle was observed to have sustained severe damages at the frontal portion, rear portion & along both its left side and right side. The body parts that were found to have been damaged includes its missing front head lamp & speedo meter, handle bar, left & right wing mirrors, chassis structure, rear brake pedal, seat assembly and rear portion amongst others. Its front forks assemblies were also observed to be severely damaged as a result of the accident.

**Photo 1** shows the mileage of the Motorcycle was not recorded due to missing speedo meter as a result of the accident.

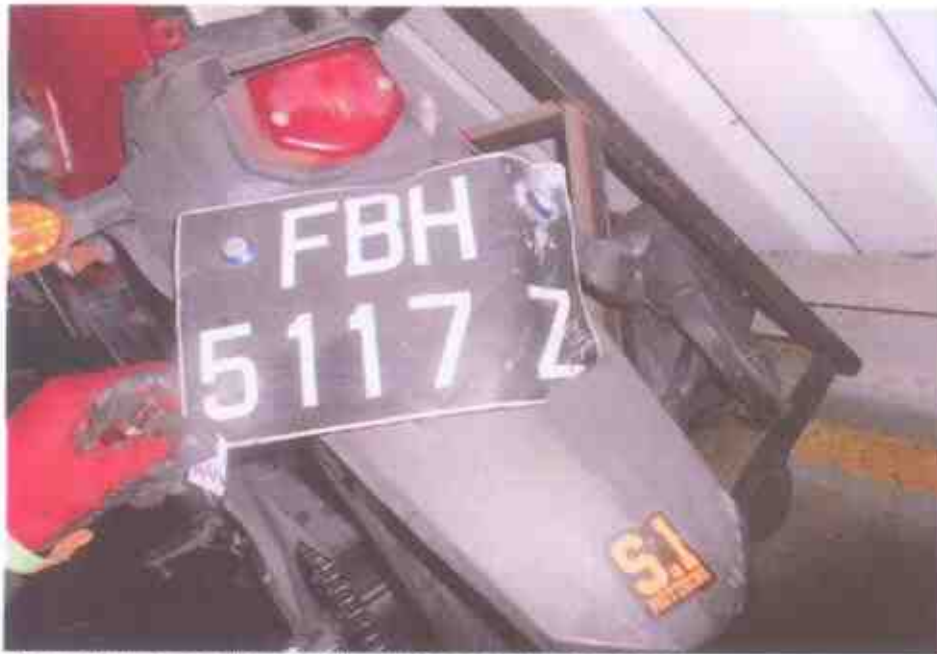
Photo 2 shows the Motorcycle number plate for identification.

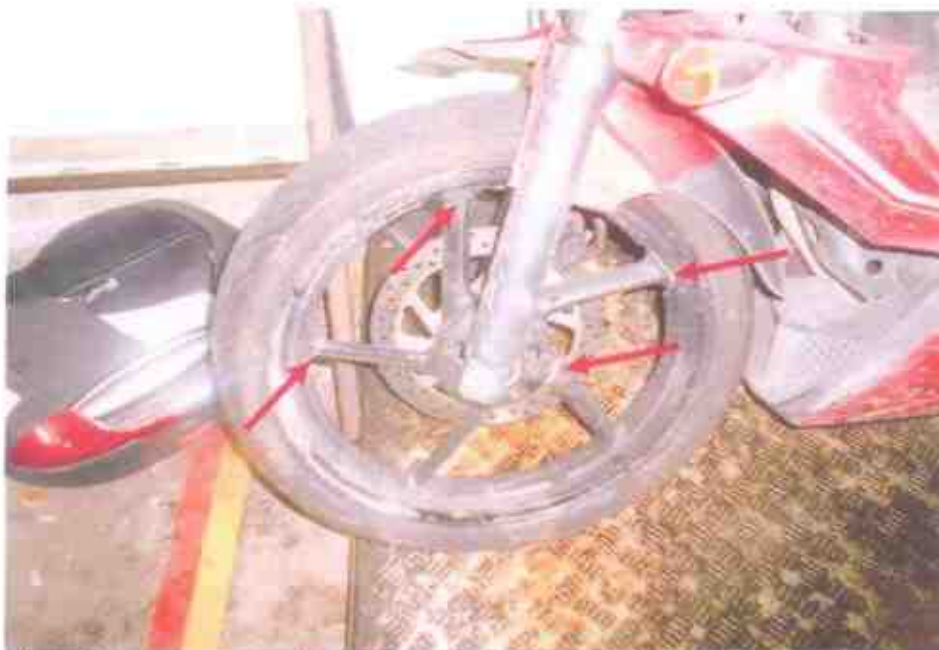
Photo 3 shows a general view of the front wheel of the Motorcycle at the time of our inspection. The Motorcycle was observed to have sustained with relatively extensive impact due to the accident collision. Amongst the body parts damaged was its front fork & broken rim (arrowed), which was observed to be broken.

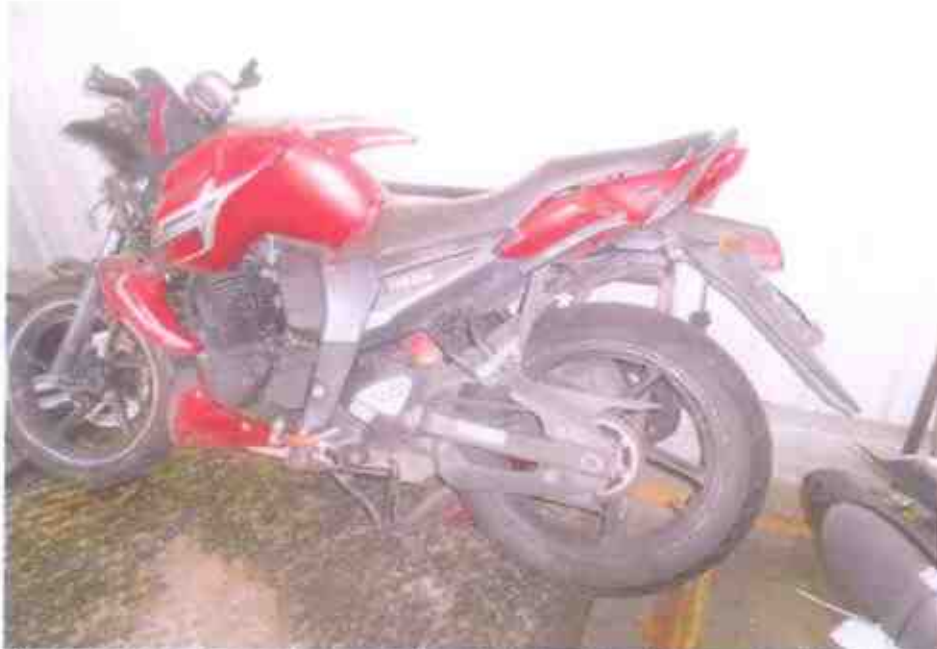
**Photo 4** shows a general view of the left body of the Motorcycle at the time of our inspection. The Motorcycle was observed to have sustained damages at the frontal portion, rear portion, along both its left side and right side.

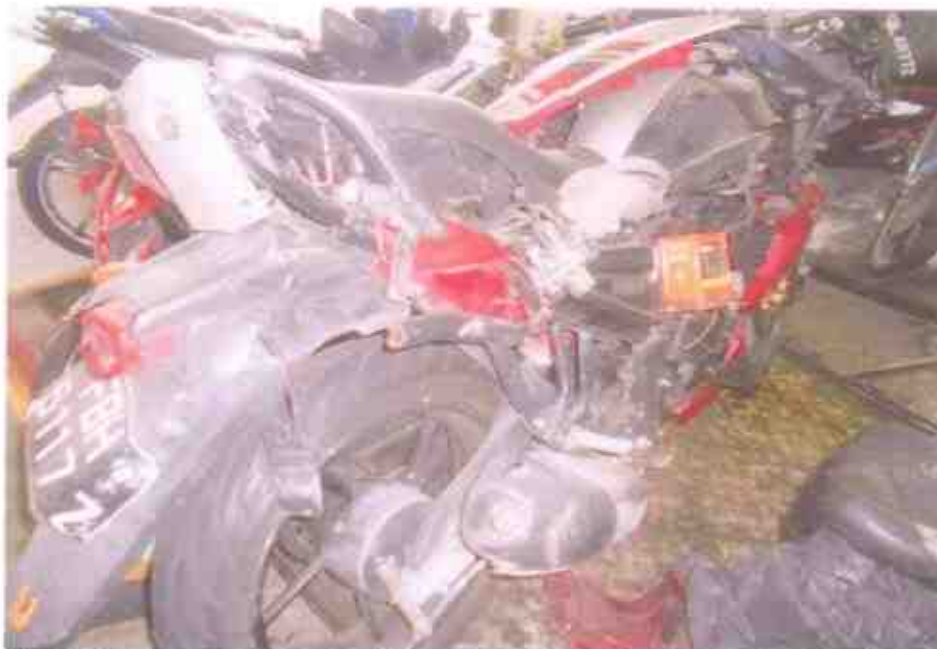
**Photo 5** shows a general view of the right portion of the Motorcycle at the time of our inspection. The Motorcycle was observed to have sustained relatively extensive impact due to the accident collision.

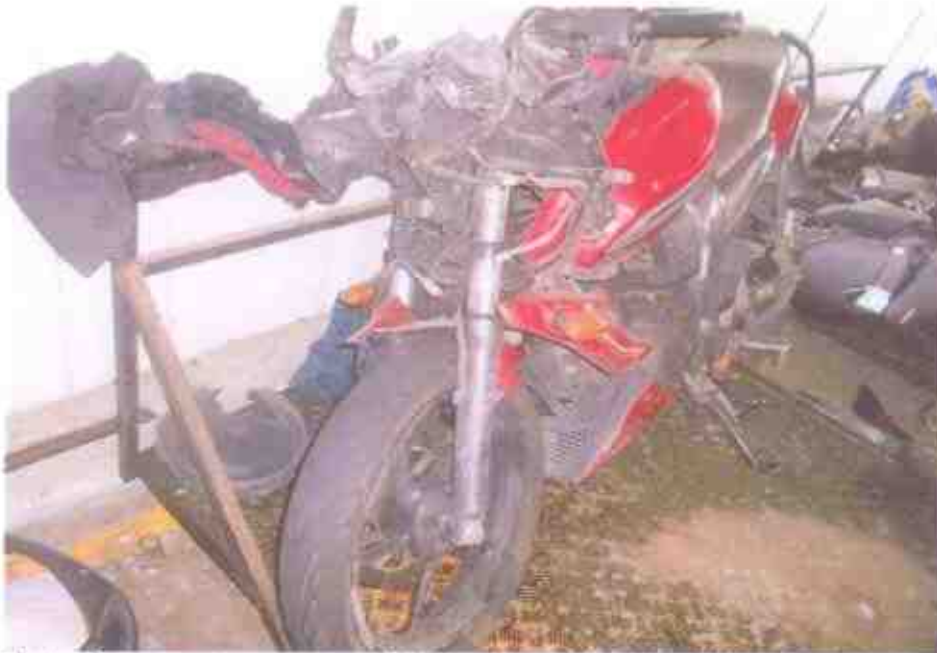
Photo 6 shows a close-up view of the frontal portion of the Motorcycle at the time of our inspection. The Motorcycle was observed to have sustained relatively extensive impact including damages to the steering system to the accident collision.

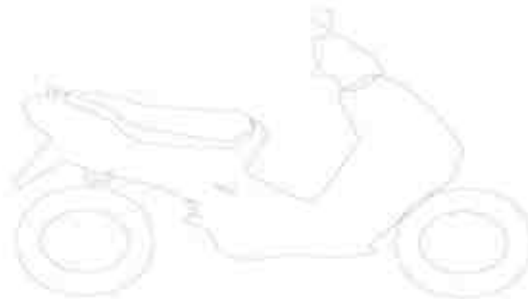
Pirelli Ngel CT 140/80 – 17(5mm)

Pirelli Ngel CT 100/80 – 17(4mm)

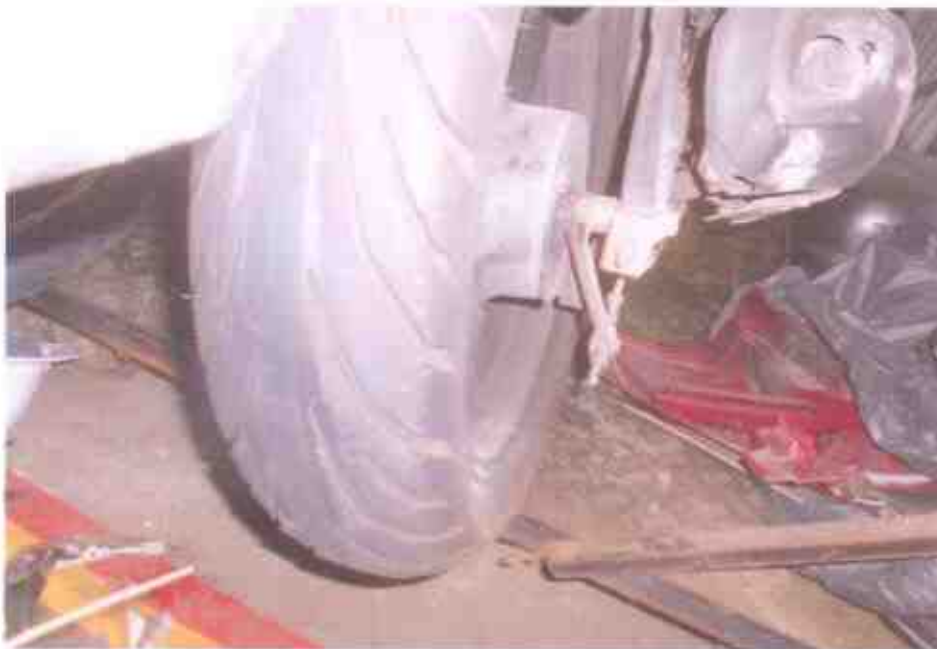
9. The rear tyre was observed to be wrapped around alloy wheel rims that were found to be without any significant damage. It was found to be in serviceable condition with adequately inflated for operational purpose.
10. As for the front wheel rim, it was noted to have sustained with damages (broken) at time of our inspection. However, was still observed to be intact & wrapped around the alloy wheel rims unaffected by the broken wheel rim that was damaged by the accident. See photo 7 & 8 below

**Photo 7** shows the rear tyre of the Motorcycle at the time of our inspection. The rear tyre was observed to be in serviceable condition with remaining tread depth of approximately 4mm. The tyre was also observed to be sufficiently inflated for vehicular operation. There was no significant damage observed on the rear wheel rim & tyre.

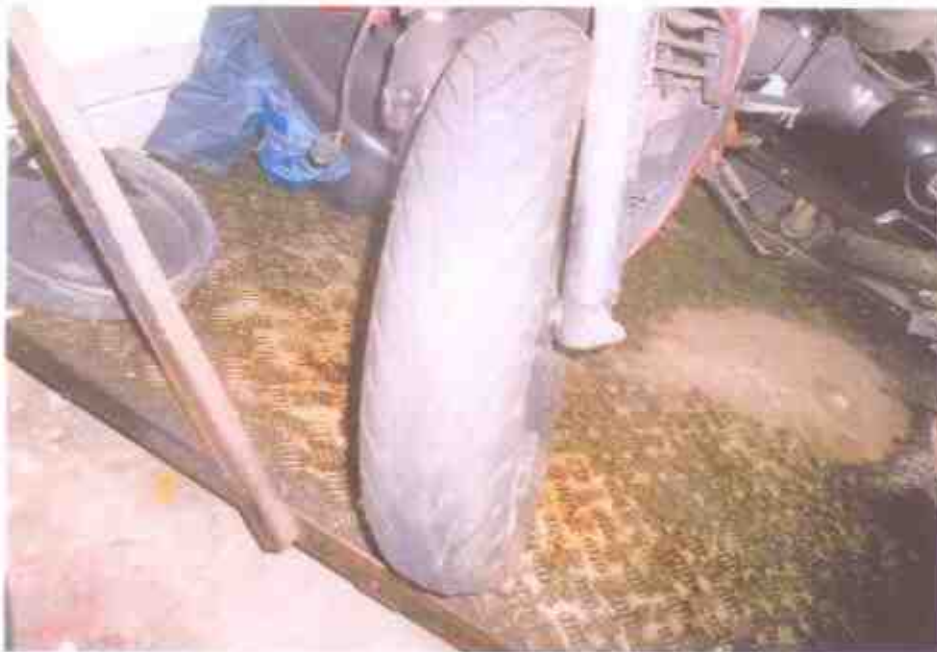
Photo 8 shows the front tyre of the Motorcycle at the time of our inspection. The pattern of the tread was clearly visible with remaining tread depth of approximately 5mm. There was no tear, burst mark(s) and/or punctured hole(s) on the sidewalls as well as across the tread of the front tyre. However, the wheel rim was observed to be broken as a result of the accident.

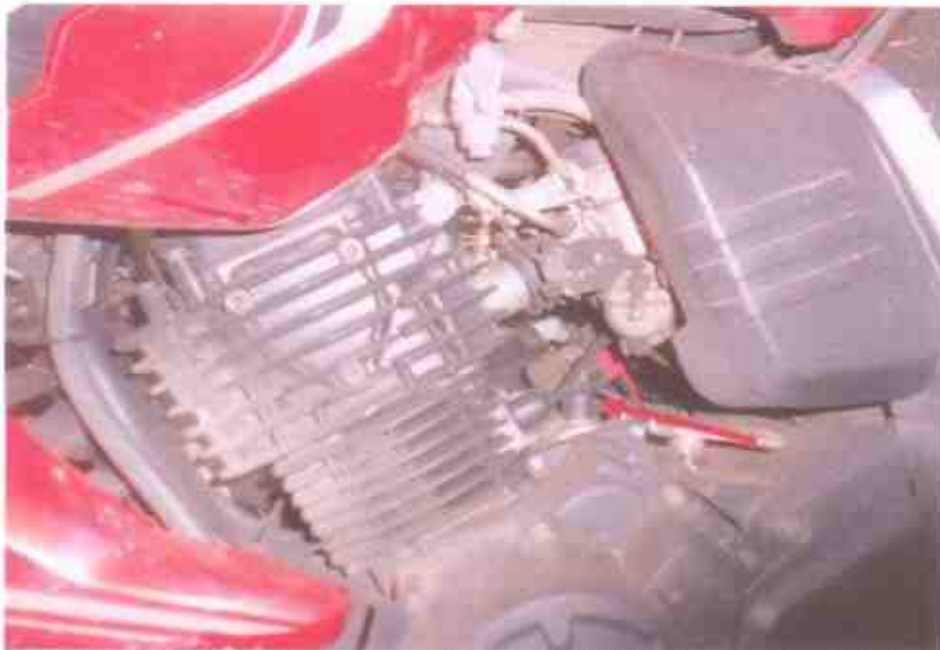
**Photo 9** shows no sign(s) or indication(s) of fluid leakage observed around the engine's underside area of the Motorcycle.

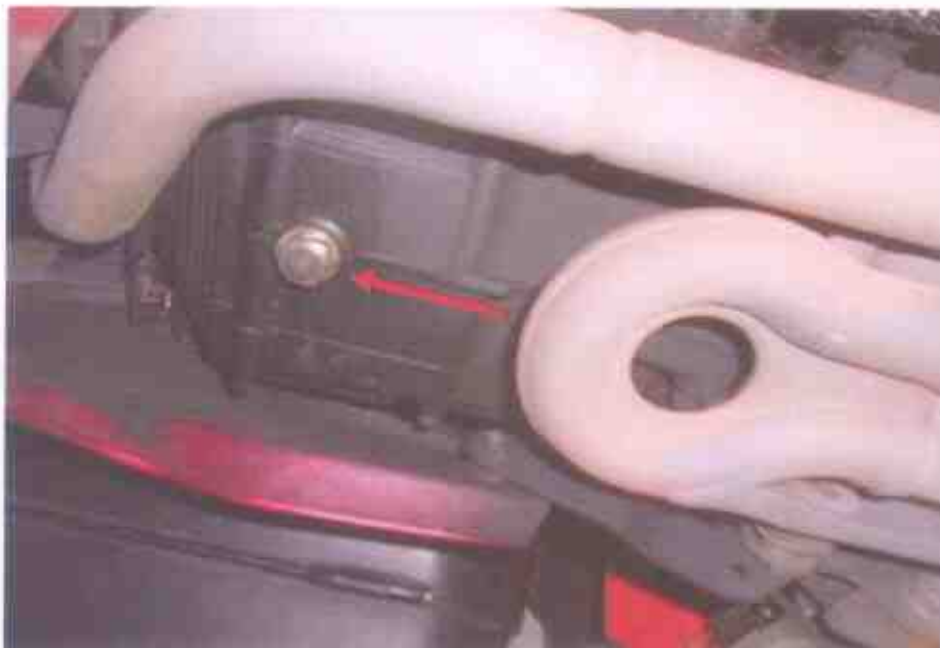
**Photo 10** shows no sign(s) or indication(s) of fluid leakage observed around the engine's undercarriage area of the Motorcycle.

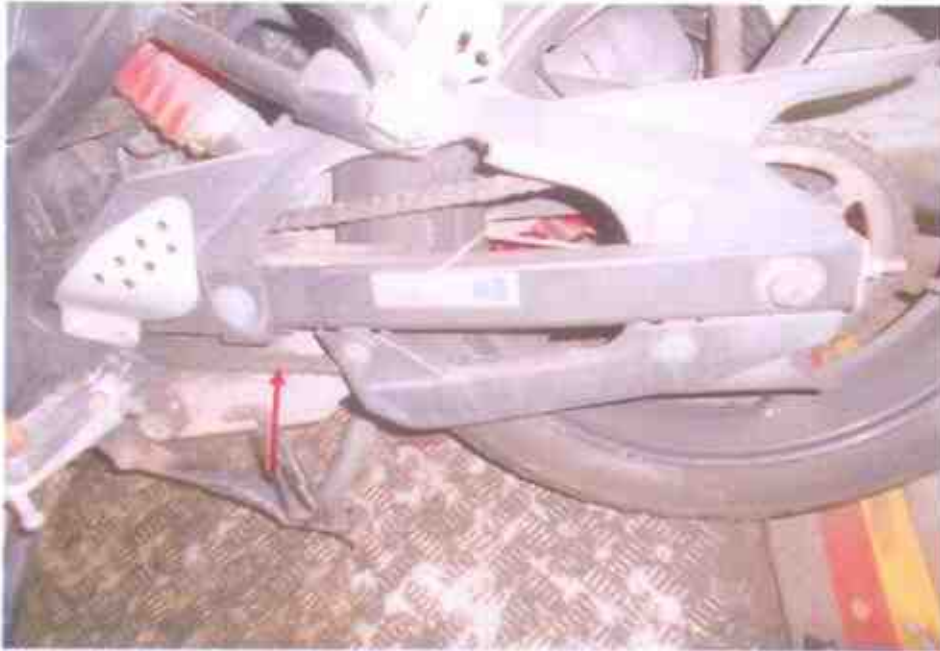
**Photo 11** shows the general view of the gear train (arrowed) of the Motorcycle, which was observed to be intact with no misalignment. It was also adequately lubricated for operating purposes.

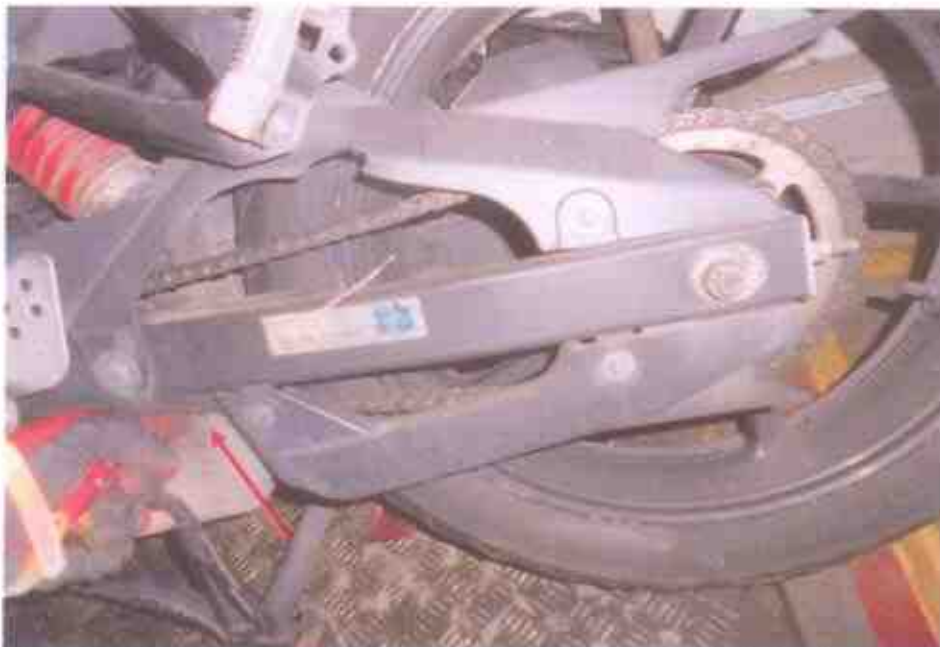
**Photo 12** shows the general view of the gear train (arrowed) of the Motorcycle, which was observed to be intact with no misalignment. It was also adequately lubricated for operating purposes.

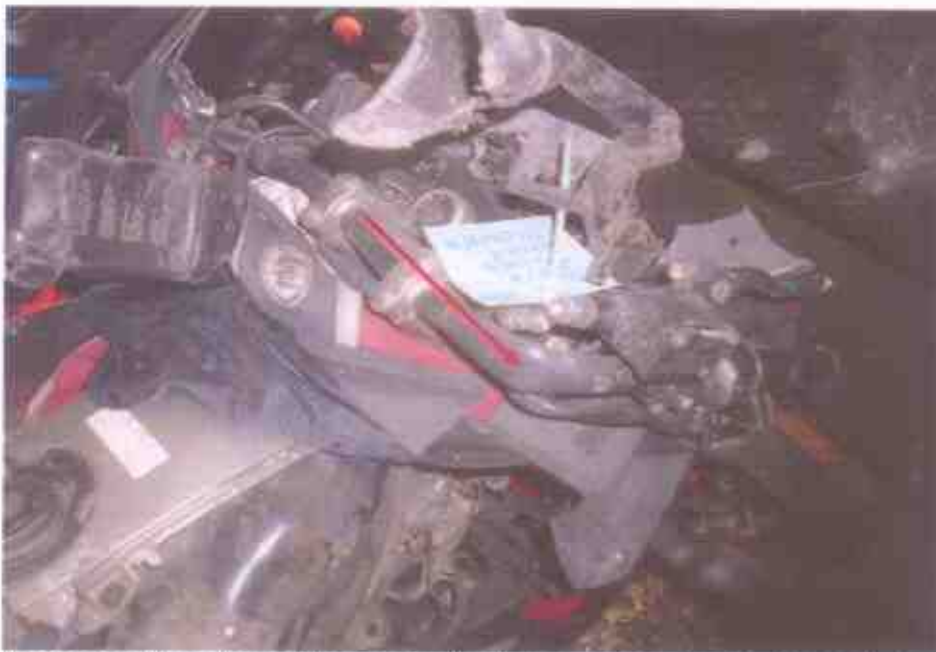
13. For this case, we were not able to conduct any test(s) on the steering system of the Motorcycle due to the damages on its handle bar, front fork and broken front wheel rim. It was found to be damaged as a result of the accident, hence causing the whole steering system to be in a state of immobility.

Photo 13 shows the handle bar (arrowed) was observed to be damaged as a result of the accident.

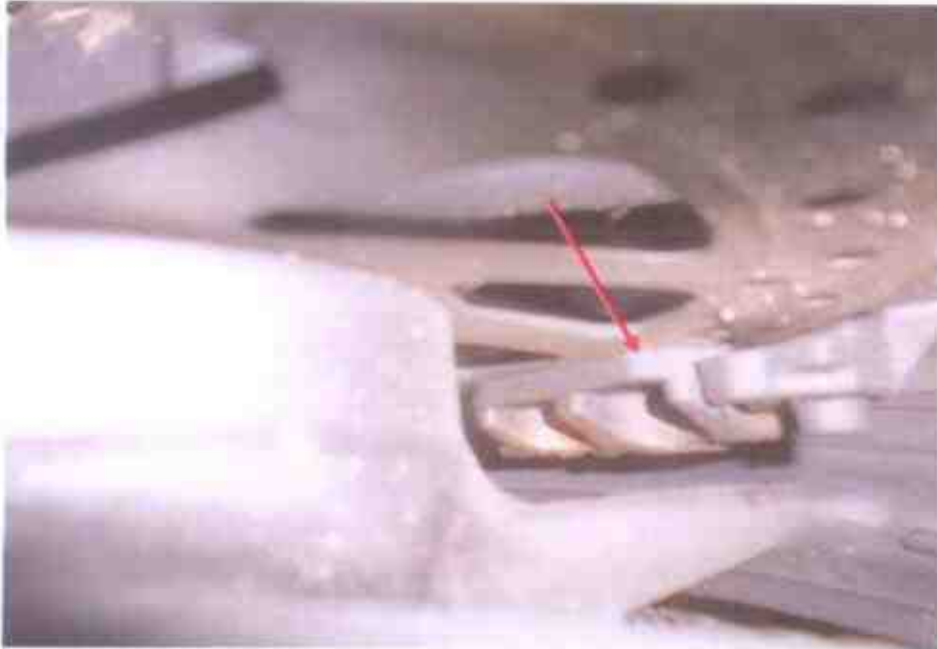
Photo 14 shows the front brake pad (arrowed). It was observed to be with sufficient frictional material at the time of our inspection.

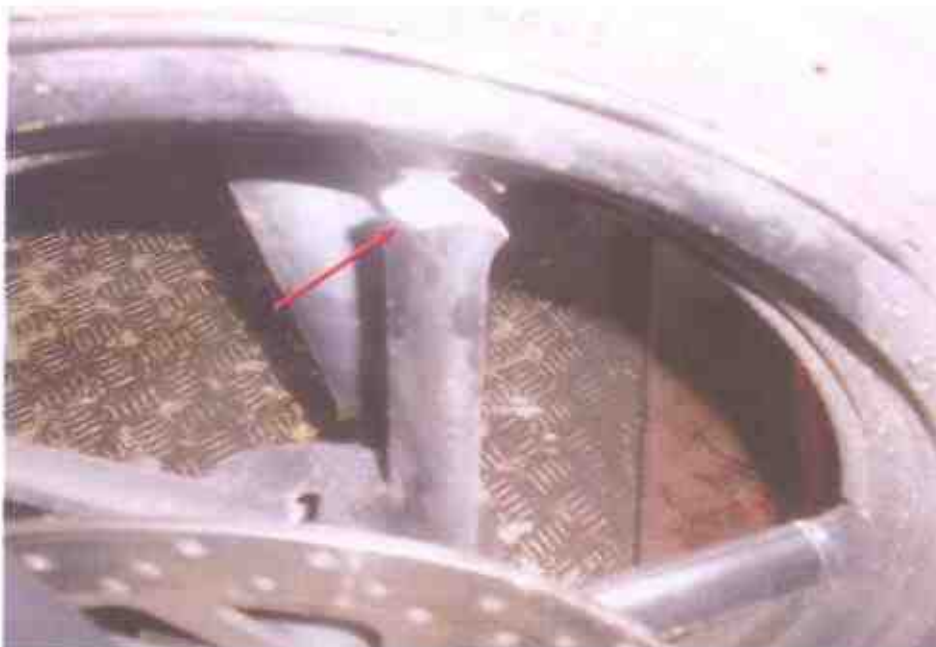
Photo 15 shows the front wheel rim that was observed to be damaged by the accident.

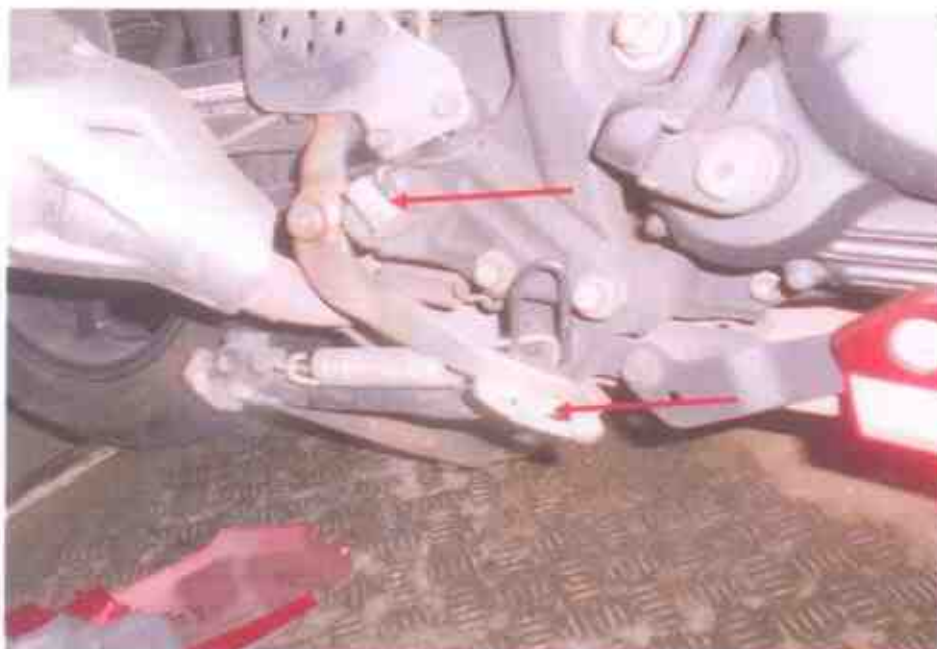
Photo 16 shows the rear brake pedal & foot rest (arrowed) that was observed to be in damaged due to the accident's impact collision.

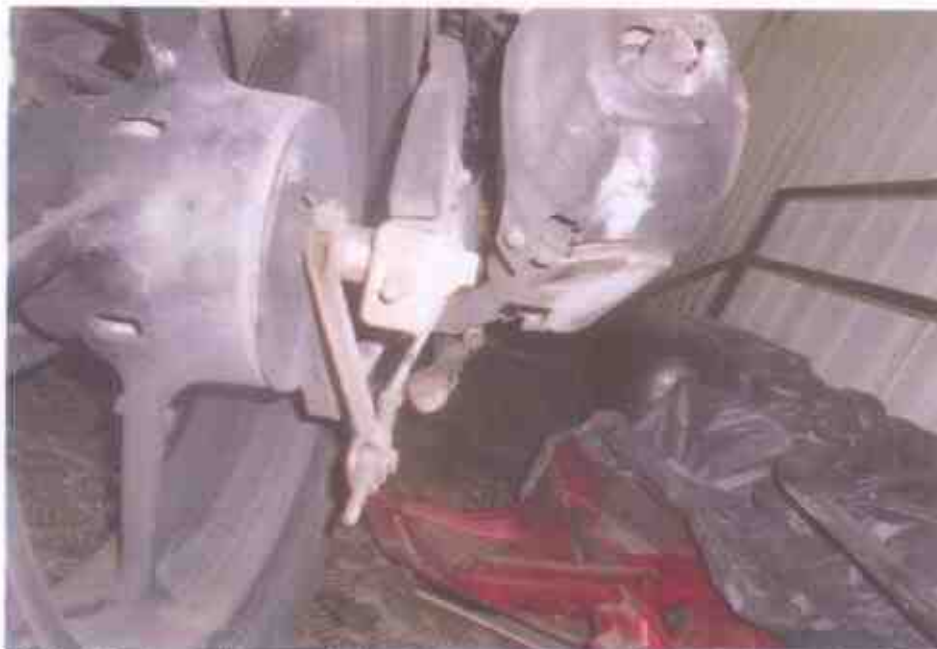
Photo 17 shows the rear brake drum spring & cable was observed to be in serviceable condition unaffected by the accident despite the damage sustained on the foot brake pedal.

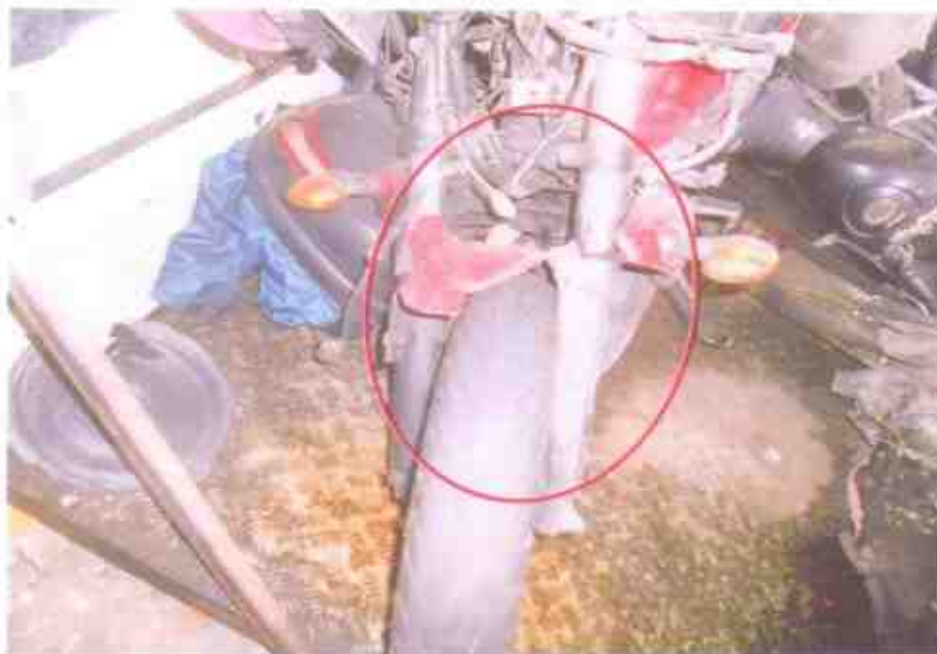
Photo 18 shows the front fork (circled) was observed to be damaged as a result of the accident. Hence, we are unable to conduct any tests on the steering system of the Motorcycle.
