Your Ref: TP/IP/38003/2018
Our Ref : CI/TPD18013736/Z

18th September 2018

MECHANICAL INSPECTION REPORT OF MOTORCYCLE JSJ 7950

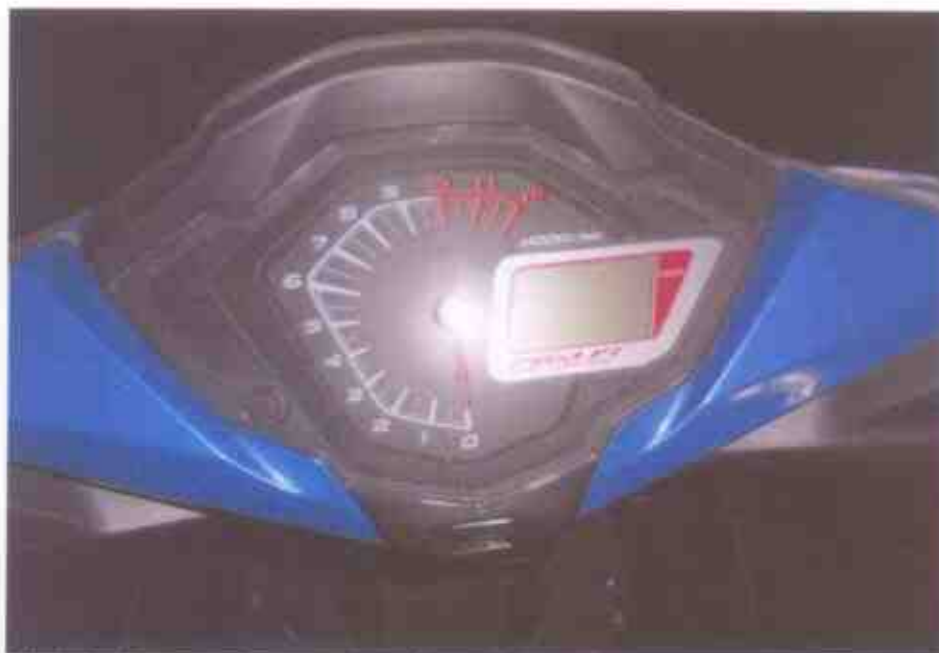
Photo 1 shows a close-up view of the mileage meter at time of our inspection. The mileage was not recorded due to the unavailability of the key.

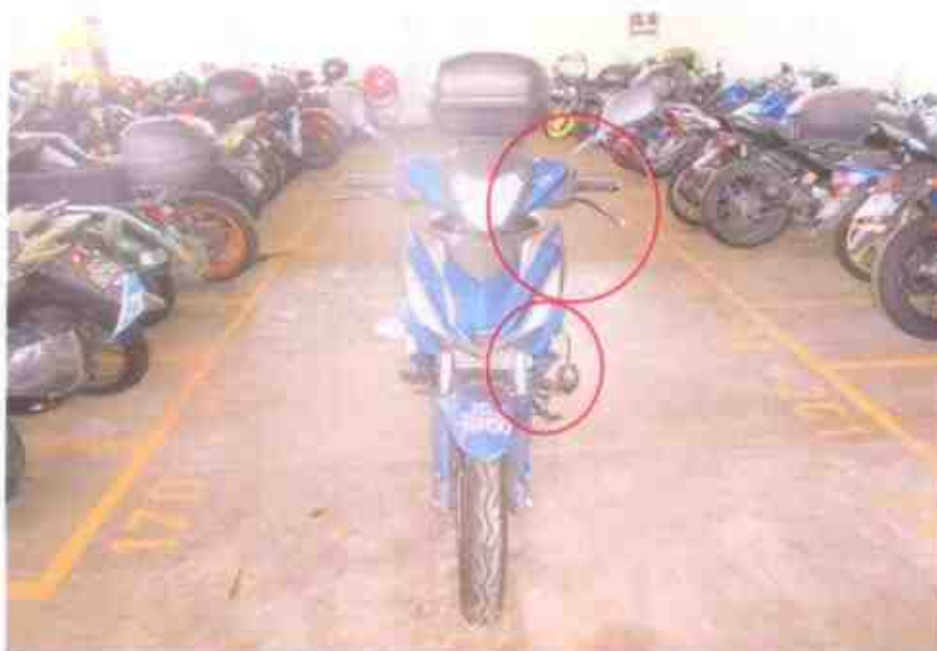
Photo 2 shows a general view of the front body of the Motorcycle at the time of our inspection. The Motorcycle was observed to have sustained relatively minor damages at time of inspection. The damages were observed to be confined to its left side of the Motorcycle.

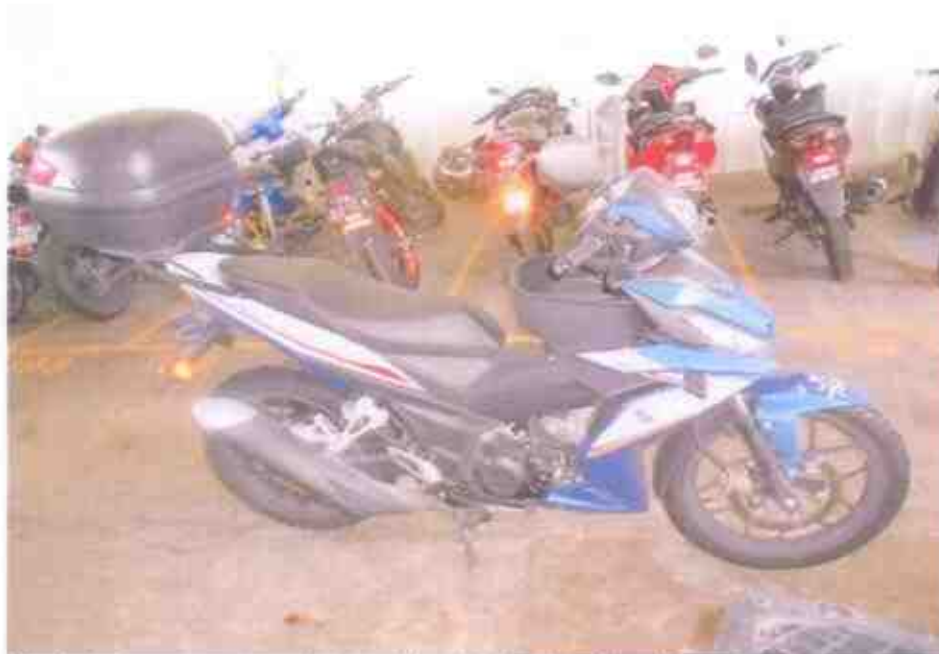
Photo 3 shows a general view of the right body of the Motorcycle at the time of our inspection. The Motorcycle was observed to be in good condition unaffected by the accident's impact.

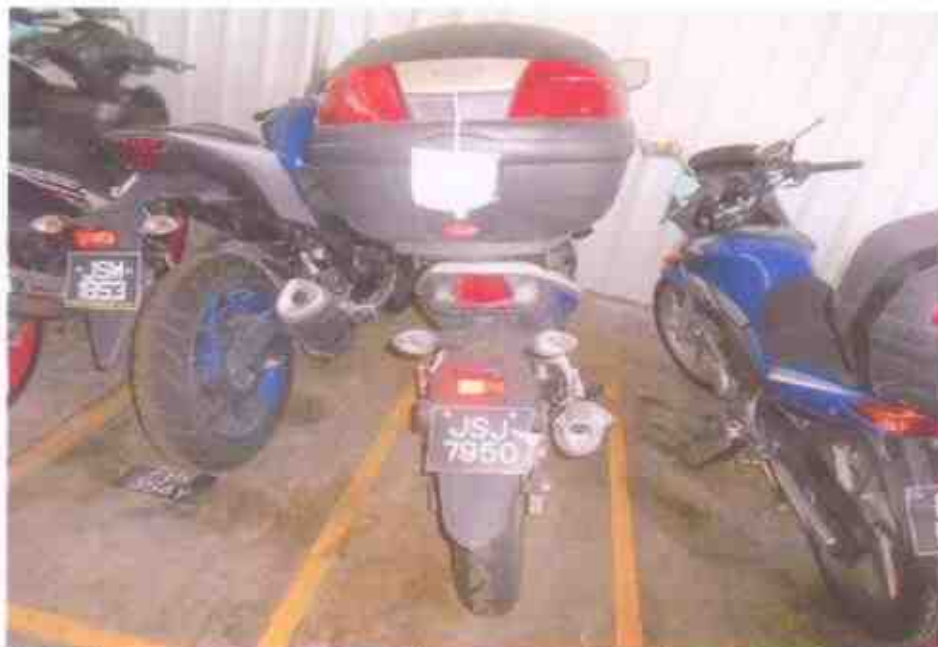
Photo 4 shows a general view of the rear body of the Motorcycle at the time of our inspection. The Motorcycle was observed to be in good condition unaffected by the accident's impact.

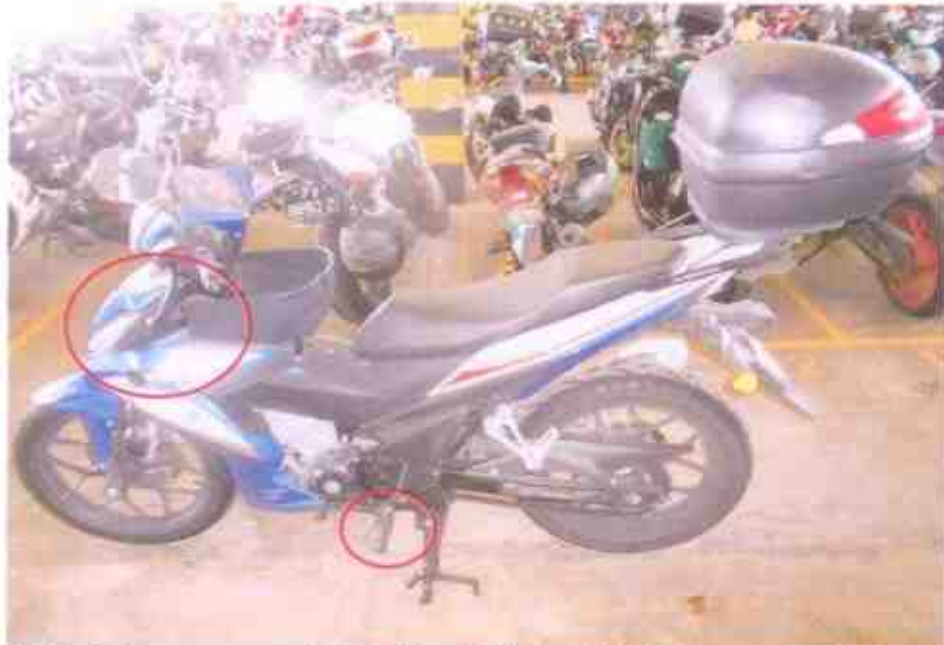
Photo 5 shows a general view of the left body of the Motorcycle at the time of our inspection. The Motorcycle was observed to have sustained relatively minor damages on the left side fairing at time of our inspection.

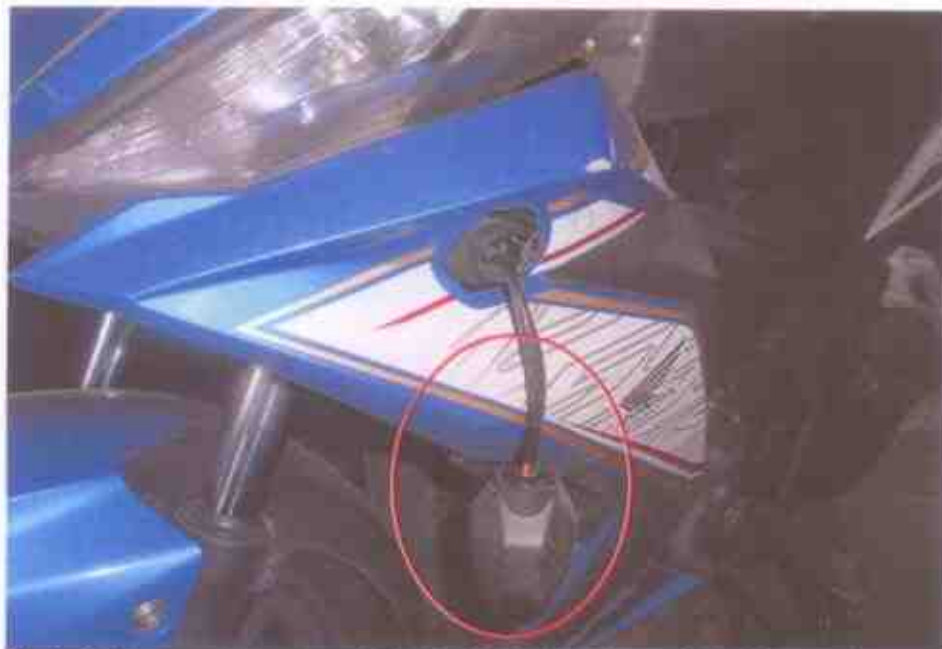
Photo 6 shows a closer view of the front left signal lamp of the Motorcycle at the time of our inspection. The Motorcycle was observed to have sustained with relatively minor damages due to the accident collision. (Circled)

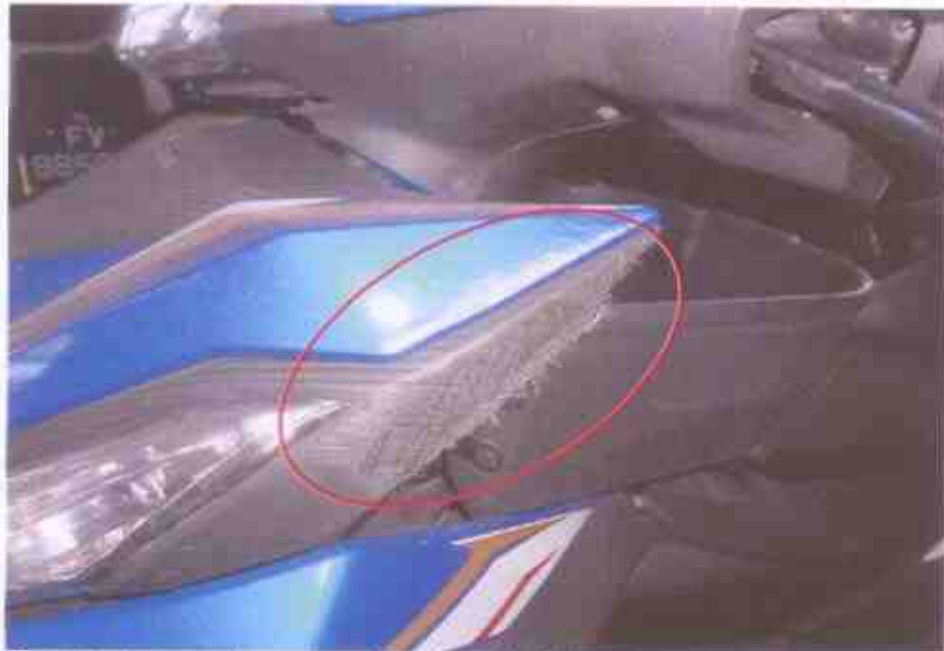
Photo 7 shows a closer view of the front left fairing of the Motorcycle at the time of our inspection. The Motorcycle was observed to have sustained with relatively minor damages due to the accident collision. (Circled)

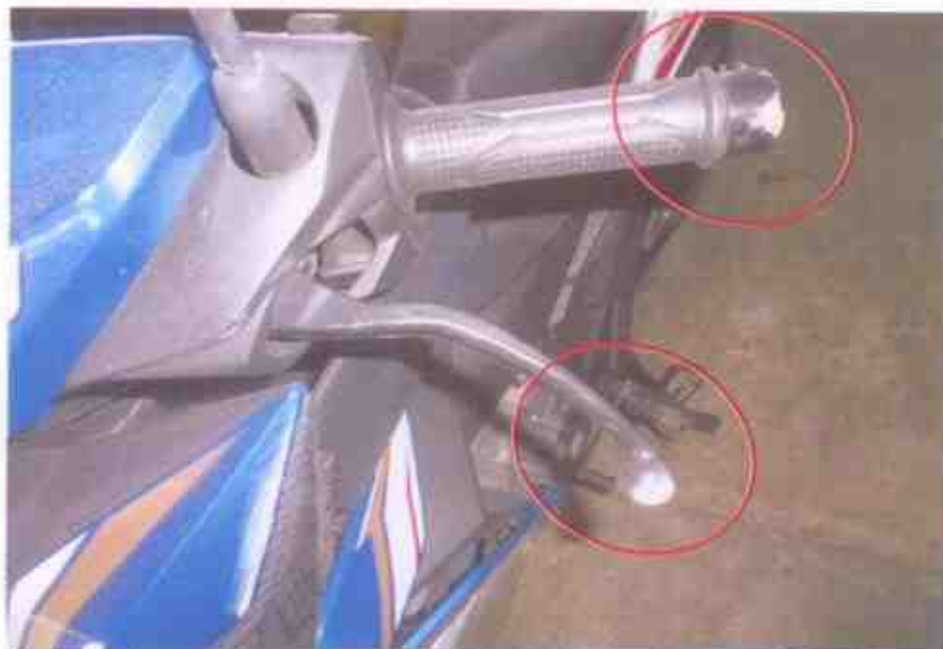
Photo 8 shows a closer view of the left handle of the Motorcycle at the time of our inspection. The Motorcycle was observed to have sustained with relatively minor damages due to the accident collision. (Circled)

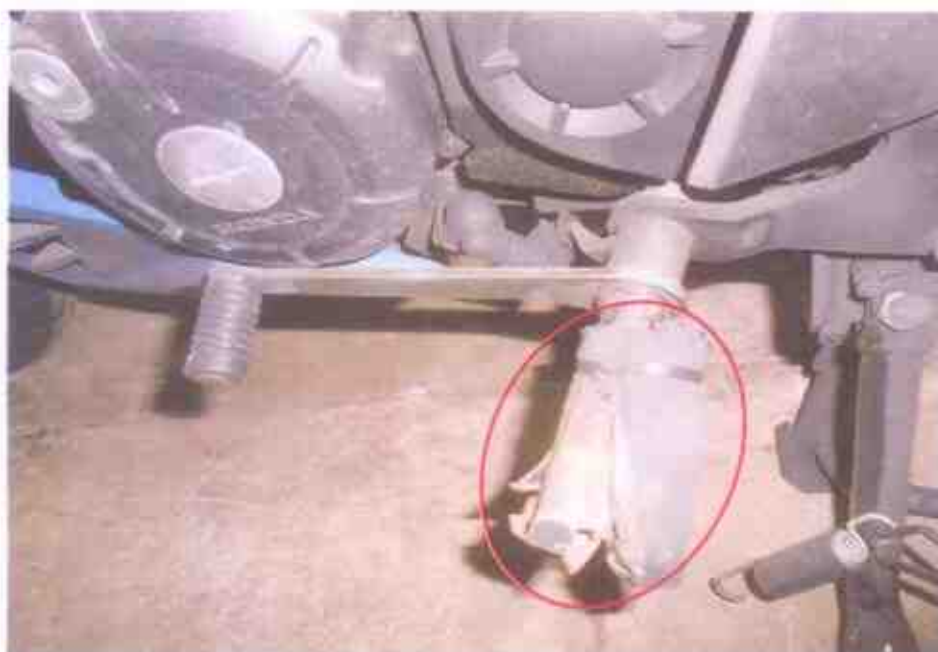
Photo 9 shows a closer view of the left foot rest of the Motorcycle at the time of our inspection. The Motorcycle was observed to have sustained with relatively minor damages due to the accident collision. (Circled)

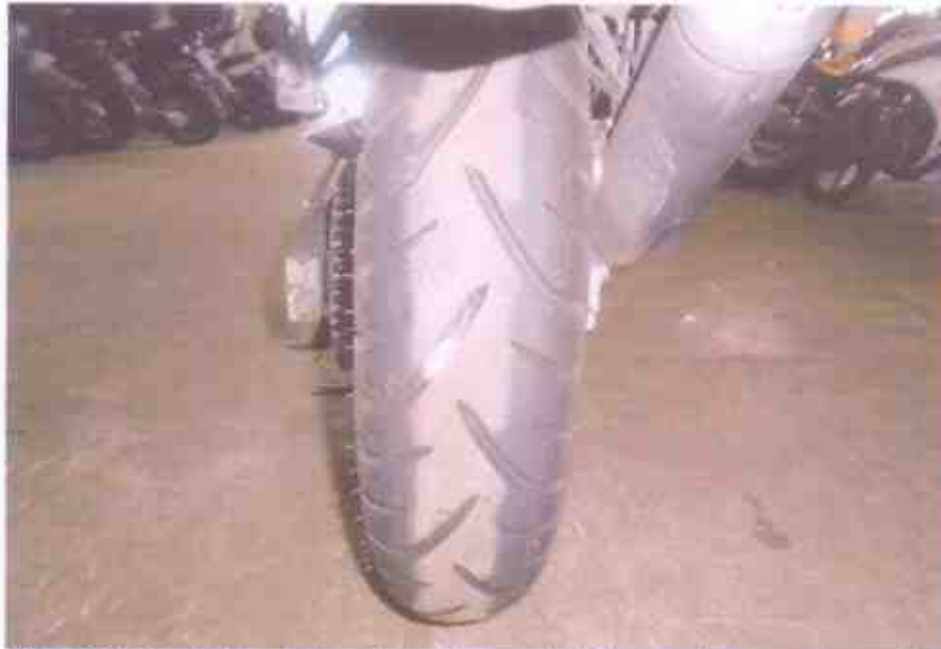
Photo 10 shows the rear tyre of the Motorcycle. The rear tyre was observed to be in serviceable condition with remaining tread depth of approximately 4mm. The tyre was also observed to be sufficiently inflated for vehicular operation.

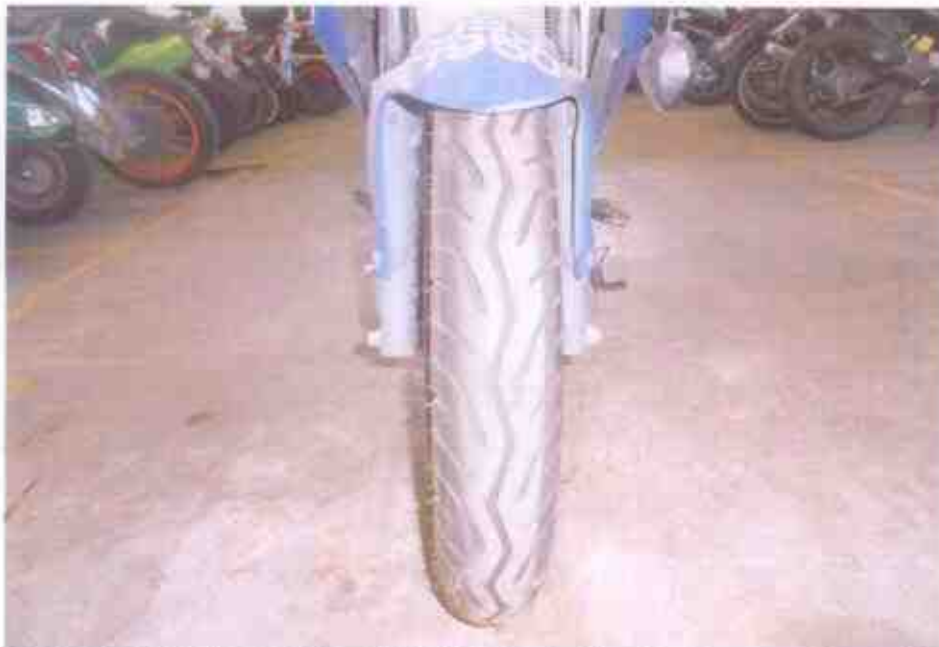
Photo 11 shows the front tyre of the Motorcycle. The front tyre was observed to be in serviceable condition with remaining tread depth of approximately 3mm. The tyre was also observed to be sufficiently inflated for vehicular operation.

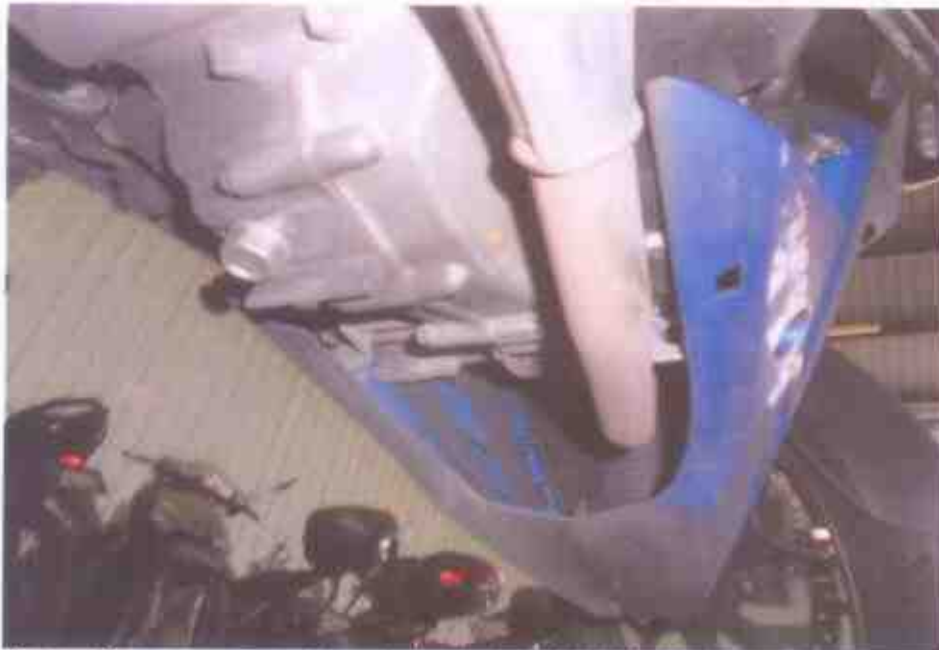
Photo 12 shows no sign(s) or indication(s) of fluid leak observed around the underside of the engine area of the Motorcycle.

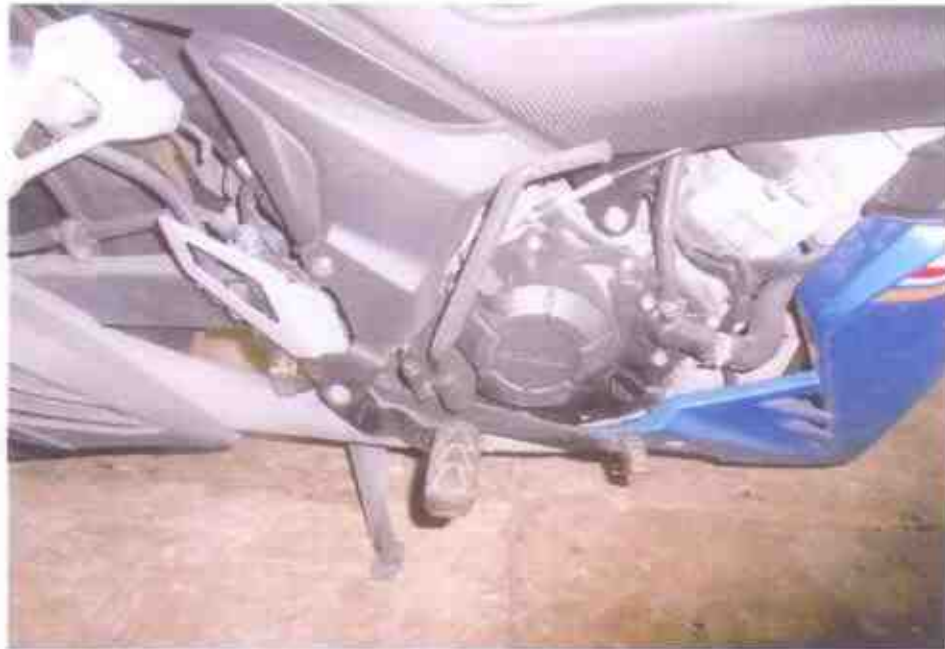
Photo 13 shows no sign(s) or indication(s) of fluid leakage stain observed around the engine area of the Motorcycle.

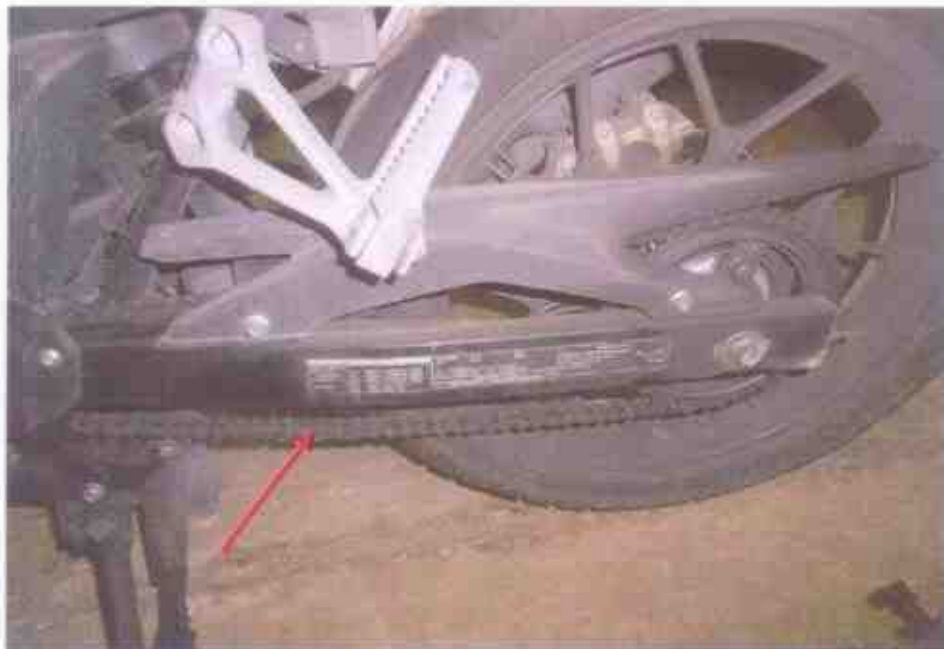
Photo 14 shows the general view of the gear train (arrowed) of the Motorcycle, which was observed to be intact with no misalignment. It was also adequately lubricated for operating purposes.

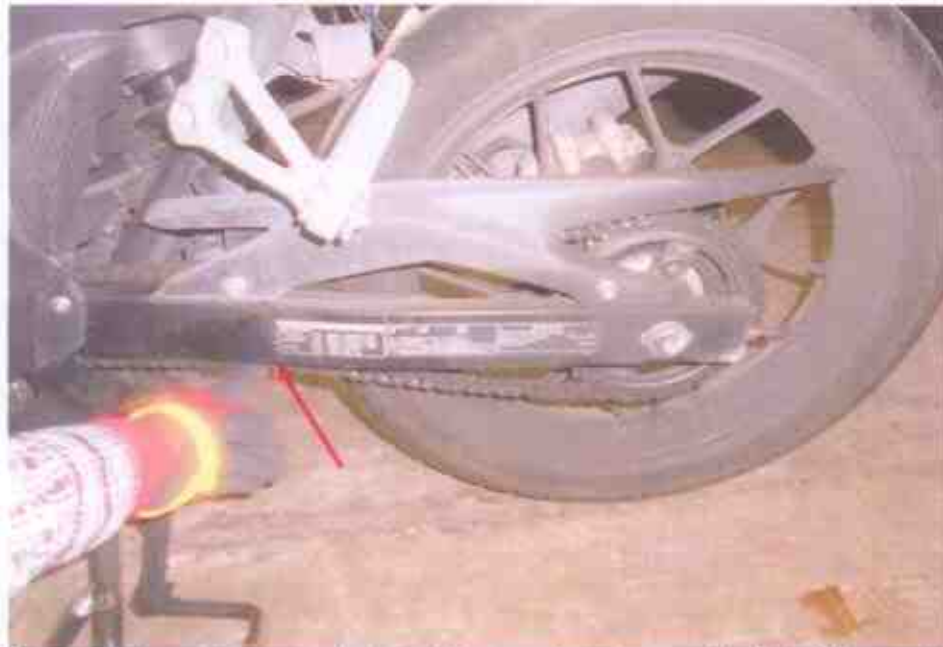
Photo 15 shows the general view of the gear train (arrowed) of the Motorcycle, which was observed to be intact with no misalignment. It was also adequately lubricated for operating purposes. Free play tension was also observed & found adequately acceptable.

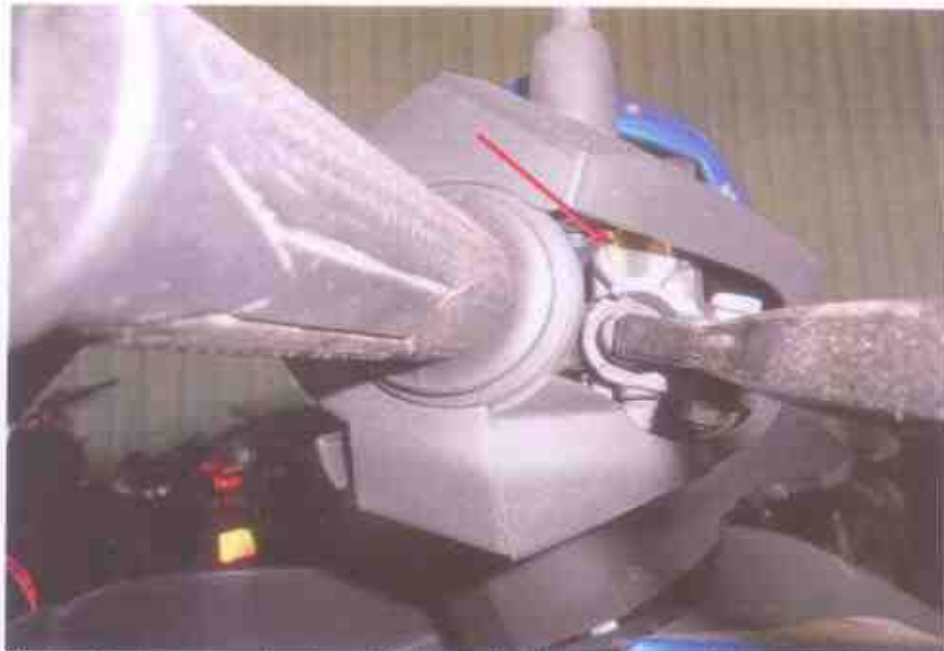
Photo 16 shows our checks on the brake fluid (front) reservoir had also indicated that the brake fluid was of sufficient level for operational purposes, and without contamination.

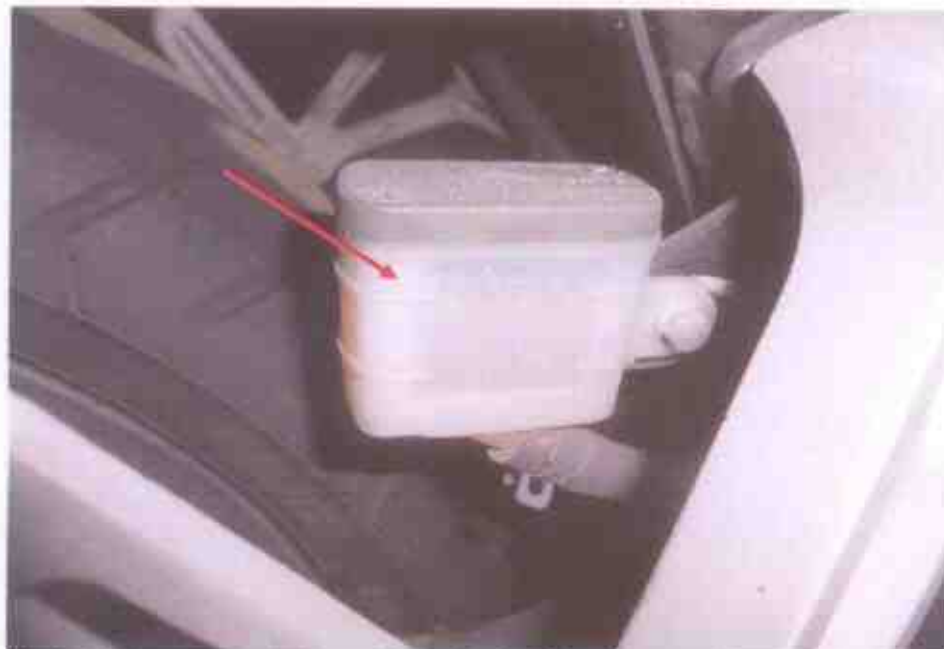
Photo 17 shows our checks on the brake fluid (rear) reservoir had also indicated that the brake fluid was of sufficient level for operational purposes, and without contamination.

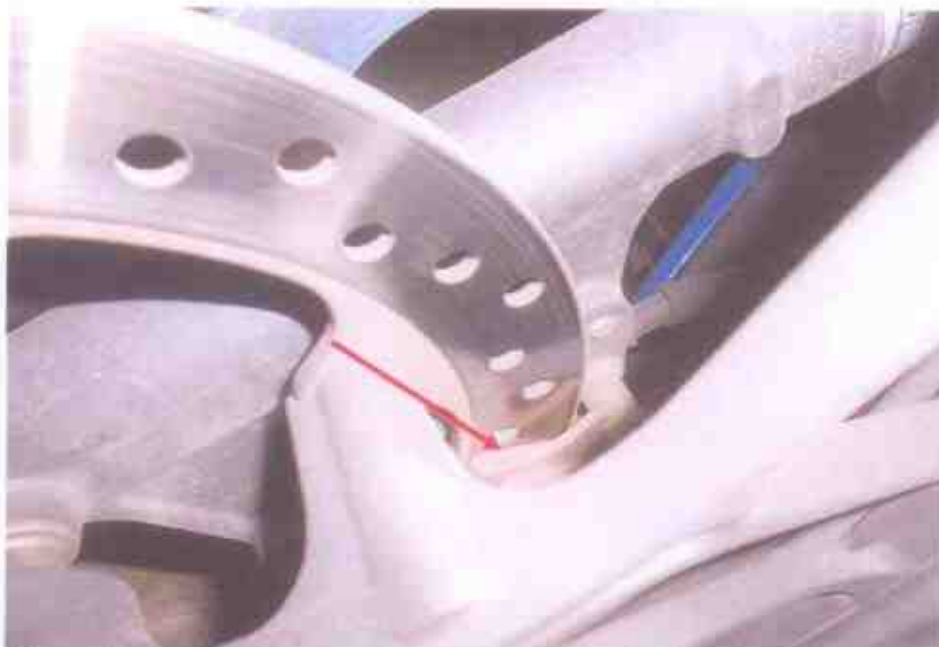
Photo 18 shows a close-up view our checks on the brake pad (front). The frictional material was observed to be in a sufficient level for operational purposes.

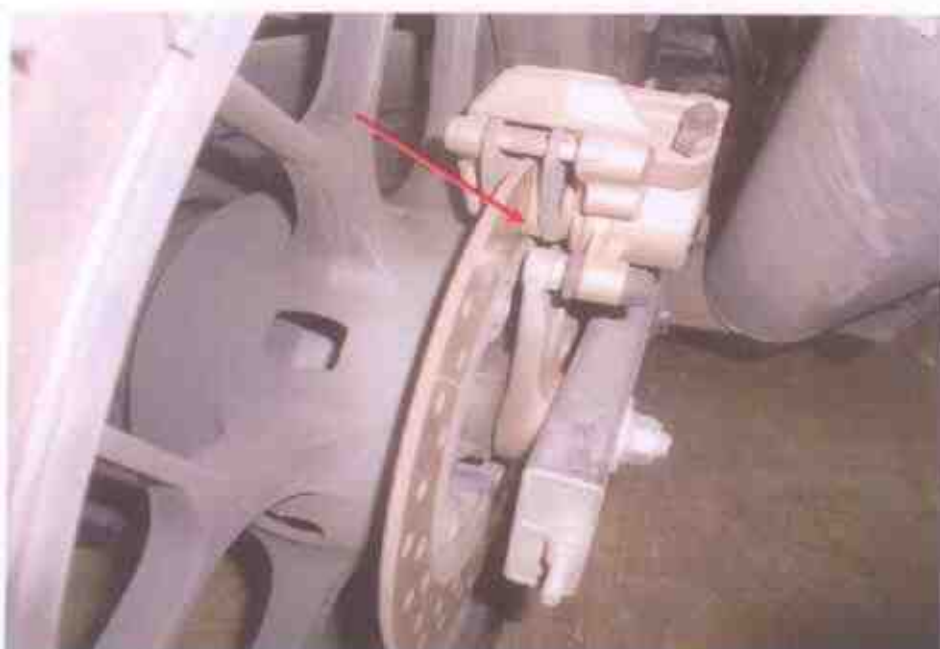
Photo 19 shows a close-up view our checks on the brake pad (rear). The frictional material was observed to be in a sufficient level for operational purposes.

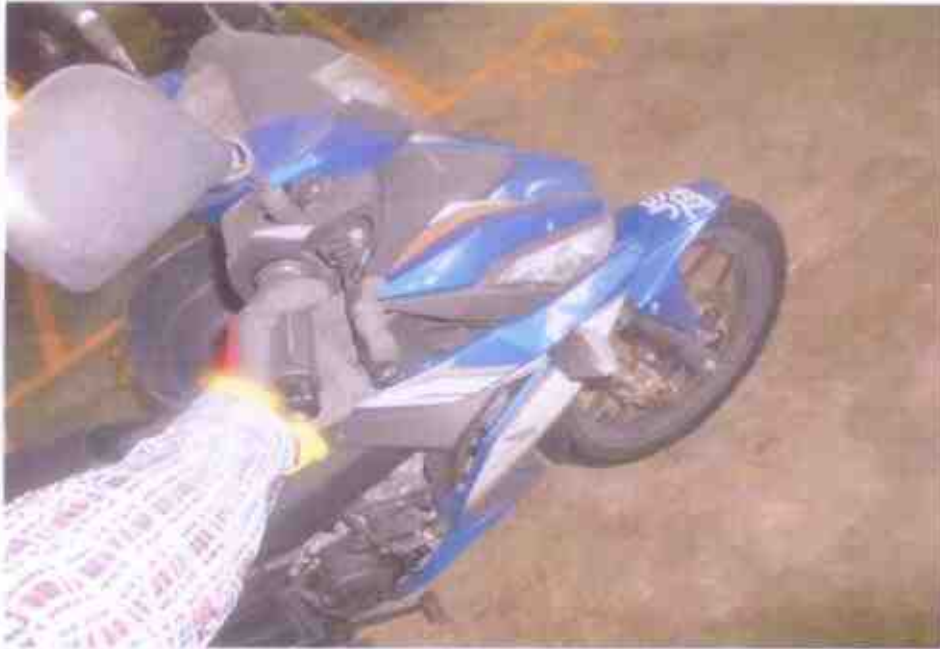
Photo 20 shows testing of the braking of the front brake in progress. There was some resistance felt (spongy like feel) upon pressing the brake lever.

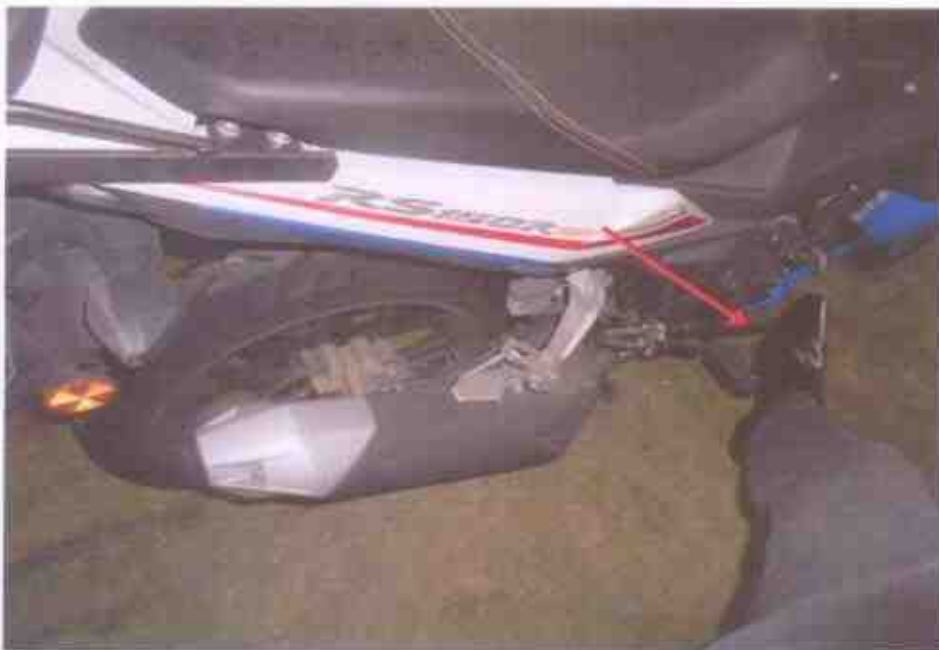
Photo 21 shows testing of the braking of the rear brake in progress. There was some resistance felt (spongy like feel) upon stepping on the brake pedal.
