Your Ref: TP/IP/38003/2018
Our Ref : CI/TPD18013739/Z

18th September 2018

MECHANICAL INSPECTION REPORT OF MOTORCYCLE JQS 5167

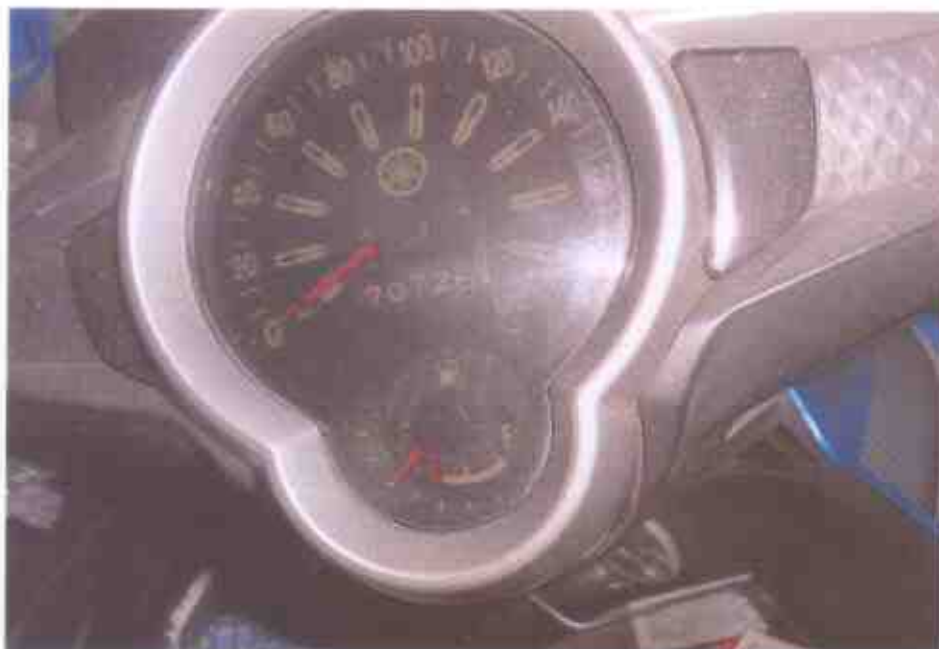
Photo 1 shows a close-up view of the mileage meter at time of our inspection. The mileage was recorded at 707229km.

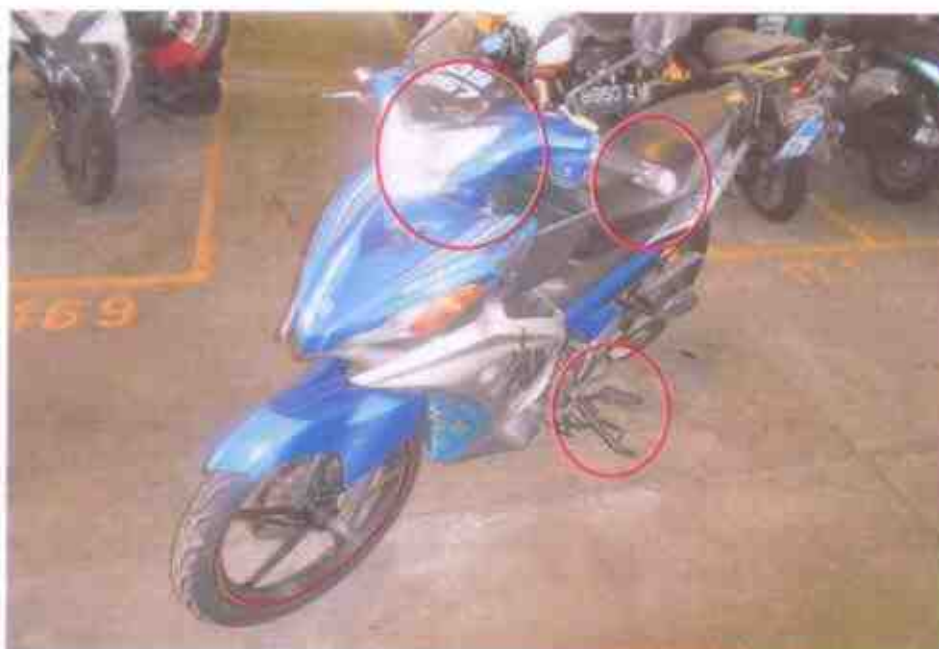
Photo 2 shows a general view of the front body of the Motorcycle at the time of our inspection. The Motorcycle was observed to have sustained relatively minor damages at time of inspection. The damages were observed to be confined to its left side of the Motorcycle.

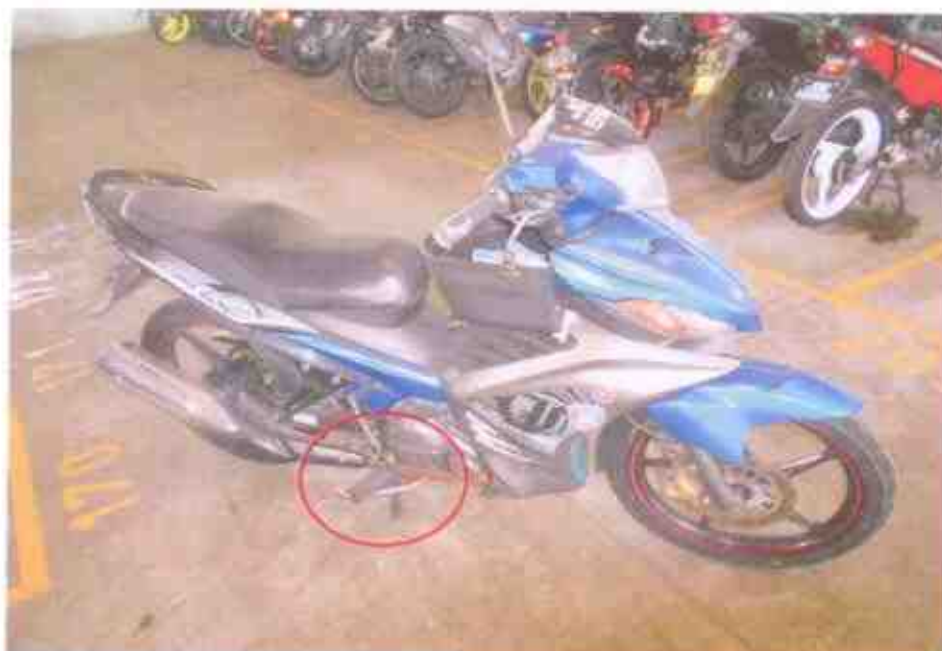
Photo 3 shows a general view of the right body of the Motorcycle at the time of our inspection. The Motorcycle was observed to sustained with damaged rear brake pedal.

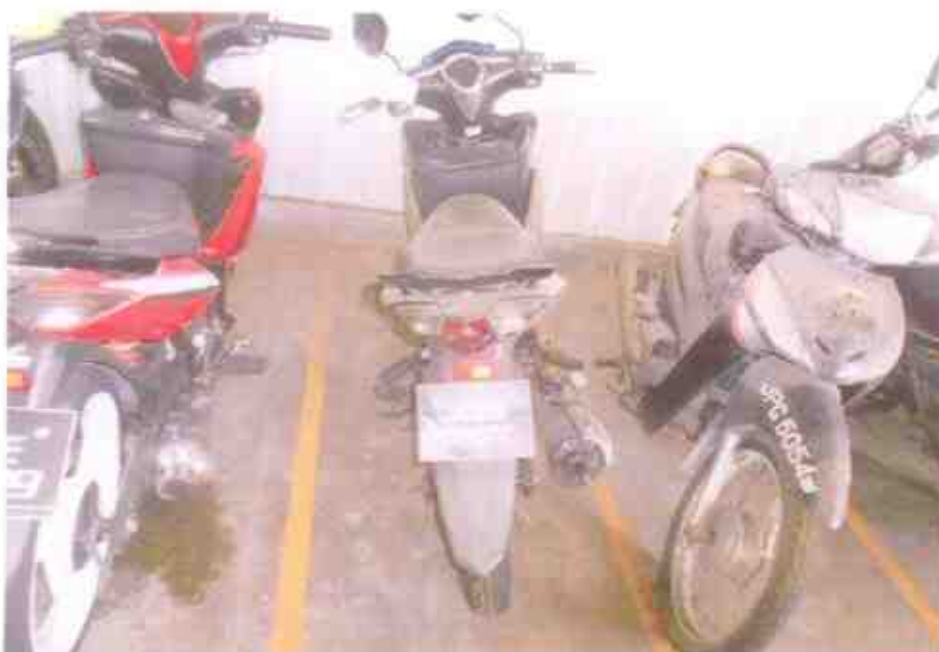
Photo 4 shows a general view of the rear body of the Motorcycle at the time of our inspection. The Motorcycle was observed to be in good condition unaffected by the accident's impact.

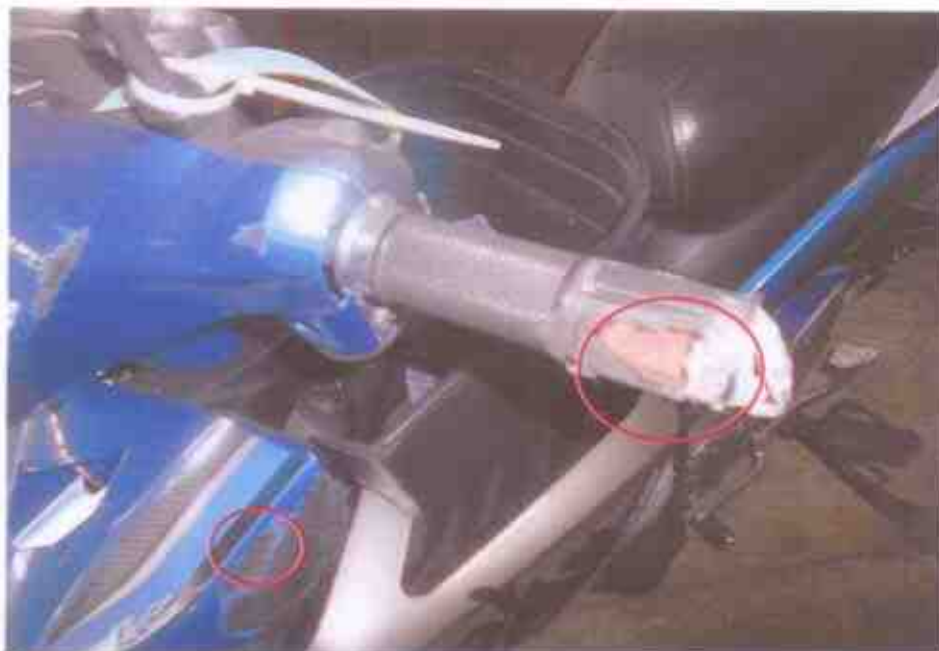
Photo 5 shows a semi close-up view of the left body of the Motorcycle at the time of our inspection. The Motorcycle was observed to have sustained relatively minor damages on the left side handle at time of our inspection.

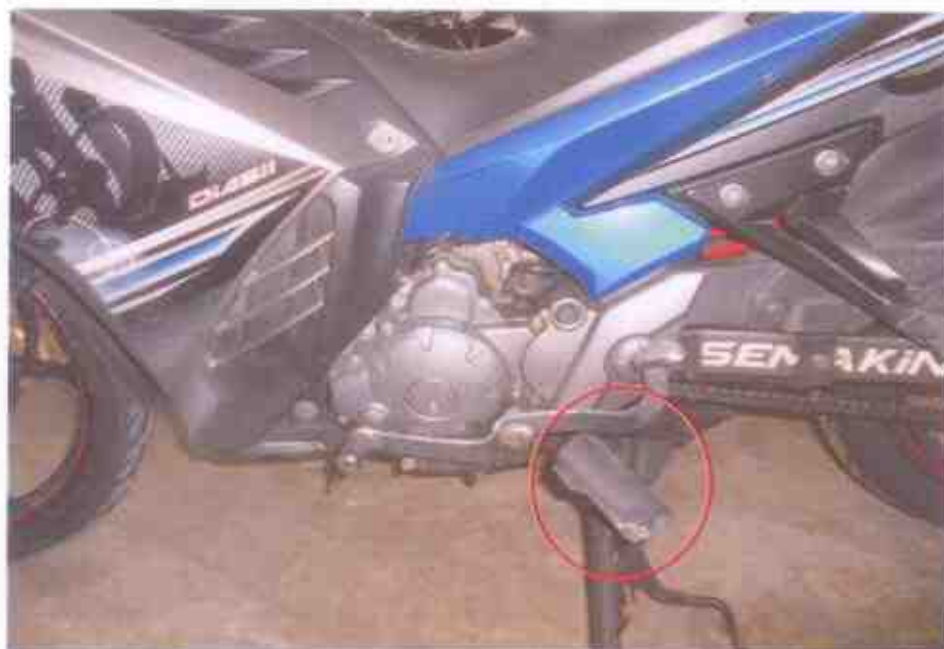
Photo 6 shows a closer view of the left foot rest of the Motorcycle at the time of our inspection. The Motorcycle was observed to have sustained with relatively minor damages due to the accident collision. (Circled)

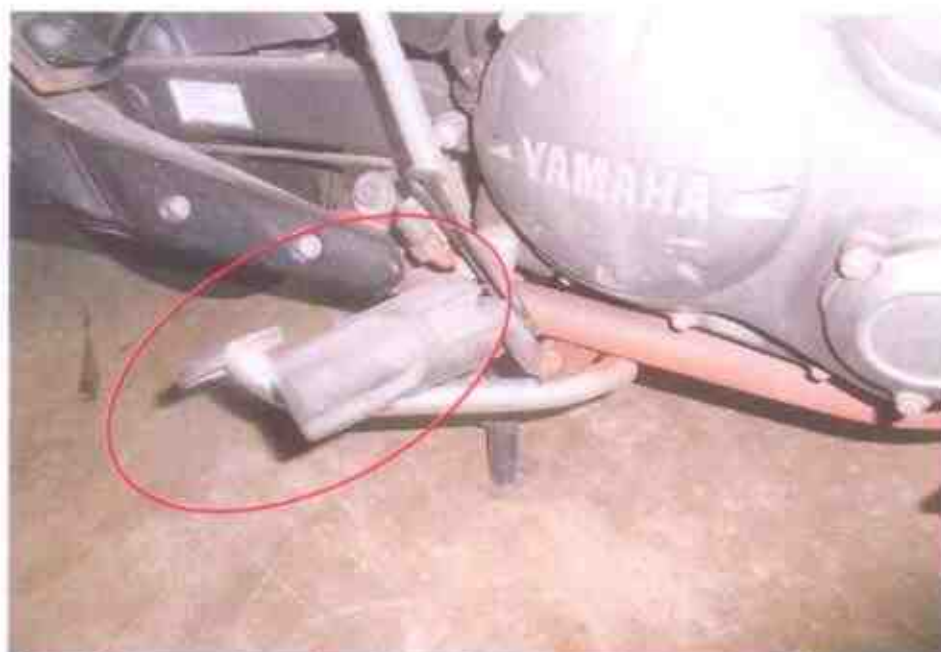
Photo 7 shows a closer view of the right rear brake pedal of the Motorcycle at the time of our inspection. The Motorcycle was observed to have sustained with relatively minor damages due to the accident collision. (Circled)

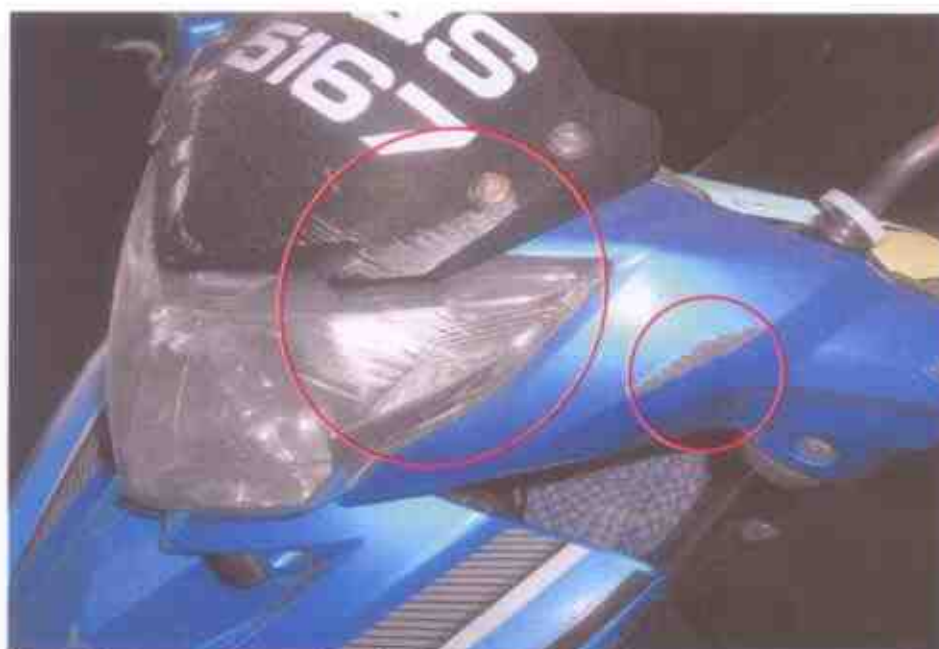
Photo 8 shows a closer view of the left side of the Motorcycle at the time of our inspection. The Motorcycle was observed to have sustained with relatively minor damages due to the accident collision. (Circled)

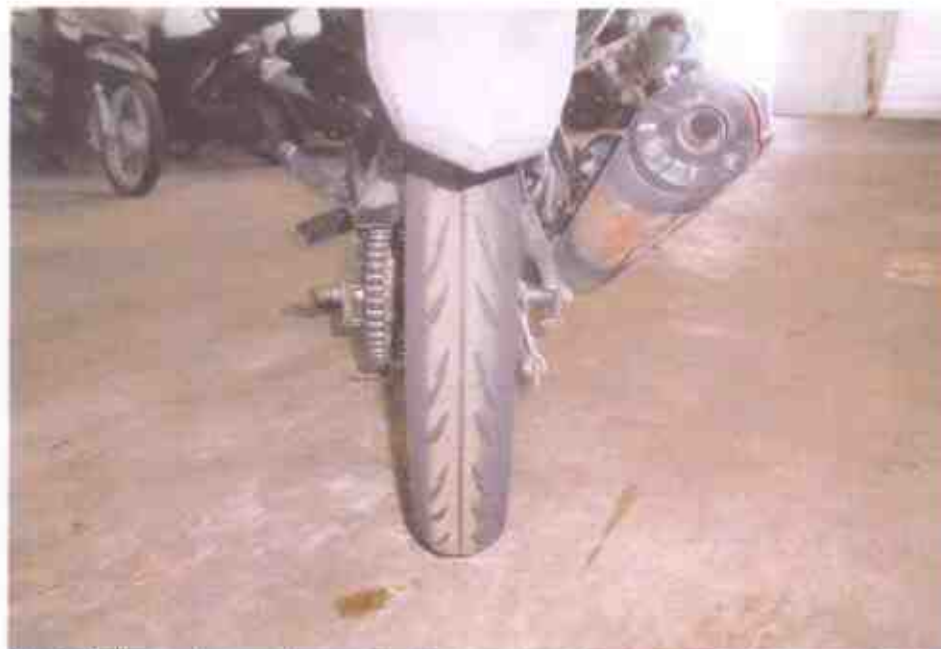
Photo 9 shows the rear tyre of the Motorcycle. The rear tyre was observed to be in serviceable condition with remaining tread depth of approximately 3mm. The tyre was also observed to be sufficiently inflated for vehicular operation.

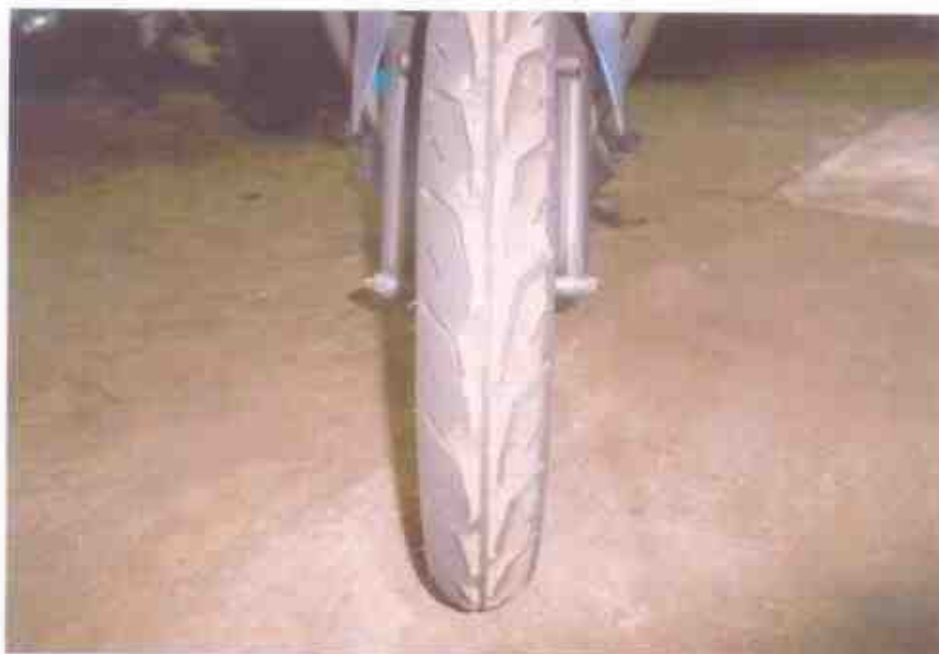
Photo 10 shows the front tyre of the Motorcycle. The front tyre was observed to be in serviceable condition with remaining tread depth of approximately 2mm. The tyre was also observed to be sufficiently inflated for vehicular operation.

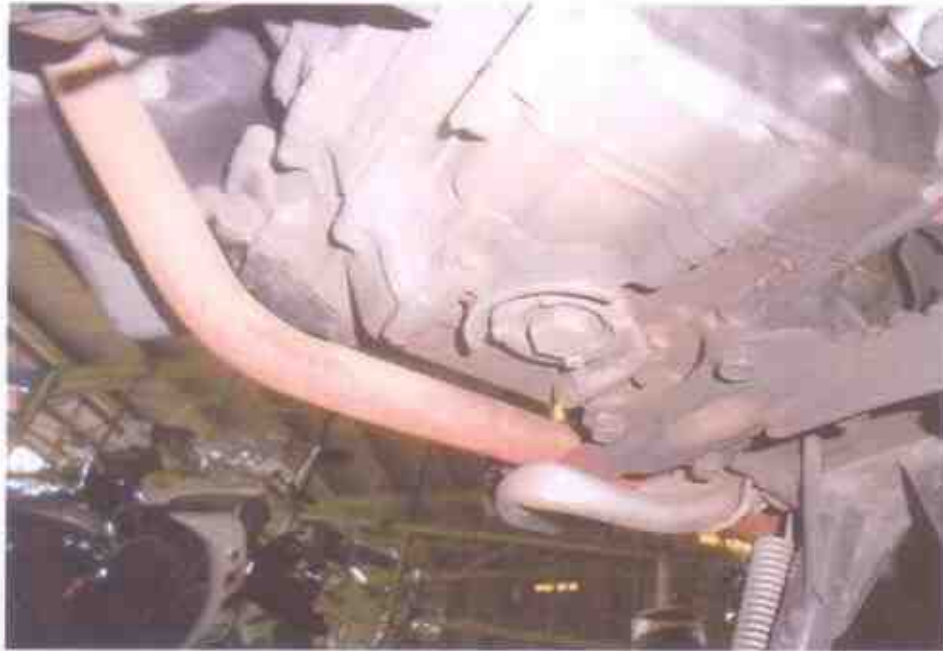
Photo 11 shows no sign(s) or indication(s) of fluid leak observed around the underside of the engine area of the Motorcycle.

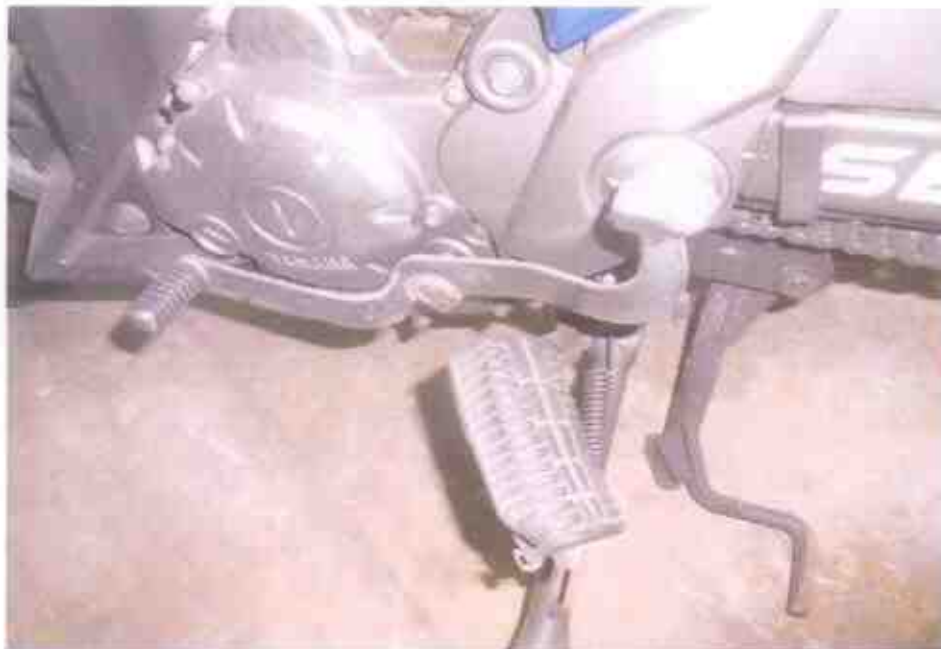
Photo 12 shows no sign(s) or indication(s) of fluid leakage stain observed around the engine area of the Motorcycle.

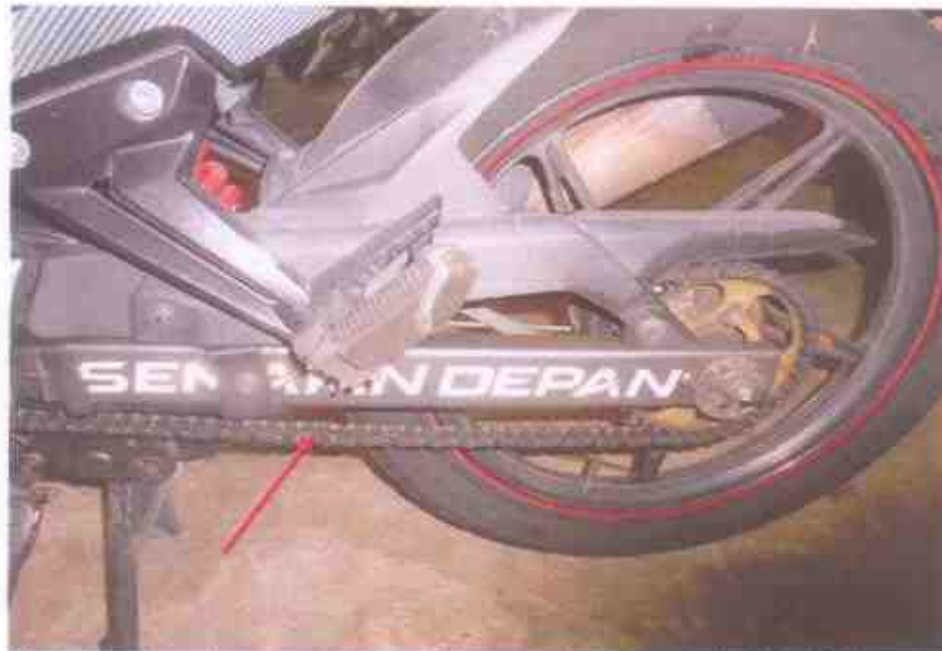
Photo 13 shows the general view of the gear train (arrowed) of the Motorcycle, which was observed to be intact with no misalignment. It was also adequately lubricated for operating purposes.

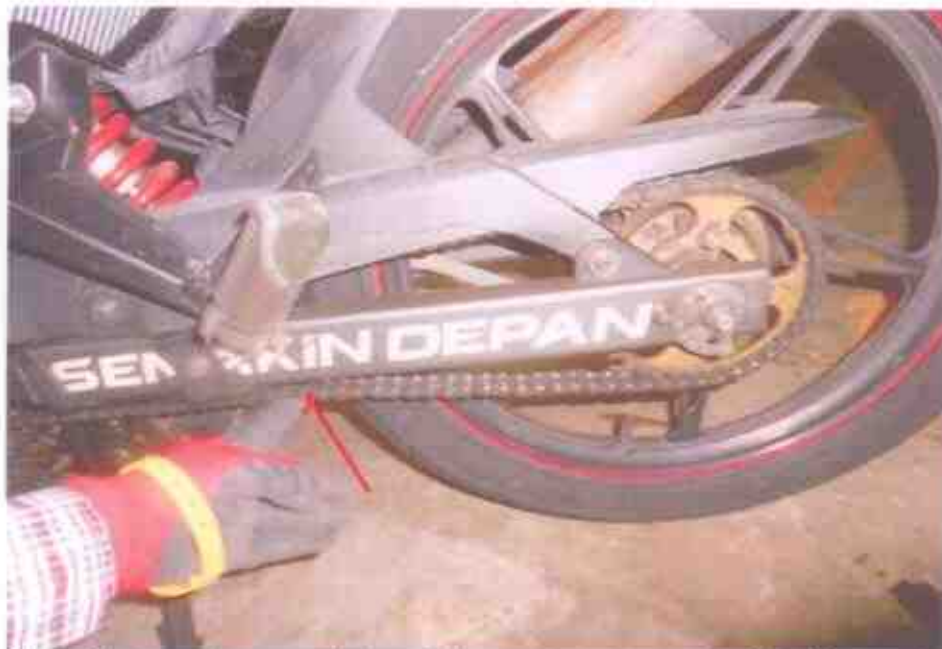
Photo 14 shows the general view of the gear train (arrowed) of the Motorcycle, which was observed to be intact with no misalignment. It was also adequately lubricated for operating purposes. Free play tension was also observed & found adequately acceptable.

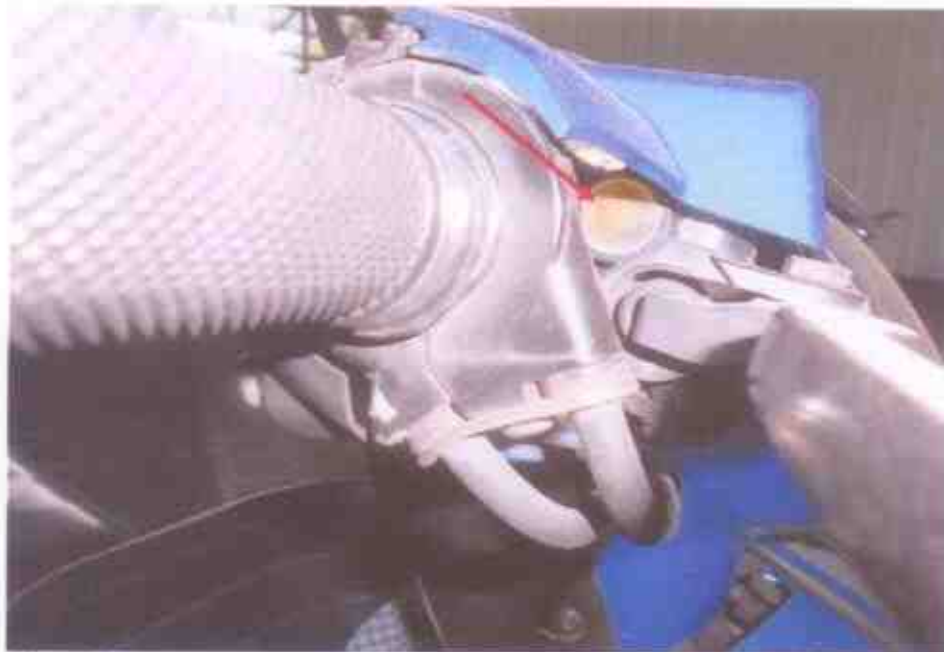
Photo 15 shows our checks on the brake fluid (front) reservoir had also indicated that the brake fluid was of sufficient level for operational purposes, and without contamination.

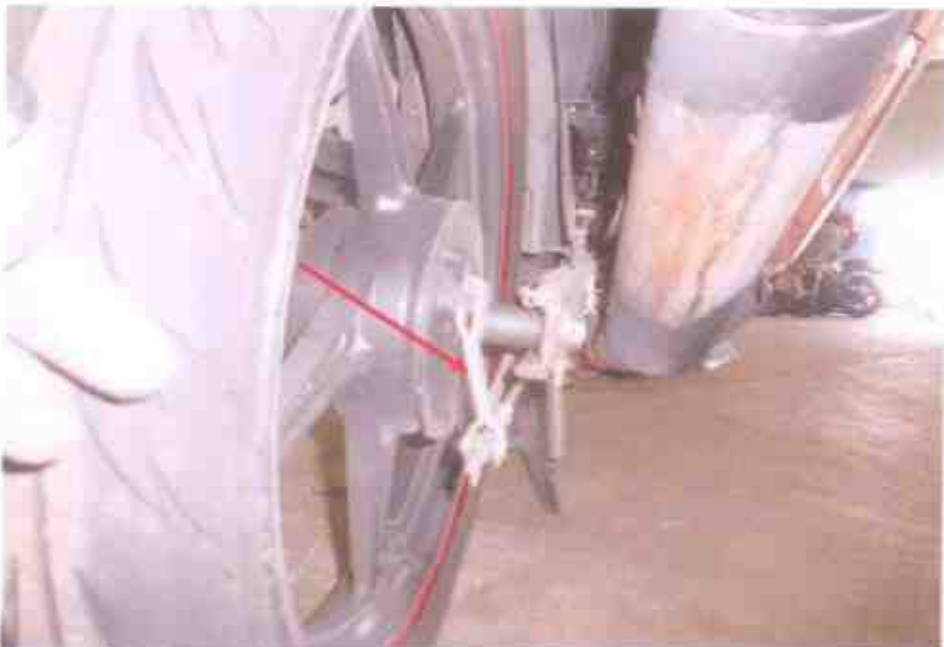
Photo 16 shows our checks on the rear brake cables & springs which was part of the rear braking system had also indicated that it was serviceable for operational purposes.

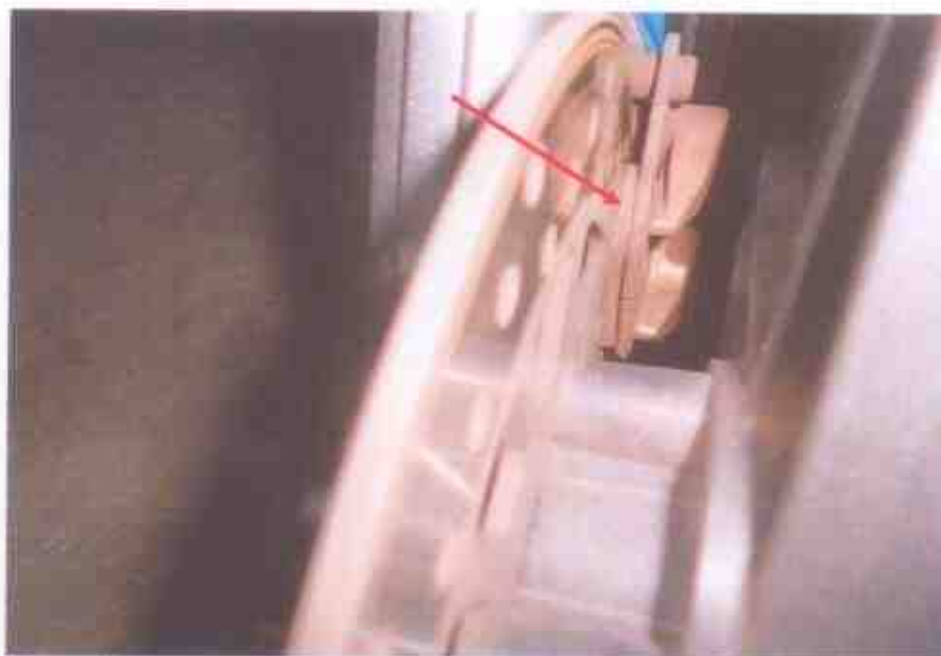
Photo 17 shows a close-up view our checks on the brake pad (front). The frictional material was observed to be in a sufficient level for operational purposes.

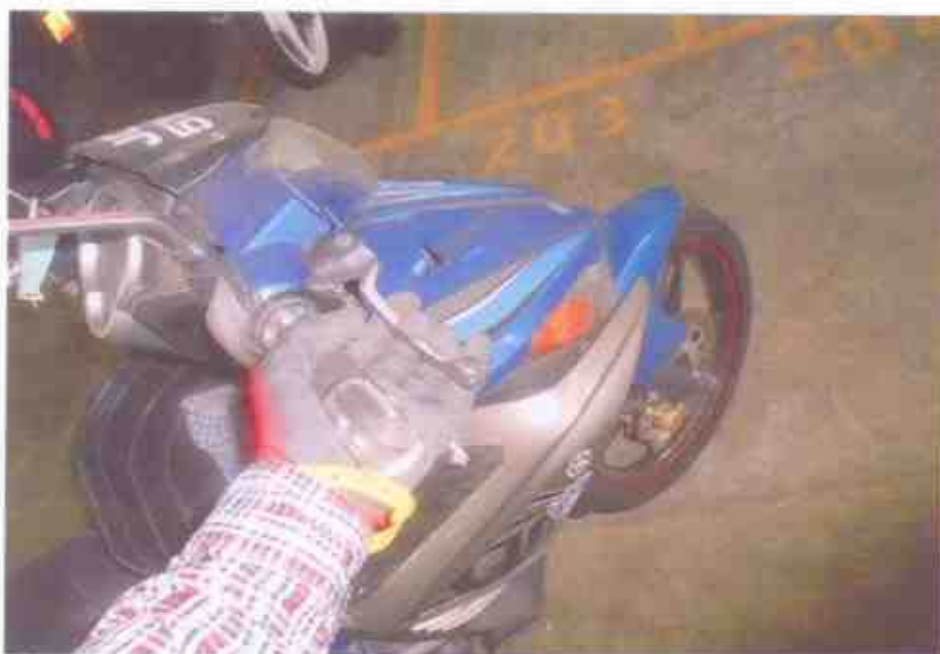
Photo 18 shows testing of the braking of the front brake in progress. There was some resistance felt (spongy like feel) upon pressing the brake lever.

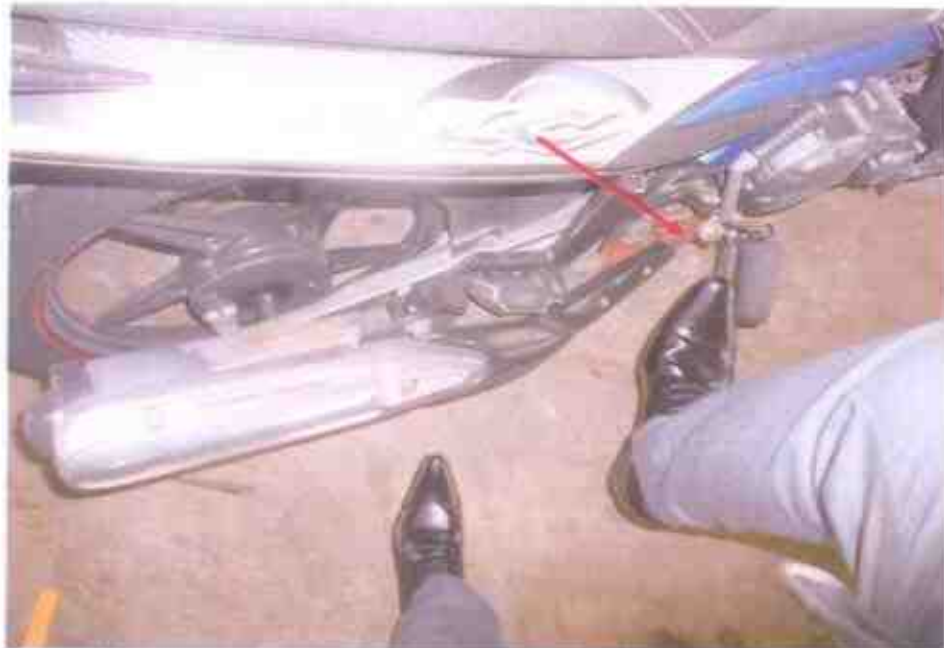
Photo 19 shows testing of the braking of the rear brake in progress. The rear brake was observed to be jammed due to the accident's impact collision.

16. Basing on our physical inspection of the Motorcycle, it appears that the steering system and braking system (front brake only) of the Motorcycle were all in serviceable condition. As for the rear brake, it was observed to be damaged due to the accident's impact collision. However, we did not find any evidence(s) to suggest that there was possible mechanical failure to the Motorcycle that may have caused and/or contributed to the accident.
17. The tyres of the Motorcycle were found to be in a serviceable condition. There was no tear, cut or burst mark(s) on the outer and the inner sidewalls as well as across the tread of the tyre. It was sufficiently inflated for vehicular operation with remaining tread depth of approximately 2 & 3mm.
