Your Ref: TP/IP/38107/2018
Our Ref : CI/TPD18013740/Z

28th September 2018

MECHANICAL INSPECTION REPORT OF MOTOR TAXI SHC 2164L

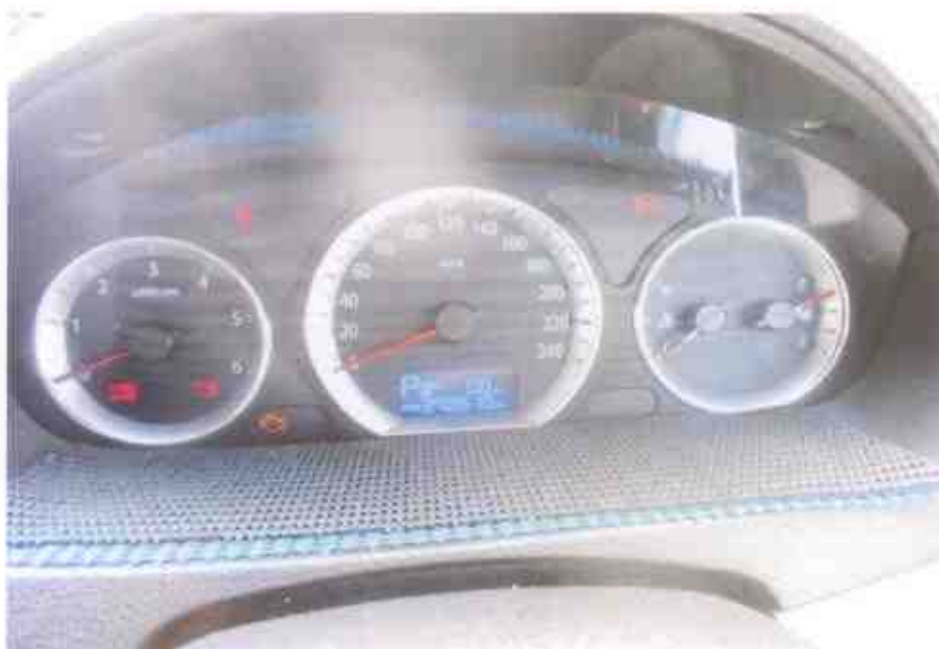
Photo 1 shows the mileage of the Motor taxi at the time of our inspection was recorded at 370510km.

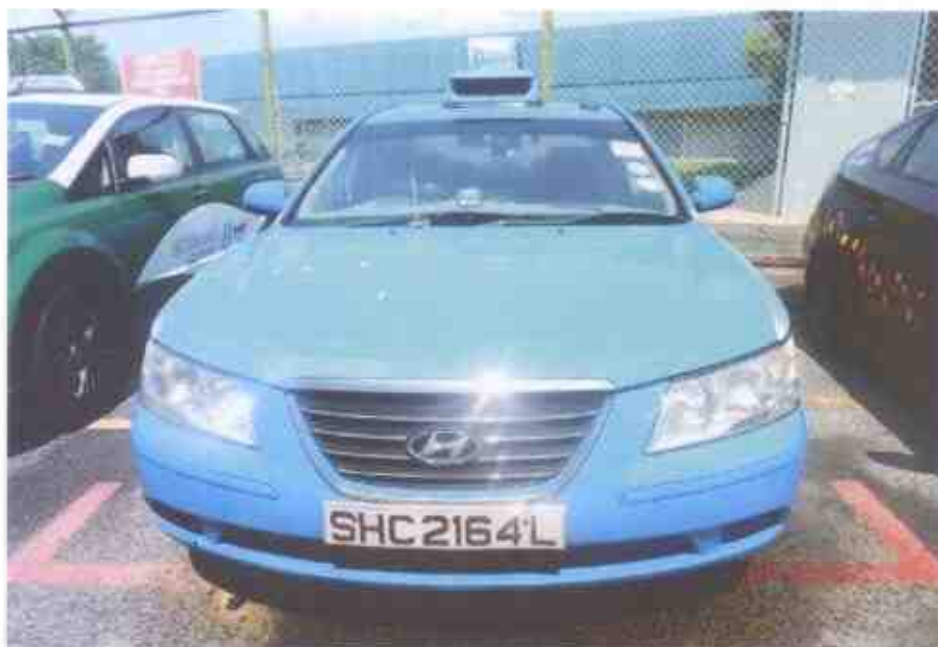
Photo 2 shows a general view of the front body of the Motor Taxi at the time of our inspection. The Motor Taxi was observed to have sustained a relatively minor impact damages that was confined to its frontal portion. its front bonnet was observed to be slightly dented likely due to the accident's collision impact.

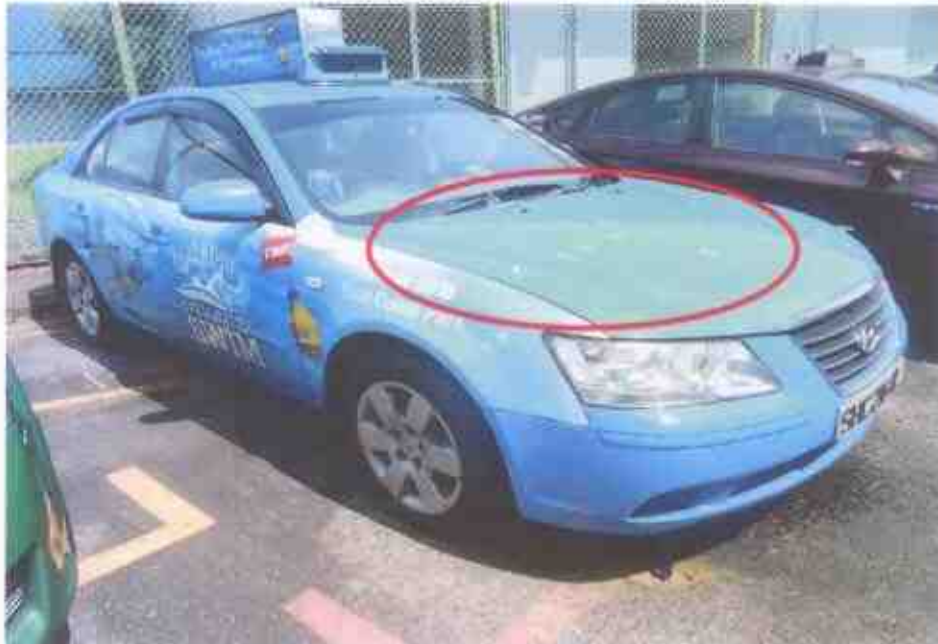
Photo 3 shows a general view of the front left body of the Motor Taxi at the time of our inspection. The Motor Taxi was observed to have sustained a relatively minor impact damages that was confined to its frontal portion.

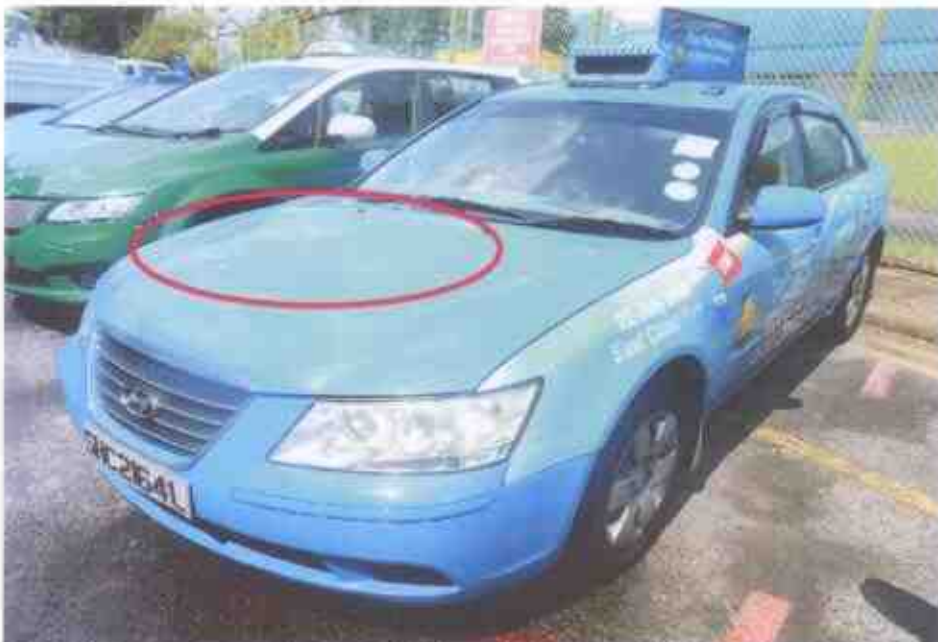
Photo 4 shows a general view of the front right body of the Motor Taxi at the time of our inspection. The Motor Taxi was observed to have sustained a relatively minor impact damages that was confined to its frontal portion.

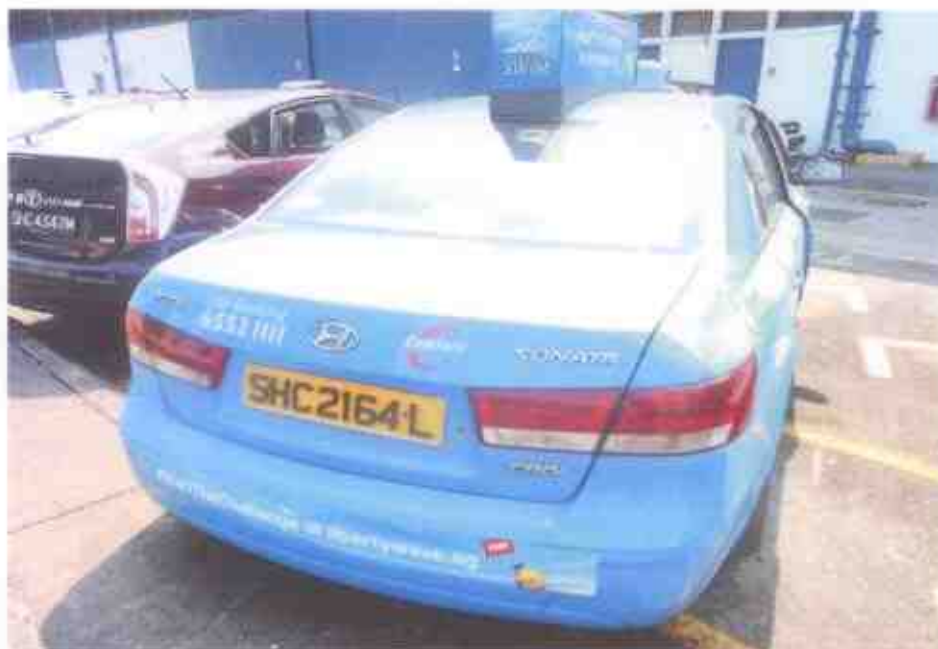
Photo 5 shows a general view of the rear body of the Motor Taxi at the time of our inspection. The Motor Taxi was observed to be in good general condition.

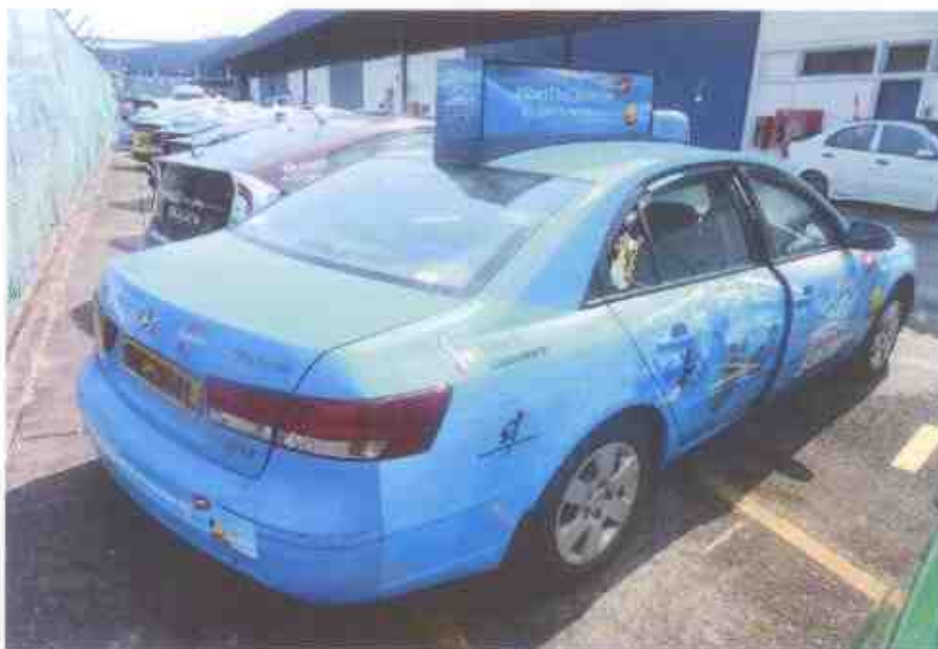
Photo 6 shows a general view of the rear right body of the Motor Taxi at the time of our inspection. The Motor Taxi was observed to be in good general condition.

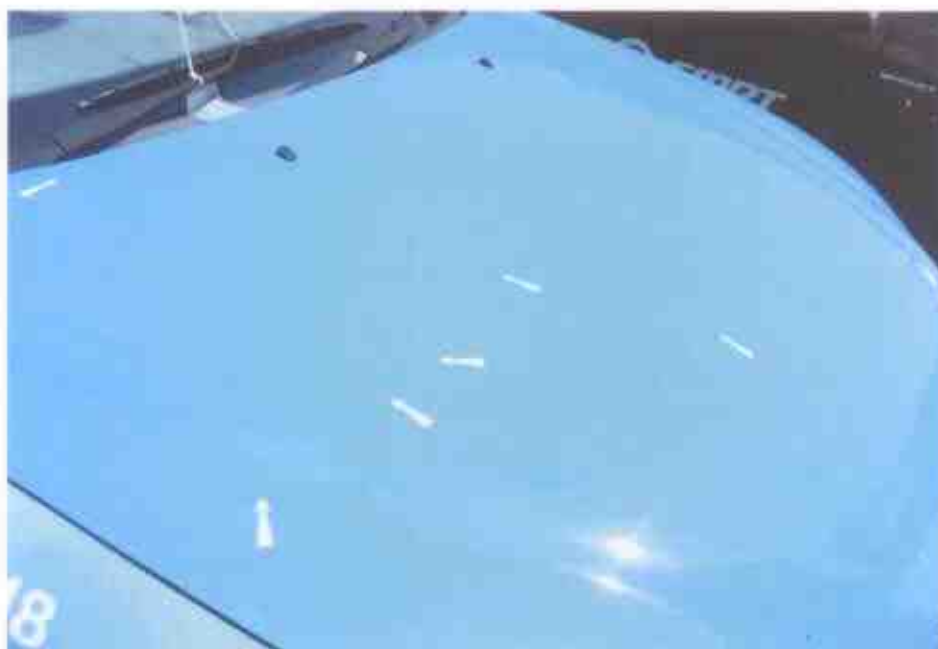
Photo 7 shows a semi close up view of the front portion of the Motor Taxi at the time of our inspection. The Motor Taxi had sustained relatively minor dent at the front bonnet portion likely due to the accident.

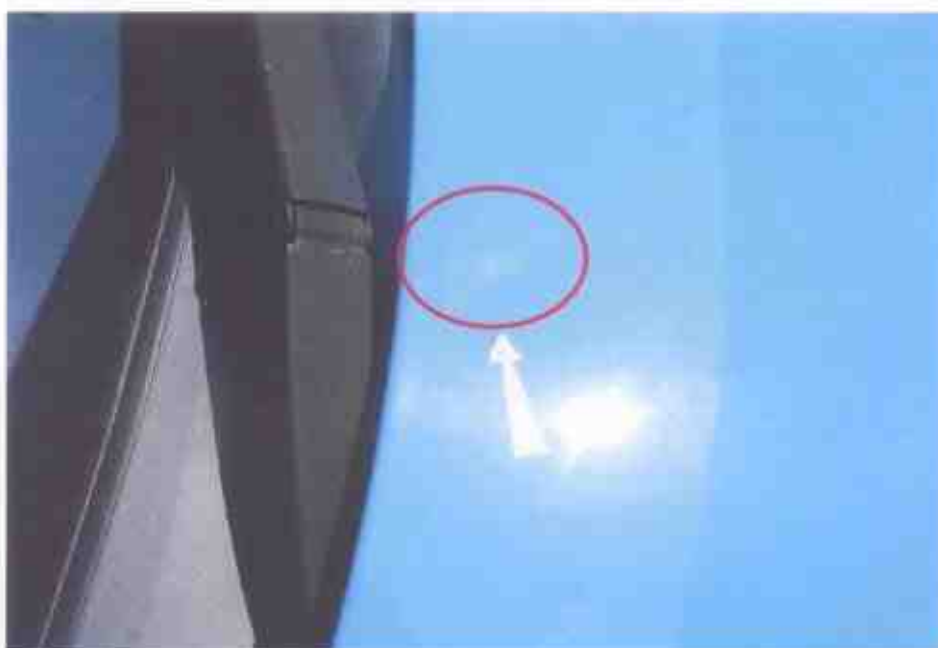
Photo 8 shows a close up view of the front bonnet portion of the Motor Taxi at the time of our inspection. Dent mark on the front bonnet amongst others.

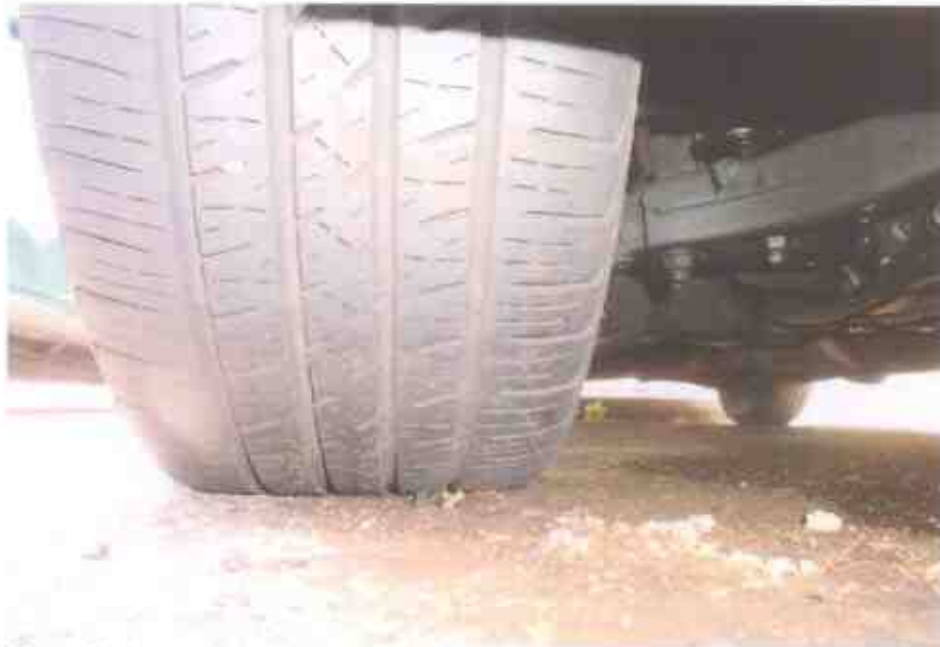
Photo 9 shows the condition of the front right tyre of the Motor Taxi, which was observed to be in serviceable condition with remaining tread depth of approximately 6mm. There was no tear, cut or burst mark(s) on the outer and the inner sidewalls.

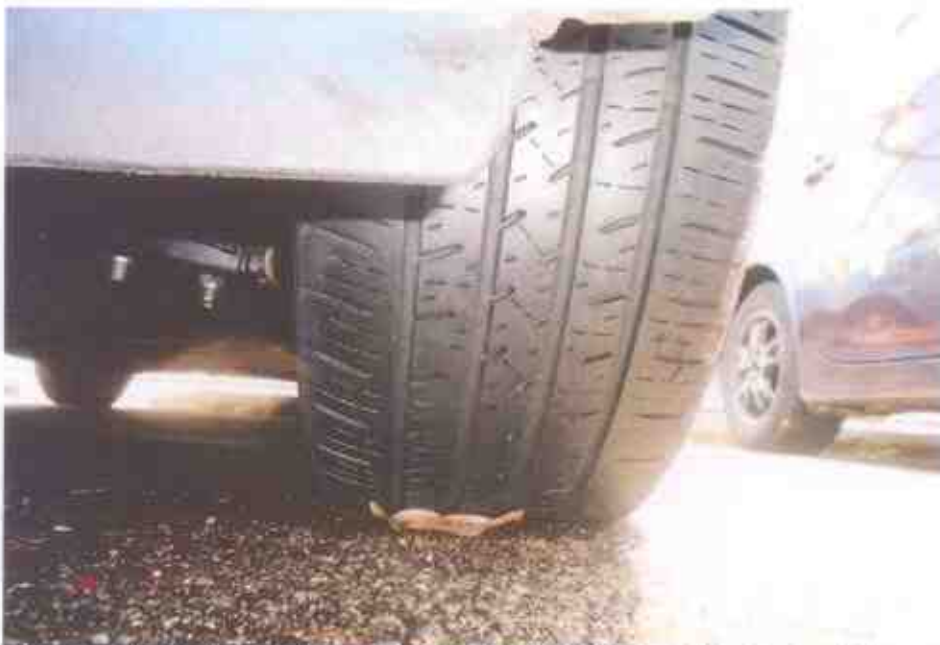
Photo 10 shows the condition of the front left tyre of the Motor Taxi, which was observed to be in serviceable condition with remaining tread depth of approximately 5mm. The tyre, which was wrapped around alloy wheel rim, was also observed to be sufficiently inflated for vehicular operation.

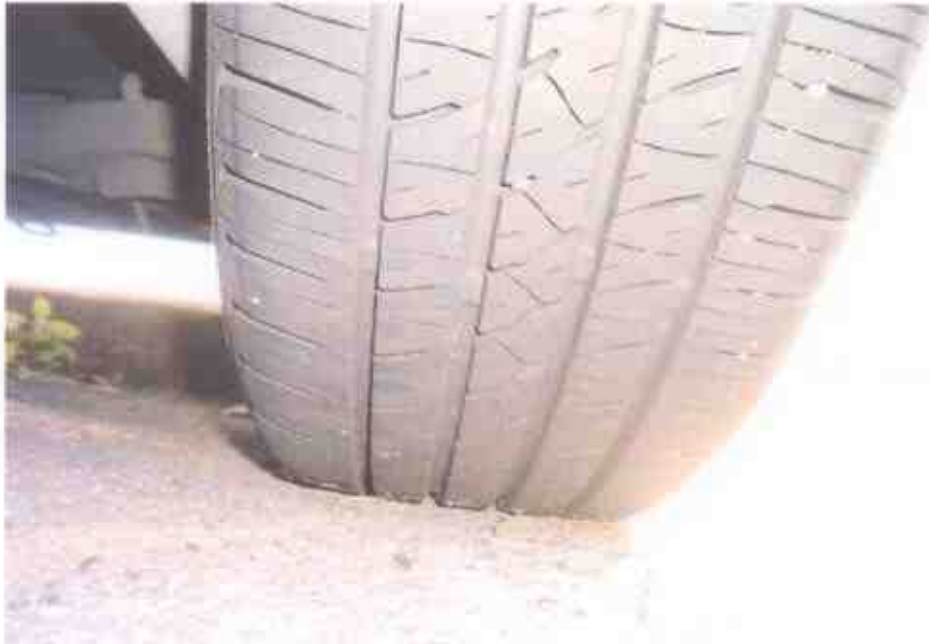
Photo 11 shows the condition of the rear left tyre of the Motor Taxi, which was observed to be in serviceable condition with remaining tread depth of approximately 7mm.

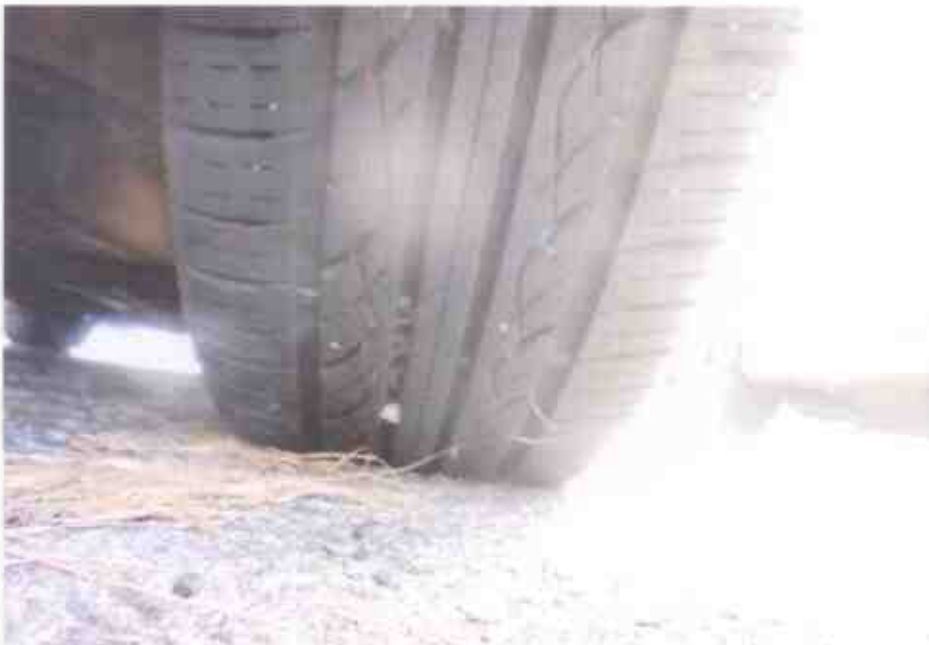
Photo 12 shows the condition of the rear right tyre of the Motor Taxi, which was observed to be in serviceable condition with remaining tread depth of approximately 6mm.

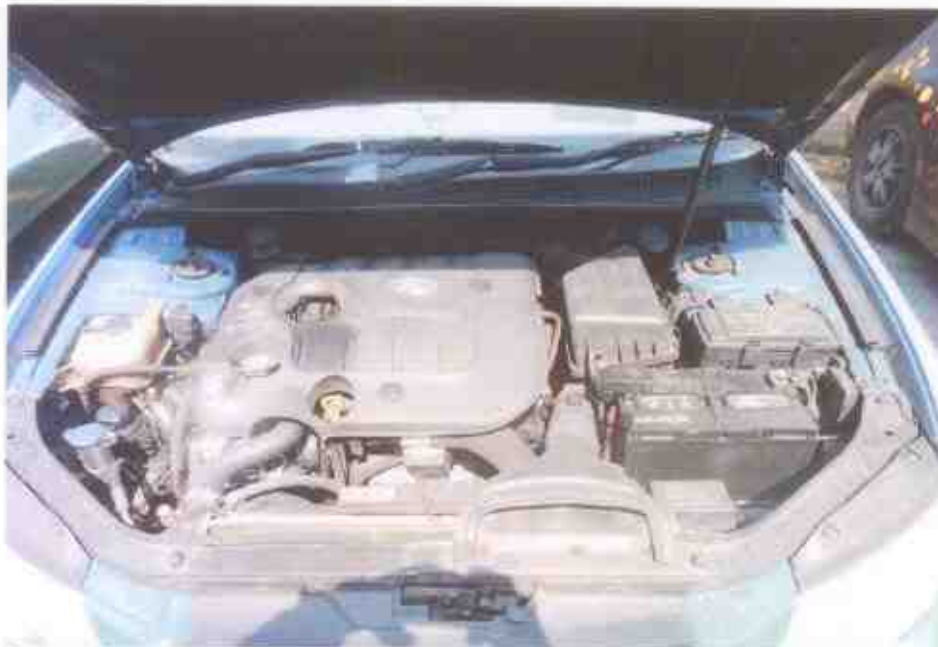
Photo 13 shows a general view of the Motor Car's engine compartment. The various parts and components inside the engine compartment were unaffected by the accident. There was also no sign(s) or indication(s) of fluid leakage and/or fluid stain within the engine compartment.

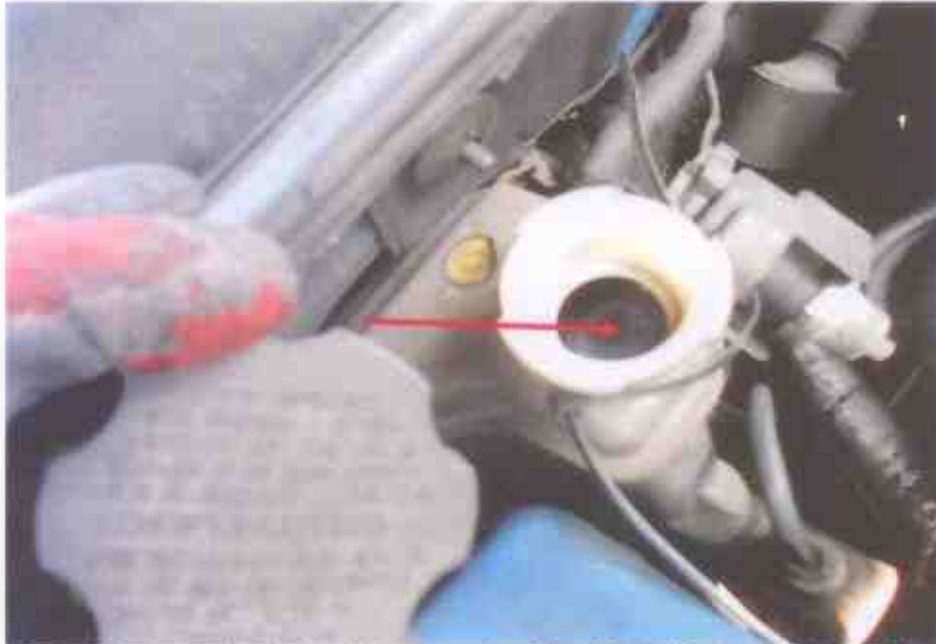
Photo 14 shows the brake fluid reservoir of the Motor Taxi at the time of our inspection. The brake fluid was observed to be of sufficient level (arrowed) and without any visible contamination.

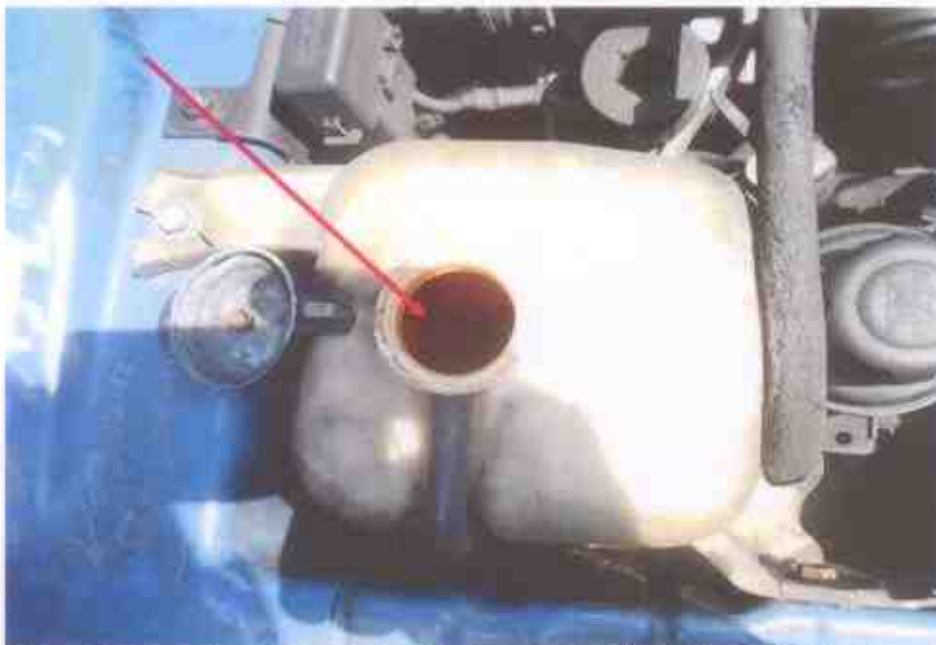
Photo 15 shows the engine coolant fluid reservoir of the Motor Taxi at the time of our inspection. The engine coolant fluid was observed to be of sufficient level and without any visible contamination.

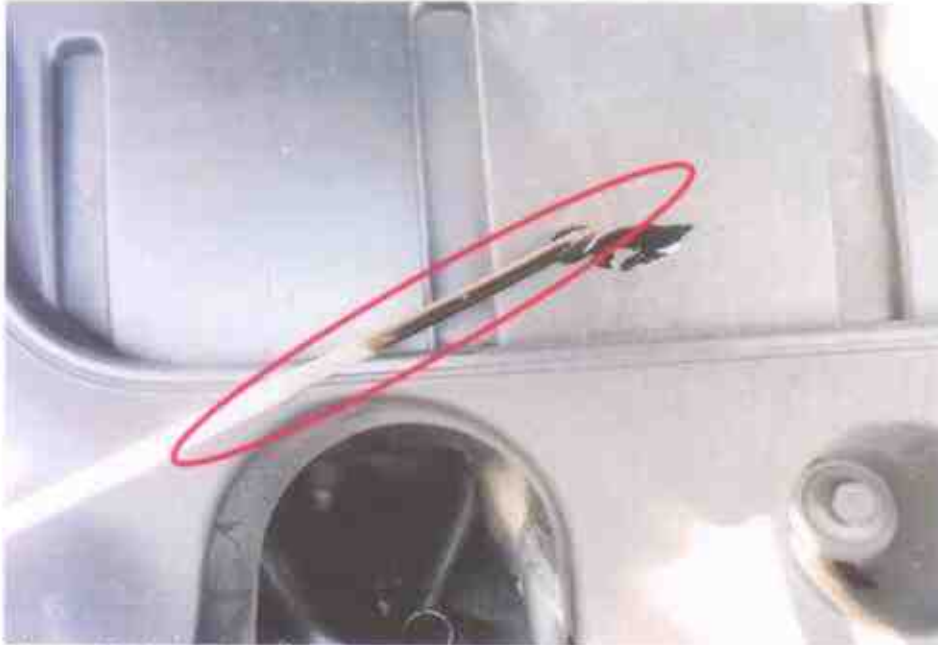
Photo 16 shows the engine oil dip stick of the Motor Taxi at the time of our inspection. The engine oil was observed to be of sufficient level and without any visible contamination.

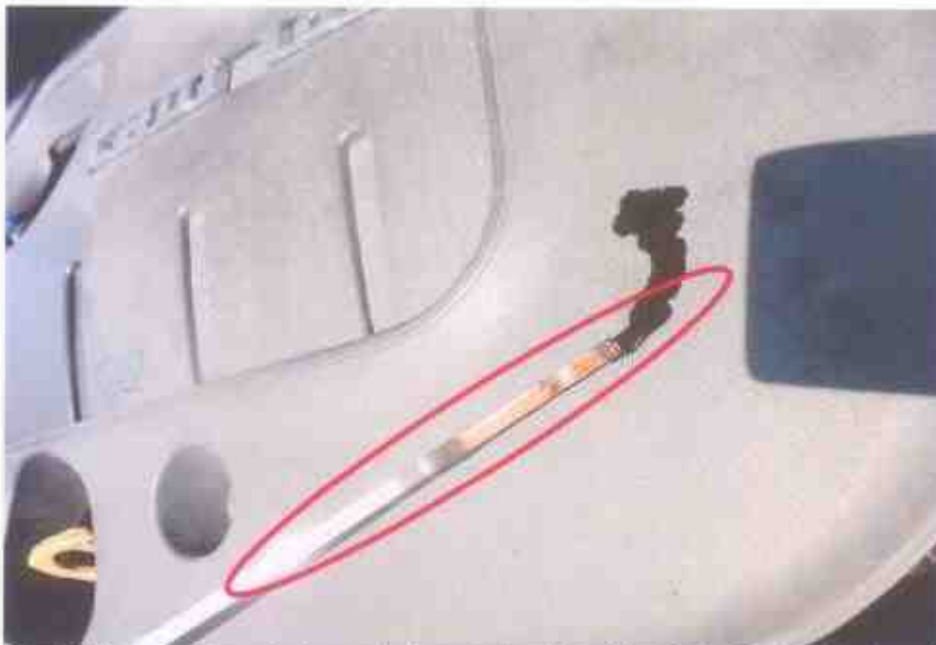
Photo 17 shows the auto transmission oil dip stick of the Motor Taxi at the time of our inspection. The ATF oil was observed to be of sufficient level and without any visible contamination.

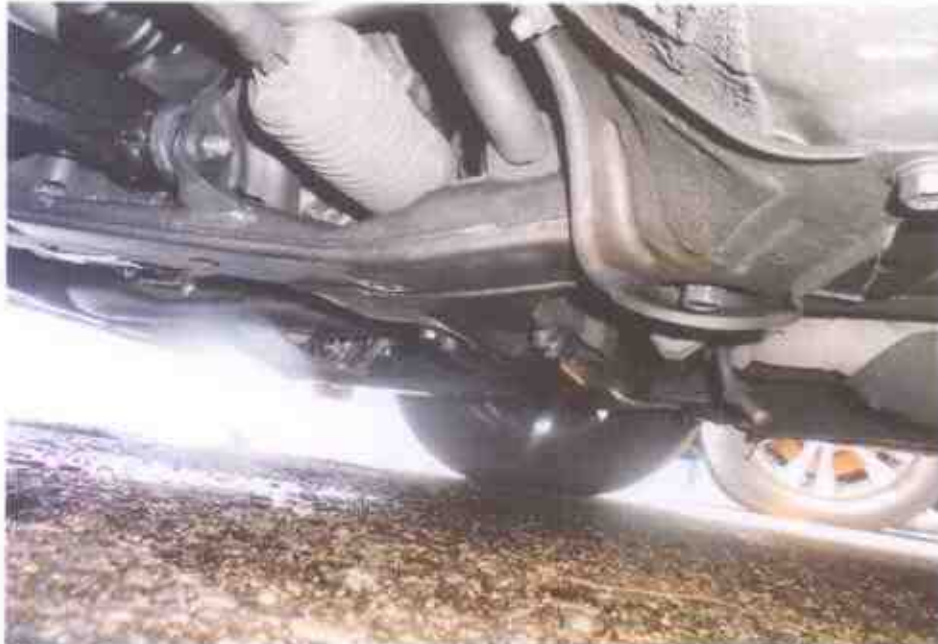
11. Our subsequent checks on the underside of the Motor Taxi revealed fluid stain observed to be pre-existed prior the accident looking at the dust accumulated with it. Our checks on the engine fluid had also indicated that the engine fluid was of sufficient level for operational purposes, and without contamination. Visually, the various undercarriage components of the Motor Taxi were all observed to be intact and without any visible damage. See photo 13 – 18 below.

Photo 18 shows the engine underside of the Motor Taxi engine at the time of our inspection. The engine was observed to be with a pre-existed oil stain prior the accident. This was based on the dust that associated with the fluid stain.

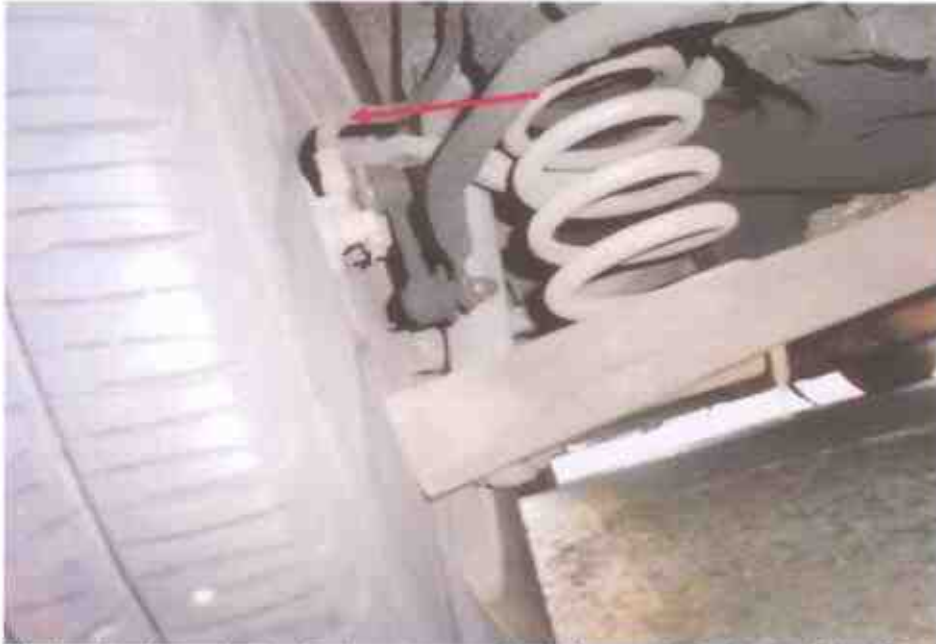
Photo 19 shows the brake hose (arrowed) at the rear left wheel of the Motor Taxi. We did not observe any leakage of brake fluid at the time of our inspection of the Motor Taxi. Our visual inspection of the various mechanical components of the Motor Taxi's braking system revealed all to be intact without visible damage.

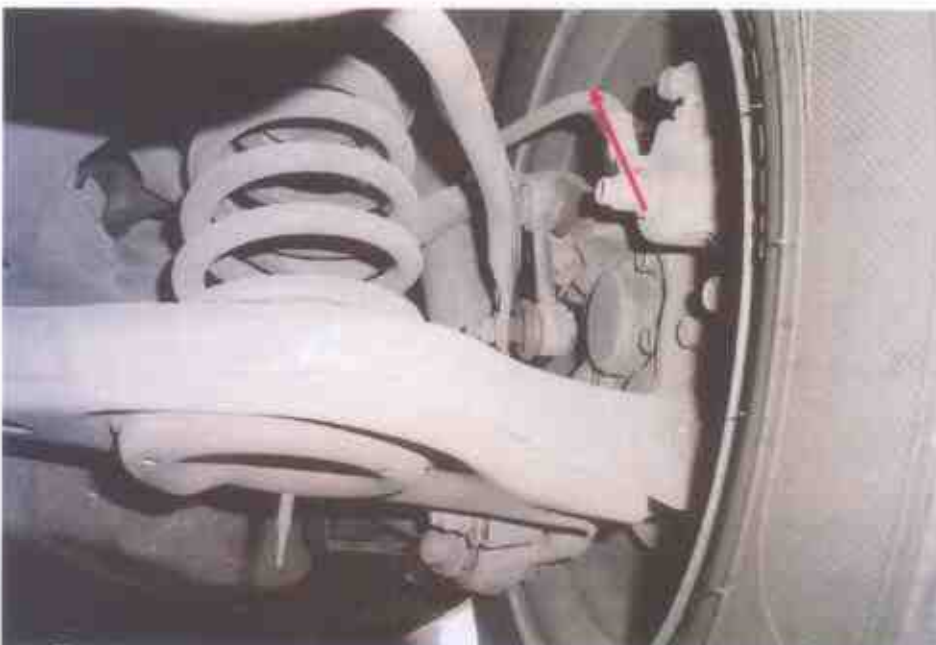
Photo 20 shows the brake hose (arrowed) at the rear right wheel of the Motor Taxi. We did not observe any leakage of brake fluid at the time of our inspection of the Motor Taxi. Our visual inspection of the various mechanical components of the Motor Taxi's braking system revealed all to be intact without visible damage.

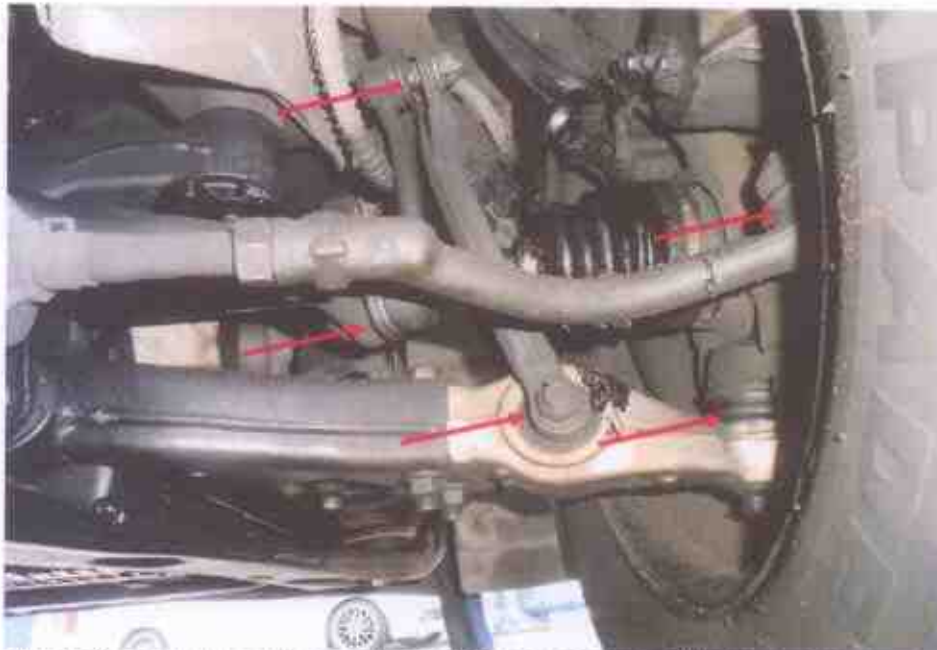
Photo 21 shows the various undercarriage components at the front right wheel of the Motor Taxi, in particular the steering tie rod (arrowed). The various steering components were all found to be intact, suggesting that the steering system of the Motor Taxi was likely to be in serviceable condition.

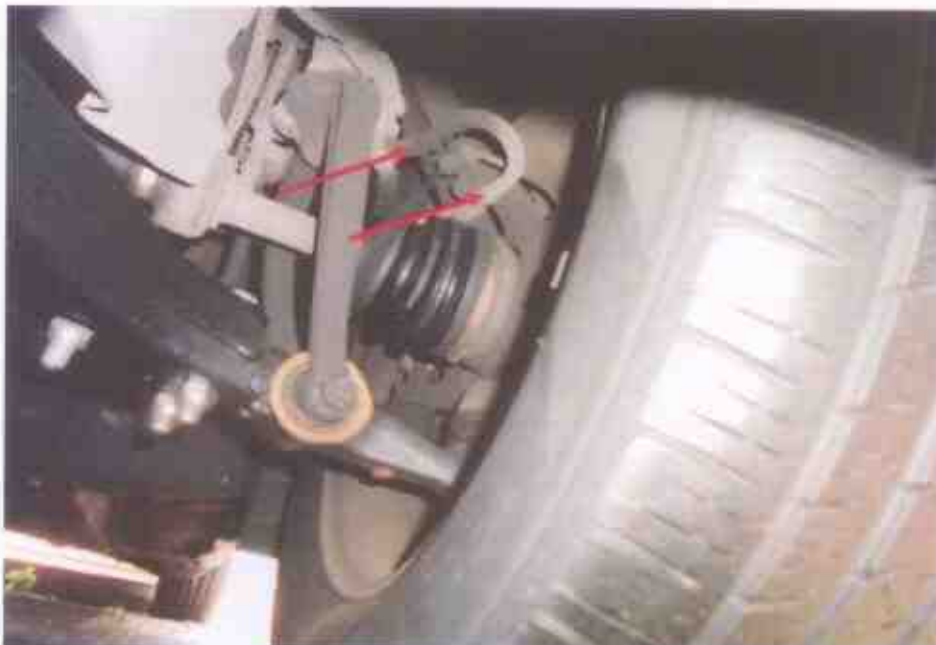
Photo 22 shows the various undercarriage components at the front left wheel of the Motor Taxi. We did not observe any leakage of brake fluid (arrowed) at the time of our inspection of the Motor Taxi. Our visual inspection of the various mechanical components of the Motor Taxi's braking system revealed all to be intact and without visible damage, indicating that the braking system was likely to be in serviceable condition at the material time of accident.

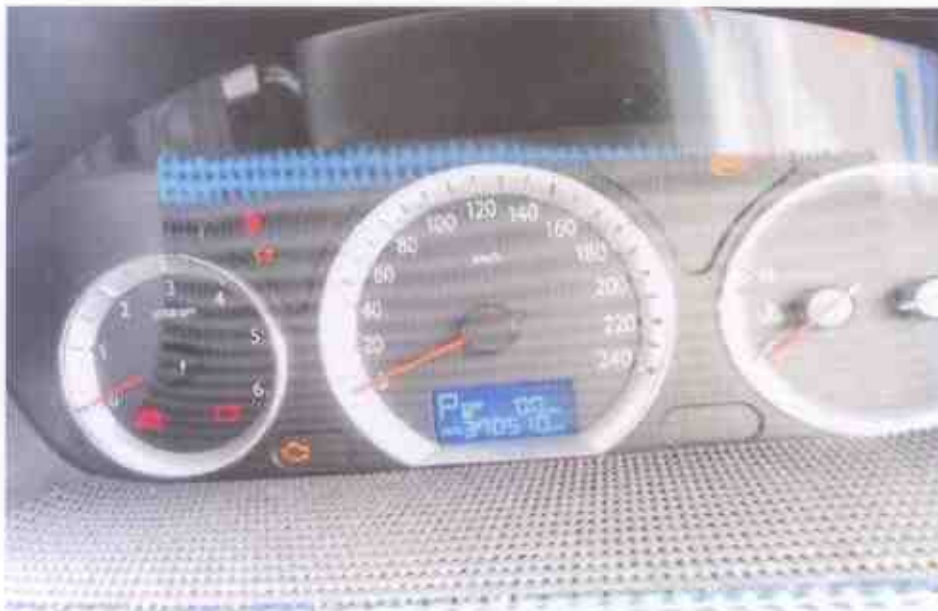
Photo 23 shows the warning lights for the various electronic operating systems of the Motor Taxi appearing on its instrument panel during the self-test when the engine is cranked, in particular the ABS light engine check light, battery light and diesel glow plug.

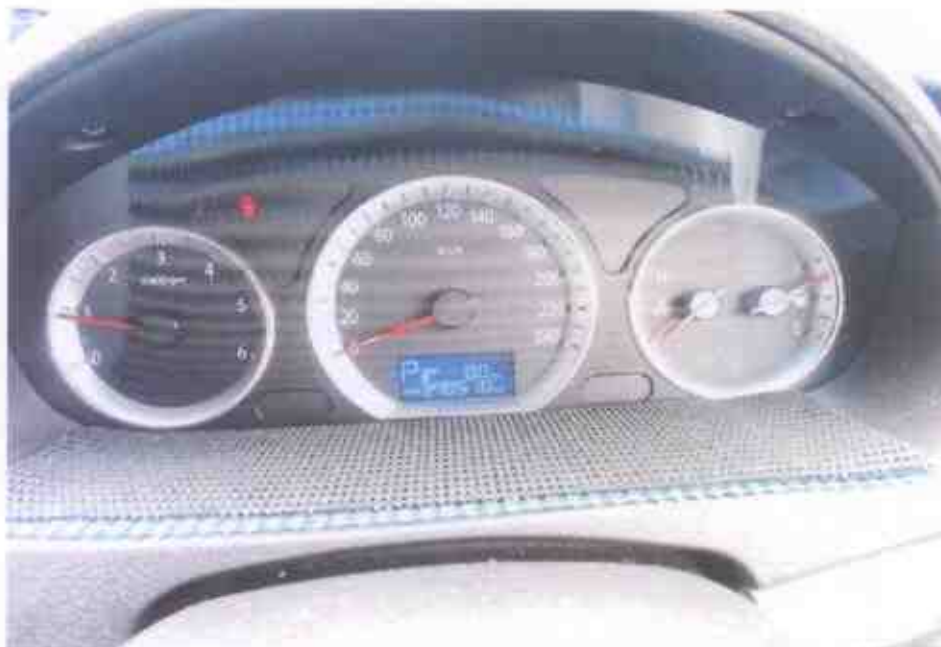
Photo 24 shows no warning lights illuminated on the instrument panel of the Motor Taxi after the engine was cranked. This would suggest that there was no abnormality to the various electronic operating systems of the Motor Taxi, like the ABS light engine check light, battery light and diesel glow plug.

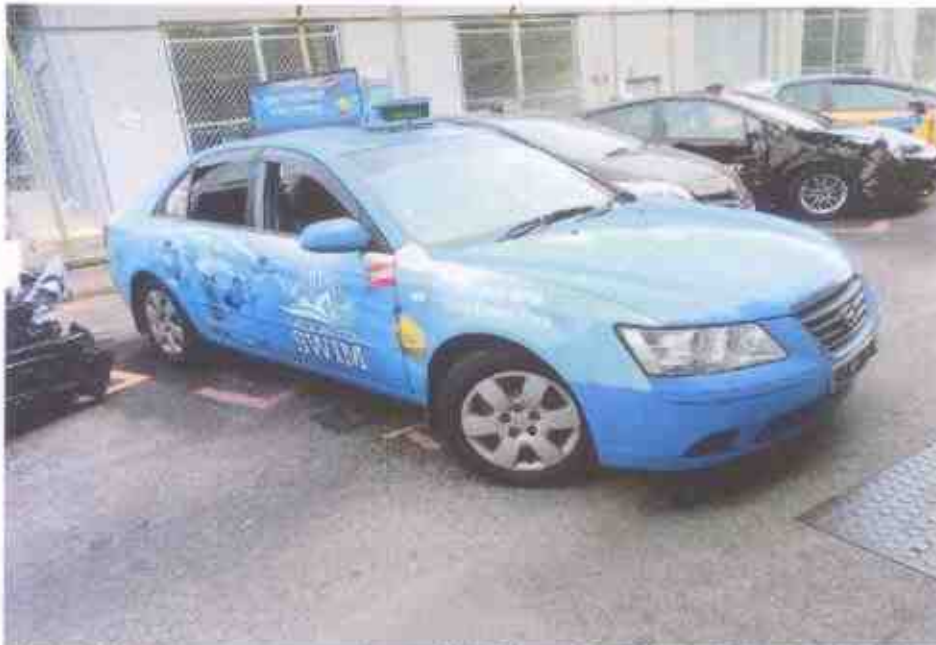
Photo 25 shows an operational test of the Motor Taxi. We were able to move the vehicle reverse, forward and backward normally.
