Your Ref: TP/IP/39585/2018
Our Ref : CI/TPD18013742/Z

07th September 2018

MECHANICAL INSPECTION REPORT OF MOTOR VAN GBG 2430T.

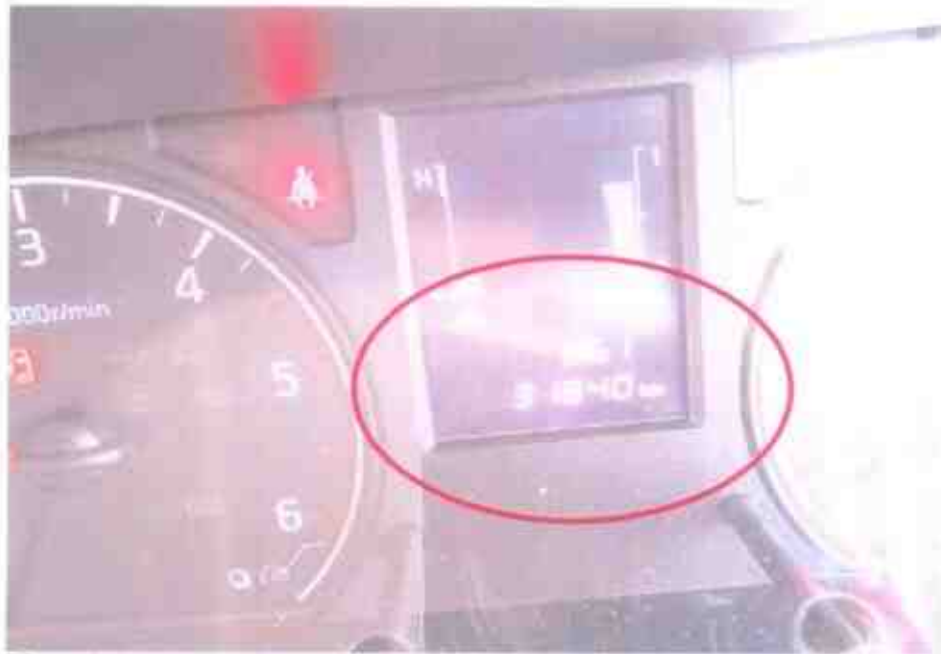
4. The mileage of the Motor Van at the time of our inspection was recorded at 31840km.
5. The Motor Van was observed to have sustained minor damages at its front left panel, front lower bumper & licence plate amongst others likely due to the accident's impact.
6. This was likely due to the consistency of the accident's case facts that on 12th July 2018 at about 0659hrs, the Motor Van was travelling along Marsiling Road towards Riverside Road on the left lane of the 2 lanes road. Upon nearing the signalised T-junction of Marsiling Road by Marsiling Drive, traffic light ahead of him was green only thus made a left turn into Marsiling Drive. The Motor Van's frontal portion collided onto a pedestrian who was crossing along the signalised pedestrian crossing from unknown direction. See photo 1 to 7 below.

Photo 1 shows the mileage of the Motor Van was recorded at 31840km.

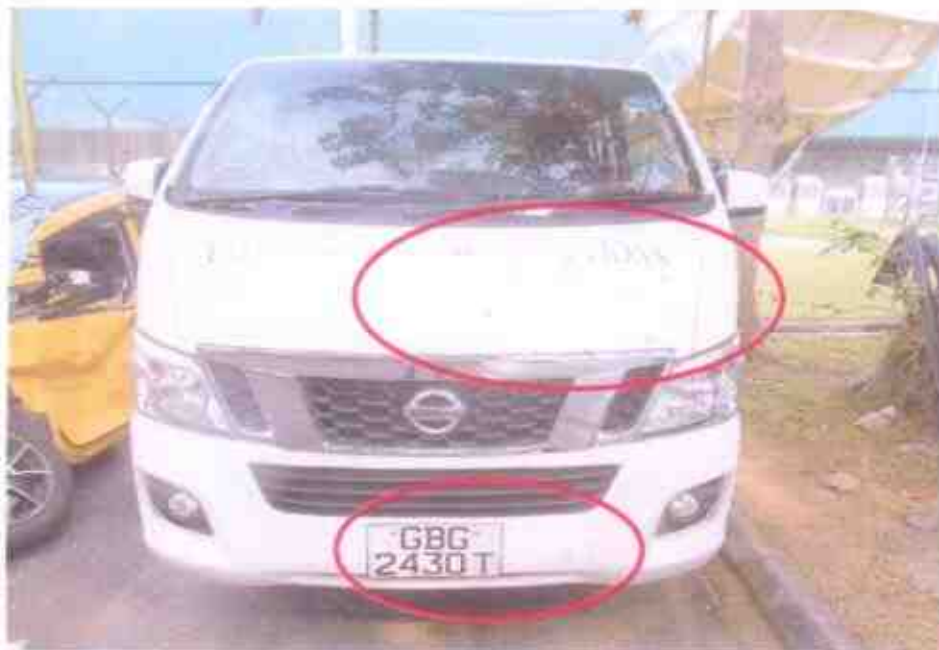
Photo 2 shows a general view of the front body of the Motor Van at the time of our inspection. The Motor Van was observed to sustained minor damage at the front left panel & lower bumper.

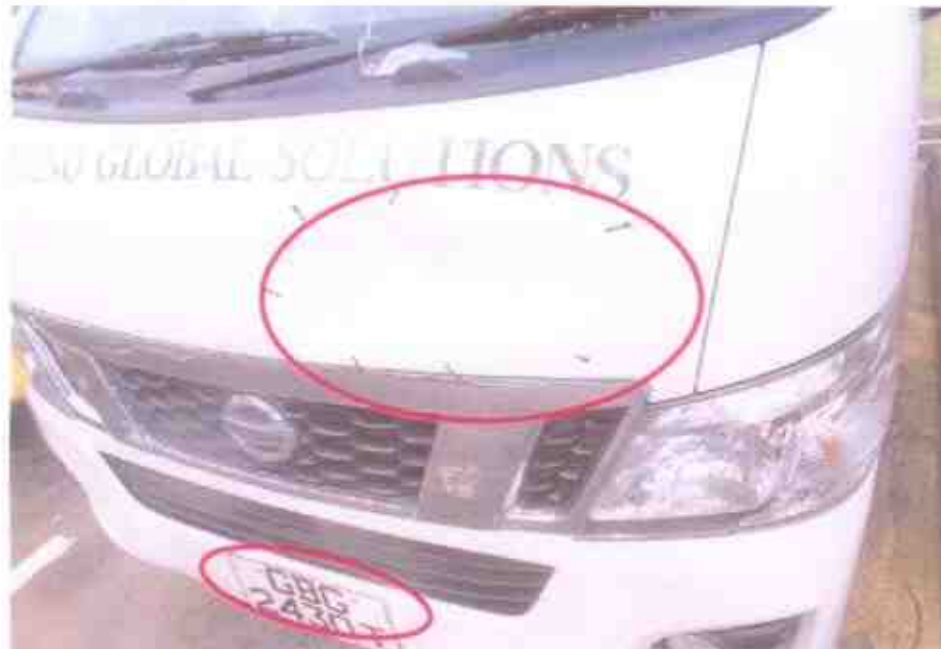
Photo 3 shows a general view of the front body of the Motor Van at the time of our inspection. The Motor Van was observed to sustained minor damage at the front left panel & lower bumper.

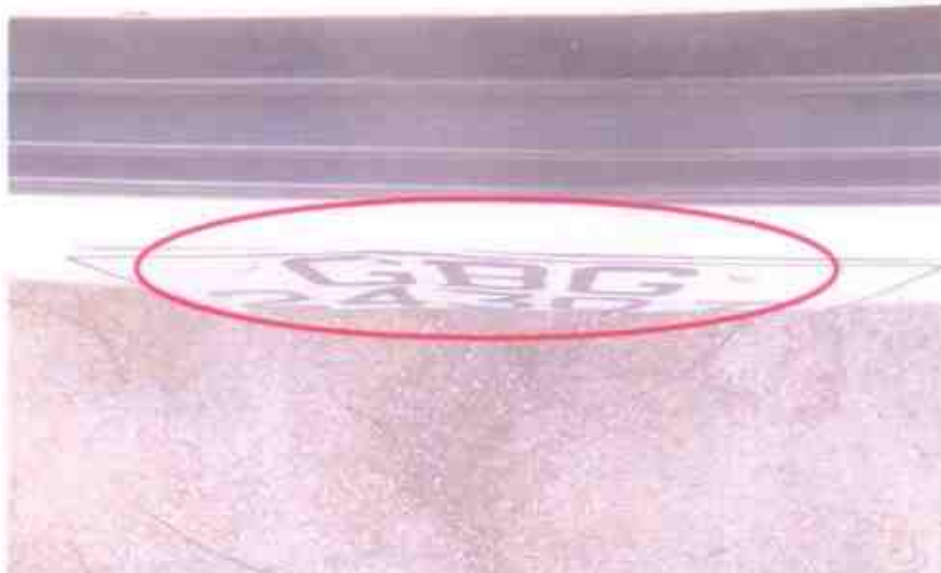
Photo 4 shows a close-up view of the front licence plate of the Motor Van at the time of our inspection. It was observed to be dented due to the accident.

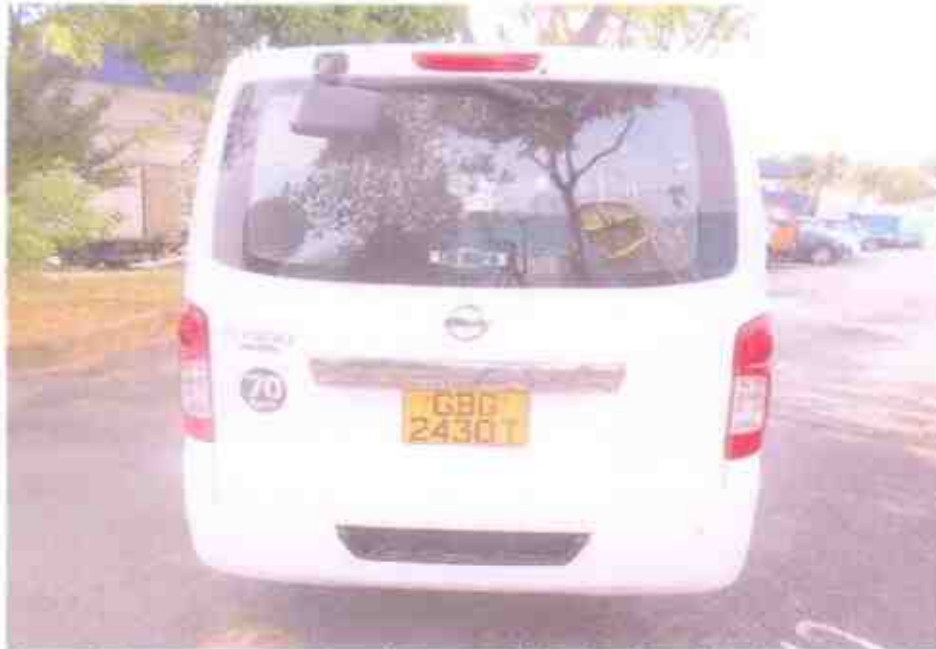
Photo 5 shows a general view of the rear left body of the Motor Van at the time of our inspection. The Motor Van was observed to be in good general condition at time of inspection.

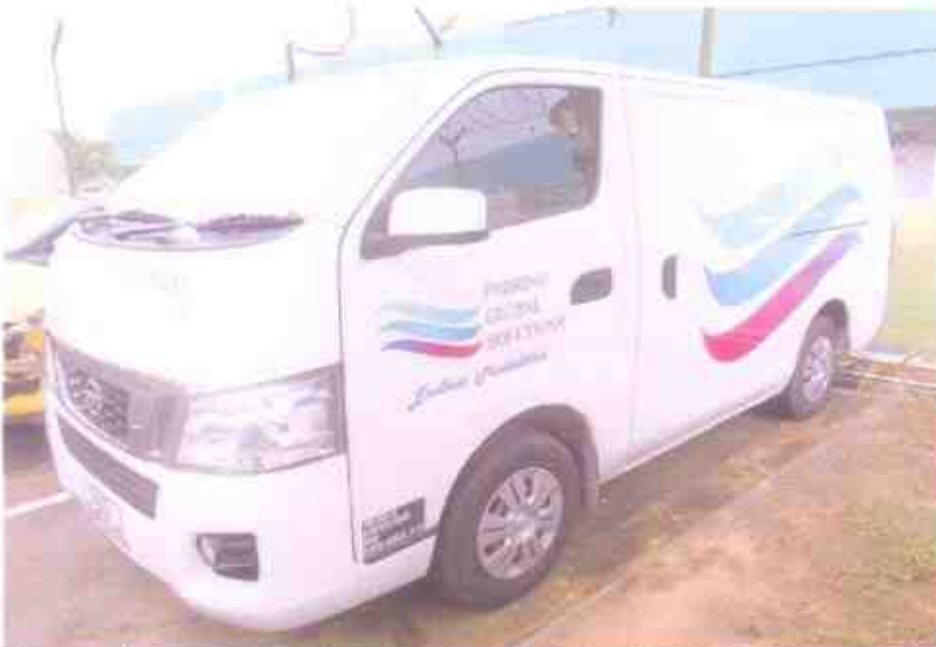
Photo 6 shows a general view of the front left body of the Motor Van at the time of our inspection. The Motor Van was observed to have sustained with minor damages due to the accident's impact.

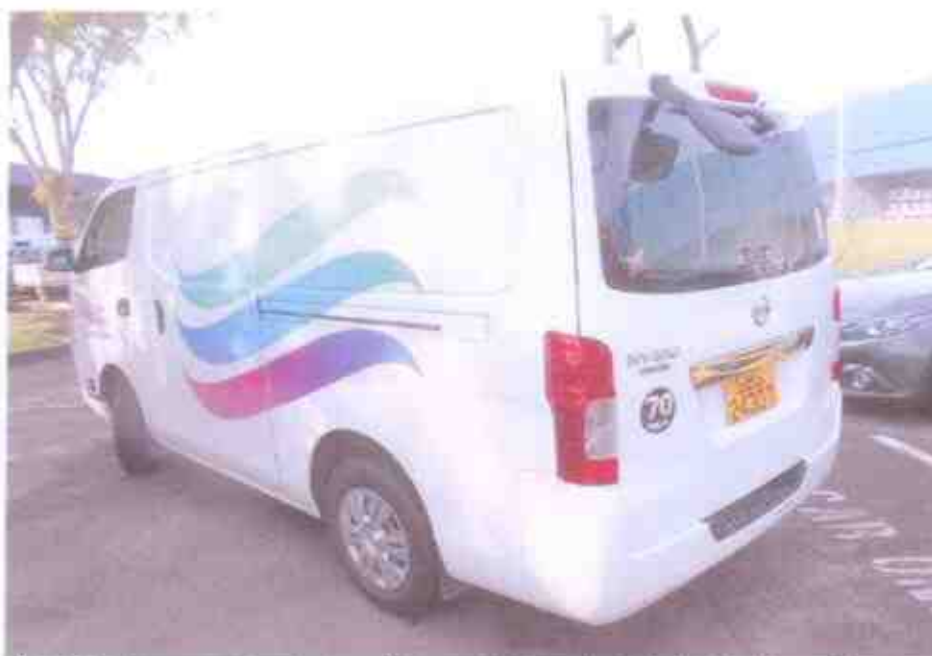
Photo 7 shows a general view of the rear left body of the Motor Van at the time of our inspection. The Motor Van was observed to be in good general condition at time of inspection.

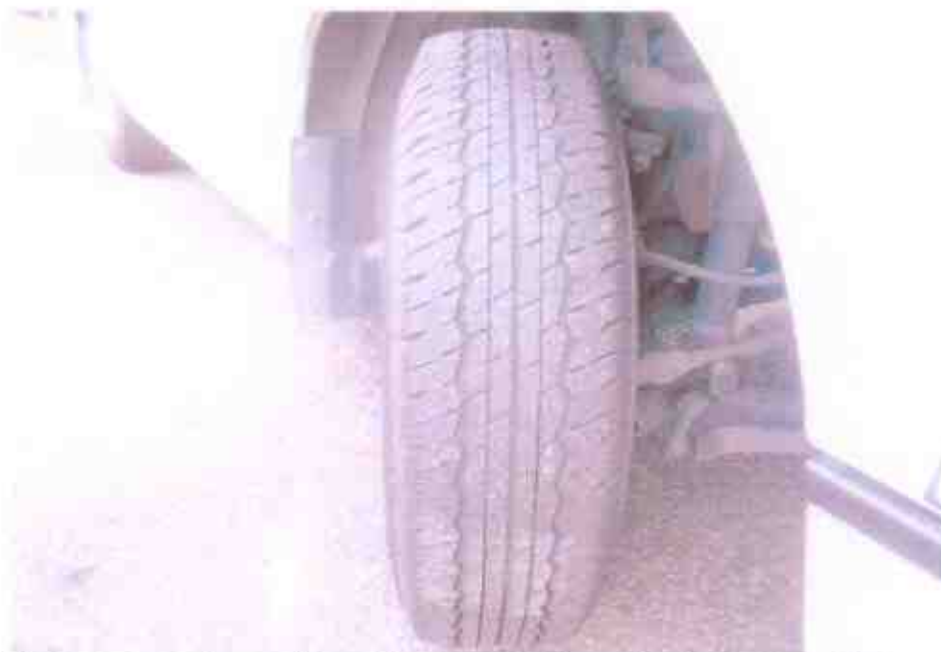
Photo 8 shows the condition of the front right tyre of the Motor Van, which was observed to be in serviceable condition with remaining tread depth of approximately 7mm. The tyres were all observed to be sufficiently inflated for vehicular operation with no tear, cut or burst mark(s) on the outer and the inner sidewalls as well as across the tread.

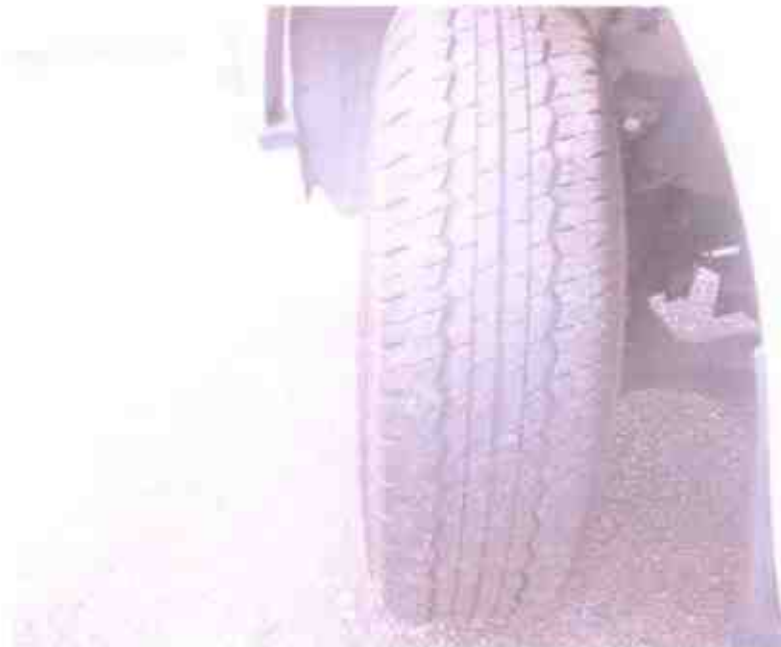
Photo 9 shows the condition of the front left tyre of the Motor Van, which was observed to be in serviceable condition with remaining tread depth of approximately 7mm. The tyre, which was wrapped around standard wheel rim, was also observed to be sufficiently inflated for vehicular operation.

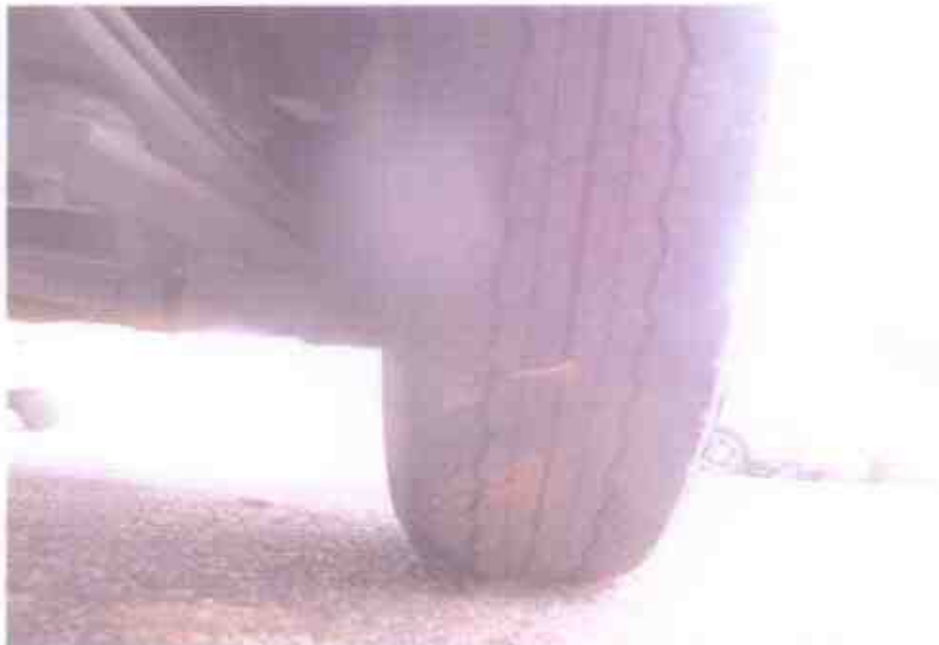
Photo 10 shows the condition of the rear left tyre of the Motor Van, which was observed to be in serviceable condition with remaining tread depth of approximately 6mm. The tyre, which was wrapped around standard wheel rim, was also observed to be sufficiently inflated for vehicular operation. There was also no significant damage found on the 4 wheel rims of the Motor Van.

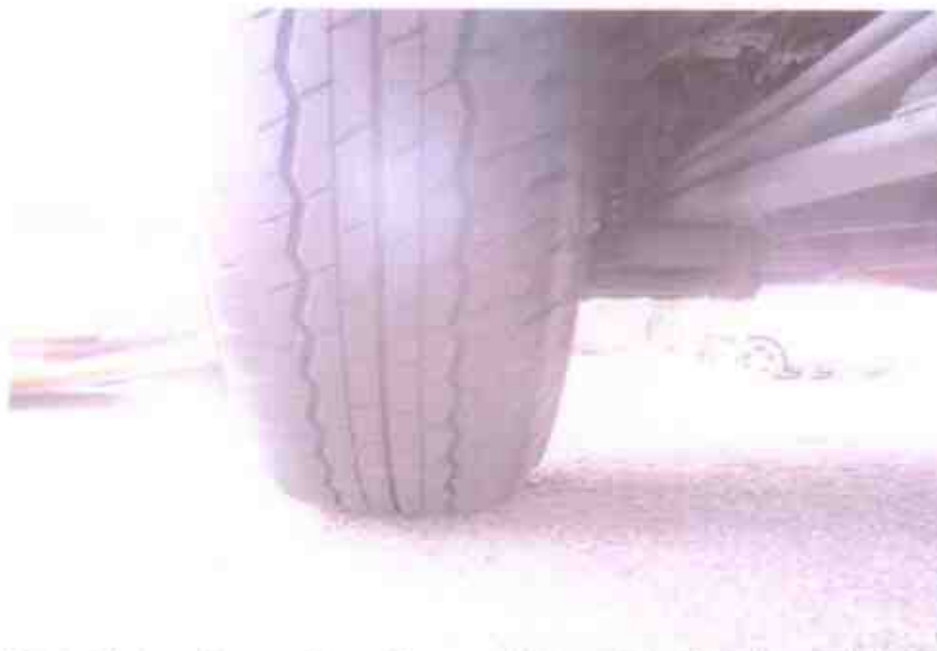
Photo 11 shows the condition of the rear right tyre of the Motor Van, which was observed to be in serviceable condition with remaining tread depth of approximately 5mm. There was also no tear, cut or burst mark(s) on the outer and the inner sidewalls as well as across the tread of the tyre, which was also sufficiently inflated for vehicular operation.

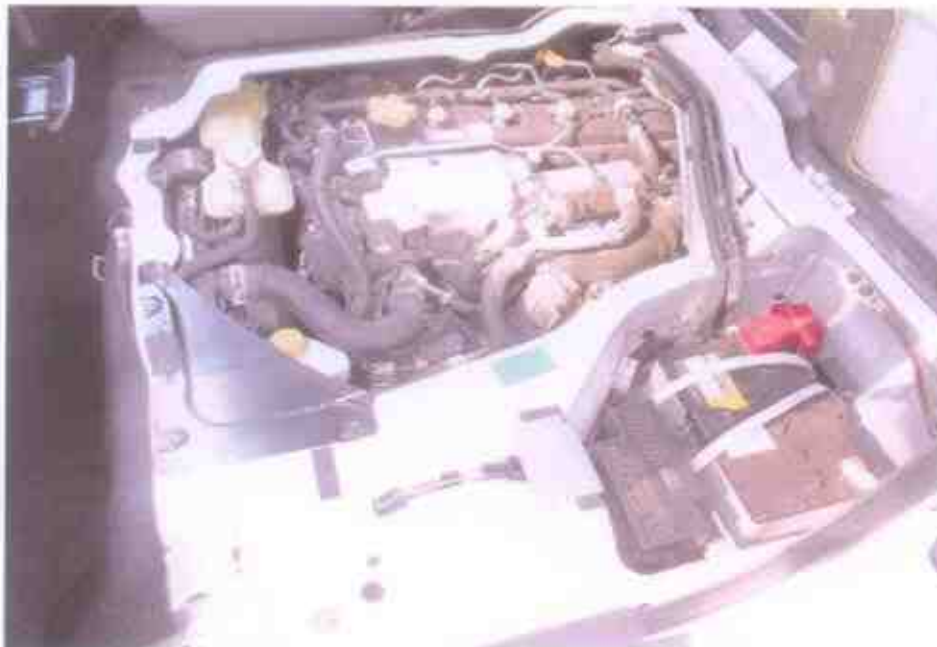
9. Upon examination of the Motor Van's engine compartment, we had observed all the parts and components inside the engine compartment to be intact and unaffected by the accident. The brake fluid, engine oil, and engine coolant were all found to be of sufficient level for operating purposes. Visually, there was also no contamination found to these fluids.
10. Further examination of the engine compartment revealed no sign(s) or indication(s) of fluid leakage and/or fluid stain within the engine compartment of the Motor Van.
11. Our subsequent checks on the underside of the Motor Van revealed no fluid stain. Visually, the various undercarriage components of the Motor Van were all observed to be intact and without any visible damage. See photo 12 to 14 below.

Photo 12 shows a general view of the Motor Van's engine compartment. The various parts and components inside the engine compartment were unaffected by the accident. There was also no sign(s) or indication(s) of fluid leakage and/or fluid stain within the engine compartment.

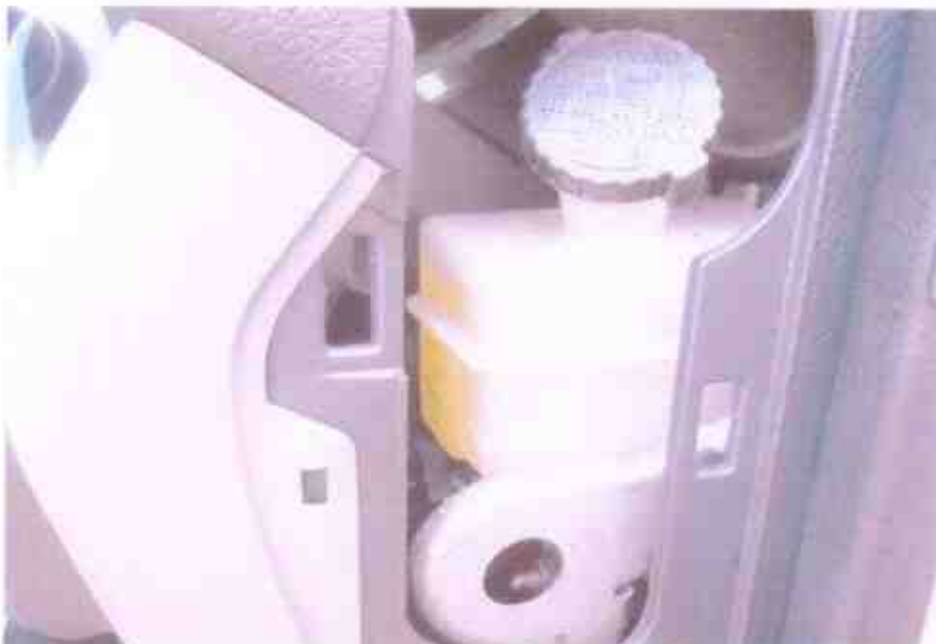
Photo 13 shows the brake fluid reservoir of the Motor Van at the time of our inspection. The brake fluid was observed to be of sufficient level and without any visible contamination.

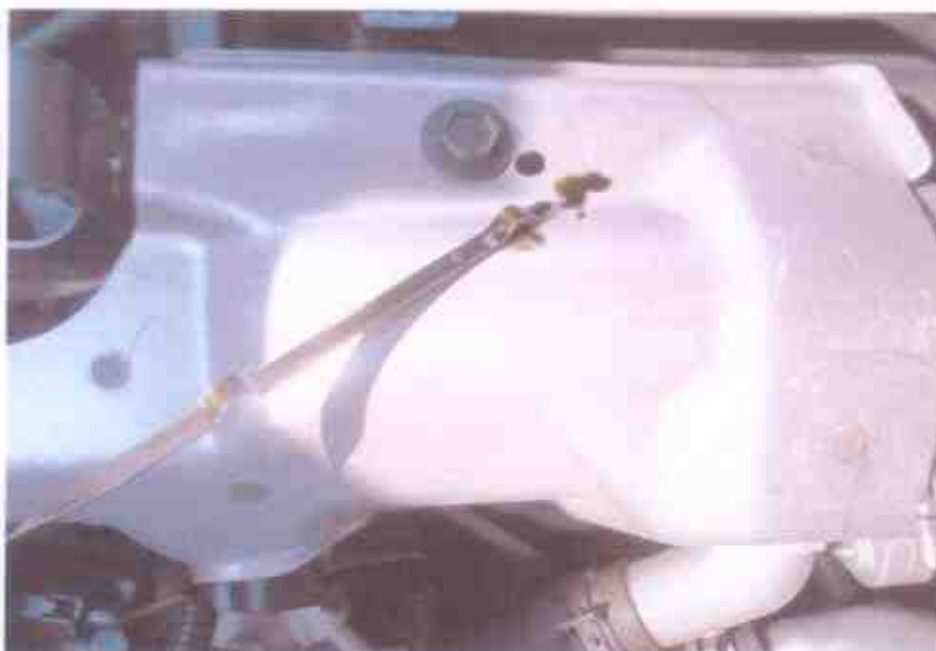
Photo 14 shows the engine dip stick of the Motor Van at the time of our inspection. The engine oil was observed to be of sufficient level and without any visible contamination.

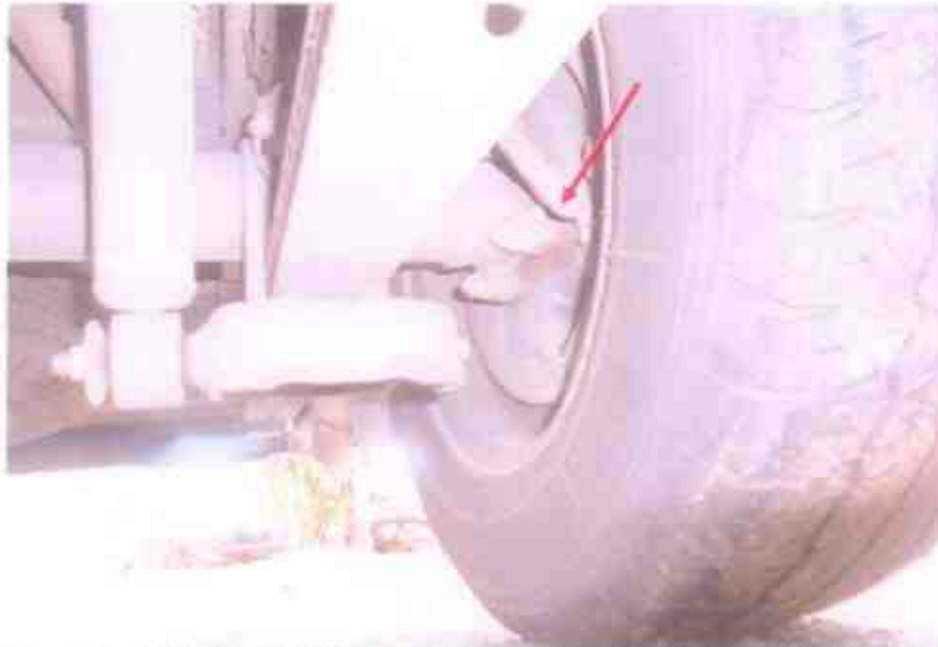
12. Static brake tests conducted on the Motor Van revealed no abnormality. The brake booster had responded well to the various tests conducted. There was also no abnormal movement of the brake pedal when it was depressed. In general, the static brake tests had suggested that there was no internal leakage of pressure/vacuum in the braking system of the Motor Van. The braking system of the Motor Van was likely to be in serviceable condition at the material time. This was also taking into consideration that the brake fluid was of sufficient level, and also that there was no sign(s) of brake fluid leakage along the brake hoses and brake pipes.

Photo 15 shows the various undercarriage components at the rear left wheel of the Motor Van, in particular the brake hose (arrowed). We did not observe any leakage of brake fluid at the time of our inspection of the Motor Van.

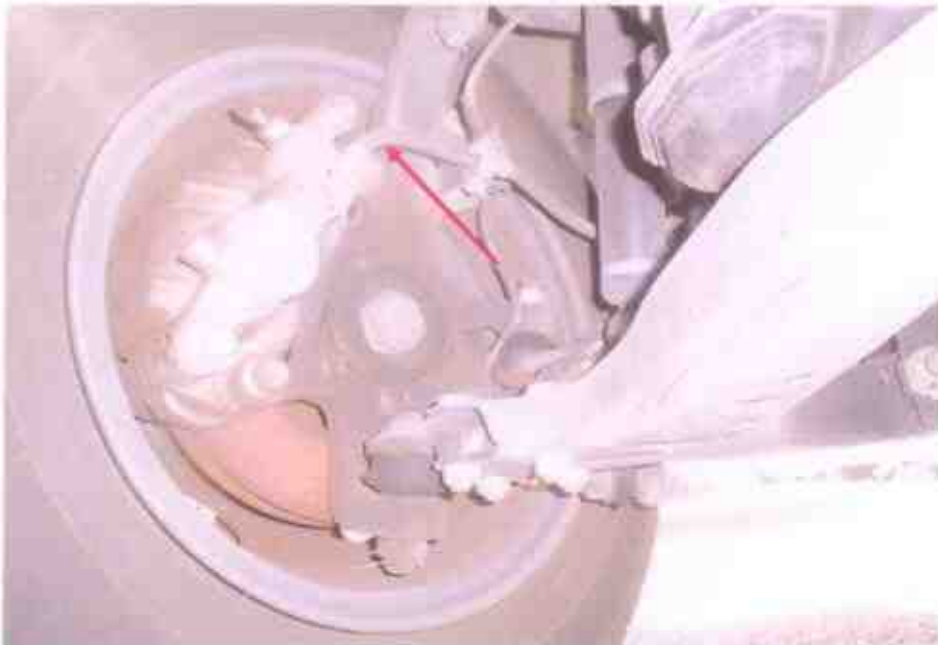
Photo 16 shows the brake hose (arrowed) at the front left wheel of the Motor Van. We did not observe any leakage of brake fluid. Our visual inspection of the various mechanical components of the Motor Van's braking system revealed all to be intact and without visible damage, indicating that the braking system was likely to be in serviceable condition at the material time of accident.

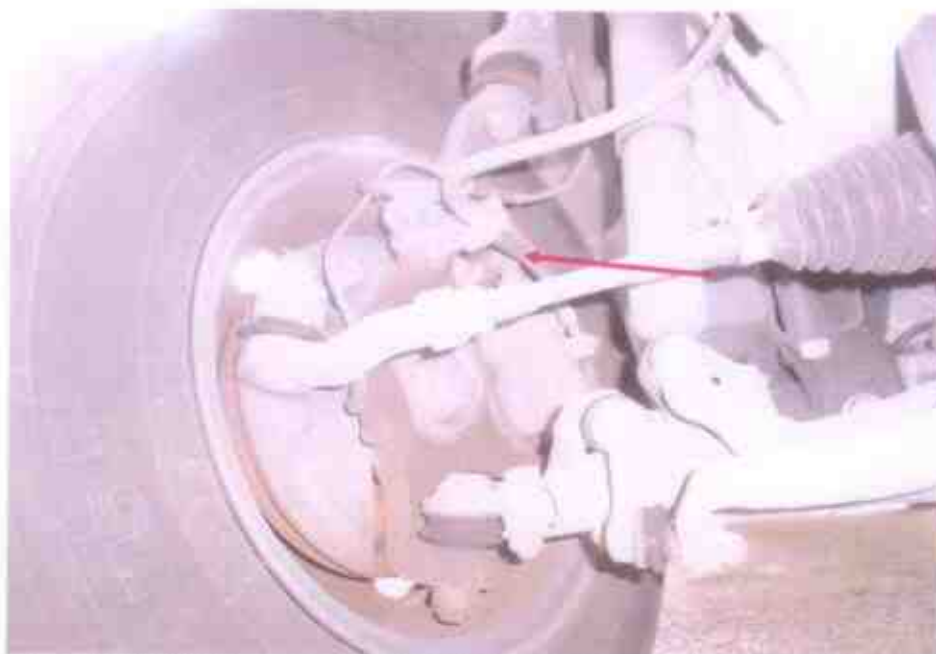
Photo 17 shows the brake hose (arrowed) at the front right wheel of the Motor Van. We did not observed any leakage of brake fluid at the time of our inspection of the Motor Van. Our visual inspection of the various mechanical components of the Motor Van's braking system, including its brake calliper, revealed all to be intact and without visible damage.

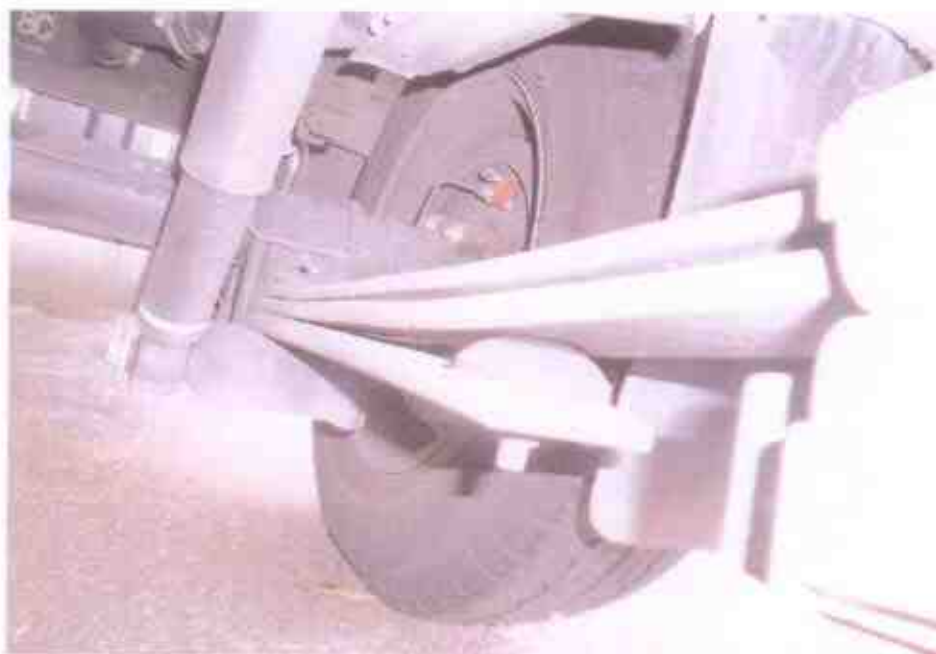
13. Static test on the steering system of the Motor Van also revealed no abnormality to the steering system. We did not experience any abnormal free play and/or other resistance when turning the steering wheel left and right to full lock positions. Our visual examination of the various steering components which had included the rack and pinion, tie rods, tie rod ends and ball joints had revealed that these components were all generally in good condition. See photo 15 to 18 below.

Photo 18 shows the various undercarriage components at the rear right wheel of the Motor Van. The various steering components were all found to be intact, suggesting that the steering system of the Motor Van was likely to be in serviceable condition at the material time of accident. There was also no sign of fluid stain(s) observed on the various undercarriage components at the 4 wheels of the Motor Van.

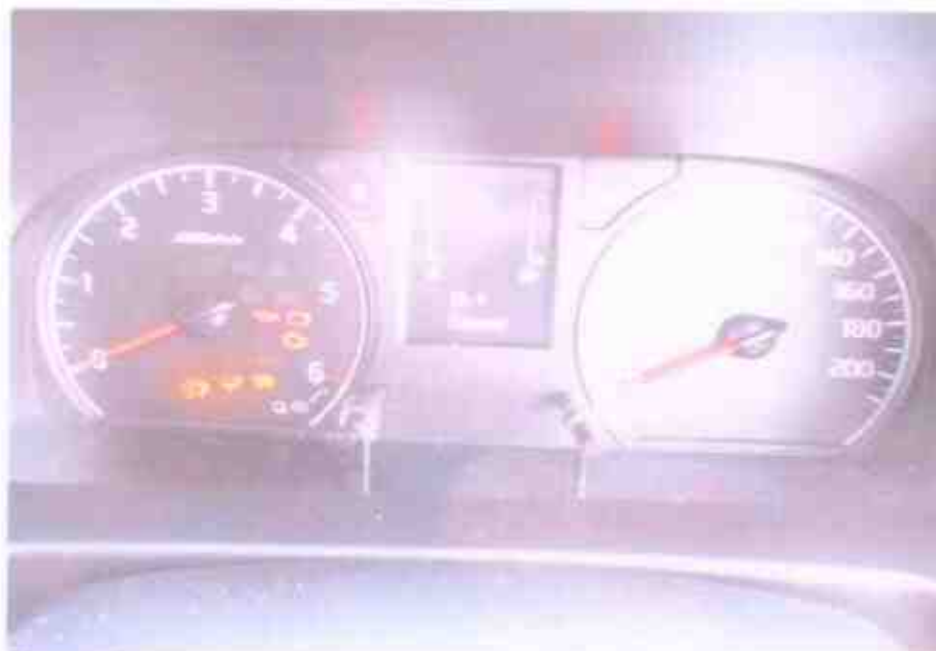
14. The Motor Van's automatic self-test of the functionality of its various electronic operating systems like the Supplemental Restraint System (SRS), engine checked light, fuel light, battery light & etc. During cranking of the engine had indicated that these systems were in working condition and without abnormality. This can be established from the warning lights disappearing from the instrument panel after the self-test. See photo 19 & 20 below.

Photo 19 shows the warning lights for the various electronic operating systems of the Motor Car appearing on its instrument panel during the self-test when the engine was cranked.

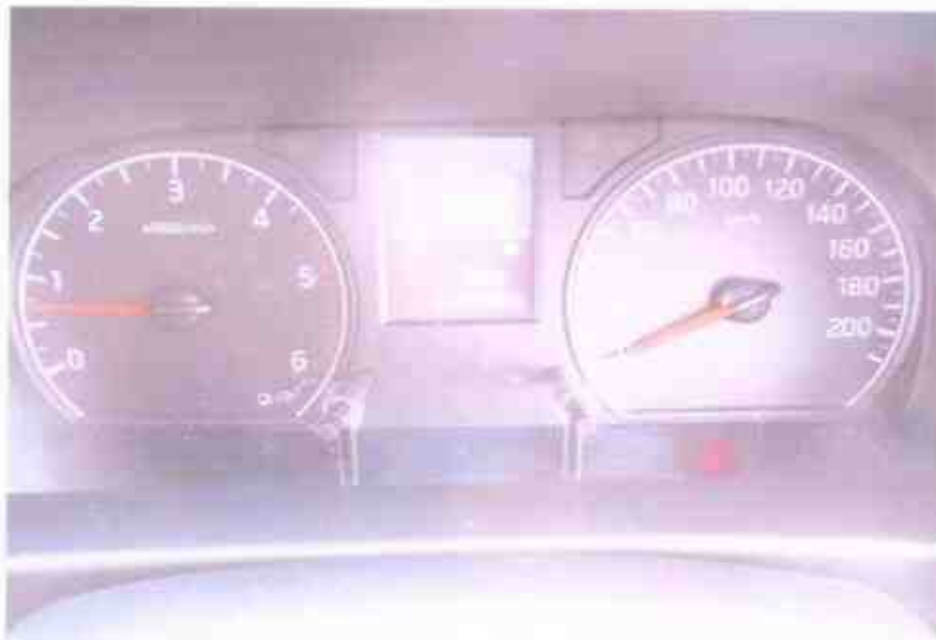
Photo 20 shows the warning lights disappearing after cranking of the engine.

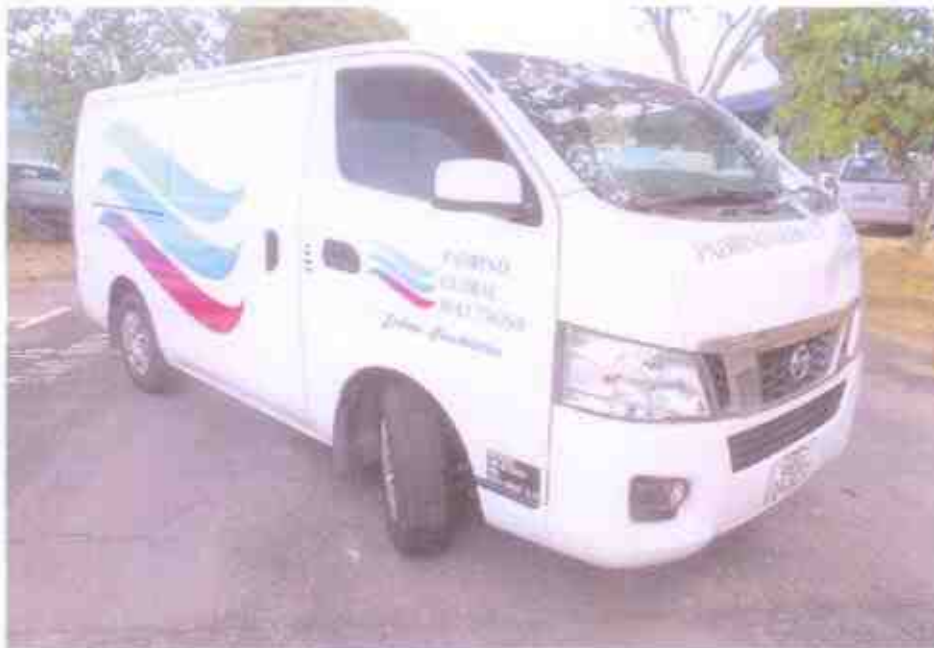
15. A short operational test of the Motor Van, to primarily determine whether there was any abnormality to its various operating systems like its engine system, its transmission system, steering system and braking system was subsequently carried out. The test was conducted by driving the Motor Van forward, stopping, before reversing and coming to a stop again.
16. During the operational test, the various transmission gears of the Motor Van were able to be engaged without any difficulty by stepping on the clutch pedal and manually shifting the gear lever. There were no abnormal sounds heard and/or abnormal behaviour of the Motor Van's engine system. It was able to move forward and backward normally. The braking system was also found to be in working condition as the Motor Van was able to slow down and come to a complete stop upon depressing of the brake pedal. See photo 21 & 22 below.

Photo 21 shows a short operational test of the Motor Van, to primarily determine whether there was any abnormality to its various operating systems like its engine system, its transmission system, steering system and braking system was subsequently carried out. The test was conducted by driving the Motor Van forward, stopping, before reversing and coming to a stop again.

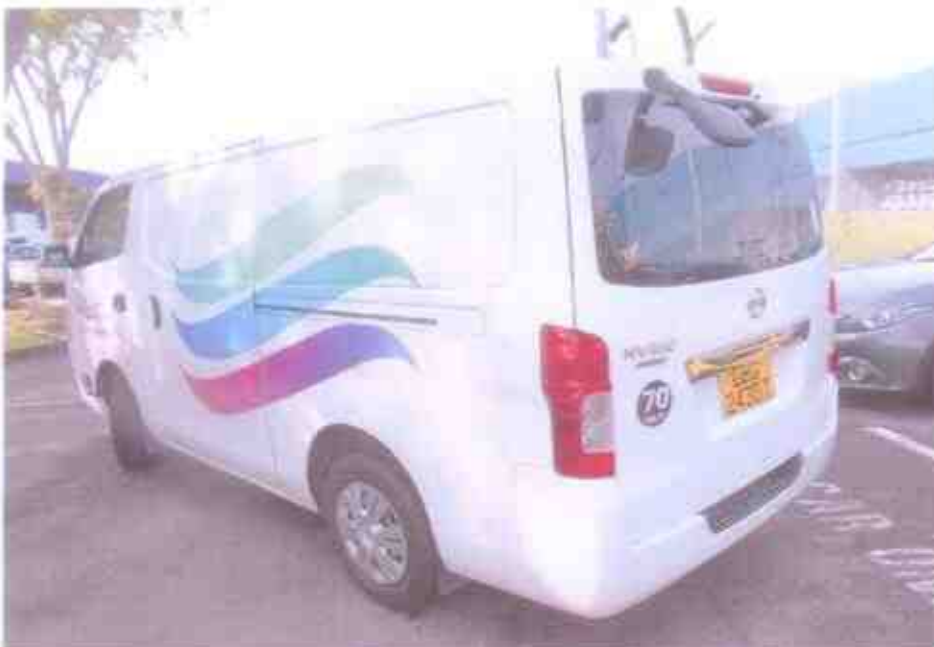
Photo 22 shows a short operational test of the Motor Van, the test was conducted by driving the Motor Van forward, stopping, before reversing and coming to a stop again.
