Your Ref: TP/IP/25259/2018
Our Ref : CI/TPD18013746/Z

14th August 2018

MECHANICAL INSPECTION REPORT OF MOTOR CAR SKC 280L

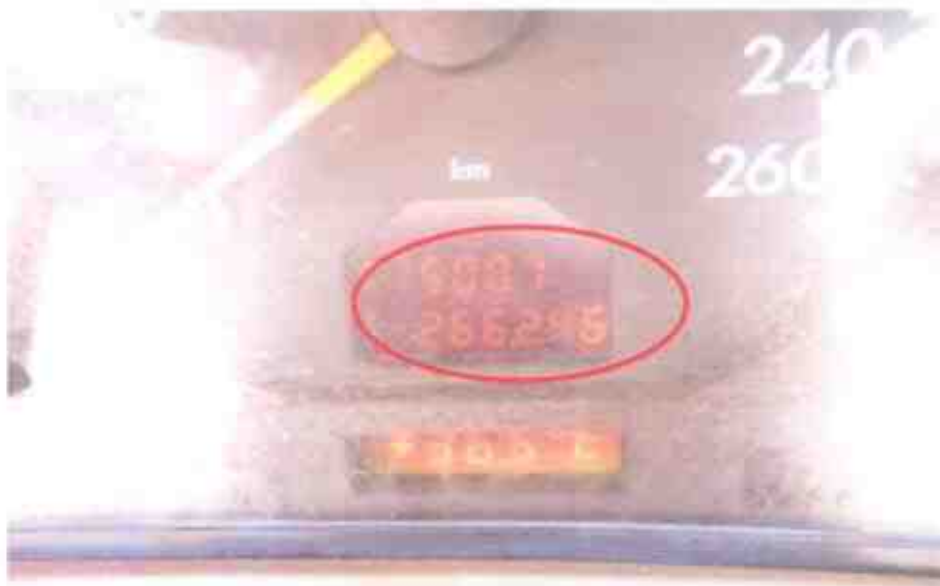
Photo 1 shows the mileage of the Motor Car at the time of our inspection was recorded at 266246km.

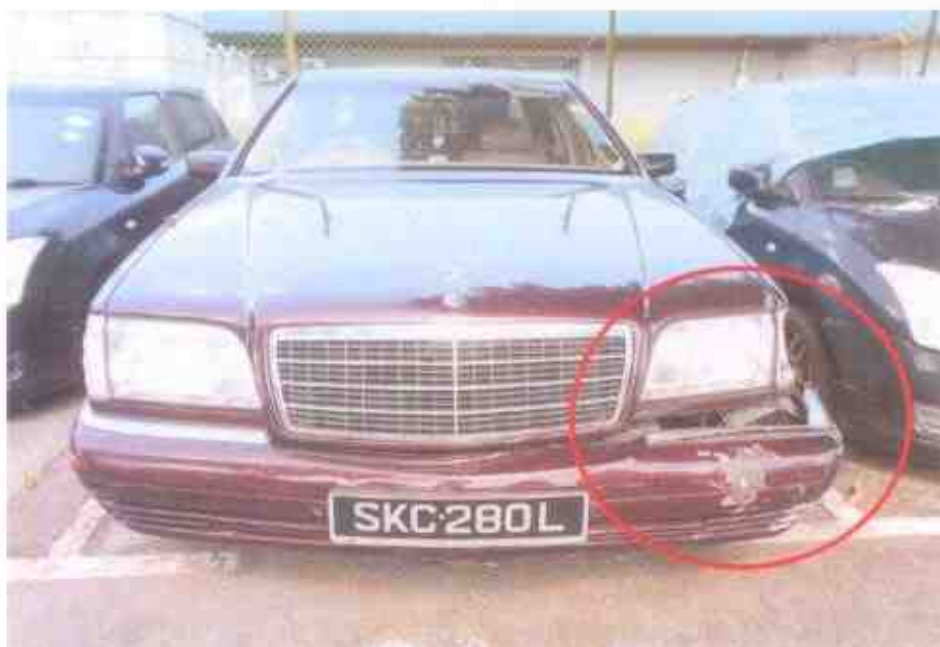
4. The mileage of the Motor Car at the time of our inspection was recorded at 266246km.
5. The Motor Car had sustained a relatively minor impact damages that was confined to its front left portion. Its front left bumper was observed to be damaged; its left hand signal light cover was broken; its front left bonnet & left fender was dented & its windshield was cracked likely due to the accident's collision impact.
6. This was likely due to the consistency of the accident's case facts that the Motor Car driver was travelling along a slip road on lane 1 on a 2 lanes road. A Motorcyclist (JQE 4779) was slightly ahead of the Motor Car when the 2 lanes merged. As such the Motor Car left portion side-swiped onto the rear wheel of the Motor Cycle and caused a collision. See photo 1 to 7 below.

Photo 2 shows a general view of the front body of the Motor Car at the time of our inspection. The Motor Car was observed to have sustained a relatively minor impact damages that was confined to its front left portion. Its front left bumper was observed to be damaged; its left hand signal light cover was broken; its front left bonnet & left fender was dented & its windshield was cracked likely due to the accident's collision impact.

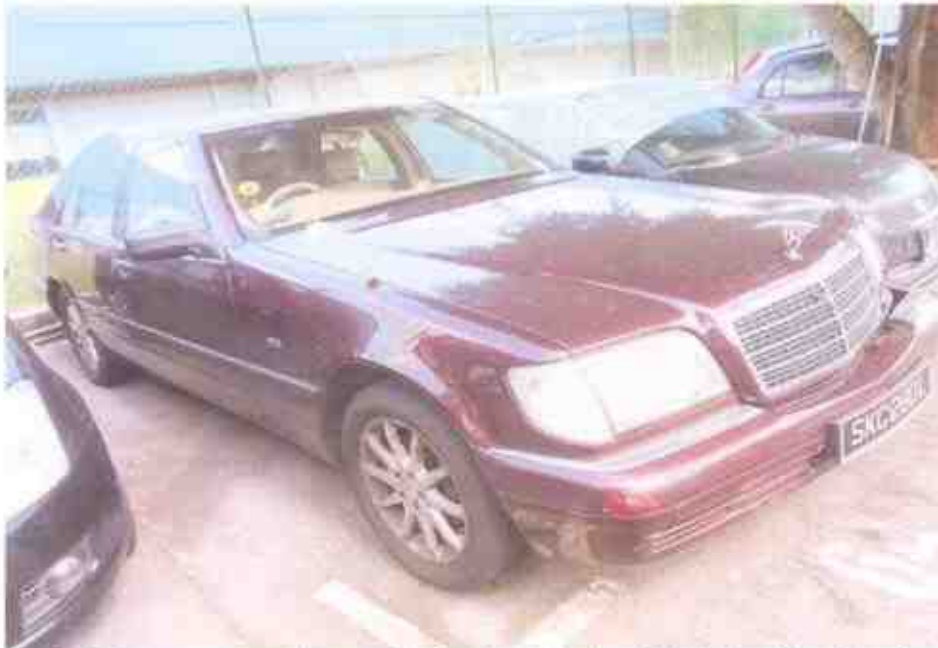
Photo 3 shows a general view of the front right body of the Motor Car at the time of our inspection. The Motor Car was observed to be in good condition unaffected by the accident's impact.

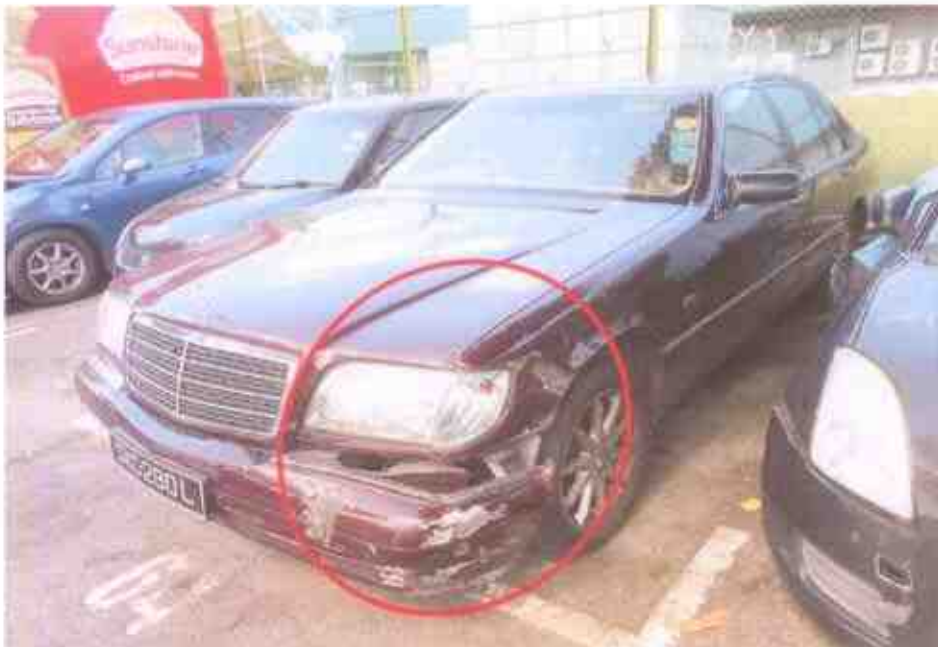
Photo 4 shows a general view of the front left body of the Motor Car at the time of our inspection. The Motor Car was observed to have sustained a relatively minor impact damages that was confined to its front left portion.

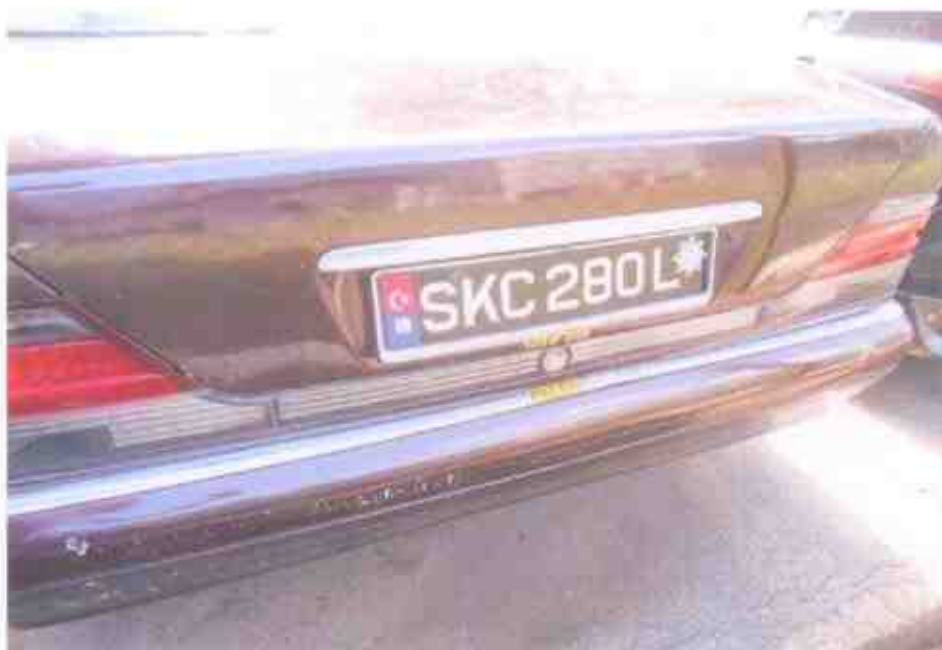
Photo 5 shows a general view of the rear body of the Motor Car at the time of our inspection. The Motor Car was observed to be in good general condition.

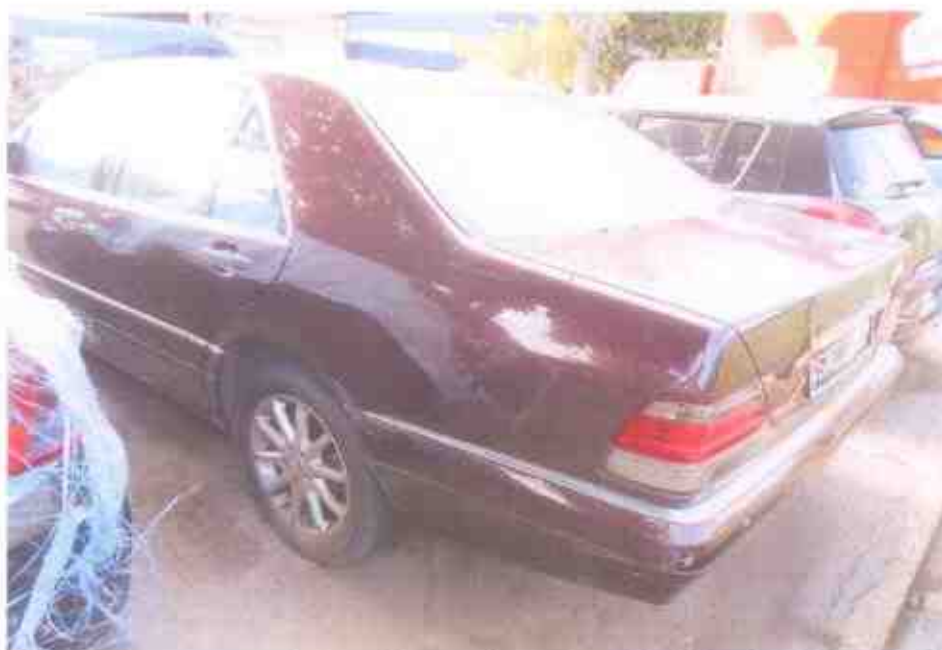
Photo 6 shows a general view of the rear left body of the Motor Car at the time of our inspection. The Motor Car was observed to be in good general condition.

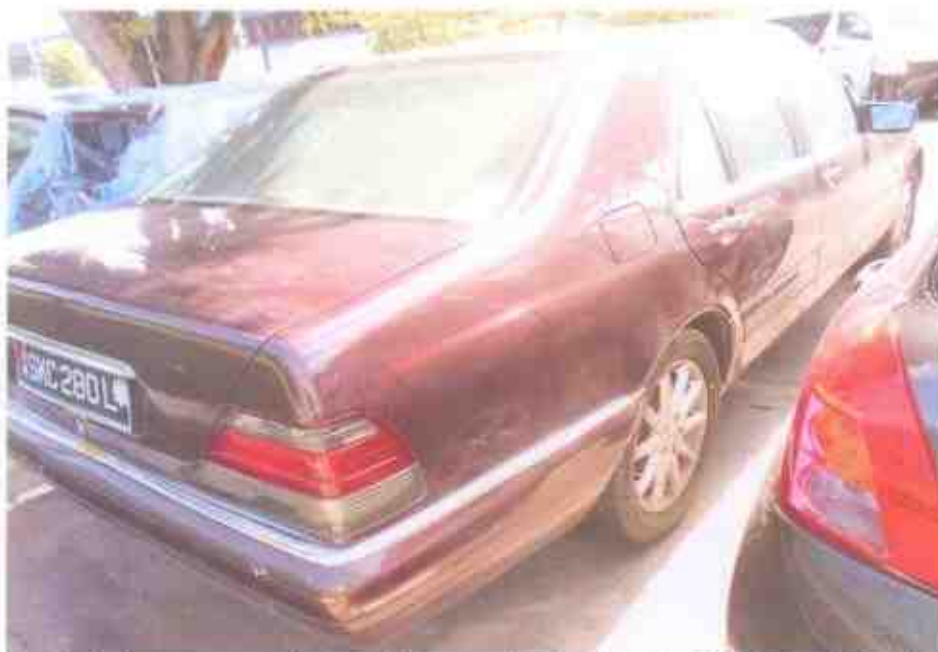
Photo 7 shows a general view of the rear right body of the Motor Car at the time of our inspection. The Motor Car was observed to be in good general condition.

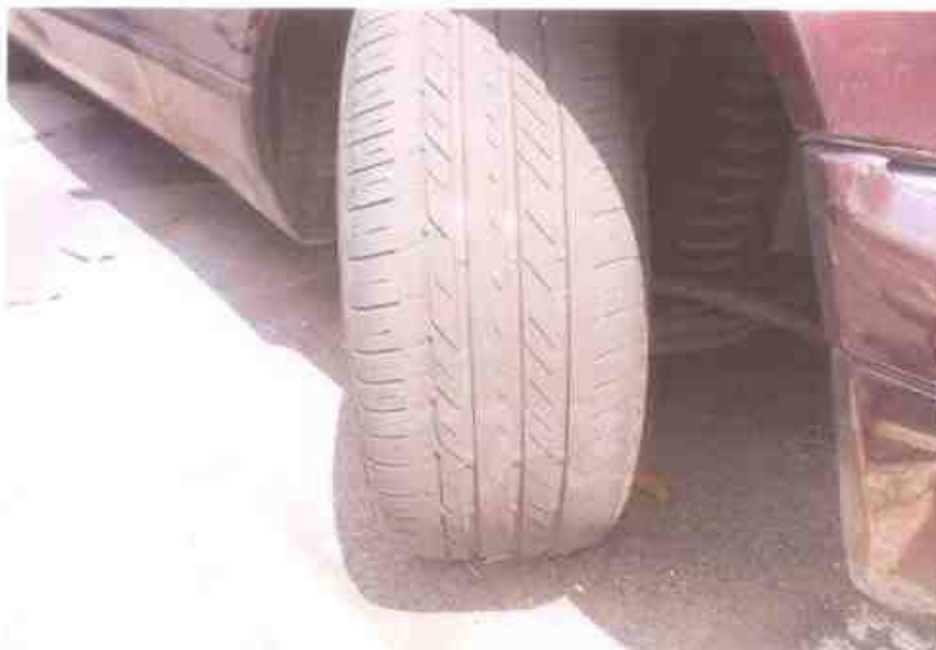
Photo 8 shows the condition of the front right tyre of the Motor Car, which was observed to be in serviceable condition with remaining tread depth of approximately 6mm. The tyre, which was wrapped around alloy wheel rim, was also observed to be sufficiently inflated for vehicular operation.

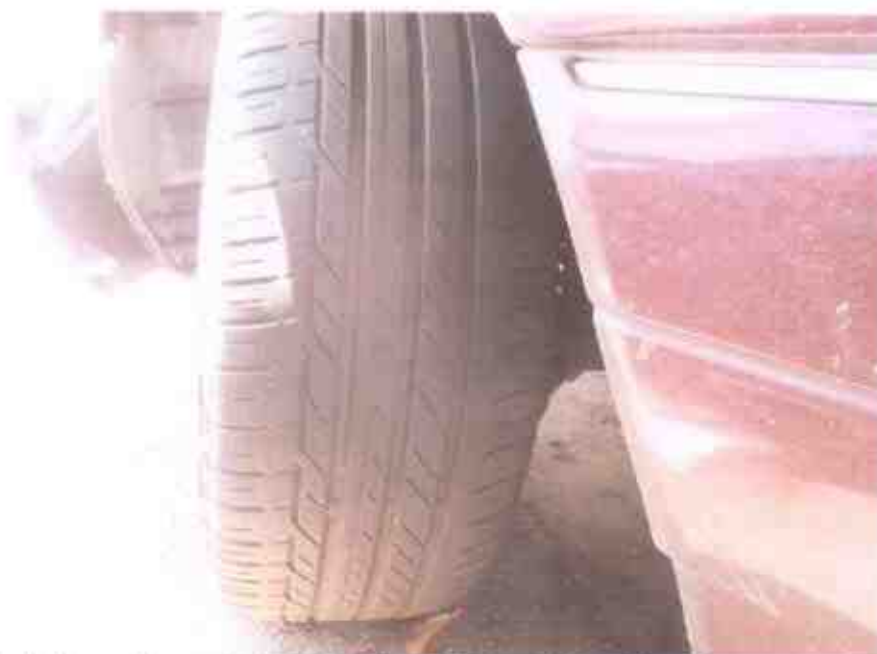
Photo 9 shows the condition of the front left tyre of the Motor Car, which was observed to be in serviceable condition with remaining tread depth of approximately 5mm. The tyre, which was wrapped around alloy wheel rim, was also observed to be sufficiently inflated for vehicular operation.

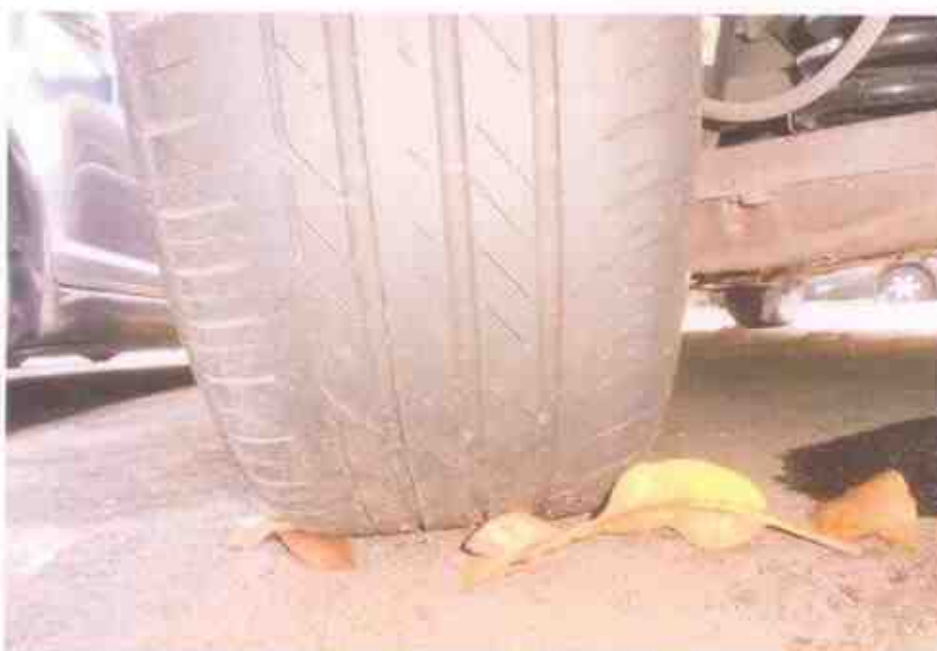
Photo 10 shows the condition of the rear left tyre of the Motor Car, which was observed to be in serviceable condition with remaining tread depth of approximately 4mm.

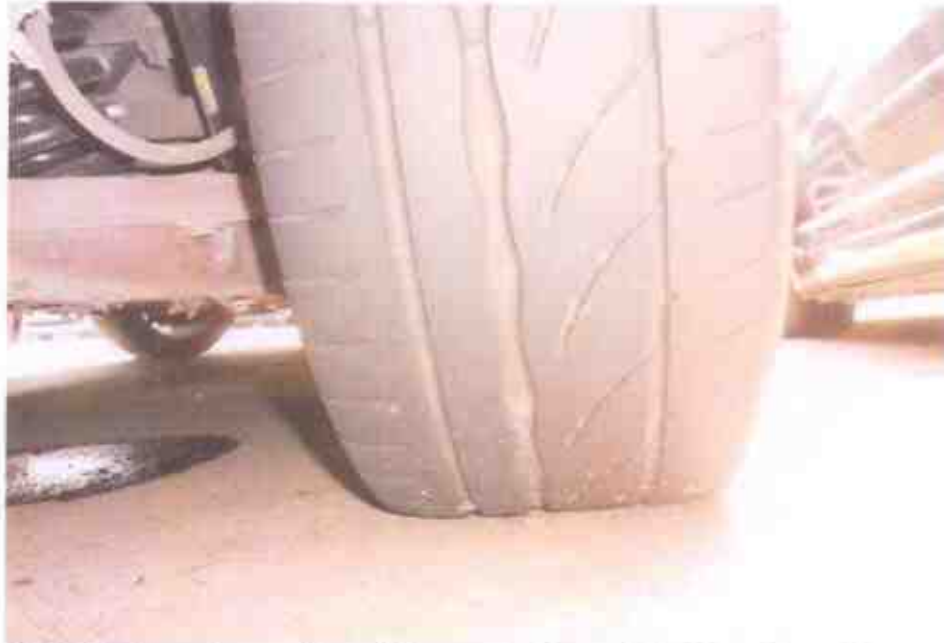
Photo 11 shows the condition of the rear right tyre of the Motor Car, which was observed to be in serviceable condition with remaining tread depth of approximately 4mm.

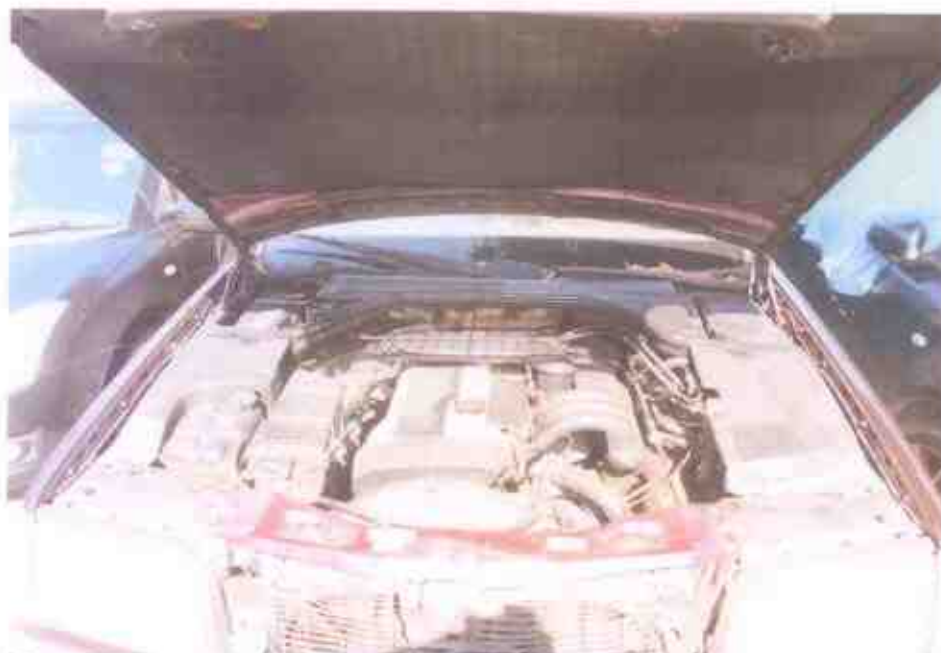
Photo 12 shows a general view of the Motor Car's engine compartment. The various parts and components inside the engine compartment were unaffected by the accident. There was also no sign(s) or indication(s) of fresh fluid leakage and/or fluid stain within the engine compartment.

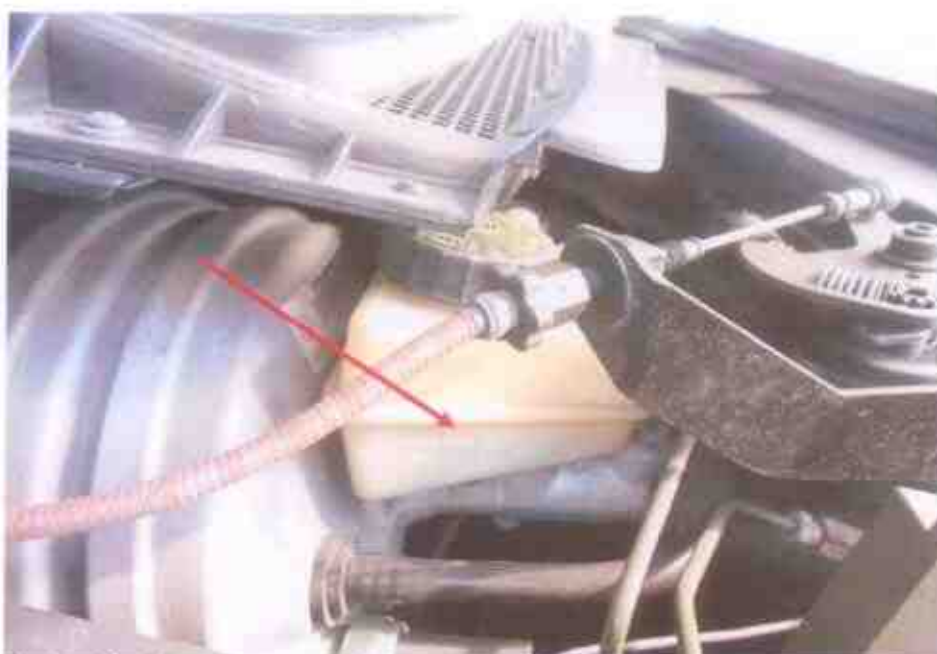
Photo 13 shows the brake fluid reservoir of the Motor Car at the time of our inspection. The brake fluid was observed to be of sufficient level (arrowed) and without any visible contamination.

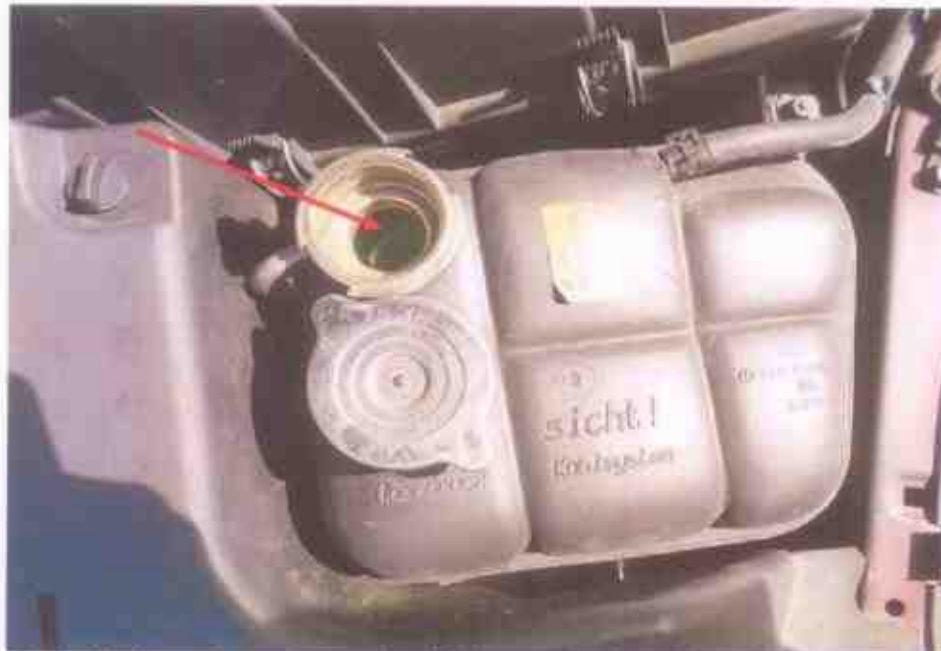
Photo 14 shows the engine coolant fluid reservoir of the Motor Car at the time of our inspection. The engine coolant fluid was observed to be of sufficient level and without any visible contamination.

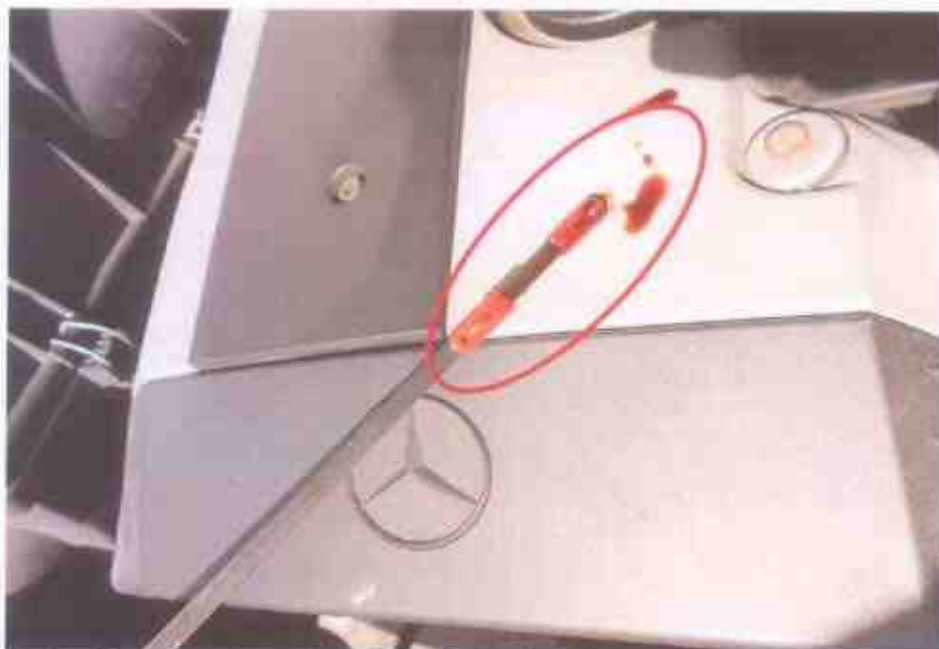
Photo 15 shows the engine oil dip stick of the Motor Car at the time of our inspection. The engine oil was observed to be of sufficient level and without any visible contamination.

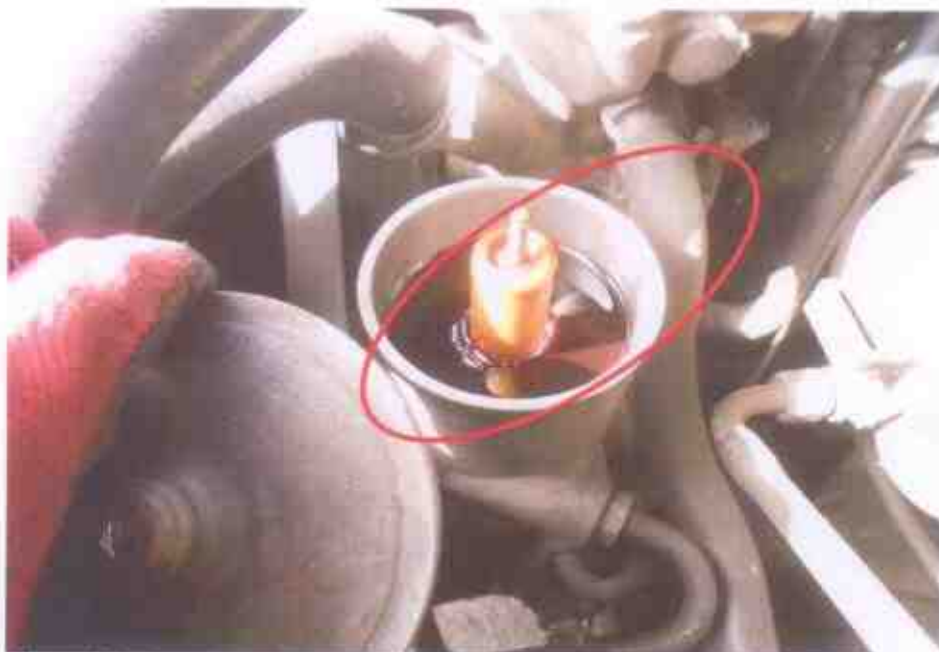
Photo 16 shows the power steering fluid of the Motor Car at the time of our inspection. It was observed to be of sufficient level and without any visible contamination.

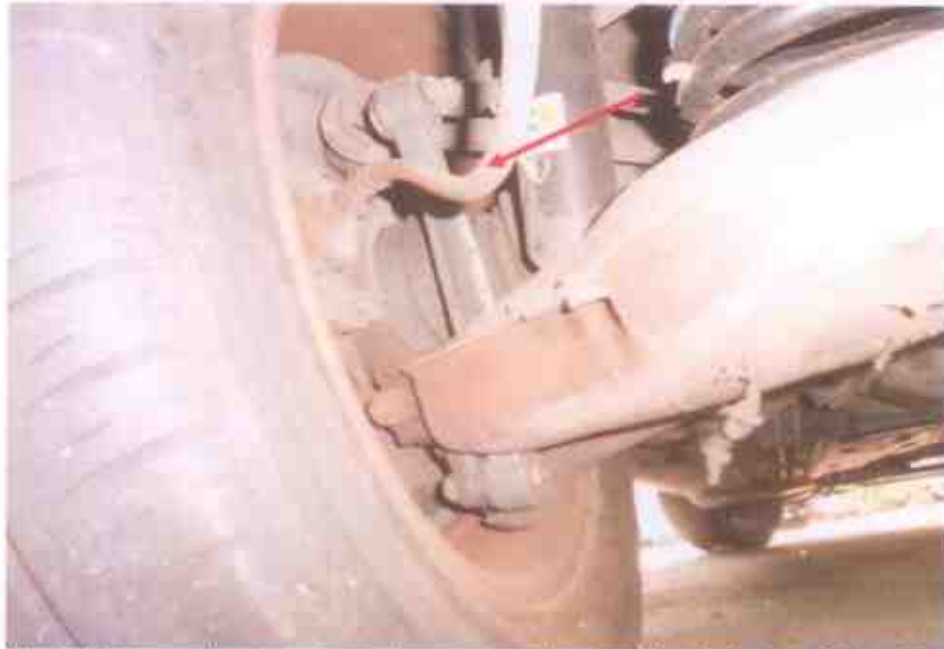
Photo 17 shows the brake hose (arrowed) at the rear left wheel of the Motor Car. We did not observe any leakage of brake fluid at the time of our inspection of the Motor Car. Our visual inspection of the various mechanical components of the Motor Car's braking system revealed all to be intact without visible damage.

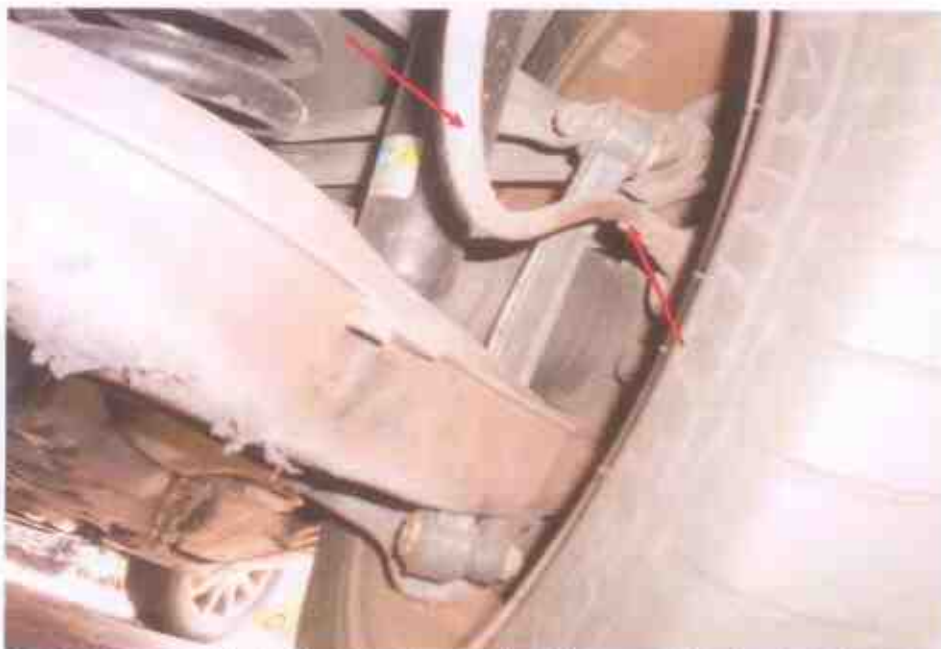
Photo 18 shows the brake hose (arrowed) at the rear right wheel of the Motor Car. We did not observe any leakage of brake fluid at the time of our inspection of the Motor Car. Our visual inspection of the various mechanical components of the Motor Car's braking system revealed all to be intact without visible damage.

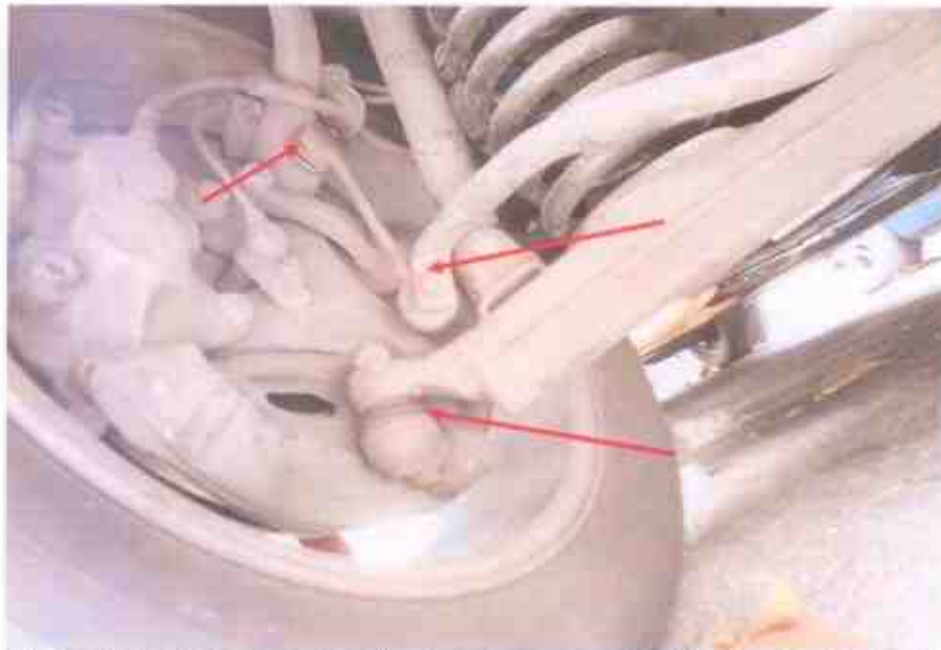
Photo 19 shows the various undercarriage components at the front right wheel of the Motor Car, in particular the steering tie rod (arrowed). The various steering components were all found to be intact, suggesting that the steering system of the Motor Car was likely to be in serviceable condition.

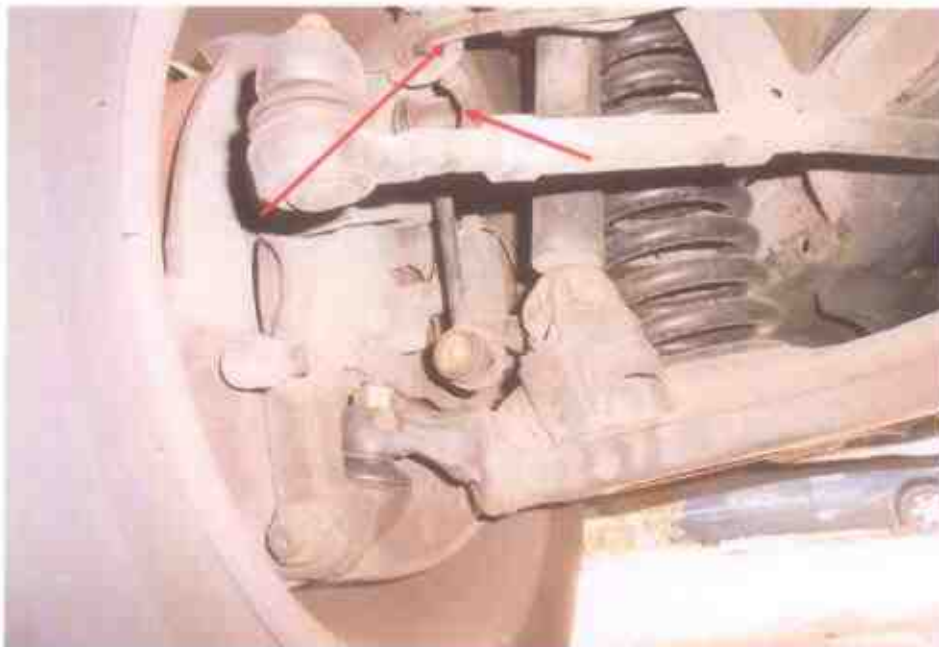
Photo 20 shows the various undercarriage components at the front left wheel of the Motor Car. We did not observe any leakage of brake fluid (arrowed) at the time of our inspection of the Motor Car. Our visual inspection of the various mechanical components of the Motor Car's braking system revealed all to be intact and without visible damage, indicating that the braking system was likely to be in serviceable condition at the material time of accident.

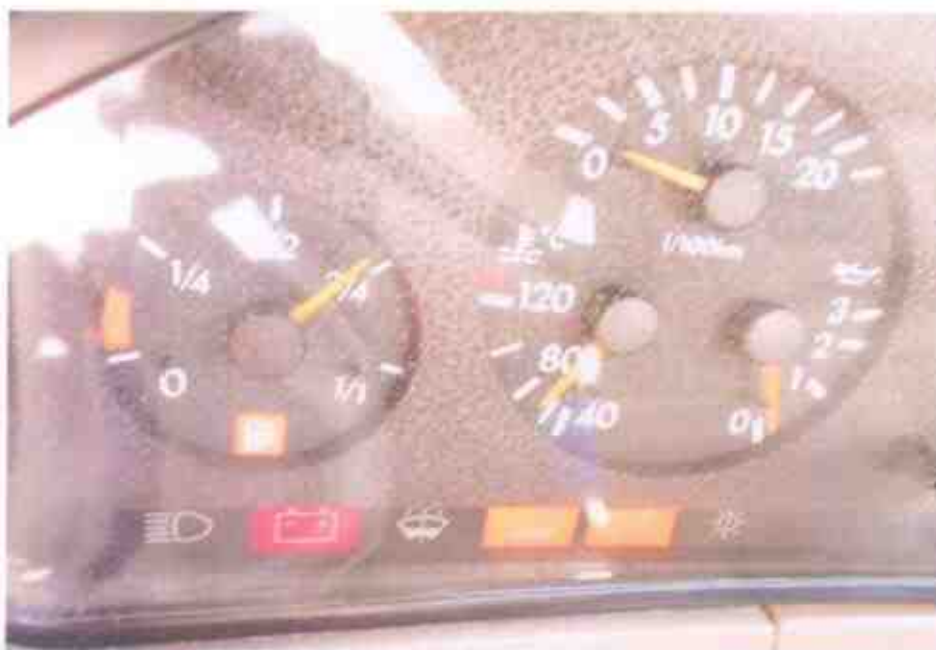
Photo 21 shows the warning lights for the various electronic operating systems of the Motor Car appearing on its instrument panel during the self-test when the engine is cranked.

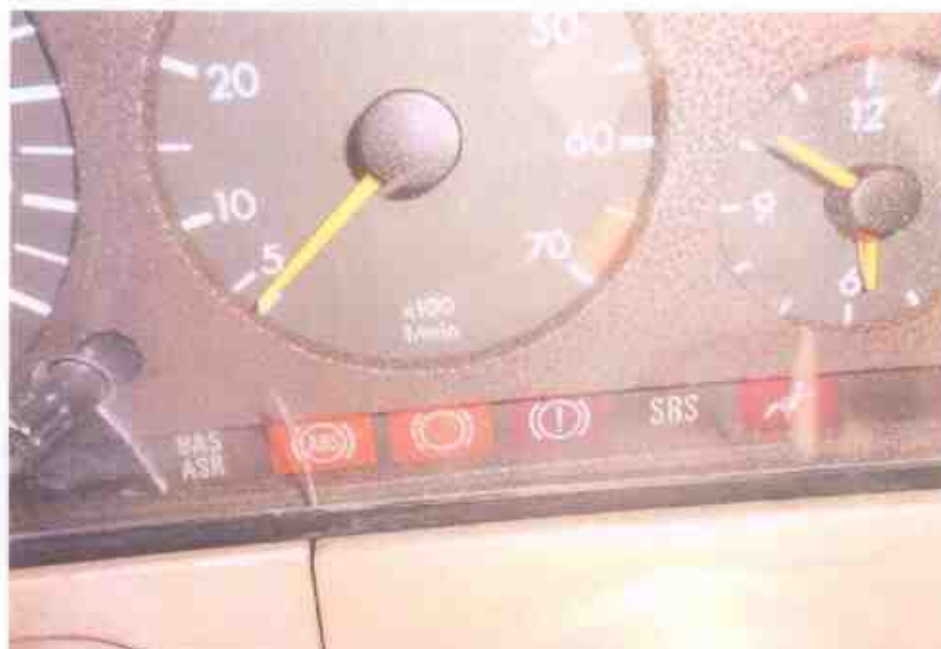
Photo 22 shows the warning lights for the various electronic operating systems of the Motor Car appearing on its instrument panel during the self-test when the engine is cranked, in particular the ABS light and SRS light.

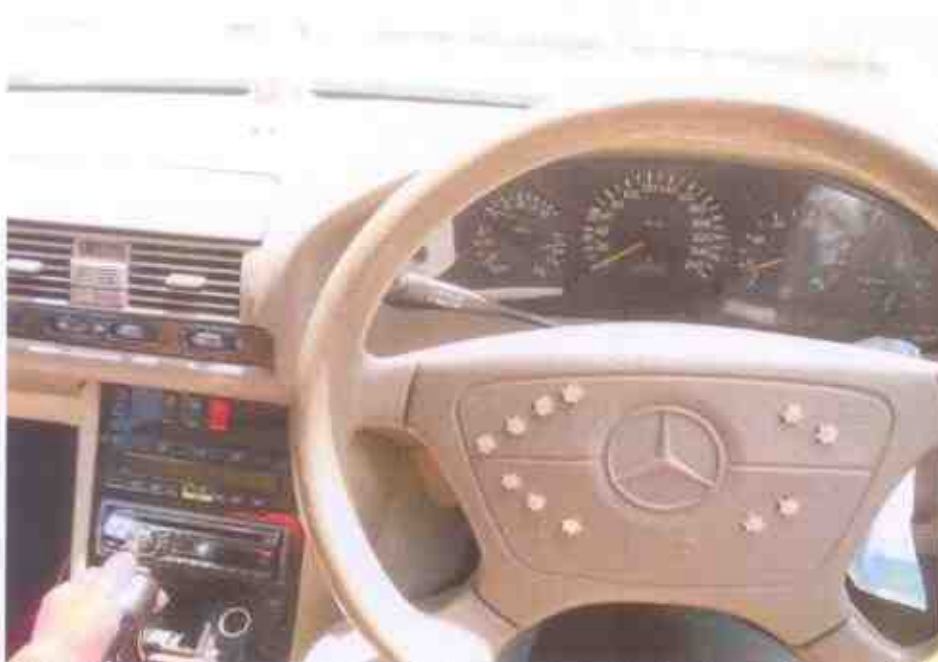
Photo 23 shows no warning lights illuminated on the instrument panel of the Motor Car after the engine was cranked. This would suggest that there was no abnormality to the various electronic operating systems of the Motor Car, like the ABS and SRS.

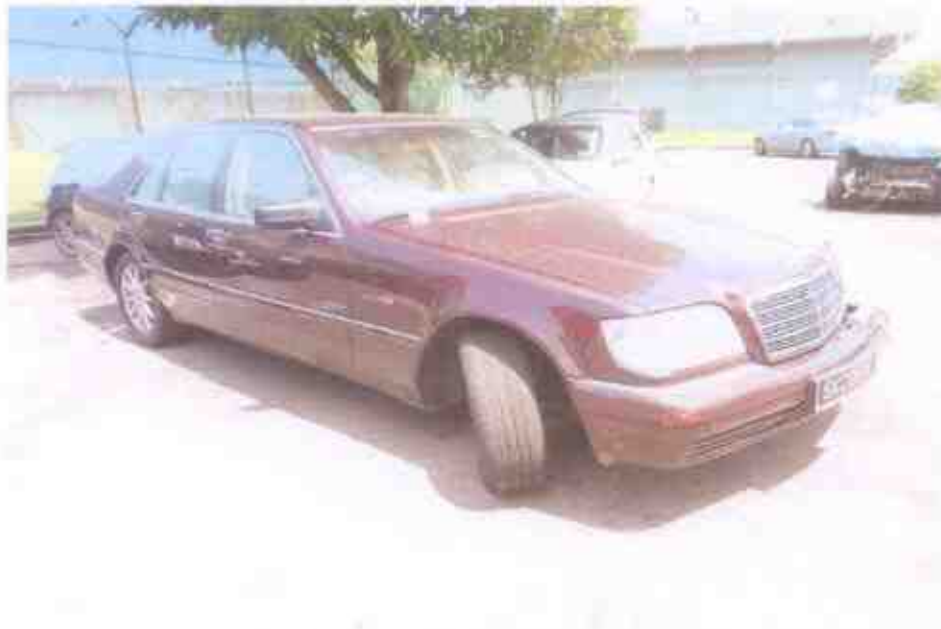
Photo 24 shows we conducted an operational test on the Motor Car. Drive mode, Reverse mode & Neutral mode were engaged at time of our test. Brake pedal was also engaged to a complete stop. There was no abnormality observed at time of testing.
