Your Ref: TP/IP/25259/2018
Our Ref : CI/TPD18013748/Z

Fatal Accident Investigation Team

MECHANICAL INSPECTION REPORT OF MOTORCYCLE JQE 4779

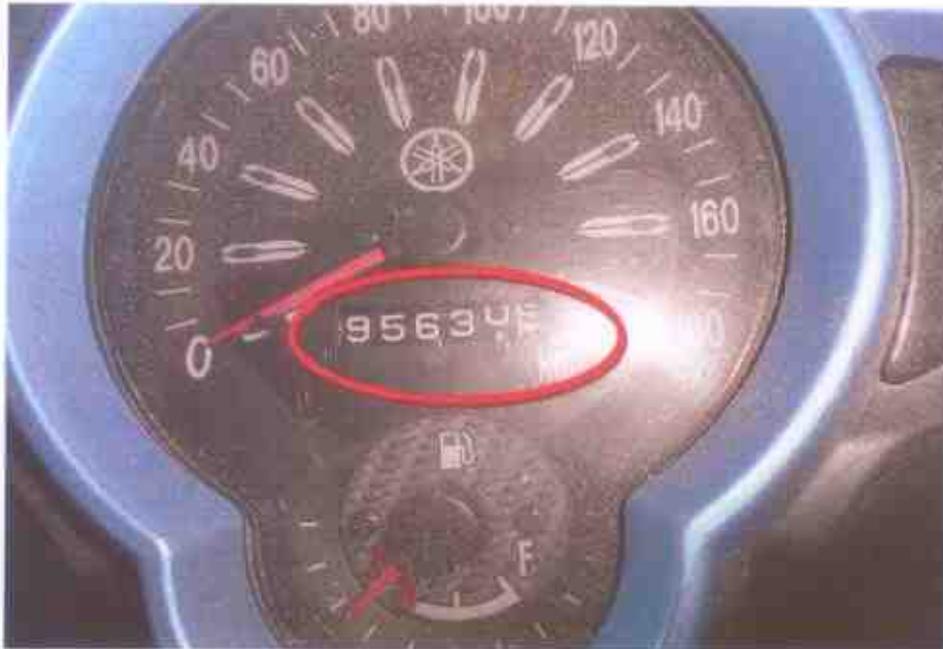
4. The mileage of the Motorcycle at the time of our inspection was 956309km.
5. The Motorcycle was observed to have sustained damages at the frontal portion, rear portion & along its right side. The body parts that were found to have been damaged include its headlamp, cracked left wing mirror, missing right wing mirror, rear box bracket and right foot rest amongst others. Its handle bar was also observed to be misaligned as a result of the accident.
6. This was likely due to the consistency of the accident's case facts that the Motor Car driver was travelling along a slip road on lane 1 on a 2 lanes road. A Motorcyclist (JQE 4779) was slightly ahead of the Motor Car (SKC 280L) when the 2 lanes merged. As such the Motor Car left portion side-swiped onto the rear wheel of the Motor Cycle and caused a collision. See photo 1 to 5 below.

Photo 1 shows the mileage at the time of inspection was recorded to be 95630.9km.

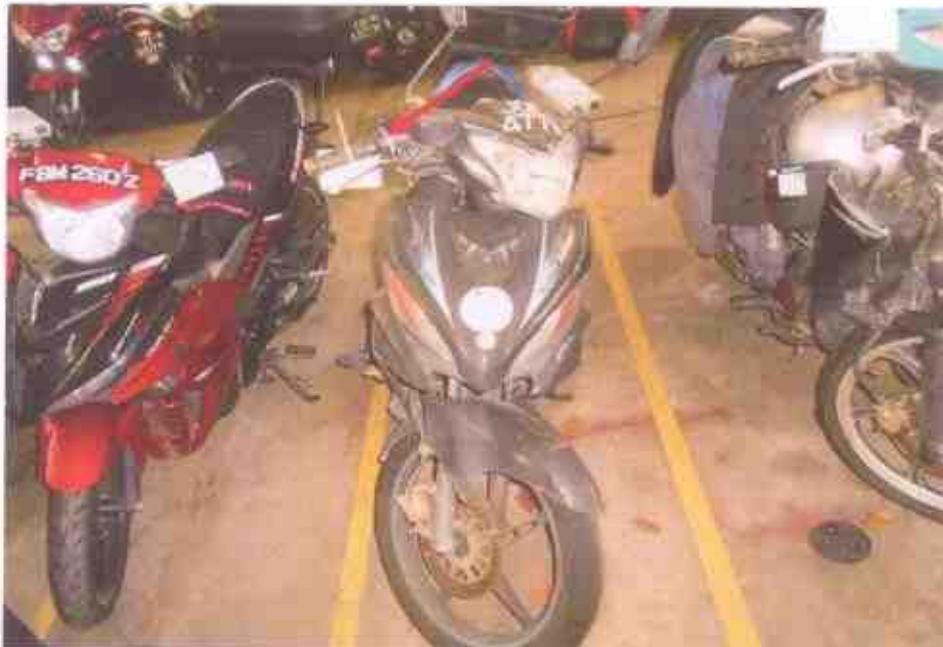
Photo 2 shows a general view of the front right body of the Motorcycle at the time of our inspection. The Motorcycle was observed to be sustained with relatively extensive impact due to the accident collision. Amongst the body parts damaged was its handle bar (arrowed), which was observed to be bent.

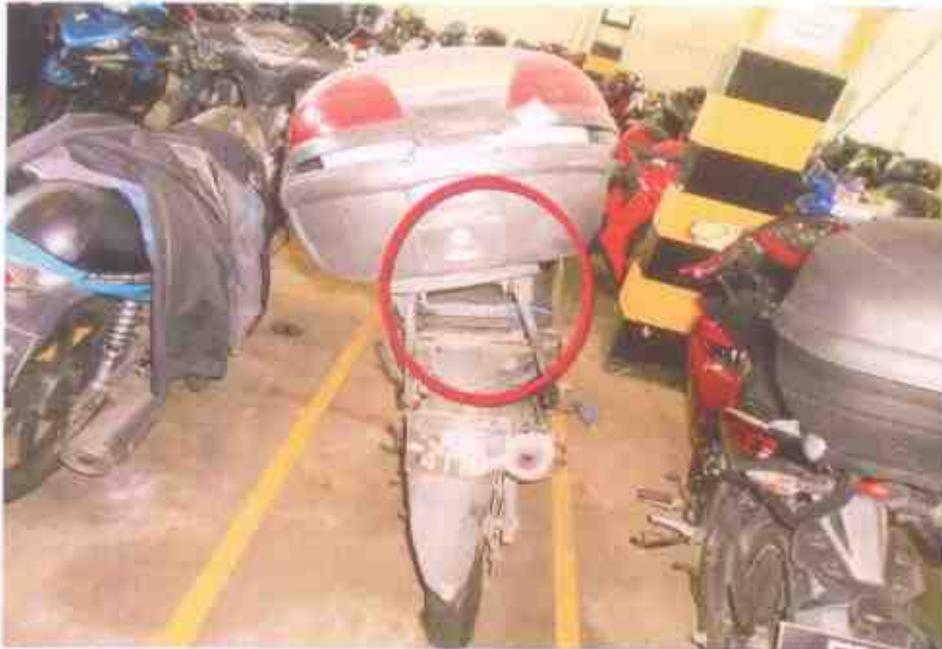
Photo 3 shows a general view of the rear left body of the Motorcycle at the time of our inspection. The Motorcycle was observed to have sustained damages at the rear portion.

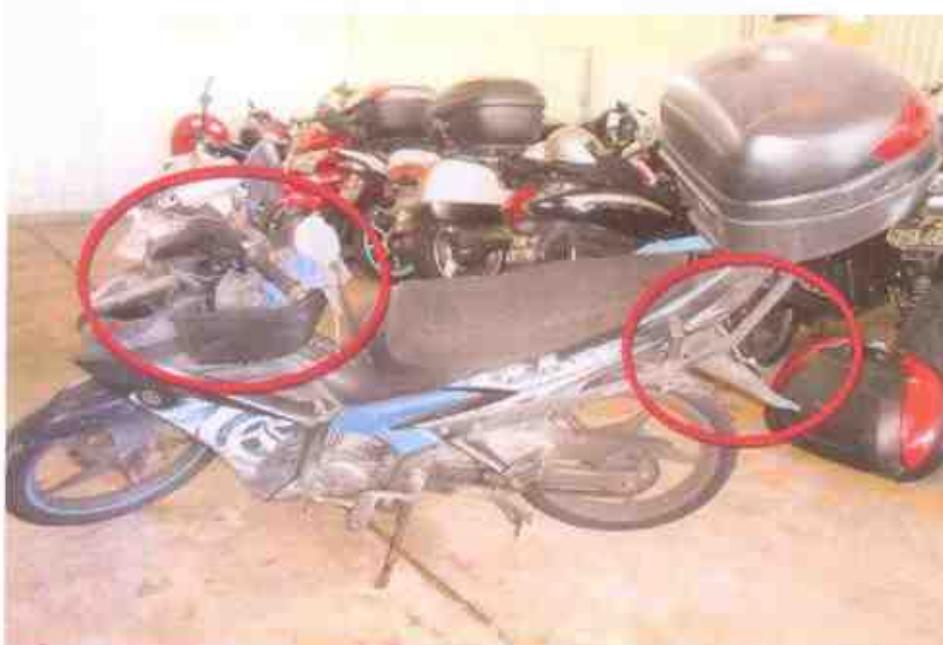
Photo 4 shows a general view of the frontal left portion of the Motorcycle at the time of our inspection. The Motorcycle was observed to be sustained relatively extensive impact due to the accident collision.

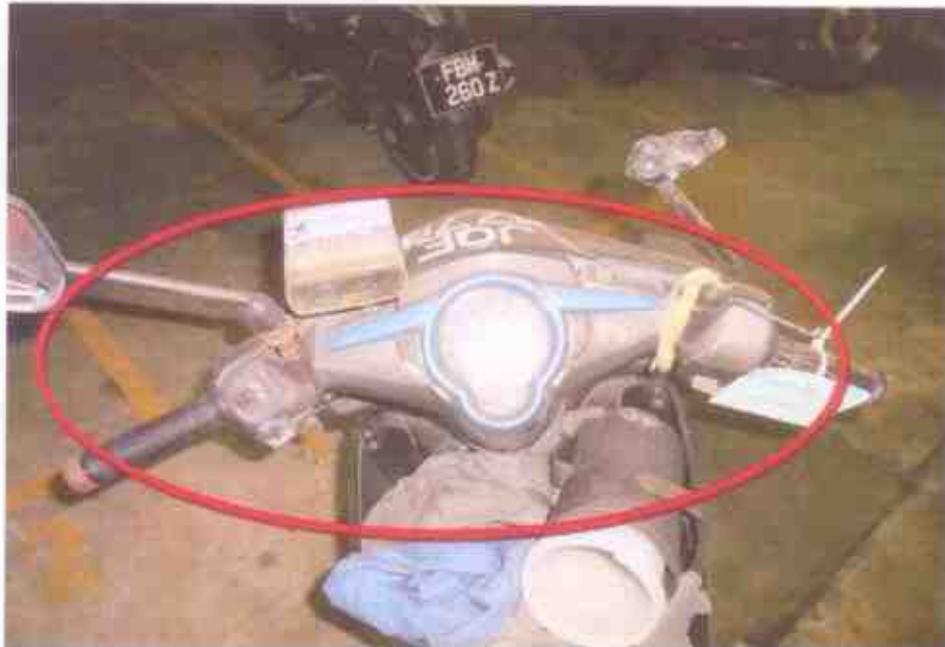
Photo 5 shows a close-up view of the handle bar & wing mirrors of the Motorcycle at the time of our inspection. The Motorcycle was observed to be sustained relatively extensive impact due to the accident collision.

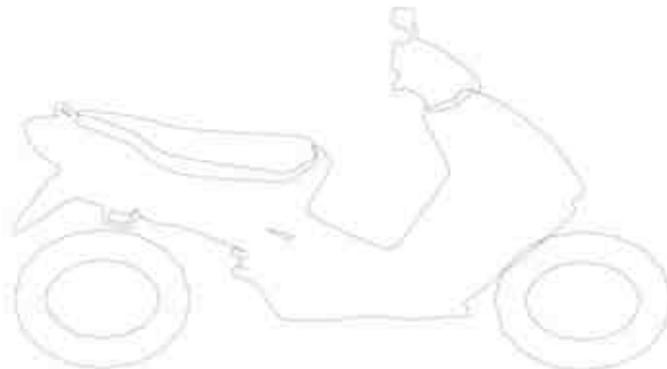
- The condition of the Motorcycle's 2 tyres was observed to be in serviceable condition. The tread pattern of the 2 tyres was clearly visible. We did not observe any tear, burst mark(s) and/or punctured hole(s) on the sidewalls as well as across the tread of the 2 tyres. The 2 tyres were both observed to be sufficiently inflated for vehicular operation. The tyre brand, tyre size and remaining tread depth of the 2 tyres were recorded as follows: See photo 6 & 7 below.

Michelin Pilot Street
90/80 - 17 (4mm)

Michelin Pilot Street
80/90 - 17 (4mm)

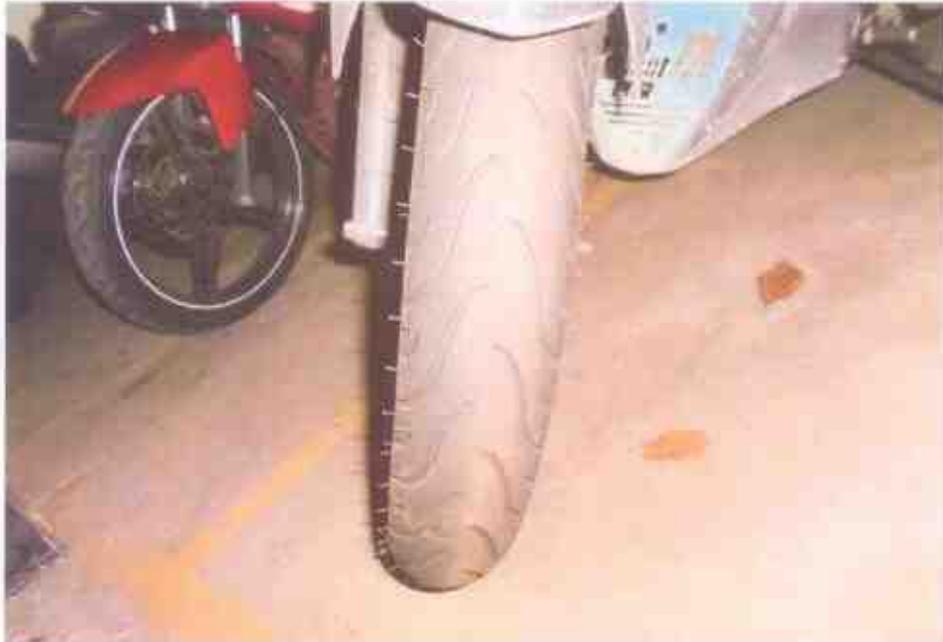
Photo 6 shows the front tyre of the Motorcycle at the time of our inspection. The rear tyre was observed to be in serviceable condition with remaining tread depth of approximately 4mm. The tyre was also observed to be sufficiently inflated for vehicular operation. There was no significant damage observed on the rear wheel rim & tyre.

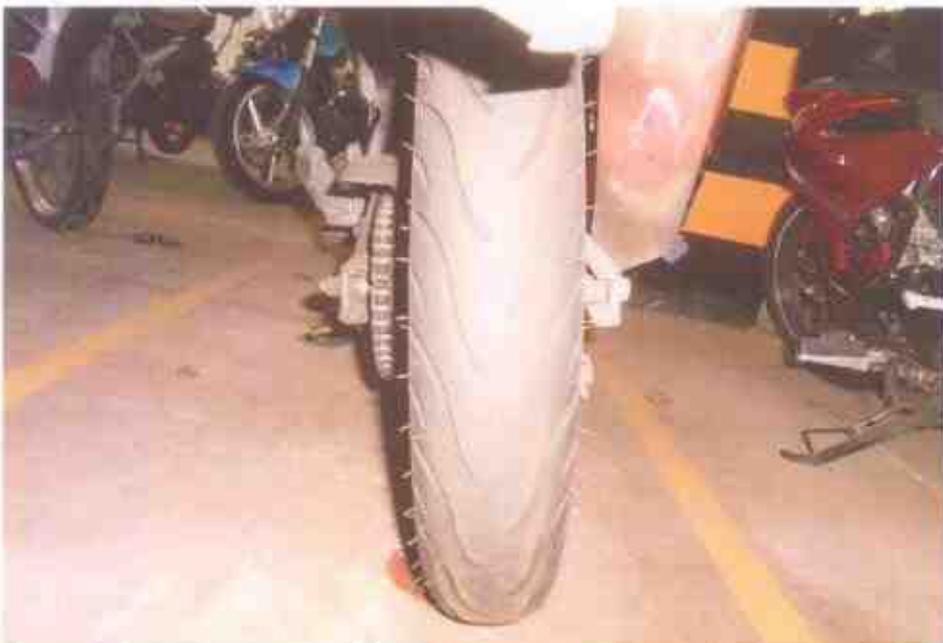
Photo 7 shows the rear tyre of the Motorcycle at the time of our inspection. The rear tyre was observed to be in serviceable condition with remaining tread depth of approximately 4mm. Although the rim was observed to be slightly it was also sufficiently inflated for vehicular operation.

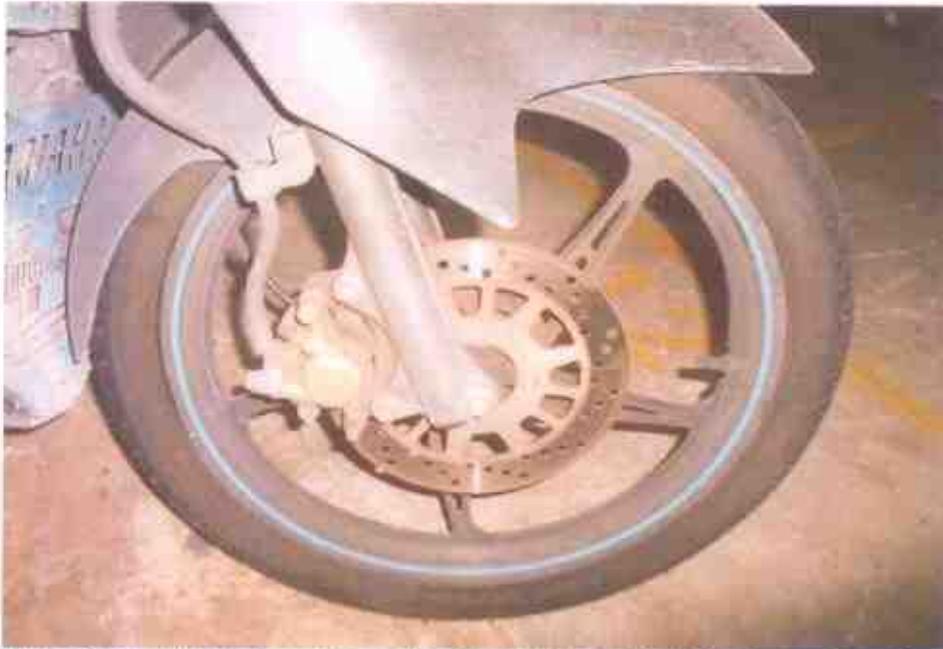
8. The tyres were wrapped around alloy wheel rim that was found to be without any significant damage. See photo 8 & 9 below.

Photo 8 shows the front tyre of the Motorcycle at the time of our inspection. There was no significant damage observed on the rear wheel rim & tyre.

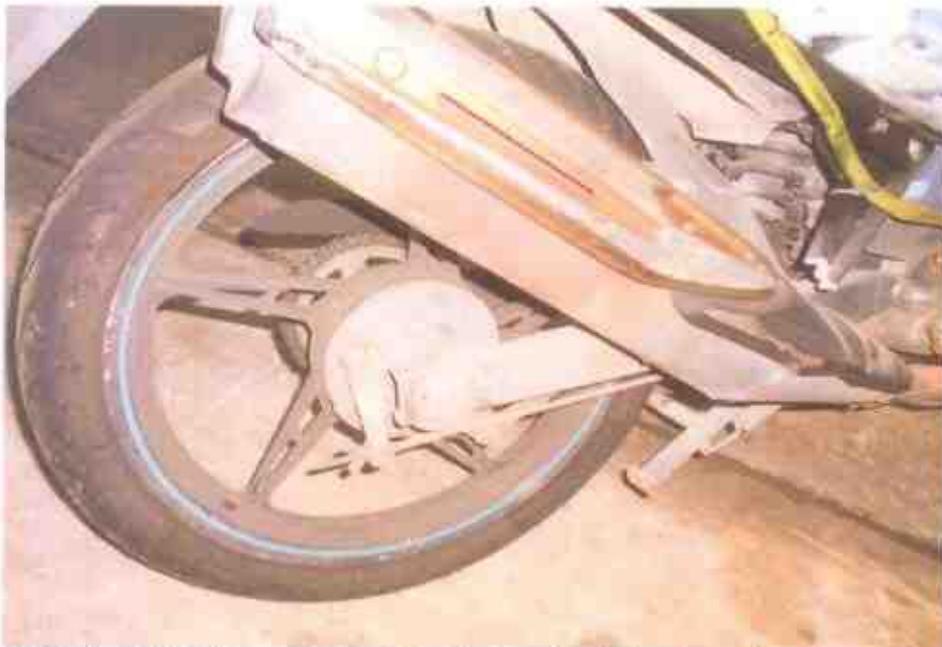
Photo 9 shows the rear tyre of the Motorcycle at the time of our inspection. There was no significant damage observed on the rear wheel rim & tyre.

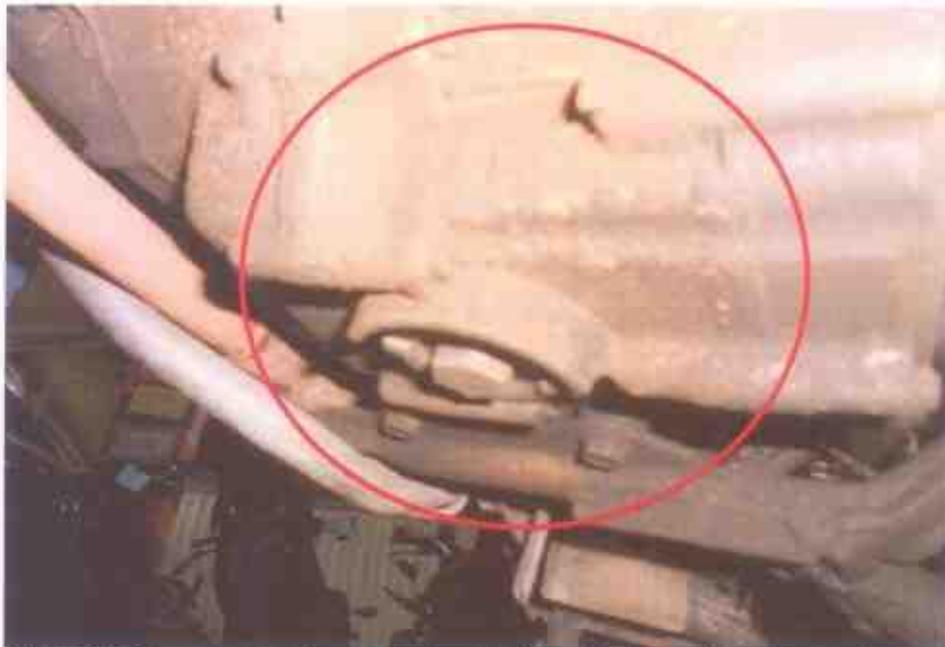
9. Upon examination of the Motorcycle's engine area, we had observed that the various engine related parts and components were intact with no visible damage. There was also no sign(s) or indication(s) of fluid leak observed around the engine area of the Motorcycle.
10. The gear chain of the motorcycle was found to be intact without any misalignment. It was also adequately lubricated for operating purposes. Free play tension test was also conducted & found adequately acceptable. See photo 10 - 12 below.

Photo 10 shows no sign(s) or indication(s) of fluid leakage stain observed around the engine undercarriage area of the Motorcycle. It was observed to be unaffected by the accident's collision impact.

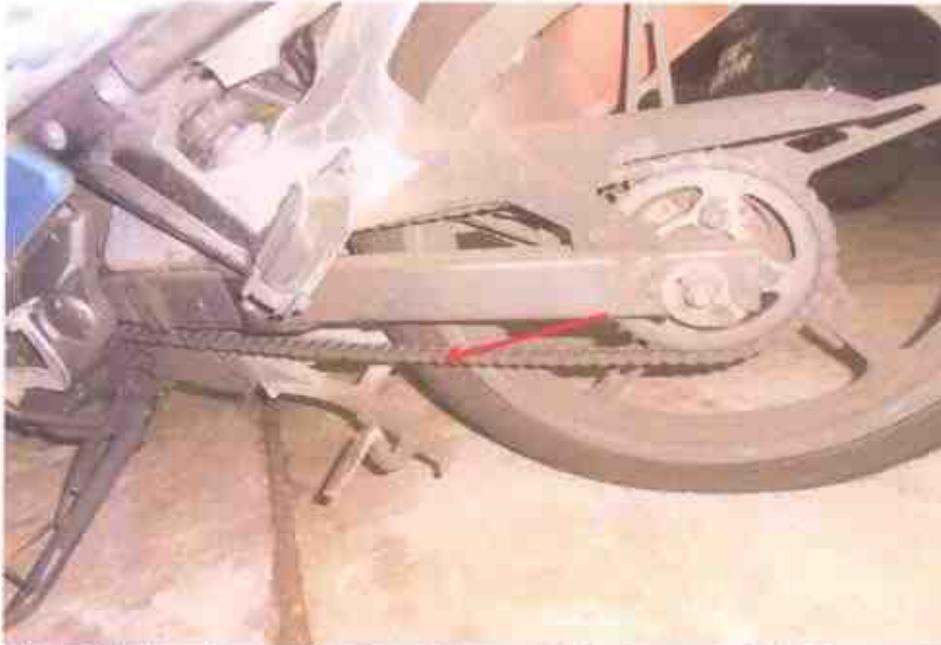
Photo 11 shows the general view of the gear train (arrowed) of the Motorcycle, which was observed to be intact with no misalignment. It was also adequately lubricated for operating purposes.

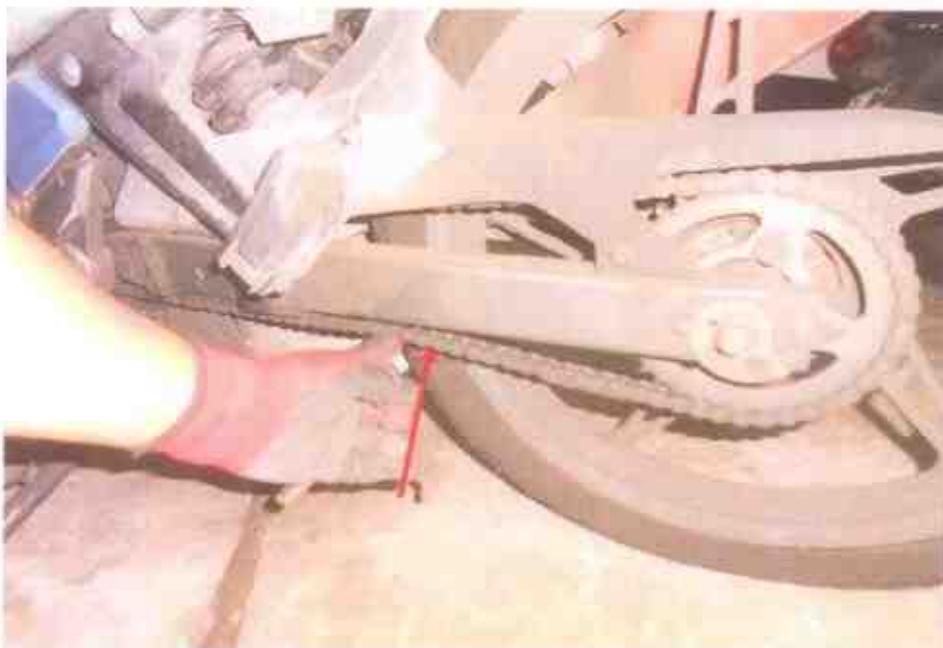
Photo 12 shows the general view of the gear train (arrowed) of the Motorcycle, which was observed to be intact with no misalignment. It was also adequately lubricated for operating purposes. Free play tension was also observed & found adequately acceptable.

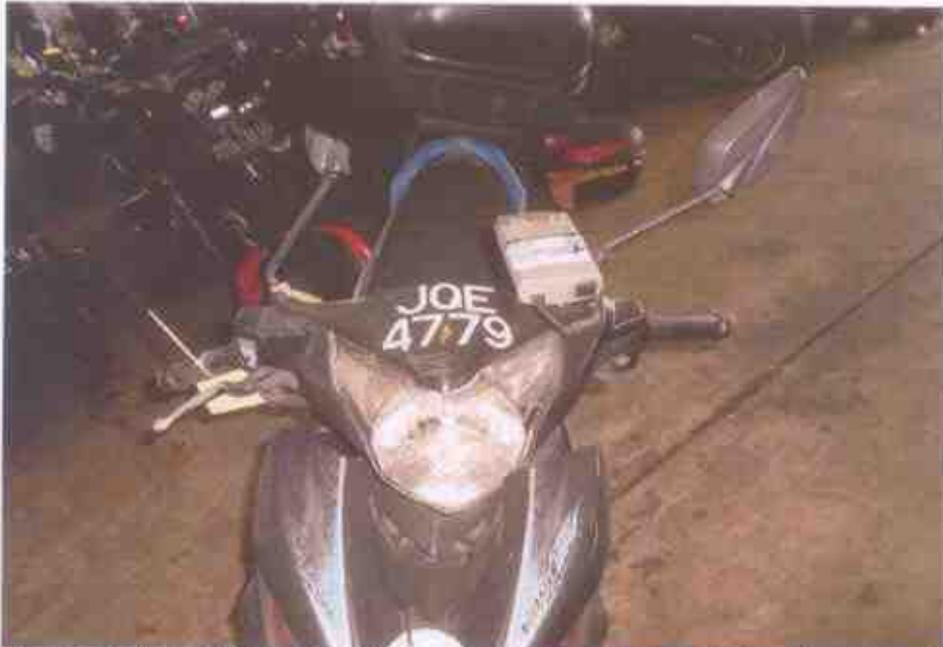
11. For this case, we were not able to conduct any test(s) on the steering system of the Motorcycle due to the damage on its handle bar. It was found to be misaligned as a result of the accident, hence causing the whole steering system not to be in a serviceable condition.

14. For this case, we was not able to carry out any operational tests to the steering system and brake system of the Motorcycle due to the damage of its handle bar, which had rendered the Motorcycle's immobility for the operational tests. We were not able to push the motorcycle manually forward and backward normally, simulating movement of the Motorcycle, for the operational tests. See photo 13 - 16 below.

Photo 13 shows the front handle bar was observed to be misaligned as a result of the accident. Hence, we are not able to conduct any tests on the steering system of the Motorcycle.

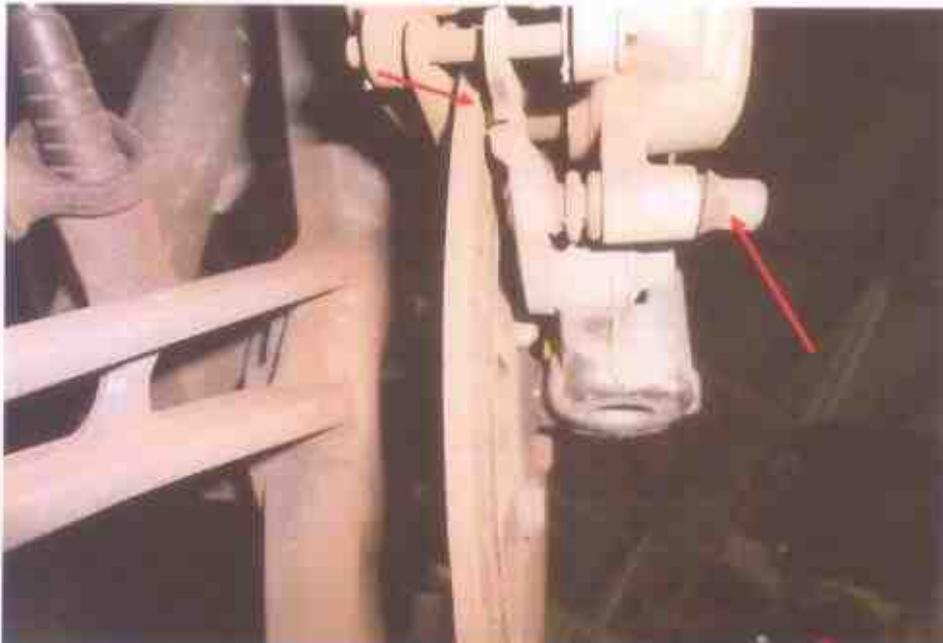
12. The brake system of the Motorcycle was of a semi-hydraulic type, where hydraulic (brake fluid) pressure controls the brake for the front wheel while the brake for the rear wheel is controlled by mechanical means (cables and springs). Our visual examination of the various components in the brake system, like the brake disc, brake calliper, drum and brake foot pedal, revealed all to be intact and without damage. There was also no visible tear or cut observed on the connecting hoses and cables.

Photo 14 shows the front brake caliper, front brake disc and brake pad of the Motorcycle (arrowed), which are all part of the components in the front brake system of the Motorcycle. Our visual checks of these various components had revealed all to be intact with no visible damage. No leakage of brake fluid was also observed.

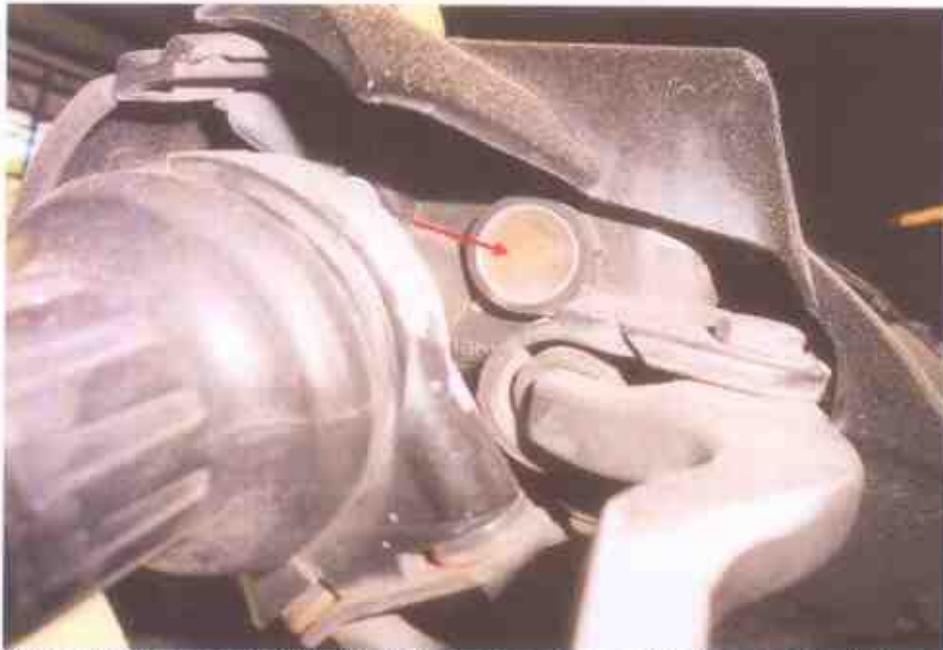
13. Static brake tests conducted on the Motorcycle had appeared to indicate that the brake system of the Motorcycle was in serviceable condition. There was some resistance felt (spongy like feel) upon gripping the hand brake lever & stepping on the rear brake foot paddle. This would indicate that there was no leakage of pressure/vacuum in the brake system also on the rear brake drum mechanical parts. Our checks on the brake fluid had also indicated that the brake fluid was of sufficient level for operational purposes, and without contamination.

Photo 15 shows the front brake fluid reservoir observed to be sufficient at time of our inspection.

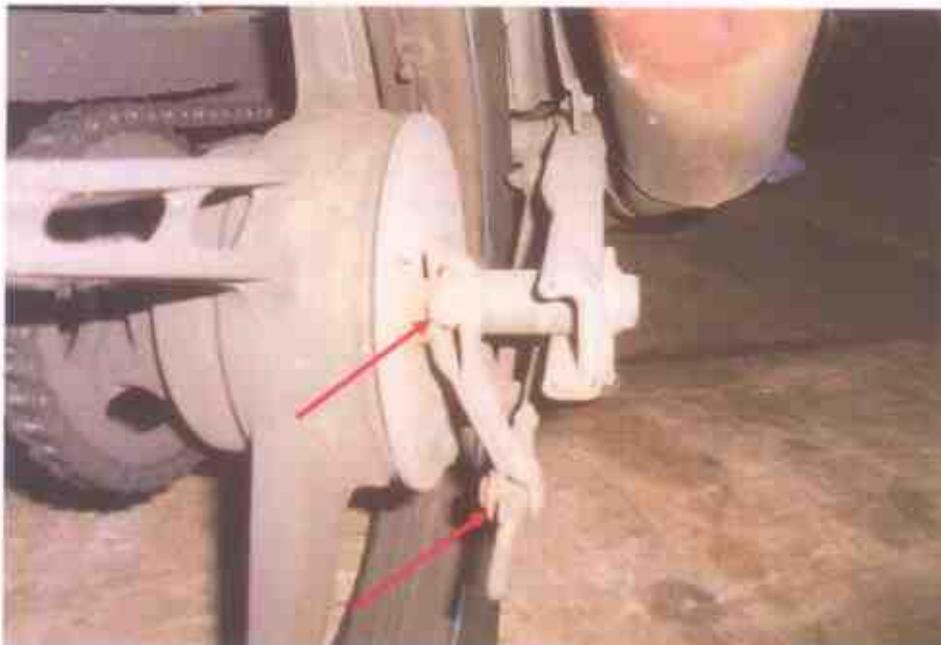
Photo 16 shows the rear wheel of the Motorcycle. The type of brake system for the rear wheel was of mechanical type, controlled by the brake foot pedal of the Motorcycle. Our checks of the cable (arrowed), spring and drum, which are all part of the components in the rear brake system of the Motorcycle reveal all to be intact and without damage.
