Your Ref: TP/IP/24523/2018
Our Ref : CI/TPD18013752/Z

MECHANICAL INSPECTION REPORT OF MOTOR CAR SLD 3604A

1. We refer to your request on 10th May 2018 to conduct a physical inspection of a motor taxi bearing registration number SLD 3604A (herein referred to as "**Motor Car**"), which was involved in a fatal road traffic accident on 22nd April 2018.
2. The purpose of this inspection is to primarily determine if there was any possible mechanical failure to the Motor Car that may have contributed to the accident.
3. Following the request, we carried out a physical inspection of the Motor Car on 08th June 2018 at the premises of Traffic Police vehicle pound, 517 Airport Road Singapore 539942. We now set out below our observations and comments with respect to this inspection.

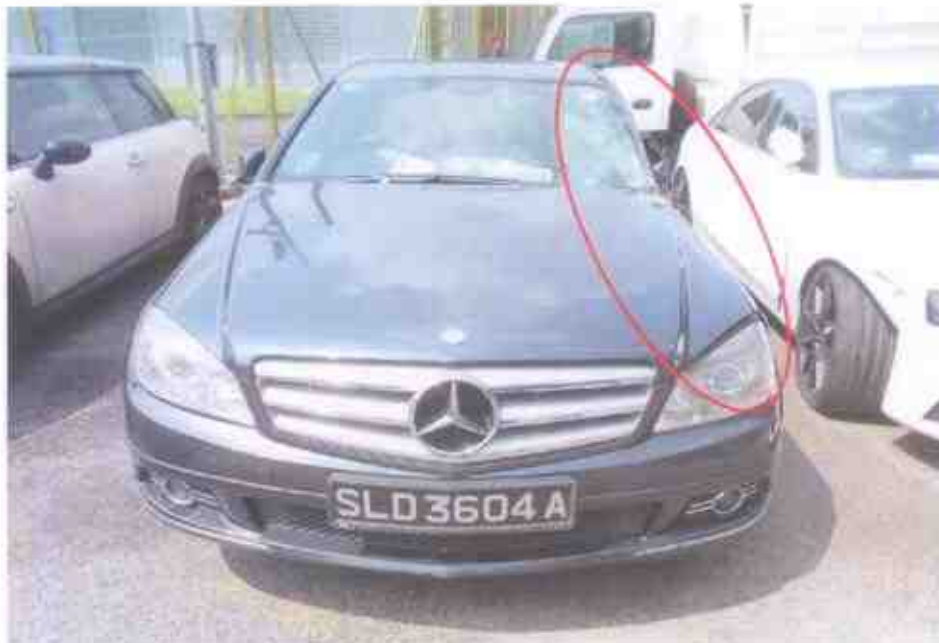
Photo 1 shows a general view of the frontal portion of the Motor Car at the time of our inspection. The Motor Car was observed to have sustained extensive impact damage at its frontal, left & rear portion. The impact force was significant, causing the various parts and components to be damaged as a result of the accident.

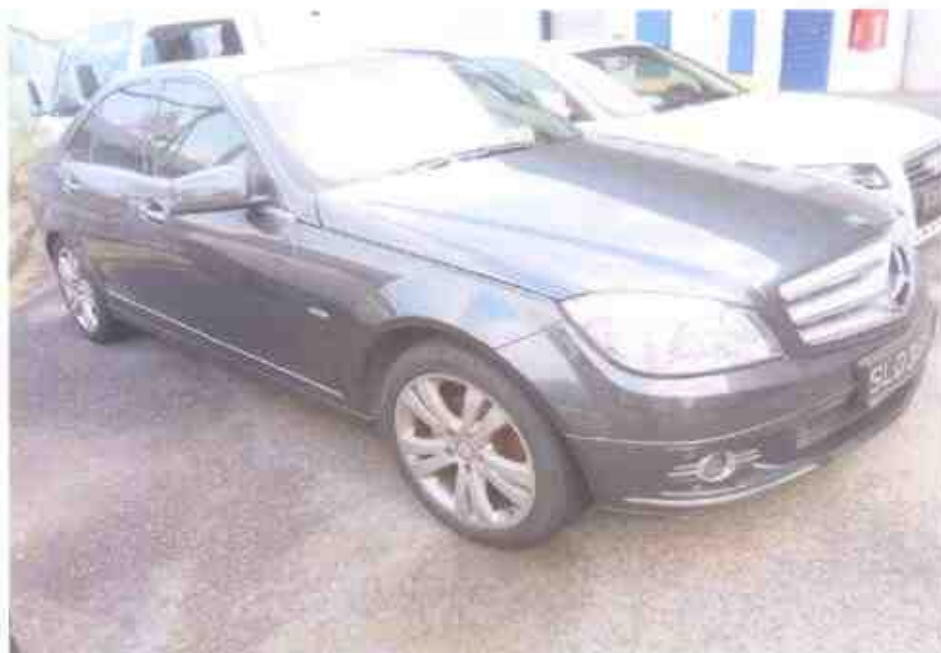
Photo 2 shows a general view of the front right portion of the Motor Car at the time of our inspection. The Motor Car was observed to be in good condition, unaffected by the accident's impact.

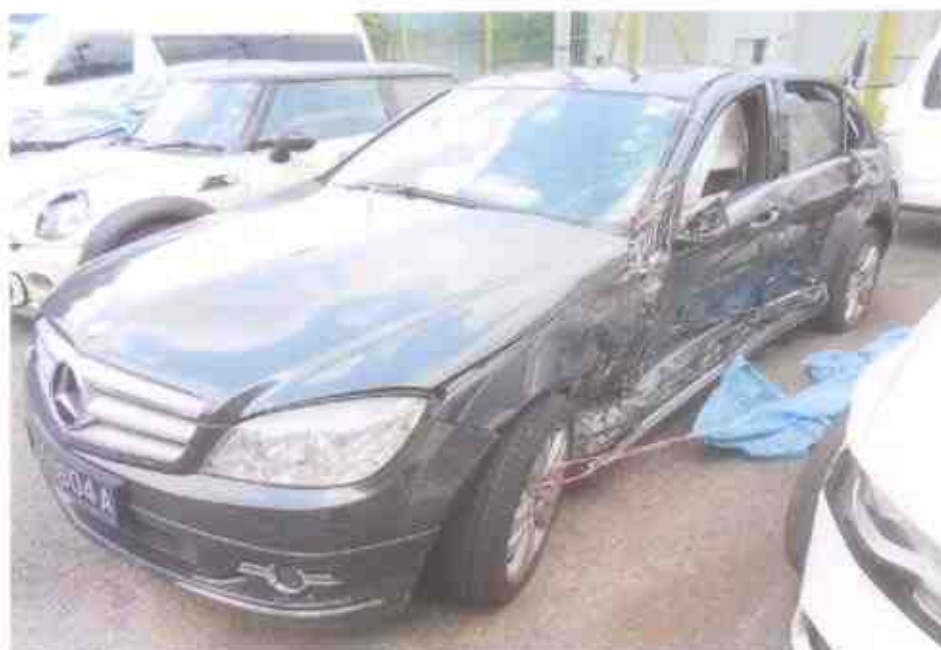
Photo 3 shows a general view of the front left portion of the Motor Car at the time of our inspection. The Motor Car was observed to have sustained extensive impact damage at its left portion.

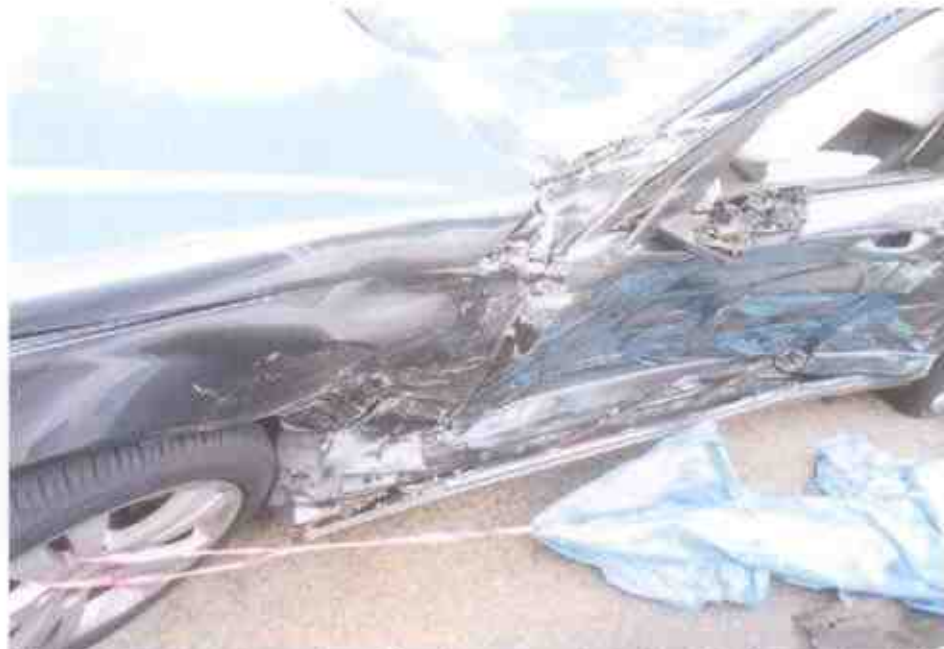
Photo 4 shows a closer view of the damage sustained on the left portion of the Motor Car. The impact force was significant, causing the left portion of the Motor Car to be pushed inwards, towards the right of the Motor Car.

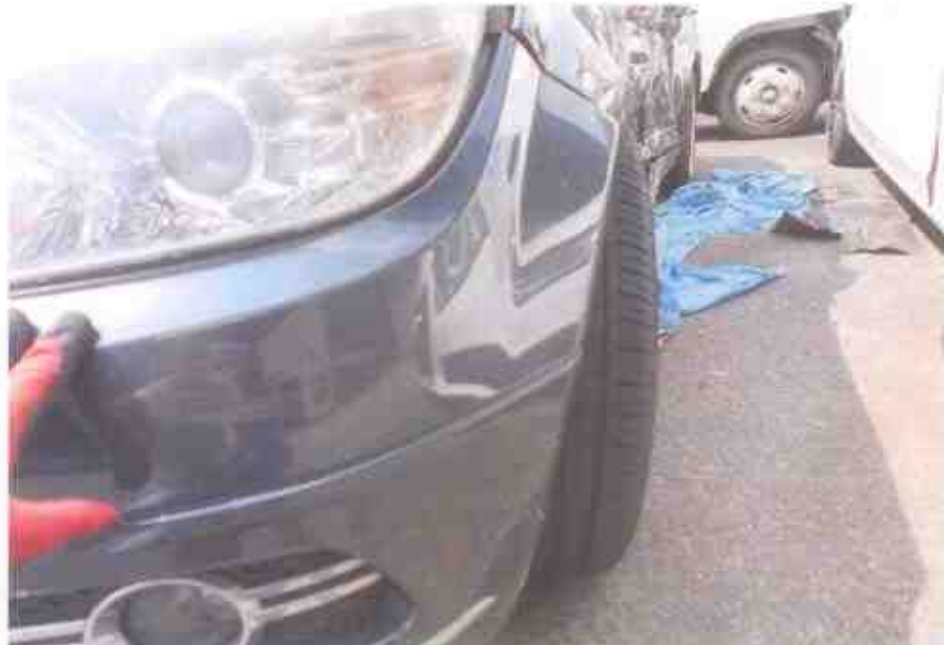
Photo 5 shows a closer view of the damage sustained on the front left of the Motor Car. The impact force was significant, causing the various parts and components inside the engine compartment to be damaged.

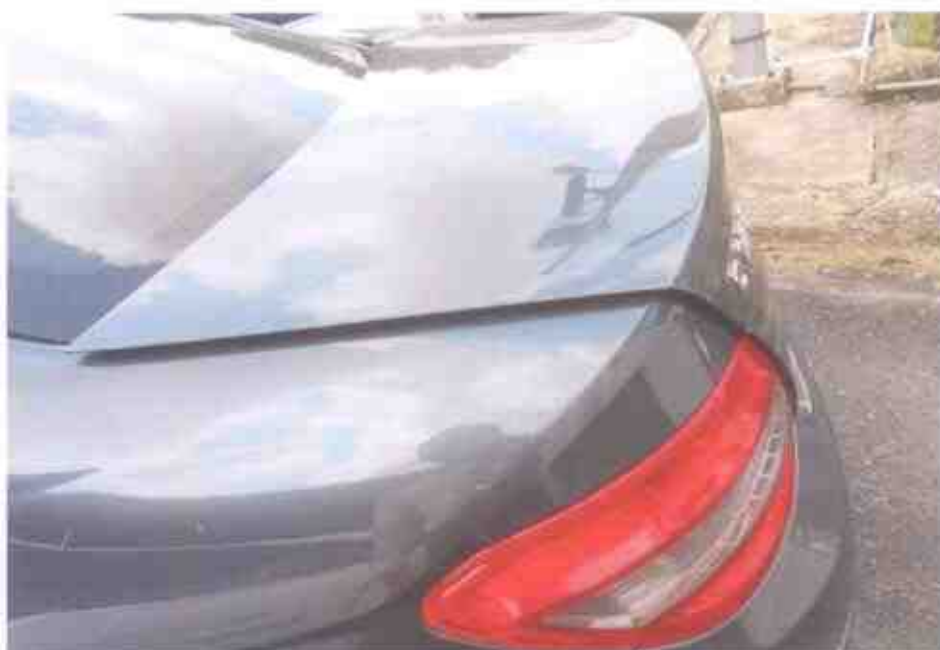
Photo 7 shows a closer view of the damaged rear boot lid. The impact force was significant, causing it to be misaligned due to the accident's impact.

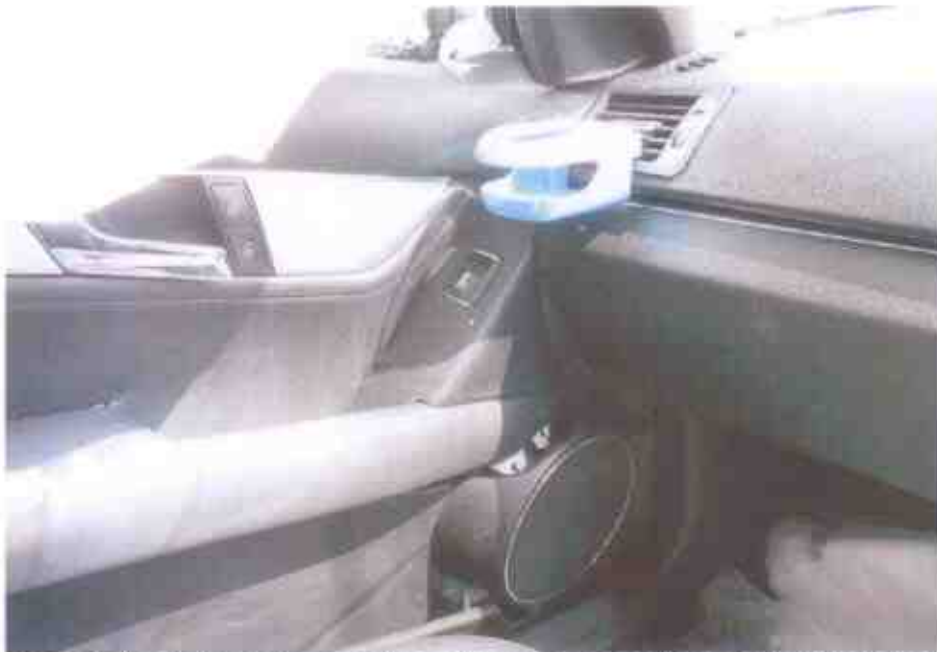
Photo 8 shows the interior portion of the Motor Car. The impact force did not affect the interior portion.

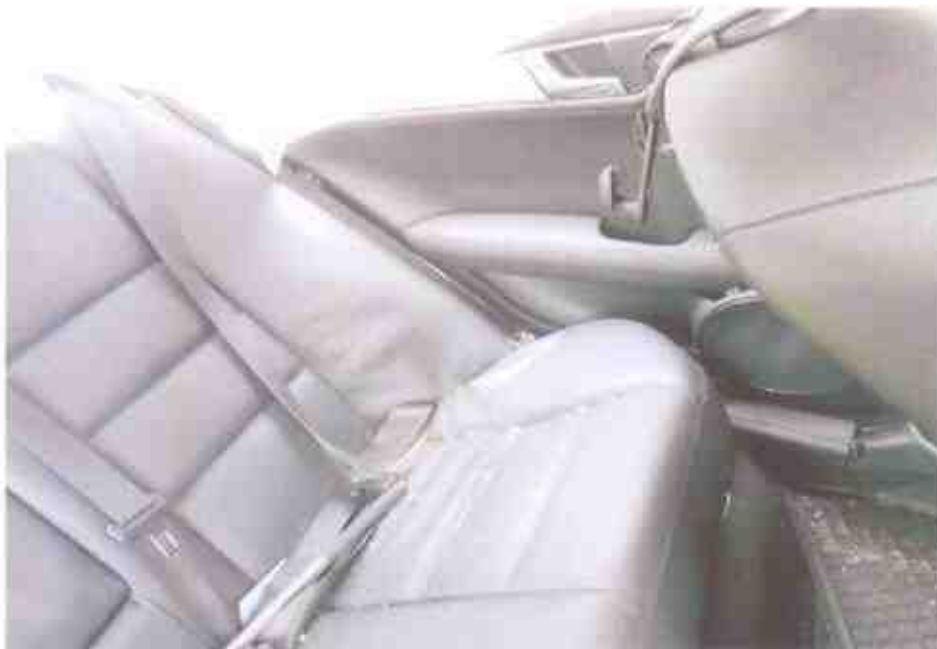
Photo 9 shows the interior portion of the Motor Car. The impact force did not affect the interior portion.

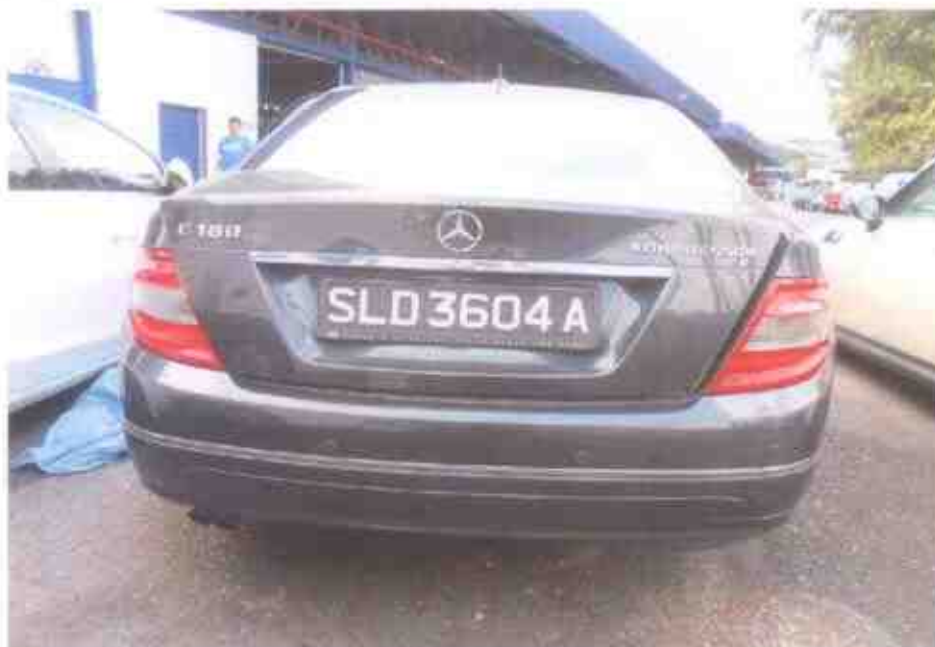
Photo 10 shows a general view of the rear right portion of the Motor Car at the time of our inspection. The rear portion was observed to have minor misalignment on the rear boot lid caused by the accident.

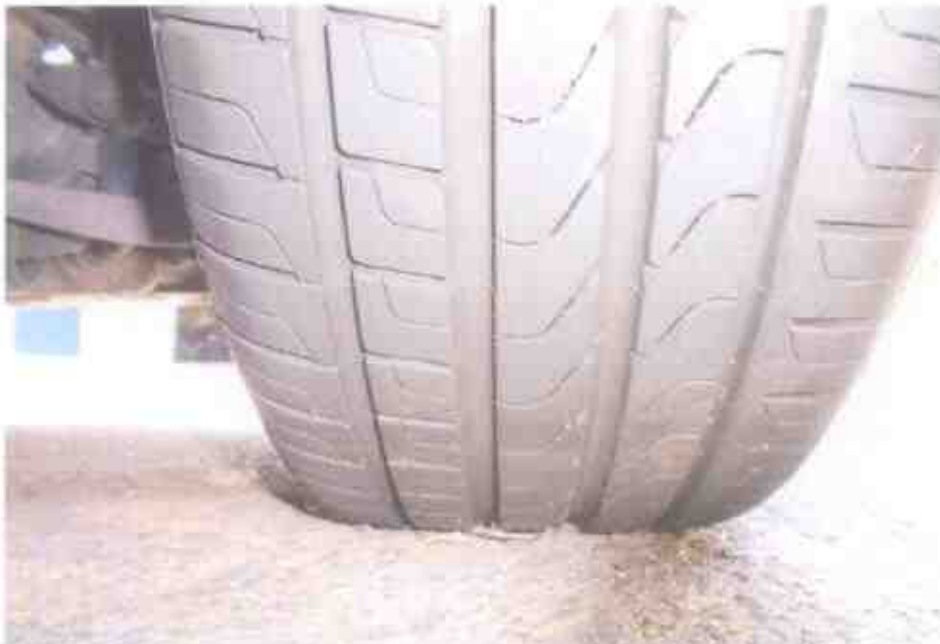
Photo 11 shows the condition of the front right tyre of the Motor Car, which was observed to be in serviceable condition with remaining tread depth of approximately 5mm. There was no tear, cut or burst mark(s) on the outer and the inner sidewalls as well as across the tread of this tyre.

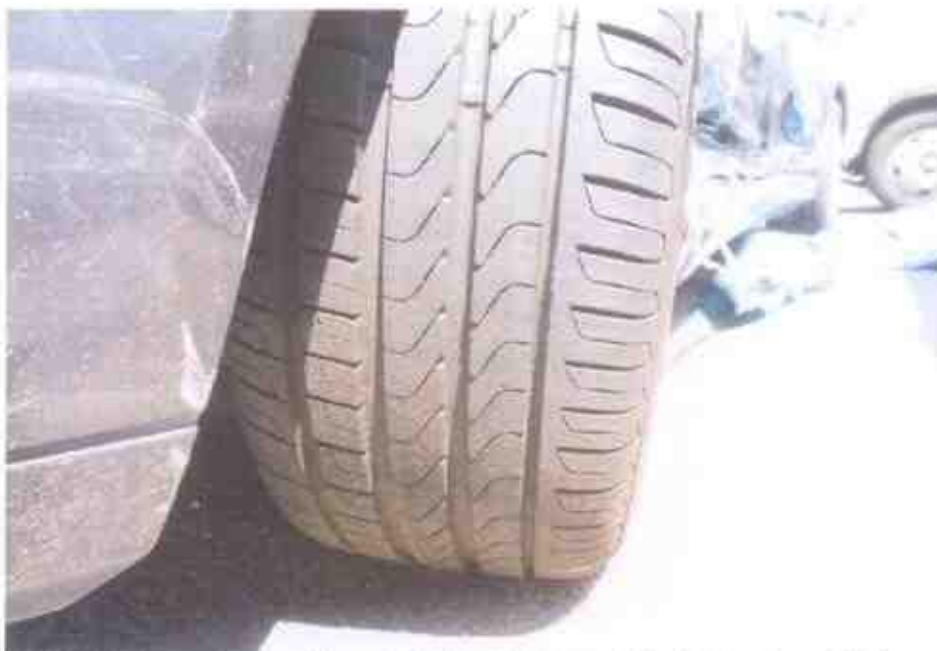
Photo 12 shows the condition of the front left tyre of the Motor Car, which was observed to be in serviceable condition with remaining tread depth of approximately 5mm. There was no tear, cut or burst mark(s) on the outer and the inner sidewalls as well as across the tread of this tyre, which was also sufficiently inflated for vehicular operation.

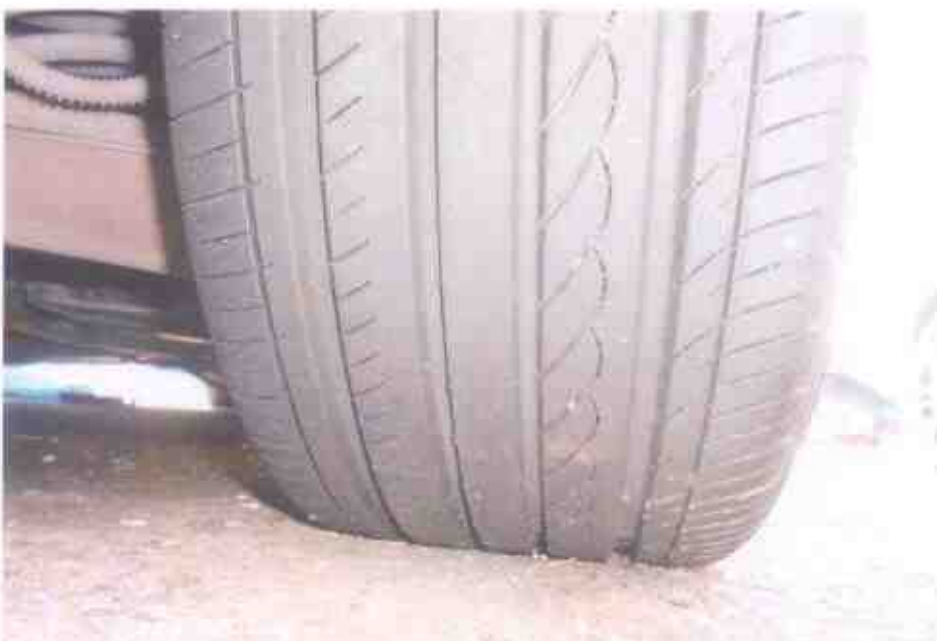
Photo 13 shows the condition of the rear right tyre of the Motor Car, which was observed to be in serviceable condition with remaining tread depth of approximately 5mm. There was also no tear, cut or burst mark(s) on the outer and the inner sidewalls as well as across the tread of this tyre.

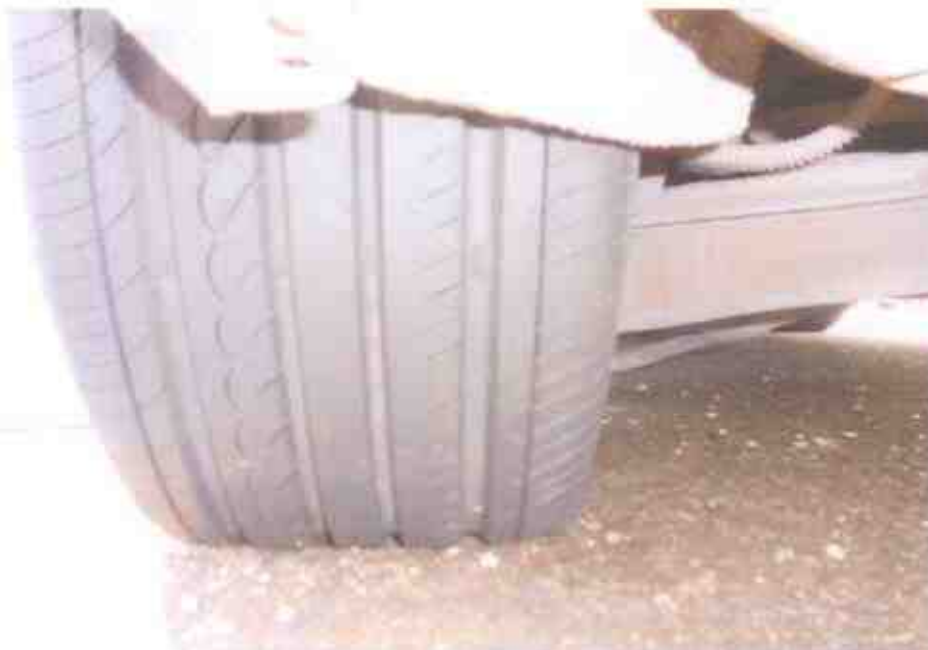
Photo 14 shows the condition of the rear left tyre of the Motor Car, which was observed to be in serviceable condition with remaining tread depth of approximately 6mm. It was also observed to be deflated due to the accident.

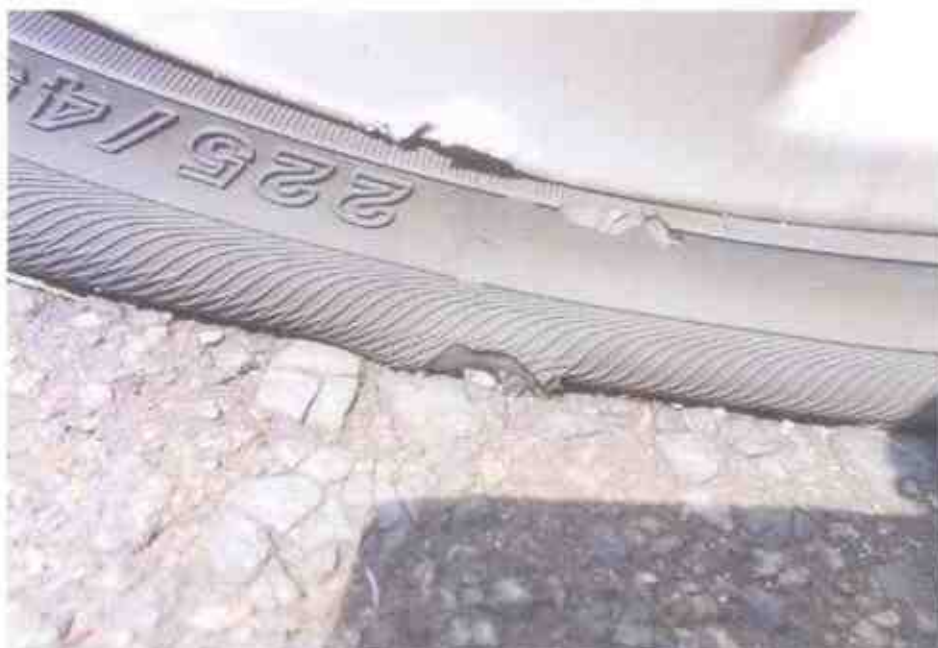
Photo 15 shows the torn mark on the rear left tyre of the Motor Car, which deflates the tyre caused by the accident.

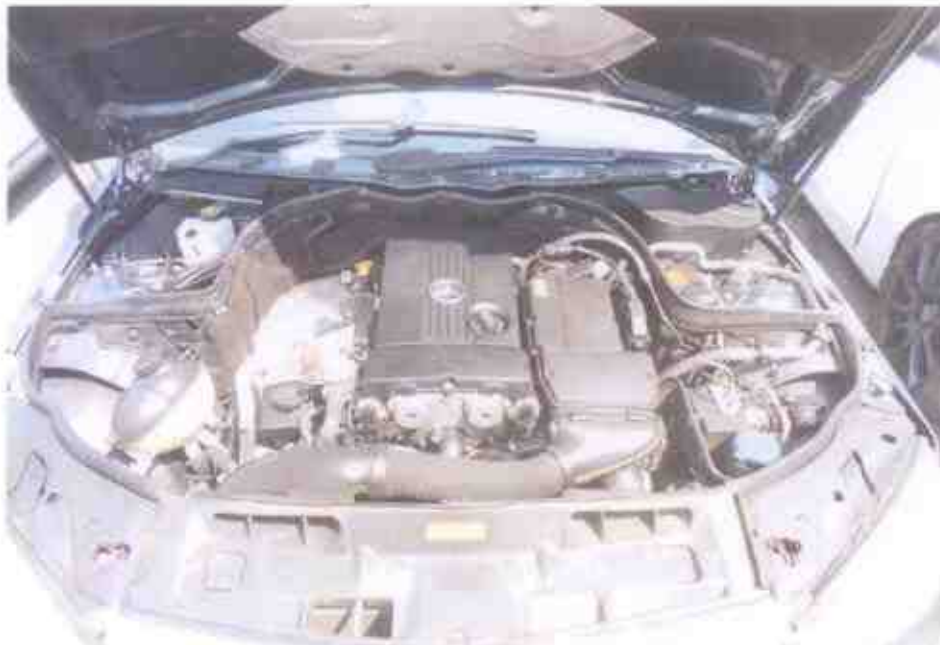
Photo 16 shows a general view of the Motor Car's engine compartment. The various parts and components inside the engine compartment were unaffected by the accident. There was also no sign(s) or indication(s) of fluid leakage and/or fluid stain within the engine compartment.

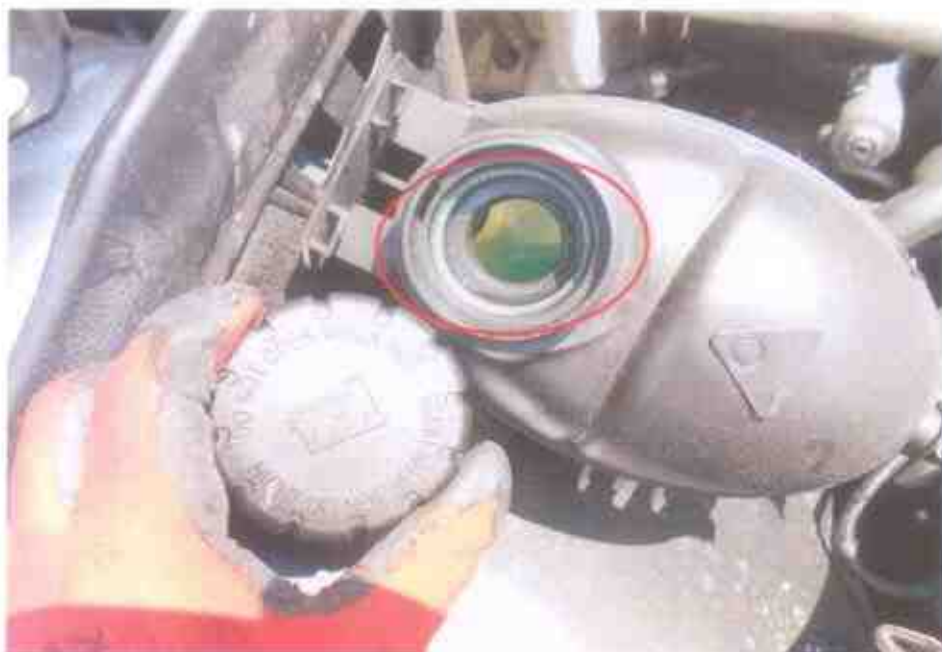
Photo 17 shows the close up view of the engine coolant that was seen with sufficient level not affected by the accident's impact

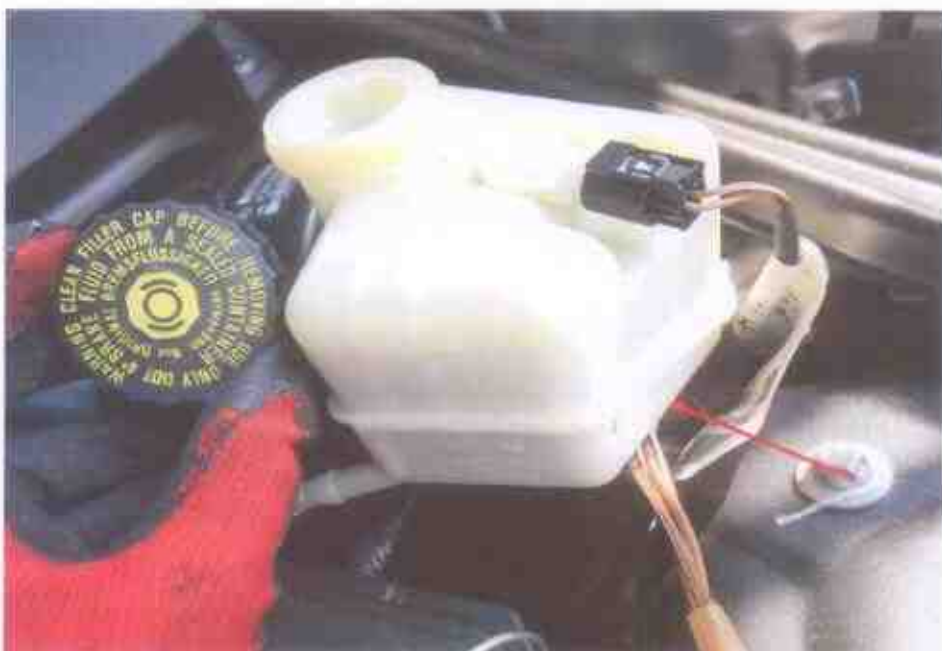
Photo 18 shows the close up view of the brake fluid that was seen with sufficient level not affected by the accident's impact.

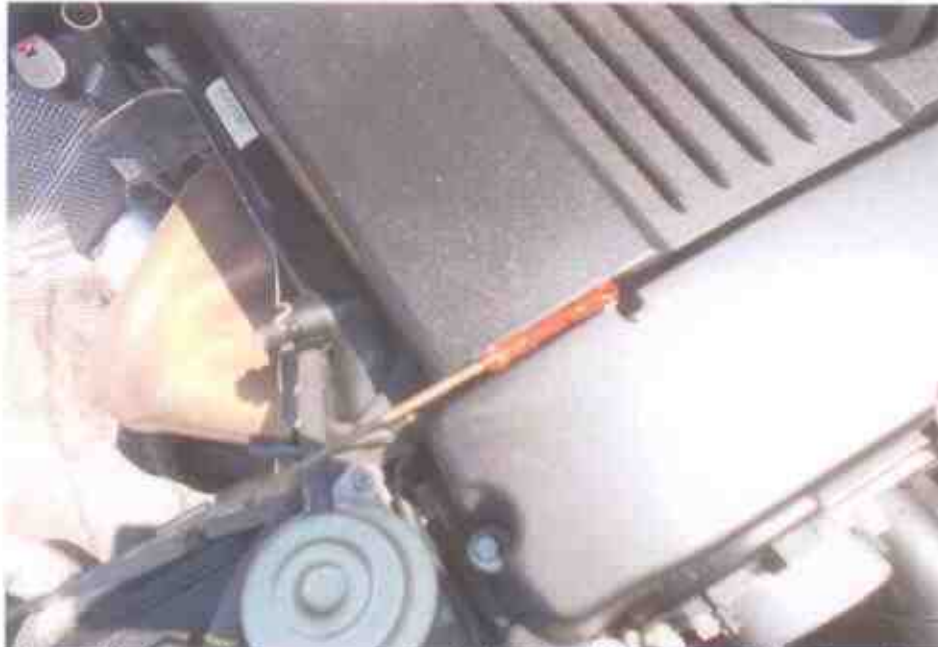
Photo 19 shows the engine oil dip stick of the Motor Taxi at the time of our inspection. The engine oil was observed to be of sufficient level and without any visible contamination.

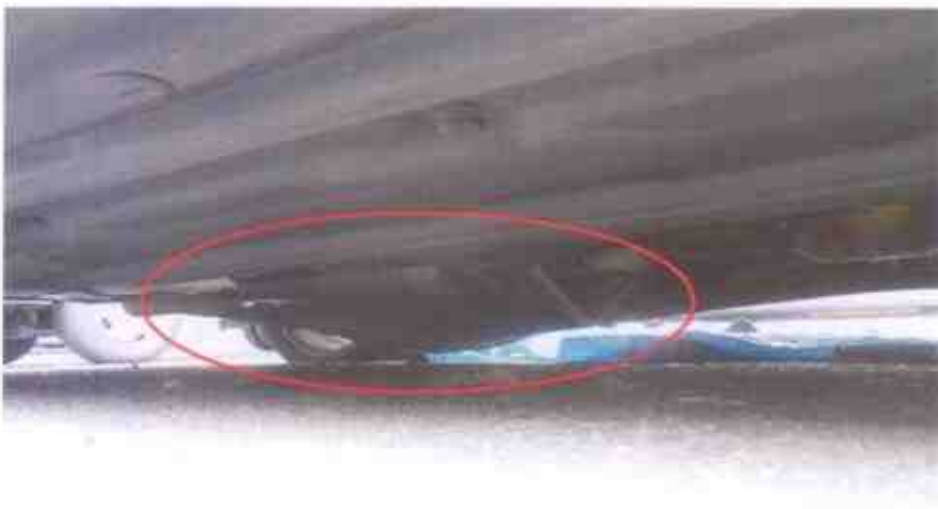
Photo 20 shows the undercarriage of the engine area. It was observed to sustained damages as a result of the accident's impact.

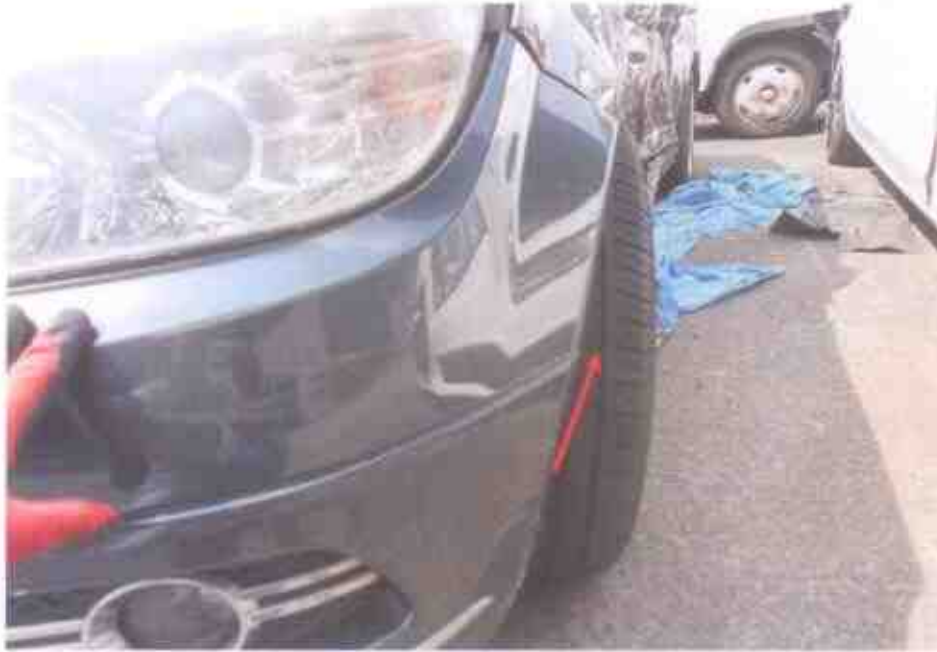
Photo 21 shows the misalignment at the front left wheel of the Motor Car.

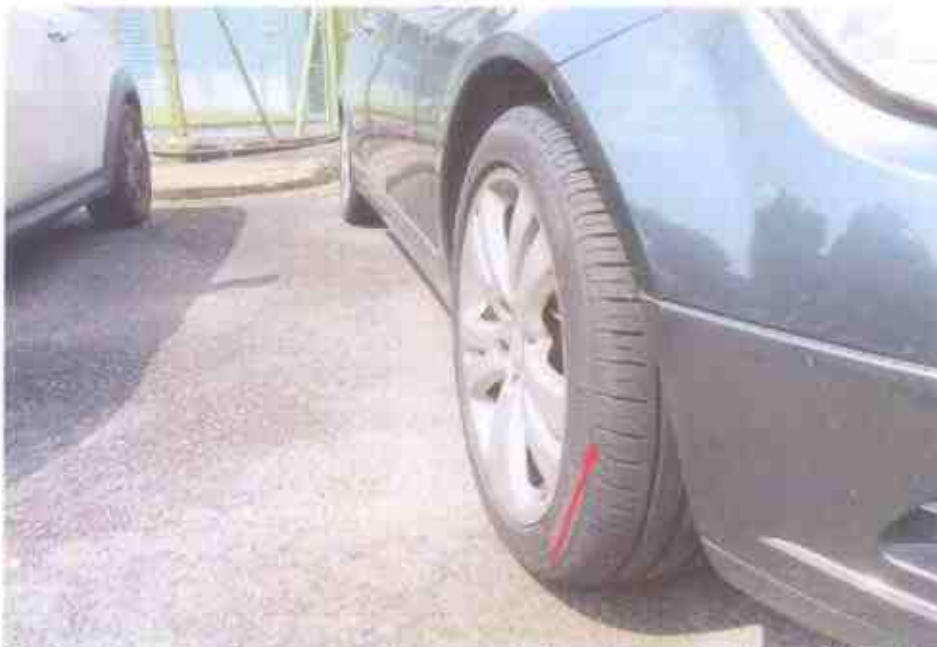
Photo 22 shows the correct alignment at the right side of the Motor Car unaffected by the accident.

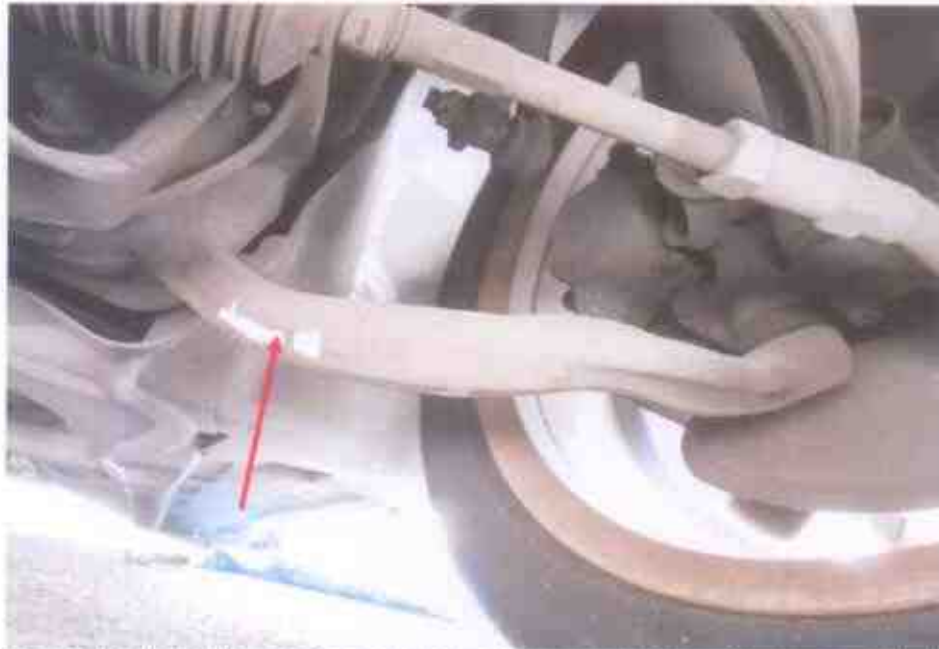
Photo 23 shows the steering rod that was observed to be with damages likely due to the accident's impact.

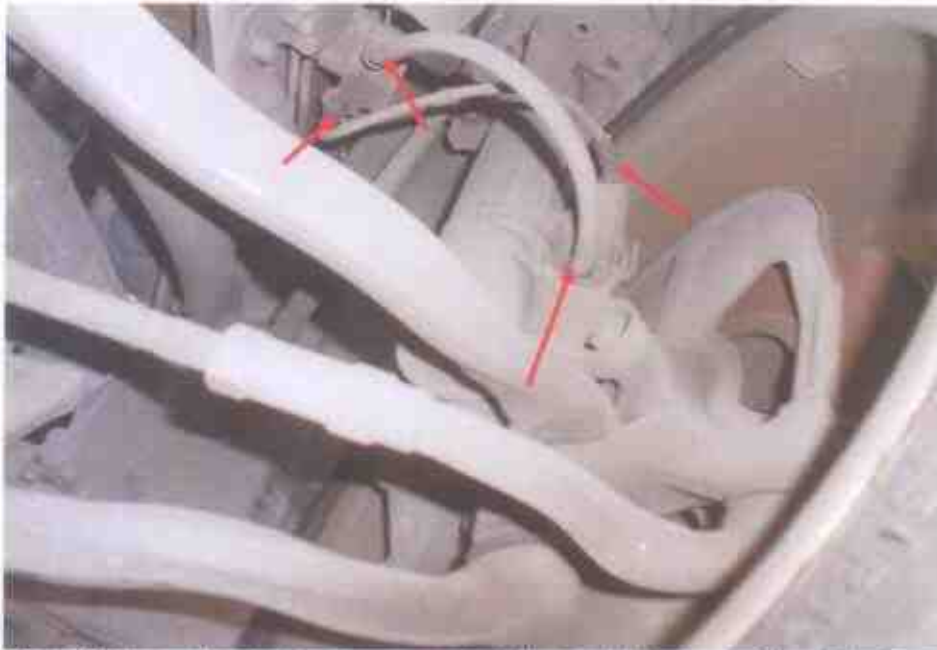
Photo 24 shows the braking components at the front left wheel of the Motor Taxi. We did not observe any leakage of brake fluid at the time of our inspection of the Motor Car.

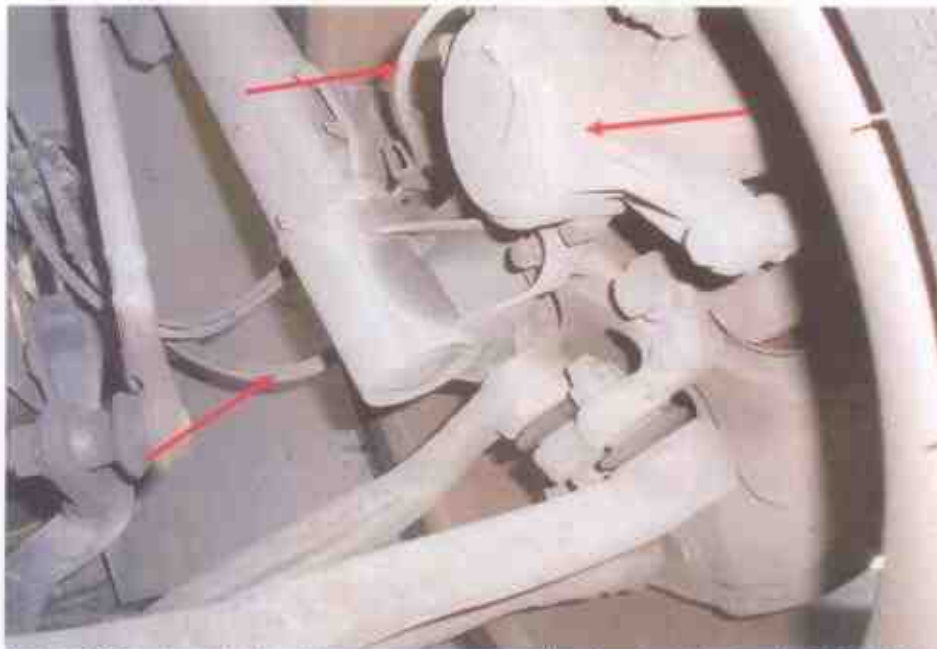
Photo 25 shows the braking components at the front right wheel of the Motor Car. We did not observe any leakage of brake fluid at the time of our inspection of the Motor Car.

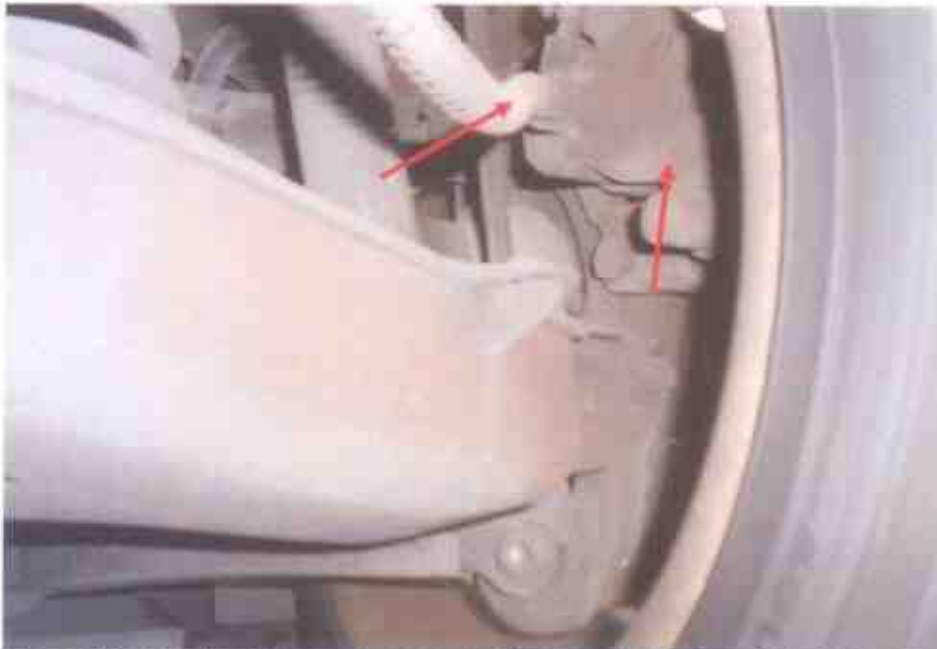
Photo 26 shows the braking components at the rear right wheel of the Motor Car. We did not observe any leakage of brake fluid at the time of our inspection of the Motor Car.

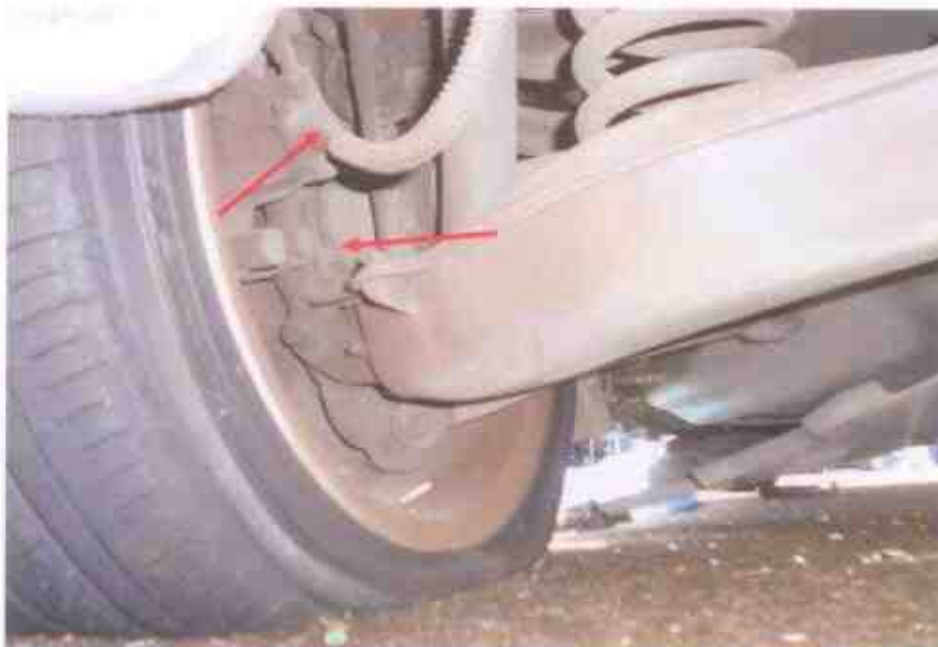
Photo 27 shows the braking components at the rear left wheel of the Motor Car. We did not observe any leakage of brake fluid at the time of our inspection of the Motor Car. Nevertheless, the tyre was found to be deflated likely due to the accident's impact.

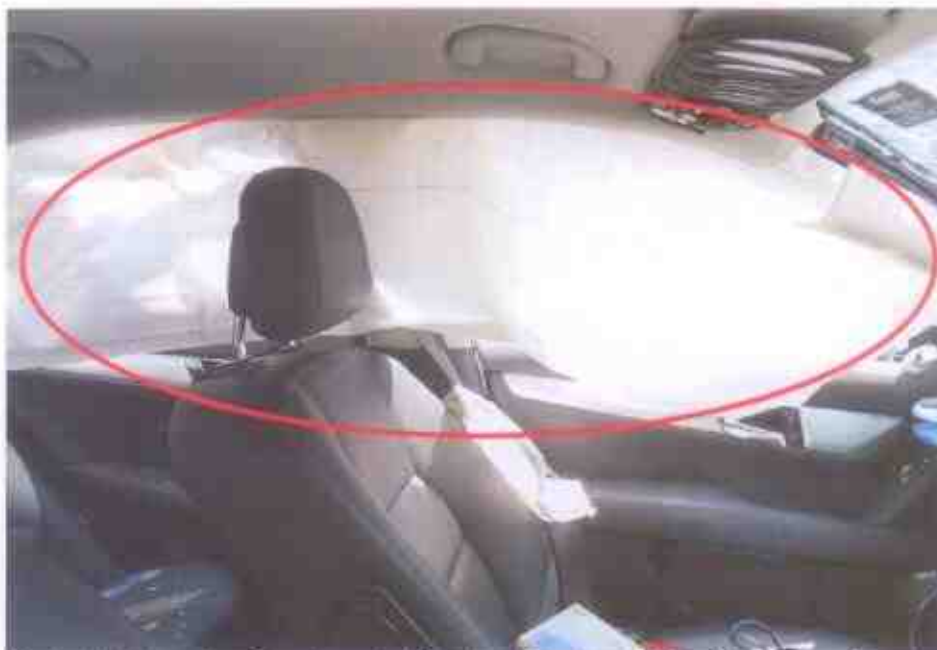
Photo 28 shows the Supplemental Restraint System (SRS) of the Motor Car was however likely to be in normal operating condition at the material time of the accident. The evidence of the deployed window's airbag indicates that the impact sensors and control module of the Motor Car's SRS were all in serviceable condition at the material time of accident.
