Your Ref: TP/IP/20003/2018
Our Ref : CI/TPD18013753/Z

10th August 2018

MECHANICAL INSPECTION REPORT OF MOTOR CAR SGV 8752L

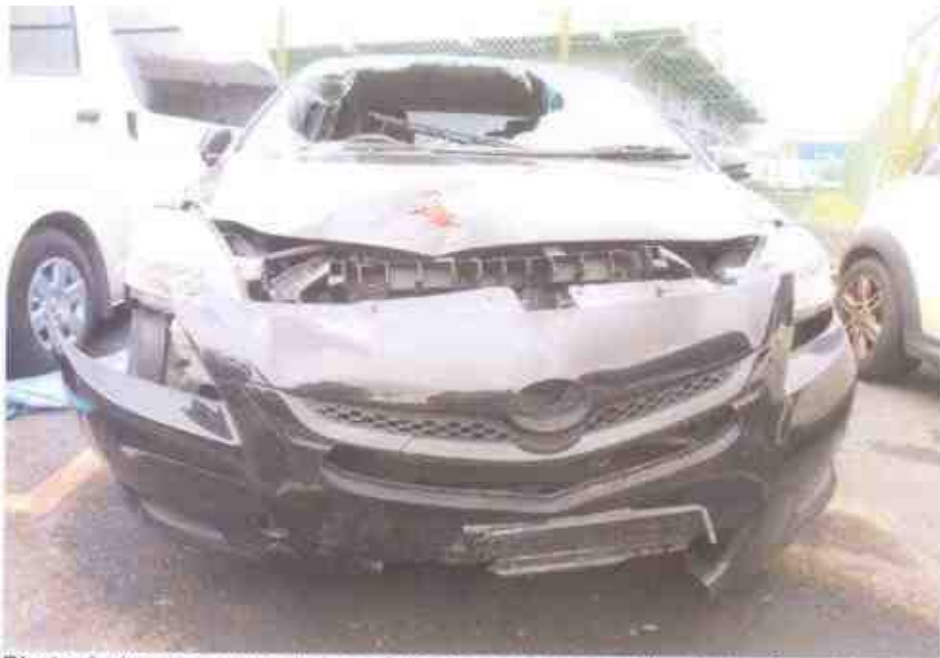
Photo 1 shows a general view of the frontal portion of the Motor Car at the time of our inspection. The Motor Car was observed to have sustained extensive impact damage at its frontal portion. The impact force was significant, causing the various parts and components inside the engine compartment to be damaged.

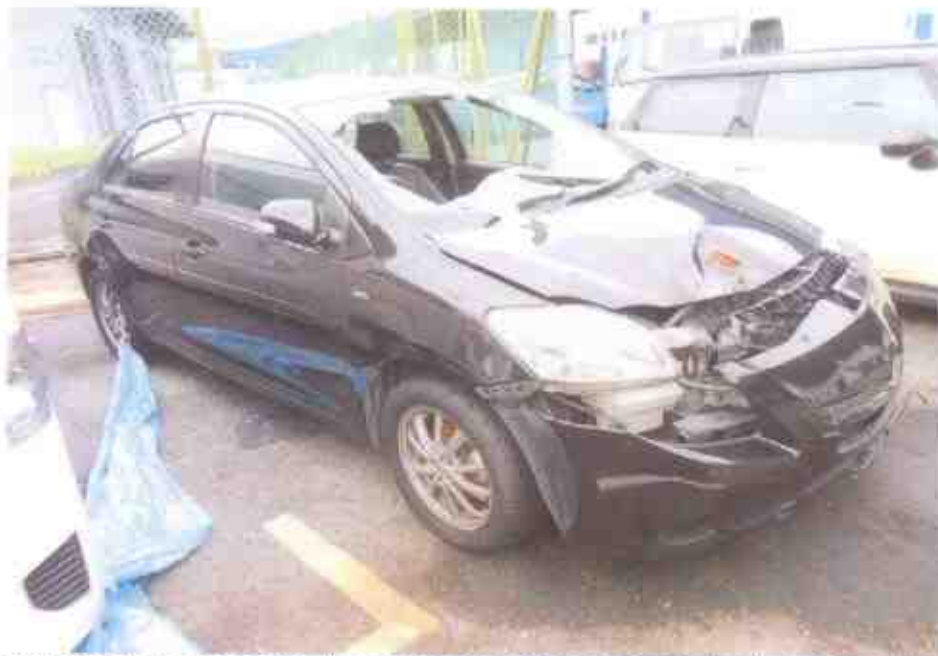
Photo 2 shows a general view of the front right portion of the Motor Car at the time of our inspection. The Motor Car was observed to have sustained extensive impact damage at its front right portion.

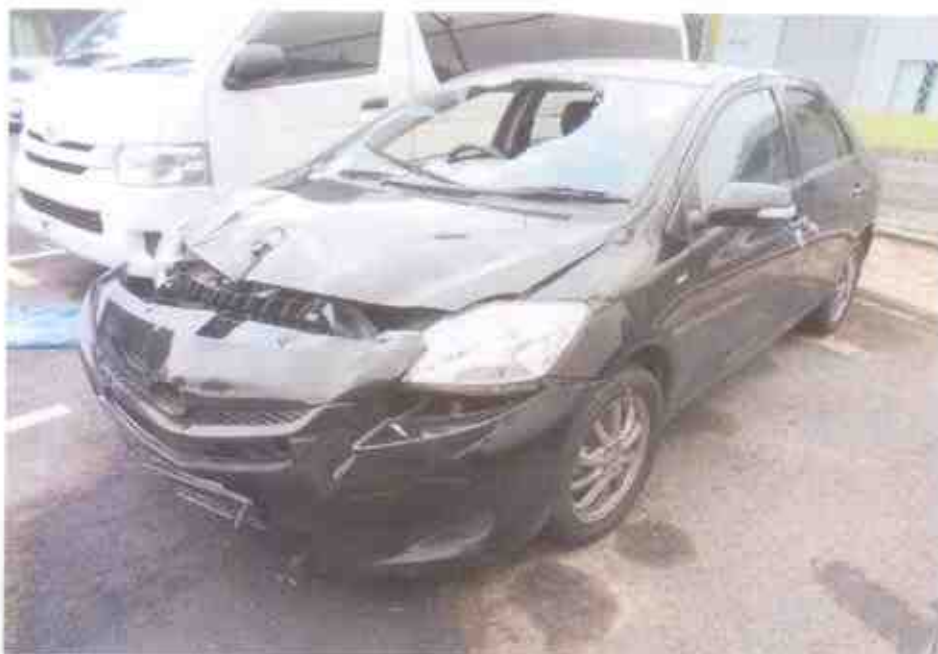
Photo 3 shows a general view of the front left portion of the Motor Car at the time of our inspection. The Motor Car was observed to have sustained extensive impact damage at its front left portion.

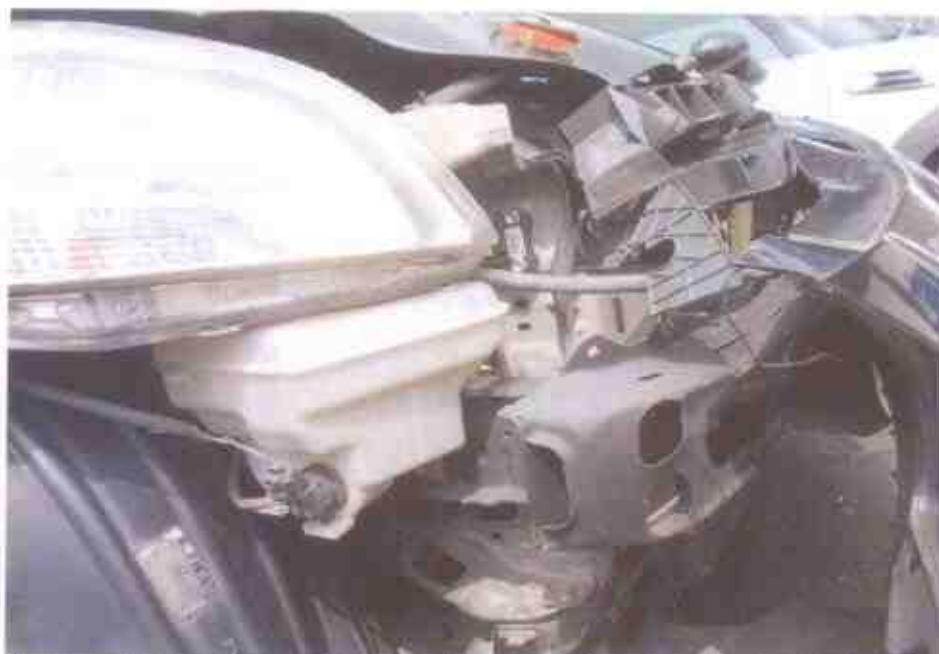
Photo 4 shows a closer view of the damage sustained on the front right of the Motor Car. The impact force was significant, causing the various parts and components inside the engine compartment to be pushed inwards, towards the rear of the Motor Car.

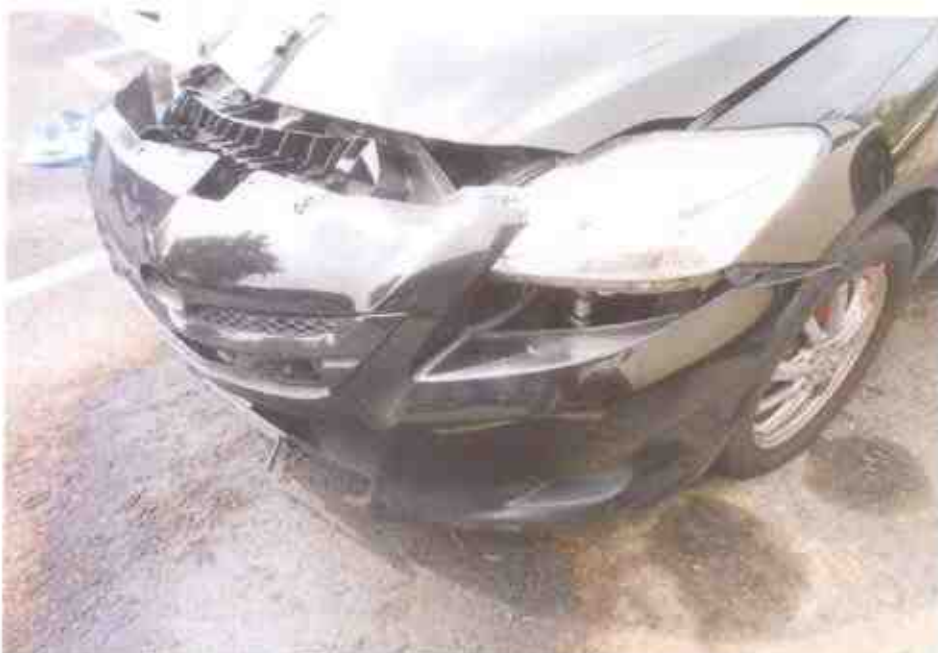
Photo 5 shows a closer view of the damage sustained on the front left of the Motor Car. The impact force was significant, causing the various parts and components inside the engine compartment to be pushed inwards, towards the rear of the Motor Car.

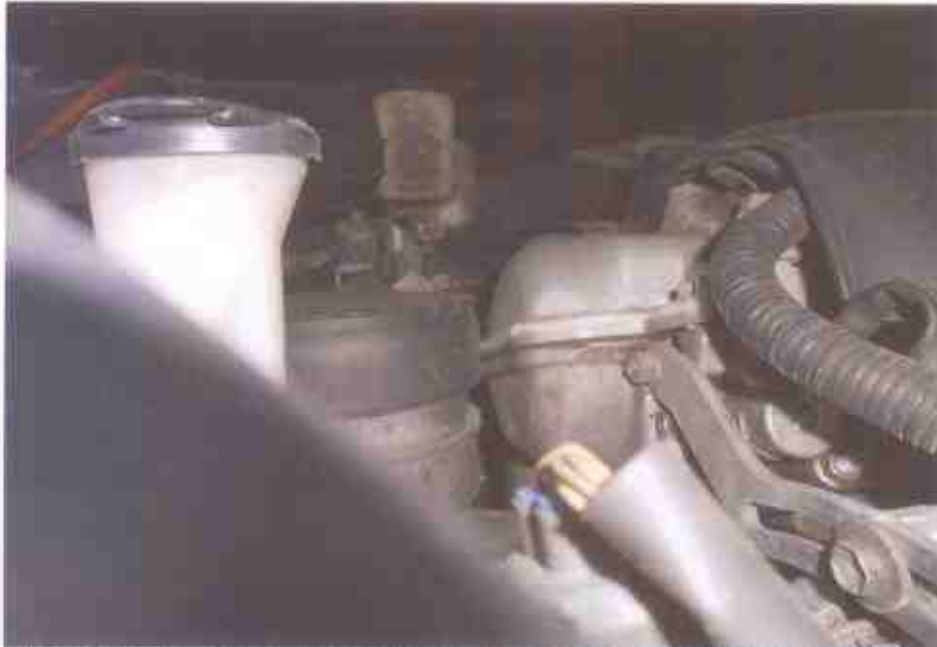
Photo 6 shows a closer view of the engine compartment of the Motor Car from the right hand side of the bonnet opening. The impact force was significant, causing the various parts and components inside the engine compartment to be pushed inwards, towards the rear of the Motor Car.

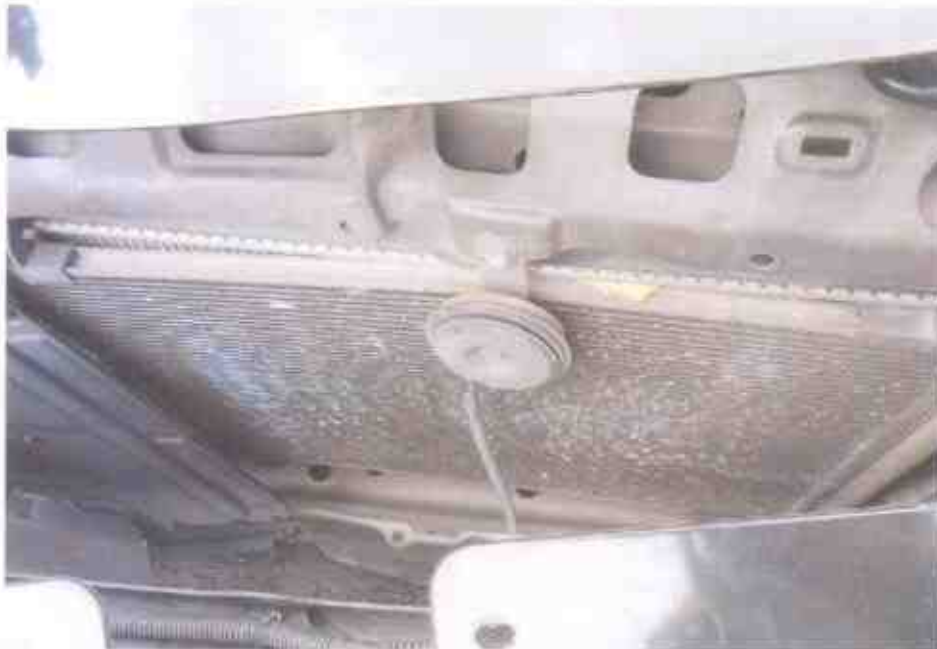
Photo 7 shows a closer view of the damaged radiator of the Motor Car from the front view. The impact force was significant, causing the various parts and components inside the engine compartment to be pushed inwards, towards the rear of the Motor Car.

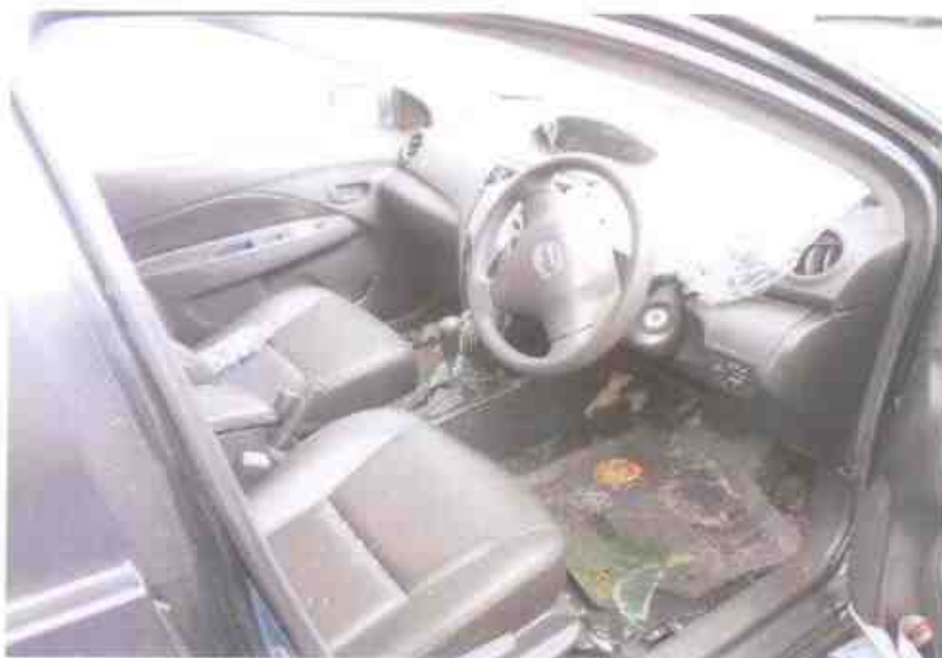
Photo 8 shows the interior portion of the Motor Car. The impact force did not affect the interior portion.

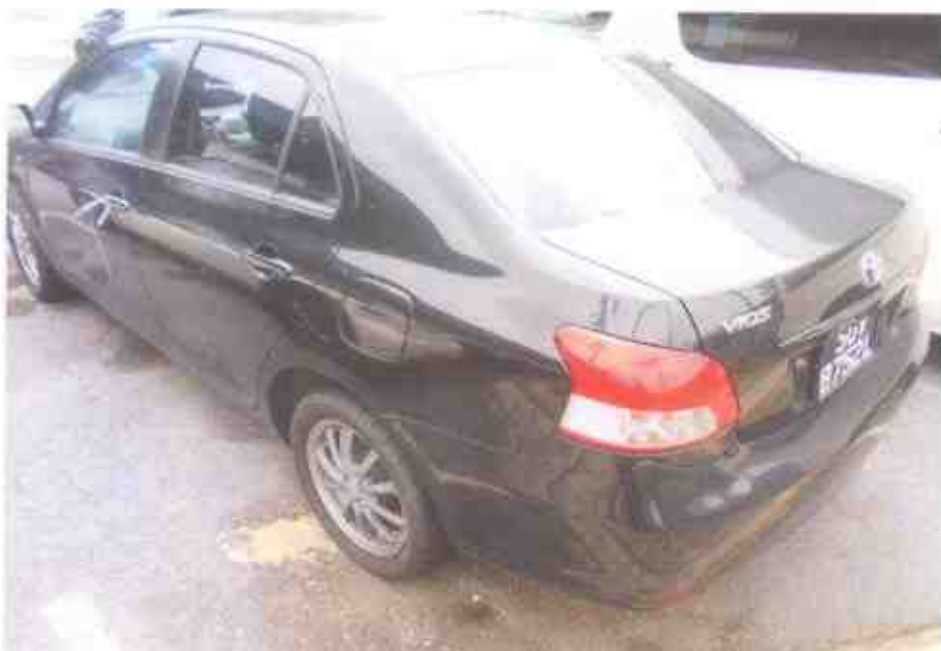
Photo 9 shows a general view of the rear left portion of the Motor Car at the time of our inspection. The rear portion was observed to be relatively unaffected by the accident.

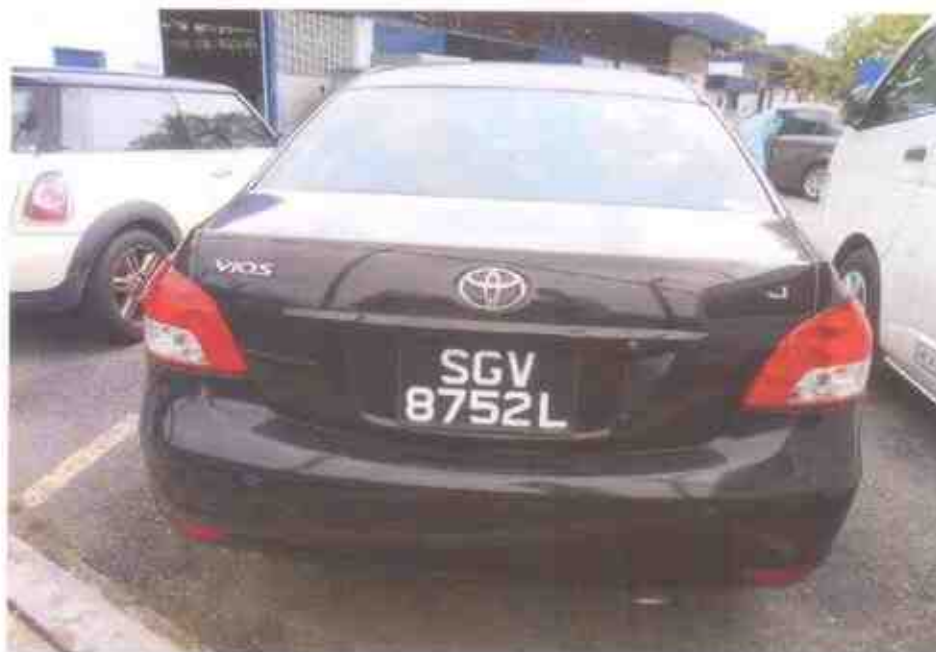
Photo 10 shows a general view of the rear right portion of the Motor Car at the time of our inspection. The rear portion was observed to be relatively unaffected by the accident.

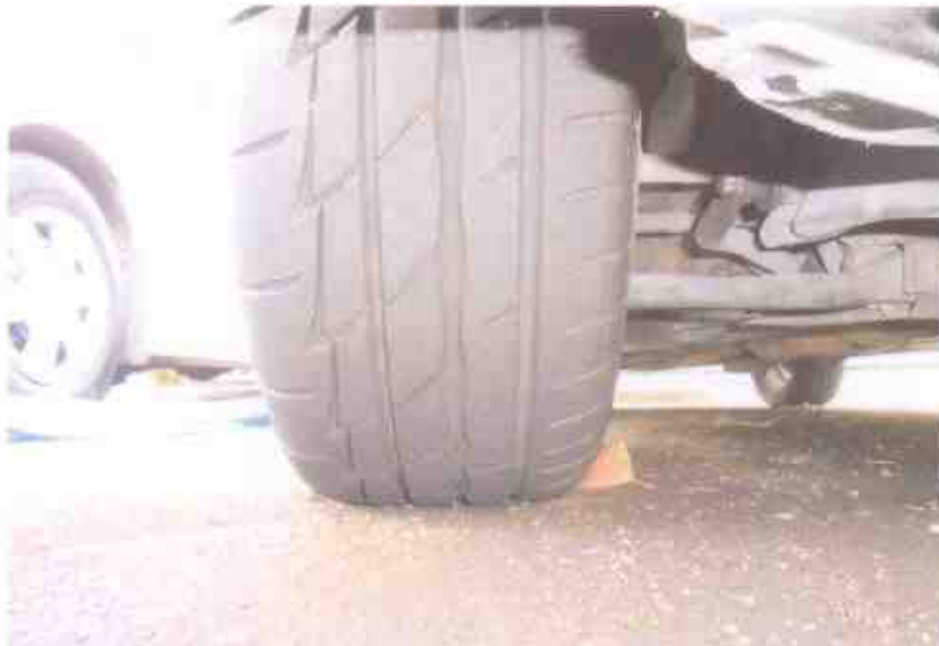
Photo 11 shows the condition of the front right tyre of the Motor Car, which was observed to be in serviceable condition with remaining tread depth of approximately 5mm. There was no tear, cut or burst mark(s) on the outer and the inner sidewalls as well as across the tread of this tyre.

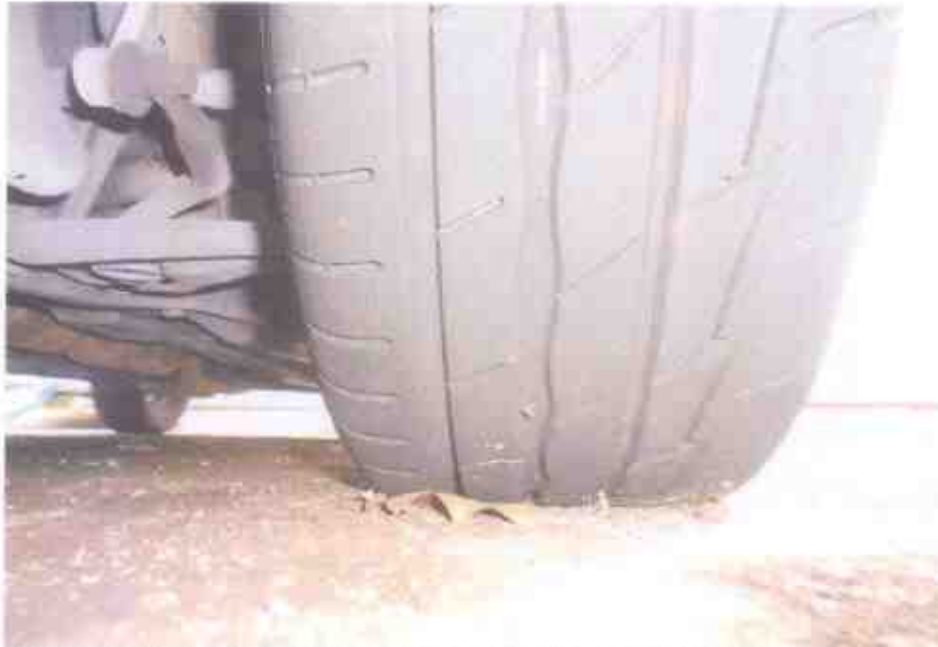
Photo 12 shows the condition of the front left tyre of the Motor Car, which was observed to be in serviceable condition with remaining tread depth of approximately 6mm. There was no tear, cut or burst mark(s) on the outer and the inner sidewalls as well as across the tread of this tyre, which was also sufficiently inflated for vehicular operation.

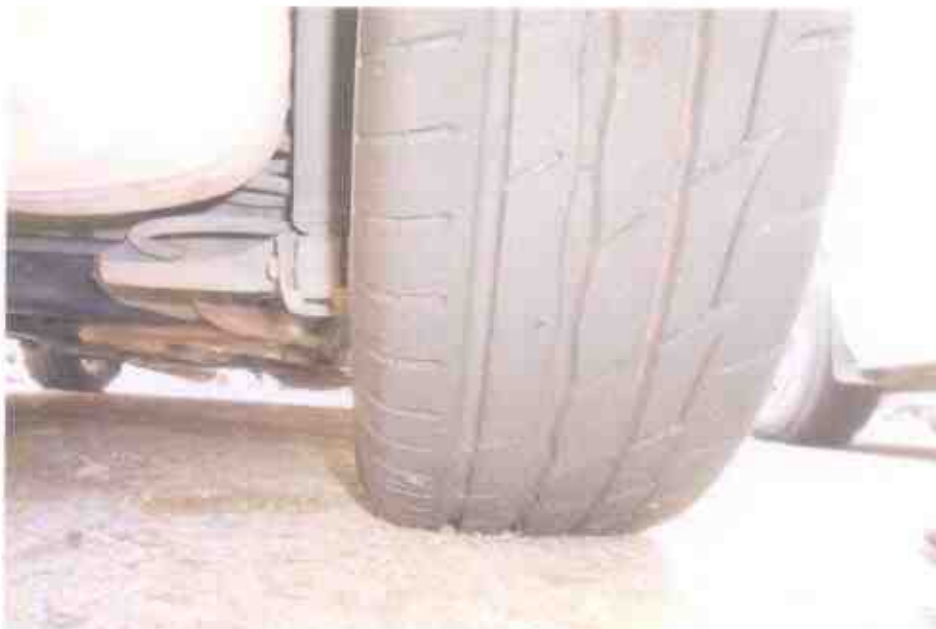
Photo 13 shows the condition of the rear right tyre of the Motor Car, which was observed to be in serviceable condition with remaining tread depth of approximately 5mm. There was also no tear, cut or burst mark(s) on the outer and the inner sidewalls as well as across the tread of this tyre.

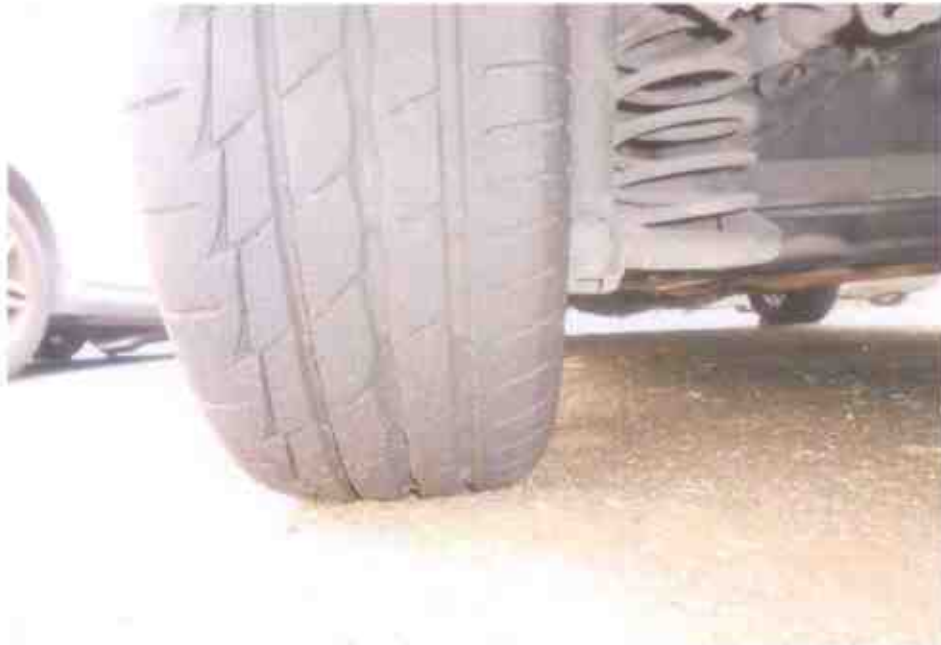
Photo 14 shows the condition of the rear left tyre of the Motor Car, which was observed to be in serviceable condition with remaining tread depth of approximately 5mm. There was also no tear, cut or burst mark(s) on the outer and the inner sidewalls as well as across the tread of this tyre.

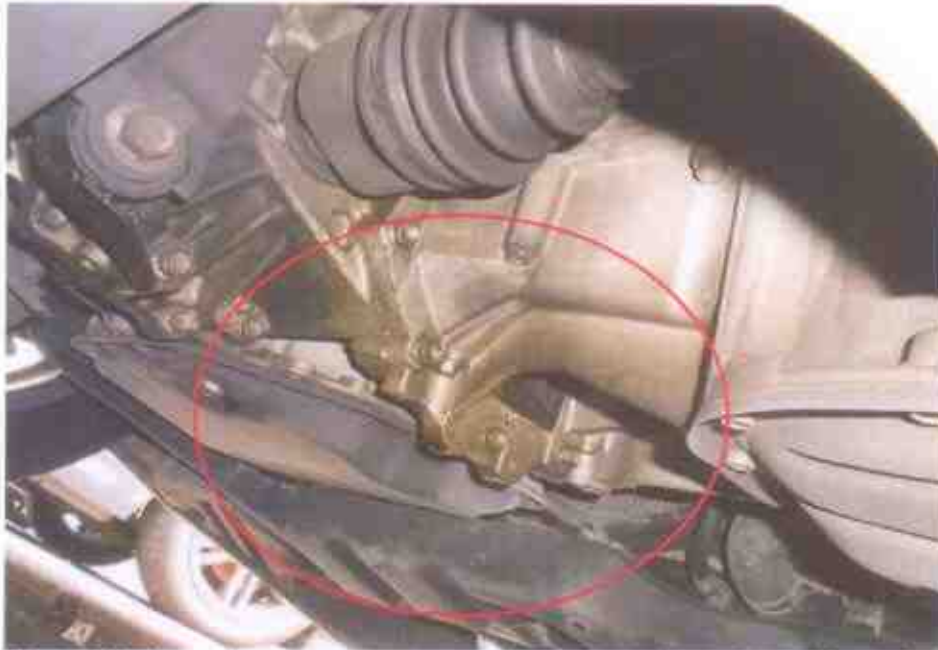
10. Leakage of the various operating fluids was noted. Given the extent of damages to the engine compartment, the leakages were likely due to the accident. The engine undercarriage was however observed to be covered with fresh fluid, suggesting leakage of fluid. There was no accumulation of dust and/or dirt particles on the engine housing where the fluid stains had formed. This would indicate that the fluid leakage was a fresh leak and likely to be a result of the accident. We were therefore unable to comment whether these operating fluids were of sufficient level and without contamination for vehicular operation prior to the accident.

Photo 15 shows the close up view of the undercarriage of the Motor Car. Leakage of fluid was seen. However, we were unable to determine where are the source of the leakage due to the inaccessibility of the engine compartment.

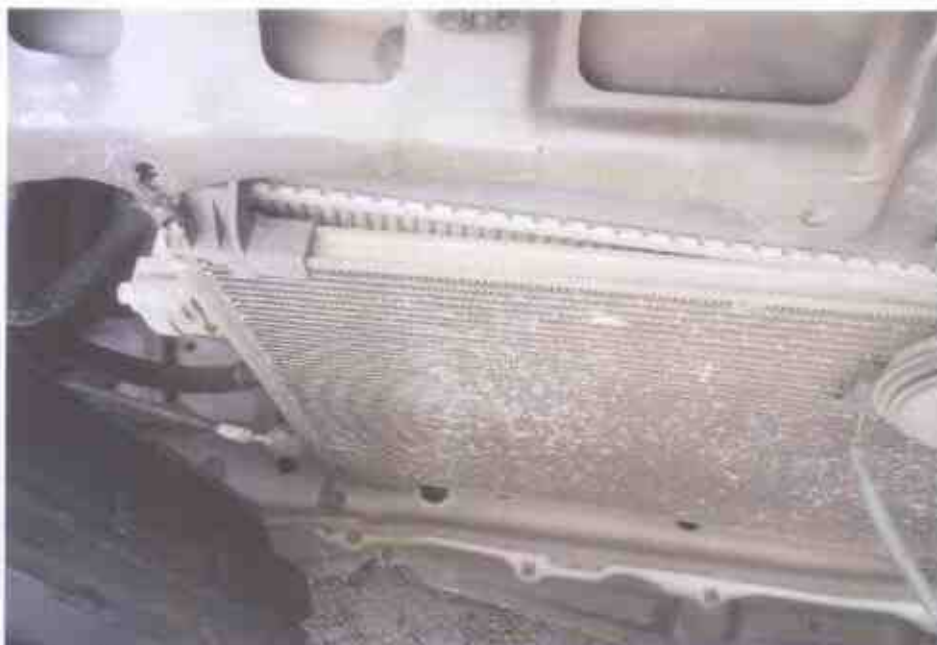
Photo 16 shows the close up view of the damaged radiator as a result of the accident.

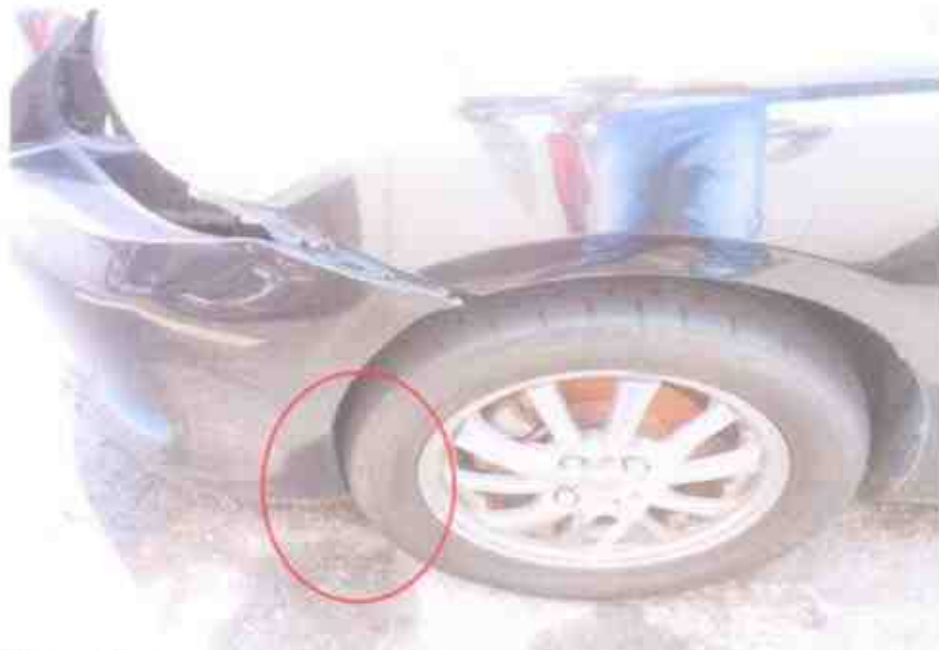
12. We were not able to conduct any tests on the steering system of the Motor Car. This was due to several mechanical components of the steering system & engine system. See photo 18 below.

Photo 18 shows the stuck lower bumper & the front tyre as a result of the accident's impact.

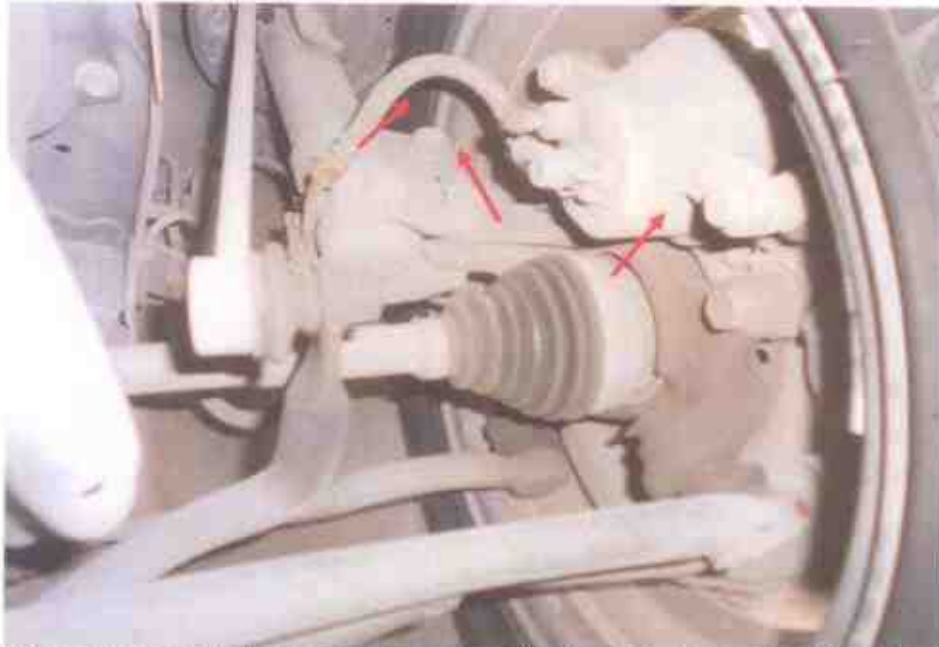
Photo 19 shows the braking components at the front left wheel of the Motor Taxi. We did not observe any leakage of brake fluid at the time of our inspection of the Motor Car.

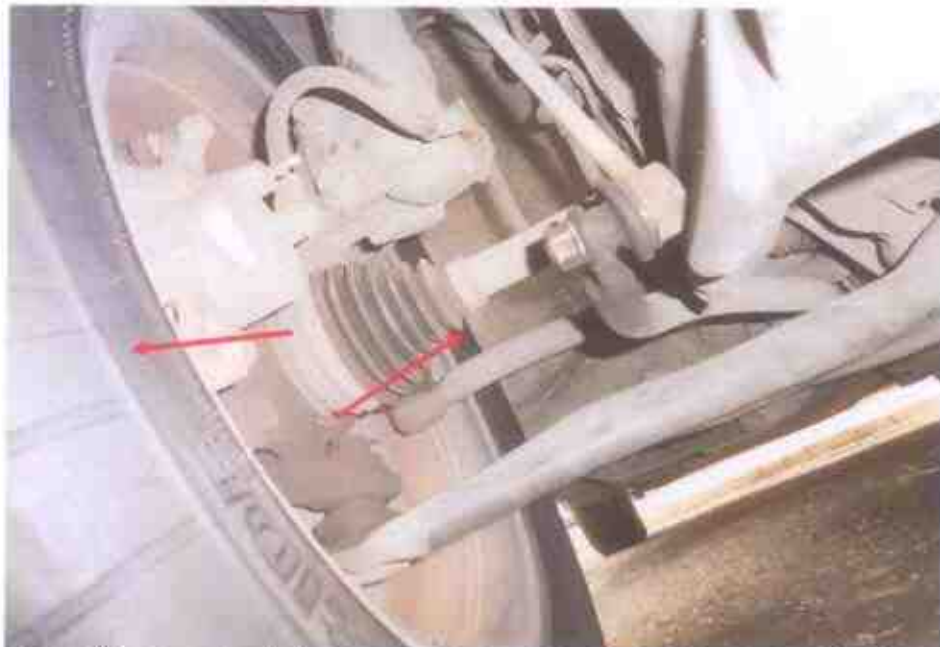
Photo 20 shows the braking components at the front right wheel of the Motor Taxi. We did not observe any leakage of brake fluid at the time of our inspection of the Motor Taxi.

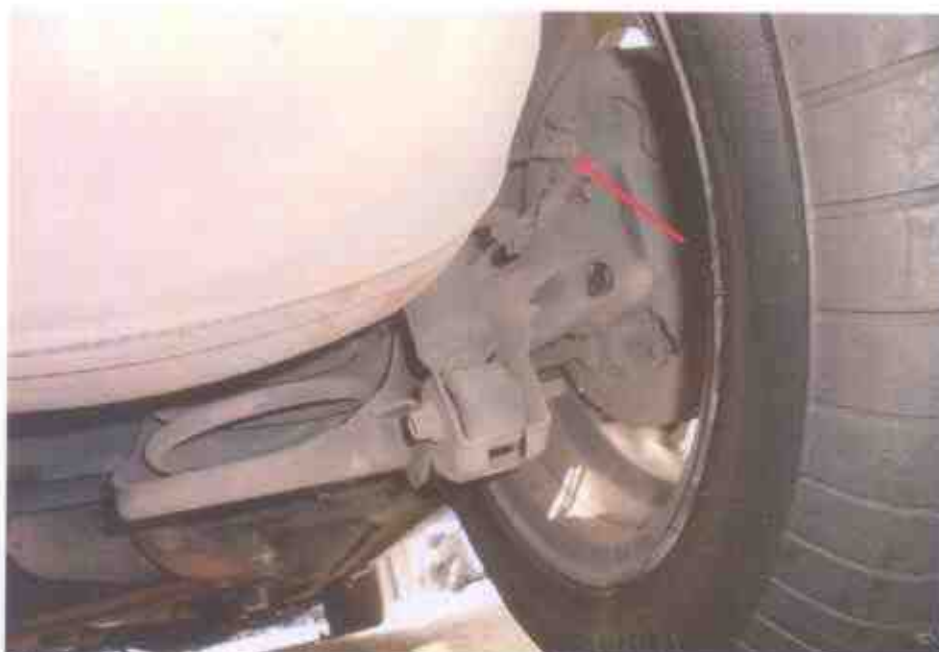
Photo 21 shows the braking components at the rear right wheel of the Motor Taxi. We did not observe any leakage of brake fluid at the time of our inspection of the Motor Taxi.

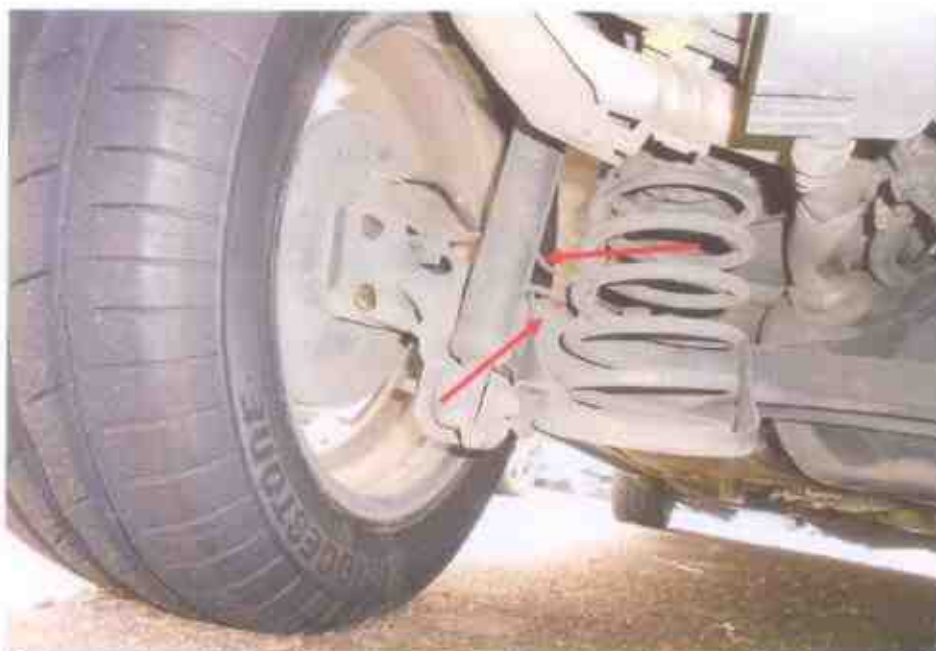
Photo 22 shows the braking components at the rear left wheel of the Motor Taxi. We did not observe any leakage of brake fluid at the time of our inspection of the Motor Taxi.
