Your Ref: TP/IP/18479/2018
Our Ref : CI/TPD18013754/Z

Fatal Accident Investigation Team
Traffic Police Department
Singapore Police Force
10 Ubi Avenue 3
Singapore 408865

MECHANICAL INSPECTION REPORT OF MOTOR LORRY GW 3731A

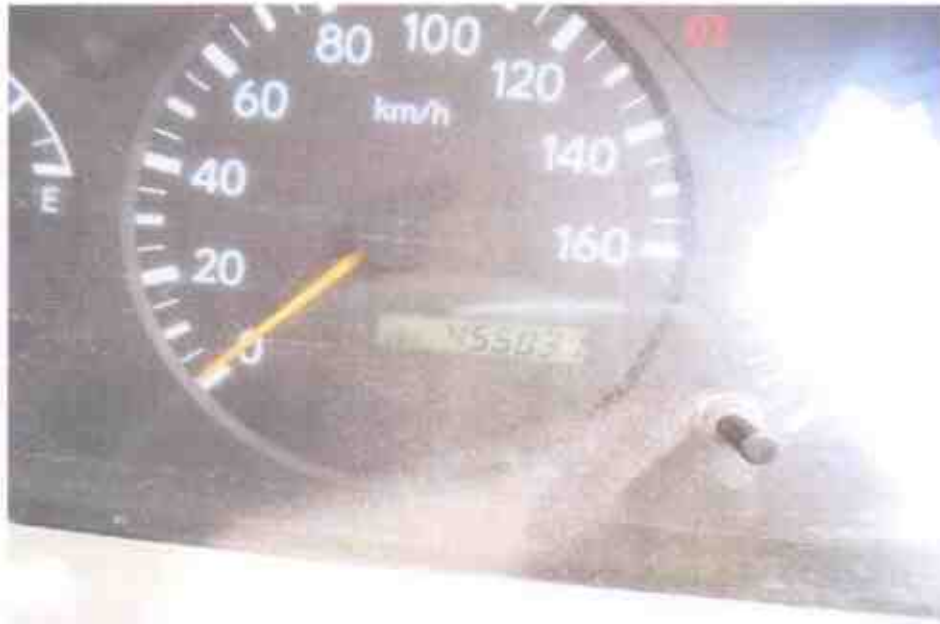
Photo 1 shows the mileage of the Motor Lorry at the time of our inspection was recorded as 455031km.

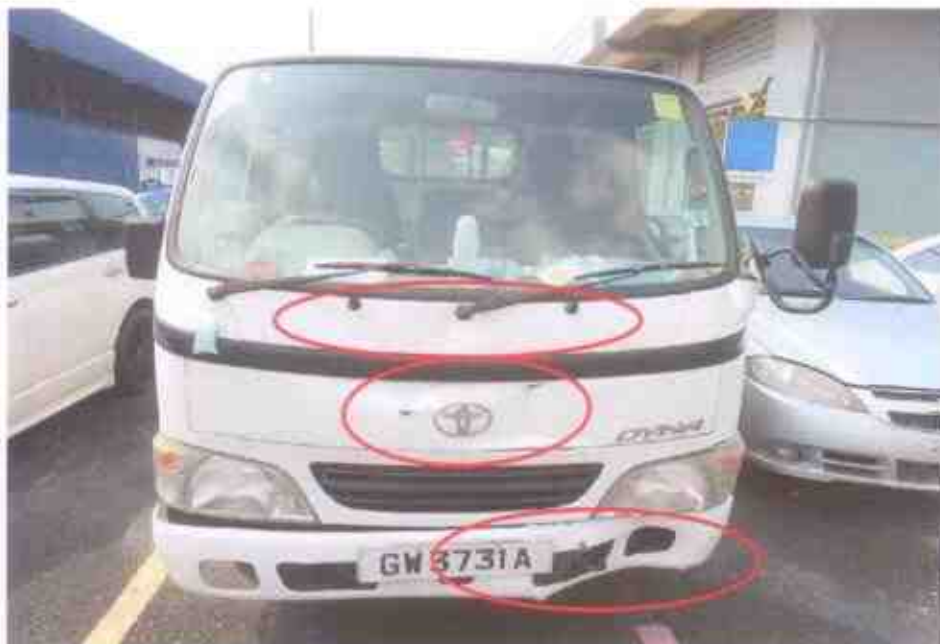
Photo 2 shows a general view of the front portion of the Motor Lorry at the time of our inspection. The Motor Lorry was observed to have sustained minor damage at its front lower bumper and its front panel were amongst the body parts that were damaged as a result of the accident.

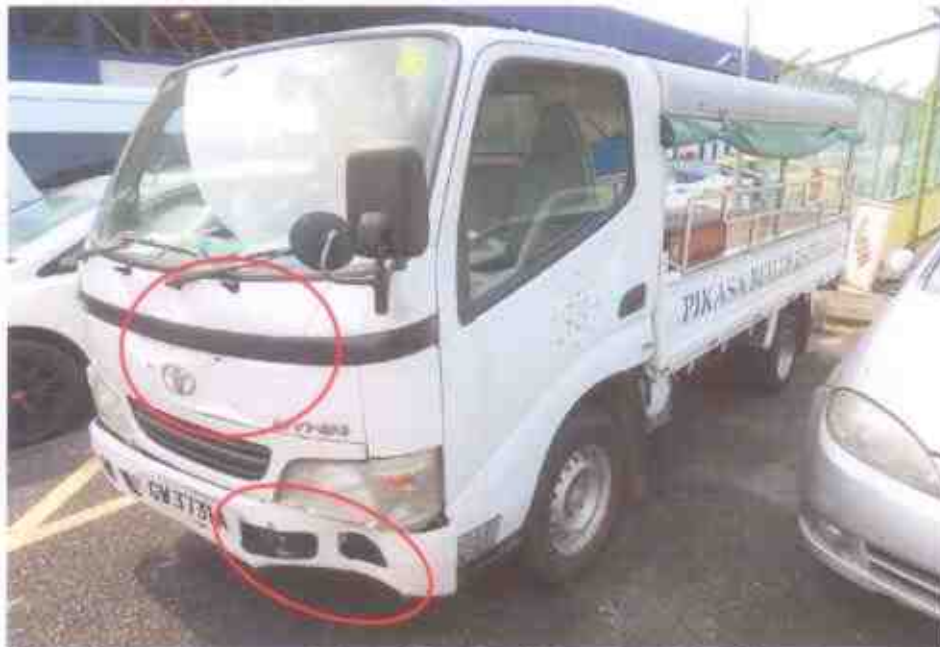
Photo 3 shows a general view of the front left portion of the Motor Lorry at the time of our inspection. The Motor Lorry was observed to have sustained minor damage at its front lower bumper and its front panel were amongst the body parts that were damaged as a result of the accident.

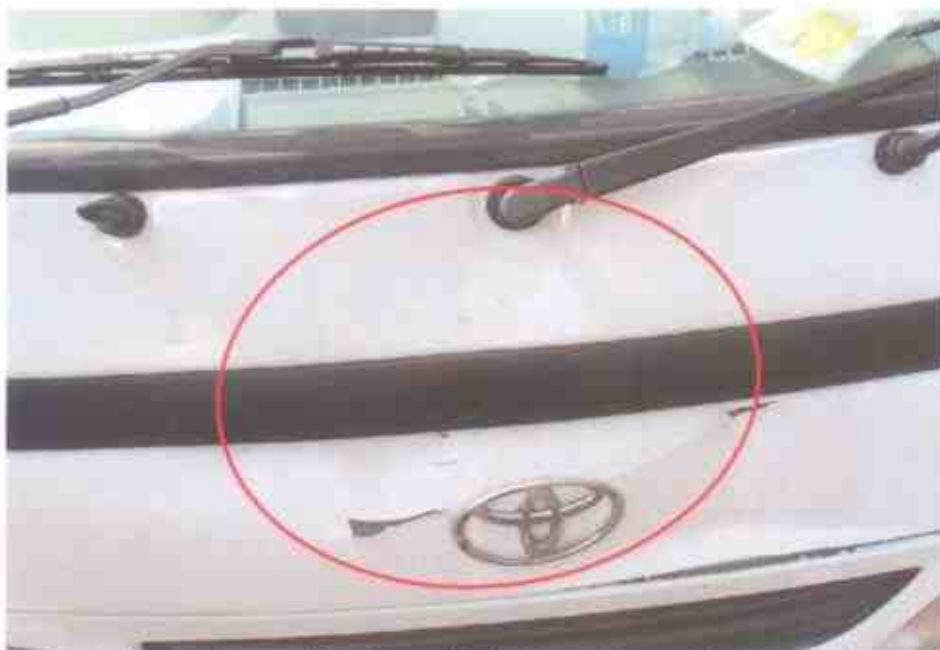
Photo 4 shows a damaged front panel likely due to the accident's impact.

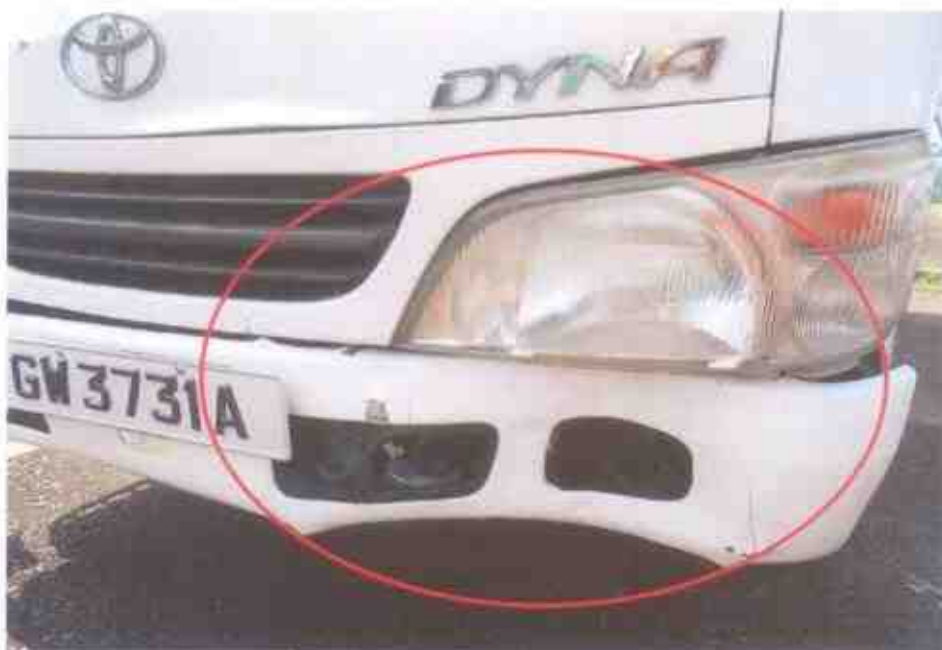
Photo 5 shows the left front lower bumper portion of the Motor Lorry. It was observed to have sustained damages as a result of the accidents.

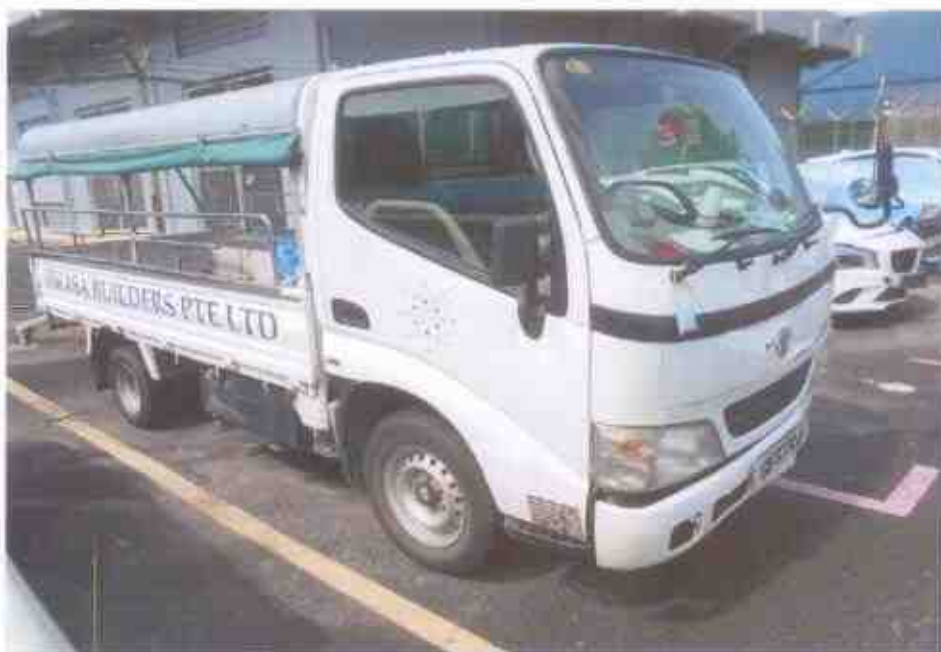
Photo 6 shows a general view of the front right portion of the Motor Lorry at the time of our inspection. The Motor Lorry was observed to be in good condition unaffected by the accident's impact.

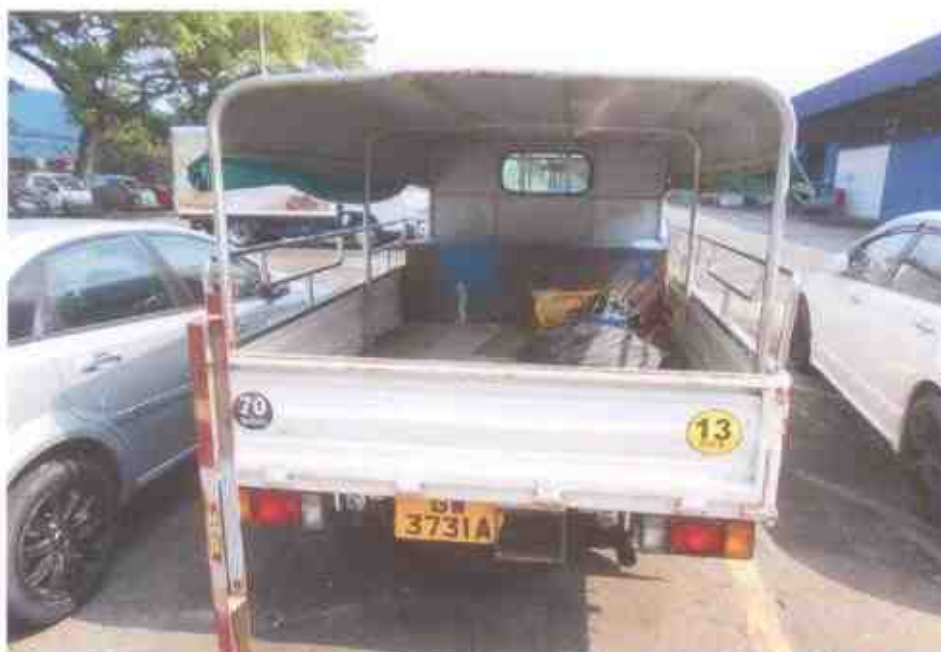
Photo 7 shows a general view of the Motor Lorry's rear body at the time of our inspection. There was no damage found to the rear portion of the Motor Lorry.

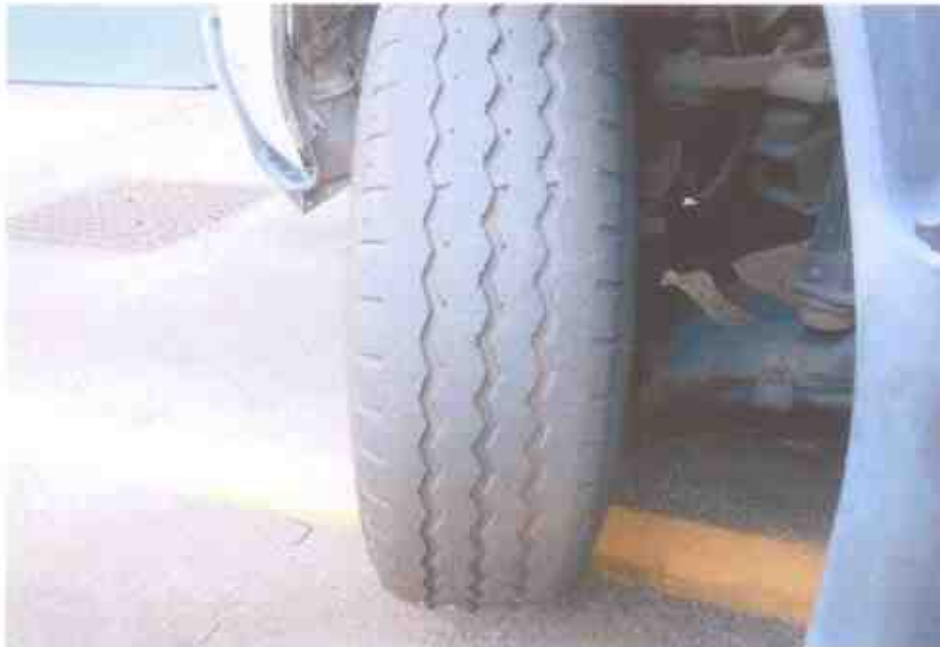
Photo 8 shows the condition of the front left tyre of the Motor Lorry, which was observed to be in serviceable condition with remaining tread depth of approximately 5mm. The tyre, which was wrapped around standard alloy wheel rim, was also observed to be sufficiently inflated for vehicular operation.

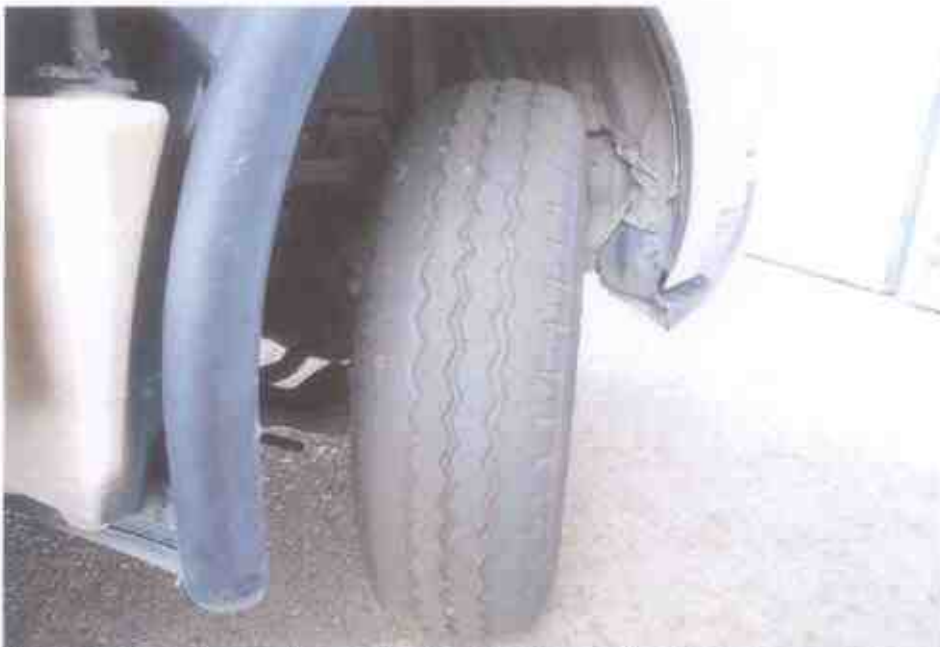
Photo 9 shows the condition of the front right tyre of the Motor Lorry, which was observed to be in serviceable condition with remaining tread depth of approximately 4mm. The tyre, which was wrapped around standard alloy wheel rim, was also observed to be sufficiently inflated for vehicular operation.

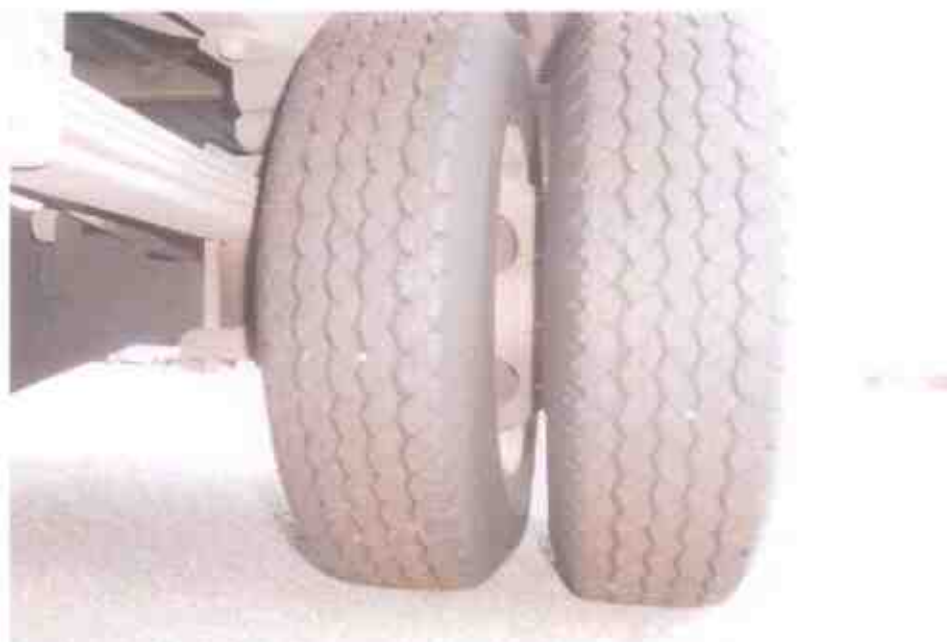
Photo 10 shows the condition of the rear left tyres of the Motor Lorry, which was observed to be in serviceable condition with remaining tread depth of approximately 5mm. The tyres, which were wrapped around standard alloy wheel rim, were also observed to be sufficiently inflated for vehicular operation,

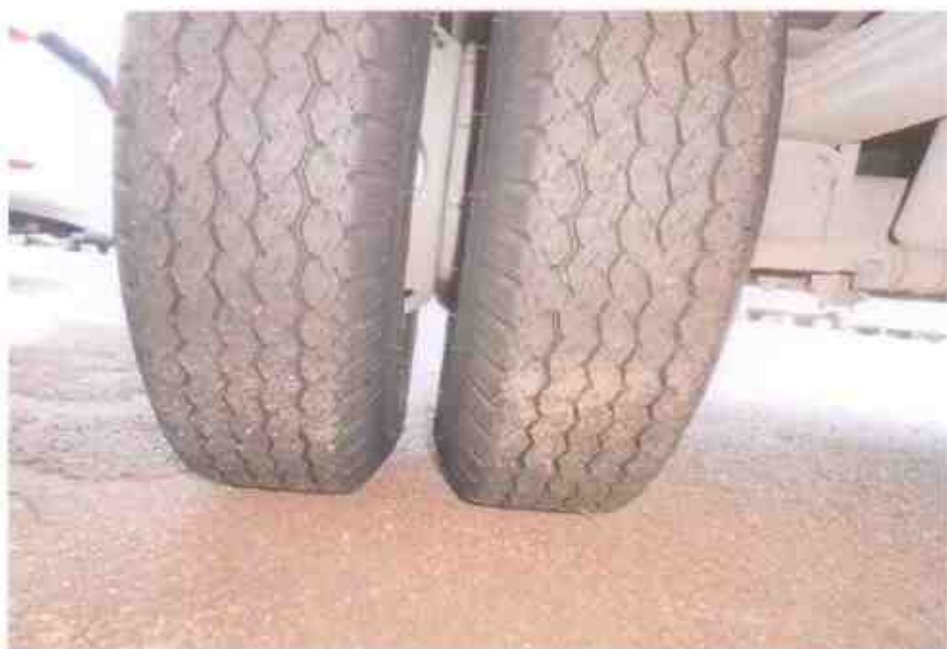
Photo 11 shows the condition of the rear right tyres of the Motor Lorry, which were observed to be in serviceable condition with remaining tread depth of approximately 5mm.

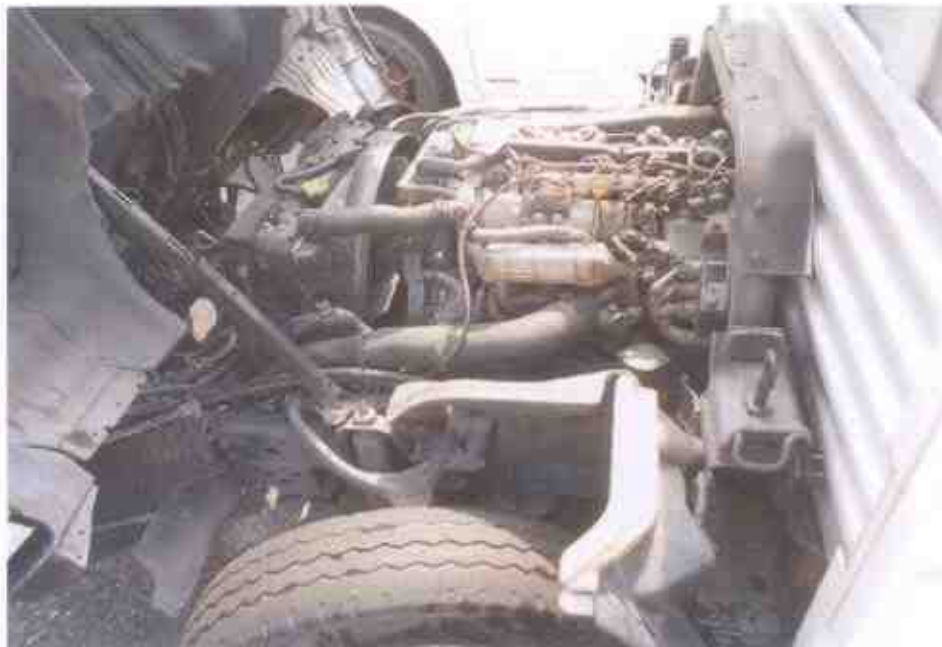
Photo 12 shows a general view of the Motor Lorry's engine compartment, which was accessed by lifting the front cabin of the Motor Lorry. The various parts and components inside the engine compartment were unaffected by the accident. There was also no sign(s) or indication(s) of fresh fluid leakage and/or fluid stain within the engine.

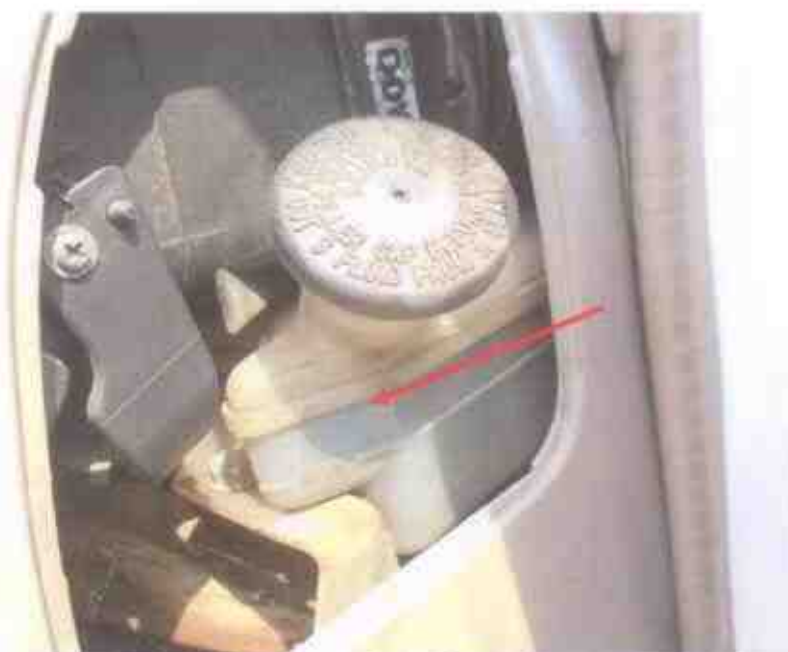
Photo 13 shows the brake fluid reservoir of the Motor Lorry at the time of our inspection. The brake fluid was observed to be of sufficient level and without any visible contamination (arrowed).

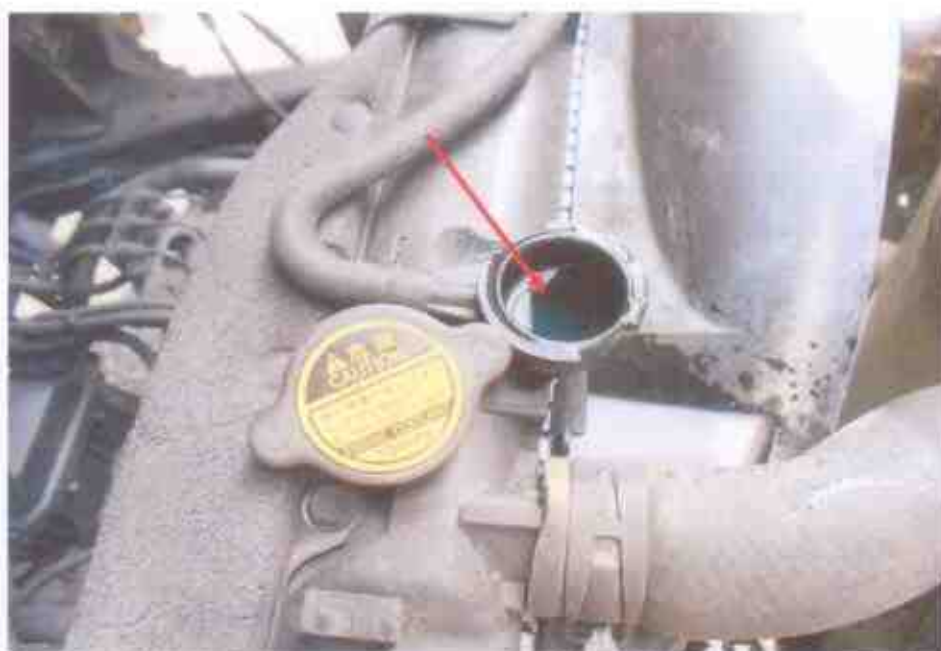
Photo 14 shows the engine coolant reservoir of the Motor Lorry at the time of our inspection. The engine coolant was observed to be of sufficient level and without any visible contamination (arrowed).

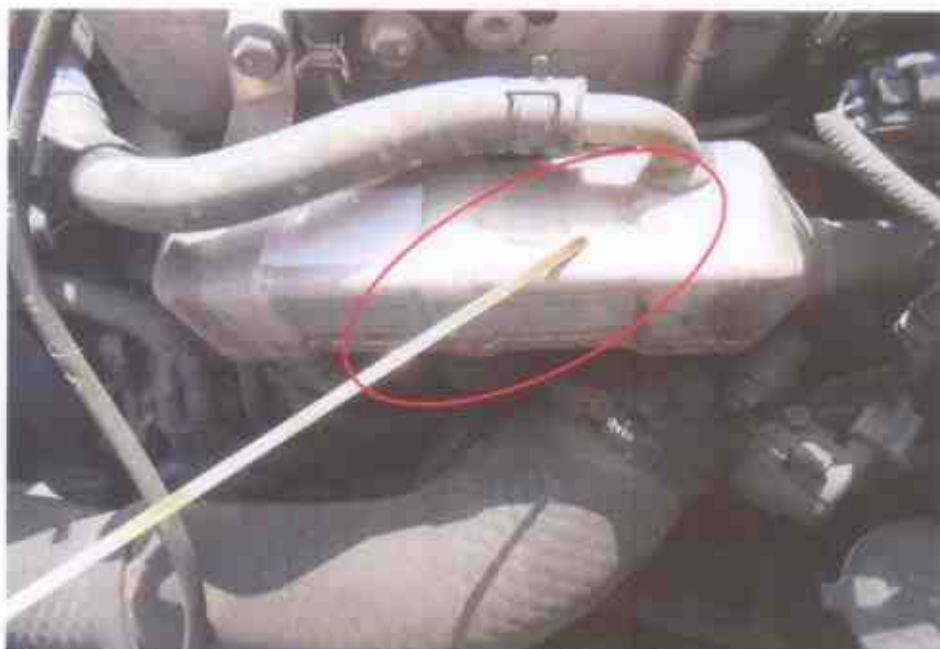
Photo 15 shows the engine dip stick of the Motor Lorry at the time of our inspection. The engine oil was observed to be of sufficient level and without any visible contamination (circled).

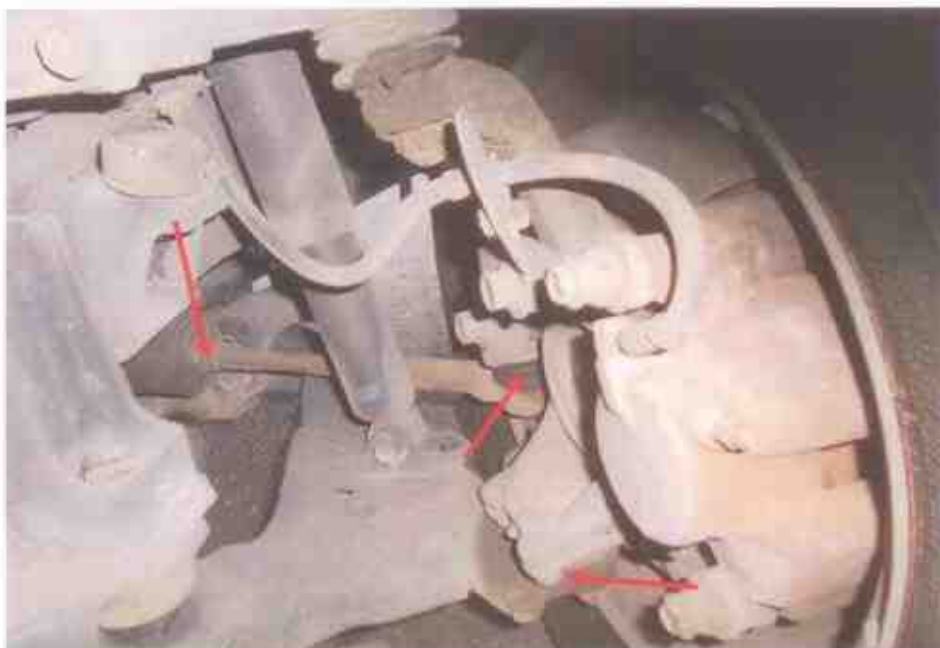
Photo 16 shows the various undercarriage components at the front left wheel of the Motor Lorry, in particular the steering tie rod end (arrowed). The various undercarriage components of the Motor Lorry were all found to be intact without any visible damage. There was also no sign of fluid stain(s) observed on the various undercarriage components.

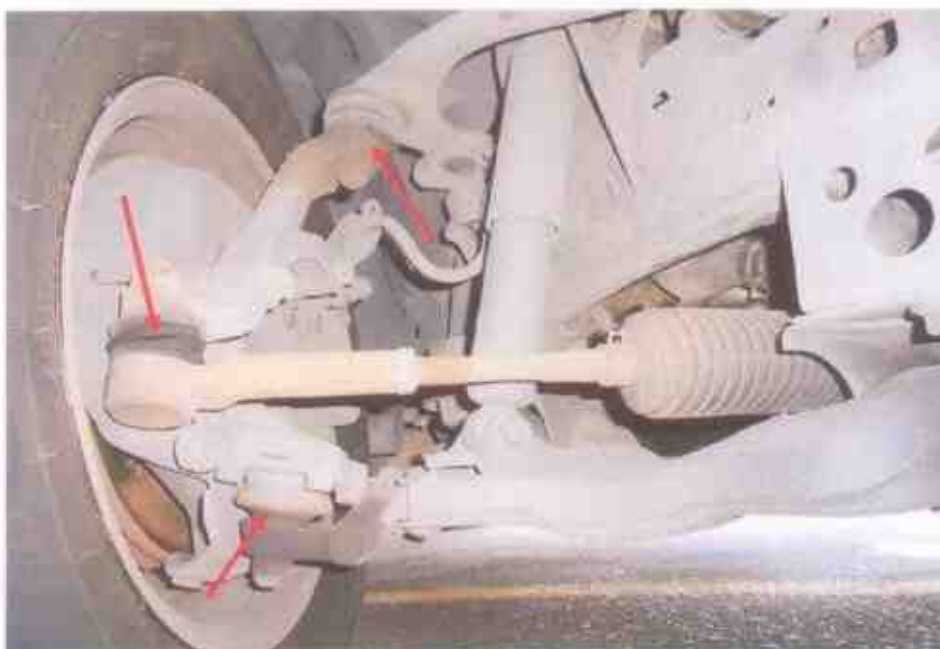
Photo 17 shows the various undercarriage components at the front right wheel of the Motor Lorry, in particular the steering tie rod end (arrowed). The various undercarriage components of the Motor Lorry were all found to be intact without any visible damage. There was also no sign of fluid stain(s) observed on the various undercarriage components.

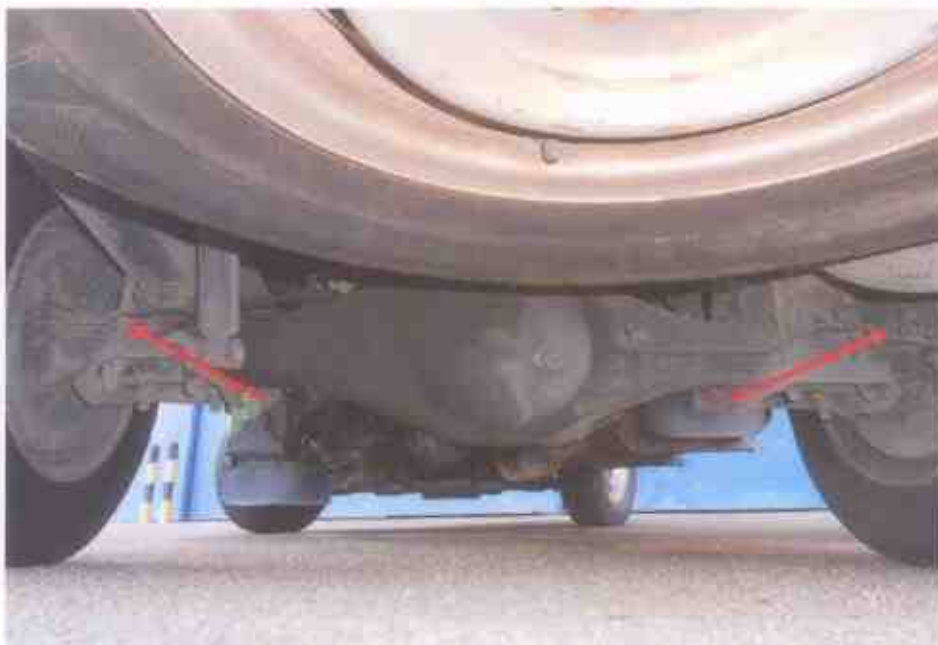
15. Checks on the brake shoes (brake pads) at the rear wheels of the Motor Lorry revealed that the brake shoes (brake pads) were in serviceable condition with sufficient frictional material for operational purposes. In general, our visual inspection of the mechanical components of the Motor Lorry's braking system appear to suggest that its braking system was in serviceable condition at the material time of accident. See photo 18 below.

Photo 18 shows the various undercarriage components at the rear wheels of the Motor Lorry. There was no sign(s) of brake fluid leakage along the brake hoses and brake pipes.

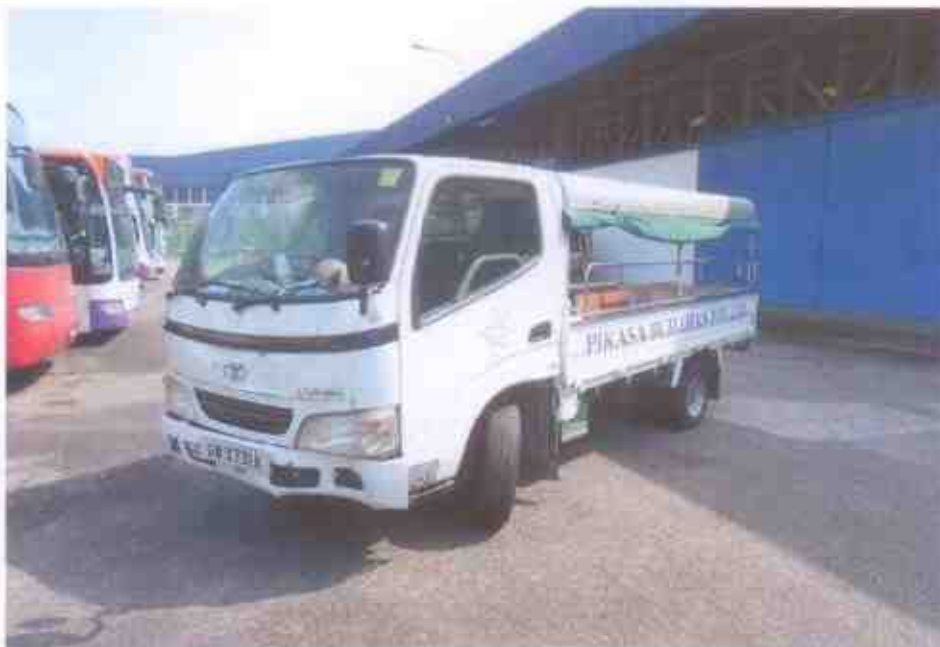
18. During the operational test, the various transmission gears of the Motor Lorry were able to be engaged without any difficulty by stepping on the clutch pedal and manually shifting the gear lever. There were no abnormal sound heard and/or abnormal behaviour of the Motor Lorry's engine system. It was able to move forward and backward normally. The braking system was also found to be in working condition as the Motor Lorry was able to slow down and come to a complete stop upon depressing of the brake pedal. See photo 19 below .

Photo 21 shows the operational test on the Motor Lorry. It was observed to be in serviceable condition. Operational test such as moving forward, turn left & right and also braking test on the Motor Lorry was conducted successfully.
