Your Ref: BMW 640i Cabriolet
(chassis number WBA6F12060D992548)
Our Ref : CI/TP18013821/D

30 July 2018

**INSPECTION REPORT OF AN UNREGISTERED BMW 640i CABRIOLET
MOTOR CAR WITH CHASSIS NUMBER WBA6F12060D992548**

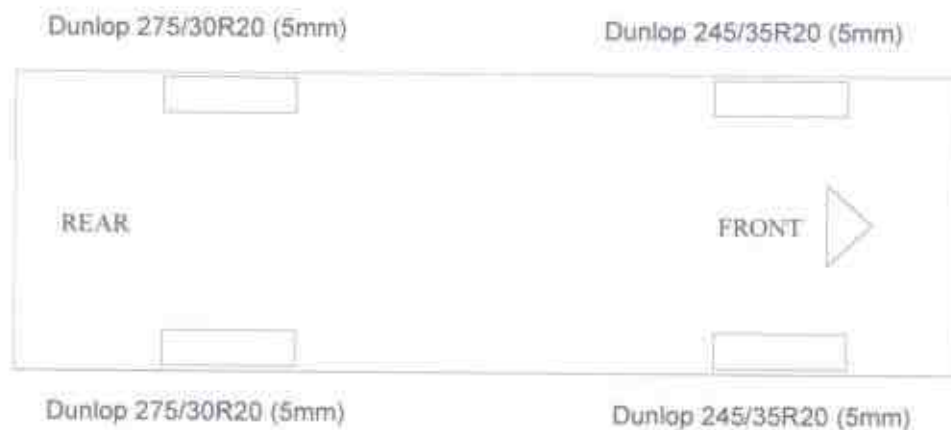
6. It was fitted with 20inch sport wheel rims that were wrapped with tyres that were observed to be of serviceable condition. The tyres were also sufficiently inflated for vehicular operation. The tyre brand, tyre size and approximate remaining tread depth of the 4 tyres of the Motor Car were recorded as follows: -

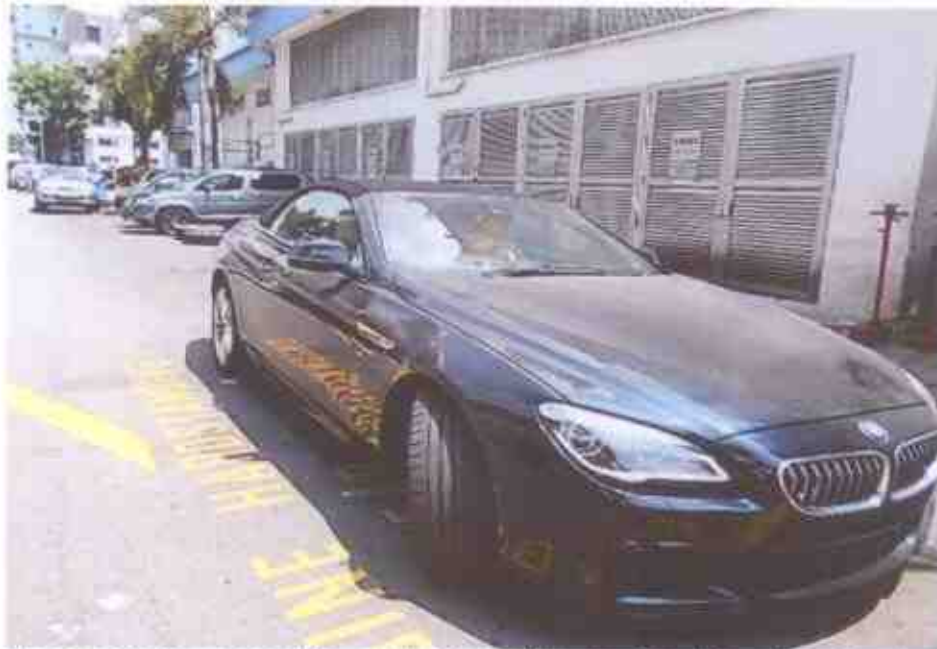
Photo 1 shows a general view of the front right body of the Motor Car at the time of my inspection. The Motor Car was observed to be in relatively good general condition with no loose exterior fittings observed.

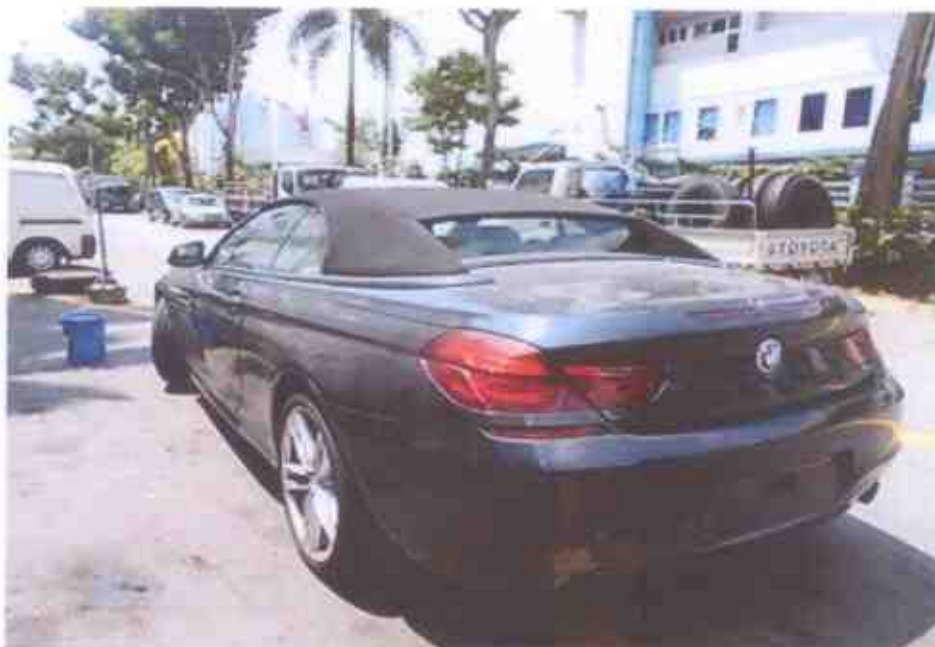
Photo 2 shows a general view of the rear left body of the Motor Car at the time of my inspection. The Motor Car was observed to be in relatively good general condition with no loose exterior fittings observed.

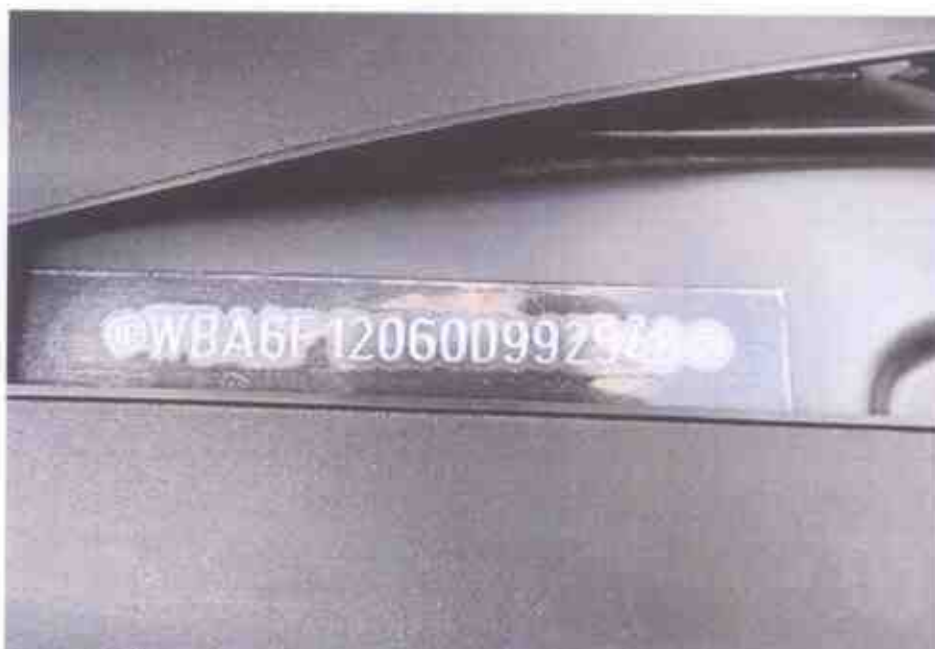
Photo 3 shows the chassis number of the Motor Car. The chassis number recorded was WBA6F12060D992548.

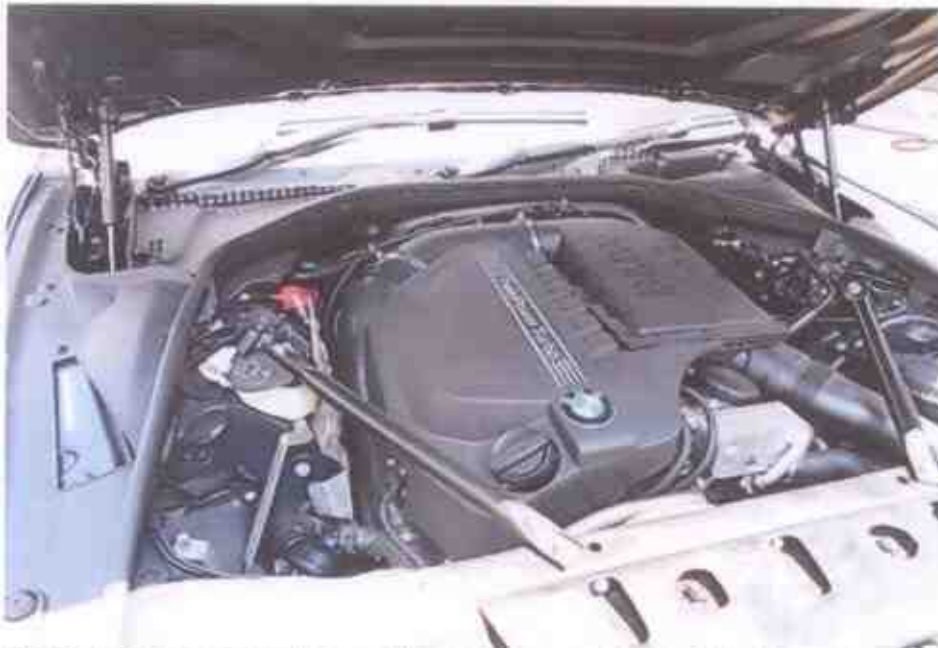
12. My examination of the engine compartment of the Motor Car revealed that the various parts and components inside the engine compartment were all intact and properly fitted. The engine oil, transmission fluid, brake fluid and engine coolant were all found to be of sufficient level for operating purposes. Visually, there was also no contamination found to these fluids.
13. My checks on the underside of the Motor Car revealed no sign(s) or indication(s) of fluid leakage and/or fluid stain(s). The engine block and automatic transmission assembly were both secured properly. They were not mounted onto the chassis body or any integral body part of the Motor Car. All undercarriage components of the Motor Car were also observed to be intact and secured in an appropriate manner.

Photo 4 shows a general view of the engine compartment of the Motor Car at the time of my inspection. The various parts and components inside the engine compartment were all observed to be intact and properly fitted. There was also no sign(s) or indication(s) of fluid leak and/or fluid stain found inside the engine compartment.

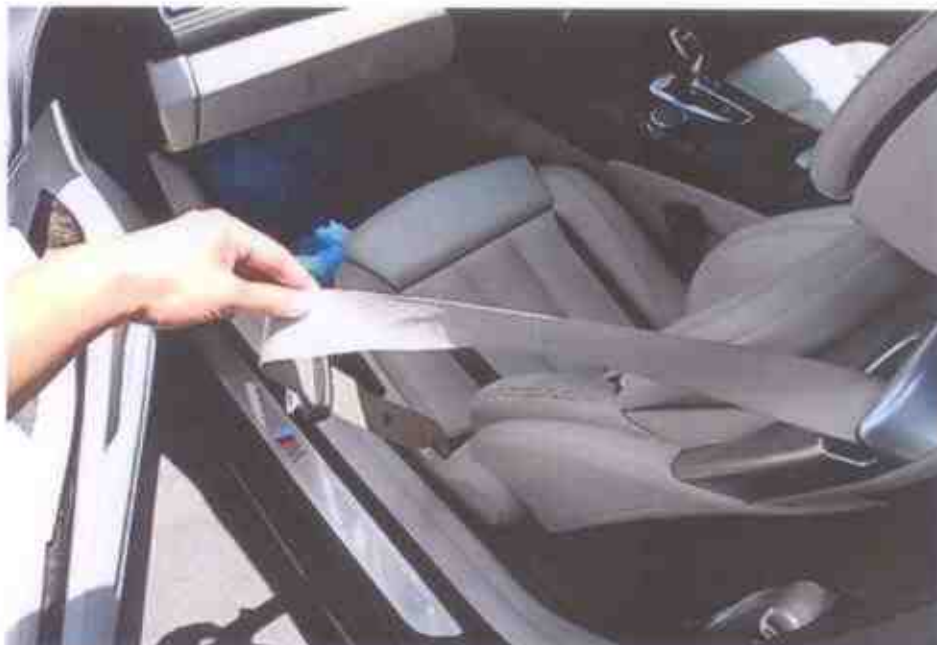
10. The seats of the Motor Car were found to be secured to the floor board of the Motor Car via seat rails bolted onto the floor board. Retractable seat belt reels and pre-tensioners were fitted on all seats of the Motor Car. The seat belt reels were able to be fastened securely to the respective pre-tensioner that is fixed to the side of all the seats.

Photo 5 shows the front left seat of the Motor Car, which were secured via seat rails to the floor board. All the seats of the Motor Car were fitted with a retractable seat belt reel and pre-tensioner. The seat belts were also able to be fastened to the pretension that were fitted on the side of each individual seat.

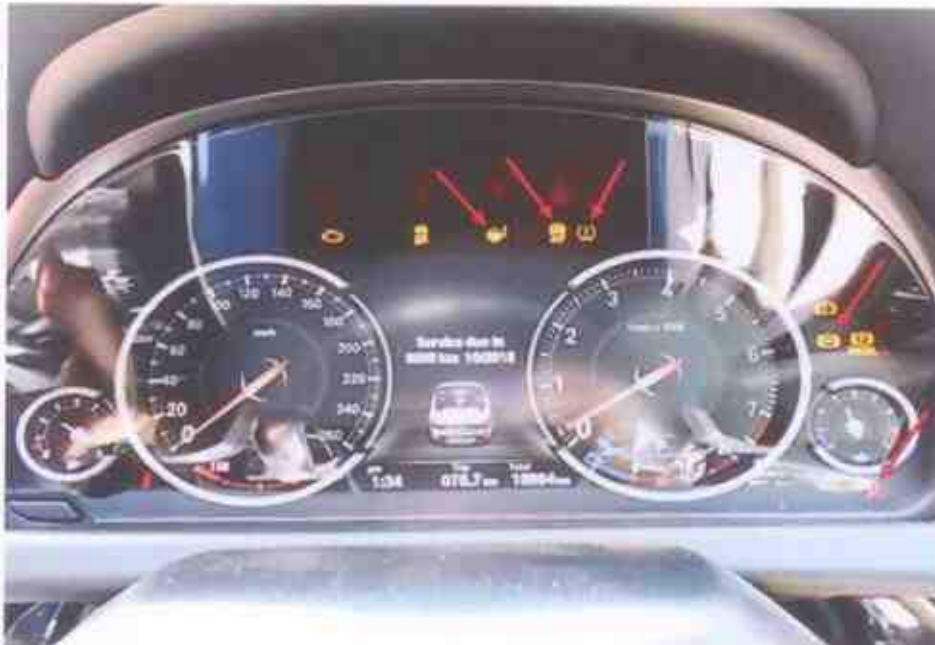
Photo 6 shows the warning lights for the various electronic safety features appearing on the instrument panel of the Motor Car during its self-test when the engine is cranked, in particular the ABS, SRS, IAS, TPM and DSC lights (arrowed).

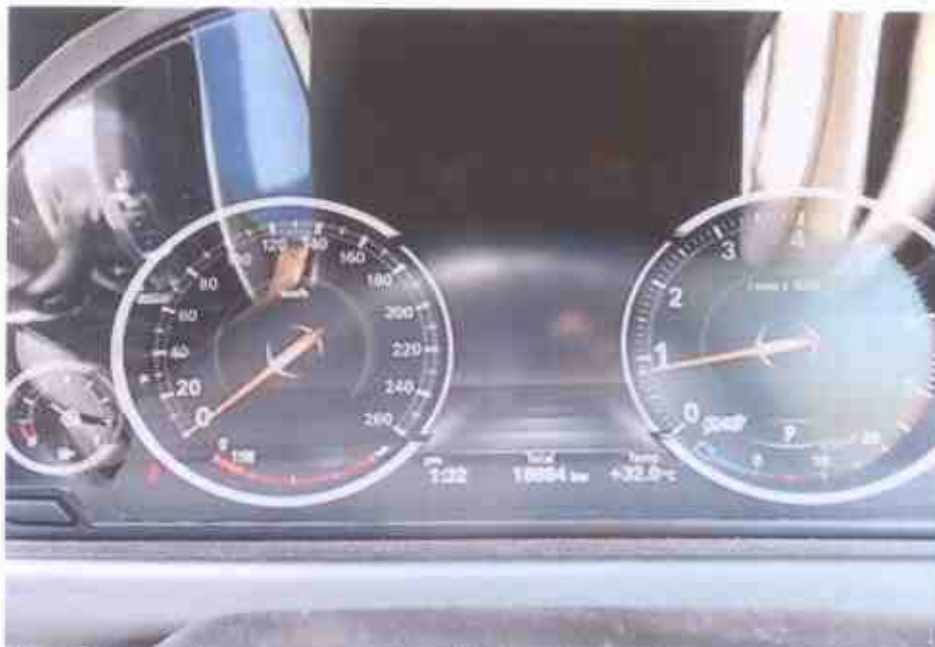
11. The Motor Car's automatic self-test of the functionality of its various electronic safety features like the Anti-Brake Lock System (ABS), Supplemental Restraint System (SRS), Integral Active Steering (IAS), Tyre Pressure Monitor (TPM) and Dynamic Stability Control (DSC) during cranking of the engine had indicated that these electronic systems were in working condition. This was determined from the respective warning lights disappearing from the instrument panel after the self-test.

Photo 7 shows the respective warning lights no longer illuminated, indicating that there is no fault detected to the ABS, SRS, IAS, TPM and DSC systems of the Motor Car during the self-test. These electronic systems were hence in working condition at the time of my inspection.

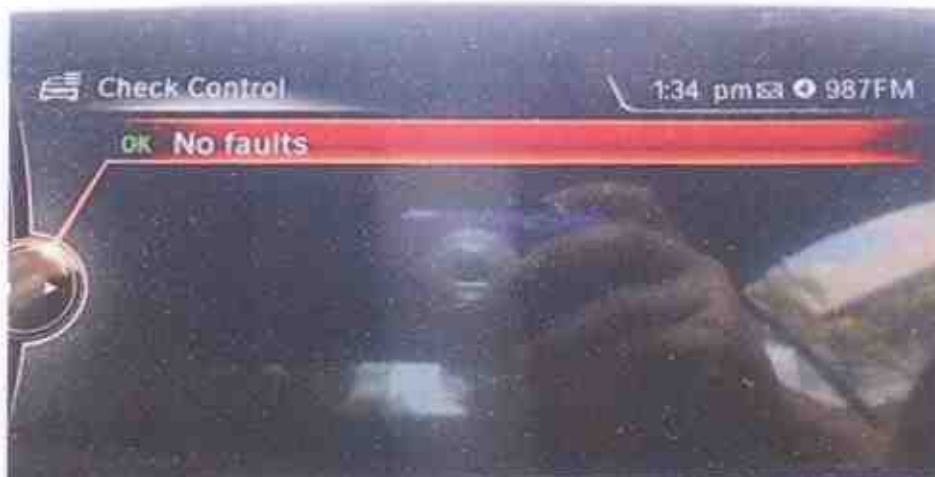
19. An on-board self-diagnostic check on the various controls of the Motor Car was initiated and at the end of the check, there was no fault(s) found.
20. The Motor Car's soft top (roof canopy) was also tested and it was observed that the soft top could open and close normally. The soft top was found adequately secured to the "A" Pillar after closing.

Photo 8 shows no fault(s) was detected to the various controls of the Motor Car after my initiation of the Motor Car's on-board self-diagnostic check.

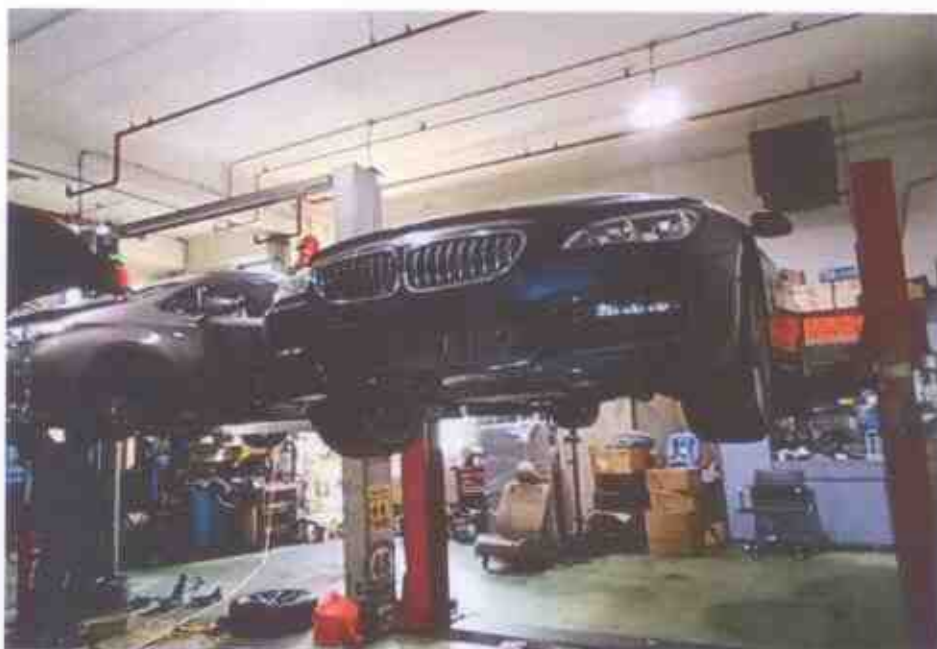
Photo 9 shows the Motor Car hoisted up for checks on its undercarriage. There was no sign(s) or indication(s) of fluid leakage and/or fluid stain(s). The undercarriage components of the Motor Car were also all observed to be intact and secured in an appropriate manner.

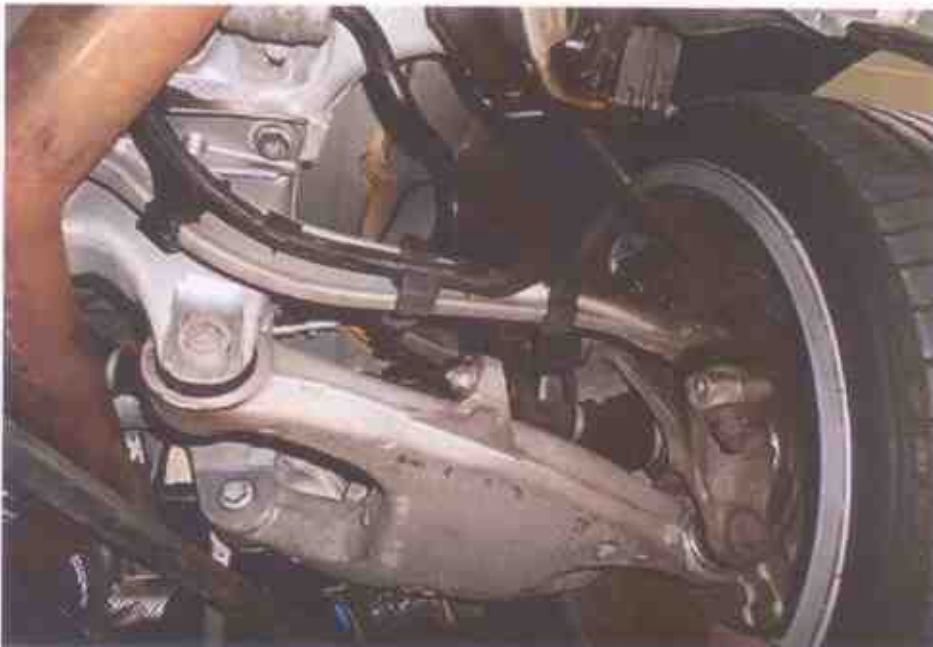
Photo 10 shows a general view of the control arms and linkages at the rear right wheel of the Motor Car. I did not observe any fluid leak and/or fluid stain on the underside of the Motor Car. All of the Motor Car's undercarriage components were observed to be intact and secured in an appropriate manner.

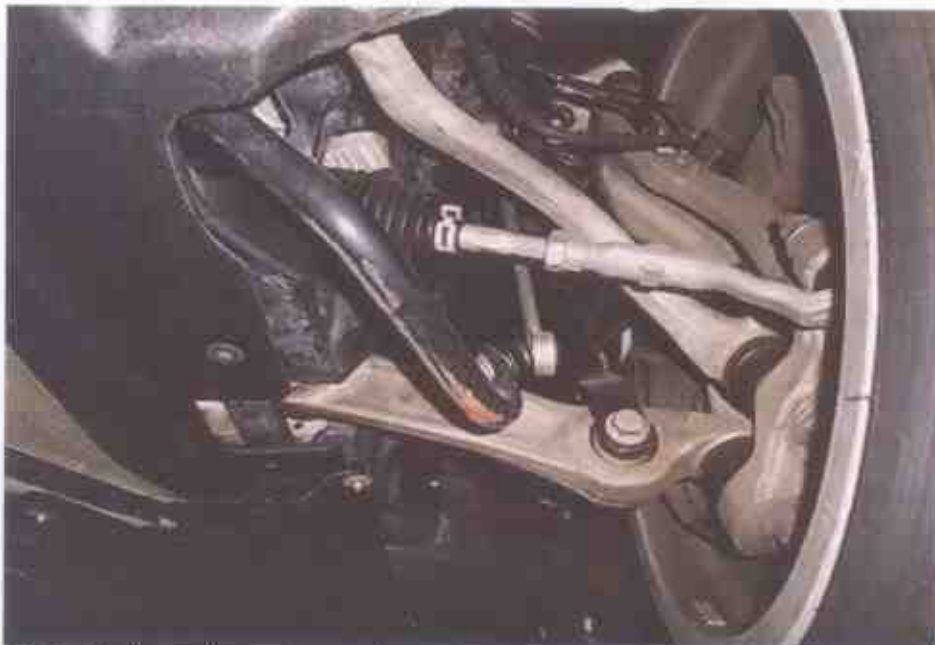
Photo 11 shows the various undercarriage components at the front left wheel of the Motor Car. The mechanical components, control arms and linkages were all found to be intact and secured in an appropriate manner.

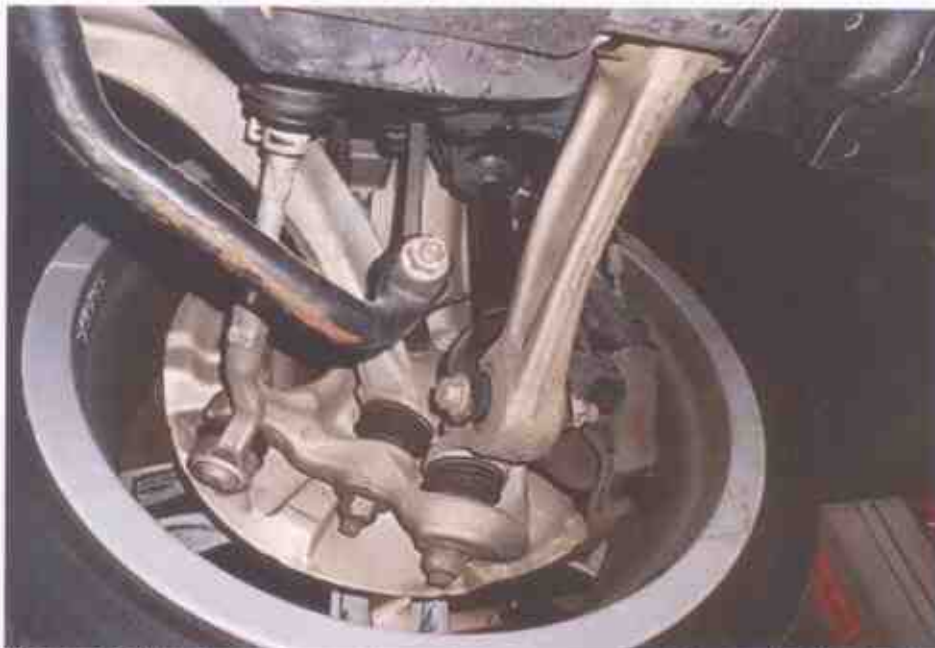
Photo 12 shows the various undercarriage components at the front right wheel of the Motor Car. The mechanical components, control arms and linkages were all found to be intact and secured in an appropriate manner.

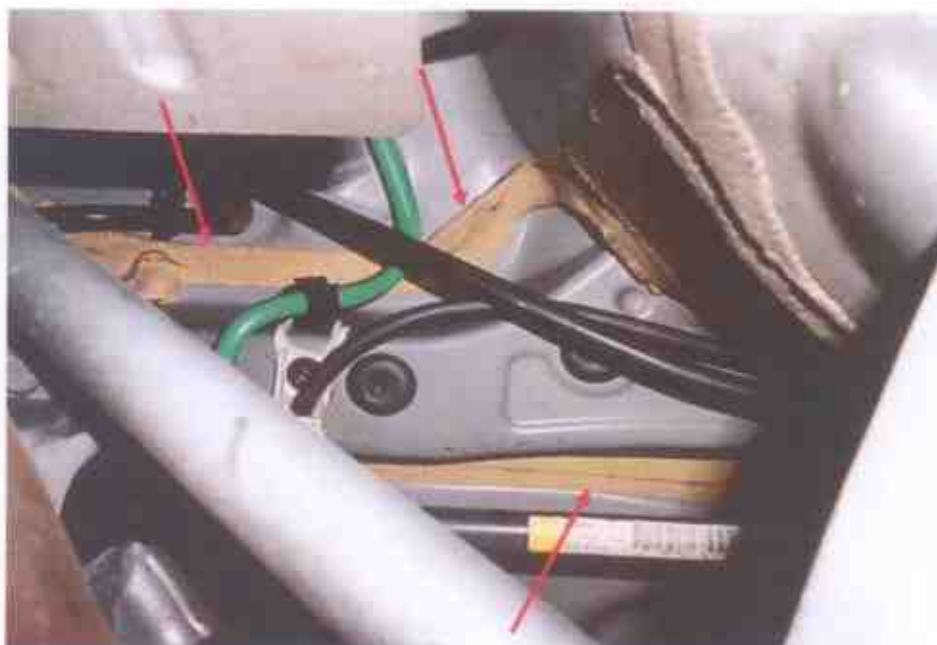
9. Visually, I did not find any weld marks, other than the original spot weld marks, on the chassis body of the Motor Car. The original factory sealant at the joints along the chassis body was also untouched, again indicating that no replacement of the chassis body was carried out; and that the chassis body was originally fitted.

Photo 13 shows the structural body at the left rear of the Motor Car. Visually, I did not find any weld marks other than original spot weld marks on the chassis body of the Motor Car. The joints (arrowed) along the chassis body was also untouched, indicating no work was done on the chassis body of the Motor Car and that the chassis body was originally fitted.

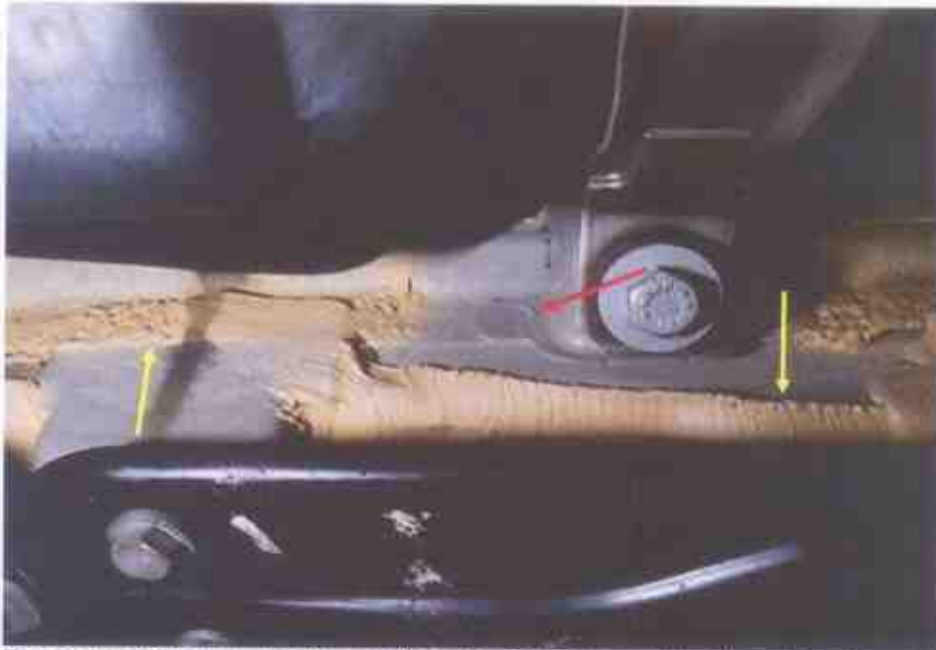
Photo 14 shows the structural body at the right centre of the Motor Car. Visually, I did not find any weld marks other than original spot weld marks (red arrow) on the chassis of the Motor Car. The joints (yellow arrow) along the chassis body was also untouched, indicating no work was done on the chassis body of the Motor Car and that the chassis body was originally fitted.

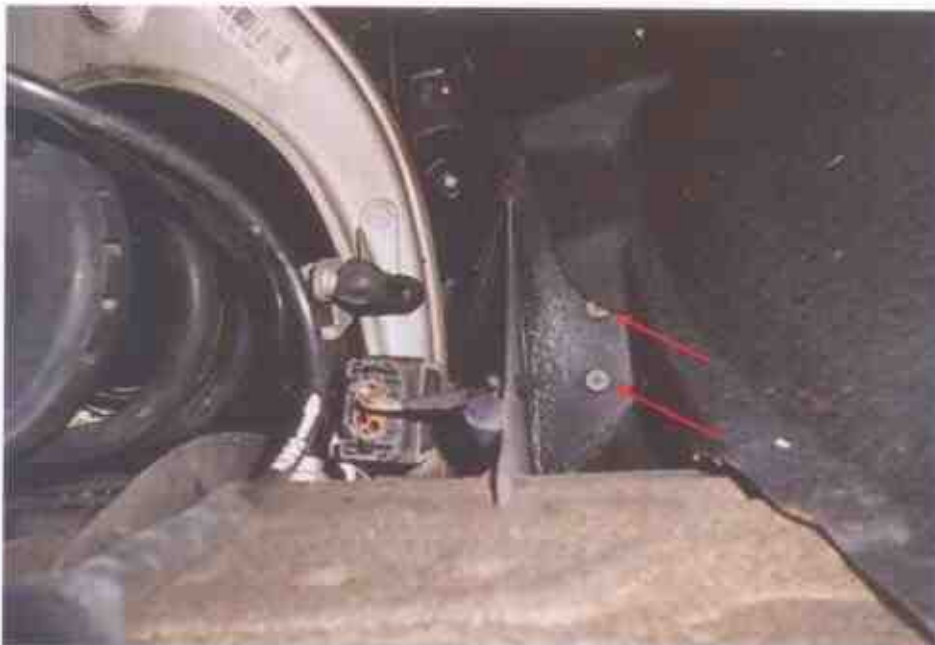
Photo 15 shows the structural body at the front left of the Motor Car. Visually, I did not find any weld marks other than original spot weld marks (arrowed) on the chassis of the Motor Car, indicating no work was done on the chassis body of the Motor Car and that the chassis body was originally fitted.

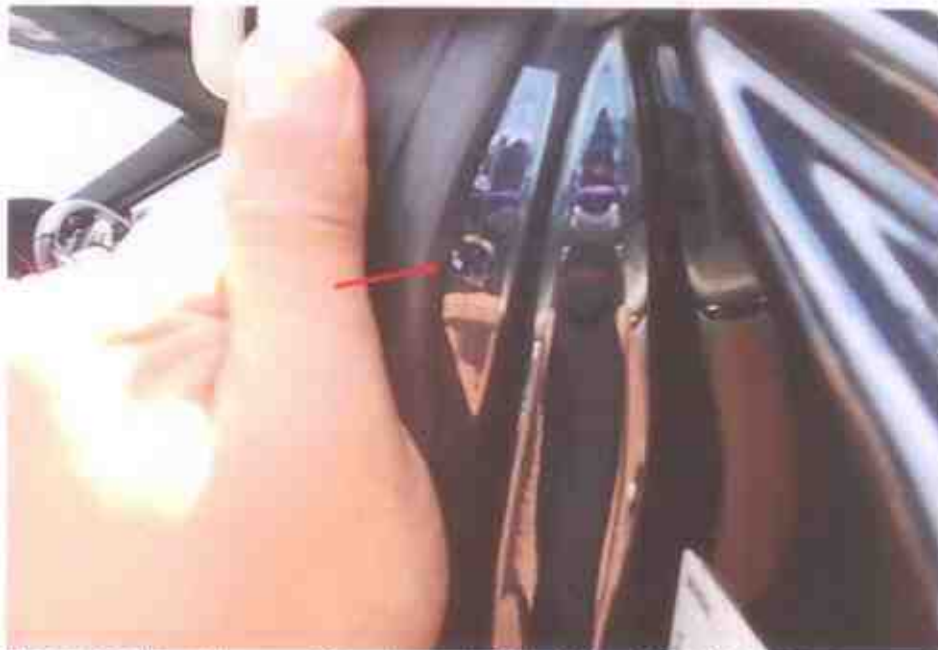
Photo 16 shows the rear left body panel of the Motor Car. I did not find any weld marks other than original spot weld marks (arrowed) on the body panels of the Motor Car, indicating that there was no re-welding works carried out; and that the body panels of the Motor Car were originally fitted
