Your Ref: BMW 640i Cabriolet
(chassis number WBA6F12060D992548)
Our Ref : CI/TP18013821/D

30 July 2018

**INSPECTION REPORT OF AN UNREGISTERD BMW 640i CABRIOLET
MOTOR CAR WITH CHASSIS NUMBER WBA6F12060D992548**

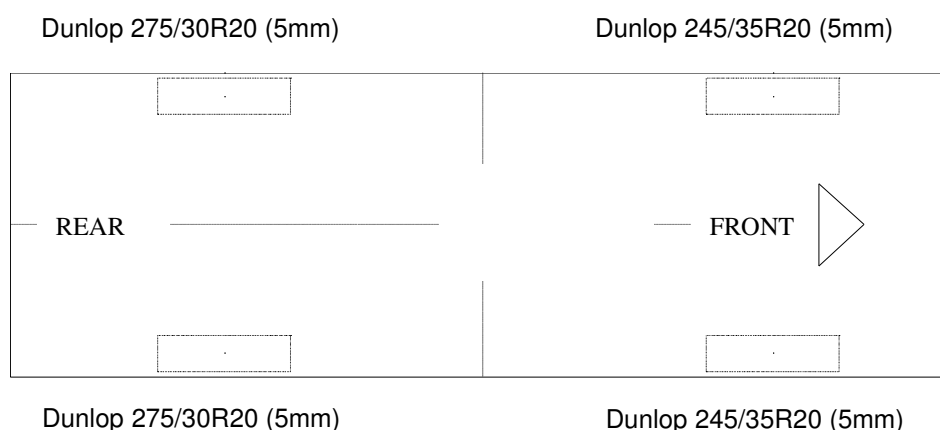
6. It was fitted with 20inch sport wheel rims that were wrapped with tyres that were observed to be of serviceable condition. The tyres were also sufficiently inflated for vehicular operation. The tyre brand, tyre size and approximate remaining tread depth of the 4 tyres of the Motor Car were recorded as follows: -

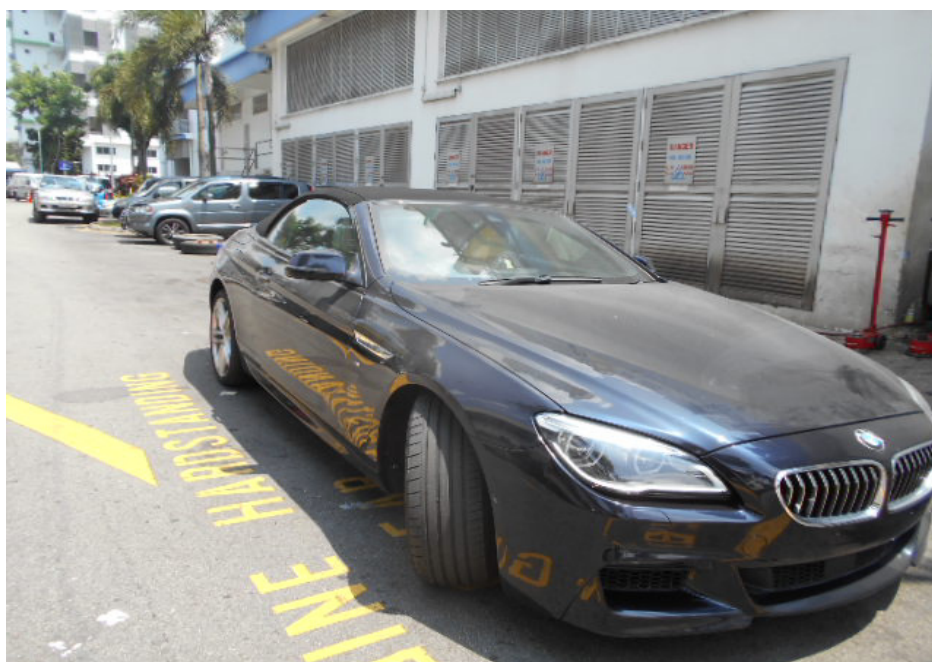
Photo 1 shows a general view of the front right body of the Motor Car at the time of my inspection. The Motor Car was observed to be in relatively good general condition with no loose exterior fittings observed.

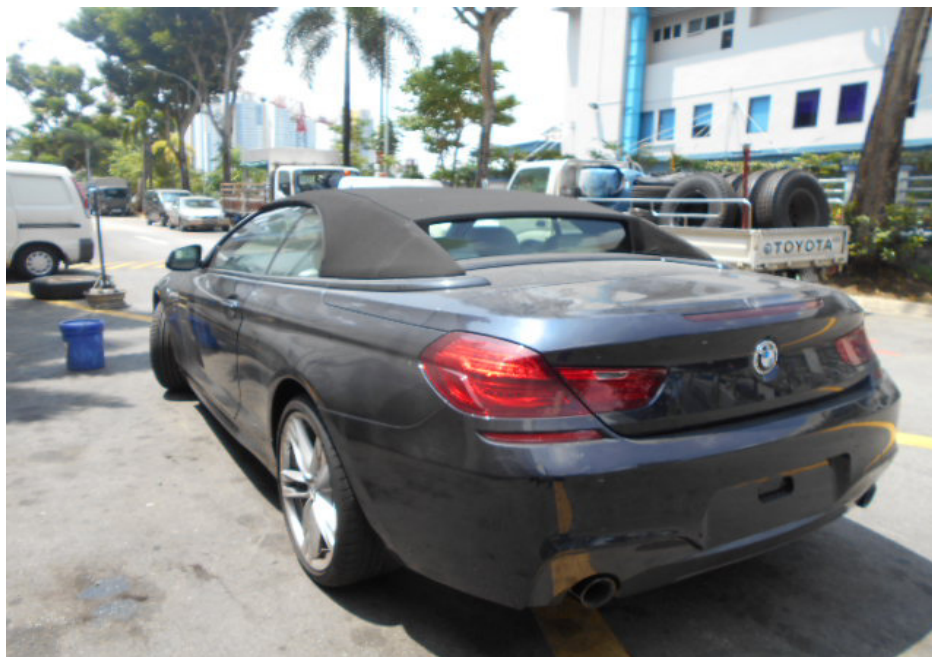
Photo 2 shows a general view of the rear left body of the Motor Car at the time of my inspection. The Motor Car was observed to be in relatively good general condition with no loose exterior fittings observed.

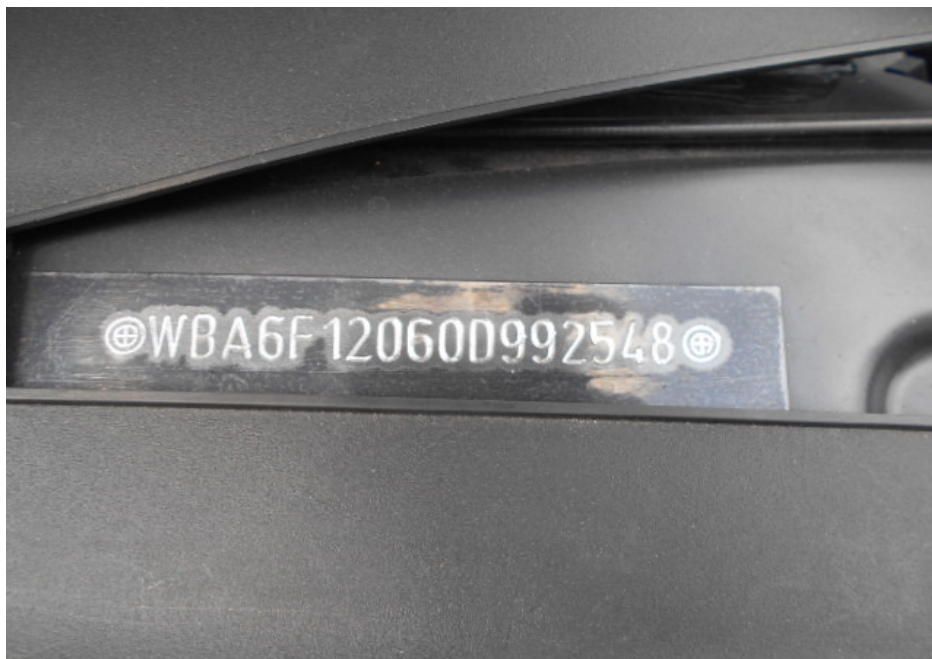
Photo 3 shows the chassis number of the Motor Car. The chassis number recorded was WBA6F12060D992548.

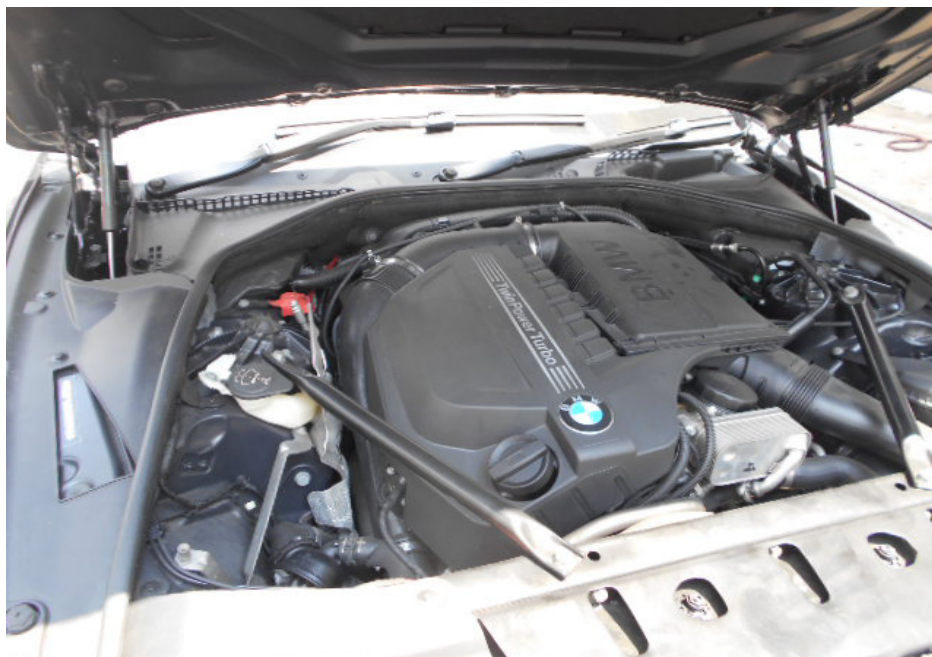
12. My examination of the engine compartment of the Motor Car revealed that the various parts and components inside the engine compartment were all intact and properly fitted. The engine oil, transmission fluid, brake fluid and engine coolant were all found to be of sufficient level for operating purposes. Visually, there was also no contamination found to these fluids.
13. My checks on the underside of the Motor Car revealed no sign(s) or indication(s) of fluid leakage and/or fluid stain(s). The engine block and automatic transmission assembly were both secured properly. They were not mounted onto the chassis body or any integral body part of the Motor Car. All undercarriage components of the Motor Car were also observed to be intact and secured in an appropriate manner.

Photo 4 shows a general view of the engine compartment of the Motor Car at the time of my inspection. The various parts and components inside the engine compartment were all observed to be intact and properly fitted. There was also no sign(s) or indication(s) of fluid leak and/or fluid stain found inside the engine compartment.

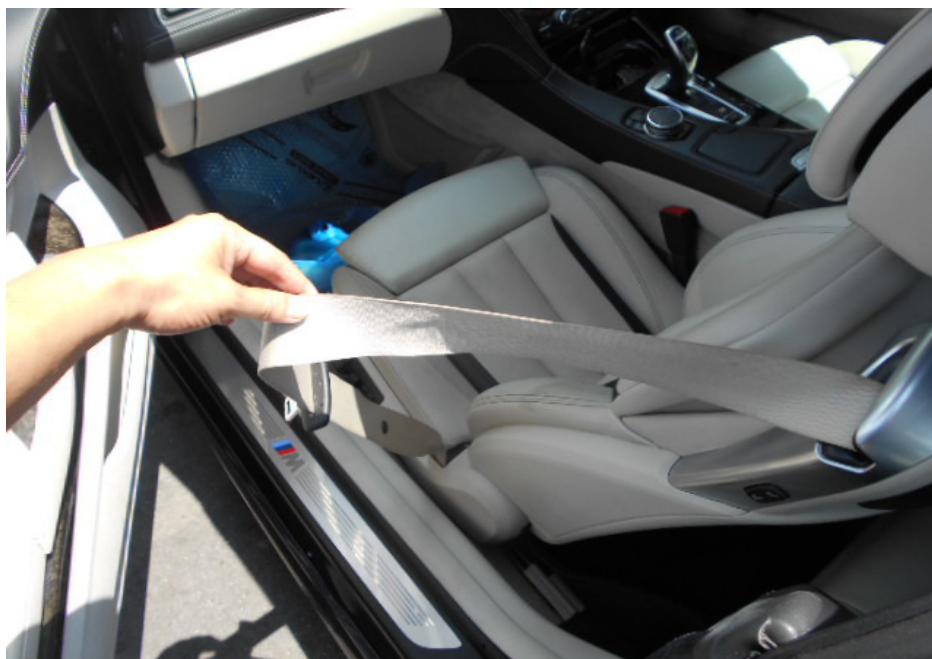
10. The seats of the Motor Car were found to be secured to the floor board of the Motor Car via seat rails bolted onto the floor board. Retractable seat belt reels and pre-tensioners were fitted on all seats of the Motor Car. The seat belt reels were able to be fastened securely to the respective pre-tensioner that is fixed to the side of all the seats.

Photo 5 shows the front left seat of the Motor Car, which were secured via seat rails to the floor board. All the seats of the Motor Car were fitted with a retractable seat belt reel and pre-tensioner. The seat belts were also able to be fastened to the pretension that were fitted on the side of each individual seat.

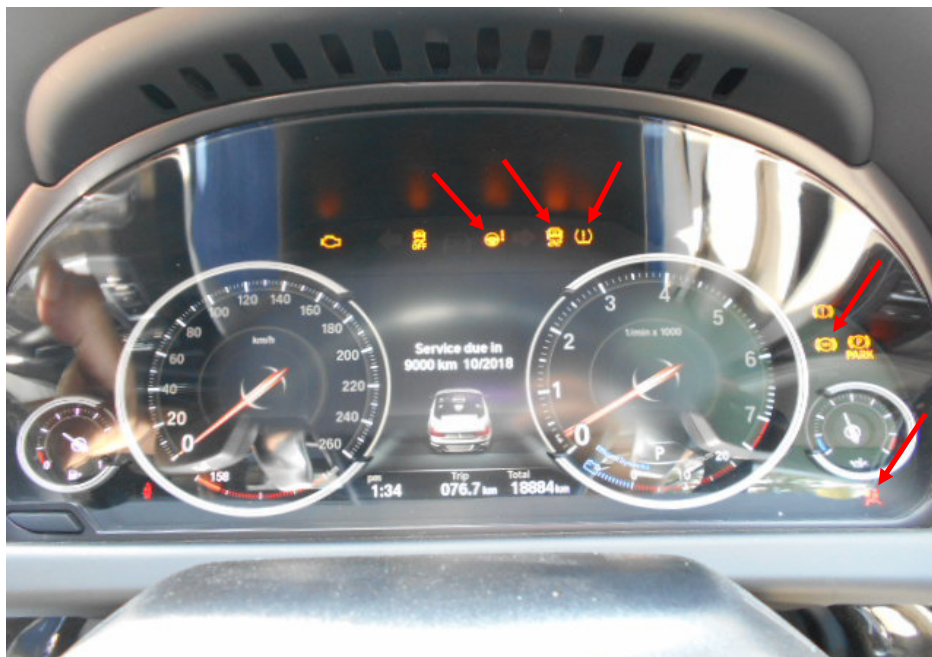
Photo 6 shows the warning lights for the various electronic safety features appearing on the instrument panel of the Motor Car during its self-test when the engine is cranked, in particular the ABS, SRS, IAS, TPM and DSC lights (arrowed).

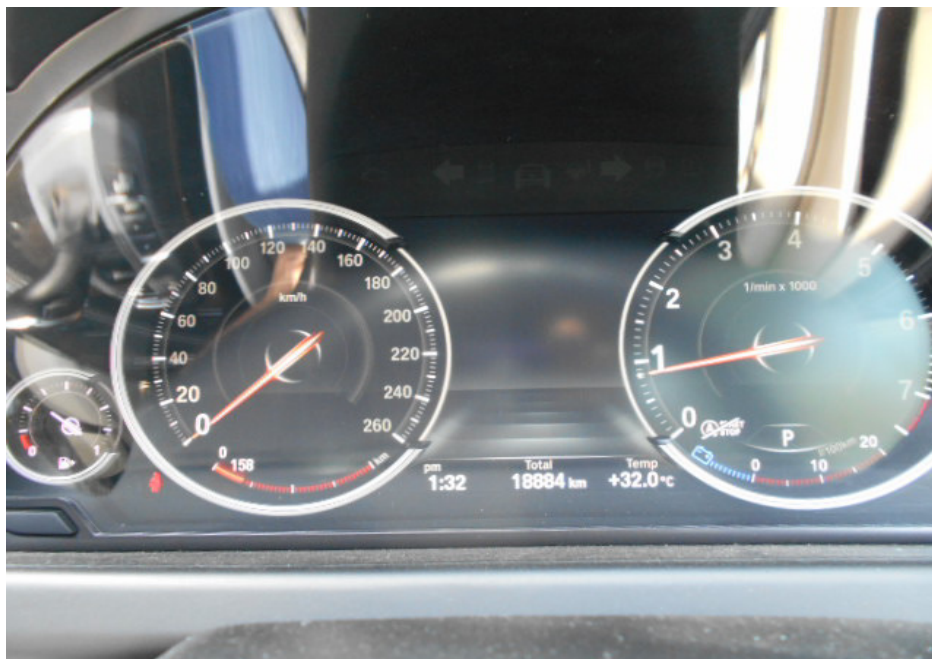
11. The Motor Car's automatic self-test of the functionality of its various electronic safety features like the Anti-Brake Lock System (ABS), Supplemental Restraint System (SRS), Integral Active Steering (IAS), Tyre Pressure Monitor (TPM) and Dynamic Stability Control (DSC) during cranking of the engine had indicated that these electronic systems were in working condition. This was determined from the respective warning lights disappearing from the instrument panel after the self-test.

Photo 7 shows the respective warning lights no longer illuminated, indicating that there is no fault detected to the ABS, SRS, IAS, TPM and DSC systems of the Motor Car during the self-test. These electronic systems were hence in working condition at the time of my inspection.

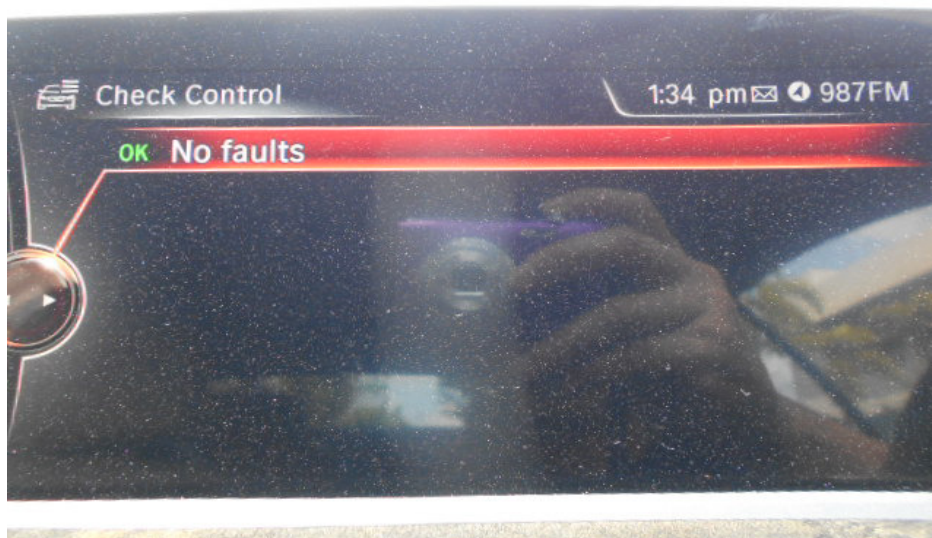
19. An on-board self-diagnostic check on the various controls of the Motor Car was initiated and at the end of the check, there was no fault(s) found.
20. The Motor Car's soft top (roof canopy) was also tested and it was observed that the soft top could open and close normally. The soft top was found adequately secured to the "A" Pillar after closing.

Photo 8 shows no fault(s) was detected to the various controls of the Motor Car after my initiation of the Motor Car's on-board self-diagnostic check.

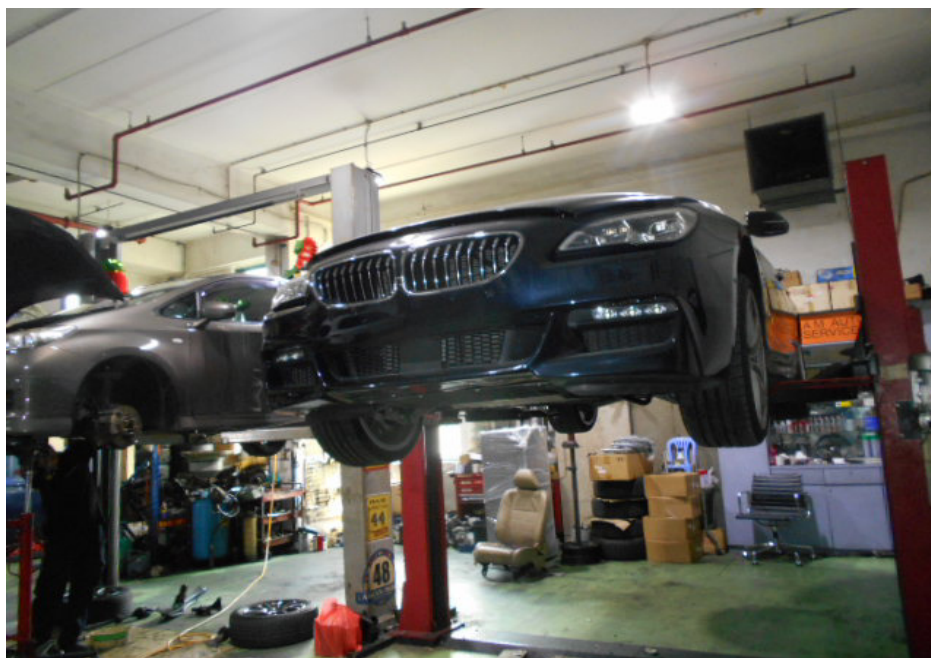
Photo 9 shows the Motor Car hoisted up for checks on its undercarriage. There was no sign(s) or indication(s) of fluid leakage and/or fluid stain(s). The undercarriage components of the Motor Car were also all observed to be intact and secured in an appropriate manner.

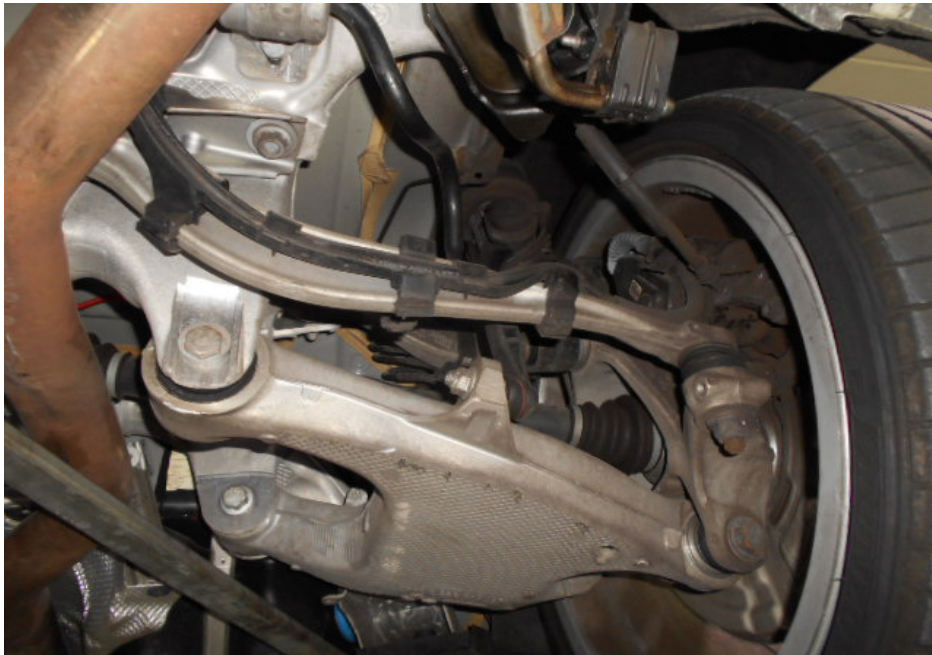
Photo 10 shows a general view of the control arms and linkages at the rear right wheel of the Motor Car. I did not observe any fluid leak and/or fluid stain on the underside of the Motor Car. All of the Motor Car's undercarriage components were observed to be intact and secured in an appropriate manner.

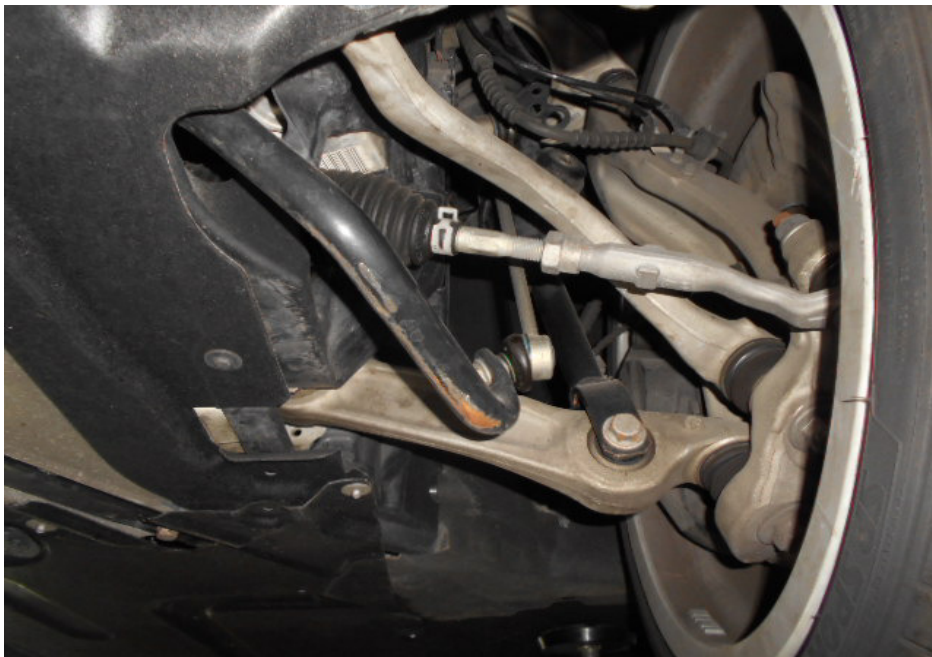
Photo 11 shows the various undercarriage components at the front left wheel of the Motor Car. The mechanical components, control arms and linkages were all found to be intact and secured in an appropriate manner.

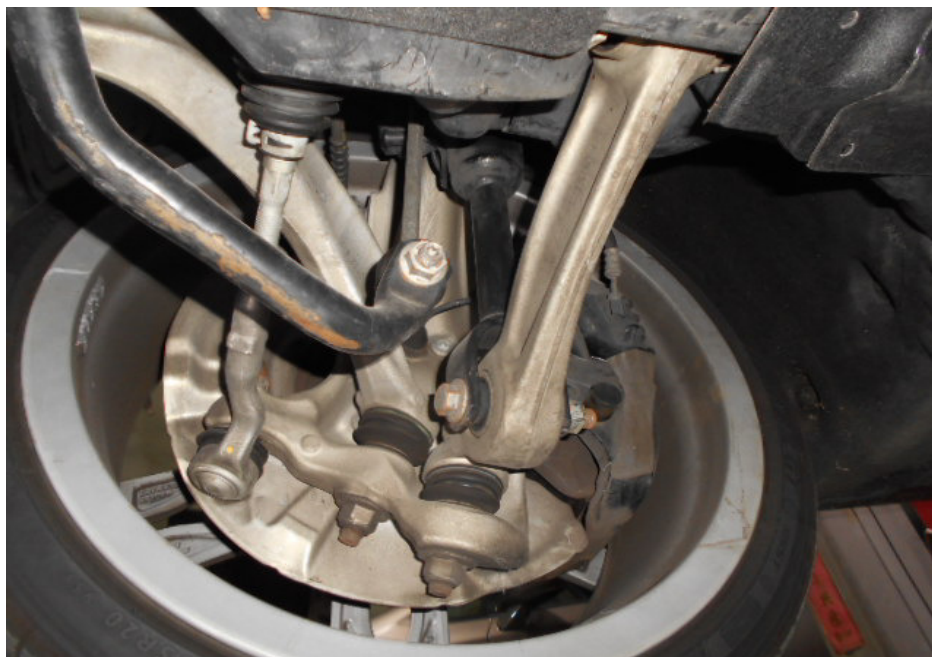
Photo 12 shows the various undercarriage components at the front right wheel of the Motor Car. The mechanical components, control arms and linkages were all found to be intact and secured in an appropriate manner.

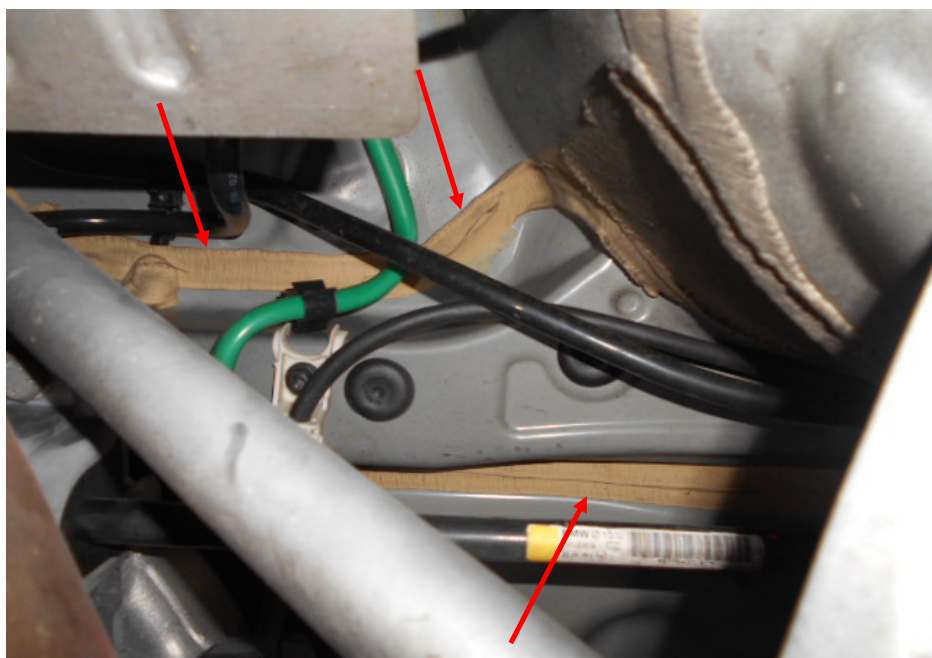
9. Visually, I did not find any weld marks, other than the original spot weld marks, on the chassis body of the Motor Car. The original factory sealant at the joints along the chassis body was also untouched, again indicating that no replacement of the chassis body was carried out; and that the chassis body was originally fitted.

Photo 13 shows the structural body at the left rear of the Motor Car. Visually, I did not find any weld marks other than original spot weld marks on the chassis body of the Motor Car. The joints (arrowed) along the chassis body was also untouched, indicating no work was done on the chassis body of the Motor Car and that the chassis body was originally fitted.

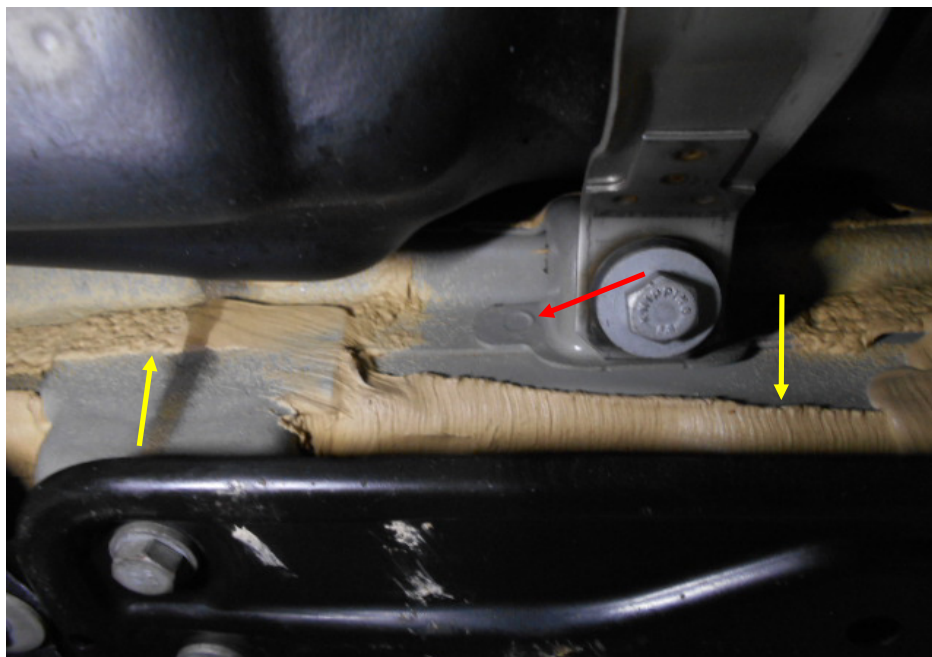
Photo 14 shows the structural body at the right centre of the Motor Car. Visually, I did not find any weld marks other than original spot weld marks (red arrow) on the chassis of the Motor Car. The joints (yellow arrow) along the chassis body was also untouched, indicating no work was done on the chassis body of the Motor Car and that the chassis body was originally fitted.

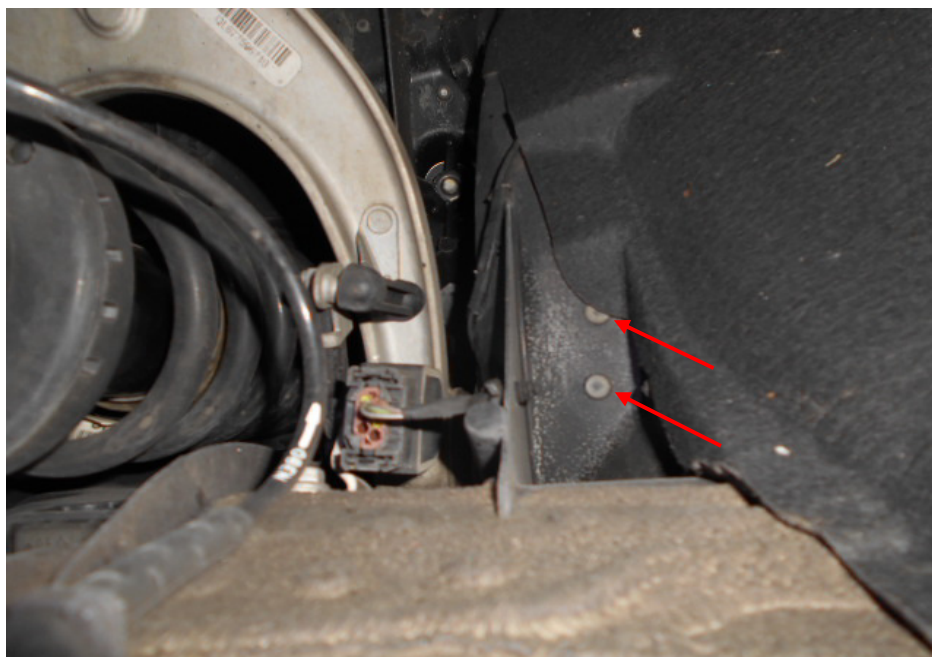
Photo 15 shows the structural body at the front left of the Motor Car. Visually, I did not find any weld marks other than original spot weld marks (arrowed) on the chassis of the Motor Car, indicating no work was done on the chassis body of the Motor Car and that the chassis body was originally fitted.

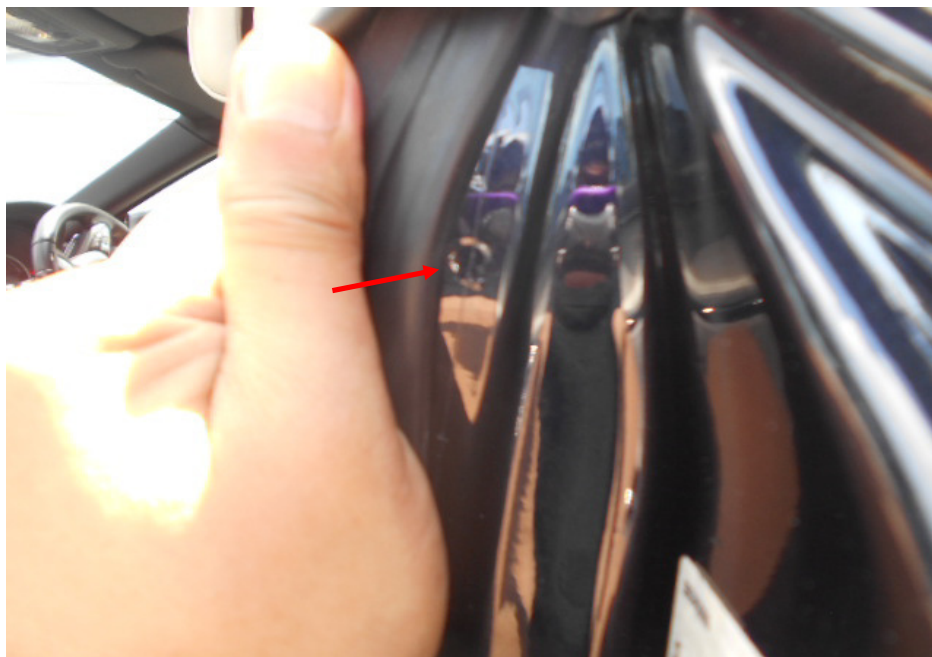
7. The detachable body panels of the Motor Car like the front fenders, front bumper, rear bumper, doors, bonnet and tailgate amongst others were all found to be fitted securely.
8. Checks on the non-detachable body panels like the rear fenders, floor board, roof panel, pillars and rocker panels amongst others, revealed that these body panels were spot welded onto the structure body of the Motor Car. The original factory sealant at the joints of the non-detachable body panels was all untouched indicating no replacement of the non-detachable body panels was carried out; and that these body panels were all originally fitted.

Photo 16 shows the rear left body panel of the Motor Car. I did not find any weld marks other than original spot weld marks (arrowed) on the body panels of the Motor Car, indicating that there was no re-welding works carried out; and that the body panels of the Motor Car were originally fitted
