Your Ref: Audi TT Coupe
(chassis number TRUZZZV6H1007874)

30 July 2018

Our Ref : CI/TP18013823/D

INSPECTION REPORT OF AN UNREGISTERD AUDI TT COUPE MOTOR CAR WITH CHASSIS NUMBER TRUZZZV6H1007874

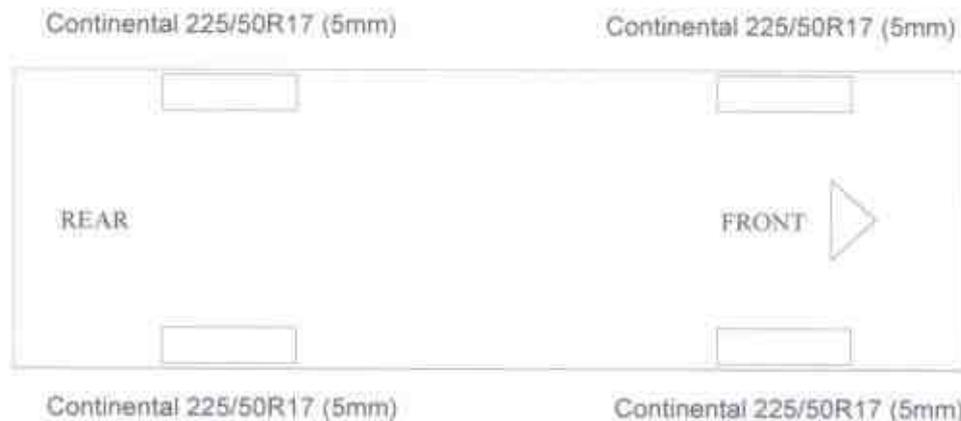
6. It was fitted with 17inch sport wheel rims that were wrapped with tyres that were observed to be of serviceable condition. The tyres were also sufficiently inflated for vehicular operation. The tyre brand, tyre size and approximate remaining tread depth of the 4 tyres of the Motor Car were recorded as follows: -

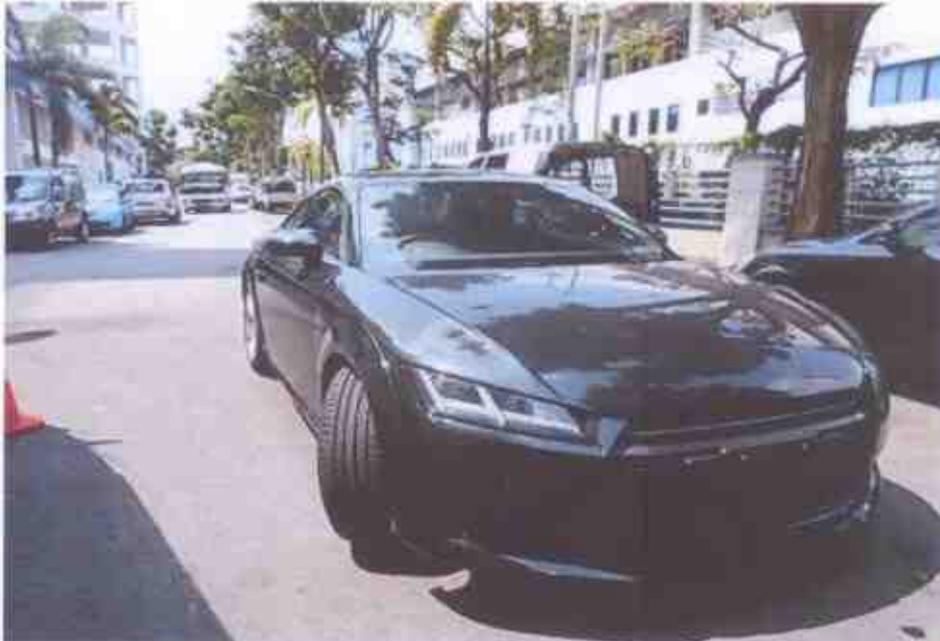
Photo 1 shows a general view of the front right body of the Motor Car at the time of my inspection. The Motor Car was observed to be in relatively good general condition with no loose exterior fittings observed.

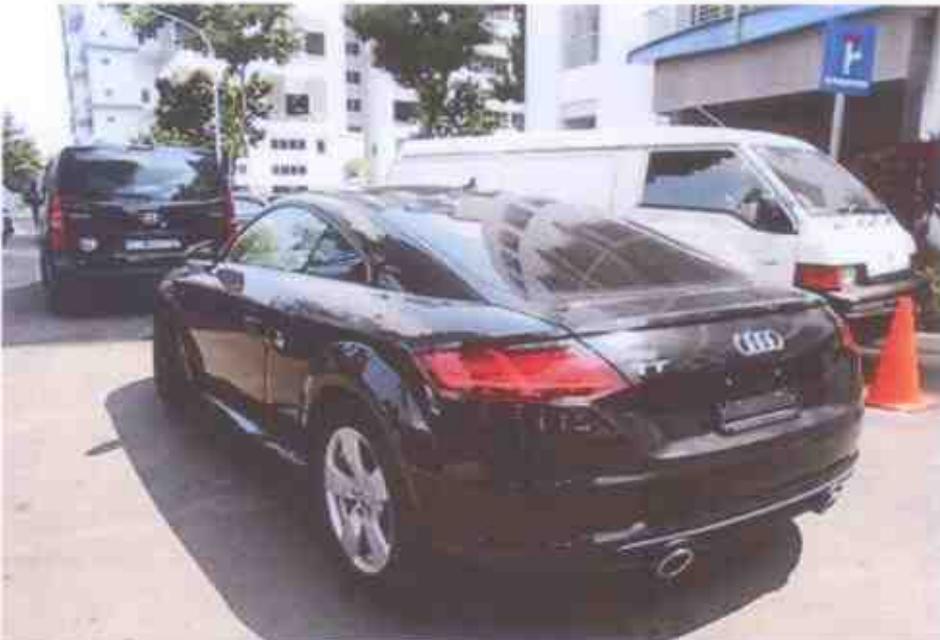
Photo 2 shows a general view of the rear left body of the Motor Car at the time of my inspection. The Motor Car was observed to be in relatively good general condition with no loose exterior fittings observed.

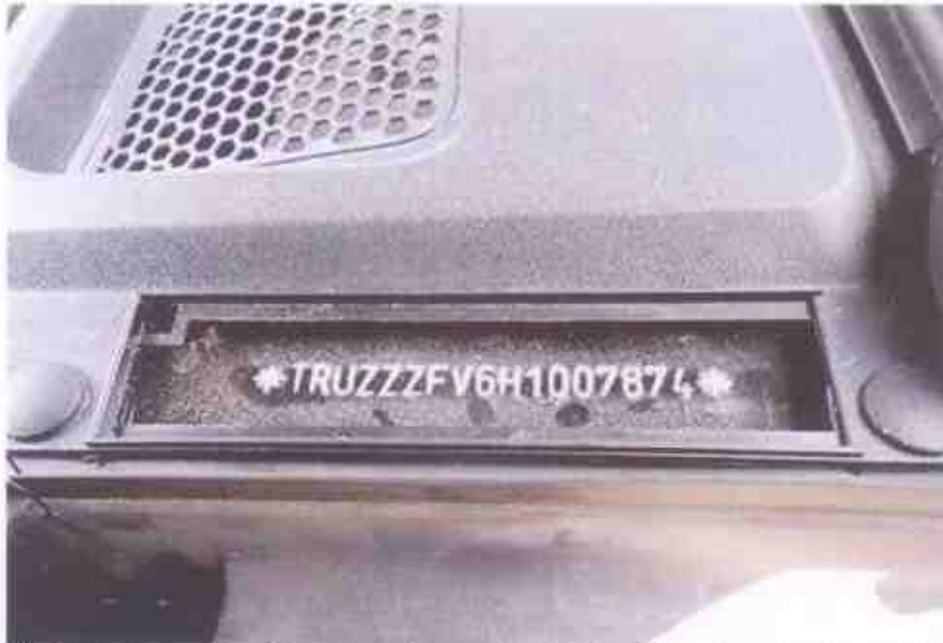
Photo 3 shows the chassis number of the Motor Car. The chassis number recorded was TRUZZZFV6H1007874.

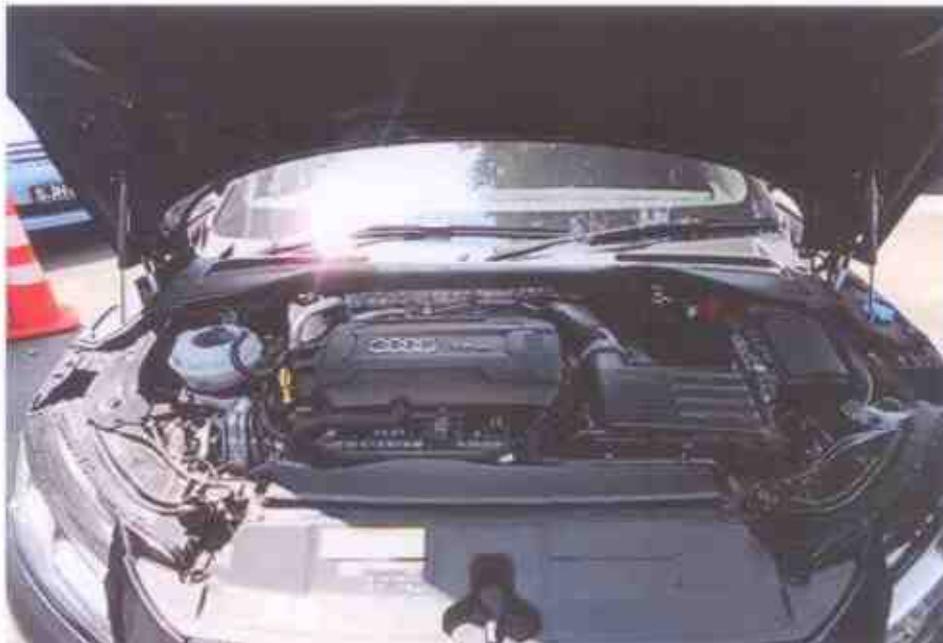
12. My examination of the engine compartment of the Motor Car revealed that the various parts and components inside the engine compartment were all intact and properly fitted. The engine oil, transmission fluid, brake fluid and engine coolant were all found to be of sufficient level for operating purposes. Visually, there was also no contamination found to these fluids.
13. My checks on the underside of the Motor Car revealed no sign(s) or indication(s) of fluid leakage and/or fluid stain(s). The engine block and automatic transmission assembly were both secured properly. They were not mounted onto the chassis body or any integral body part of the Motor Car. All undercarriage components of the Motor Car were also observed to be intact and secured in an appropriate manner.

Photo 4 shows a general view of the engine compartment of the Motor Car at the time of my inspection. The various parts and components inside the engine compartment were all observed to be intact and properly fitted. There was also no sign(s) or indication(s) of fluid leak and/or fluid stain found inside the engine compartment.

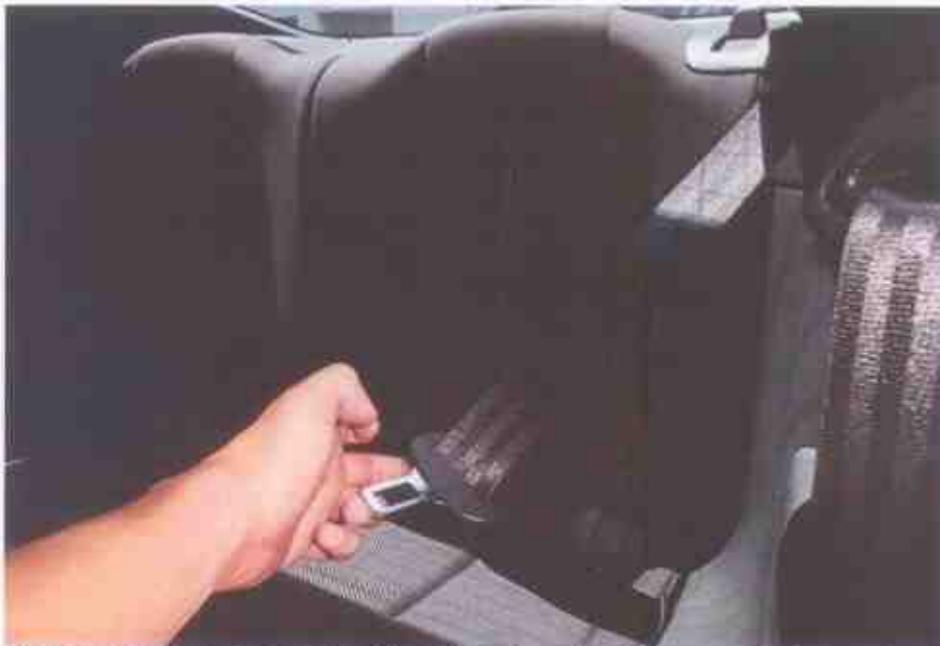
10. The seats of the Motor Car were found to be secured to the floor board of the Motor Car via seat rails bolted onto the floor board. Retractable seat belt reels and pre-tensioners were fitted on all seats of the Motor Car. The seat belt reels were able to be fastened securely to the respective pre-tensioner that is fixed to the side of all the seats.

Photo 5 shows the rear seats of the Motor Car, which were secured via seat rails to the floor board. All the seats of the Motor Car were fitted with a retractable seat belt reel and pre-tensioner. The seat belts were also able to be fastened to the pretension that were fitted on the side of each individual seat.

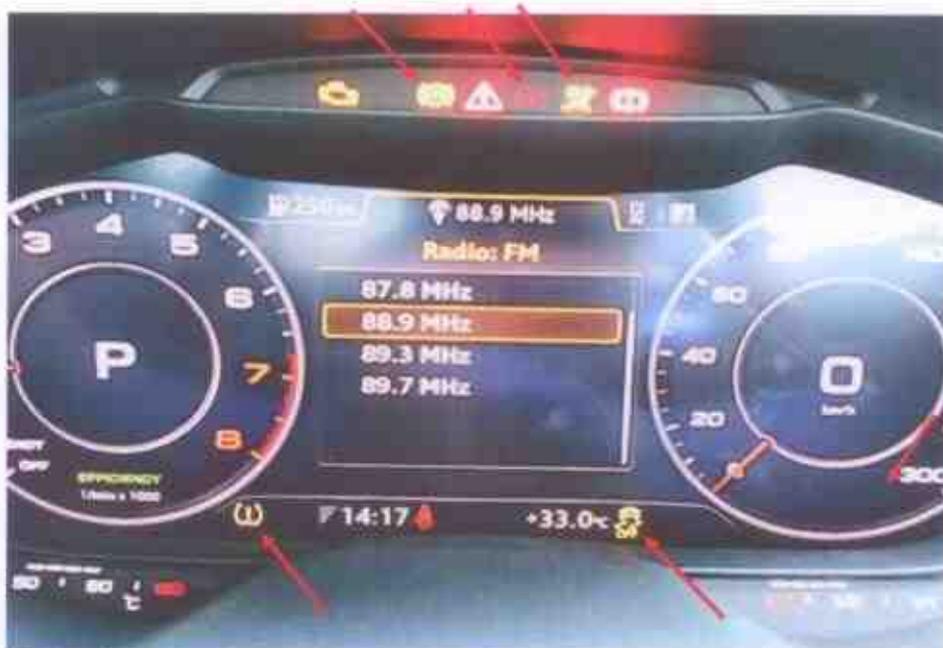
Photo 6 shows the warning lights for the various electronic safety features appearing on the instrument panel of the Motor Car during its self-test when the engine is cranked, in particular the ABS, SRS, EPS, TPM and ESC lights (arrowed).

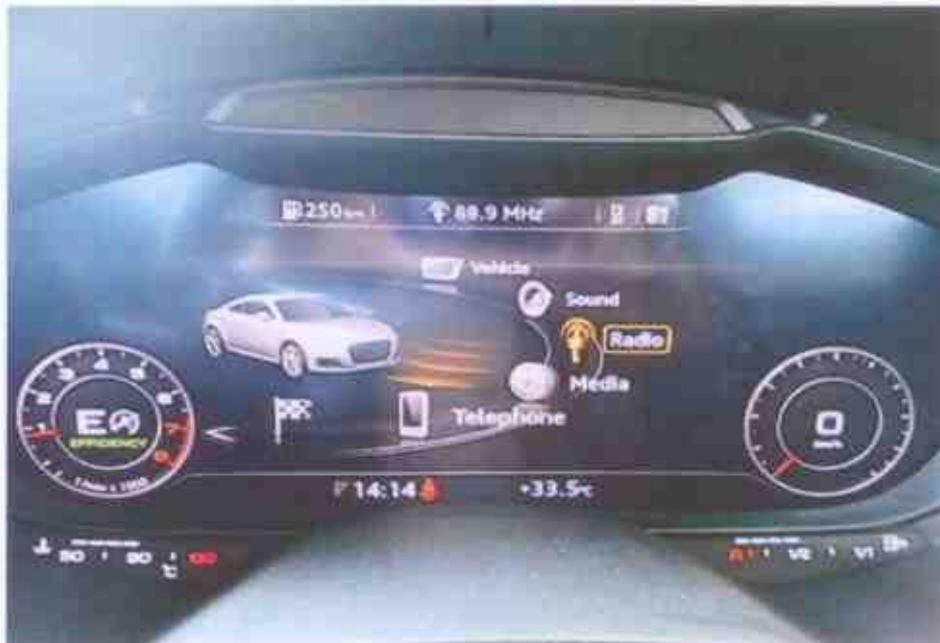
11. The Motor Car's automatic self-test of the functionality of its various electronic safety features like the Anti-Brake Lock System (ABS), Supplemental Restraint System (SRS), Electronic Power Steering (EPS), Tyre Pressure Monitor (TPM) and Electronic Stabilization Control (ESC) during cranking of the engine had indicated that these electronic systems were in working condition. This was determined from the respective warning lights disappearing from the instrument panel after the self-test.

Photo 7 shows the respective warning lights no longer illuminated, indicating that there is no fault detected to the ABS, SRS, EPS, TPM and ESC systems of the Motor Car during the self-test. These electronic systems were hence in working condition at the time of my inspection.

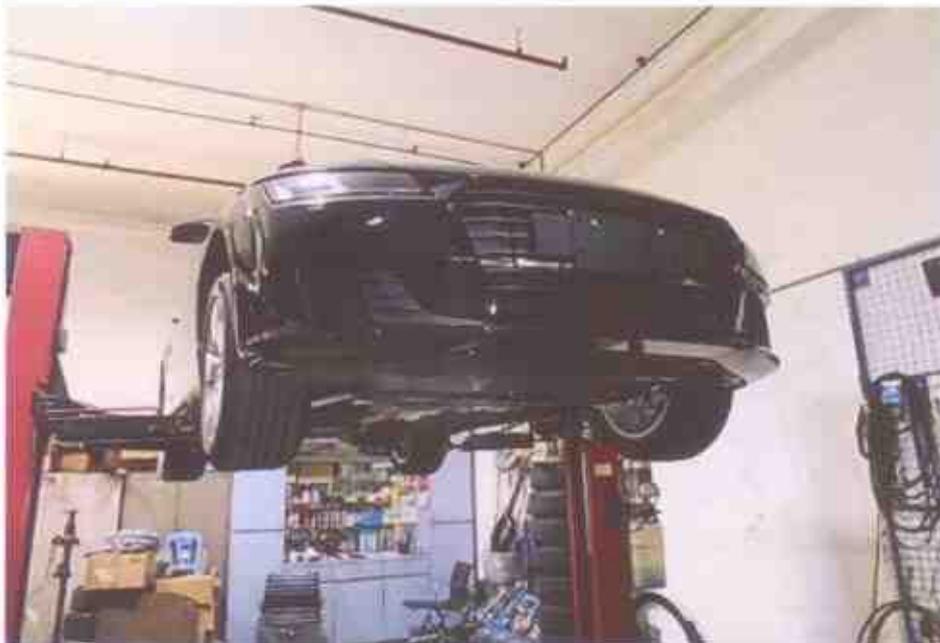
Photo 8 shows the Motor Car hoisted up for checks on its undercarriage. There was no sign(s) or indication(s) of fluid leakage and/or fluid stain(s). The undercarriage components of the Motor Car were also all observed to be intact and secured in an appropriate manner.

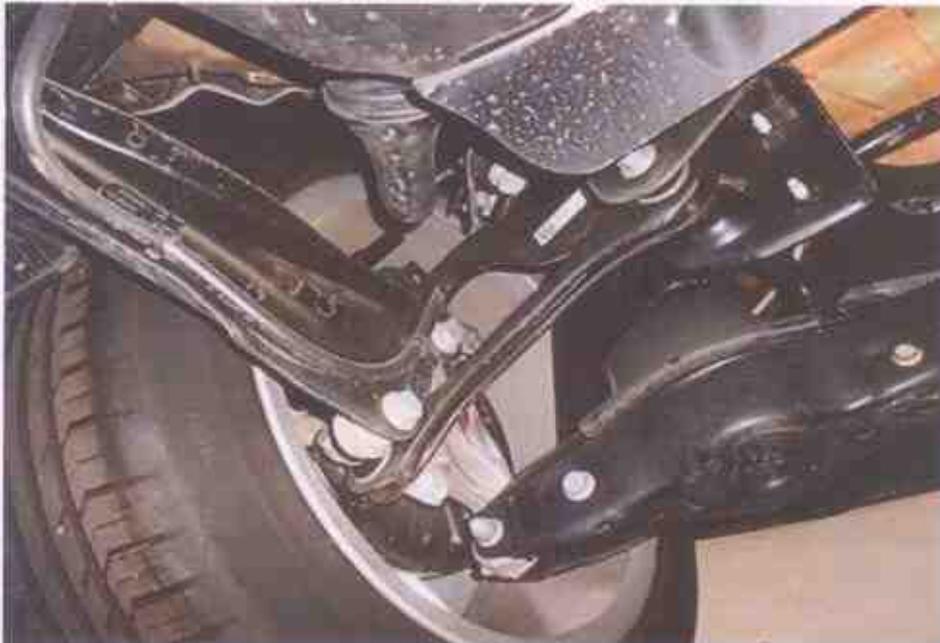
Photo 9 shows a general view of the control arms and linkages at the rear right wheel of the Motor Car. I did not observe any fluid leak and/or fluid stain on the underside of the Motor Car. All of the Motor Car's undercarriage components were observed to be intact and secured in an appropriate manner.

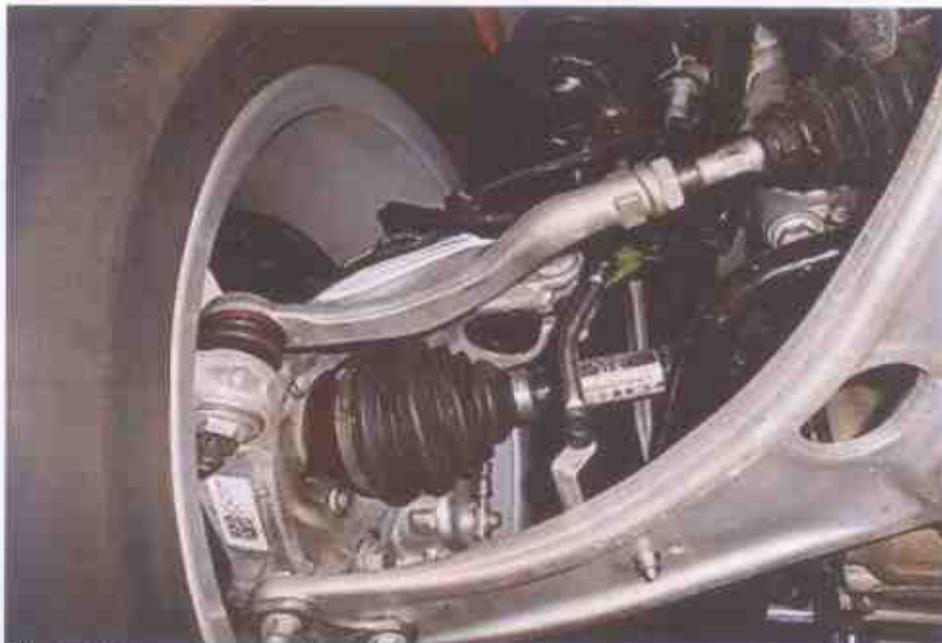
Photo 10 shows the various undercarriage components at the front left wheel of the Motor Car. The mechanical components, control arms and linkages were all found to be intact and secured in an appropriate manner.

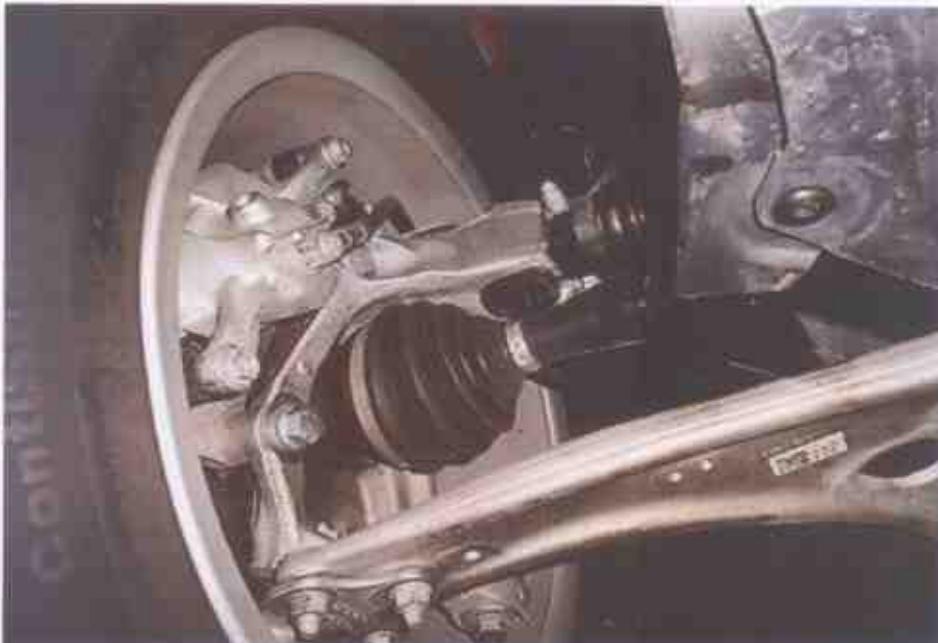
Photo 11 shows the various undercarriage components at the front right wheel of the Motor Car. The mechanical components, control arms and linkages were all found to be intact and secured in an appropriate manner.

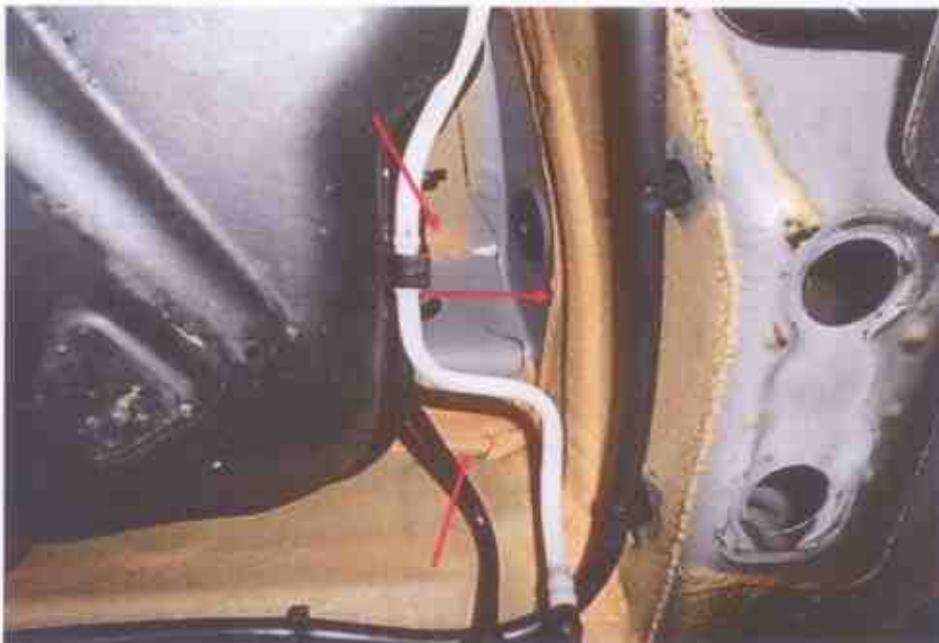
9. Visually, I did not find any weld marks, other than the original spot weld marks, on the chassis body of the Motor Car. The original factory sealant at the joints along the chassis body was also untouched, again indicating that no replacement of the chassis body was carried out; and that the chassis body was originally fitted.

Photo 12 shows the structural body at the right centre of the Motor Car. Visually, I did not find any weld marks other than original spot weld marks on the chassis body of the Motor Car. The joints (arrowed) along the chassis body was also untouched, indicating no work was done on the chassis body of the Motor Car and that the chassis body was originally fitted.

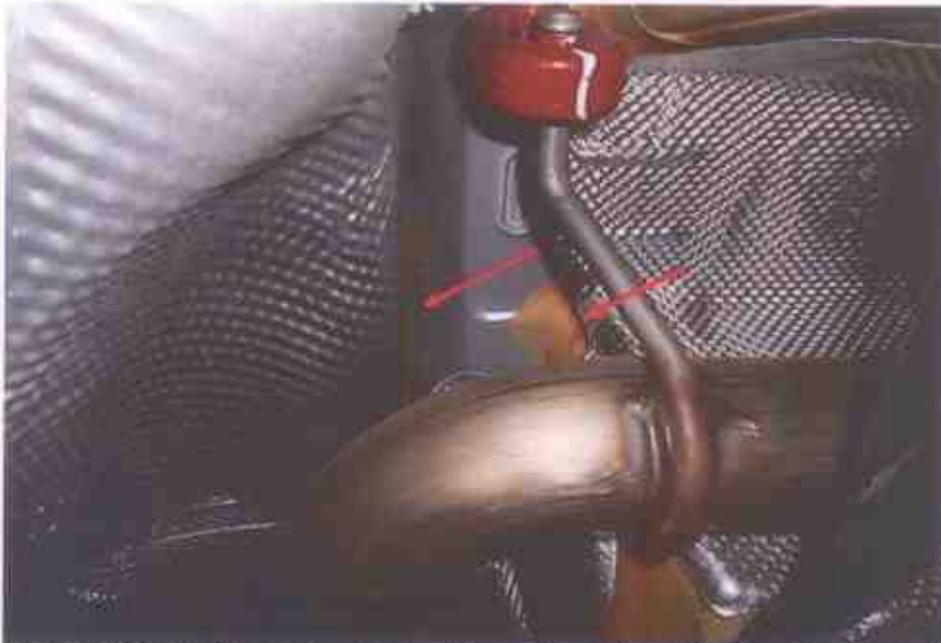
Photo 13 shows the structural body at the centre of the Motor Car. Visually, I did not find any weld marks other than original spot weld marks on the chassis of the Motor Car. The joints (arrowed) along the chassis body was also untouched, indicating no work was done on the chassis body of the Motor Car and that the chassis body was originally fitted.

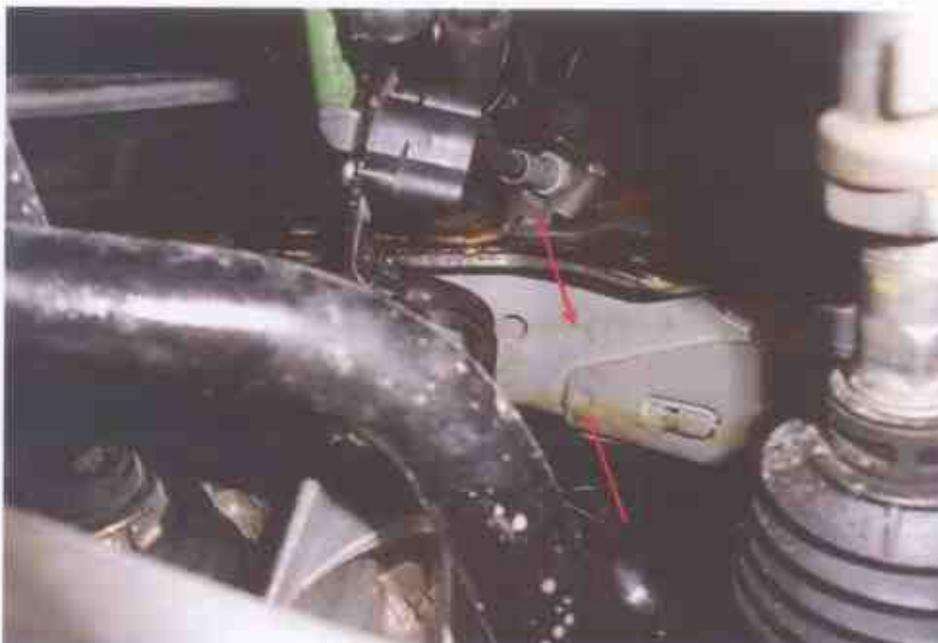
Photo 14 shows the structural body at the front left of the Motor Car. Visually, I did not find any weld marks other than original spot weld marks (arrowed) on the chassis of the Motor Car, indicating no work was done on the chassis body of the Motor Car and that the chassis body was originally fitted.

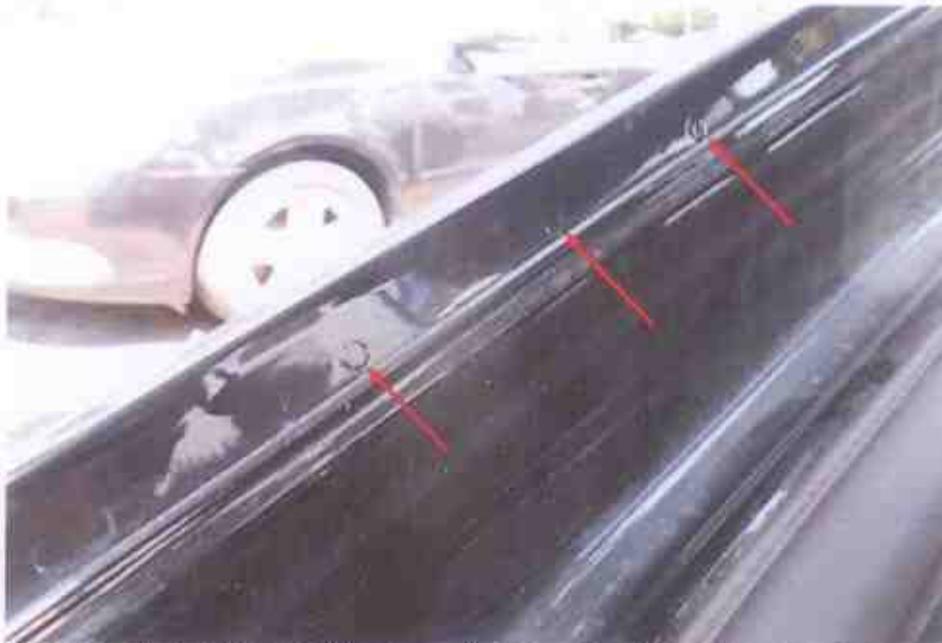
Photo 15 shows the rear left body panel of the Motor Car. I did not find any weld marks other than original spot weld marks (arrowed) on the body panels of the Motor Car, indicating that there was no re-welding works carried out; and that the body panels of the Motor Car were originally fitted
