Your Ref: Honda Odyssey
(chassis number RC1-1127118)
Our Ref : CI/TP18013824/D

30 July 2018

INSPECTION REPORT OF AN UNREGISTERD HONDA ODYSSEY MOTOR CAR WITH CHASSIS NUMBER RC1-1127118

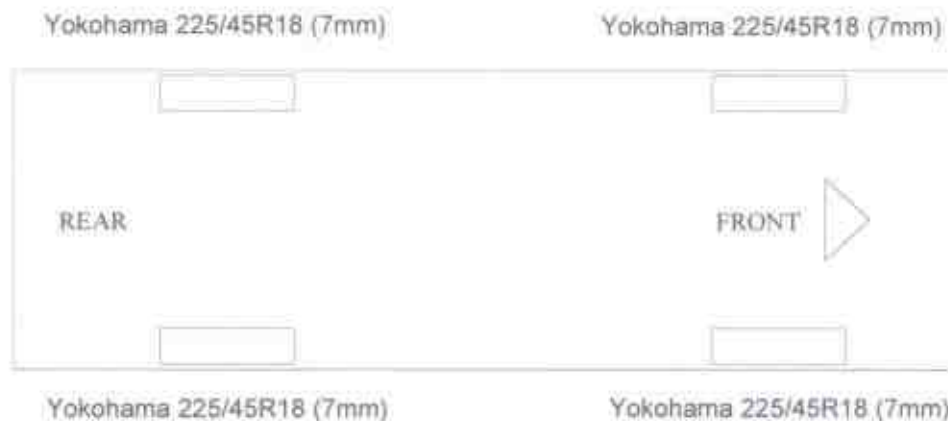
6. It was fitted with 18inch sport wheel rims that were wrapped with tyres that were observed to be of serviceable condition. The tyres were also sufficiently inflated for vehicular operation. The tyre brand, tyre size and approximate remaining tread depth of the 4 tyres of the Motor Car were recorded as follows; -

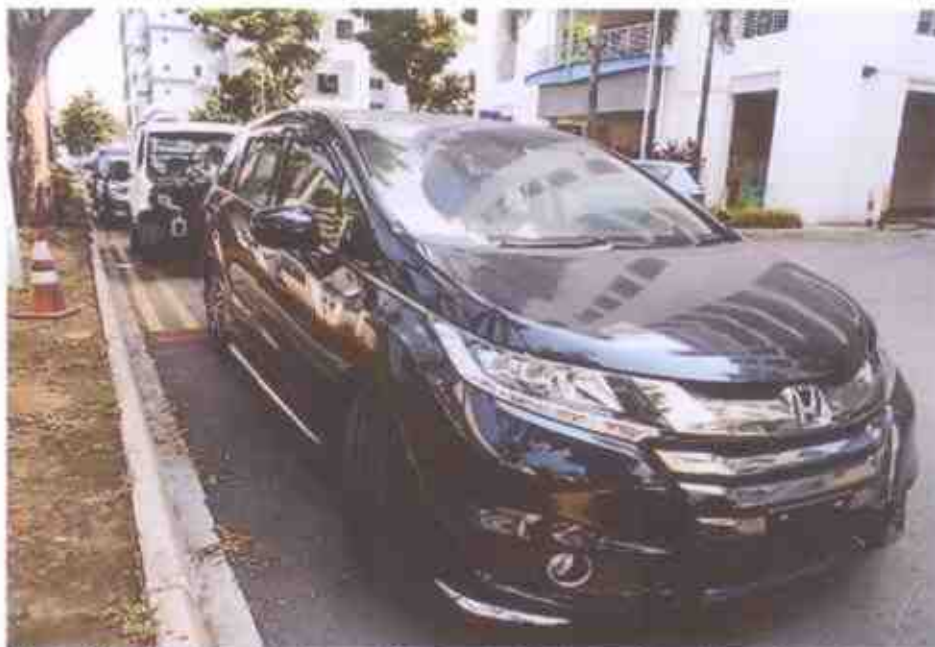
Photo 1 shows a general view of the front right body of the Motor Car at the time of my inspection. The Motor Car was observed to be in relatively good general condition with no loose exterior fittings observed.

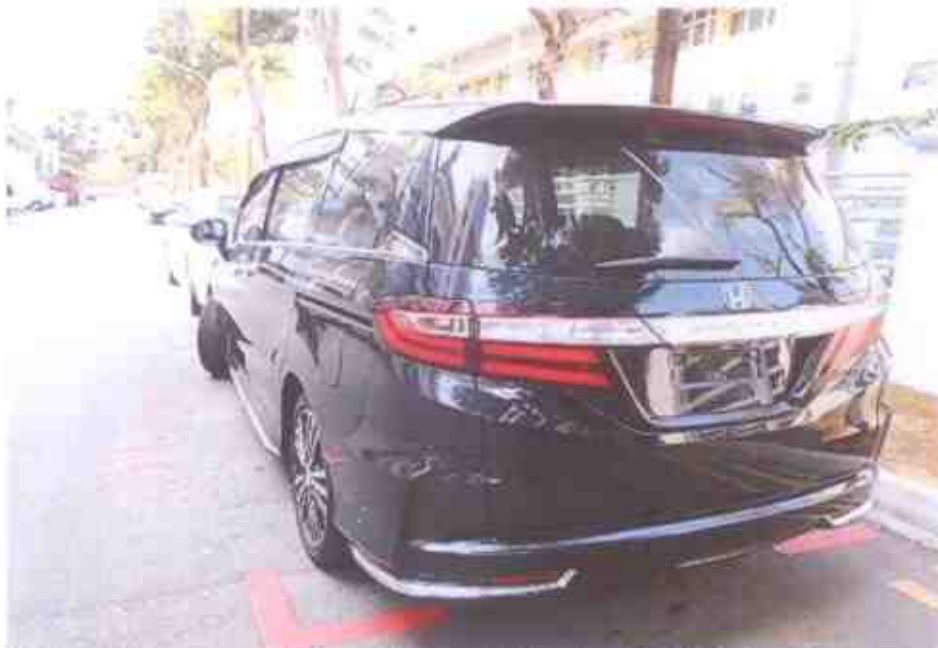
Photo 2 shows a general view of the rear left body of the Motor Car at the time of my inspection. The Motor Car was observed to be in relatively good general condition with no loose exterior fittings observed.

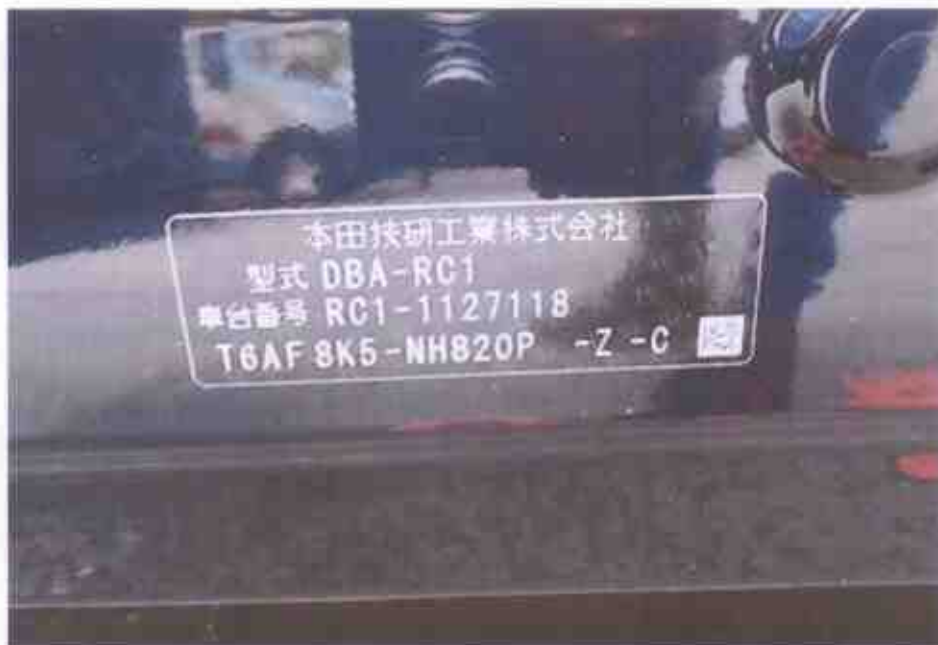
Photo 3 shows the chassis number of the Motor Car. The chassis number recorded was RC1-1127118.

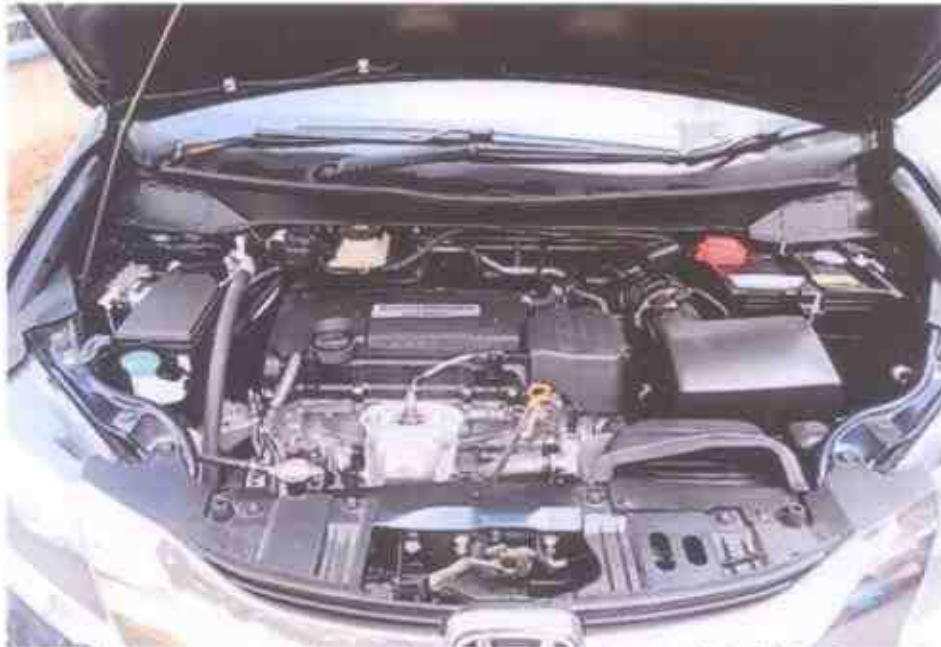
13. My examination of the engine compartment of the Motor Car revealed that the various parts and components inside the engine compartment were all intact and properly fitted. The engine oil, transmission fluid, brake fluid and engine coolant were all found to be of sufficient level for operating purposes. Visually, there was also no contamination found to these fluids.
14. My checks on the underside of the Motor Car revealed no sign(s) or indication(s) of fluid leakage and/or fluid stain(s). The engine block and automatic transmission assembly were both secured properly. They were not mounted onto the chassis body or any integral body part of the Motor Car. All undercarriage components of the Motor Car were also observed to be intact and secured in an appropriate manner.

Photo 4 shows a general view of the engine compartment of the Motor Car at the time of my inspection. The various parts and components inside the engine compartment were all observed to be intact and properly fitted. There was also no sign(s) or indication(s) of fluid leak and/or fluid stain found inside the engine compartment.

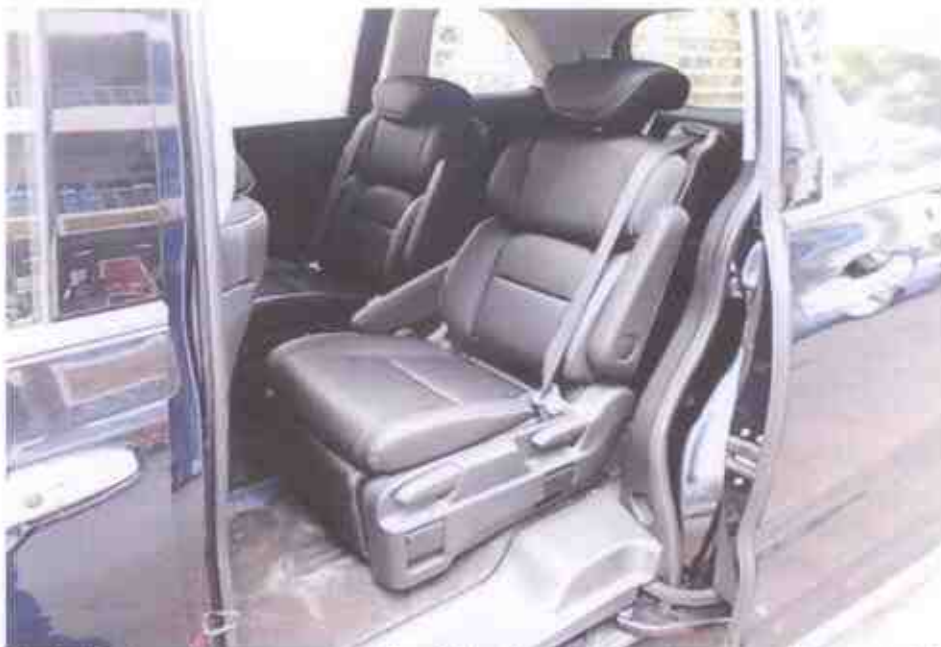
11. The seats of the Motor Car were found to be secured to the floor board of the Motor Car via seat rails bolted onto the floor board. Retractable seat belt reels and pre-tensioners were fitted on all seats of the Motor Car. The seat belt reels were able to be fastened securely to the respective pre-tensioner that is fixed to the side of all the seats.

Photo 5 shows the rear seats of the Motor Car, which were secured via seat rails to the floor board. All the seats of the Motor Car were fitted with a retractable seat belt reel and pre-tensioner. The seat belts were also able to be fastened to the pretension that were fitted on the side of each individual seat.

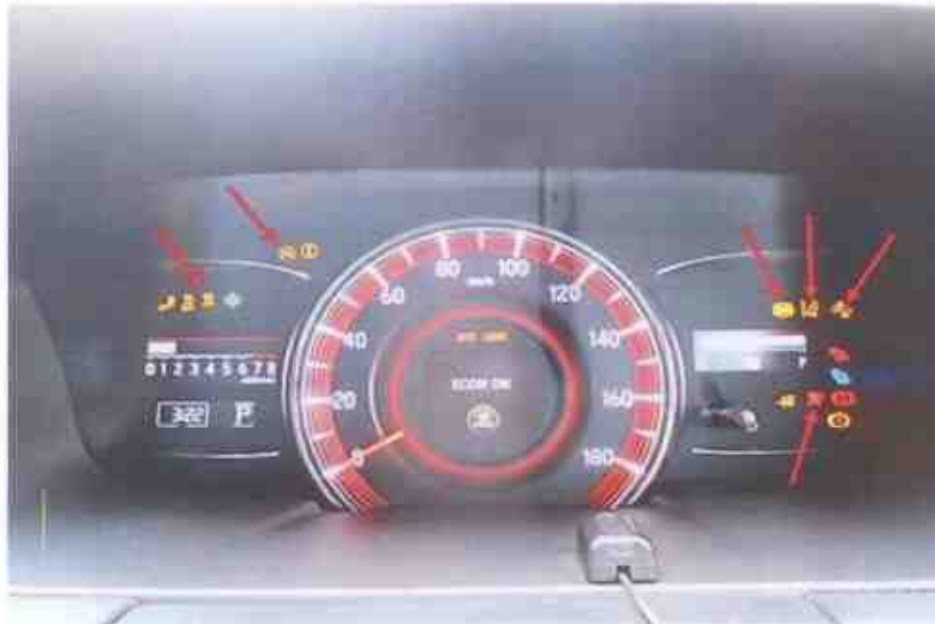
Photo 6 shows the warning lights for the various electronic safety features (arrowed) appearing on the instrument panel of the Motor Car during its self-test when the engine is cranked, in particular the Anti-Brake Lock System (ABS), Supplemental Restraint System (SRS), Electronic Power Steering (EPS), Collision Mitigation Braking System (CMBS), Lane Departure Warning (LDW) and Vehicle Stability Assist (VSA).

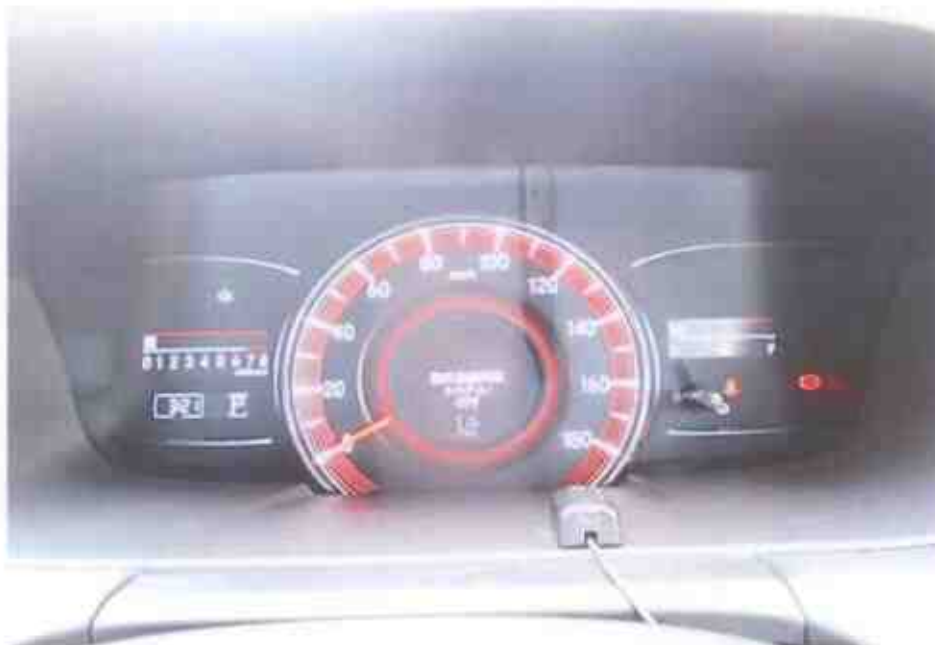
12. The Motor Car's automatic self-test of the functionality of its various electronic safety features like the Anti-Brake Lock System (ABS), Supplemental Restraint System (SRS), Electronic Power Steering (EPS), Collision Mitigation Braking System (CMBS), Lane Departure Warning (LDW) and Vehicle Stability Assist (VSA) during cranking of the engine had indicated that these electronic systems were in working condition. This was determined from the respective warning lights disappearing from the instrument panel after the self-test.

Photo 7 shows the respective warning lights no longer illuminated, indicating that there is no fault detected to the ABS, SRS, EPS, CMBS, LDW and VSA systems of the Motor Car during the self-test. These electronic systems were hence in working condition at the time of my inspection.

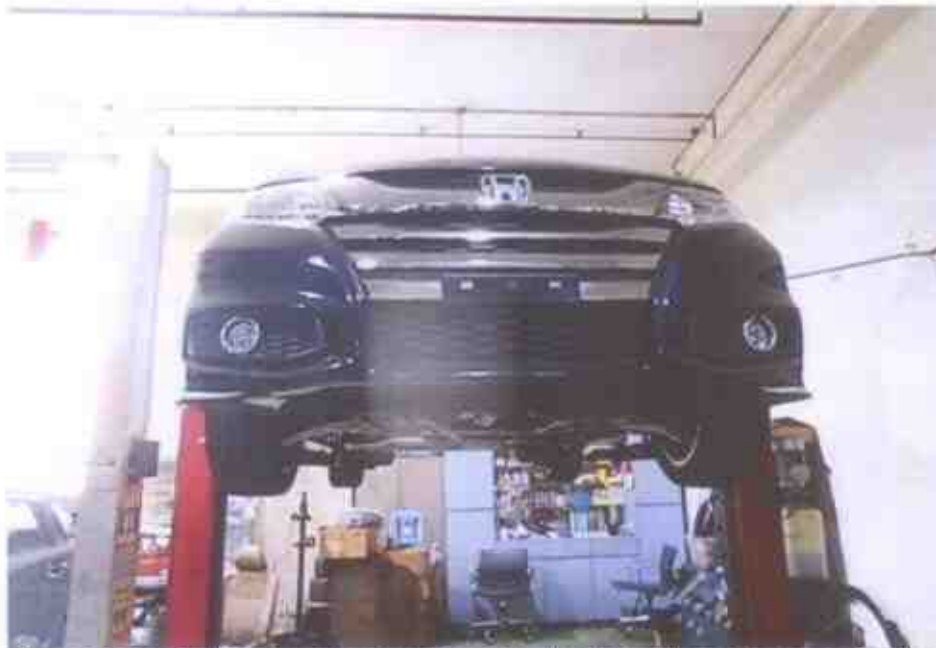
Photo 8 shows the Motor Car hoisted up for checks on its undercarriage. There was no sign(s) or indication(s) of fluid leakage and/or fluid stain(s). The undercarriage components of the Motor Car were also all observed to be intact and secured in an appropriate manner.

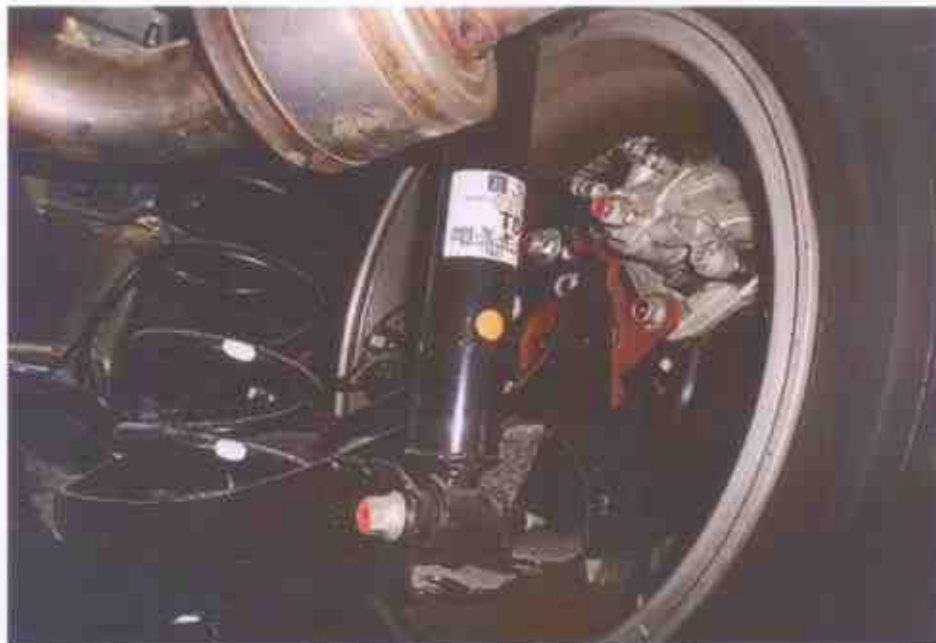
Photo 9 shows a general view of the control arms and linkages at the rear right wheel of the Motor Car. I did not observe any fluid leak and/or fluid stain on the underside of the Motor Car. All of the Motor Car's undercarriage components were observed to be intact and secured in an appropriate manner.

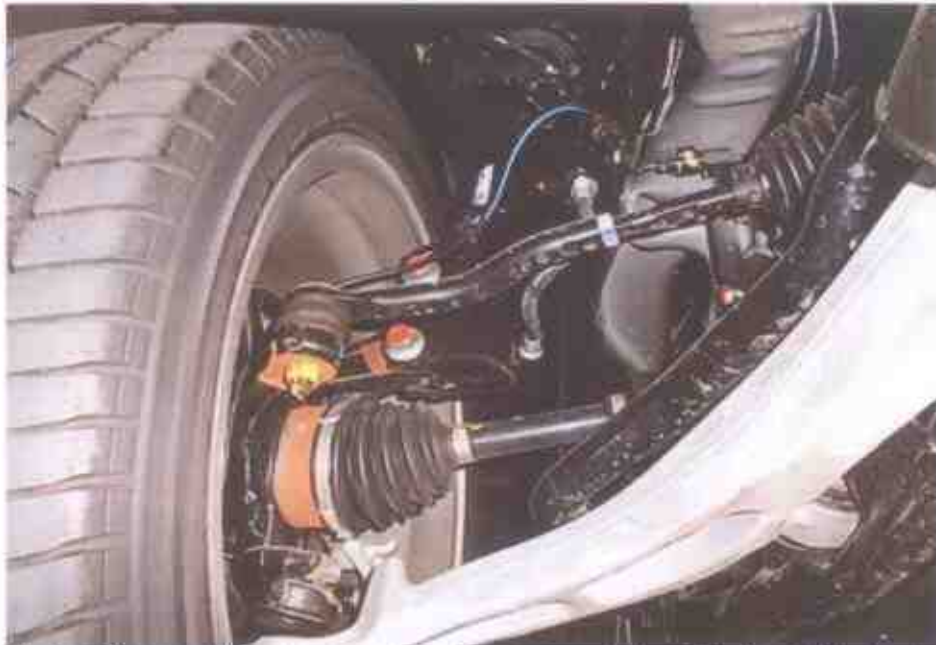
Photo 10 shows the various undercarriage components at the front left wheel of the Motor Car. The mechanical components, control arms and linkages were all found to be intact and secured in an appropriate manner.

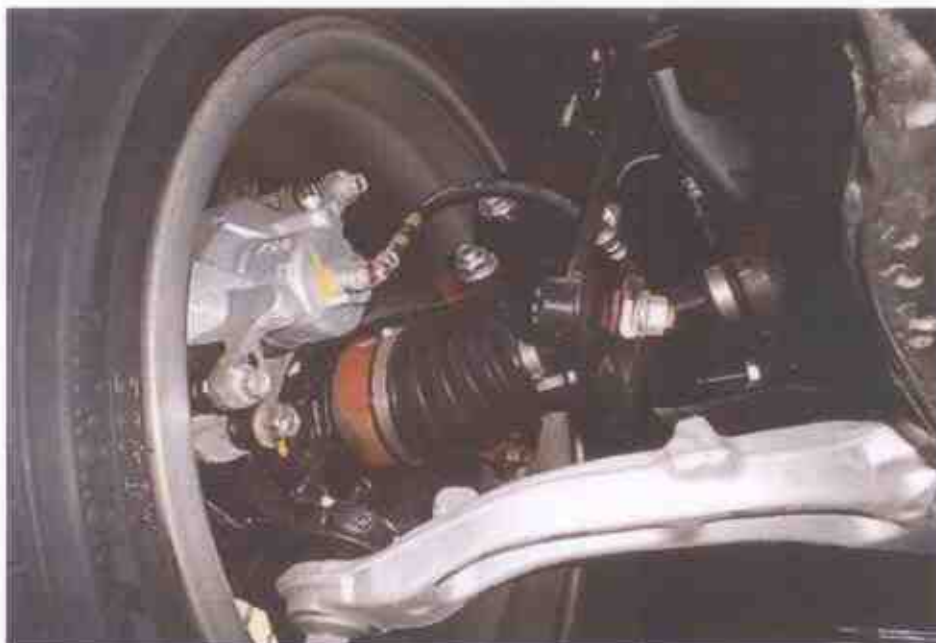
Photo 11 shows the various undercarriage components at the front right wheel of the Motor Car. The mechanical components, control arms and linkages were all found to be intact and secured in an appropriate manner.

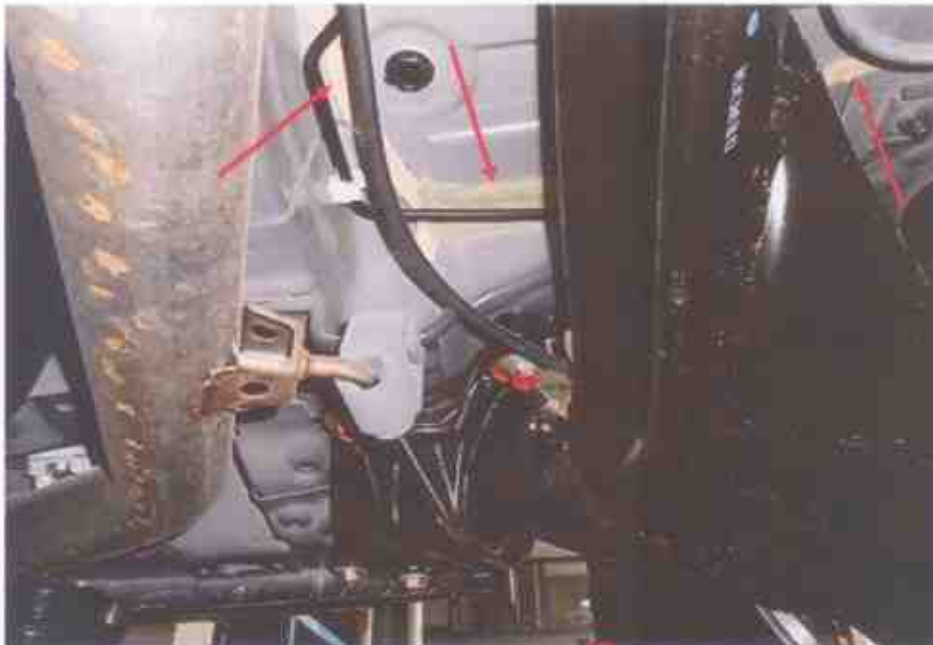
10. Visually, I did not find any weld marks, other than the original spot weld marks, on the chassis body of the Motor Car. The original factory sealant at the joints along the chassis body was also untouched, again indicating that no replacement of the chassis body was carried out; and that the chassis body was originally fitted.

Photo 12 shows the structural body at the right rear of the Motor Car. Visually, I did not find any weld marks other than original spot weld marks on the chassis body of the Motor Car. The joints (arrowed) along the chassis body was also untouched, indicating no work was done on the chassis body of the Motor Car and that the chassis body was originally fitted.

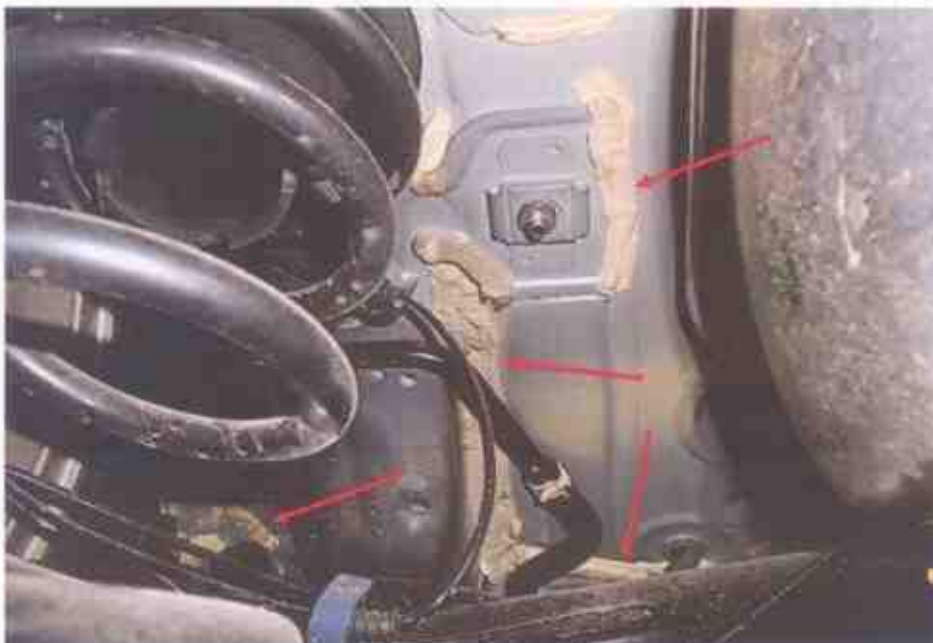
Photo 13 shows the structural body at the left rear of the Motor Car. Visually, I did not find any weld marks other than original spot weld marks on the chassis of the Motor Car. The joints (arrowed) along the chassis body was also untouched, indicating no work was done on the chassis body of the Motor Car and that the chassis body was originally fitted.

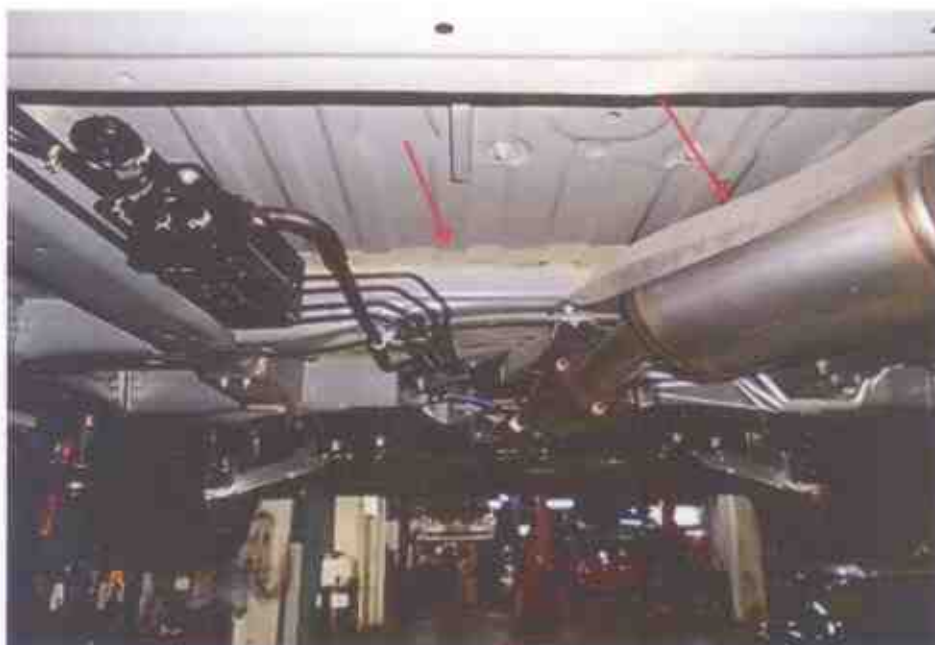
Photo 14 shows the structural body at the centre of the Motor Car. The joints (arrowed) along the chassis body was also untouched, indicating no work was done on the chassis body of the Motor Car and that the chassis body was originally fitted.

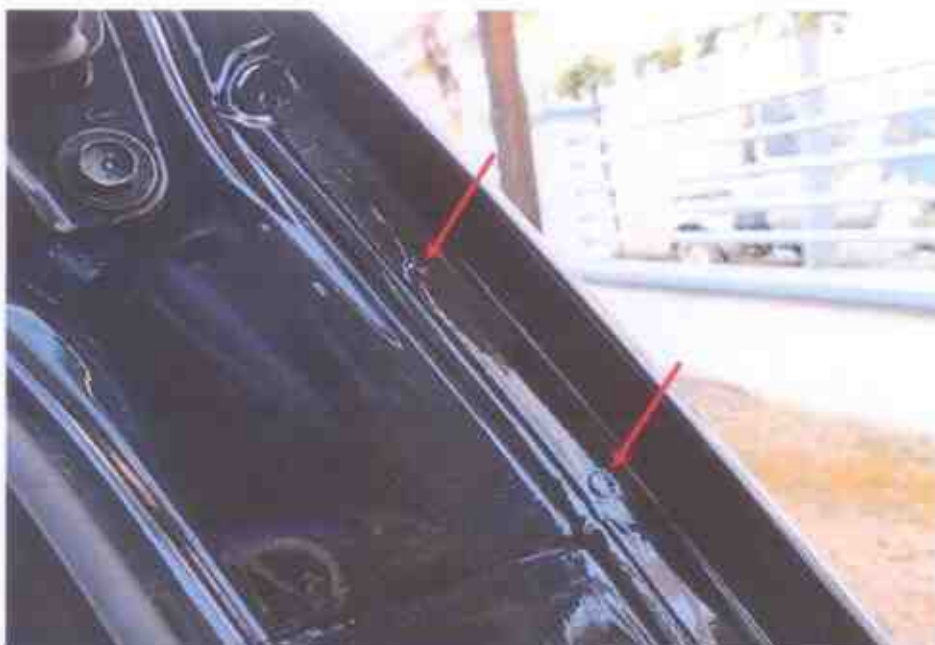
9. The other non-detachable body panels like the rear right fender, floor board, roof panel, pillars and rocker panels amongst others, revealed that these body panels were spot welded onto the structure body of the Motor Car. The original factory sealant at the joints of the non-detachable body panels was all untouched indicating no replacement of the non-detachable body panels was carried out; and that these body panels were all originally fitted.

Photo 15 shows the original spot weld marks (arrowed) on the rear right fender of the Motor Car. The body panels of the Motor Car were found to be with original welding marks except for the rear left fender of the Motor Car, where signs of removal and re-fitting were found (refer to photograph 16 below).

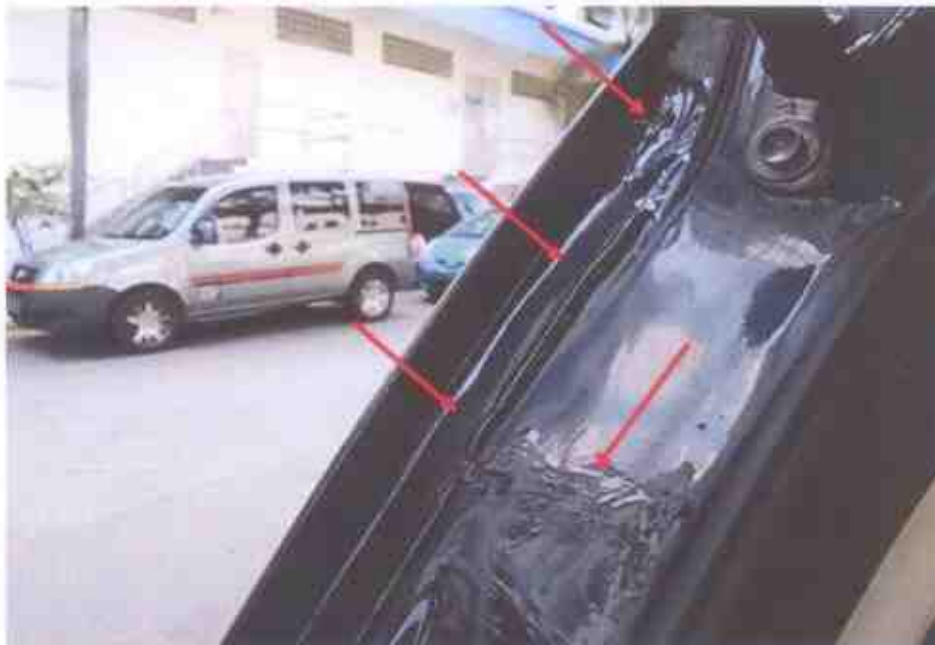
8. Checks on the non-detachable body panels revealed signs of removal and re-fitting of the rear left fender. The original welding of the rear left fender onto the body of the Motor Car could not be seen, indicating possible repair/replacement work carried out to the rear left fender. However, the repair/replacement work did not affect the structural body of the Motor Car as this rear left fender is an outer panel of the Motor Car and is originally not welded directly onto the structural body of the Motor Car.

21. Signs of removal and re-fitting of the Motor Car's rear left fender were found, which would indicate possible repair/replacement work carried out. However, the repair/replacement work did not affect the structural body of the Motor Car as this rear left fender is an outer panel and is originally not welded directly onto the structural body of the Motor Car.
22. My test drive of the Motor Car revealed no evidence to suggest possible mechanical problem(s) to the Motor Car. I did not experience any abnormal behaviour and/or sound(s) from the various operating systems of the Motor Car. The general performance, stability, braking and handling of the Motor Car were satisfactory throughout the Motor Car's short test drive. In general, I had found the Motor Car to be of road worthy condition. See photo 1 – 16 below taken at the time of my inspection.

Photo 16 shows the rear left fender of the Motor Car. Signs (arrowed) of removal and re-fitting of the rear left fender were observed. The original spot weld marks on the rear left fender of the Motor Car could not be seen as compared to the same area on the rear right fender (refer to photograph 15 above). The removal and re-fitting of the rear left fender would indicate possible repair/replacement work was carried out to the rear left fender. However, the repair/replacement work did not affect the structural body of the Motor Car as this rear left fender is an outer panel and is originally not welded directly onto the structural body of the Motor Car.
