Your Ref: Honda Odyssey
(chassis number RC1-1127118)
Our Ref : CI/TP18013824/D

30 July 2018

INSPECTION REPORT OF AN UNREGISTERD HONDA ODYSSEY MOTOR CAR WITH CHASSIS NUMBER RC1-1127118

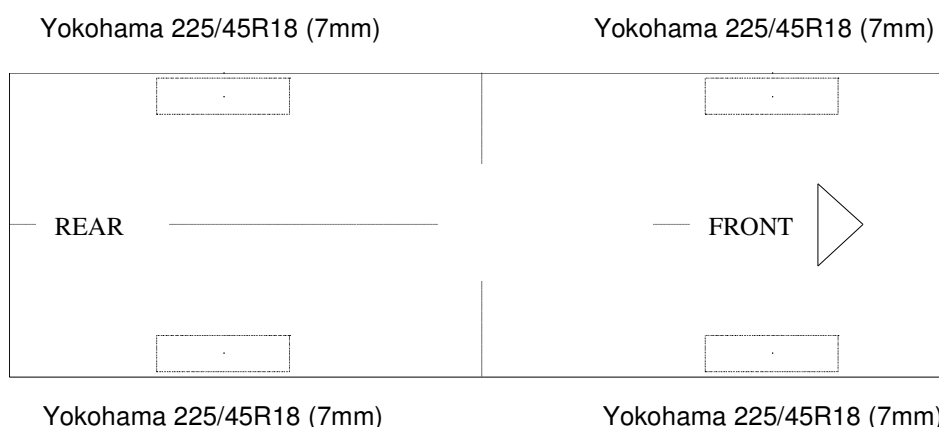
6. It was fitted with 18inch sport wheel rims that were wrapped with tyres that were observed to be of serviceable condition. The tyres were also sufficiently inflated for vehicular operation. The tyre brand, tyre size and approximate remaining tread depth of the 4 tyres of the Motor Car were recorded as follows: -

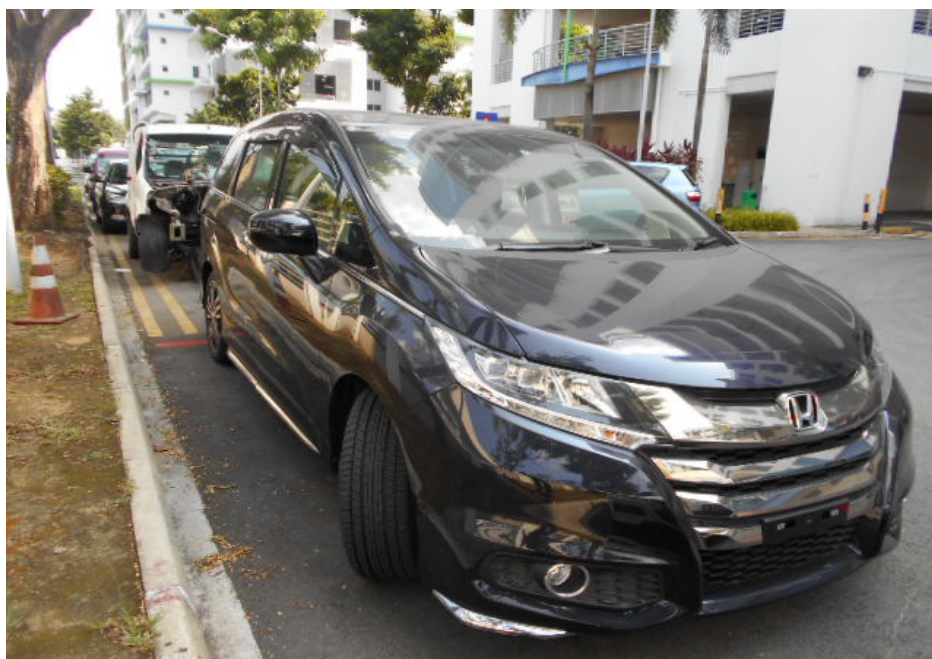
Photo 1 shows a general view of the front right body of the Motor Car at the time of my inspection. The Motor Car was observed to be in relatively good general condition with no loose exterior fittings observed.

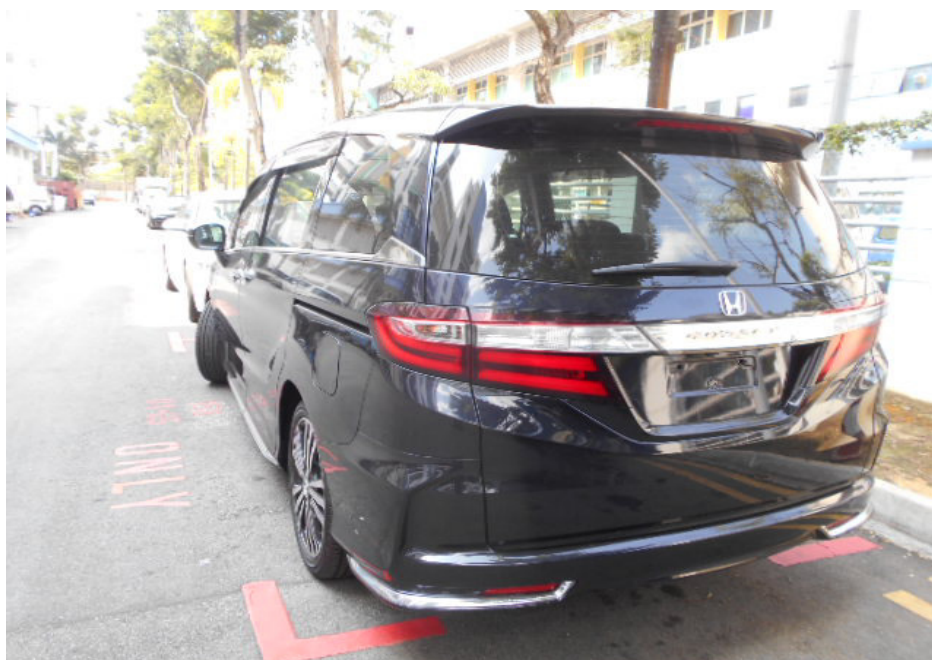
Photo 2 shows a general view of the rear left body of the Motor Car at the time of my inspection. The Motor Car was observed to be in relatively good general condition with no loose exterior fittings observed.

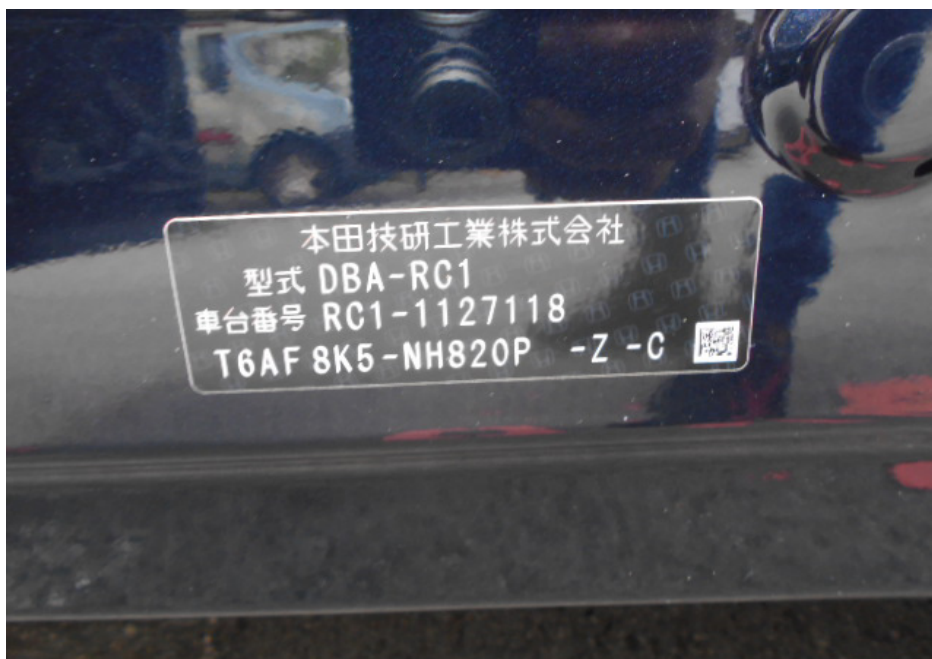
Photo 3 shows the chassis number of the Motor Car. The chassis number recorded was RC1-1127118.

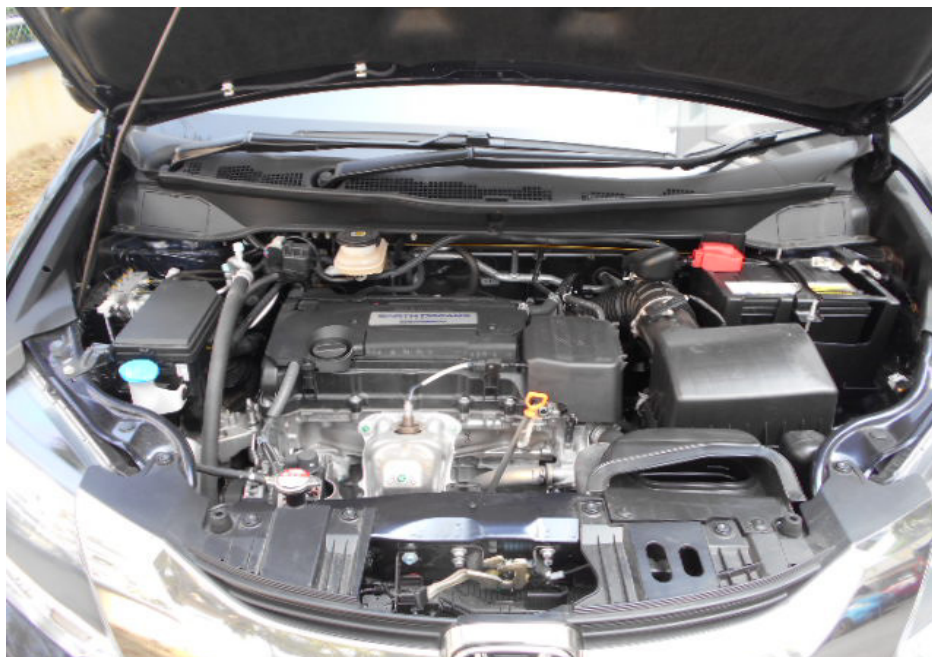
13. My examination of the engine compartment of the Motor Car revealed that the various parts and components inside the engine compartment were all intact and properly fitted. The engine oil, transmission fluid, brake fluid and engine coolant were all found to be of sufficient level for operating purposes. Visually, there was also no contamination found to these fluids.
14. My checks on the underside of the Motor Car revealed no sign(s) or indication(s) of fluid leakage and/or fluid stain(s). The engine block and automatic transmission assembly were both secured properly. They were not mounted onto the chassis body or any integral body part of the Motor Car. All undercarriage components of the Motor Car were also observed to be intact and secured in an appropriate manner.

Photo 4 shows a general view of the engine compartment of the Motor Car at the time of my inspection. The various parts and components inside the engine compartment were all observed to be intact and properly fitted. There was also no sign(s) or indication(s) of fluid leak and/or fluid stain found inside the engine compartment.

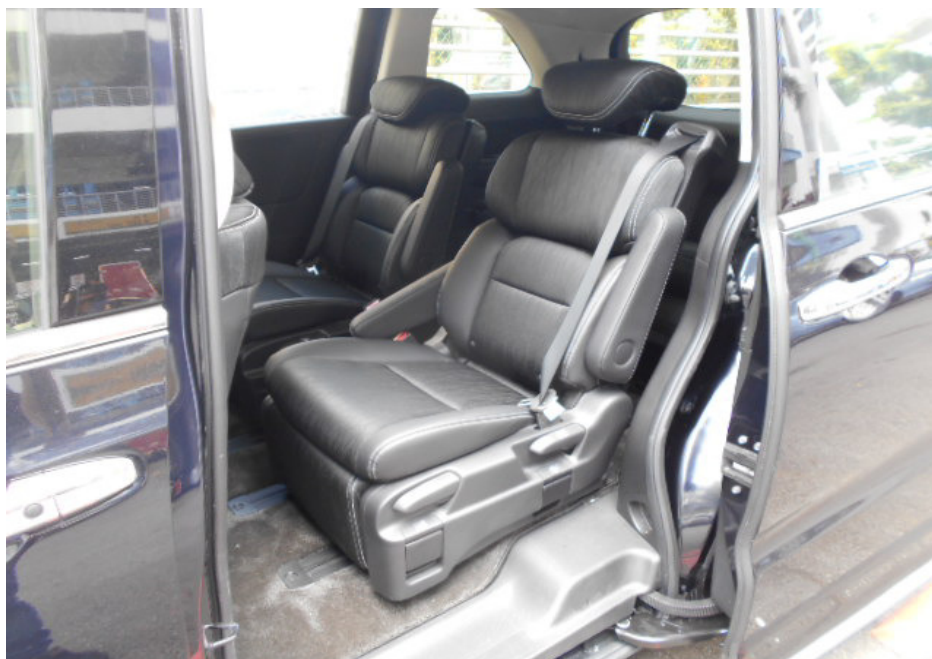
11. The seats of the Motor Car were found to be secured to the floor board of the Motor Car via seat rails bolted onto the floor board. Retractable seat belt reels and pre-tensioners were fitted on all seats of the Motor Car. The seat belt reels were able to be fastened securely to the respective pre-tensioner that is fixed to the side of all the seats.

Photo 5 shows the rear seats of the Motor Car, which were secured via seat rails to the floor board. All the seats of the Motor Car were fitted with a retractable seat belt reel and pre-tensioner. The seat belts were also able to be fastened to the pretension that were fitted on the side of each individual seat.

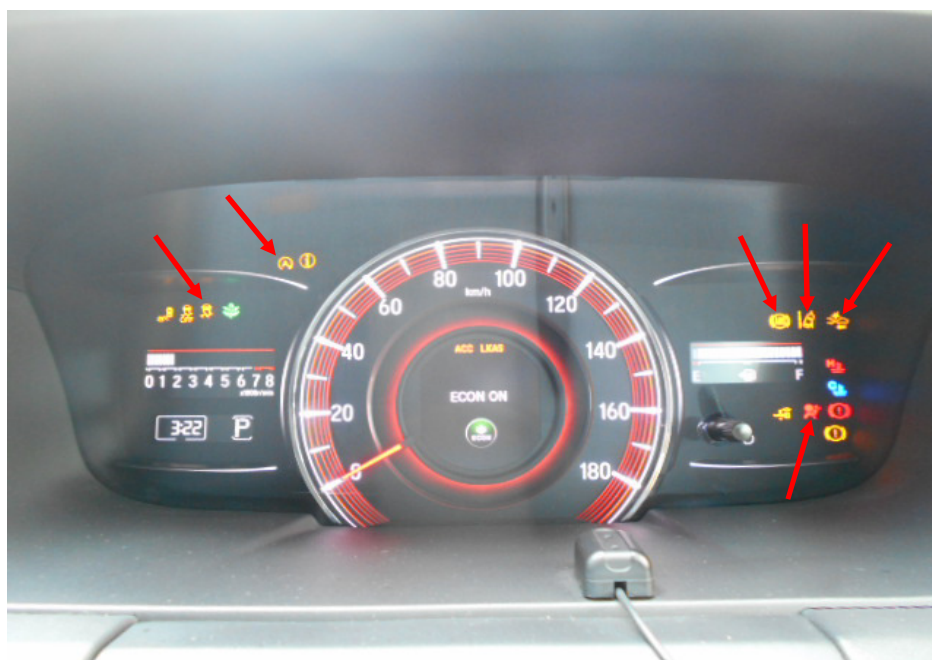
Photo 6 shows the warning lights for the various electronic safety features (arrowed) appearing on the instrument panel of the Motor Car during its self-test when the engine is cranked, in particular the Anti-Brake Lock System (ABS), Supplemental Restraint System (SRS), Electronic Power Steering (EPS), Collision Mitigation Braking System (CMBS), Lane Departure Warning (LDW) and Vehicle Stability Assist (VSA).

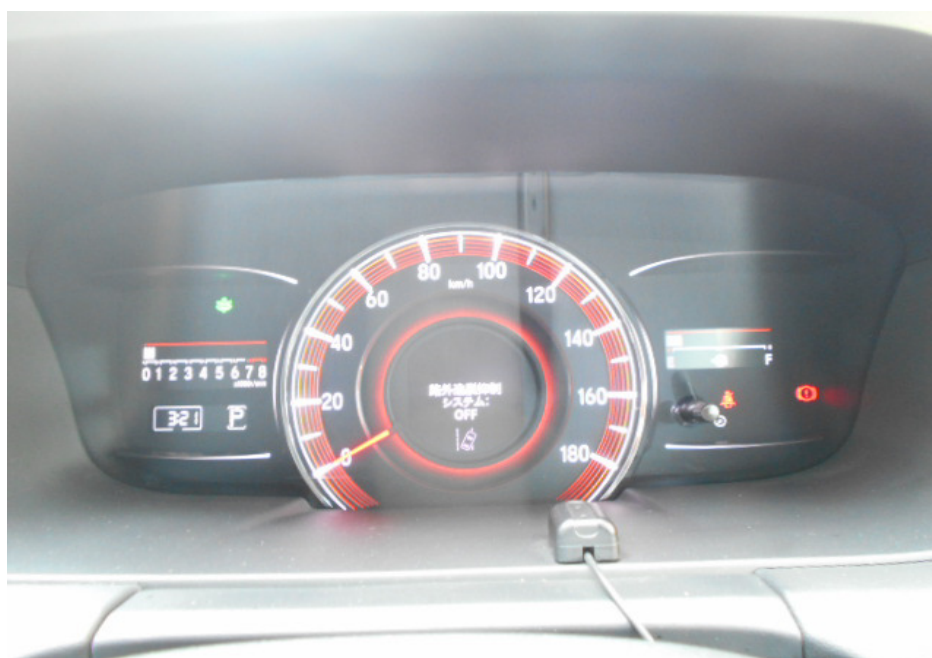
12. The Motor Car's automatic self-test of the functionality of its various electronic safety features like the Anti-Brake Lock System (ABS), Supplemental Restraint System (SRS), Electronic Power Steering (EPS), Collision Mitigation Braking System (CMBS), Lane Departure Warning (LDW) and Vehicle Stability Assist (VSA) during cranking of the engine had indicated that these electronic systems were in working condition. This was determined from the respective warning lights disappearing from the instrument panel after the self-test.

Photo 7 shows the respective warning lights no longer illuminated, indicating that there is no fault detected to the ABS, SRS, EPS, CMBS, LDW and VSA systems of the Motor Car during the self-test. These electronic systems were hence in working condition at the time of my inspection.

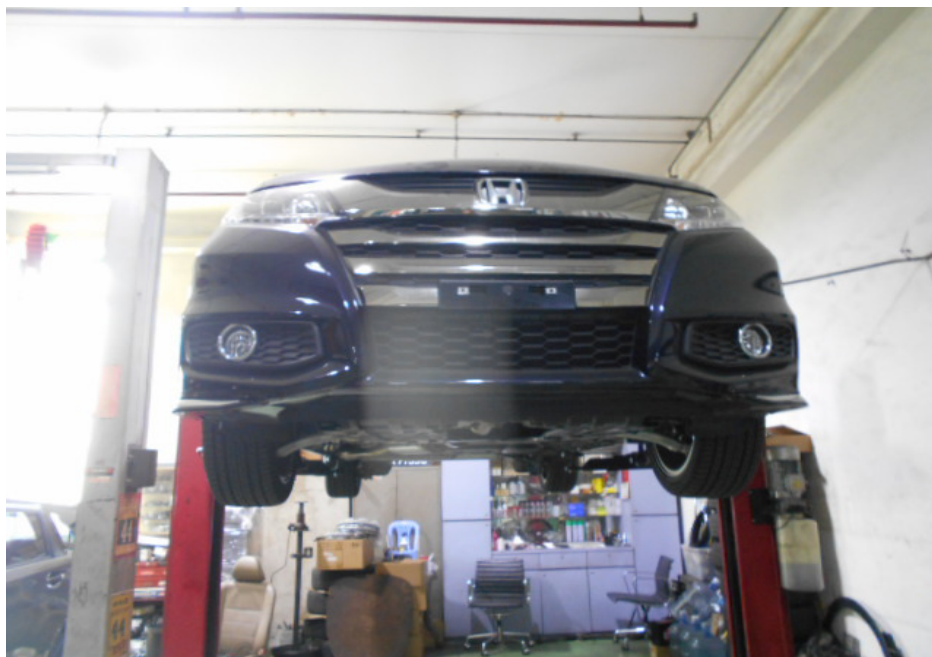
Photo 8 shows the Motor Car hoisted up for checks on its undercarriage. There was no sign(s) or indication(s) of fluid leakage and/or fluid stain(s). The undercarriage components of the Motor Car were also all observed to be intact and secured in an appropriate manner.

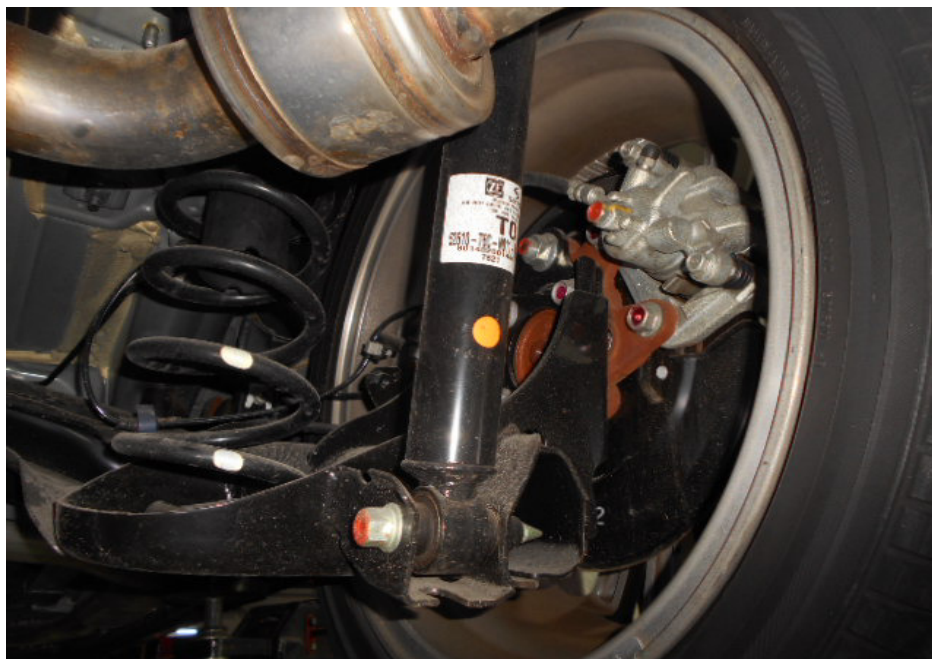
Photo 9 shows a general view of the control arms and linkages at the rear right wheel of the Motor Car. I did not observe any fluid leak and/or fluid stain on the underside of the Motor Car. All of the Motor Car's undercarriage components were observed to be intact and secured in an appropriate manner.

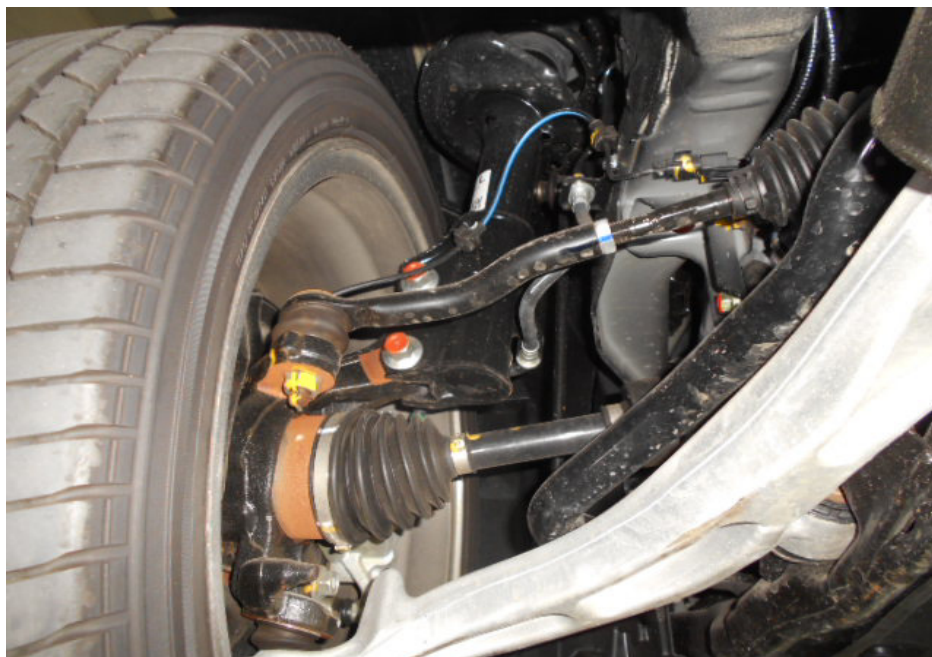
Photo 10 shows the various undercarriage components at the front left wheel of the Motor Car. The mechanical components, control arms and linkages were all found to be intact and secured in an appropriate manner.

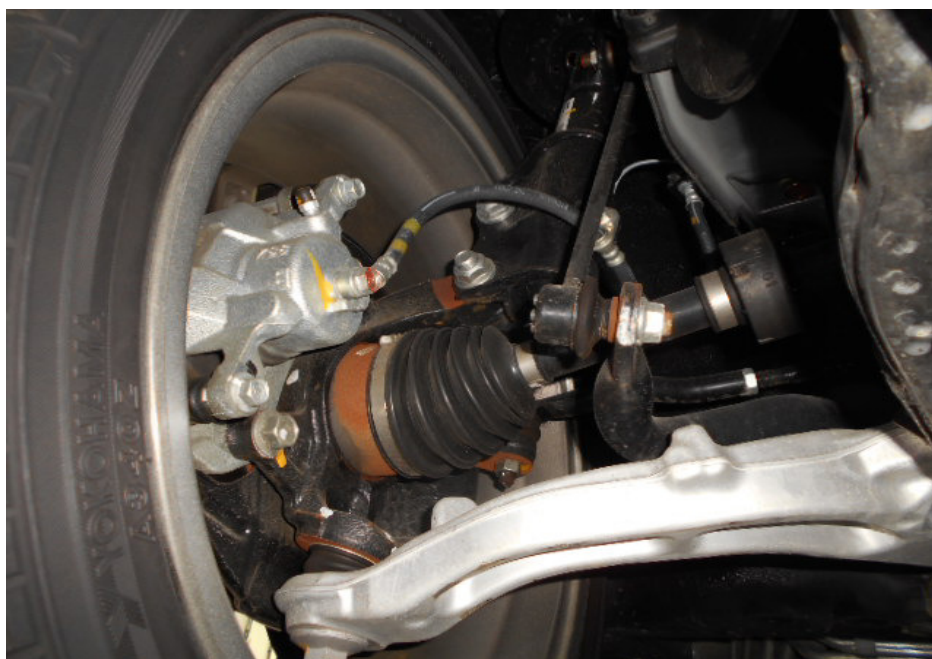
Photo 11 shows the various undercarriage components at the front right wheel of the Motor Car. The mechanical components, control arms and linkages were all found to be intact and secured in an appropriate manner.

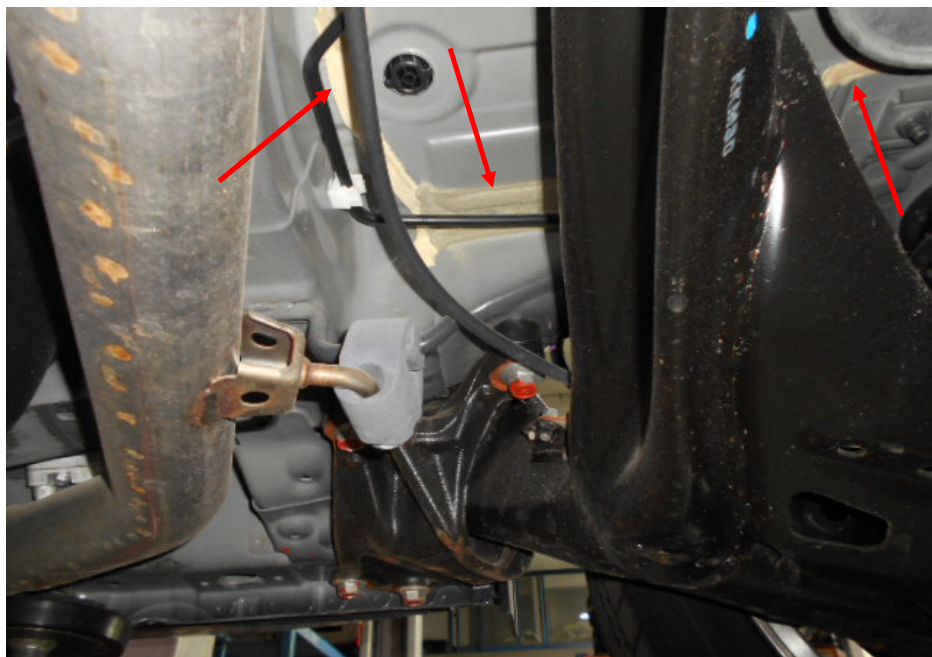
10. Visually, I did not find any weld marks, other than the original spot weld marks, on the chassis body of the Motor Car. The original factory sealant at the joints along the chassis body was also untouched, again indicating that no replacement of the chassis body was carried out; and that the chassis body was originally fitted.

Photo 12 shows the structural body at the right rear of the Motor Car. Visually, I did not find any weld marks other than original spot weld marks on the chassis body of the Motor Car. The joints (arrowed) along the chassis body was also untouched, indicating no work was done on the chassis body of the Motor Car and that the chassis body was originally fitted.

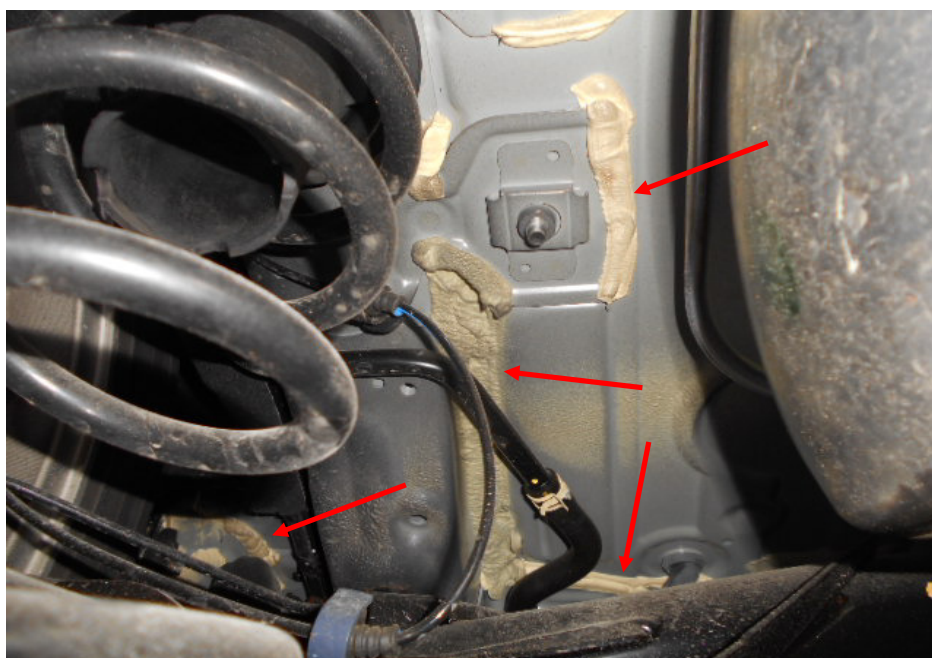
Photo 13 shows the structural body at the left rear of the Motor Car. Visually, I did not find any weld marks other than original spot weld marks on the chassis of the Motor Car. The joints (arrowed) along the chassis body was also untouched, indicating no work was done on the chassis body of the Motor Car and that the chassis body was originally fitted.

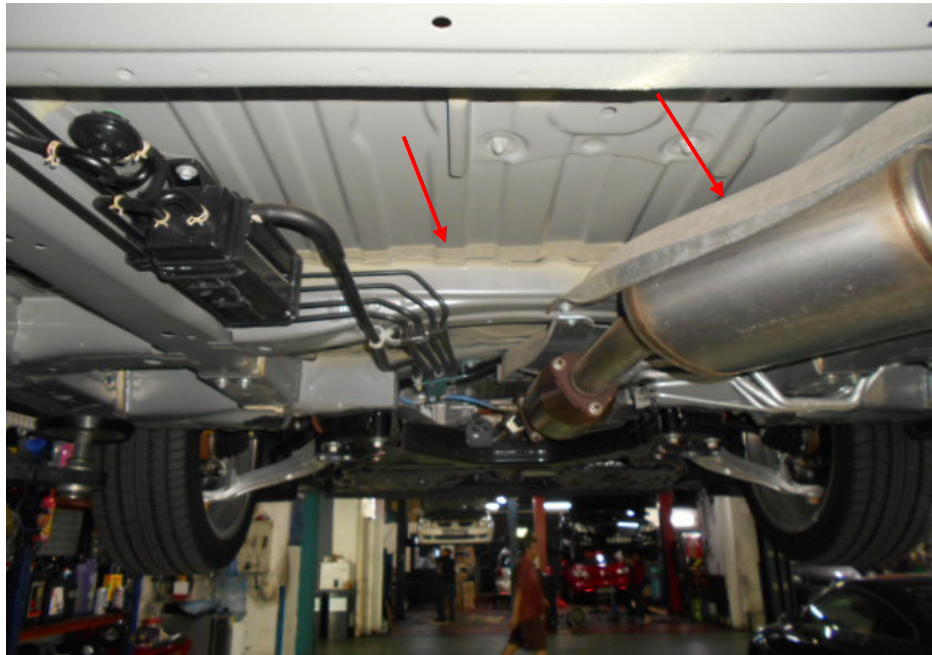
Photo 14 shows the structural body at the centre of the Motor Car. The joints (arrowed) along the chassis body was also untouched, indicating no work was done on the chassis body of the Motor Car and that the chassis body was originally fitted.

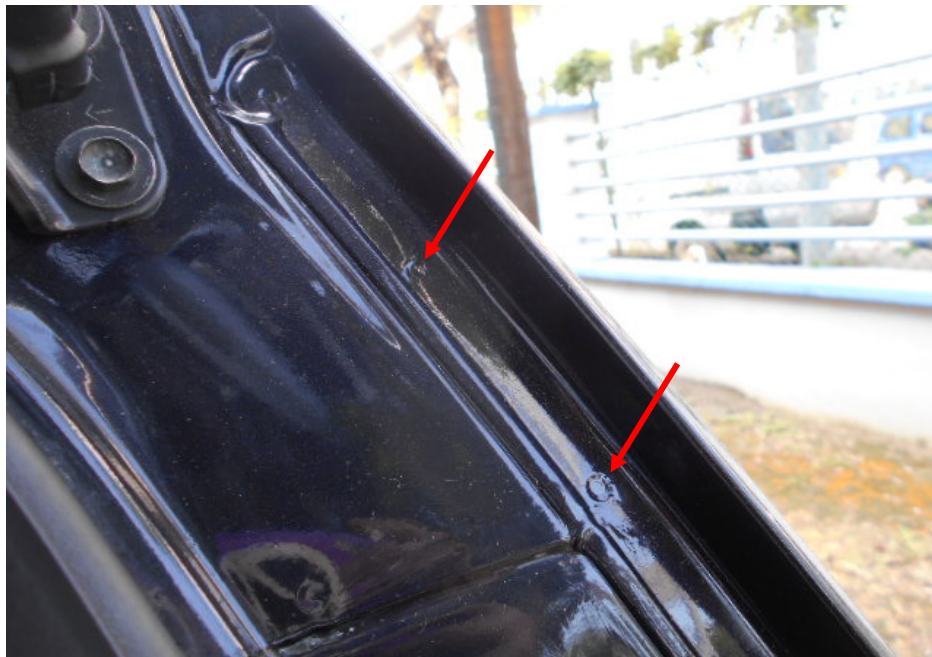
9. The other non-detachable body panels like the rear right fender, floor board, roof panel, pillars and rocker panels amongst others, revealed that these body panels were spot welded onto the structure body of the Motor Car. The original factory sealant at the joints of the non-detachable body panels was all untouched indicating no replacement of the non-detachable body panels was carried out; and that these body panels were all originally fitted.

Photo 15 shows the original spot weld marks (arrowed) on the rear right fender of the Motor Car. The body panels of the Motor Car were found to be with original welding marks except for the rear left fender of the Motor Car, where signs of removal and re-fitting were found (refer to photograph 16 below).

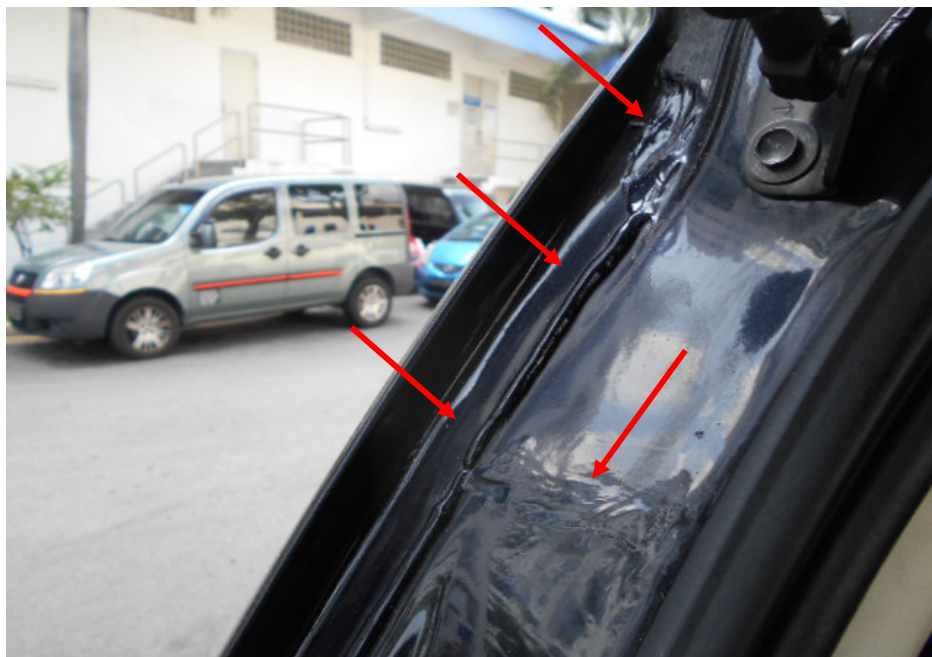
8. Checks on the non-detachable body panels revealed signs of removal and re-fitting of the rear left fender. The original welding of the rear left fender onto the body of the Motor Car could not be seen, indicating possible repair/replacement work carried out to the rear left fender. However, the repair/replacement work did not affect the structural body of the Motor Car as this rear left fender is an outer panel of the Motor Car and is originally not welded directly onto the structural body of the Motor Car.

21. Signs of removal and re-fitting of the Motor Car's rear left fender were found, which would indicate possible repair/replacement work carried out. However, the repair/replacement work did not affect the structural body of the Motor Car as this rear left fender is an outer panel and is originally not welded directly onto the structural body of the Motor Car.
22. My test drive of the Motor Car revealed no evidence to suggest possible mechanical problem(s) to the Motor Car. I did not experience any abnormal behaviour and/or sound(s) from the various operating systems of the Motor Car. The general performance, stability, braking and handling of the Motor Car were satisfactory throughout the Motor Car's short test drive. In general, I had found the Motor Car to be of road worthy condition. See photo 1 – 16 below taken at the time of my inspection.

Photo 16 shows the rear left fender of the Motor Car. Signs (arrowed) of removal and re-fitting of the rear left fender were observed. The original spot weld marks on the rear left fender of the Motor Car could not be seen as compared to the same area on the rear right fender (refer to photograph 15 above). The removal and re-fitting of the rear left fender would indicate possible repair/replacement work was carried out to the rear left fender. However, the repair/replacement work did not affect the structural body of the Motor Car as this rear left fender is an outer panel and is originally not welded directly onto the structural body of the Motor Car.
