Your Ref: CMTD1802777/GPL  
Our Ref : CI/SMO18013863/D

31 July 2018

**AUTOMOBILE INSPECTION REPORT OF INSURED VEHICLE GBD 2586T  
INVOLVED IN AN ACCIDENT ON 26 JUNE 2018**

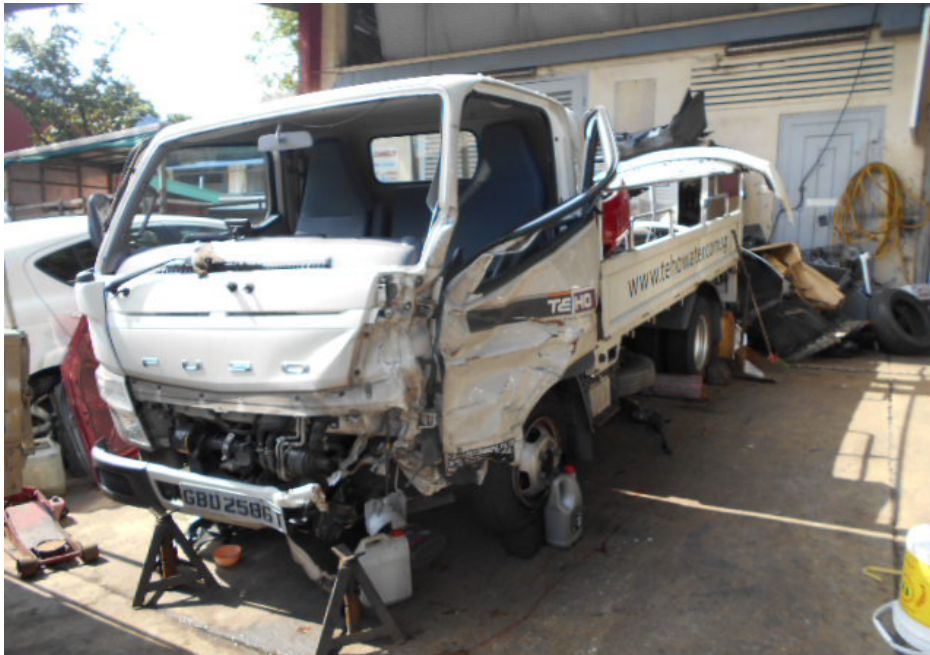
3. The insured vehicle was observed to have sustained impact damages on its frontal body and left front body. Its front bumper, front panel, front left headlamp, front grille, front right door, front left door and front windscreen were amongst the exterior body parts that were observed to have been damaged. Its front left wheel rim was dented and front left tyre was punctured as a result of the accident.

**Photo 1** shows a general view of the front left body of the insured vehicle at the time of my inspection. The front bumper, front panel, front grille, front left headlamp and front left door were amongst the exterior body parts that had sustained impact damages as a result of the accident.

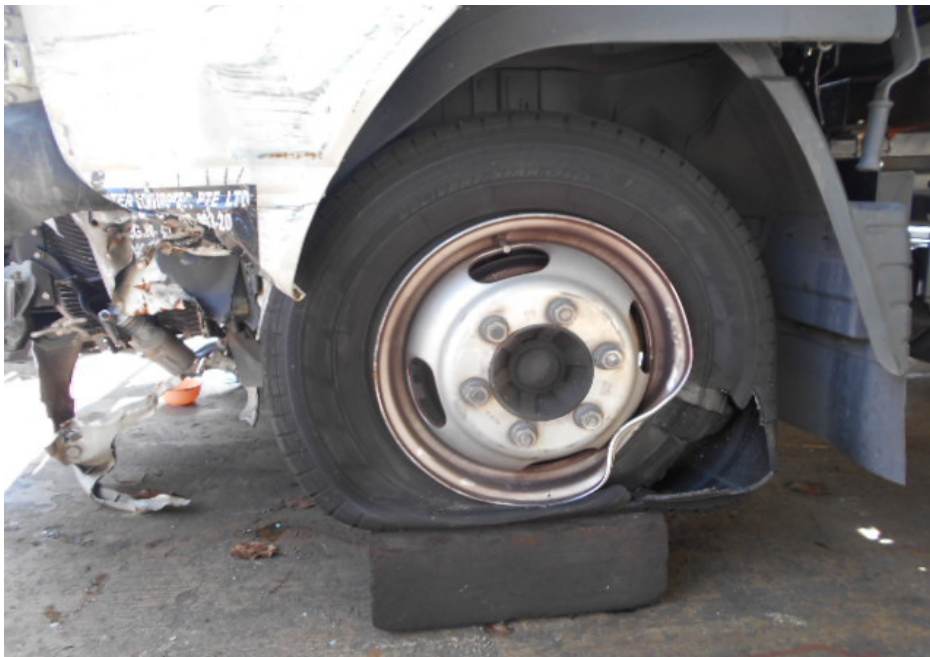
5. The front left tyre, on the other hand, was observed to be deflated with a hole on its outer sidewall. This was due to the accident impact as the front left wheel rim was dented, at the area adjacent to where the hole on the outer sidewall was found. See photo 1 – 4 below.

**Photo 2** shows a general view of the front left tyre and front left wheel rim of the insured vehicle. The front left wheel rim was observed to be dented. A hole was also observed on the outer sidewall of the front left tyre. These were damages arising from the accident impact. As a result, the front left tyre was punctured.

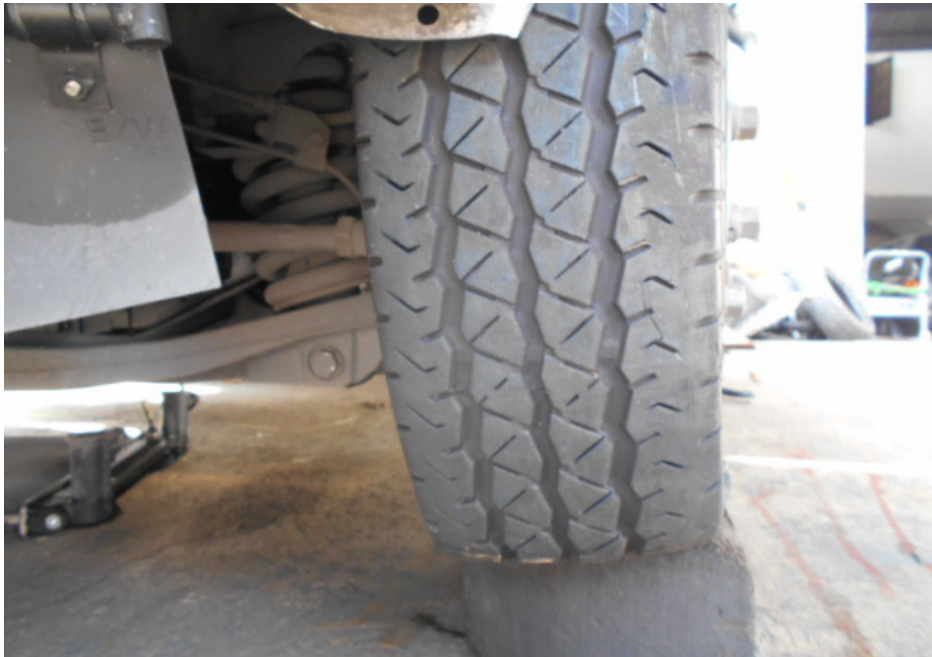
**Photo 3** shows the condition of the front left tyre of the insured vehicle, which was observed to be in serviceable condition with remaining tread depth of approximately 5mm. It was however punctured as a result of the accident impact (see photograph 2 above).

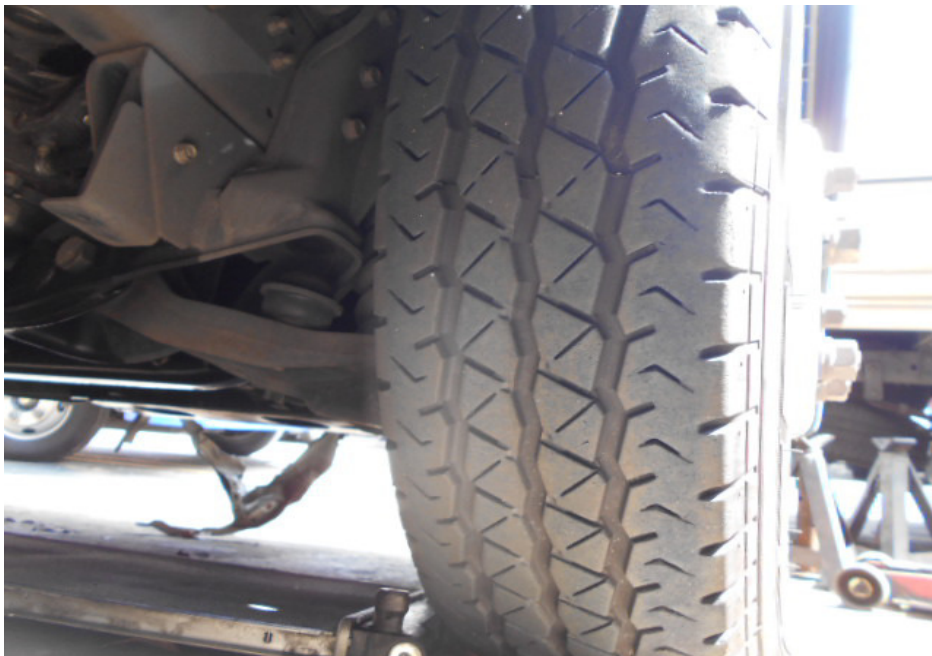
4. Examination carried out to the front tyres that were fitted on the insured vehicle revealed both its front tyres to be in serviceable condition with remaining tread depth of approximately 5mm each. The front right tyre was found to be sufficiently inflated for vehicular operation and without any tear, cut or burst mark(s) on the outer and the inner sidewalls as well as across the tread.

**Photo 4** shows the condition of the front right tyre of the insured vehicle, which was observed to be in serviceable condition with remaining tread depth of approximately 5mm. The front right tyre was also observed to be sufficiently inflated for vehicular operation with no tear, cut or burst mark(s) on its outer and inner sidewalls, as well as across its tread.

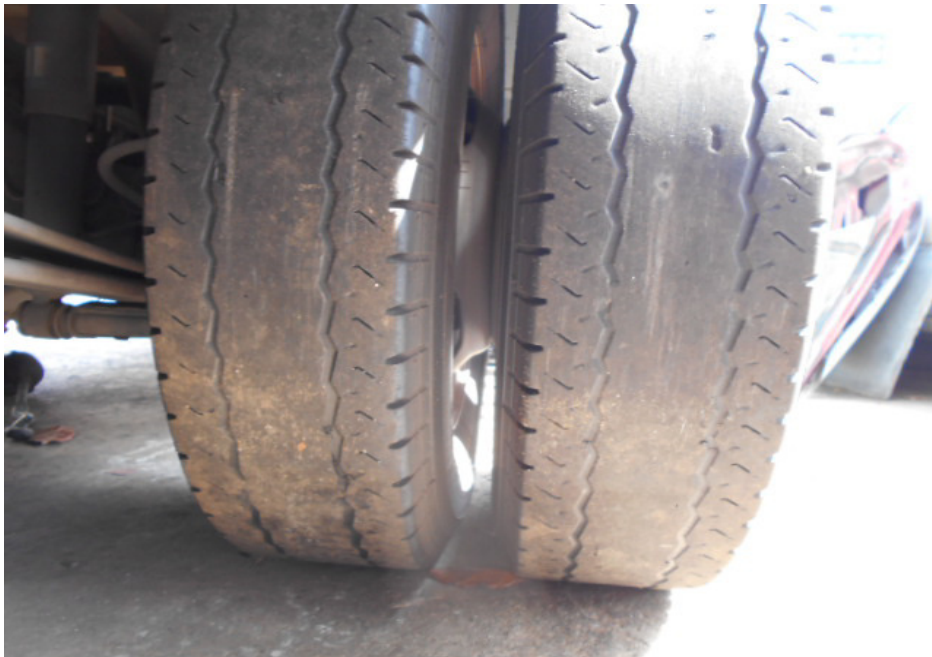
6. Upon examination of the insured vehicle's rear tyres, I note that there was a total of 4 tyres fitted. 2 at the rear right axle and 2 at the rear left axle. The pattern of the tread at the centre area of both rear right tyres were observed to be no longer visible. This was around the entire circumference of both the rear right tyres, and was largely due to the rubber wearing off. The pattern of the tread at the outer side of both these tyres were still visible. Both these tyres were found to be sufficiently inflated for vehicular operation and without any tear, cut or burst mark(s) on the outer and the inner sidewalls as well as across the tread.

**Photo 5** shows the rear right tyres of the insured vehicle at the time of my inspection. The pattern of the tread at the centre area of both rear right tyres were observed to be no longer visible. This was around the entire circumference of both the rear right tyres, and was largely due to the rubber wearing off. The pattern of the tread at the outer side of both these tyres were however still visible. Both these tyres were found to be sufficiently inflated for vehicular operation and without any tear, cut or burst mark(s) on the outer and the inner sidewalls as well as across the tread.

12. The condition of the inner and outer rear right tyres of the insured vehicle does not comply with SECTION 109(f) CAP 276 of THE ROAD TRAFFIC ACT, ROAD TRAFFIC (MOTOR VEHICLES, CONSTRUCTION AND USE) RULES. Under this section, it states that *"where the tyre is fitted to a wheel of a motor vehicle, being a motor cycle whereof the cylinder capacity of the engine does not exceed 50 cubic centimetres, the tread of the tyre does not show throughout at least 75% of the breadth of the tread and round the entire outer circumference of the tyre a pattern the relief of which is clearly visible, or where the tyre is fitted to the wheel of any other motor vehicle or any trailer, the tread pattern (excluding any tie-bar) of the tyre does not have a depth of at least one millimetre throughout at least 75% of the breadth of the tread and round the entire outer circumference of the tyre"*.

13. Basing on my observations and measurements of the rear right tyres of the insured vehicle, the centre part of both these tyres does not have a depth of at least 1mm around the entire circumference of the tyres. Both the tyres also do not have a pattern at the centre area that is visible around the entire circumference of the tyres.

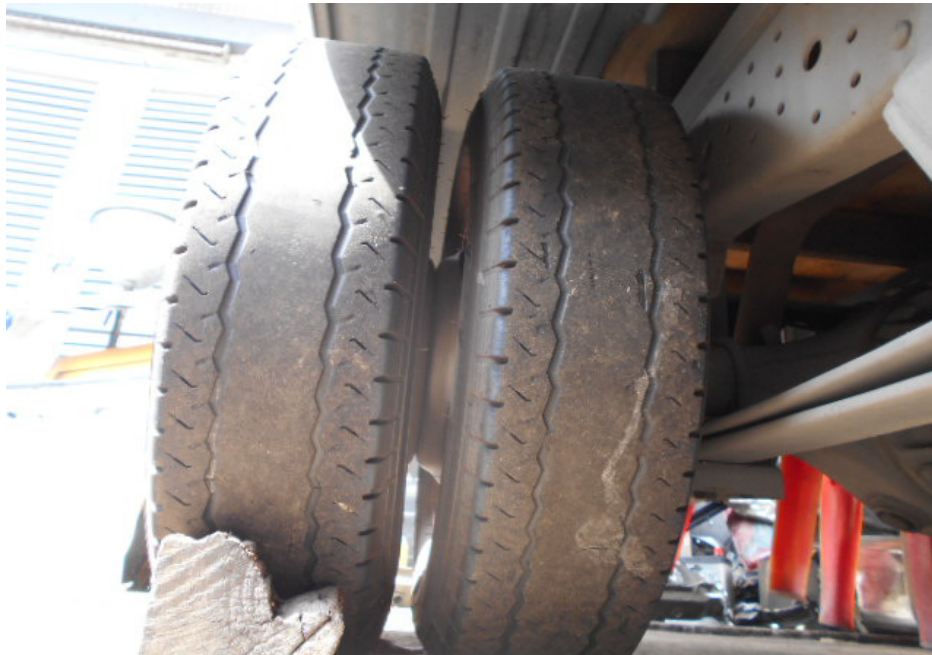
**Photo 6** shows the rear right tyres of the insured vehicle at the time of my inspection. The pattern of the tread at the centre area of both rear right tyres were observed to be no longer visible. This was around the entire circumference of both the rear right tyres, and was largely due to the rubber wearing off. The pattern of the tread at the outer side of both these tyres were however still visible. Both these tyres were found to be sufficiently inflated for vehicular operation and without any tear, cut or burst mark(s) on the outer and the inner sidewalls as well as across the tread.

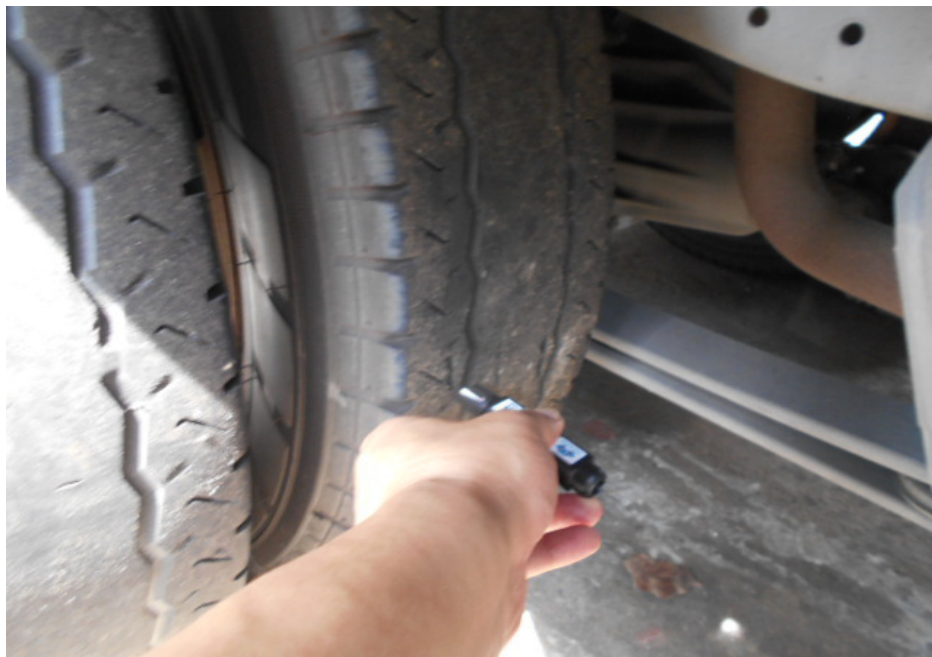
7. My measurements of the remaining depth of the tread pattern at the outer side of the 2 rear right tyres revealed remaining depth of approximately 1mm each. Since the tread pattern at the centre area of both the rear right tyres was no longer visible, the depth of the remaining tread pattern for the centre area can be considered to be 0mm. The 2 rear right tyres of the insured vehicle are thus not in serviceable condition. See photo 5 - 9 below.

**Photo 7** shows measurement being carried out to the remaining tread depth of the insured vehicle's rear right tyres.

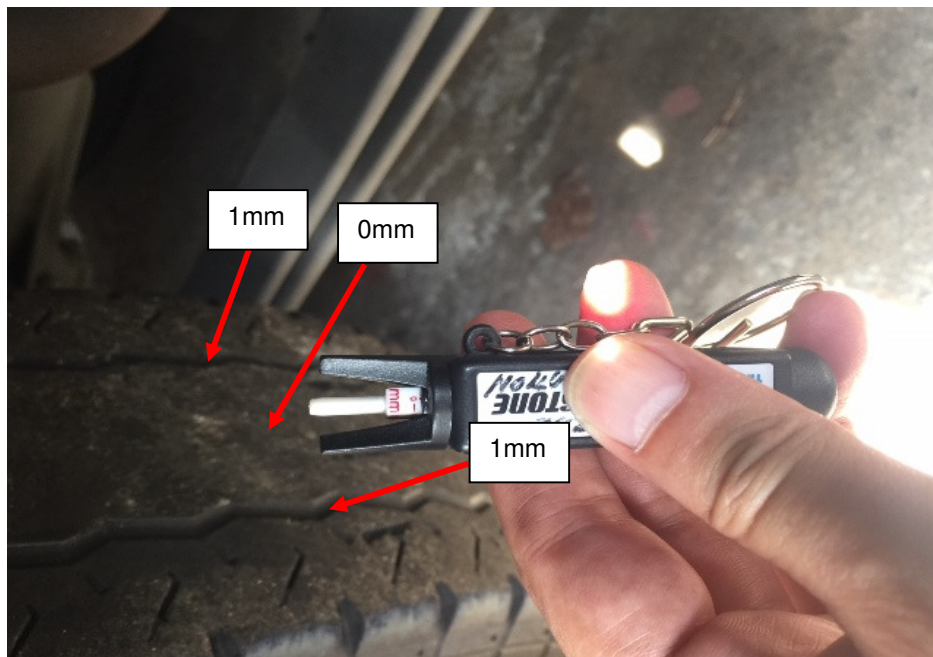
**Photo 8** shows the measurement of the remaining depth of the tread pattern at the outer side of the inner rear right tyre. The measurement had indicated approximately 1mm. Since the tread pattern at the centre area of the inner rear right tyre was no longer visible, the depth of the remaining tread pattern for the centre area of the inner rear right tyre can be considered to be 0mm.

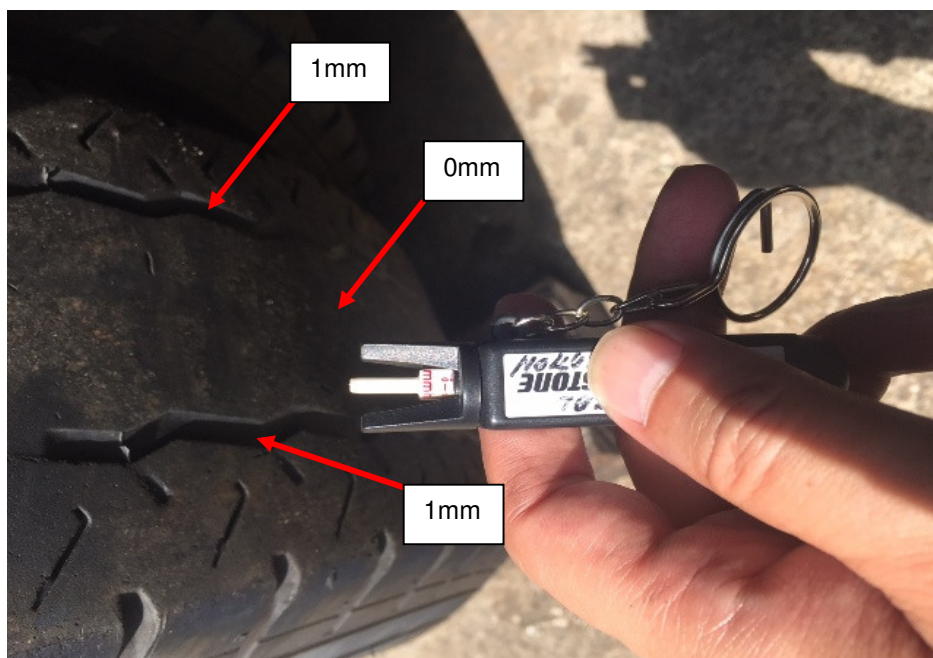
**Photo 9** shows the measurement of the remaining depth of the tread pattern at the outer side of the outer rear right tyre. The measurement had indicated approximately 1mm. Since the tread pattern at the centre area of the outer rear right tyre was no longer visible, the depth of the remaining tread pattern for the centre area of the outer rear right tyre can be considered to be 0mm.

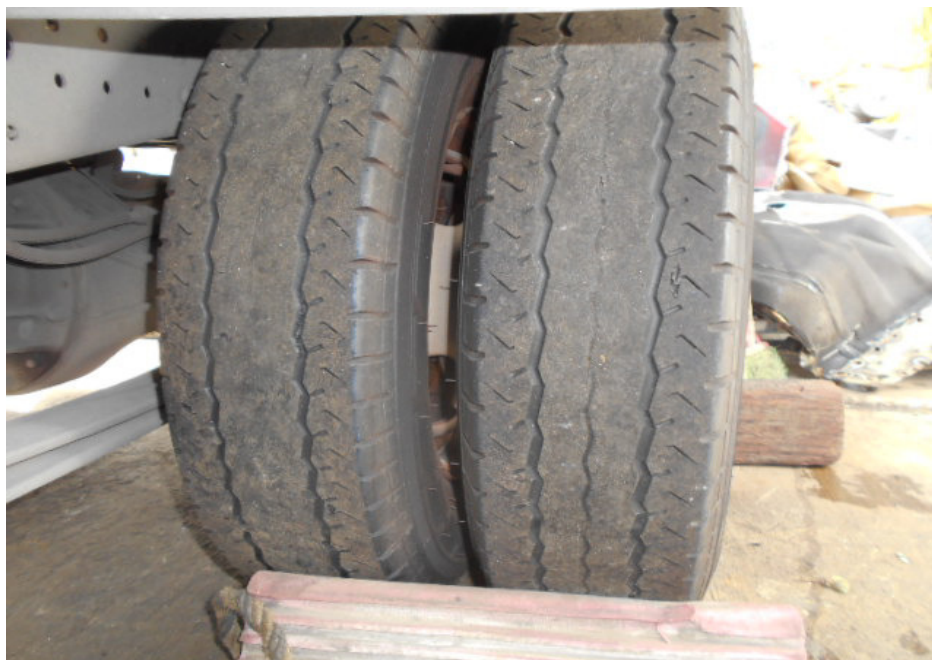
8. The rear left tyres of the insured vehicle on the other hand, were observed to be in a condition that was almost similar to the condition of the rear right tyres. The pattern of the tread at the centre area of both rear left tyres were observed to be no longer visible at some areas due to the rubber wearing off. Similar to the rear right tyres, the pattern of the tread at the outer side of both the rear left tyres were still visible. The 2 rear left tyres were found to be sufficiently inflated for vehicular operation and without any tear, cut or burst mark(s) on the outer and the inner sidewalls as well as across the tread.

**Photo 10** shows the rear left tyres of the insured vehicle at the time of my inspection. The pattern of the tread at the centre area of both rear left tyres were observed to be no longer visible at some areas due to the rubber wearing off. The pattern of the tread at the outer side of both these tyres were however still visible. Both these tyres were found to be sufficiently inflated for vehicular operation and without any tear, cut or burst mark(s) on the outer and the inner sidewalls as well as across the tread. The overall condition of the rear left tyres of the insured vehicle was slightly less worn as compared to the rear right tyres.

11. The inner and outer rear left tyres of the insured vehicle, although not in serviceable condition, may possibly be still within the requirements of the local governing body as the tread pattern at the centre area of both these tyres was still visible at some areas (borderline case).

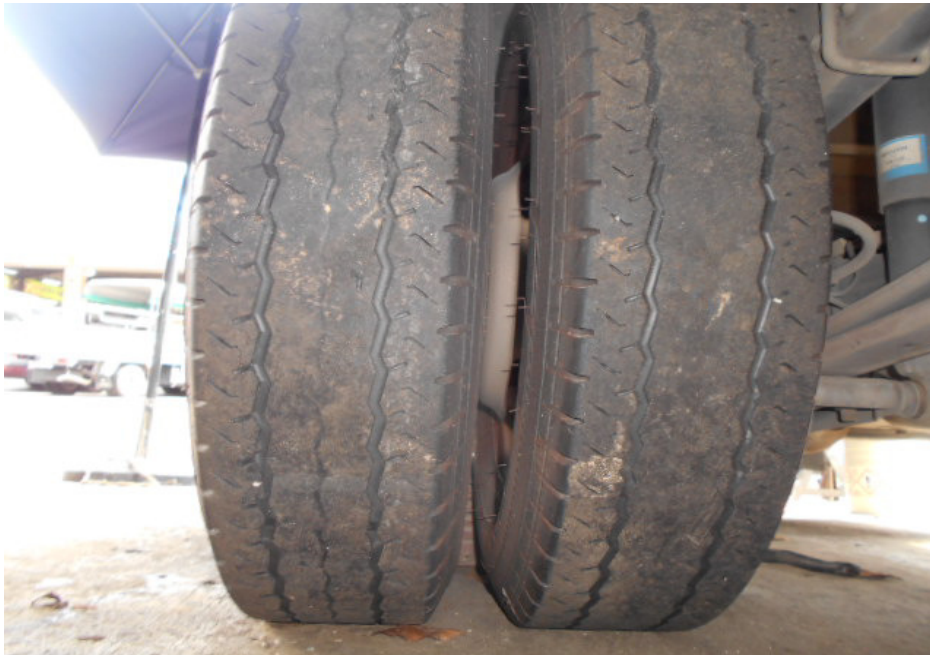
**Photo 11** shows the rear left tyres of the insured vehicle at the time of my inspection. The pattern of the tread at the centre area of both rear left tyres were observed to be no longer visible at some areas due to the rubber wearing off. The pattern of the tread at the outer side of both these tyres were however still visible. Both these tyres were found to be sufficiently inflated for vehicular operation and without any tear, cut or burst mark(s) on the outer and the inner sidewalls as well as across the tread. The overall condition of the rear left tyres of the insured vehicle was slightly less worn as compared to the rear right tyres.

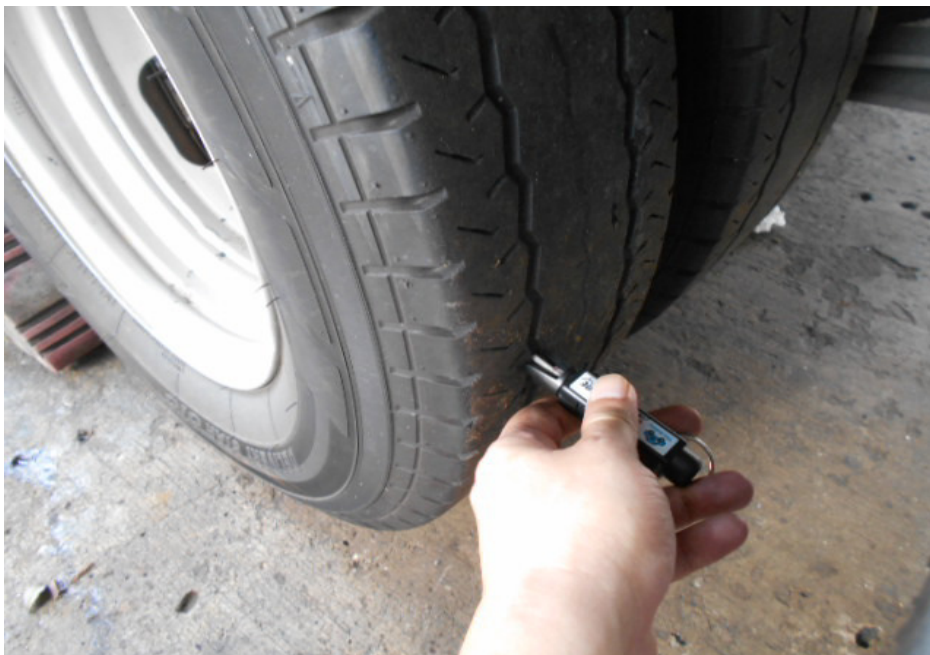
9. Measurements of the remaining depth of the tread pattern at the outer side of the 2 rear left tyres revealed remaining depth of approximately 1mm to 1.6mm. Since the tread pattern at the centre area of both the rear left tyres was no longer visible at some areas, the depth of the remaining tread pattern for the centre area can be considered to be 0mm at the area where the pattern of the tread is no longer visible. Similar to the 2 rear right tyres, the 2 rear left tyres are hence not in serviceable condition See photo 10 - 14 below.

**Photo 12** shows measurement being carried out to the remaining tread depth of the insured vehicle's rear left tyres.

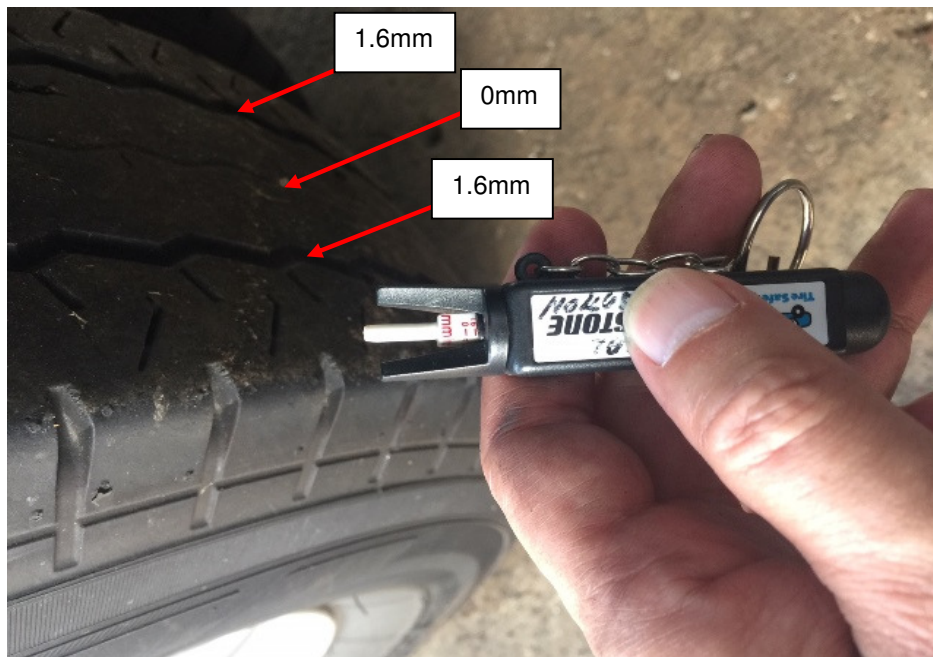
**Photo 13** shows the measurement of the remaining depth of the tread pattern at the outer side of the outer rear left tyre. The measurement had indicated approximately 1.6mm. Since the tread pattern at the centre area of the outer rear left tyre was no longer visible at some areas, the depth of the remaining tread pattern for the centre area of the outer rear left tyre can be considered to be 0mm, at the area where the pattern of the tread is no longer visible.

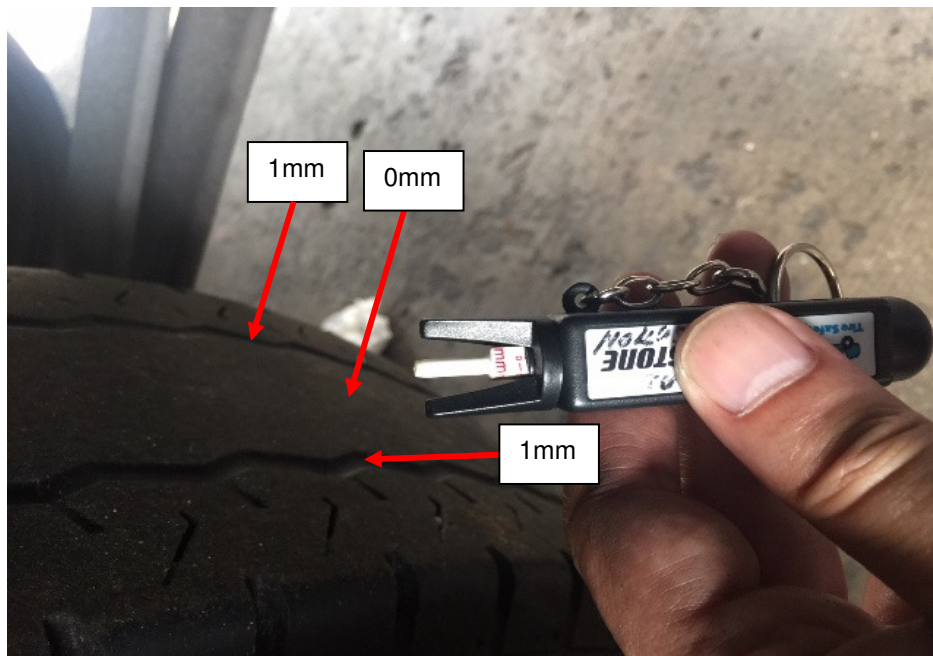
**Photo 14** shows the measurement of the remaining depth of the tread pattern at the outer side of the inner rear left tyre. The measurement had indicated approximately 1mm. Since the tread pattern at the centre area of the inner rear left tyre was no longer visible, the depth of the remaining tread pattern for the centre area of the inner rear left tyre can be considered to be 0mm.
