Claim Reference:
Assessment Number: AH000889
Version: AHLIM001/1
Date Calculated: 30/07/2018 03:16

Full Report - V1
Registration: SJG8288D
Printed: 30/07/2018 10:16

Manufacturer: MERCEDES
 Model: S Class
 Sub Model: S 300 LONG
 Model Sheet Number: 349 96
 Registration: ✓ SJG8288D
 Registration Month: July
 Registration Year: 2012
 VIN Number: WDD2211542A481697
 Manufacture Year: 2012
 Odometer: Not Known
 Colour:
 Engine Number: 27294632049991
 Fuel Level: %

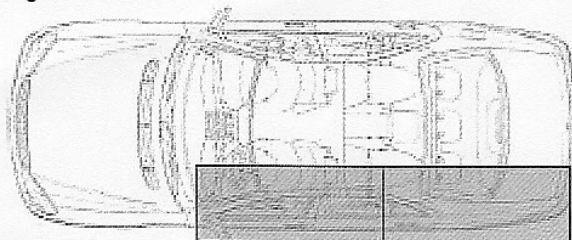
Tread Depth LHR:
Damage Areas:

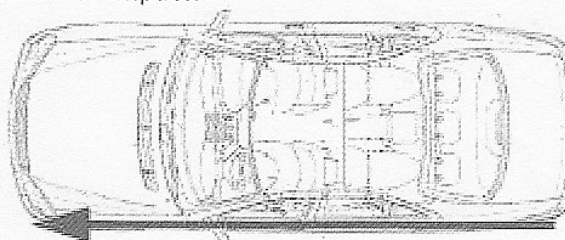
Tread Depth RHR:
Direction of Impact:
