Your Ref: TP/IP/40617/2018
Our Ref : CI/TPD18014209/Z

Fatal Accident Investigation Team
Traffic Police Department
Singapore Police Force
10 Ubi Avenue 3
Singapore 408865

MECHANICAL INSPECTION REPORT OF MOTOR CAR SDV 234D

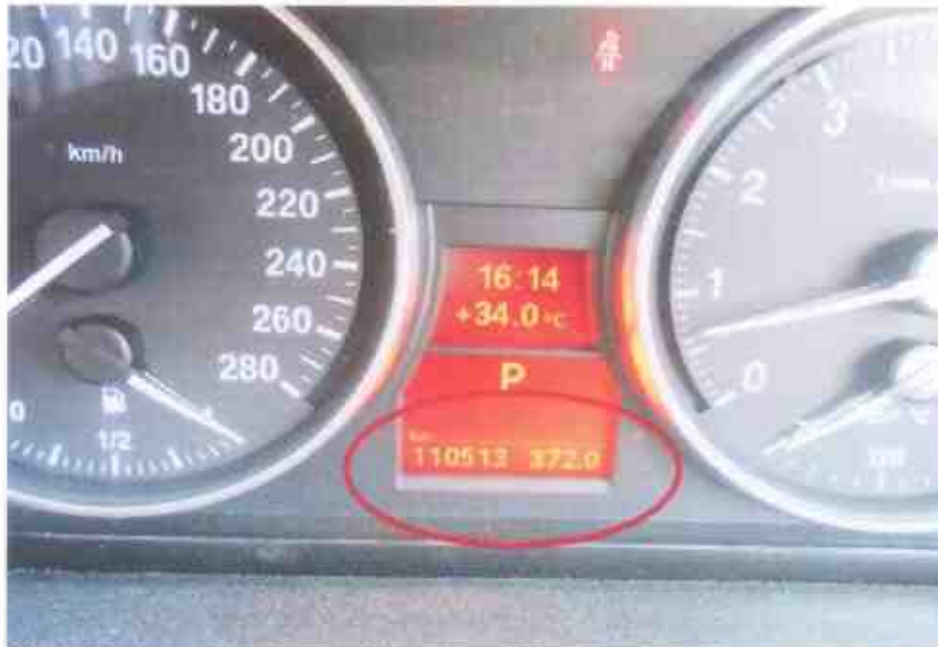
Photo 1 shows the mileage of the Motor Car at the time of our inspection was recorded at 110513km.

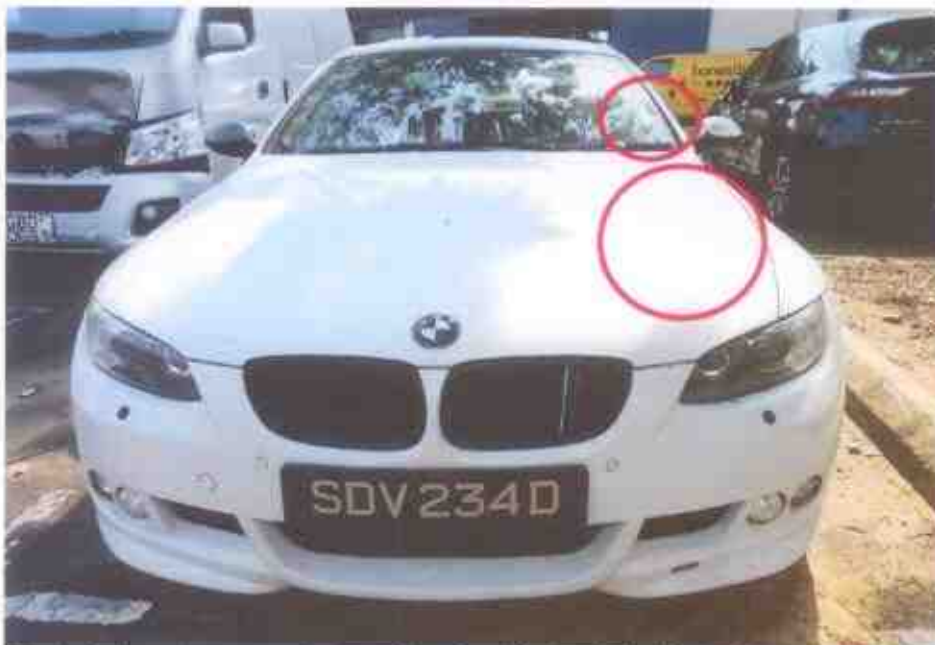
Photo 2 shows a general view of the front body of the Motor Car at the time of our inspection. The Motor Car was observed to have sustained a relatively minor impact damages that was confined to its frontal portion. Its front left bonnet was corrugated & its shattered windshield was observed to be affected likely due to the accident.

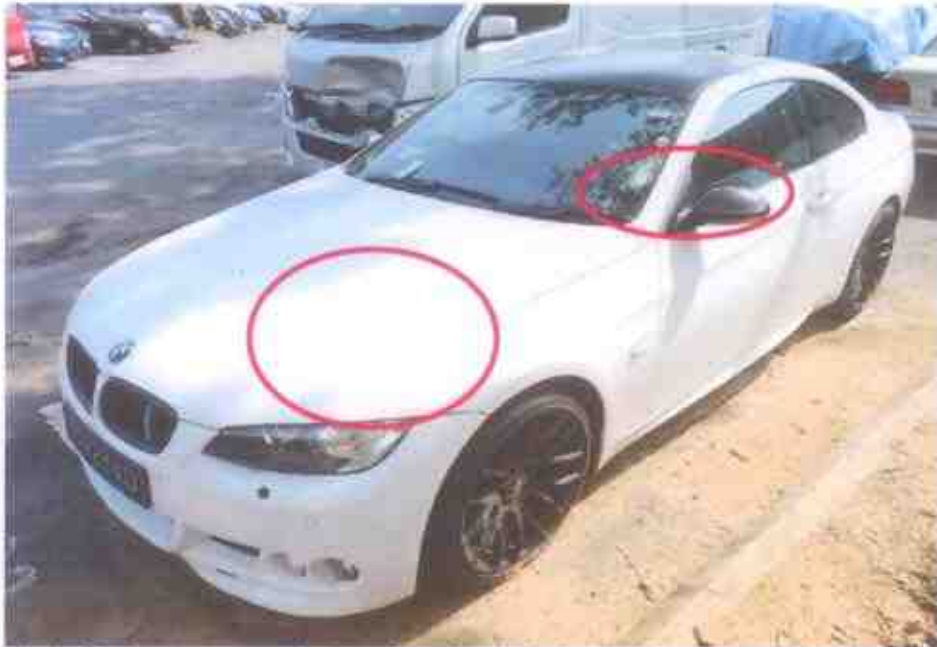
Photo 3 shows a general view of the front left body of the Motor Car at the time of our inspection. The Motor Car was observed to have sustained a relatively minor impact damages that was confined to its frontal portion. Its front left bonnet was corrugated & its shattered windshield was observed to be affected likely due to the accident.

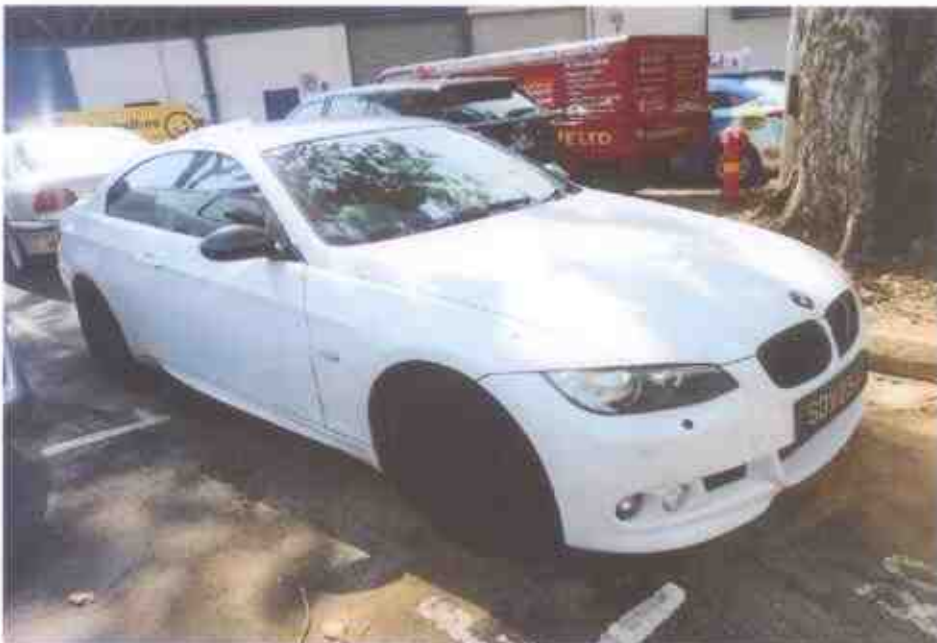
Photo 4 shows a general view of the front right body of the Motor Car at the time of our inspection. The Motor Car was observed to be in good condition.

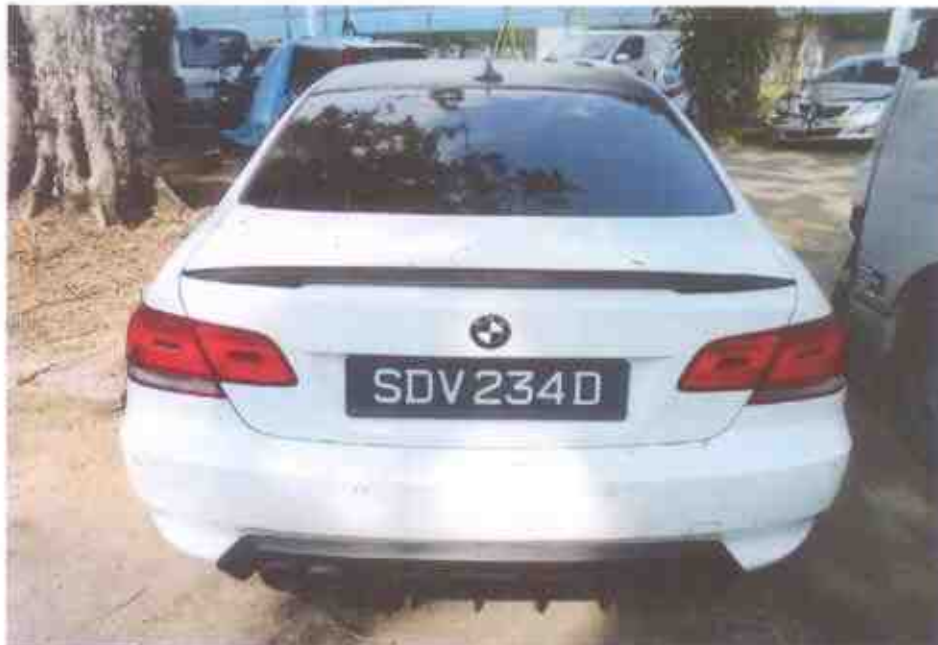
Photo 5 shows a general view of the rear body of the Motor Car at the time of our inspection. The Motor Car was observed to be in good general condition.

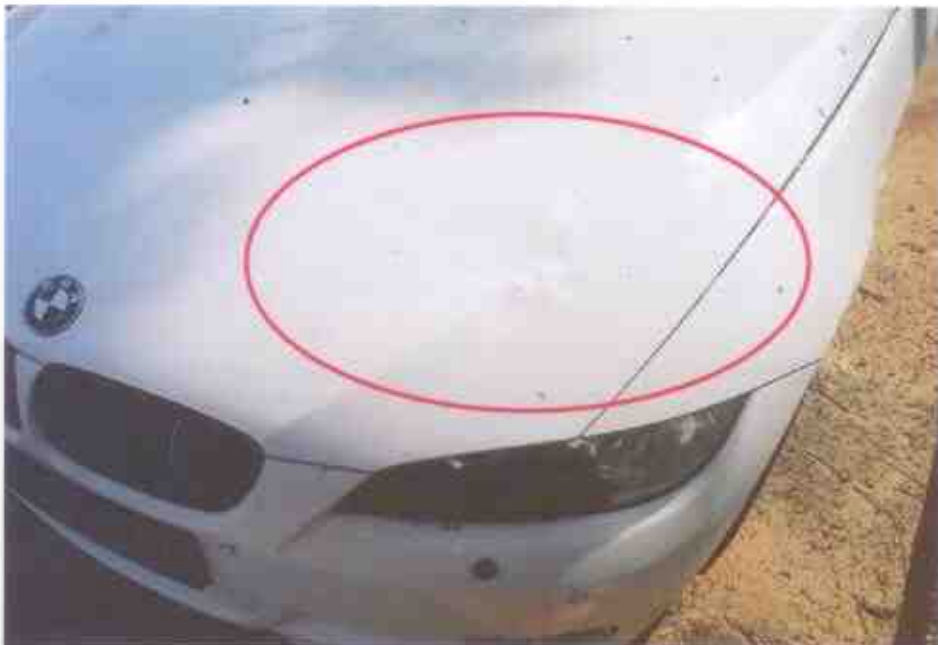
Photo 6 shows a close up view of the front left portion of the Motor Car at the time of our inspection. The Motor Car had sustained relatively minor damages at the front left bonnet of the Motor Car.

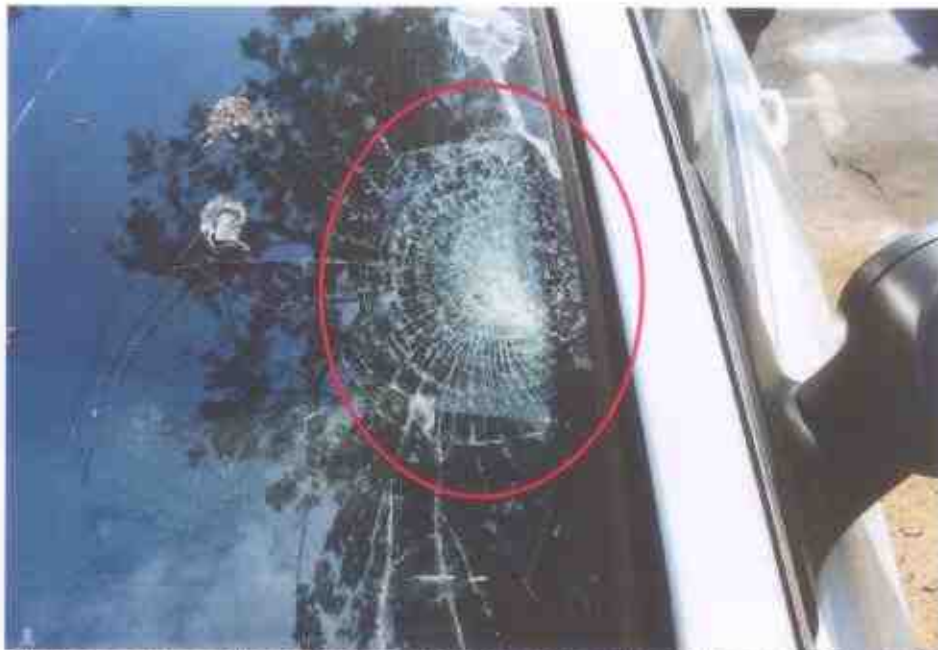
Photo 7 shows a close up view of the front left portion of the Motor Car at the time of our inspection. The Motor Car had sustained shattering cracked at the front left portion of the Motor Car.

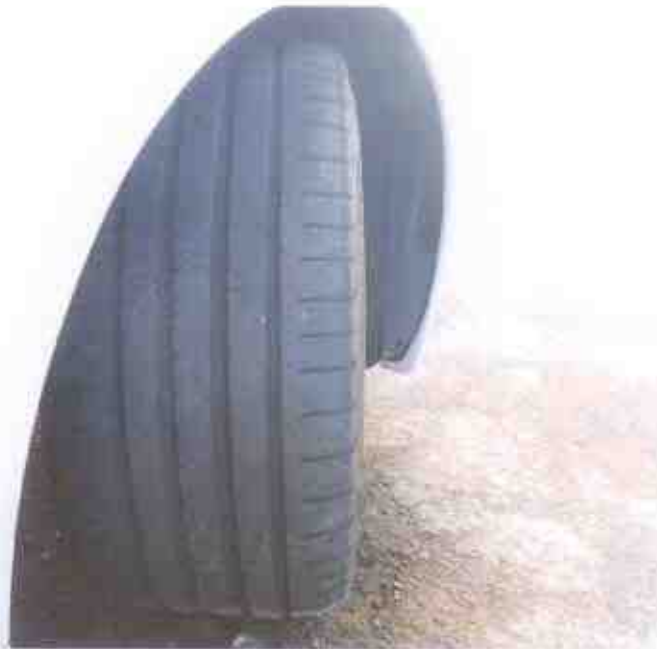
Photo 8 shows the condition of the front right tyre of the Motor Car, which was observed to be in serviceable condition with remaining tread depth of approximately 6mm. The tyre, which was wrapped around alloy wheel rim, was also observed to be sufficiently inflated for vehicular operation.

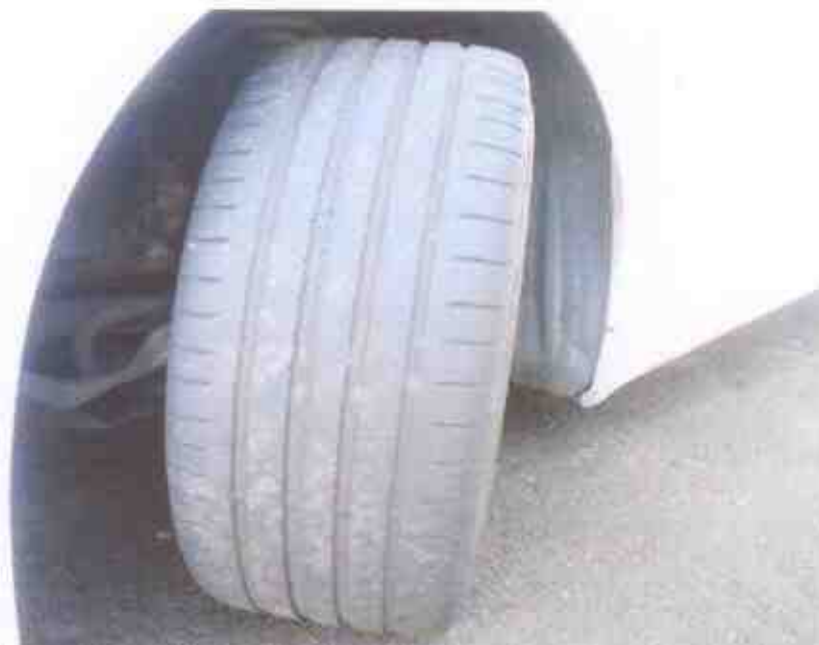
Photo 9 shows the condition of the front left tyre of the Motor Car, which was observed to be in serviceable condition with remaining tread depth of approximately 6mm. The tyre, which was wrapped around alloy wheel rim, was also observed to be sufficiently inflated for vehicular operation.

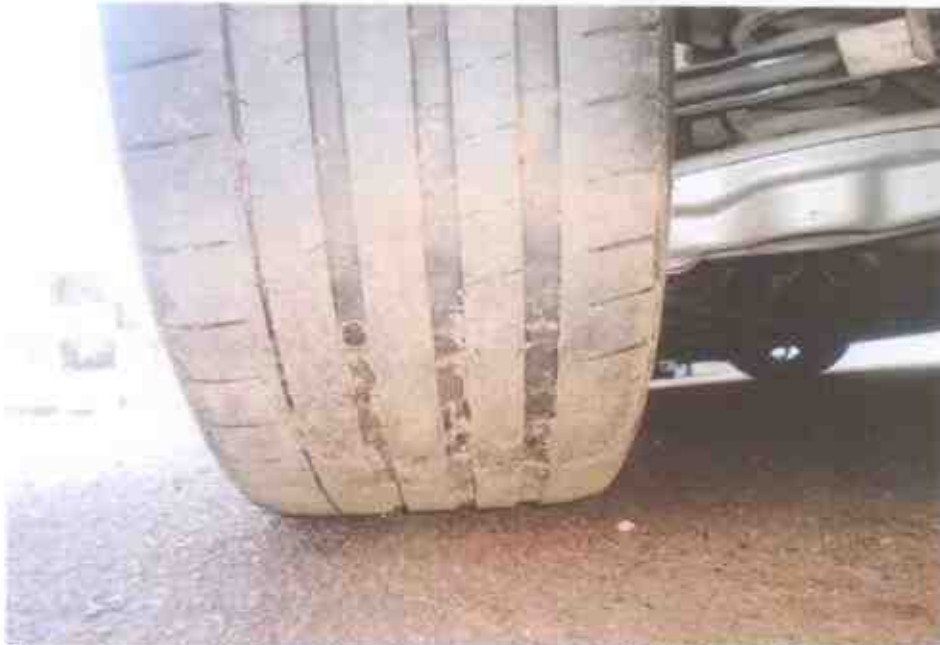
Photo 10 shows the condition of the rear left tyre of the Motor Car, which was observed to be in serviceable condition with remaining tread depth of approximately 4mm.

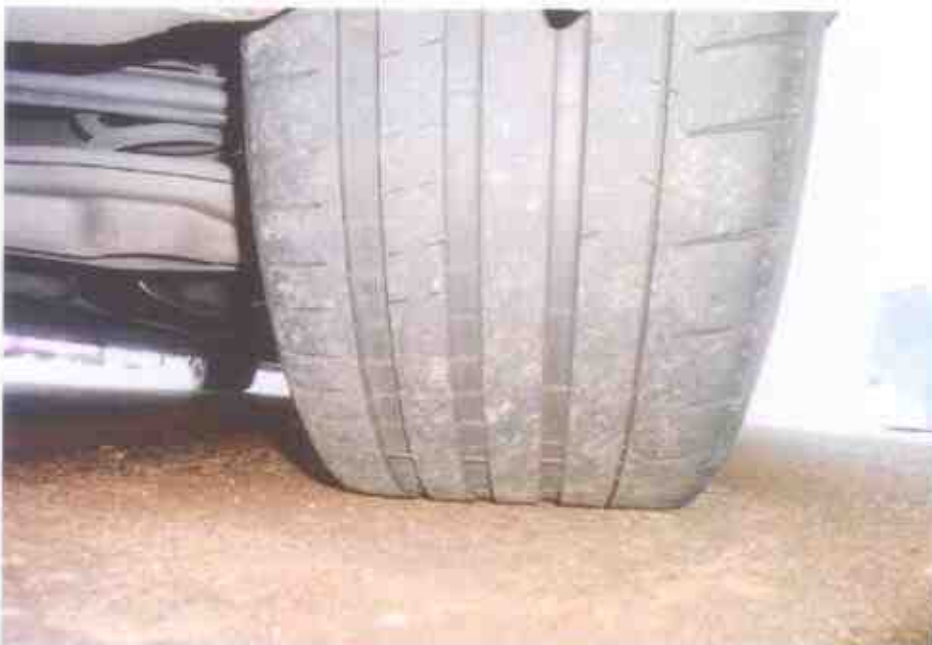
Photo 11 shows the condition of the rear right tyre of the Motor Car, which was observed to be in serviceable condition with remaining tread depth of approximately 4mm.

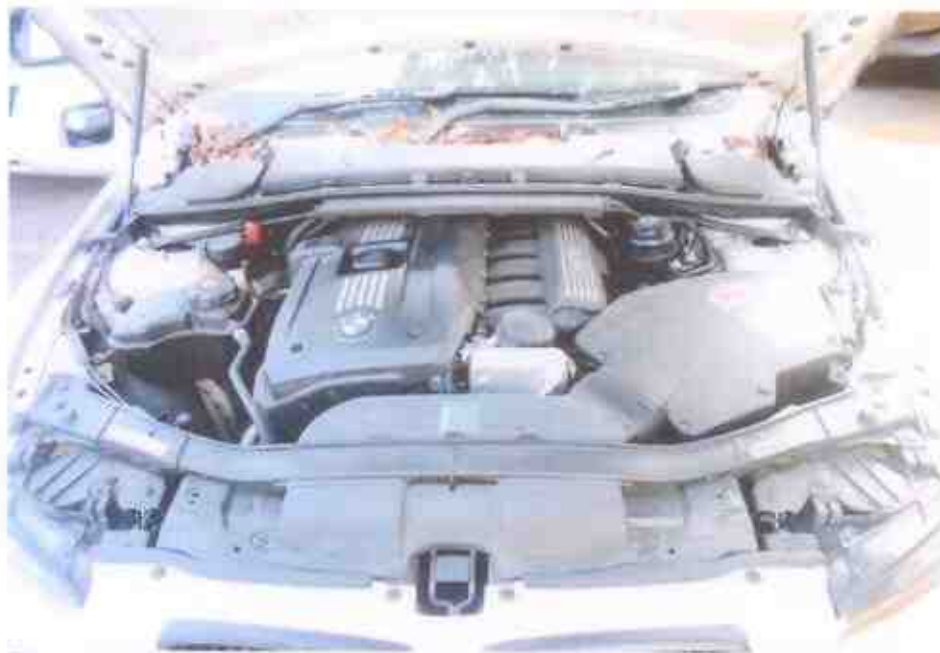
Photo 12 shows a general view of the Motor Car's engine compartment. The various parts and components inside the engine compartment were unaffected by the accident. There was also no sign(s) or indication(s) of fresh fluid leakage and/or fluid stain within the engine compartment.

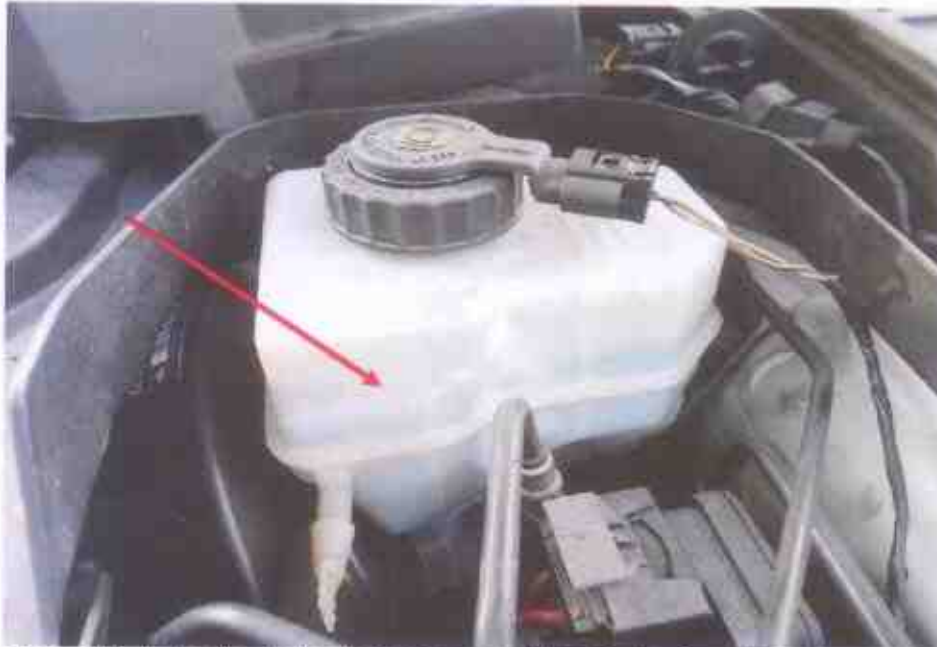
Photo 13 shows the brake fluid reservoir of the Motor Car at the time of our inspection. The brake fluid was observed to be of sufficient level (arrowed) and without any visible contamination.

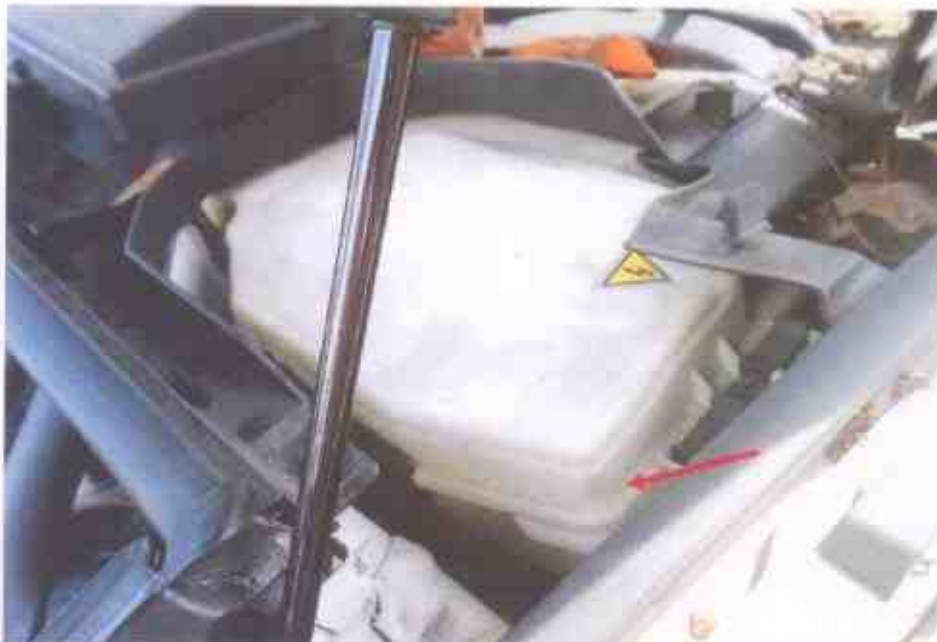
Photo 14 shows the engine coolant fluid reservoir of the Motor Car at the time of our inspection. The engine coolant fluid was observed to be of sufficient level and without any visible contamination.

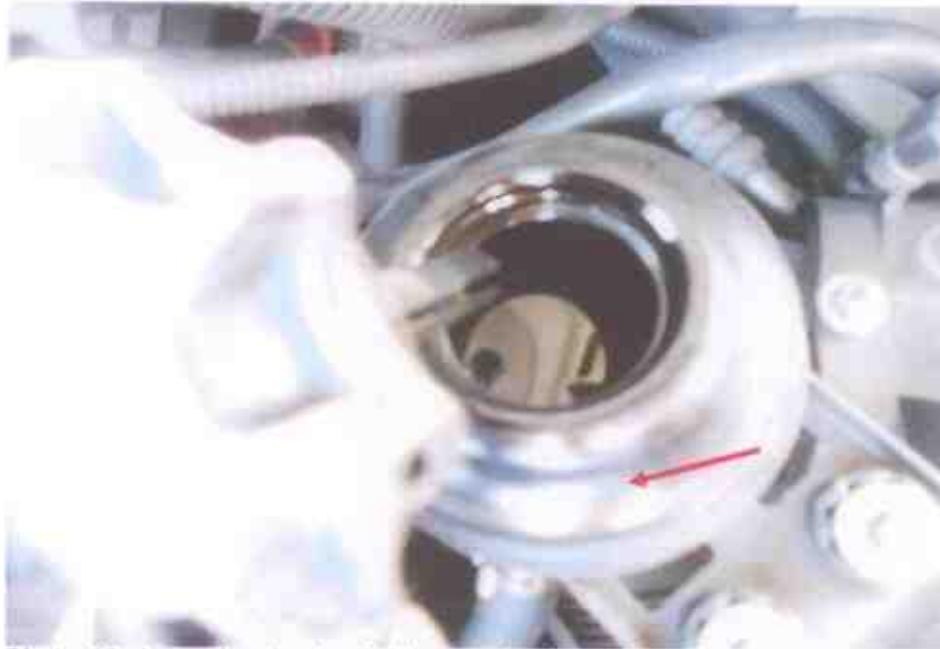
Photo 15 shows the steering fluid reservoir of the Motor Car at the time of our inspection. It was observed to be of sufficient level and without any visible contamination.

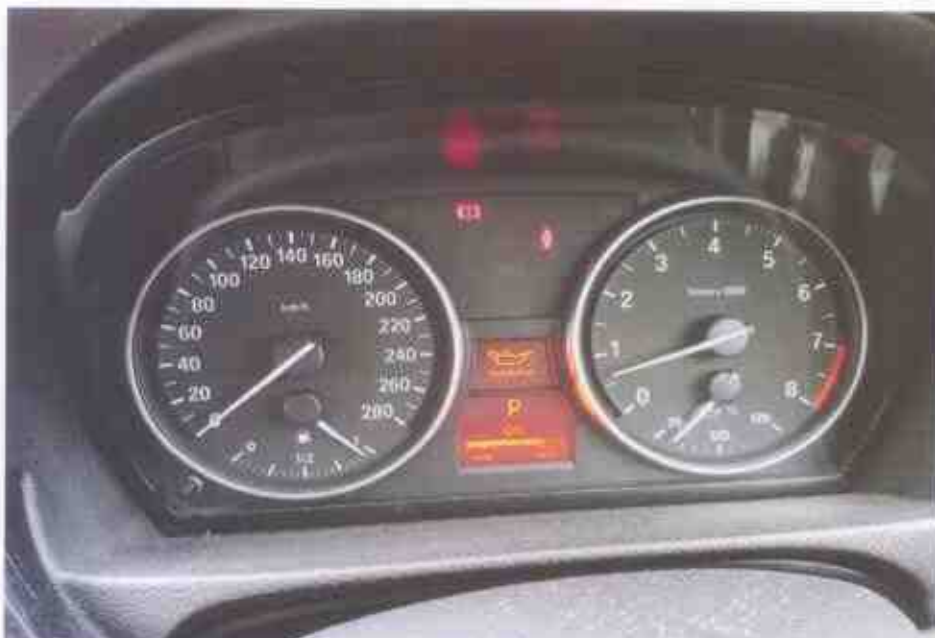
Photo 16 shows the engine fluid indication on the system of the Motor Car at the time of our inspection. The engine oil was observed to be of sufficient level from the system reading.

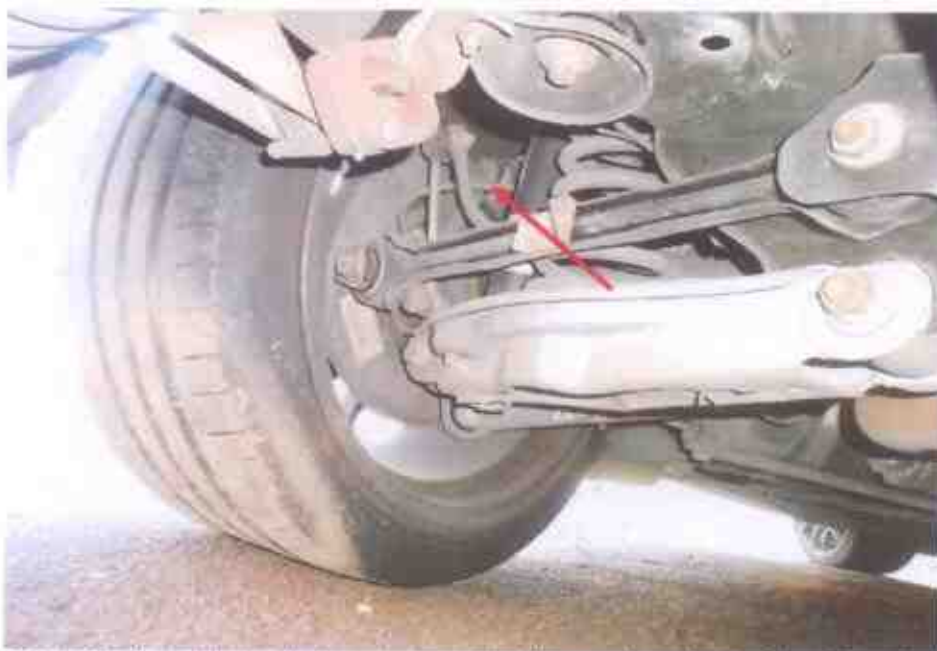
Photo 17 shows the brake hose (arrowed) at the rear left wheel of the Motor Car. We did not observe any leakage of brake fluid at the time of our inspection of the Motor Car. Our visual inspection of the various mechanical components of the Motor Car's braking system revealed all to be intact without visible damage.

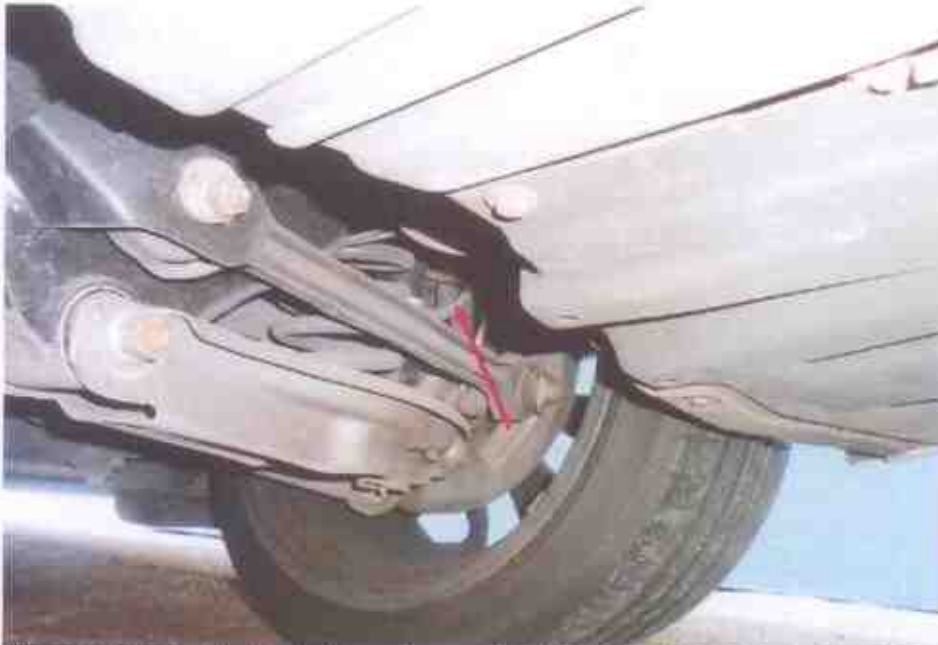
Photo 18 shows the brake hose (arrowed) at the rear right wheel of the Motor Car. We did not observe any leakage of brake fluid at the time of our inspection of the Motor Car. Our visual inspection of the various mechanical components of the Motor Car's braking system revealed all to be intact without visible damage.

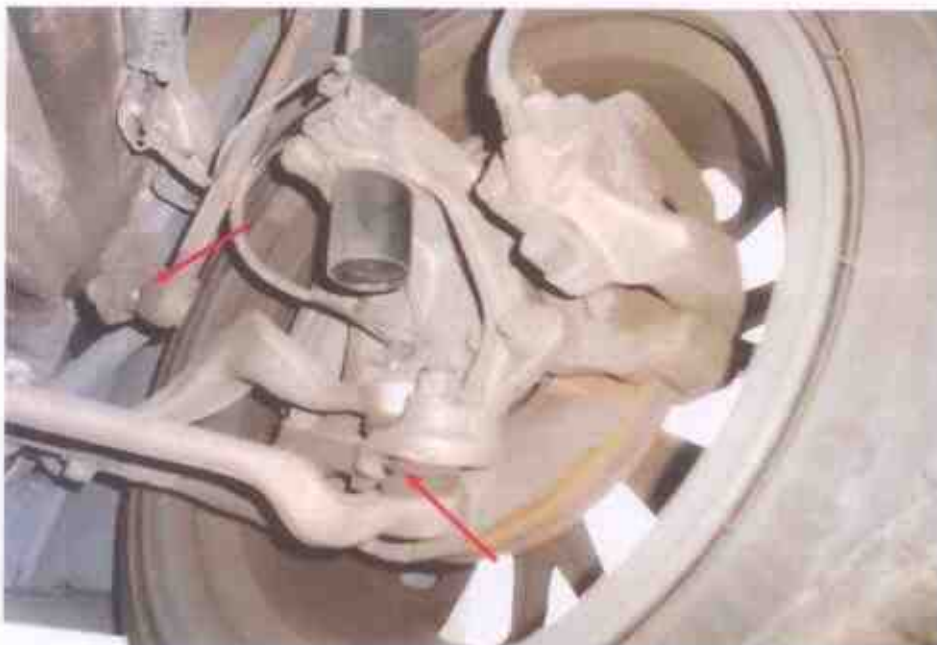
Photo 19 shows the various undercarriage components at the front right wheel of the Motor Car, in particular the steering tie rod (arrowed). The various steering components were all found to be intact, suggesting that the steering system of the Motor Car was likely to be in serviceable condition.

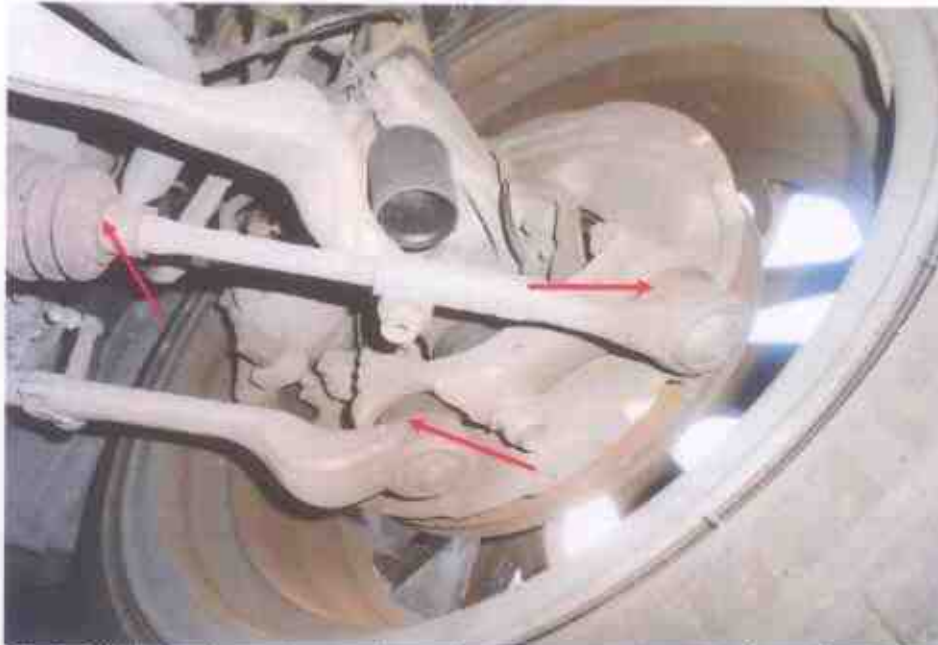
Photo 20 shows the various undercarriage components at the front left wheel of the Motor Car. We did not observe any leakage of brake fluid (arrowed) at the time of our inspection of the Motor Car. Our visual inspection of the various mechanical components of the Motor Car's braking system revealed all to be intact and without visible damage, indicating that the braking system was likely to be in serviceable condition at the material time of accident.

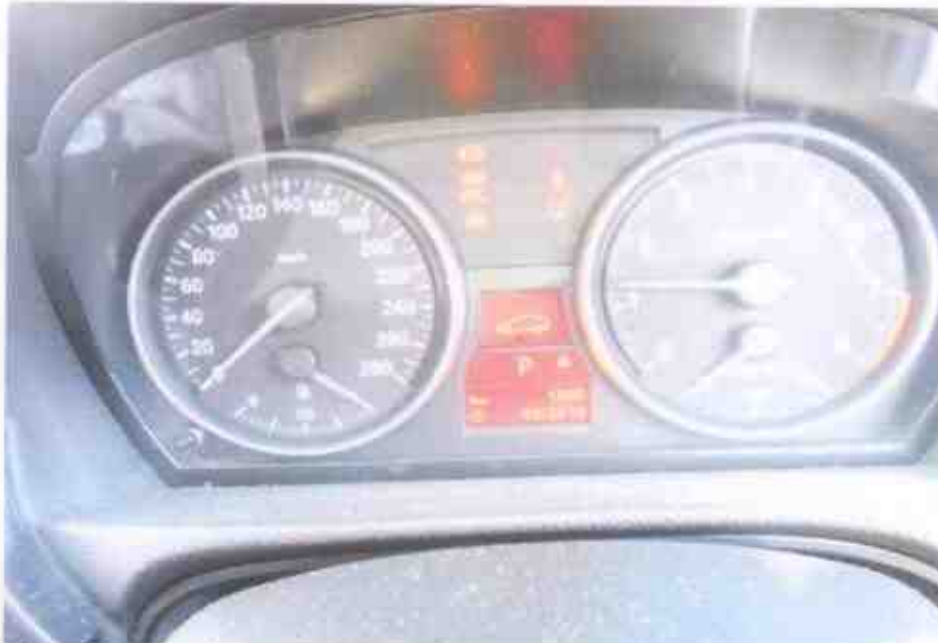
Photo 21 shows the warning lights for the various electronic operating systems of the Motor Car appearing on its instrument panel during the self-test when the engine is cranked, in particular the ABS light.

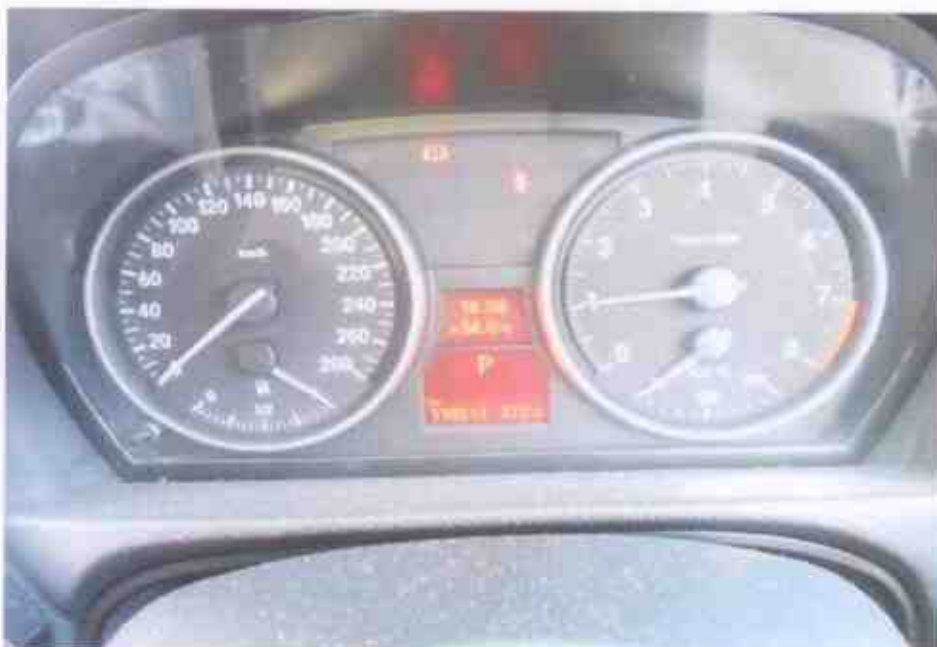
Photo 22 shows most warning lights disappearing from the instrument panel of the Motor Car after the engine was cranked.

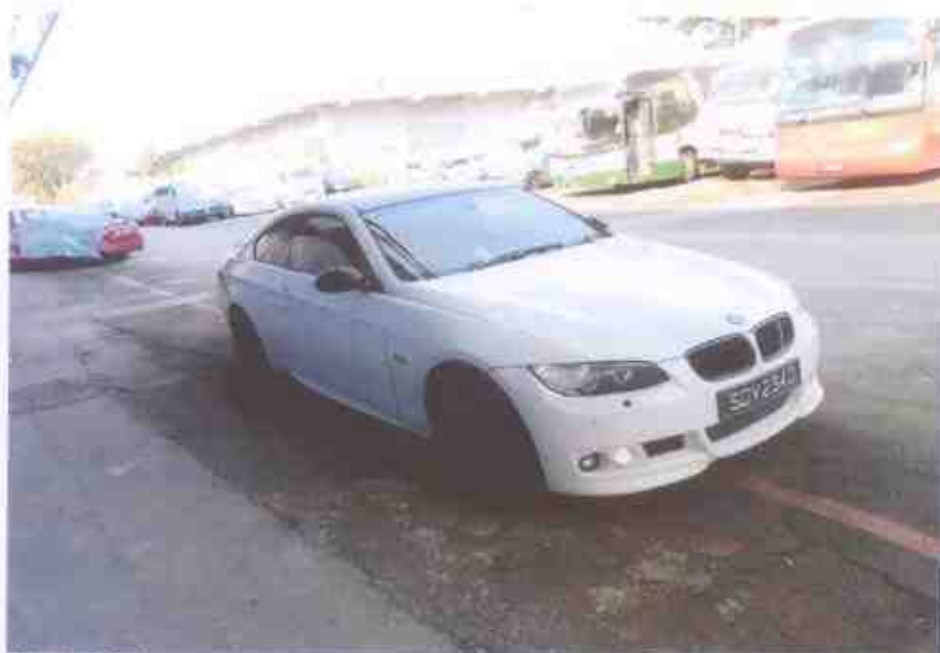
Photo 23 shows we conducted an operational test on the Motor Car. Drive mode, Reverse mode & Neutral mode were engaged at time of our test. Brake pedal was also engaged to a complete stop. There was no abnormality observed at time of testing.
