Your Ref: TP/IP/42503/2018  
Our Ref :CI/TPD18014211/Z

**Fatal Accident Investigation Team**  
Traffic Police Department  
Singapore Police Force  
10 Ubi Avenue 3  
Singapore 408865

### **MECHANICAL INSPECTION REPORT OF MOTORCYCLE FQ 6299E**

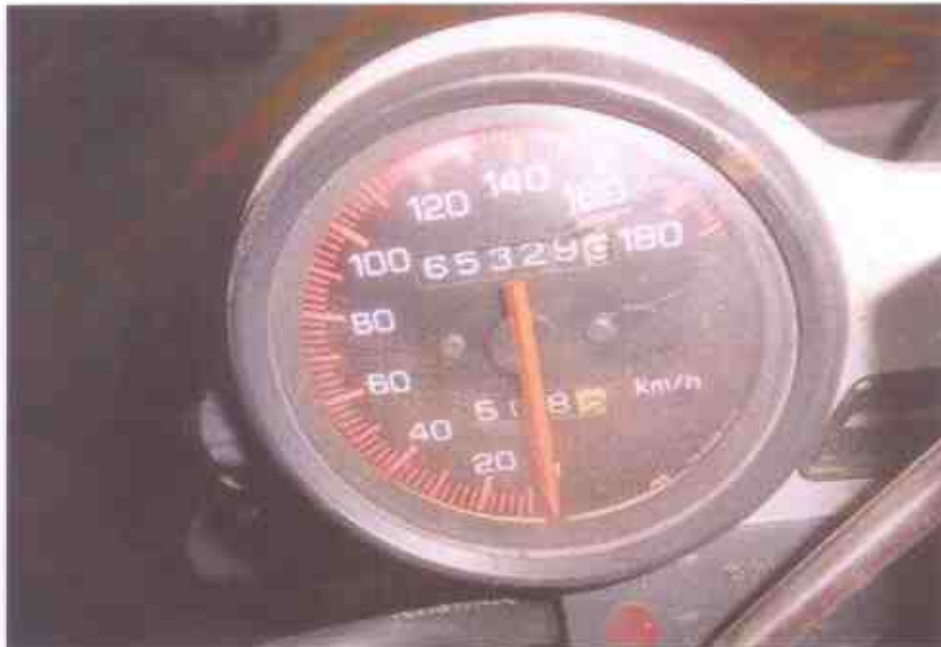
4. The mileage of the Motorcycle recorded at time of our inspection was 653299km.
5. The Motorcycle was observed to have sustained minor damages at the frontal portion, left & right portion. The body parts that were found to have been damaged include its front fairing, rear brake pedal, wing mirrors, clutch lever, handle bar, left foot rest, dislodged IU, seat assembly and front mudguard amongst others as a result of the accident.

**Photo 1** shows a close-up view of the mileage meter at time of our inspection. The mileage was recorded at 653299km.

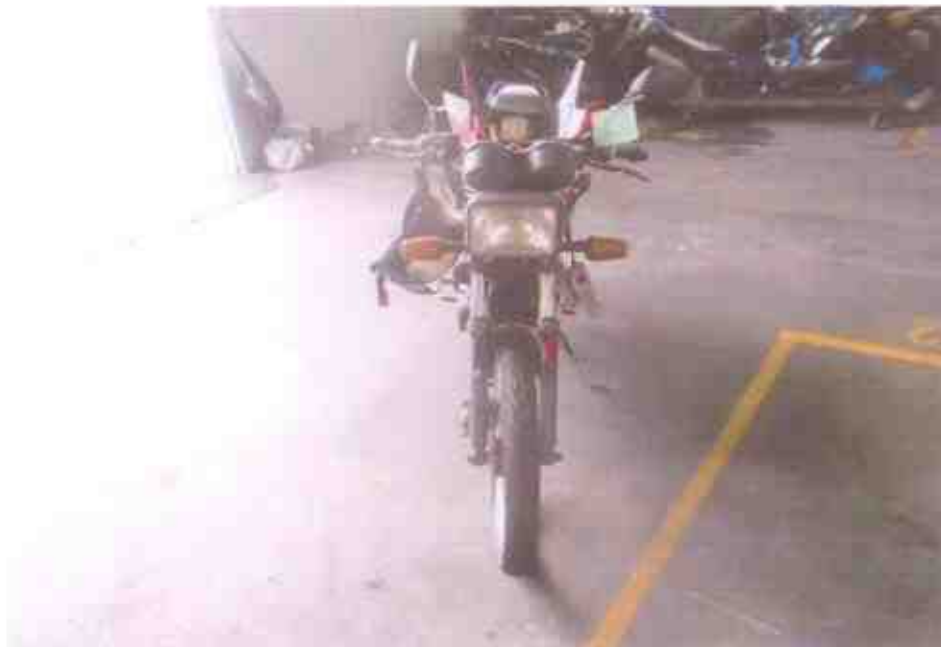
**Photo 2** shows a general view of the front body of the Motorcycle at the time of our inspection. The Motorcycle was observed to have sustained damages at time of inspection.

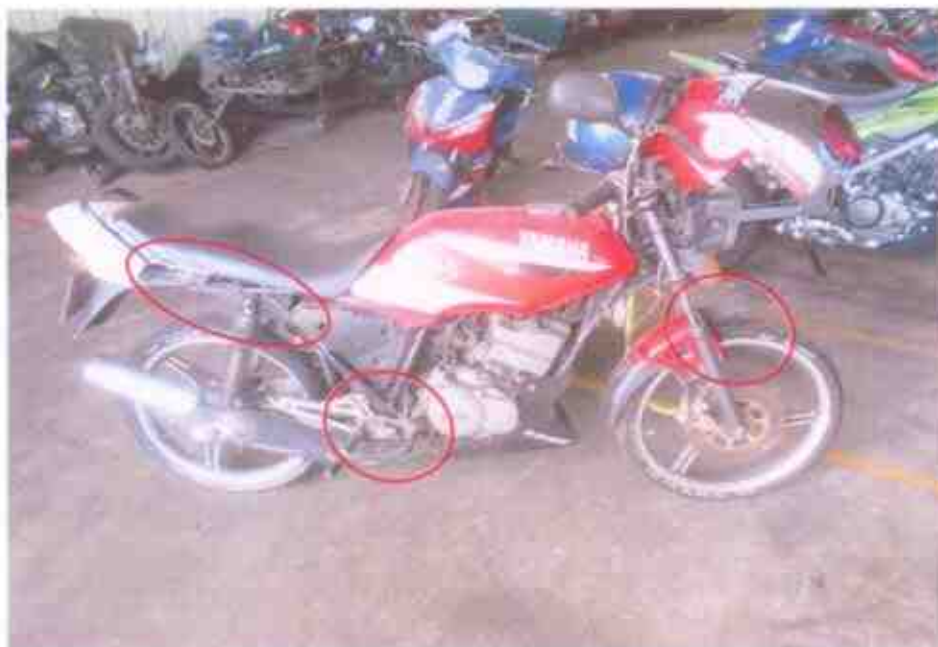
**Photo 3** shows a general view of the right body of the Motorcycle at the time of our inspection. The Motorcycle was observed to have sustained damages on the right side fairing, rear brake pedal & mudguard at time of our inspection.

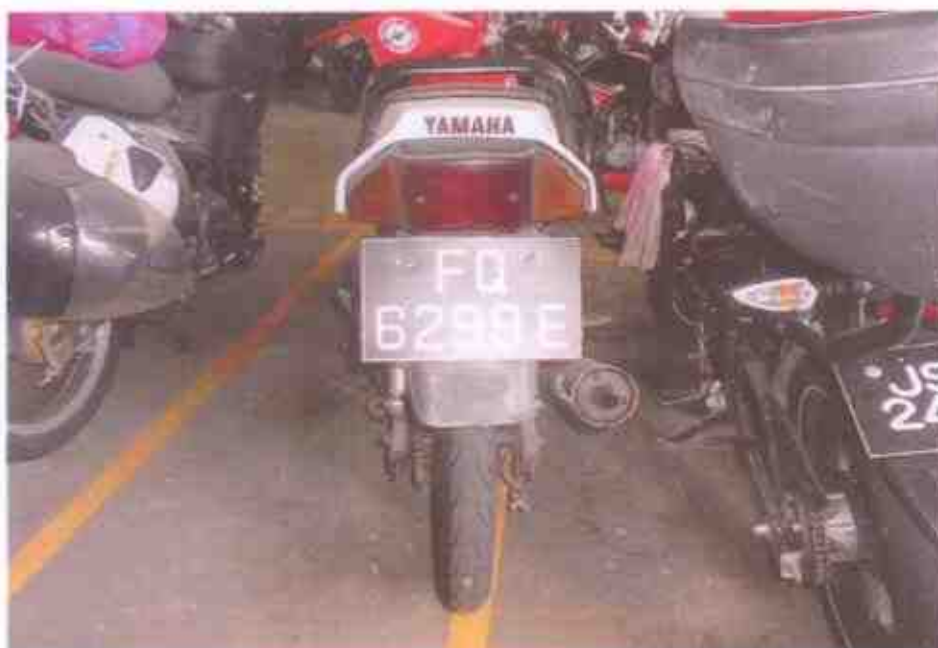
**Photo 4** shows a general view of the rear body of the Motorcycle at the time of our inspection. The Motorcycle was observed to be in good condition unaffected by the accident.

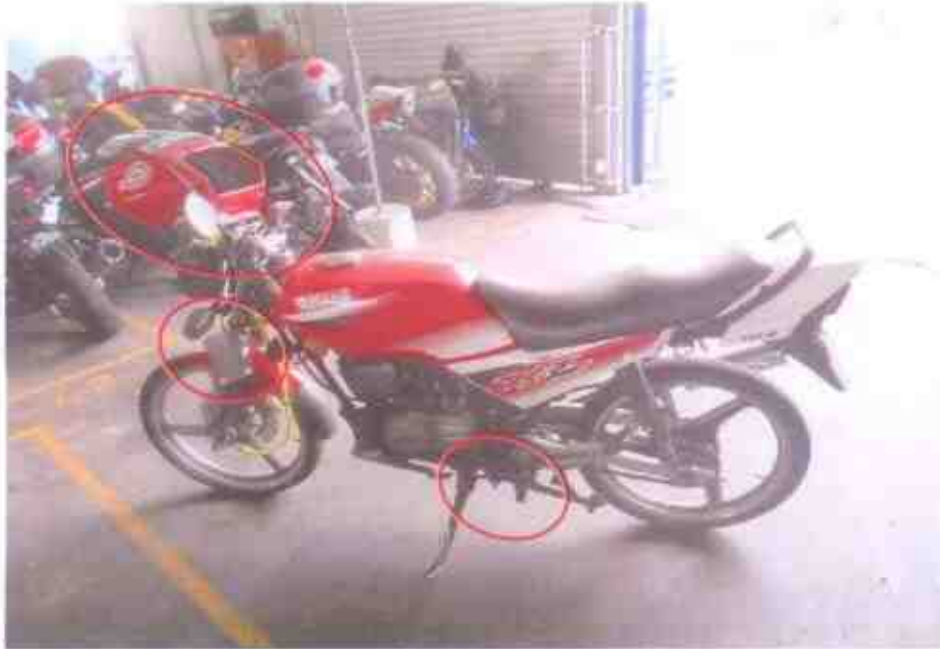
**Photo 5** shows a general view of the left body of the Motorcycle at the time of our inspection. The Motorcycle was observed to have sustained damages on the front fairing, IU & foot rest amongst others at time of our inspection.

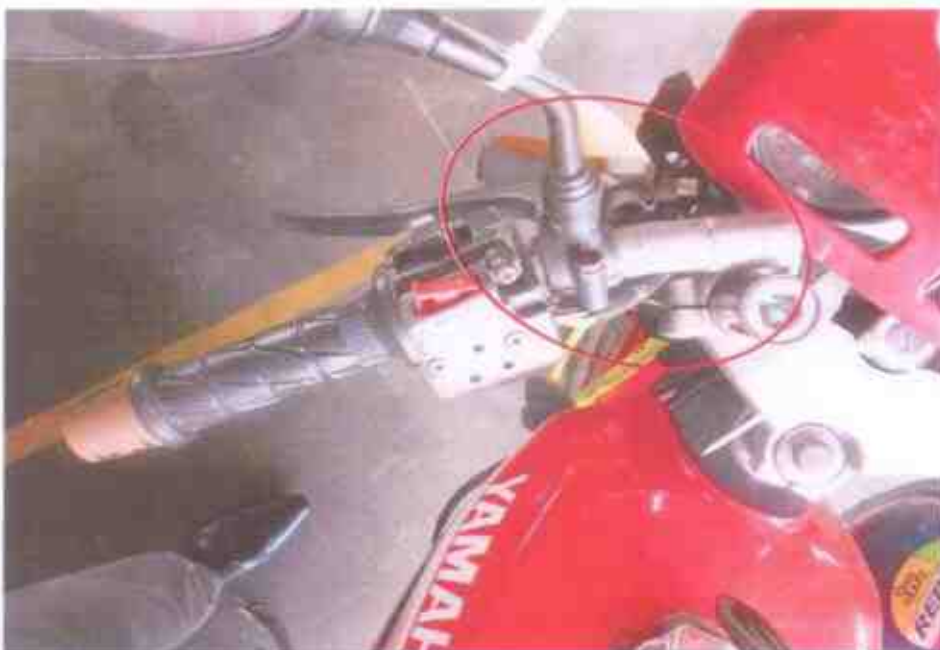
**Photo 6** shows a closer view of the dented handle bar as a result of the accident.

11. Our checks on the various steering components of the Motorcycle had revealed that its steering system was in serviceable condition. Its front fork was found to slightly misaligned & its handle bar was observed to be bent as a result of the accident's impact.

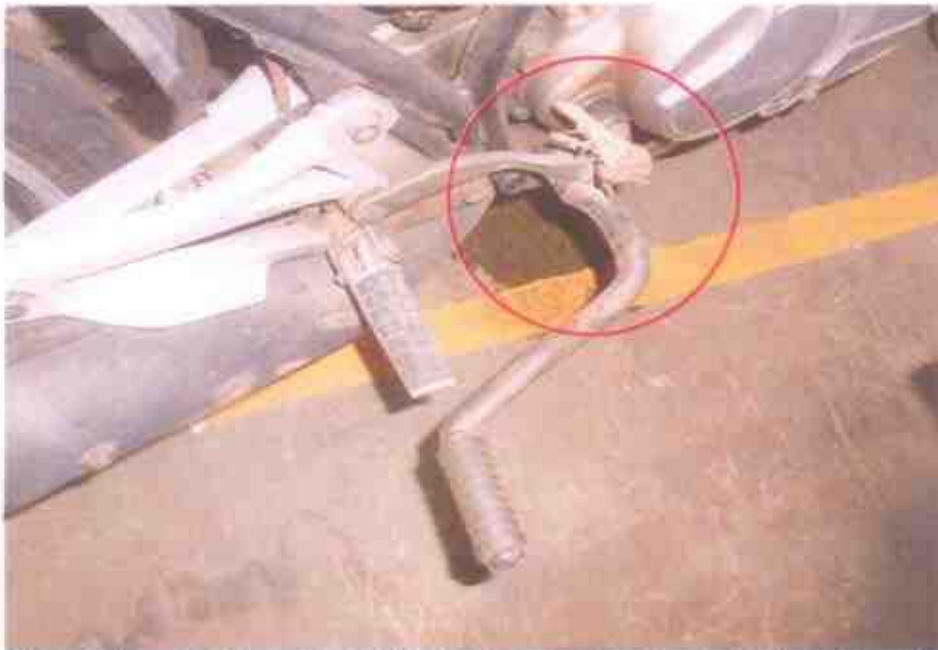
Photo 7 shows a closer view of the damaged rear brake pedal of the Motorcycle at the time of our inspection. The Motorcycle was observed to have sustained with relatively minor damages due to the accident's collision. (Circled)

14. As for the rear braking system, it was found that the rear brake pedal was damaged/ stuck likely due to the accident's impact collision. However, the Motorcycle's rear braking system like the brake spring, brake cable, and brake supports revealed all to be intact and without damage.

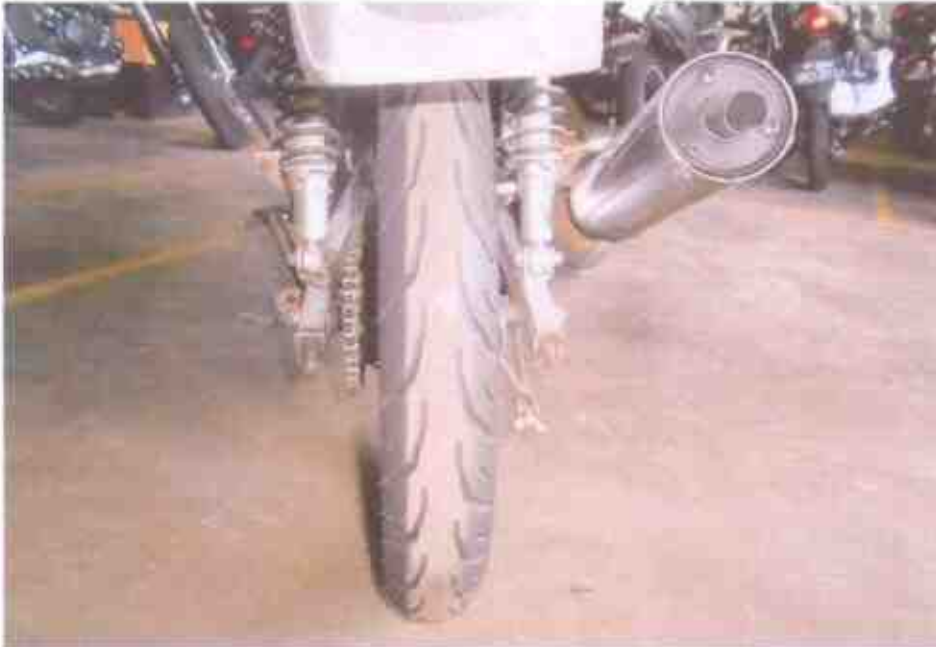
**Photo 8** shows the rear tyre of the Motorcycle. The rear tyre was observed to be in serviceable condition with remaining tread depth of approximately 3mm. The tyre was also observed to be sufficiently inflated for vehicular operation.

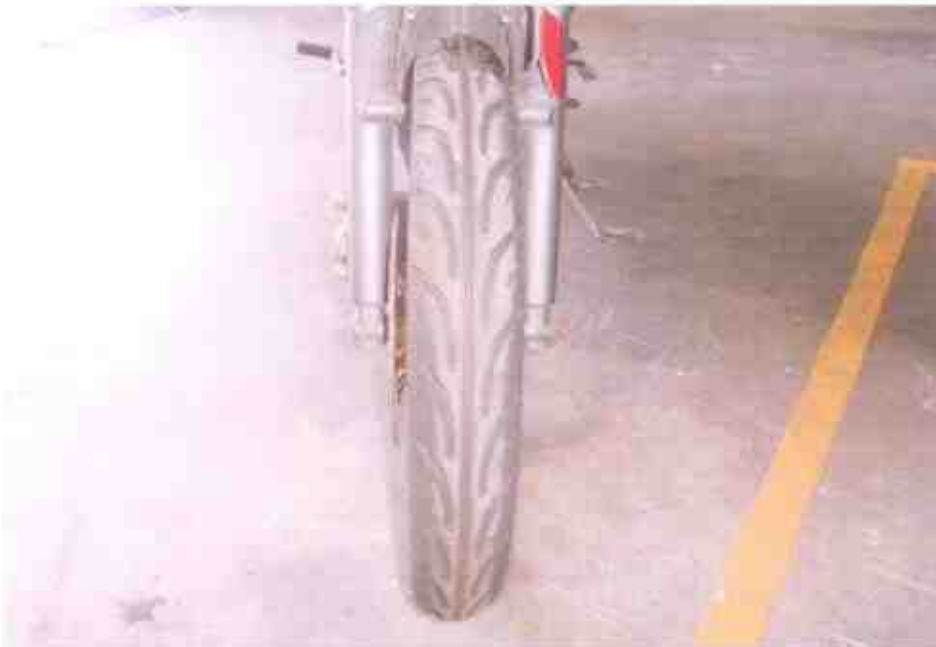
**Photo 9** shows the front tyre of the Motorcycle. The front tyre was observed to be in serviceable condition with remaining tread depth of approximately 3mm. The tyre was also observed to be sufficiently inflated for vehicular operation.

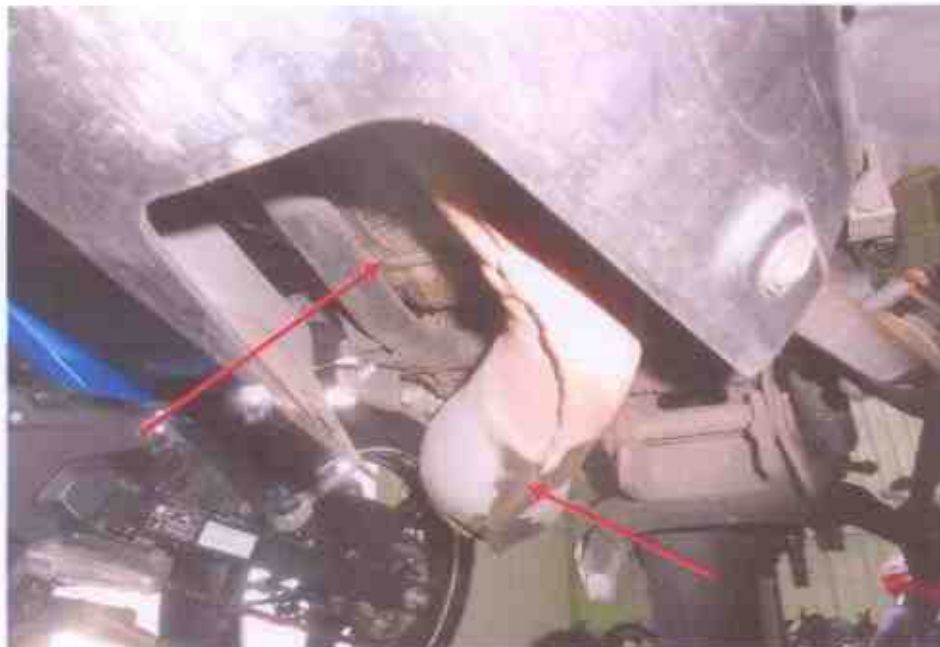
9. Upon examination of the engine area of the Motorcycle, we had observed that the various engine related parts and components were intact with no visible damage. The engine underside was however observed to be covered with fluid, suggesting leakage of fluid. There was no accumulation of dust and/or dirt particles on the engine housing where the fluid stains had formed. This would indicate that the fluid leakage was a fresh leak and likely to be a result of the accident.
10. The gear chain of the motorcycle was found to be intact without any misalignment. It was also adequately lubricated for operating purposes. Free play tension test was also conducted & found adequately acceptable. See photo 10 – 12 below.

Photo 10 shows sign(s) or indication(s) of fluid leak observed around the underside of the engine area of the Motorcycle. Traces of fluid leakage was also observed on the exhaust pipe.

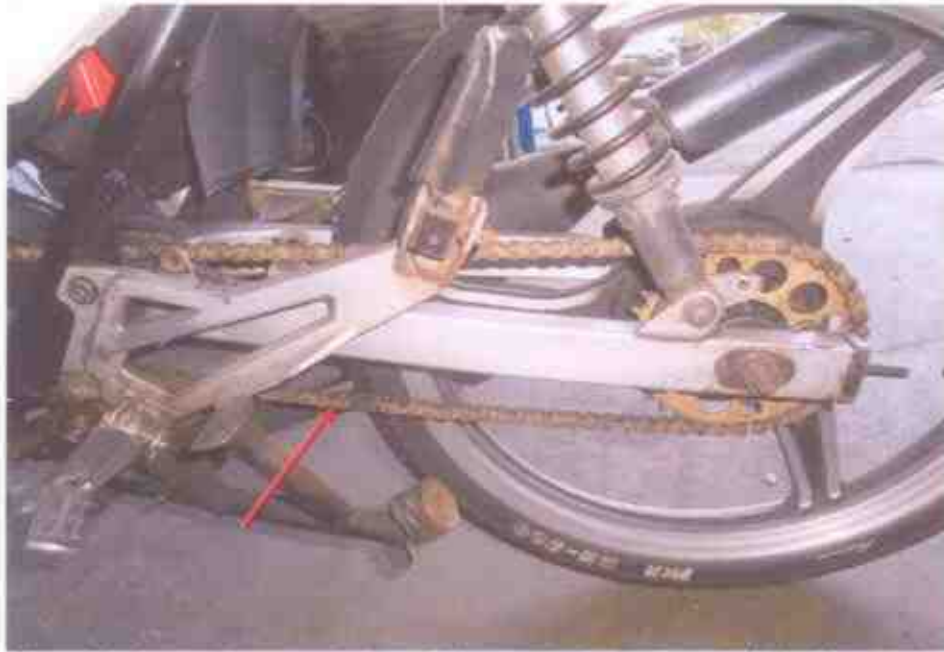
**Photo 11** shows the general view of the gear train (arrowed) of the Motorcycle, which was observed to be intact with no misalignment. It was also adequately lubricated for operating purposes.

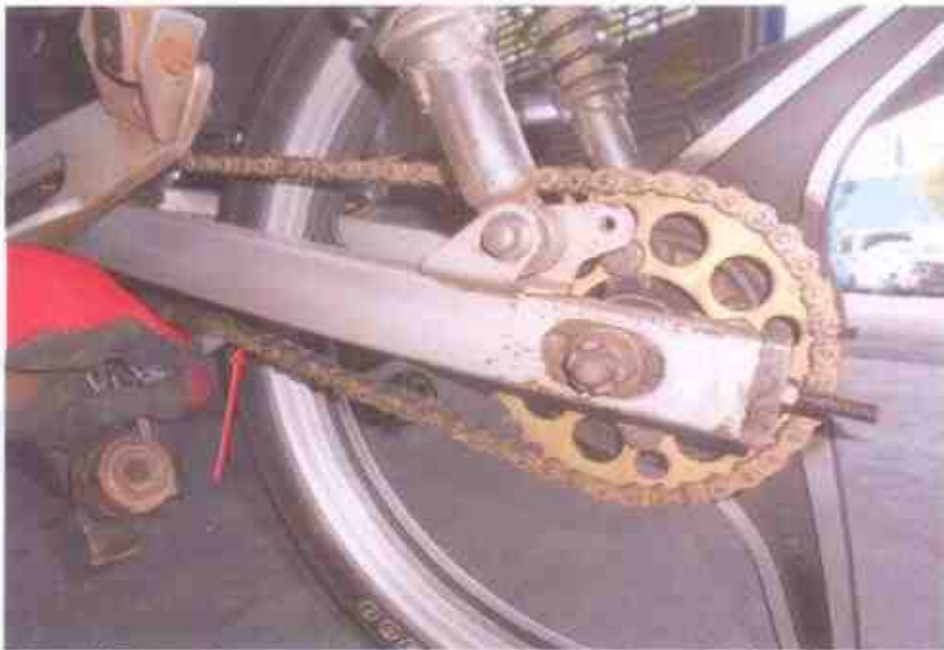
**Photo 12** shows the general view of the gear train (arrowed) of the Motorcycle, which was observed to be intact with no misalignment. It was also adequately lubricated for operating purposes. Free play tension was also observed & found adequately acceptable.

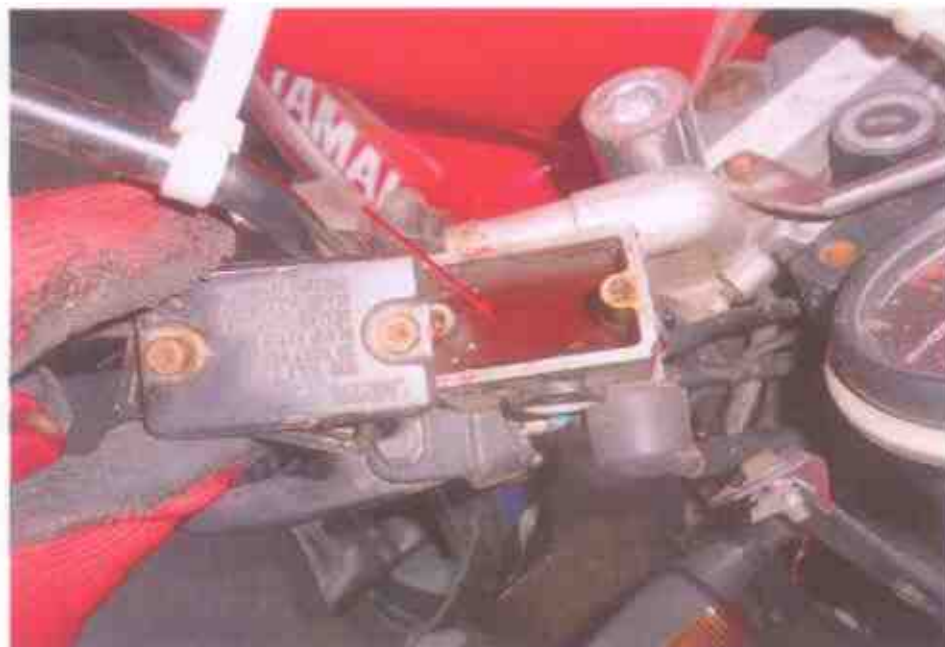
**Photo 13** shows our checks on the brake fluid (front) reservoir had indicated that the brake fluid was of sufficient level for operational purposes, and without contamination.

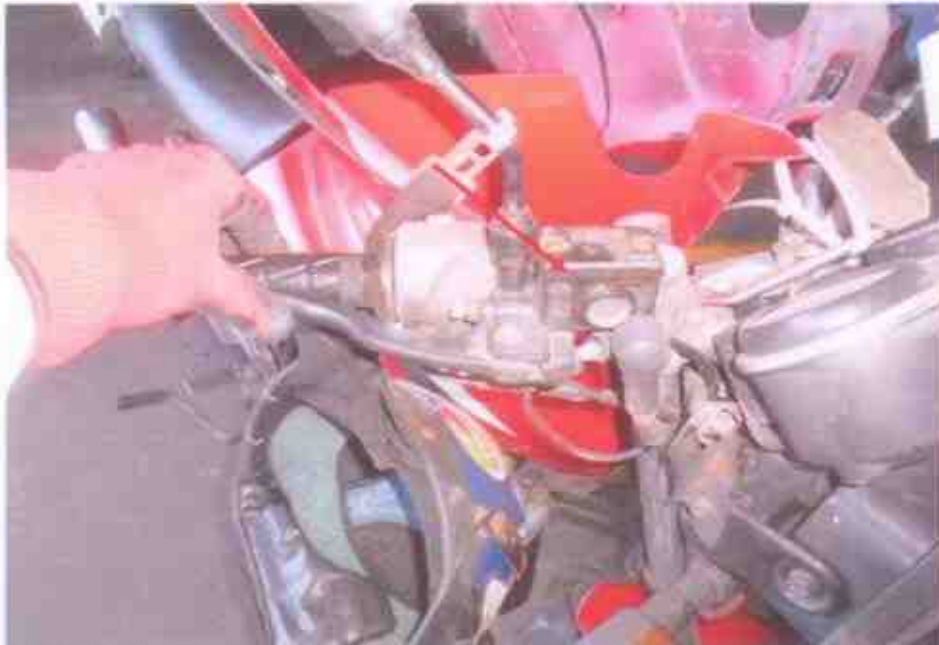
13. Static brake tests conducted on the Motorcycle front & rear brakes had appeared to indicate that the braking system of the Motorcycle was not in serviceable condition. There was no resistance felt (spongy like feel) upon pressing the brake lever. This would indicate that there was leakage of pressure/vacuum in the front brake system. Further investigation on the front braking system, we found that the leakage was on the brake fluid reservoir cover likely due to the accident's impact collision. However, our checks on the brake fluid had indicated that the brake fluid was of sufficient level for operational purposes, and without contamination. The Motorcycle's front braking system like the brake discs, brake callipers, brake pad, brake lever, and brake hoses revealed all to be intact and without damage.

**Photo 14** shows our checks on the brake fluid (front) reservoir. It was observed to sustained fluid leakage at the brake fluid reservoir cover. There was no spongy feeling when depressing the brake lever.

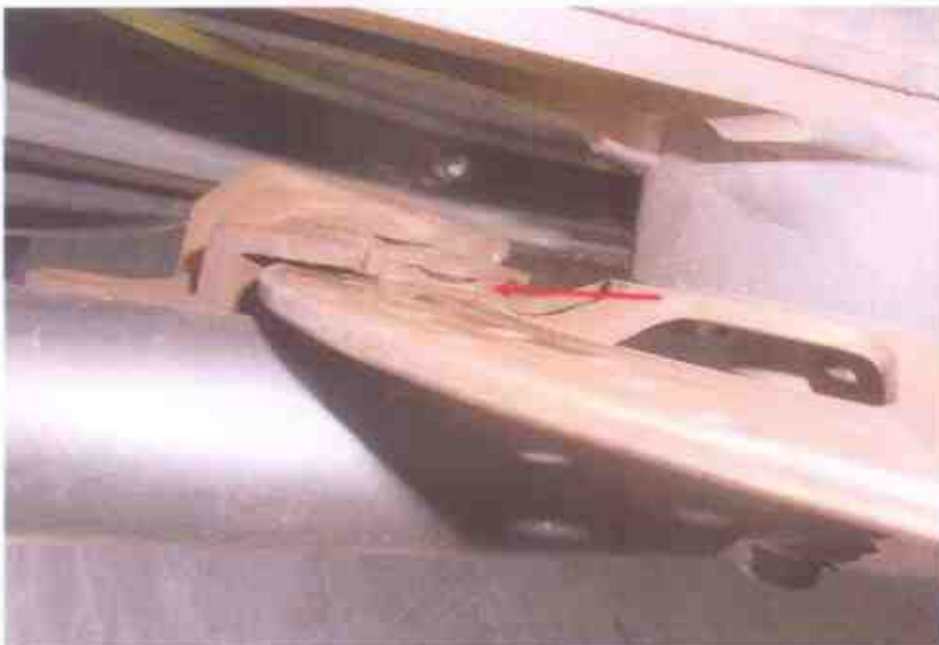
**Photo 15** shows the front brake pad at time of our inspection. The frictional material was observed to be sufficient for operational purposes.

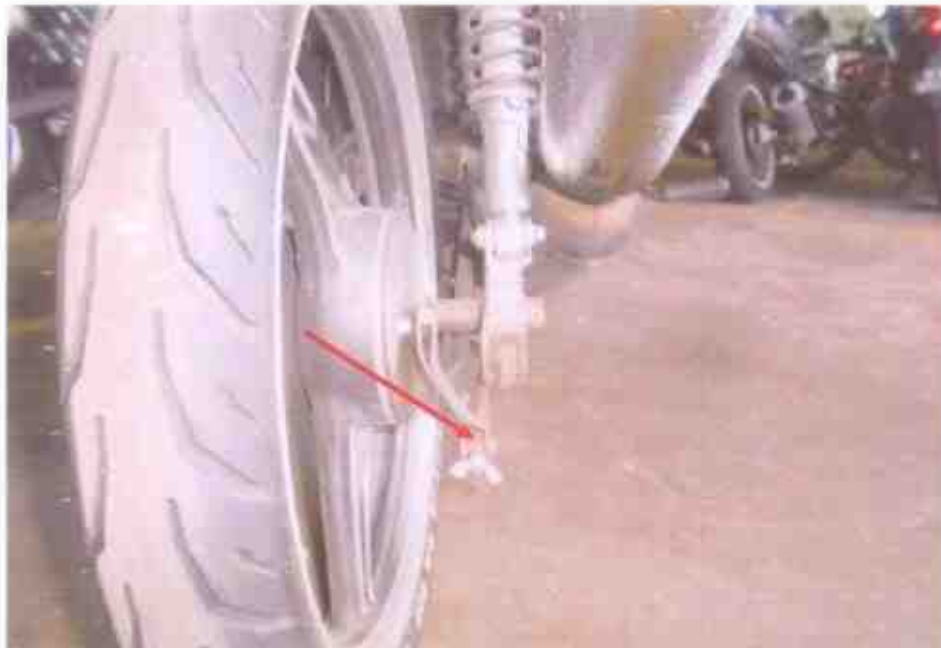
**Photo 16** shows our checks on the rear brake component had indicated that the mechanical components were in serviceable condition unaffected by the accident's impact.

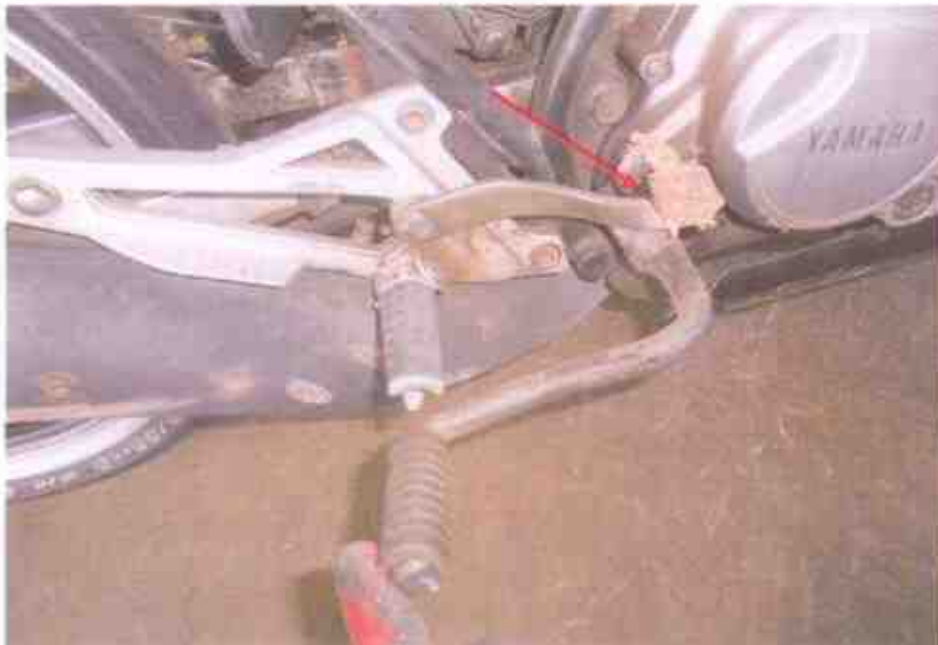
**Photo 17** shows the rear brake pedal was stuck likely due to the accident's impact collision.
