Your Ref: TP/IP/38041/2018
Our Ref : CI/TPD18014212/Z

27th September 2018

MECHANICAL INSPECTION REPORT OF MOTOR TAXI SHB 2124H

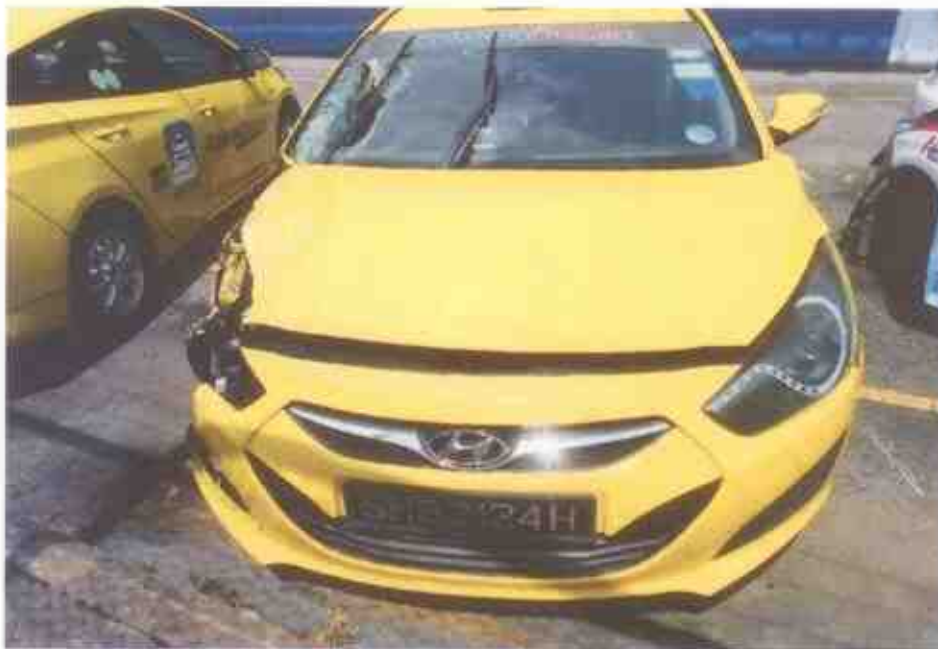
Photo 1 shows a general view of the frontal portion of the Motor Taxi at the time of our inspection. The Motor Taxi was observed to have sustained extensive impact damage at its frontal right portion. The impact force was significant, causing the various parts and components to be damaged as a result of the accident.

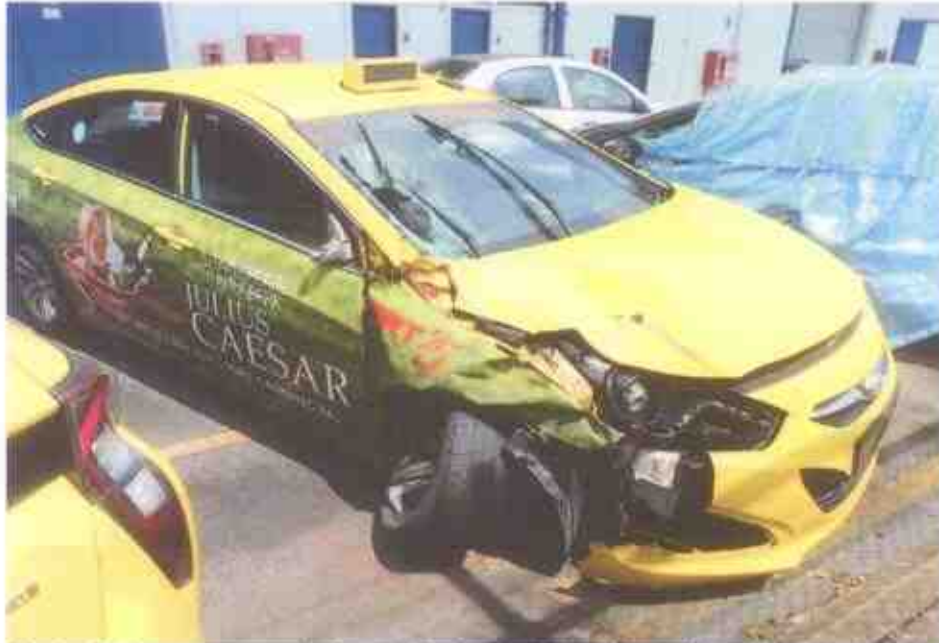
Photo 2 shows a general view of the front right portion of the Motor Taxi at the time of our inspection. The Motor Taxi was observed to have sustained extensive impact damage at its front right portion.

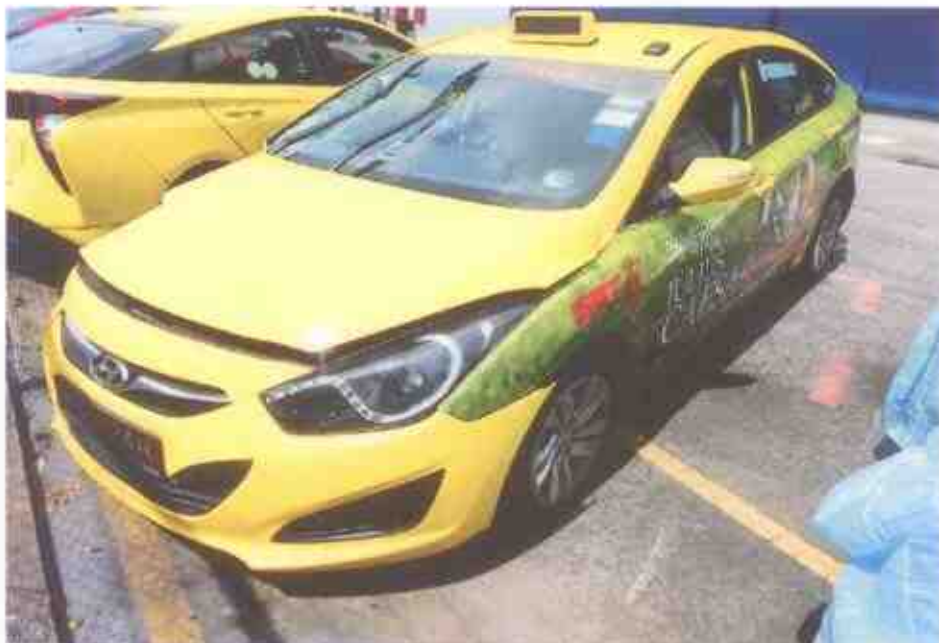
Photo 3 shows a general view of the front left portion of the Motor Taxi at the time of our inspection. The Motor Taxi was observed to have sustained minor impact damage at its front left portion.

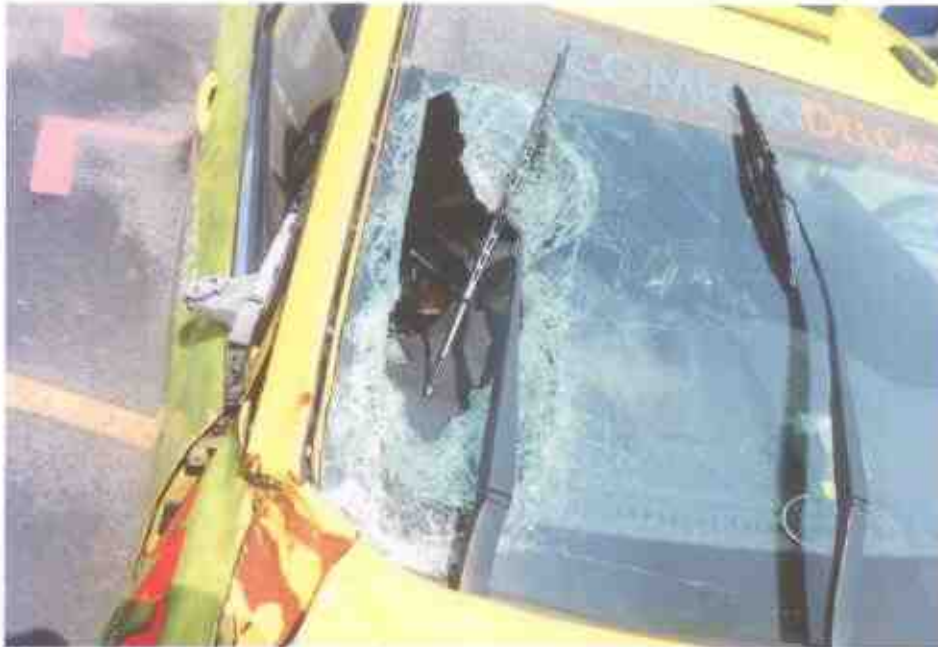
Photo 4 shows a closer view of the damage sustained on the right portion of the Motor Taxi. The impact force was significant, causing the right portion of the windshield to be shattered due to the accident.

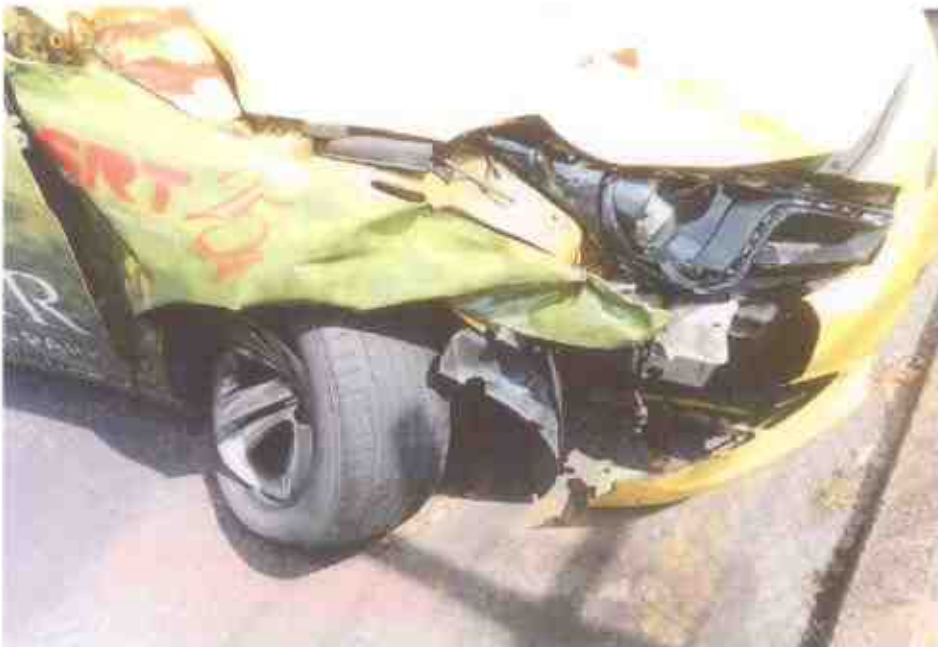
Photo 5 shows a closer view of the damage sustained on the front right of the Motor Taxi. The impact force was significant, causing the various parts and components inside the engine compartment to be damaged, which includes the headlamp, rim & tyre amongst others.

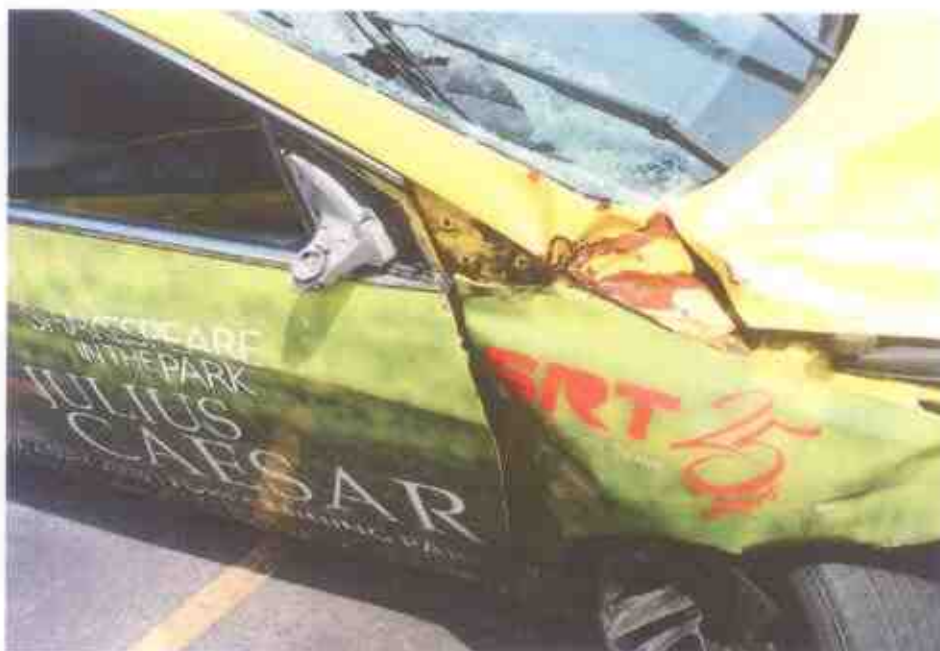
Photo 6 shows a closer view of the Motor Taxi right side mirror. The impact force was significant, causing it to be dislodged.

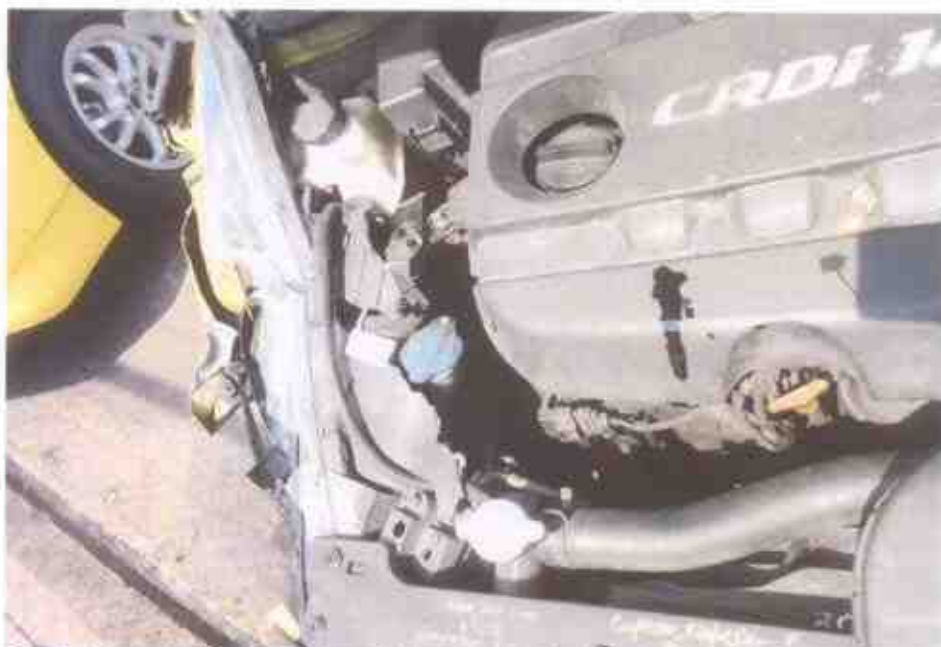
Photo 7 shows a closer view of the damaged engine component. The impact force was significant, causing the engine coolant reservoir to be damaged due to the accident's impact.

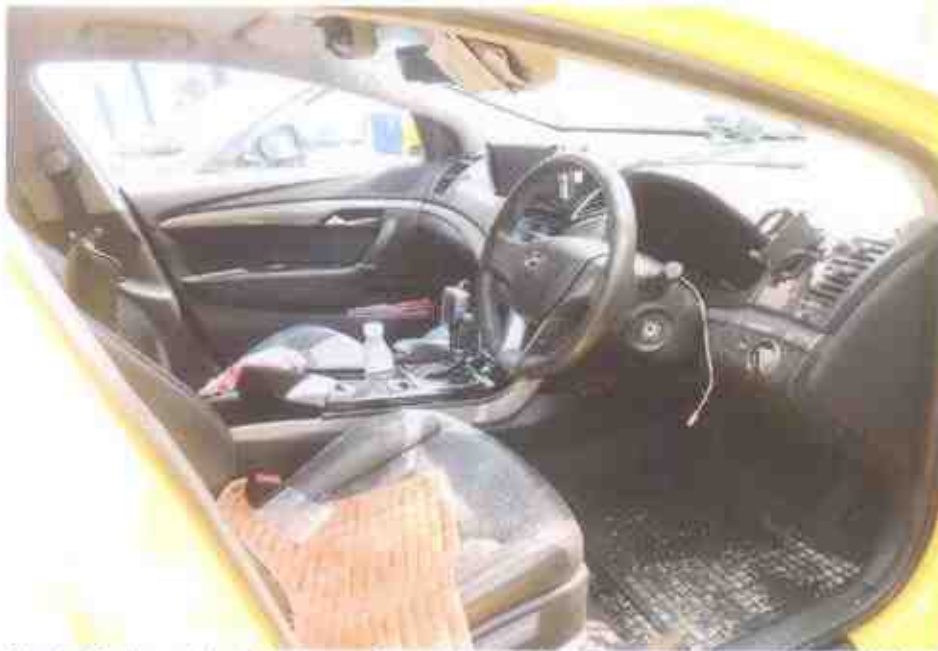
Photo 8 shows the interior portion of the Motor Taxi. The impact force did not affect the interior portion.

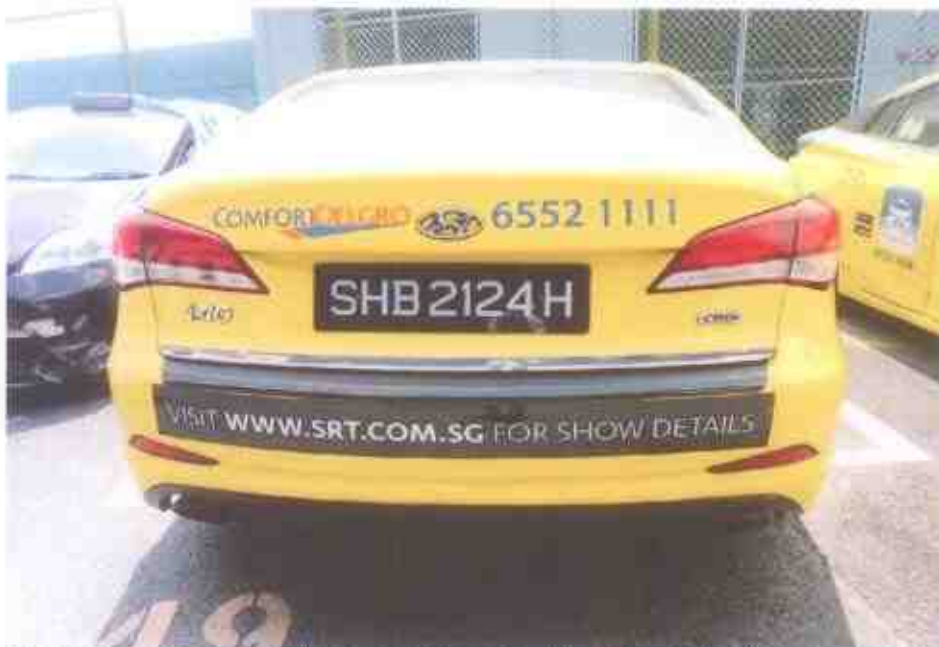
Photo 9 shows a general view of the rear right portion of the Motor Taxi at the time of our inspection. The rear portion was observed to be in good condition unaffected by the accident.

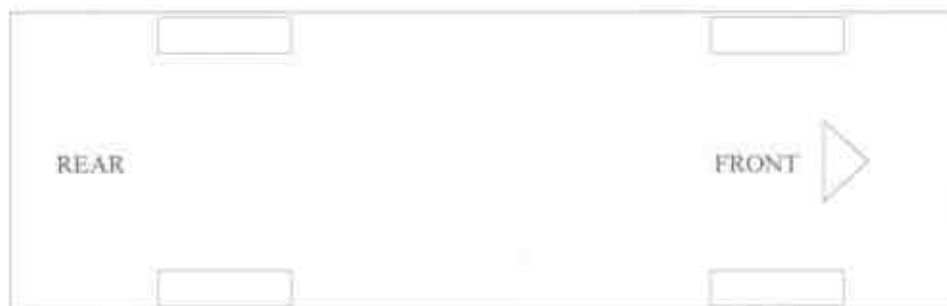
Westlake Radial RP 26
205/60R16 (6mm)

Westlake Radial RP 26 205/60R16 (4mm)
(Cut mark on the outer sidewall)(Inflated)

Westlake Radial RP 26
205/60R16 (5mm)

Westlake Radial RP 26 205/60R16 (4mm)
(Deflated)(Dislodged from the wheel rim)

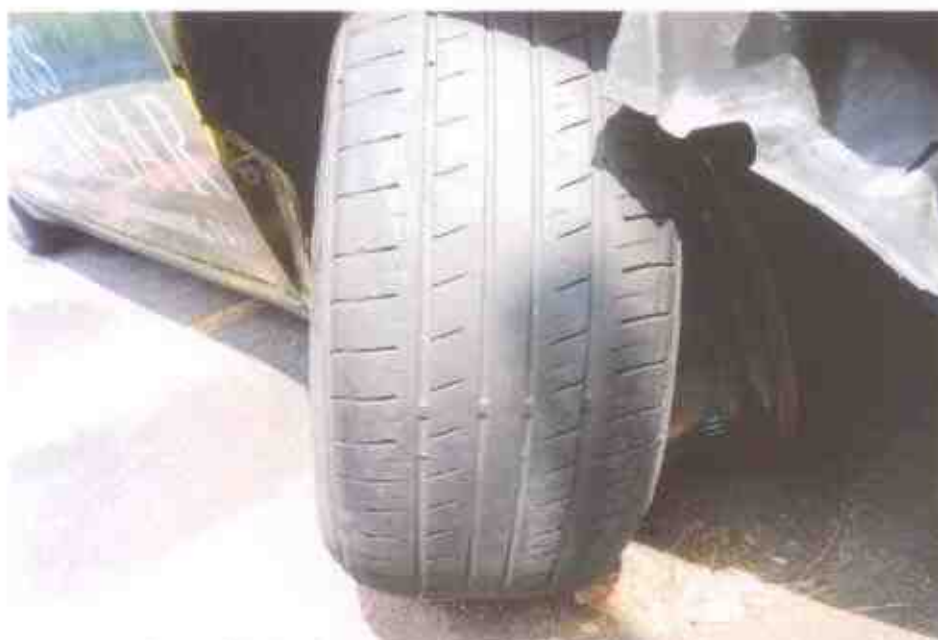
10. As for the front right tyre, it was observed to be dislodged from the wheel rim due to the accident's impact collision. We did find torn mark & cut mark on the outer sidewall as well as across the tyre surface which was likely due to the result of the accident.

Photo 10 shows the condition of the front right tyre of the Motor Taxi, which was observed to be dislodged as a result of the accident. We did find cut mark on the outer sidewall as well as across the tyre surface which was likely due to the result of the accident.

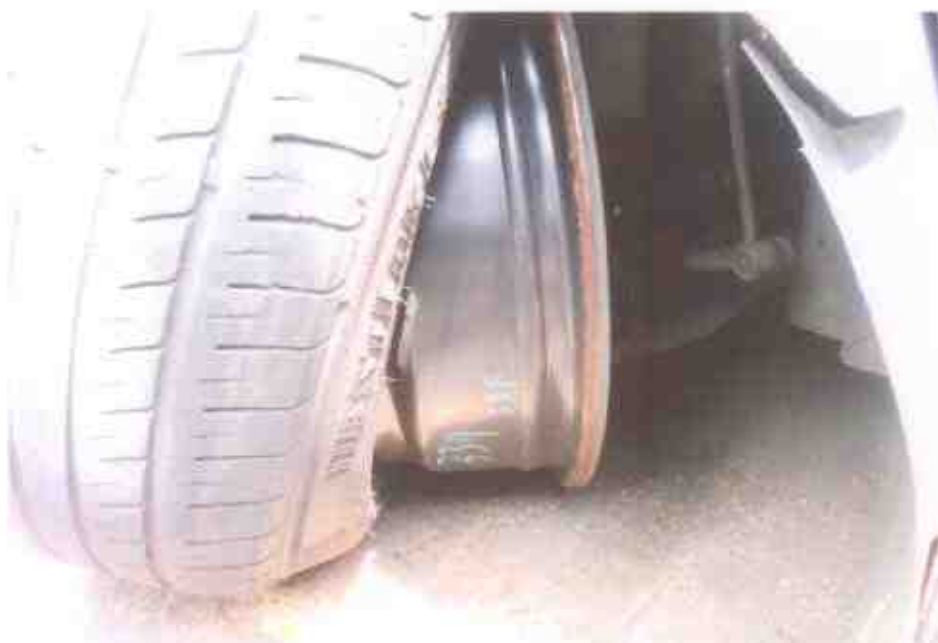
Photo 11 shows the condition of the front right tyre of the Motor Taxi, which was observed to be dislodged from the wheel rim as a result of the accident.

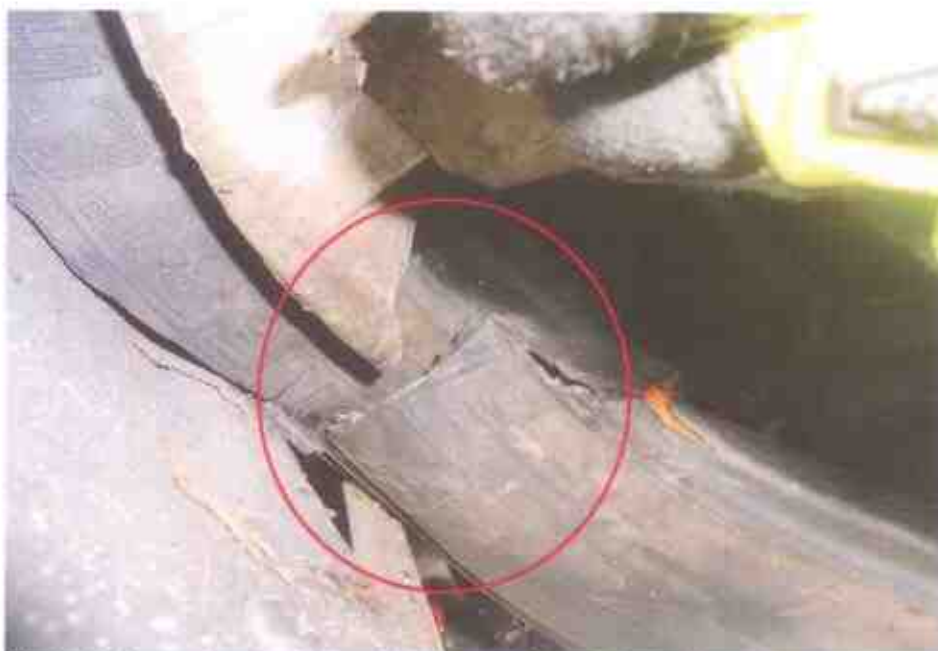
Photo 12 shows the condition of the front right tyre of the Motor Taxi, which was observed to be dislodged as a result of the accident. We did found cut mark on the outer sidewall as well as across the tyre surface which was likely due to the result of the accident.

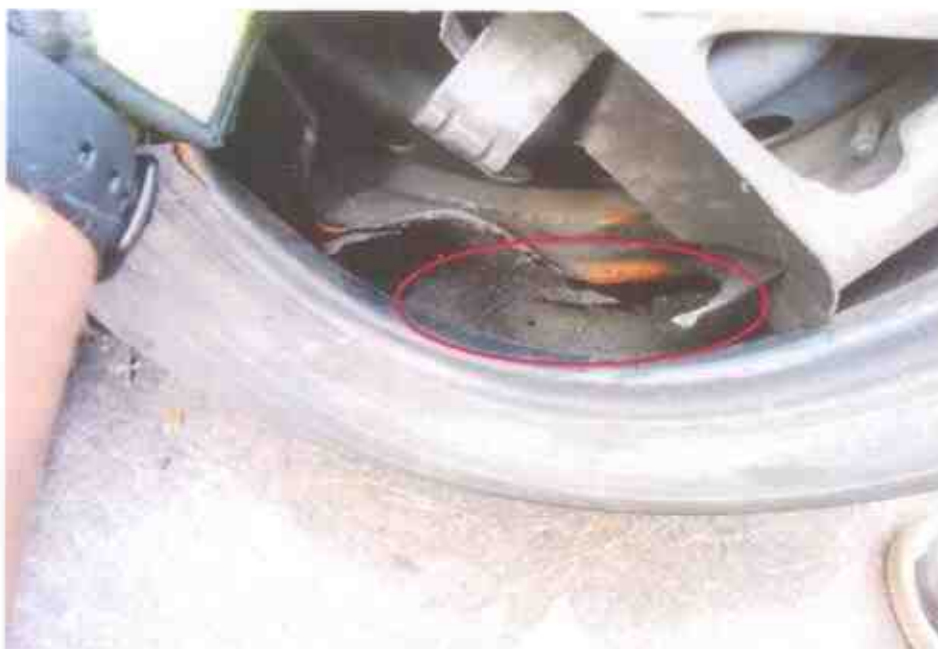
Photo 13 shows the condition of the front right tyre of the Motor Taxi, which was observed to be dislodged as a result of the accident. We did found cut mark on the outer sidewall as well as across the tyre surface which was likely due to the result of the accident.

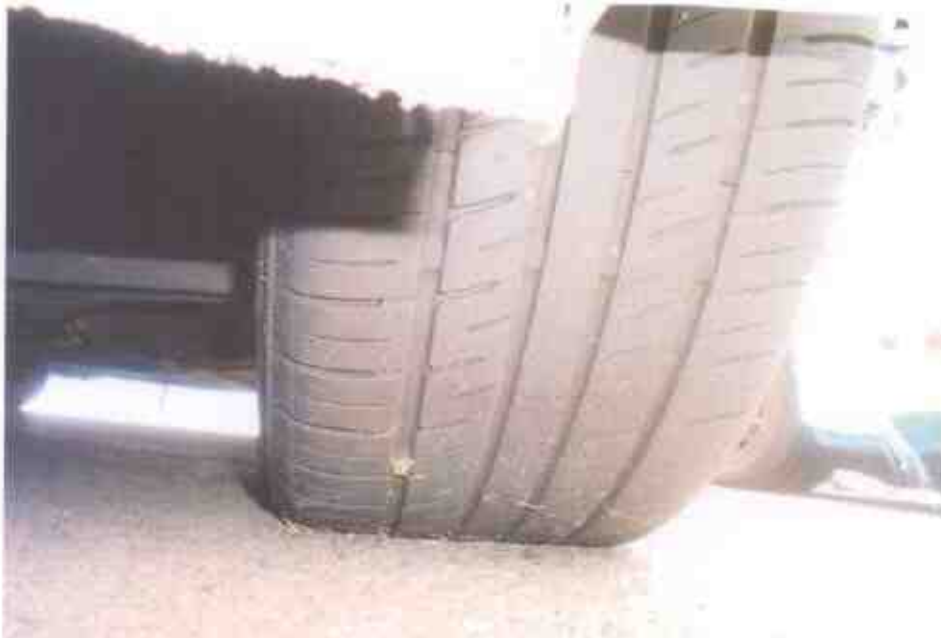
9. The condition of the front left tyre was observed with a small cut mark on the outer wall likely due to the accident's impact collision. However, it was observed to be sufficiently inflated for vehicular operation.

Photo 14 shows the condition of the front left tyre of the Motor Taxi, which was observed to be in serviceable condition with remaining tread depth of approximately 4mm. However, a small cut mark was observed on the outer sidewall of the tyre likely due to the accident.

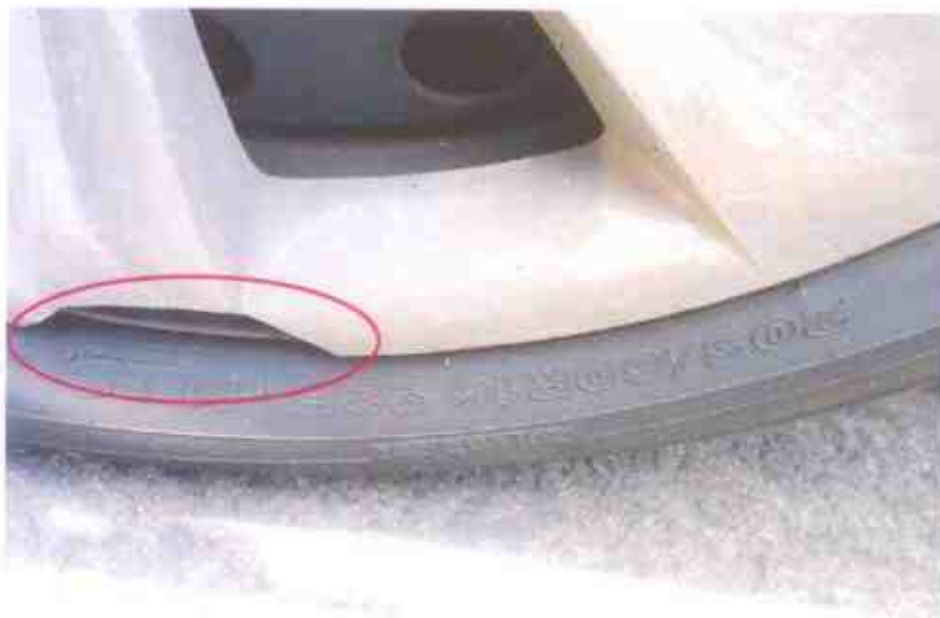
Photo 15 shows the condition of the front left tyre of the Motor Taxi, which was observed to be in serviceable condition with remaining tread depth of approximately 4mm. However, a small cut mark was observed on the outer sidewall of the tyre likely due to the accident.

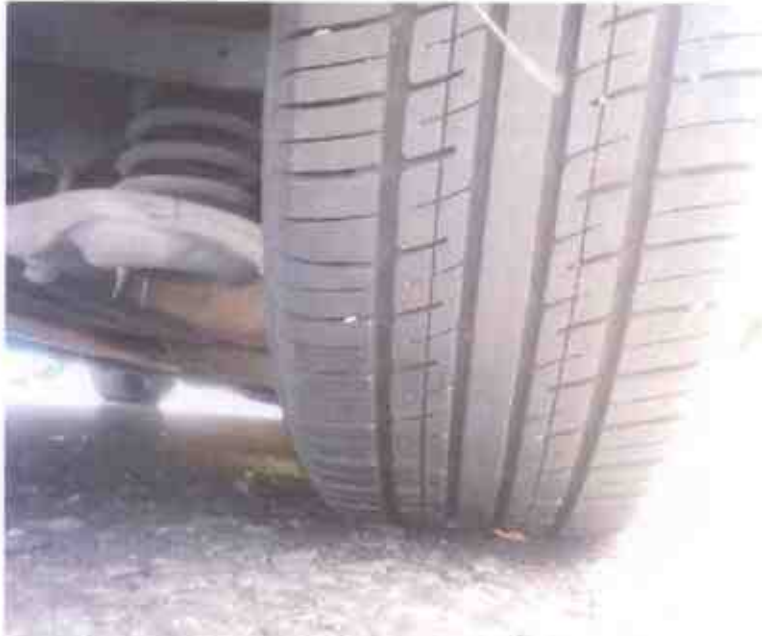
Photo 16 shows the condition of the rear right tyre of the Motor Taxi, which was observed to be in serviceable condition with remaining tread depth of approximately 6mm. There was also no tear, cut or burst mark(s) on the outer and the inner sidewalls as well as across the tread of this tyre.

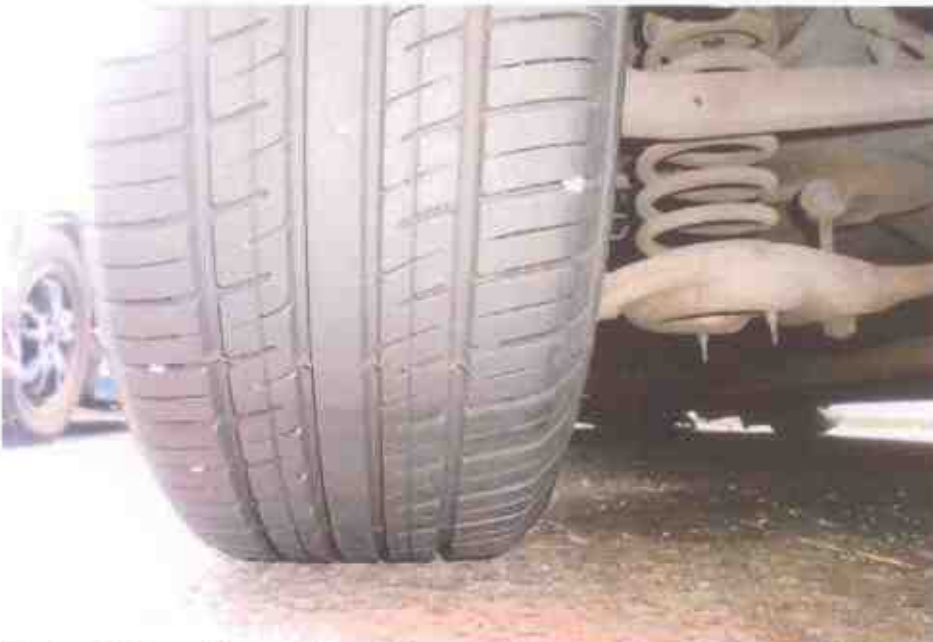
Photo 17 shows the condition of the rear left tyre of the Motor Taxi, which was observed to be in serviceable condition with remaining tread depth of approximately 5mm. There was also no tear, cut or burst mark(s) on the outer and the inner sidewalls as well as across the tread of this tyre.

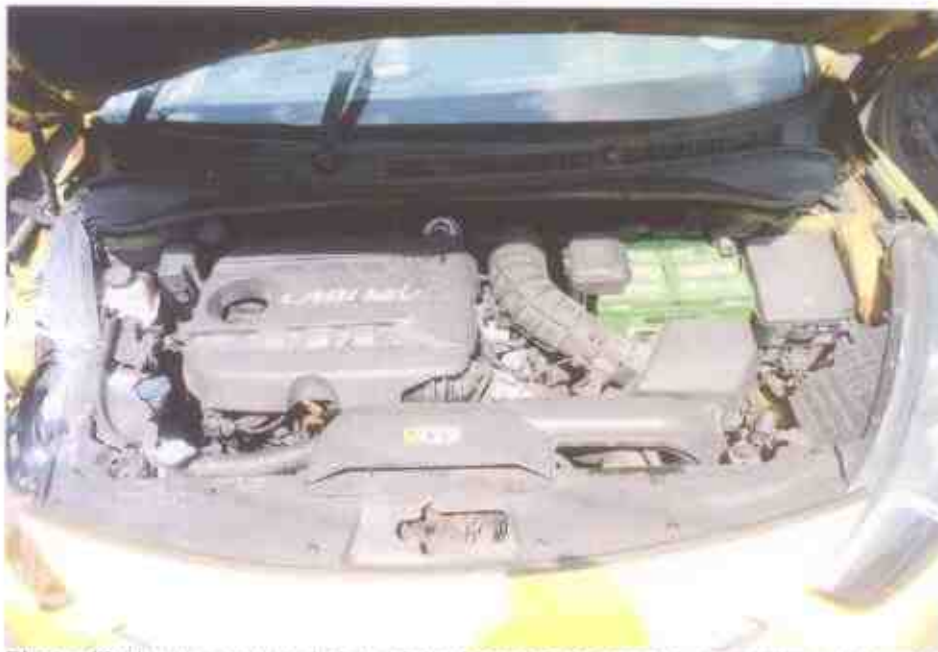
Photo 18 shows a general view of the Motor Car's engine compartment. Most of the various parts and components inside the engine compartment were unaffected by the accident. There was also no sign(s) or indication(s) of fluid leakage and/or fluid stain within the engine compartment.

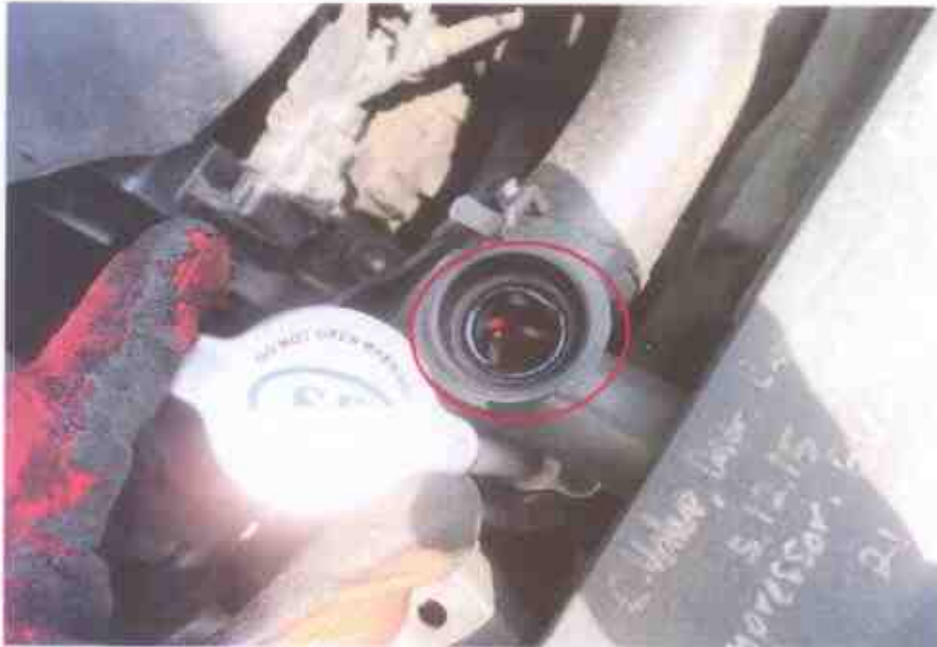
Photo 19 shows the close up view of the engine coolant that was seen with sufficient level not affected by the accident's impact

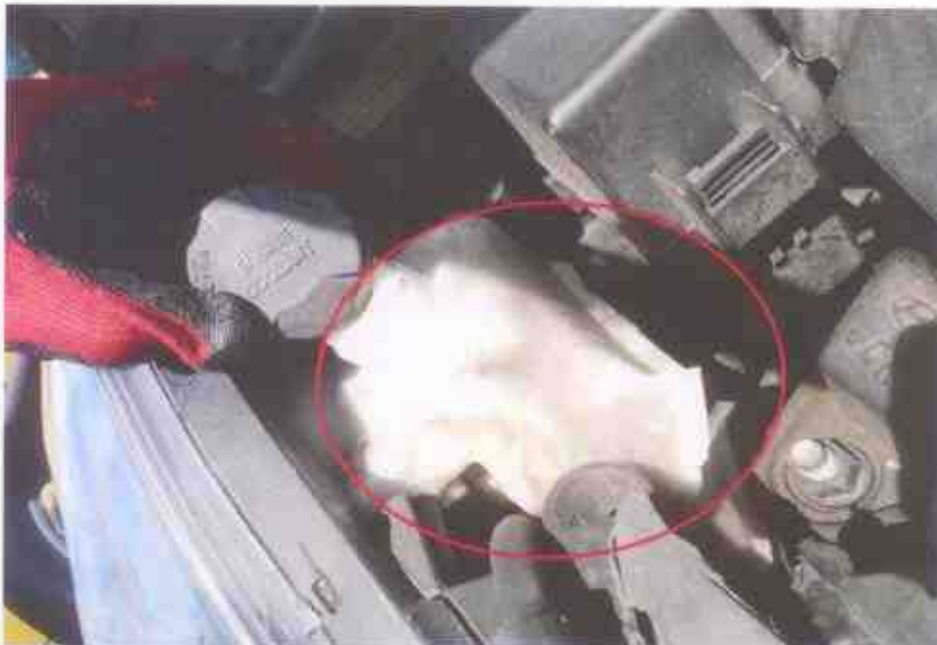
Photo 20 shows the close up view of the engine coolant reservoir that was observed to be damaged (cracked) by the accident's impact

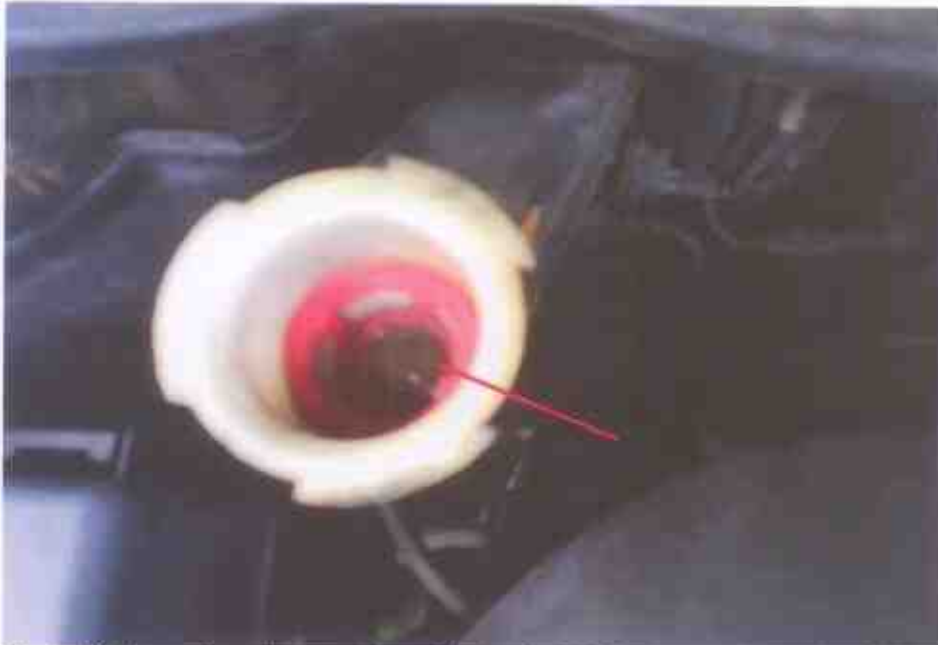
Photo 21 shows the close up view of the brake fluid that was seen with sufficient level not affected by the accident's impact.

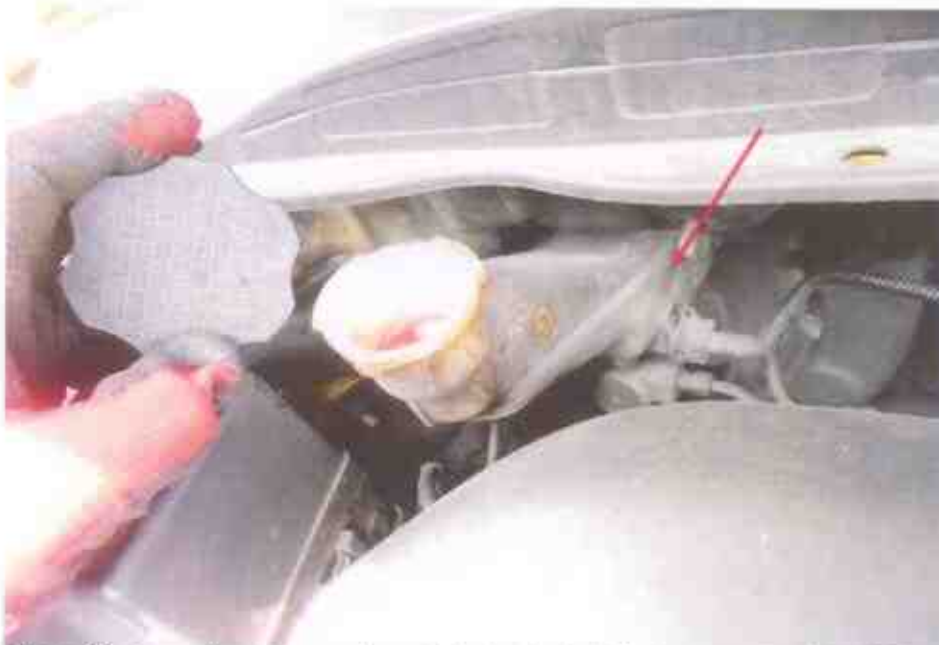
Photo 22 shows the close up view of the brake fluid that was seen with sufficient level not affected by the accident's impact.

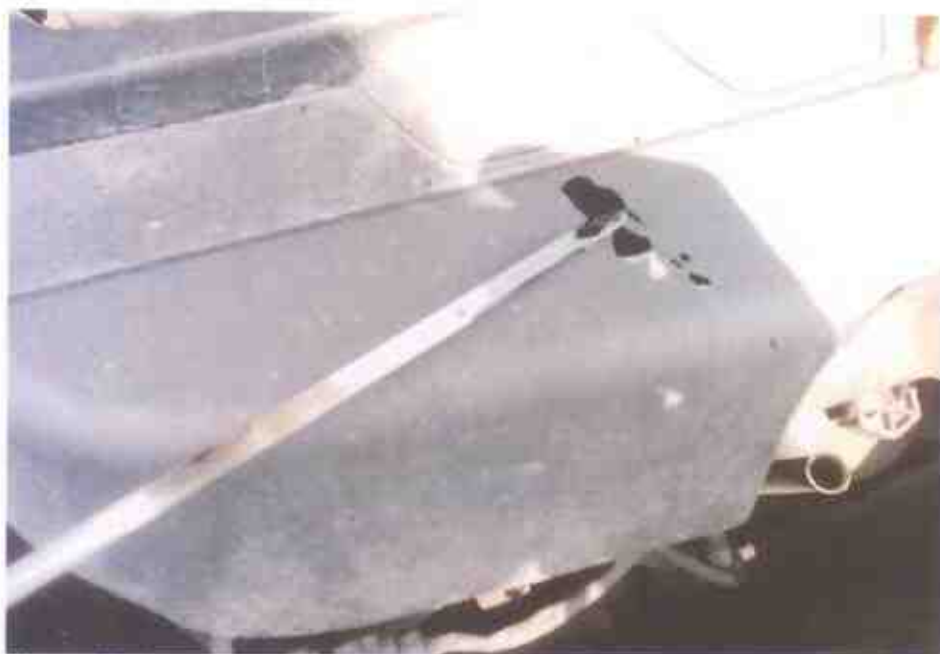
Photo 23 shows the engine oil dip stick of the Motor Taxi at the time of our inspection. The engine oil was observed to be of sufficient level and without any visible contamination.

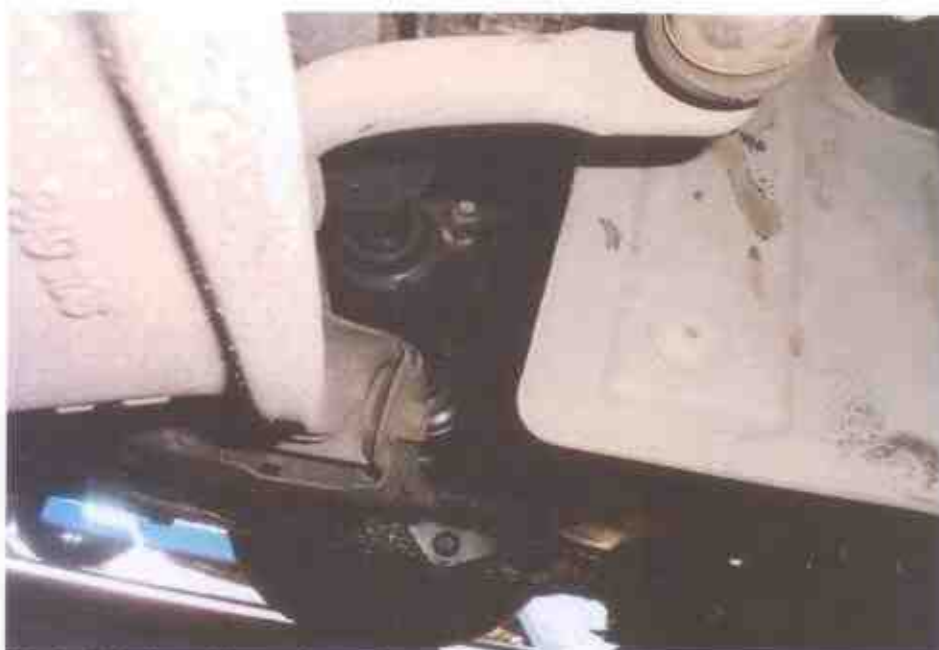
Photo 24 shows the undercarriage of the engine area. It was observed to be unaffected by the accident's impact.

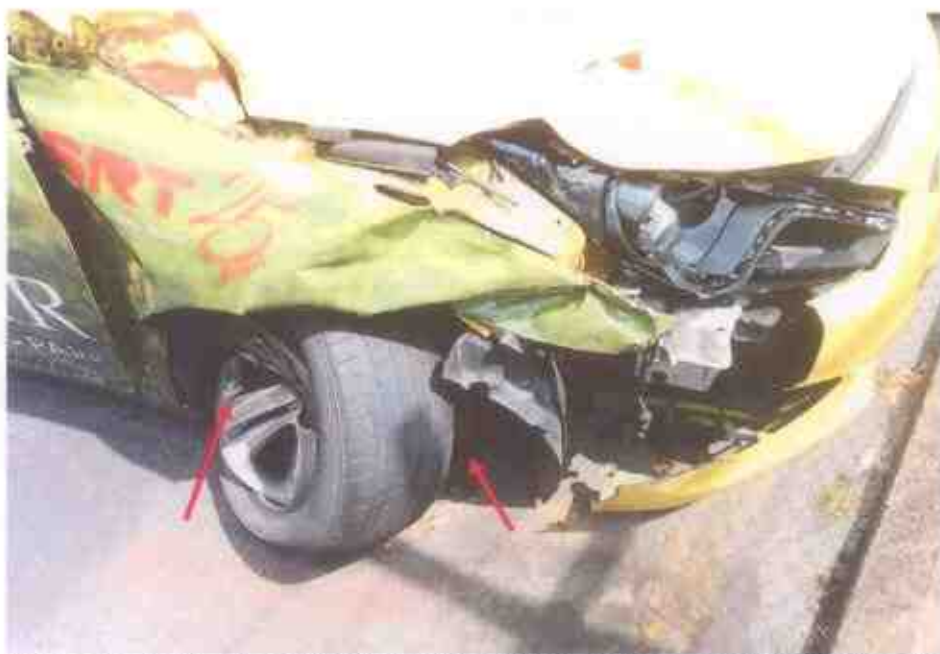
Photo 25 shows the damaged steering system at the front right wheel of the Motor Taxi.

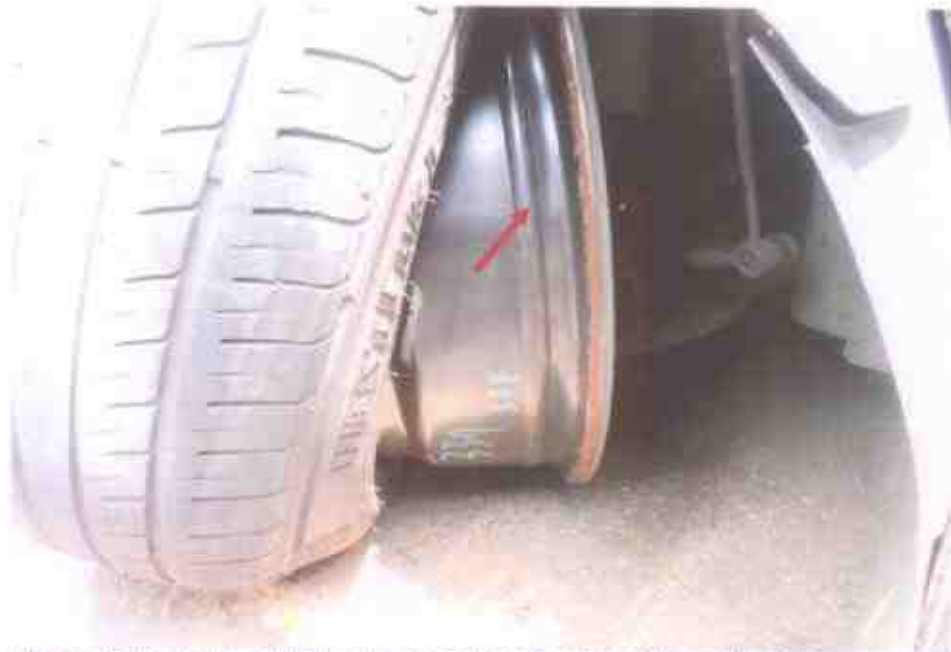
Photo 26 shows the dislodged front right wheel rim of the Motor Taxi as a result of the accident's impact collision.

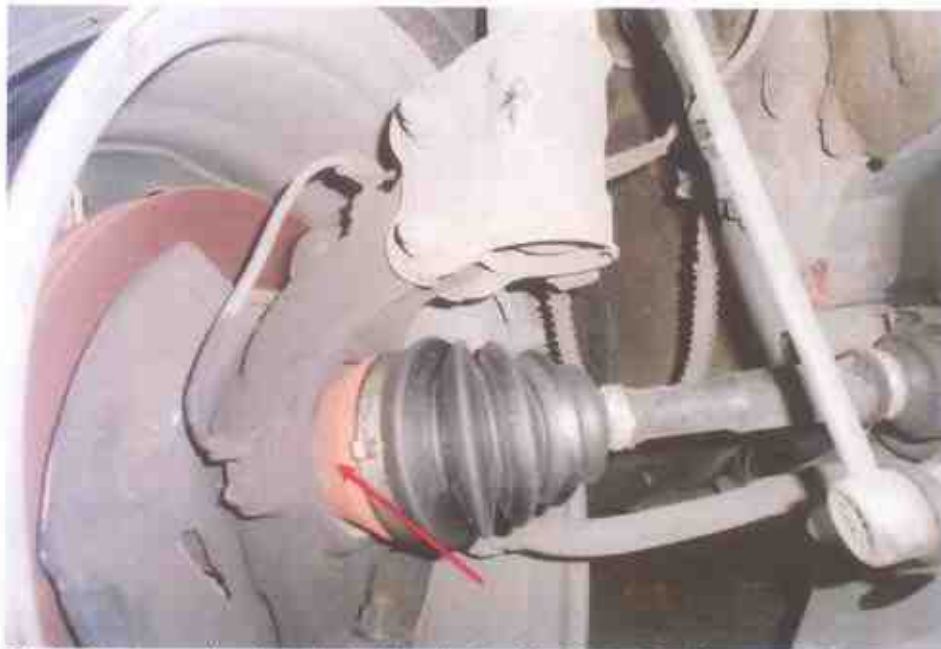
Photo 27 shows the dislodged drive shaft of the Motor Taxi front right wheel as a result of the accident's impact collision.

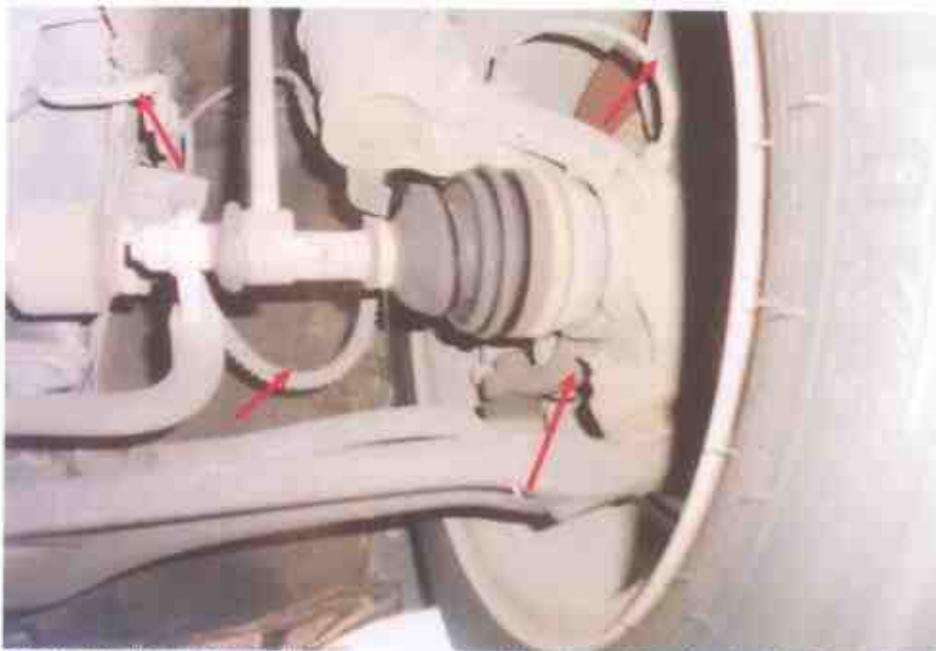
Photo 28 shows the braking components at the front left wheel of the Motor Taxi. We did not observe any leakage of brake fluid at the time of our inspection of the Motor Car.

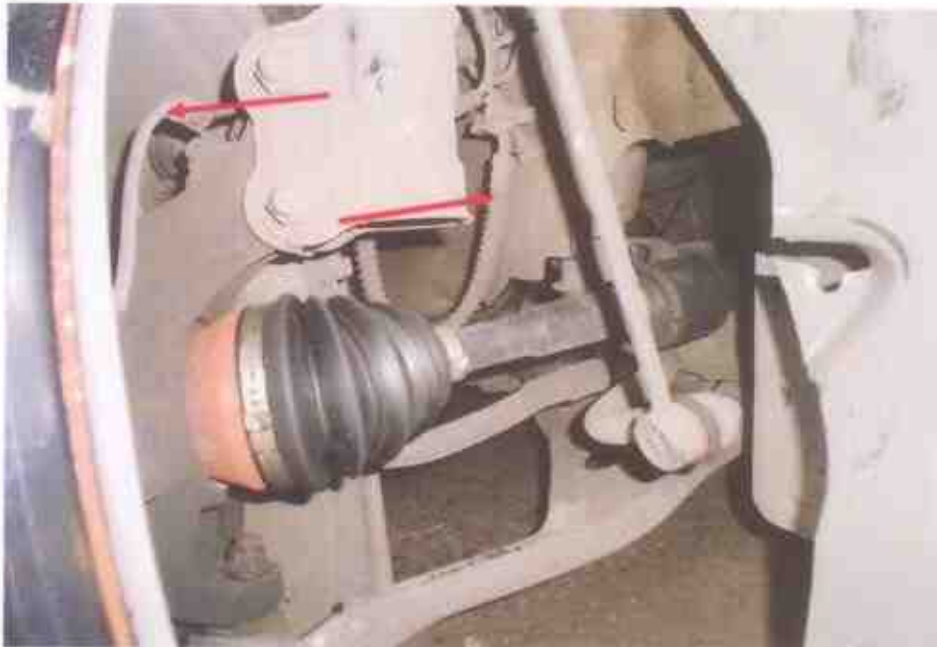
Photo 29 shows the braking components at the front right wheel of the Motor Taxi. We did not observe any leakage of brake fluid at the time of our inspection of the Motor Taxi.

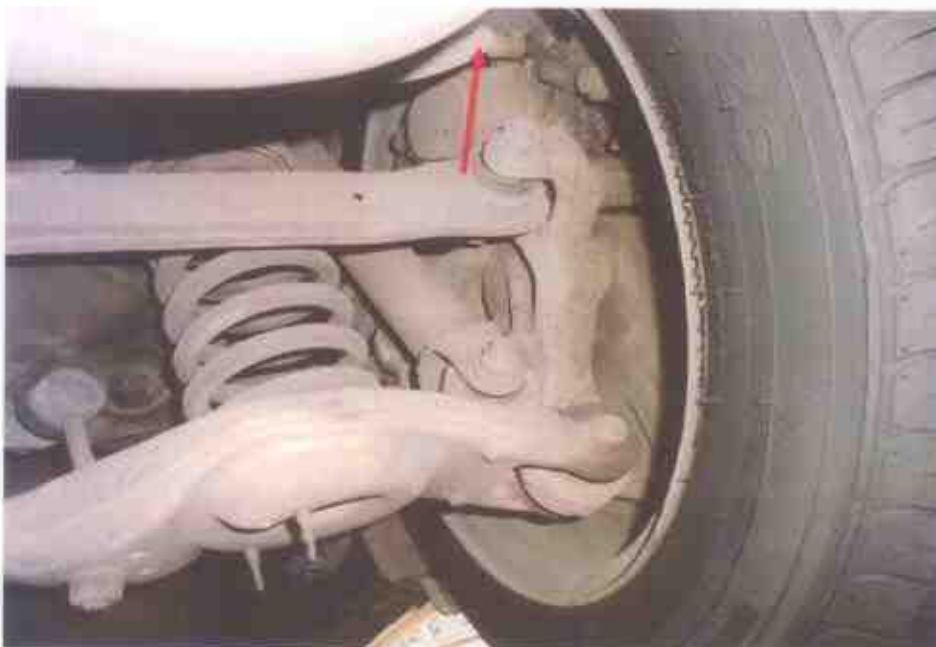
Photo 30 shows the braking components at the rear right wheel of the Motor Taxi. We did not observe any leakage of brake fluid at the time of our inspection of the Motor Taxi.

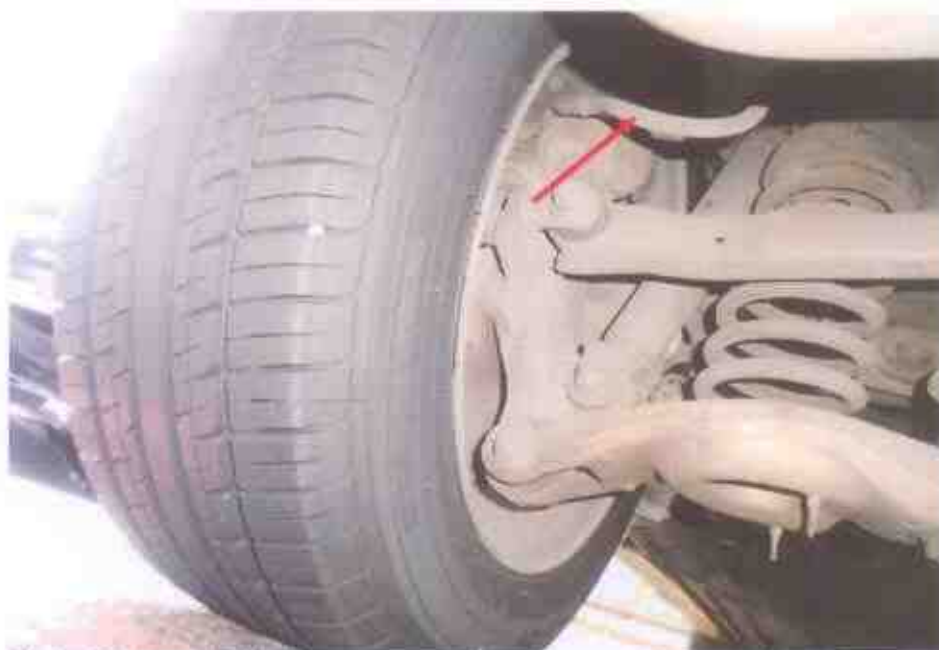
Photo 31 shows the braking components at the rear left wheel of the Motor Taxi. We did not observe any leakage of brake fluid at the time of our inspection of the Motor Taxi.
