Your Ref: TP/IP/40567/2018
Our Ref: CI/TPD18014215/Z

MECHANICAL INSPECTION REPORT OF MOTORCYCLE DBC 8052

1. We refer to your request dated 02nd August 2018 to conduct a physical inspection of a motorcycle bearing registration number DBC 8052 (herein referred to as "**Motorcycle**"), which was involved in a fatal road traffic accident on 17th July 2018.
2. The purpose of this inspection is to primarily determine if there was any possible mechanical failure to the Motorcycle that may have contributed to the accident.
3. Following the request, we had carried out a physical inspection of the Motorcycle on 31st August 2018 at the premises of Traffic Police vehicle pound, 517 Airport Road Singapore 539942. We now set out below our observations and comments with respect to this inspection.

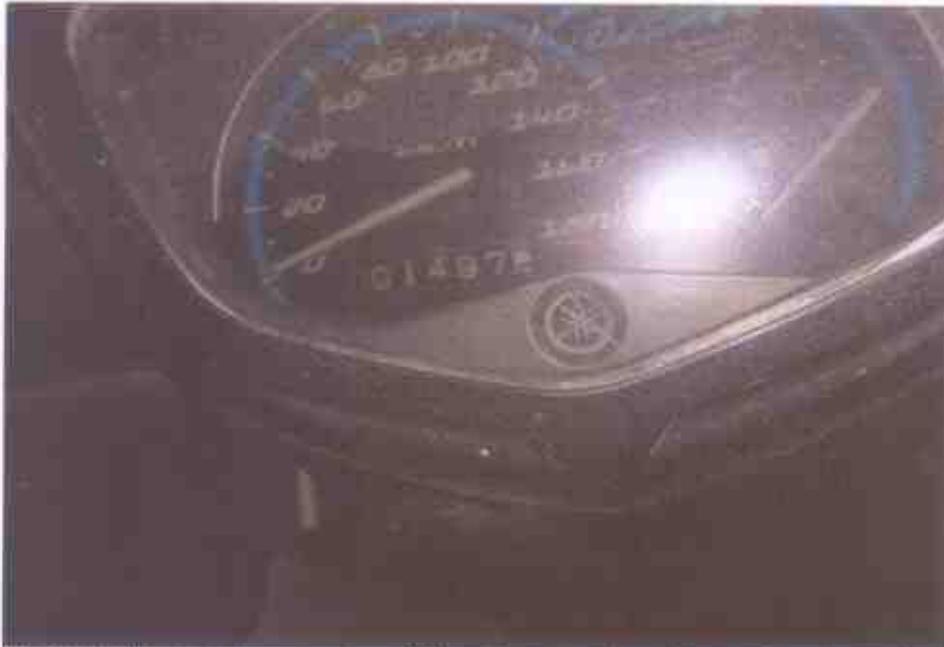
Photo 1 shows a close-up view of the mileage meter at time of our inspection. The mileage was recorded at 014975km.

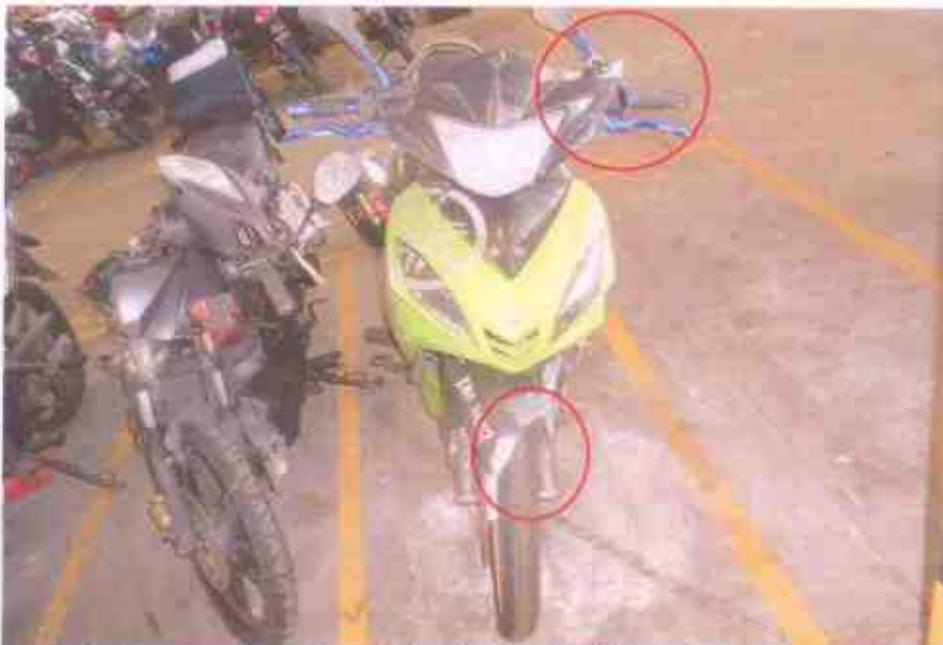
Photo 2 shows a general view of the front body of the Motorcycle at the time of our inspection. The Motorcycle was observed to have sustained relatively minor damages at time of inspection. The damages were observed to be confined to its left side of the Motorcycle.

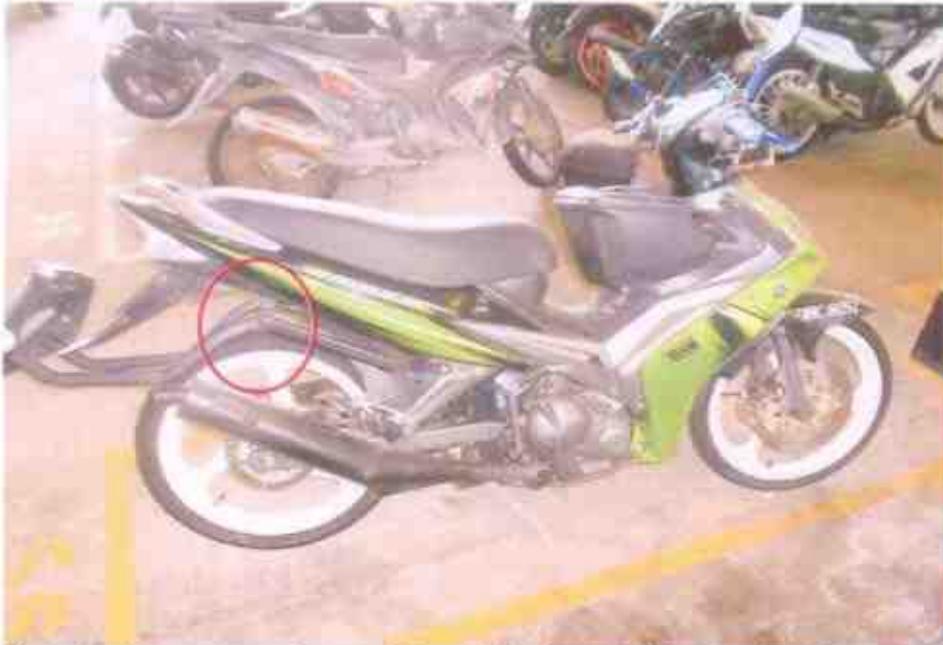
Photo 3 shows a general view of the right body of the Motorcycle at the time of our inspection. The Motorcycle was observed to be in good condition generally unaffected by the accident's impact except for a broken rear box bracket.

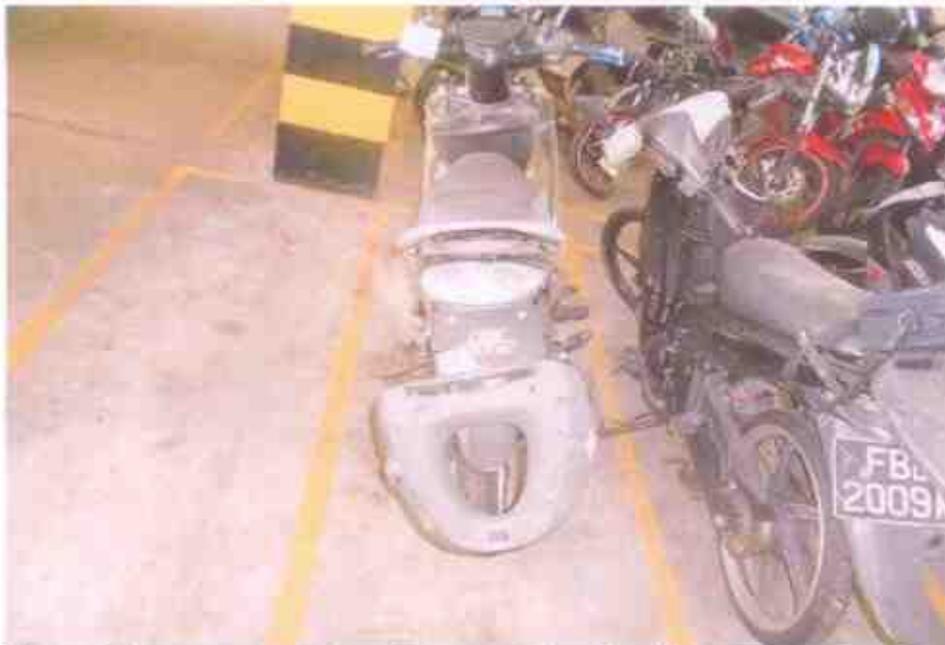
Photo 4 shows a general view of the rear body of the Motorcycle at the time of our inspection. The Motorcycle was observed to be in good condition generally unaffected by the accident's impact except for a broken rear box bracket.

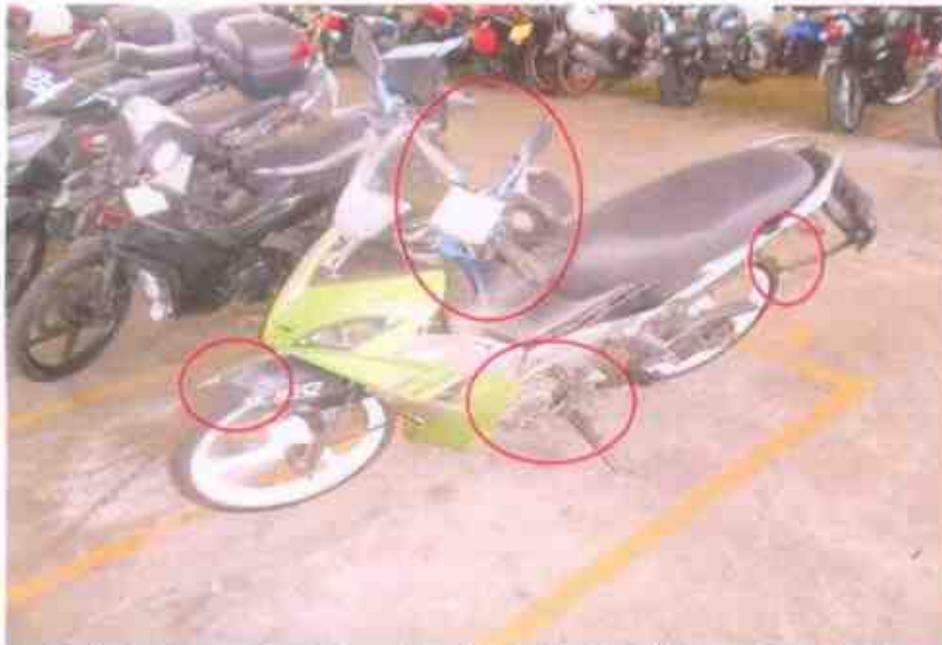
Photo 5 shows a general view of the left body of the Motorcycle at the time of our inspection. The Motorcycle was observed to have sustained relatively minor damages on the left portion as a result of the accident.

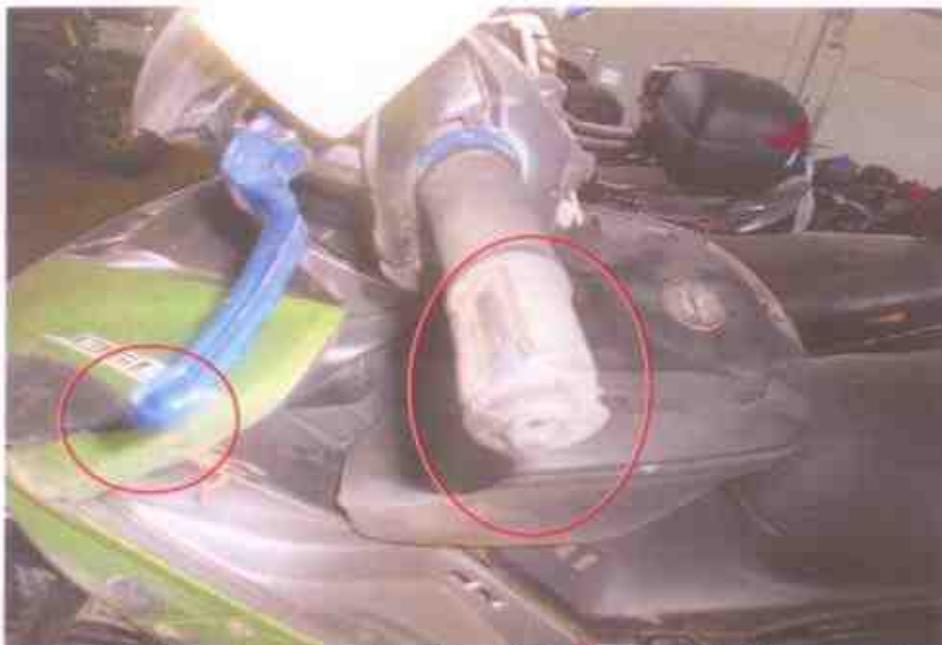
Photo 6 shows a closer view of the front left handle bar of the Motorcycle at the time of our inspection. The Motorcycle was observed to have sustained with relatively minor damages due to the accident collision. (Circled)

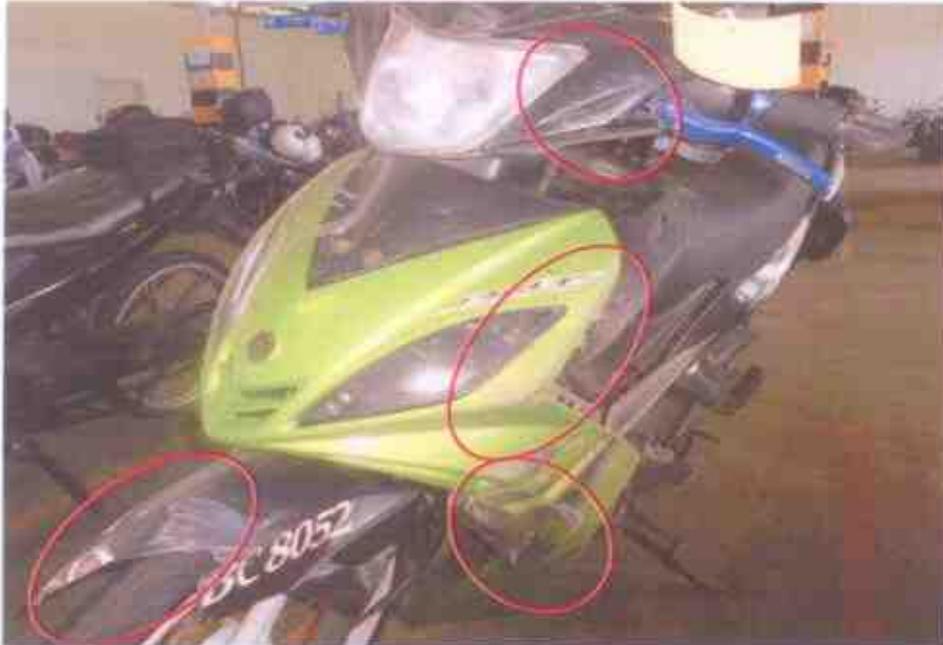
Photo 7 shows a closer view of the front left portion of the Motorcycle at the time of our inspection. The Motorcycle was observed to have sustained with relatively minor damages due to the accident collision. (Circled)

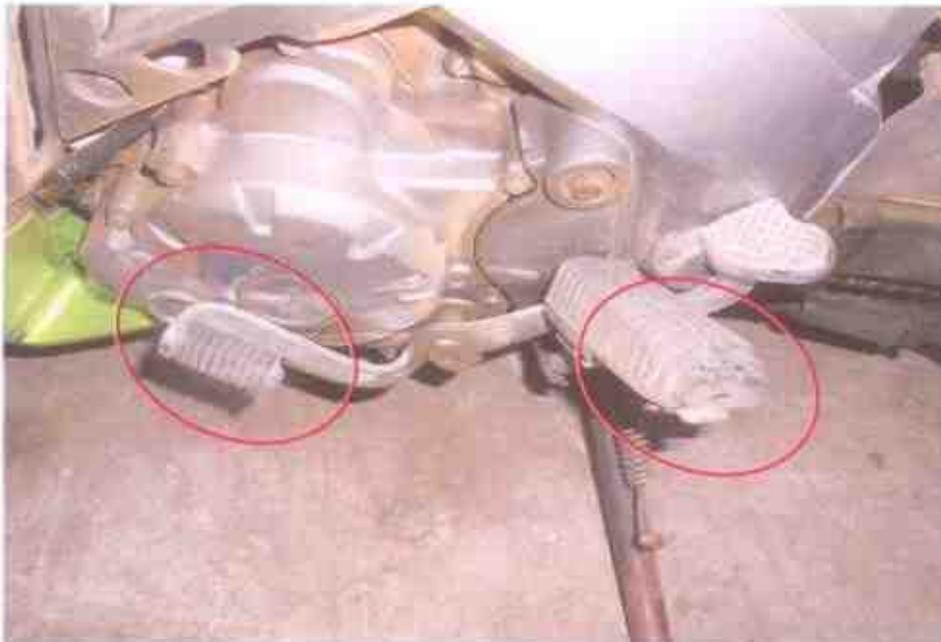
Photo 8 shows a closer view of the left foot rest & gear shift pedal of the Motorcycle at the time of our inspection. The Motorcycle was observed to have sustained with relatively minor damages due to the accident collision. (Circled)

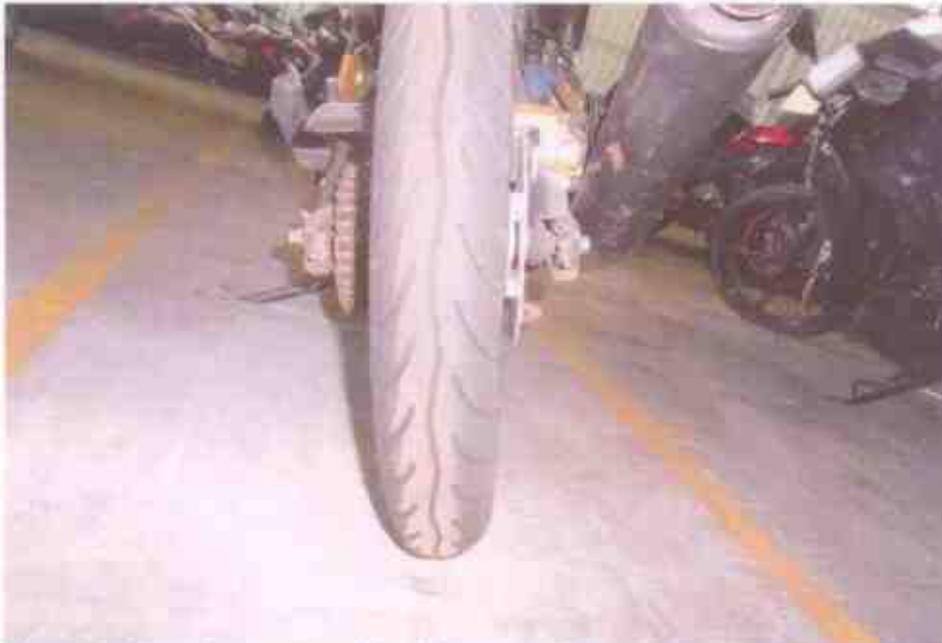
Photo 9 shows the rear tyre of the Motorcycle. The rear tyre was observed to be in serviceable condition with remaining tread depth of approximately 3mm. The tyre was also observed to be sufficiently inflated for vehicular operation.

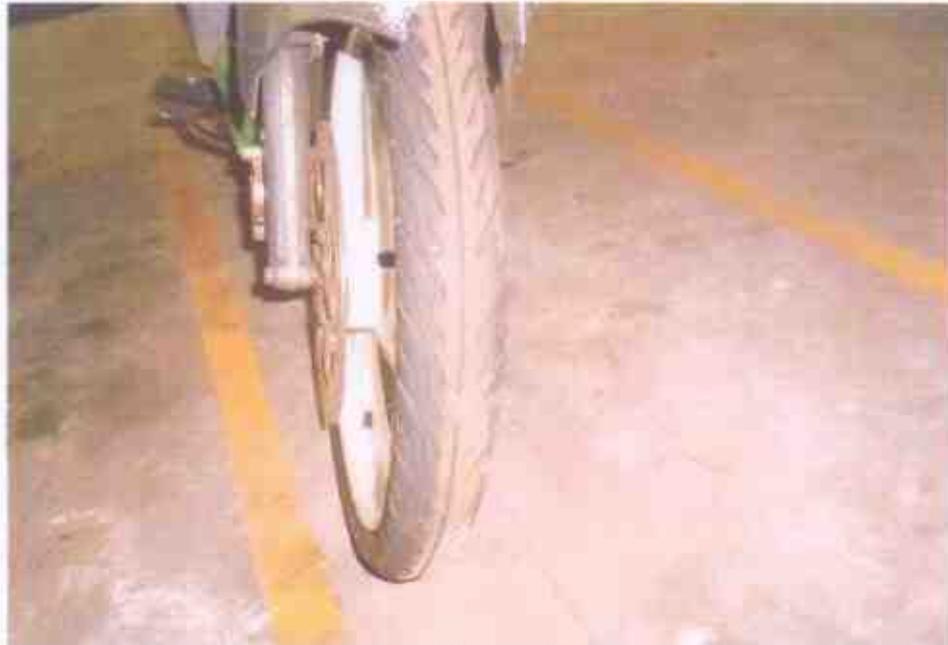
Photo 10 shows the front tyre of the Motorcycle. The front tyre was observed to be in serviceable condition with remaining tread depth of approximately 3mm. The tyre was also observed to be sufficiently inflated for vehicular operation.

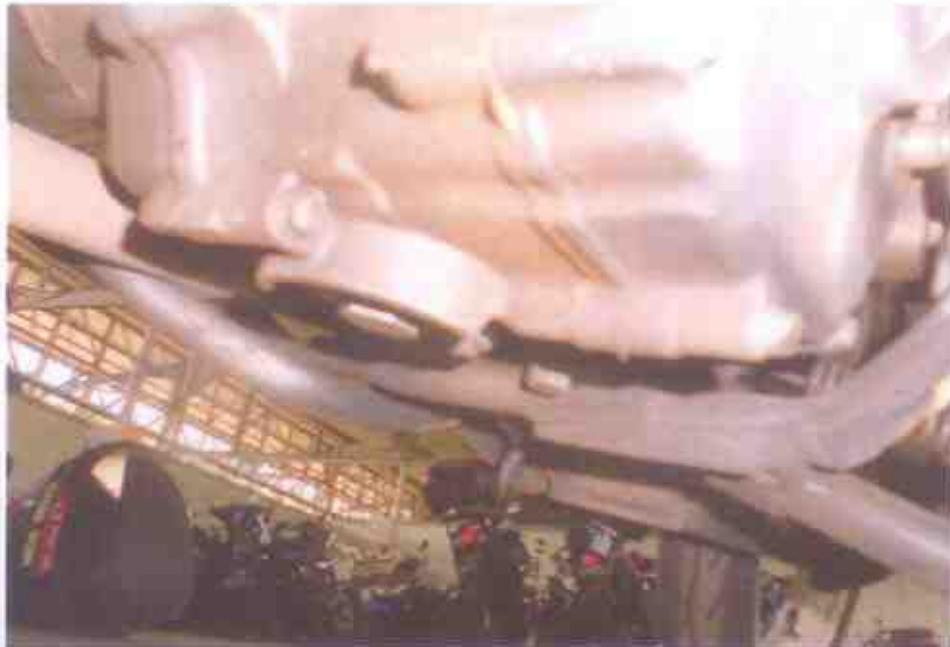
Photo 11 shows no sign(s) or indication(s) of fluid leak observed around the underside of the engine area of the Motorcycle.

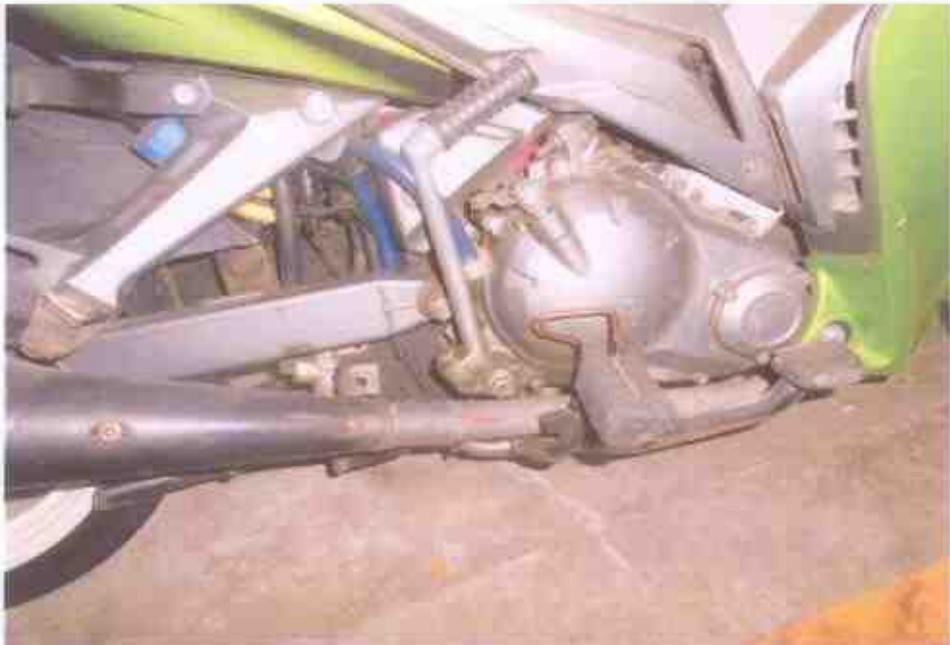
Photo 12 shows no sign(s) or indication(s) of fluid leakage stain observed around the engine area of the Motorcycle.

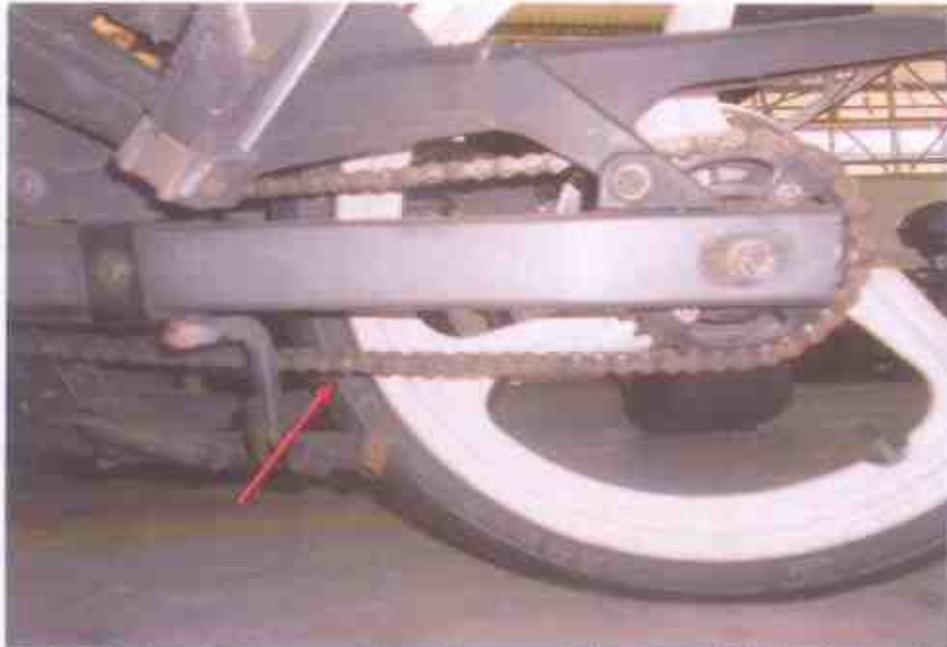
Photo 13 shows the general view of the gear train (arrowed) of the Motorcycle, which was observed to be intact with no misalignment. It was also adequately lubricated for operating purposes.

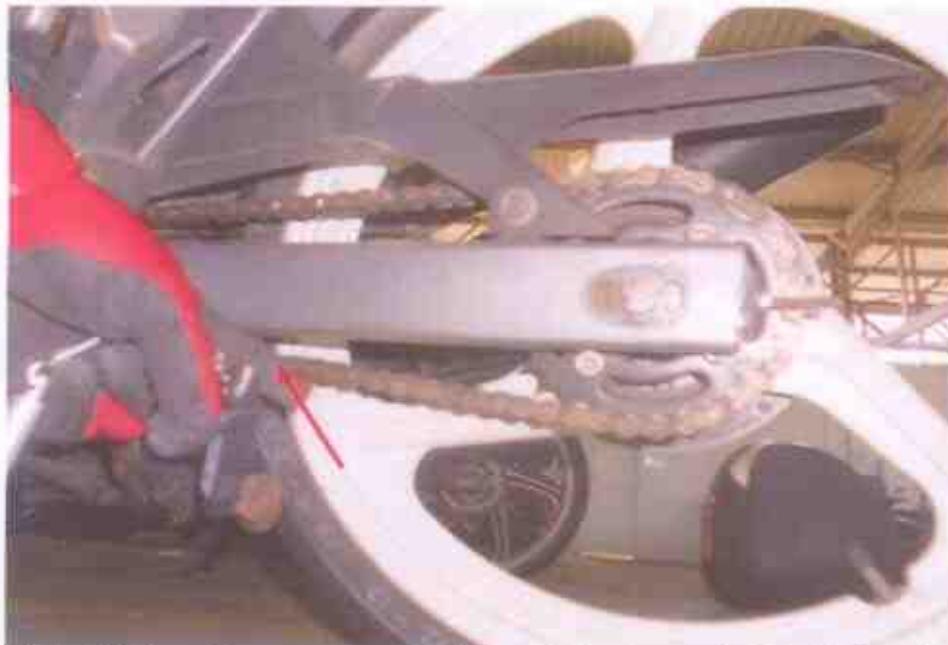
Photo 14 shows the general view of the gear train (arrowed) of the Motorcycle, which was observed to be intact with no misalignment. It was also adequately lubricated for operating purposes. Free play tension was also observed & found adequately acceptable.

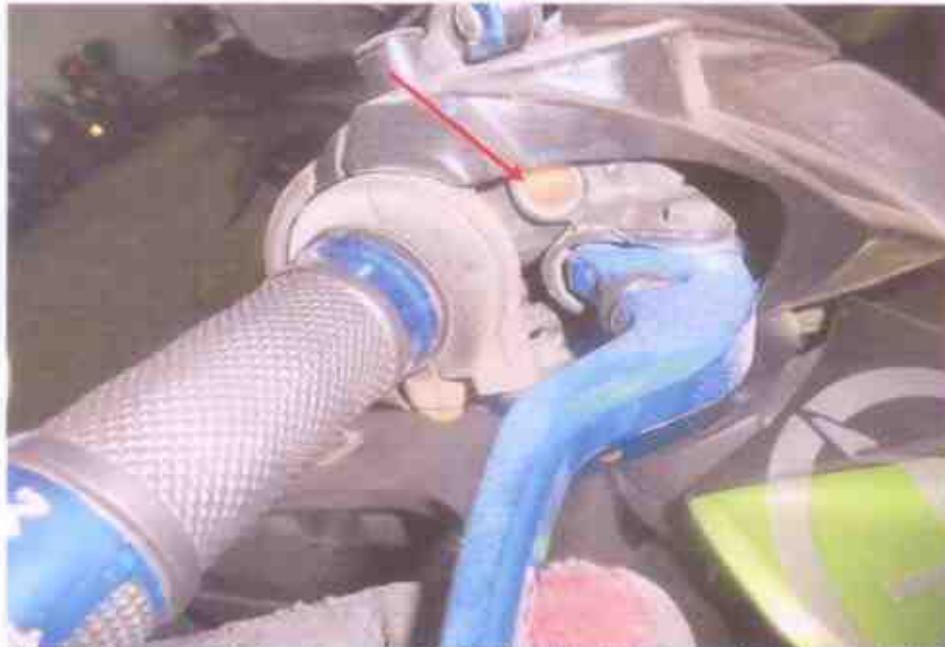
Photo 15 shows our checks on the brake fluid (front) reservoir had also indicated that the brake fluid was of sufficient level for operational purposes, and without contamination.

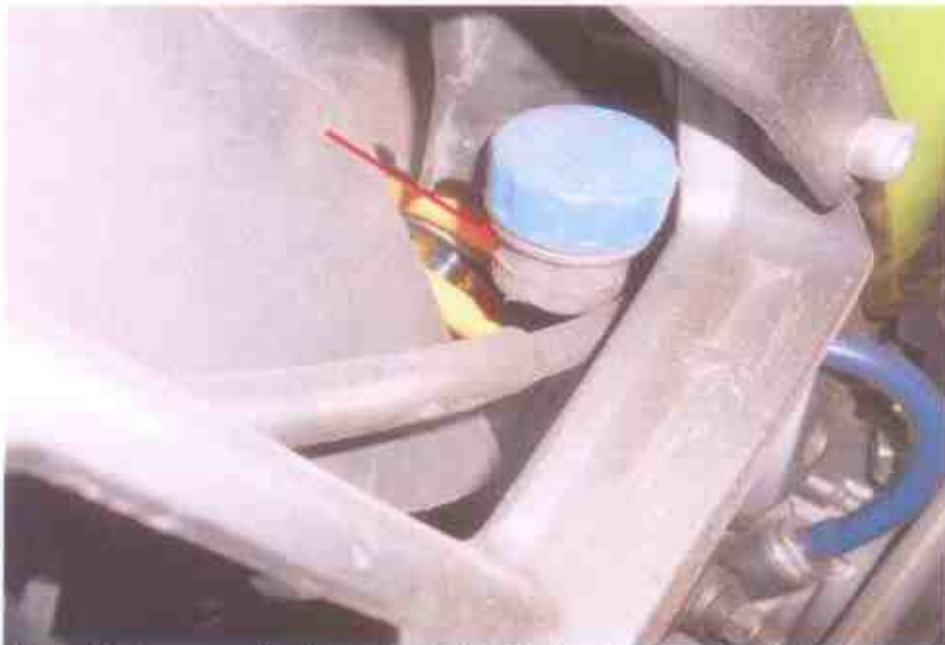
Photo 16 shows our checks on the brake fluid (rear) reservoir had also indicated that the brake fluid was of sufficient level for operational purposes, and without contamination.

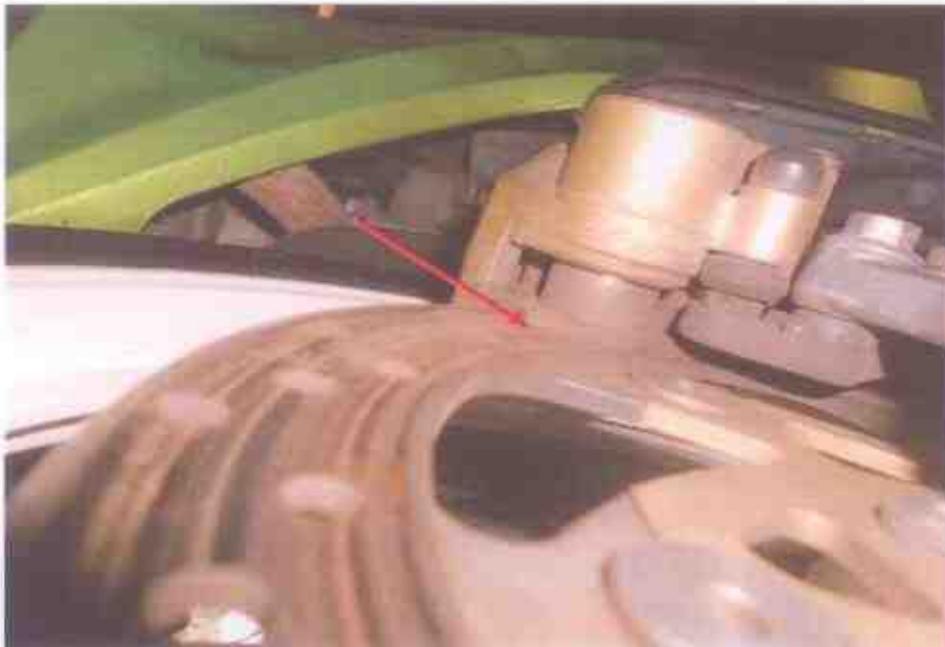
Photo 17 shows a close-up view our checks on the brake pad (front). The frictional material was observed to be in a sufficient level for operational purposes.

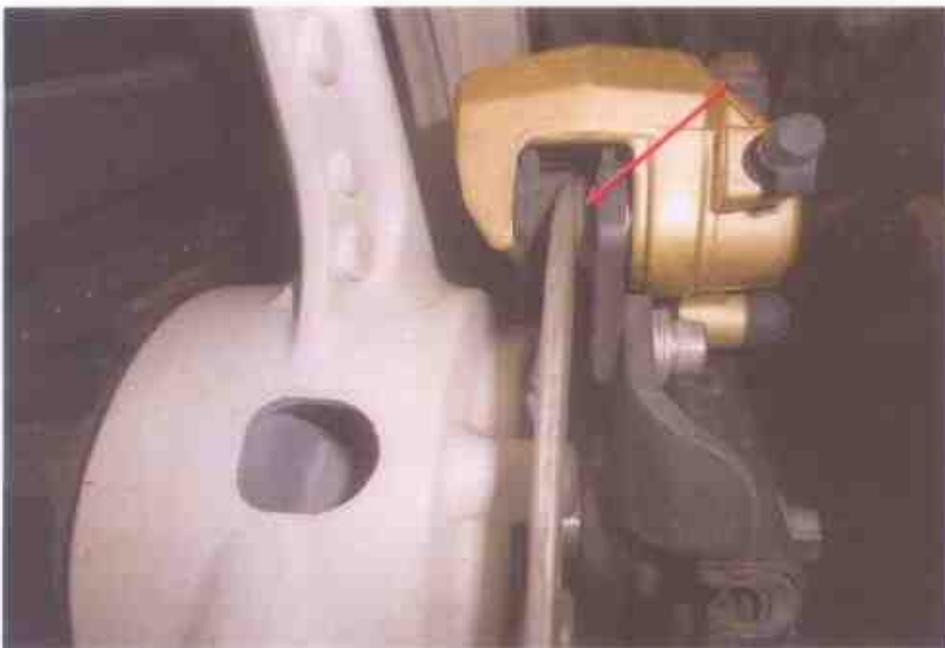
Photo 18 shows a close-up view our checks on the brake pad (rear). The frictional material was observed to be in a sufficient level for operational purposes.

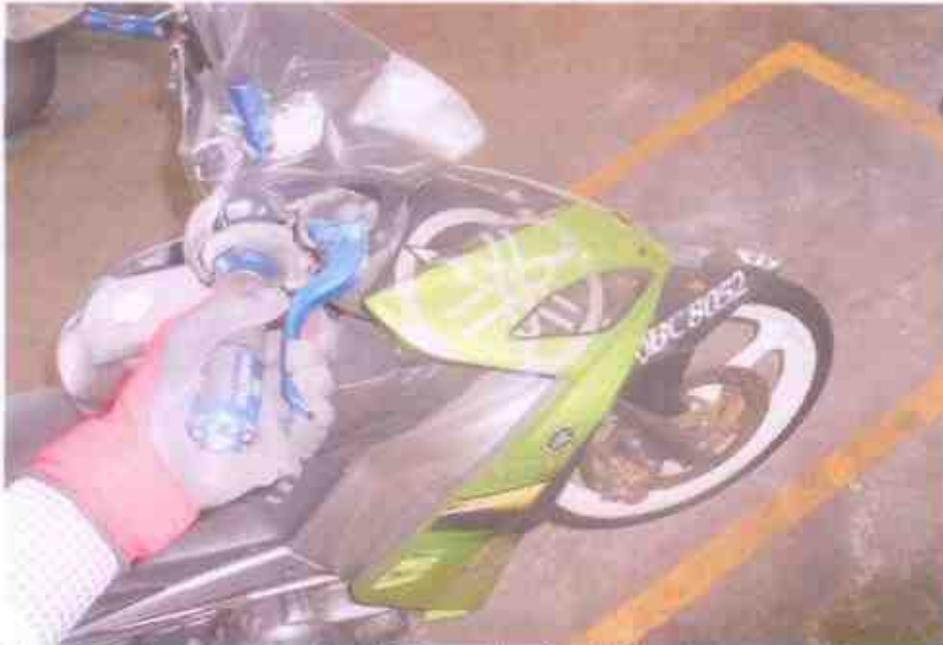
Photo 19 shows testing of the braking of the front brake in progress. There was some resistance felt (spongy like feel) upon pressing the brake lever.

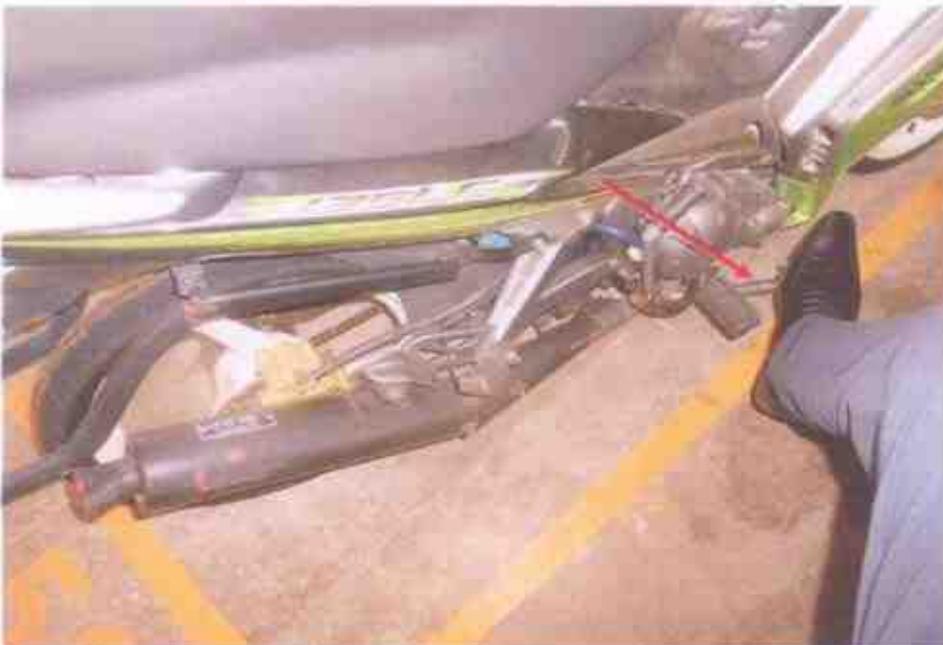
Photo 20 shows testing of the braking of the rear brake in progress. There was some resistance felt (spongy like feel) upon stepping on the brake pedal.
