Your Ref: TP/IP/41029/2018
Our Ref : CI/TPD18014216/Z

27th September 2018

MECHANICAL INSPECTION REPORT OF MOTORCYCLE FBF 228E

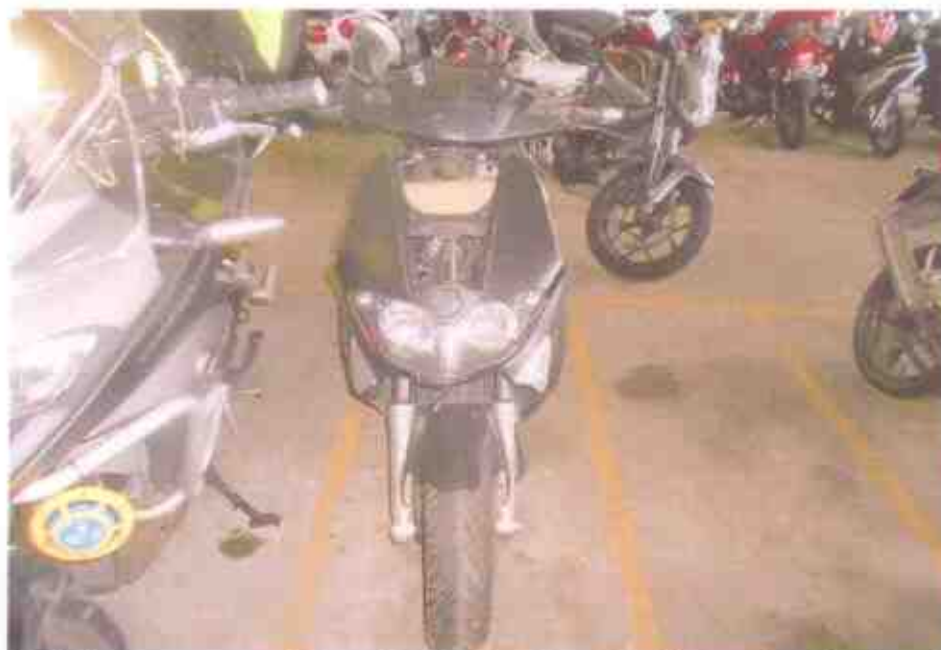
Photo 1 shows a general view of the front portion of the Motorcycle at the time of our inspection. The Motorcycle was observed to have sustained with relatively minor impact due to the accident collision.

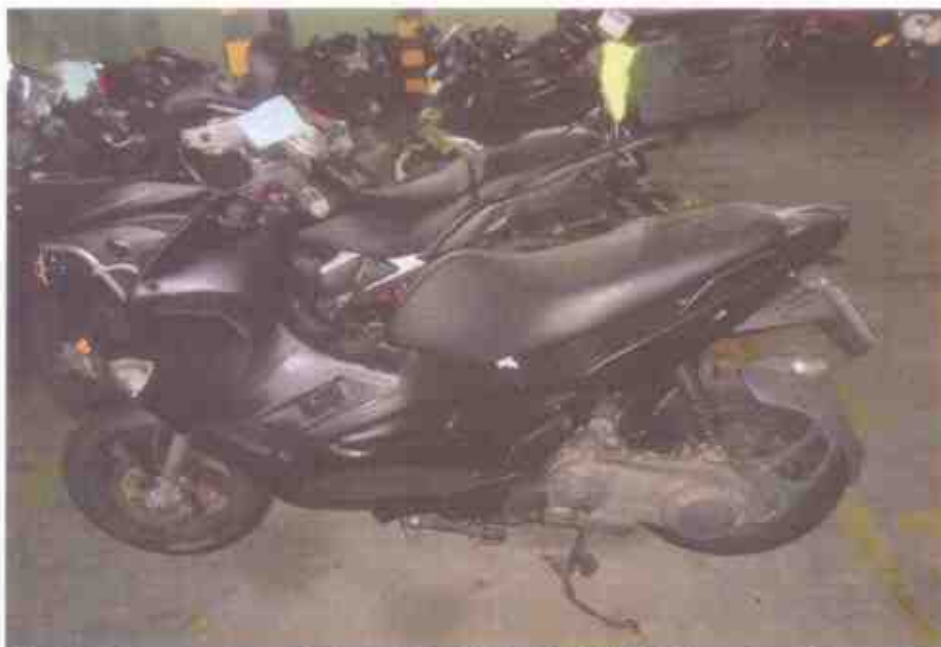
Photo 2 shows a general view of the left body of the Motorcycle at the time of our inspection. The Motorcycle was observed to have sustained with relatively minor impact due to the accident collision.

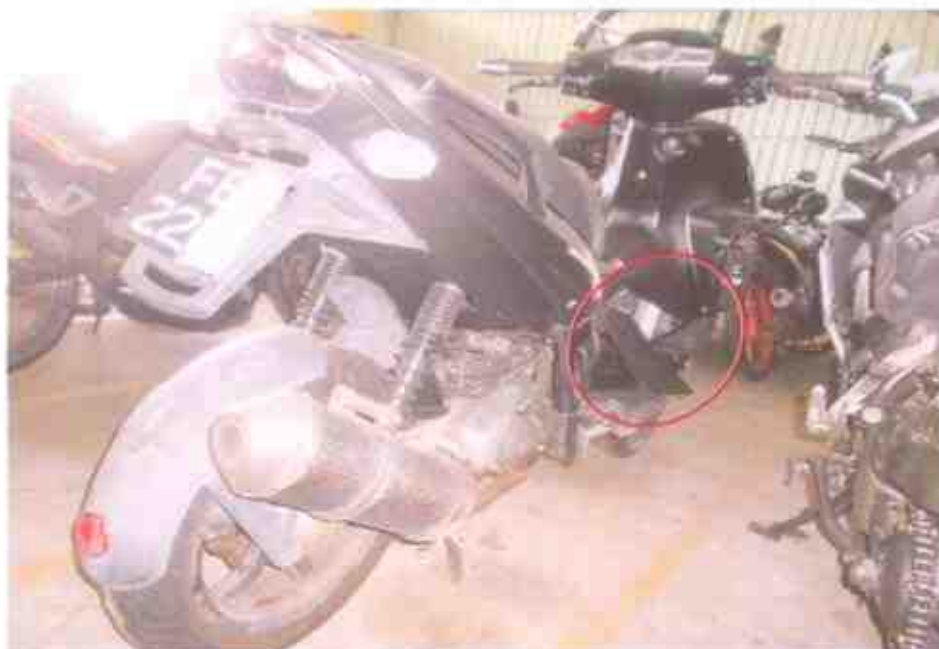
Photo 3 shows a general view of the right body of the Motorcycle at the time of our inspection. The Motorcycle was observed to have sustained minor damages at the frontal portion, along its right side. (Circled)

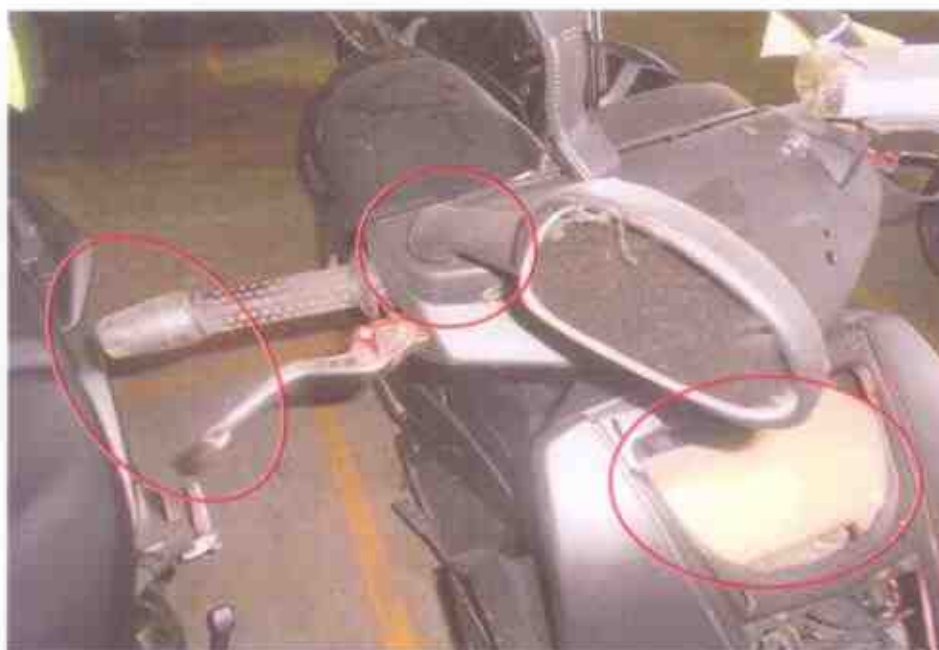
Photo 4 shows a closer view of the frontal portion of the Motorcycle at the time of our inspection. The Motorcycle was observed to have sustained relatively minor impact due to the accident collision. (Circled)

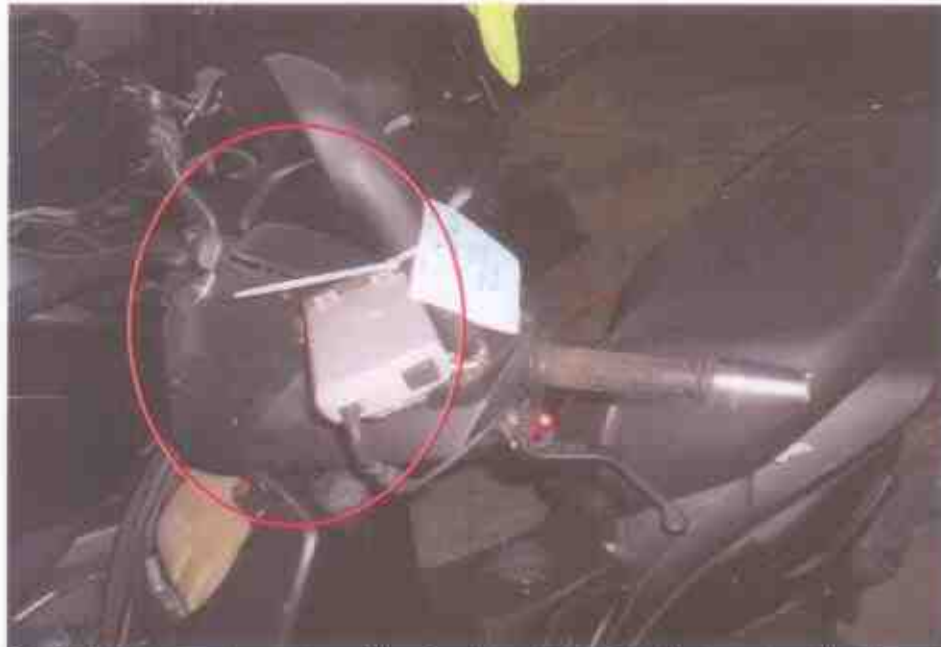
Photo 5 shows a closer view of the frontal portion of the Motorcycle at the time of our inspection. The Motorcycle was observed to have sustained broken front top fairing due to the accident collision. (Circled)

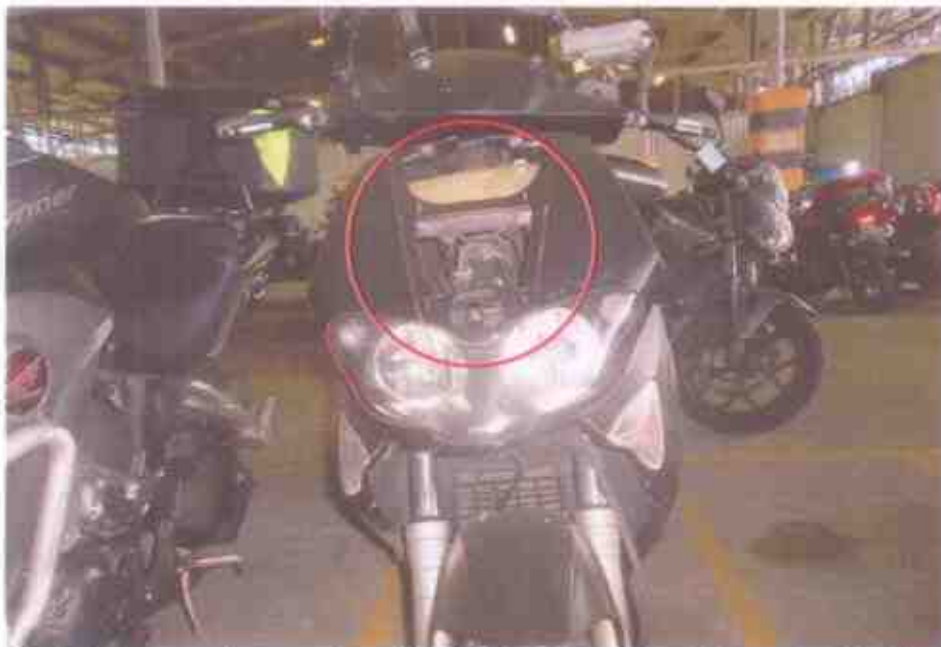
Photo 6 shows a close-up view of the front portion of the Motorcycle at the time of our inspection was observed to sustained damages on the outer cover due to the accident collision. (Circled)

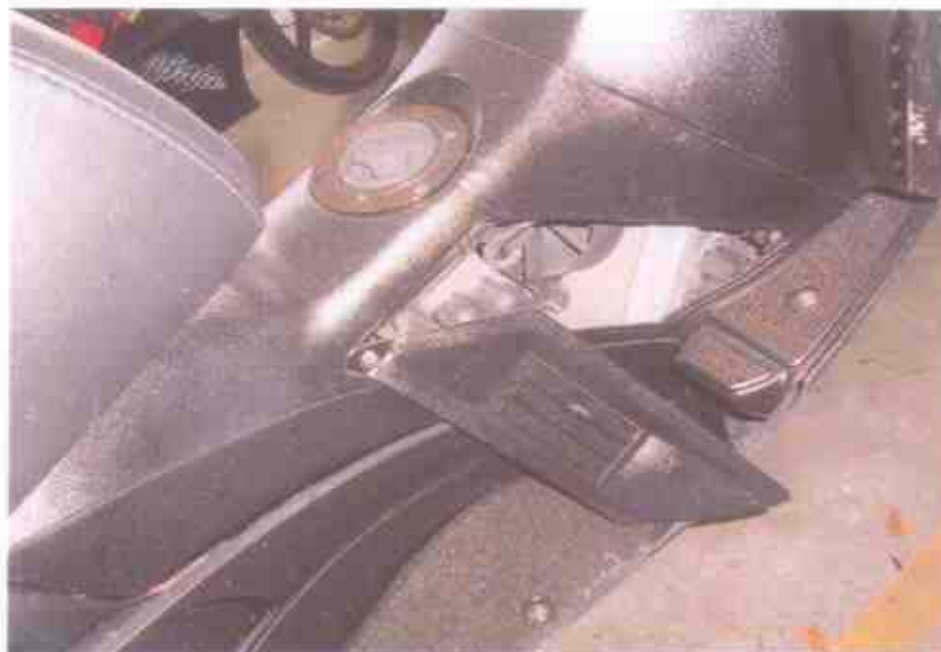
Photo 7 shows a closer view of the right side engine cover of the Motorcycle at the time of our inspection. It was observed to have sustained damages due to the accident collision. (Circled)

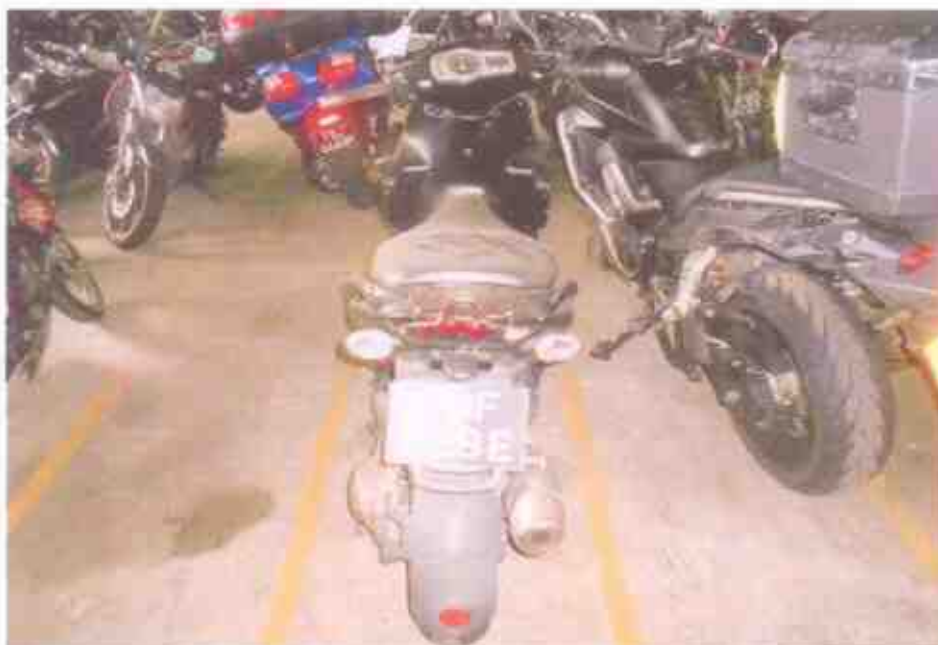
Photo 8 shows a view of the rear portion of the Motorcycle at the time of our inspection. It was observed to be in generally good condition unaffected by the accident.

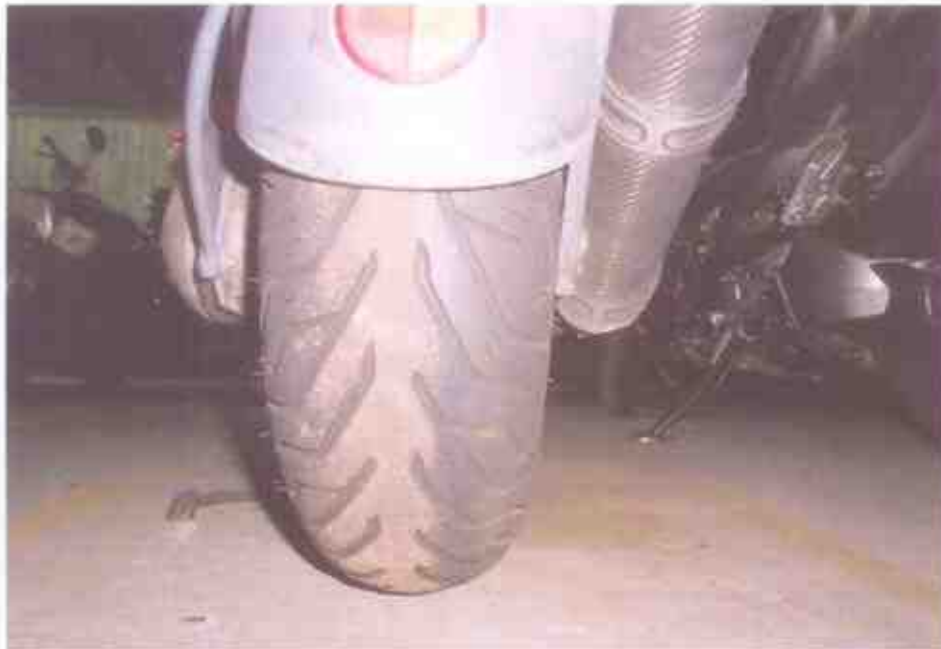
Photo 9 shows the rear tyre of the Motorcycle. The rear tyre was observed to be in serviceable condition with remaining tread depth of approximately 4mm. The tyre was also observed to be sufficiently inflated for vehicular operation.

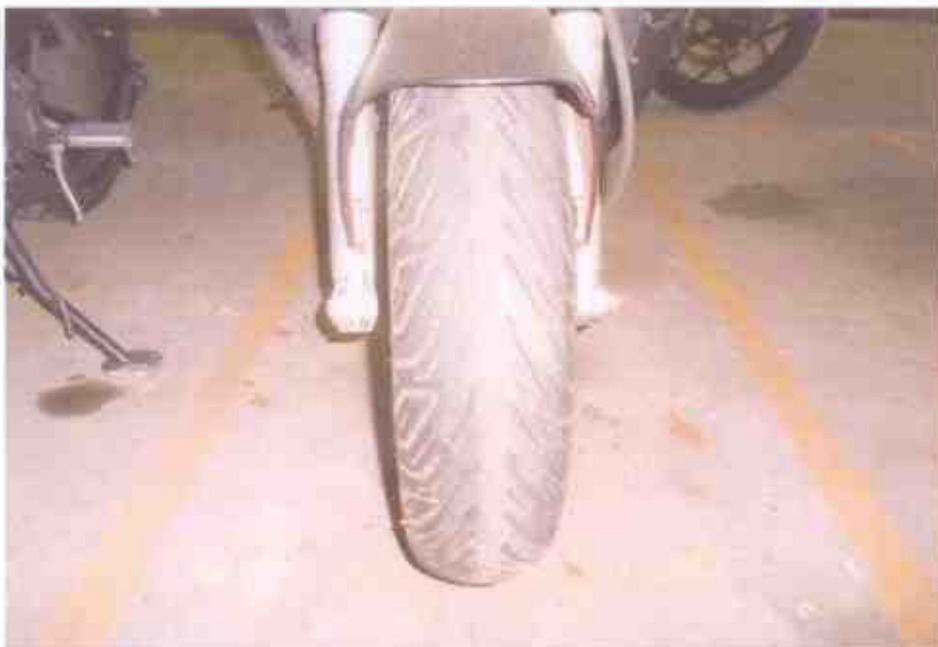
Photo 10 shows the front tyre of the Motorcycle. The pattern of the tread was clearly visible. There was no tear, burst mark(s) and/or punctured hole(s) on the sidewalls as well as across the tread of the front tyre.

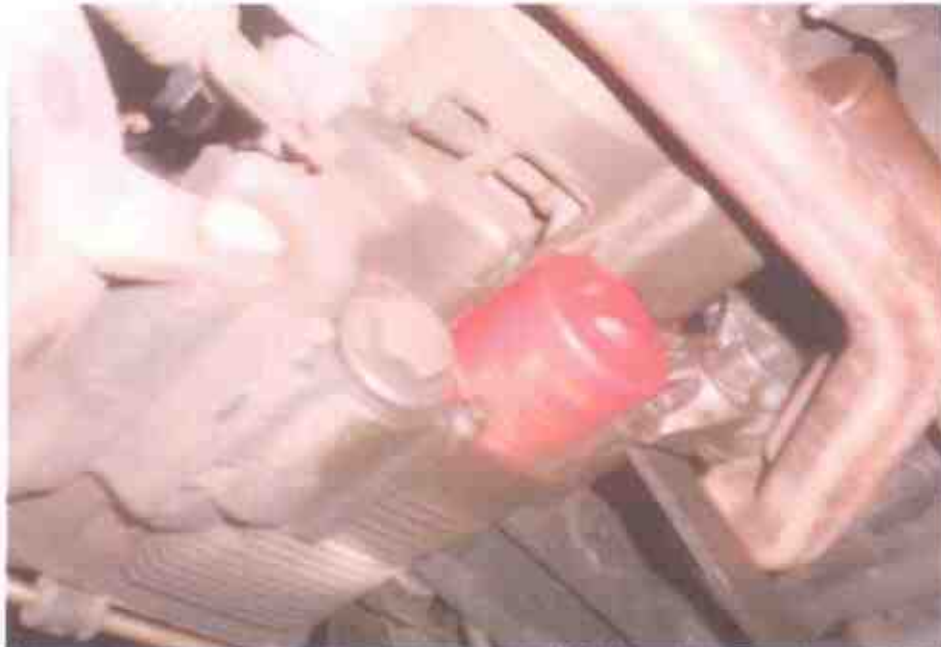
Photo 11 shows no sign(s) or indication(s) of fluid leak observed around the underside of the engine area of the Motorcycle.

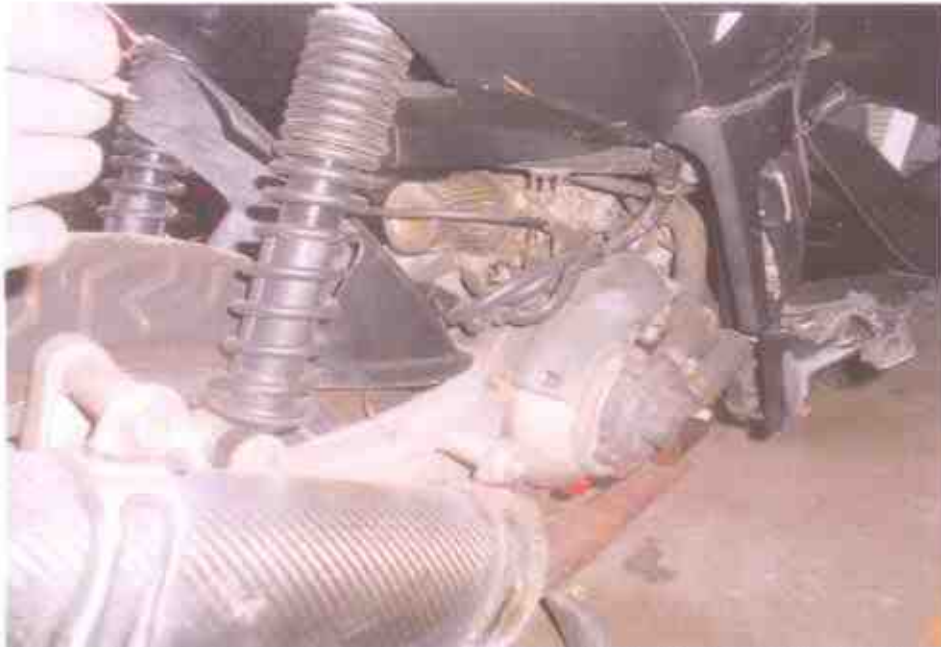
Photo 12 shows no sign(s) or indication(s) of fluid leak observed around the underside of the engine area of the Motorcycle.

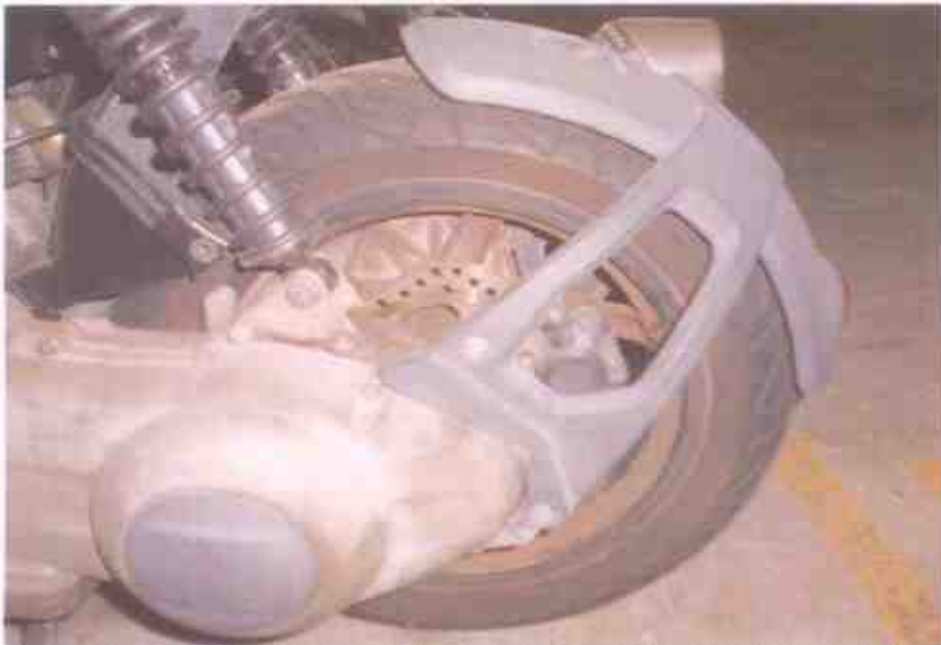
Photo 13 shows the drive train of the motorcycle was found to be intact without any misalignment.

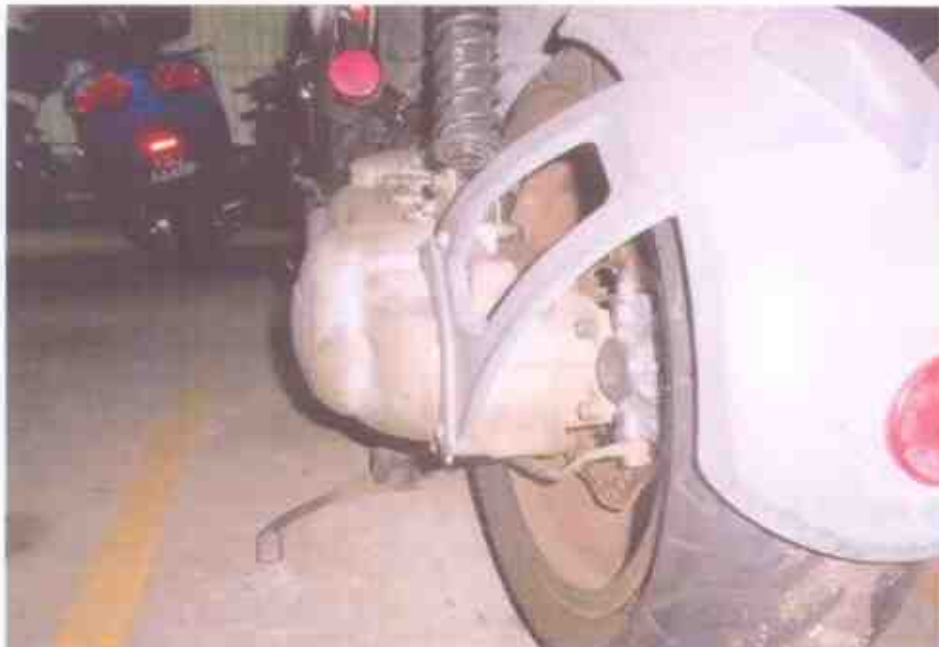
Photo 14 shows the drive train of the motorcycle was found to be intact without any misalignment.

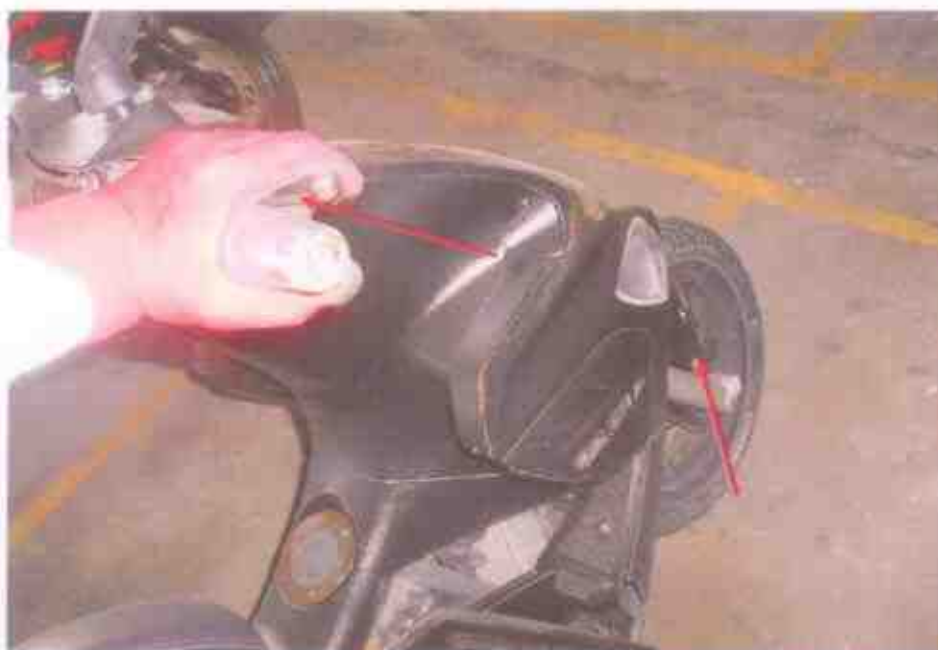
Photo 15 shows the front brake static test. Static braking test was conducted to the front braking system & found to be in serviceable condition.

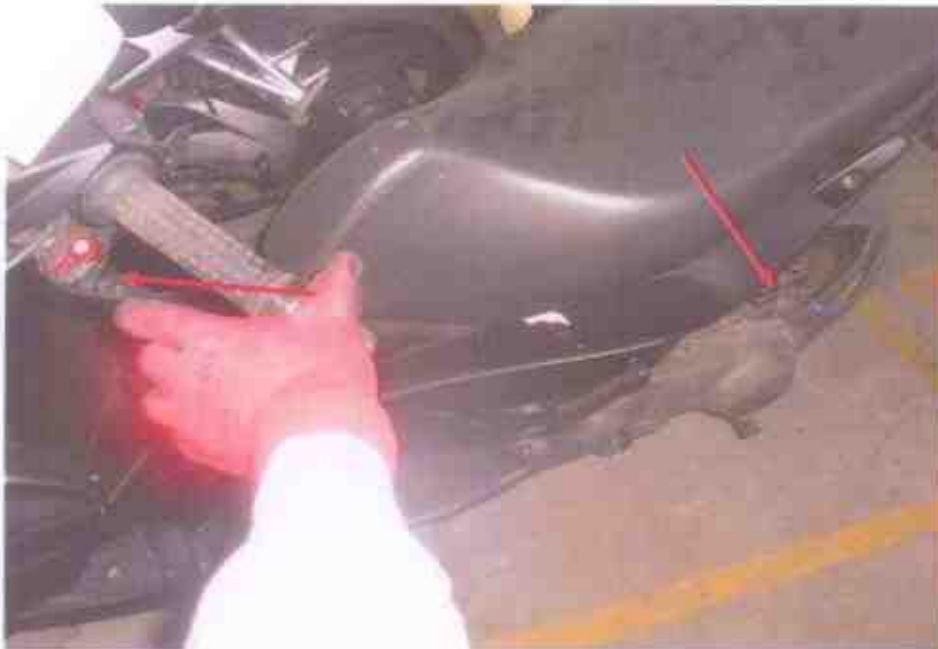
Photo 16 shows the rear brake static test. Static braking test was conducted to the rear braking system & found to be in serviceable condition.

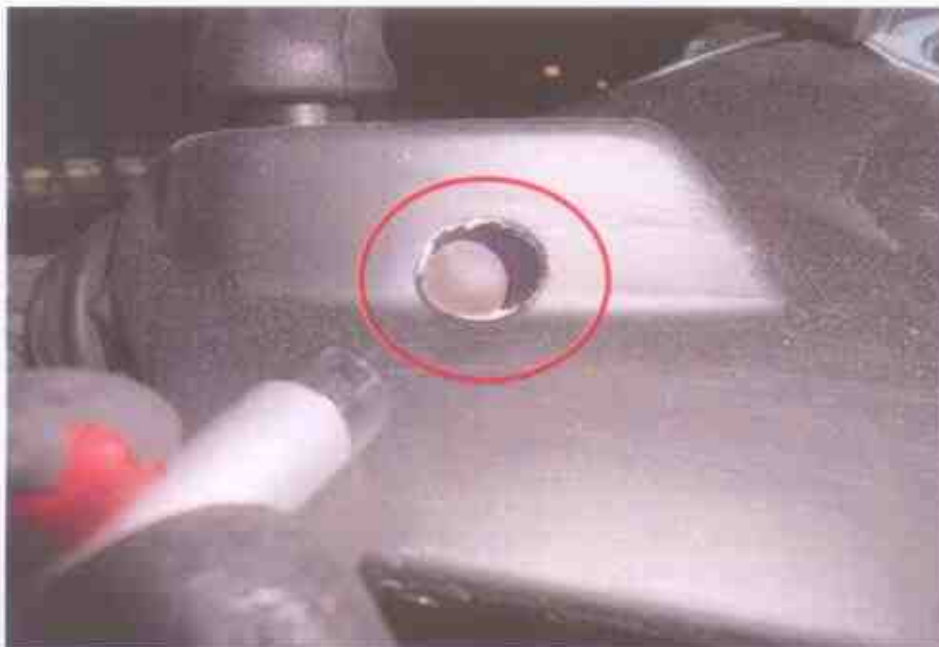
Photo 17 shows the brake fluid reservoir on the right hand handle however was noted to be of sufficient level for operational purposes, and without contamination.

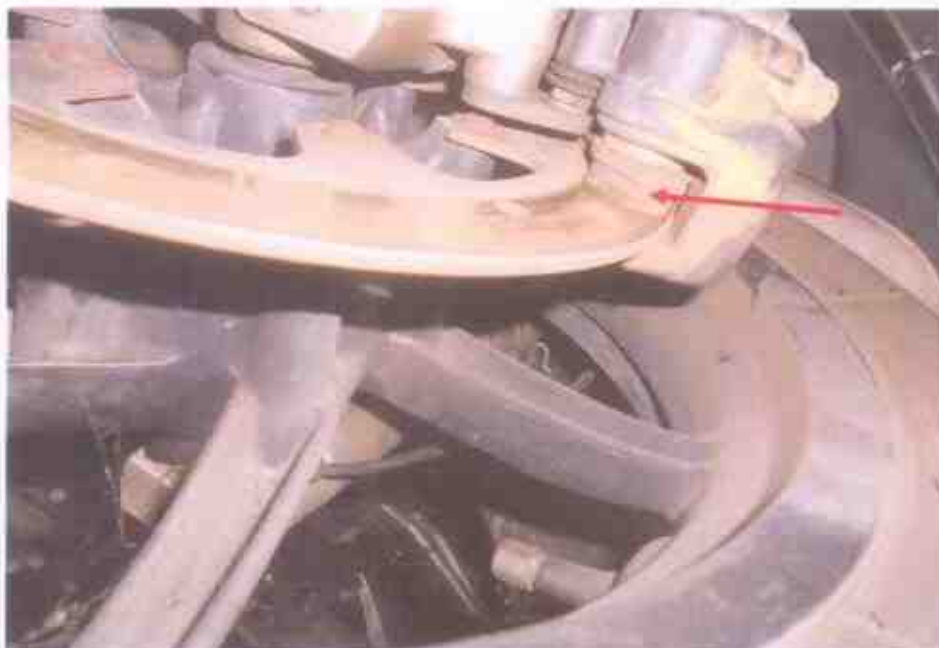
Photo 18 shows the front brake pad of the front wheel was noted to be of sufficient frictional material for operational purposes.

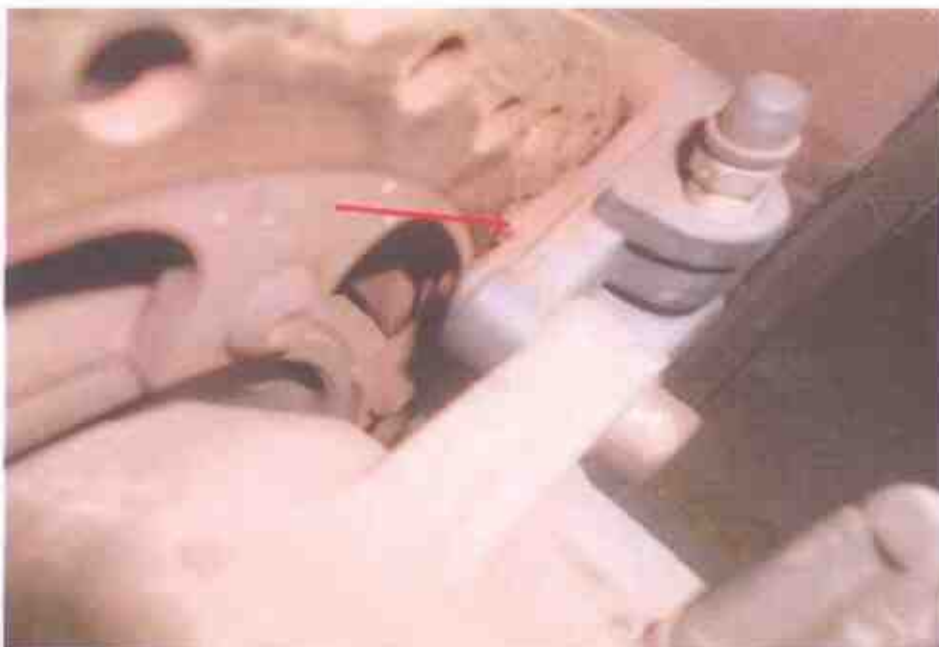
Photo 19 shows the rear brake pad of the rear wheel was noted to be of sufficient frictional material for operational purposes.
