Your Ref: TP/IP/39647/2018
Our Ref : CI/TPD18014218/Z

01st November 2018

MECHANICAL INSPECTION REPORT OF MOTOR LORRY GBD 9032D.

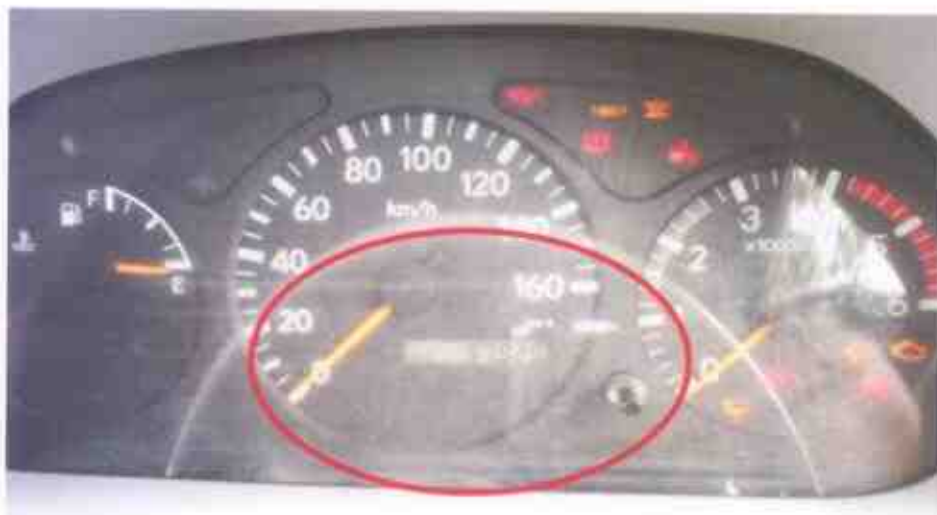
Photo 1 shows the mileage of the Motor Lorry was 97925km.

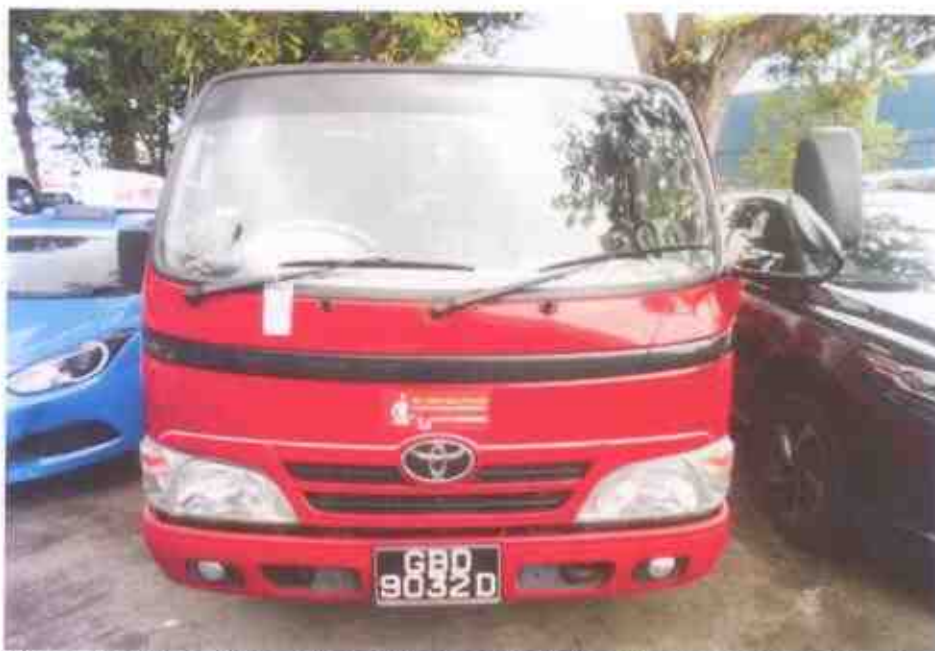
Photo 2 shows a general view of the front left body of the Motor Lorry at the time of our inspection. The Motor Lorry was observed to be in good condition unaffected by the accident.

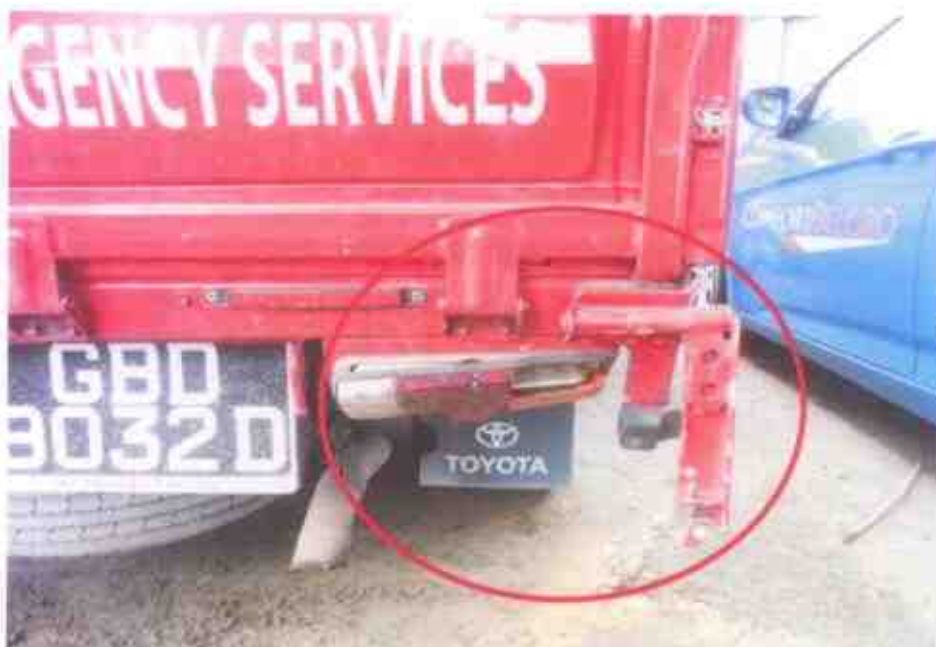
4. The mileage of the Motor Lorry at the time of our inspection was 97925km.
5. The Motor Lorry was observed to have sustained damages at its rear right tail lamp and bracket support were amongst the body parts that were damaged as a result of the accident.

Photo 3 shows the damages to the rear right tail lamp & lock bracket as a result of the accident.

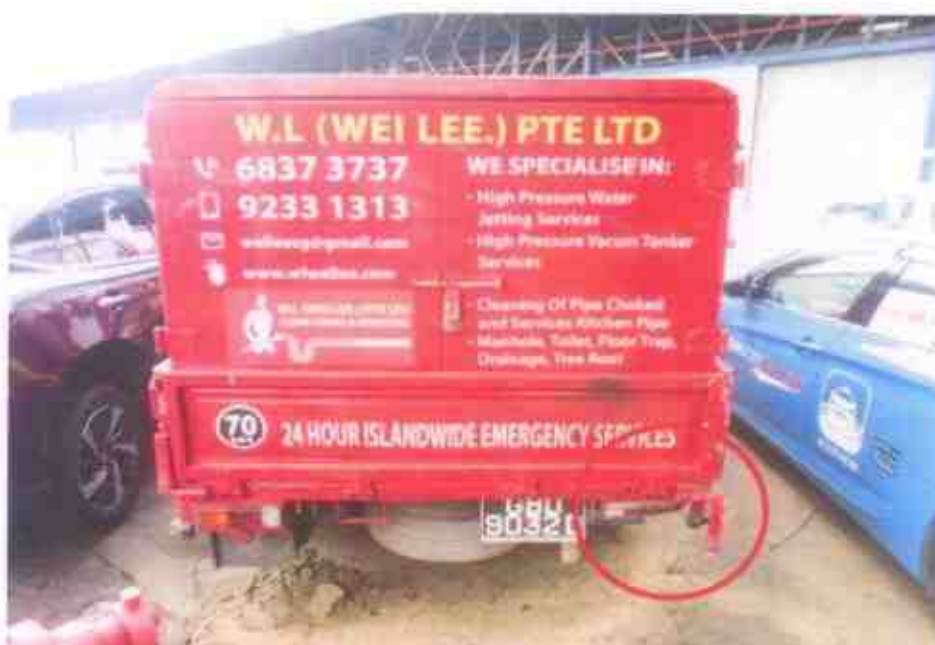
Photo 4 shows a general view of the rear body of the Motor Lorry at the time of our inspection. The Motor Lorry was observed to sustained damages to the rear right tail lamp & lock bracket as a result of the accident.

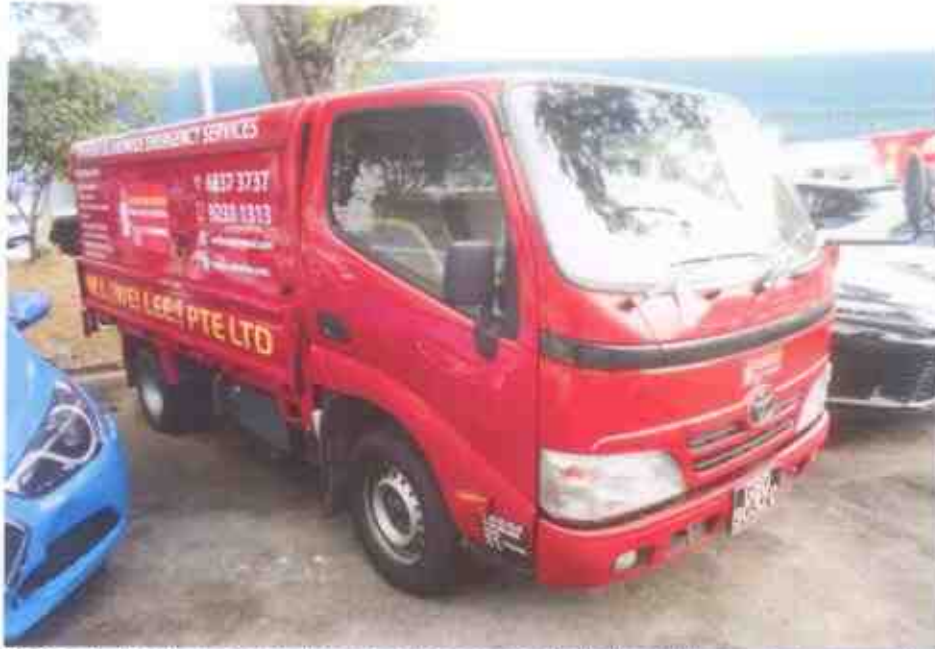
Photo 5 shows a general view of the front right body of the Motor Lorry at the time of our inspection. The Motor Lorry was observed to be in good general condition at time of inspection.

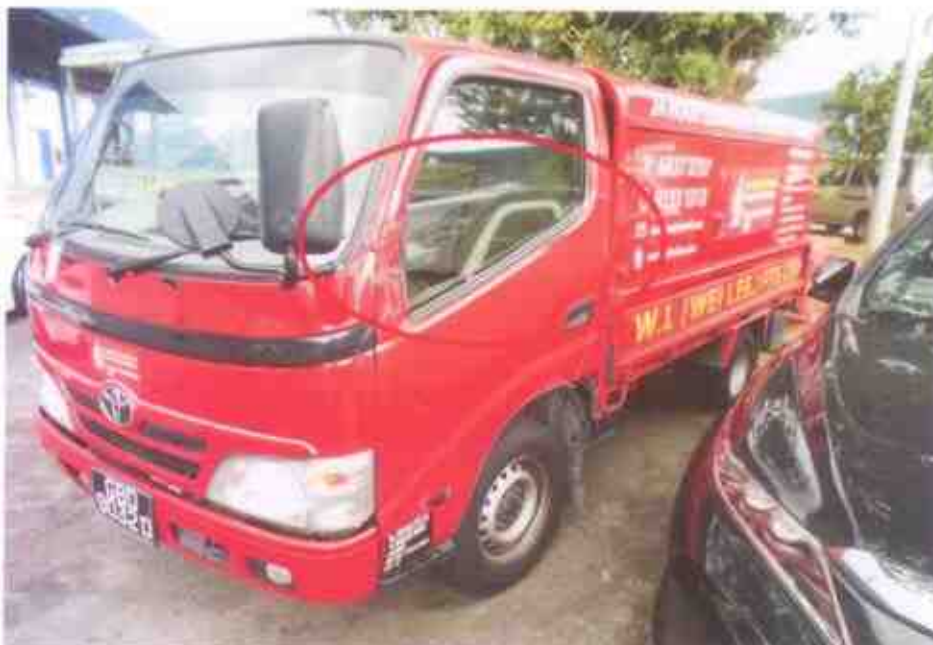
6. Further observation reveals that minor damages/scratches were also found on the left portion which was not related to the accident.
7. This was likely due to the consistency of the accident's case facts that a motorcyclist (NCY1262) was travelling along PIE (Tuas), 36.5km on left of the 2 lanes road when it suddenly collided into the rear of a Motor Lorry (GBD 9032D) that was travelling on the left lane, directly ahead of him. Due to the impact, the deceased skidded to the right side and encroached into the travelling path of Motor Taxi (SHA 7941M) that was travelling on the right lane. As it was too sudden, the Motor Taxi was unable to brake in time hence collided into the Motorcycle. See photo 1 to 6 below.

Photo 6 shows a general view of the front left body of the Motor Lorry at the time of our inspection. The Motor Lorry was observed sustained minor damages that were believe not related to the accident.

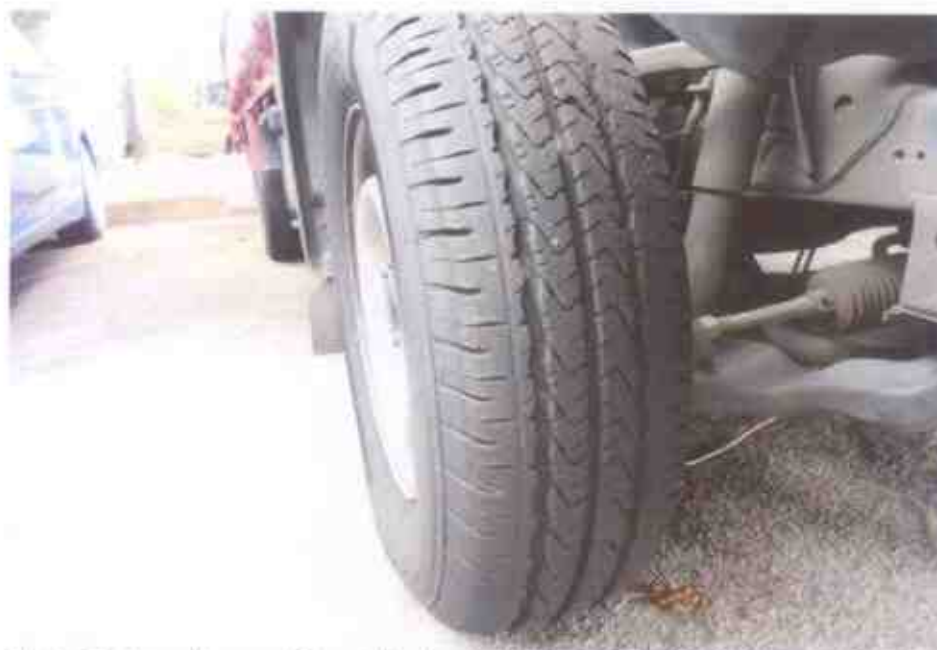
Photo 7 shows the condition of the front right tyre of the Motor Lorry, which was observed to be in serviceable condition with remaining tread depth of approximately 7mm.

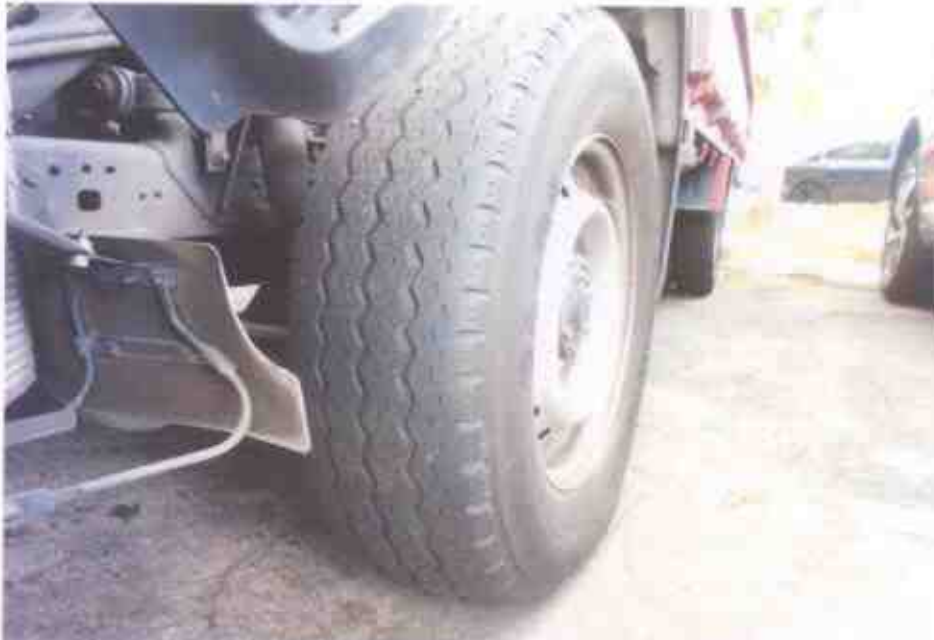
Photo 8 shows the condition of the front left tyre of the Motor Lorry, which was observed to be in serviceable condition with remaining tread depth of approximately 5mm. The tyre, which was wrapped around standard wheel rim, was also observed to be sufficiently inflated for vehicular operation.

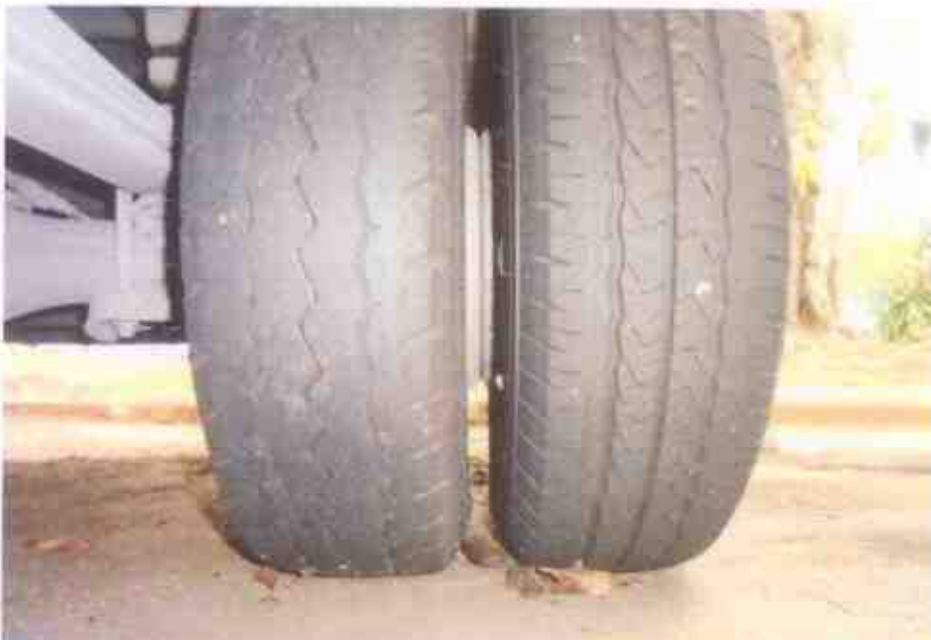
Photo 9 shows the condition of the rear left tyre of the Motor Lorry, which was observed to be in serviceable condition with remaining tread depth of approximately 4mm. The tyre, which was wrapped around standard wheel rim, was also observed to be sufficiently inflated for vehicular operation.

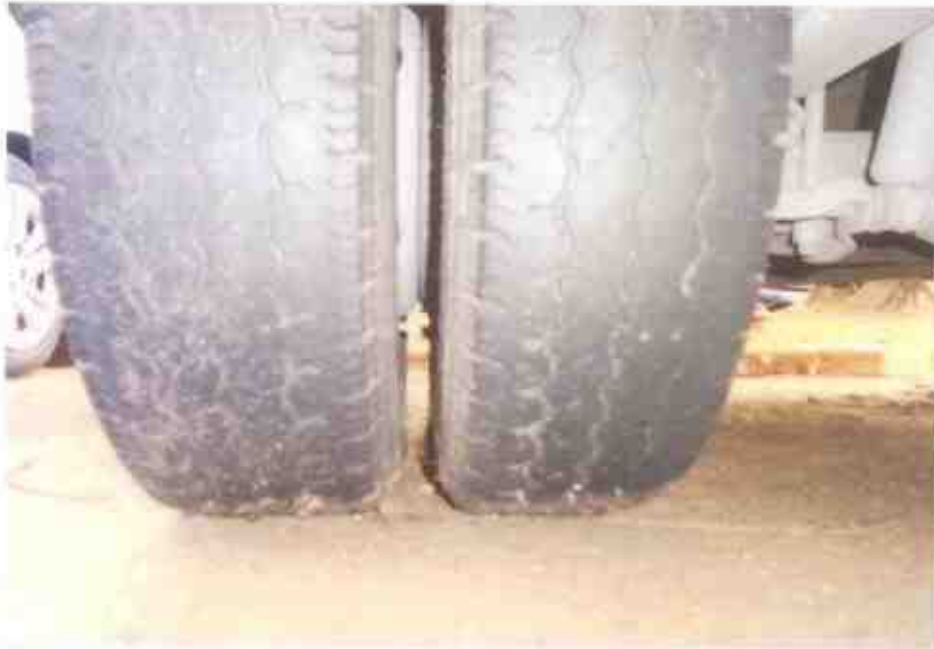
Photo 10 shows the condition of the rear right tyre of the Motor Lorry, which was observed to be in serviceable condition with remaining tread depth of approximately 2mm. There was also no tear, cut or burst mark(s) on the outer and the inner sidewalls as well as across the tread of the tyre, which was also sufficiently inflated for vehicular operation.

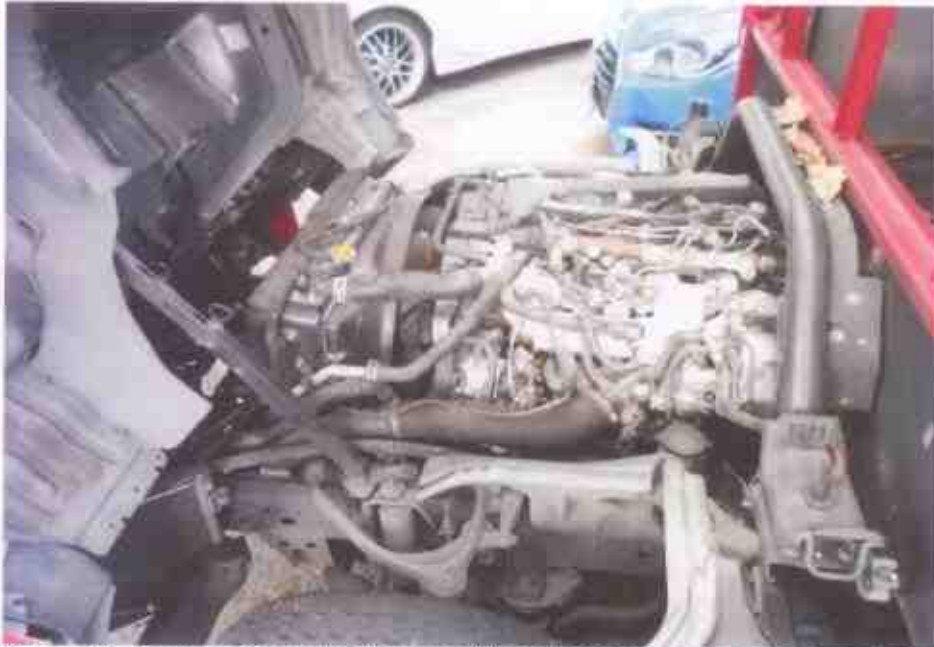
Photo 11 shows a general view of the Motor Lorry's engine compartment. The various parts and components inside the engine compartment were unaffected by the accident. There was also no sign(s) or indication(s) of fluid leakage and/or fluid stain within the engine compartment.

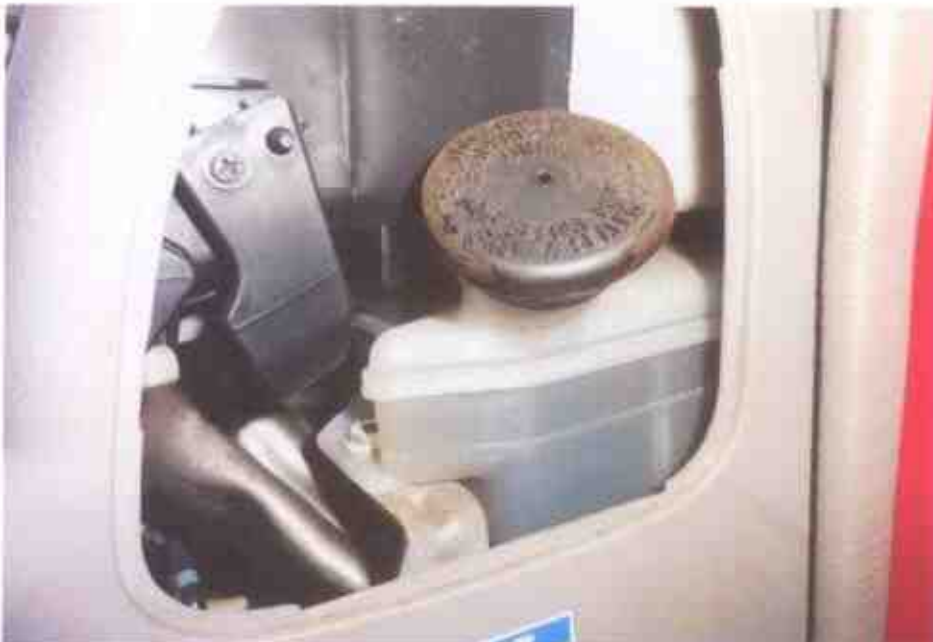
Photo 12 shows the brake fluid reservoir of the Motor Lorry at the time of our inspection. The brake fluid was observed to be of sufficient level and without any visible contamination.

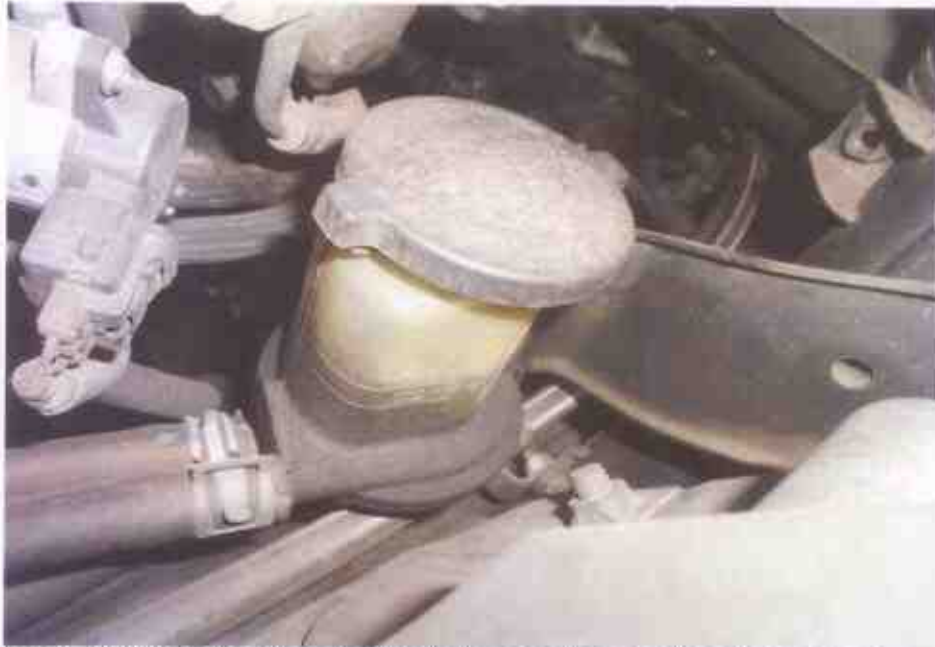
Photo 13 shows the power steering fluid reservoir of the Motor Lorry at the time of our inspection. The power steering fluid was observed to be of sufficient level and without any visible contamination.

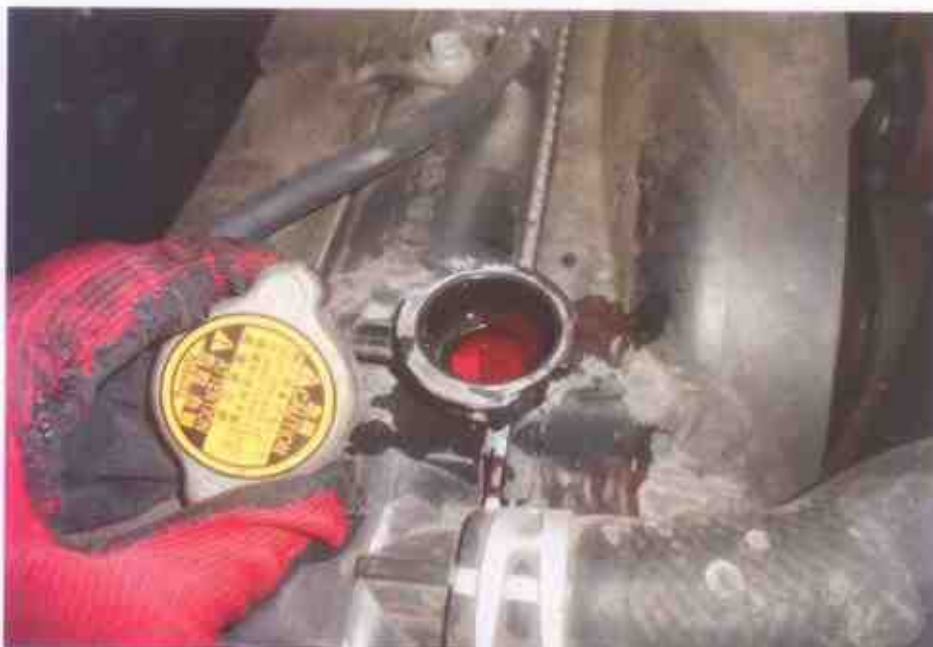
Photo 14 shows the engine coolant reservoir of the Motor Lorry at the time of our inspection. The engine coolant was observed to be of sufficient level and without any visible contamination.

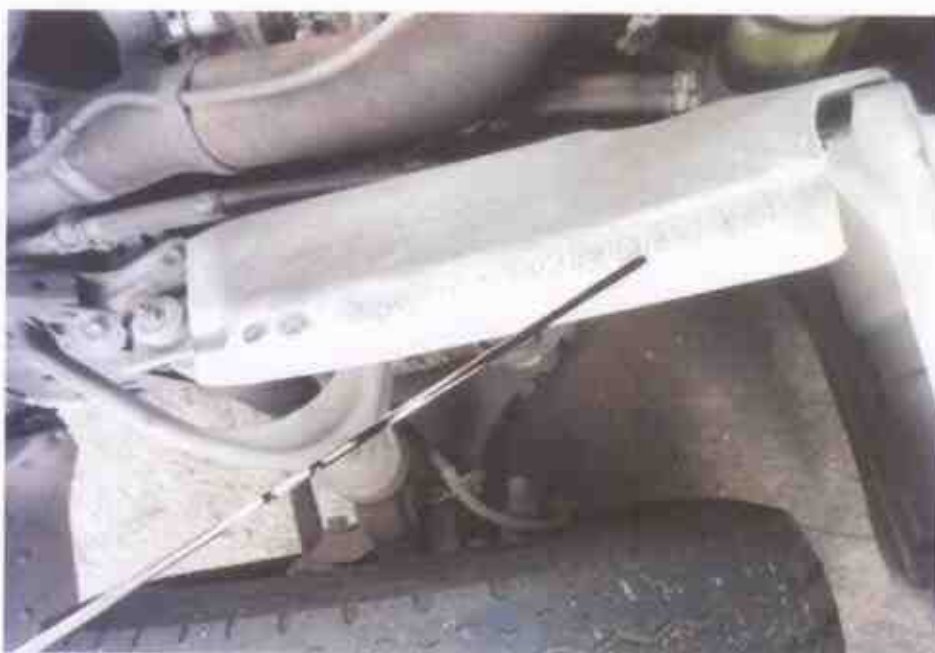
Photo 15 shows the engine dip stick of the Motor Lorry at the time of our inspection. The engine oil was observed to be of sufficient level and without any visible contamination.

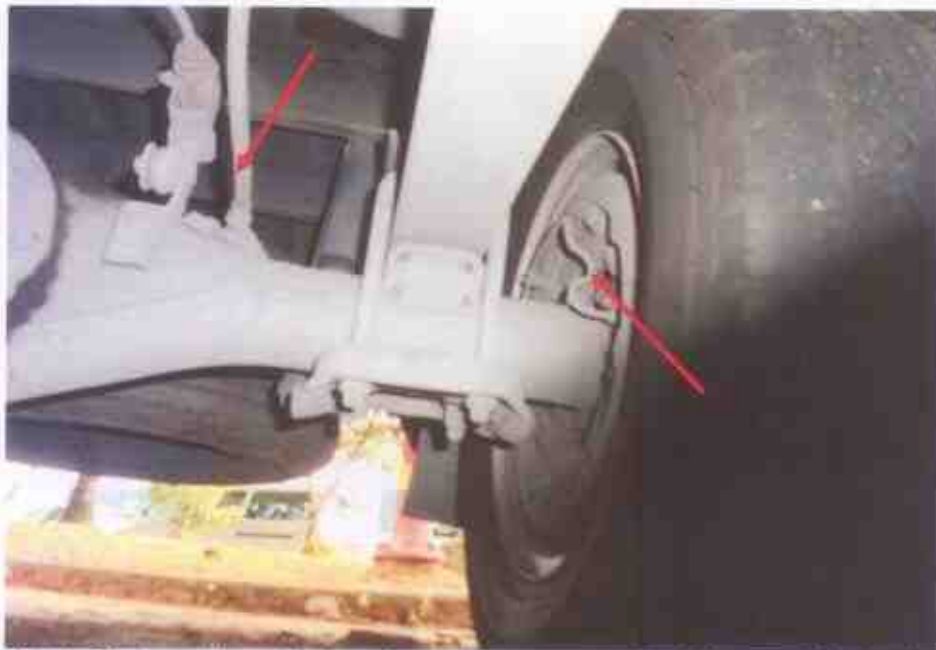
Photo 16 shows the various undercarriage components at the rear left wheel of the Motor Lorry, in particular the brake hose (arrowed). We did not observe any leakage of brake fluid at the time of our inspection of the Motor Lorry.

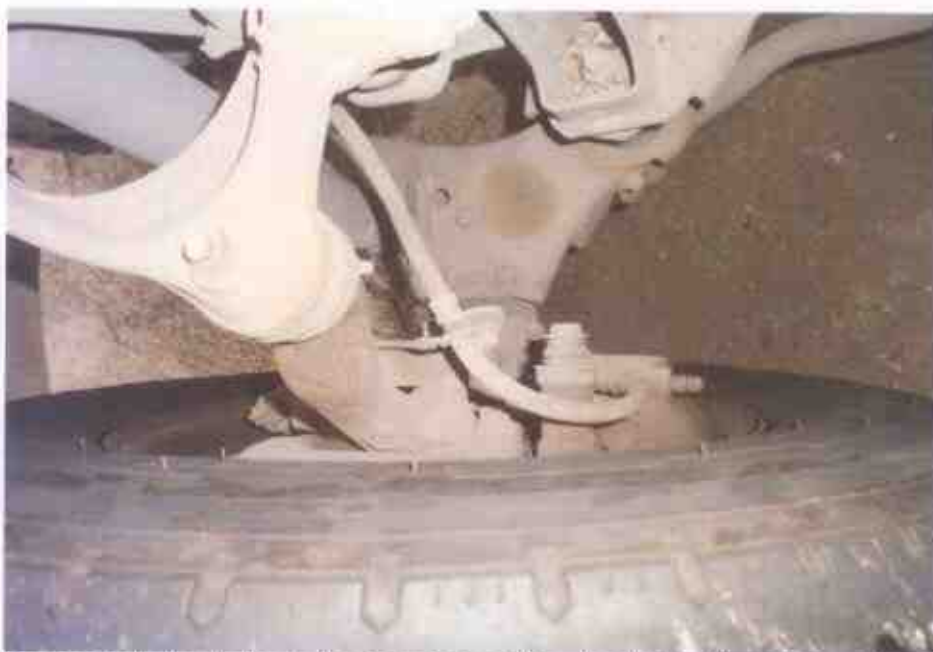
Photo 17 shows the brake hose at the front left wheel of the Motor Lorry. We did not observe any leakage of brake fluid. Our visual inspection of the various mechanical components of the Motor Lorry's braking system revealed all to be intact and without visible damage, indicating that the braking system was likely to be in serviceable condition at the material time of accident.

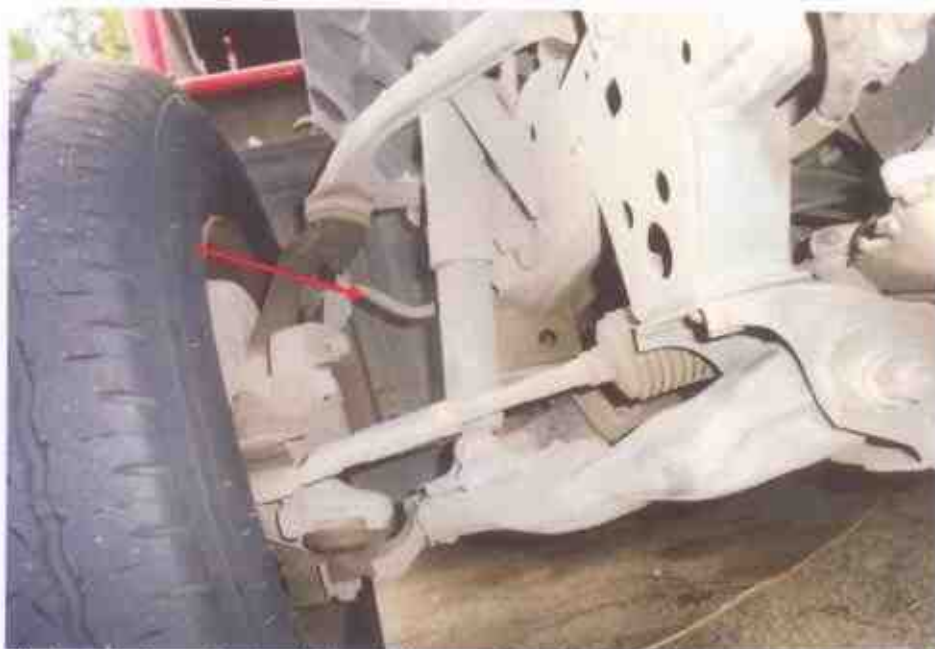
Photo 18 shows the brake hose (arrowed) at the front right wheel of the Motor Lorry. We did not observed any leakage of brake fluid at the time of our inspection of the Motor Lorry. Our visual inspection of the various mechanical components of the Motor Lorry's braking system, including its brake calliper, revealed all to be intact and without visible damage.

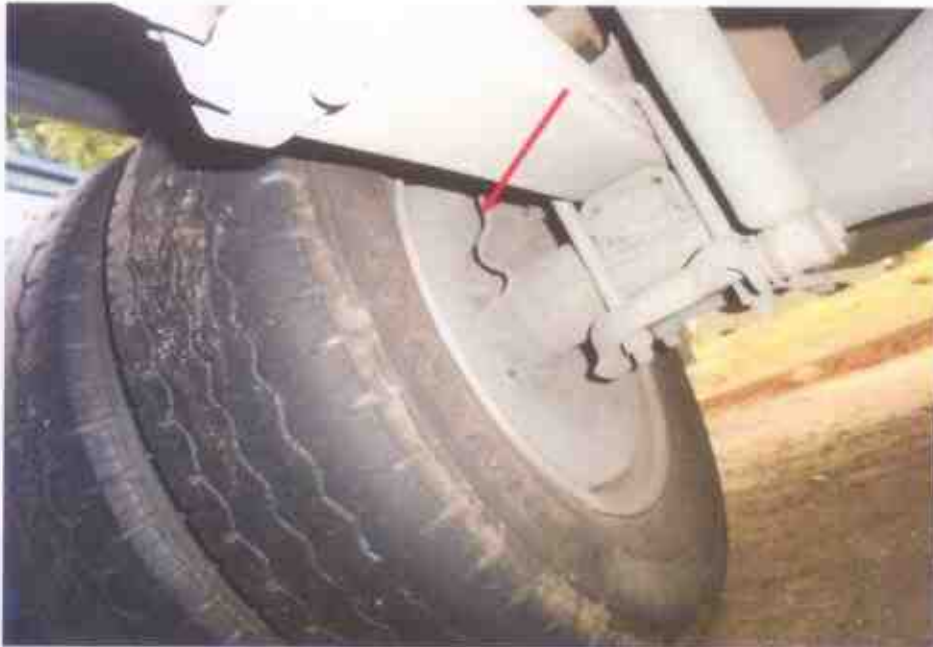
Photo 19 shows the various undercarriage components at the rear right wheel of the Motor Lorry. The various steering components were all found to be intact, suggesting that the steering system of the Motor Lorry was likely to be in serviceable condition at the material time of accident.
